# NATIONAL TRANSPORTATION SAFETY BOARD

## MATERIALS LABORATORY FACTUAL REPORT

Report No. 20-044

Place : Penobscot, ME  
Date : November 16, 2019  
Vehicle : Agusta A109E, N901EM  
NTSB No. : ENG20IA005  
Investigator : Chich Shin (AS-40)

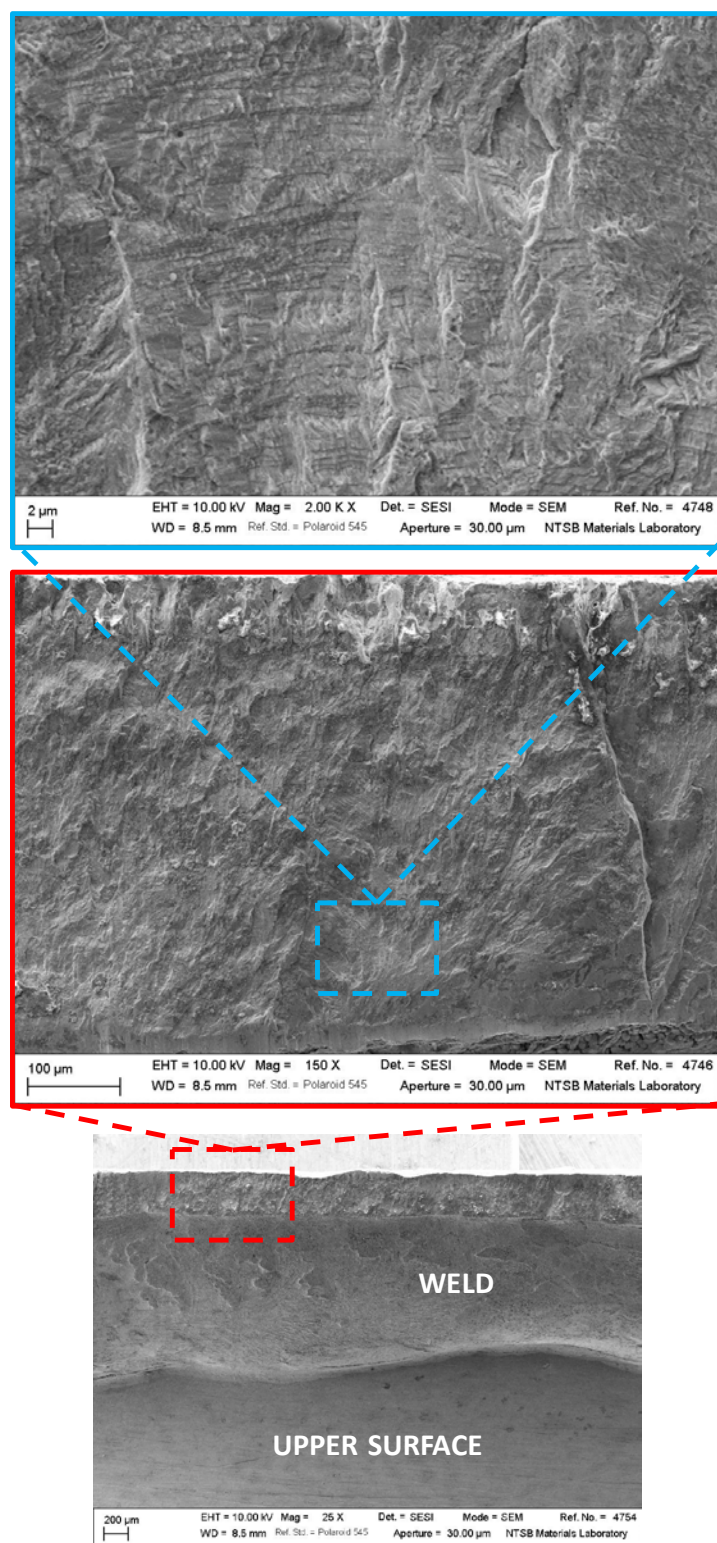
The sectioned pieces of tip cap were examined using a Zeiss Auriga 40 field emission (FE) scanning electron microscope (SEM). SEM images of the L265 tip cap are shown in Figures 13-15 and the L251 tip cap are shown in Figure 16. The fracture surfaces on both tip caps had micro features consistent with multiple initiation fatigue cracking. Fatigue striations were also observed on the fracture surfaces that were emanating from the internal edge of the tip cap lower surface. A few thumbnail-shaped fatigue patterns were observed emanating from the external edge of the lower surface, likely secondary activation that occurred as the fatigue cracking from the internal edge progressed through the cross-section of the lower surface.

Figure 16: SE SEM images of the fracture surface on the L251 tip cap. Fatigue striations were observed emanating from the internal edge of the lower surface at the toe of the weld.

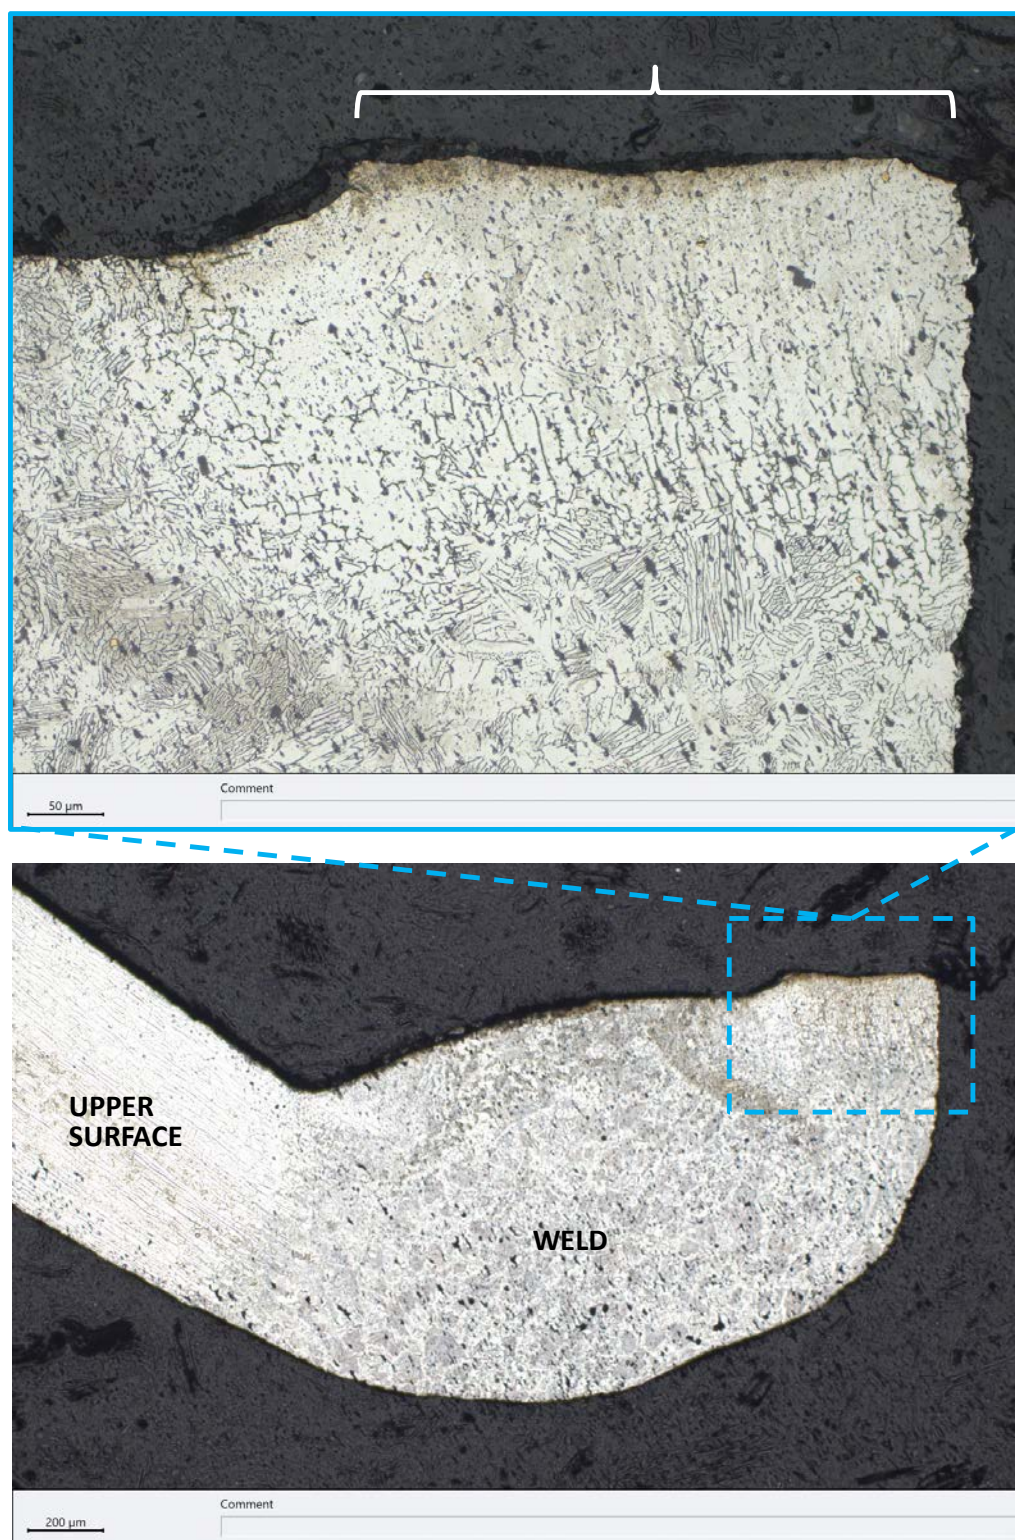
A cross-section was prepared through the L265 tip cap at Location B. Figure 17 shows there was a flat fracture surface through the lower surface at the toe of the weld. No defects were observed within the weld and the weld appeared to be of good quality. The base metal of the upper surface was consistent with wrought type 321 stainless steel strip.

Figure 17: Bright field micrographs of the cross-section prepared through the L265 tip cap at Location B. The white bracket indicates the fracture surface on the lower surface.  
(Etch: Kalling's Reagent)
