# NATIONAL TRANSPORTATION SAFETY BOARD

## MATERIALS LABORATORY FACTUAL REPORT

Report No. 22-040

Place : Sacramento, CA  
Date : February 15, 2020  
Vehicle : Airbus A319-132, N521NK  
NTSB No. : ENG20LA016  
Investigator : Michael Hauf (AS-10)

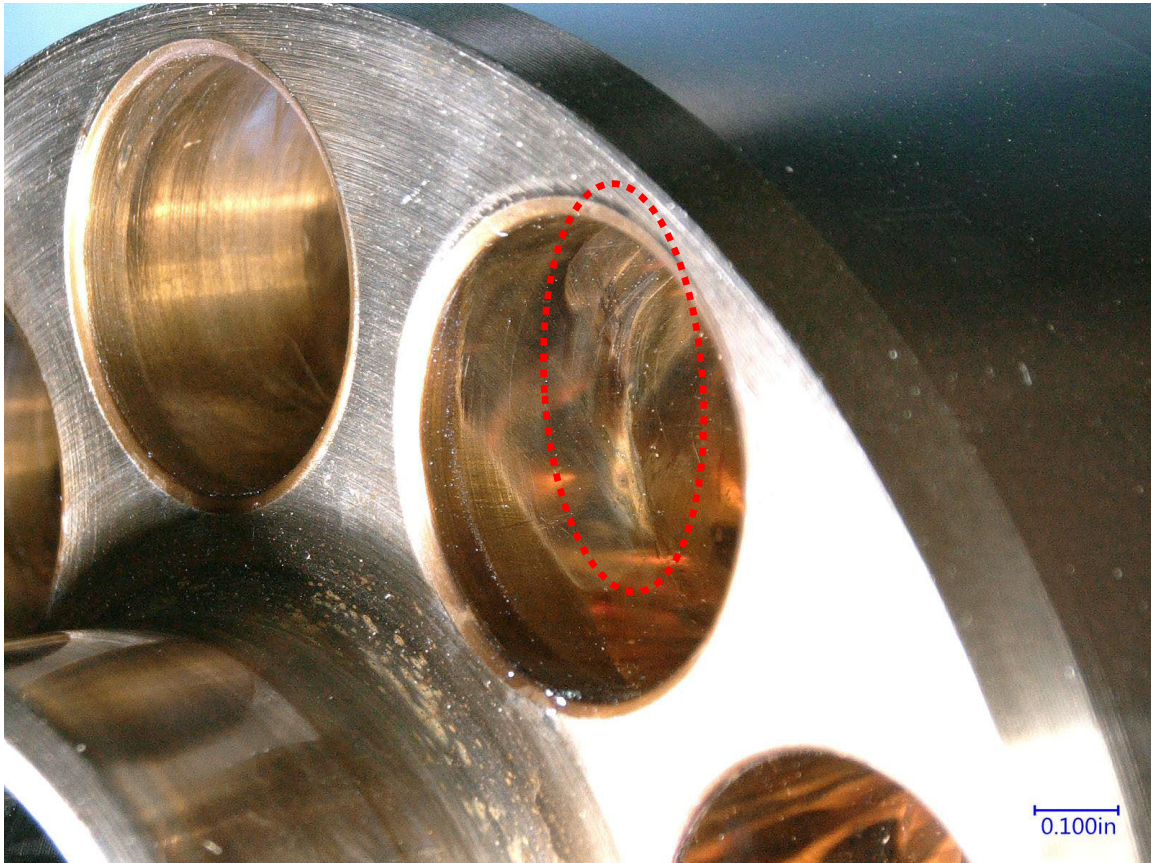
Wear was observed in the gold-colored liners assembled inside the bores of the fixed cylinder block. The wear was uneven around the circumference and occurred close to either end of the bores, with the heaviest wear extending up from the bottom of the bores. The gold-colored liners were worn through in some areas in several bores, and silver-colored base metal was visible (encircled by red dotted lines in Figures 3–5). Areas on bores 3, 5, and 6 were missing segments of gold-colored liner; the areas with missing liner ranged in size from very small to almost half the liner length.

Figure 3: Digital microscope image showing bore 2 in fixed cylinder block S/N Y10-245-19. The red dotted line encircles wear on the gold-colored liner and silver-colored base metal visible underneath.

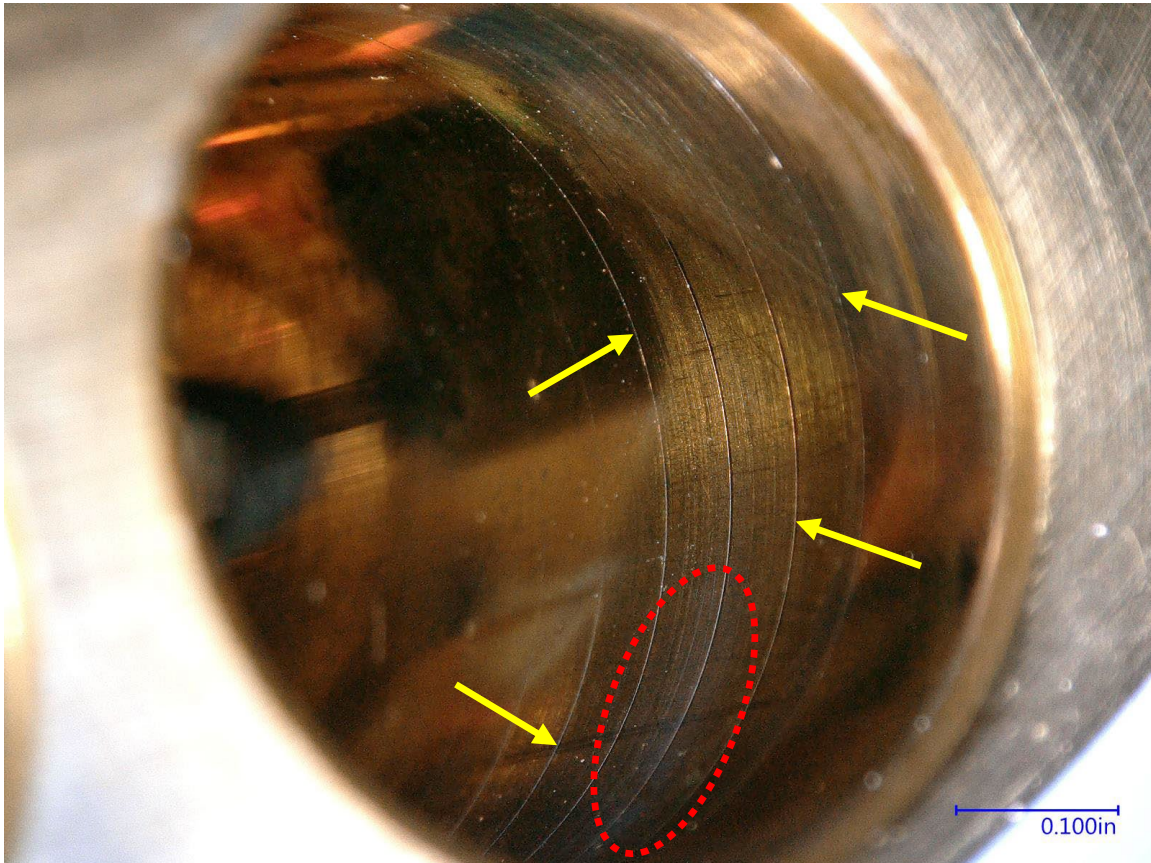
In areas where the gold-colored liner was beginning to wear through, thin circumferential rings became visible (yellow arrows, Figure 4). In areas where the gold-colored liner was missing, thicker circumferential rings consistent with machining were visible (yellow arrows, Figure 5). Piece of gold-colored debris was present in the bottom of at least one of the bores (Figure 6).

Figure 4: Digital microscope image showing bore 1 in fixed cylinder block S/N Y10-245-19. The red dotted line encircles wear on the gold-colored liner and silver-colored base metal visible underneath. The yellow arrows point to circumferential rings visible under the liner.

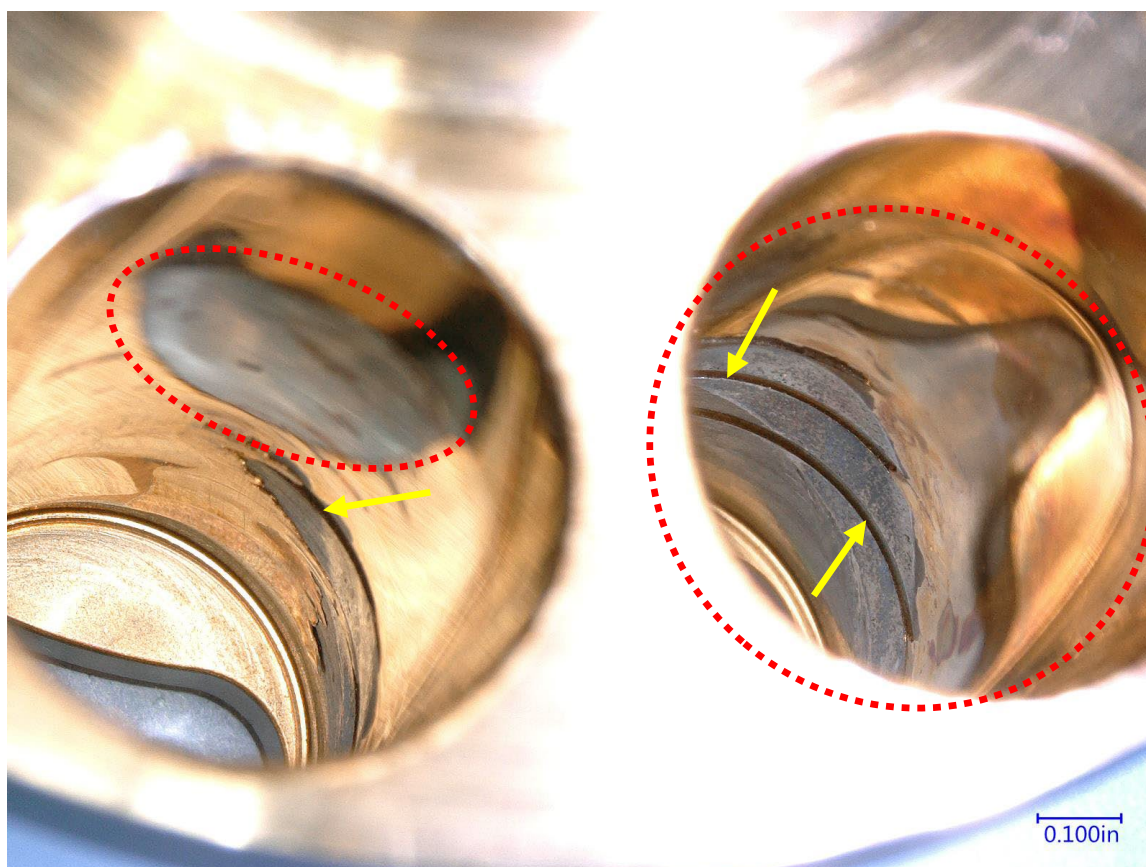
Figure 5: Digital microscope image showing bores 5 (left) and 6 (right) in fixed cylinder block S/N Y10-245-19. The red dotted lines encircle wear on the gold-colored liners and silver-colored base metal visible underneath. The yellow arrows point to machined circumferential rings visible in the base metal under the liner.

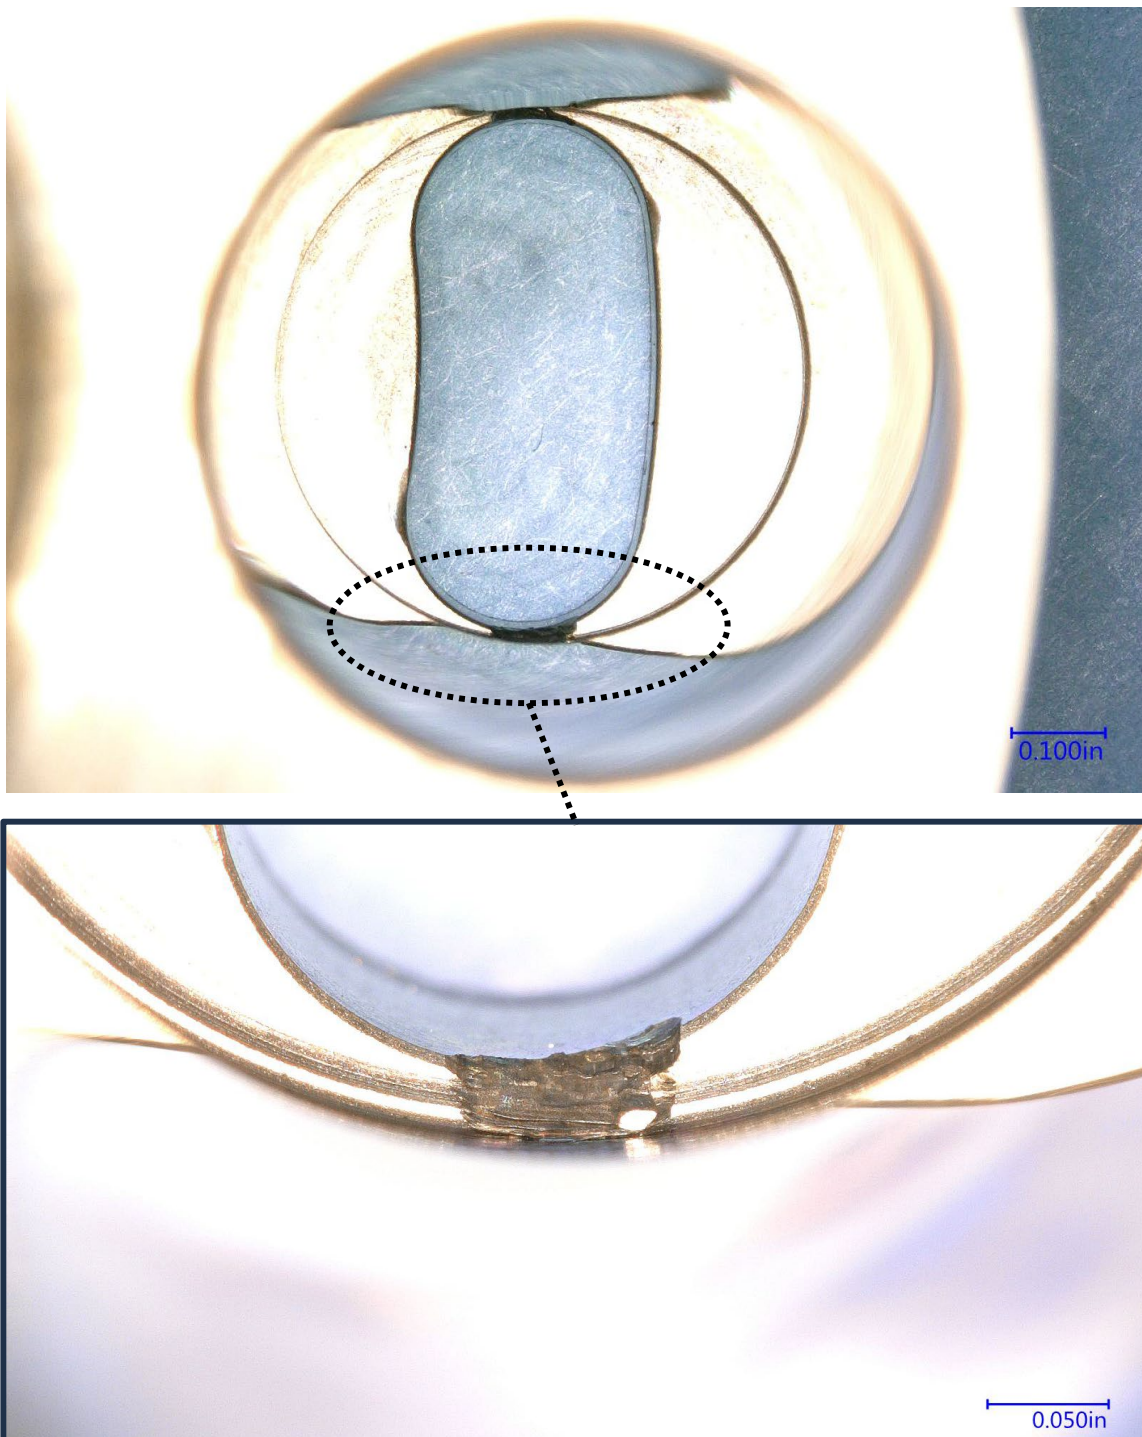
Figure 6: Digital microscope images showing a piece of gold-colored debris in the bottom of bore 9 in fixed cylinder block S/N Y10-245-19.

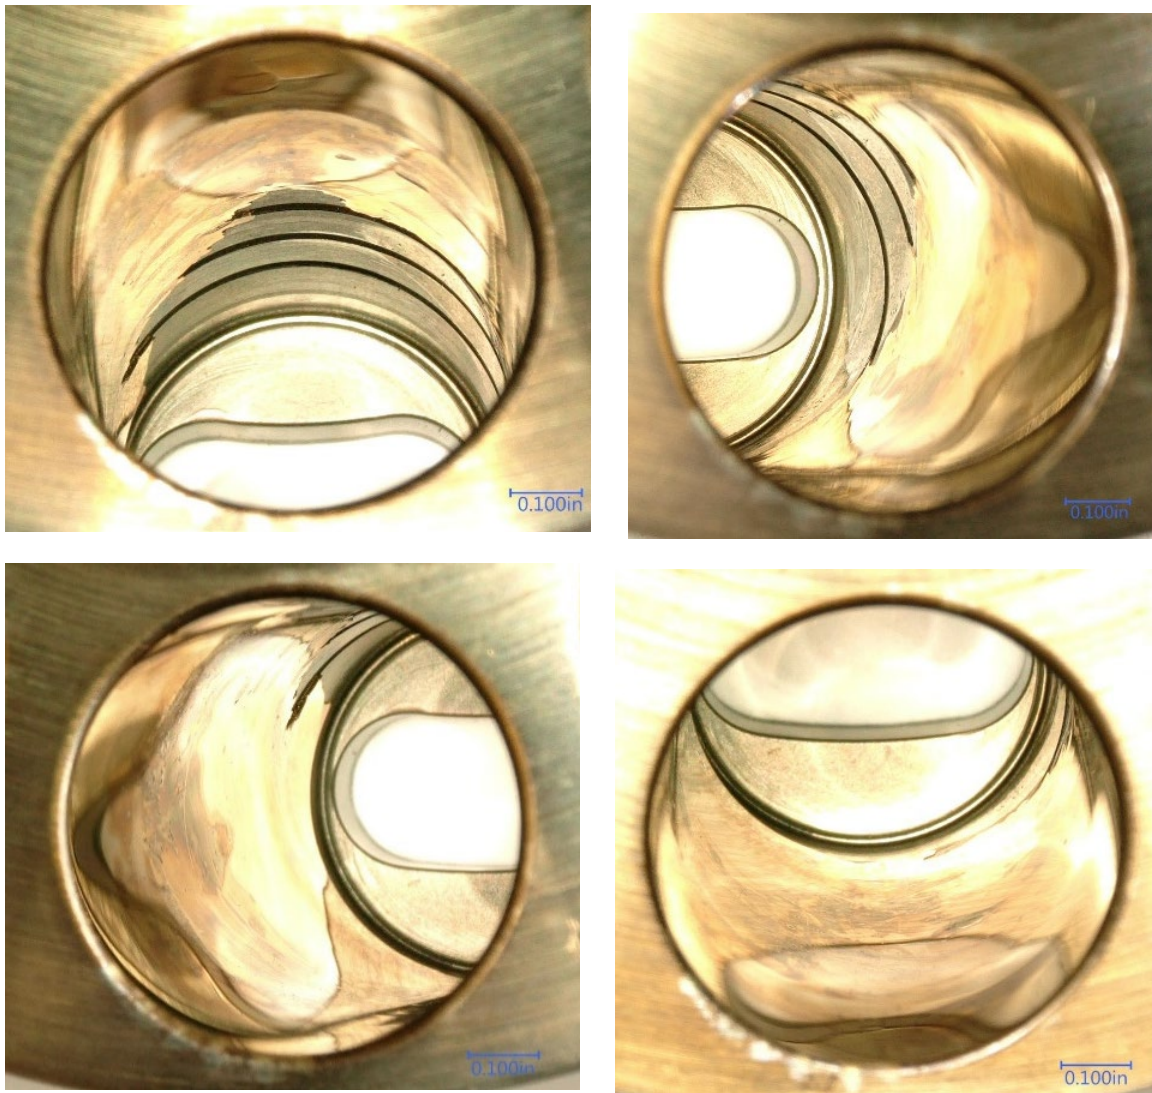
Bore 5 was one with the heaviest wear, as shown in Figure 7. The liner was removed from the bore by chiseling an axial line through its length. The bore with the liner removed is shown in Figure 8. Seven parallel circumferential grooves were revealed on the bore inner diameter (ID) once the sleeve was removed. The grooves were evenly spaced along the bore length and were consistent with a machining operation. There was a substance adhering to the ID surface of the bore between the machined grooves (yellow arrows, Figure 9).

Figure 7: Digital microscope images showing around the entire circumference of bore 5 in fixed cylinder block S/N Y10-245-19.

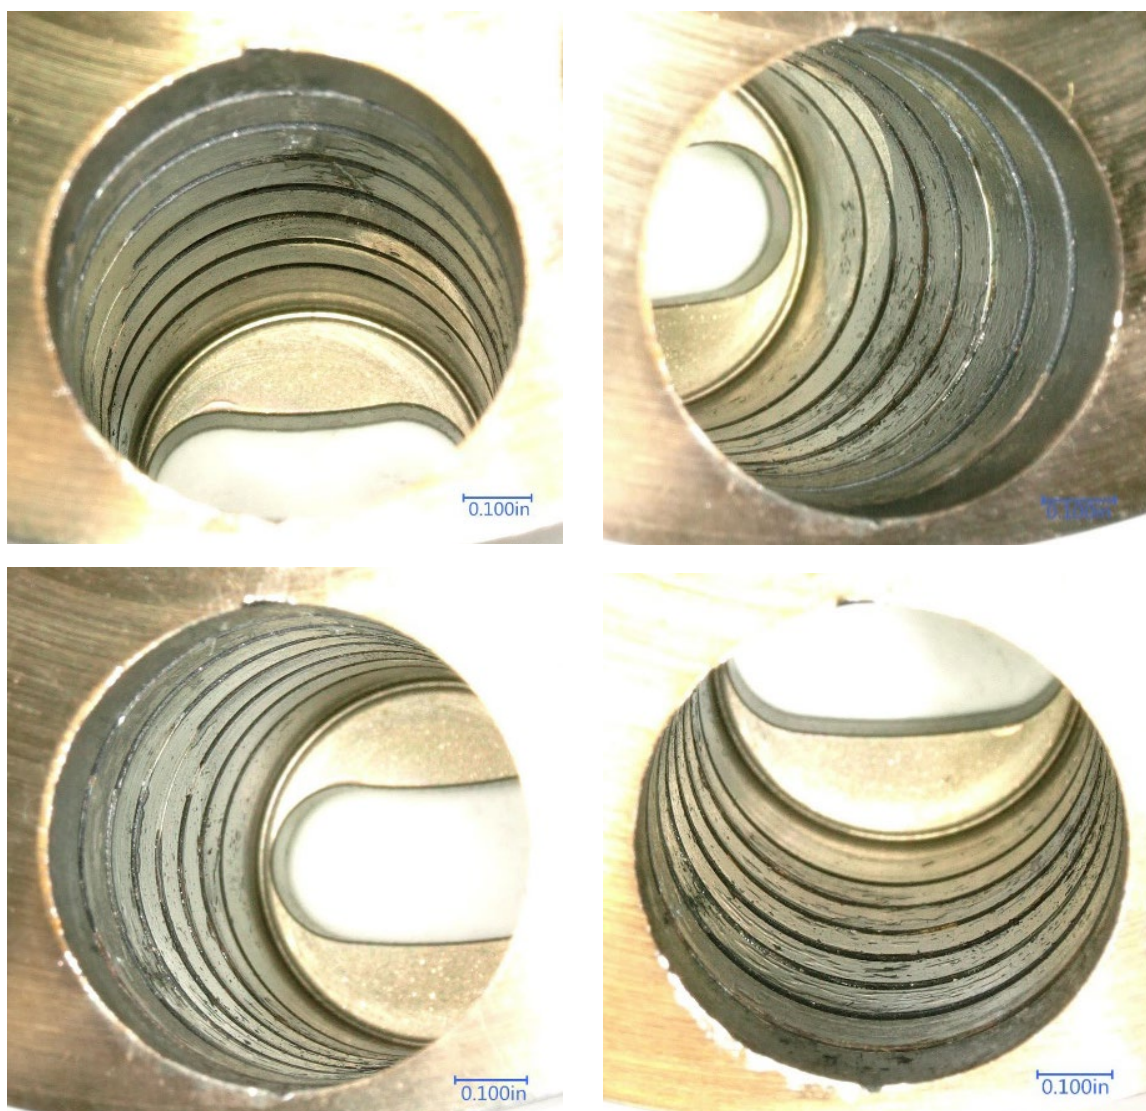
Figure 8: Digital microscope images showing around the entire circumference of bore 5 in fixed cylinder block S/N Y10-245-19 after the gold-colored liner had been removed.

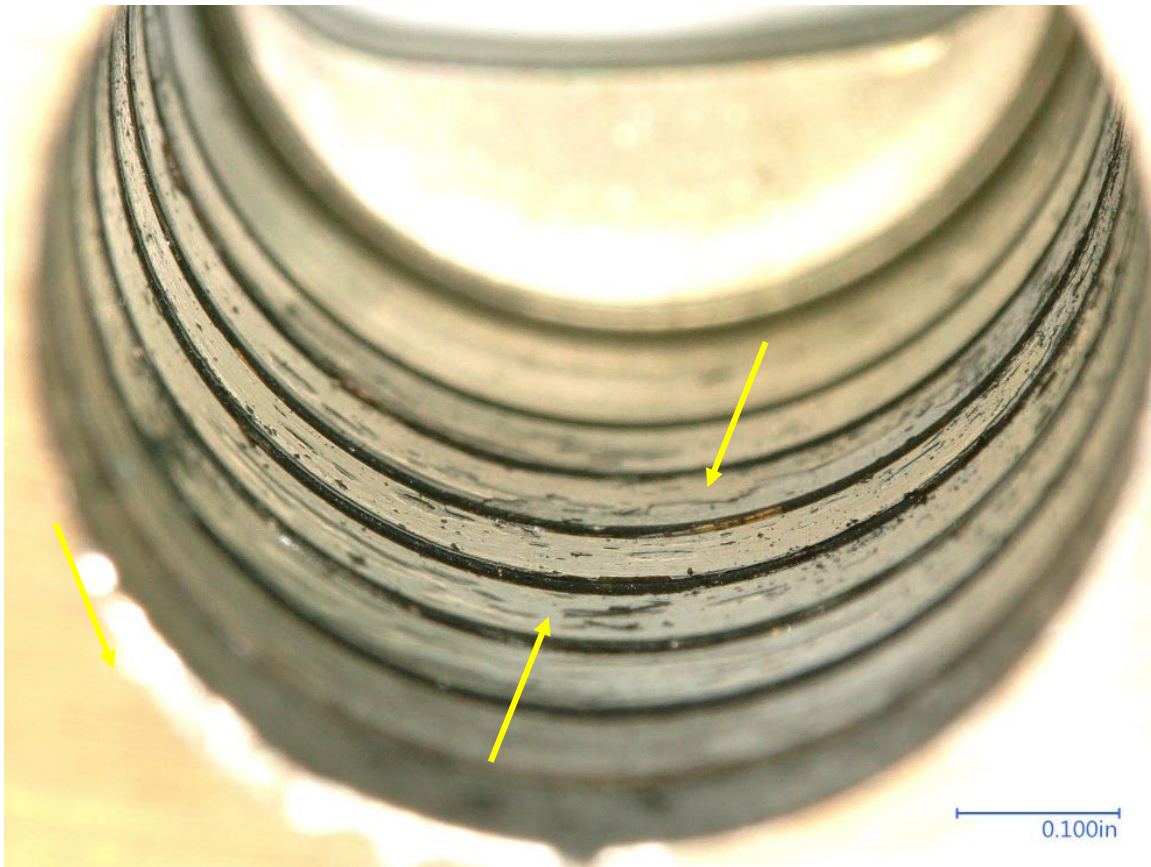
Figure 9: Digital microscope image showing a substance (yellow arrows) adhering to the ID surface of bore 5 in fixed cylinder block S/N Y10-245-19 after the gold-colored liner had been removed.

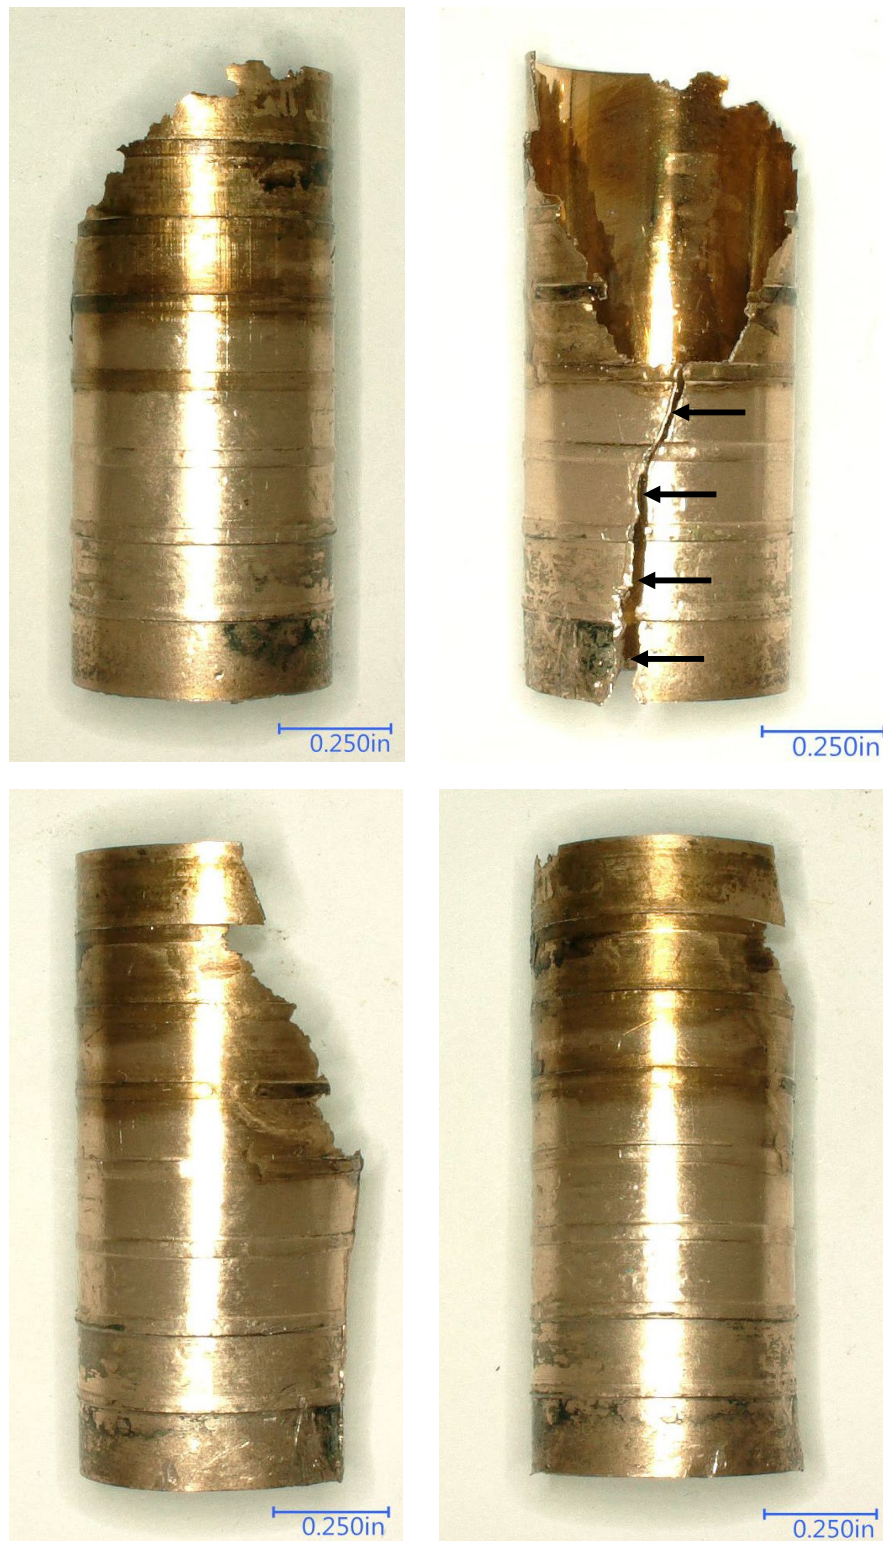
The removed liner is shown in Figures 10–12. The chiseled axial line created in the lab to facilitate liner removal is indicated by the black arrows in Figure 10. A segment of liner around about half the circumference and extending approximately 0.5 inches up from the bottom of the bore was missing. Seven raised rings of material were observed in parallel lines around the OD circumference of the liner; the rings likely mated with the machined grooves in the ID of the block bore. The edges of the liner adjacent to the missing portion are shown in Figure 11. One edge (green dashed line) had thinned down to a knife edge. The other edge (black dashed line) was thicker and had features consistent with the liner separating in pieces.

Figure 10: Digital microscope images showing the entire circumference of the gold-colored liner removed from bore 5 in fixed cylinder block S/N Y10-245-19. The black arrows point to the chiseled axial line that facilitated removal of the liner from the bore.

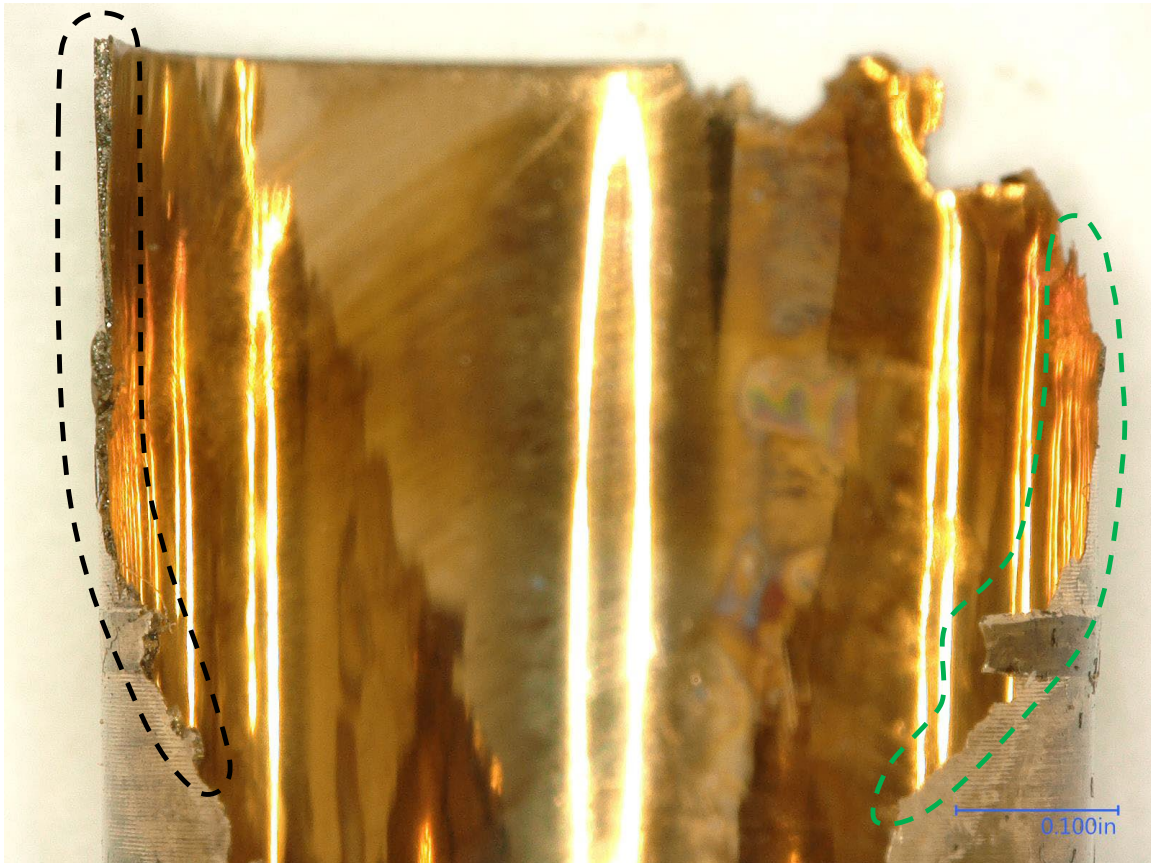
Figure 11: Digital microscope image showing the edges along the missing segment in the liner removed from bore 5 in fixed cylinder block S/N Y10-245-19. One edge (green dashed line) had thinned down to a knife edge. The other edge (black dashed line) was thicker and had features consistent with the liner separating in pieces.

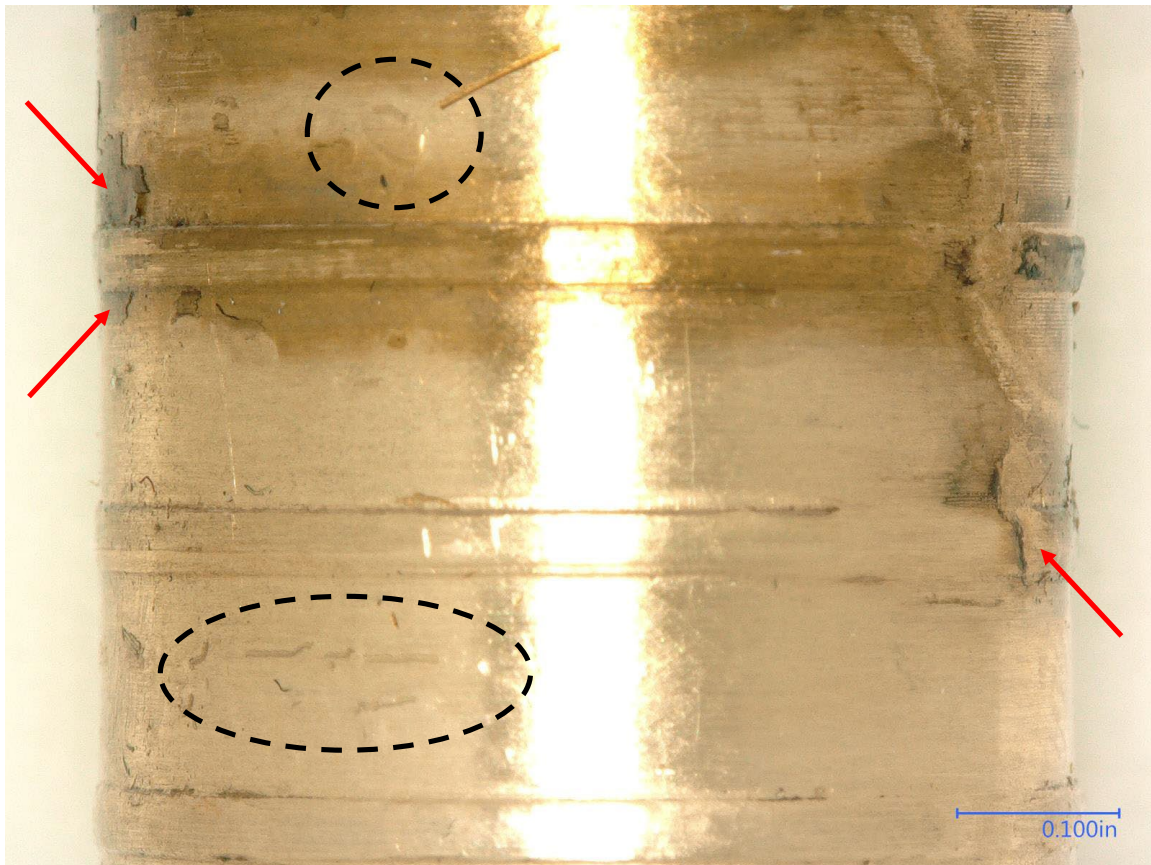
The black dashed lines in Figure 12 encircle dents on the OD of the liner that mated with the ID of the bore. The dents likely resulted from contact with the substance observed on the ID of the bore. Pieces of flattened gold-colored debris were also visible on the OD of the liner (red arrows).

Figure 12: Digital microscope image showing OD surface of the gold-colored liner removed from bore 5 in fixed cylinder block S/N Y10-245-19. The black dashed lines encircle dents. The red arrows point to pieces of flattened gold-colored debris.

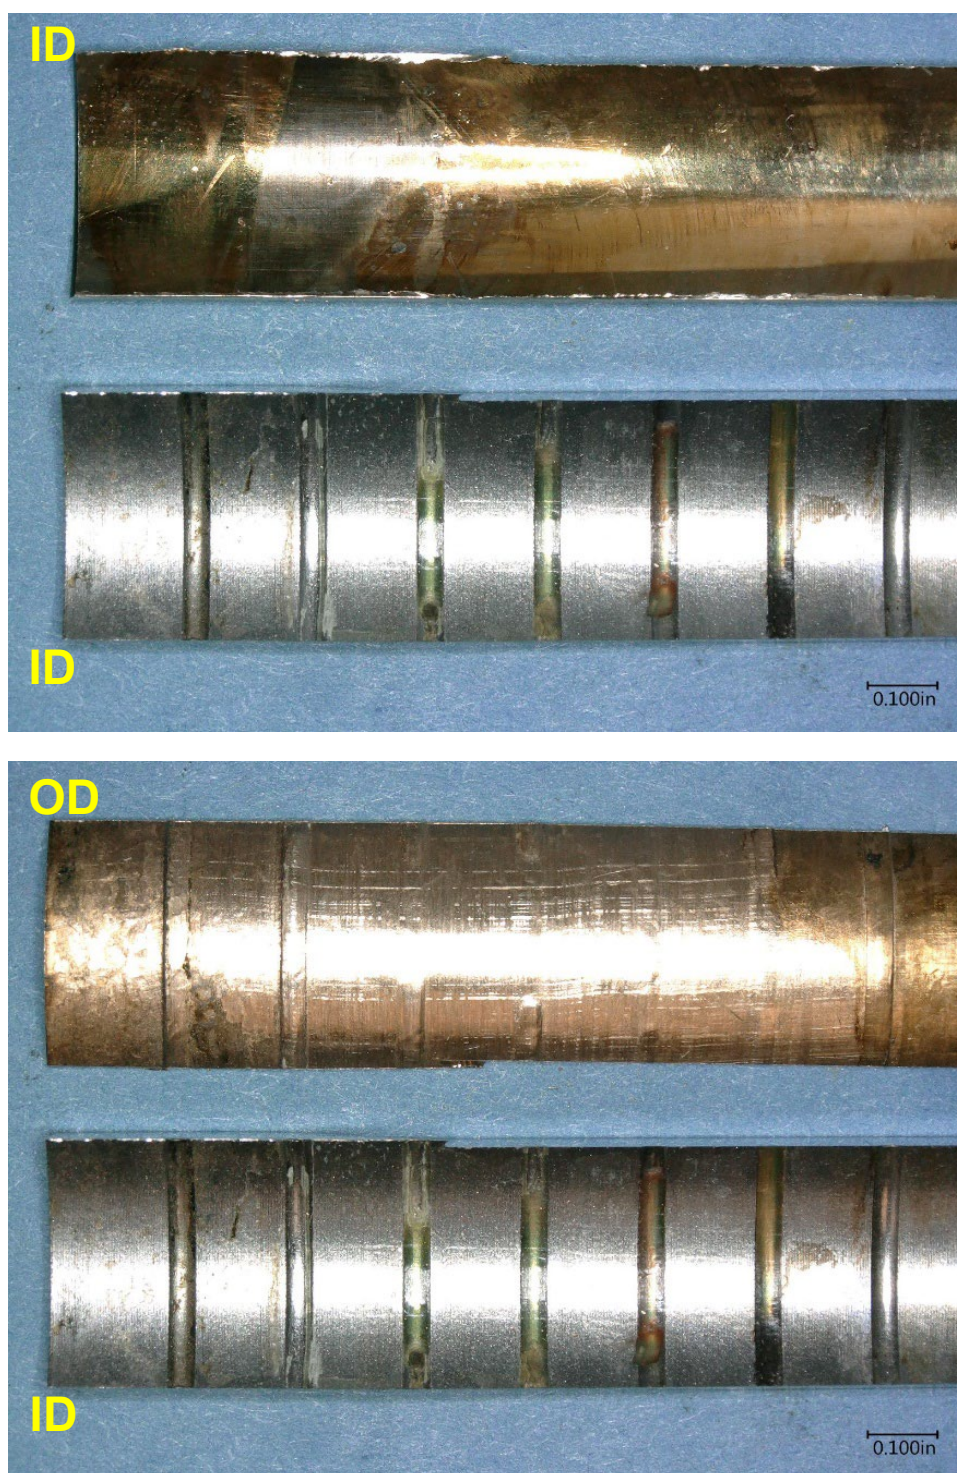
The ID of the block piece and the ID and OD of the liner piece from bore 3 are shown in Figure 14. The sectioned piece of liner was whole and intact. The ID surface of the block piece had a translucent substance on it (indicated by yellow arrows in Figure 15) consistent with the substance observed on the ID surface of bore 5 after the liner was removed. A few sections of the machined rings were entirely filled with the substance (indicated by yellow brackets in Figure 15). The raised rings on the mating OD of the liner had flat sections where the material was flush with the rest of the OD surface that likely mated to the sections of ID grooves in the bore filled with substance. The flat sections on the liner OD piece are encircled by black dashed lines in Figure 16.

Figure 14: Digital microscope images showing the ID of the block piece and the ID and OD of the liner piece sectioned from bore 3 in fixed cylinder block S/N Y10-245-19.

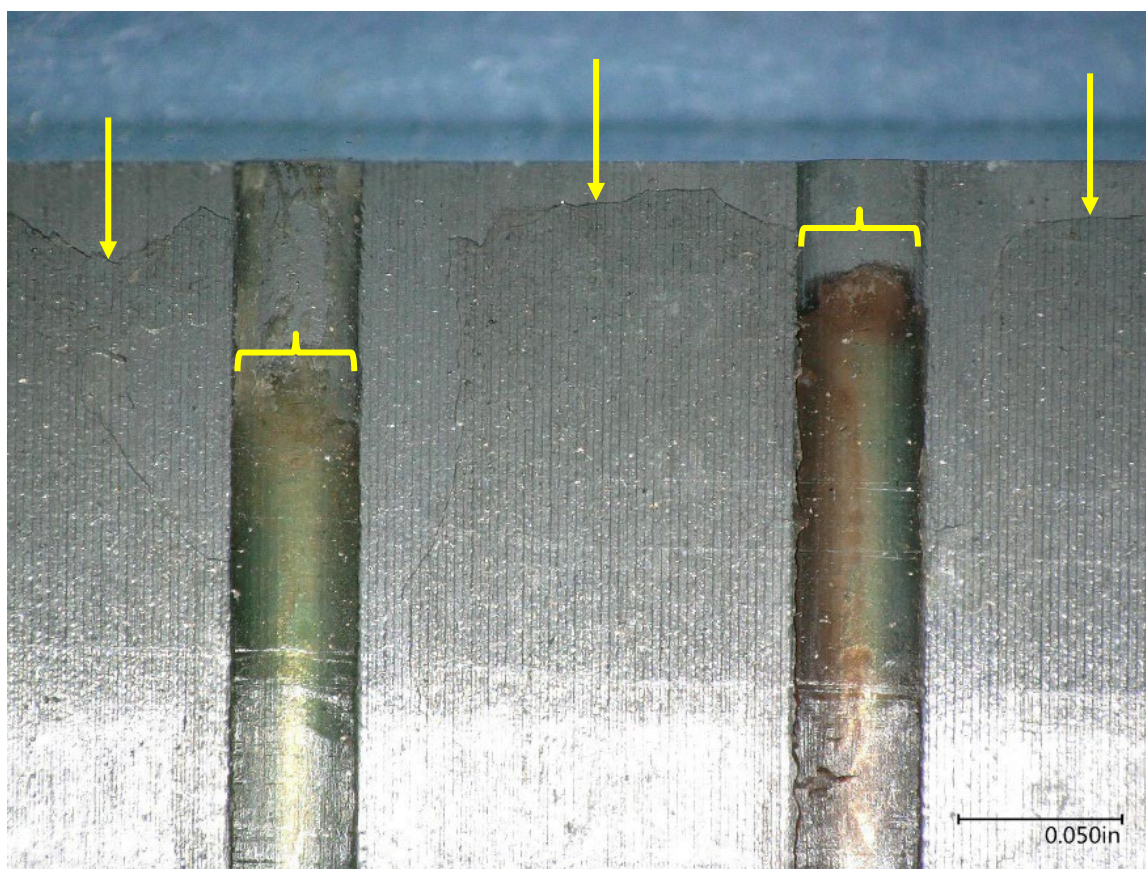
Figure 15: Digital microscope image showing the ID of the block piece sectioned from bore 3 in fixed cylinder block S/N Y10-245-19. The yellow arrows point to a translucent substance adhering to the ID surface of the bore. The yellow brackets indicate the substance also completely filling the machined grooves.

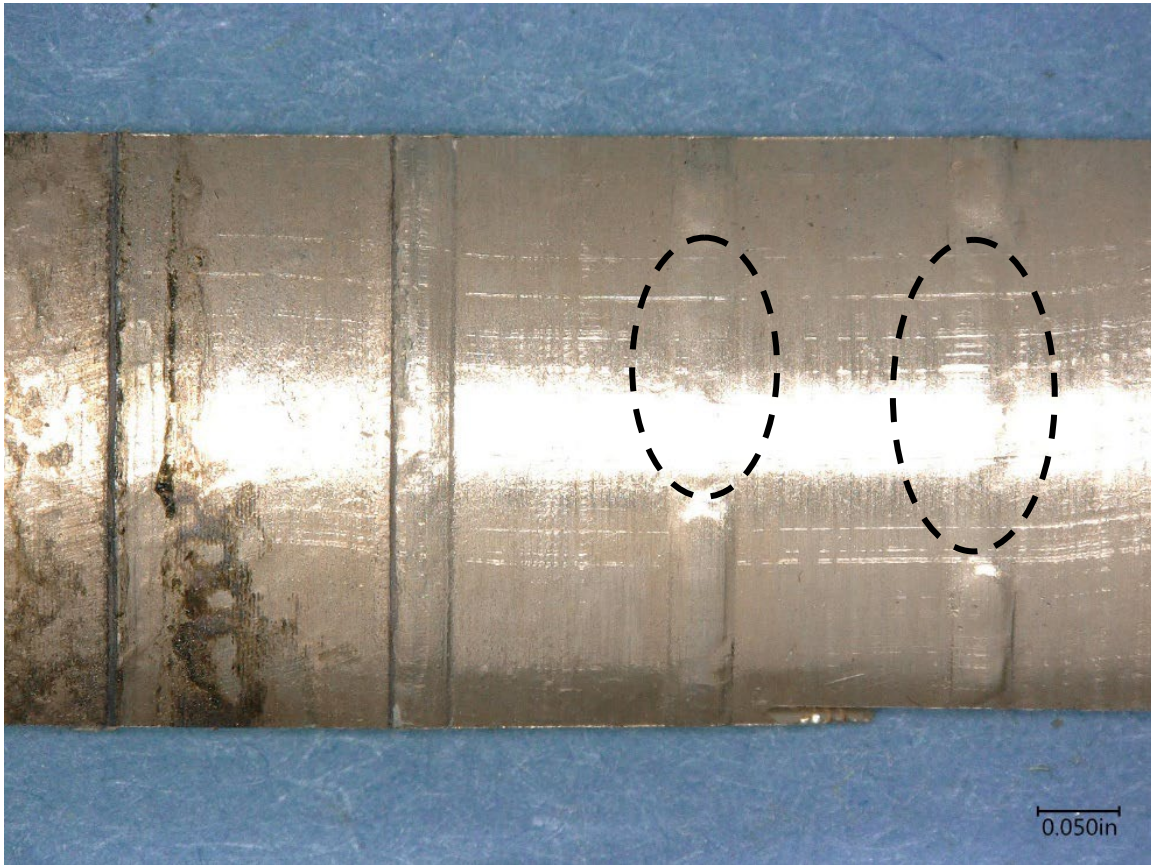
Figure 16: Digital microscope image showing the OD of the liner piece sectioned from bore 3 in fixed cylinder block S/N Y10-245-19. The black dashed lines encircle flat sections that mated with the machined grooves in the block piece filled with substance.

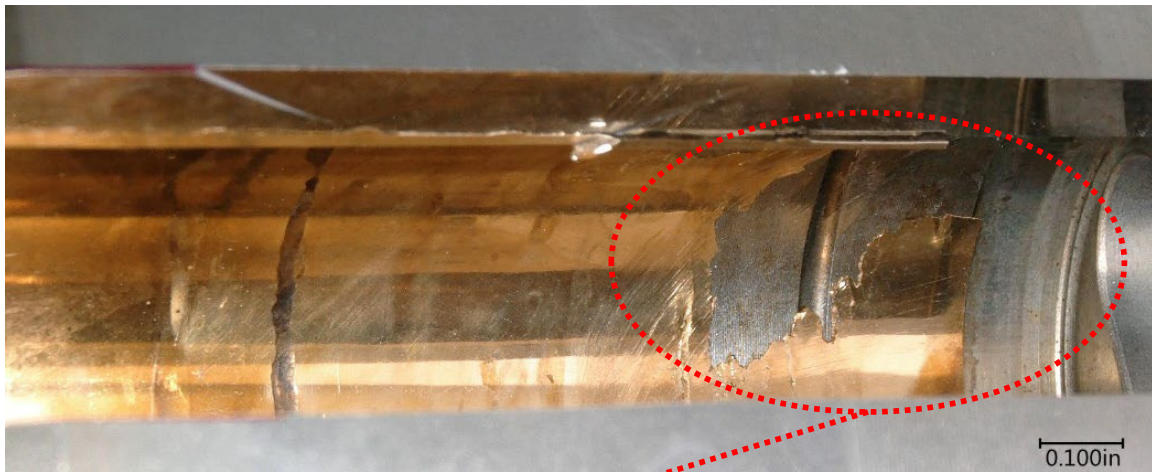
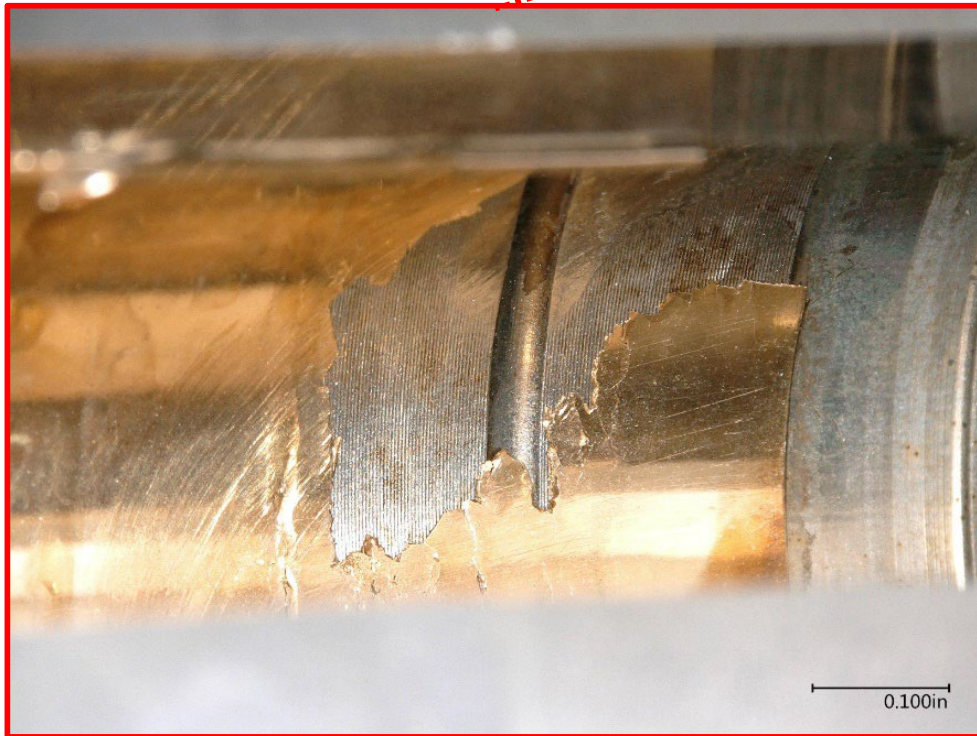
Figure 17: Digital microscope images showing the ID liner still installed inside bore 3 in fixed cylinder block S/N Y10-245-19.

The remaining portion of block with the liner still installed in bore 3 is shown in Figures 17–19. A segment of the liner at the bottom of the bore was missing, as indicated by the red dotted line in Figure 17. The edges of the missing piece were thinned, and a machined groove was visible in the exposed block ID surface. A curved wear pattern was visible on the liner adjacent to the missing portion (black dashed line in Figure 18). Further along the axis from the bottom of the bore there were areas where the liner had begun to wear through the thickness, as indicated by the yellow arrows in Figure 19. The areas aligned circumferentially and likely coincided with machined grooves in the ID of the mating block.

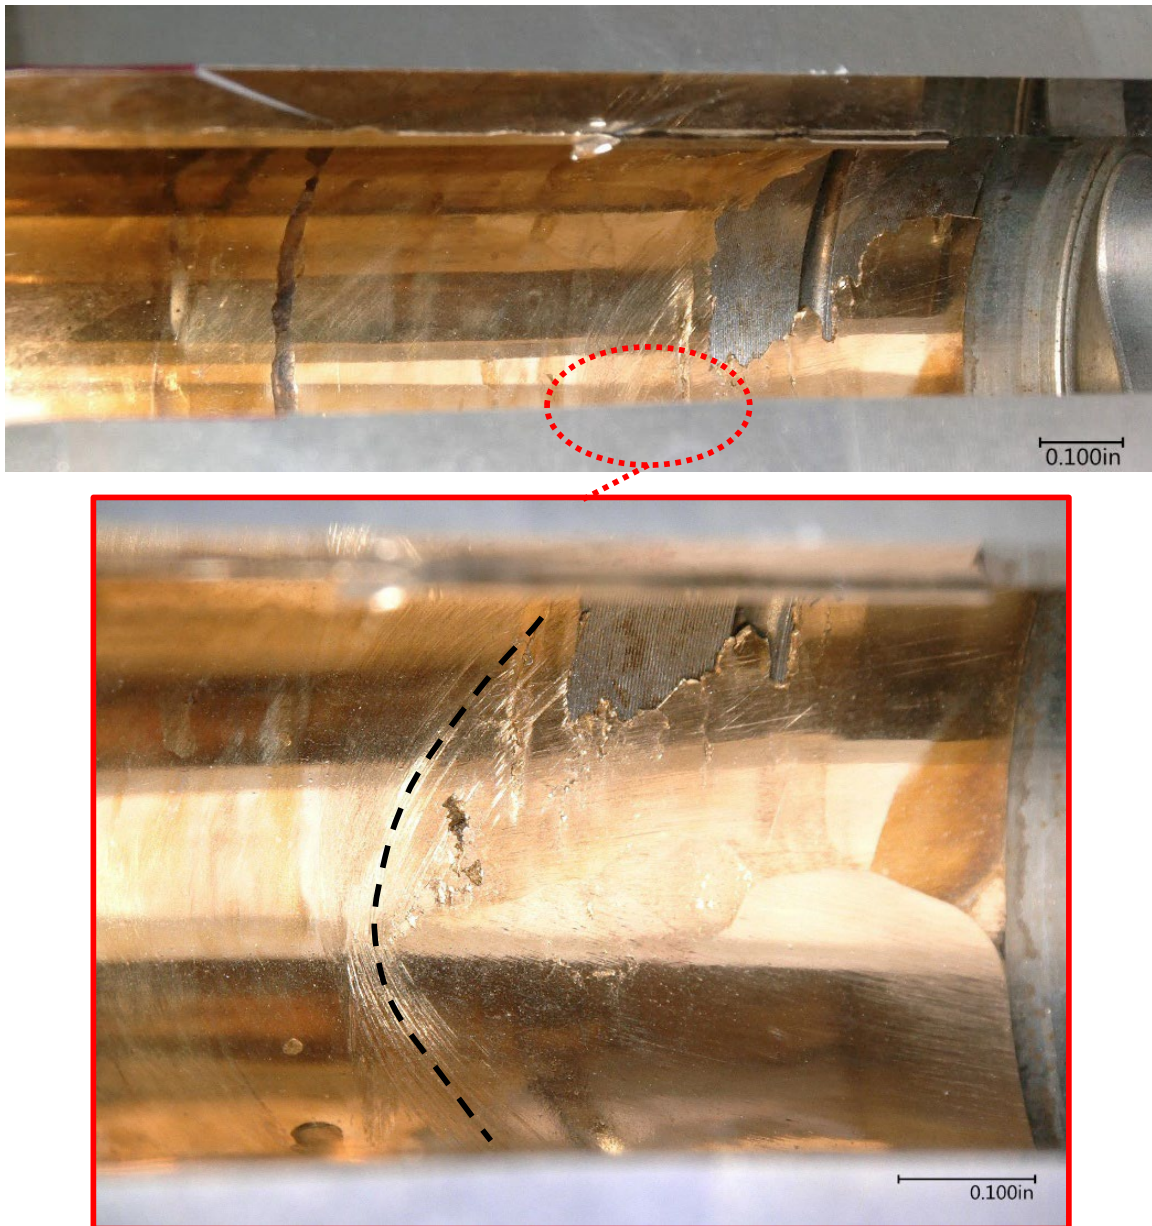
Figure 18: Digital microscope images showing the ID liner still installed inside bore 3 in fixed cylinder block S/N Y10-245-19. The black dashed line highlights a curved wear pattern visible on the liner ID surface.

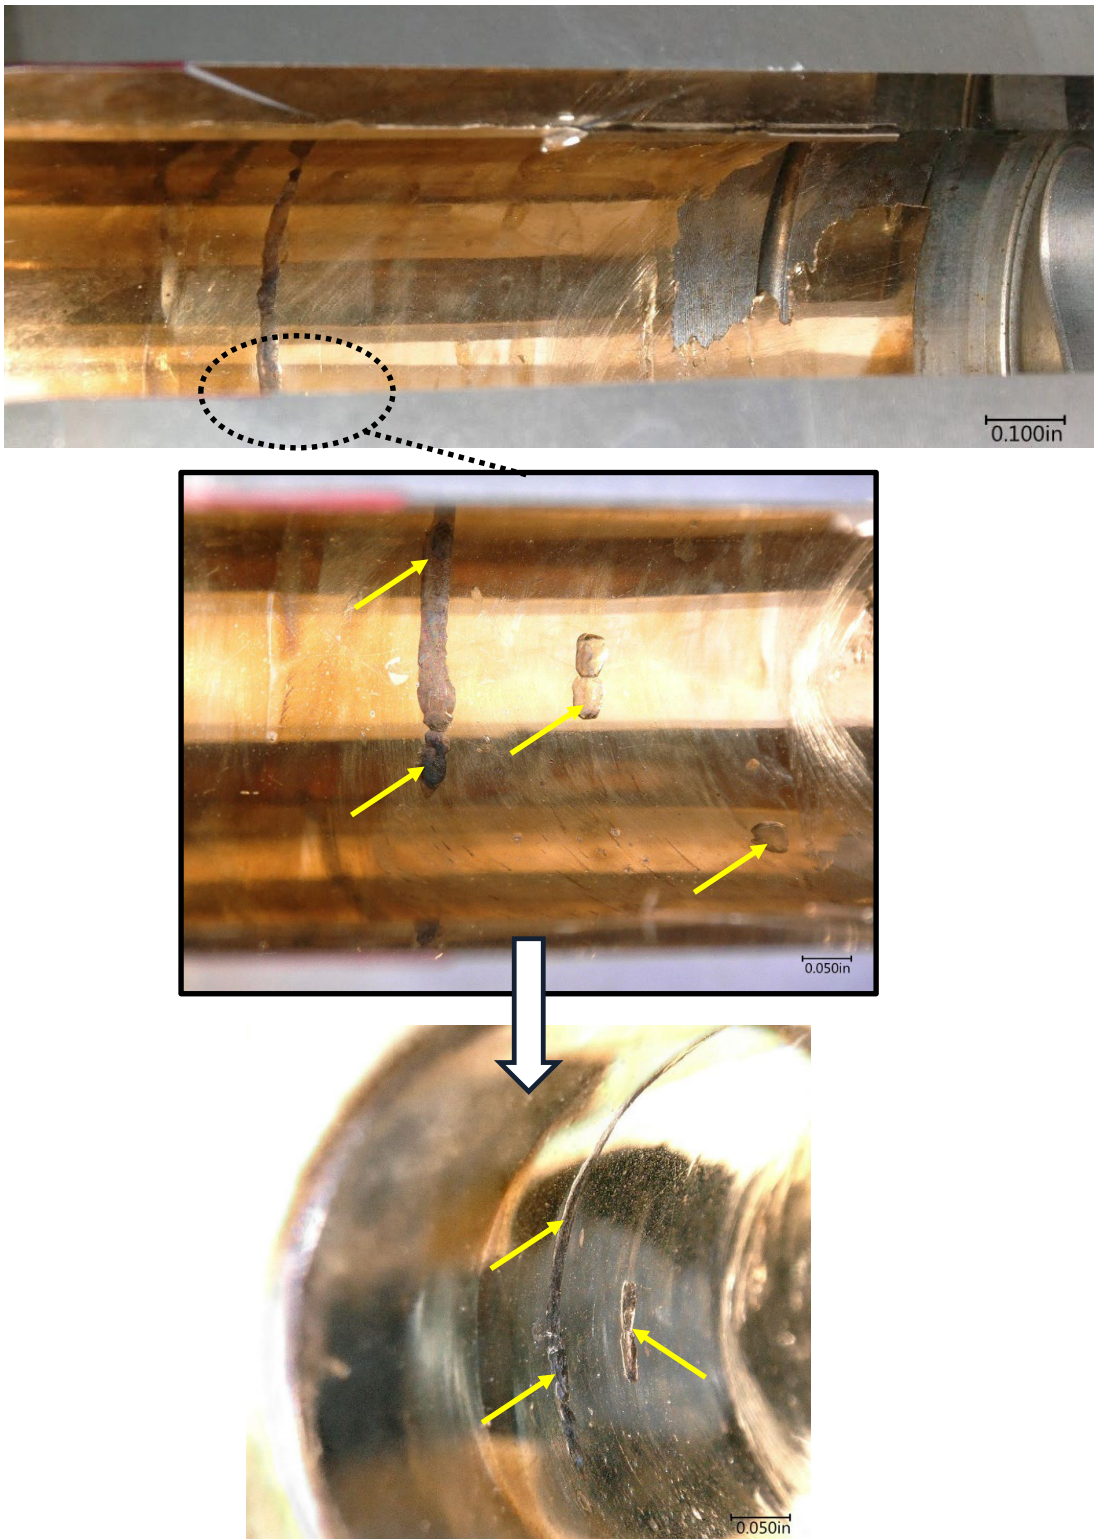
Figure 19: Digital microscope images showing the ID liner still installed inside bore 3 in fixed cylinder block S/N Y10-245-19. The yellow arrows point to areas where the liner had begun to wear through the thickness.

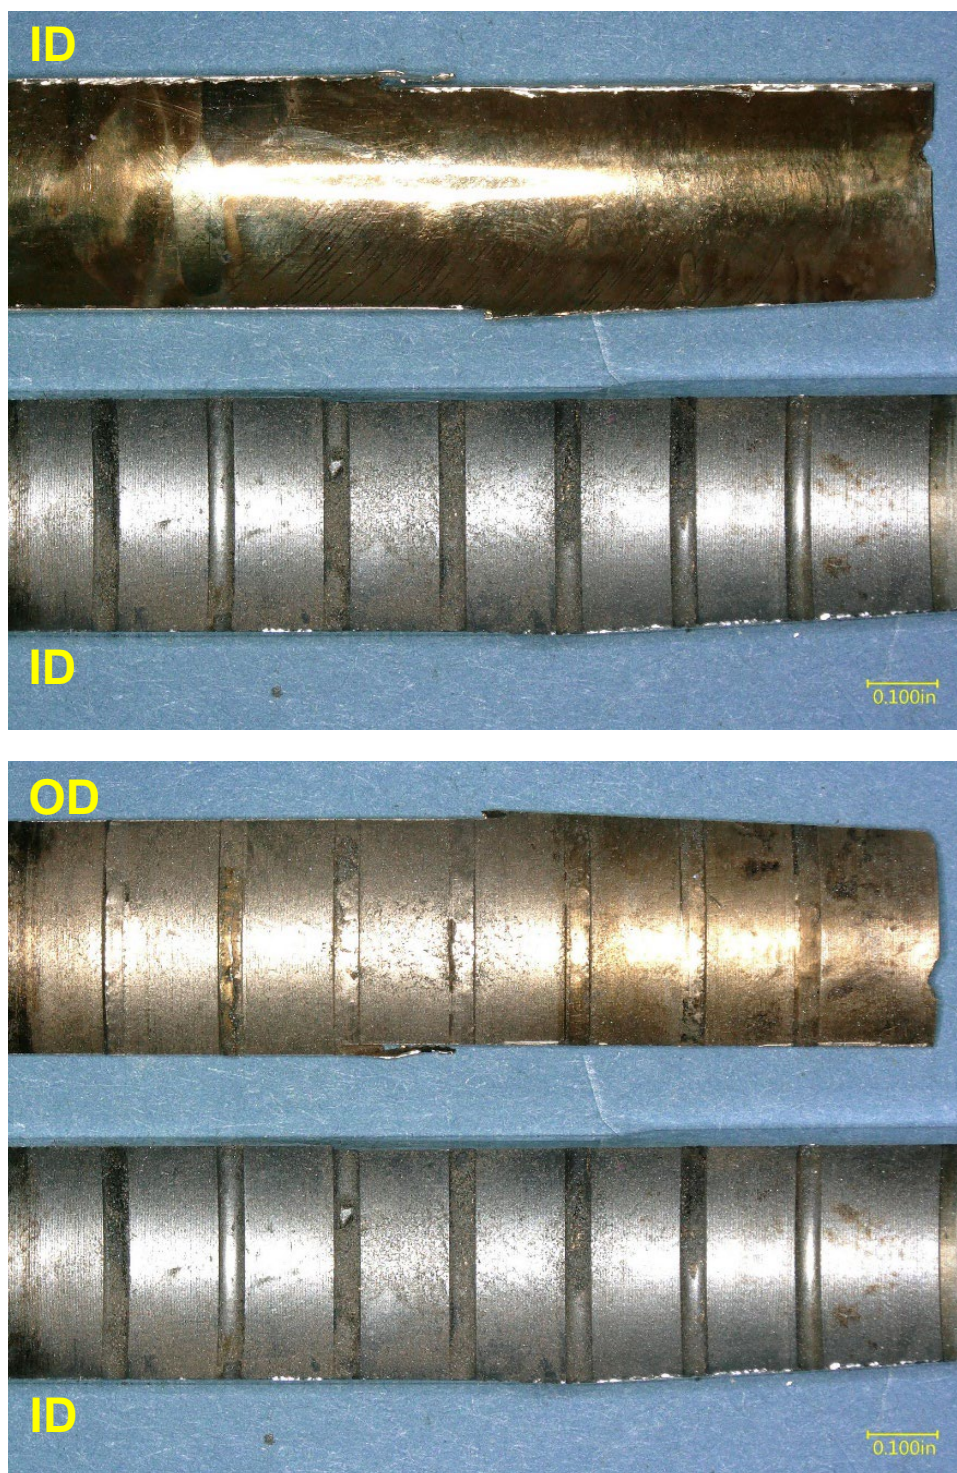
The ID of the block piece and the ID and OD of the liner piece from bore 6 are shown in Figure 20. The sectioned piece of liner was whole and intact. Both the OD of the liner and the ID of the block had had the same substance on it as the other bores. While there were thicker sections of substance visible on some of the raised rings of the liner OD, no areas of the machined grooves in the block ID were completely filled with it.

Figure 20: Digital microscope images showing the ID of the block piece and the ID and OD of the liner piece sectioned from bore 6 in fixed cylinder block S/N Y10-245-19.
