# NATIONAL TRANSPORTATION SAFETY BOARD

## MATERIALS LABORATORY FACTUAL REPORT

Report No. 22-040

Place : Sacramento, CA  
Date : February 15, 2020  
Vehicle : Airbus A319-132, N521NK  
NTSB No. : ENG20LA016  
Investigator : Michael Hauf (AS-10)

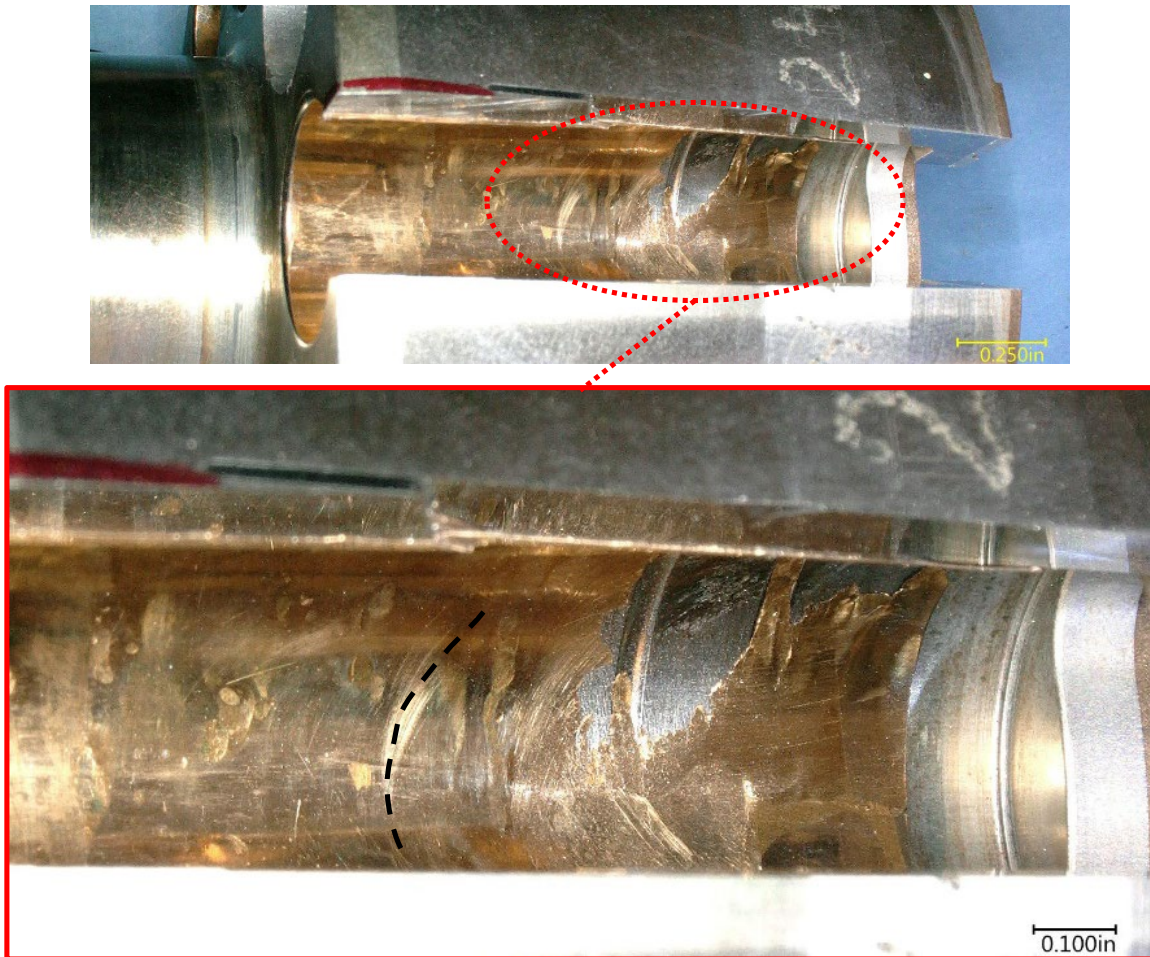
The remaining portion of block with the liner still installed in bore 6 is shown in Figures 21–23. A segment of the liner at the bottom of the bore was missing (red dotted line, Figure 21), and again a curved wear pattern was visible on the liner adjacent to the missing portion (black dashed line, Figure 21). The edges of the liner along one side of the missing segment were thinned, as shown in Figure 22. In other locations along the missing segment the edges were thick and had features consistent with pieces of the liner separating (black dotted circle, Figure 23).

Figure 21: Digital microscope images showing the ID liner still installed inside bore 6 in fixed cylinder block S/N Y10-245-19. The black dashed line highlights a curved wear pattern visible on the liner ID surface.

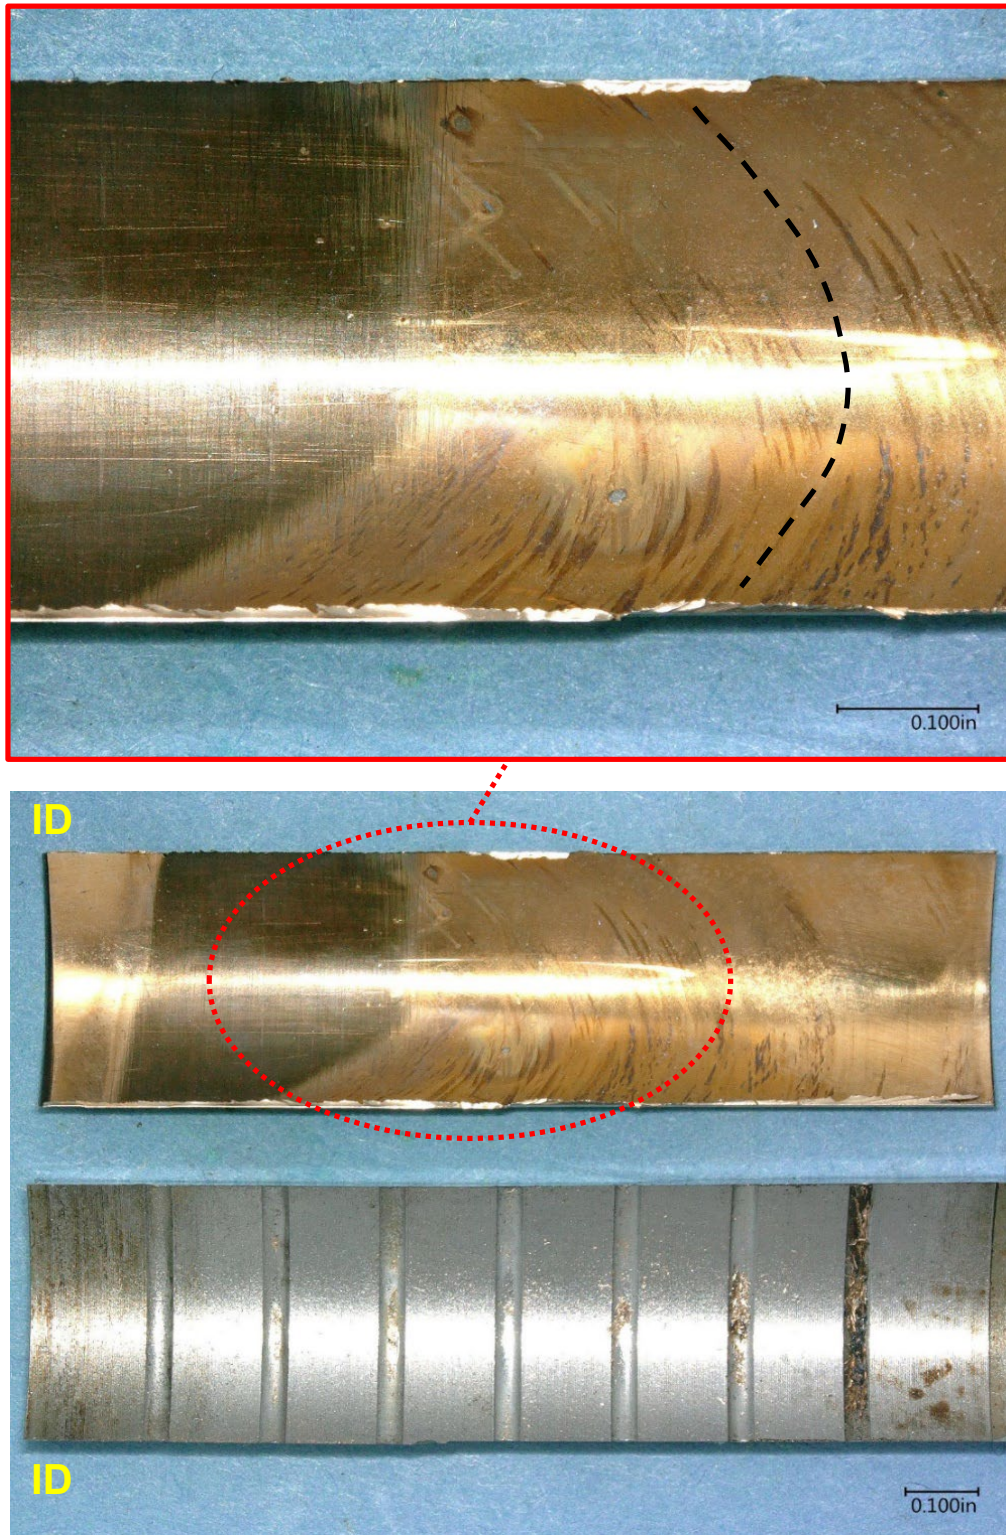
The ID of the block piece and the ID and OD of the liner piece from bore 8 are shown in Figure 24. The sectioned piece of liner was whole and intact. Both the OD of the liner and the ID of the block had had the same substance on it as the other bores, and the OD of the liner also had the raised rings from being pressed inside the mating machined grooves in the ID of the block. Debris was visible inside some of the machined

Figure 24: Digital microscope images showing the IDs of the block and liner pieces sectioned from bore 8 in fixed cylinder block S/N Y10-245-19. The black dashed line highlights a curved wear pattern visible on the liner ID surface.

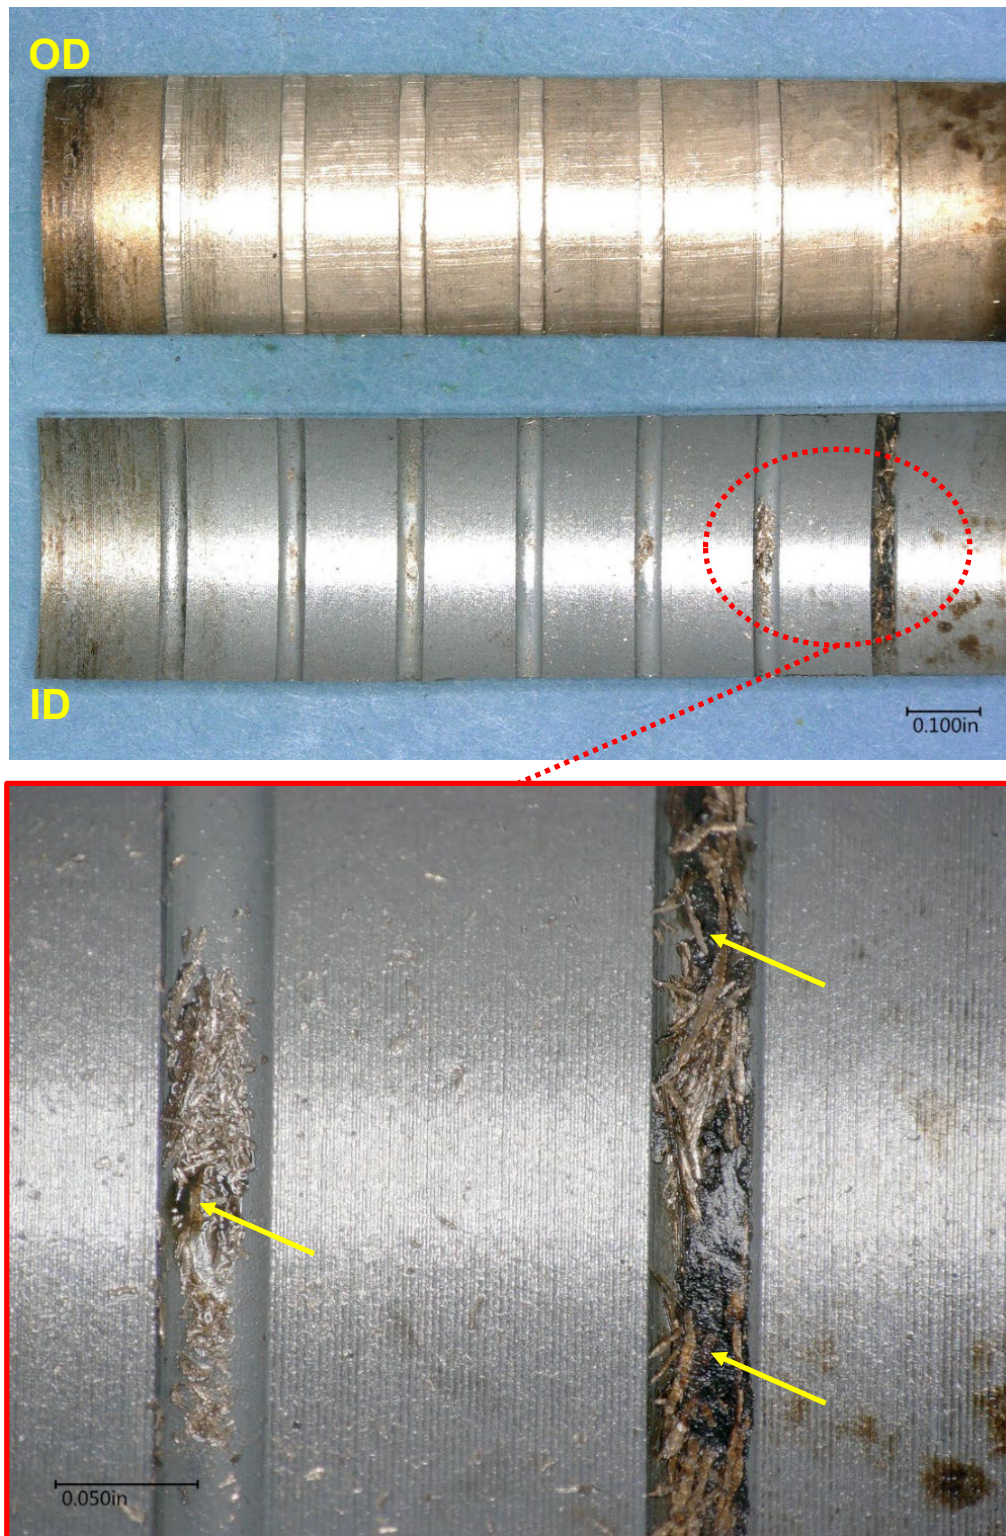
grooves in the ID of the block, as indicated by the yellow arrows in Figure 25. The debris was adhered with substance that had darkened in color in some areas and appeared to consist of gold-colored shavings.

Figure 25: Digital microscope images showing the ID of the block piece and the OD of the liner piece sectioned from bore 8 in fixed cylinder block S/N Y10-245-19. The yellow arrows point to debris inside some of the machined grooves in the ID of the block.

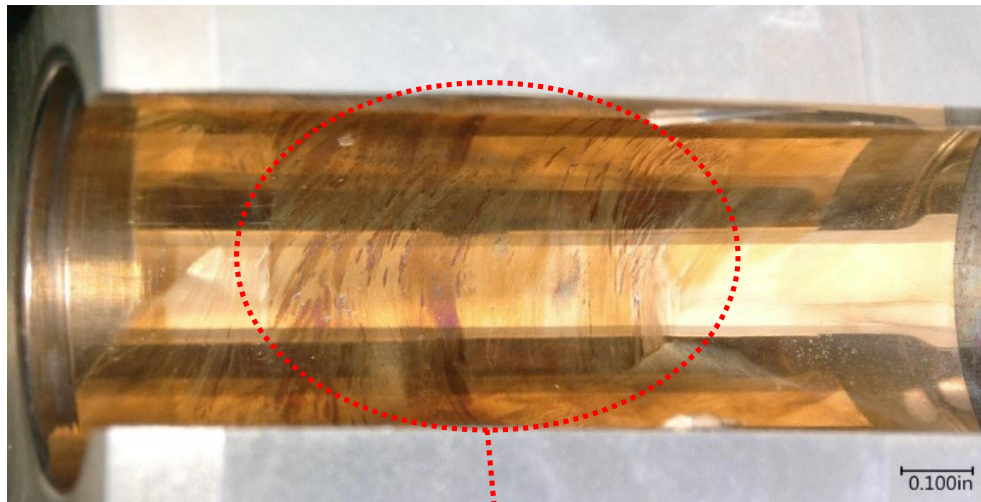
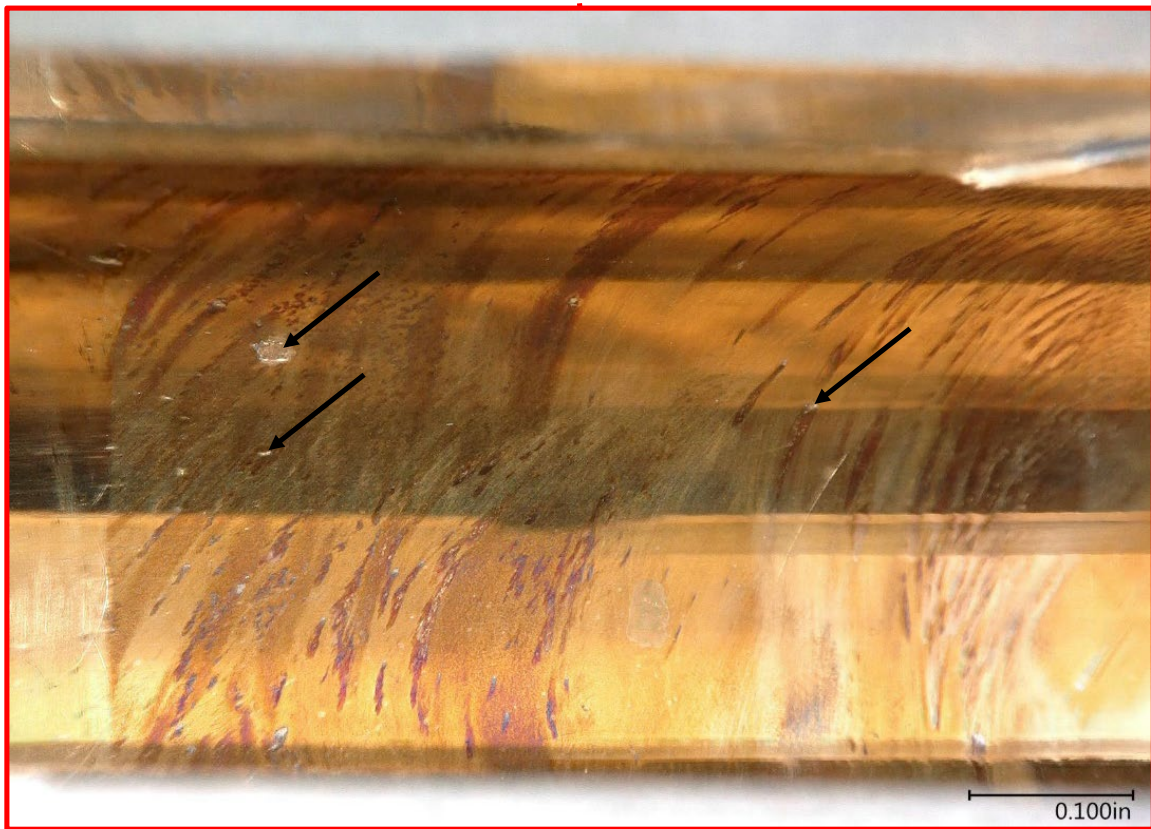
The remaining portion of block with the liner still installed in bore 8 is shown in Figure 26. The remaining liner was intact along the entire axial length. Circumferential wear was observed in the middle of the liner ID surface. The wear closer to the bottom of the bore had a curved pattern. A few locations where pieces of liner were missing were observed in the worn area (black arrows, Figure 26).

Figure 26: Digital microscope images showing the ID liner still installed inside bore 8 in fixed cylinder block S/N Y10-245-19. The black arrows point to areas where pieces of liner were missing.

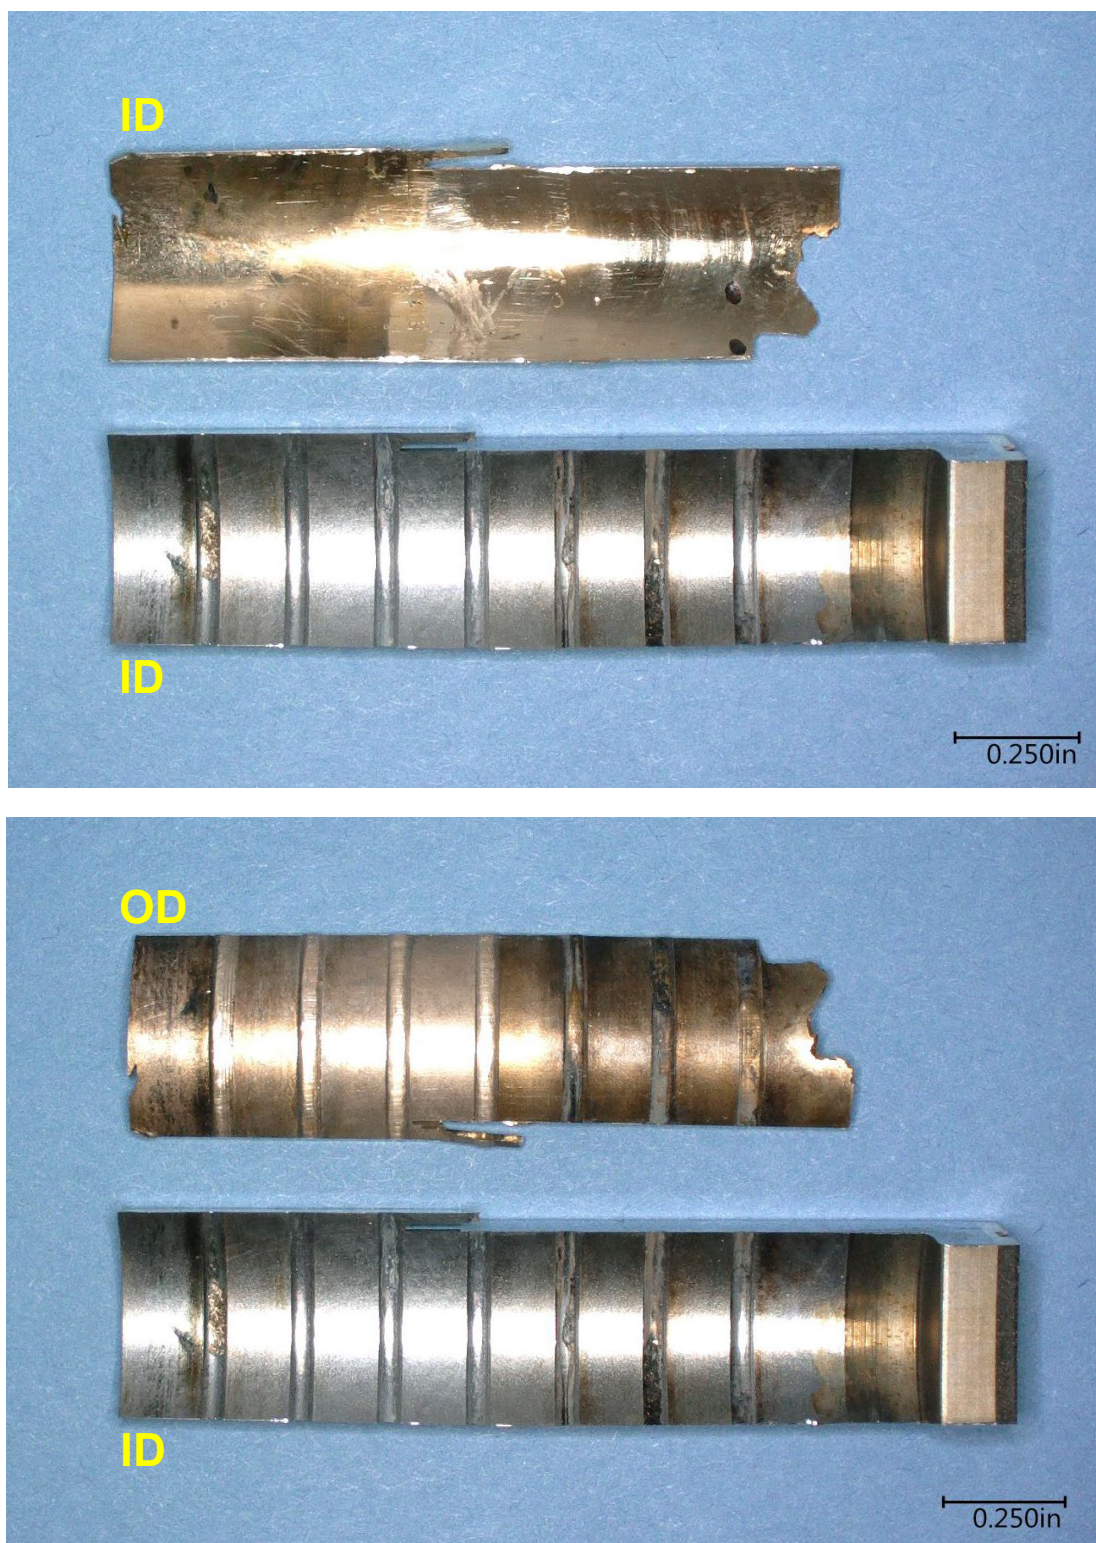
Bore 3 after sectioning is shown in Figure 29. The ID of the block piece and the ID and OD of the liner piece are shown in Figure 30. The bottom 0.1 inches of the sectioned piece of liner was missing, and the edge of the liner adjacent to the missing portion had thinned. The ID surface of the block piece and OD surface of the liner had a substance on it consistent with the bores examined from the other fixed block. The substance along the bottom half of the liner OD had darkened in color, along with several areas on the ID of the block piece. Debris was visible adhering to the substance inside some of the machined grooves in the ID of the block.

Figure 30: Digital microscope images showing the ID of the block piece and the ID and OD of the liner piece sectioned from bore 3 in fixed cylinder block S/N Y04-232-49.

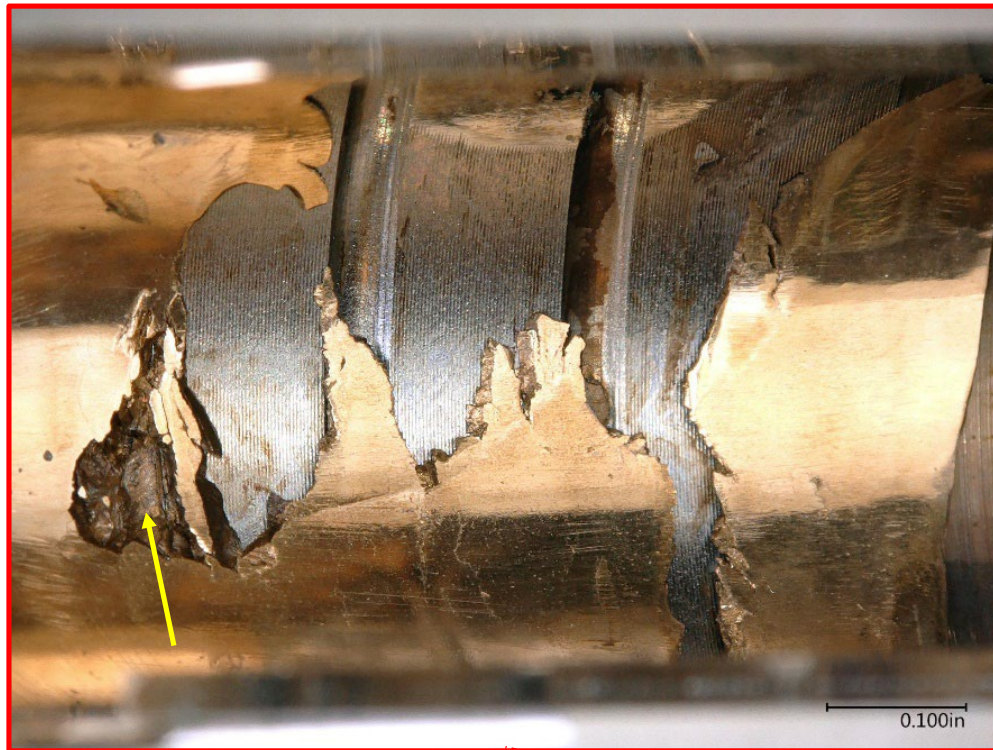
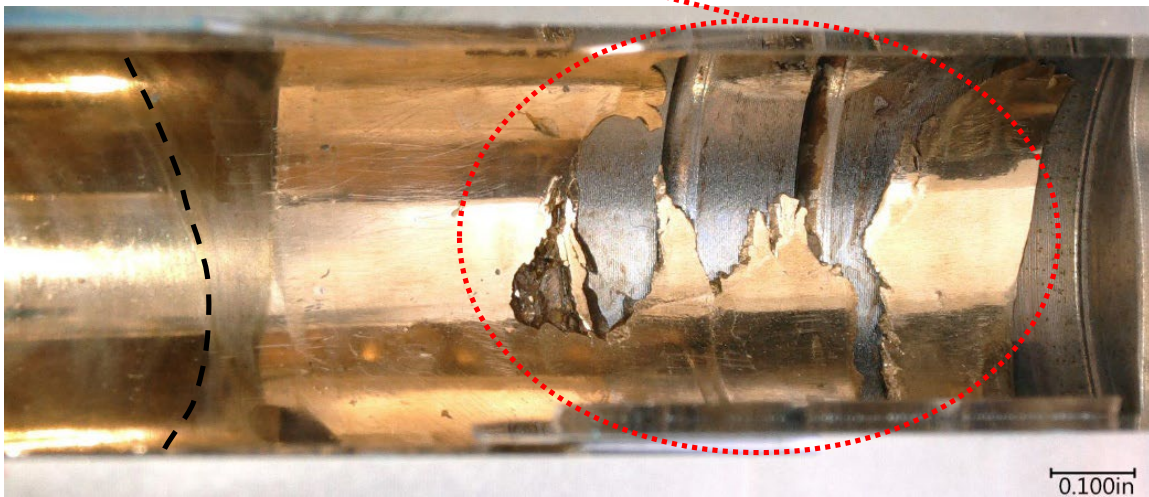
The remaining portion of block with the liner still installed in bore 3 is shown in Figure 31. A segment of the liner near but not immediately adjacent to the bottom of the bore was missing, as indicated by the red dotted line. The edges of the missing segment were a mix of thinned and thick with features consistent with pieces of the liner separating. The yellow arrow in Figure 31 points to a large piece from the top half of the liner thickness that had separated near the missing liner segment. Machined grooves were visible in the exposed block ID surface, and one area within a groove had darkened substance adhering to it. A curved wear pattern was visible on the liner away from the missing portion (black dashed line, Figure 31).

Figure 31: Digital microscope images showing the ID liner still installed inside bore 3 in fixed cylinder block S/N Y04-232-49. The black dashed line highlights a curved wear pattern visible on the liner ID surface. The yellow arrow points to a large piece from the top half of the liner thickness that had separated.

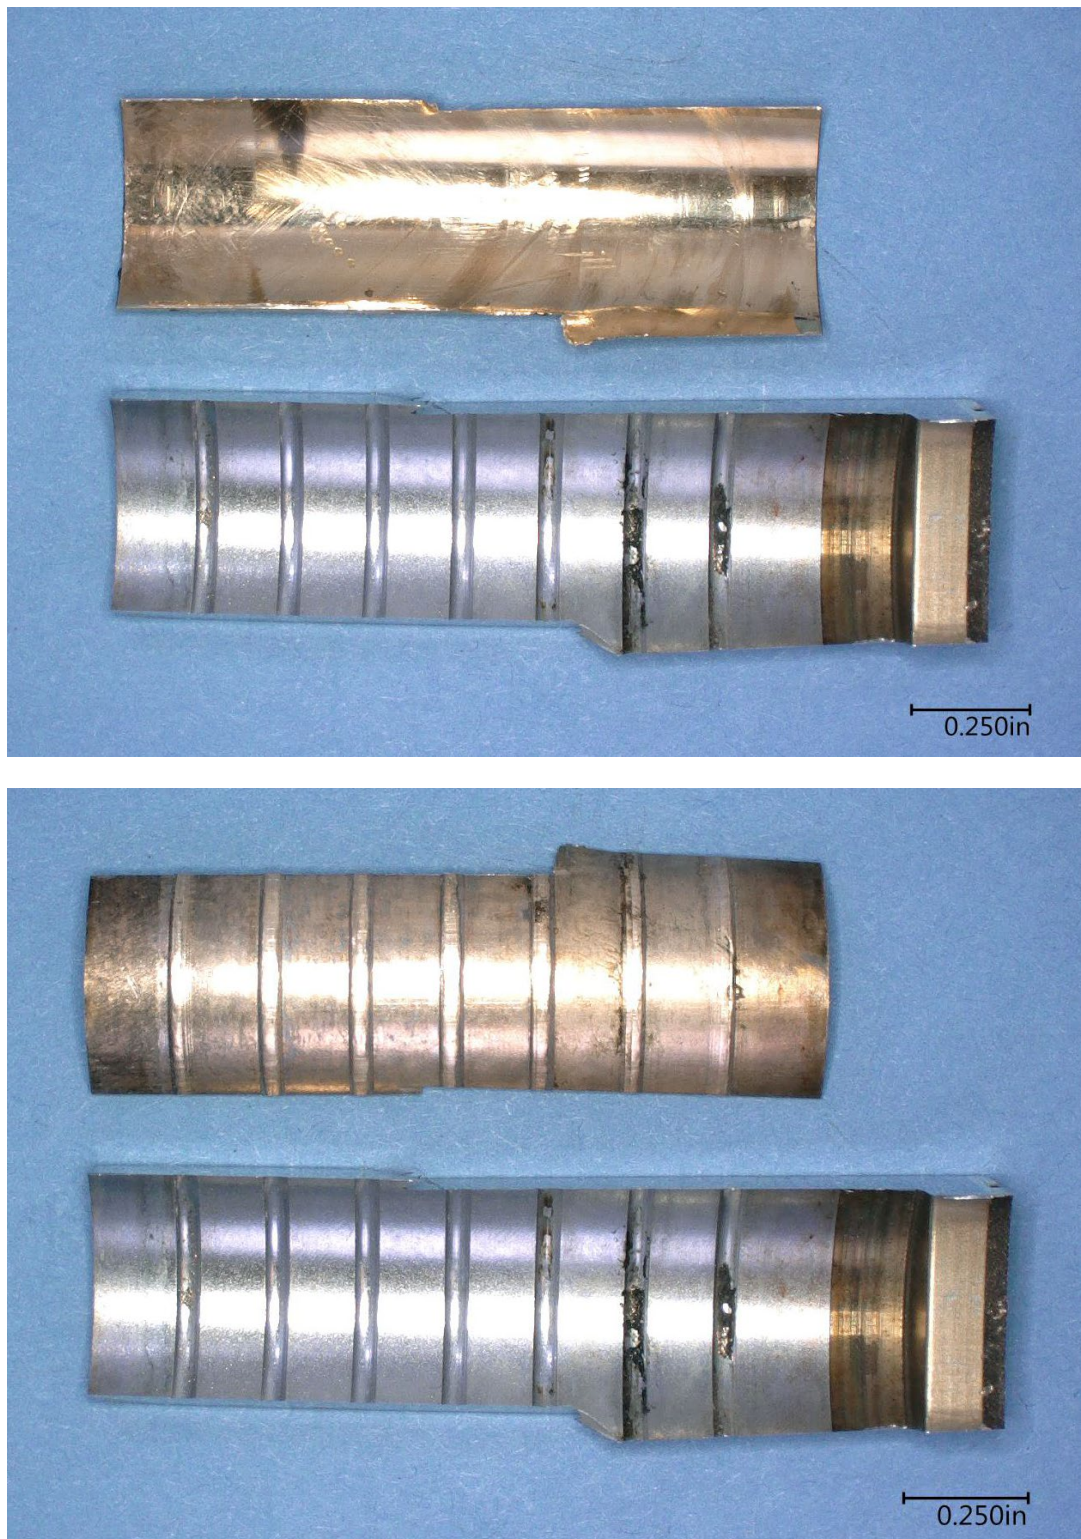
Bore 7 after sectioning is shown in Figure 32. The sectioned piece of liner was whole and intact. The ID of the block piece and the ID and OD of the liner piece are shown in Figure 33. The ID surface of the block piece and OD surface of the liner had a substance on it consistent with the bores examined from the other fixed block, and a few areas of substance within the grooves in the block ID had darkened in color.

Figure 33: Digital microscope images showing the ID of the block piece and the ID and OD of the liner piece sectioned from bore 8 in fixed cylinder block S/N Y04-232-49.

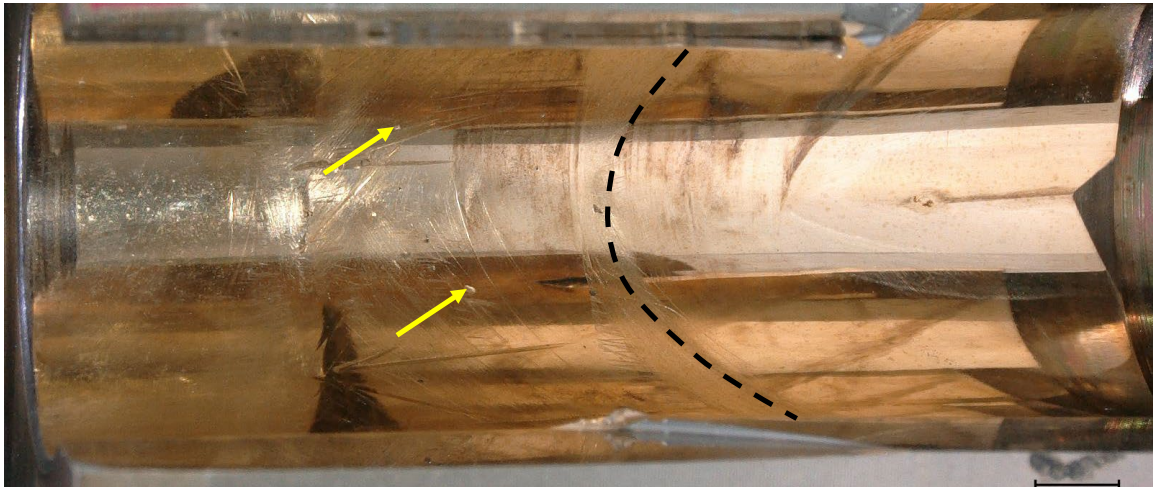
The remaining portion of block with the liner still installed in bore 7 is shown in Figure 34. The remaining liner was intact along the entire axial length. A curved wear pattern was visible on the liner (black dashed line). A few small areas where the liner had begun to wear through the thickness were observed (yellow arrows).

Figure 34: Digital microscope images showing the ID liner still installed inside bore 7 in fixed cylinder block S/N Y04-232-49. The black dashed line highlights a curved wear pattern visible on the liner ID surface. The yellow arrows point to areas where pieces of liner were missing.

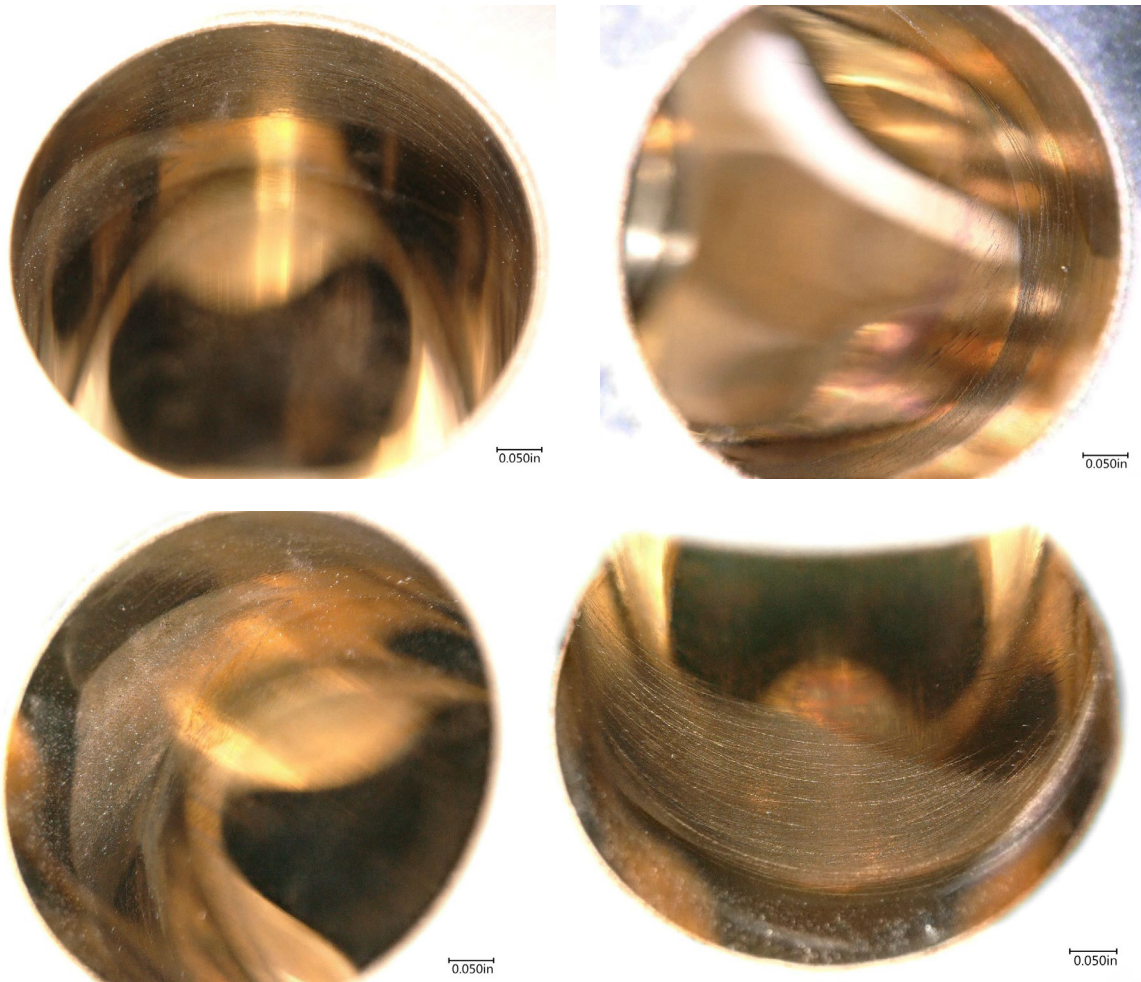
Wear was observed in the gold-colored liners assembled inside the bores of the fixed cylinder block. The wear was uneven around the circumference and typically occurred close to the top end the bores. The heaviest wear around the circumference were in areas diametrically opposite each other. No areas of silver-colored base metal were visible and no discrete pieces where the liner had separated due to wear through were observed.

Figure 36: Digital microscope images showing around the entire circumference of a representative bore in the exemplar fixed cylinder block submitted by the OEM.

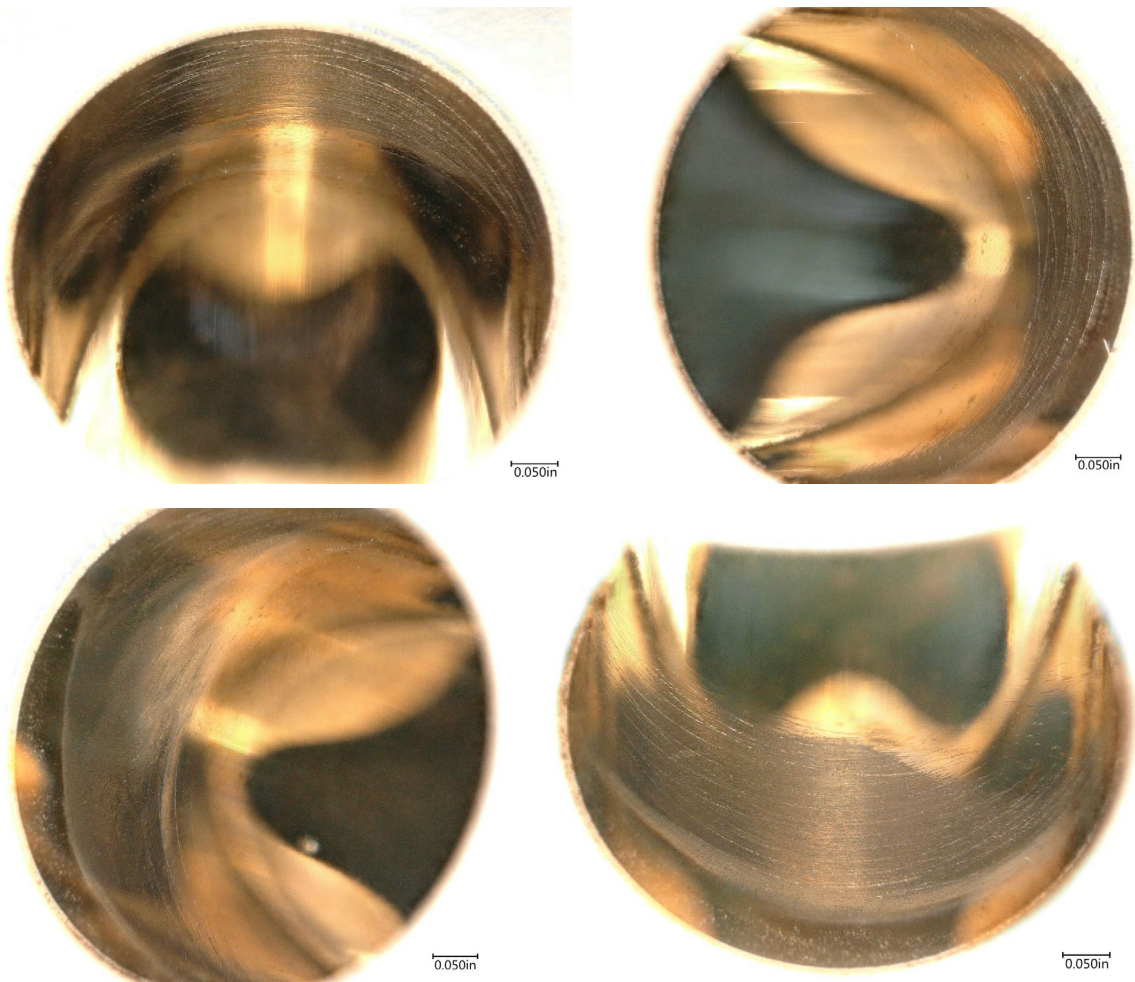
Figure 37: Digital microscope images showing around the entire circumference of a second representative bore in the exemplar fixed cylinder block submitted by the OEM.
