| <p><b>AIRBUS</b><br/>HELICOPTERS</p> <p>QUALITY MATERIALS &amp; PROCESSES<br/>LABORATORY</p> | | <p align="center"><b>SYNTHESIS REPORT</b></p> <p align="center"><b>2020-3223 indB</b></p> <p align="center"><i>(Cancels and replaces the version without index)</i></p> <p align="center">Airbus Helicopters - LMP - Aéroport International<br/>Marseille Provence - 13725 Marignane</p> | |
| Affair designation | Hydraulic pump drive bearing seizure POST MOD 07-9568 | | |

| Helicopter N° : | AS 350 B3 | Part number: | 350A35013201 (Post Mod 07-9568) |
| Customer/user: | MACNEIL AVIATION LLC | Part Designation: | Hydraulic pump drive assy |

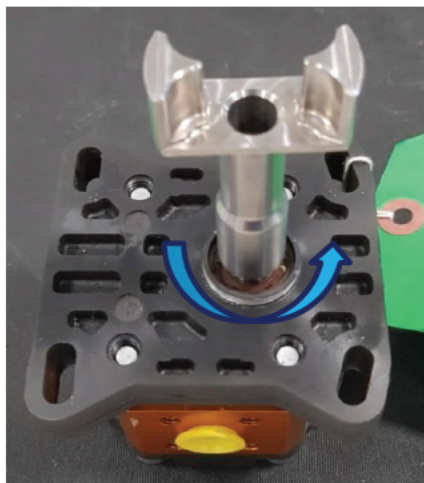
Using the drive shaft, the rotation of the pump is possible.

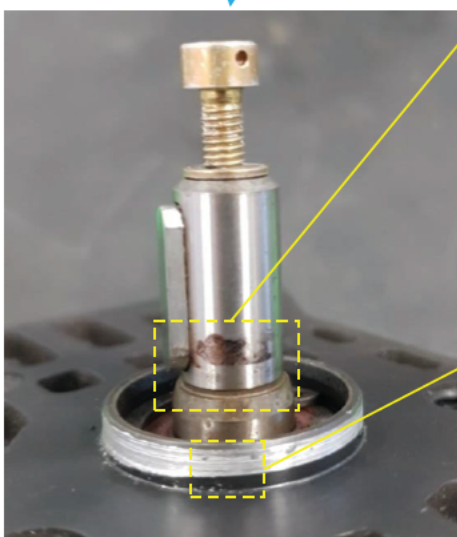
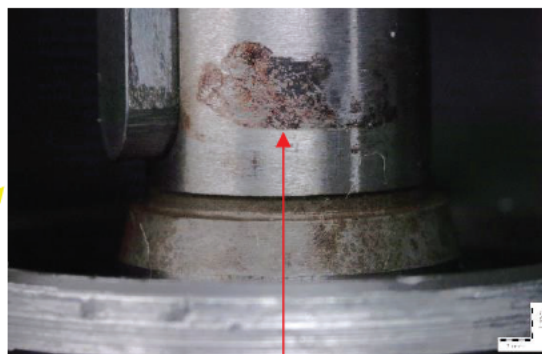
Fretting and corrosion are observed on the axis (on 90°).

Friction marks are observed, on 360°, probably due to the assembly/disassembly.

No sign of overheating of the pump housing or leakage is observed.

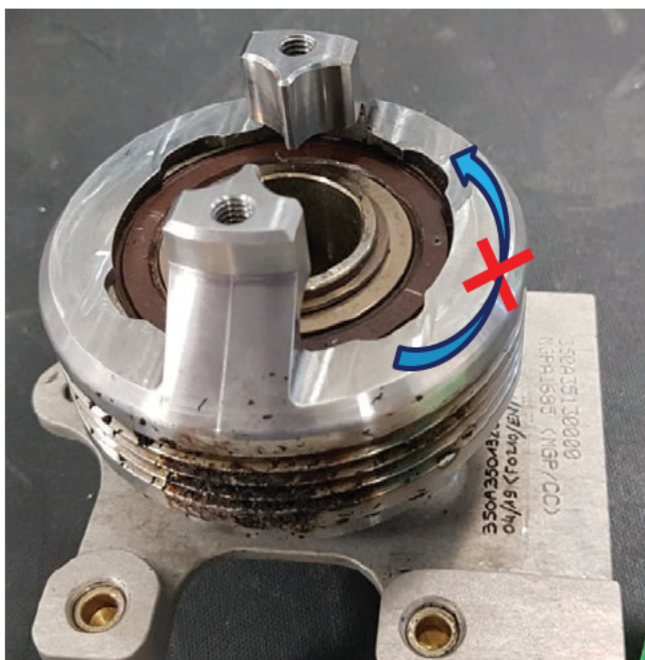
Rotation of the pulley is not possible.

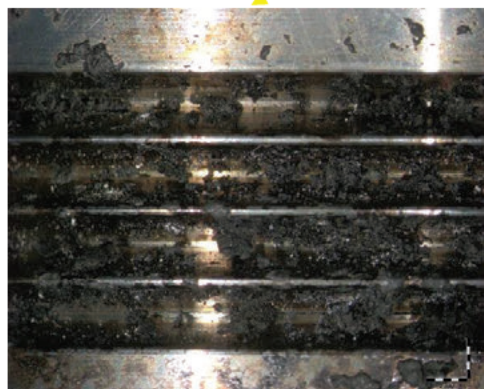
In the thread, on approximately 100°, black residues are observed. It is most likely belt residues.

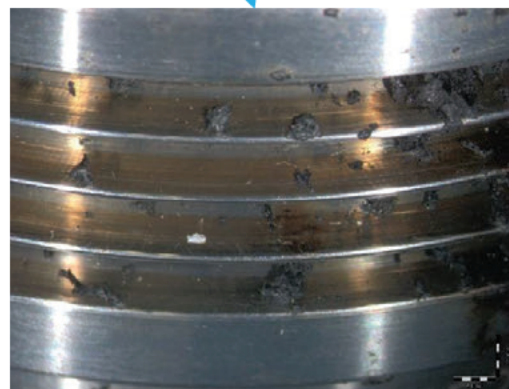
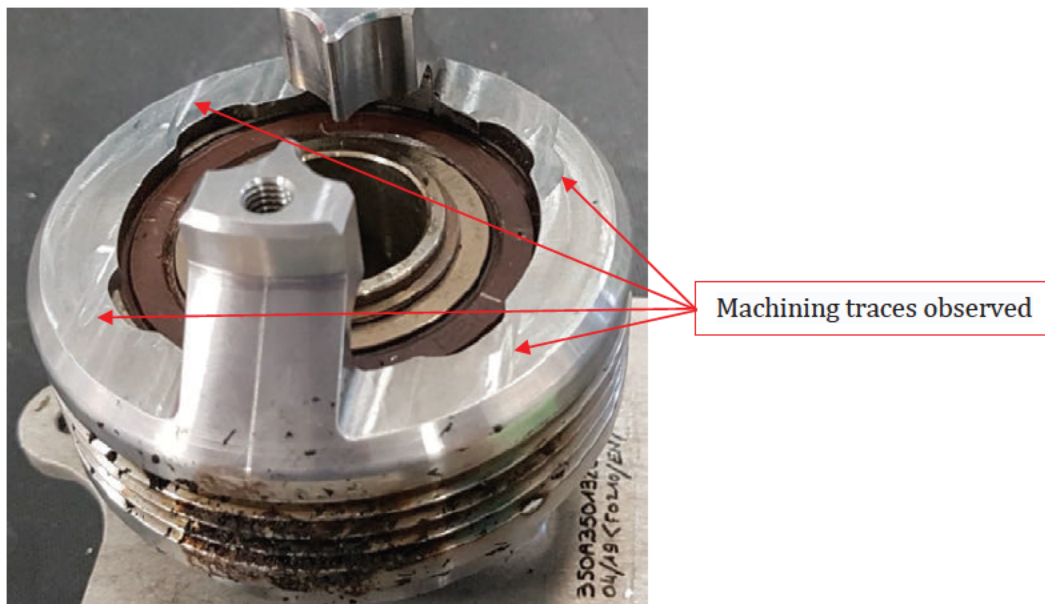
The rotation of the **pulley** is impossible. In the thread, belt residues are found and surface oxidation is observed. This damages are probably due to overheating resulting by the locked rotation of the pulley.

Surface oxidation is observed in the thread (360°), probably due to overheating.

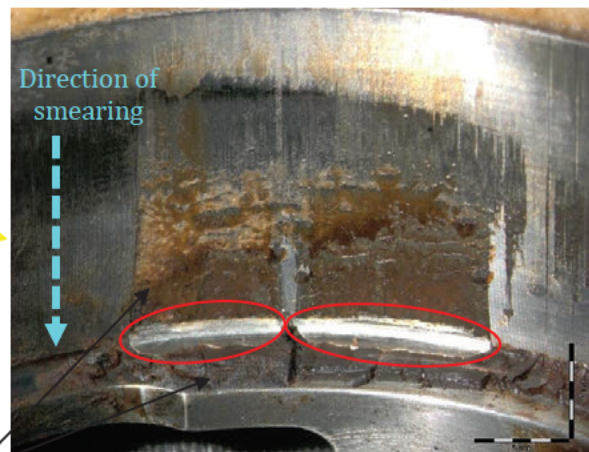
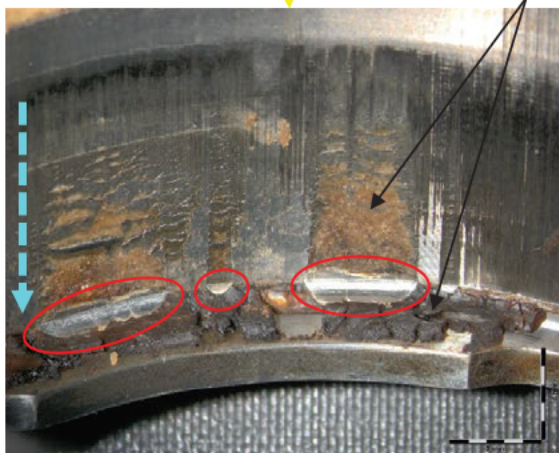
On the inner diameter, material repulsions due to a smearing phenomenon are observed. They are probably created when the bearing is fitted in the pulley. This material repulsions can lead to improper placement of the bearing in the pulley.

Grease residues

On the inner diameter (140°), **material repulsions** due to a smearing phenomenon are observed. They are probably created when the bearing is fitted in the pulley. Material repulsions can lead to improper placement of the bearing in the pulley.

Grease residues are also present.

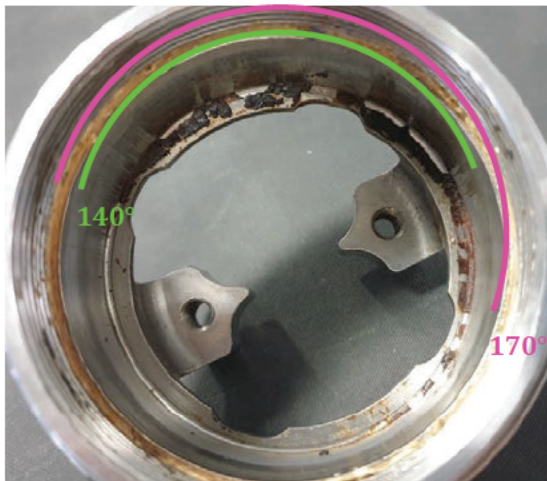
Grease residues  
Material repulsions

The grease residues observed come from the bearing during its fitting in the pulley.

The residues are located on the section of 170° where the bearing is probably not in contact with the end (drive shaft side) of the pulley. This illustrates the improper placement of the bearing in the pulley.

A piece of grease residue is taken to measure its thickness to estimate the gap between the bearing and the end of the pulley.  
The measured thickness is 0,52 mm.

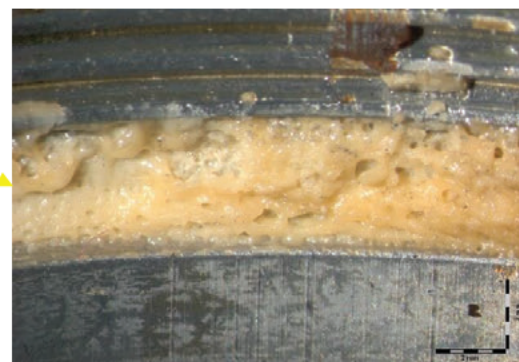
Grease residues observed (360°)

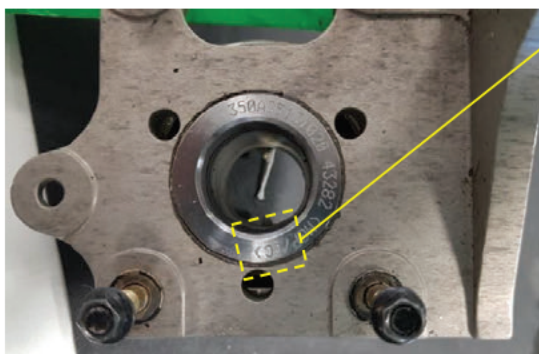
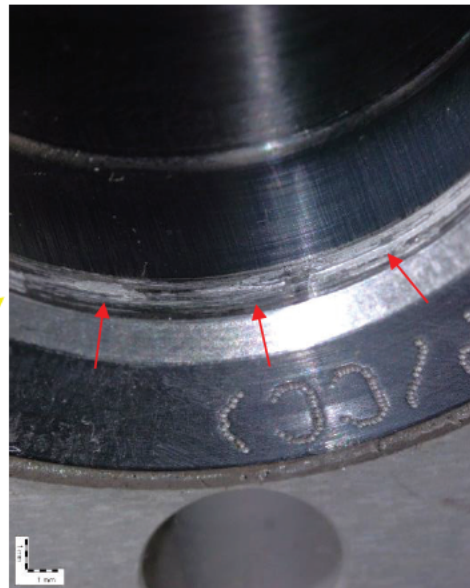
On 360°, friction marks were observed, probably due to the assembly/disassembly.

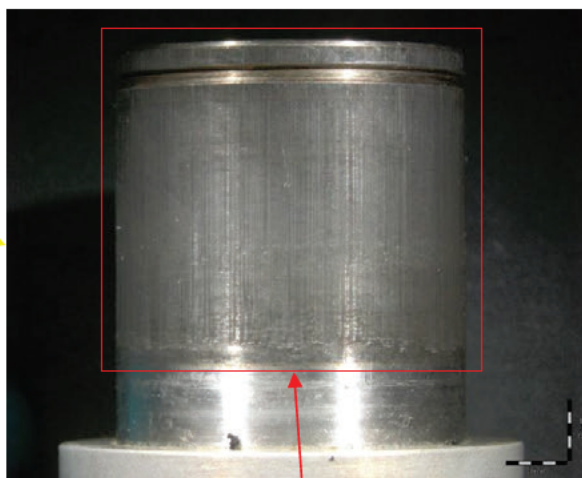
Presence of longitudinal scratches on the stud (360°), on which the inner ring of the bearing is fitted. They were probably caused during assembly/disassembly.

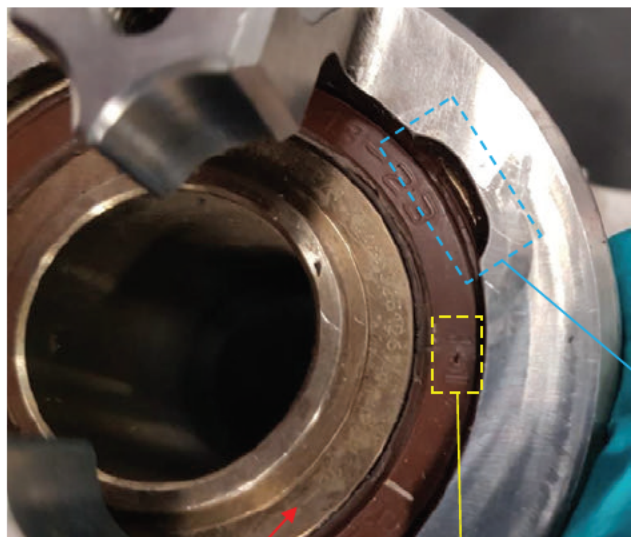
An oxidation of the inner ring is observed, probably due to overheating.

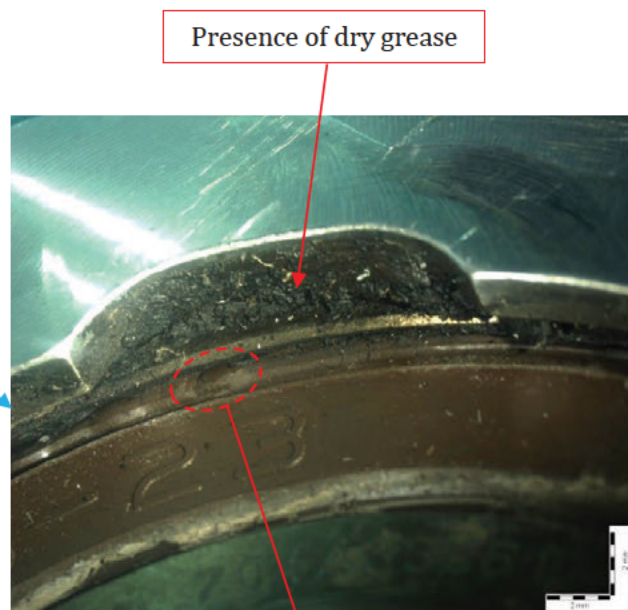
Presence of dry grease

The flange has one over more material (beading) on different areas.

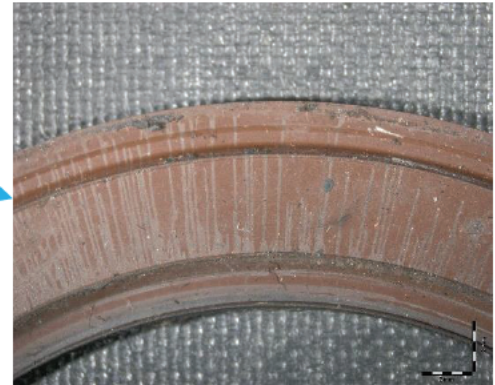
Radial drips, probably corresponding to grease escaping from the bearing. They are observed on the 2 flanges.

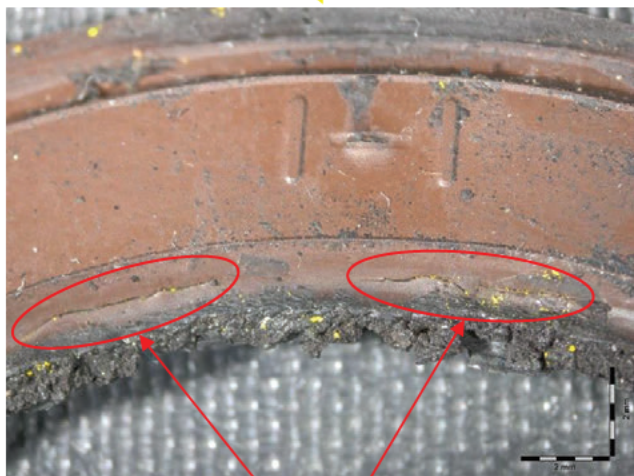
Both **flanges** have scratches and drips showing loss of grease. The end of the flange seal, drive shaft side, is torn off.

Presence of scratches on the 2 flanges allowing a loss of grease.

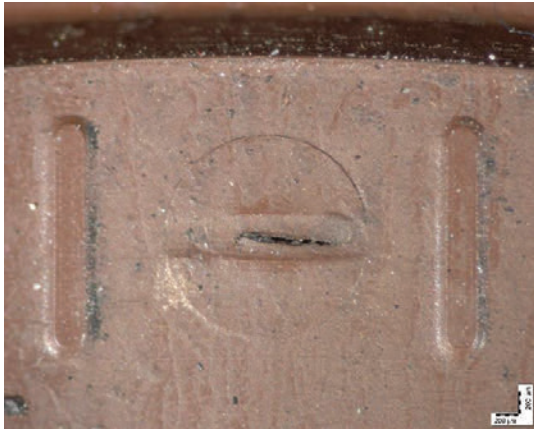
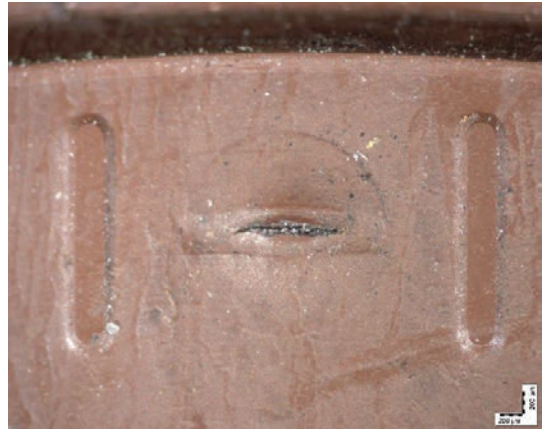
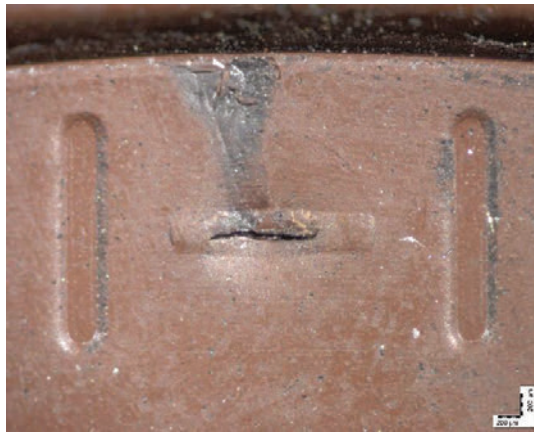
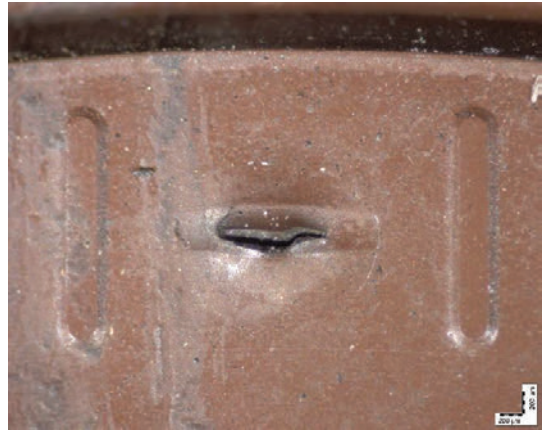
Observation of the flange lids, drive shaft side :

The laboratory was informed (by the design office) that the lids were pre-drilled in new by the supplier to facilitate regreasing in use.

Ind A Tests of lids drilling, carried out by the laboratory (see report 2021-40244), have shown that the difference between the condition of a lid that has only been pre-drilled and one drilled (regreasing) is not significant. The observation of the lids does not make it possible to determine if the bearing has been regreased.

The observation of the bearing lids, drive shaft side, shows that they are actually pre-drilled.

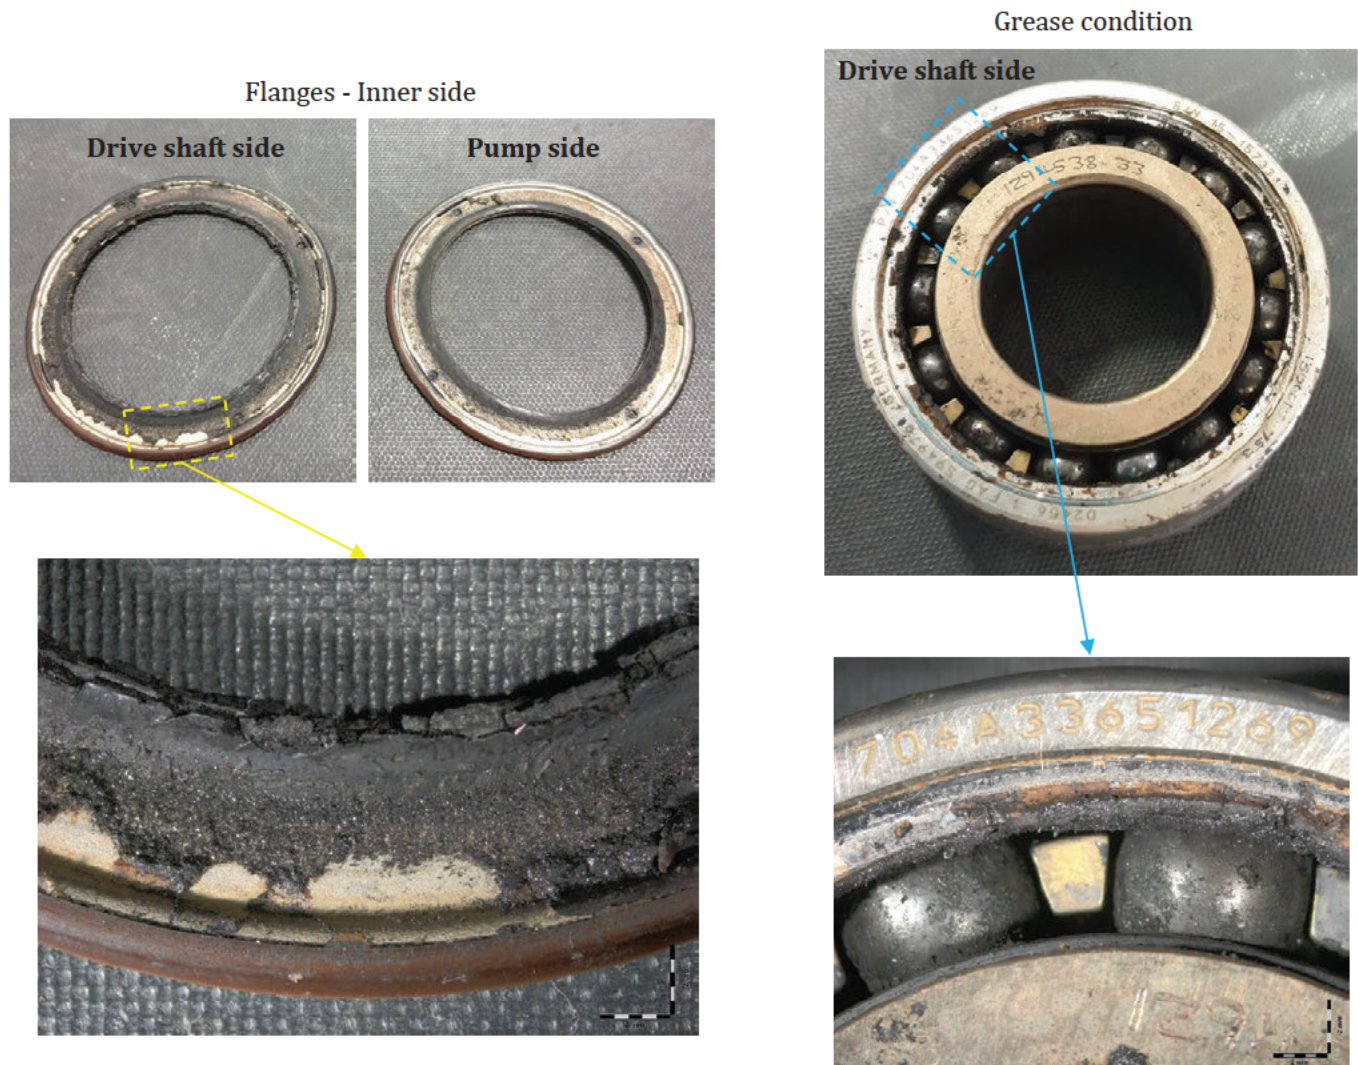
Black residues are observed inside the bearing and on the 2 flanges. This black residues are probably coked grease.

This abnormal appearance shows a degradation of grease, probably due to overheating. In addition, the small amount found shows a loss of grease, as suspected with the observation of drips on flanges.

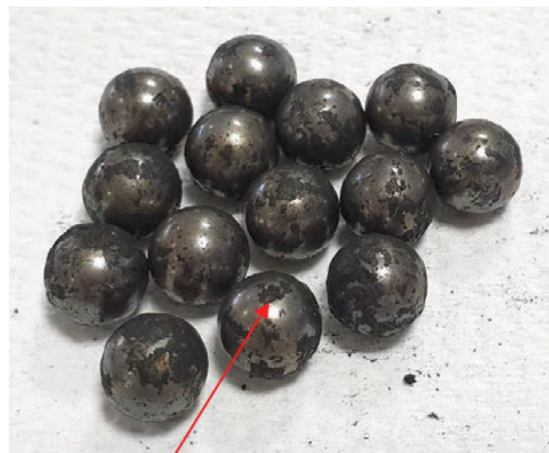
Presence of coked grease on all the balls.

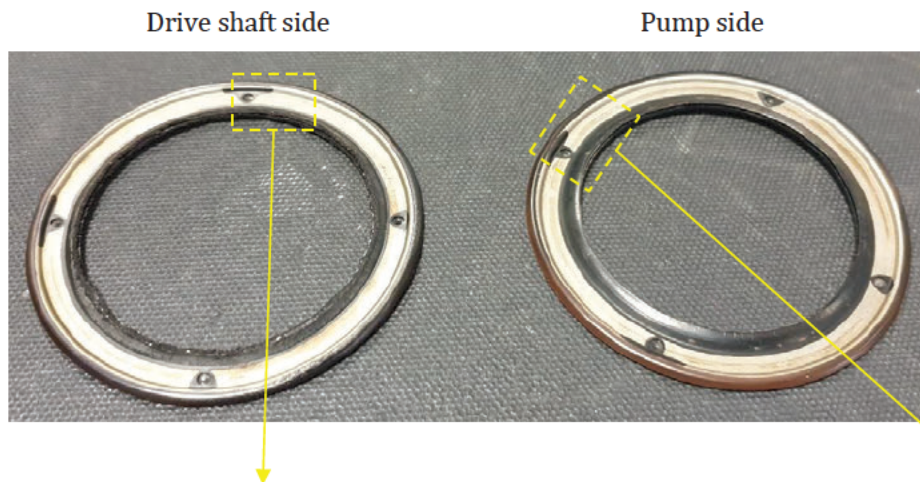
There is no trace of rust on the 2 flanges.

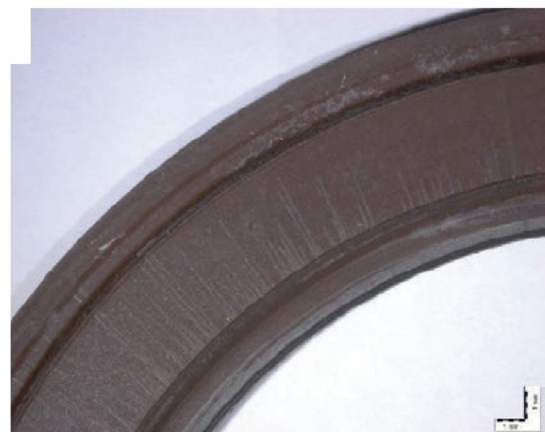
The end of the flange seal, drive shaft side, is torn off.

The end of the flange seal, pump side, is not damaged.

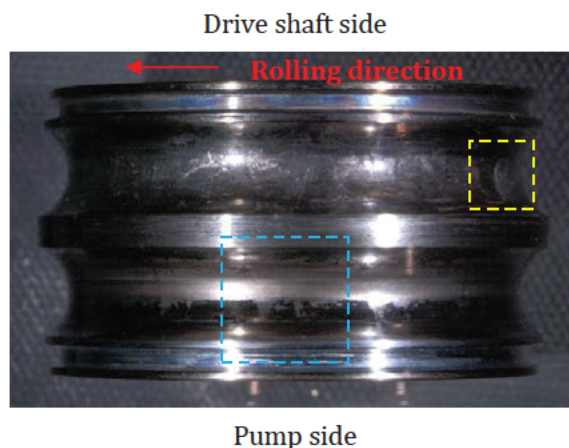
Drive shaft side of bearing, plastic deformation of the surface raceway of the **inner ring / outer ring** is present: pile up of material is observed probably due to locked balls which slid on the raceway.

Plastic deformation of the surface of the raceway : pile up of material is observed probably due to locked balls which slid on the raceway.

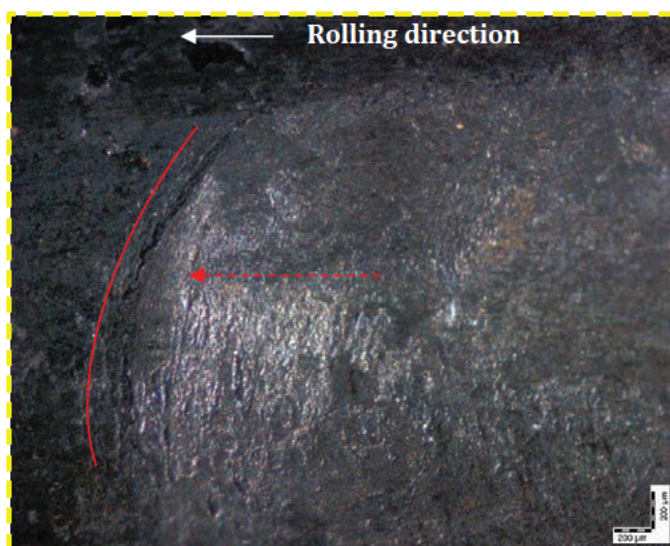
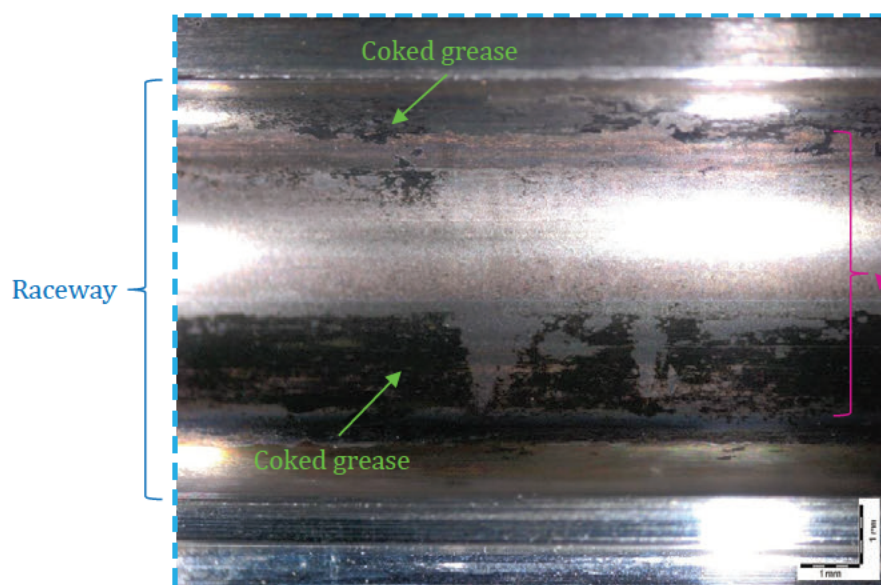
The preferential contact area presents abrasion wear.

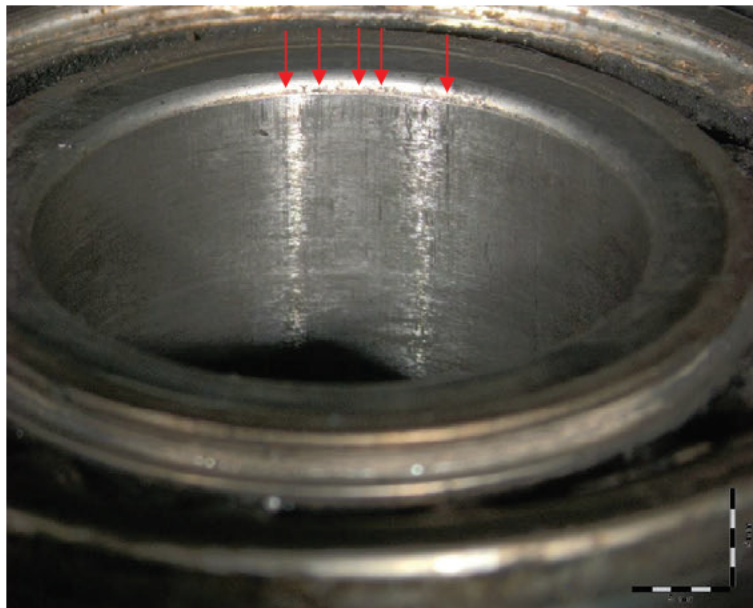
Inner diameter :

Presence of longitudinal scratches on the inner diameter ( $360^\circ$ ), of the inner ring. They were probably caused during assembly/disassembly of the bearing on the pulley support stud.

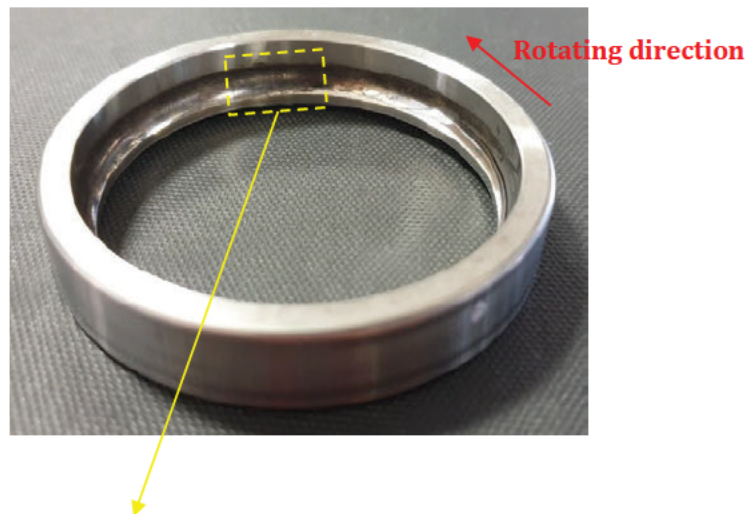
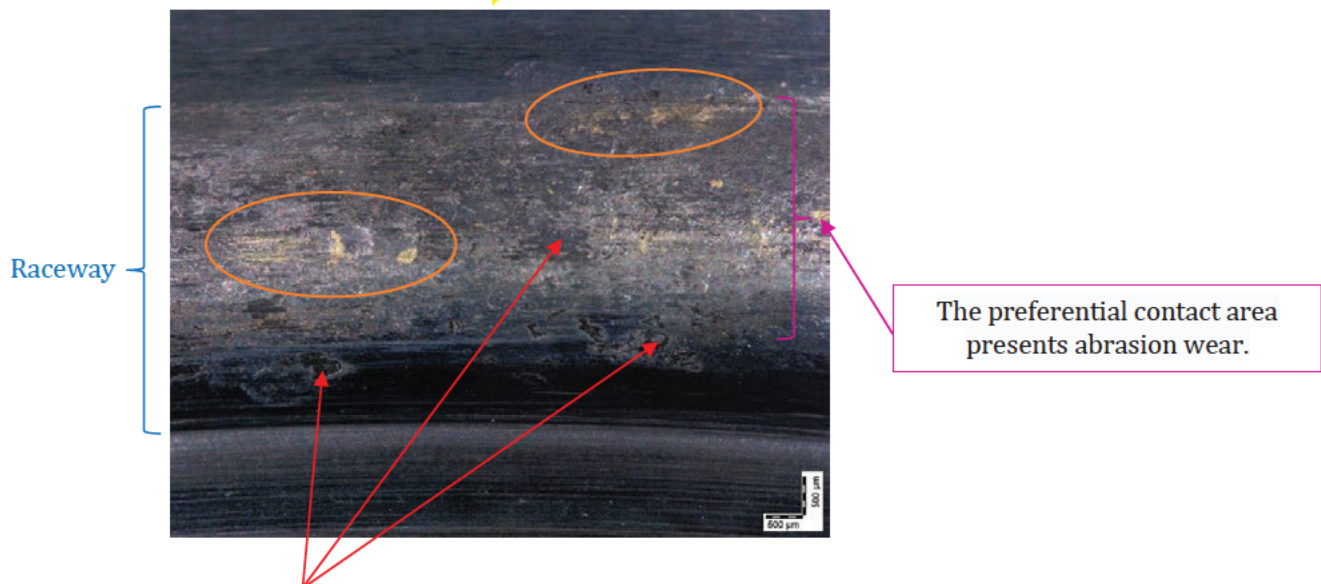
Outer ring - Drive shaft side

Plastic deformation of the surface of the raceway : pile up of material is observed probably due to locked balls which oppose the rotation of the outer ring.

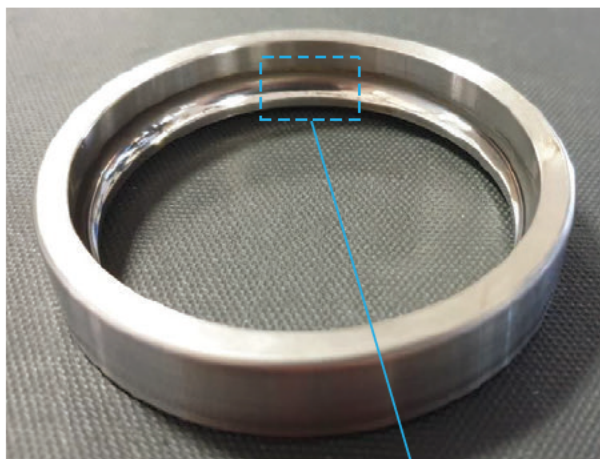
Outer ring - Pump side

The preferential contact area presents abrasion wear.

Presence of coked grease on the raceway.

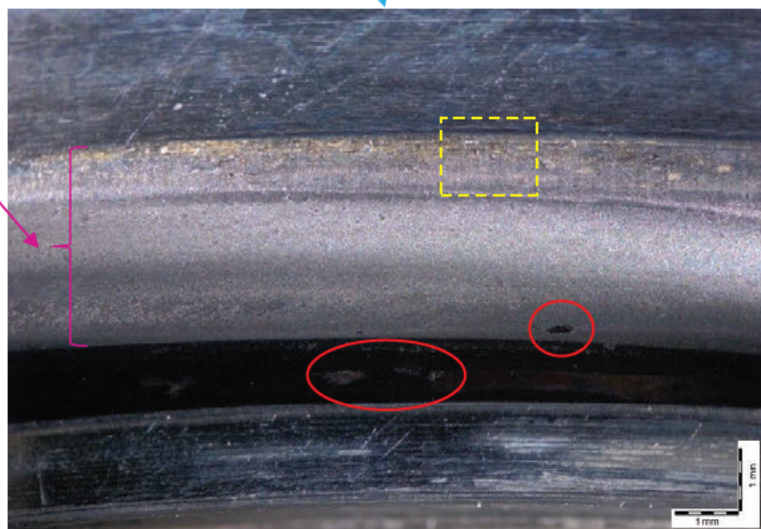
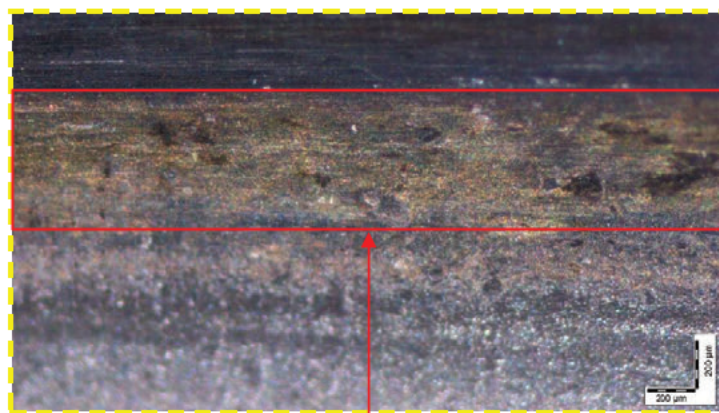
Particles coming from the cage are observed on the raceway.

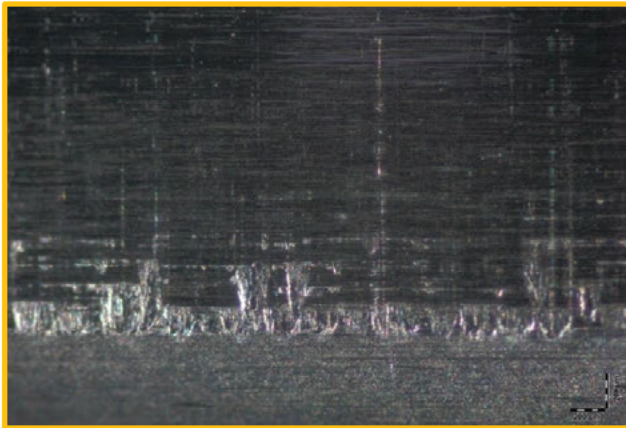
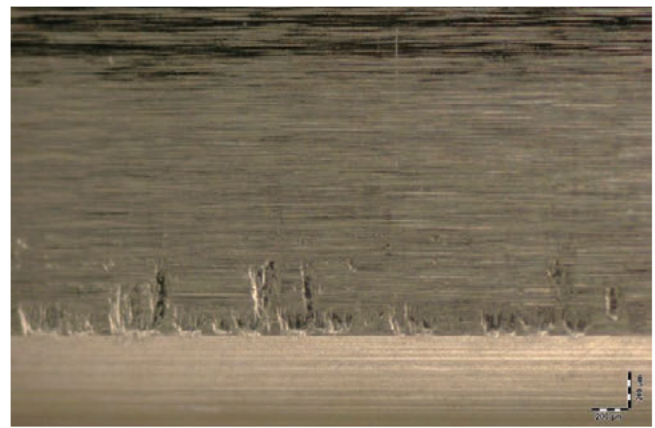
Backscattered light (used to show the material aggregates)

Longitudinal scratches (on 360°) are observed on the outer diameter of the outer ring, drive shaft side. In addition, material aggregates are present on the ends of the outer diameter. They are probably created when the bearing is fitted in the pulley, as shown in the picture below of the inner diameter of the pulley with scratches. It is possible that these aggregates are material transfers from the pulley to the outer ring.

Slight longitudinal scratches but no aggregate are observed on the outer diameter of the other ring, pump side.

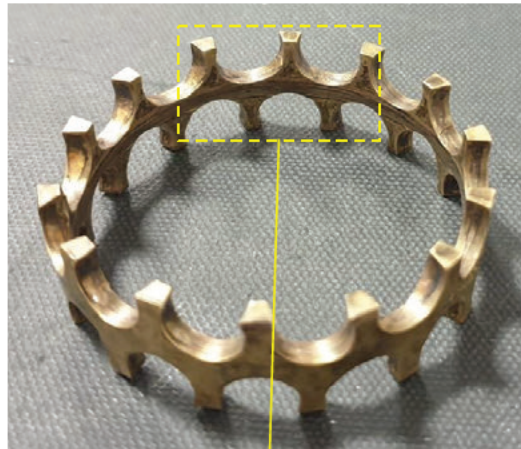
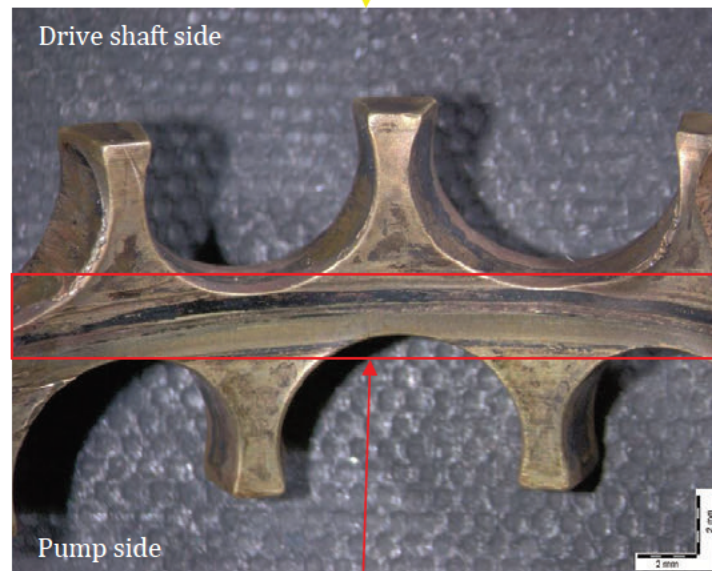
Operating wear on the entire inner diameter.

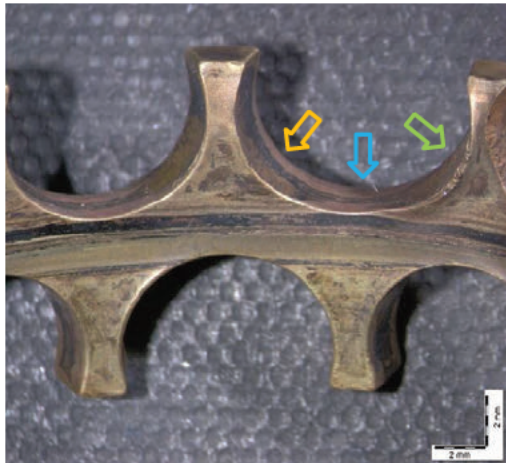
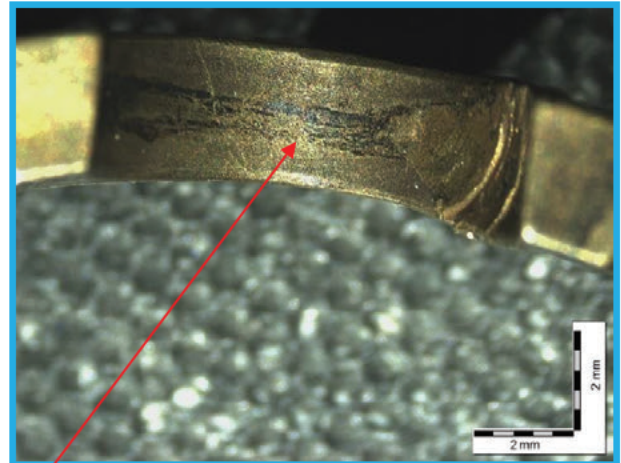
The **cage** present significant wear of the cells with material removal. Drive shaft side, material removal causing material pile up and then material pick-up.

Operating wear due to the rotation of the balls in their cells.  
Significant wear with material removal causing **material pile up**.

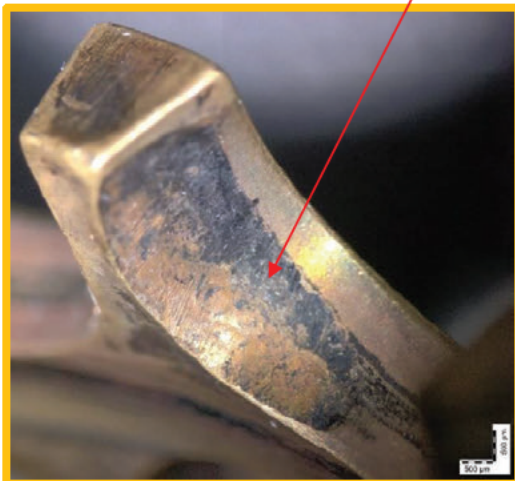
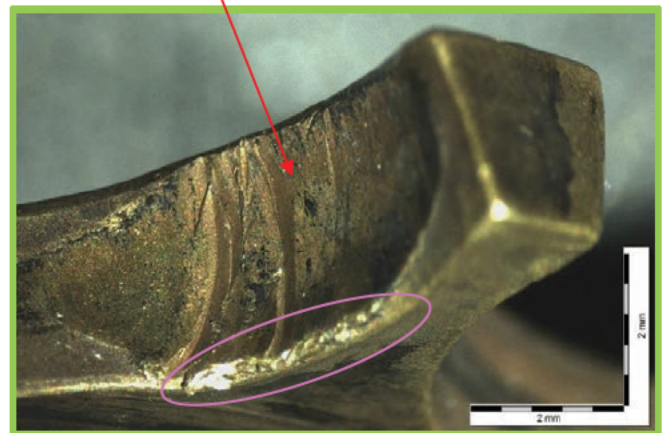
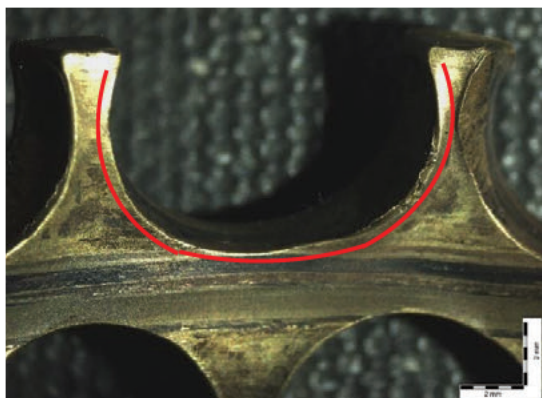
The pile up of material causes deformation of the cell and also material pick-up.

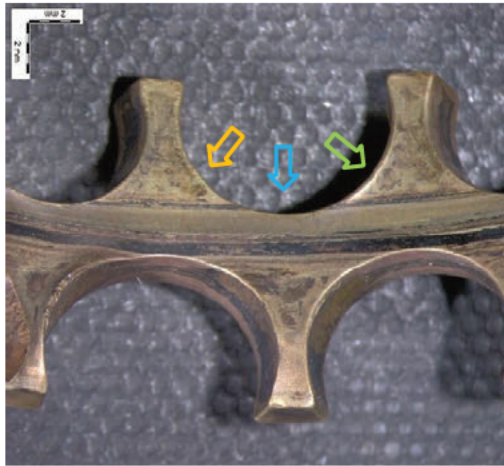
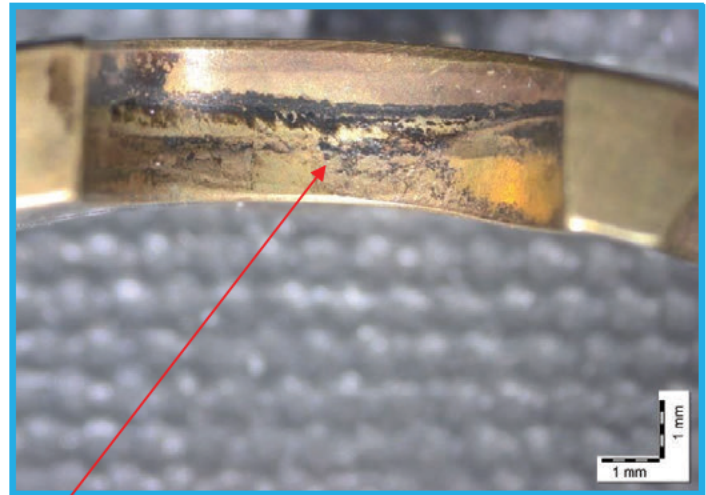
Operating wear due to the rotation of the balls in their cells.  
Wear with start of material removal.

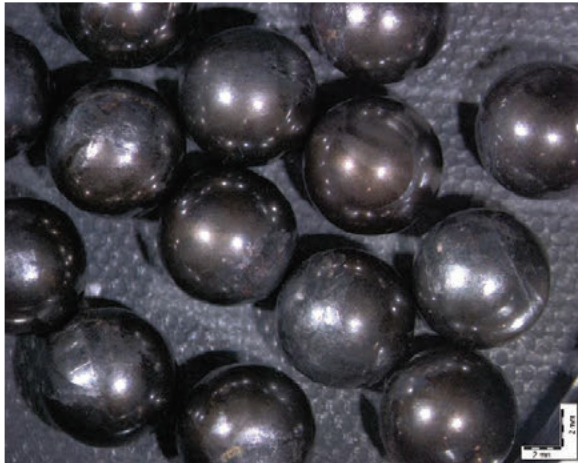
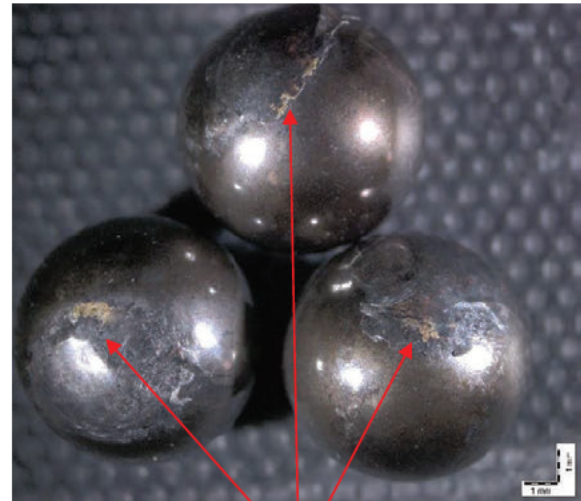
Coked grease with particles of cage are present on all the balls.

In addition, the surface of the balls has an « orange peel » appearance due to abrasion wear.

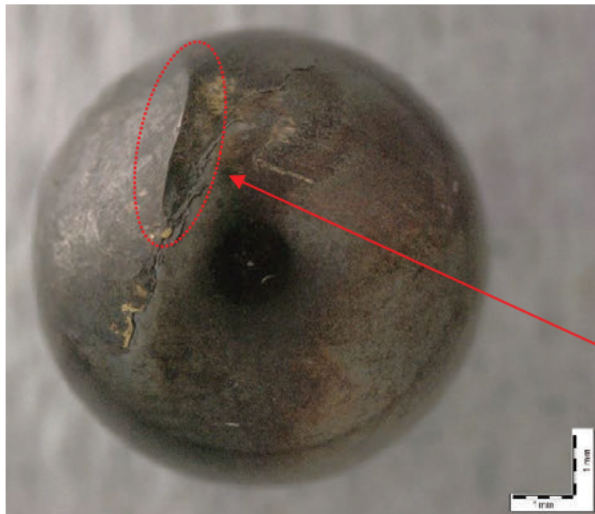
The surface of the **balls**, drive shaft side, show plastic deformation which can cause bad rolling / lock of the balls in the cage. The locking of the balls leads to the pile up of material observed on the raceways of inner / outer rings.

Plastic deformation of the ball surface which can cause bad rolling / lock of the ball in the cage.

The locking of the ball leads to the pile up of material previously observed on the raceways.

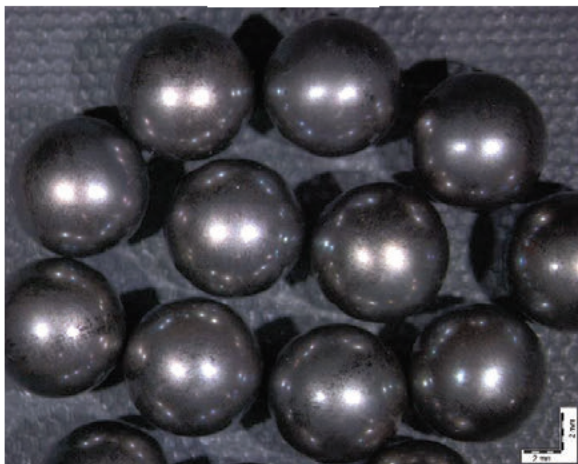
The surface of the balls has an « orange peel » appearance due to abrasion wear.

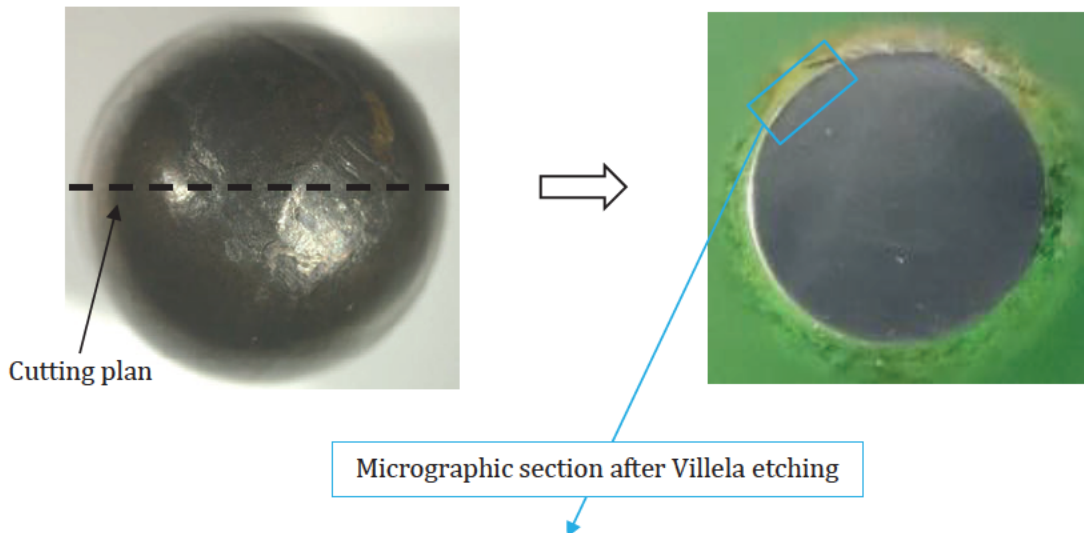
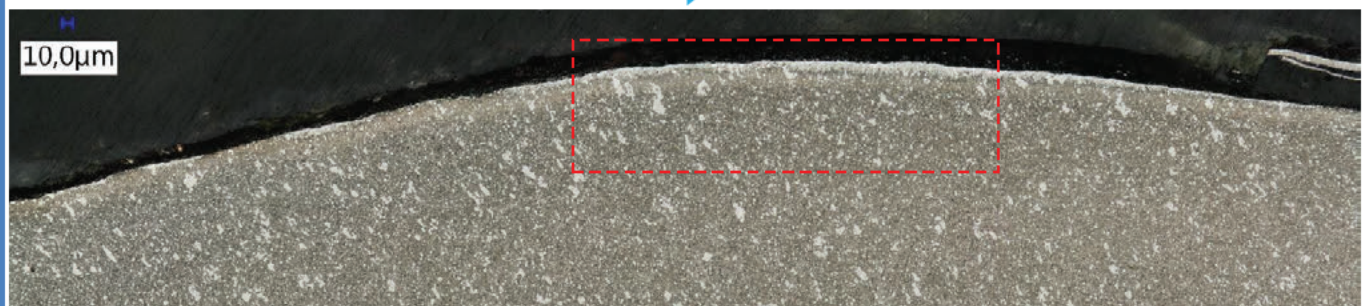
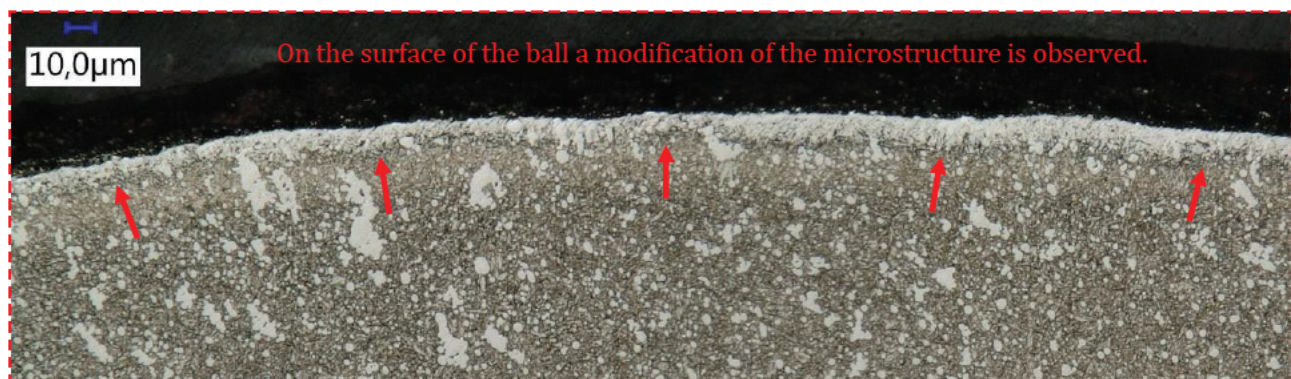
The presence of plastic deformations seems to show a modification in the properties of the material. To support this information, a micrographic section is made on a ball (drive shaft side) having a plastic deformation, to observe the microstructure.

The tempering temperature of the balls material and also inner/outer rings ( ) is about 140°C.

Following this observation, we can say that the bearing reached temperatures of a least 140°C, which resulted in a loss of mechanical properties of the material, as illustrated by the modification of the microstructure.

This loss of mechanical properties resulted in the observed plastic deformations observed on balls and also on the raceway of the inner ring and outer ring, drive shaft side.

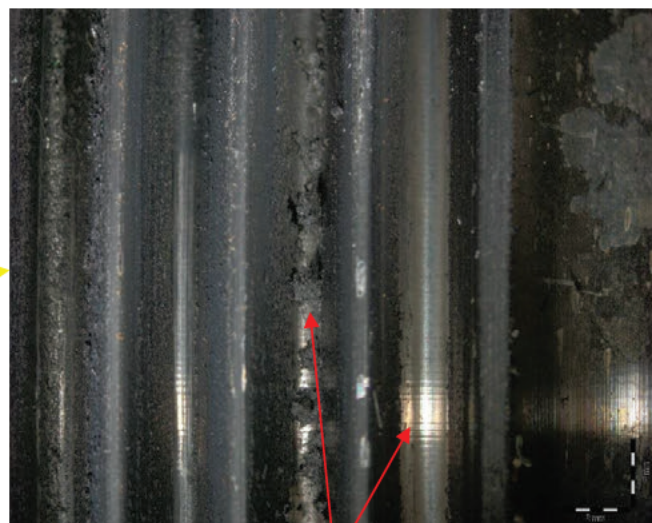
In the thread (360°) of the **driving pulley**, belt residues are found and surface oxidation is observed. This damages are probably due to overheating resulting from the locked rotation of the pulley.

Black residues are found in the thread (360°), probably belt residues. In addition, surface oxidation is observed, probably due to overheating.

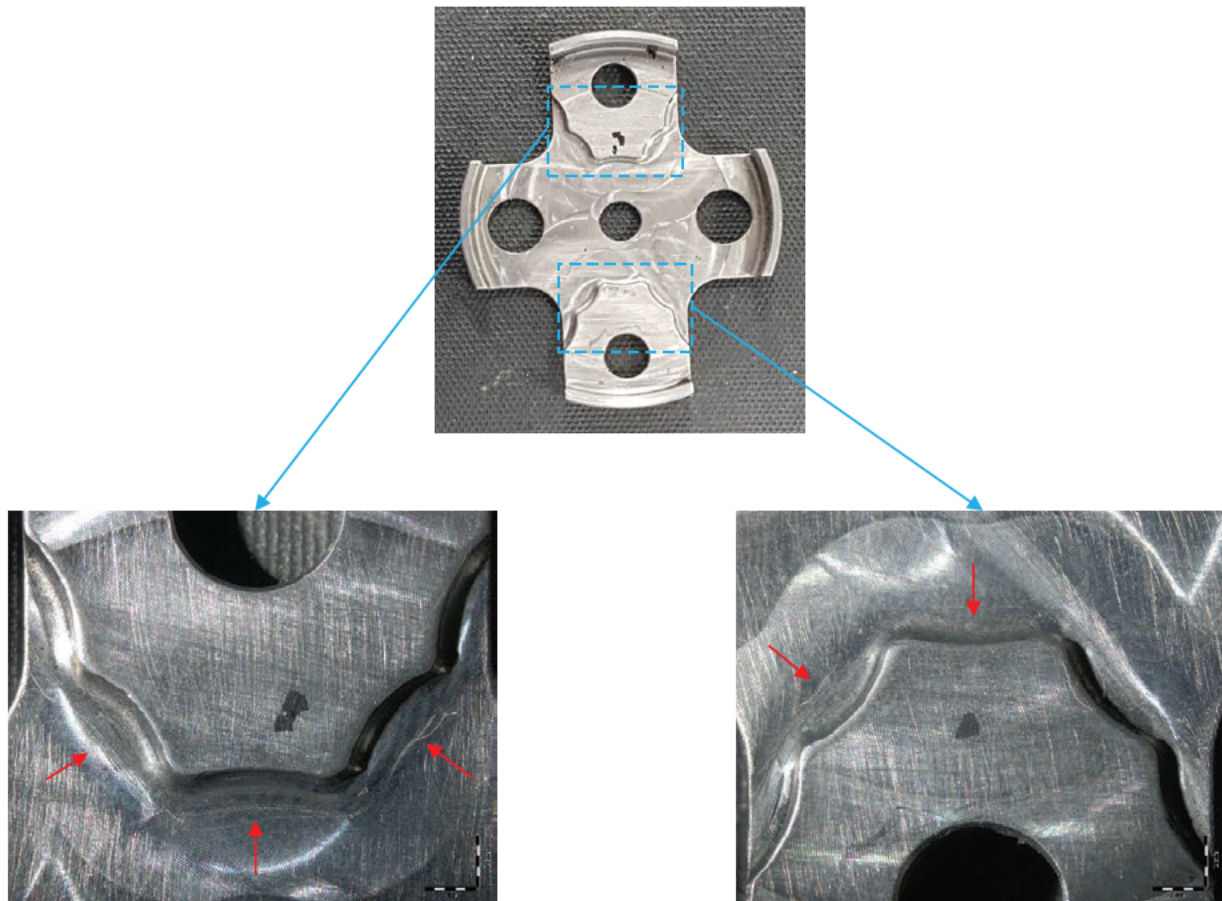
Slight scratches are observed

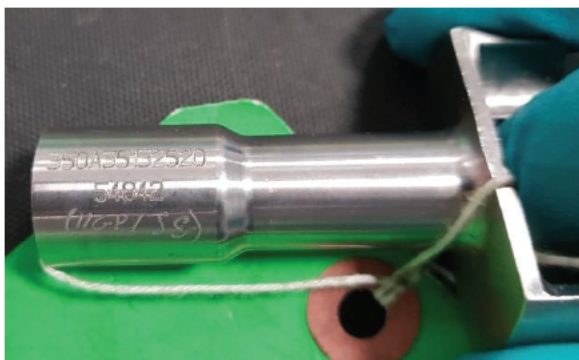
No damage observed on the drive shaft.
