# **NATIONAL TRANSPORTATION SAFETY BOARD**

## **Attachment 1 - Metallurgical Report**

**ENG20LA046**

**Spring Creek Aviation LLC / Donalsonville GA, USA / Thrush Aircraft 510G (registration N6216K)**  
**METALLURGICAL REPORT**

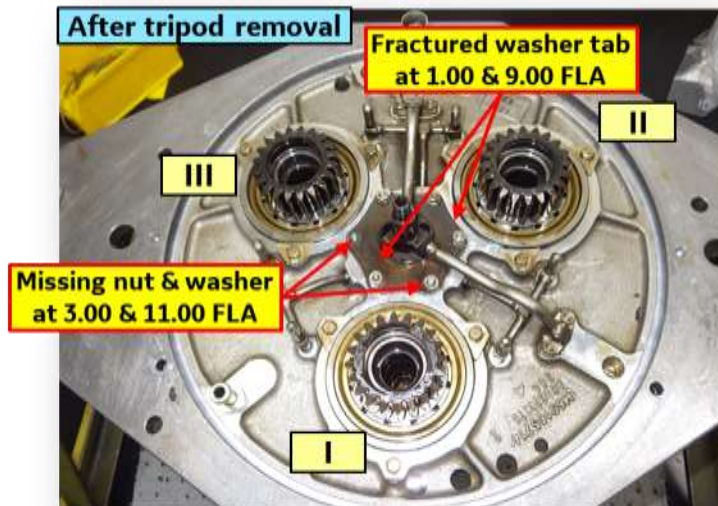
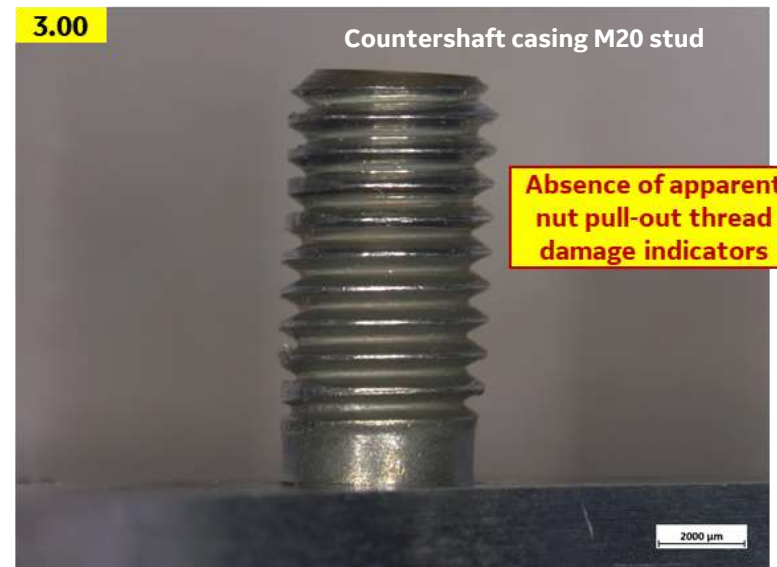
Reported missing two (2) M5 nuts and two (2) securing tab washers at locations 3.00 and 11.00 (ALF) during RGB disassembly

- Thorough examination indicated the following
  - Flange side edge/face contact pattern appears to be similar irrespective of clockwise position, hence supposing washer tabs were initially secured.

- Measurements of the axial displacement of M20 studs of countershaft casing was shown to be within drawing tolerance at 3.00 o'clock location (FLA) only, while exceedance was the greatest at surrounding locations 1.00 and 5.00 (FLA). This feature might indicate a higher load-carrying as a result of either missing or loosen M5 nut, despite the presence of through crack of countershaft casing at these locations might also have contributed to the displacement.

- Moreover, the relative elongation of stud was measured to be the highest at 11.00 (7.5%) and 7.00 (6.4%) compared to other locations ( $\leq 3\%$ ), the same trend being noticed for axial flatness exceedance of TQ-meter flange (CMM) supporting uneven repartition of axial pulling force/load in fwd direction.

**=> In light of the above and the absence of apparent pull-out damage indicators on the stud thread at 3.00 location (neither bending nor distortion component), the assumption of missing M5 nut at location 3.00 prior to event occurrence is concluded as pertinent.**

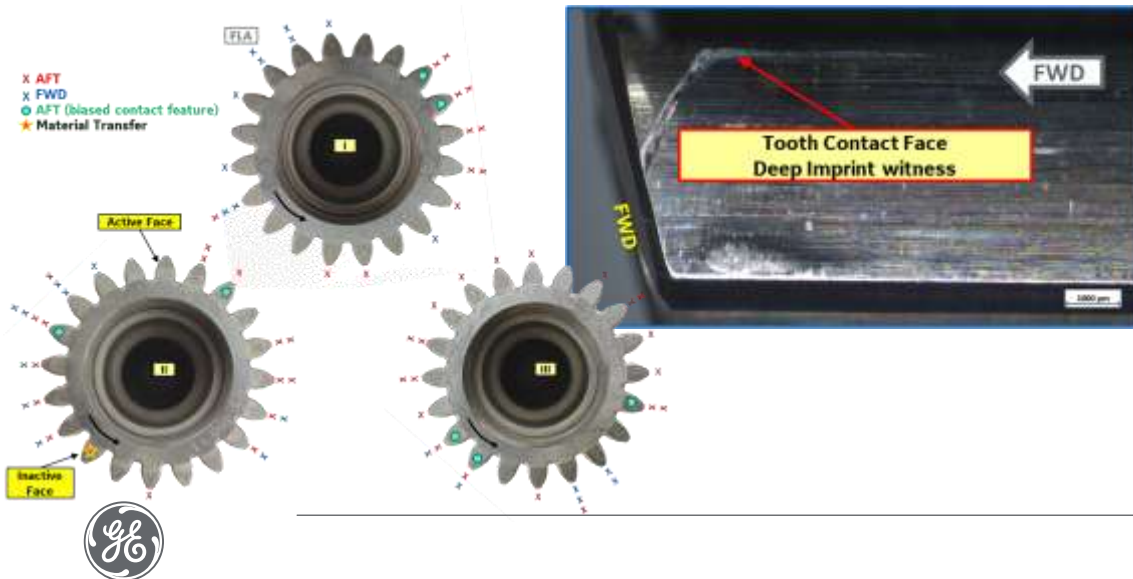
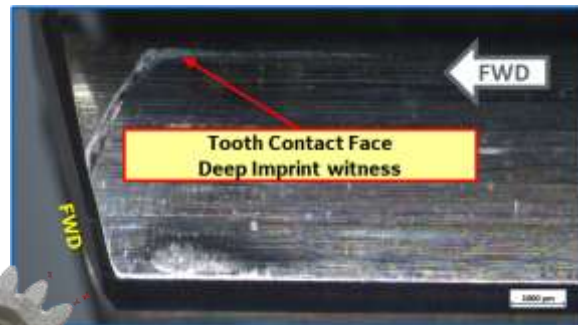
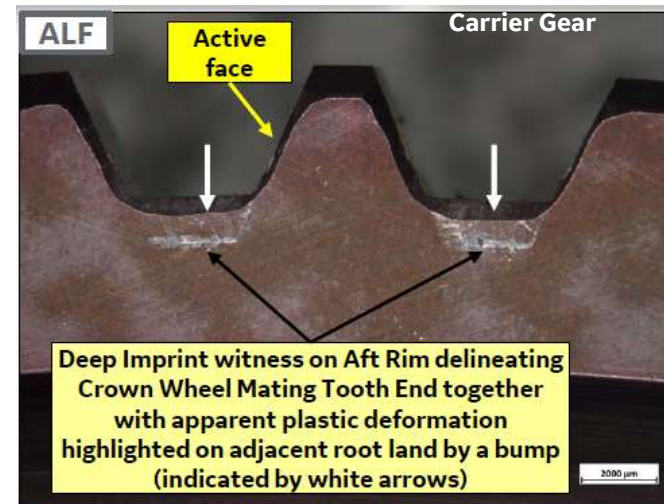
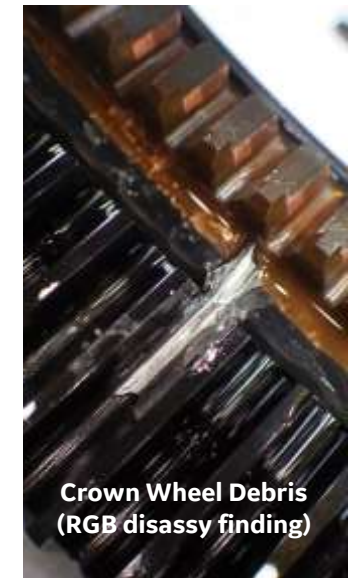
**Active faces** examination revealed the presence of **higher contact stress distresses 360°**, irrespective of the examined gear & RGB position

- **Damage map summary in FLA clocked positions: most distressed/rated segment appears to be synched to the single evidence of material transfer demonstrated on gear S/N 1530 (position 2) and compatible with washer &/or M5 nut (or combination thereof)**
- **Deeper imprint witnesses on gear S/N H1515 fwd end (position 1)** were not correlated to conclusive indications accounting of material transfer (**nut ingestion**)
- Note that the presence of biased contact imprints on active faces aft region might support radial misalignment with Crown Wheel

- The hypothesis of **Domestic Object Damage DOD** (i.e. liberated M5 nut) is further corroborated by the extensive work conducted on engine debris with a particular attention paid to **metal debris found on Crown Wheel** adjacent to local distressed observed on the fwd groove.
- Outcome is that parent material was **determined to be consistent with M5 nut material**, while the total mass of debris matching M5 nut (including a partially damaged and recovered M5 nut) appears to exceed the average representative mass of random damage-free nut, thereby indicating that a **M5 nut had to be crushed into the gearing (in line with 1 missing nut out of 22 expected in RGB after recount)**
- **Crown Wheel and Carrier Gear** also display unusual condition that supports **contact distress**

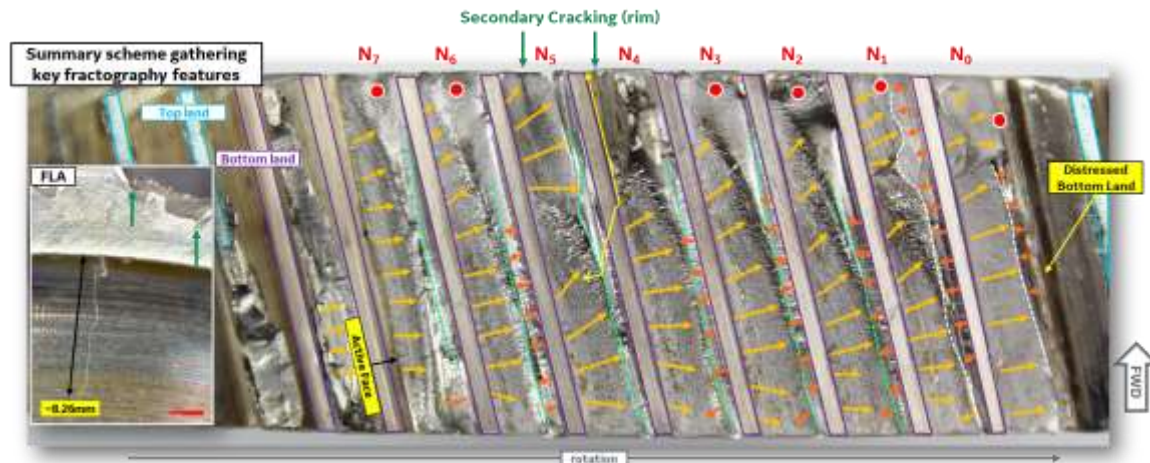
### Stage 1 Planetary Gear S/N 1815, position 1 – 12.00 o'clock

Visual examination revealed **8 consecutive fractured teeth (numbered from  $N_0$  to  $N_7$ )** in the vicinity of root land/radius area with apparent **fatigue macro-features indicating primary origin on active/loaded teeth face**.

- **MPI** enabled to reveal **one (1) indication** emanating from fractured tooth root radius emerging on fwd rim and developing inboard the web ~ 25mm radial length.

- **Fractography** demonstrated **multiple surface-initiated cracking on teeth active faces span in the vicinity of root radius**.
  - Fatigue region morphological features indicate a **high alternating stress propagation** with **coarser fatigue striation pattern** and **secondary cracking** along the propagation direction towards inactive face of the teeth.

- Additionally, a **minor fatigue component emanating from teeth inactive face** was also noted. A narrow band of tensile overload was locally observed when intersecting main fatigue front emerging from active faces in the absence of excessive smearing.

- The **striation density** was assessed and determined to **vary between 50-70k striations/inch** (resolved beyond ~ 0.5mm from crack edge) to **20-30k striations/inch** as the crack progresses, hence **within the range of a higher alternating stress propagation condition**.

- **Crack edge** of all active faces (fractured or not) display common **witness of high contact stress initiation condition** \* emphasized by the presence of significant deformation (original machined lines vanished). Note also the occurrence of numerous secondary cracking underlying the main fracture plane and initiated primarily by ratchet marks and along original machined lines.

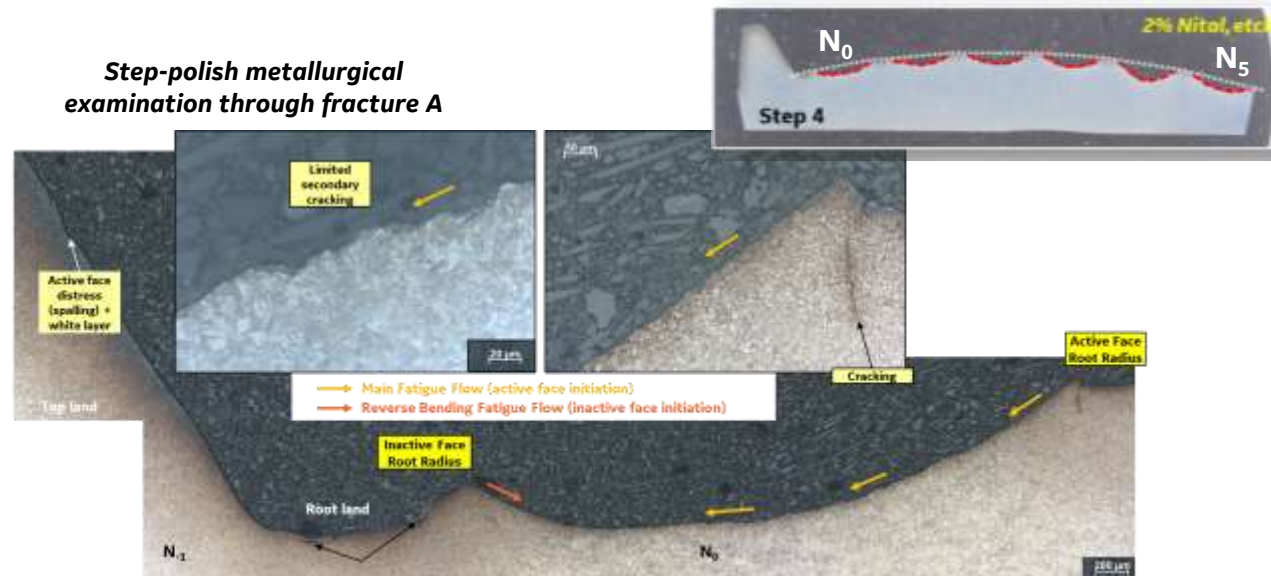
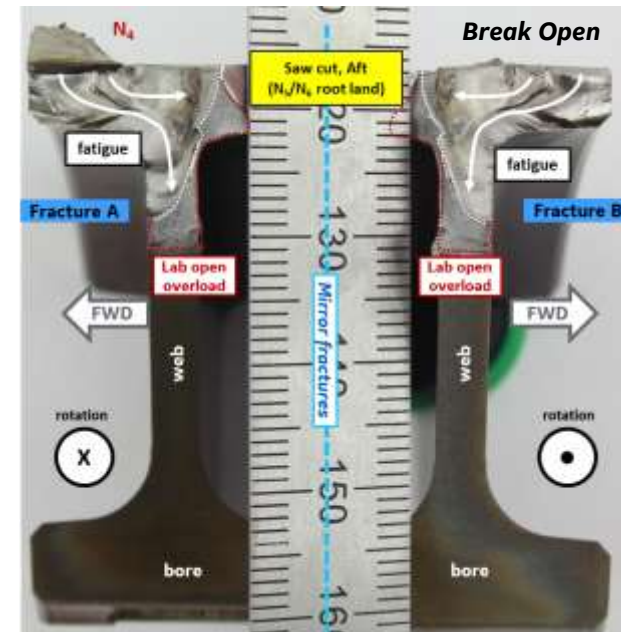
**Lab break open of Planetary Gear S/N 1815 secondary cracking** revealed by MPI between teeth  $N_4$  &  $N_5$  allowed to document the fatigue crack propagation inboard the gear web initiated from tooth  $N_4$  fwd root radius and developing through adjacent tooth  $N_5$  (the extent of smear damages prevented a thorough fractography work).

- **Metallographic step-polishing into Planetary Gear S/N 1815 fracture A** consisting of consecutive teeth from  $N_{-1}$ , i.e. 1<sup>st</sup> “damage-free” tooth adjacent to  $N_0$ , to  $N_4$ ) **did not reveal any material microstructural anomalies of base material** (*axial polish perpendicular to teeth axis - from mid span toward aft side of the gear teeth*). The apparent increase of secondary cracking density and crack-entry steepness from tooth  $N_0$  to  $N_7$  noted during surface fractography was further confirmed as well as the **trans-granular nature of crack propagation**.

- Worth mentioning the surface distresses specifically observed on root land adjacent to 1<sup>st</sup> fractured tooth  $N_0$  with the alteration of its original dimensions and microstructure (thin superficial white layer, plastic deformation) implying contact with top land of mating Sun Gear.

- The 1<sup>st</sup> “damage-free” tooth shows relatively thick and even white layer on its top land as well as thin and discontinuous white layer and surface-initiated cracking/spalling on its loaded face only.

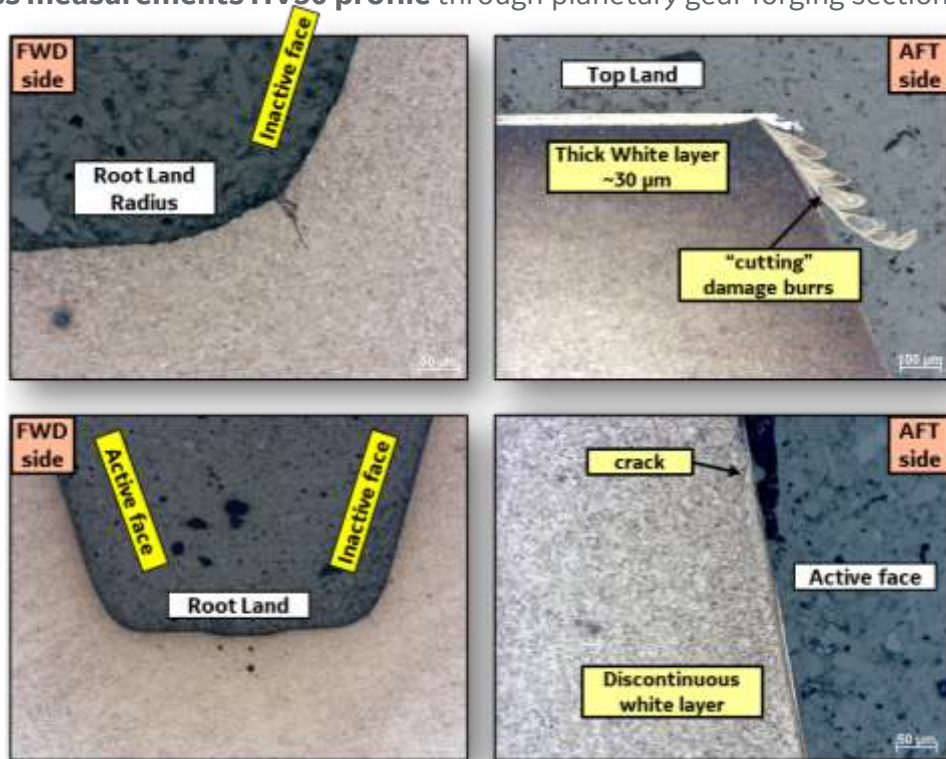
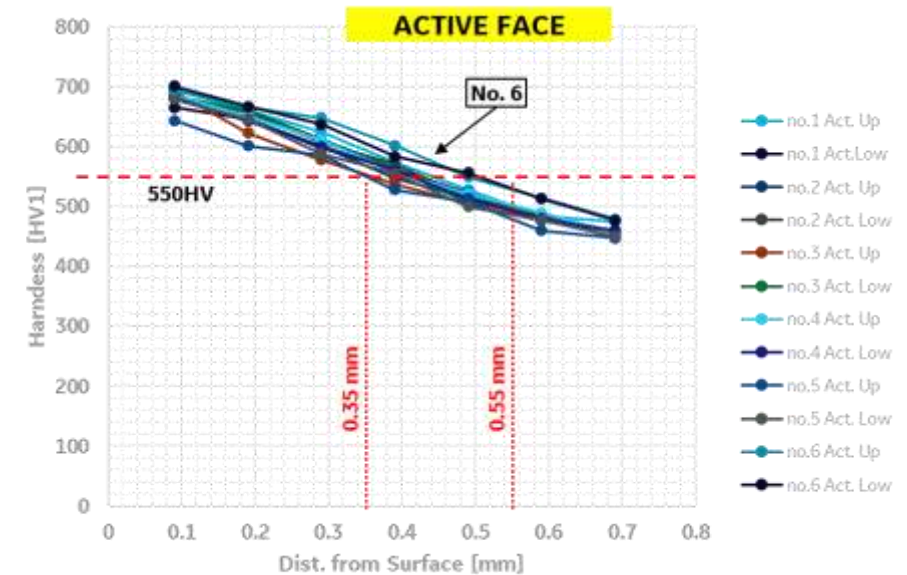
Metallurgical cut-up prepared on segment 4.00-5.00 away from the main fracture and damage zone indicated comparable distress on contact/loaded faces, i.e.:

- surface-initiated cracking and spalling)
- top land (thick and even white layer with presence of “cutting damage” burrs on edges)
- numerous occurrences of crack initiation on root radii of inactive faces
- **CHD measurement results** conforming to requirements for new-make parts irrespective of measurement location.
- **Micro-hardness measurements HV30 profile** through planetary gear forging section **did not reveal abnormality.**

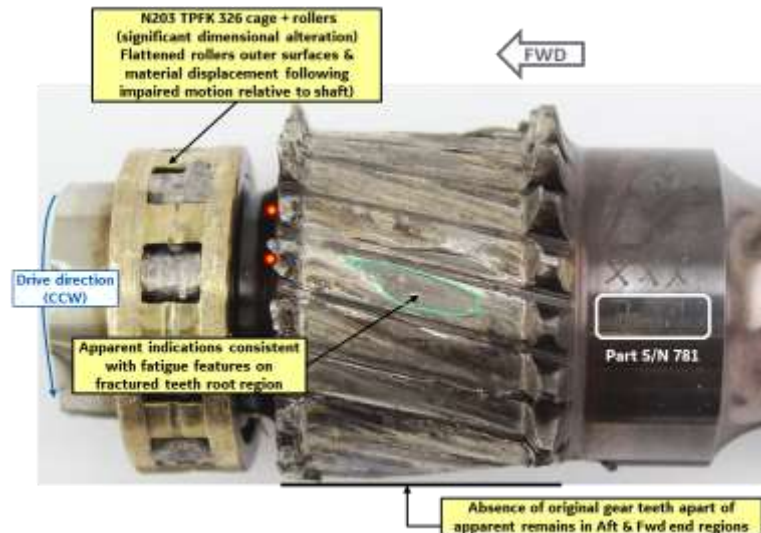
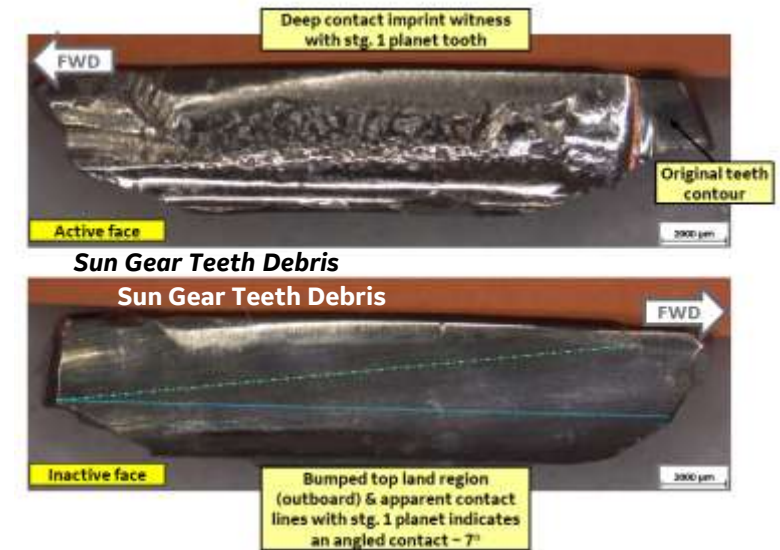
### Sun Gear S/N 781

Visual examination indicated the **absence of teeth 360°** (root land fractures) and apparent **fatigue macro-features emanating from the active/loaded face** on a limited number of teeth in the absence of secondary damages.

- The extent of wear on spline active faces does not appear to be excessive compared to average single engine application RGBs with comparable life.
- The aft spline coupled to the PT rotor shows both bending and torsion components measured to be ~ 21° and 4°, respectively.

- **MPI** did not reveal any interpretable indications
- **Fractography** demonstrated comparable features to those reported for Planetary Gear and consisting of

- **1) multiple surface initiation** with apparent indications of **high contact stress condition** with severe deformation and material displacement on crack edges

- **2) high alternating stress propagation condition.**
- A limited number of **Sun Gear liberated teeth debris were recovered** and emphasized
  - **1) high contact stress** with the presence of **planetary Gear teeth contour imprint witness**

- **2) apparent indications of contact mismatch with radial offset** documented on inactive teeth faces that might suggest a **sudden TQ-transfer shock.**

- **Microstructure and micro-hardness** were demonstrated to be conforming to new-make requirements.

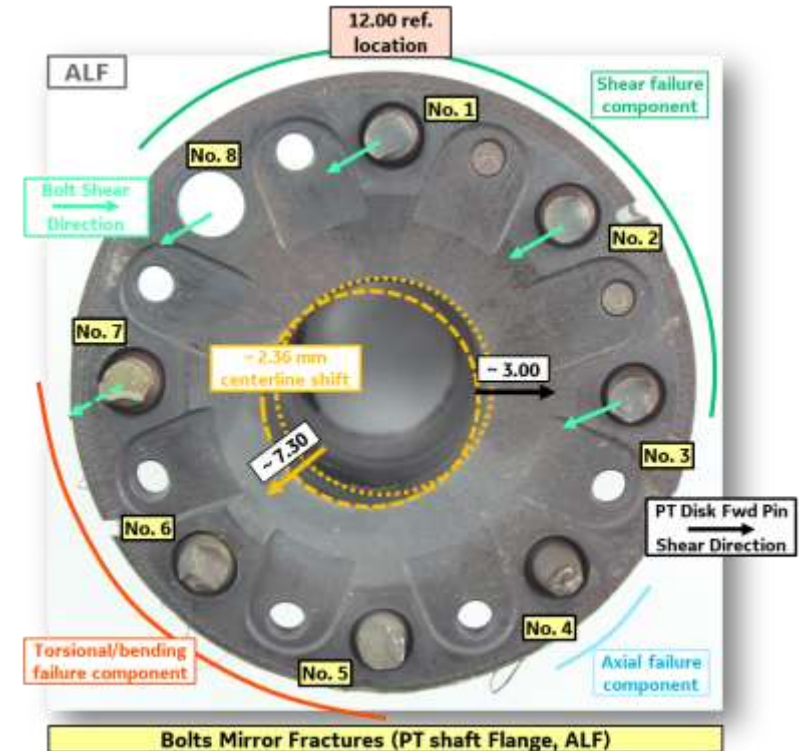
- **Altered circularity and outboard deformation from bending** is observed on fwd end ~ 7.30 location (FLA) in line with Quill-Shaft spline condition (connected to Quill-Shaft through spline coupling)

- Shaft Aft End also displays deformation component at ~ 7.30 (ALF) and relates to the PT disk fwd pin deformation direction
- **Mapping of seized T-head bolts fracture aspect features (ALF) allowed to demonstrate to presence of two (2) main failure component, i.e.**

- Shear / angled 45°: primarily from 3.00 (bolt no. 3) to 9.00 (bolt no. 7)
  - Torsional/bending / flatter: from 6.00 (bolt no. 5) to 7.00 (bolt no. 6) ⇔ associated with ovalized flange bolt hole (tangential direction to rotation)

- Axial / necking: at 5.00 o'clock only (bolt no. 4)
- Flange contour also indicates greater damage and deformation between bolts no. 4 (5.00) to no. 7 (9.00) supporting higher axial load component

- In light of the above, a **damage sequence might be derived** as follows: **1) shear seizure** of bolts no. 3 to 8 (3.00 to 11.00 o'clock); **2) torsional overload** of bolts no. 5 to 7 (6.00 to 9.00 o'clock) and **3) axial pull with apparent necking and overload**

Severe damages 360° and apparent rub marks ~180° FLA. Two (2) bolt nuts in position (no. 4 & 7), no. 4 being removable without applying force

- **Fractured Fwd pin sheared outboard** at ~ 3.00 o'clock ALF and **blue tinted**
- Bolt holes show features consistent with observations made on PT shaft flange & seized T-head bolts

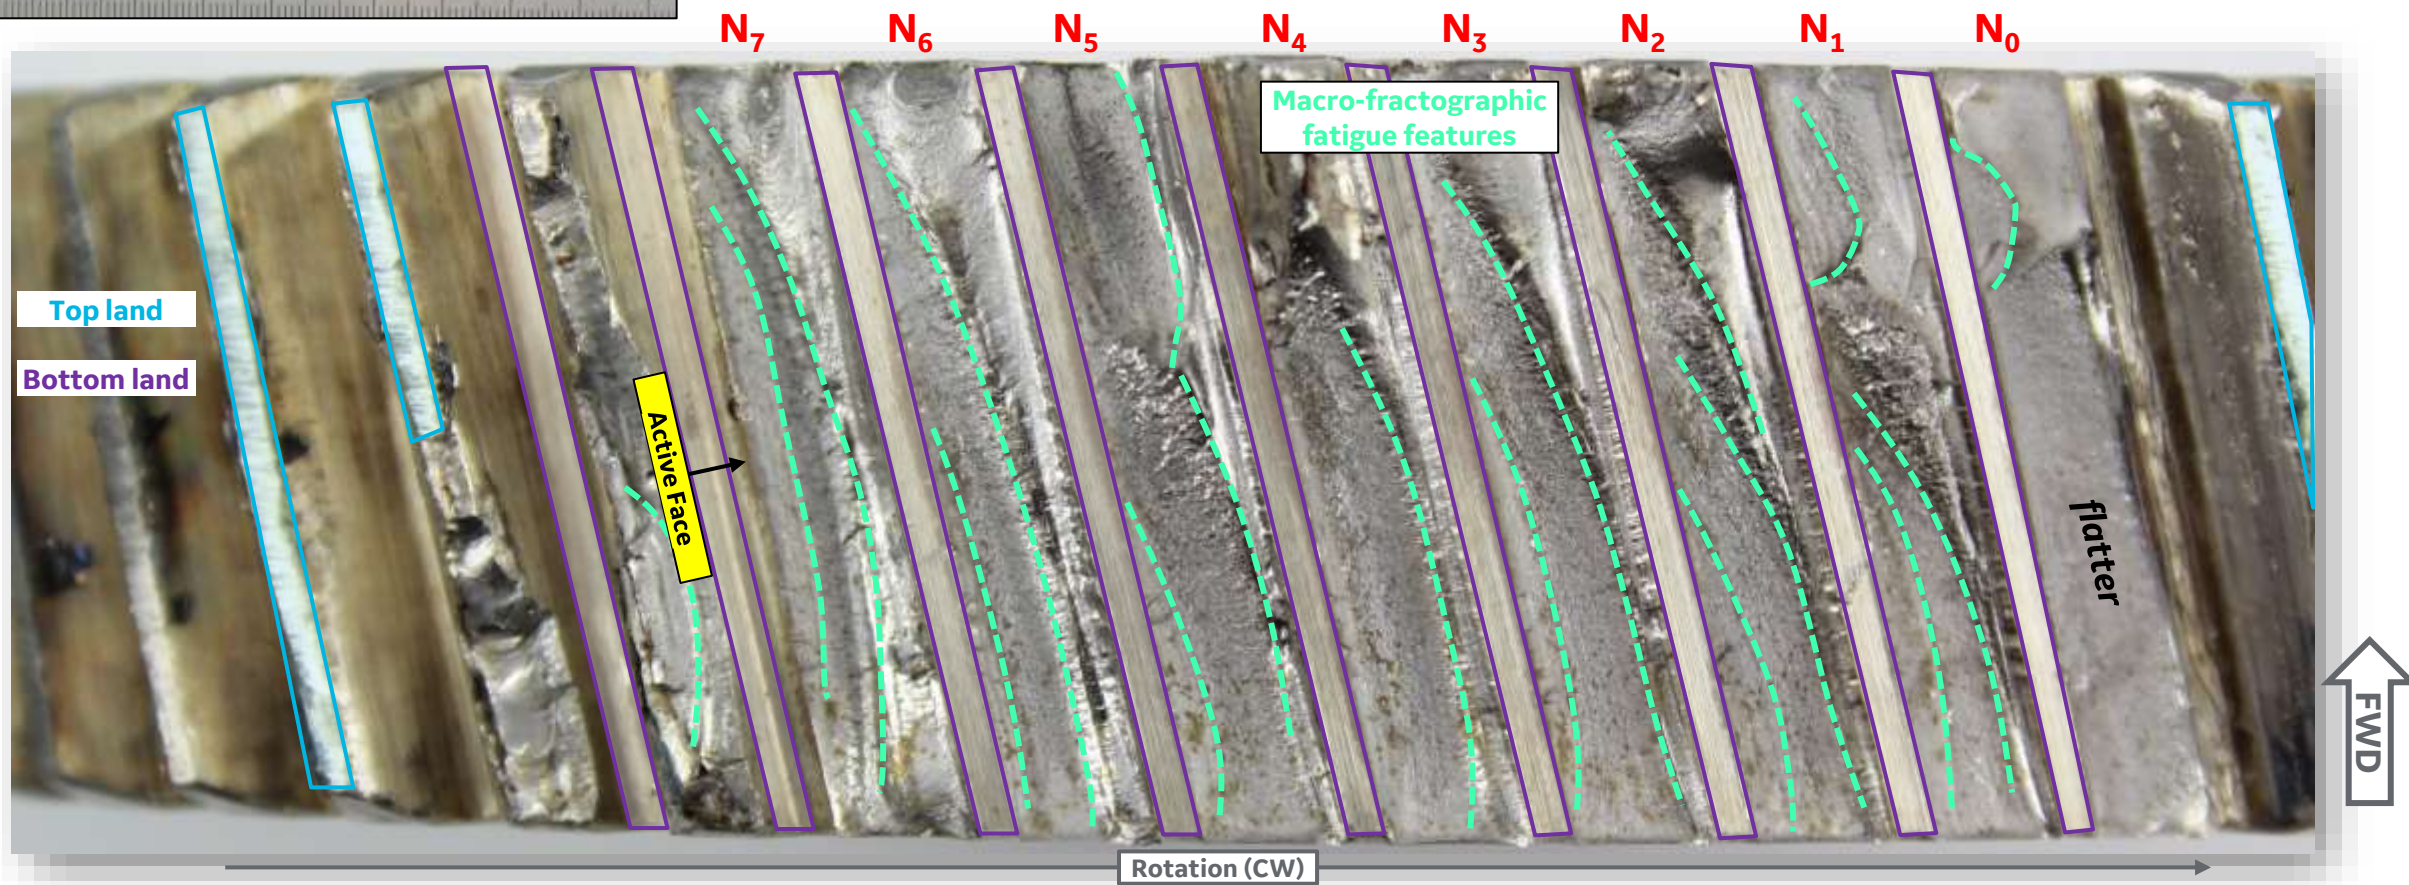
# Visual Inspection (as-cleaned, A1815, pos. I)

- Macro-fractographic features indicating fatigue fracture emanating from root area on active faces of teeth (multiple origin) – note flatter fracture on  $N_0$
- Smoother initiation region & transition to greater apparent topographical changes along crack propagation ( $\Leftrightarrow$  cycles)

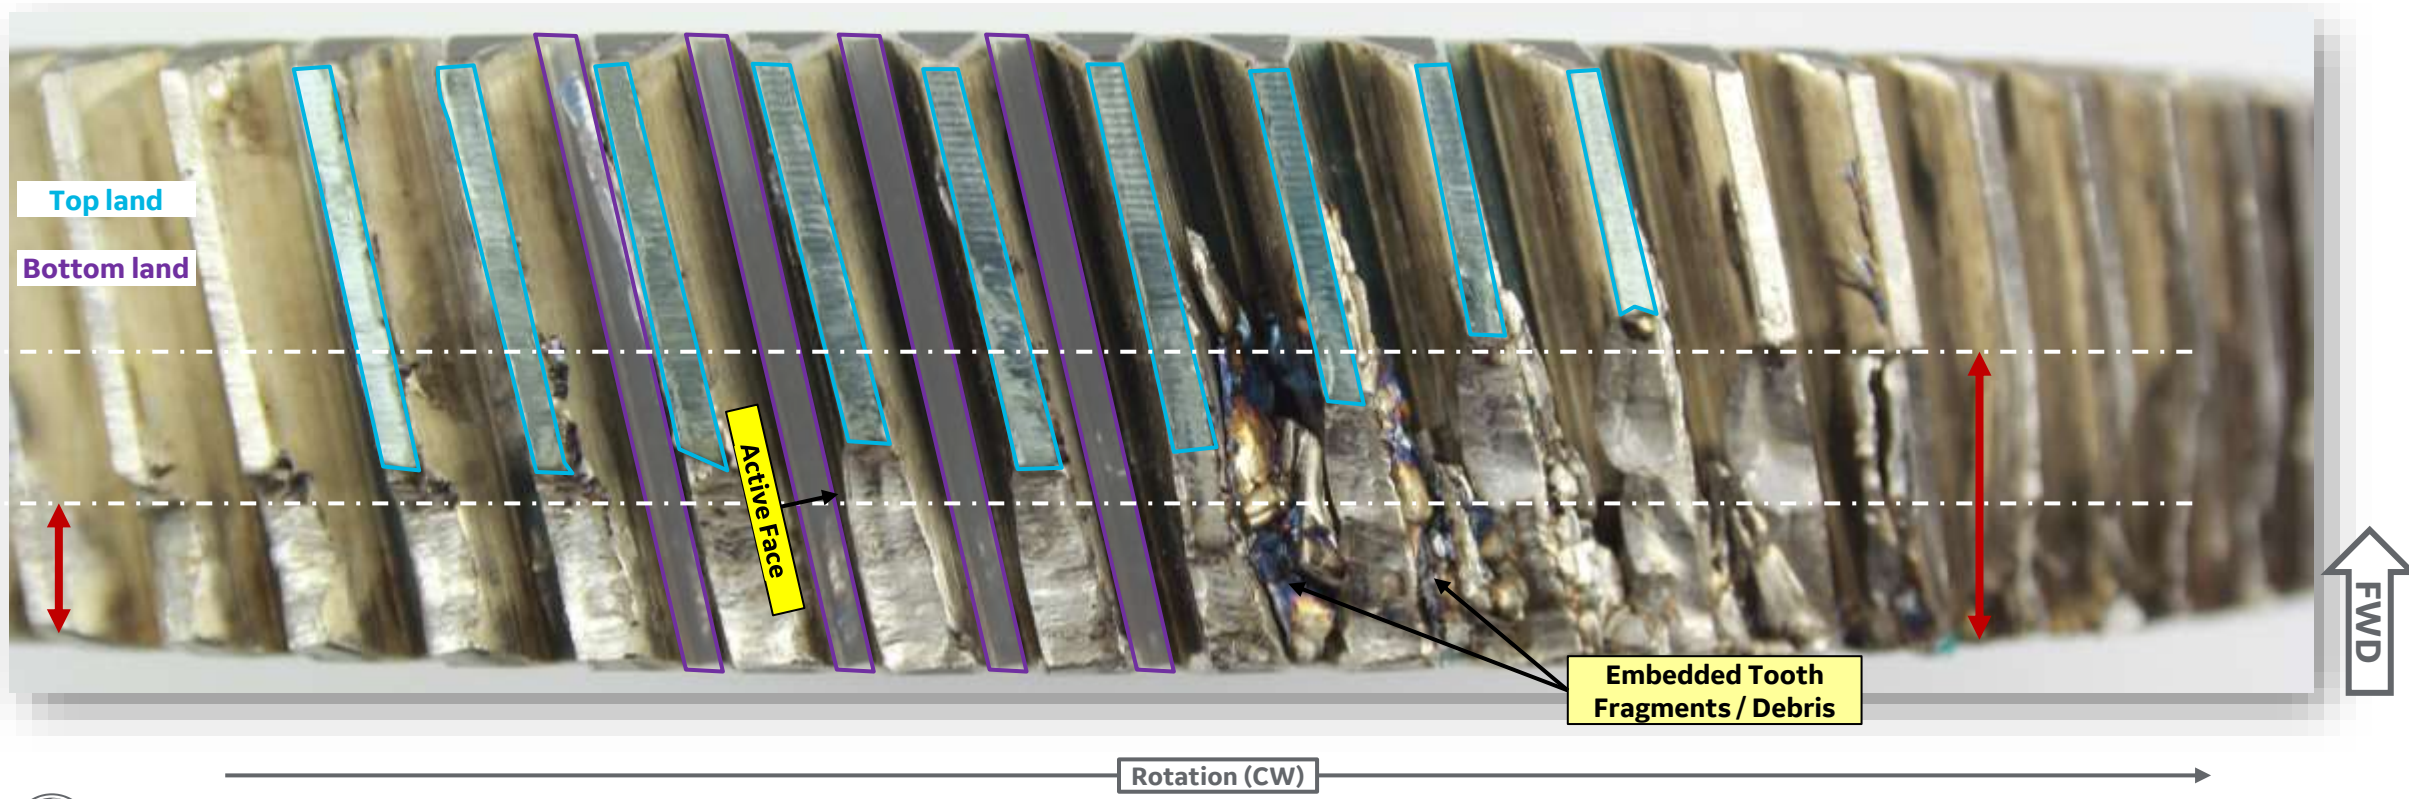
# Visual Inspection (as-cleaned, A1818, pos. II)

- Expanding span of teeth damages towards forward direction  
⇔ wheel rotation direction
- Secondary damages

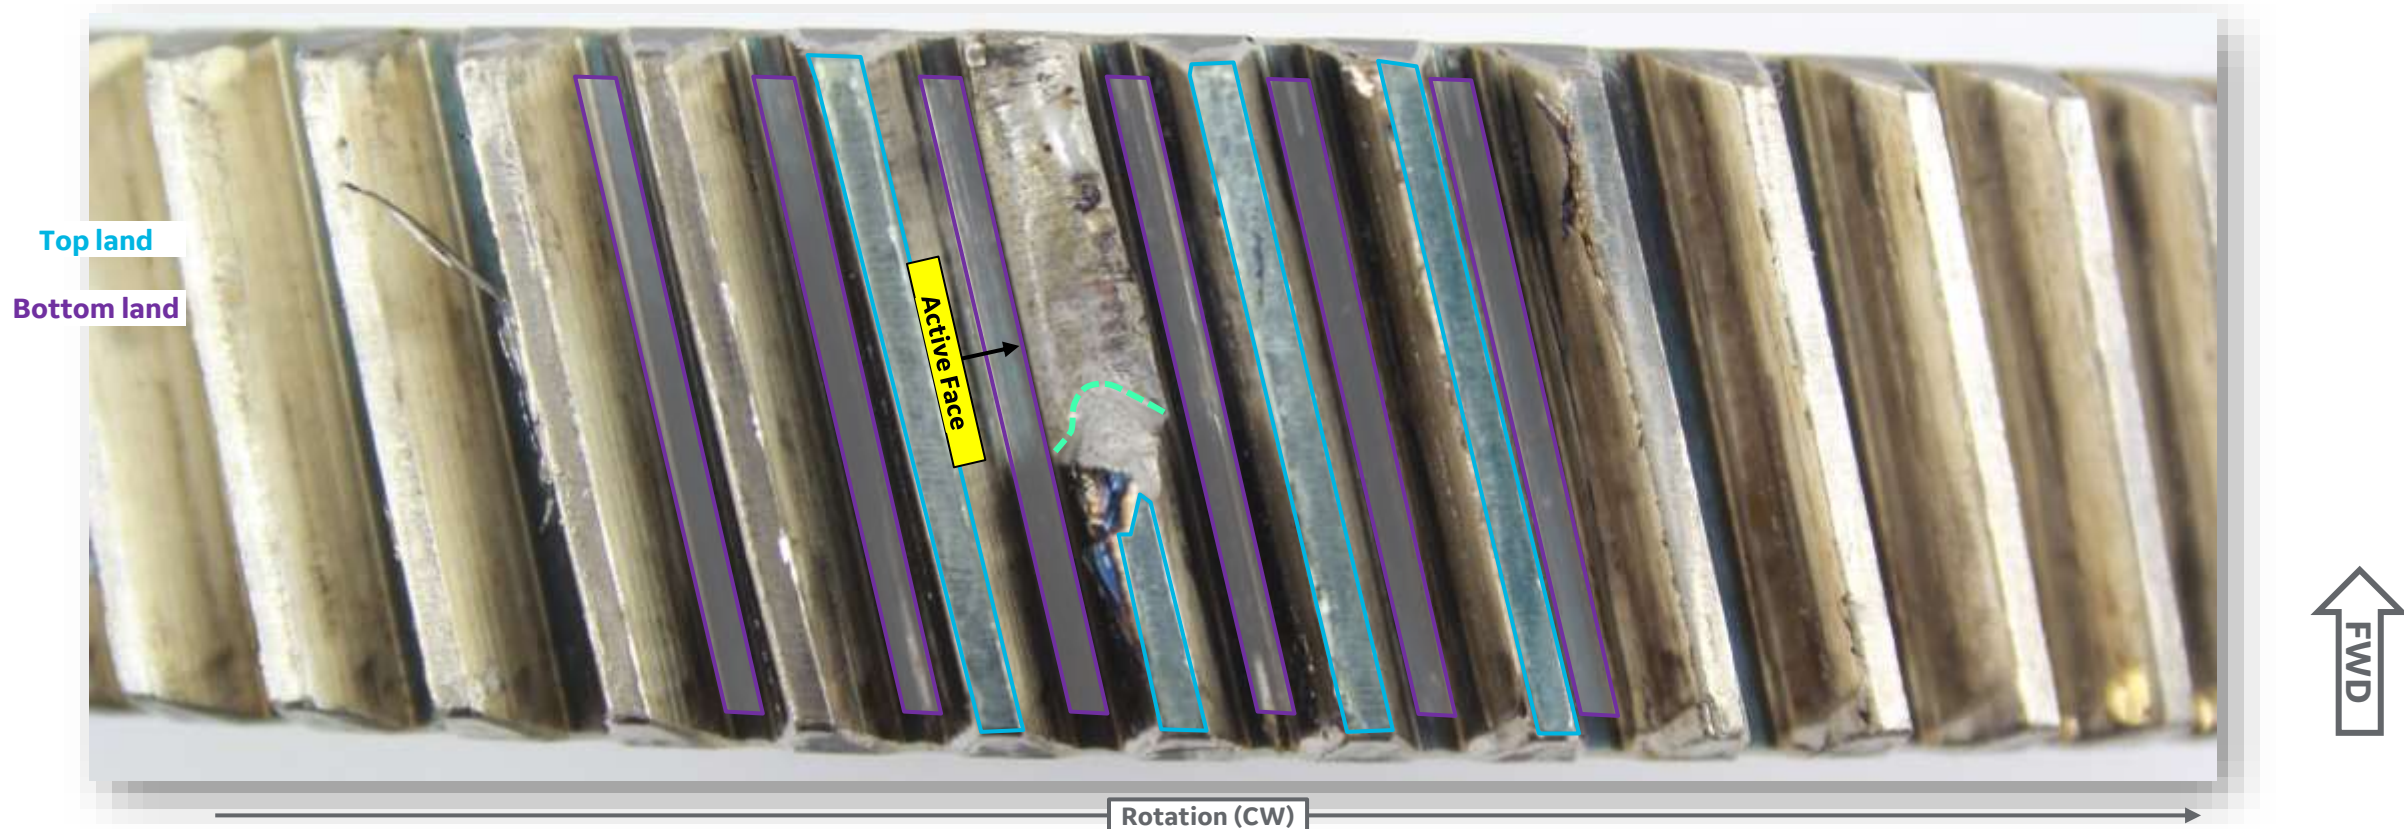
# Visual Inspection (as-cleaned, **A1838**, **pos. III**)

- Partial tooth liberation under mid-chord plane ( $>$  root radius) surrounded by teeth with minor distresses comparatively
- Secondary damages

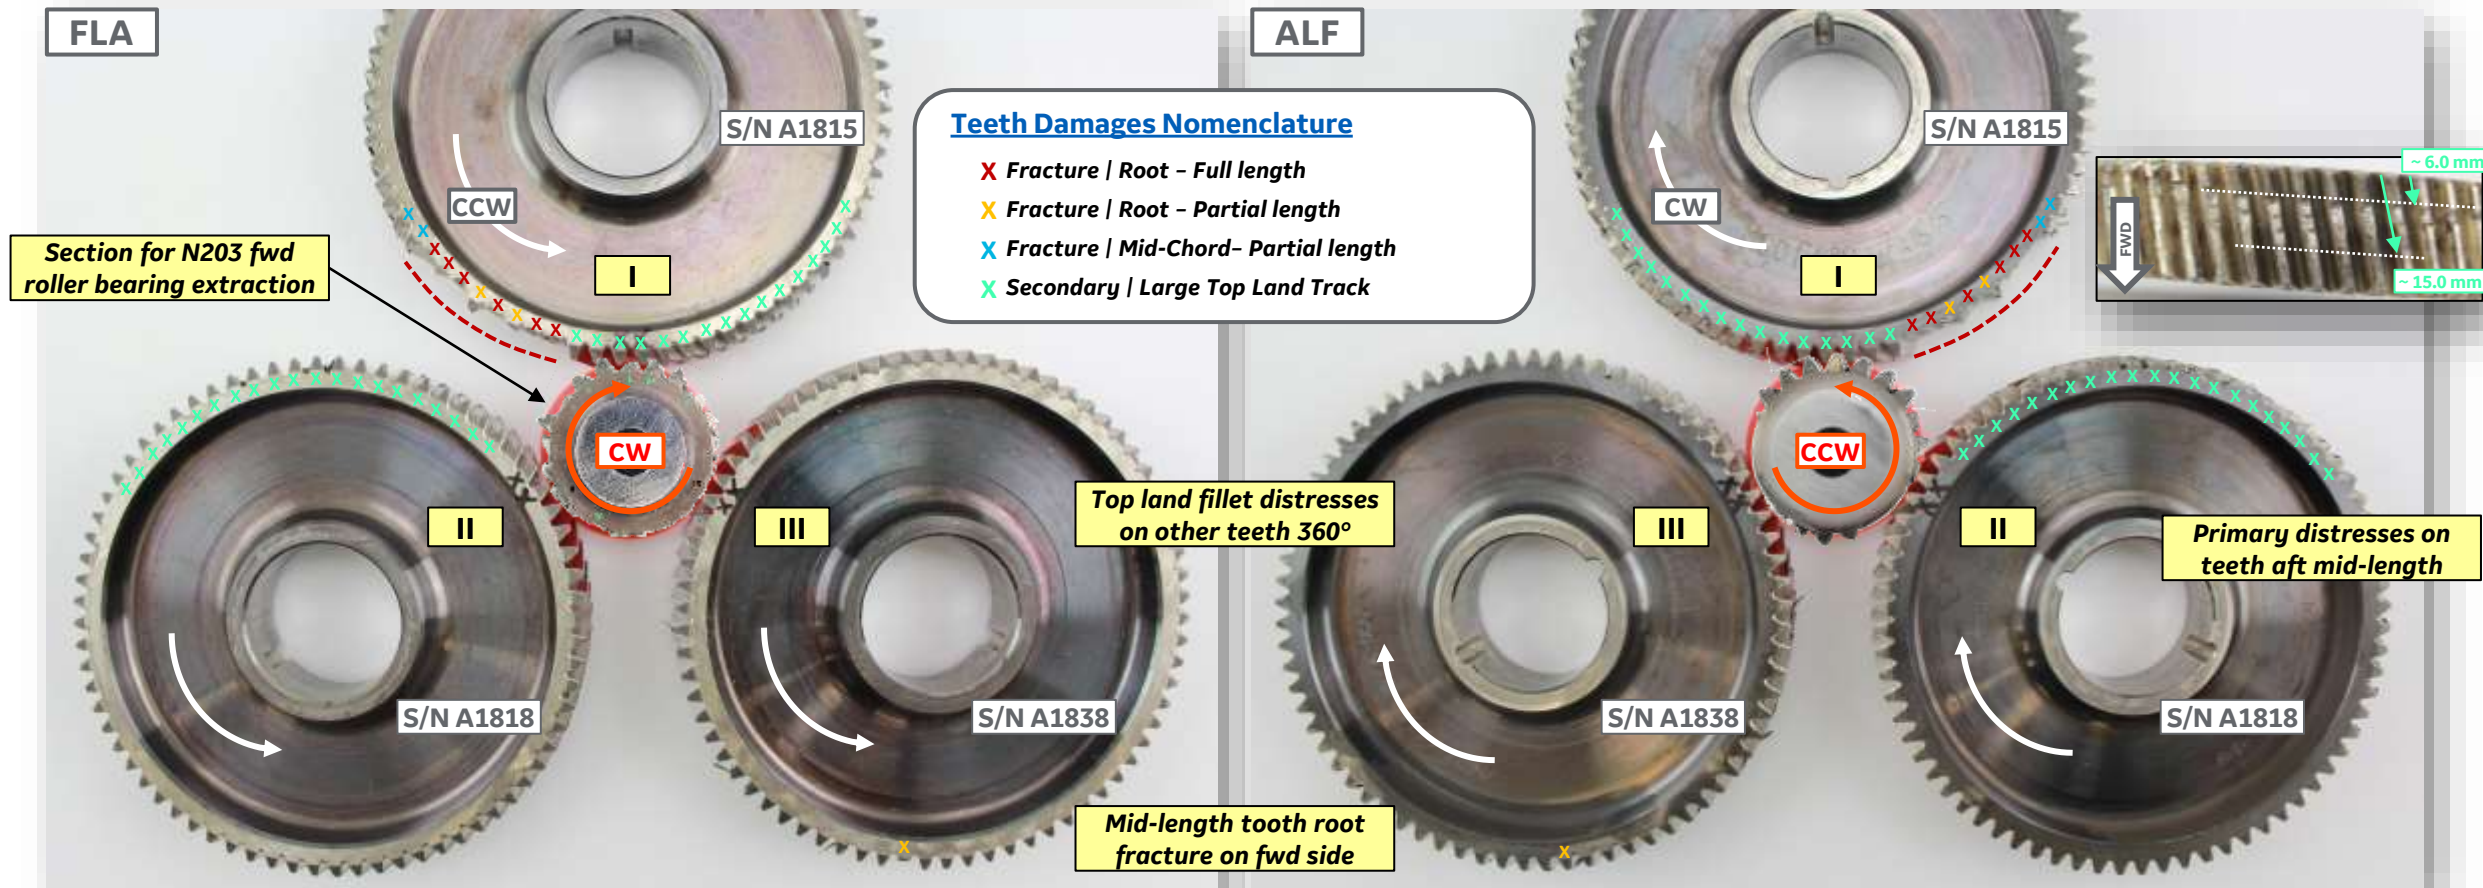
**Countershaft wheels clocking** (quill-shaft sun gear center position - XXX marking coincides with position I wheel XX marks per dwg. definition in initial assy condition \*)

- **Position 1:** Primary damages with eight (8) adjacent teeth fractured in the root area
- **Position 2:** Secondary fractures & Top Land Track + Inter-teeth Debris
- **Position 3:** One (1) tooth fracture (loose Inner Ring of mid-shaft roller bearing PLC 46-8-4) + Inter-teeth Debris

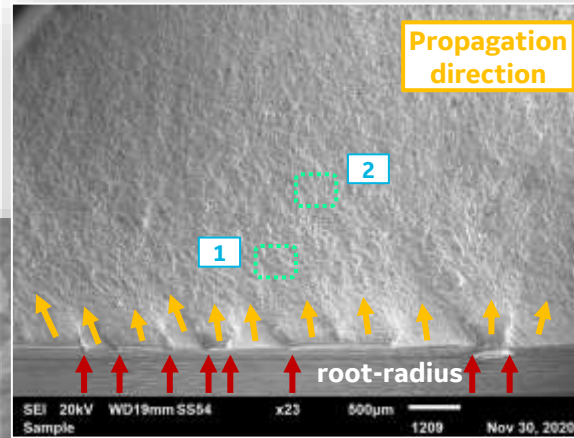
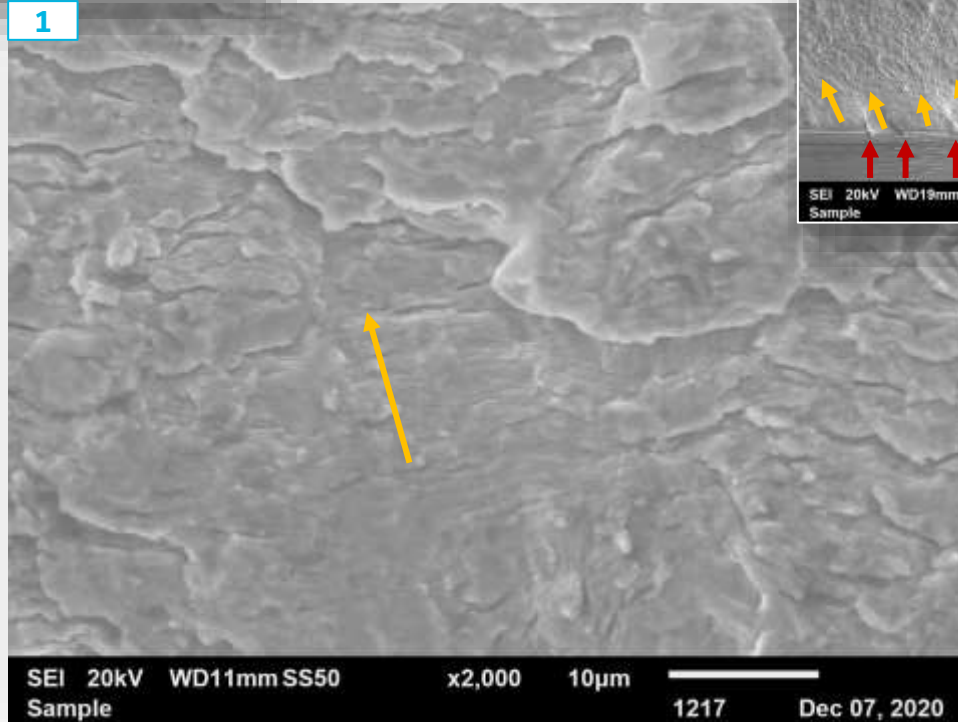
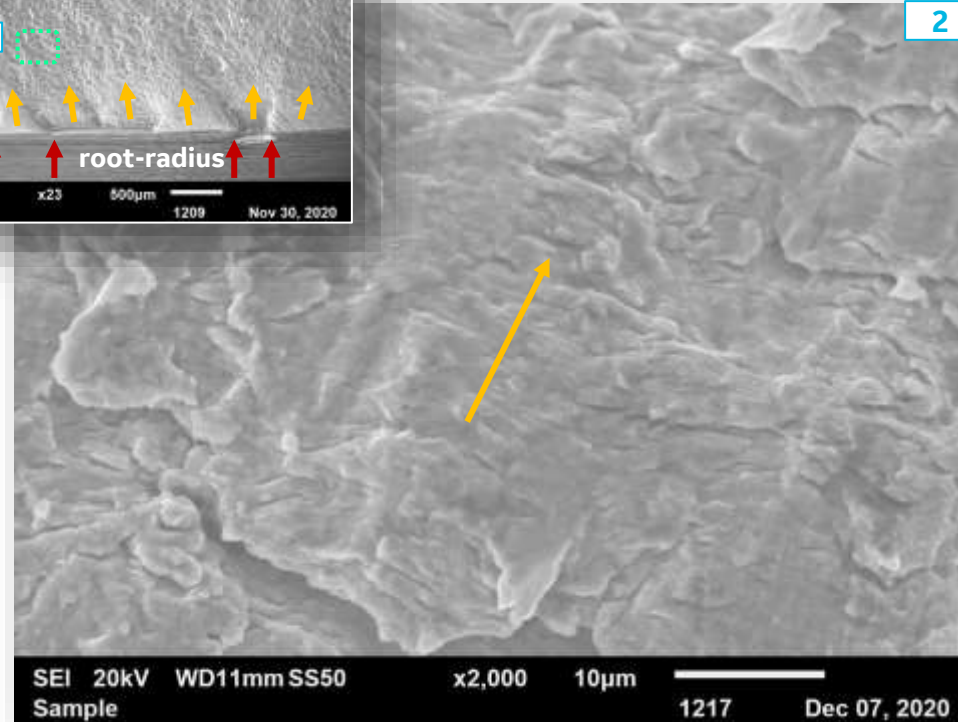
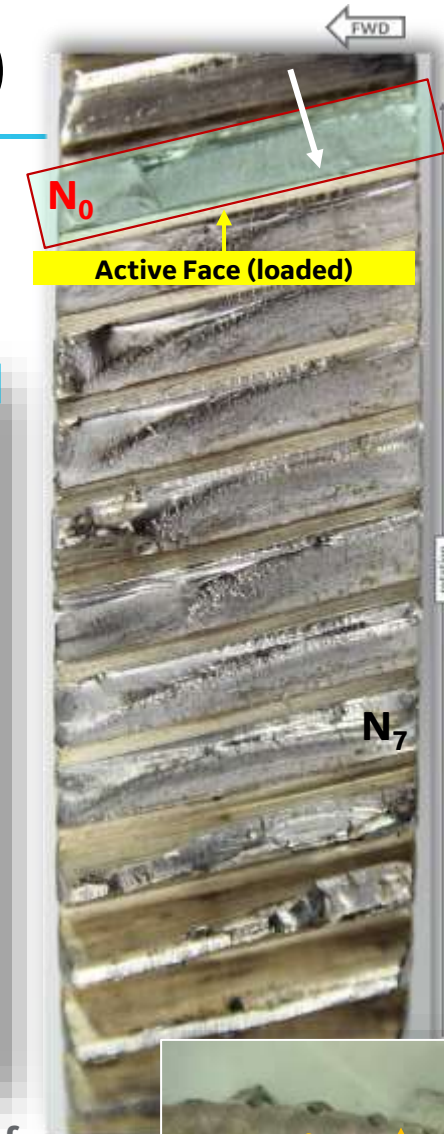
# Fractography (wheel S/N A1815, tooth N<sub>0</sub>)

- ❑ Multiple surface initiation (depicted by orange arrows) along original machined line in the vicinity of root-land radius to contact face lower region (red arrows underline ratchet marks)
- ❑ Relatively coarse striation pattern (high alt. stress condition) & apparent secondary cracking

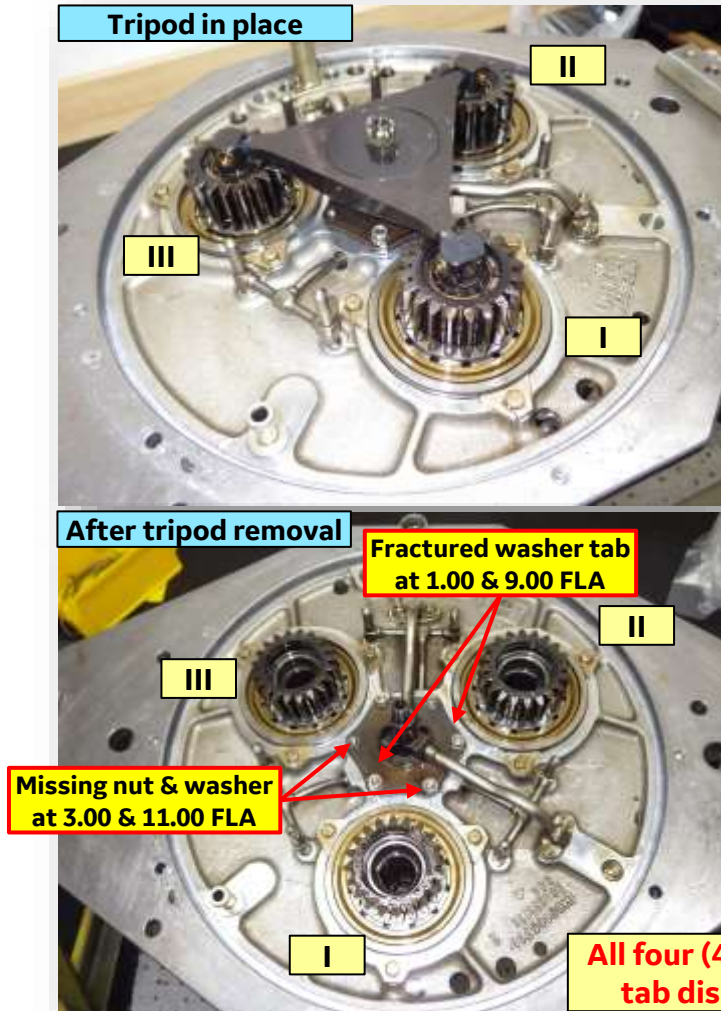
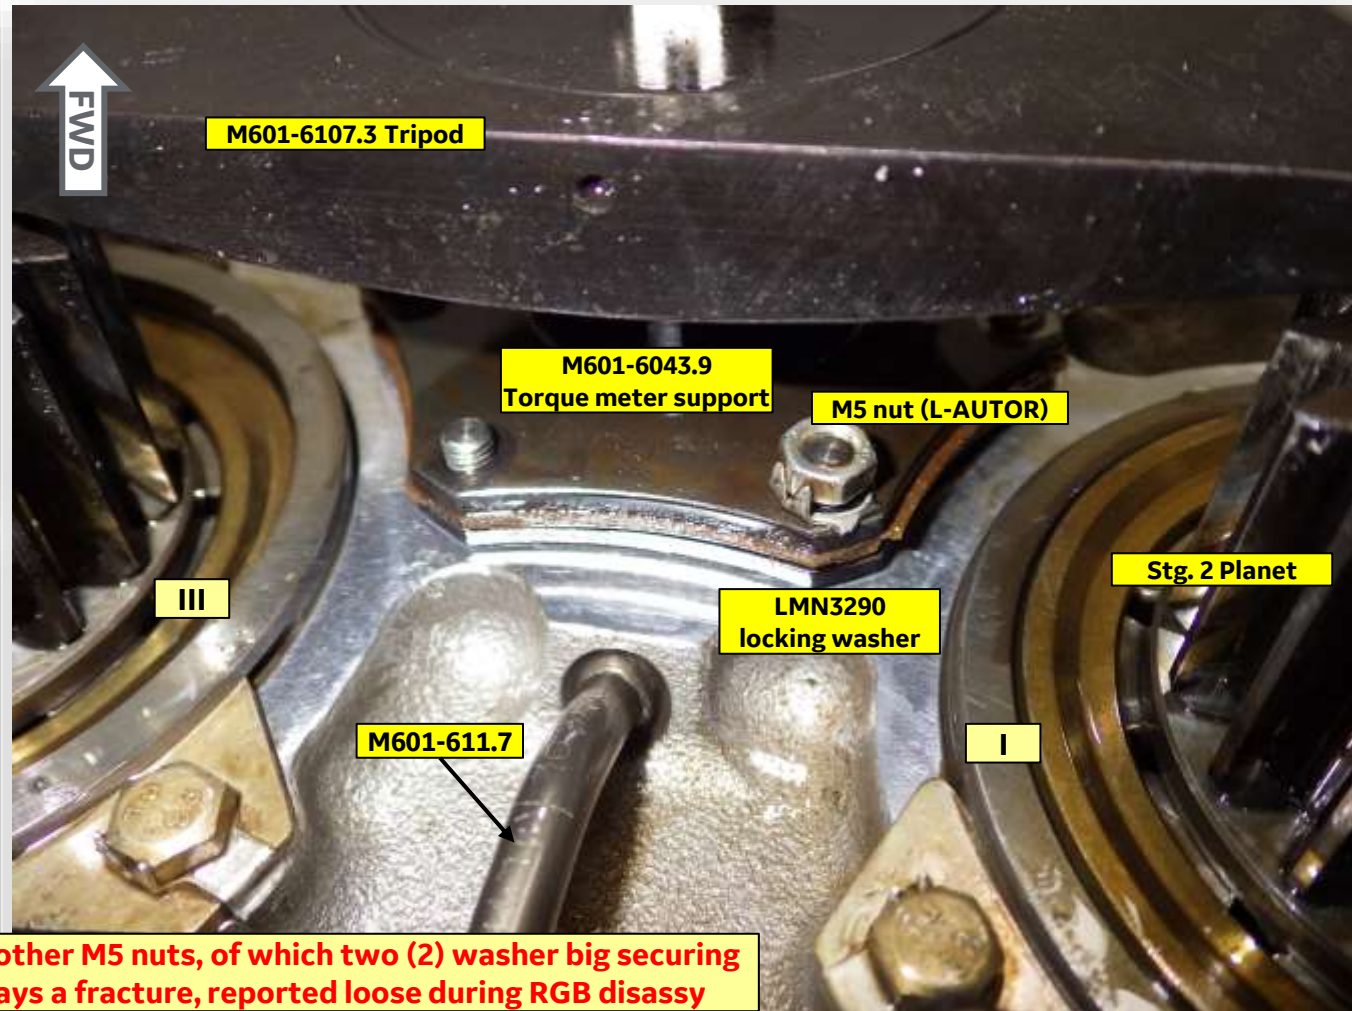
# Visual Inspection (engine TDR)

**All four (4) other M5 nuts, of which two (2) washer big securing tab displays a fracture, reported loose during RGB disassy**

**Fractured washer tab at 1.00 & 9.00 positions documented in Appendix 6**
