# **NATIONAL TRANSPORTATION SAFETY BOARD**

## **Attachment 1 - Metallurgical Report**

**ENG20LA046**

**Spring Creek Aviation LLC / Donalsonville GA, USA / Thrush Aircraft 510G (registration N6216K)**  
**METALLURGICAL REPORT**

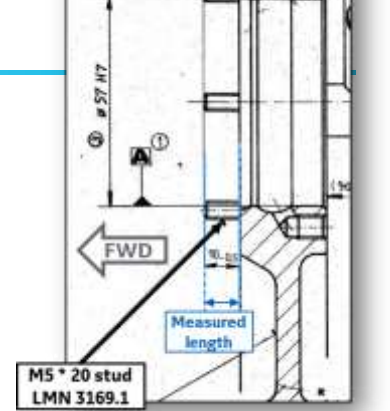
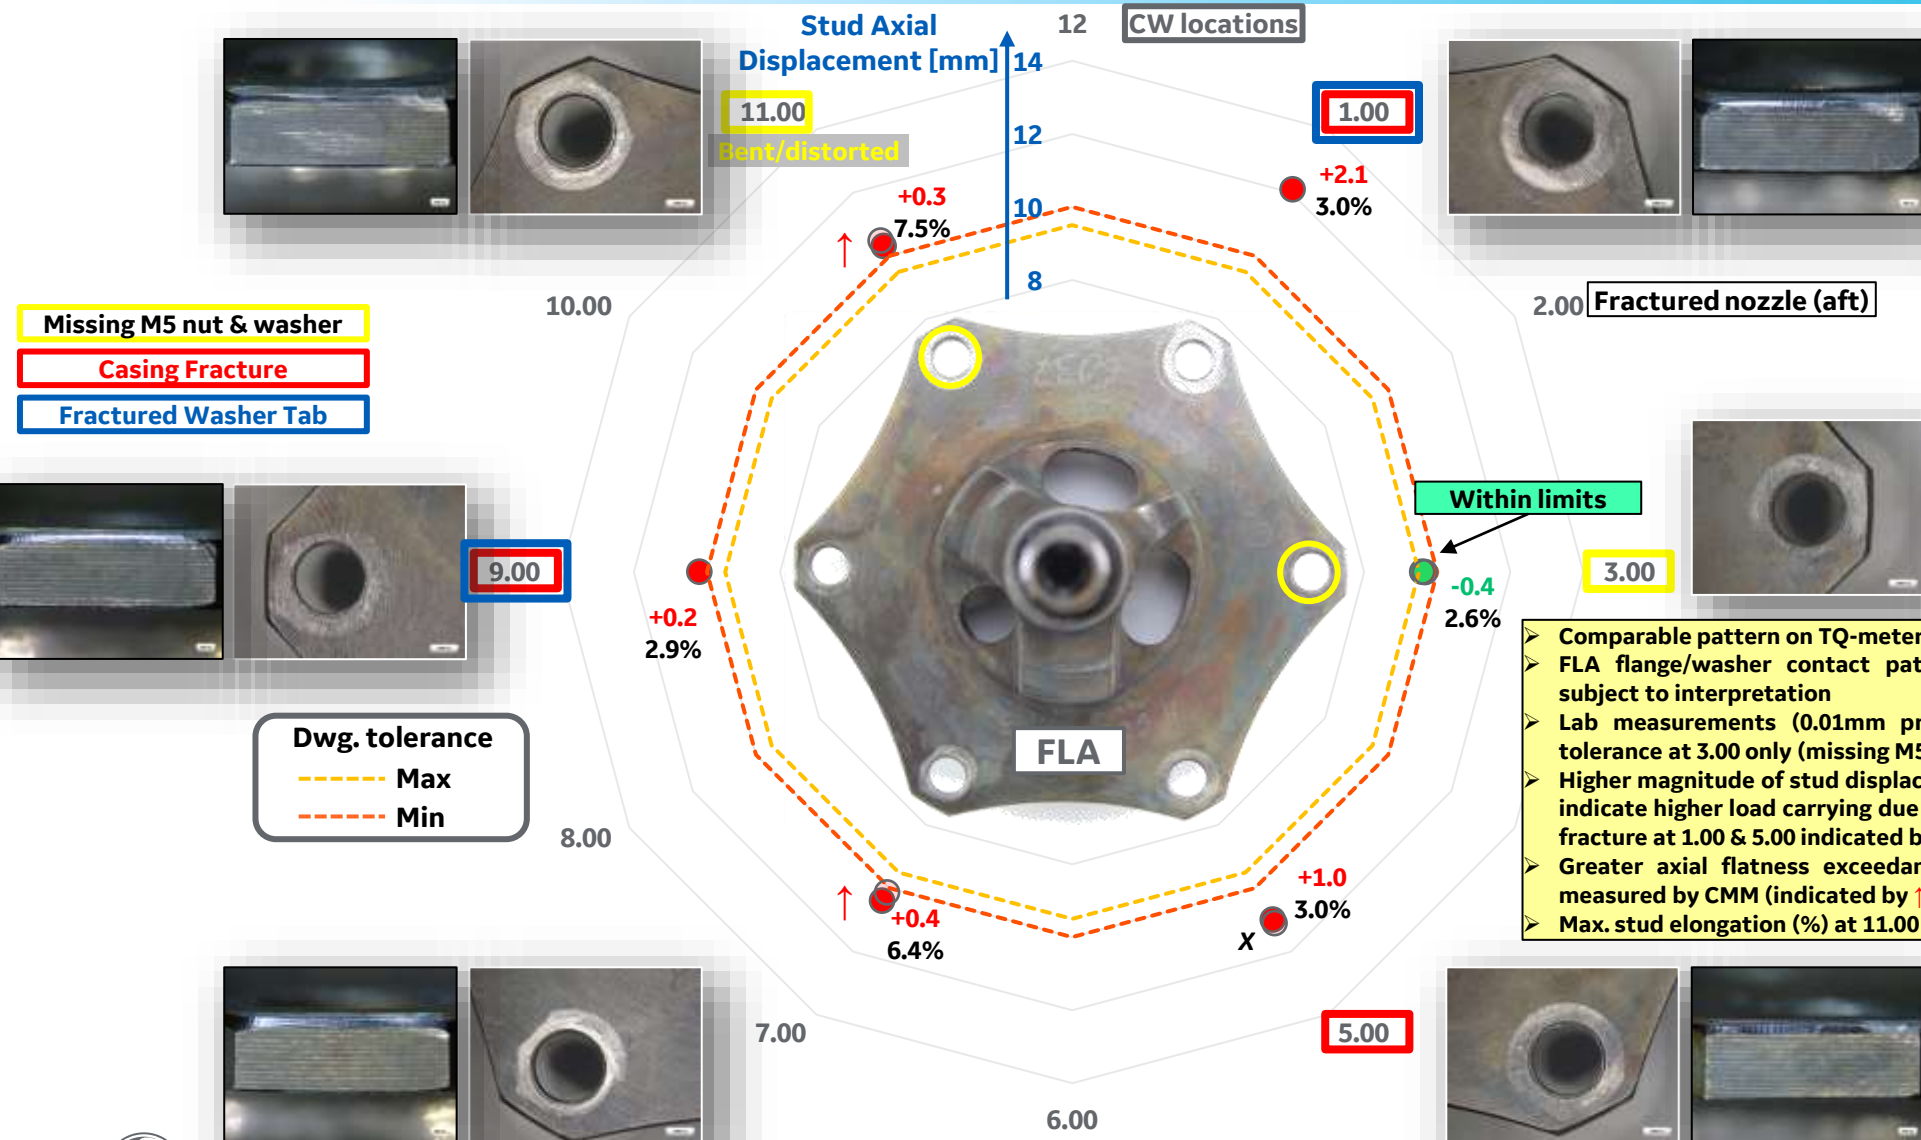
# TQ-meter Flange & Stud Assessment

- Comparable pattern on TQ-meter flange edge/side face supporting initial tab securing
- FLA flange/washer contact pattern variation (indicated by tin-plating transfer) subject to interpretation
- Lab measurements (0.01mm precision) of stud axial displacement within dwg. tolerance at 3.00 only (missing M5 nut) & corroborated by CMM (indicated by "O") \*
- Higher magnitude of stud displacement @1.00 & 5.00 locations adjacent to 3.00 might indicate higher load carrying due to missing/loosen nut (worth mentioning the casing fracture at 1.00 & 5.00 indicated by "X" as displacement contributor)
- Greater axial flatness exceedance at 11.00 & 7.00 locations of TQ-meter flange measured by CMM (indicated by ↑)
- Max. stud elongation (%) at 11.00 & 7.00 locations (0.01mm precision measurement)

\* compatible with missing M5 nut further connoted by the absence of pull-out damage indications on stud thread

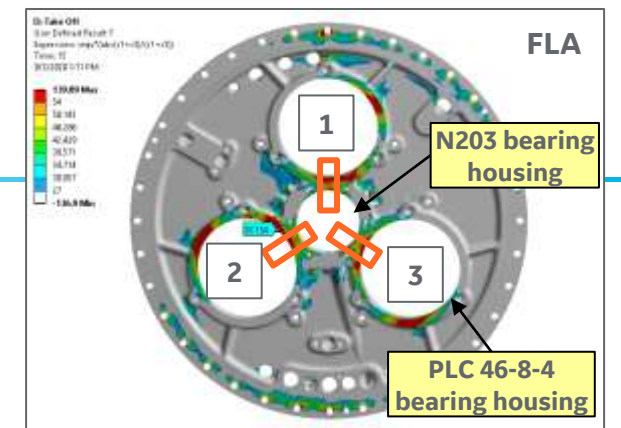
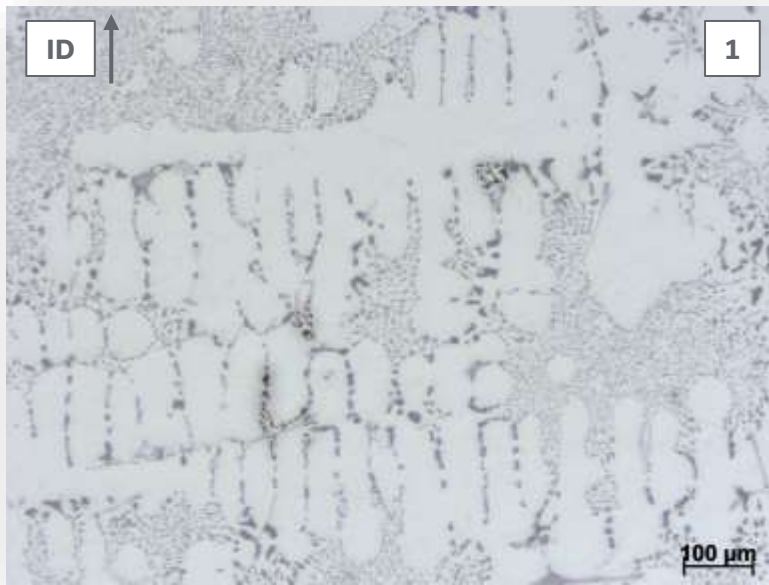
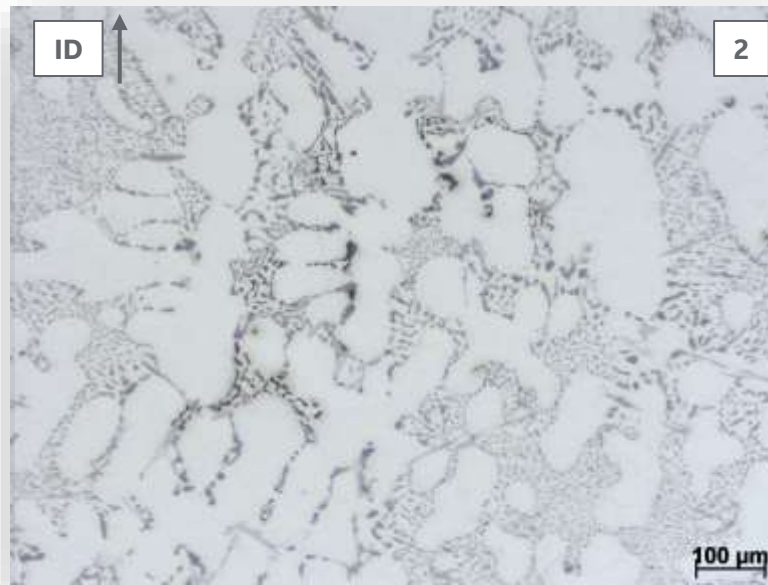
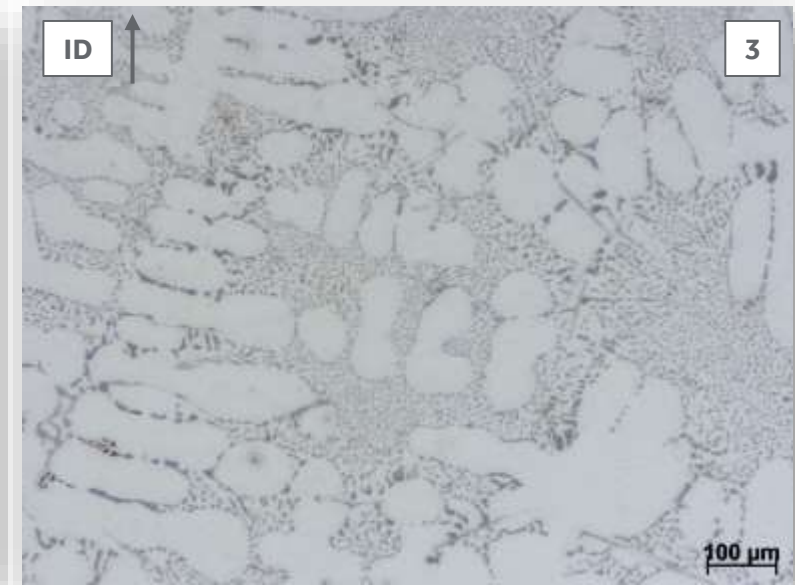
- Radial cut-ups at critical locations CW positions (FLA)
  - 1 (12.00)
  - 2 (8.00)
  - 3 (4.00)
- 100 ± 10 HV5

=> Microstructure & micro-hardness conforming to technical specification TPF 01-2018-11 for EN AC-43100 casting in HIP & solution annealed + aged heat treat condition

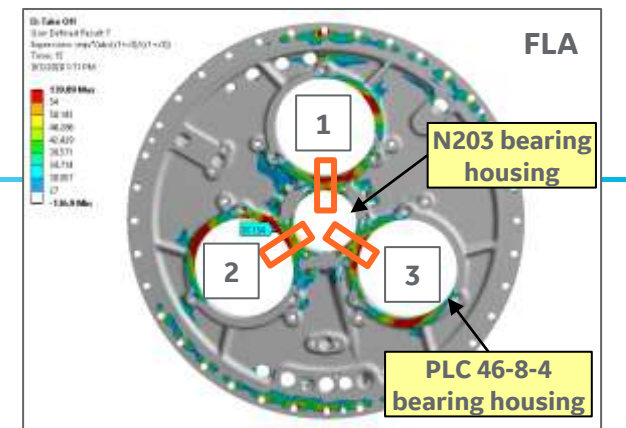
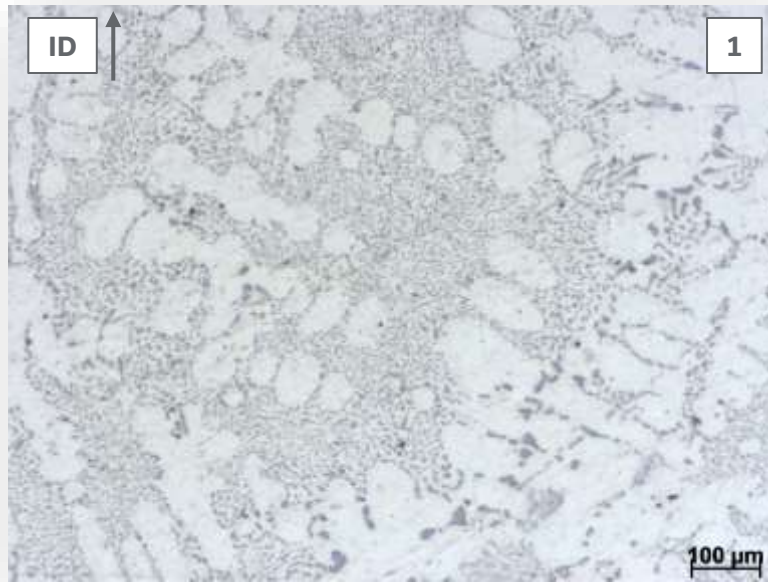
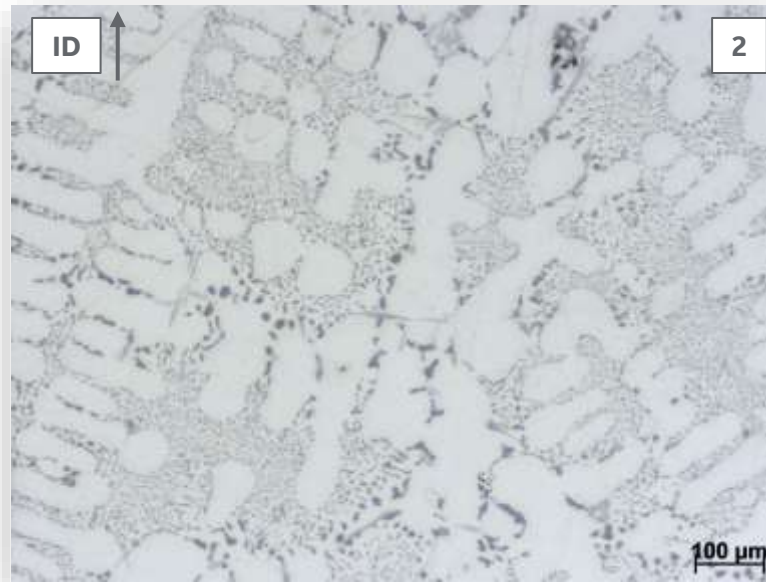
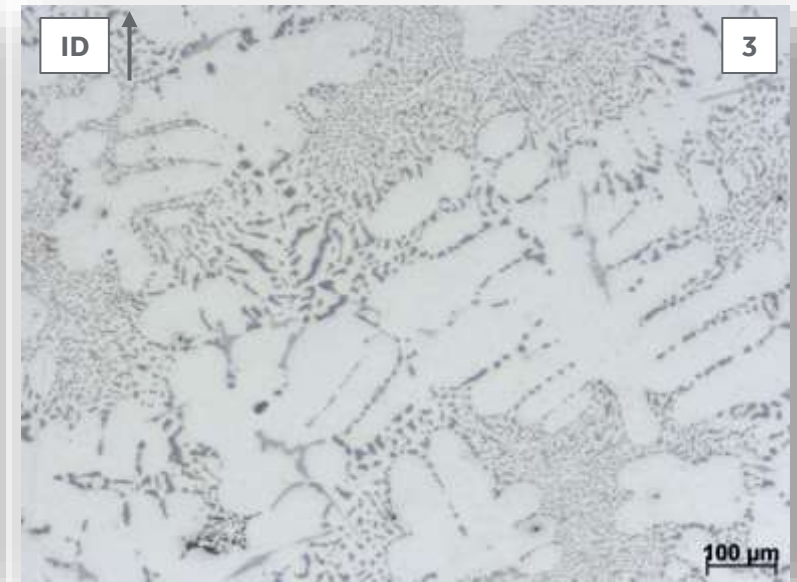
- Tangential cut-ups at critical locations CW positions (FLA)
  - 1 (12.00)
  - 2 (8.00)
  - 3 (4.00)
- $101 \pm 12$  HV5

=> Microstructure & micro-hardness conforming to technical specification TPF 01-2018-11 for EN AC-43100 casting in HIP & solution annealed + aged heat treat condition
