## **NATIONAL TRANSPORTATION SAFETY BOARD**

### **POWERPLANT GROUP CHAIRMAN'S FACTUAL REPORT**

NTSB No.: ENG20LA046

Aircraft: Thrush S2R-H80, Registration N6216K

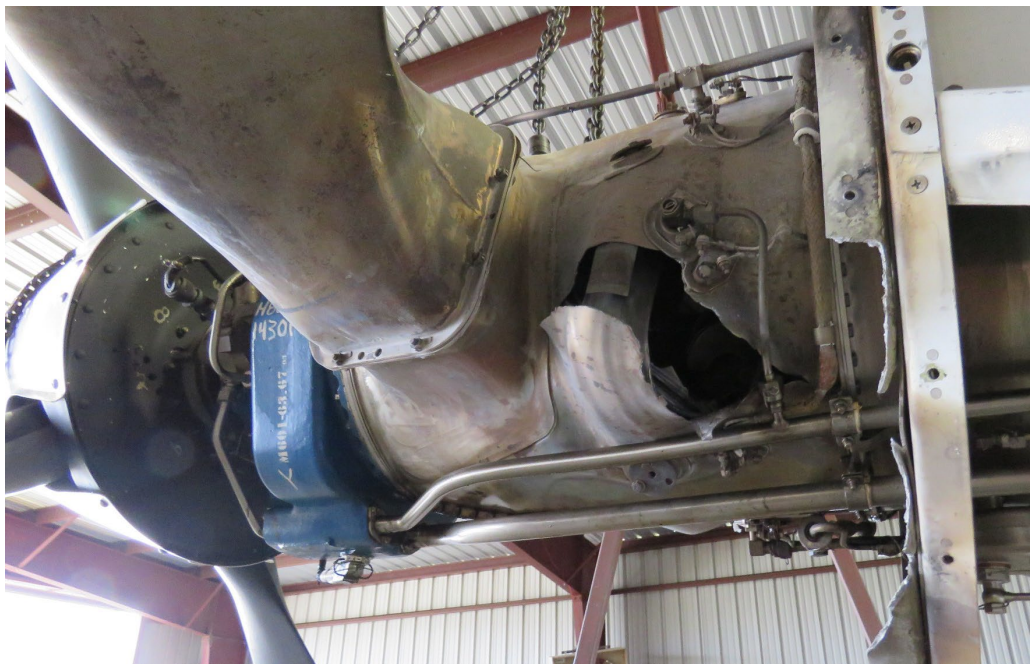
The airplane landed in a peanut field (**Photo 1**) and it was revealed the engine had a hole at approximately the 7 o'clock position (**Photo 2**).

**Photo 2:** Hole Seen in Left-Hand Side of Engine after Engine Cowl Removal

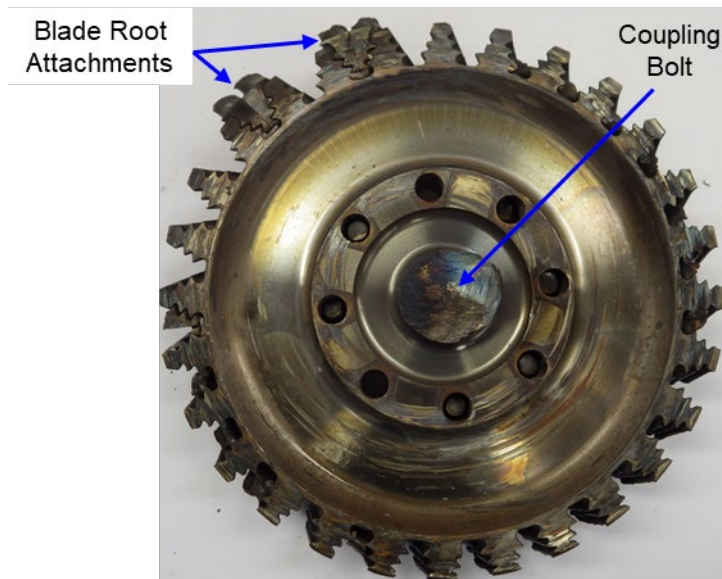
The PT disk (**Photo 6**) was found separated from the PT shaft with a fractured forward pin and all eight PT disk coupling bolts fractured. Five blade root attachments were found still installed in the disk. Additionally, nine blade attachments and remnants from several PT blades were found inside the engine. All of the recovered blade attachments were found with transverse airfoil fractures near the air-foil-to-platform transition area.

**Photo 6:** Separated PT Disk, Damaged Blade Attachments and Fractured Coupling Bolt

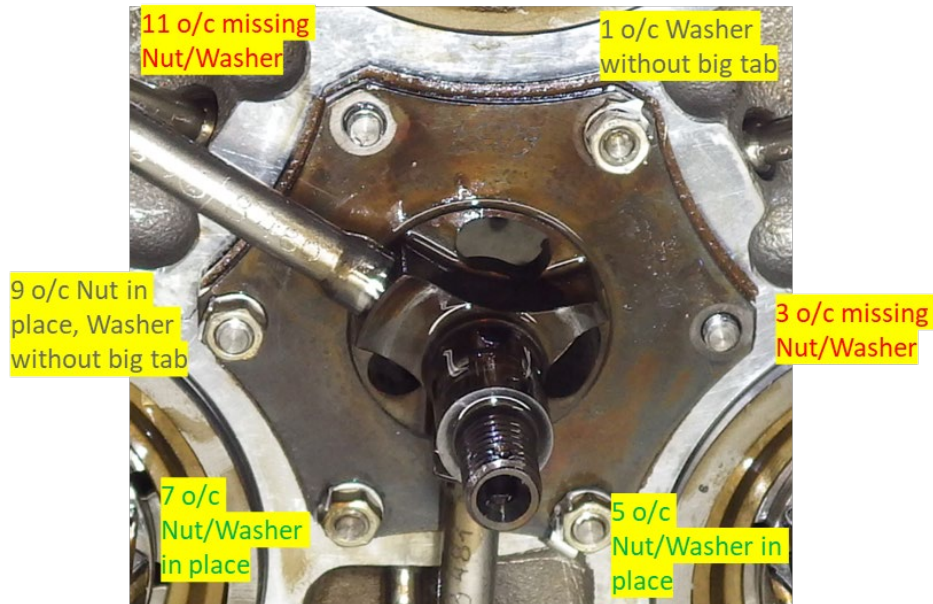
The roller bearing housing was exposed when the RGB was removed from the engine. The torque meter support was secured to the roller bearing housing by nuts and lock washers that are threaded onto six studs. Two of the six studs located at the 3 and 11 o'clock positions forward looking aft (FLA) were found with the nuts and lock washers missing. The lock washers at the 1 and 9 o'clock positions were found with the large tabs broken off (**Photo 7**). One nut was found crushed within the crown wheel gear teeth while another was found fragmented within the RGB.

**Photo 7:** FLA View of Torque Meter Support within RGB

GEAC released Service Bulletin SB-H80-72-00-00-0090 on February 23, 2021 defining the inspection of fasteners that secure the torque meter support to the roller bearing housing. Missing nuts, lock washers, or washer locking tabs are not permitted. Nuts and lock washers must not be free to rotate under finger pressure. Engine operation is not permitted if either of the above conditions are found.

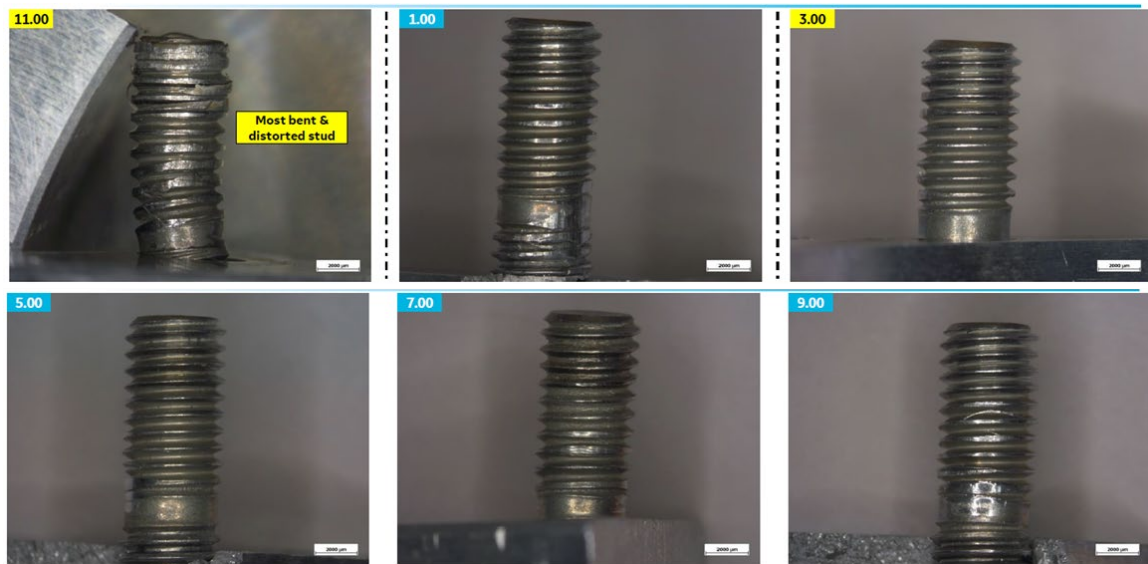
Five of the six threaded studs exhibited deformation (bent), damaged threads, or both (**Photo 8**). Only the 3 o'clock position threaded stud appeared undamaged. The countershaft casing had radial cracks located at the 1, 5, and 9 o'clock stud positions (**Photo 9**).

**Photo 8:** Condition of Threaded Studs With The 3 o'clock Stud Relatively Undamaged

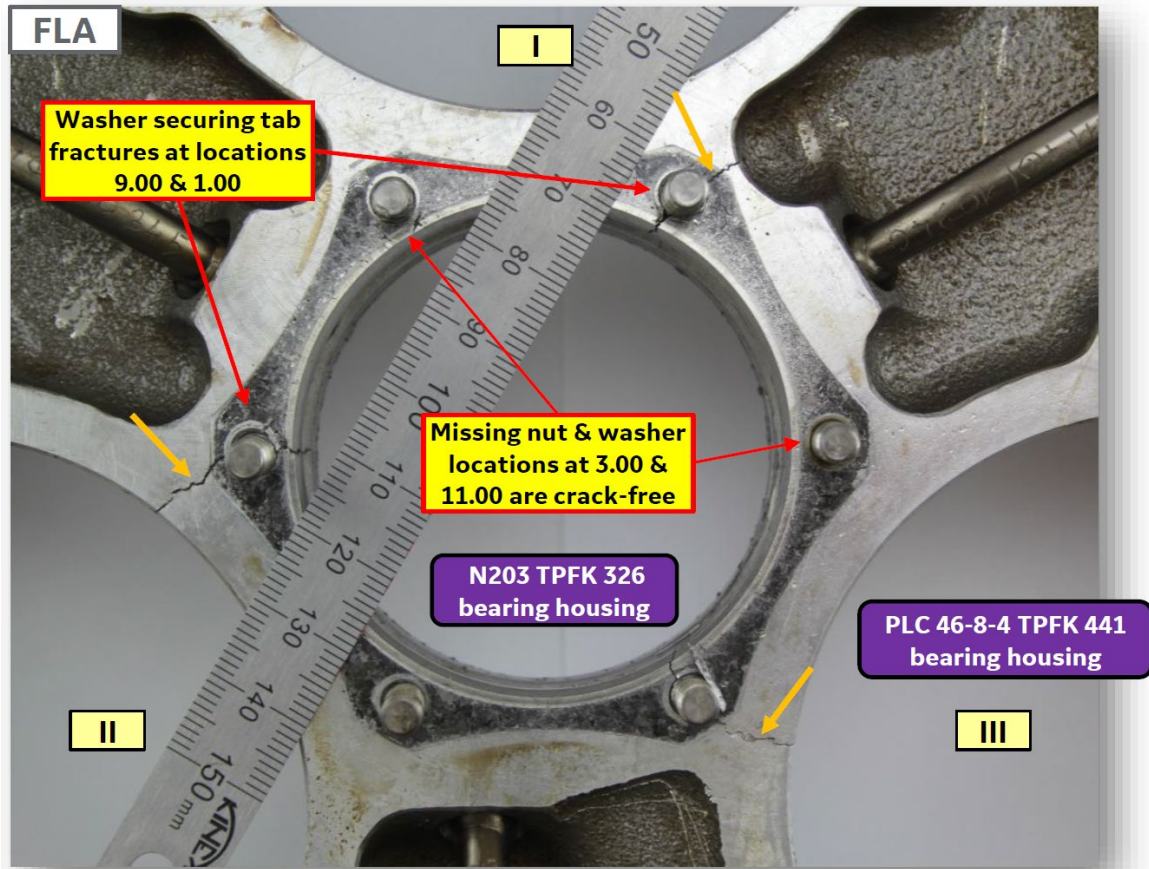
**Photo 9:** Orange Arrows Indicate Radial Crack Locations in the Countershaft Casing  
(Photo Courtesy of GEAC)

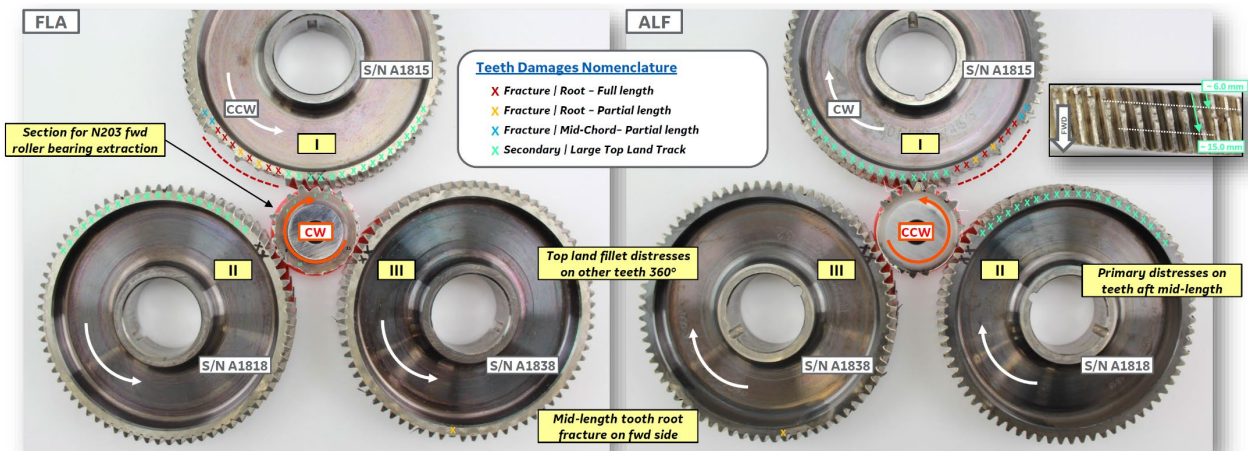
A diagram of how the countershaft gears, quill shaft, and crown wheel mesh together within the RGB is shown in **Figure 3** below. Three countershaft gears, referred to as stage 1 planetary gears, exhibited sections of consecutive teeth around the disk with various levels of damage (**Photo 10**).

**Photo 10:** Damage Mapping of Stage 1 Planetary Gears

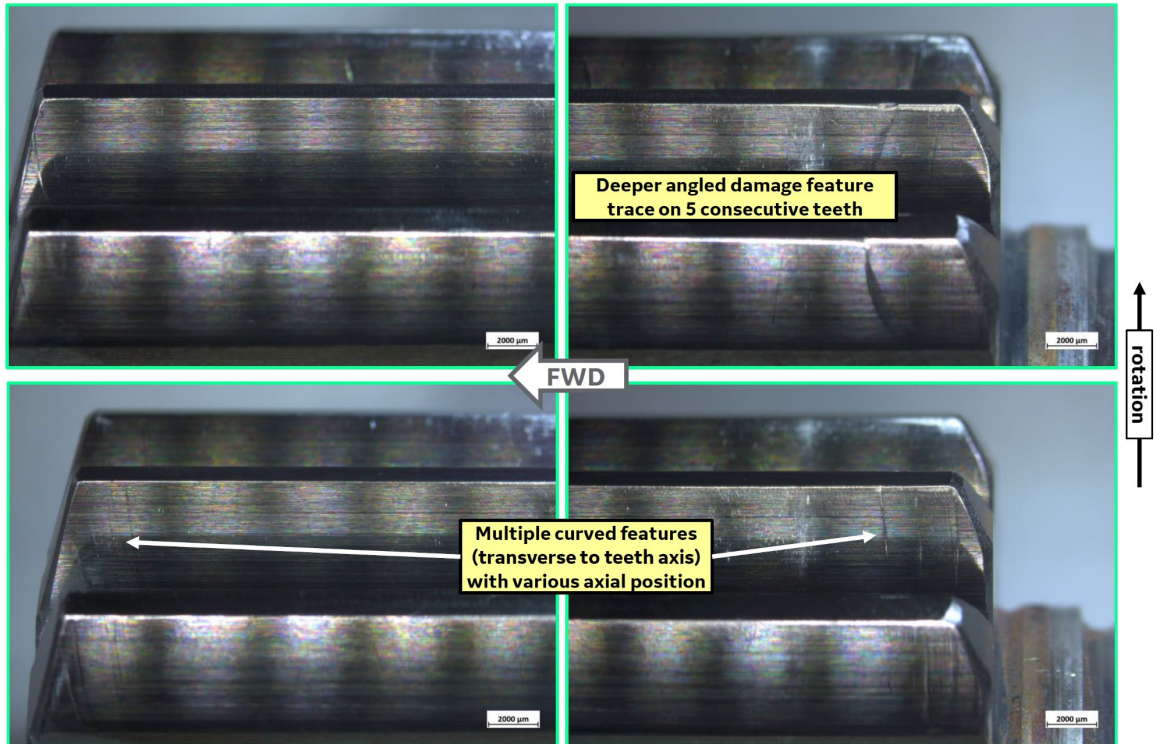
All three countershafts, referred to as stage 2 planetary gears, were intact. One gear (**Photo 11**) had imprint marks transverse to both the loaded and unloaded faces of multiple gear teeth.

**Photo 11:** Imprint Marks Seen on Stage 2 Planetary Gear s/n H1515

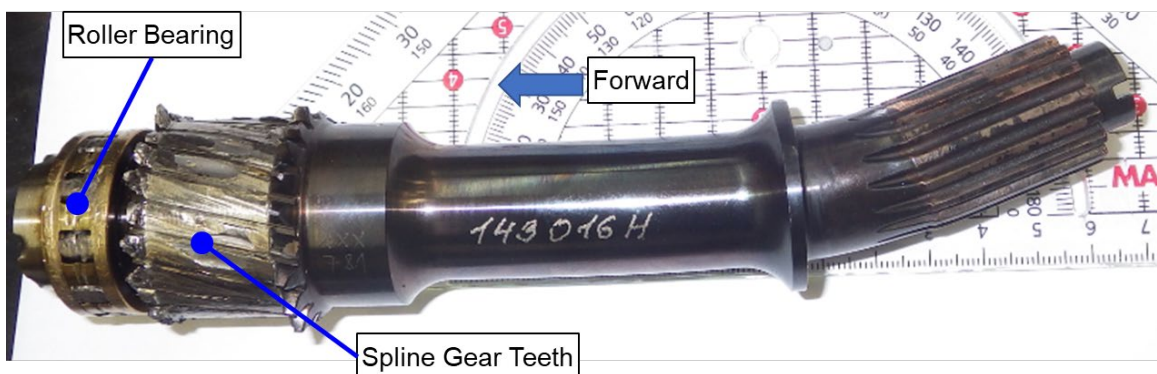
The aft end of the quill shaft (**Photo 12**) was visibly bent and displayed torsional deformation immediately forward of the aft splines. All the forward roller bearings were flattened and had material displacement. The forward spline gear teeth were missing apart from the apparent remains of the forward and aft spline regions. The aft end of the shaft had a semicircular region of discoloration.

**Photo 12:** Quill Shaft As-Received

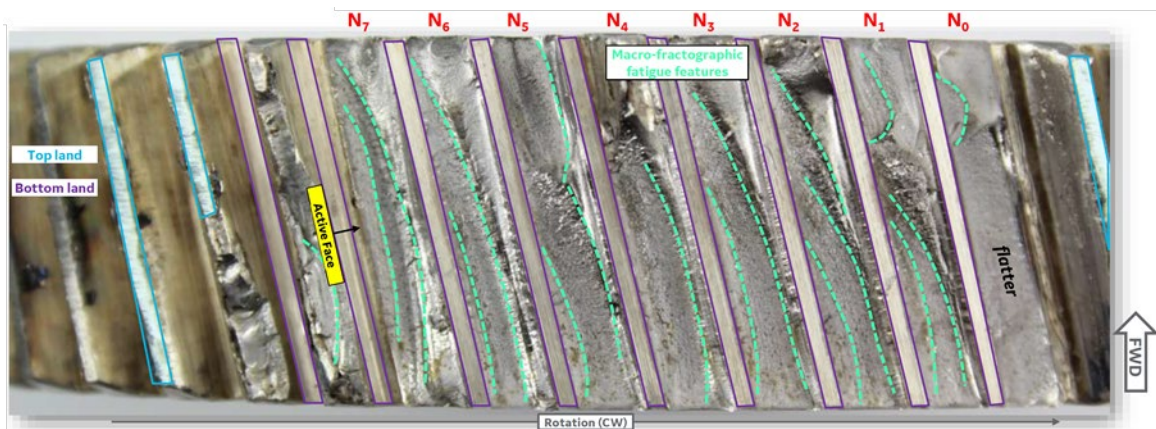
Visual inspection of the stage 1 planetary gear located in position one (**Photo 10**) showed eight consecutive gear teeth (numbered  $N_0$  to  $N_7$ ) with macro-fractographic features (**Photo 13**). Smooth initiation regions can be seen transitioning to greater topographical changes suggesting the fractured teeth had fatigue initiation from the root fillet area of the loaded tooth faces that propagated across the tooth in the circumferential direction toward the unloaded faces. Tooth  $N_0$  had a noticeably larger flat fracture surface than the adjacent fractured teeth.

**Photo 13:** Fatigue Features Seen on Eight Adjacent Teeth of Stage 1 Planetary Gear s/n A1815  
(Photo Courtesy of GEAC)

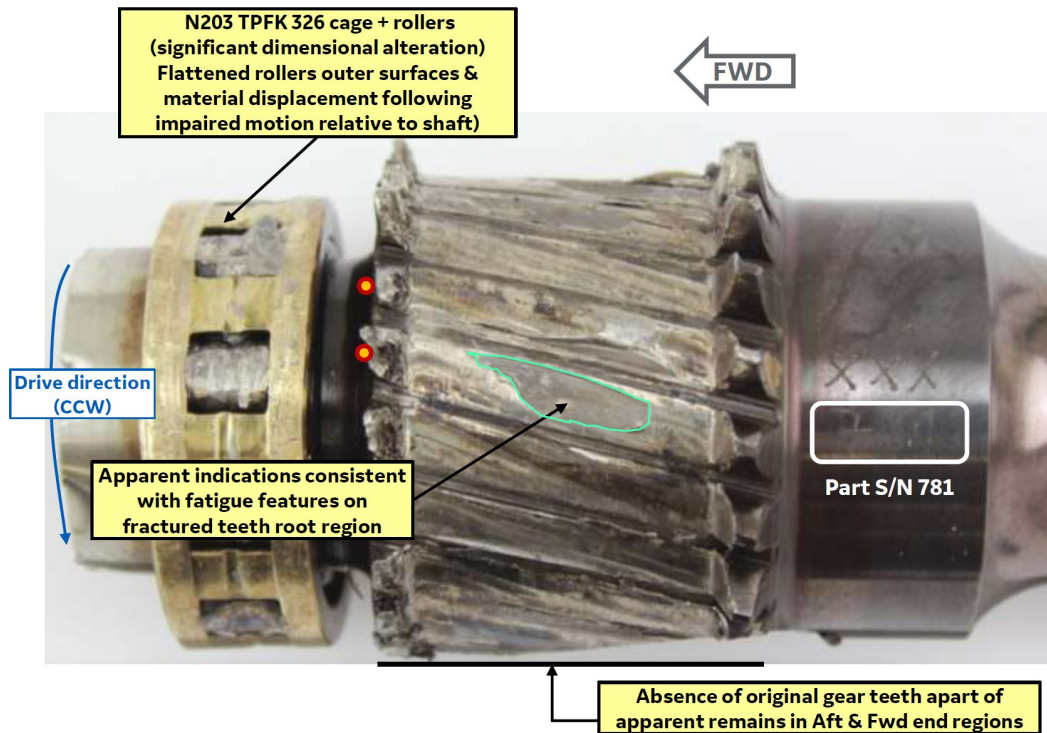
Fatigue macro-features were found emanating from the loaded tooth faces on several sun gear teeth root land fracture surfaces (**Photo 14**). Imprint witness marks were found on the liberated sun gear teeth debris indicating high contact stress from the mating planetary gear teeth. Microstructure and micro-hardness tests demonstrated the sun gear material conformed to the intended material specifications.

**Photo 14:** Forward End of Sun Gear

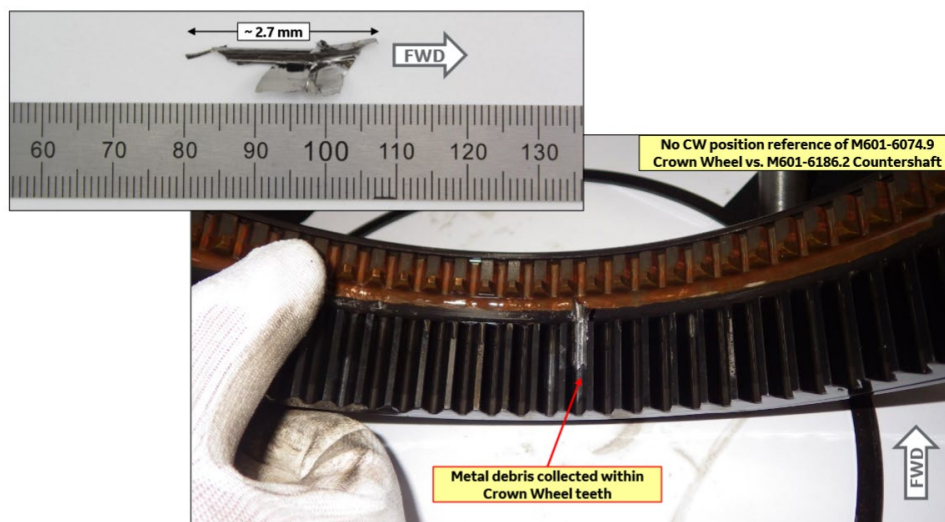
The crown wheel was found with deformed metal debris lodged between the gear teeth (**Photo 15**). This debris was consistent with the M5 nut material used to secure the torque meter support flange to the countershaft casing.

**Photo 15:** Crushed Metal Debris Found Lodged in Crown Wheel

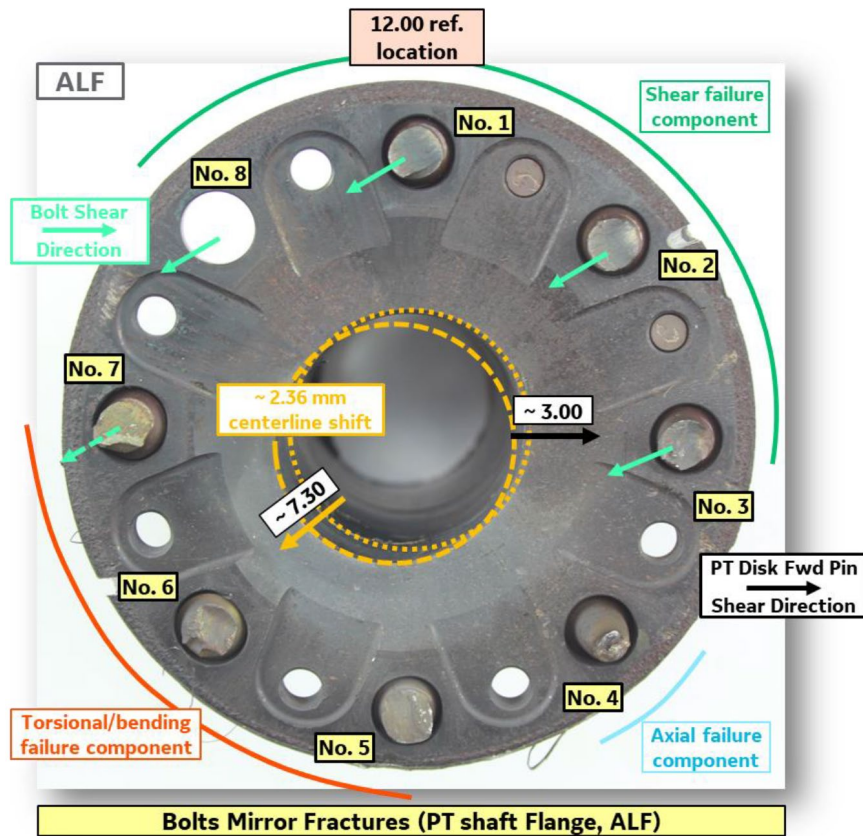
Mapping of the seized T-head bolts that connect the PT shaft to the PT disk showed three failure components (**Photo 16**).

1. Shear from the 9 o'clock (bolt no. 7) to 3 o'clock (bolt no. 3) positions ALF indicated by the T-head bolts having 45° fracture surfaces;
2. Torsion from the 7 o'clock (bolt no. 6) to 6 o'clock (bolt no. 5) positions ALF indicated by the T-head bolts having flat fracture surfaces; and,
3. Axial at the 5 o'clock (bolt no. 4) position ALF indicated by the T-head bolt necking.

**Photo 16:** Distinct Failure Components Seen in PT Shaft Flange Bolt Fractures  
(Photo Courtesy of GEAC)

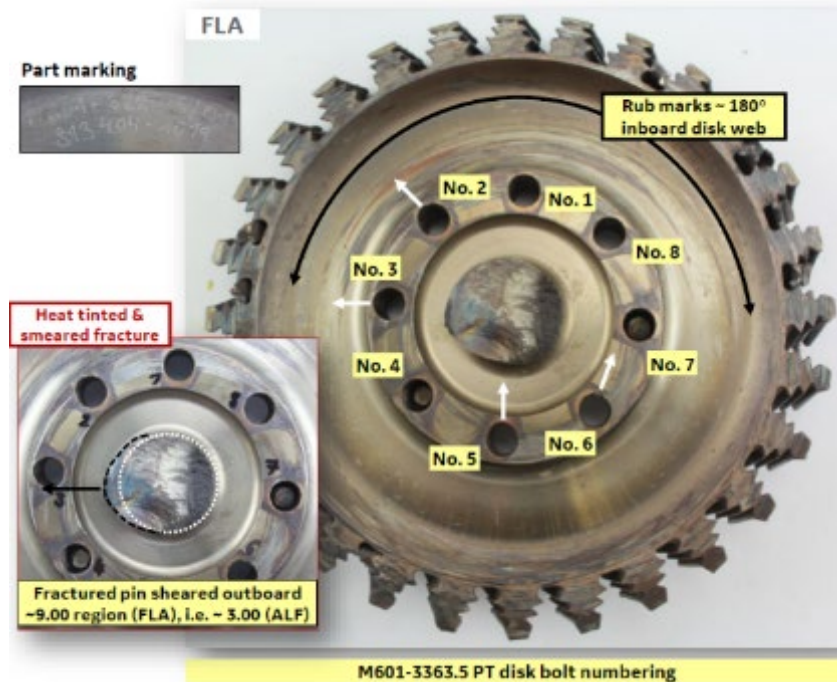
The PT disk (**Photo 17**) had circumferential rub marks on the forward side inboard disk web approximately 180° around the circumference. The disk forward pin was sheared outboard at approximately the 3 o'clock position ALF. The fracture surface was smeared and had a blueish tint.

**Photo 17:** Fractured PT Disk Pin and Circumferential Rub Marks Seen on Forward Side  
(Photo Courtesy of GEAC)

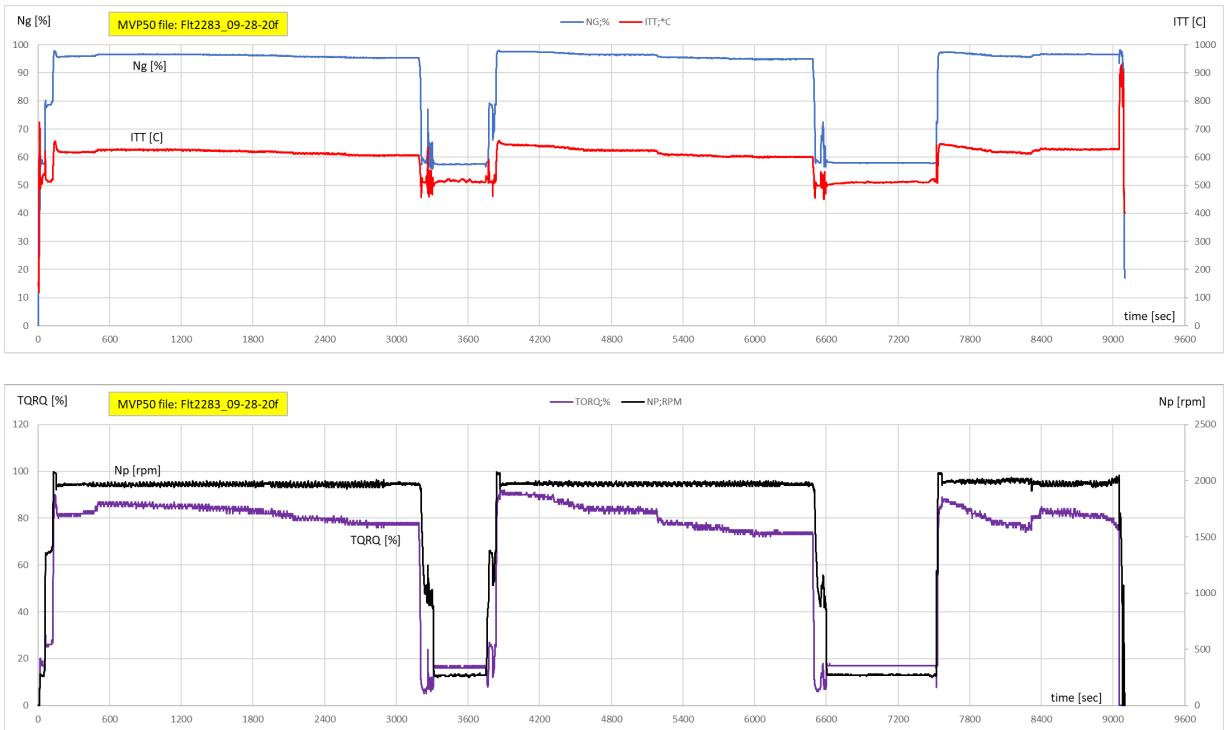
The incident airplane was equipped with an Electronics International, Inc. MVP-50T engine monitor. The operator shipped the monitor to the NTSB Vehicle Recorders Laboratory in Washington, D.C. where the data from 2,289 flights was successfully downloaded. The data was delivered to GEAC on December 7, 2020. Intermittent fluctuations and signal drops in engine torque were recorded during previous flights however no abnormal behavior was observed during the incident flight (**Figure 4**).

**Figure 4: No Abnormal Torque Indications Observed During the Incident Flight**
