**NATIONAL TRANSPORTATION SAFETY BOARD**  
**Office of Aviation Safety**  
**Washington, D.C. 20594**

**POWERPLANT GROUP CHAIRMAN'S FACTUAL REPORT**

**NTSB No: ENG21LA013**

**Aircraft:** Aerotransportes Mas de Carga, S.A. de C.V (Mas Air Cargo), Boeing 767-338F, registration number N363CM, Flight MMA6853

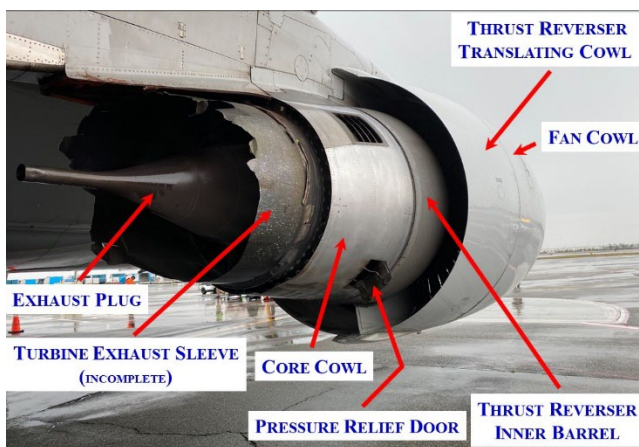
The fan cowl, thrust reverser cowls, and the core cowls were closed, fully latched, and secure; the pressure relief door<sup>6</sup> on the outboard core cowl was open and still attached (**PHOTO 3**), and the IDG access door was closed. When all the cowls were unlatched, all the latch hardware - latch hooks and latch keepers - appeared to be intact and in good condition (**PHOTO 4**). No debris exit penetrations holes or burn-through holes were observed on any of the cowls.

**PHOTO 3: INITIAL ON-SCENE OF NO. 2 ENGINE**  
PHOTO COURTESY OF JETT PRO

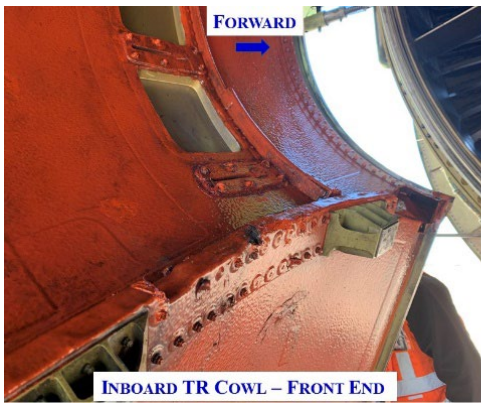
The TR exhibited thermal distress to the inner barrel inner skin MA25S red/orange-colored thermal coating on both the inboard (**PHOTO 5**) and outboard (**PHOTO 6**) halves; the thermal distress was localized towards the rear of the TR and consisted of discoloring and flaking/blistering of the coating (**PHOTO 5** – yellow outline). Debris was found in the frame of the IDG access door (**PHOTO 7**).

**PHOTO 5: LEFT TR DISTRESS**

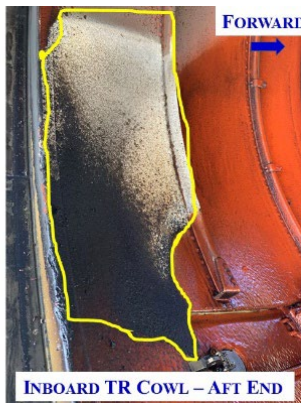
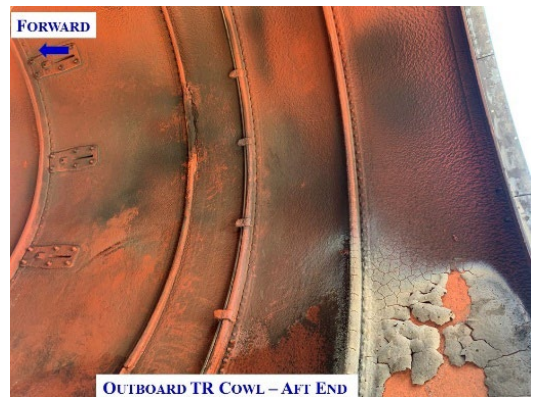
**PHOTO 6: RIGHT TR DISTRESS**

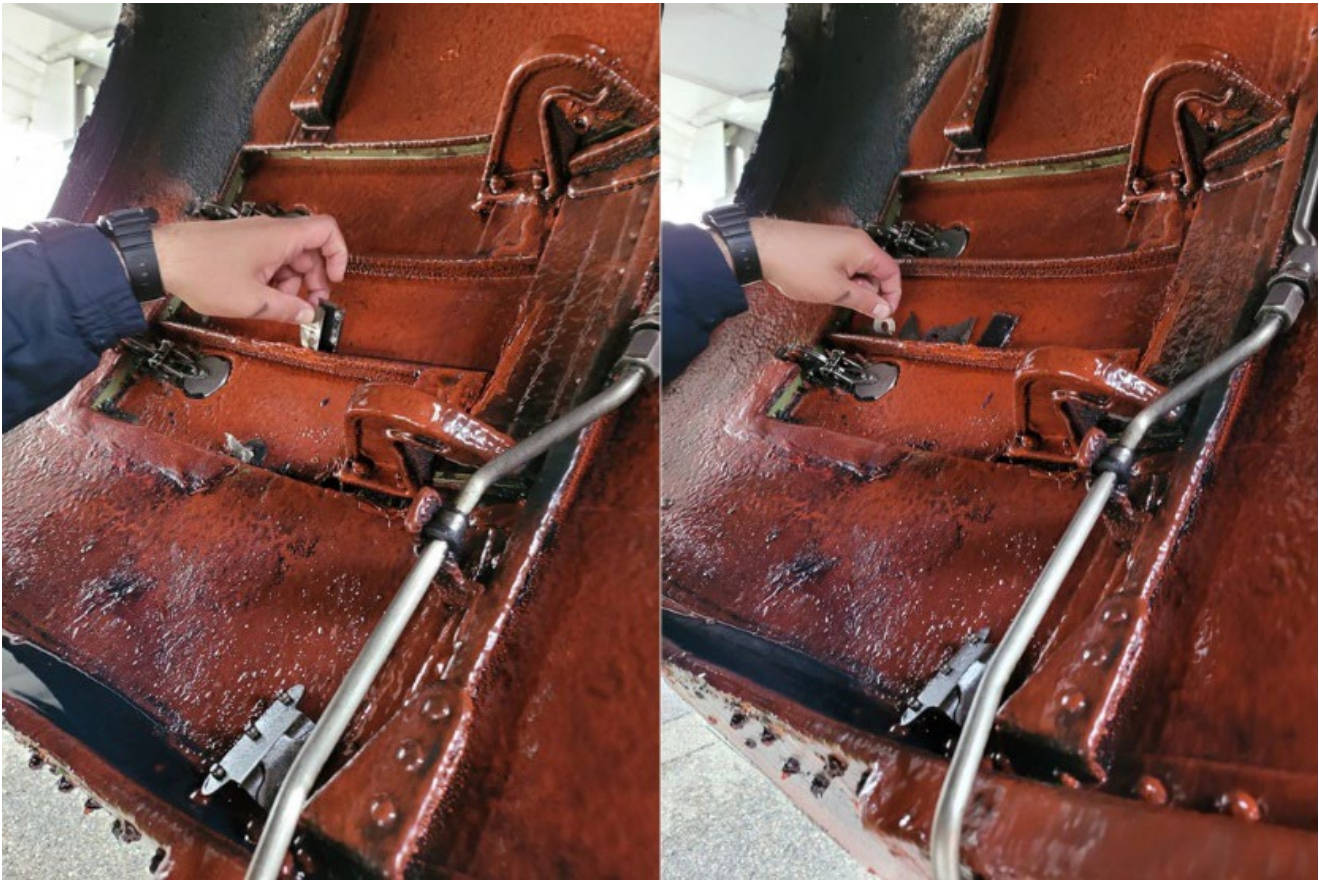
**PHOTO 7: DEBRIS COLLECTED IN THE TR**

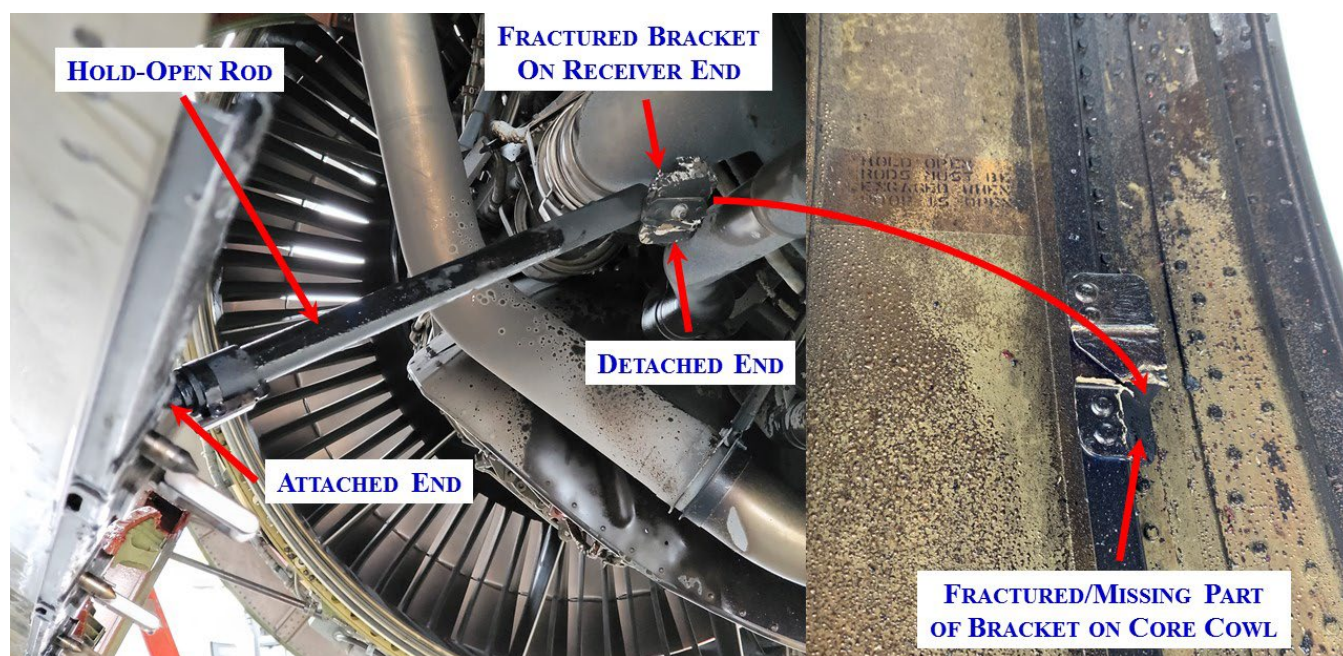
The left core cowl was unable to be opened fully; the hold-open rod was found barely attached to the cowl structure at the receiver end of the rod and detached at the cowl structure bracket end (**PHOTO 8**). Significant damage was observed that included cracked circumferential frames, missing pieces of the rear flange, missing and melted sections of the rear circumferential channel just forward of the core cowl aft hat sections, blistered and peeled primer paint, and missing sections of the rear flange (**PHOTO 9**). Some debris was found in the leading edge frame channels.

**PHOTO 8: FRACTURE LEFT CORE COWL HOLD-OPEN ROD BRACKET**

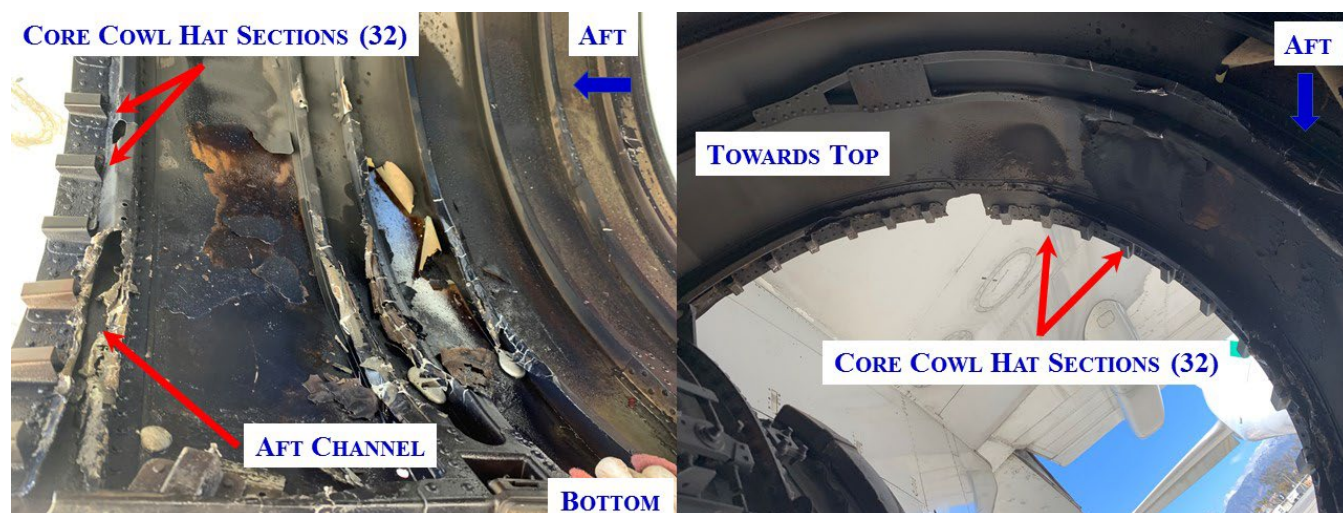
**PHOTO 9: LEFT CORE COWL THERMAL DISTRESS**

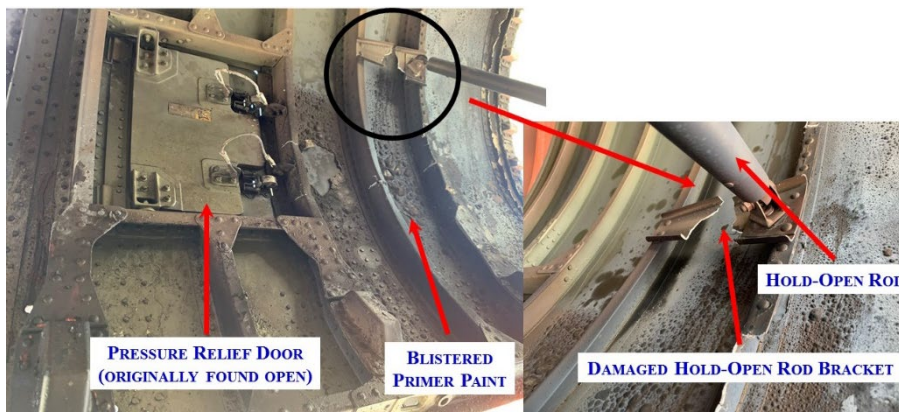
The right core cowl was opened fully using the hold-open rod; the hold-open rod was still attached and secured to the outboard cowl, but the bracket was fractured (**PHOTO 10**). Similar thermal distress that was also observed on the left core cowl was also observed on the right core cowl that included cracked frames, blistered primer paint, and eroded and missing aft channel near the hat sections (**PHOTO 11**). Due to distortion, the core cowls were not able to fully close after they were initially opened.

**PHOTO 10: FRACTURE HOLD-OPEN DOOR BRACKET**

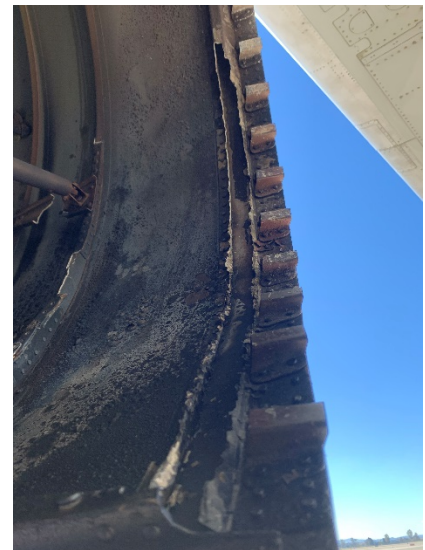
**PHOTO 11: AFT END  
THERMAL DISTRESS**

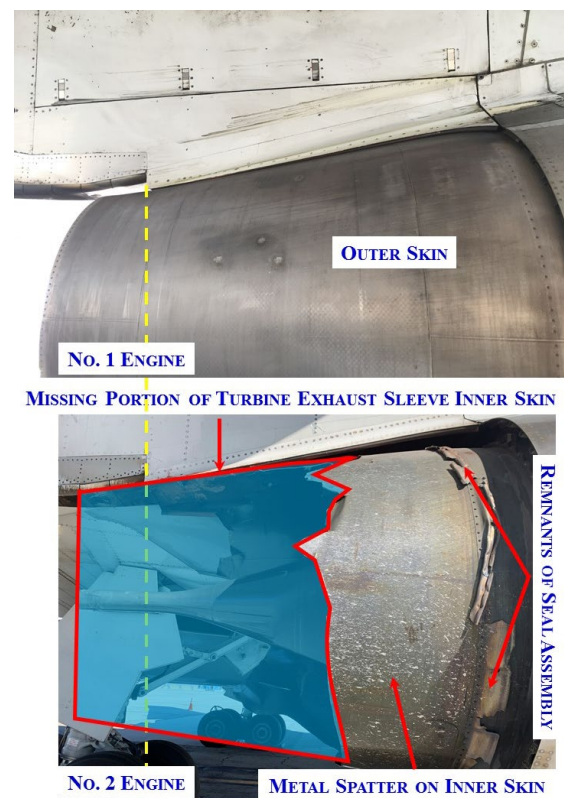
The entire outer portion of the double walled turbine exhaust nozzle assembly was missing. What remained was the forward half of the turbine exhaust inner sleeve which remained attached to the TRF; the remnants of the inner sleeve were torn, impact marks were observed on the outer surface, and oil was puddled on the inside inner surface at the 6:00 o'clock position (**PHOTO 12**). Remnants of damaged and torn seal assembly remained; the exhaust plug exhibited several impact dents along its length and no holes were noted.

**PHOTO 12: SIDE-BY-SIDE COMPARISON  
OF TURBINE EXHAUST NOZZLE**

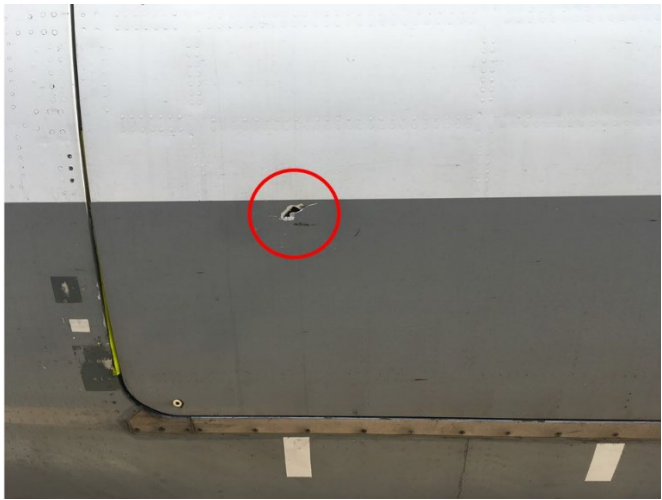
The right cargo door exhibited impact damage and a gouge/hole; the inner door frame and inner cargo door wall showed no signs of penetration into the frame or cargo compartment (**PHOTO 13**). The underside of the right wing and the flap fairing exhibited several dings and scrape marks and as well as the flap directly behind the No. 2 engine; the flap had small metallic piece embedded in the outer skin. Some of the impact marks appeared old and it could not be confirmed if all the damage observed was from this event. The vertical stabilizer exhibited a gouge but could not confirm if the damage was from this event (**PHOTO 14**). The right horizontal stabilizer exhibited small dings near the root and on the leading edge (LE) about mid span.

**PHOTO 13: RIGHT CARGO DOOR IMPACT**

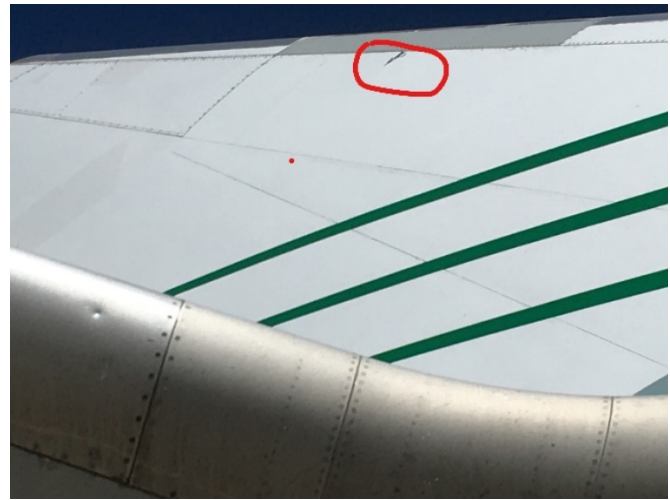
**PHOTO 14: VERTICAL STABILIZER DAMAGE**

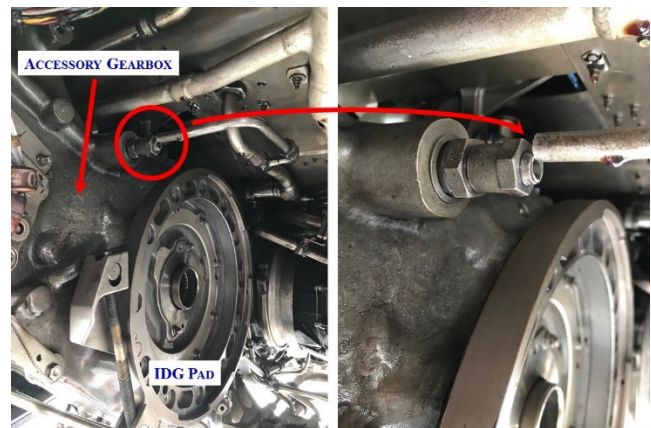
**PHOTO 17: FRACTURE OIL LINE**

The fractured oil supply (pressure) line (See **PHOTO 17**) fracture surfaces exhibited plastic deformation and a planar fracture consistent with secondary high amplitude fatigue/cyclic tensile loading (**PHOTO 48**; picture taken from **ATTACHMENT 1**).

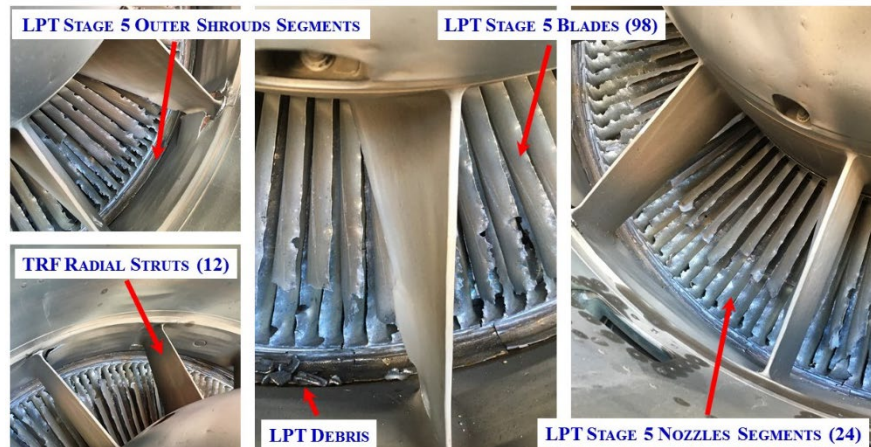
Looking through both the turbine exhaust sleeve and the engine's TRF, the LPT stage 5 blades were visible; all the blade roots were still installed in the disk and all the blades exhibited a combination of airfoil transverse fractures at various lengths and airfoil impact damage, tears, gouges, and missing airfoil material. All the LPT stage 5 blade outer shroud segments were still present and installed in the LPT stator case and exhibited a combination of gouging, missing material, heavy rub, and the honeycomb was worn down to the backing strip. Several metal pieces were found resting on the LPT stage 5 blade shroud segments at the 6:00 o'clock position; the material was consistent with LPT rotor and stator material. The LPT stage 5 nozzles segments were also visible, and they were all present and exhibited a combination of trailing edge (TE) airfoil impact damage, gouges, tears, and missing material (**PHOTO 18**).

**PHOTO 18: LPT STAGE 5 DAMAGE**

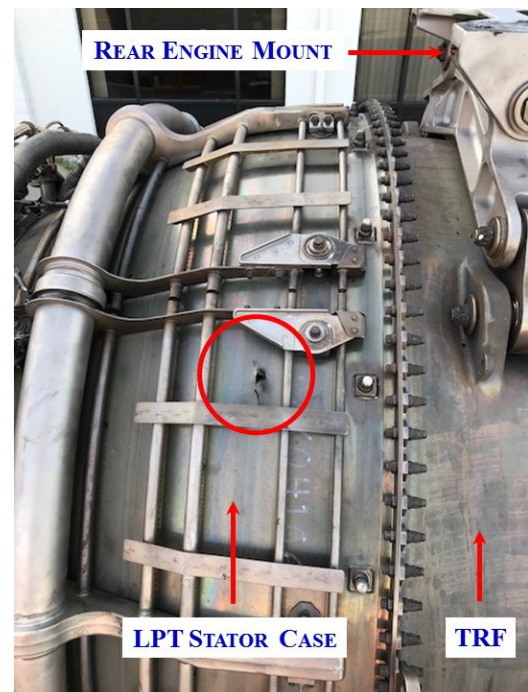
With the engine removed and placed in a shipping stand, a hole with debris stuck in it was observed at about the 10:30 o'clock position in the LPT stator case; the location of the hole appears to be in-line with the LPT stage 4 rotor (**PHOTO 19**). No signs of any LPT debris penetrating through the LPT stator case out skin was observed.

**PHOTO 19: LPT STATOR CASE HOLE**

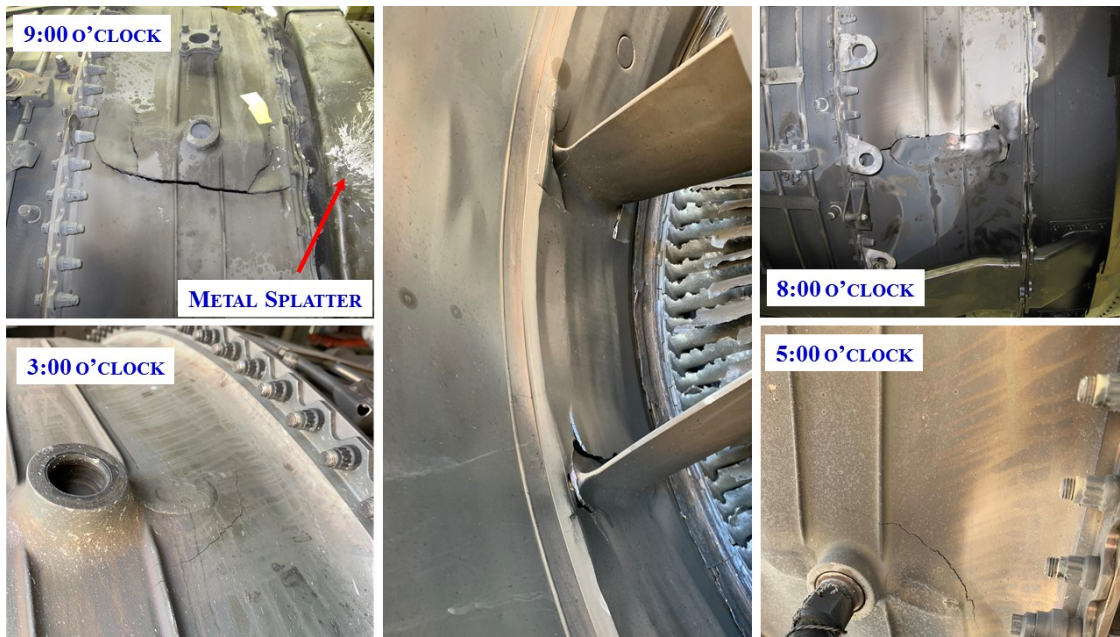
The damage to the TRF was comprised of cracks around the outer skin bosses, radial struts that had pushed through the outer skin creating gaps, outer skin tears, and the radial struts themselves exhibited leading edge damage (**PHOTO 20**). No signs of any LPT debris penetrating through the TRF out skin; however, molten metal splatter deposits were observed on what remained of the turbine exhaust nozzle inner skin wall (See **PHOTO 12** lower picture) as well as on the TRF outer surface at the locations where the TRF skin was pushed outwards at the 4:00 o'clock and at the 9:00 o'clock positions where the ground handling/shipping bosses were located. The low pressure (LP) recoup manifold, located at the 9:00 o'clock position, was covered in metal spatter in-line axially with the opening in the case at the 9:00 o'clock ground handle boss. The TRF exhibited the following cracks or openings: 1) a crack at the ground handling boss at the 3:00 o'clock position, 2) the case skin pushed outwards creating an opening at the 4:00 o'clock position, 3) a crack at the No. 6 bearing oil supply boss at the 5:00 o'clock position, 4) the case skin was pushed outwards creating a gap at 8:00 o'clock position, and 5) the case skin was pushed outwards creating a gap at 9:00 o'clock position at the ground handling hole where metal spatter was noted on the LP recoup manifold.

**PHOTO 20: TURBINE REAR FRAME DAMAGE**

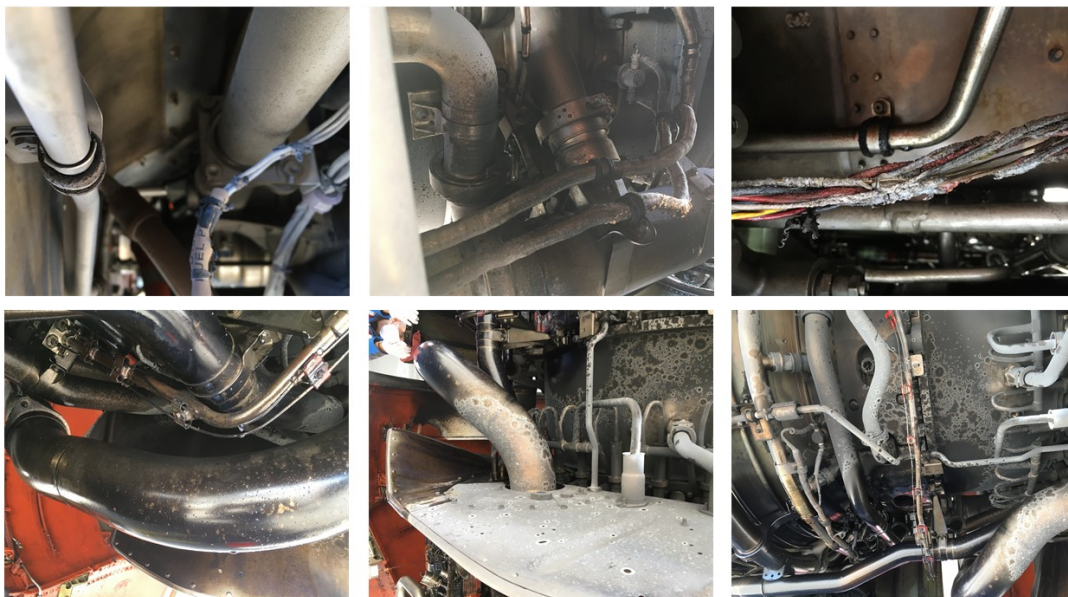
The outside of the engine exhibited low grade thermal distress comprised of sooting and melted, consumed, and damaged cushion clamps, fire detector loop isolators, and electrical wire outer sheathing (**PHOTO 21**). All the fire loops appeared to be intact and continuous, the only distress noted was to some of the fire loop isolators. Thermal distress was only noted above and aft of the engine heat shield; no thermal distress was noted under the heat shield in what is designated a fire zone. The components under the heat shield appeared wetted coin the area between the 4:00 and 7:00 o'clock positions. None of the oil or fuel lines exhibited any thermal distress or damage except for the oil line coming from the accessory gearbox which was previously mentioned (**PHOTO 22**).

**PHOTO 21: FIRE DAMAGE LOCATED ABOVE AND AFT OF HEAT SHIELD**

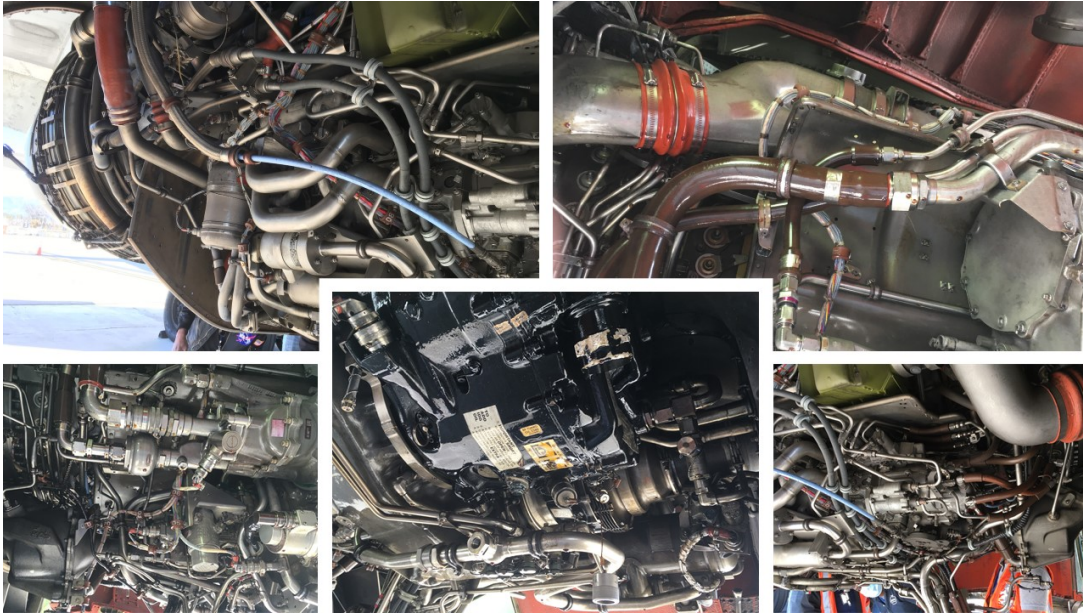
**PHOTO 22: NO FIRE DAMAGE UNDERNEATH THE HEAT SHIELD**

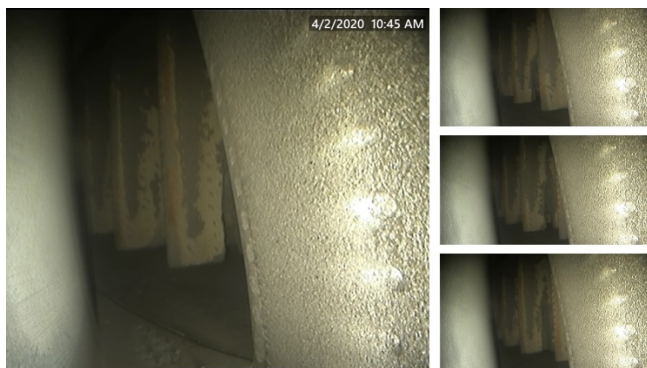
The NTSB authorized GE to perform a preliminary incoming borescope inspection (BSI) prior to the arrival of the Powerplant Group. The BSI was started in the HPT rotor section and no visible impact damage was observed; however, many HPT stage 1 blades exhibited thermal distress consistent with mid-span core burn-through. From there, BSIs were performed working aft (**PHOTO 26**). The first indication of event-related turbine damage or distress was to the leading edge of the LPT stage 1 blades (**PHOTO 27** bottom right corner photo). Damage was observed throughout all five stages of the LPT rotor; the damage included fractured blades at various lengths, missing blade and vane airfoil material, and LE and TE blade and vane airfoil impact damage. The LP rotor system (Fan-LPT, also commonly referred to as the N1 rotor) rotated smoothly during the borescope inspection. The combustion section also underwent a BSI as part of the Powerplant Group engine examination and no damage was observed.

**PHOTO 26: NO HPT ROTOR SECTION DAMAGE**

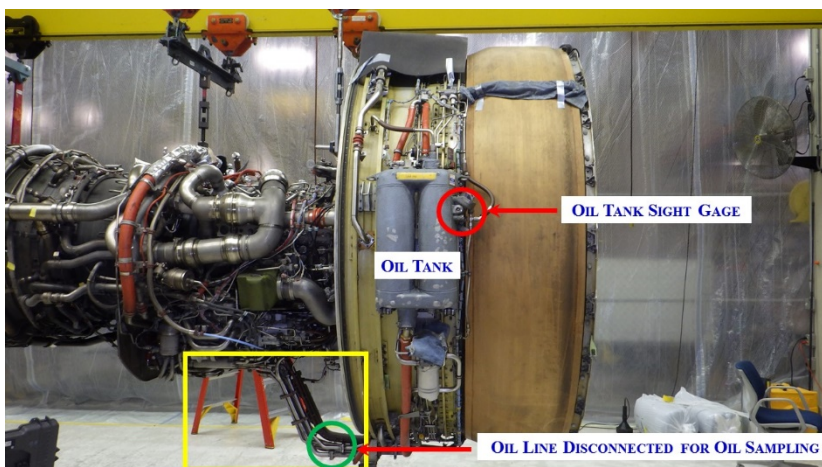
The oil and fuel drain lines located below the bifurcation panel (**PHOTO 28**, yellow box) towards the 6:00 o'clock position were wetted; however, no visible damage was observed on the fuel and oil tubes, lines, and hoses or to the electrical cables and brackets. As noted during the on-scene examination of the engine, the oil tank sight gage indicated that the oil tank was empty. The oil drain line at the lowest point on the engine (**PHOTO 28**, green circle) was disconnected and oil samples were collected. The main fuel supply line was intact and the orange thermal sleeve exhibited minor thermal distress at its lowest point near the 4:00 o'clock position.

**PHOTO 28: OIL SAMPLE LOCATION**

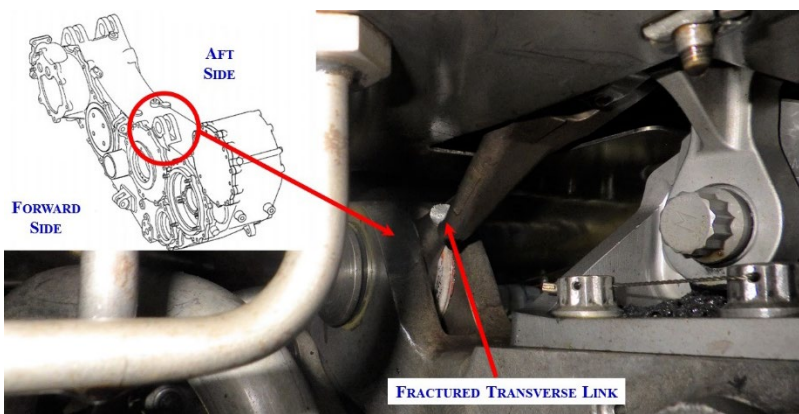
The AGB assembly is installed on the bottom of the engine and is attached to the compressor stator case. The transverse link attached to the AGB mount lug located at the 7:00 o'clock position towards the center AGB housing was found separated (**PHOTO 29**).

**PHOTO 29: FRACTURED TRANSVERSE LINK**

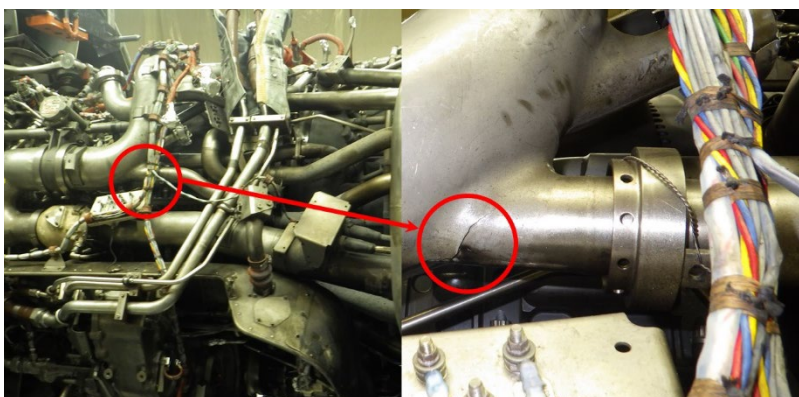
A crack was observed around the 9:00 o'clock position in the cooling manifold (**PHOTO 30**).

**PHOTO 30: CRACKING COOLING MANIFOLD**

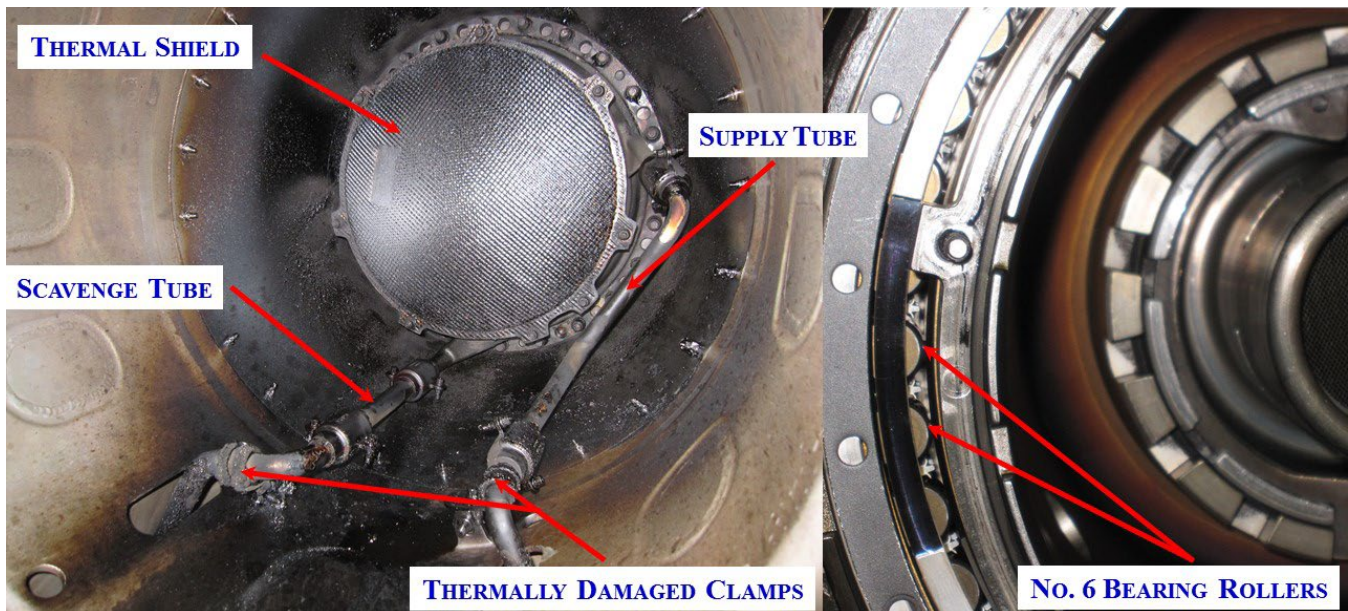
The exhaust plug was removed exposing the aft end of the "D" sump and the No. 6 bearing housing where vent air is discharged from the engine. The discharge air cavity was sooted, oil wetted and stained, exhibited black particles consistent with coke formation, the clamps and brackets that secure of the oil tubes were present and intact, and the oil tubes (supply and scavenge) appeared intact and undamaged. The oil tubes clamps exhibited minor thermal distress and the thermal insulation shield was intact and blackened. According to GE, that amount of oil, sooting, coking seen in this compartment was greater than what is usually seen on a normal in-service engine; however, it was consistent with their experience when a LPT failure occurs. The insulation shield, the No. 6/"D" sump rear cover and No. 6 bearing oil slinger were removed to expose the No. 6 bearing/"D" sump area; all the nuts and bolts that secure the rear bearing cover to the oil slinger were intact and tight. All the No. 6 bearing rollers elements were present, intact, and appeared shiny and oil wetted (**PHOTO 32**).

**PHOTO 32: NO. 6 BEARING COMPARTMENT/"D" SUMP CONDITION – OIL AND COKE NOTED**

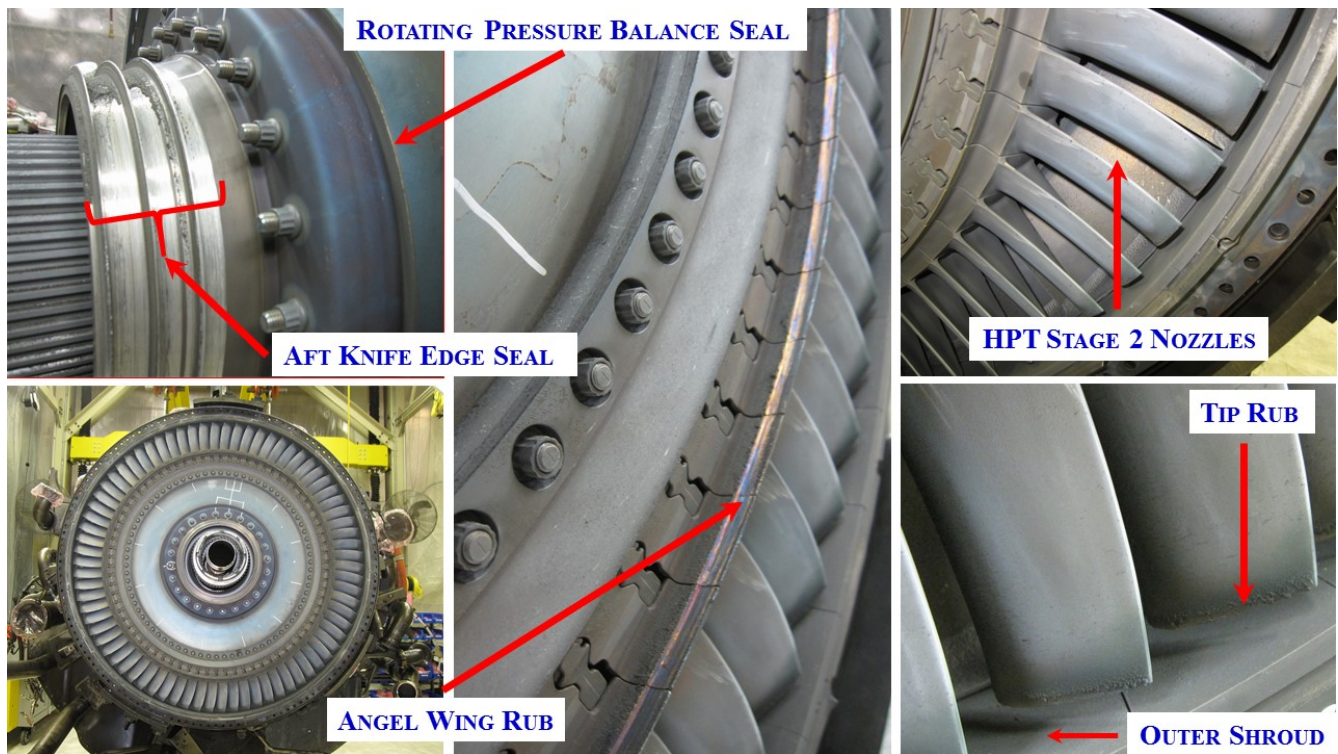
The LPT module was separated from the rest of the engine, exposing the aft end of the HPT assembly. **FIGURE 5** is a cross-sectional view of the HPT rotor assembly and **PHOTO 33** is representative of the HPT stage 2 damage observed. The HPT rotor spun freely by hand. All the HPT stage 2 blade outer shroud segments, which are part of HPT stage 2 nozzle assembly were present, intact, and exhibited minor contact rub. All the HPT stage 2 blades were present and intact; no airfoil damage was noted, and all the blades exhibited minor tip roll-over with the material rolled over in the direction opposite of rotation. The HPT stage 2 blade “angel wing” aft seal land (the seal lands that protrude away from both the forward and aft sides of the LPT blade shanks are commonly referred to as an “angel wing” seal as a description of their geometry and shape) exhibited circumferential scoring, bluing, and metal transfer on both the outboard and inboard surfaces 360° circumferentially around. The HPT stage 2 blade retainer plate was intact, and the outboard lip exhibited rub and material roll-over. The HPT rotor aft rotating air seal is comprised of a single seal that seals with the pressure balance seal land on the LPT stator assembly and a three knife-edge seal that seals with the forward rotating honeycomb seal attached to the LPT shaft. All the tips of the seals exhibited contact rub and tip roll-over; the pressure balance seal appeared bluish. No damage to the HPT stage 2 disk was observed. Looking forward through the HPT stage 2 blades, the HPT stage 2 nozzle segments were visible; no TE damage was observed. No disassembly of the HPT section was performed.

**PHOTO 33: HPT ROTOR DAMAGE**

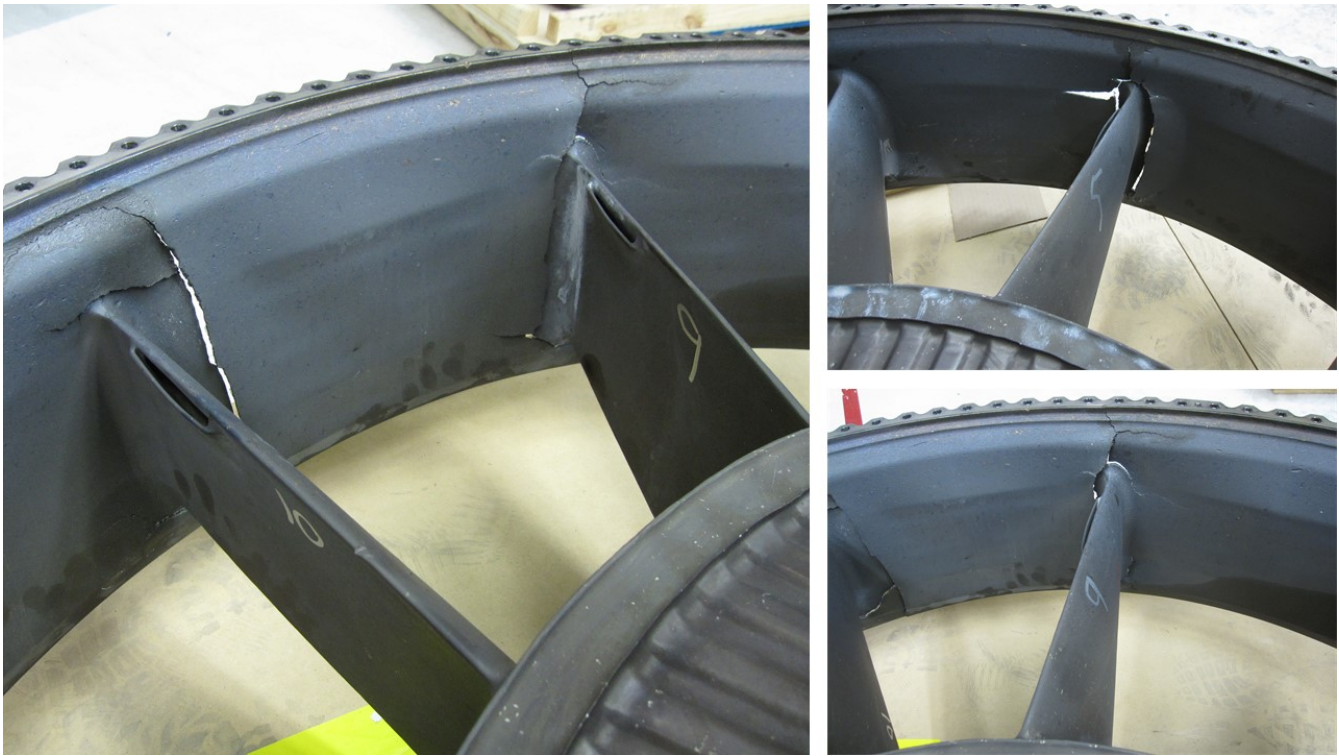
**PHOTO 34: TRF CASE OPENINGS AT STRUTS NO. 5, 9, AND 10**

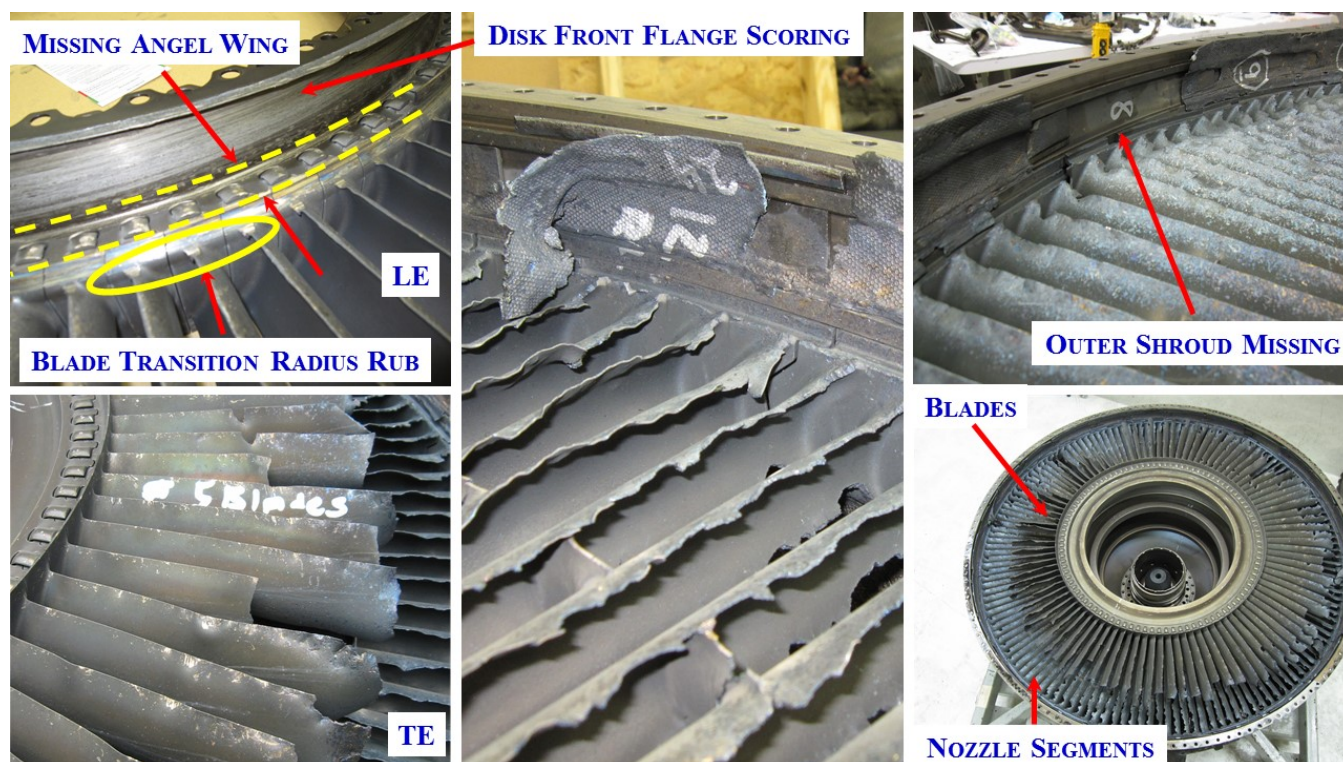
All the stage 5 blade outer shroud segments were sequentially numbered clockwise ALF 1 to 24 starting clockwise from the 12:00 o'clock position and were still installed in the stator case except for one segment located about the 4:30 o'clock position; this would have been blade outer shroud segment No. 8 (**PHOTO 35** upper right photo). Those blade outer shroud segments that remained were all heavily battered and exhibited a combination of damage consisting wear of the honeycomb seal down to the backing strip, torn/missing material, distortion, and some were worn completely through. Blade outer shroud segment No. 24 located one spot counterclockwise from the 12:00 o'clock position had become partially dislodged from the stator case and was curled and rolled into the gas path.

**PHOTO 35: LPT STAGE 5 DISK, BLADE, AND BLADE SHROUD DAMAGE**

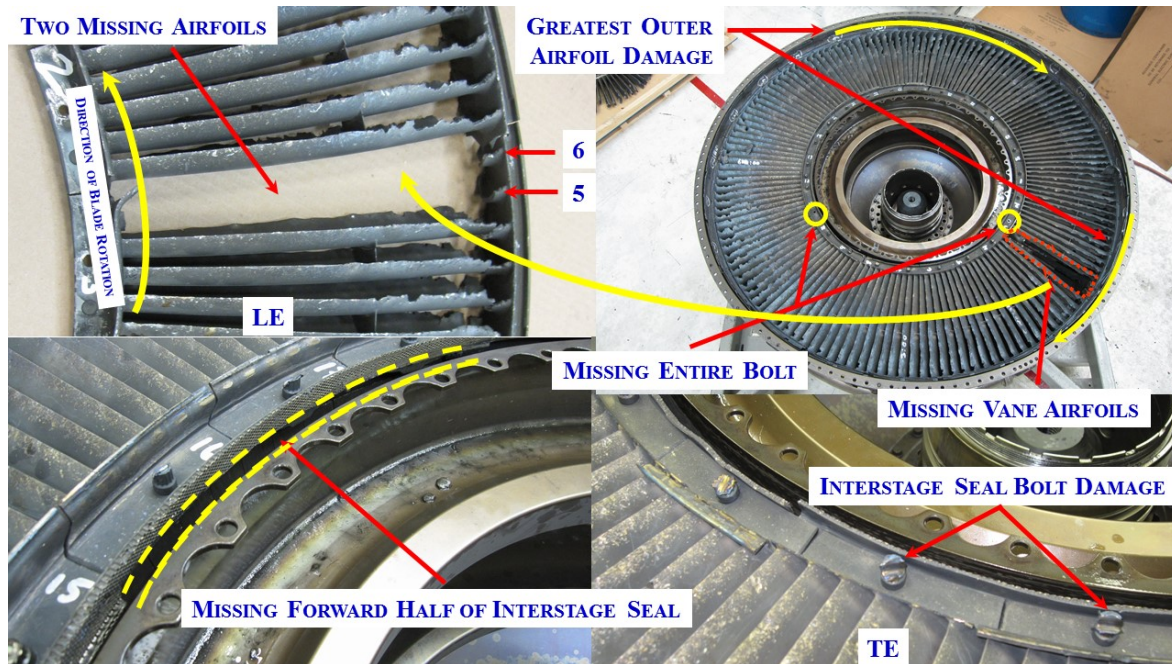
the shank was still present (**PHOTO 36** lower right photo). All the stage 4/5 interstage honeycomb seal segments exhibited gouging, wear down to the backing strip, and trenching of the honeycomb seal consistent with contact with stage 4/5 rotating knife edge interstage seal that is sandwiched between the LPT stage 4 and stage 5 disks; a section of stage 4/5 interstage honeycomb seal centered around the 9:00 o'clock position attached to nozzle segments Nos. 16 to 19 were circumferentially machined and forward half of the seal was missing (**PHOTO 36** lower left photo). The rotating knife edge seal was intact and exhibited contact rub.

**PHOTO 36: LPT STAGE 5 NOZZLE SEGMENT AND INTERSTAGE HONEYCOMB SEAL DAMAGE**

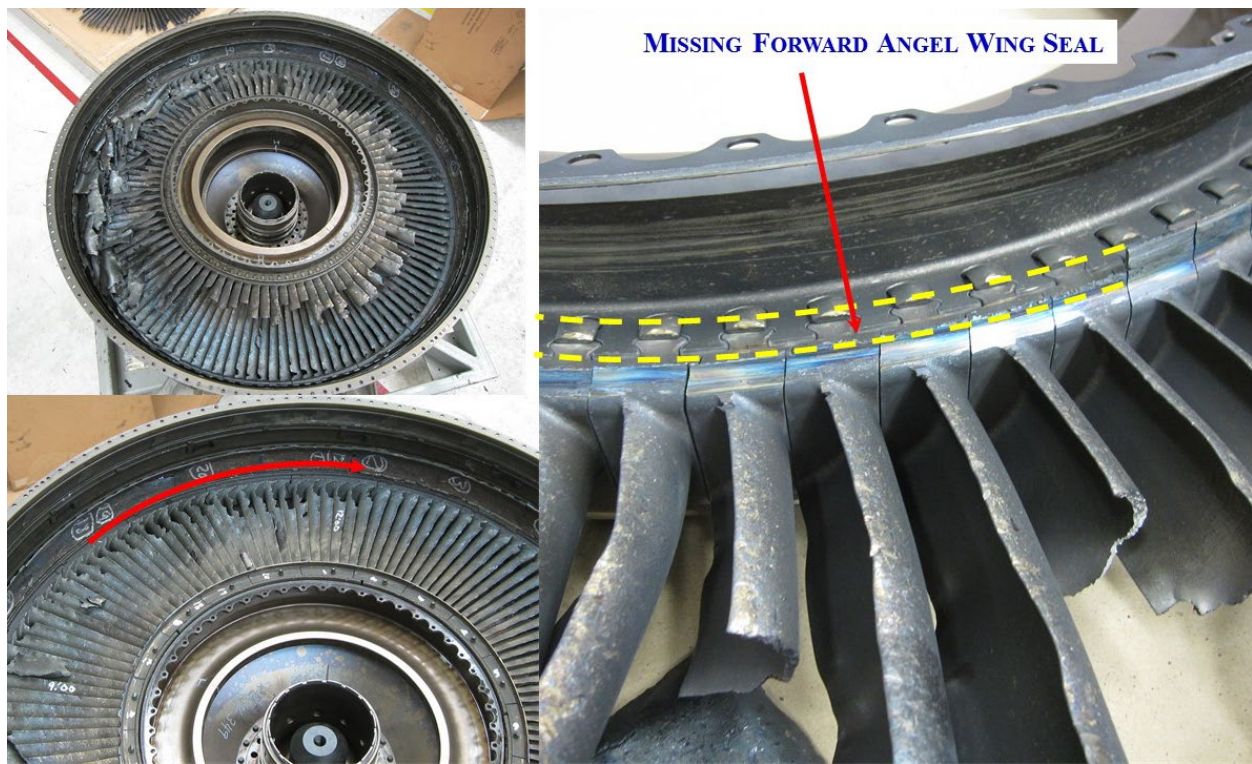
The front side of the LPT stage 4 disk outer diameter front flange exhibited a band of rotation scoring marks coincident with contact with the stage 3/4 interstage stationary honeycomb seal (**PHOTO 37** right photo); this is similar to the front flange damage observed in the LPT stage 5 disk.

**PHOTO 37: LPT STAGE 4 BLADE AND BLADE SHROUD SEGMENT DAMAGE**

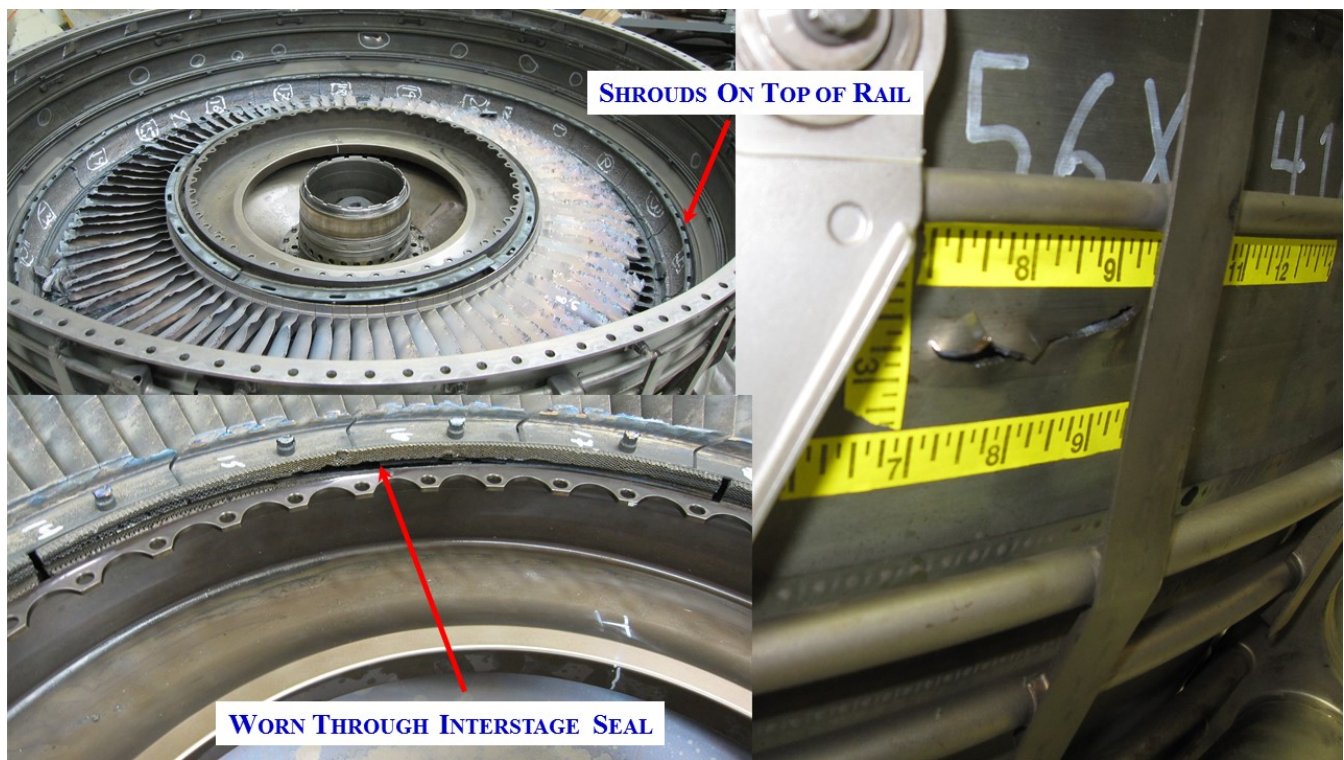
All the stage 4 blade outer shroud segments again were sequentially numbered ALF clockwise 1 to 20 starting slight counterclockwise from the 12:00 o'clock position. All the blade outer shroud segments were present, still secured to the stator case rail by the front "C" channel but disengaged from the case at the aft hooks (**PHOTO 38**, upper left photo), the aft hooks were collapsed upon themselves, and the honeycomb was worn down to the backing strip. The most significant rub and bluing consistent with heat distress was noted between blade outer shroud segments Nos. 14 to 3 (about the 7:00 to 2:00 o'clock position) (See **PHOTO 37** lower left photo) and from the Nos. 8 to 10 (about the 8:00 to 10:00 o'clock position). Blade outer shroud segments Nos. 2 and 15 exhibited a rub through, but no distortion or breach of the case was noted in these areas. Blade outer shroud segments Nos. 17 and 18 (about the 10:00 o'clock position) were also rubbed through and a small outward bulge in the stator case was noted but no breach. Blade outer shroud segment No. 19 (about the 10:30 o'clock position) exhibited a rub through and a corresponding breach of the stator case. Near the blade outer shroud segment No. 19 rub through, the case exhibited a 2.5-inch circumferential bulge and tear with a corresponding 0.5-inch hole; the hole appeared not be a penetration hole (**PHOTO 38** right photo). With all the blade outer shroud segments removed, 12 total impact bents/breaches were documented in-line radially with the stage 4 blade running path; the only breach observed was the one previously documented about the 10:30 o'clock position. All 12 bents/breaches were in an arc from about the 8:00 to 2:00 o'clock position, except for one (**PHOTO 38** upper left photo).

**PHOTO 38: LPT STAGE 3/4 INTERSTAGE DAMAGE AND STATOR CASE DAMAGE**

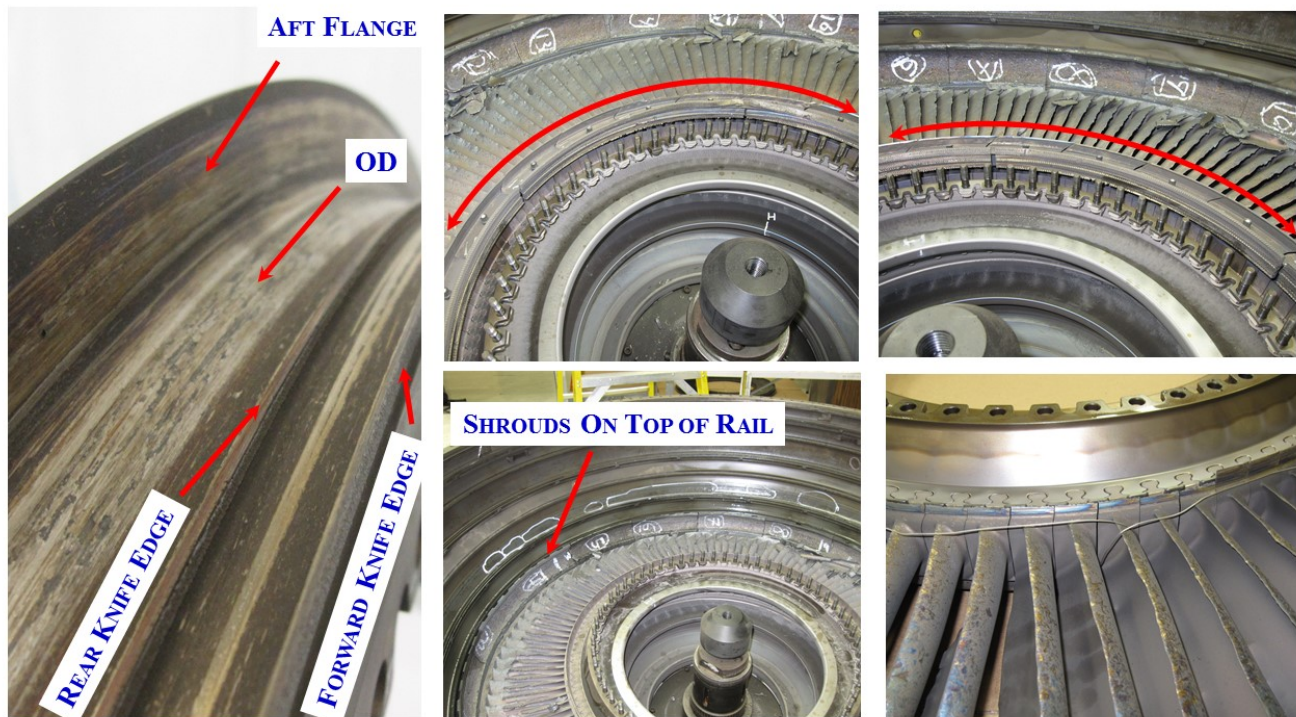
All the stage 3 nozzle segments were sequentially numbered ALF clockwise 1 to 20 starting counterclockwise from the 12:00 o'clock position. All the stage 3 nozzle segments were intact with no missing airfoils like was what observed for the stage 4 nozzles. The TE edges exhibited impact damage and material loss while the LE exhibited minor impact damage and material loss in comparison with the stages 4 and 5 nozzle segments. Many of the bolt heads of the stage 2/3 interstage honeycomb seal were machined consistent with contact with the forward edge of stage 4 blade LE angel wing seal land; none were missing like in the LPT stage 5. The stage 2/3 interstage honeycomb seals were present and exhibited appreciable gouging and trenching of the honeycomb from about the 3:00 to 10:00 o'clock positions. The most significant damage was centered around the 9:00 o'clock position seals Nos. 14 to 17 (**PHOTO 39** upper center photo) and at the 3:00 o'clock position seals Nos. 4 to 9 where the honeycomb was trenched down to the backing strip and cutting the backing strip.

**PHOTO 39: LPT STAGE 3 DAMAGE**
