**NATIONAL TRANSPORTATION SAFETY BOARD**  
**Office of Aviation Safety**  
**Washington, D.C. 20594**

**POWERPLANT GROUP CHAIRMAN'S FACTUAL REPORT**

**NTSB No: ENG21LA013**

**Aircraft:** Aerotransportes Mas de Carga, S.A. de C.V (Mas Air Cargo), Boeing 767-338F, registration number N363CM, Flight MMA6853

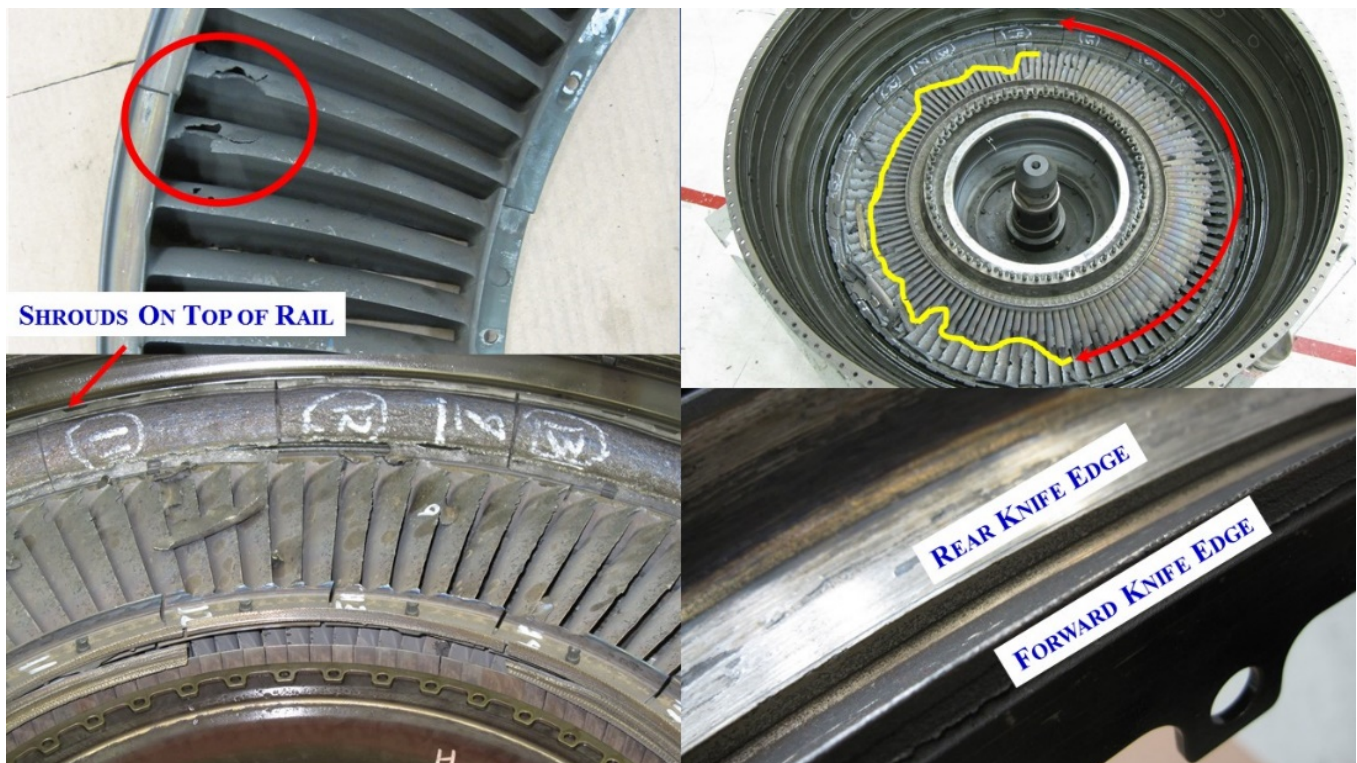
All stage 1/2 interstage honeycomb seal segments exhibited circumferential rub and some amount of trenching with greatest amount of damage centered around the 9:00 o'clock position. Interstage segments Nos. 12 and 13 were cut in half and forward edge was missing consistent with being cut by the knife edge from the rotating stage 1/2 knife edge seal and stage 2 blade retainer. Interstage segments No. 11 and 12 were cut in a similar fashion but remained together (**PHOTO 40**, lower left photo).

**PHOTO 40: LPT STAGE 2 DAMAGE**

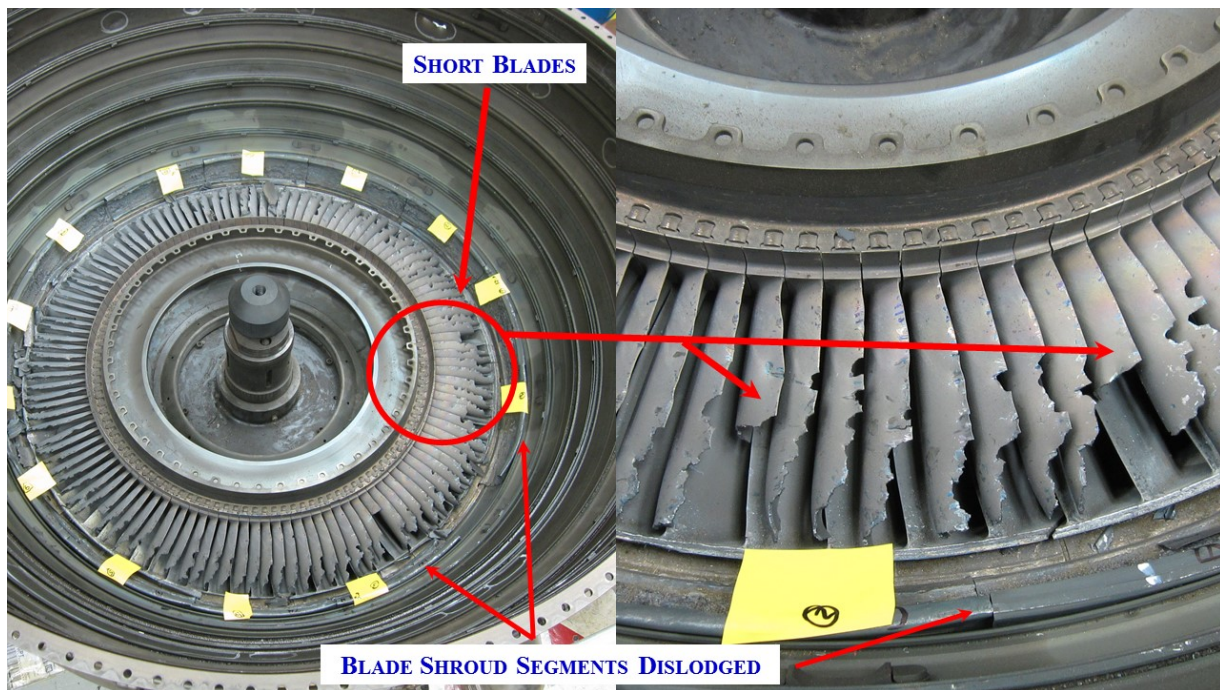
visual review of all the blade fracture surfaces (did not exam loose airfoil fragments debris) and did not find any evidence of a preexisting fatigue cracks.

**PHOTO 41: LPT STAGE 1 BLADE DAMAGE**

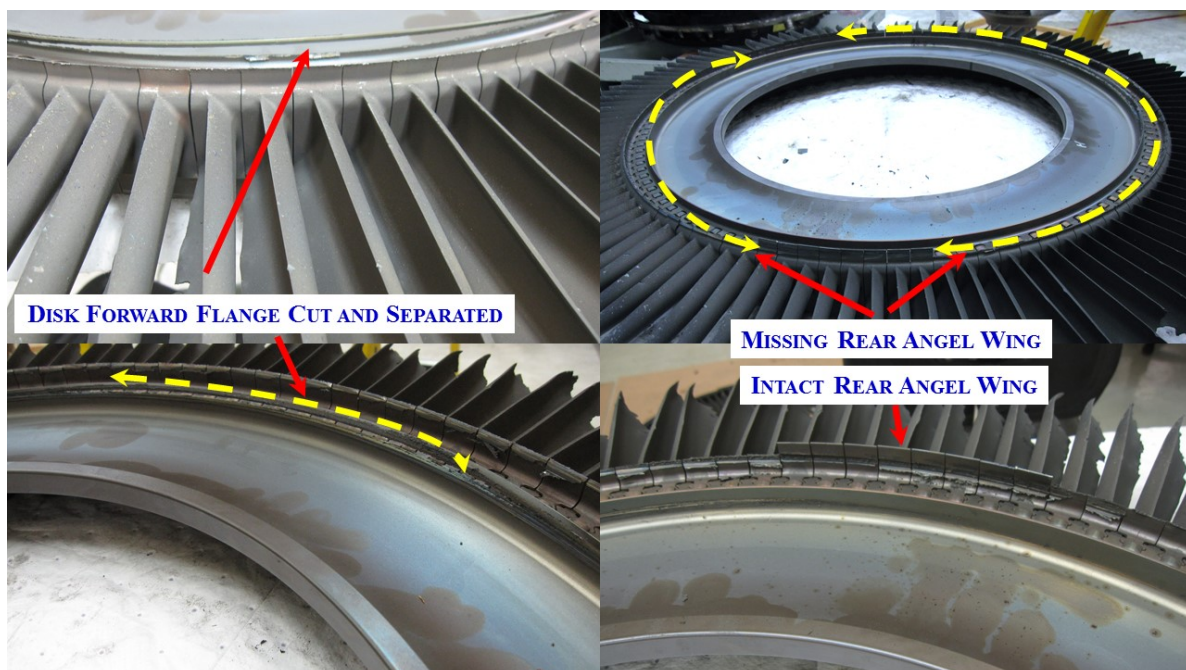
The disk forward flange exhibited continuous circumferential scoring around 80% on the ID surface; about 20% of the scoring resulted in a cut through and slight separation of that flange (**PHOTO 42**).

**PHOTO 42: LPT STAGE AFT ANGEL WING DAMAGE AND DISK DAMAGE**

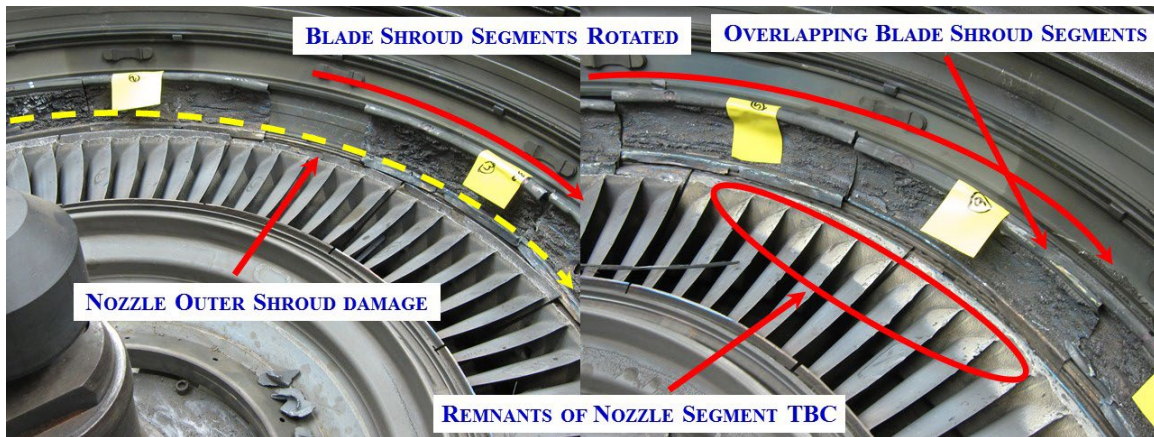
All the stage 1 nozzle segments were sequentially numbered ALF clockwise 1 to 13 starting counterclockwise from the 12:00 o'clock position. All the stage 1 nozzle segments were present, no airfoils were missing, and very few minor TE impacts and missing material were noted. The TE inner shroud platform aft face exhibited rub, heat distress, and small pieces of the platform were missing. The TE outer shroud platform was more damaged and the nozzle segments Nos. 3 to 5 from the 2:00 to 4:00 o'clock position were missing the rear platform. The stage 1 nozzles are coated with a white thermal barrier coating (TBC) applied on the outboard portion of the airfoil. Only remnants of the TBC were observed on suction side of segments Nos. 6 and 7. The coating was only on the suction side edge none were observed on the pressure side (**PHOTO 43**). The LE of the stage 1 nozzles exhibited no impact damage or heat distress and all the interstage temperature (ITT) probes were intact, whole, and undamaged (**PHOTO 44**); one vane exhibited a tight LE pressure side crack that measured about 0.7-inches.

**PHOTO 43: LPT STAGE 1 BLADE SHROUD AND NOZZLE SEGMENT DAMAGE**

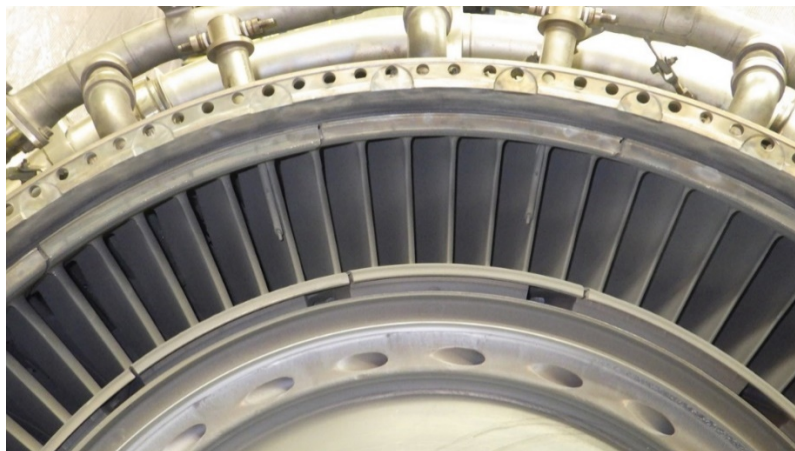
**PHOTO 44: LPT STAGE 1 NOZZLE SEGMENTS – LE FRONT VIEW**

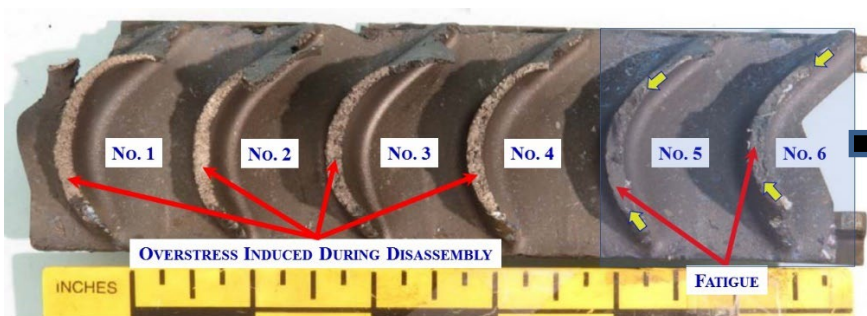
Examination of all the LPT blades showed signs consistent with overstress and the TRF struts showed bulk deformation and the fracture surfaces exhibited a rough appearance consistent with overstress. As previously stated, none of the fractured LPT blades were at or near the blade platform. The only LPT part that exhibited signs of fatigue was the stage 5 nozzle segment No. 3 that was completely missing two adjacent airfoils (airfoils Nos. 5 and 6) (See [PHOTO 36](#) upper right and left photo). Even though most of the fracture surface of what remained of airfoils Nos. 5 and 6 were heavily damaged due to post-event impact damage, binocular examination of the remnants revealed regions consistent with fatigue on both the outboard and inboard fracture surfaces. The outboard fracture surfaces on both the Nos. 5 and 6 airfoils showed cracking extending from the LE and TE edges towards the middle ([PHOTOS 45 and 46](#)). Under higher magnification using a scanning electron microscope (SEM), the fracture surface showed signs consistent with high cycle fatigue (HCF) growth from both the LEs and TEs ([PHOTO 47](#); picture taken from [ATTACHMENT 1](#)). In the interpretable areas (not damaged area), GE found no material anomalies in the base material, aside from the areas of intergranular oxidation (IGO). Due to the LE and TE impact damage on airfoils Nos. 5 and 6 at the fracture locations, no determination could be positively made on whether a repair had been previously performed in that area, so no assessment as the repair conformity was made.

**PHOTO 45: STAGE 5 NOZZLE OUTER SHROUD AIRFOIL FATIGUE FRACTURES – TOP VIEW**

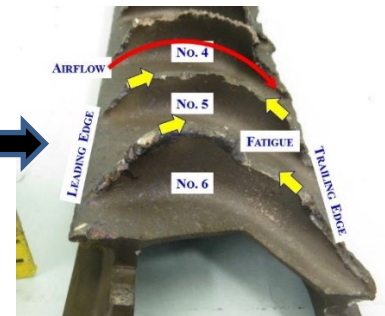
**PHOTO 46: FATIGUE FRACTURES – AIRFOIL VIEW**

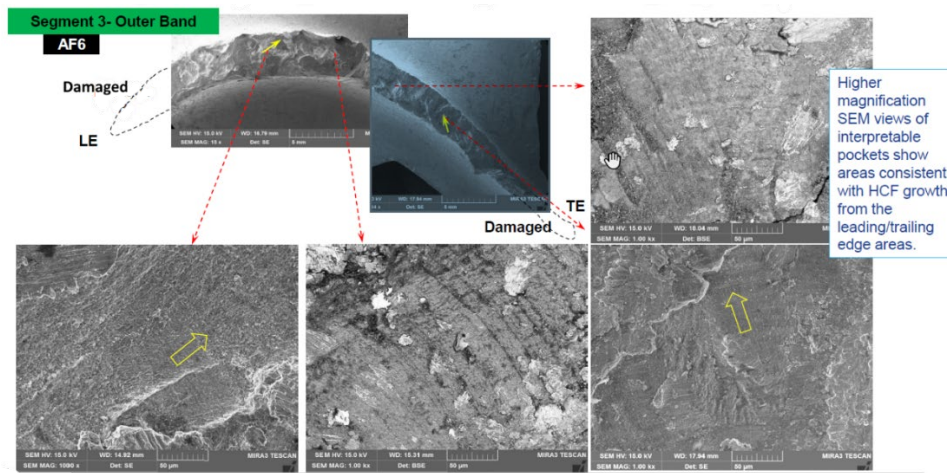
Low pressure turbine stage 5 nozzle segment No. 3, part number 9367M85P10, serial number HCM21194, had an extensive overhaul repair conducted in 2014 and at the time of the event had been in operational service for 10,232 hours and 4,068 cycles since the overhaul repair was performed. Due to the leading and trailing edge impact damage on airfoils Nos. 5 and 6 of the low pressure turbine stage 5 nozzle segment No. 3 at the fracture locations, no determination could be positively made on whether a repair had been previously performed in that area, so no assessment of the repair conformity was made.

**PHOTO 47: SEM VIEW OF FATIGUE ON STAGE 5 NOZZLE SEGMENT NO. 3, AIRFOIL 6**

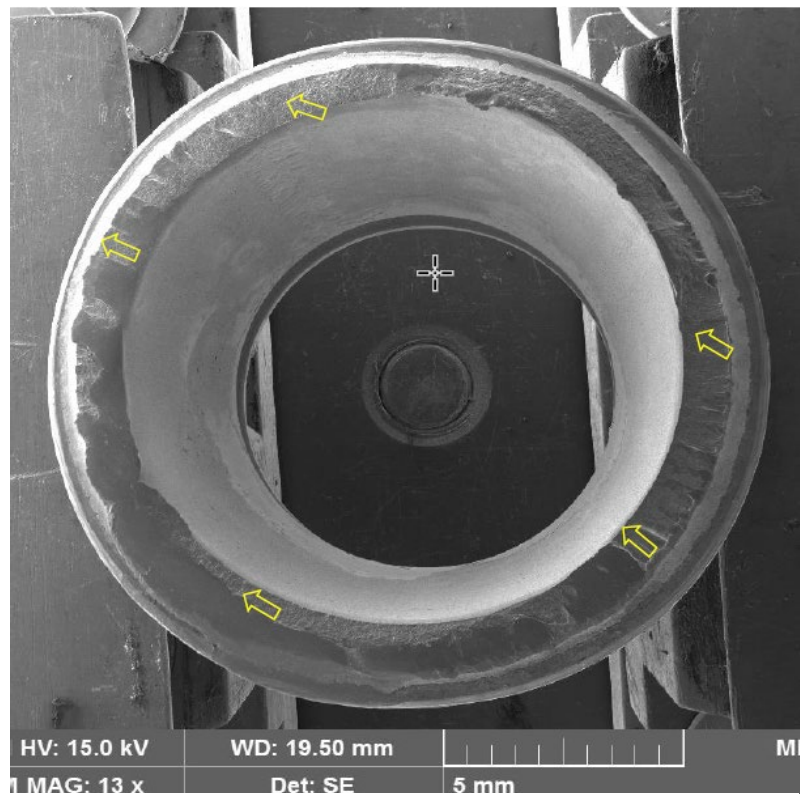
The fractured oil supply (pressure) line (See **PHOTO 17**) fracture surfaces exhibited plastic deformation and a planar fracture consistent with secondary high amplitude fatigue/cyclic tensile loading (**PHOTO 48**; picture taken from **ATTACHMENT 1**).

**PHOTO 48: SEM VIEW OF FATIGUE ON OIL SUPPLY TUBE**

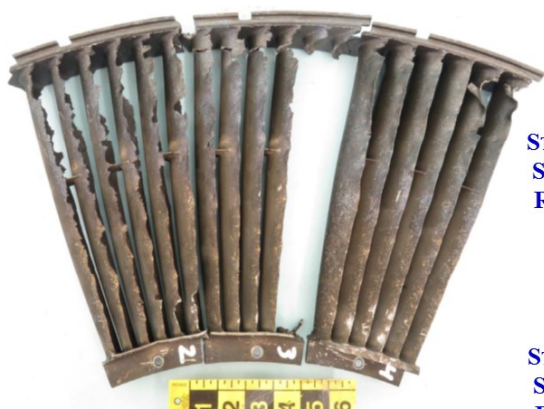
STAGE 5 NOZZLE SEGMENTS NOS. 2-4

STAGE 5 NOZZLE  
SEGMENT NO. 4  
REPAIR MARKS

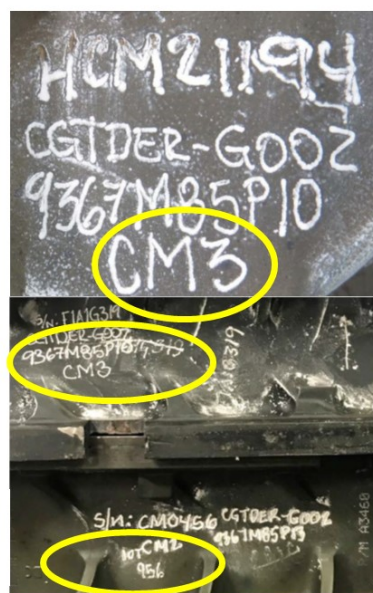
STAGE 5 NOZZLE SEGMENT REPAIR MARKING
