## **POWERPLANT GROUP CHAIRMAN'S FACTUAL REPORT**

**ENG21LA013**

**GE's MAS Air Cargo ESN 695440 Failure Analysis Findings & Root  
Cause Summary Presentation**

4/1/2021

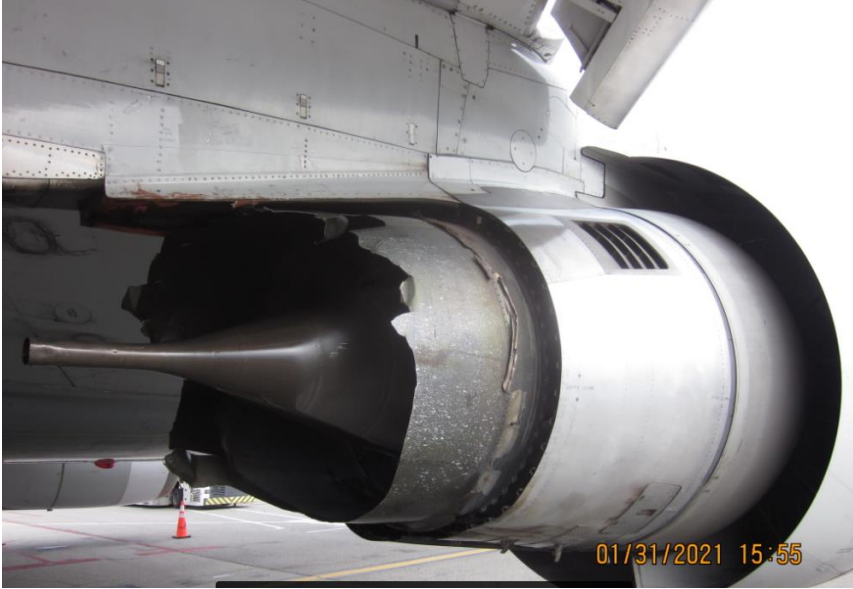
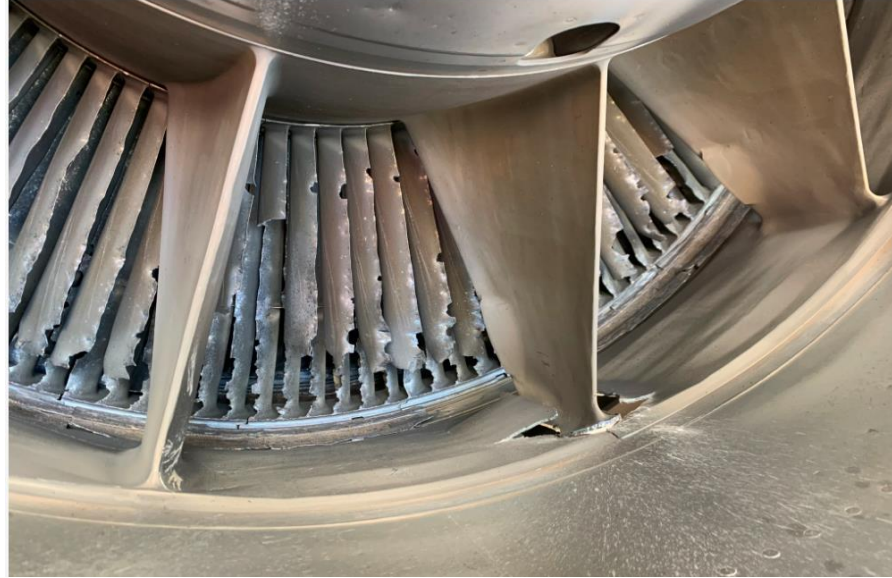
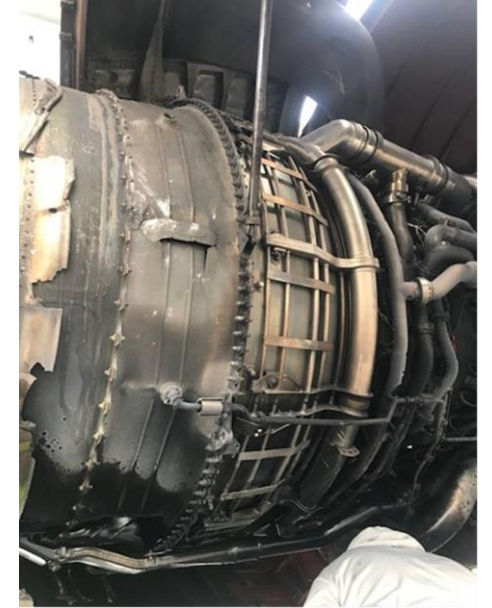
**Engine Condition:** Exhaust Nozzle missing material, TRF strut cracking, ABG Transverse link separated ,Oil tube broken , Evidence of heat distress on various tubes from the 9 -6 o'clock position (ALF).

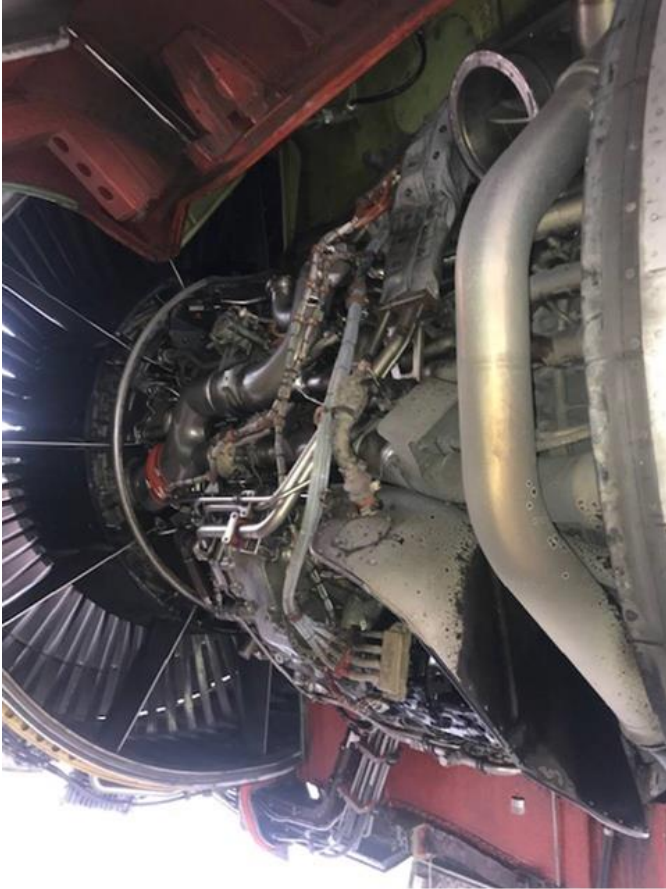
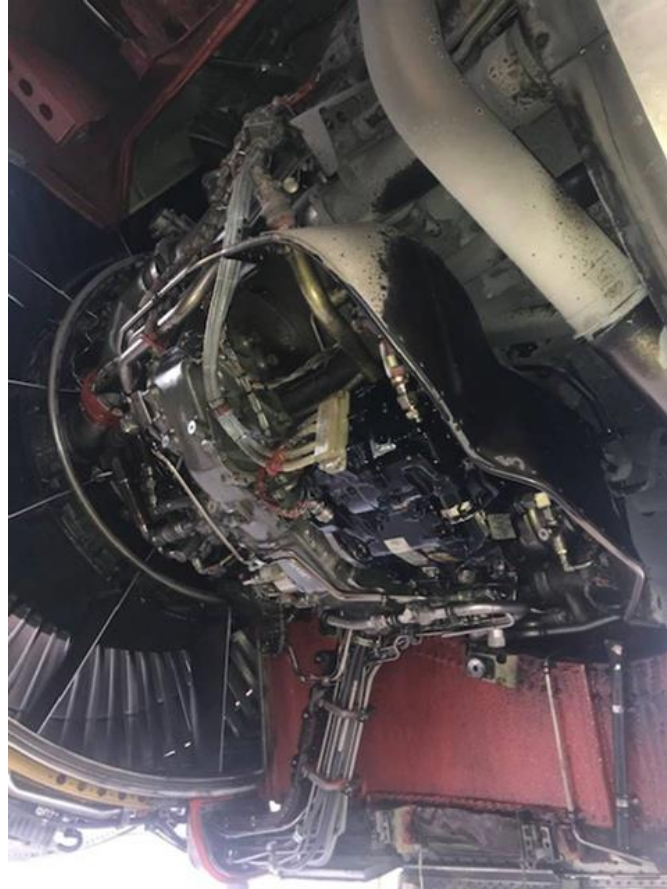
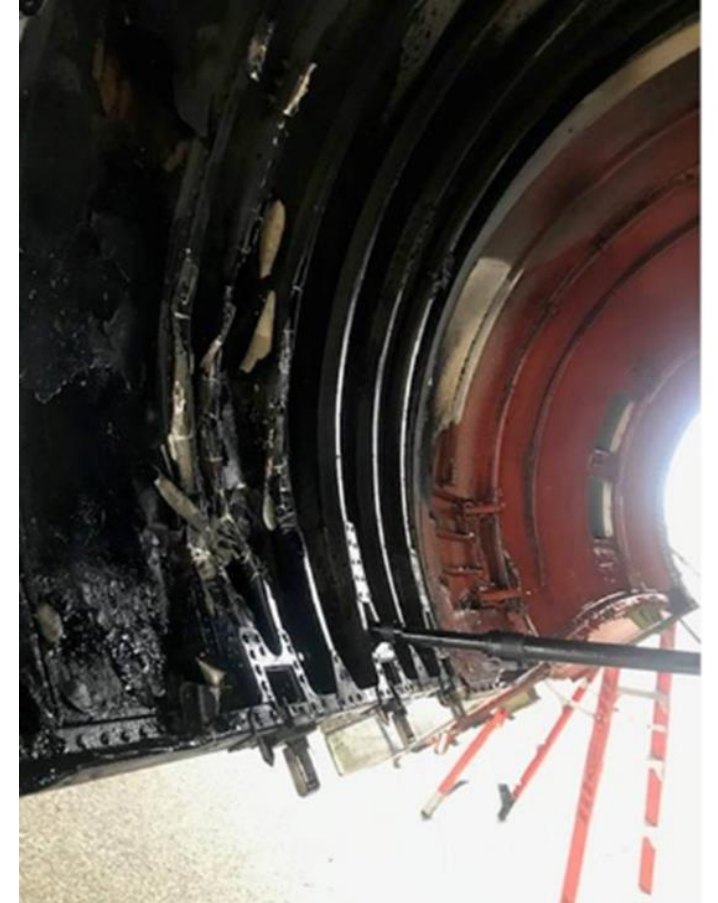
Distress observed on engine and Cowl doors from engine fire

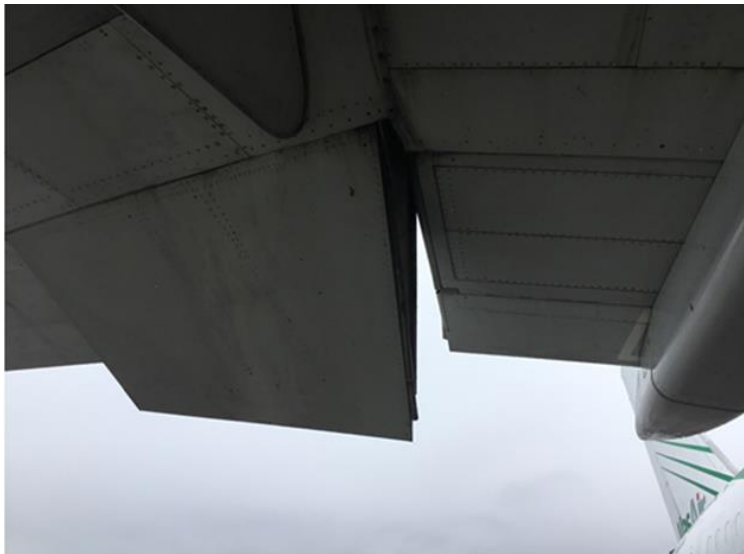
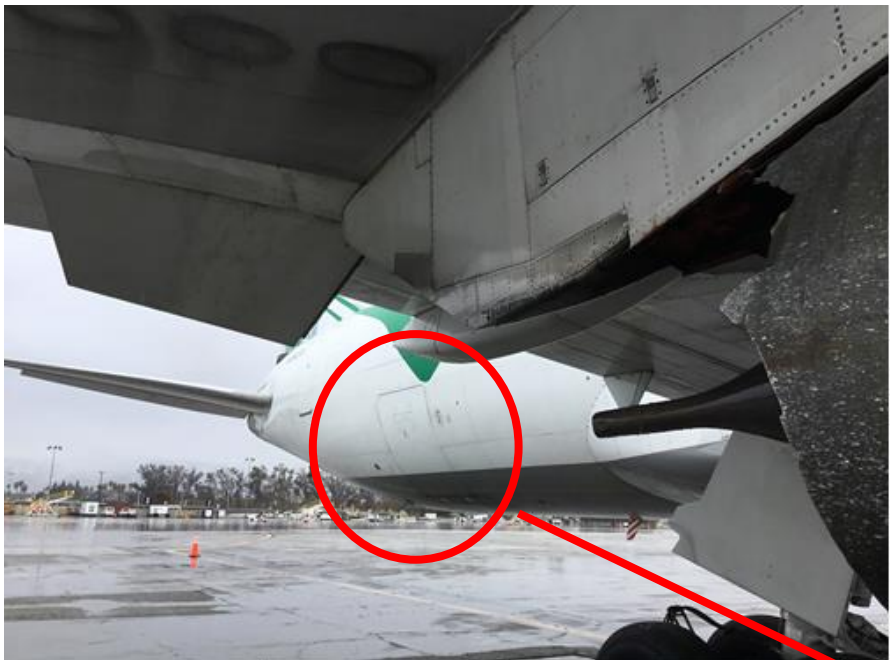
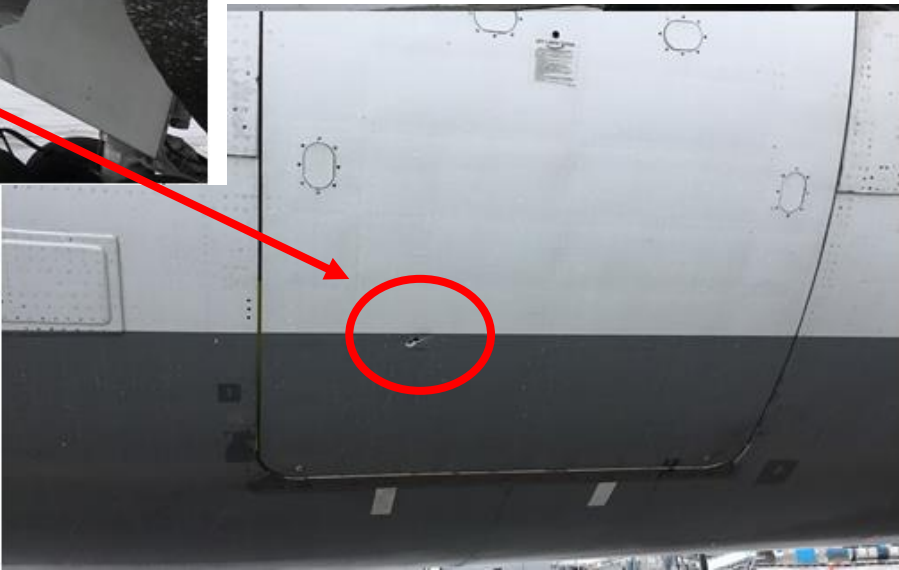
Damage observed on Exhaust Nozzle with AC  
distress observed on Aileron Flaps and Cargo door

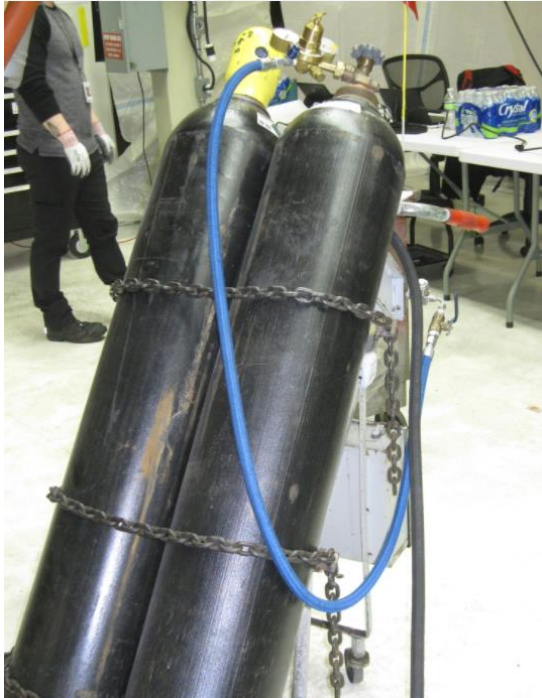
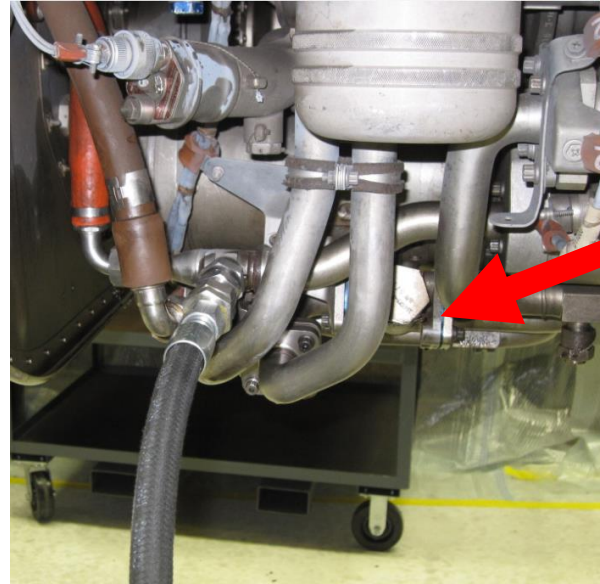
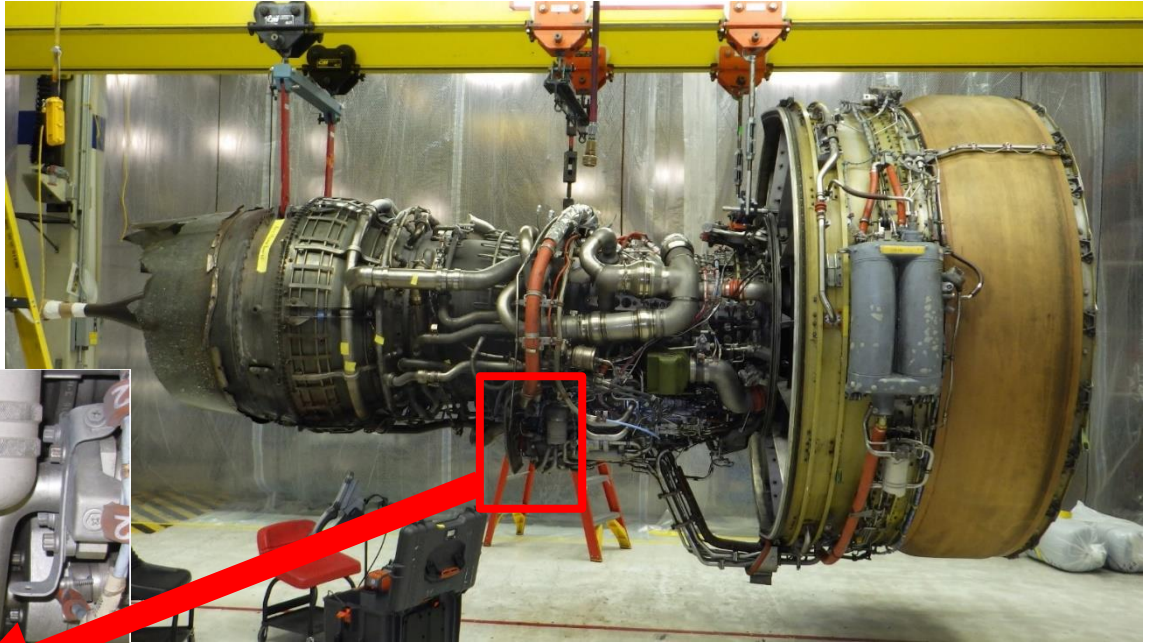
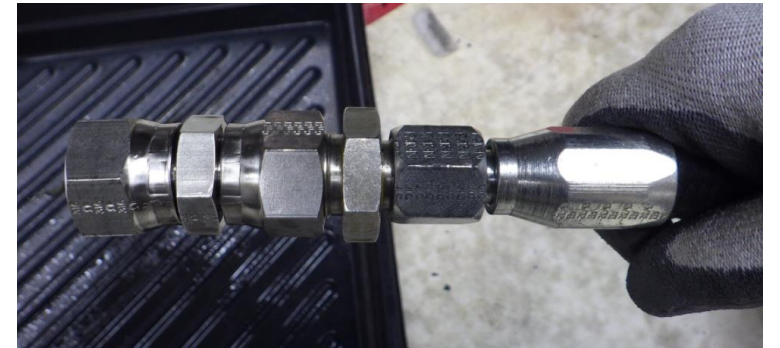
Nitrogen Fuel System pressure/leak check performed.

. (Fuel Nozzles pigtails were not tested)

**No fuel leaks identified**

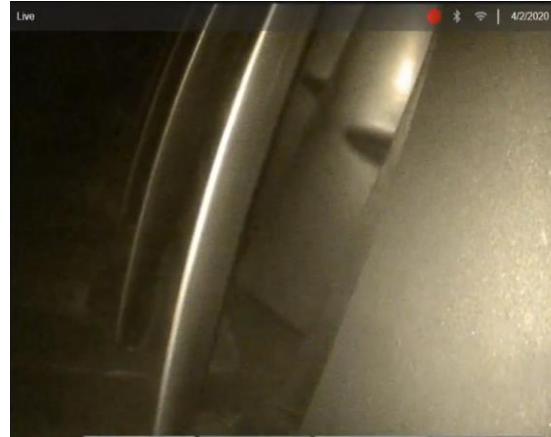
HPC Stage 1 Airfoil

- No distress observed on HPC Blades or Vanes
- No missing airfoils observed.
- No signs of impact damage.
- Core rotation was noted as normal.

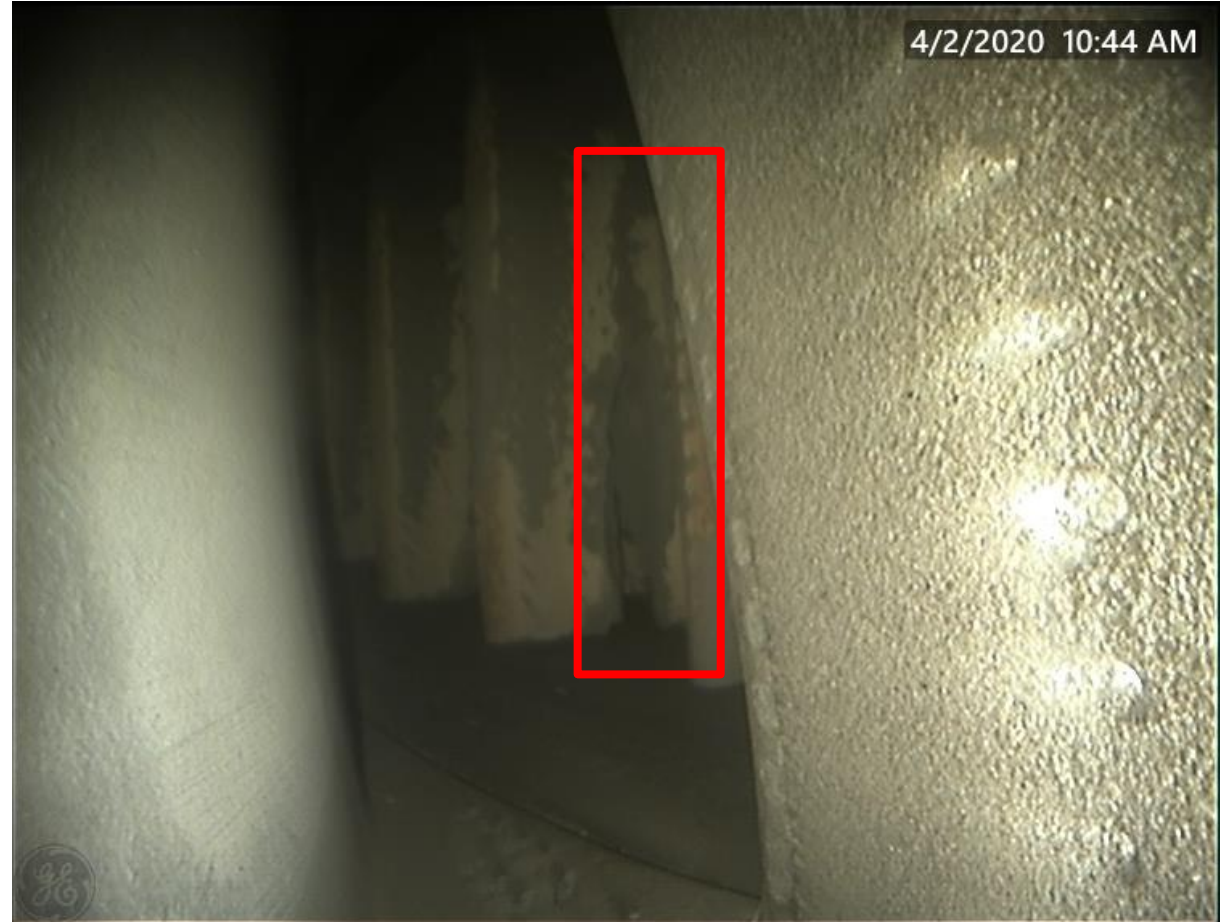
- HPT Stage 1 blades, mid core burnout was noted on various blades.
- No missing airfoils observed.
- No signs of impact

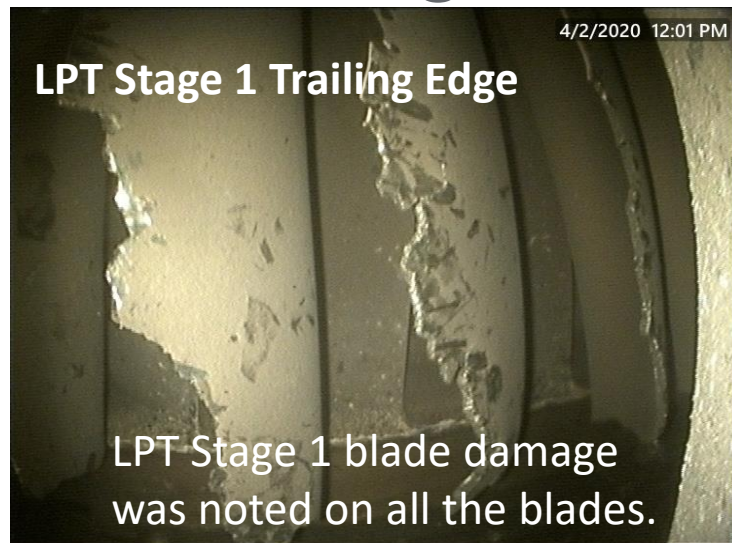
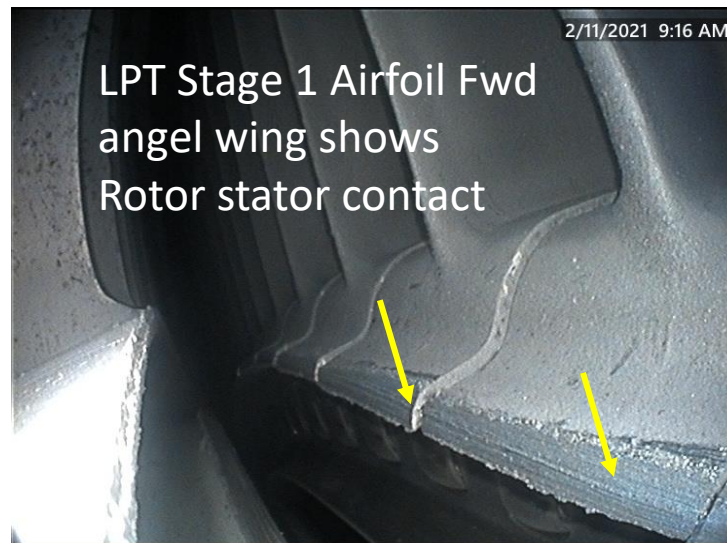
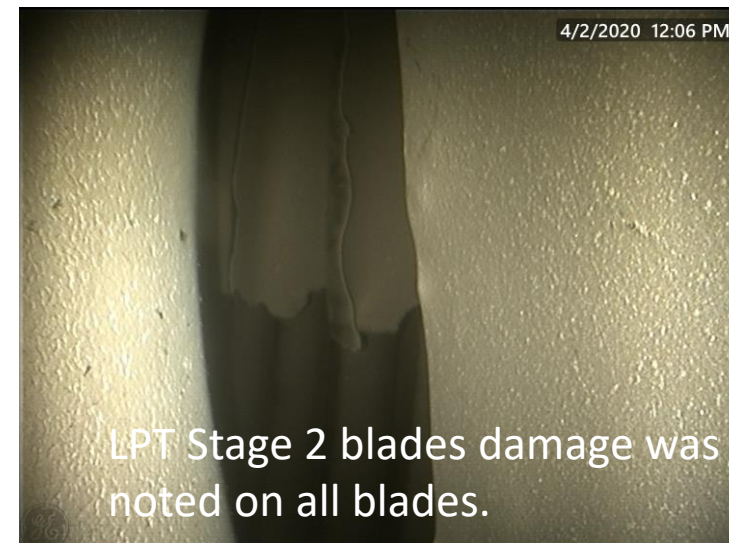
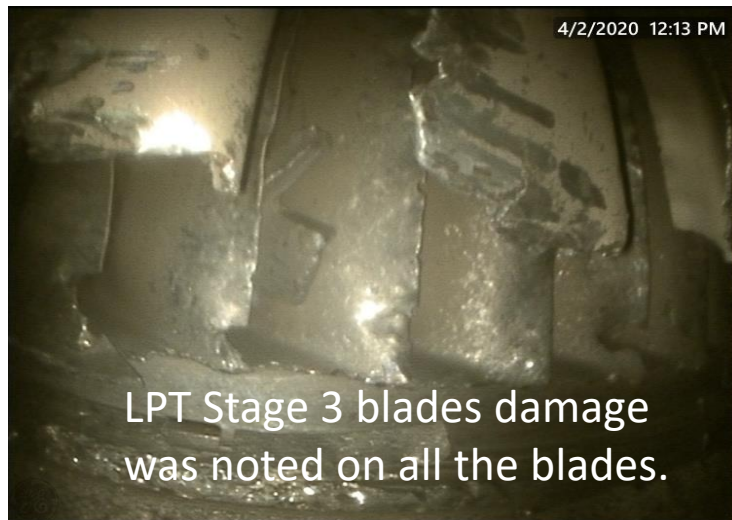
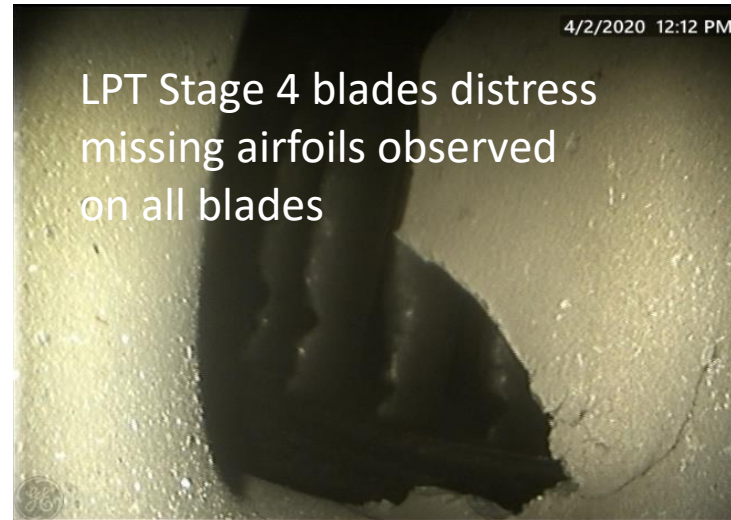
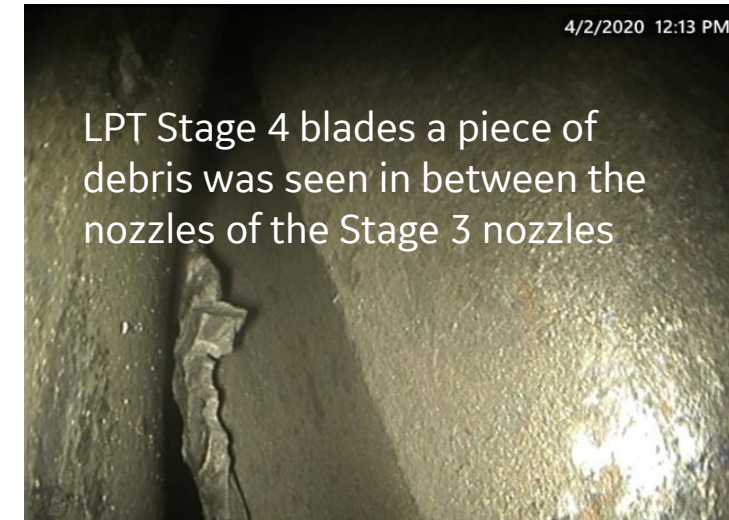
**Severe distress observed on all LPT stages**

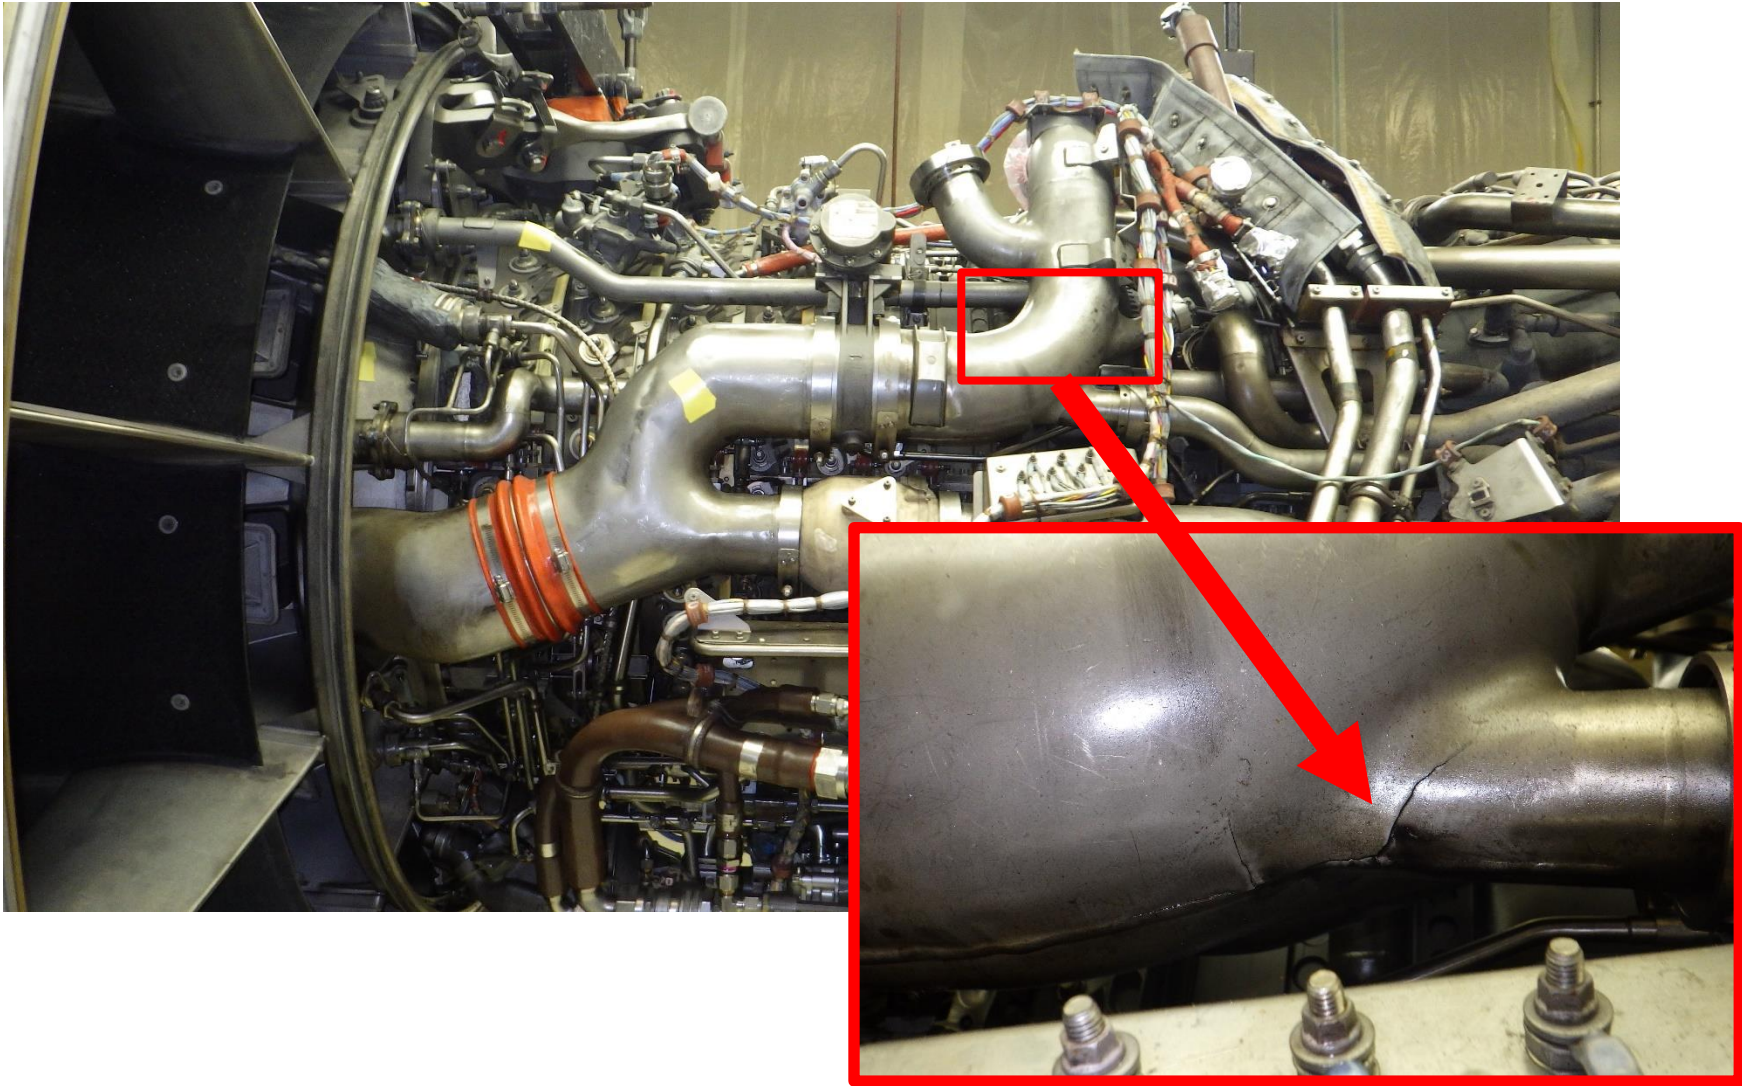
Crack can be seen on the compartment cooling manifold around the 9 o'clock position (ALF)

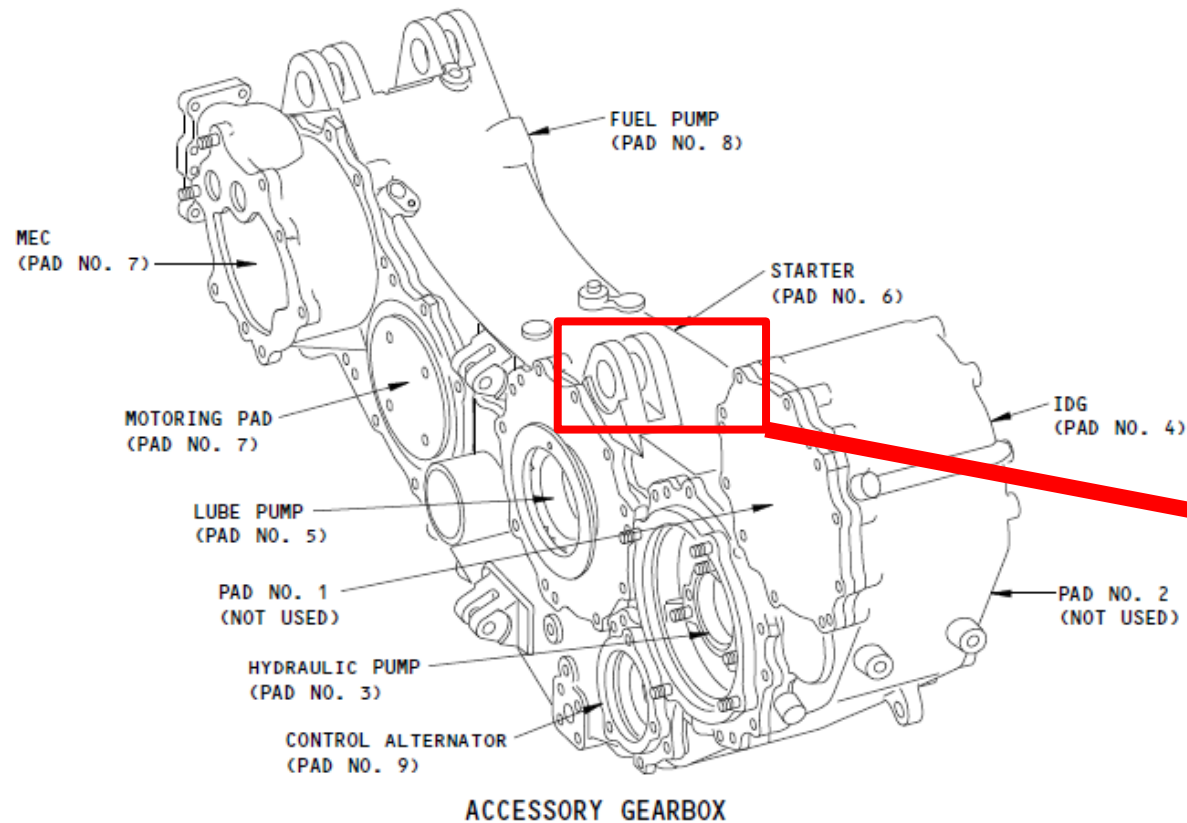
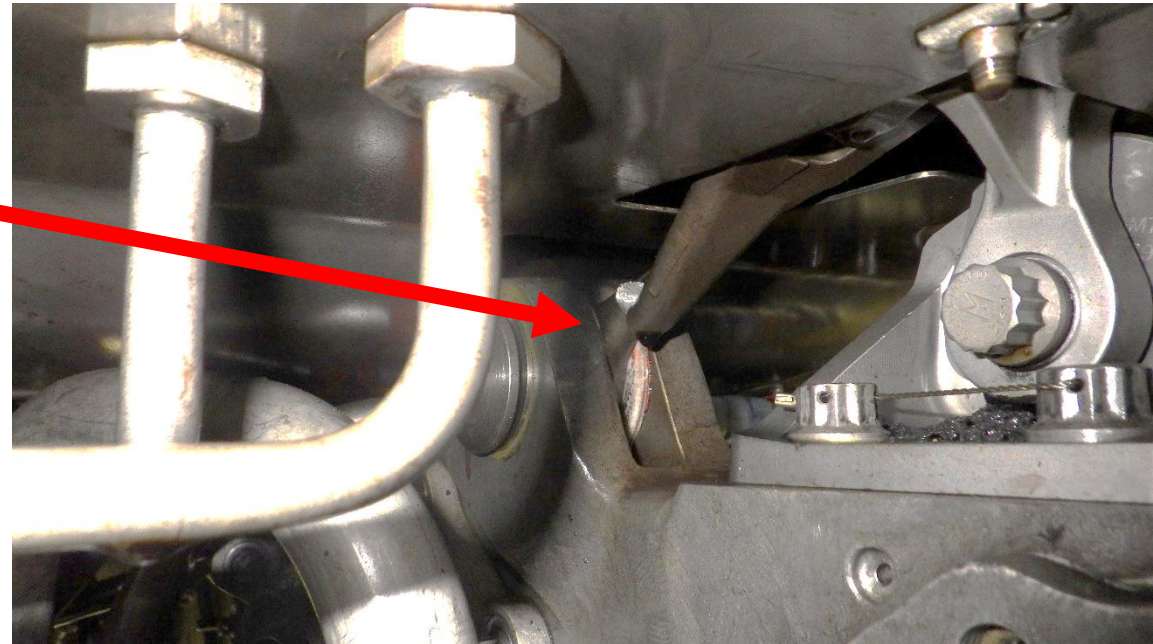
ABG Transverse link separated at the 7 o'clock position toward the center of the AGB.

- Unusual finding, link not previously reported broken

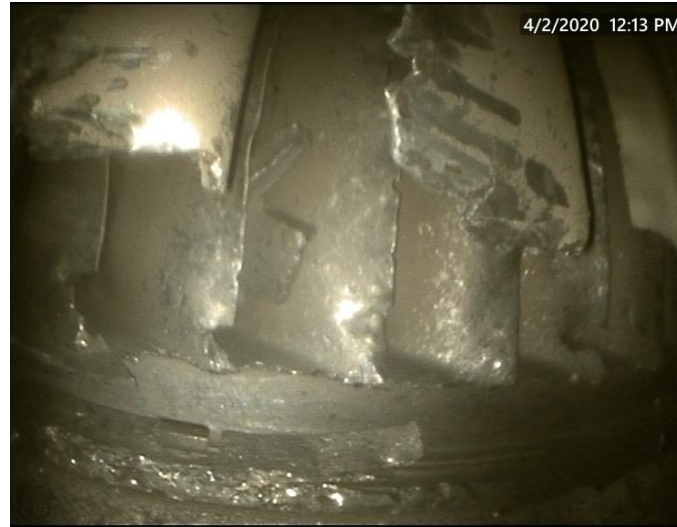
LPT Stages 1-5 showed missing airfoils and nozzle distress

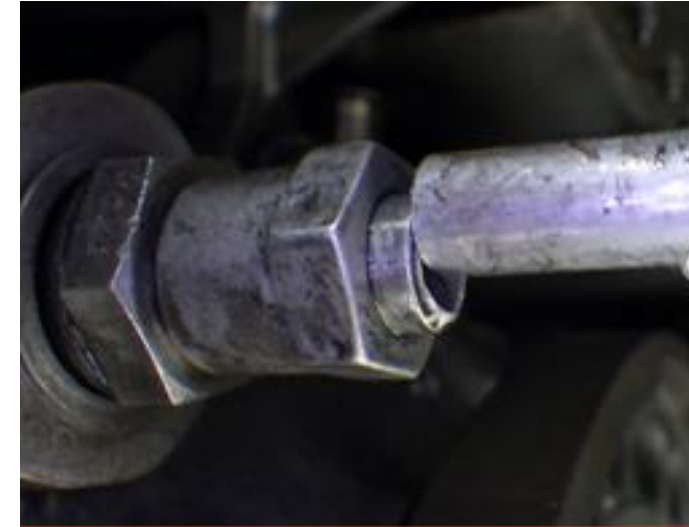
Broken Oil Tube on AGB

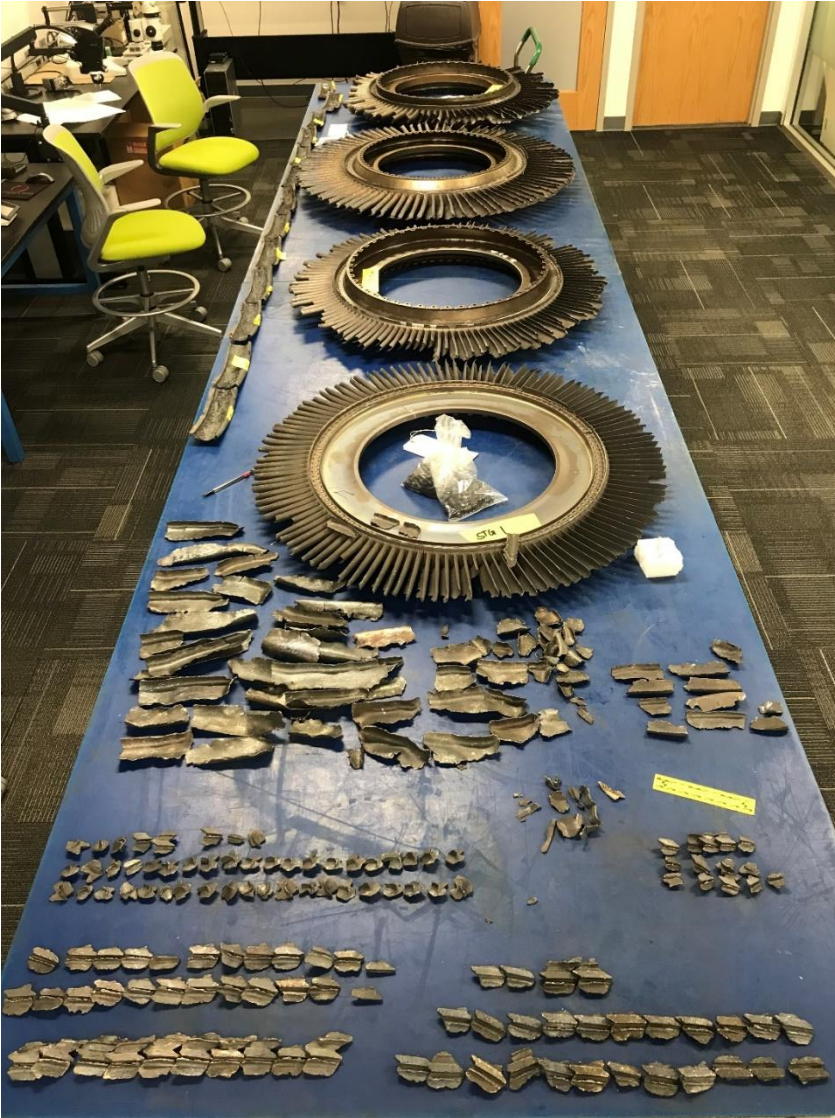
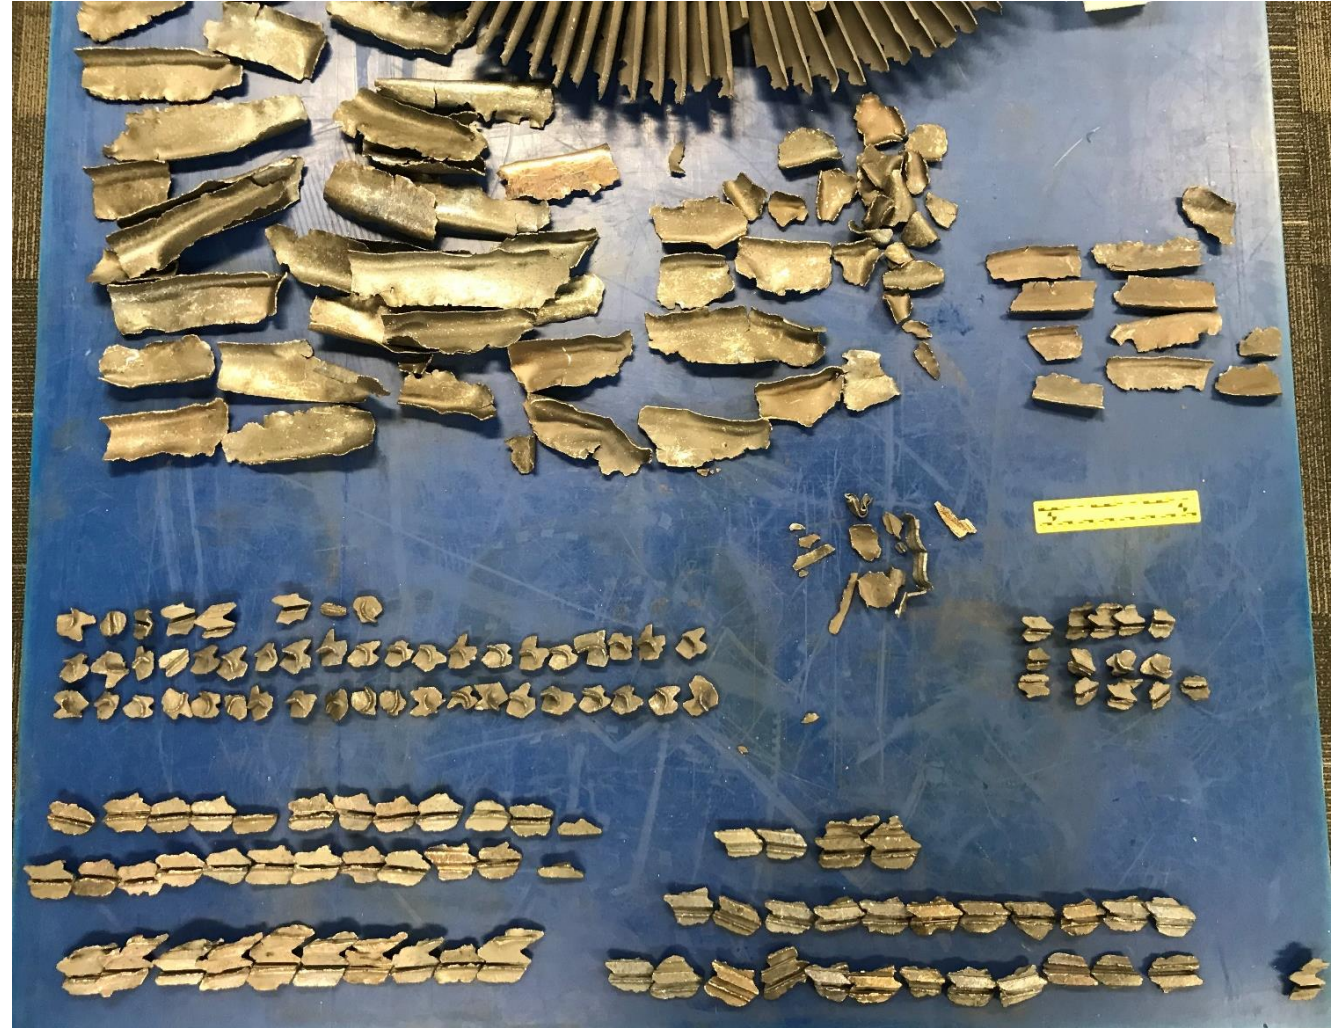
**All LPT blades had features consistent with overstress.**

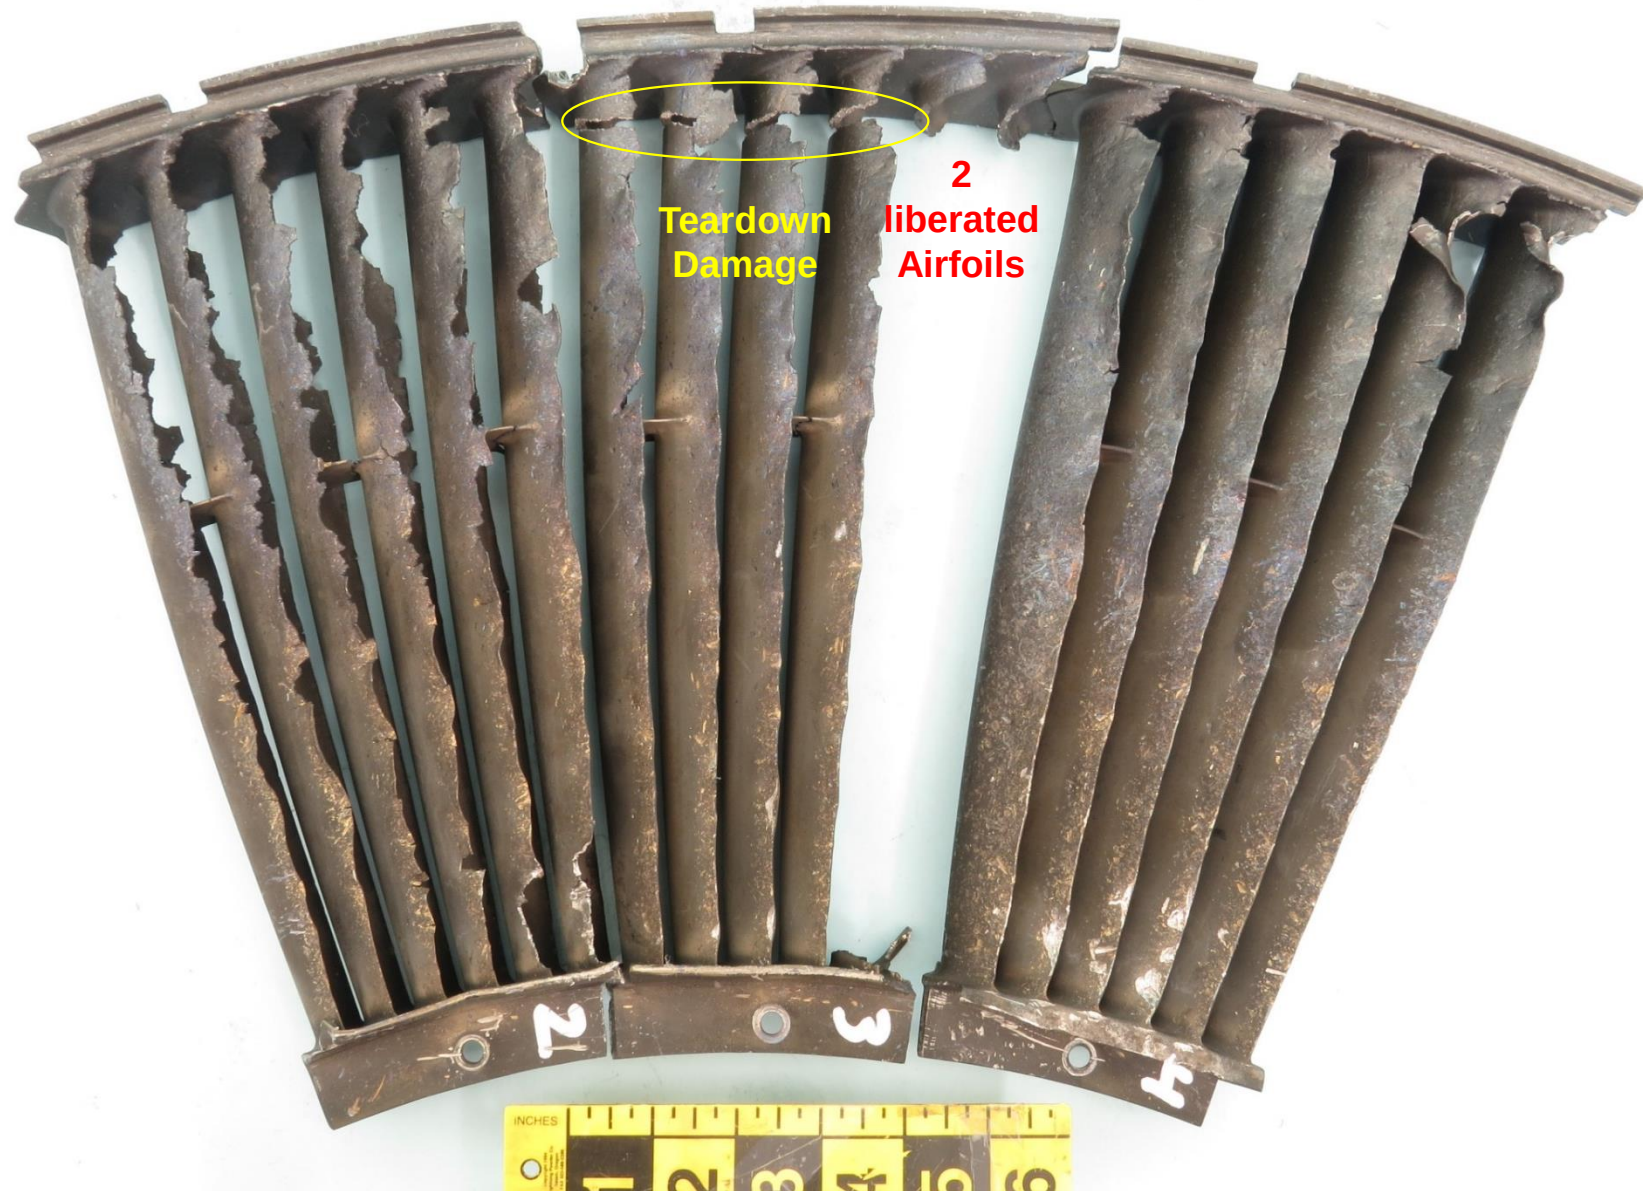
Overall view of stage 5 nozzle segment 3 with 2 missing airfoils.

All 4 fracture surfaces had regions with fatigue with the outboard 2 fractures extending in toward /airfoils near the outer band radius.

On the inboard end one fracture extended at the airfoil base near the high-C (airfoil 6) and one extended from the airfoil leading and training edge areas.

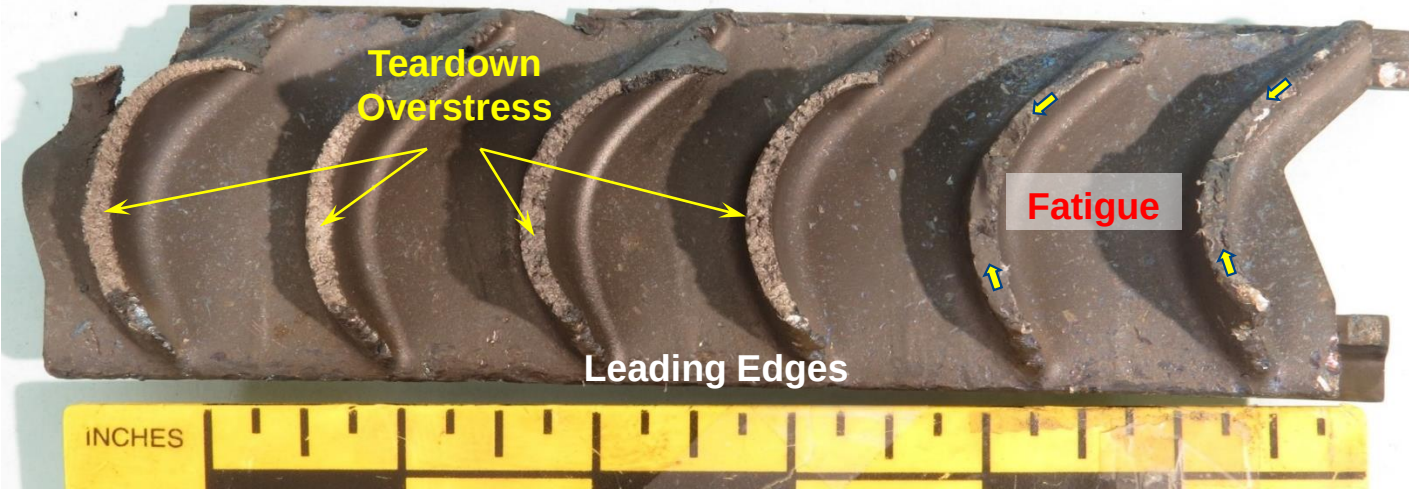
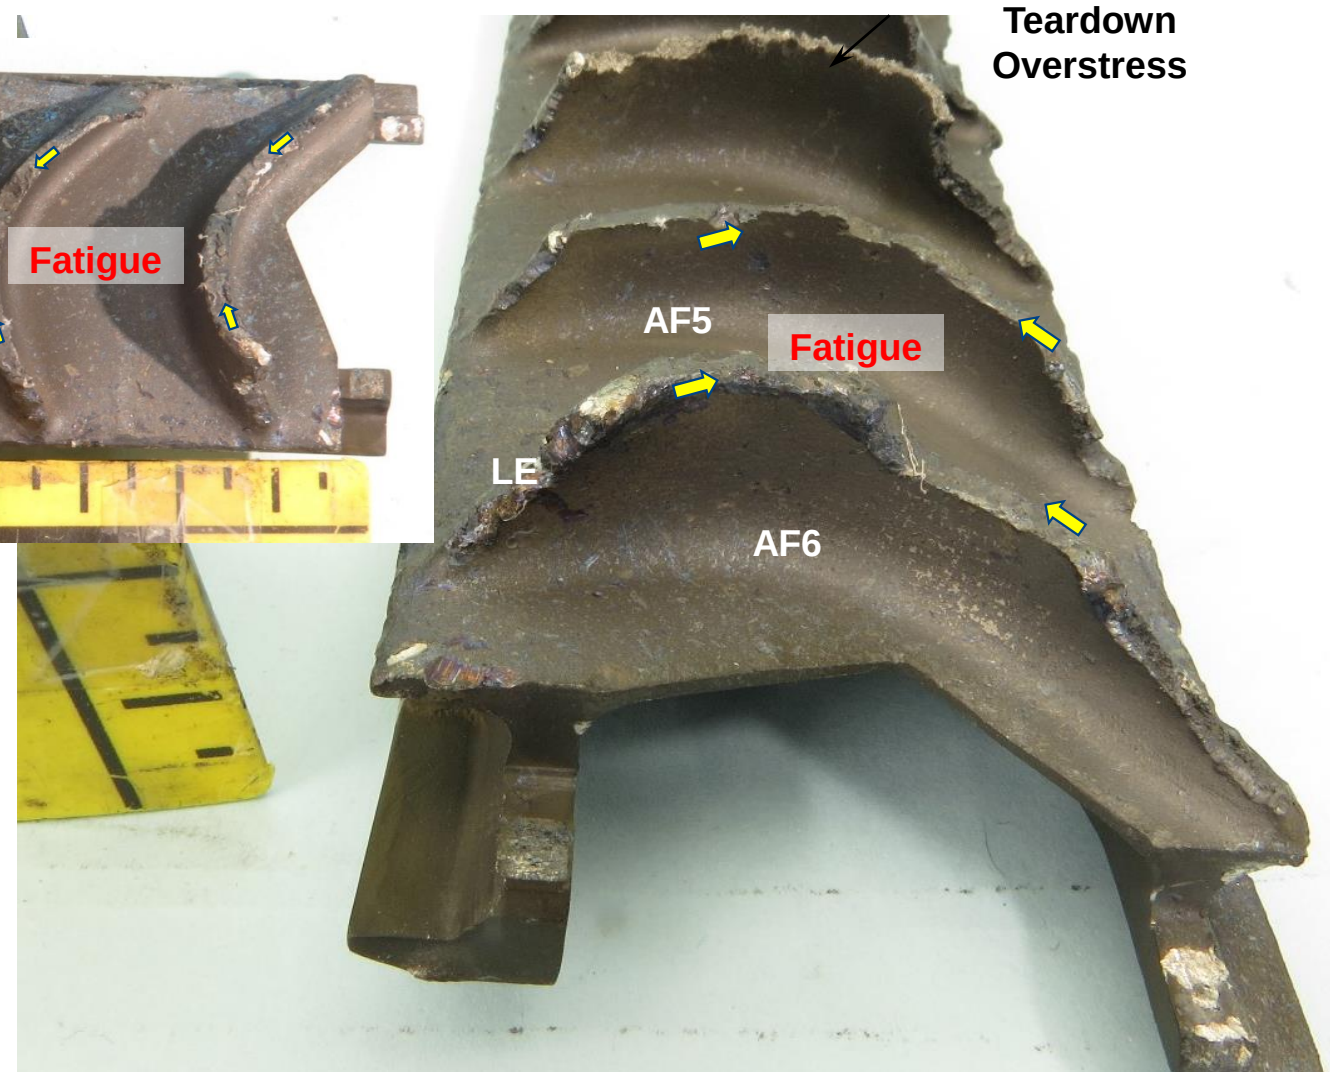
## Segment 3- Outer Band

Overall view of the outboard fractures showing that airfoils 5 and 6 had cracking extending in the airfoils near the tip extending from both the leading and trailing edges (that were damaged by post-fracture impacts).

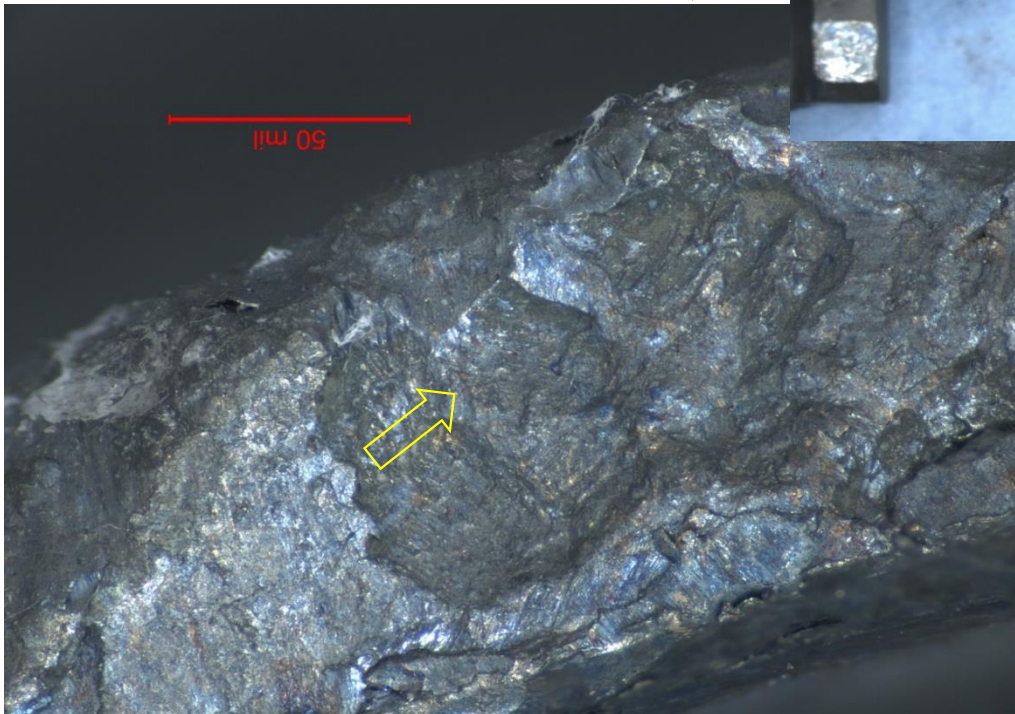
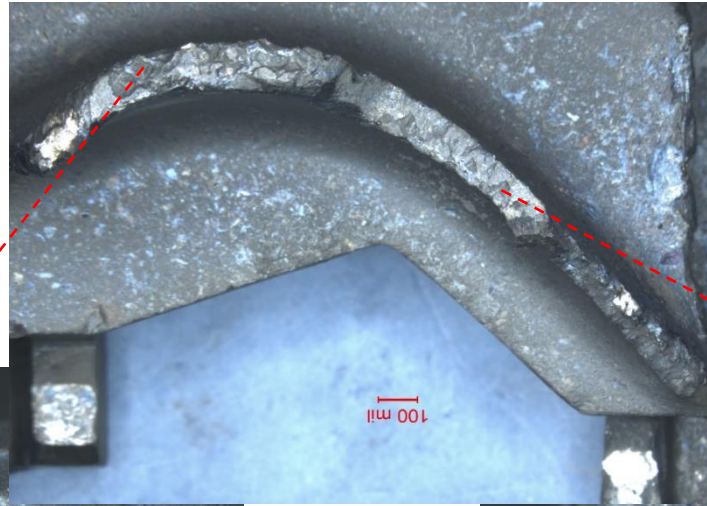
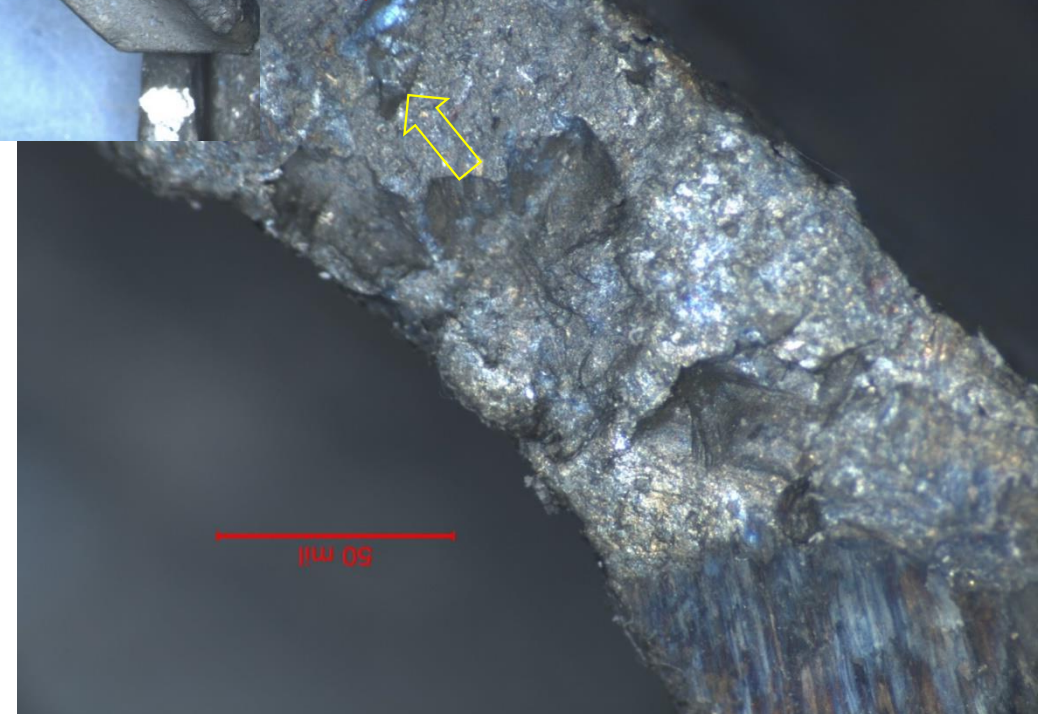
AF6

Optical views of the outboard fracture of airfoil 6 showing features consistent with fatigue growth extending from both the leading and trailing edge areas (also see next page). The majority of the fracture, however, was damaged by post-fracture impacts.
