## **POWERPLANT GROUP CHAIRMAN'S FACTUAL REPORT**

**ENG21LA013**

**GE's MAS Air Cargo ESN 695440 Failure Analysis Findings & Root  
Cause Summary Presentation**

4/1/2021

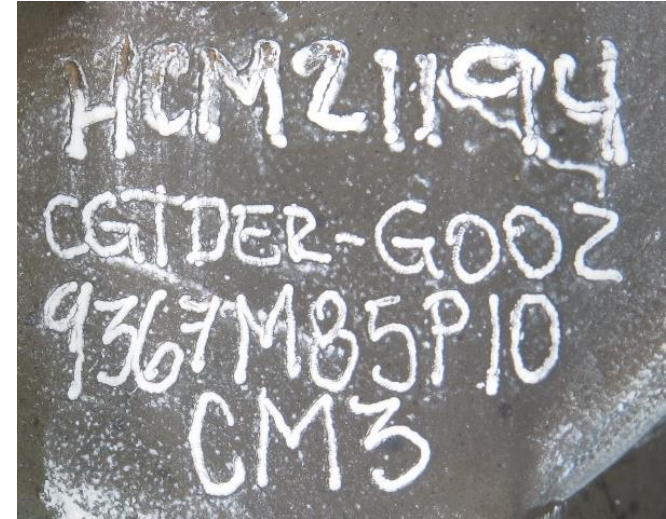
**Nozzle segment 3**

- The LPT5 vanes were last subjected to a full heavy maintenance in 2014.
- Repair documents show vanes were repaired per DAL Repair 01; Chromalloy DER Repair 93-CLA-002-17.
- Chromalloy confirmed the CGTDER-G002 marking does indicate the DER repair 93-CLA-002-17
- LPT Stage 5 Nozzles repaired outside CF6-80C2 ENGINE MANUAL GEK92451 procedures.

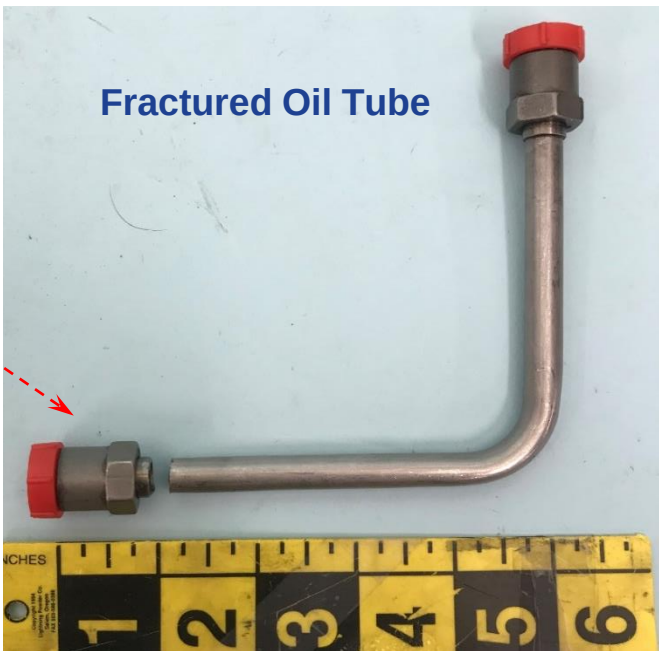
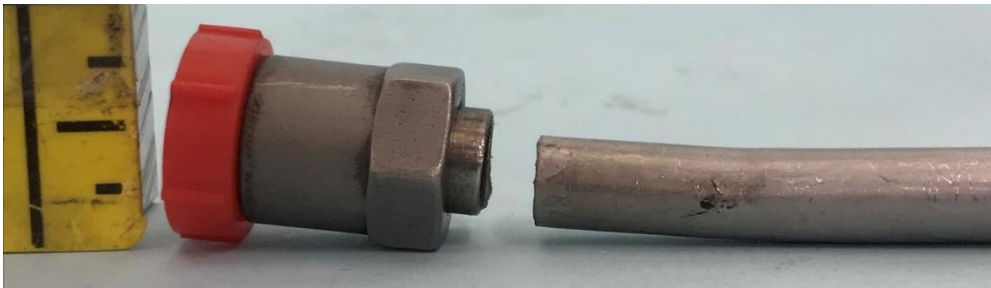
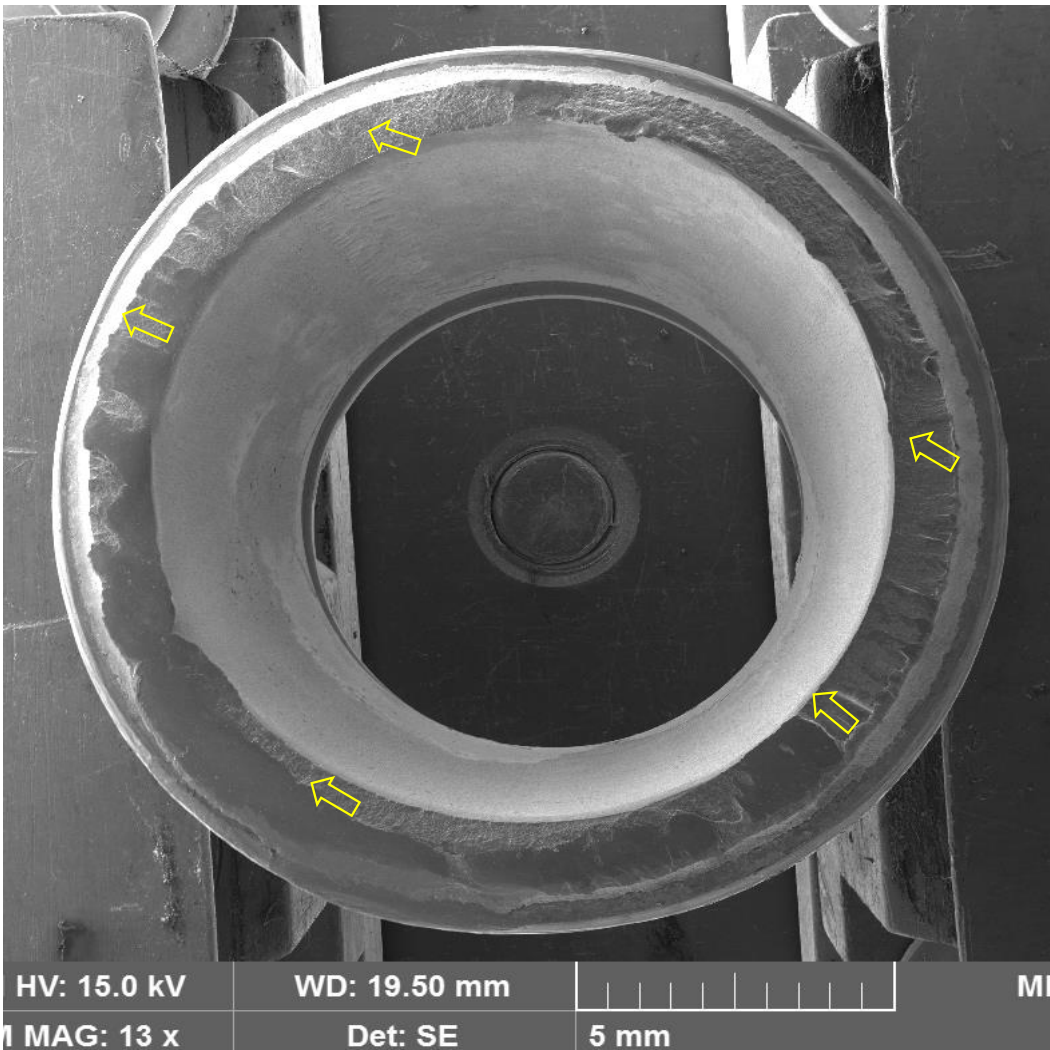
Fractured oil tube showing plastic deformation and a planar fracture consistent with fatigue/cyclic tensile.

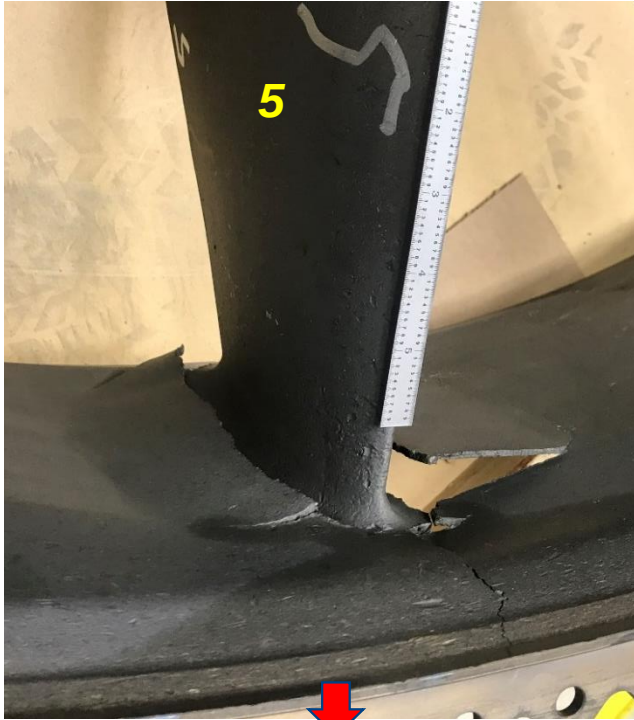
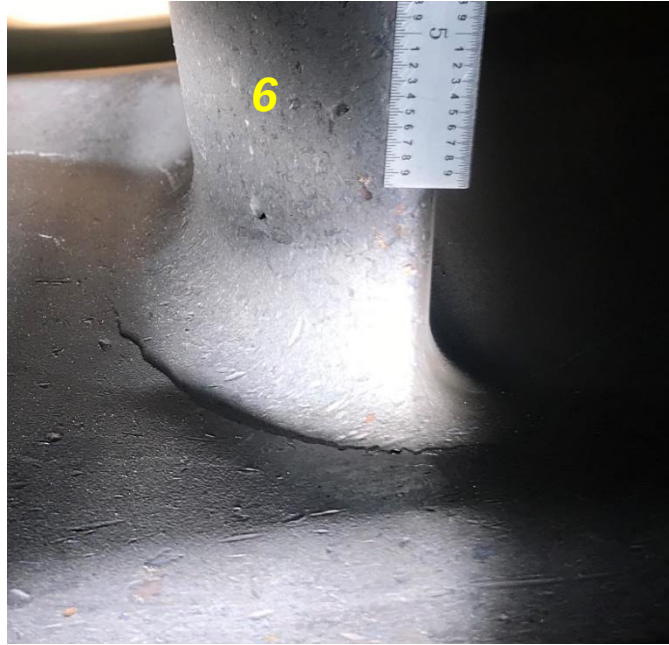
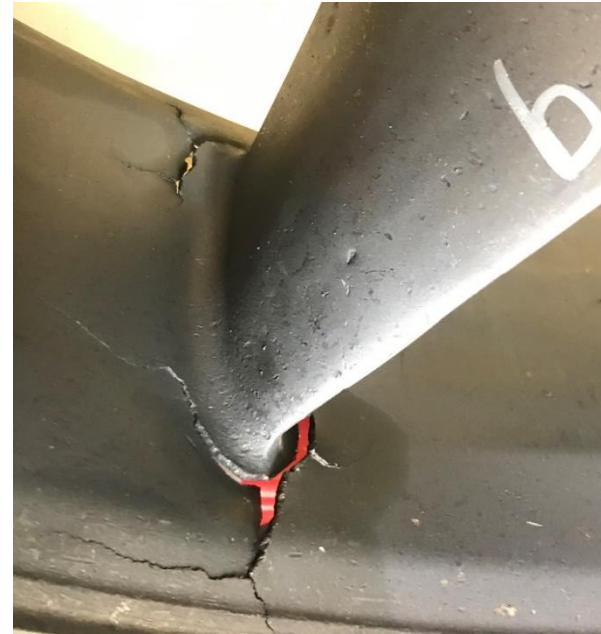
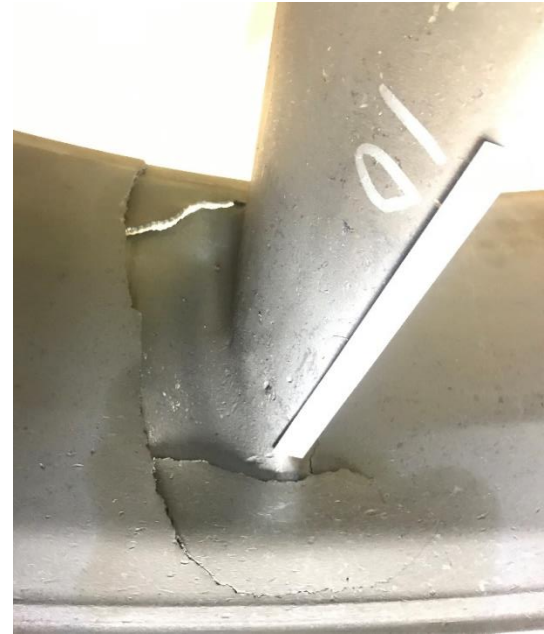
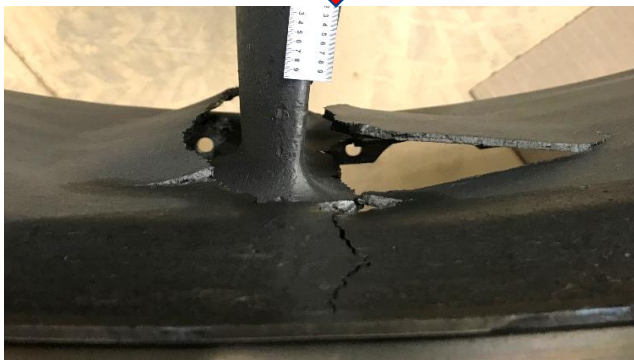
**Cracking around the TRF struts showing bulk deformation and rough fracture features consistent with overstress.**

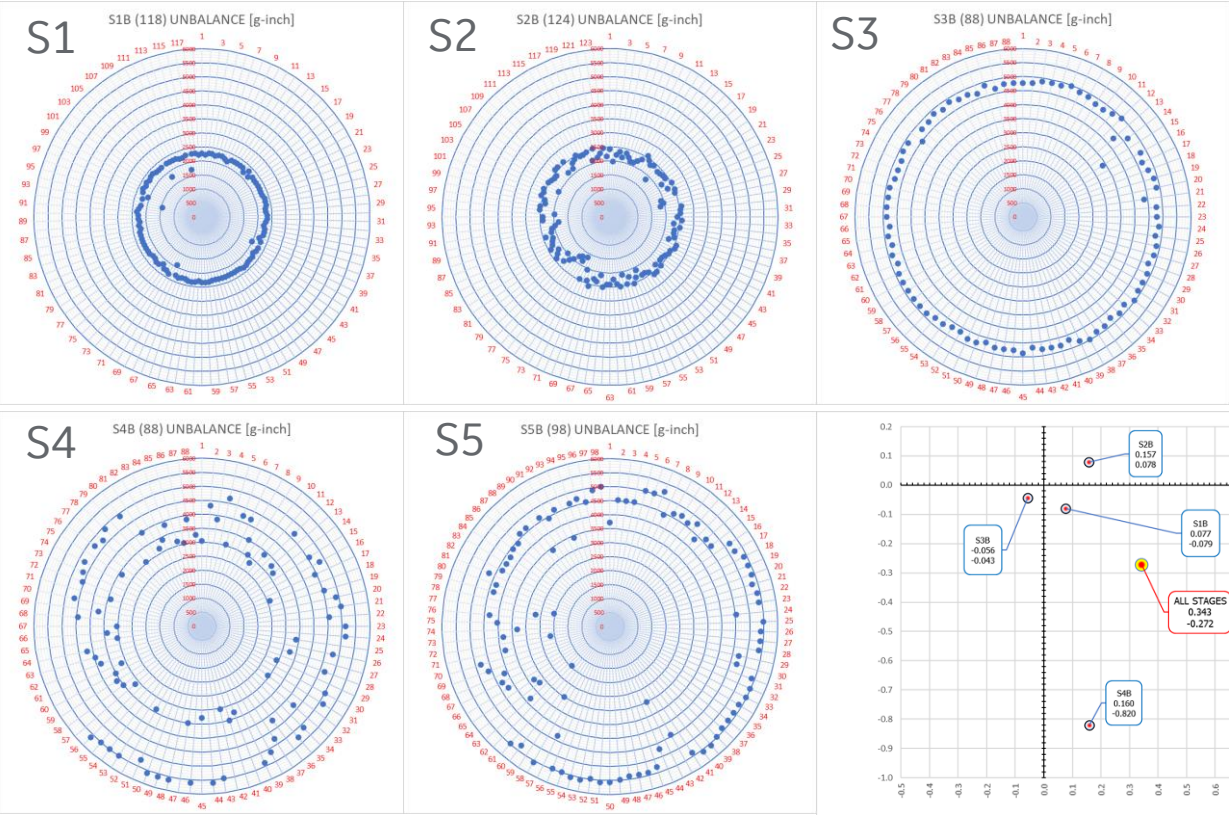
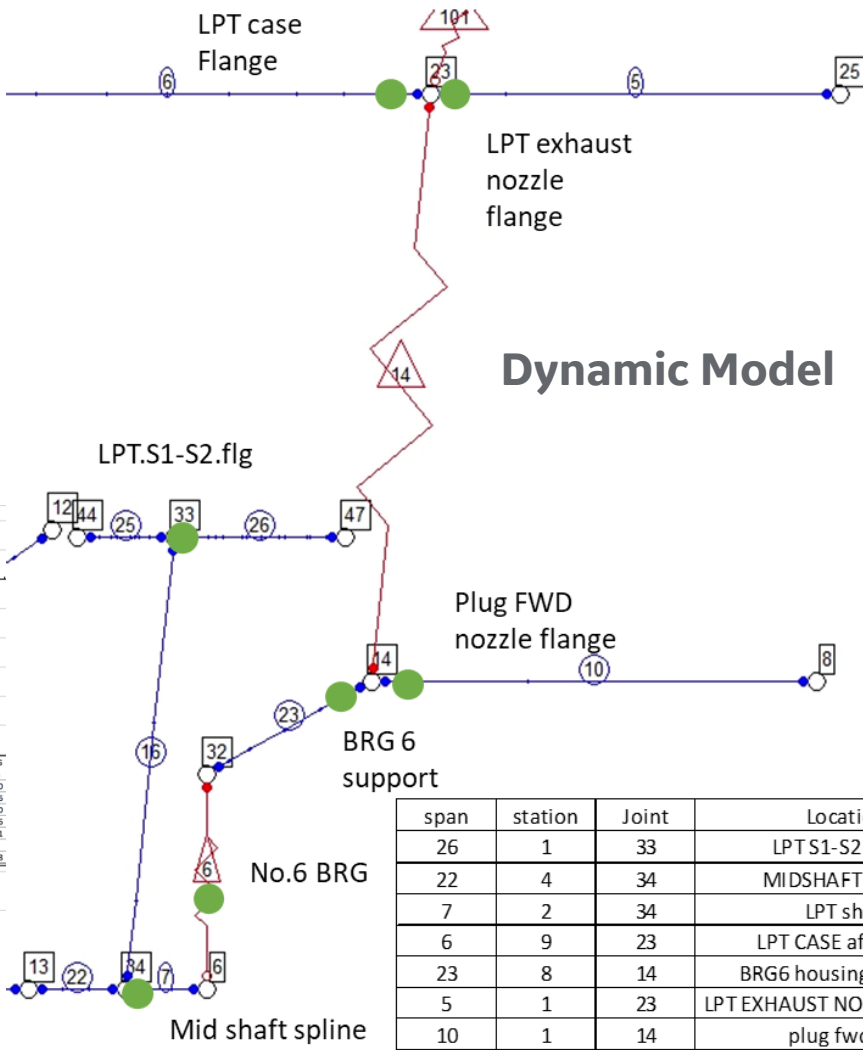
Radial plots show worst damage and unbalance present in LPT Stages 4 & 5

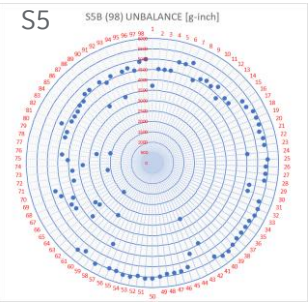
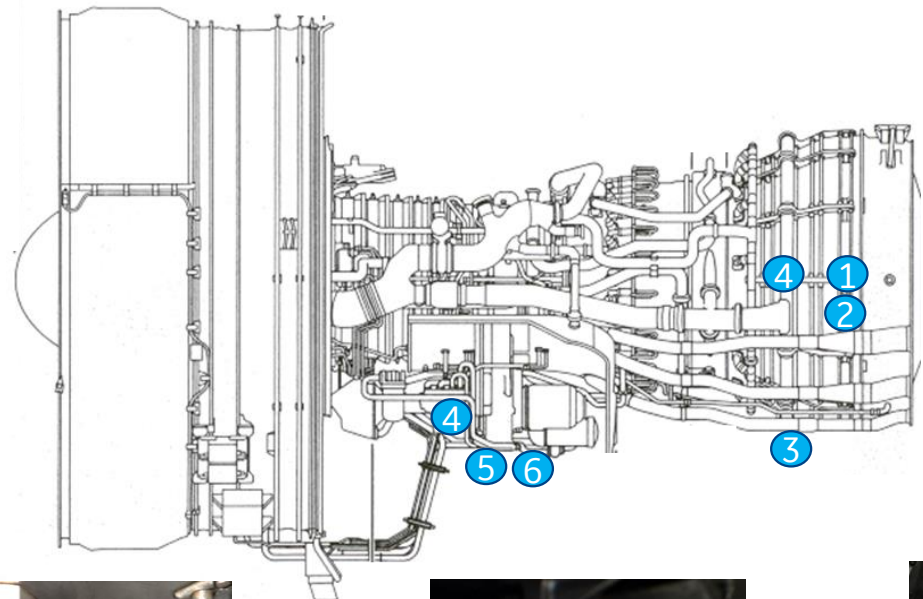
LPT S5N initiated failure led to secondary damage to LPT S4. Ultimately leading to 50.0+ CU rotor imbalance.

Secondary damage includes LPT Fwd. Stages, exhaust nozzle, TRF cracking, broken ABG Transverse link and broken oil line resulting in engine oil fire.
