Subject: Boeing Equipment Quality Analysis Report on Right Main Landing Gear – Sun  
Country 737-800 N817SY Landing Gear Collapse in Las Vegas 04 February  
2022

## Equipment Quality Analysis Report

**SUBJECT:** *Right Main Landing Gear Collapse*

**SUBJECT:** Metallurgical Fracture Analysis of Main Landing Gear Outer Cylinder

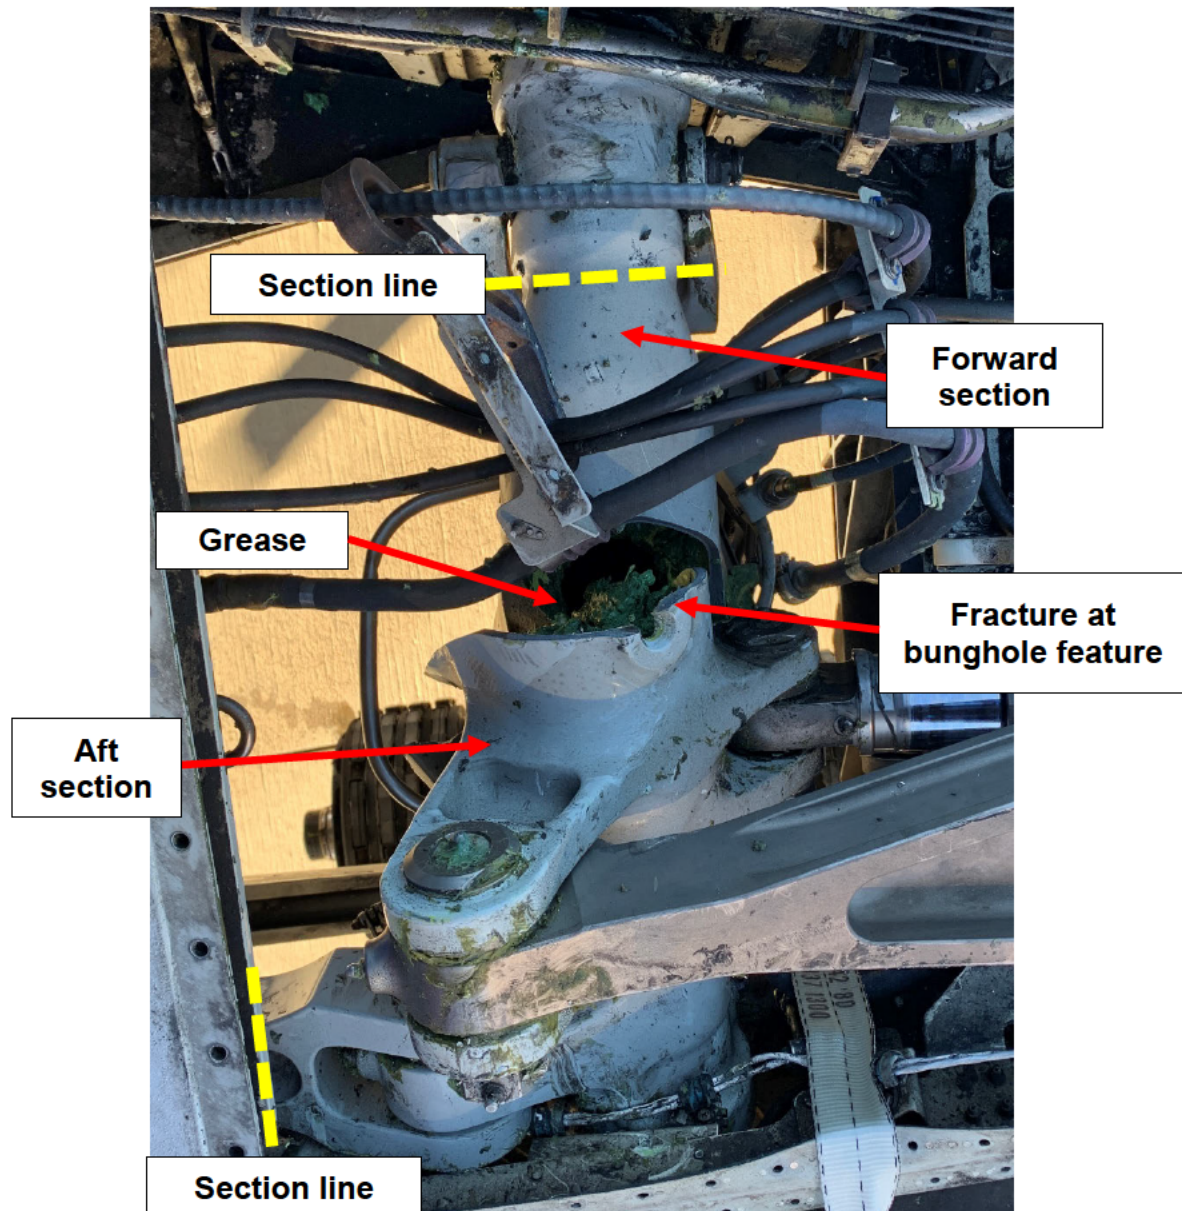
Figure 1, shows the right main landing gear outer cylinder after the incident, before parts were removed from the aircraft. The portions were identified as Forward and Aft. The uppermost Forward portion, was sectioned at the point illustrated in Figure 1 during removal from the aircraft. The Forward and Aft portions were sent by the NTSB to Boeing Equipment Quality Analysis (EQA) in Seattle for the next phase of the examination under the direction of the NTSB.

Figure 1: Forward and Aft portions as installed in original configuration

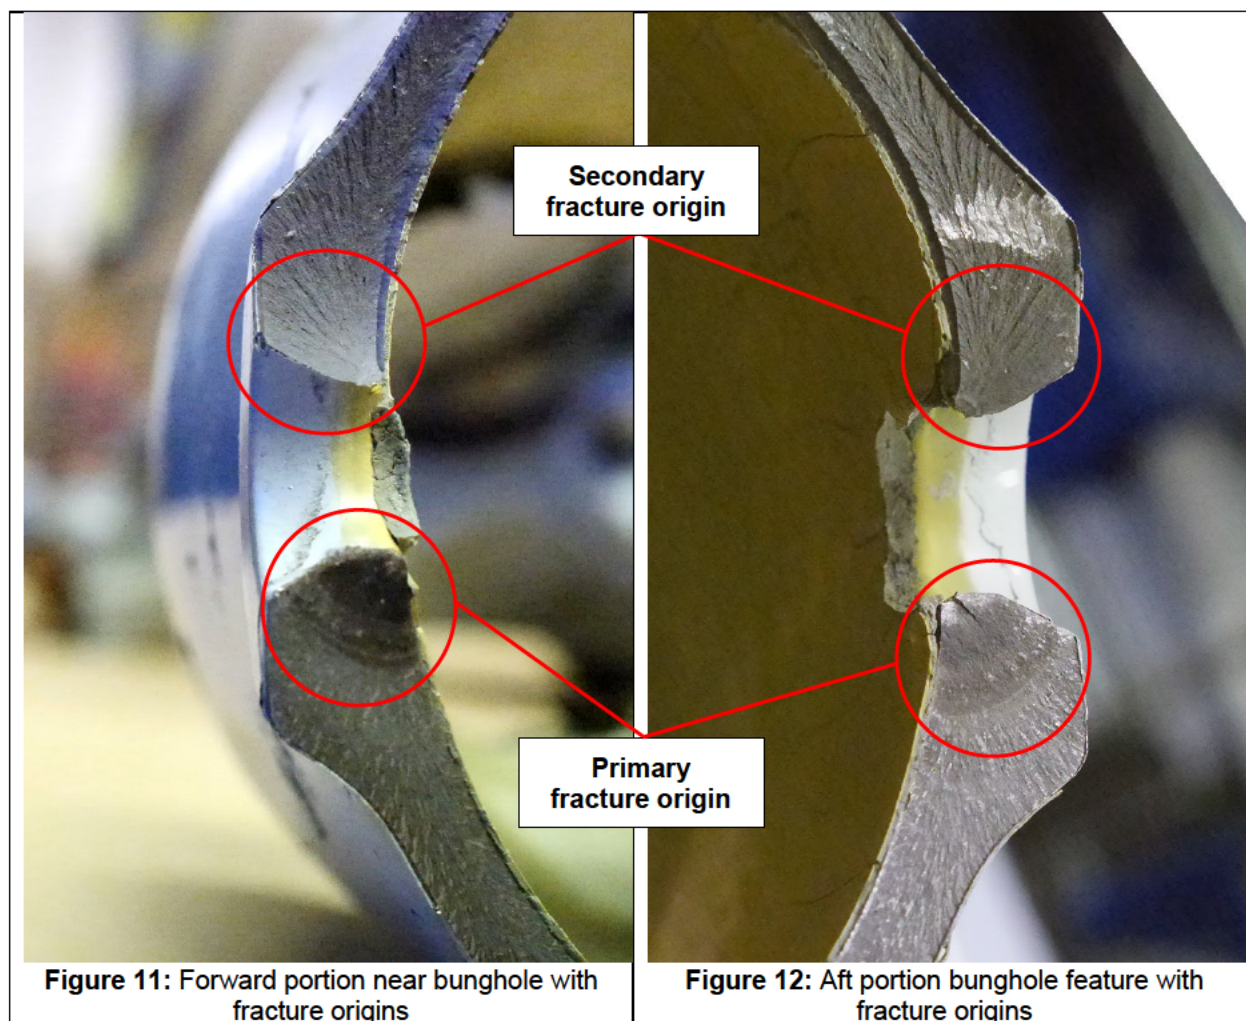
During the initial examination, BR&T identified the apparent primary and secondary fracture origin thumbnail locations in the bunghole area of the Forward and Aft portions, as shown in Figure 11 and Figure 12.

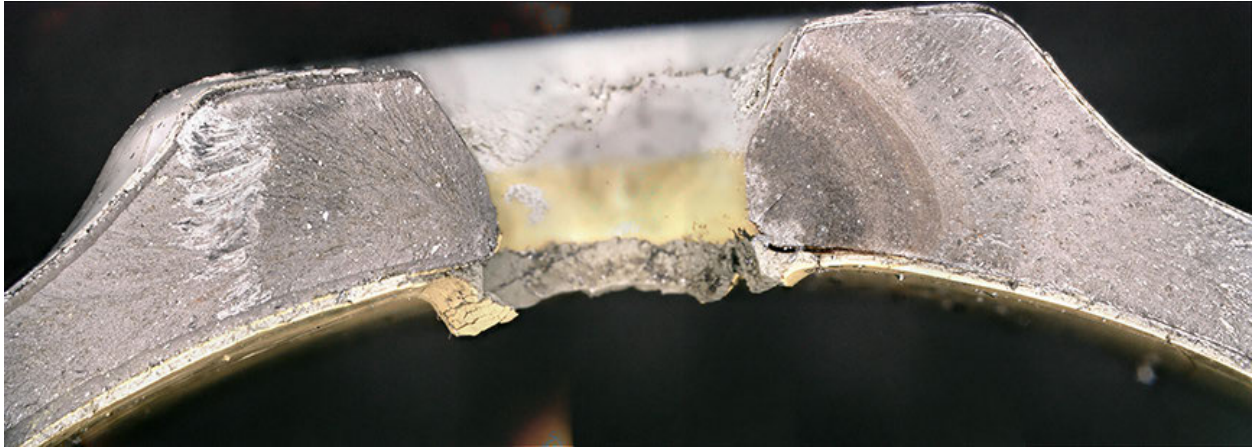
**Figure 19:** Microscopic image of the Aft fracture face

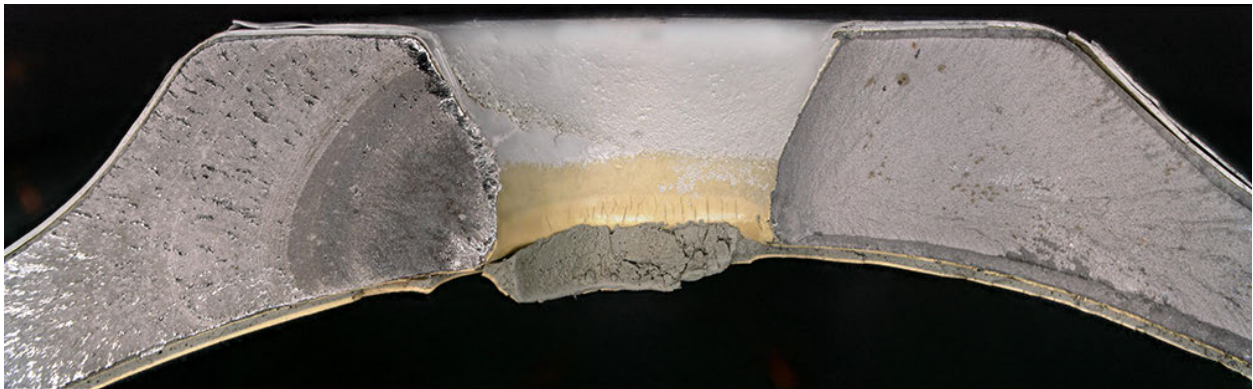
**Figure 20:** Microscopic image of the Forward fracture face

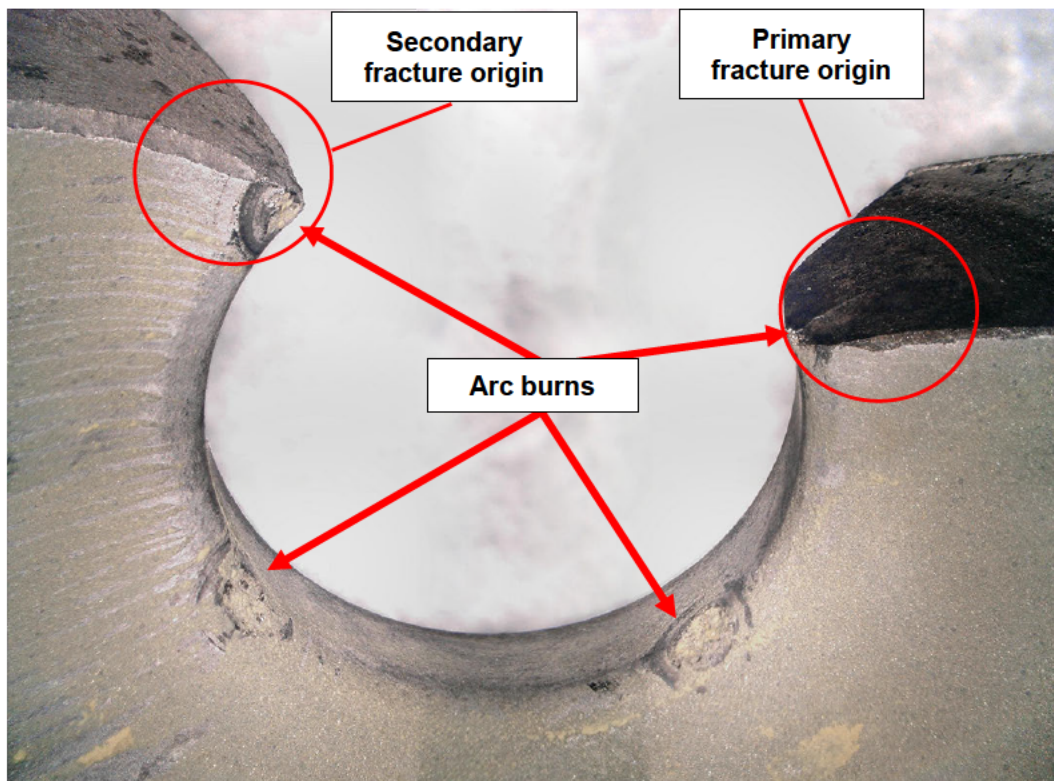
During the examination the team discovered spherical anomalies on portion A2, these anomalies are consistent with metal burn damage created by electrical arcing, see Figure 30. Figure 31 shows the possible arc burn at the primary fracture origin

**Figure 30:** A2 paint and primer removed, possible arc burns

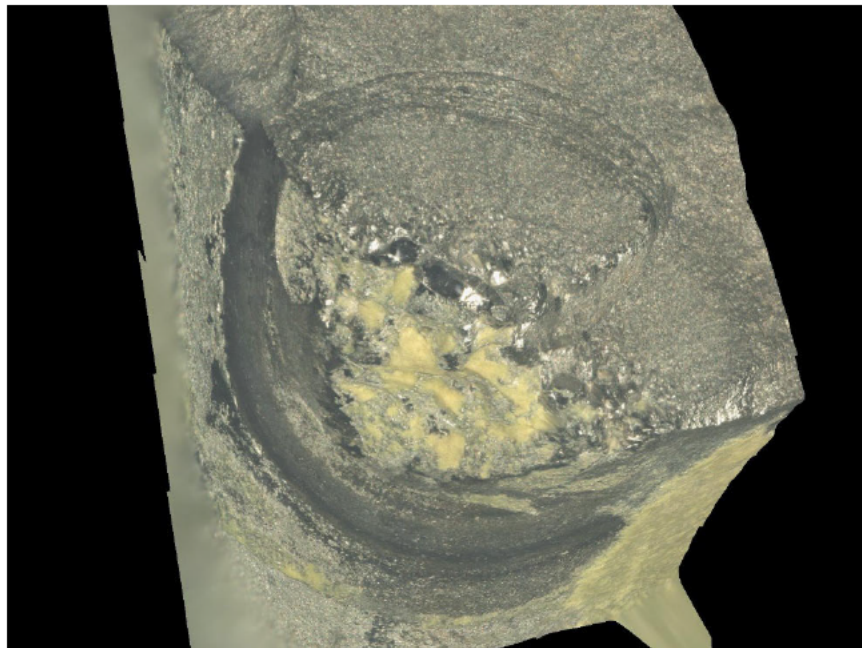
**Figure 31:** Close up image of possible arc burn at the primary origin

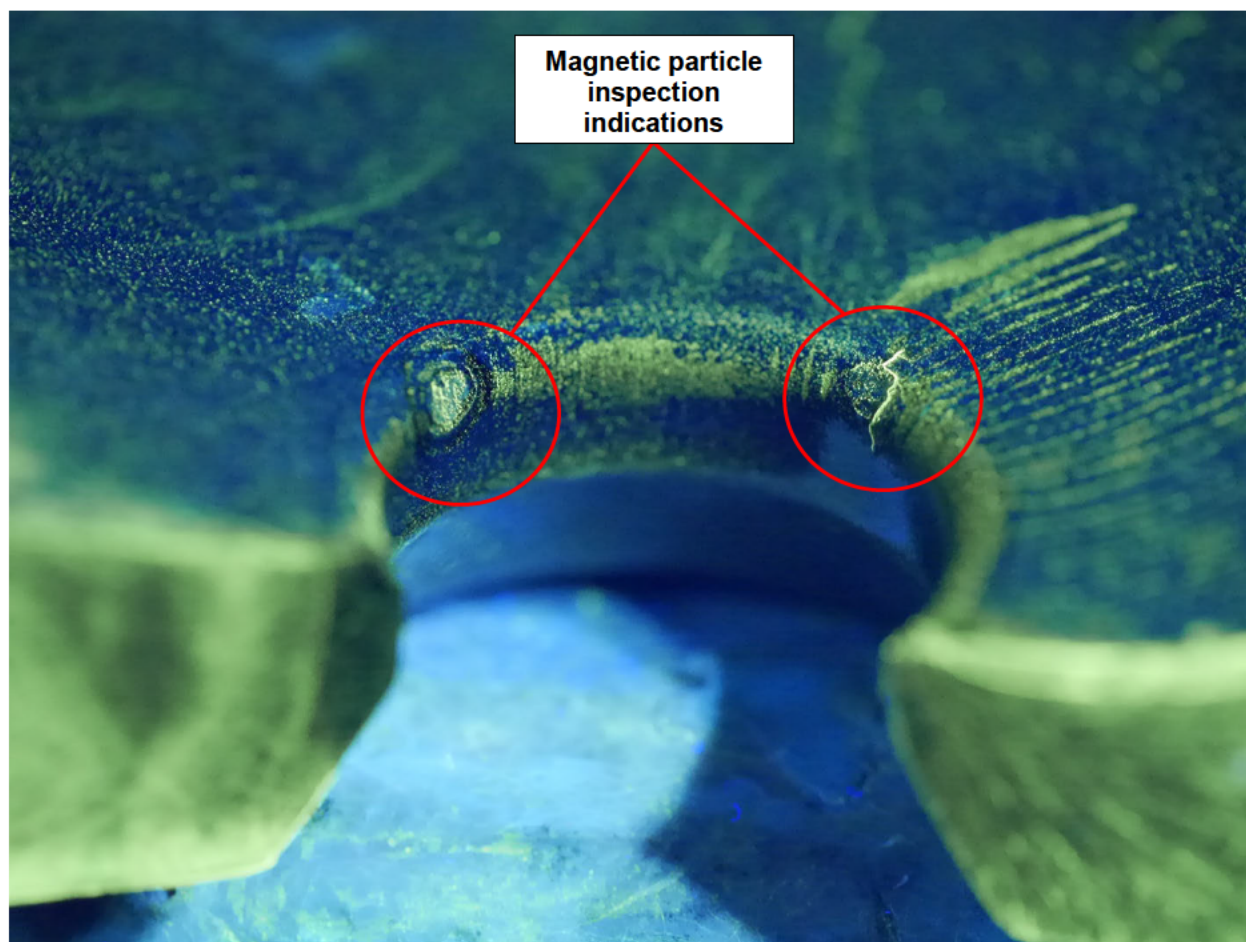
The Aft portion was subjected to magnetic particle inspection (MPI). BR&T found magnetic particle indication at the spherical burn areas and an area showing a linear indication for a crack, see Figure 32.

**Figure 32:** Magnetic particle indications on the Aft portion

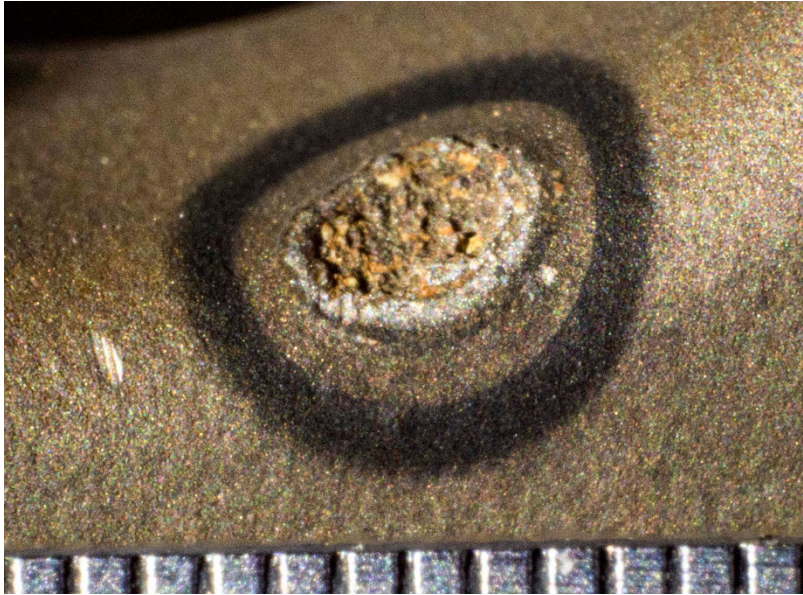
Nital etch of showed the presence of under-tempered (light colored etching) and over-tempered (dark ring) martinsite, see Figure 36.

**Figure 36:** Close up of arc burn after nital etch showing damage consistent with arc burn

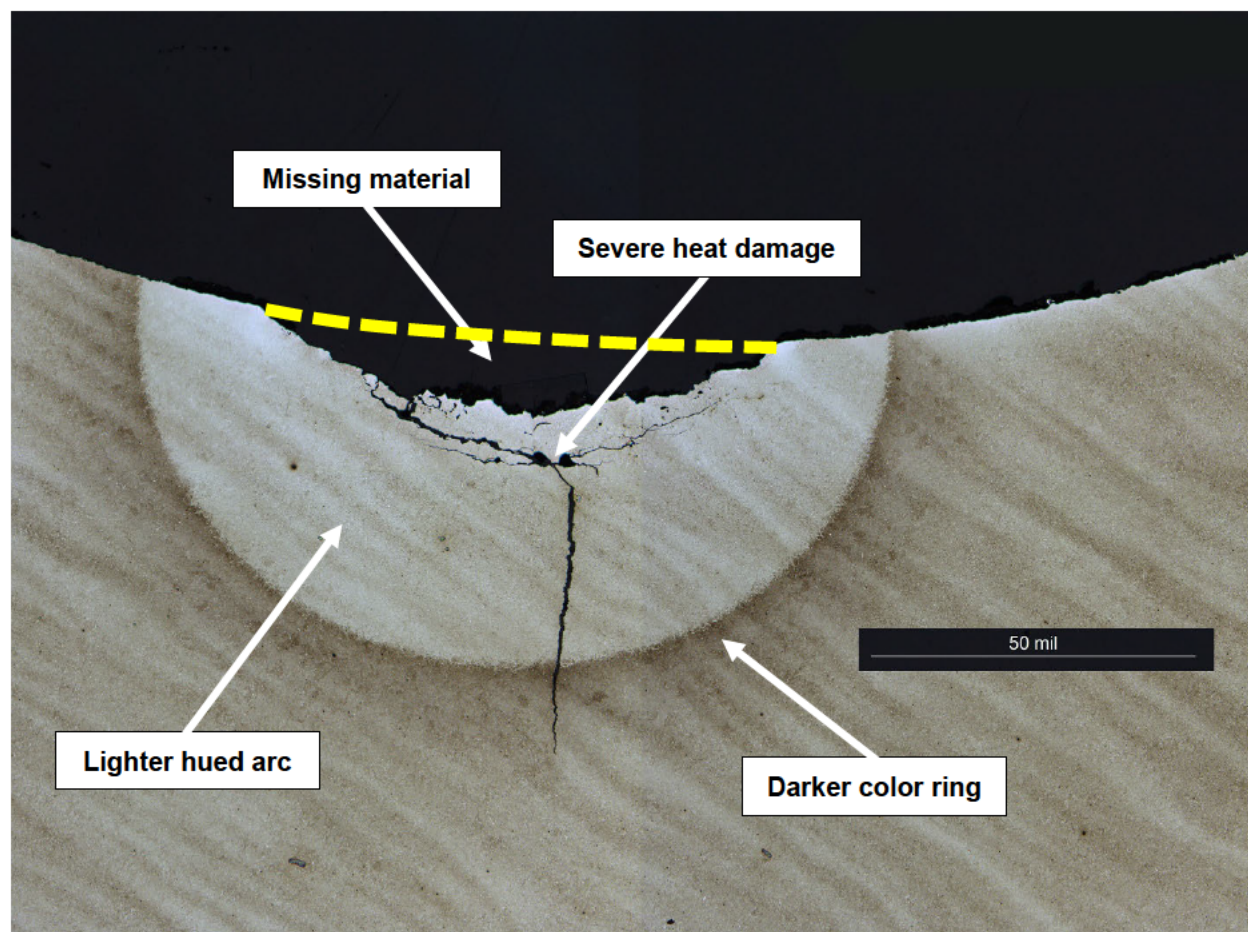
**Figure 38:** SEM imagery of the arc burn area on portion A2B1

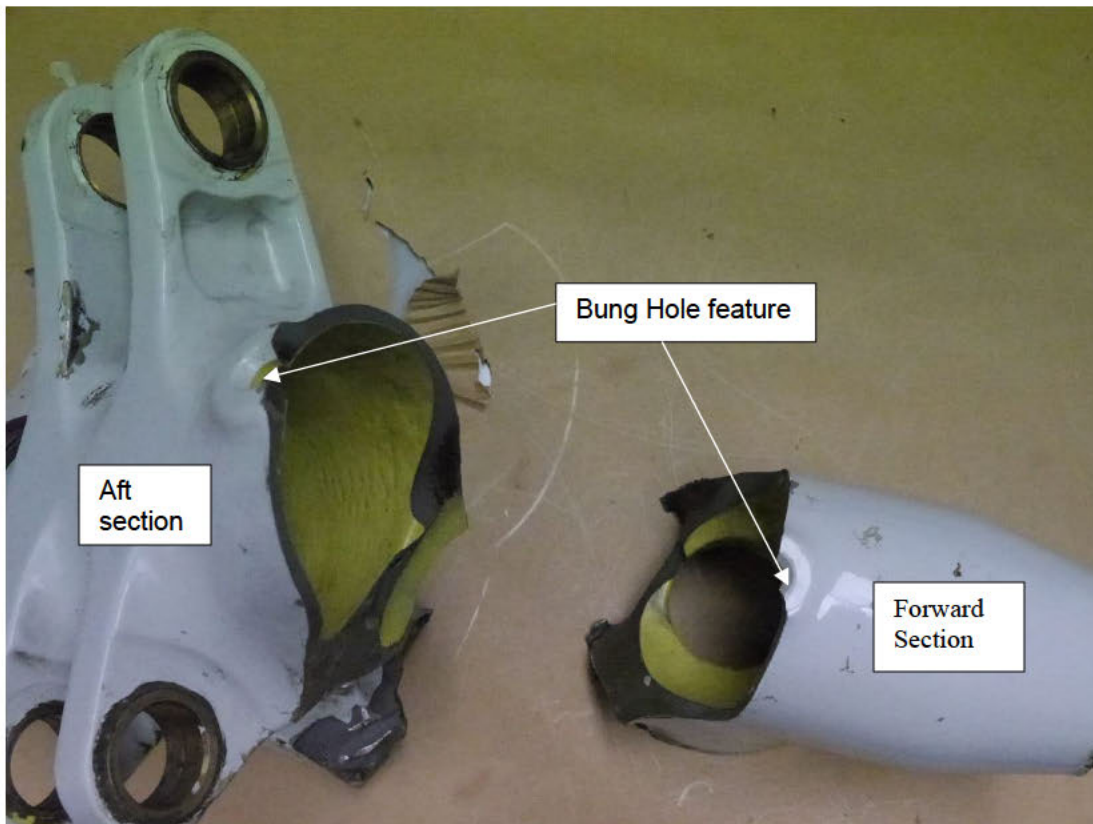
The subject right main landing gear outer cylinder had fractured through the trunnion of the outer cylinder, through the bung hole (a tooling hole).

Figure 2. Fractured parts showing Bung Hole that fractured. The parts had been cleaned of grease and Corrosion Inhibiting Compound by the NTSB prior to shipping to Boeing.

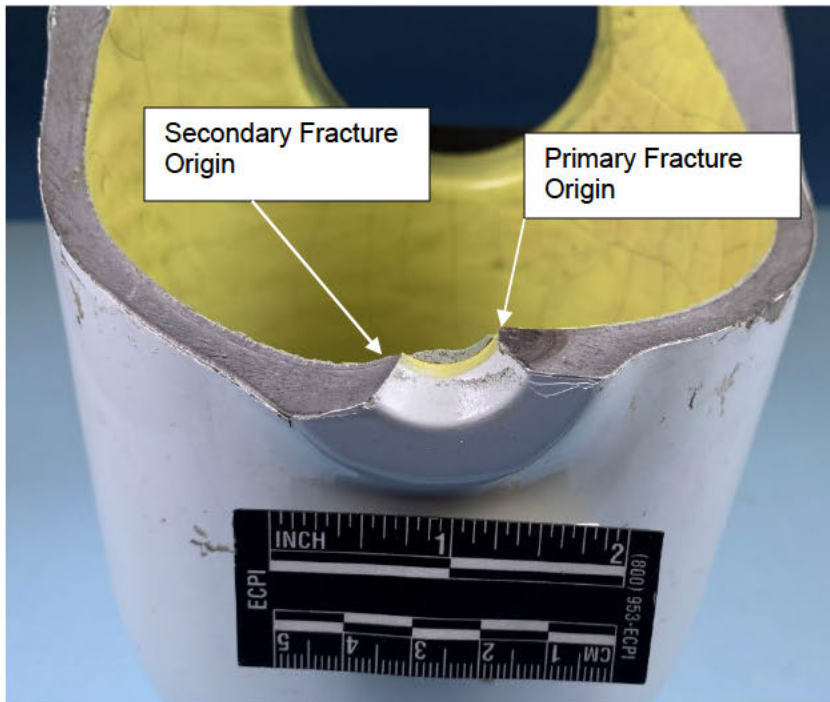
The fracture faces were well preserved and visual examination revealed the presence of slow crack growth thumbnail features on both sides of the hole (Figure 4 and 5). The fracture appearance in these regions was consistent with fatigue crack propagation. SEM microscopy confirmed the origin of both fractures was located at the corner created by the intersection of the bung hole and the inner surface of main landing gear outer cylinder trunnion (Figure 6a). The fatigue cracking propagated from intergranular regions that were present at the corner (Figure 6b). The intergranular fracture portion had unusual particles on grain faces and boundaries (Figure 6c). EDS of the particles revealed that they were essentially pure cadmium as shown in figure 6d, indicating that the intergranular portions of the fracture were possibly the result of cadmium embrittlement. The secondary origin exhibited intergranular fracture features with cadmium at the grain boundaries that were similar to those at the primary origin (Figures 7a, b, and c). At the primary origin, the intergranular fracture mode extended to a depth of approximately 0.02 inches prior to transitioning to transgranular fatigue cracking to a depth of approximately 0.42 inches (Figure 8a). At the secondary origin, the slow growth fatigue fracture growth extended to a depth of 0.07 inches (figure 8b).

Figure 4. Fracture face on the forward side of the trunnion with respect to the bung hole. Due to the slope of the fracture, the secondary origin cannot be seen in this photograph. The thumbnail features consistent with fatigue crack propagation.

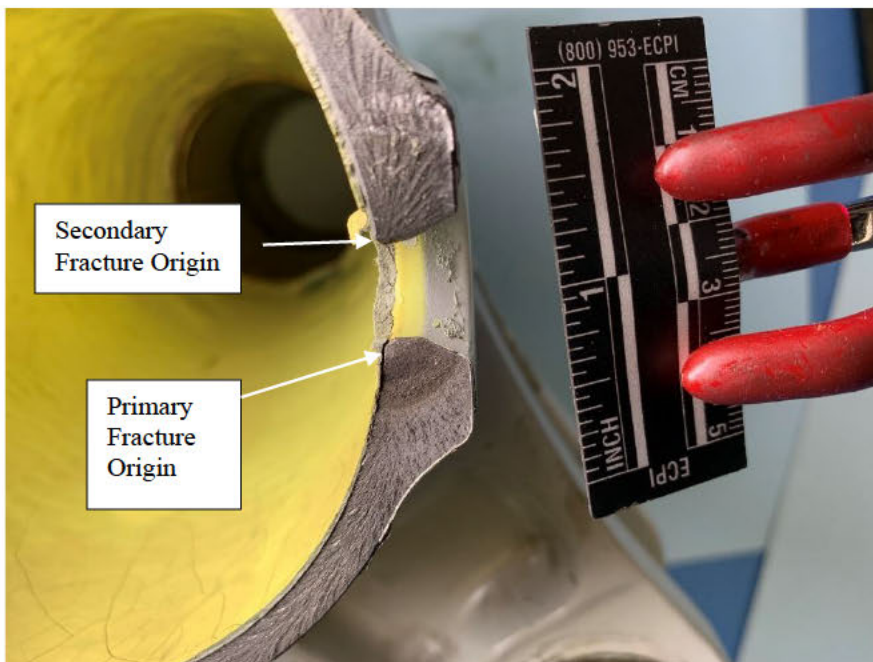
Figure 5. Fracture faces on the aft side of the trunnion with respect to the bung hole. Both the primary and secondary origins can be seen with the primary showing several growth regions.

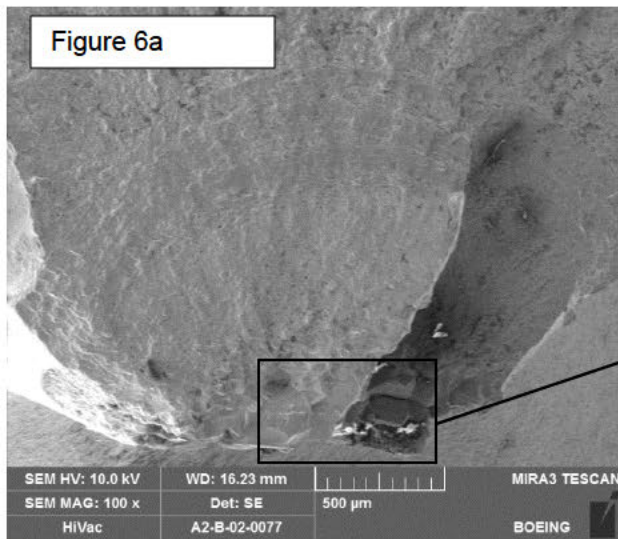
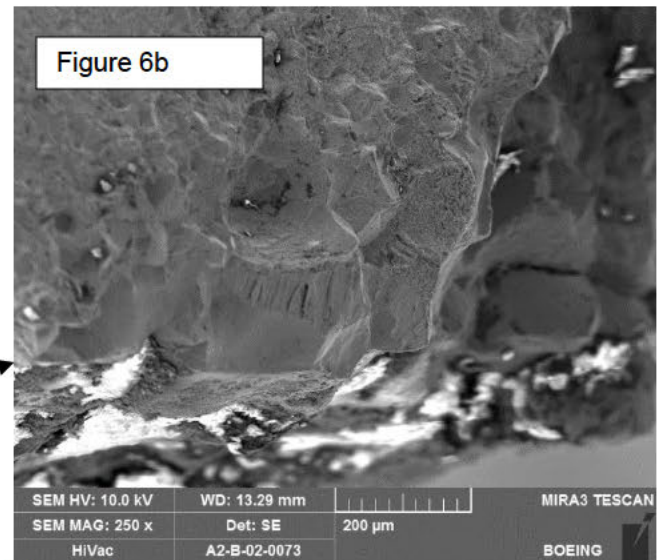
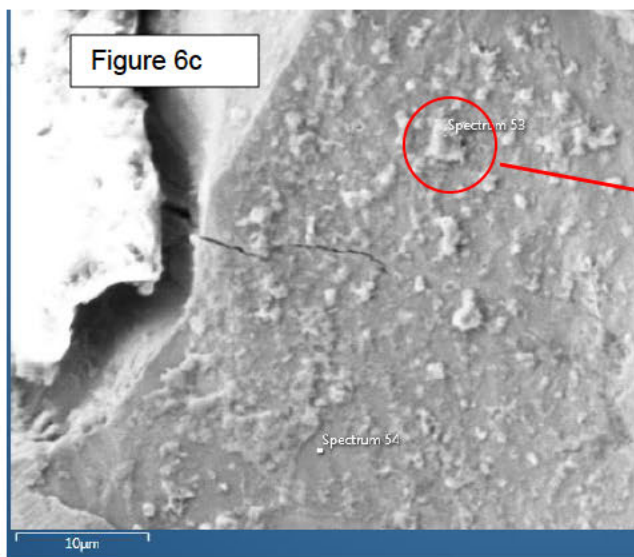
The fracture originated at two locations along the corner feature that is formed between the inner diameter of the bung hole and the inner surface of the trunnion. The initiation occurred by an intergranular separation mechanism characteristic of cadmium embrittlement to a depth of .02 inches.

Figure 6a. SEM image of the thumbnail area at the primary origin located on the Forward portion. Figure 6b is a higher magnification photo of the intergranular initiation site boxed in photograph 6a. Photograph 6c shows the particles present on the intergranular facets. It is noteworthy that the facets were free of corrosion.

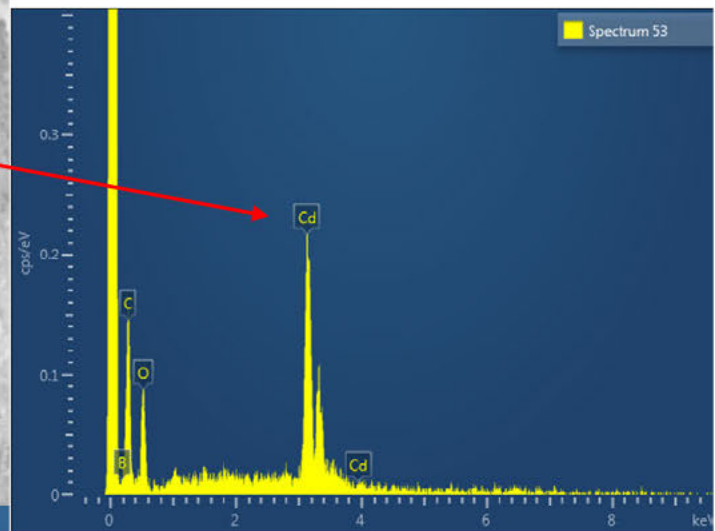
Figure 6d: EDS spectrum of typical particle on the intergranular facets shown in the red circle of figure 6c. The particles were essentially pure cadmium

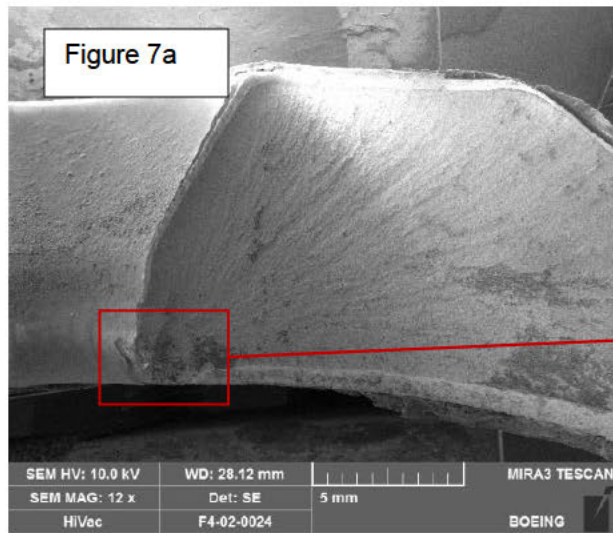
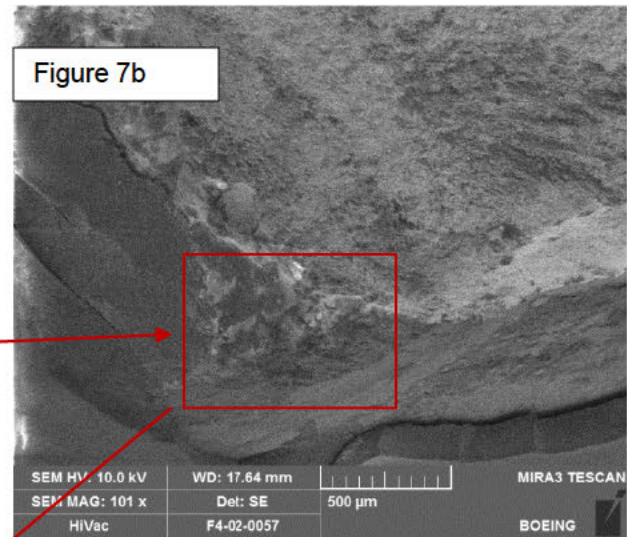
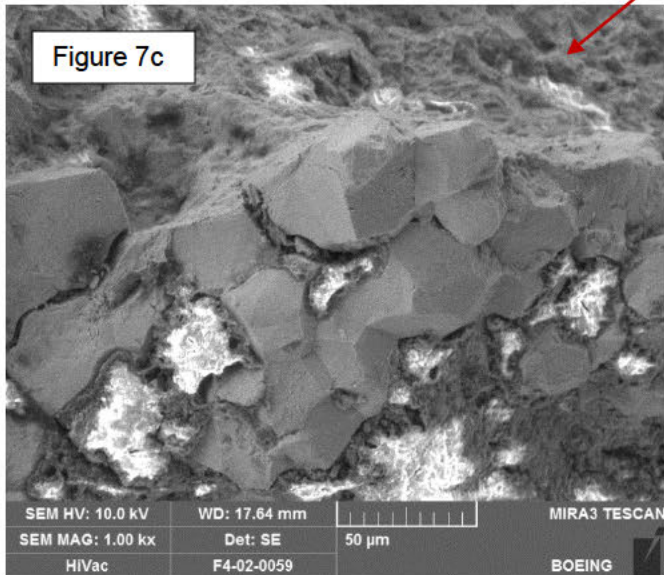
Figure 7a,b. and c. Scanning electron microscope images of the slow growth thumbnail area of the secondary origin, showing that the initial stages of cracking occurred at the surface where the bung hole meets the inner diameter of the Main Landing Gear Outer Cylinder and cracking origin morphology was consistent with intergranular fracture.

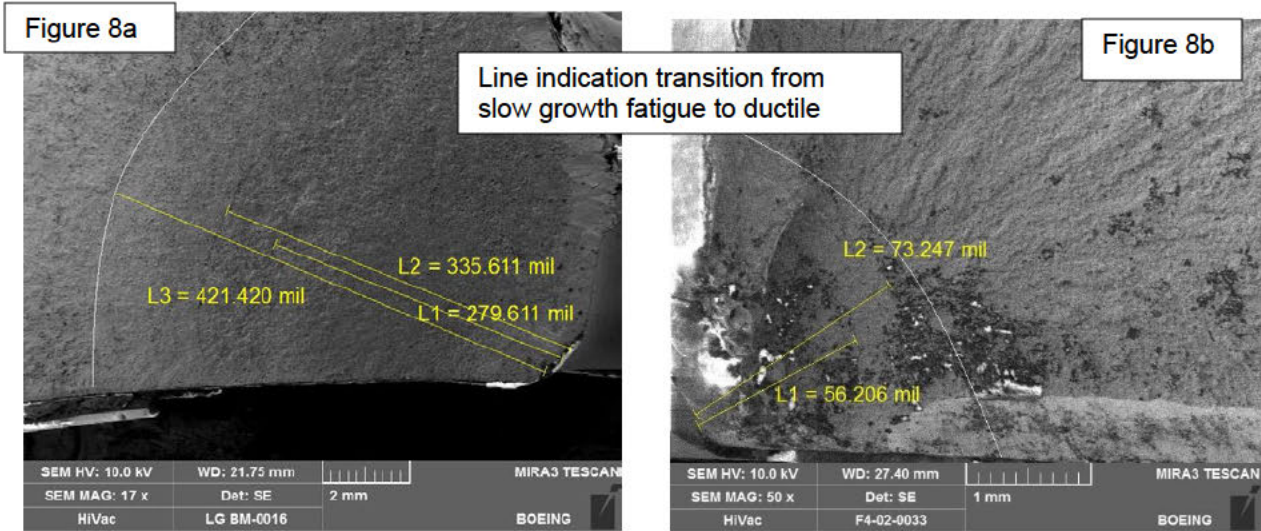
Beyond the intergranular fracture area, the growth mechanism changed to fatigue crack propagation to a final depth of 0.42 inches before final fracture occurred.

Figure 8a and b. Crack origin areas showing length of fatigue crack growth prior to transition to ductile separation at the primary (Figure 8a) and secondary origin (Figure 8b).

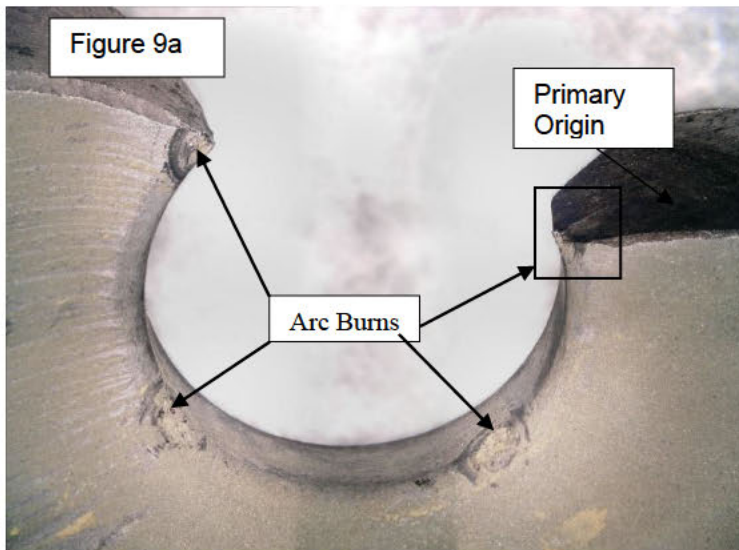
The section containing the Aft Fracture Face was chemically stripped and lightly grit blast to aid in removal of the finishes (the fracture faces were protected during these operations to prevent damage). When the finishes were removed, the presence of four spherical anomalies approximately 0.1 inches in diameter were revealed. These spherical artifacts were centered on the intersection of the inner diameter of the bung hole and the inner diameter of the outer cylinder trunnion. The spherical features were consistent with base metal burn damage created by electrical arcing. Two of these were coincident with the fracture origins. Figure 9a and 9b show the arc burn that was present at the primary fracture origin.

Figure 9a. Partially stripped Aft section showing 4 arc burns. Figure 9b shows a close up view of the primary origin outlined by the boxed area in Figure 9a.

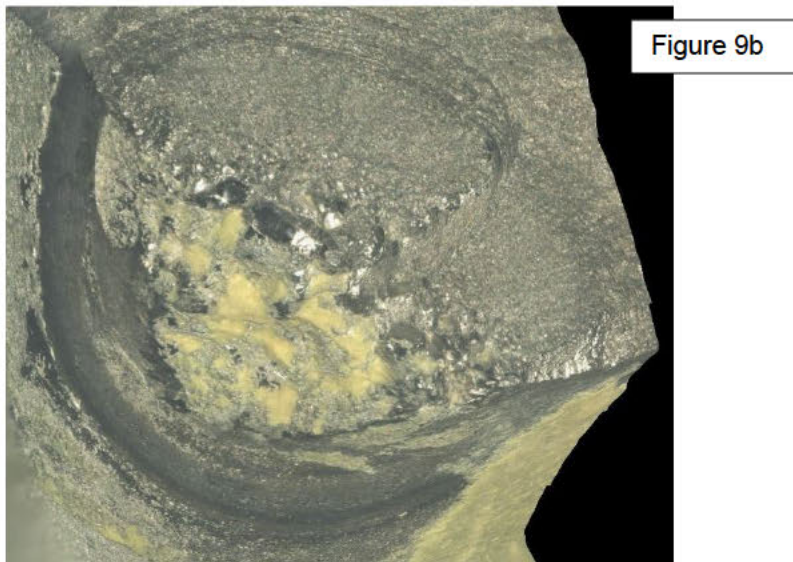
Metallurgical evaluation revealed that primary and secondary origins were coincident with arc burns which created base metal heat damage.

Figure 9b. Close up of the arc burn detected at the primary origin prior to stripping all finishes.

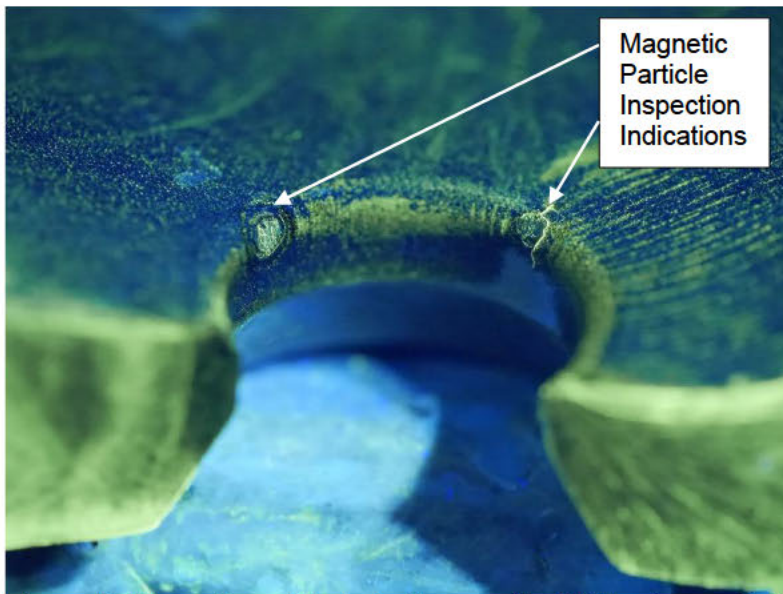
Magnetic particle inspection was performed on the stripped Aft Fractured part and magnetic particle indications were coincident with the spherical burn areas on the radius, with one of these areas also showing a linear indication for a crack (Figure 10). This piece was further sectioned to enable cross-sectioning of one of the arc burns for metallographic examination and nital etch inspection (Figure 11). Two dark etched rings were present on the intersection of the inner diameter of the cylinder and the bung hole feature (Figure 12a and b). These indications were coincident with the locations that had magnetic particle inspection indications. These darker etched areas were characteristic of overtempered martensite (OTM) and consistent with heat damage created during arc burning. Figure 13 shows a magnified image of an arc burn observed on the bung hole.

Figure 10. Magnetic particle indications on the Aft Fracture part after all finishes had been removed.

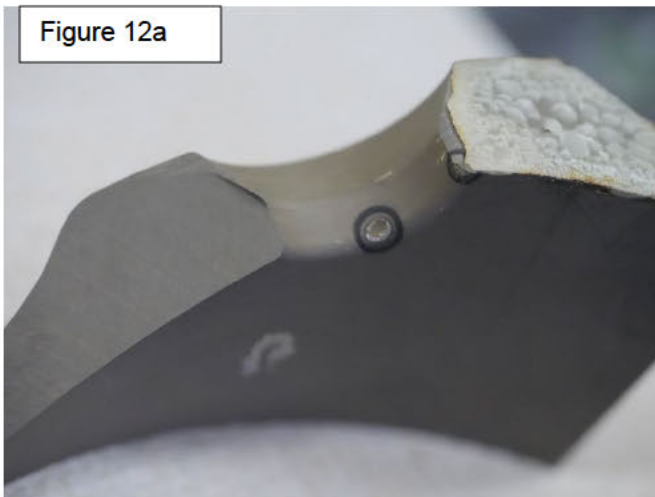
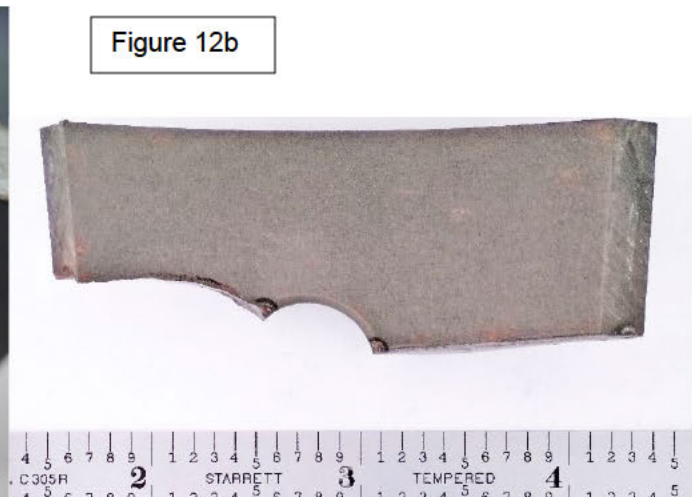
Figures 12a and 12b. Nital Etch inspection of section Aft section A2b (from cut out shown above) and the Forward section showing presence of under tempered (light etching at the center of the indication) and overtempered martensite (dark etching rings). (Close up of etch inspection indication shown in Figure 13)

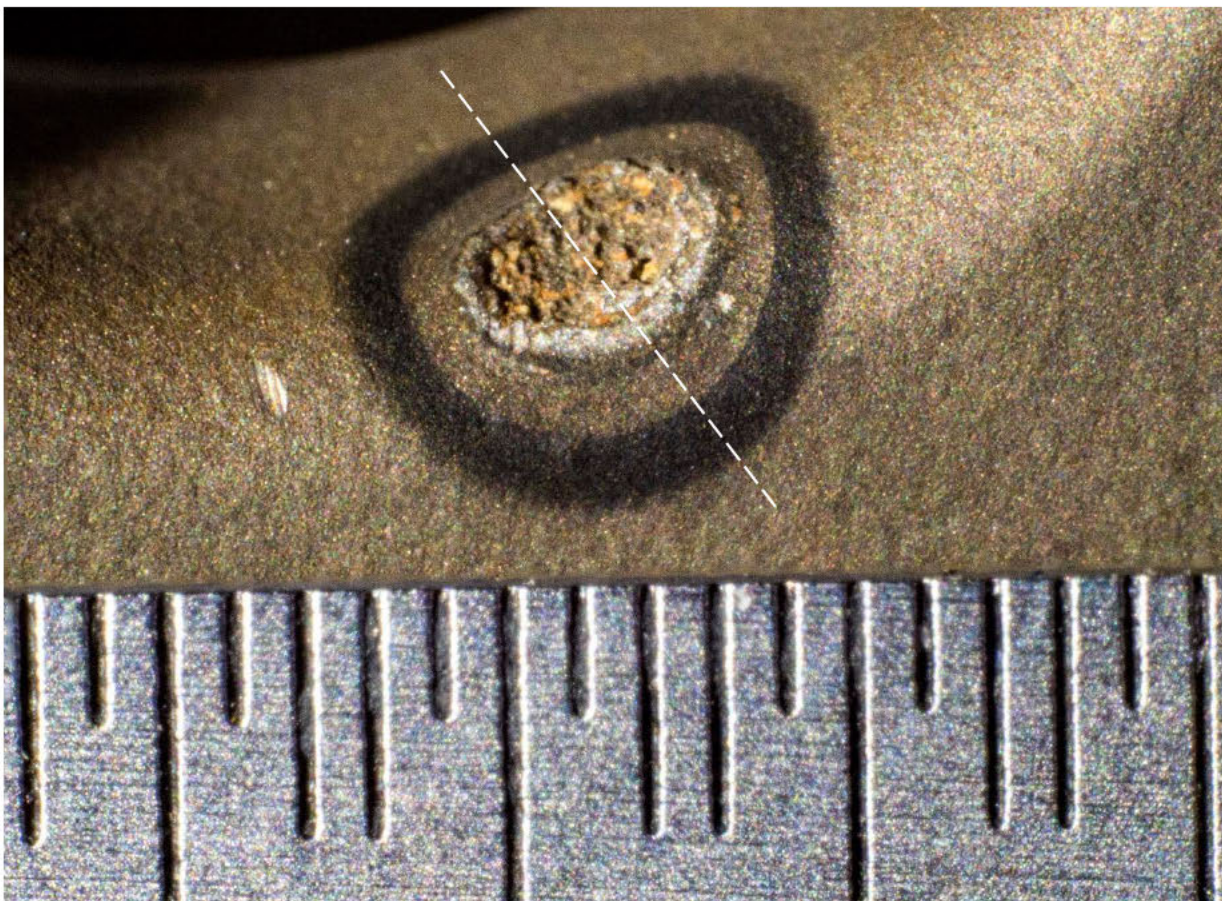
Figure 13. Close up of etch inspection indication showing presence of under tempered (light etching around the porous region) and over tempered martensite (dark etching ring). Dashed line indicates example of location of cross section in photos below.

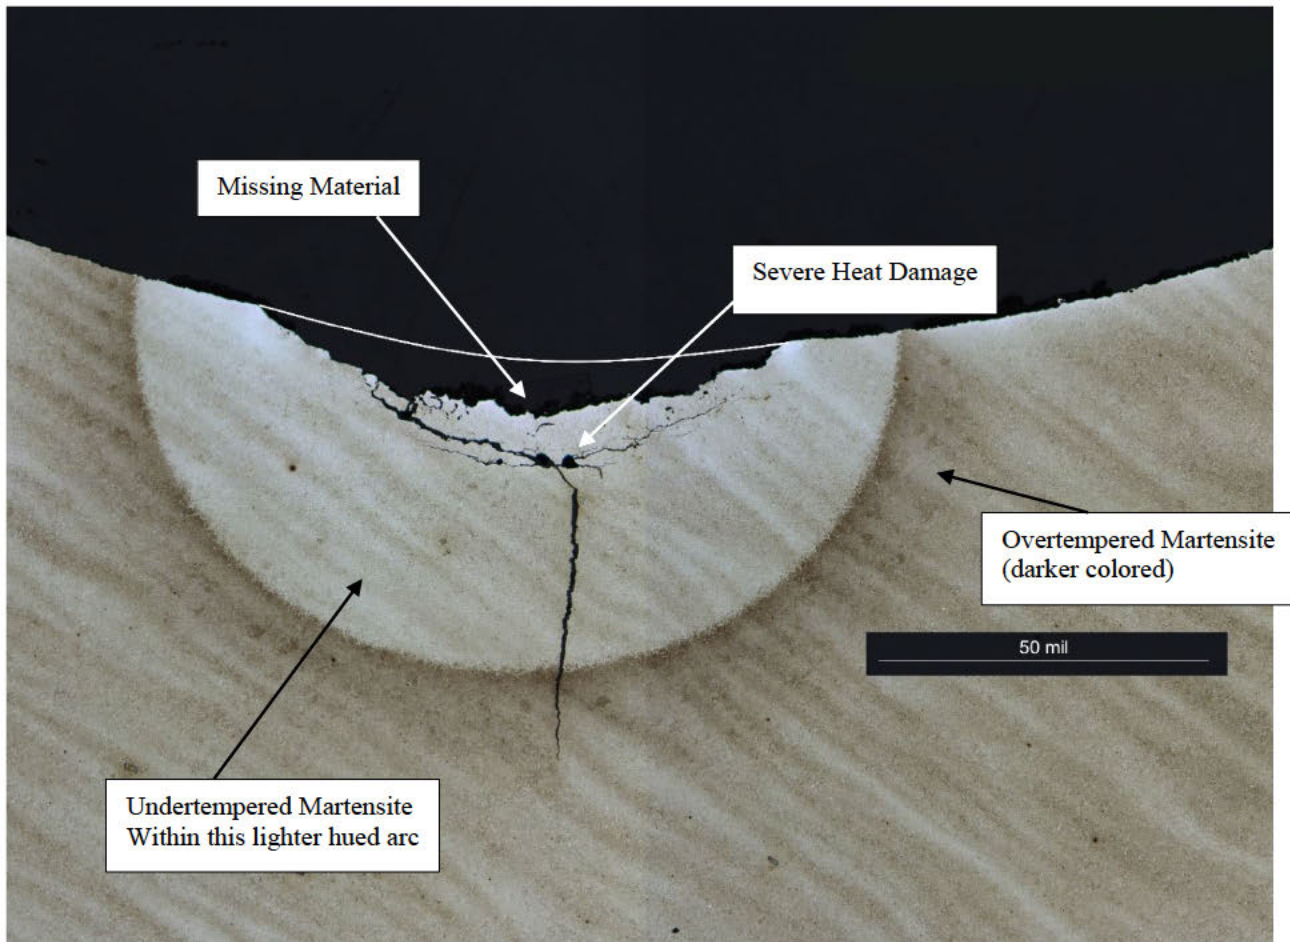
The arc burn selected for cross-sectioning was mounted and prepared for metallographic examination. The inner most region was missing material. Four regions of interest were observed (Figure 15). Hardness measurements

Figure 14 showing the 4 regions present in the microstructure under the arc burn.

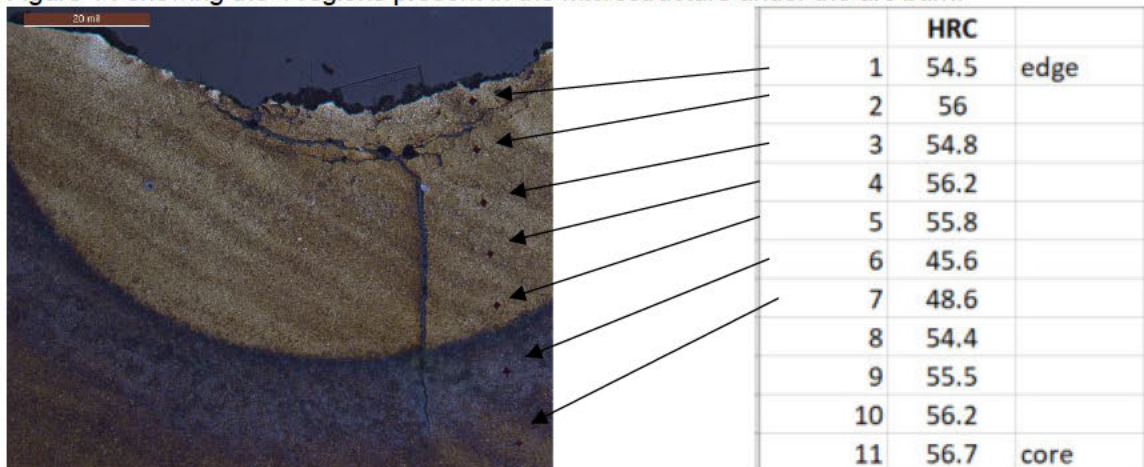
were made from the surface into the matrix of the three regions present. The surface was approximately 56 Rc, consistent with undertempered martensite, the next region was approximate 45 Rc, consistent with overtempered martensite, and the matrix was approximately 56 Rc, which is typical of the proper 275-300ksi temper for 4340M (Figure 15a and b). The microstructural modifications and hardness values were consistent with heat damage that occurs during electrical arcing events. The second layer was a porous area that did not have a typical wrought metallic microstructure and was consistent with pronounced, localized base metal heat damage (Figure 16).

Figure 15. Metallographic mount showing indentations from hardness measurements and the 7 most inner measurements.

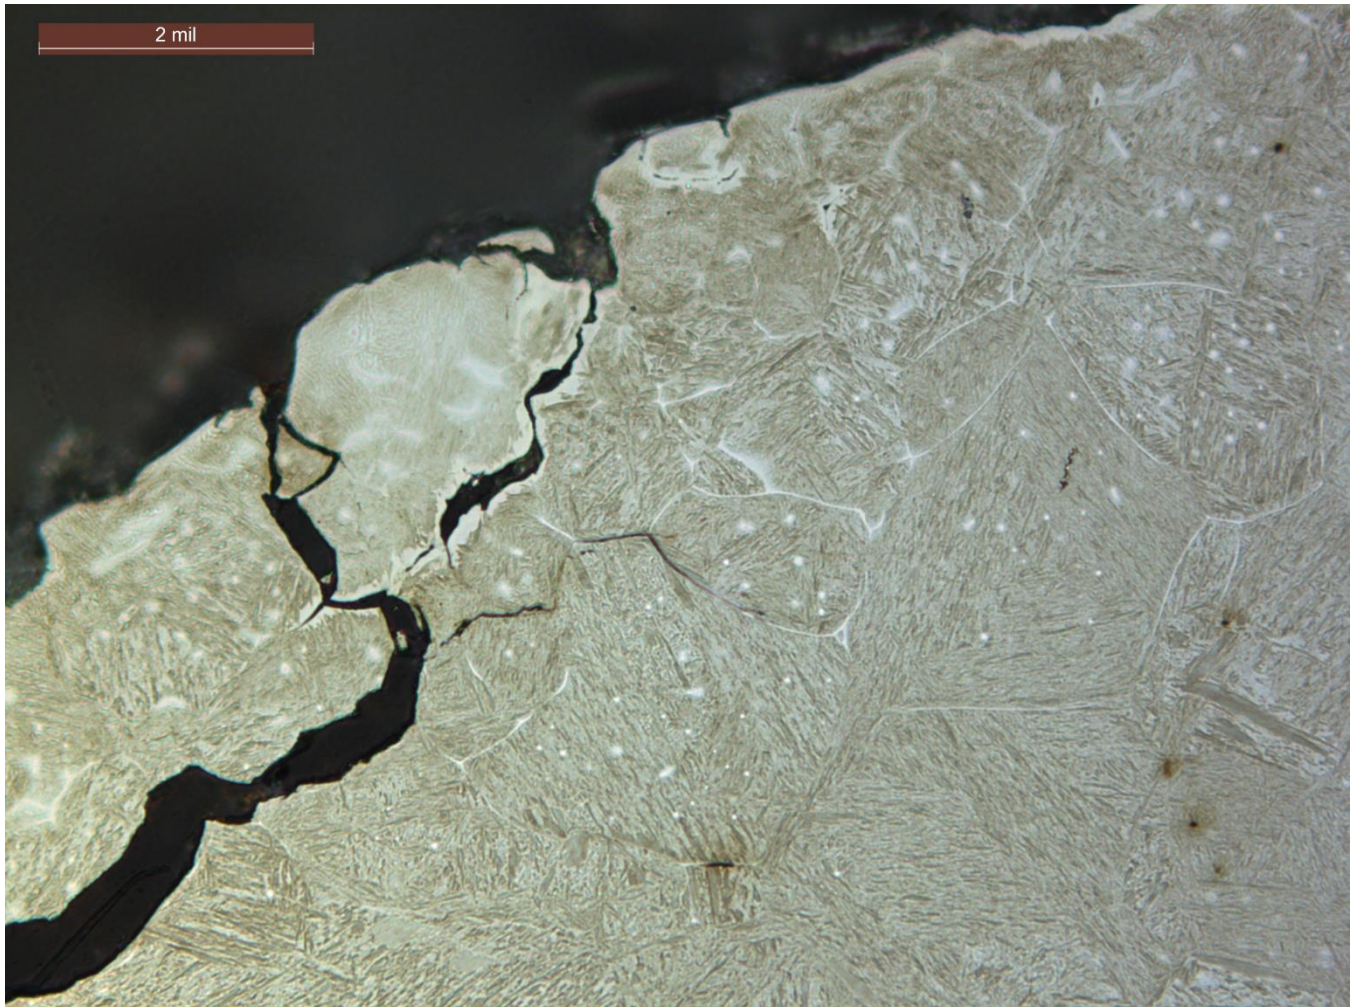
Figure 16. 500x photograph of area at the surface of the cross-section of the cross-sectioned arc burn. Note the difference in the grain morphology at the surface.

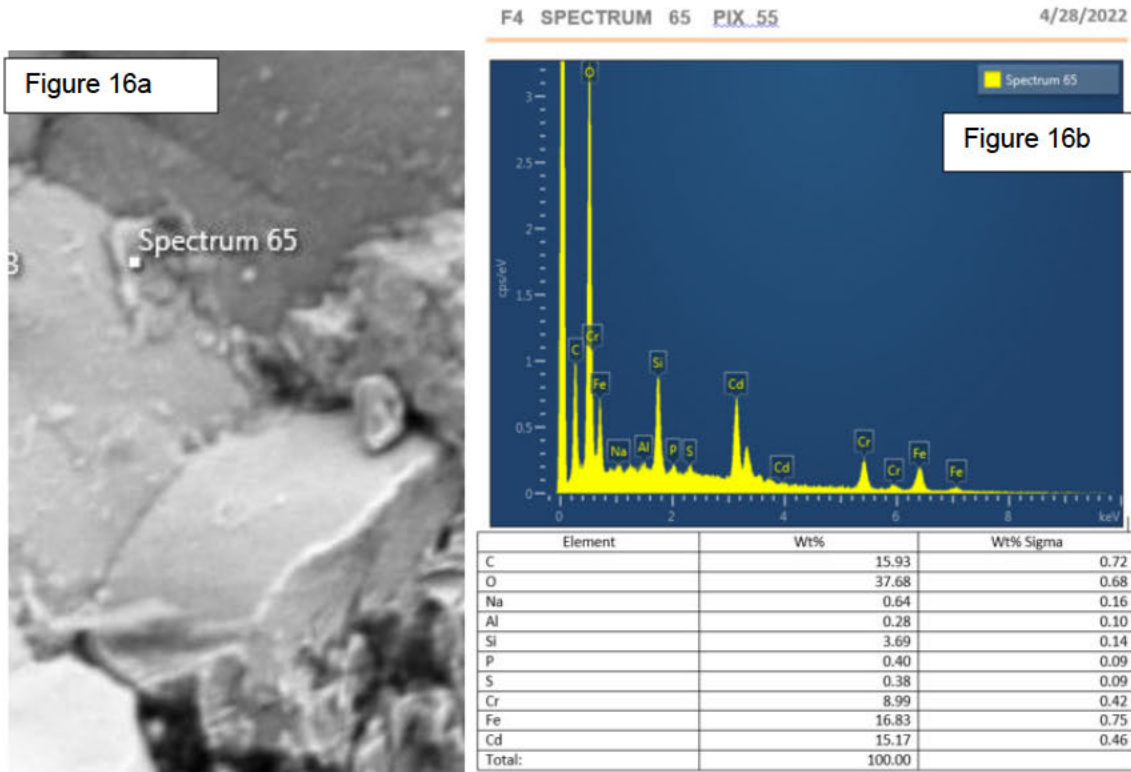
Additional SEM work was done to further characterize the burn. The mount was coated with Au-Pd (Gold Palladium) enabling EDAX to be performed. The porous area in the subsurface of the indication was located using the SEM, and the spectrum showed Cd present in the region of the arc burn that had severe heat damage (Figure 17a and b). The presence of Cadmium was also detected in a crack emanating from the arc burn (Figure 18a and b).

Figure 17a and b. EDX scan at fracture surface of particulate found in intergranular cracking morphology. Scan at location "Spectrum 65" showed high level of Cadmium present.
