Subject: Boeing Equipment Quality Analysis Report on Right Main Landing Gear – Sun  
Country 737-800 N817SY Landing Gear Collapse in Las Vegas 04 February  
2022

## Equipment Quality Analysis Report

**SUBJECT:** *Right Main Landing Gear Collapse*

**SUBJECT:** Metallurgical Fracture Analysis of Main Landing Gear Outer Cylinder

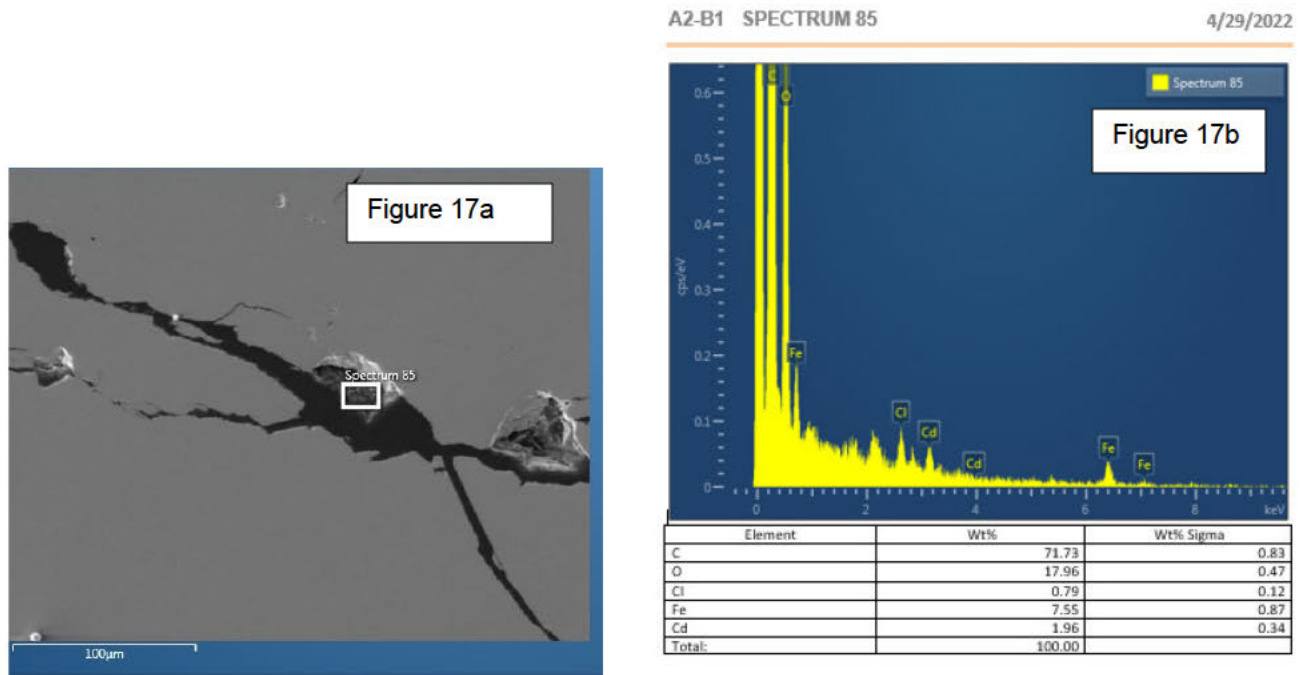
After all finishes were removed, Cadmium was detected in the porous surface layer and within secondary cracks that emanated from the arc burns indicating that Cadmium plating was present when the arc burns occurred. Possible sources for the arcing damage are during post –plate magnetic particle inspection, or more likely, during a stylus cadmium plating operation.

Figure 18a and b. EDX scan within the crack of the metallographic mount revealed the presence of Cadmium in cracking emanating from the arc burn.
