ENG22LA049

Group Chair's Factual Report - Attachment 1

GE Passport 20 Core Compartment Fires In Service, dated March 14, 2023

# GE Passport 20

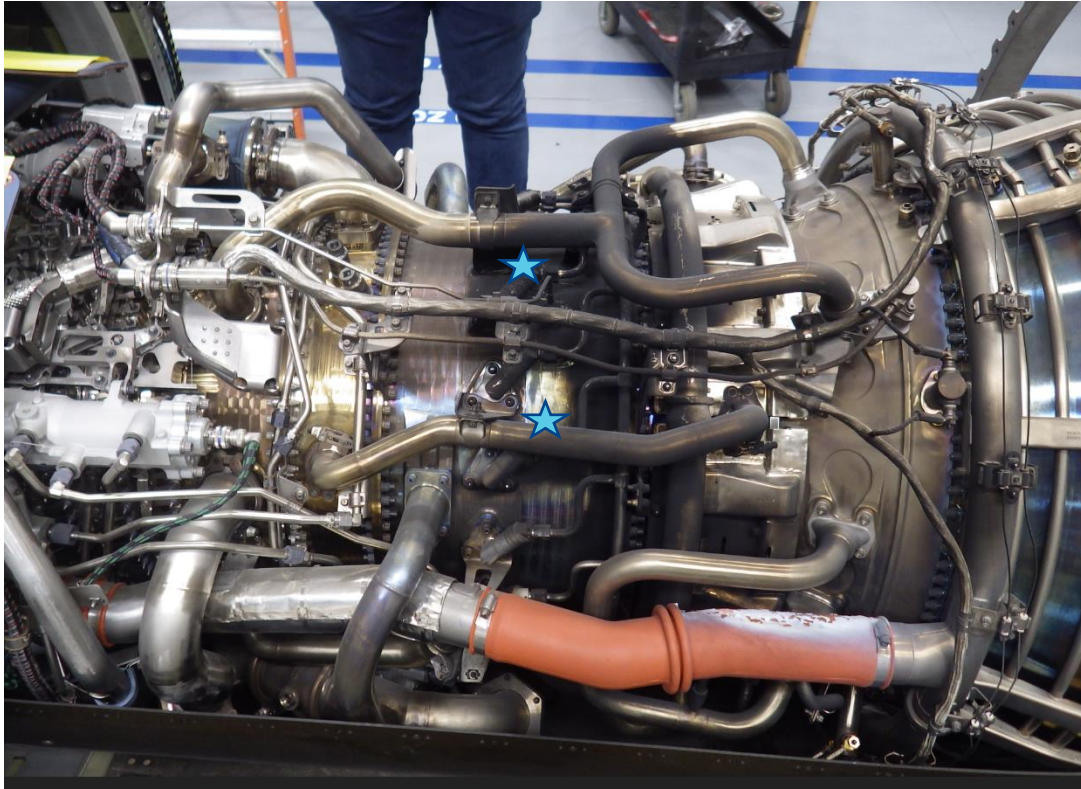
IFSD in Riyadh, 904-292

- Engine 904-292 experienced an IFSD during service due to a fire warning indication. The indication came on during takeoff but went away when throttle was reduced. Indication recurred when power was increased, and engine was shut down. Aircraft landed safely.

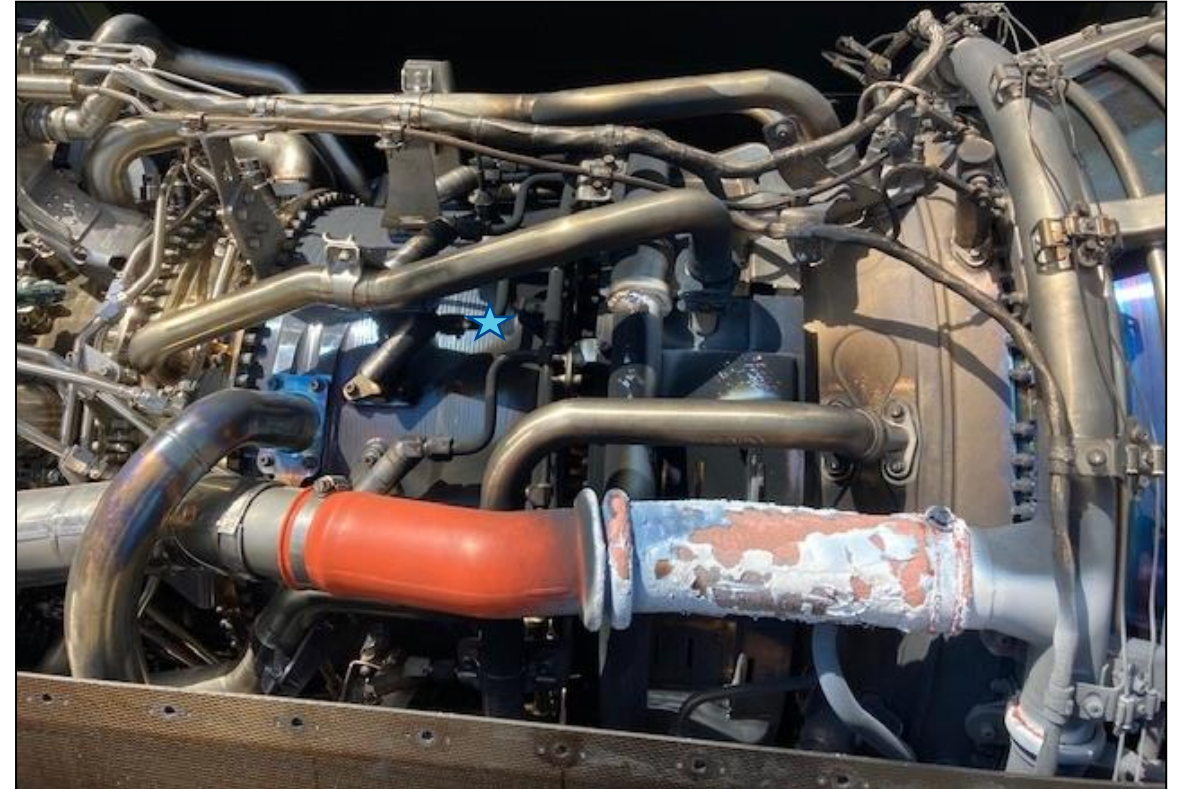
Air Turn Back in West Palm, 904-265

- Engine 904-265 experienced an air turnback. During takeoff pilots received LH engine fire warning. They held at 4000 feet and reduced engine power. Indication went away. Pilots notified ATC that fault was intermittent and were going to proceed on their flight. At subsequent climb, with engine at high power, fire indication again annunciated. Pilots turned back and landed safely. Indication went out again during decent.

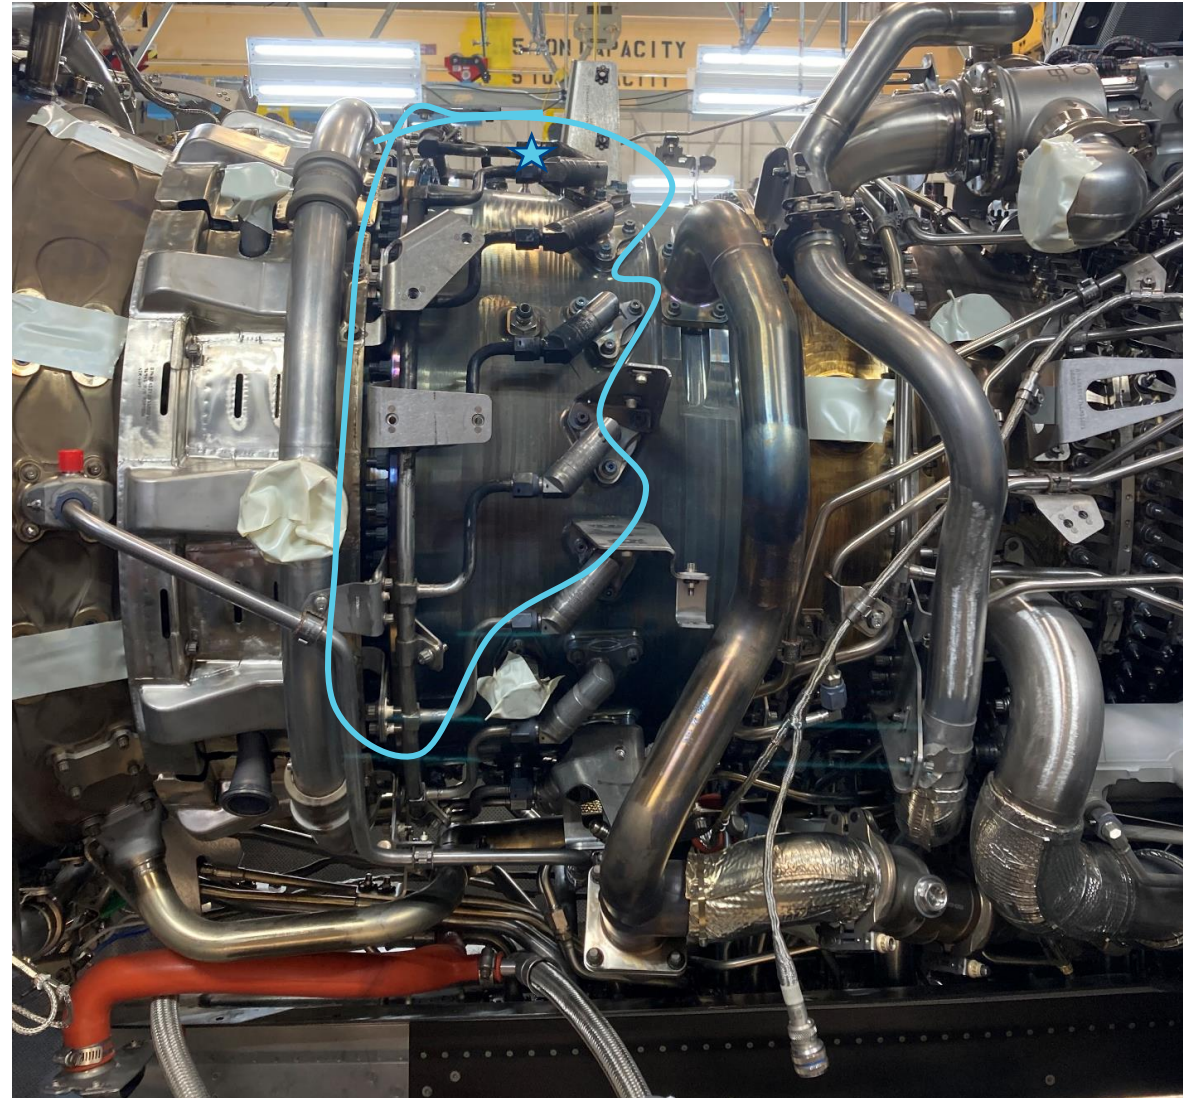
- This engine was scheduled for fuel manifold nut tightening and core compartment soot was found on October 6, 2022
- No operational event occurred
- Deposits are consistent with fuel leakage and small fire
- Non-metallic hardware was not damaged

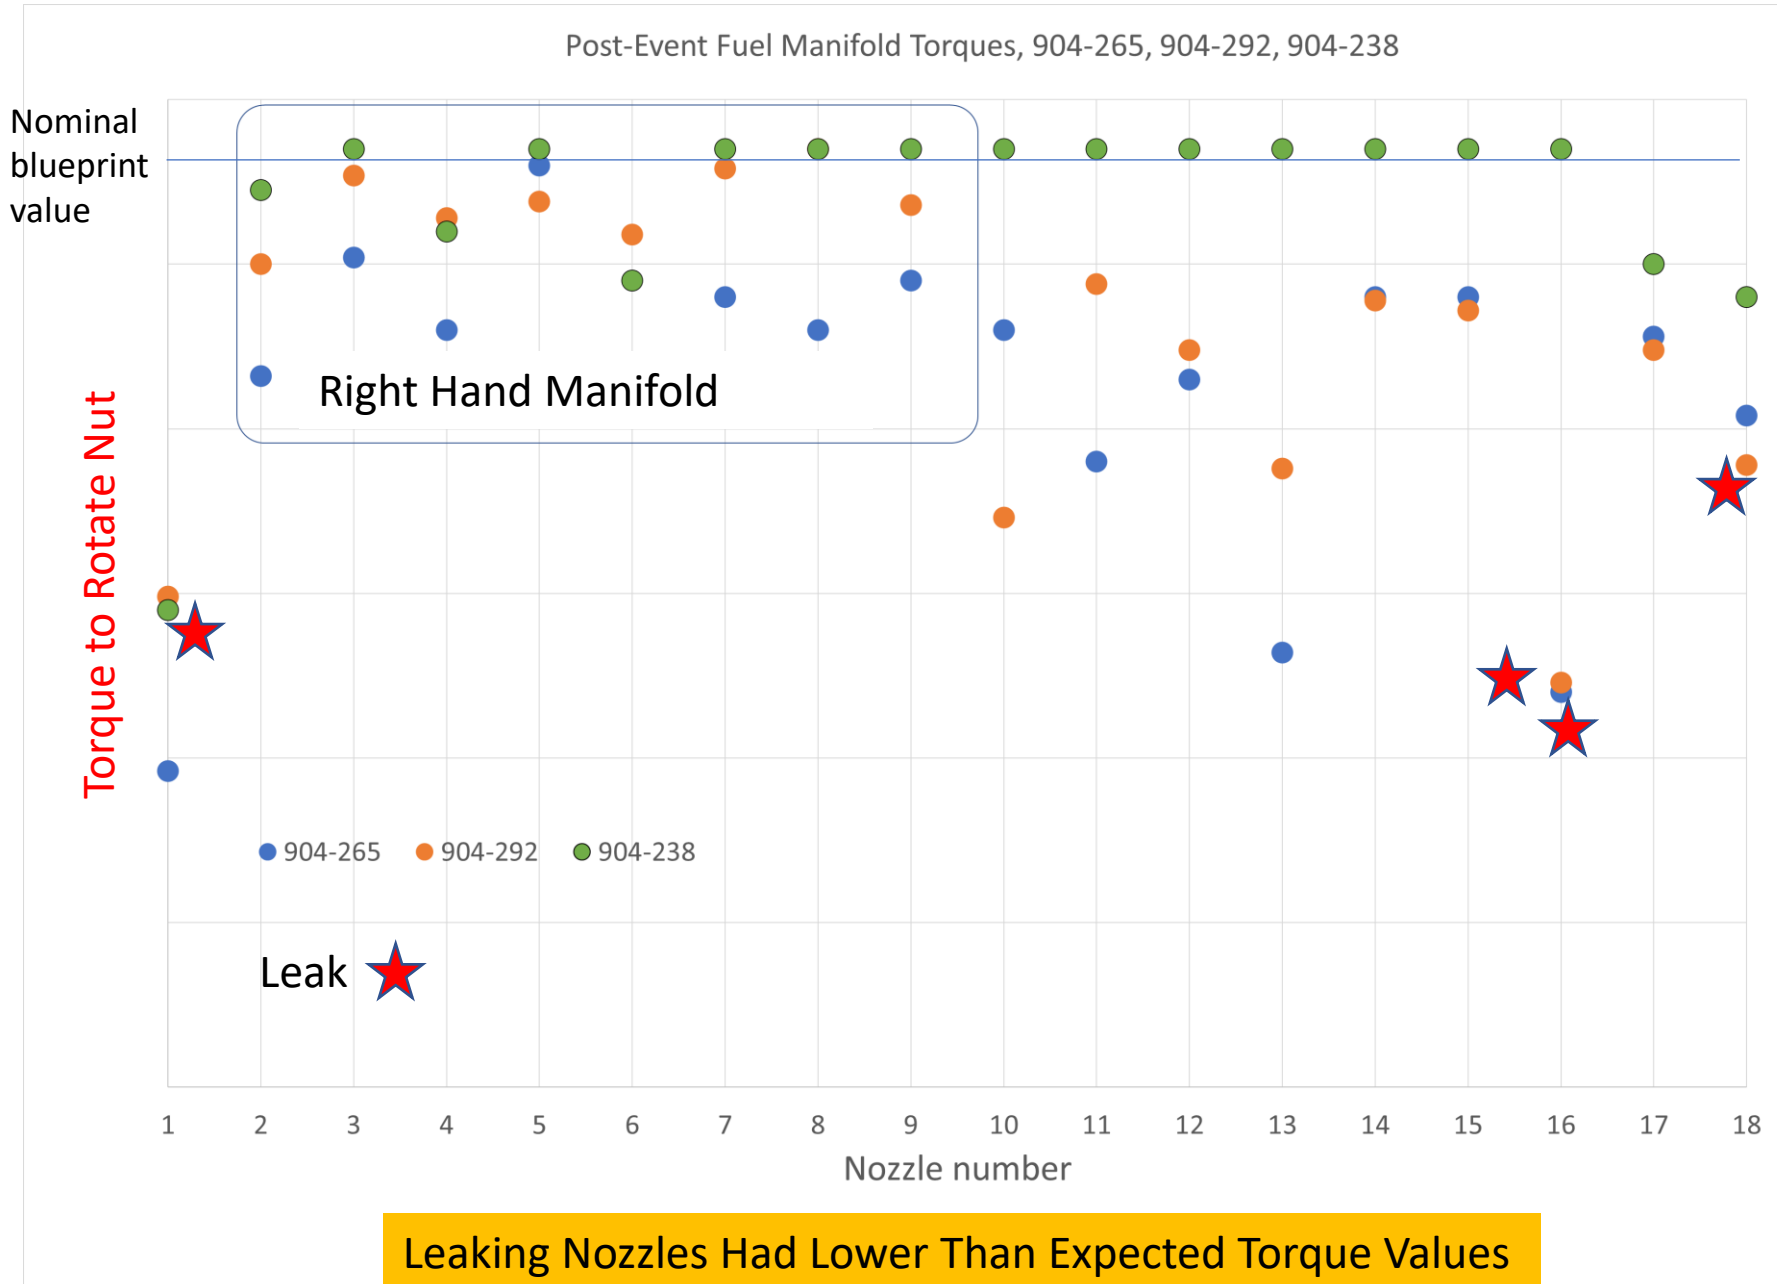
- Left hand manifold contains nozzles #1, #10-#18
- Right hand manifold contains nozzles #2-#9
- Both event engines exhibit similar torque signature – made at assembly site ‘A’
- Non-event engine was made at assembly site ‘B’ and exhibits a different torque signature
- RH manifold has more consistent and higher tightening torques
- LH manifolds had lower tightening torques
- All leaks occurred on the LH manifolds
  - #1 on 904-238
  - #18 and #16 on 904-292
  - #16 on 904-265

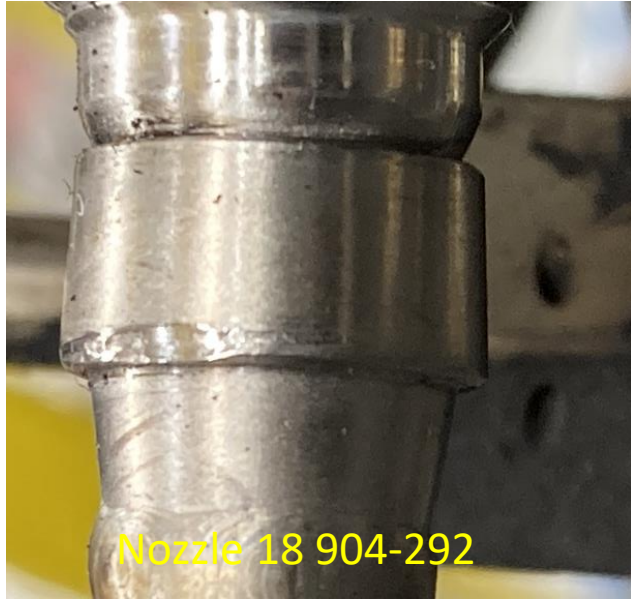
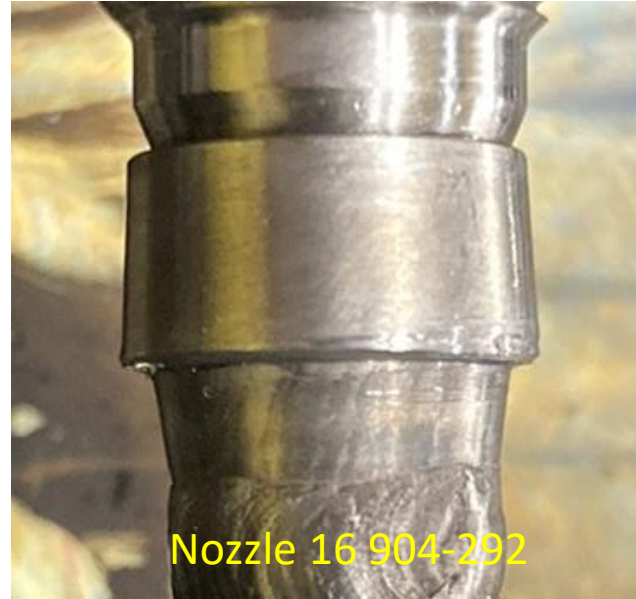
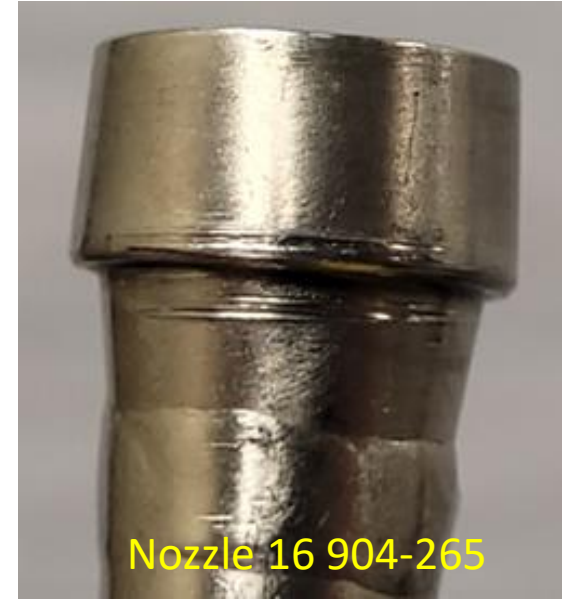
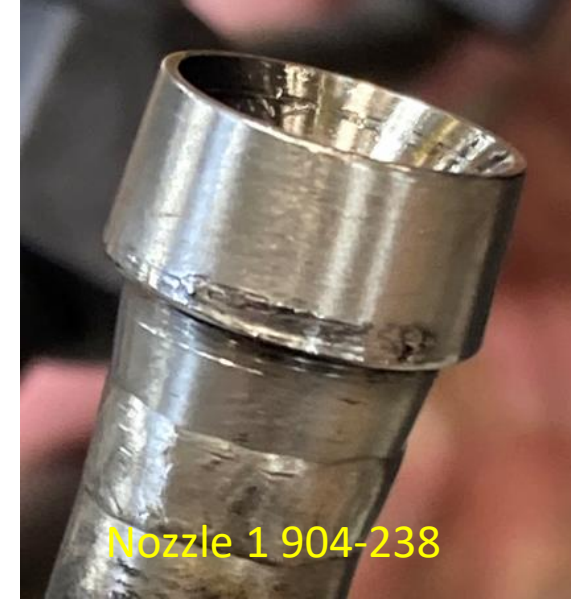
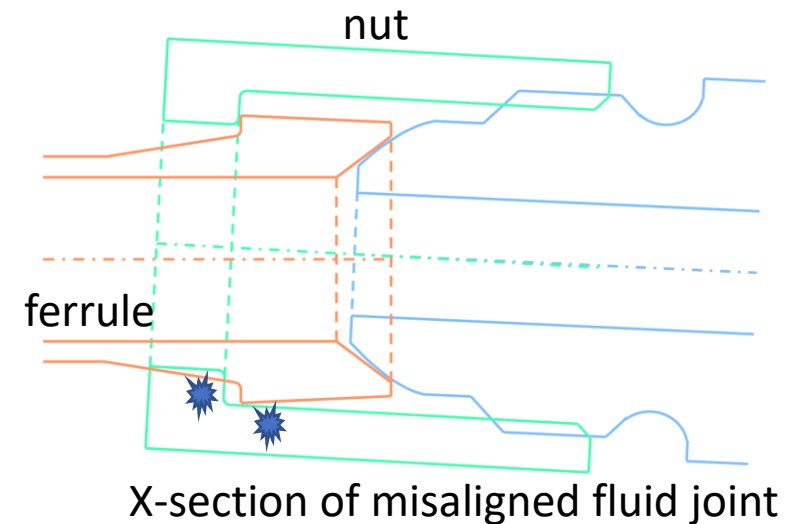
## All Leaking Nozzles Had Evidence of Misalignment

Examination of the outside diameters of ferrules show evidence of joint misalignment – signs of ‘galling’ on the outside surface indicative of metal transfer between the nut and the ferrule outside diameter

1. Assembly process change that improves alignment control during the nut torque process

- ★ Protects alignment at fluid joint (minimizes risk of false torque)

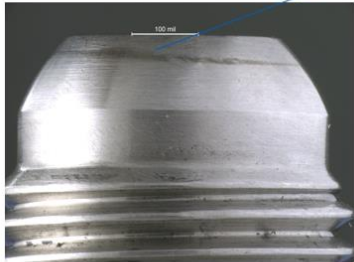
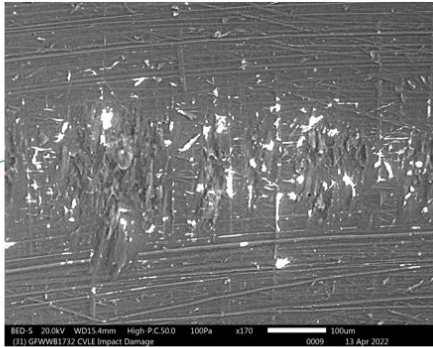
Sealing surface shows sign of relative movement, likely during assembly

- Most leaking nozzles had sealing surface damage, in addition to low tightening torque and signs of misalignment
- Surface damage is an aggravator for fuel leakage, making it more difficult for a fluid seal

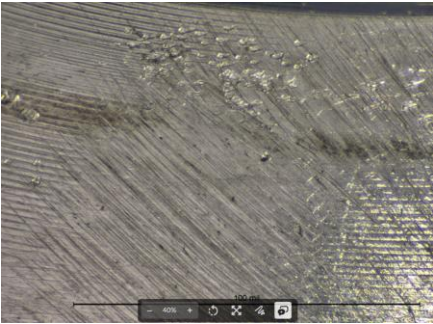
Abrasive operation had been performed on one of the leaking nozzles

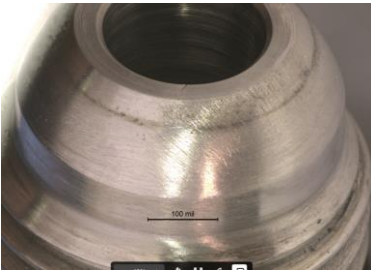
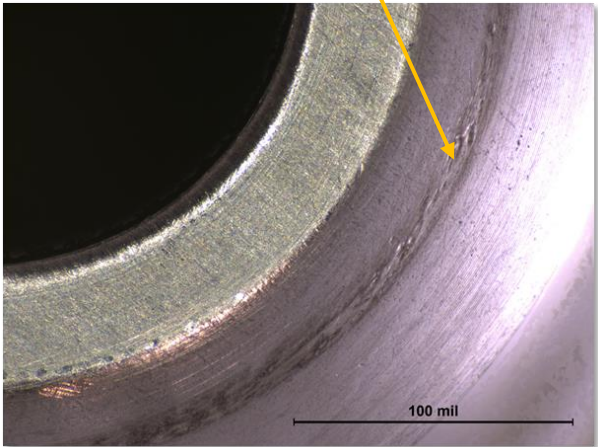
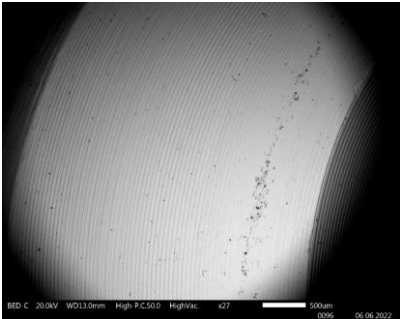
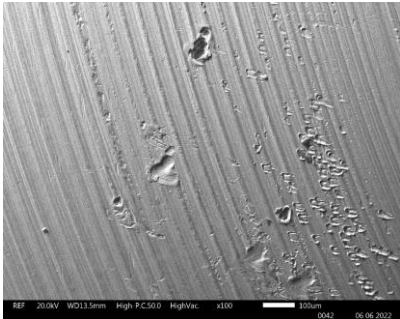
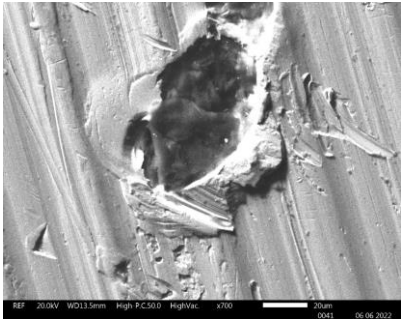
Surface shows signs of relative movement between ferrule and ball nose

Debris damage present
