**NATIONAL TRANSPORTATION SAFETY BOARD**  
**Office of Aviation Safety**  
**Washington, D.C. 20594**

**POWERPLANT GROUP CHAIRMAN'S FACTUAL REPORT**

**NTSB No: ENG22LA049**

**NTSB No: ENG22LA020**

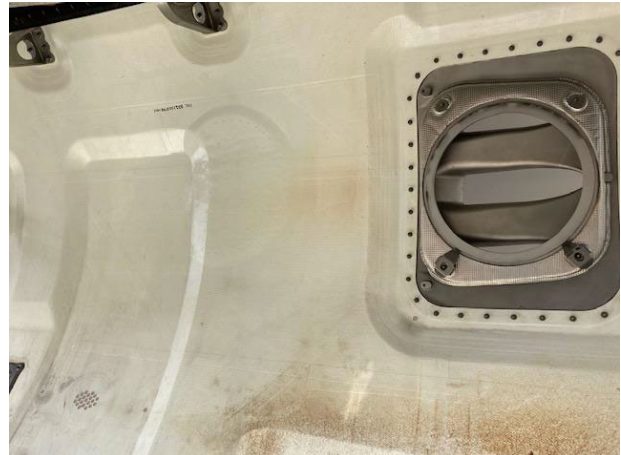
GE and Bombardier fleet support engineers met at the airplane to document the airplane and engine damage; a team from GE Strother was also there to provide maintenance assistance. A borescope inspection (BSI) of the core of the left engine, ESN 904265, through the core cowl vent revealed no unusual findings around the bottom on the engine. The upper fan cowl door was opened, the pre-cooler rope seals and insulation blanket were damaged, and slight discoloration of the lower fan cowl paint (**PHOTO 1**) was noted.

**PHOTO 1: LOWER FAN COWL DISCOLORED**

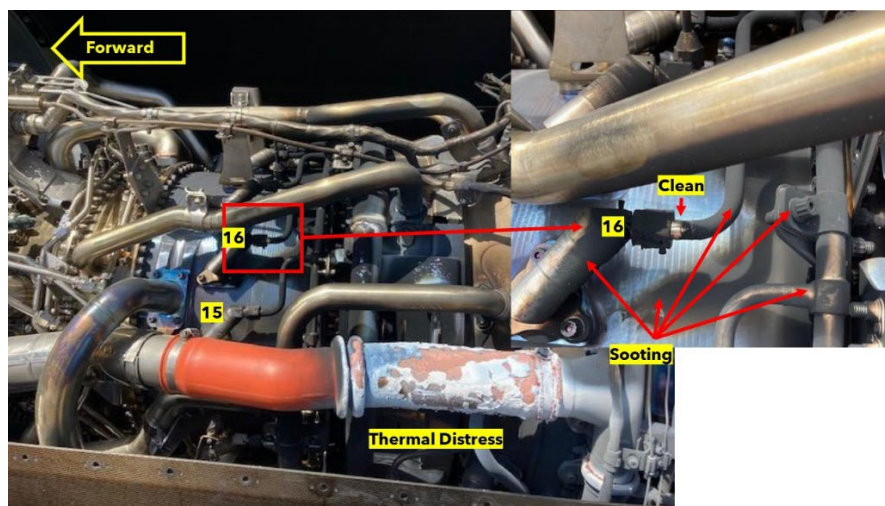
The engine FFD and CC panels were removed to expose the outside of the engine core compartment. Evidence of light thermal distress was found at about the 10:00-11:00 o'clock position, aft of the FNs, comprised of sooting and damage to an air duct thermal sleeve (**PHOTO 2**). All the fire detection loops appeared normal and undamaged. At FN location No. 16, the FN-to-fuel manifold b-nut connection appeared shiny and lacked the sooting that neighboring FN-to-fuel manifold b-nut connections exhibited; this was thought to be a possible fuel leak location. All the visible FN-to-fuel manifold b-nut connections were safety cabled, and the cable was in the correct orientation. For brevity, the FN-to-fuel manifold b-nut connection will be referred to simply as the "fuel manifold b-nut connection" for the remainder of the report.

**PHOTO 2: THERMAL DISTRESS AND NO. 16 FN LOCATION AS POSSIBLE LEAK LOCATION**

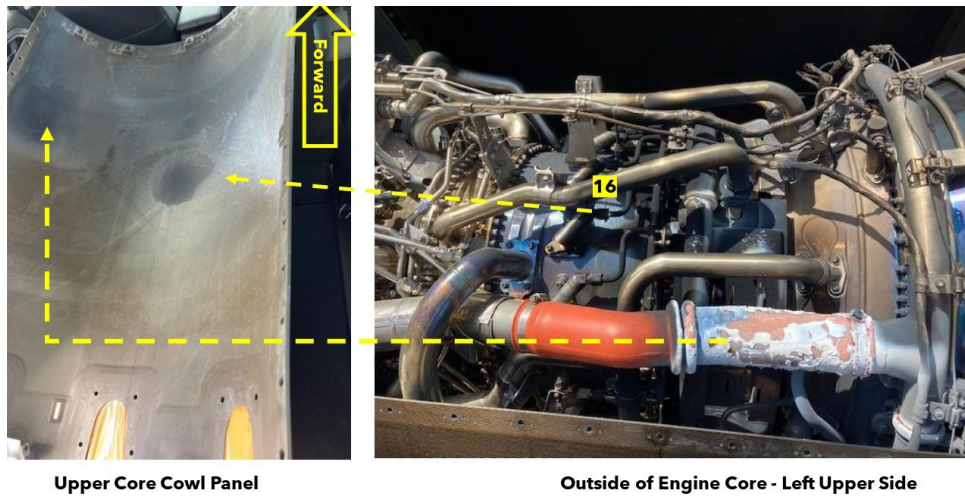
Localized discoloration was observed on the inside to the upper core cowl consistent with the general location of FN No. 16 and the thermally distressed air duct sleeve (**PHOTO 3**). The possible fuel spray impingement location on the FFD appeared to be at an angle aft of FN No. 16.

**PHOTO 3: POSSIBLE FUEL AND THERMAL IMPINGEMENT LOCATIONS**

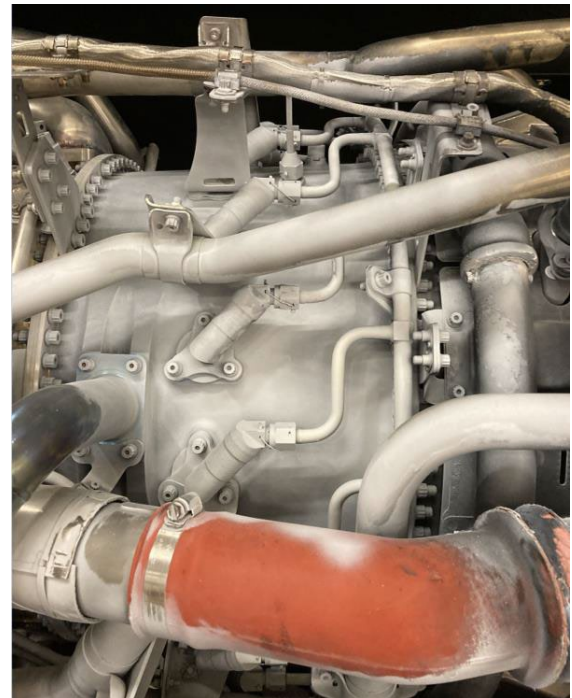
ESN 904265 was removed from the event airplane and shipped to the GE Peebles Test Operations (PTO) facility in Peebles, Ohio to perform a series of leak checks. The FN and fuel manifold areas were covered with white leak developer (**PHOTO 4**) and the engine was wet motored<sup>5</sup>; no leaks were found. The wet motoring was conducted at a fuel pressure much lower than what was experienced during the event. The low fuel pressure used during the wet motor simulated fuel start pressures and not the high fuel pressures the engine experienced during the event; maximum fuel pressure at high power is about 1,000 pounds per square inch differential (psid). A nitrogen check, with soapy liquid at the fuel manifold b-nut connections, was also conducted and again no leaks were found.

**PHOTO 4: FUEL LEAK CHECK WITH DEVELOPER**

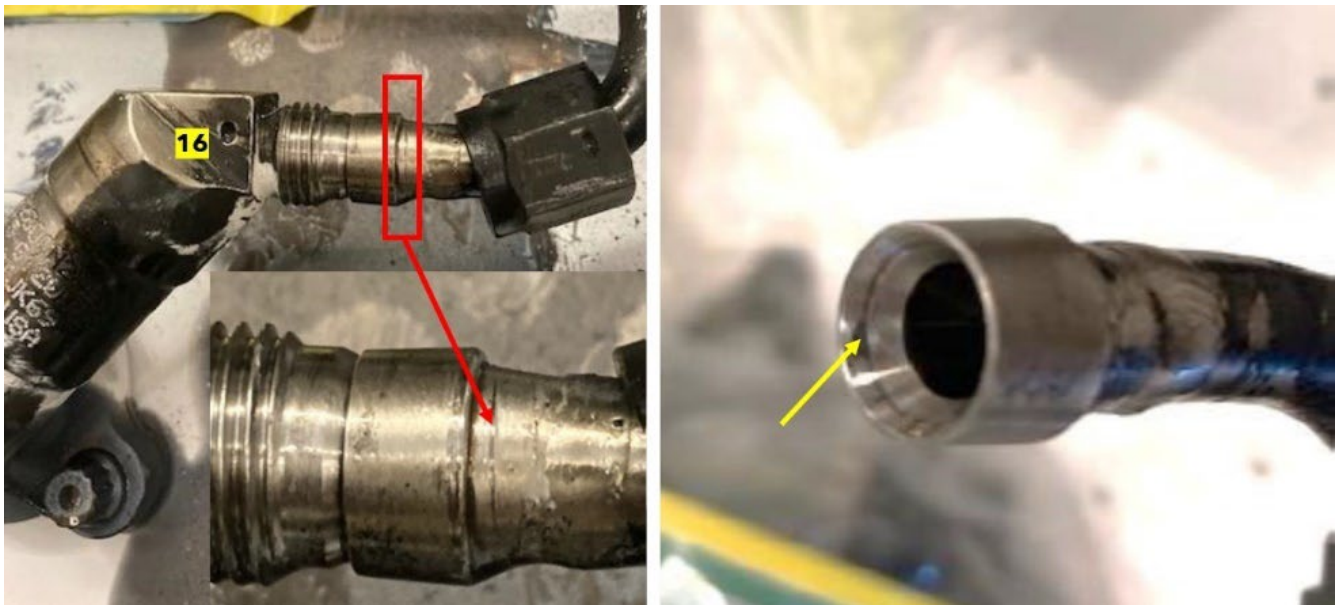
Removal of the No. 1/left (M44) fuel manifold revealed that the fuel manifold female ferrule sealing surface for the FN No. 16 location exhibited: 1) galling on the outer diameter consistent with the b-nut running onto the tube (**PHOTO 6**, left side see inset) and 2) signs of galling and grooving on the female inner conical sealing surface that mates with FN male bullnose sealing surface (**PHOTO 6**, right side, yellow arrow). According to GE, the observed female ferrule sealing surface damage is indicative of misalignment and relative movement within the connection due to high load and low cycle contact and not vibratory wear. Visual examination found no other fuel manifold b-nut connections exhibiting similar ferrule sealing surface damage.

**PHOTO 6: FUEL MANIFOLD FERRULE DAMAGE AT FUEL NOZZLE NO. 16 LOCATION**

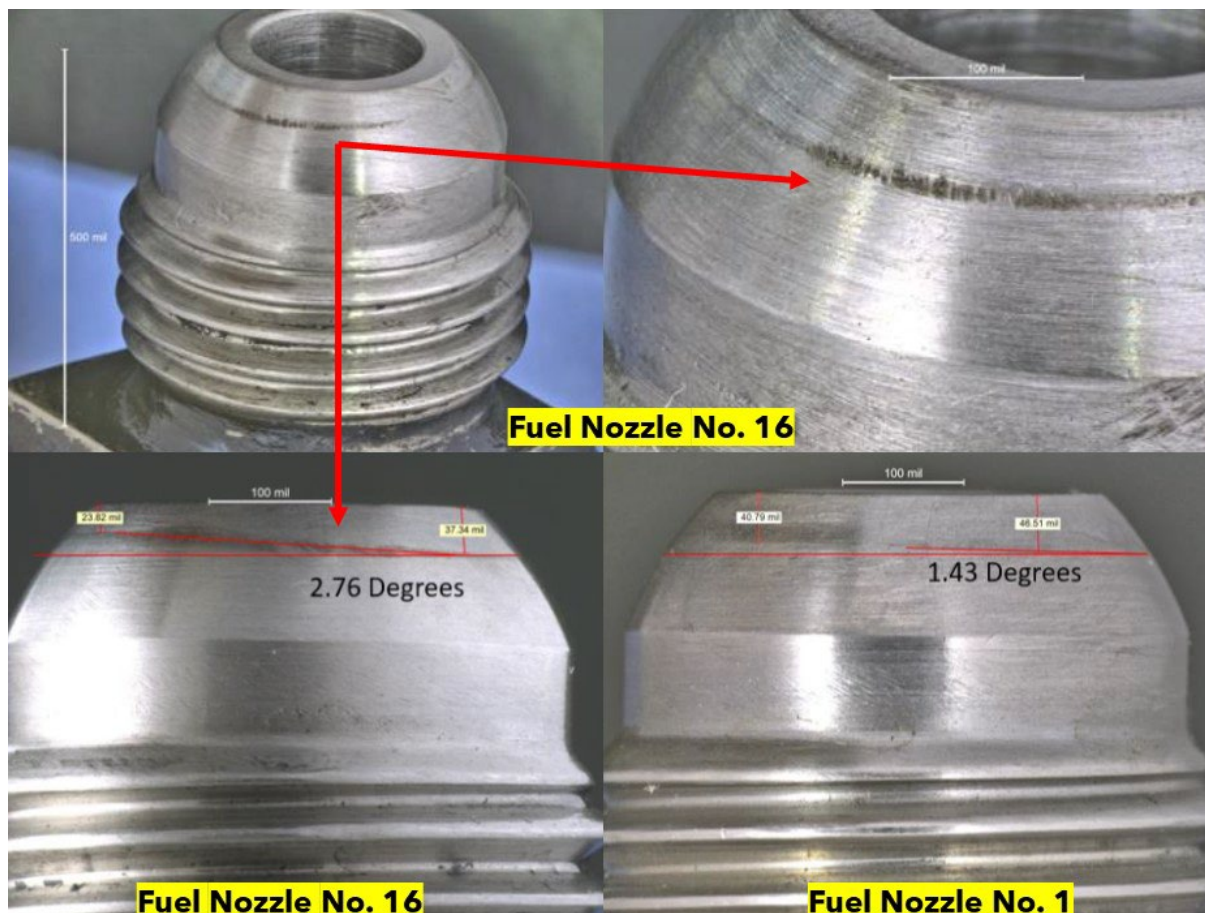
Closer examination of the contact mark on the FN No. 16 male bullnose sealing surface showed indications of galling that according to GE was indicative of high contact stress and relative motion between the two components (**PHOTO 7**, top row). The FN male bullnose sealing surface contact mark was elliptical and intermittent around the sealing conical surface consistent with misalignment contact with the fuel manifold female ferrule sealing surface; the wear mark was not in the same plane around the entire surface. Comparing the witness marks on the FN male bullnose sealing surfaces for positions Nos. 1 and 16 (both had significantly lower measured b-nut installation torques - see **TABLE 1**) revealed that the FN No. 16 position had more angular offset misalignment (**PHOTO 7**, bottom row) than the FN No. 1.

**PHOTO 7: ELLIPTICAL CONTACT PATTERN ON THE FUEL NOZZLE MALE BULLNOSE SEALING SURFACE**

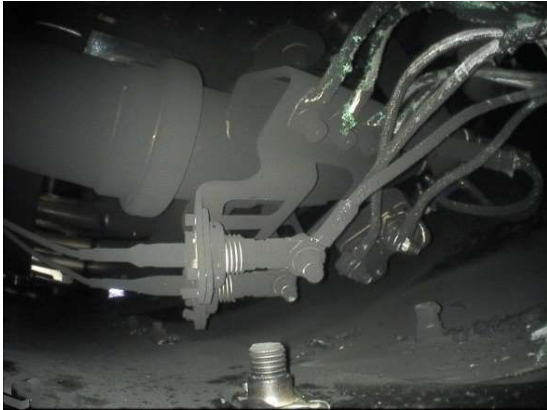
**PHOTO 8: CORE FIRE HARNESS THERMALLY  
DAMAGE (6:00-7:00 O'CLOCK POSITION ALF)**

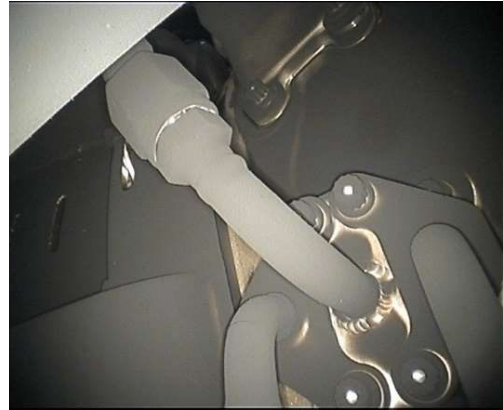
**PHOTO 9: TURBINE CENTER FRAME (TCF)  
DRAIN TUBE SOOTED**

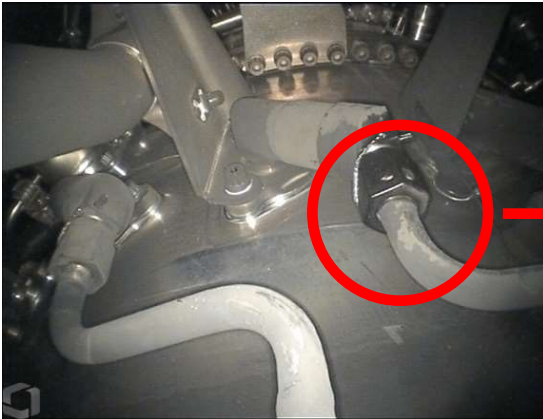
**PHOTO 10: FUEL MANIFOLD B-NUT WETTED  
(12:00-1:00 O'CLOCK POSITION ALF)**

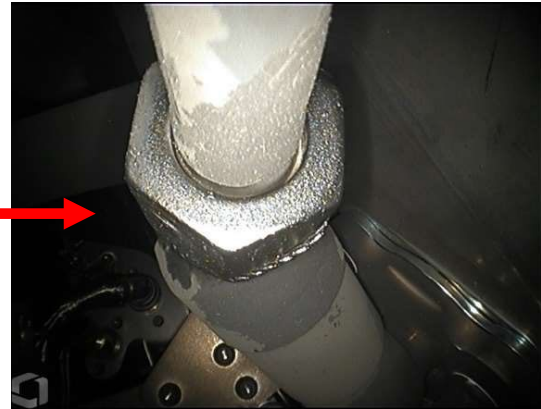
**PHOTO 11: FUEL MANIFOLD B-NUT WETTED  
(12:00-1:00 O'CLOCK POSITION ALF)**

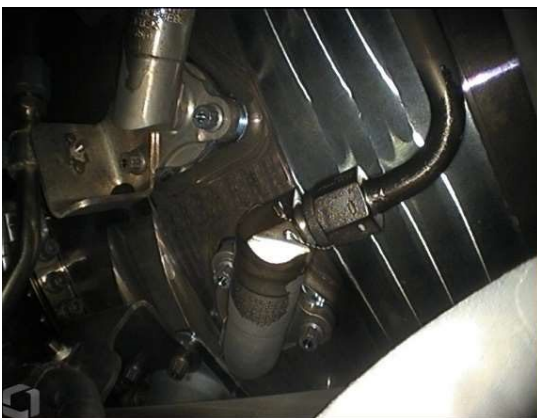
**PHOTO 12: FUEL MANIFOLD B-NUT WETTED  
(6:00-7:00 O'CLOCK POSITION ALF)**

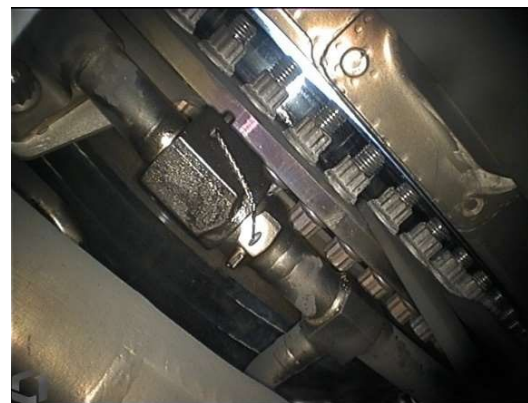
**PHOTO 13: FUEL MANIFOLD B-NUT WETTED  
(6:00-7:00 O'CLOCK POSITION ALF)**

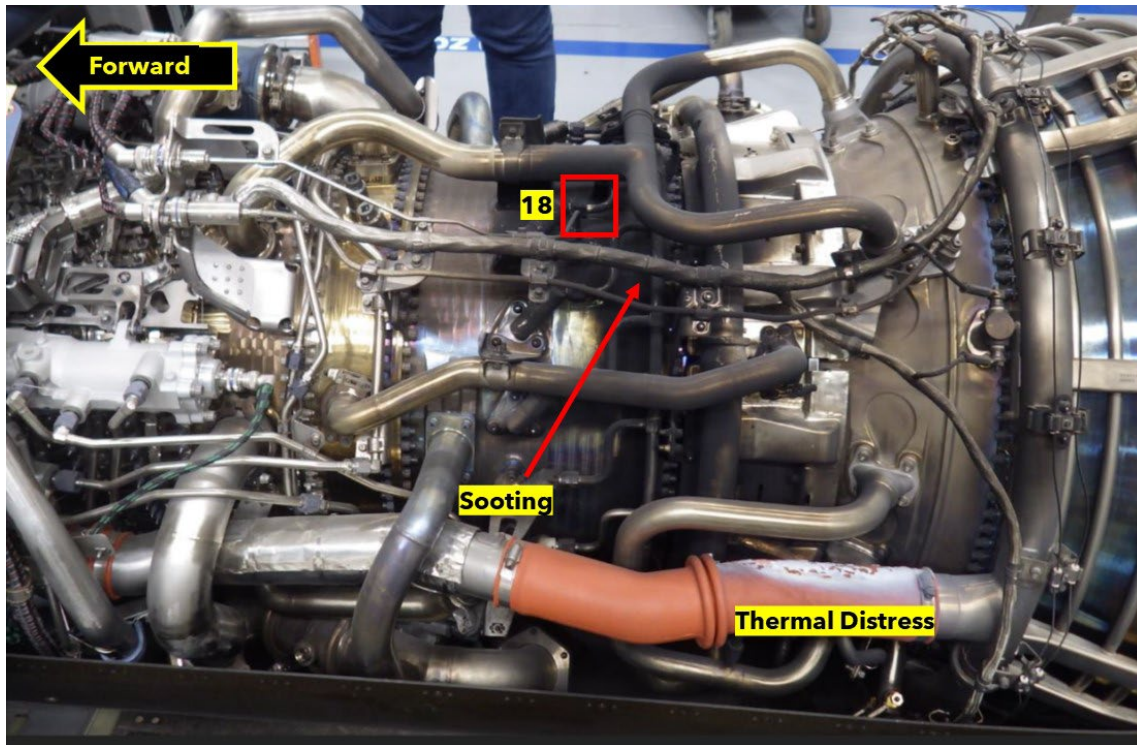
ESN 904292 was shipped back to GE Cincinnati to be evaluated. Light sooting, aft of the FNs, along with minor thermal damage to an air duct thermal sleeve was observed (**PHOTO 14**). All the fire detection loops appeared normal and undamaged. At FN No. 18, the fuel manifold b-nut connection appeared shiny and lacked sooting; it also exhibited a fluid flow pattern emanating from the connection (**PHOTO 15**). FNs Nos. 12, 14, and 16 were wetted but only FN No. 16 exhibited a fluid flow pattern (**PHOTO 16**). All the visible fuel manifold b-nut connections were safety cabled, and the cable was in the correct orientation. A leak check using nitrogen at just under 30 psig was performed; pressure held for an hour with no decay. The fuel leak was not reproduced just like the testing results of ESN 904265 (Palm Beach).

**PHOTO 14: THERMAL DISTRESS AND POSSIBLE LEAK LOCATION**

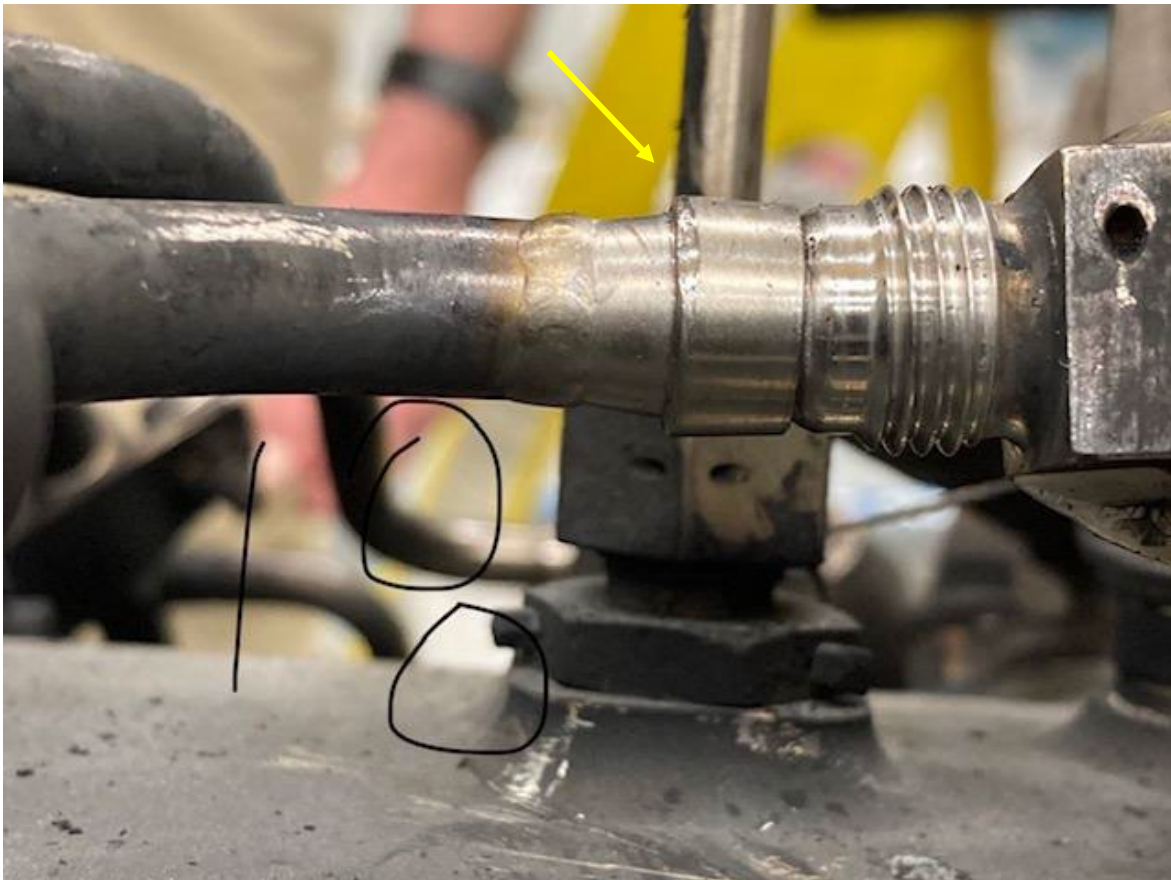
The fuel manifold female ferrule outer diameter at location FN No. 18 exhibited contact/witness marks consistent with the b-nut threads wearing onto the shoulder (**PHOTO 17**).

**PHOTO 17: FUEL MANIFOLD FERRULE DAMAGE AT FUEL NOZZLE No. 18 LOCATION**

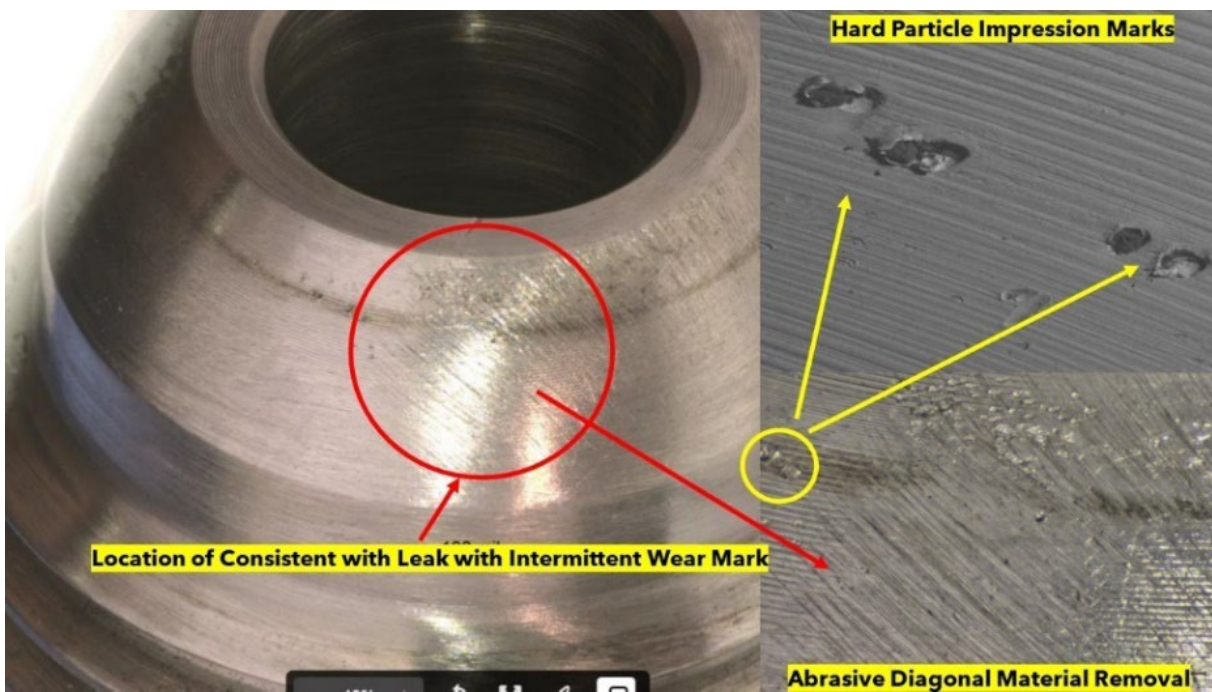
ESN 904292 FN No. 18 fuel manifold ferrule outer diameter surface exhibited galling, and elliptical and intermediate contact marks indicative of misalignment contact with the fuel manifold female ferrule sealing surface. However, along with the intermittent galling, there were signs of contaminants (hard particles) on the FN male bullnose sealing surface in the form of craters, indentations, and imbedded material on the sealing surface. Diagonal orientated abrasive material marks/material removal, consistent with what appears to be previous repair (**PHOTO 18**), was also observed.<sup>8</sup> According to GE, there was no record of a repair operation being performed on this specific nozzle at the fuel nozzle manufacturer<sup>9</sup> or at the engine assembly site; GE concluded that this possible repair may have occurred sometime during engine assembly. The engine manual does not allow for any nicks or scratches but does allow for blending. However, blending is only allowed in the circumferential direction for conical/cylindrical parts; the blend/abrasive material removal marks on FN No. 18 male bullnose sealing surface were in the diagonal direction along the axis of the part. Therefore, the blending in the area would be inconsistent with the engine manual blending instructions.

**PHOTO 18: No. 18 FN MALE BULLNOSE WITH ABRASIVE MARKS AND PARTICLE IMPRESSION**

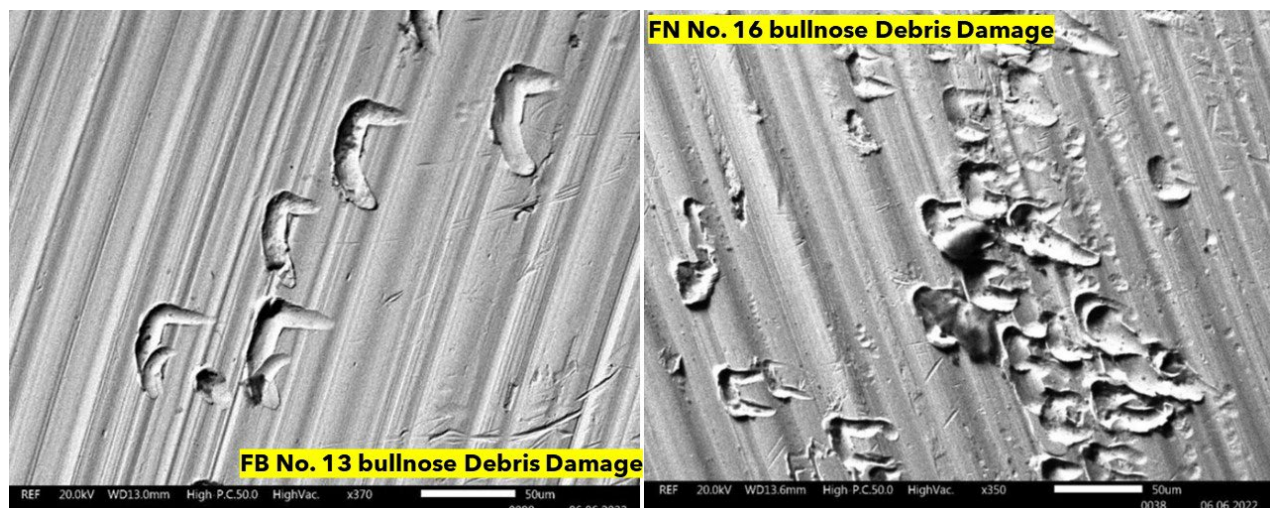
Only the FN No. 18 male bullnose sealing surface showed evidence of rework/repair; however, hard particle damage was also observed on the male bullnose seal surfaces of FNs Nos. 12, 13, and 16 (**PHOTO 19**). GE was unable to confirm the source of the contaminates.

**PHOTO 19: HIGH MAGNIFICATION OF SIMILAR SHAPED DEBRIS DAMAGE ON FUEL NOZZLE MALE BULLNOSE SEALING SURFACE ON NOS. 13 AND 16**

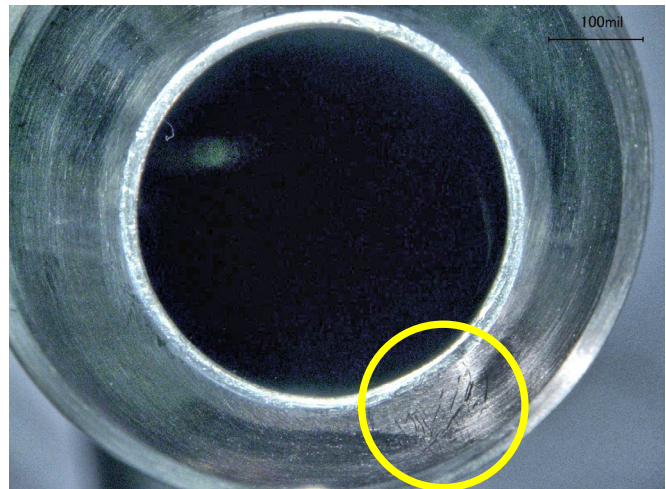
On April 28, 2022, while Bombardier was performing the retorque FEI on their final assembly line, evidence of a fuel leak on the outboard lower cowl and the fuel manifold b-nut connection at the 6:00 o'clock position was found on ESN 904365. All the torque values for the FN attachment bolts, the fuel manifold b-nuts connections, and the fuel manifold-to-fuel manifold b-nut connection were all within the acceptable range. The engine had accumulated 3 hours TSN and 3 CSN when it was removed from the airplane. The engine was shipped to the GE facility in Lafayette, Indiana, for disassembly, and the fuel manifolds were removed and sent to the supplier, GE Hookset, New Hampshire, for dimensional inspection and then to the GE failure analysis lab in Evendale for evaluation; the FNs were also sent to Evendale for evaluation. The male bullnose sealing surface on the No. 2/right (M26) fuel manifold that mates with the female ferrule sealing surface on the No. 1/left (M44) fuel manifold exhibited a flat area/dent that intersected the sealing band and an area of abrasive operations/material removal consistent with what appears to be a previous repair; the leak is thought to have occurred at the flat area (**FIGURE 20**). GE conducted a records search at the supplier, GE Hookset, and the individual assembly router cards at the assembly facility, GE Lafayette, to find any record of a rework/repair<sup>12</sup> having been performed on the No. 2/right (M26) manifold; no record indicating that a rework/repair was performed was found.

**PHOTO 20: M26 MALE BULLNOSE FLAT SPOT/DENT AND MATERIAL REMOVAL**

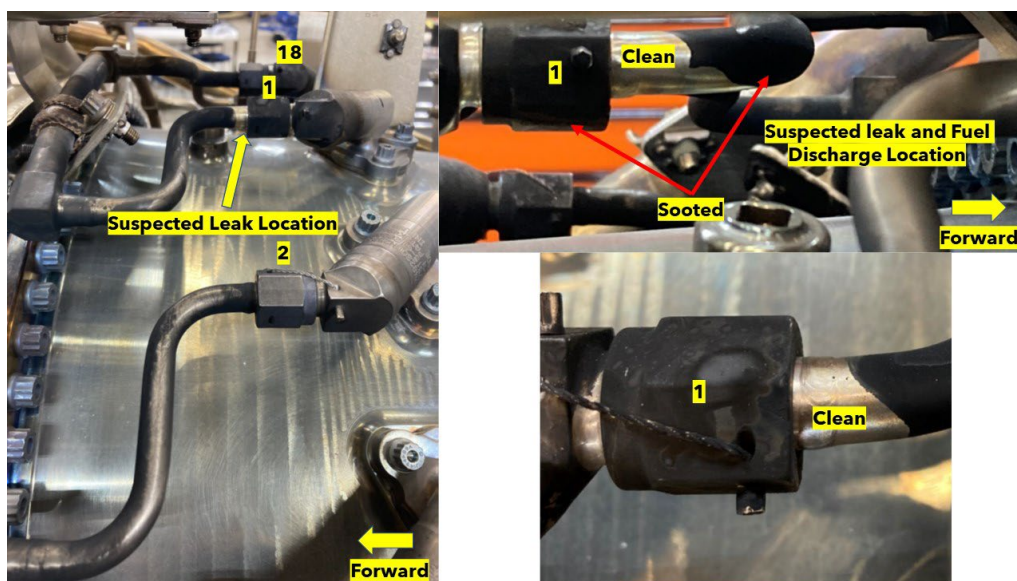
The engine was removed from the airplane and shipped to GE Strother, Strother Kansas, facility for inspection and documentation; unlike the previous fuel leak engines (ESNs 904265, 904292, and 904365) ESN 904238 was assembled at the GE Strother facility and not at GE Lafayette facility. Areas of sooting were found from about the 9:00 to 12:00 o'clock location in the vicinity of the fuel manifolds and fuel nozzles. No thermal distress was noted to any non-metallic components, such as fire loop grommets; the left side of the engine showed no signs of sooting or fuel leaks; no signs of burning, thermal, or fire distress in the core compartment; and the core cowls showed very light discoloration adjacent to the No. 1 FN location. Closer visual examination showed that the FN No. 1 showed heavy sooting on the fuel manifold b-nut connection and along the pigtail but was clean in an area just forward of the b-nut (**PHOTO 21**); soot does not normally adhere to fuel wetted surfaces.

**PHOTO 21: SUSPECTED FUEL LEAK FROM FUEL NOZZLE NO. 1 LOCATION**

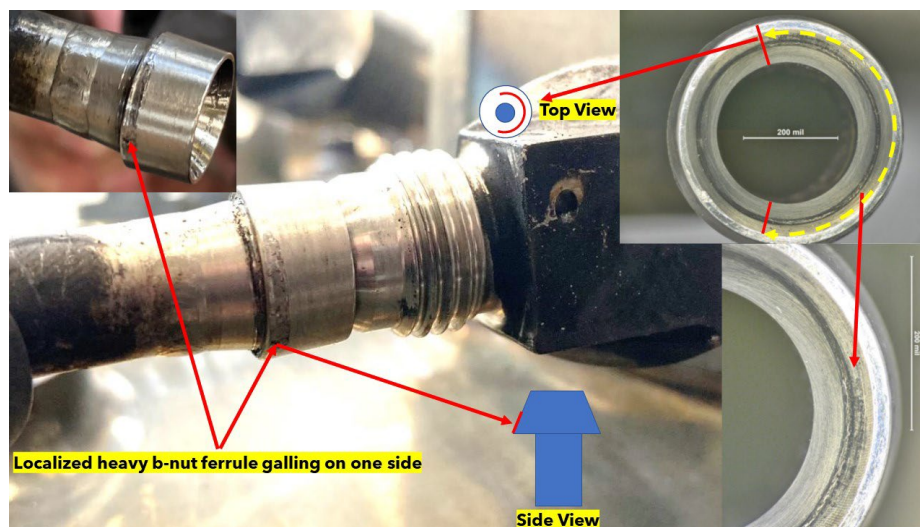
Heavy localized galling was observed on the fuel manifold female ferrule outer diameter (**PHOTO 22**). The female inner conical sealing surface exhibited the normal 360° contact mark from mating with the FN male bullnose seal surface along with heavy galling outboard of the normal contact mark around an arc that was over 180° (**PHOTO 22**, upper right hand).

**PHOTO 22: FN No. 1 FERRULE DAMAGE AND FEMALE SEALING SURFACE GALLING**

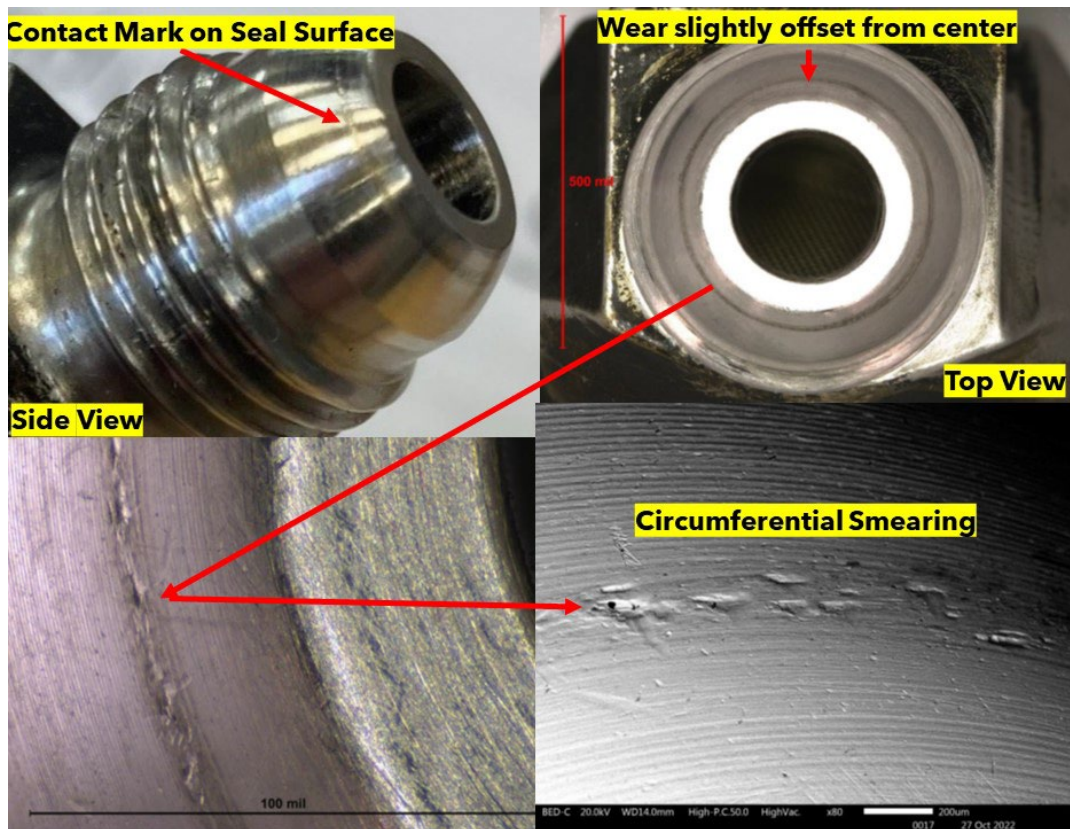
The FN No. 1 male bullnose sealing surface exhibited the normal 360° contact mark from mating with the female ferrule inner conical sealing surface; however, it was not centered on the male bullnose sealing surface but had shifted slightly upwards. Along with the normal contact wear, heavy circumferential galling/material smearing was observed consistent with the contact mark (**PHOTO 23**). According to GE, the galling observed on the sealing surfaces of the FN No. 1 ferrule and male bullnose are consistent with misalignment of the joint.

**PHOTO 23: FN No. 1 MALE BULLNOSE DAMAGE AND MALE SEALING SURFACE GALLING**

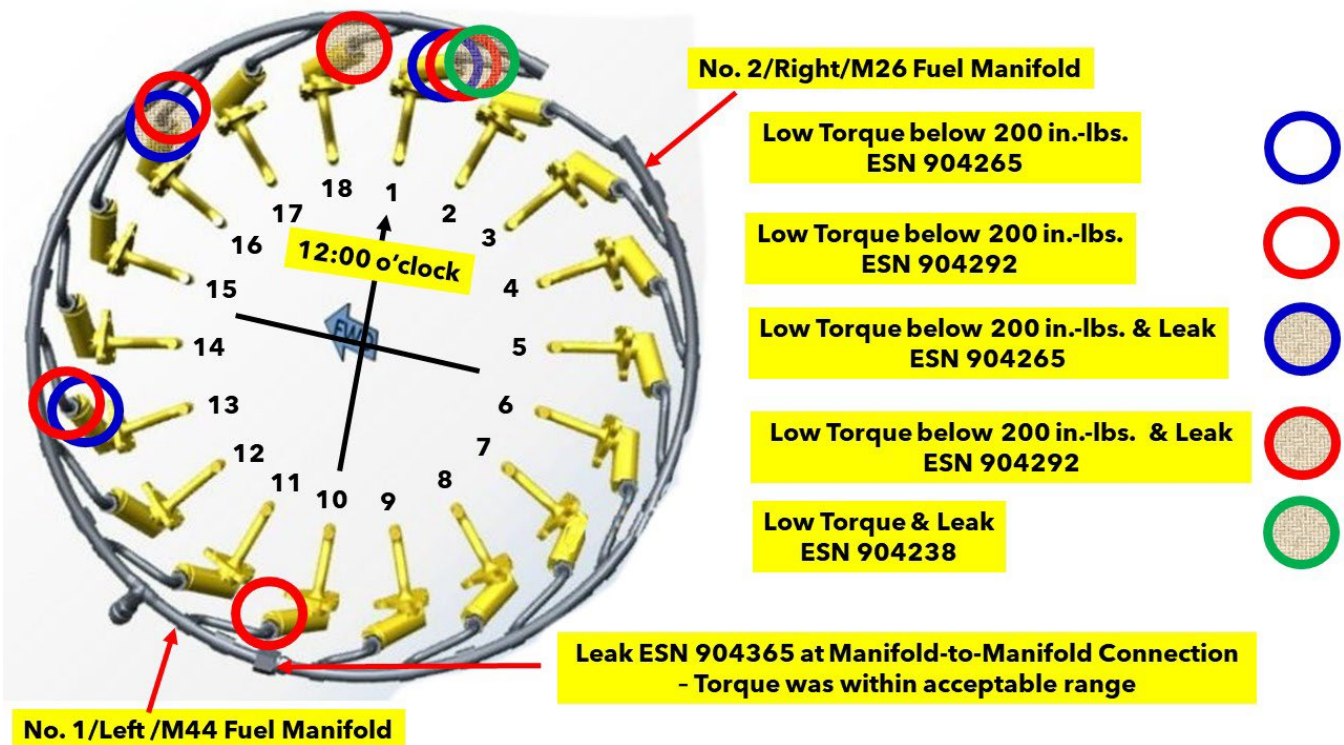
A review of the data collected on the fuel manifold leak engines revealed several common factors and trends. **TABLE 3** provides a list of common features/factors and **FIGURE 8** provides a pictorial view of the fuel leak versus low torque locations. All the fuel manifold leaks were considered to have occurred at high power setting based on pilot statements for the operational events and the inability to replicate the fuel leaks during the low pressure test.

**FIGURE 8: FUEL MANIFOLD B-NUT LOW TORQUE AND FUEL LEAK LOCATIONS**

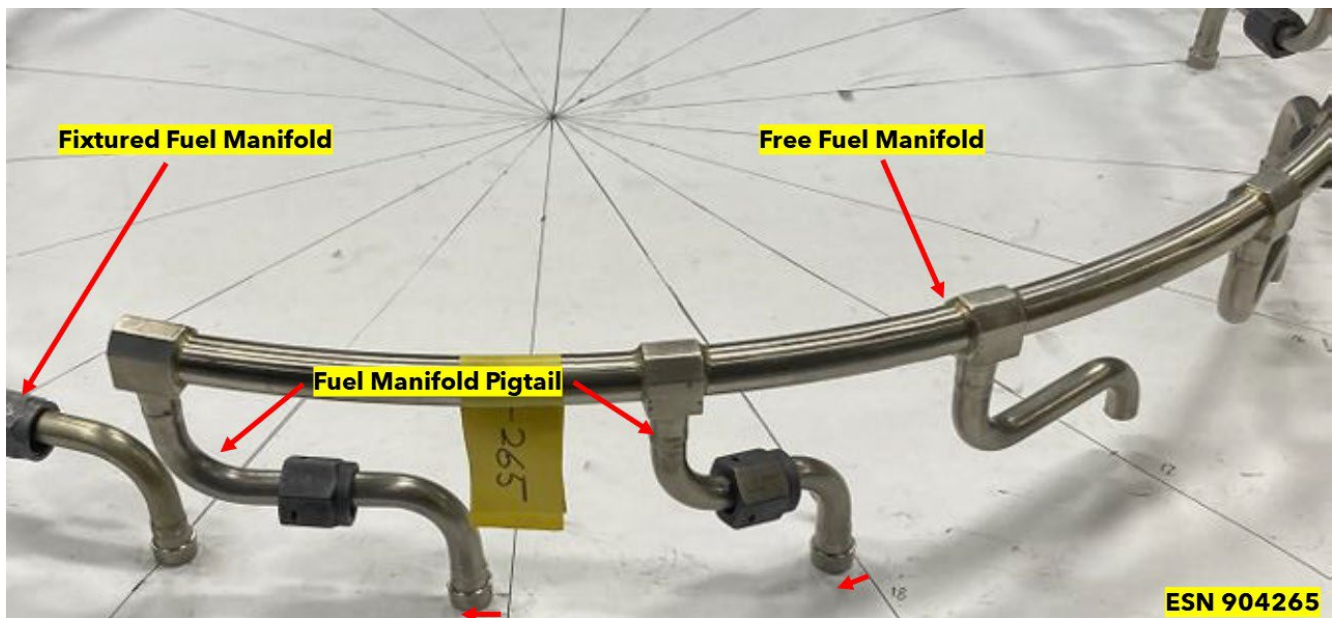
In the free state condition where the fuel manifolds are not joined at the manifold-to-manifold b-nut connection, all the fuel manifold pigtails were aligned with the radial lines. None of the fuel manifold pigtails showed any circumferential misalignment circumferentially away from the radial centerlines. With fuel manifolds connected at the manifold-to-manifold connect and holding one of the fuel manifolds fixed so that the pigtails remained on the radial centerlines (semi-free state), a slight shift (circumferential misalignment) in the fuel manifold pigtails on the non-fixed fuel manifold was observed. The direction of the misalignment was consistent on all three engine fuel manifolds evaluated and the shift was in the direction of closing/tightening the circular shape (**PHOTOS 30** and **31**). Although not shown, ESN 904238 fuel manifolds exhibited the same circumferential misalignment. Thus, connections of the fuel manifolds at the 6:00 o'clock fuel manifold-to-fuel manifold b-nut was shown to be a contributor to the system assembly stresses and circumferential misalignments.

**PHOTO 30: SEMI-FREE STATE MISALIGNMENT ON ESN 904265 FUEL MANIFOLD**

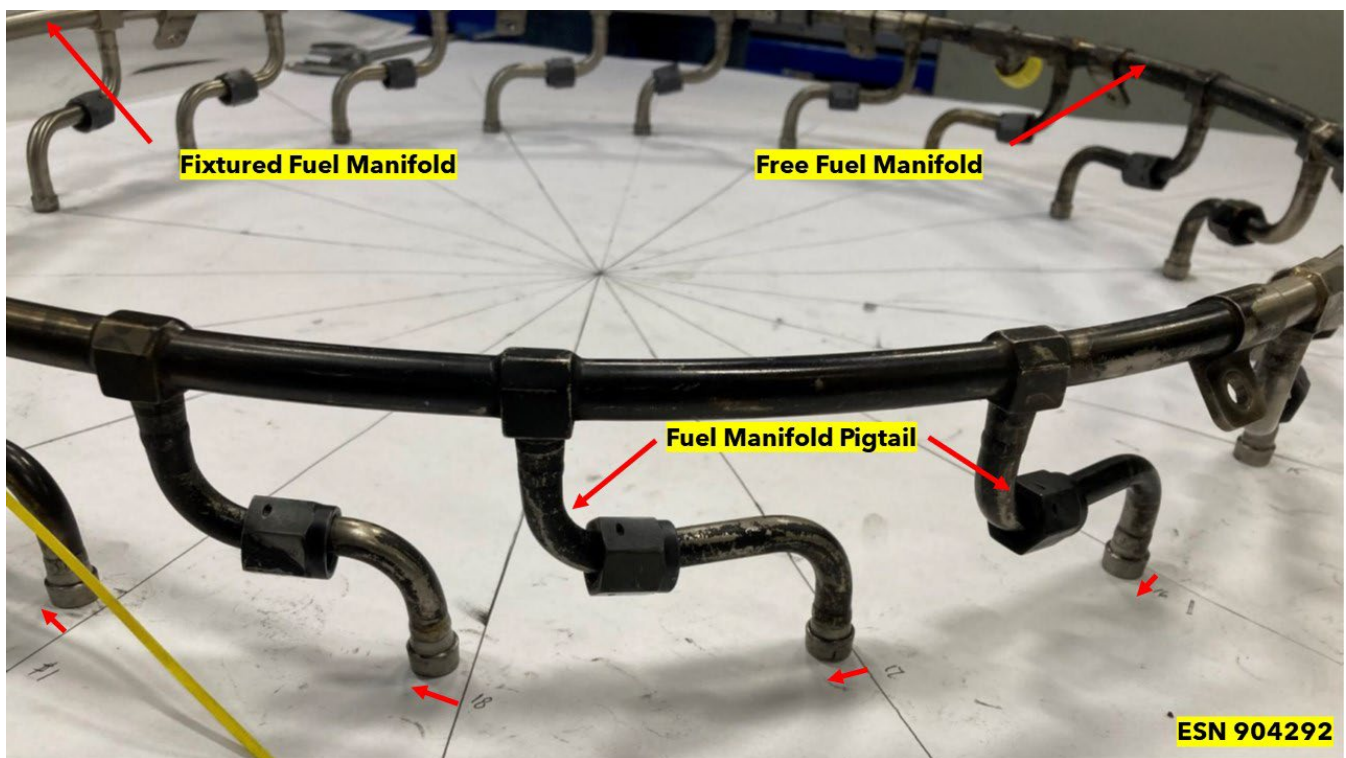
**PHOTO 31: SEMI-FREE STATE MISALIGNMENT ON ESN 904292 FUEL MANIFOLD**

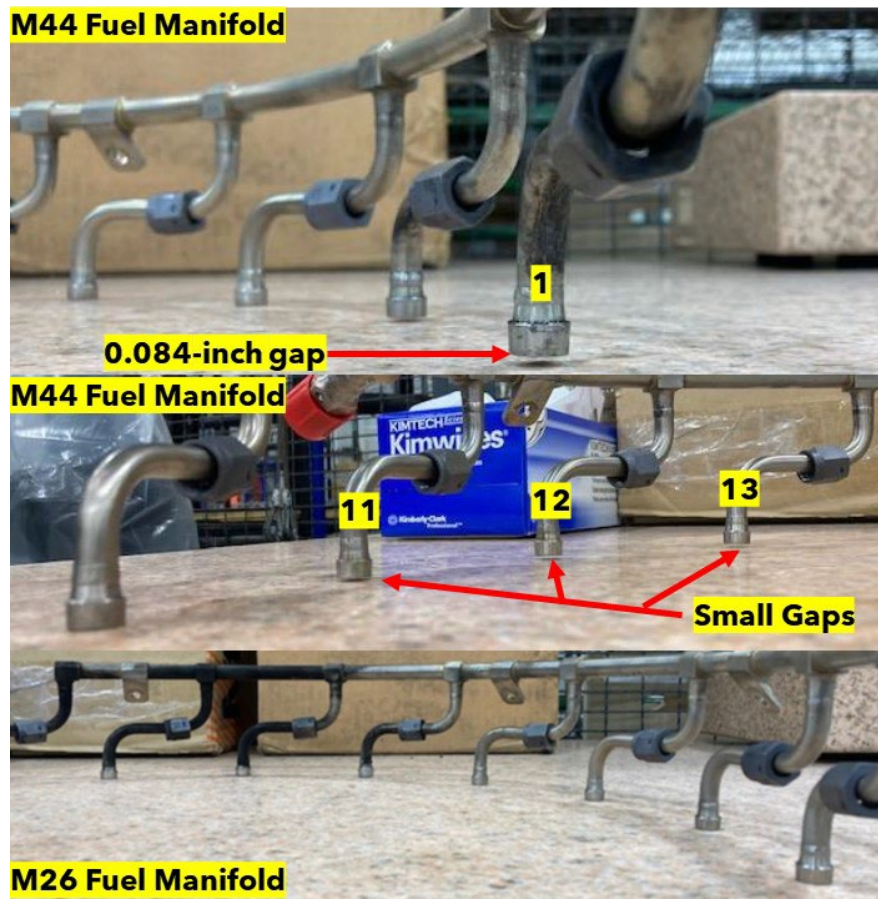
The fuel manifolds from ESN 904238 showed an additional alignment contributor; some of the fuel manifold pigtails were not flush with the table and were vertically displaced some amount when viewed on the gage table (**PHOTO 32**)<sup>20</sup>. All the vertically displaced pigtails were on the M44 fuel manifold; none of the pigtails on the M26 fuel manifold showed this same anomaly. FN No. 1 pigtail was visibly and dimensionally shorter than the adjacent pigtails (**PHOTO 32**, top picture).

**PHOTO 32: PIGTAILS ON ESN 904238 NOT FLUSH WITH TABLE**
