ENG23LA031

Metallurgical Evaluation of LEAP-1B Fuel Nozzles, Fuel Manifold, and Fireproof Plate

# Metallurgical Investigation Report DRB AvEng-548136

## METALLURGICAL EVALUATION OF LEAP-1B FUEL NOZZLES

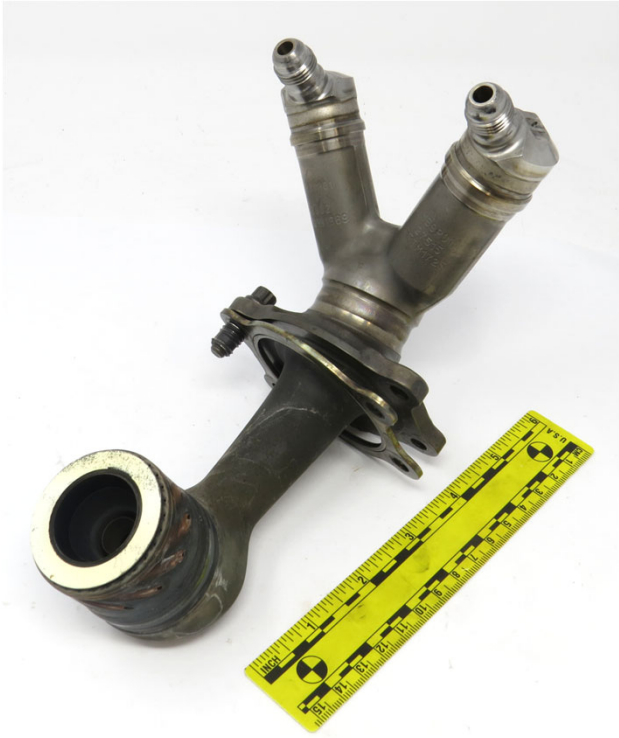
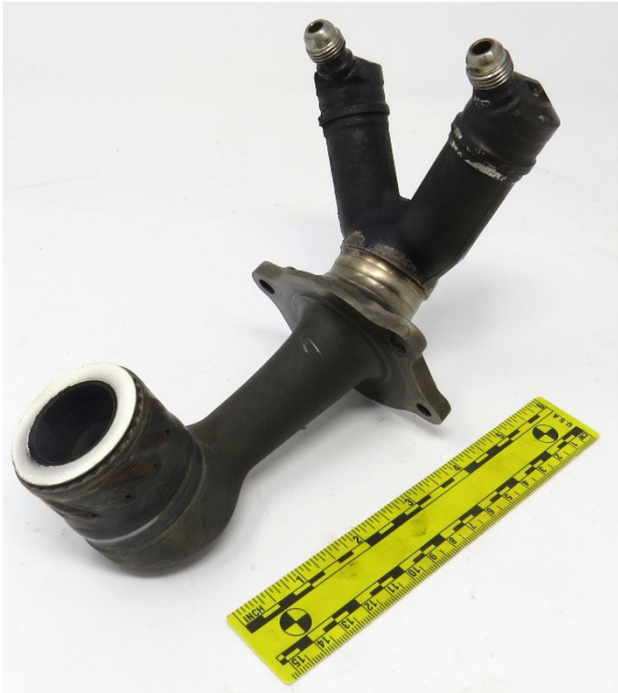
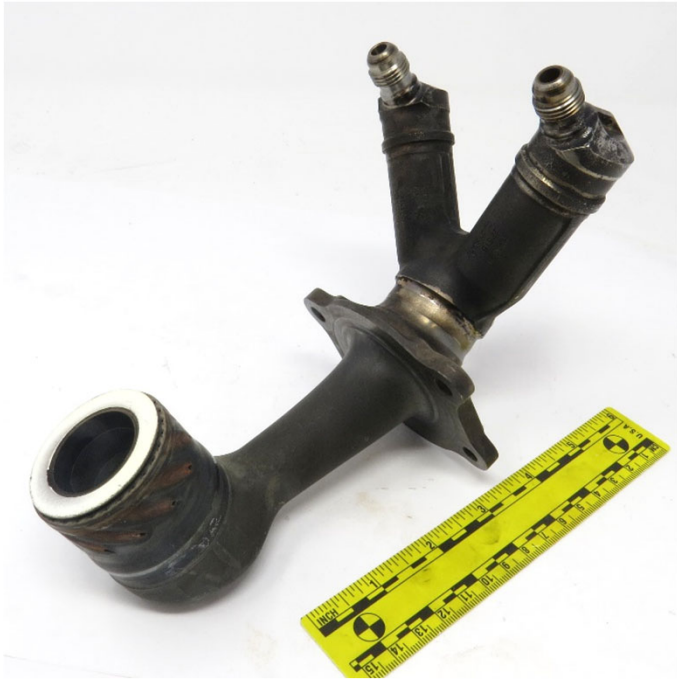
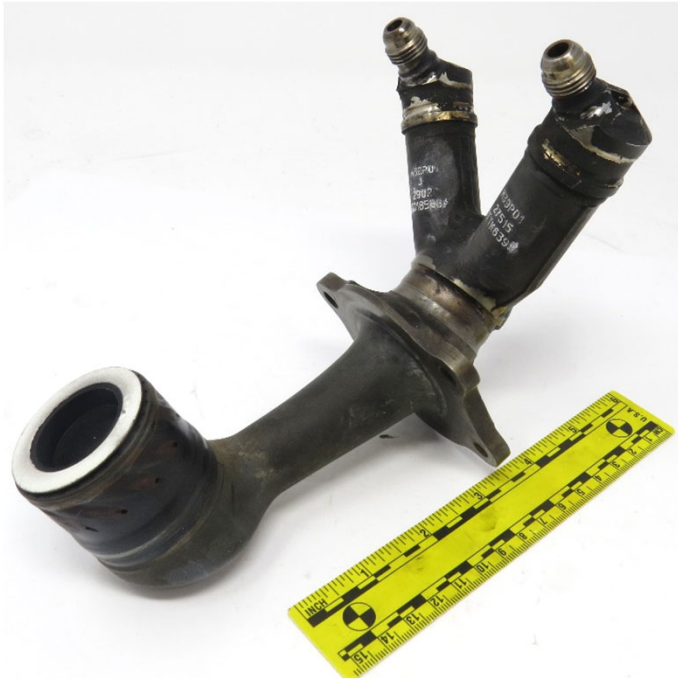
**Figure 1:** Overall images of four fuel nozzles.

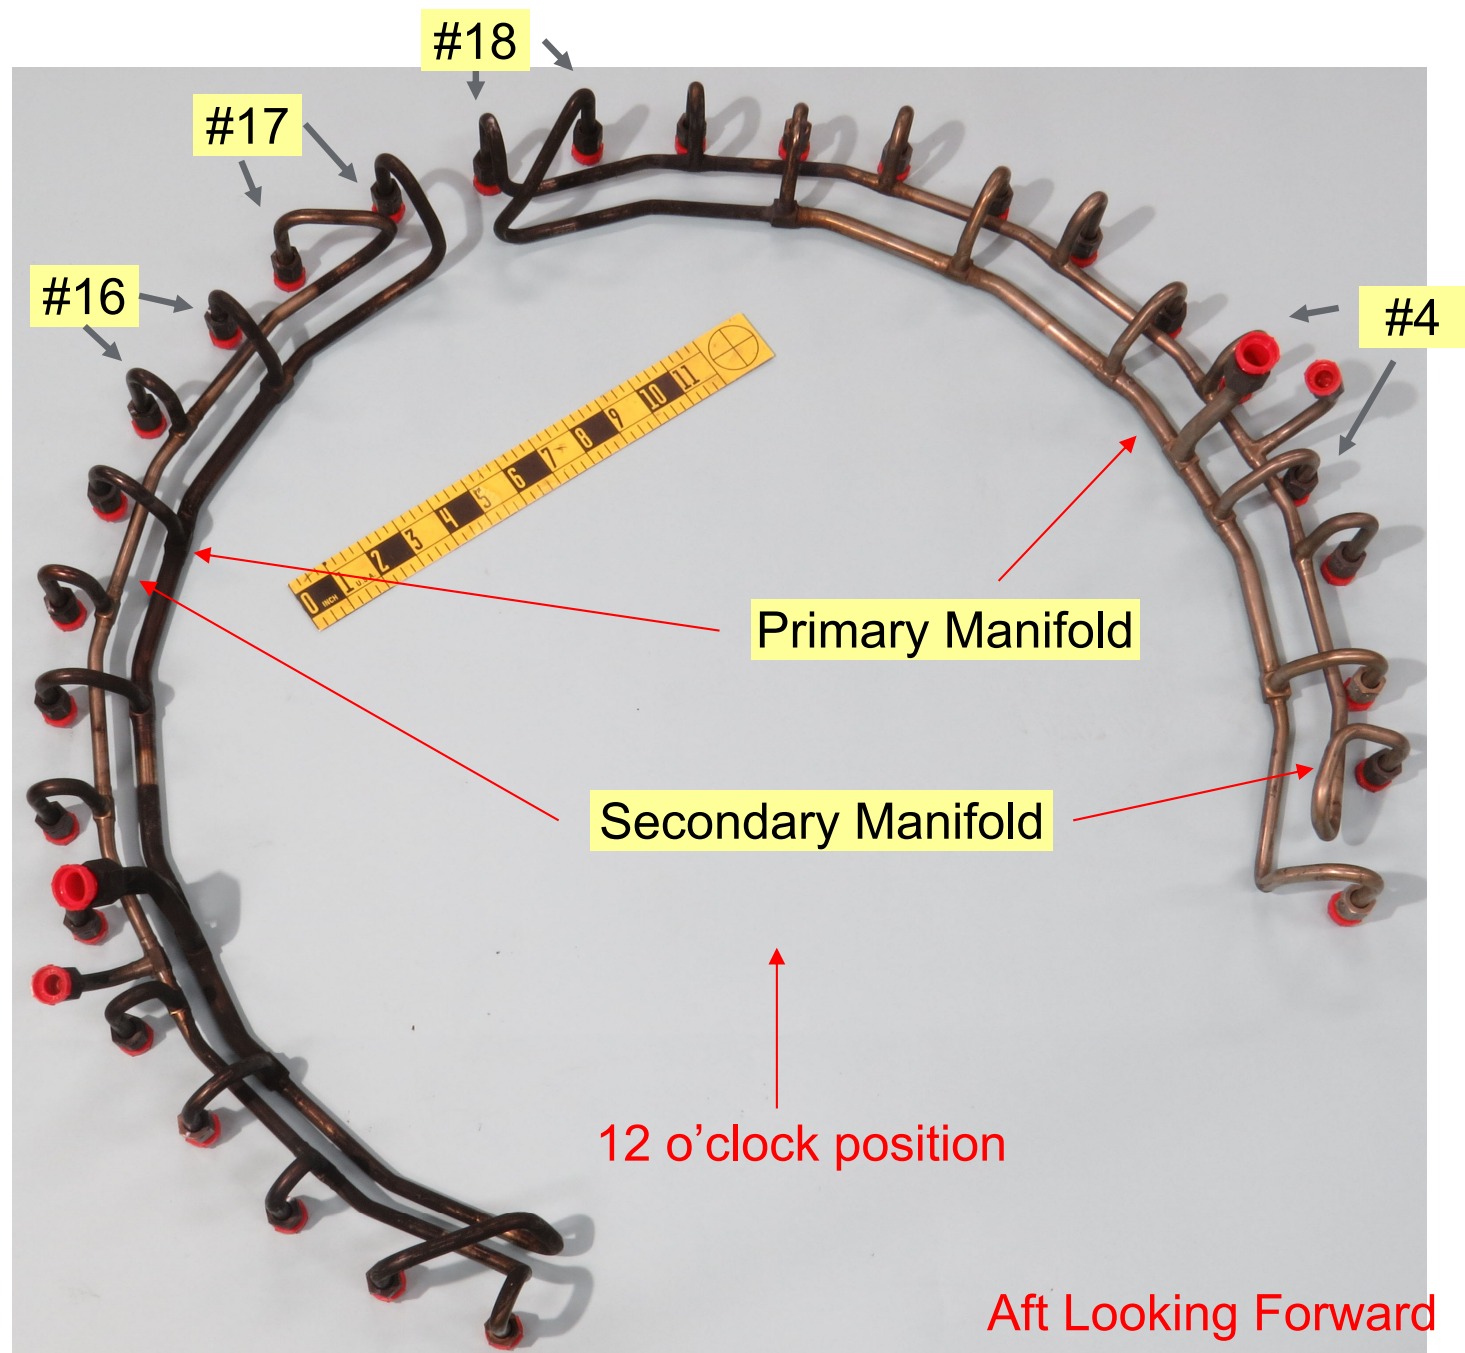
**Figure 2:** Overall images of fuel manifolds.

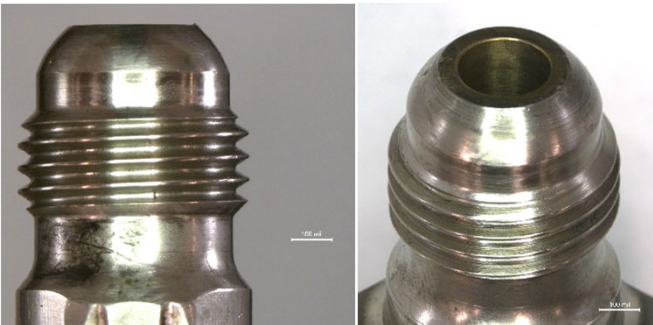
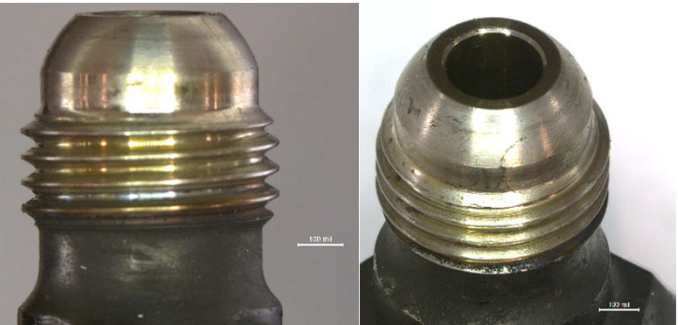
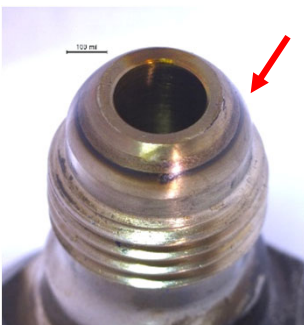
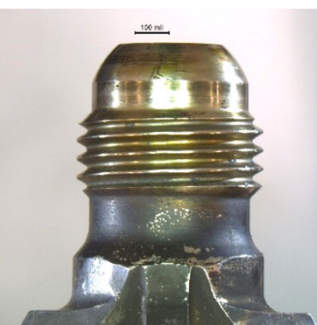
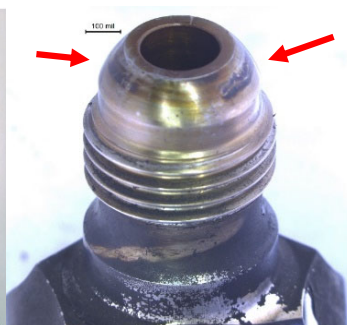
- Coking was observed around the mating surface of the secondary inlet of fuel nozzles #17 and #18.
- FTIR was performed for the varnish on the 12 o'clock bifurcation heat shield. The varnish was a 40% match for coke but did not match well to other signatures in the GE library.

**Figure 3:** Well-defined coking only present around nozzles in fire with zero break-away torque (secondary on nozzle 17 and 18, indicated by red arrows). All nozzles in fire show discoloration (yellowing) at threads and coking about nozzle.

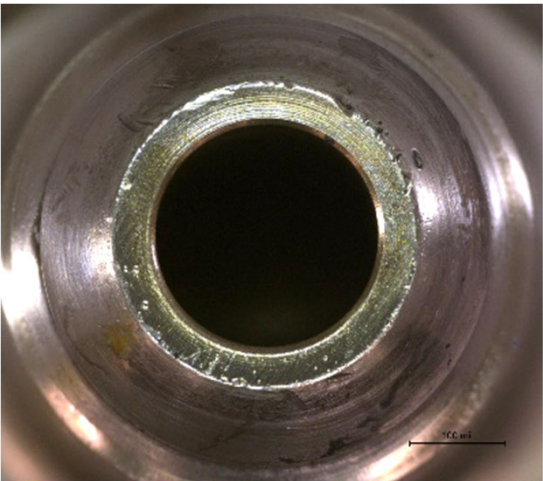
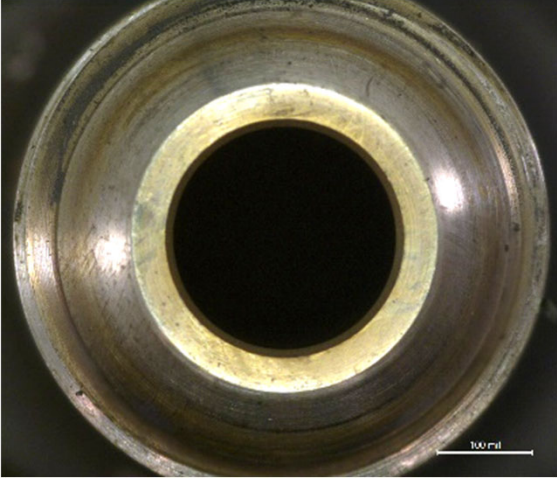
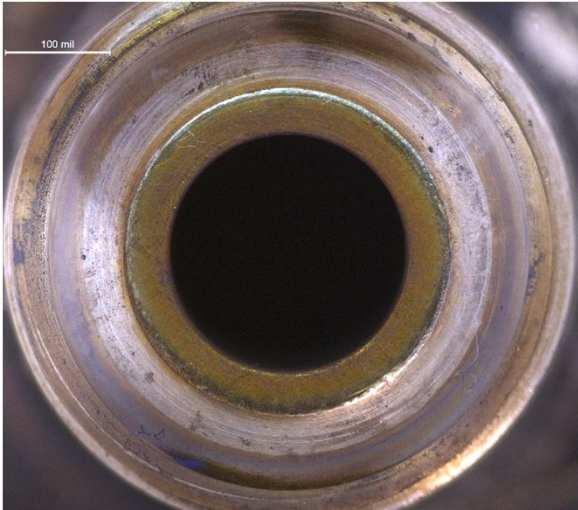
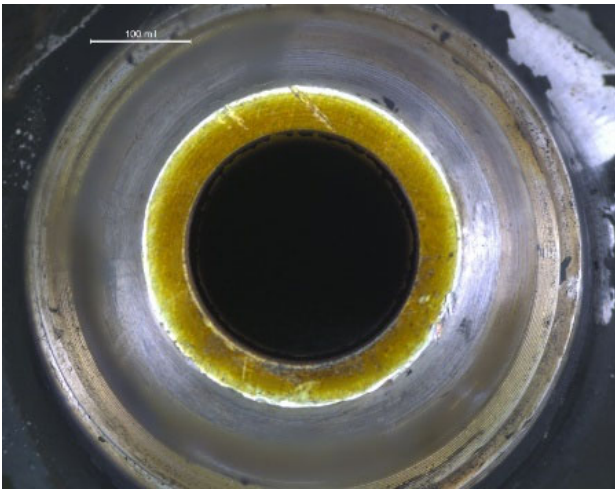
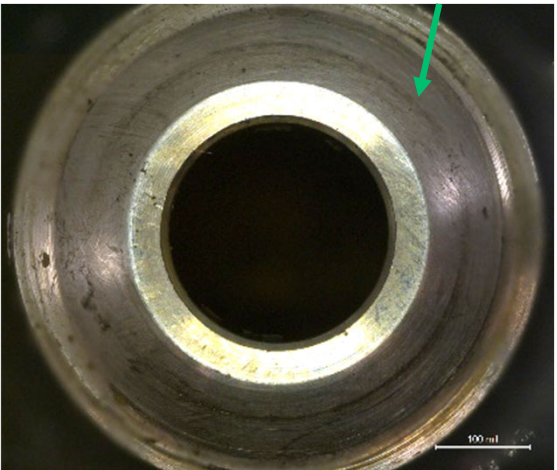
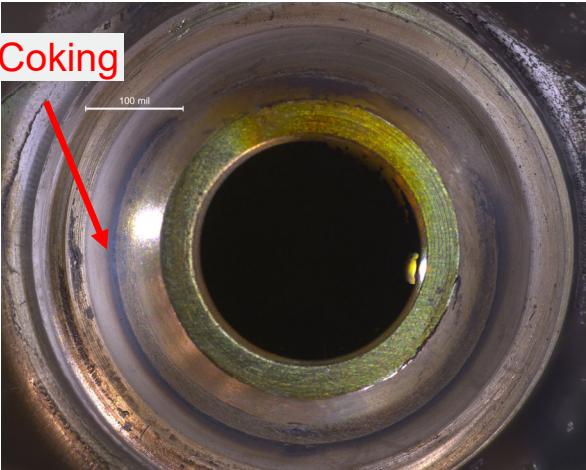
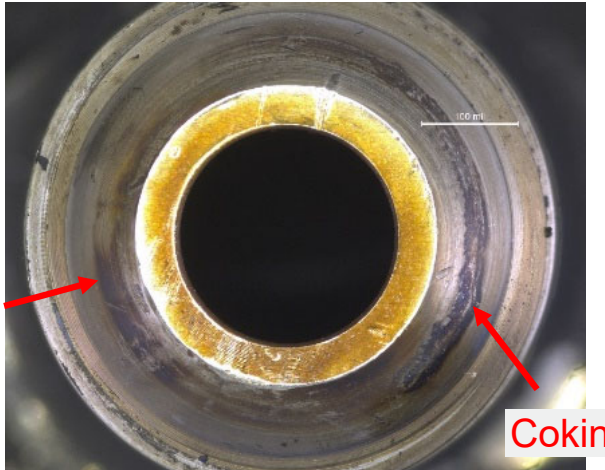
**Figure 4:** Images show top-down view of mating surfaces of the fuel nozzles, as well as coking present around the secondary mating surface of nozzles #17 and #18. No wear was noted about the mating surface of the fuel nozzles.

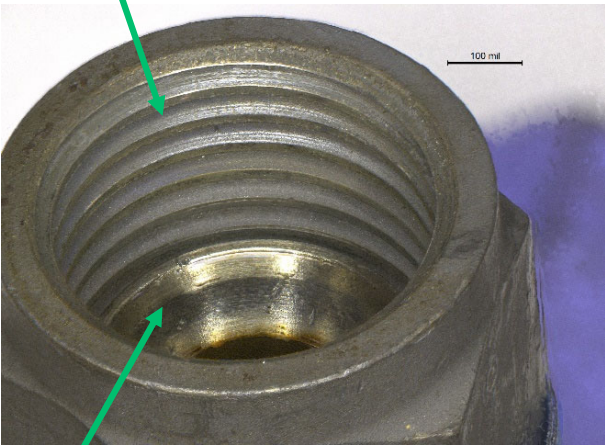
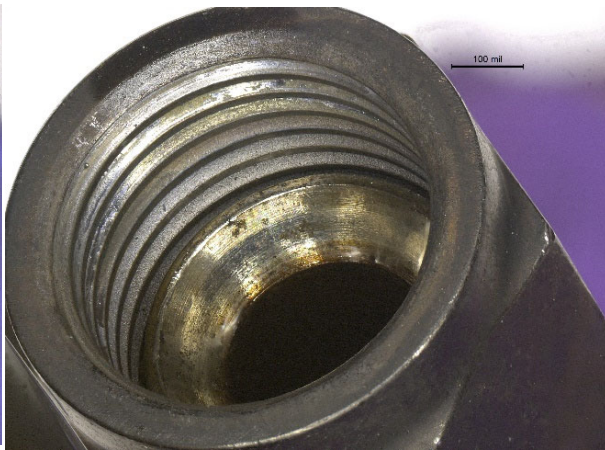
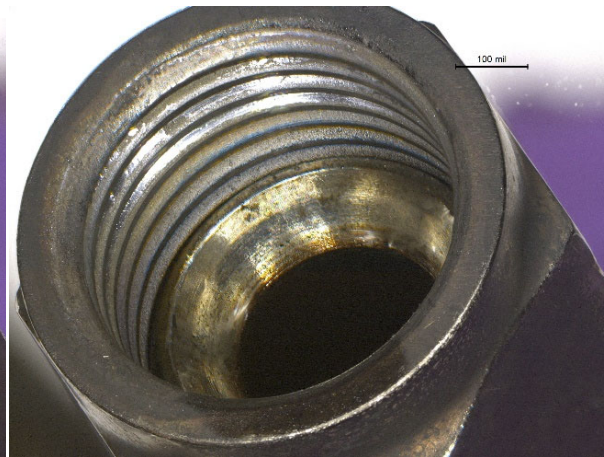
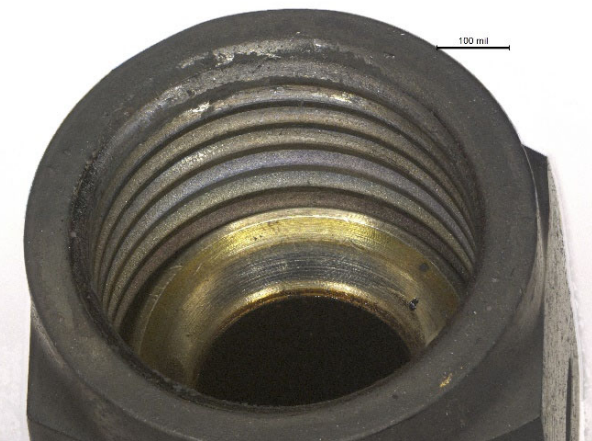
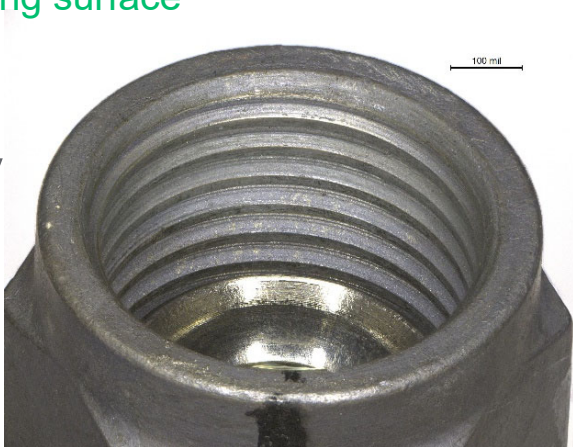
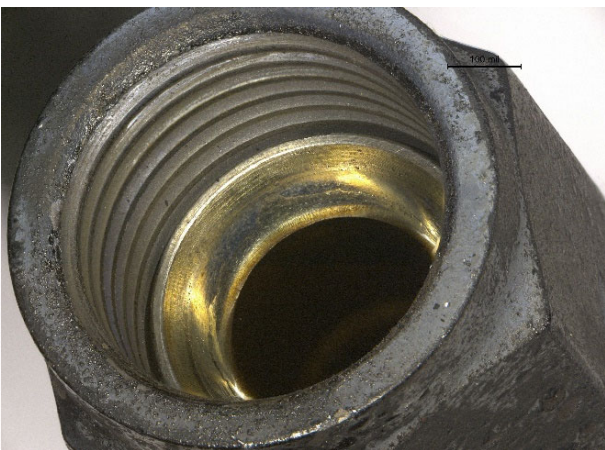
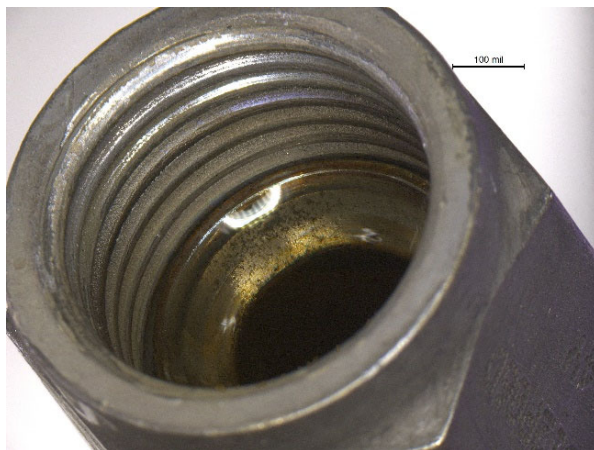
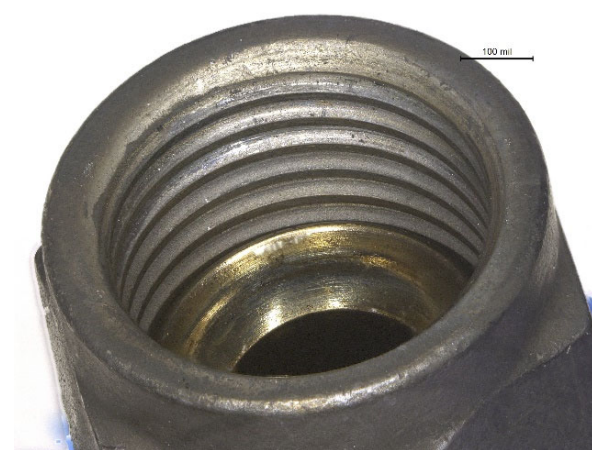
**Figure 5:** The fuel manifold b-nuts were inspected for damage that would result in a lack of sealing. Macrographs show no indication of cross-threading. No evidence of wear (scratching, bench marks) was noted about the mating surface of the fuel manifold ferrules.

Minor wear, no damage to threads

No wear observed on ferrule mating surface

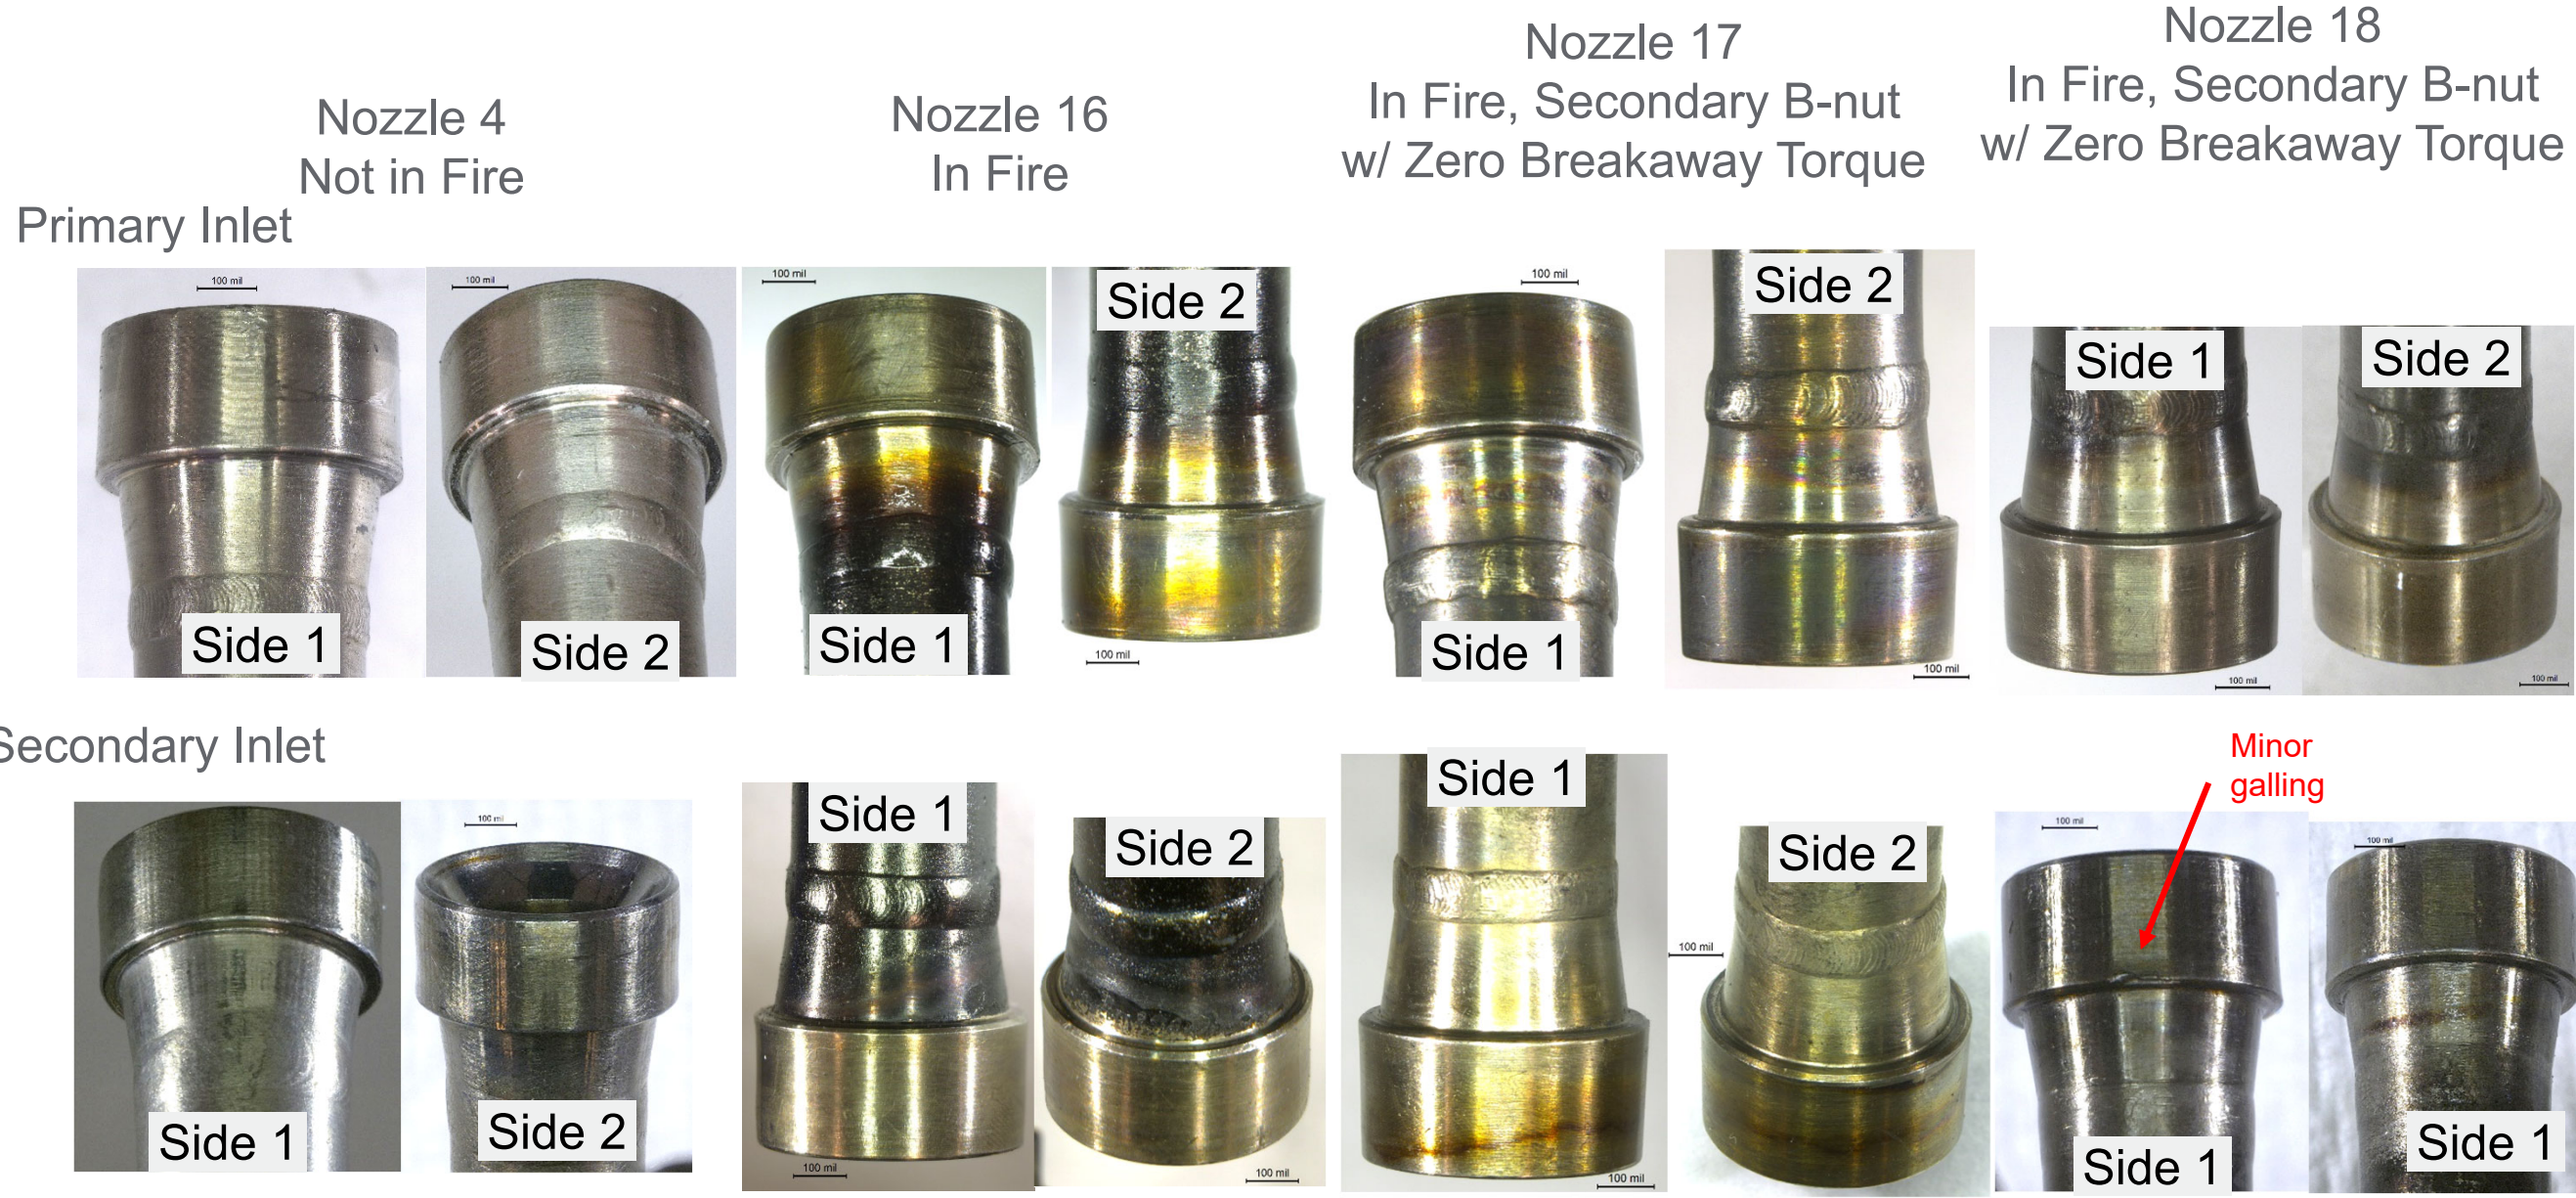
**Figure 6:** The fuel manifold ferrules were inspected for damage that would result in a lack of sealing. Macrographs show no indication of galling, cracking, or mechanical deformation present at fuel manifold ferrules.

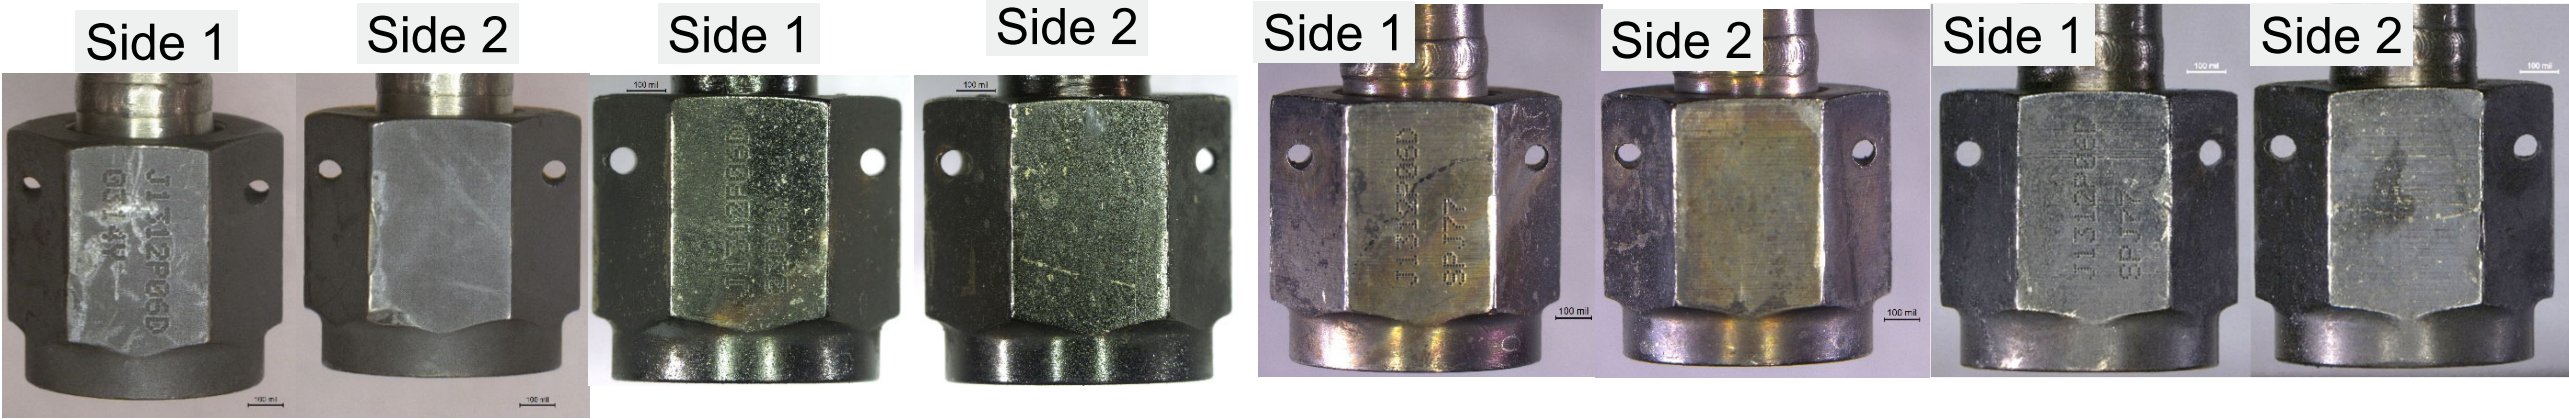
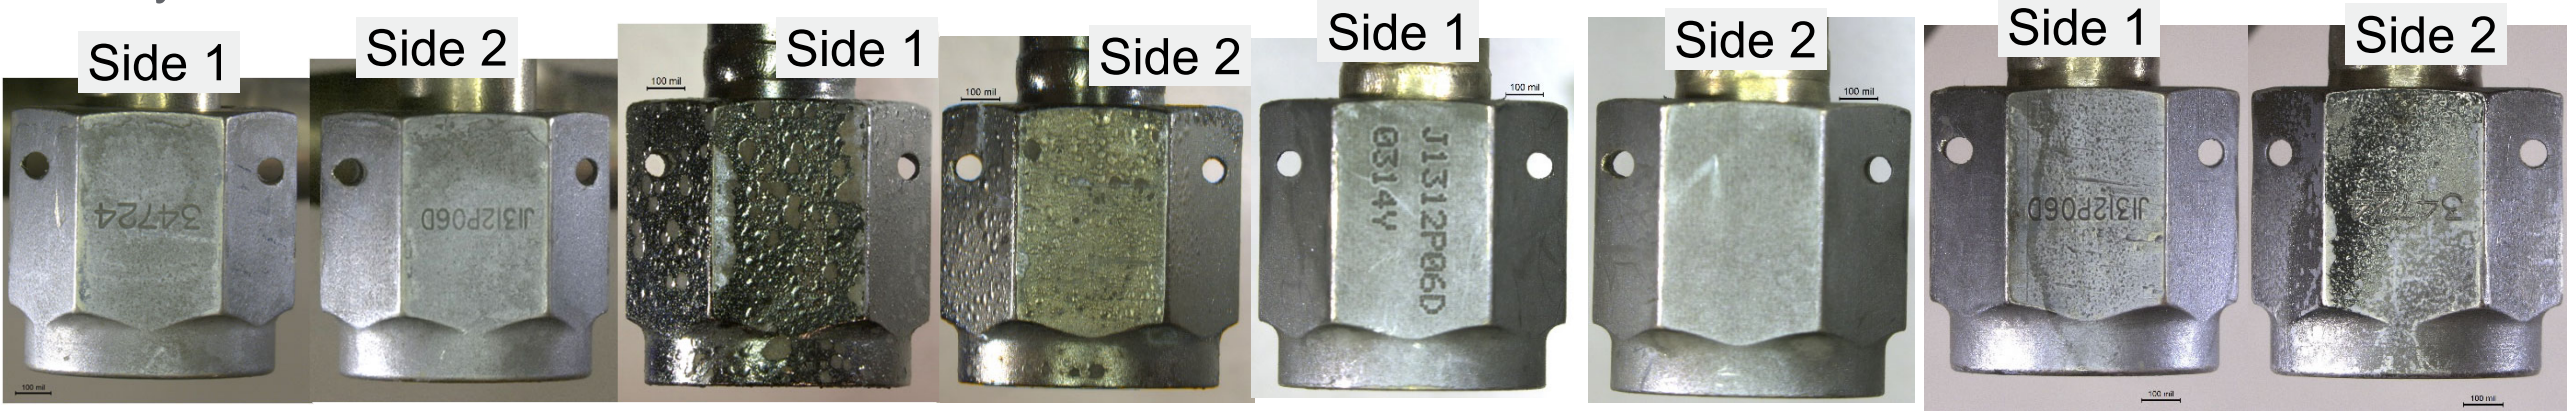
**Figure 7:** The fuel manifold b-nuts were inspected for damage that would result in a lack of sealing. Macrographs show no indication of mechanical deformation present on the fuel manifold b-nut surfaces.

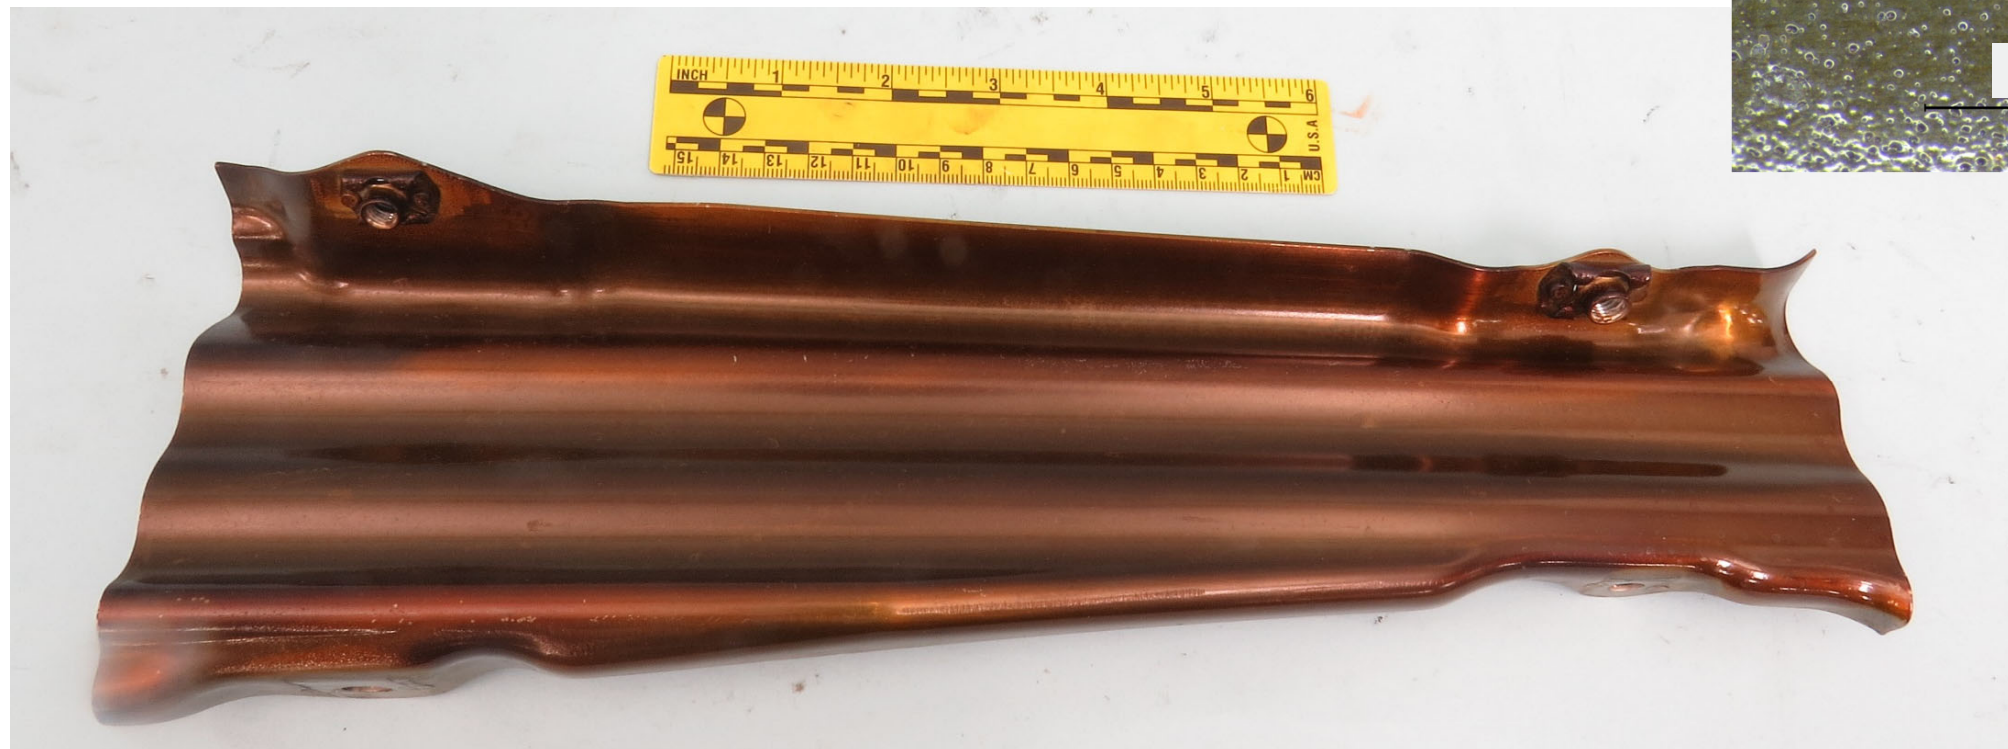
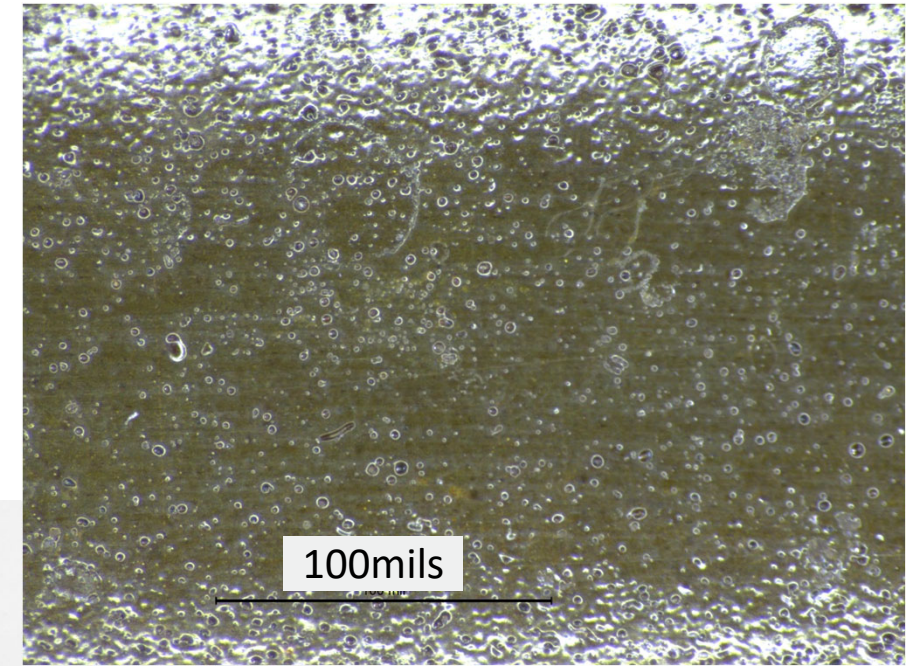
**Figure 8:** Overall image of 12 o'clock position bifurcation heat shield, and a close-up image of varnishing on the surface.

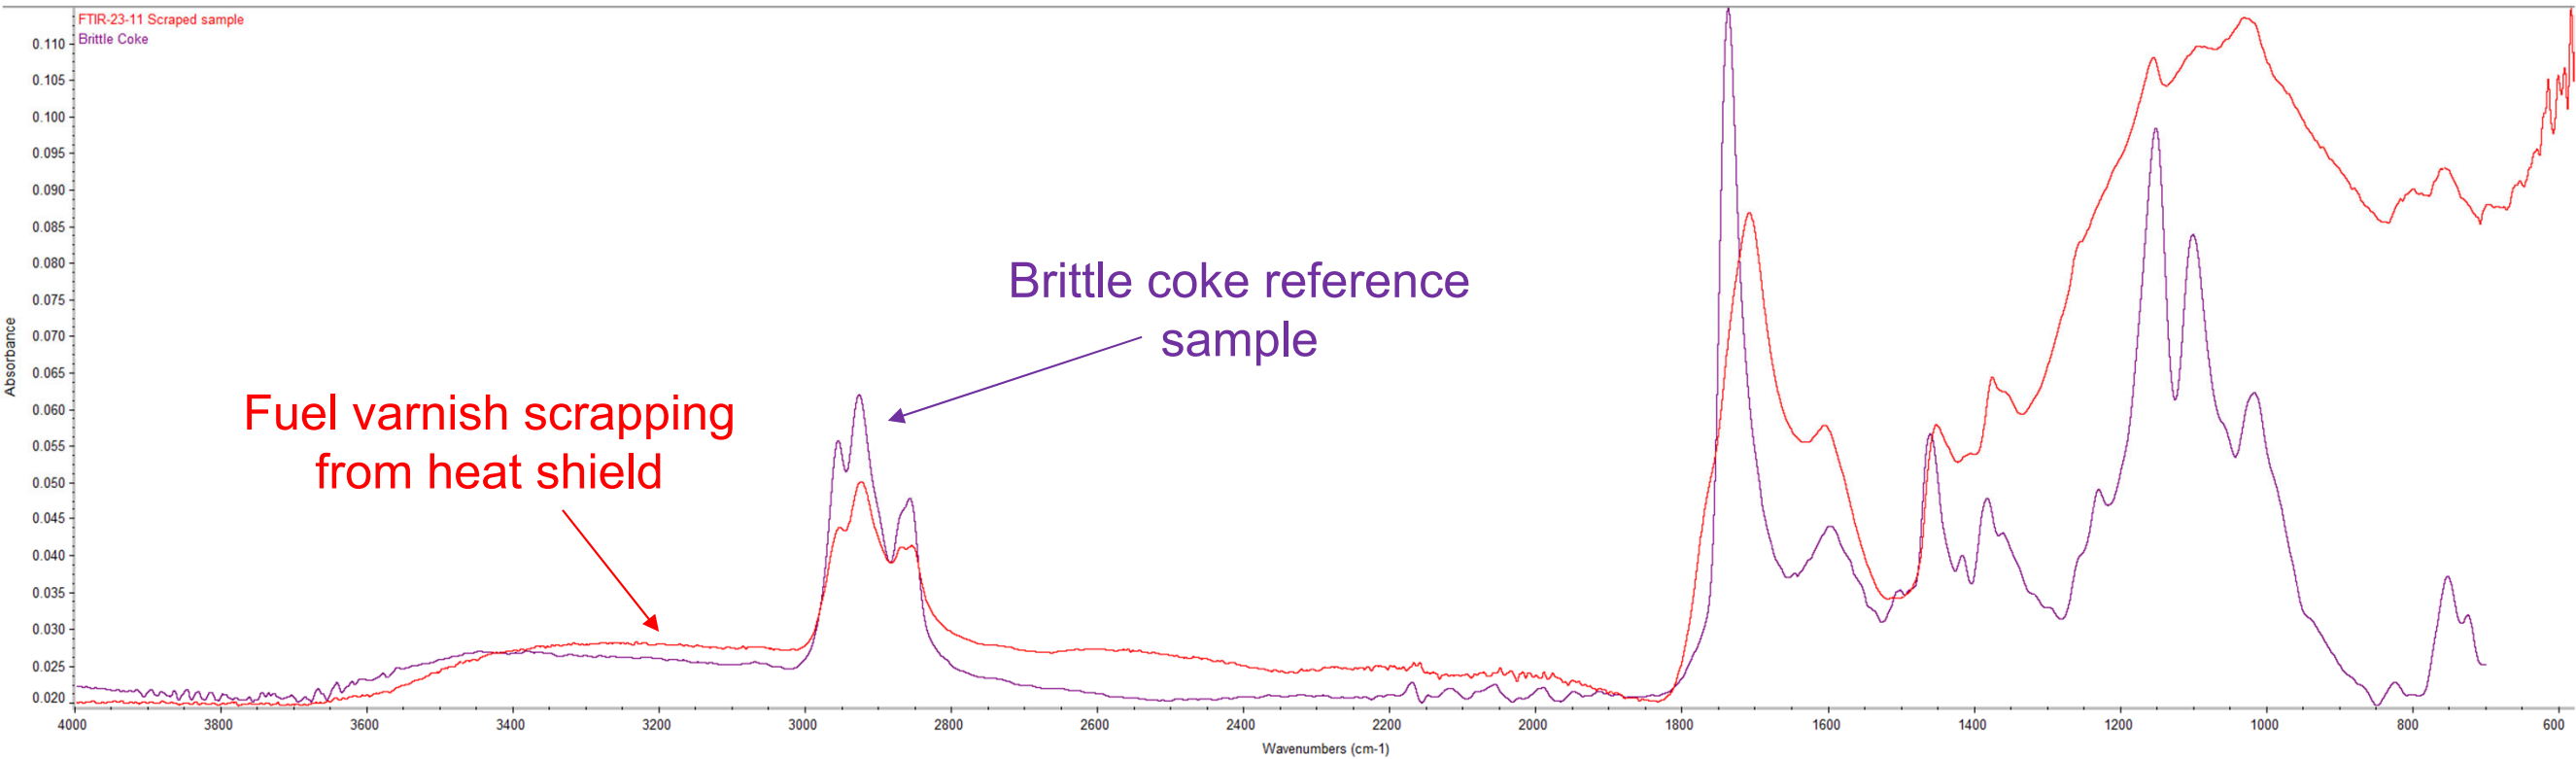
**Figure 9:** The FTIR spectrum (absorbance v. wavelength) indicates coke is present on heat shield. No additional matches could be made to materials in the GE FTIR library.

The scraping showed a 40.40% match to a brittle coke sample.

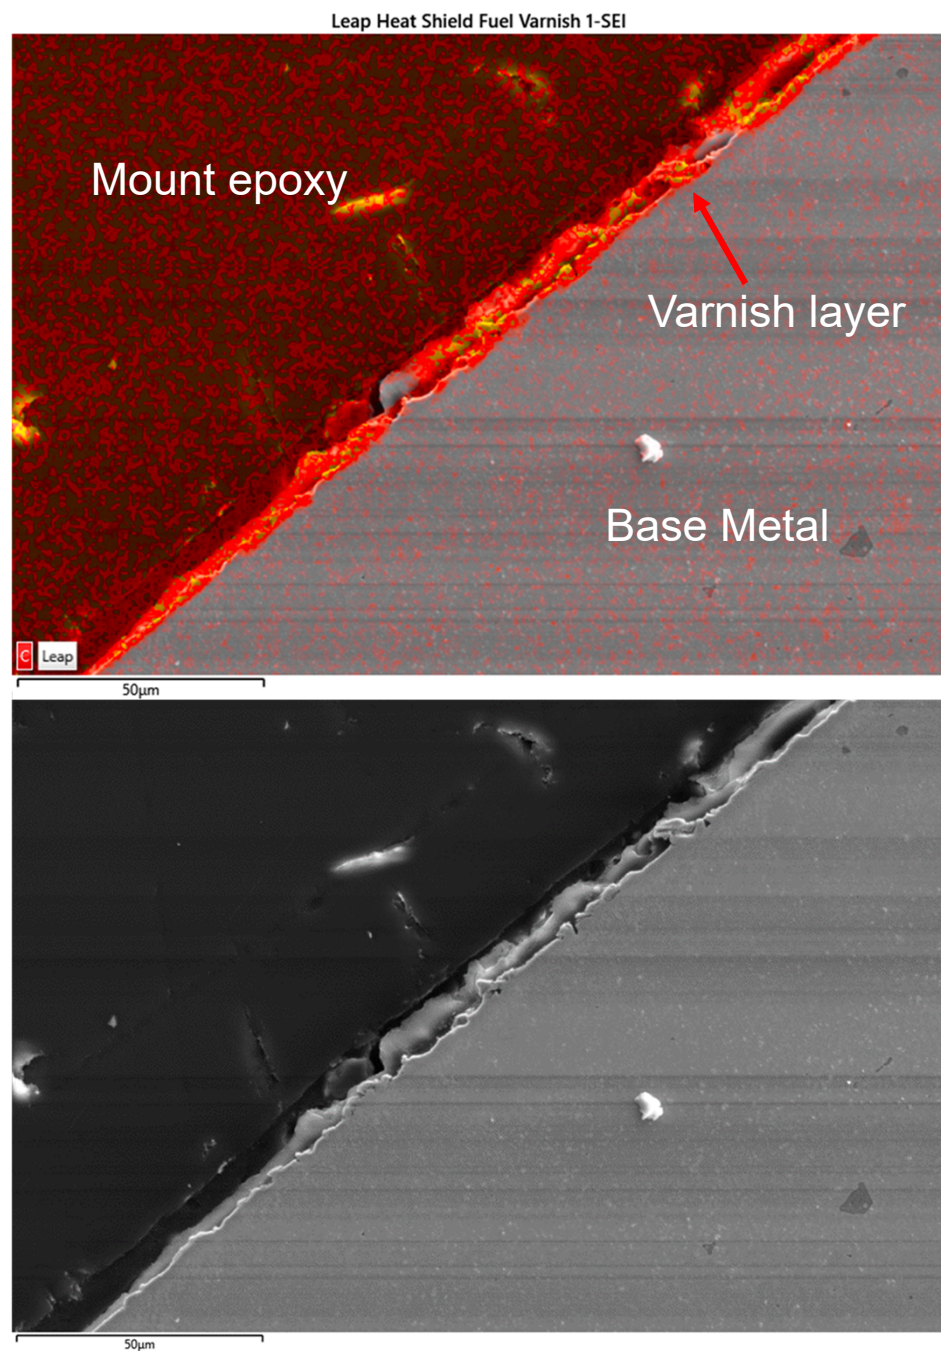
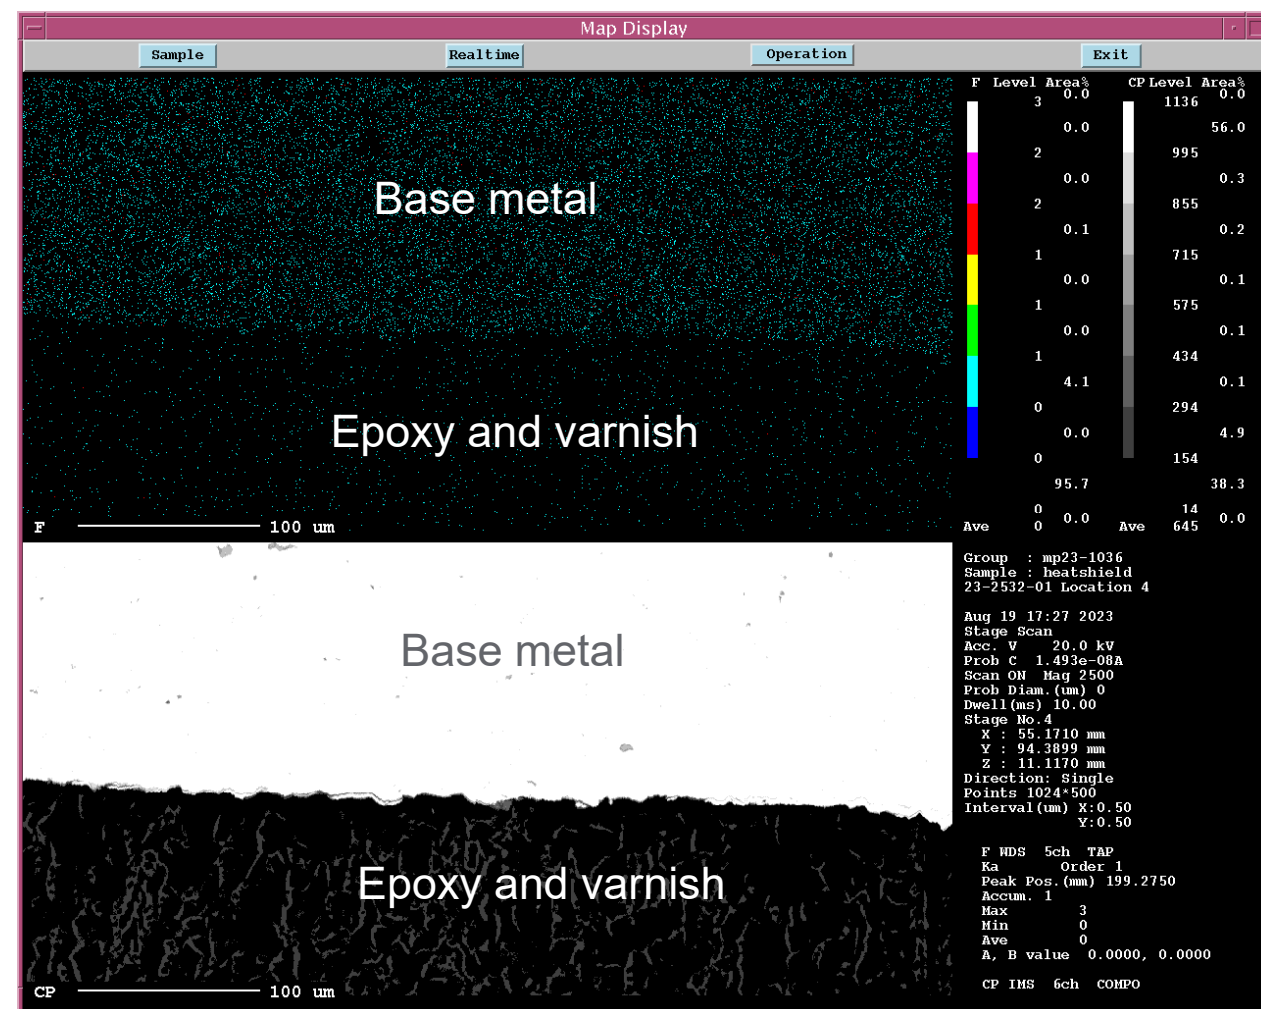
- A microprobe evaluation of the varnish did not show high fluorine levels as would be expected if Viton was in the residue.
- Distinct layers could not be seen optically, or in the SEM, in the varnish layer.

**Figure 10:** SEM and EDS images (shown left) of the cross-section of the heat shield show a carbon-rich region where varnish is present. Layers cannot be distinctly seen. Microprobe evaluation (shown below) of the cross-section did not show high levels of fluorine, a component in Viton, in the varnish.
