ENG23LA031

Metallurgical Evaluation of LEAP-1B Fuel Nozzles, Fuel Manifold, and Fireproof Plate

# Metallurgical Investigation Report DRB AvEng-548136

## METALLURGICAL EVALUATION OF LEAP-1B FUEL NOZZLES

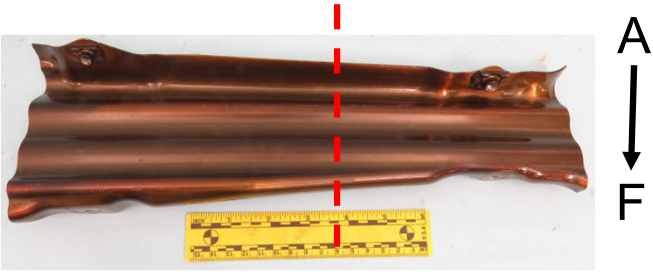
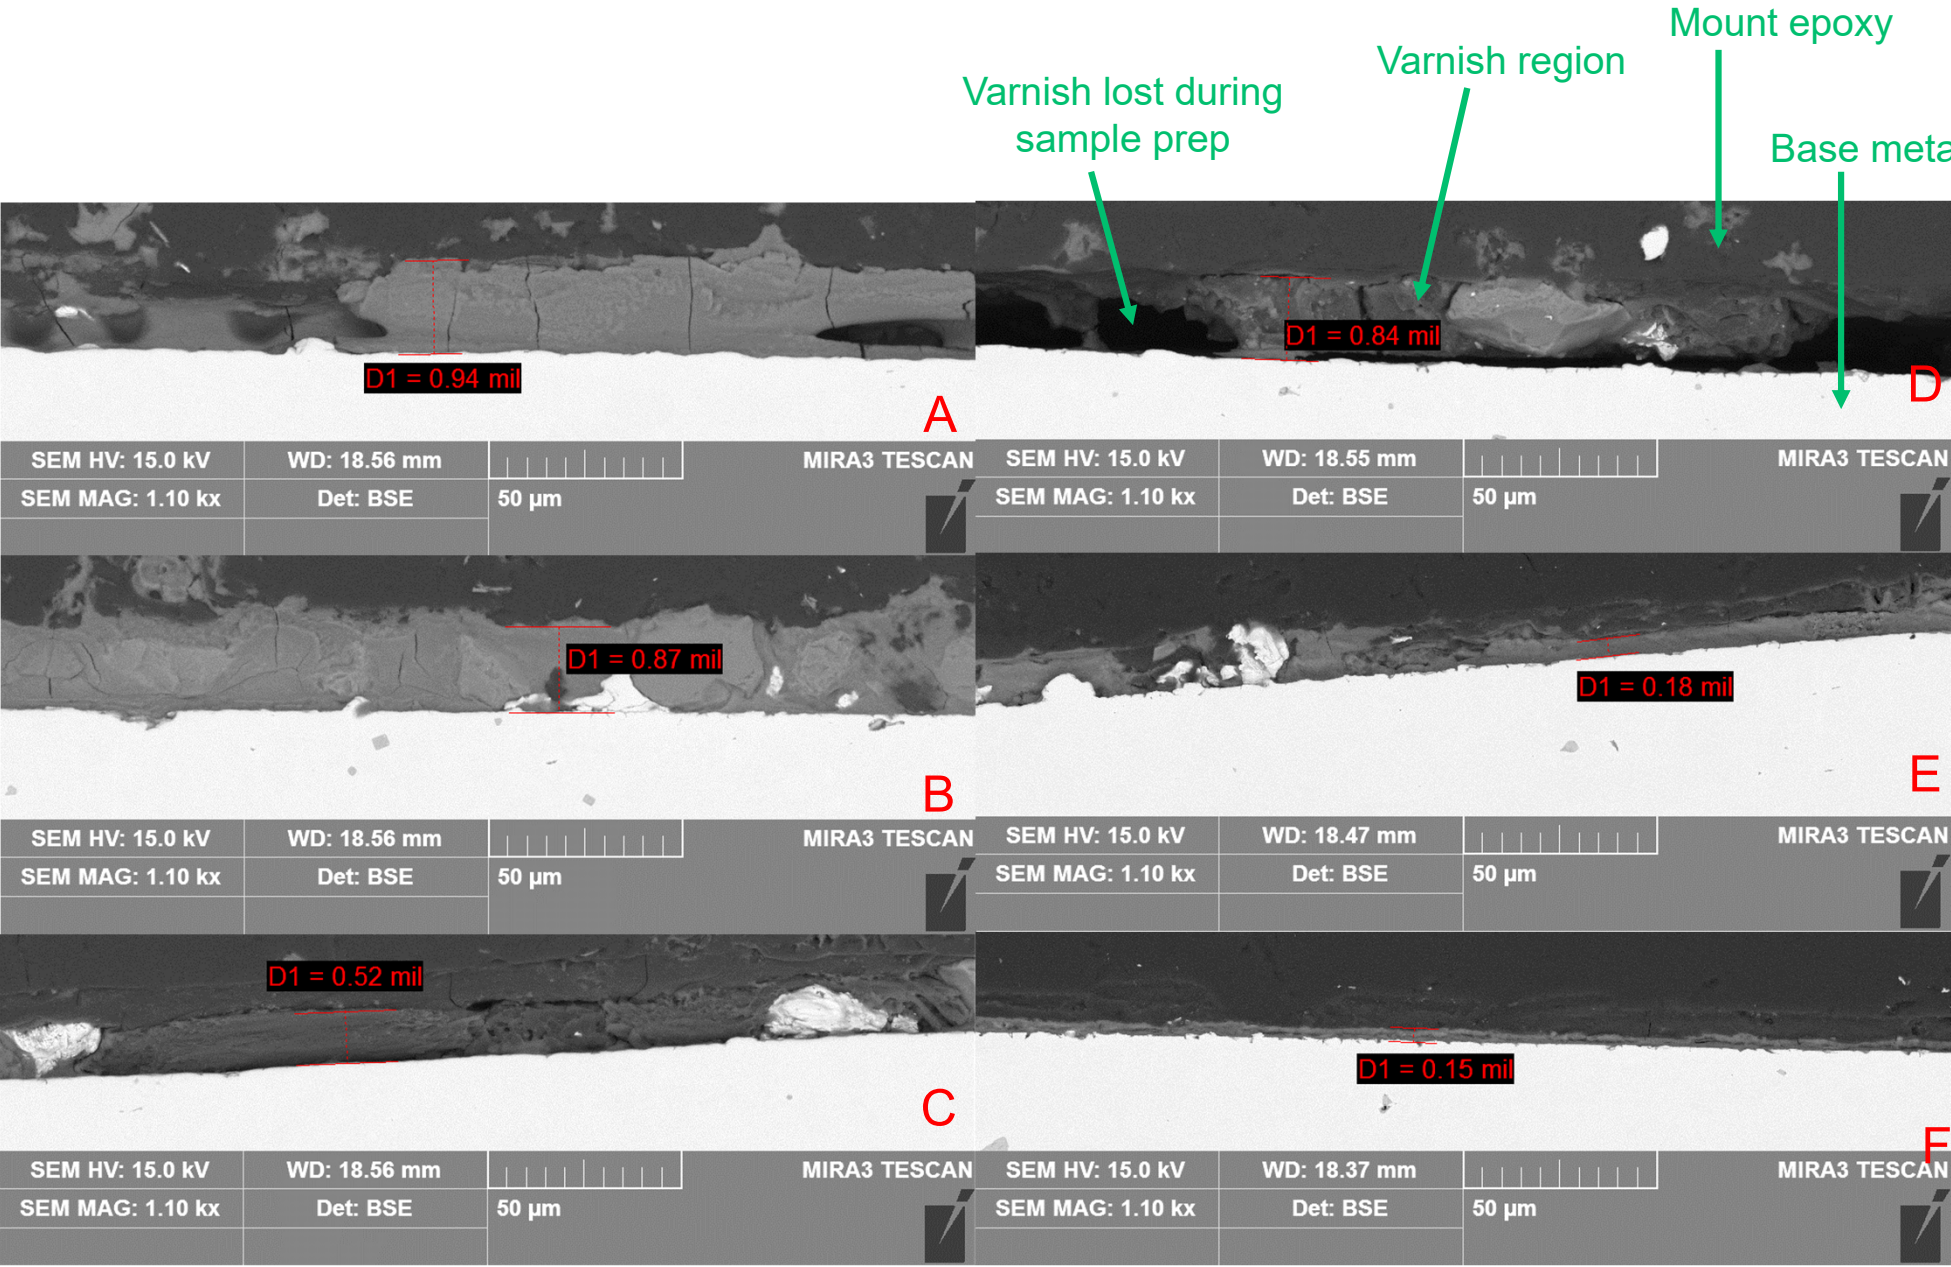
**Figure 11:** SEM images indicate varnish thickness variation, as expected based on variation in varnish color on hardware. The varnish thickness was <1mil in all areas observed.

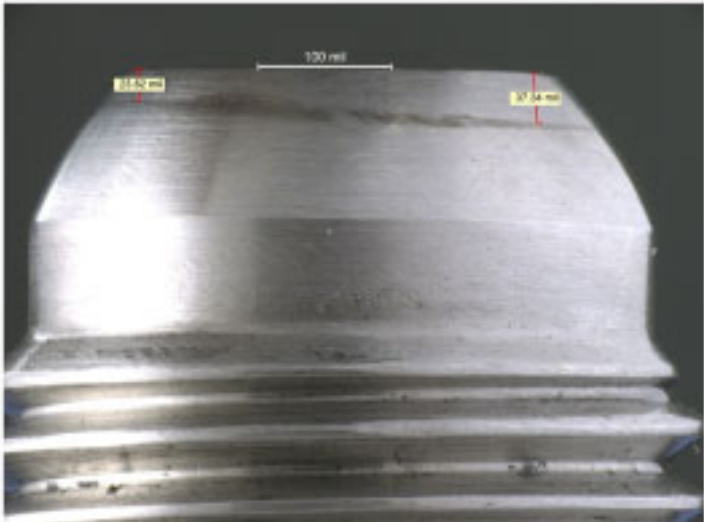
Nozzle #16

Figure 7: The bullnose from fuel nozzle #16 is shown. A witness mark from contact between the bullnose and the ferrule on the pigtail is clearly visible. From the end, the mark is slightly off center from the centerline of the hole. Viewed from the side, the witness mark is clearly at an angle. These observations are consistent with a slight misalignment of the centerlines of the nozzle and the pigtail – they are not parallel.

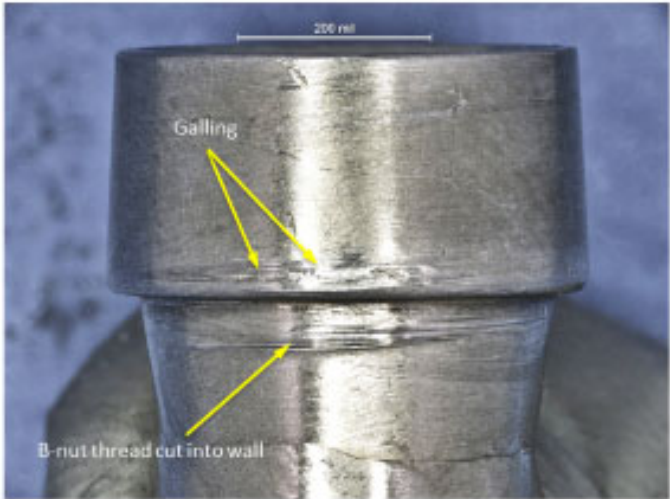
Pigtail #16

Figure 22: The OD surface of the ferrule from pigtail #16 is shown at the 6 o'clock (inboard) and 12 o'clock (outboard) locations. At the 12 o'clock position, galling from contact with the threads (on the inside) of the B-nut was noted. This is consistent with a rotational misalignment of the bullnose to the pigtail ferrule. A radial or circumferential misalignment could also cause the B-nut threads to contact the ferrule. (The centerlines of the parts are not concentric and parallel.)

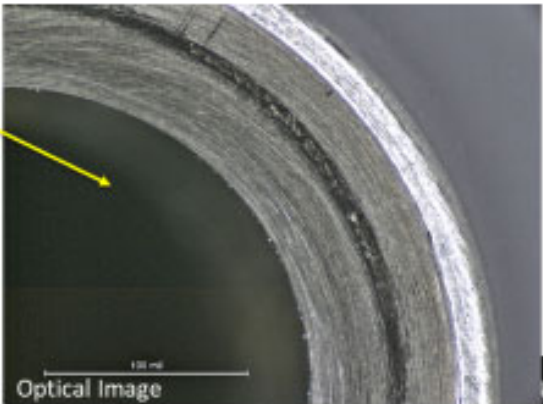
Pigtail #16

Figure 15: On the ferrule sealing surface of pigtail #16, some surface distress was noted. This is shown here and in the following figures. The location was within the witness mark on the ferrule surface and appeared to be galling with metal loss.

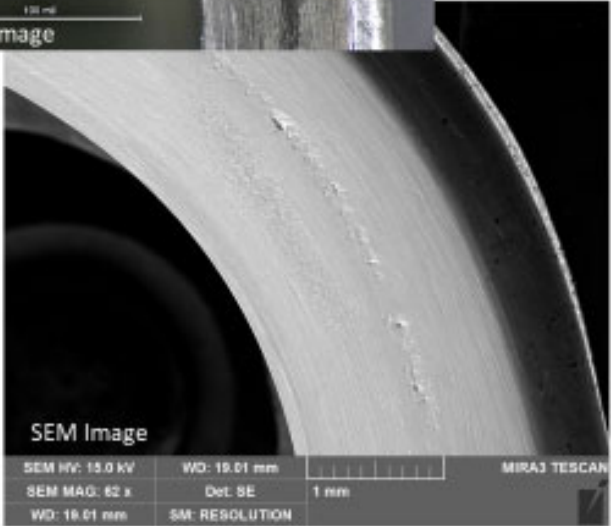
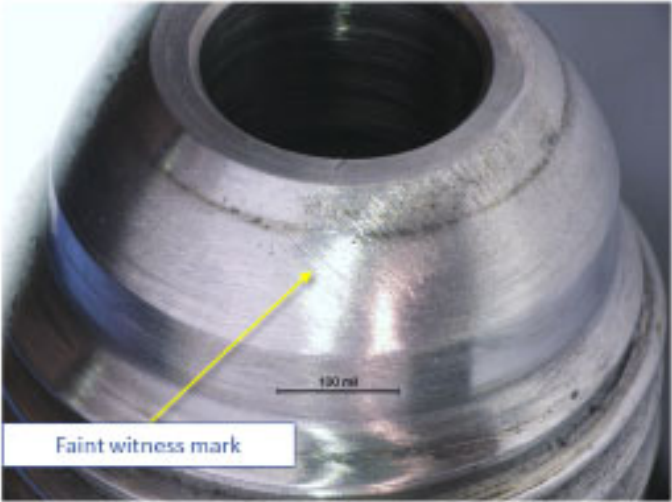
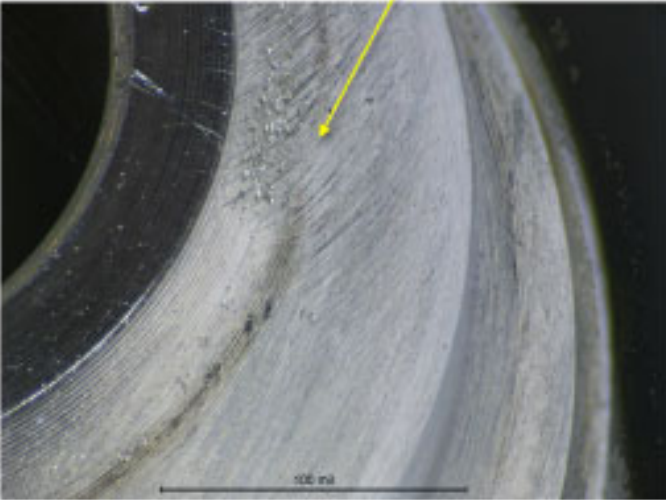
Nozzle #18

Figure 11: At the location where the witness mark (from sealing against the ferrule), scratches were noted that are consistent with benching. This is shown at higher magnification in the following figure.

- Faint/missing witness mark.
- Benching marks (scratches) visible

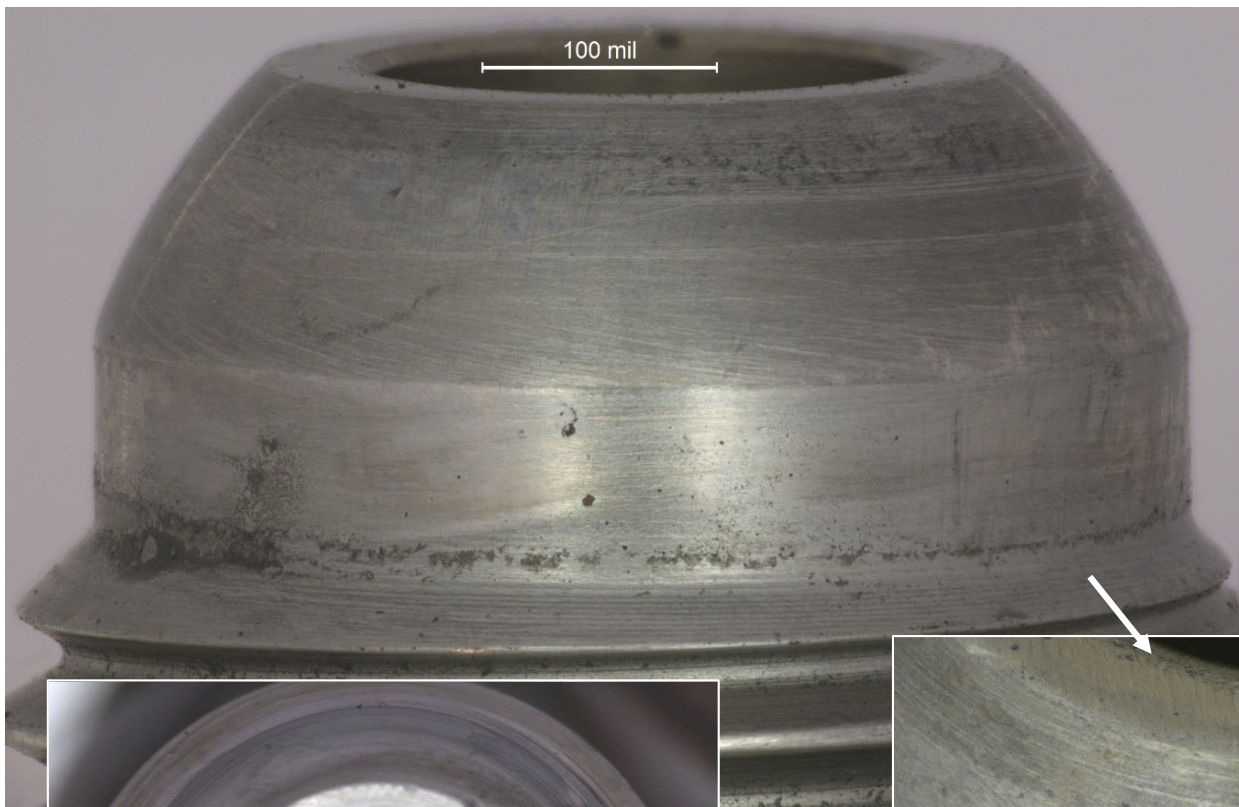
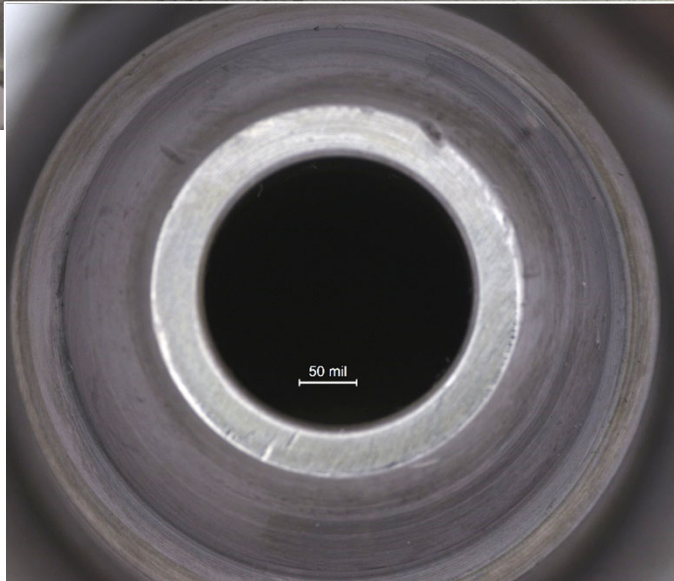
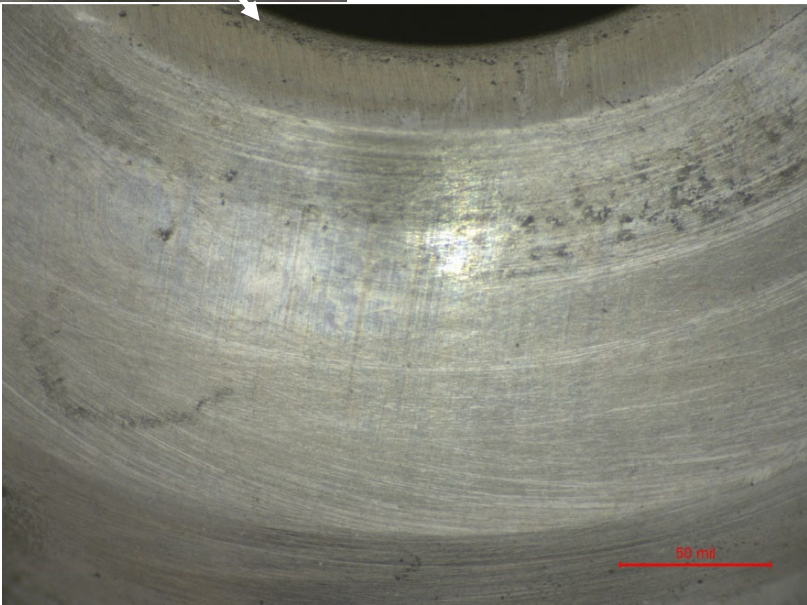
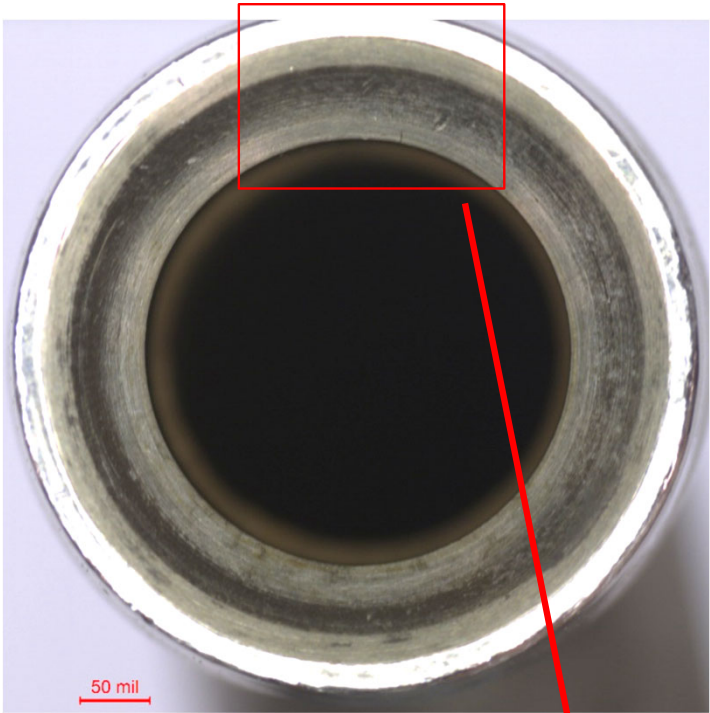
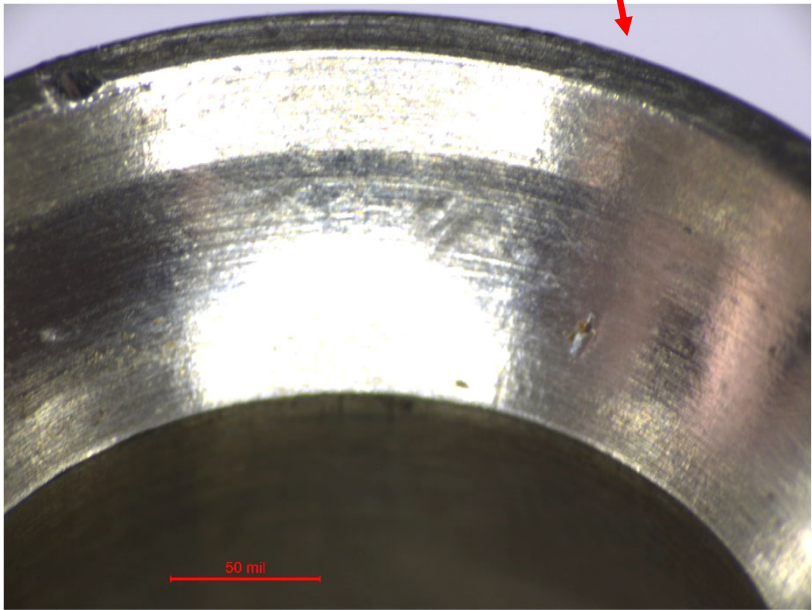
Nozzle 4, Primary Fuel Nozzle

**Figure 12:** Markings on bullnose of fuel nozzle are centered about the nozzle, inconsistent with the other GE commercial engine investigation (AvEng-536107 and AvEng-536108).

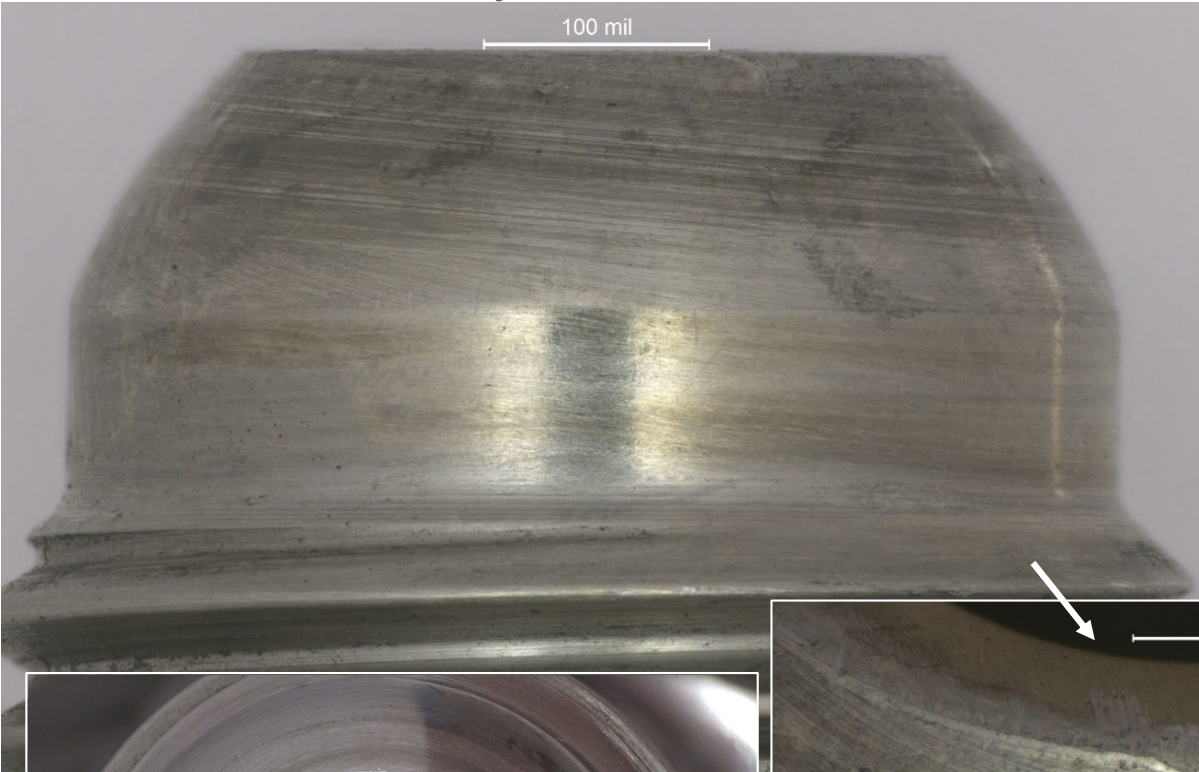
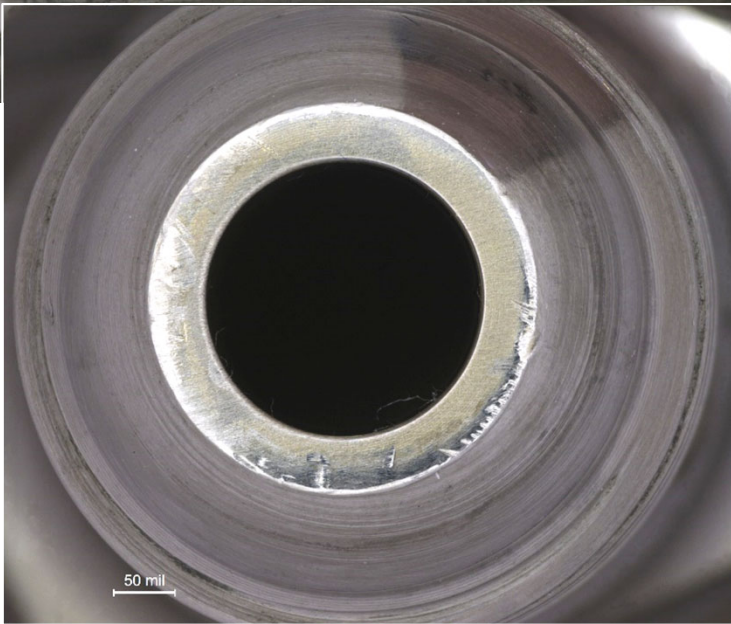
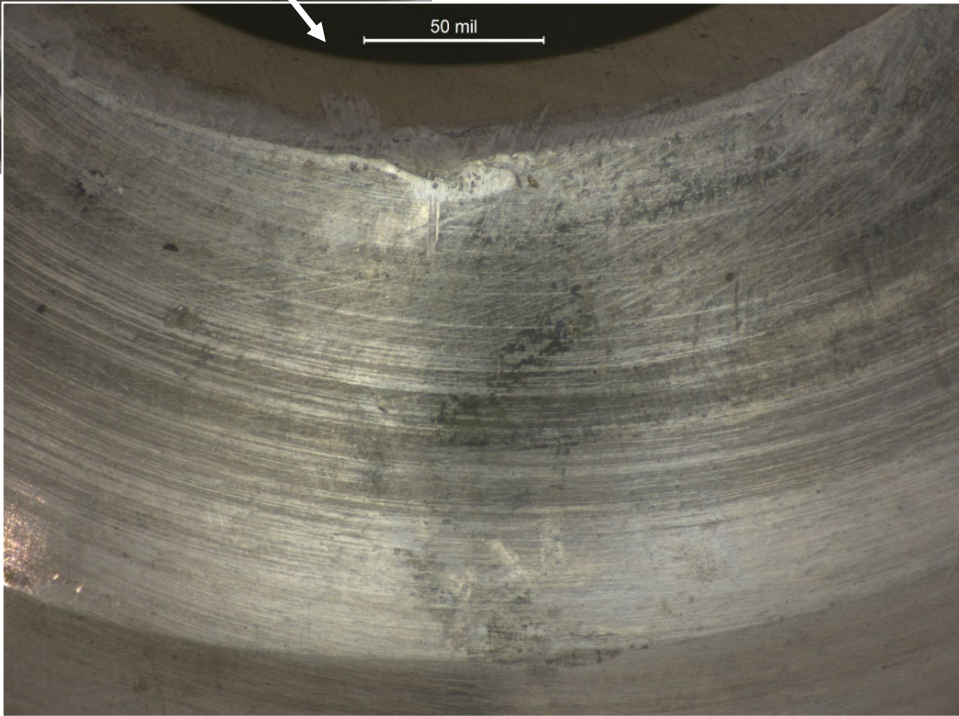
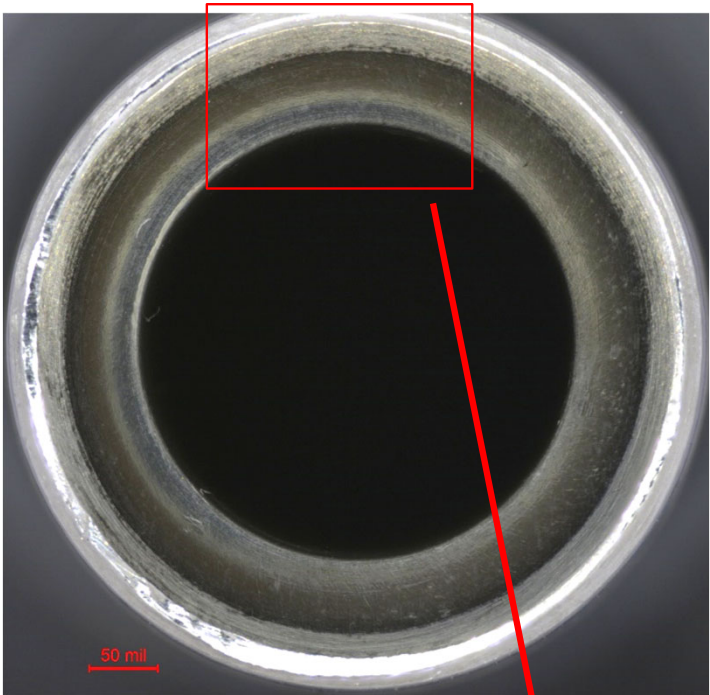
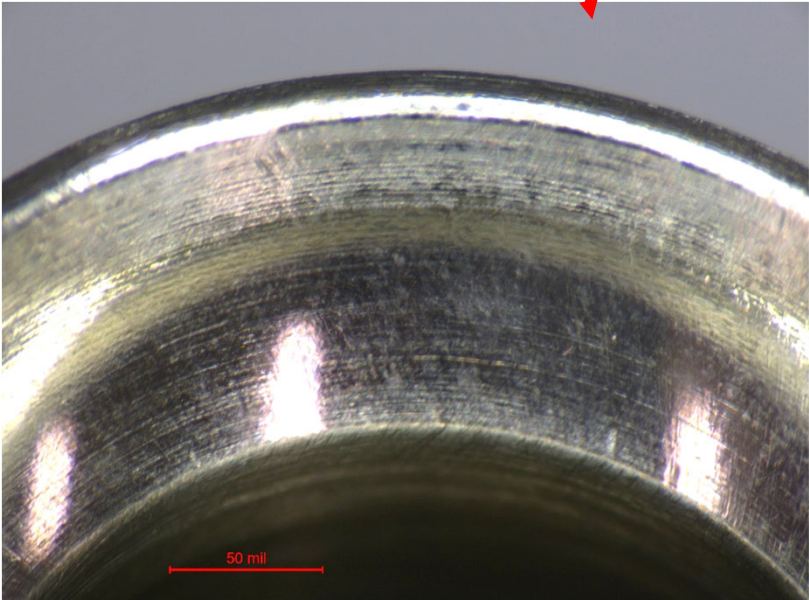
Nozzle 4, Secondary Nozzle

**Figure 13:** Witness marks are less distinct than in the other GE commercial engine investigation (AvEng-536107 and AvEng-536108), but benching marks were not observed.

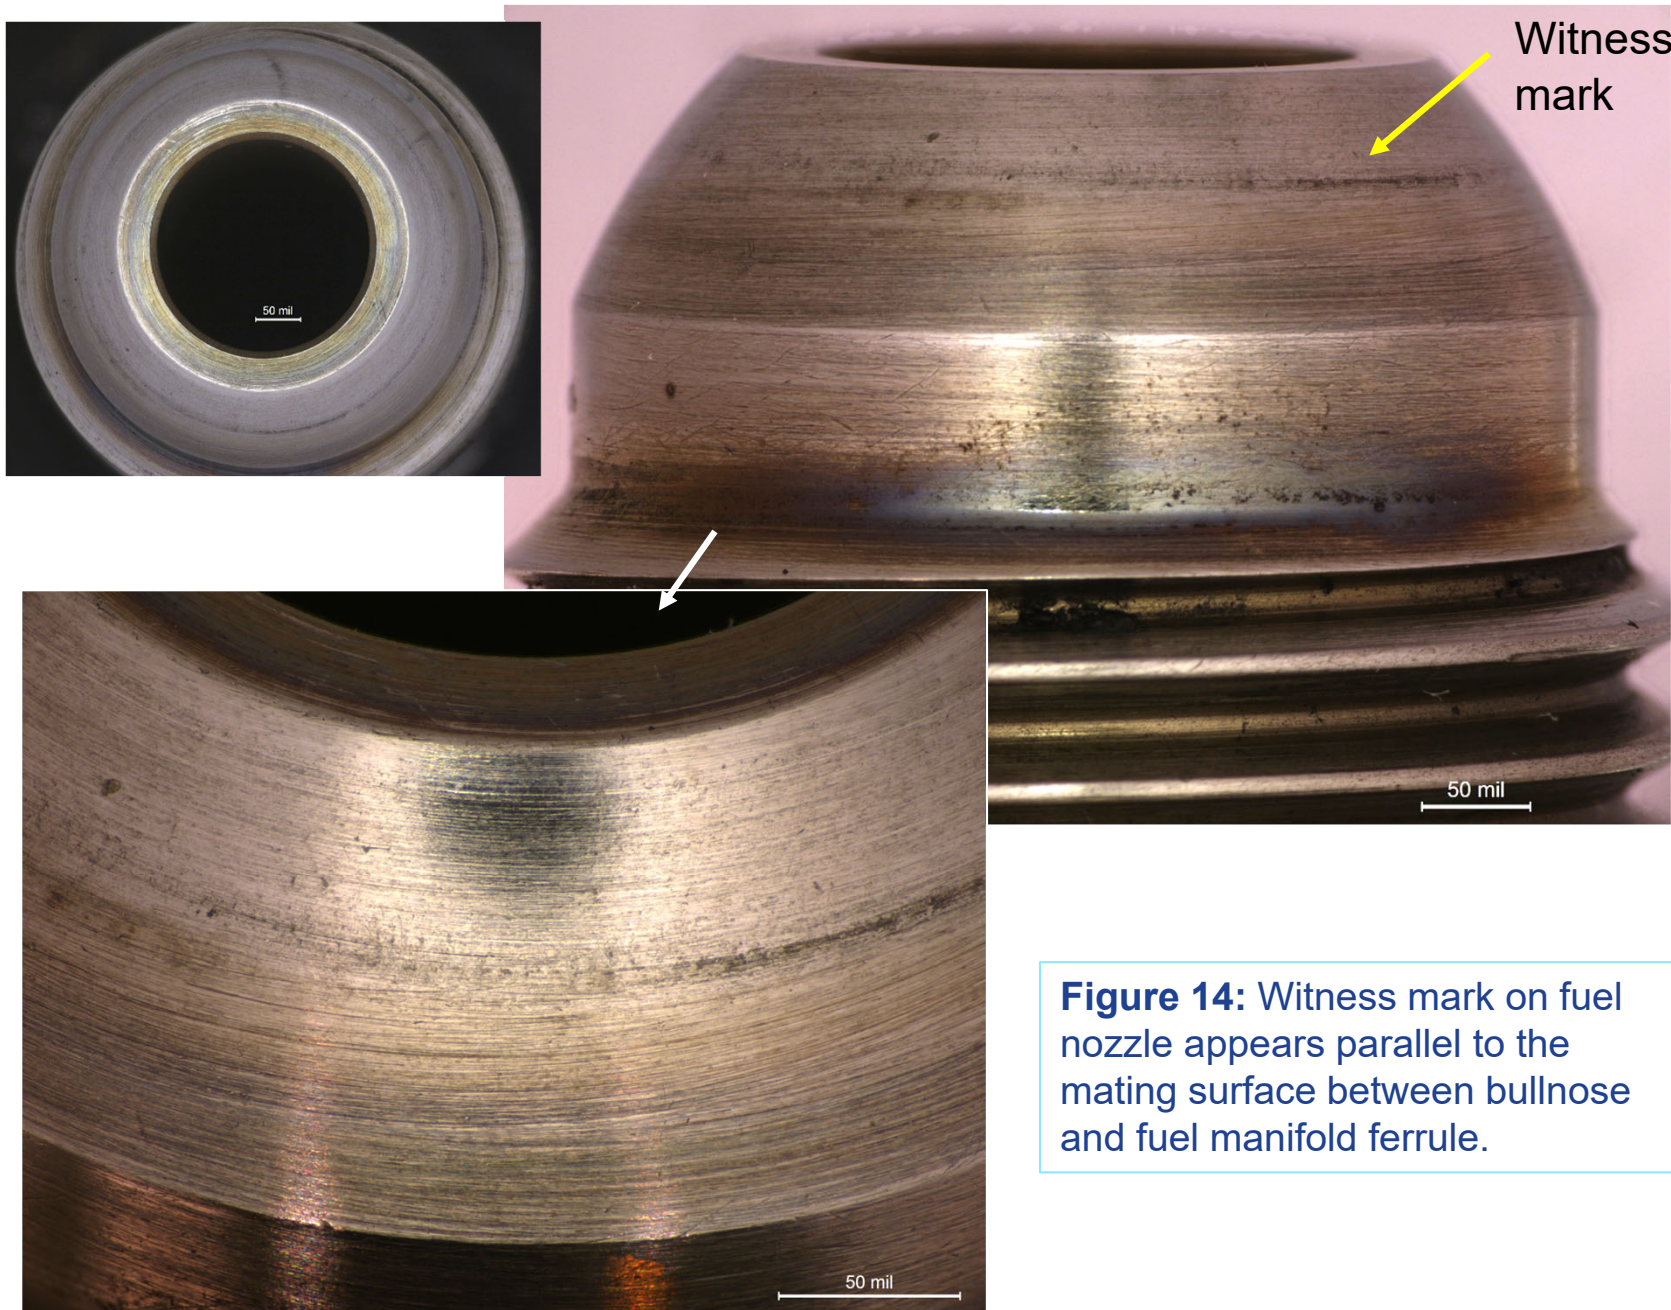
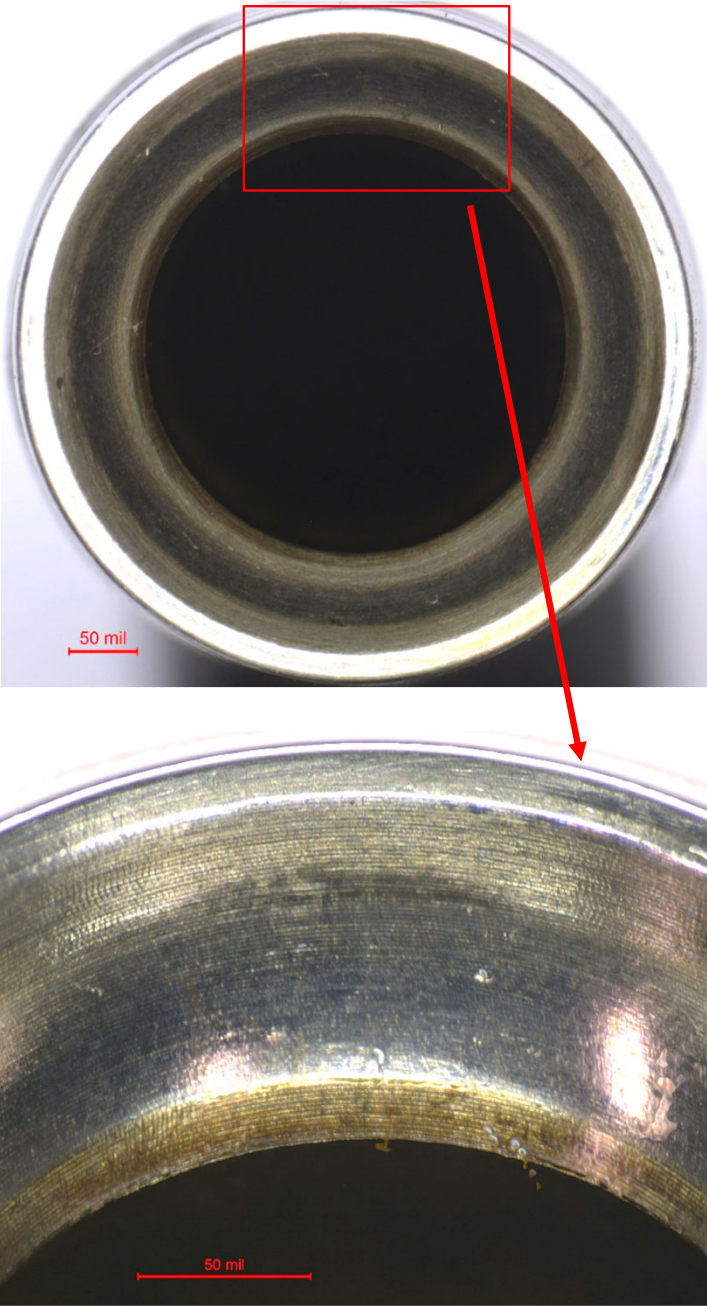
Nozzle 16, Primary Nozzle

**Figure 14:** Witness mark on fuel nozzle appears parallel to the mating surface between bullnose and fuel manifold ferrule.

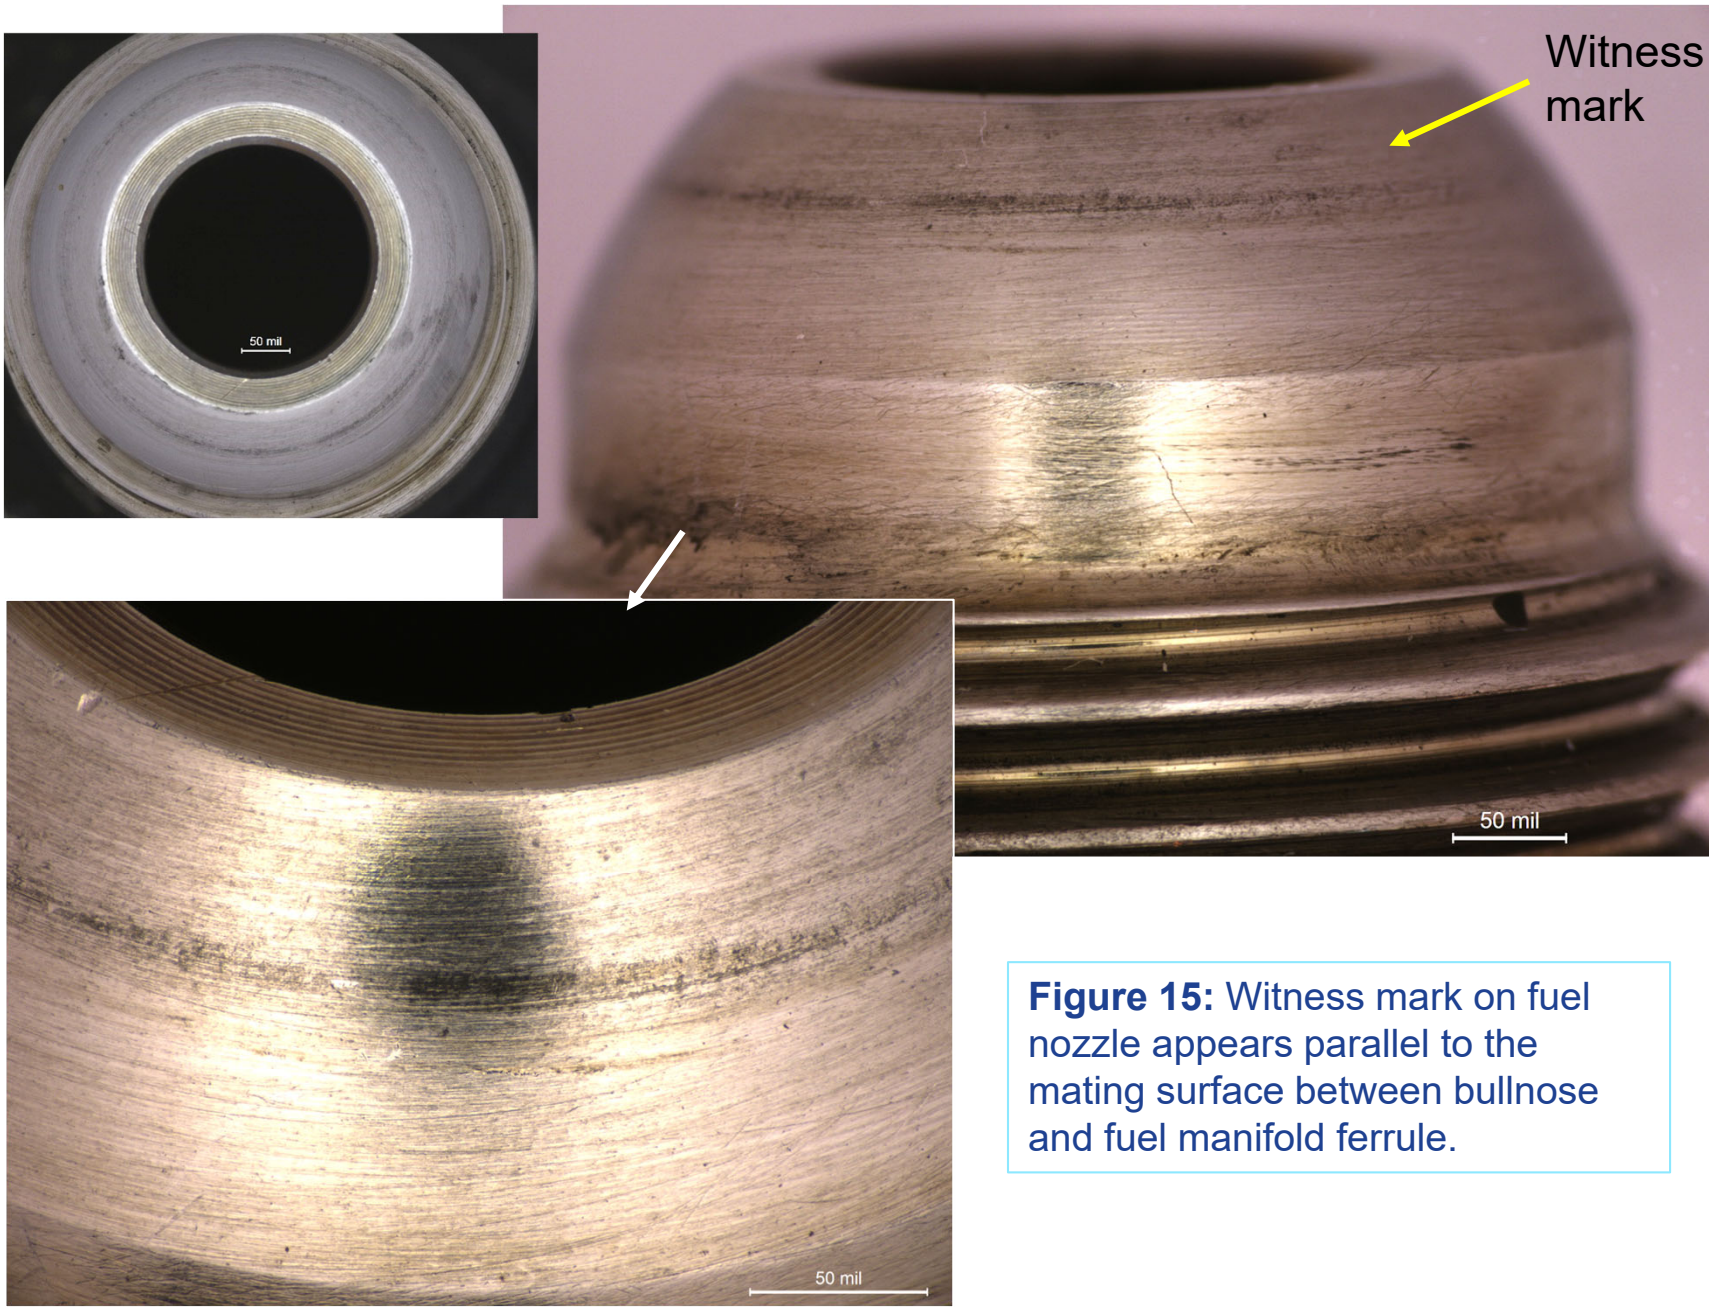
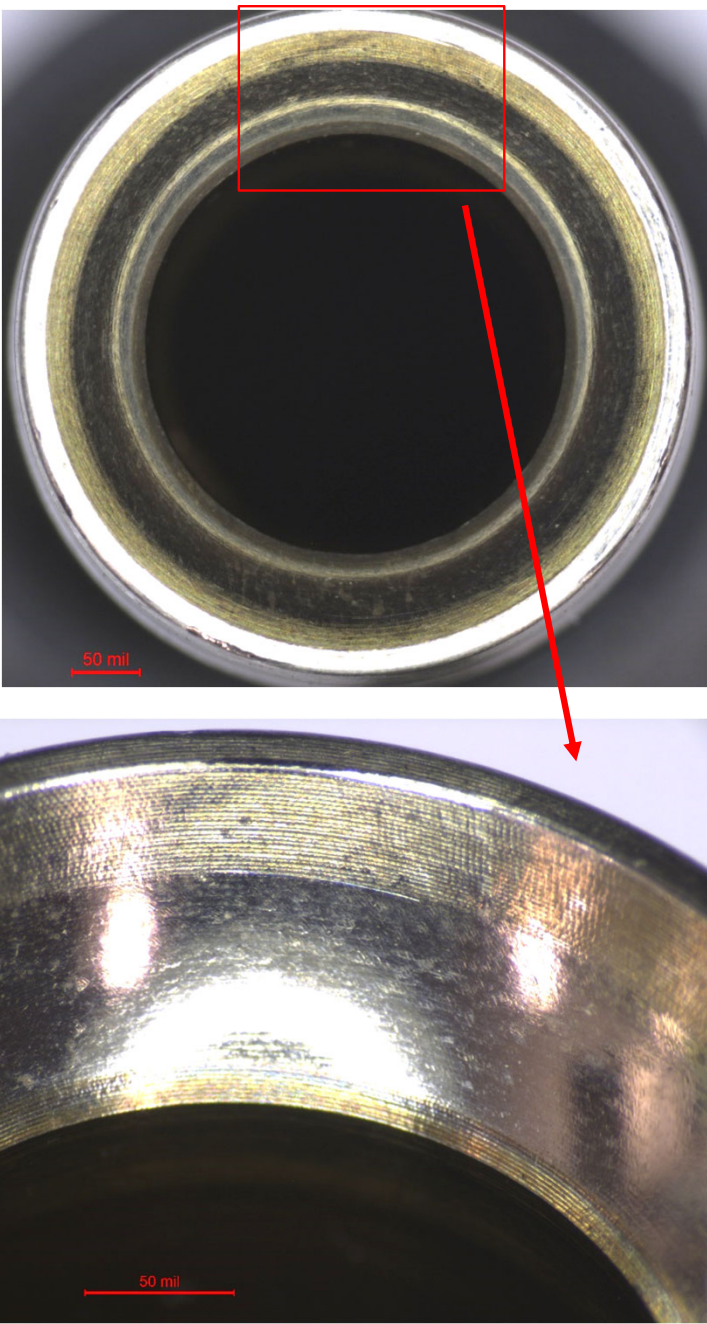
Nozzle 16, Secondary Nozzle

**Figure 15:** Witness mark on fuel nozzle appears parallel to the mating surface between bullnose and fuel manifold ferrule.

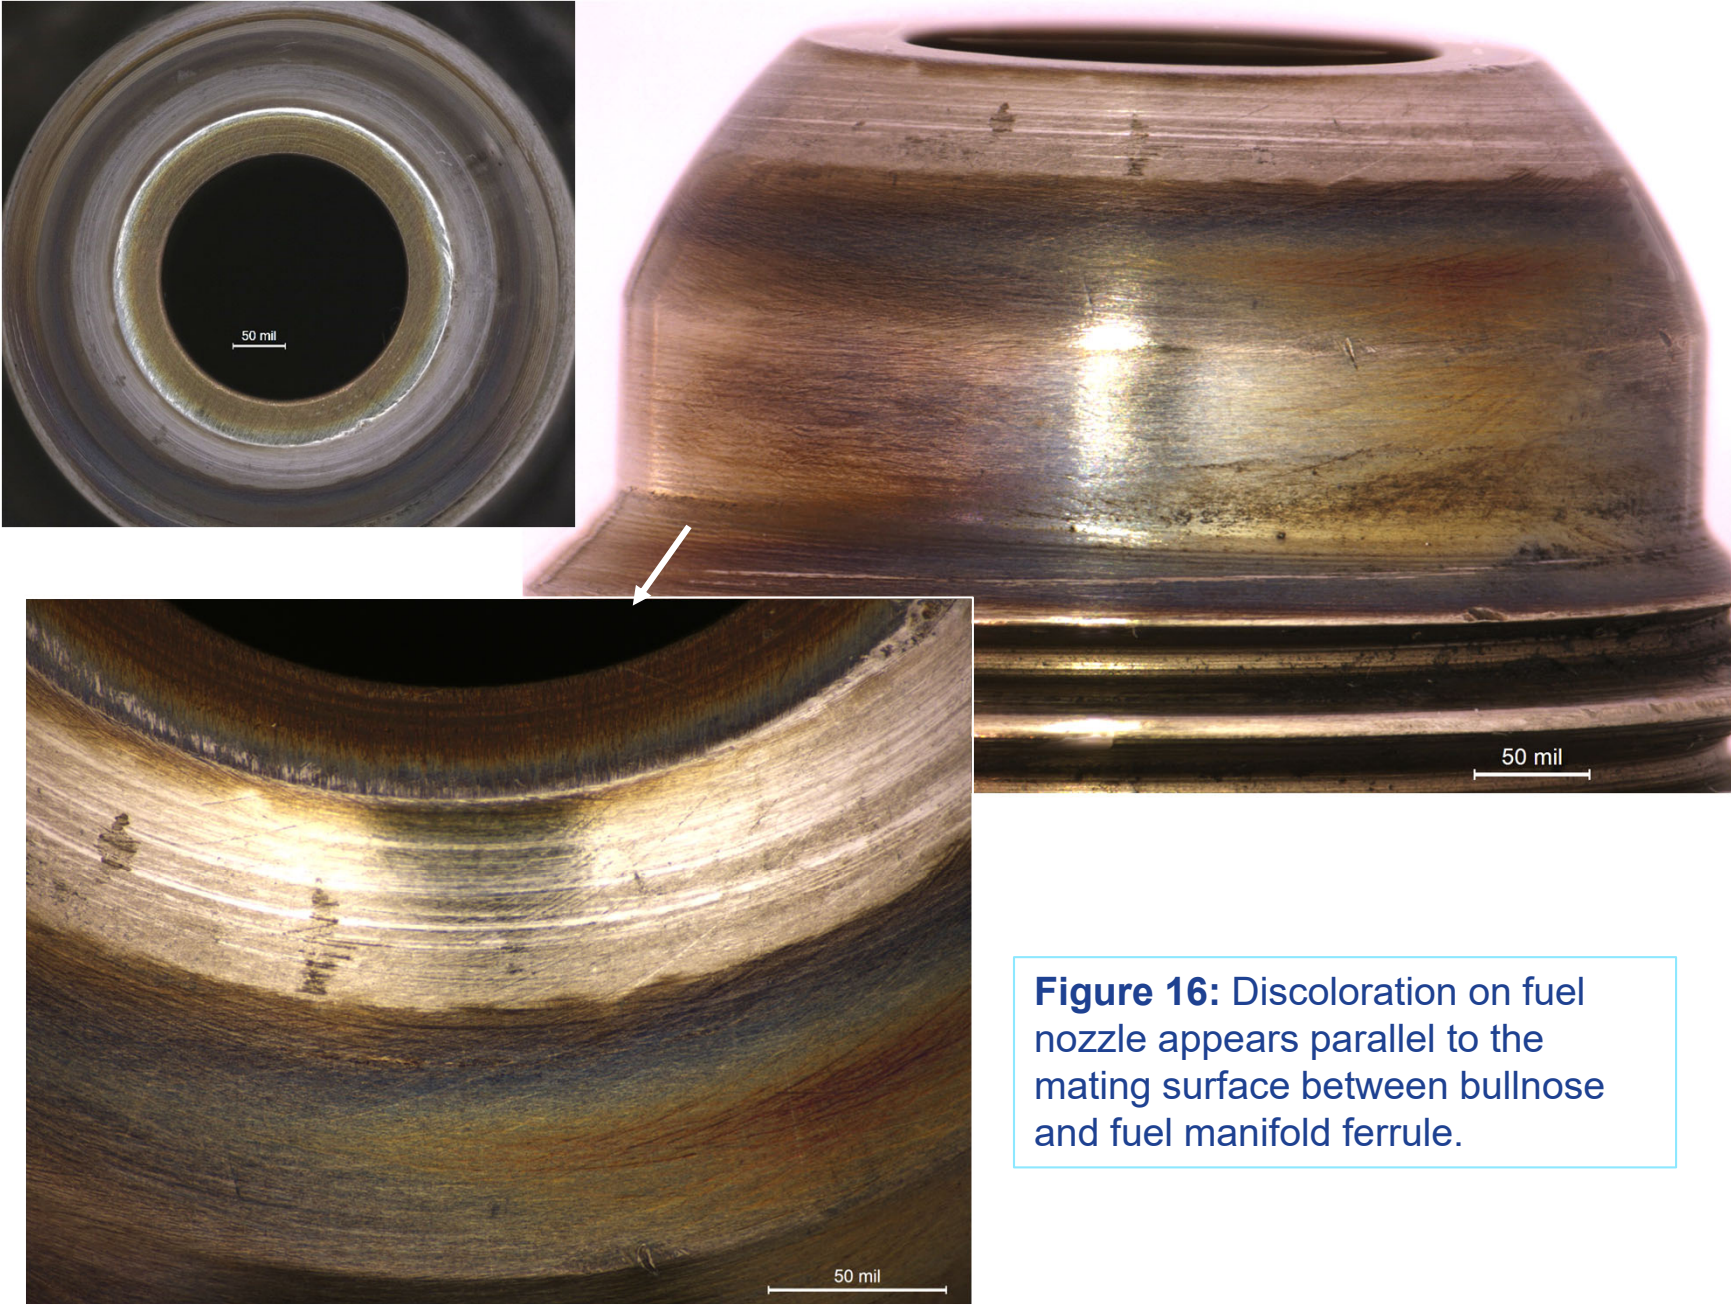
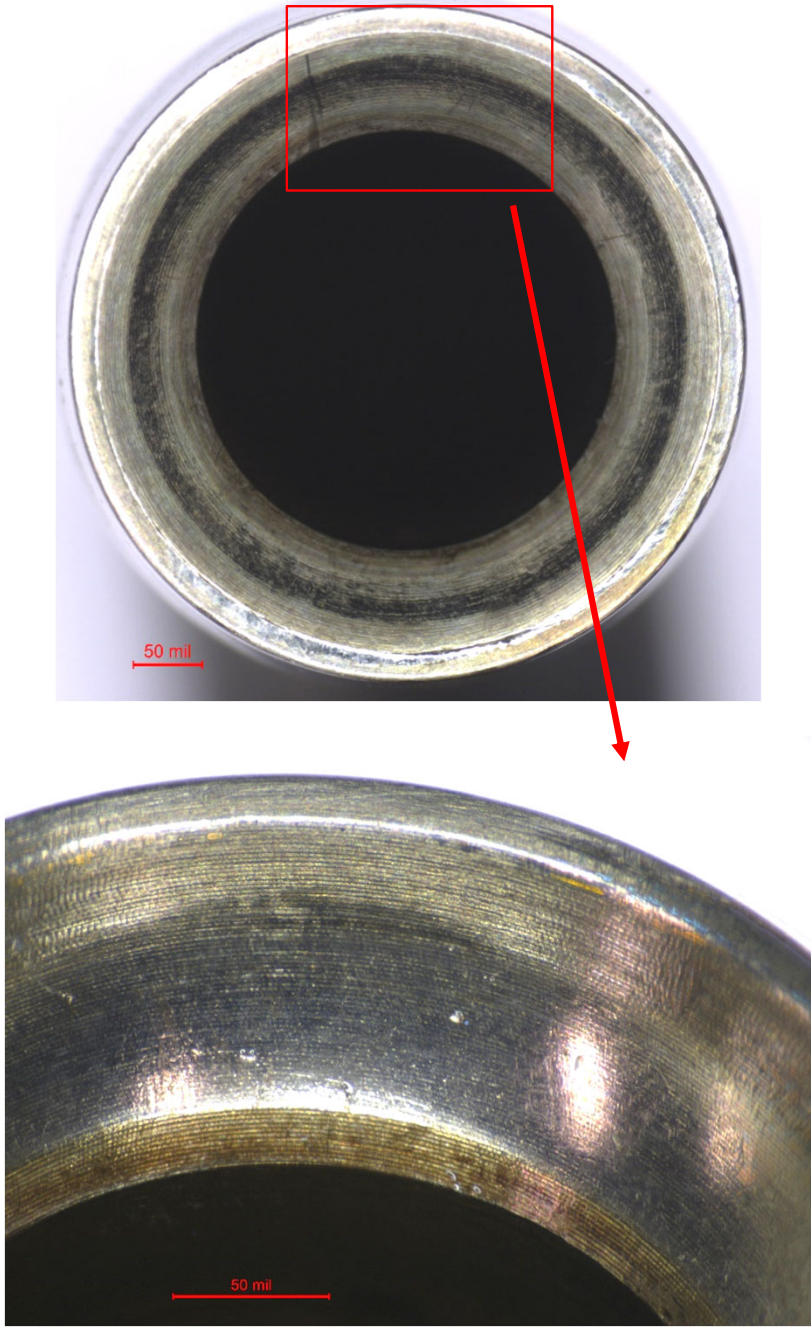
Nozzle 17, Primary Nozzle

**Figure 16:** Discoloration on fuel nozzle appears parallel to the mating surface between bullnose and fuel manifold ferrule.
