ENG23LA031

Metallurgical Evaluation of LEAP-1B Fuel Nozzles, Fuel Manifold, and Fireproof Plate

# Metallurgical Investigation Report DRB AvEng-548136

## METALLURGICAL EVALUATION OF LEAP-1B FUEL NOZZLES

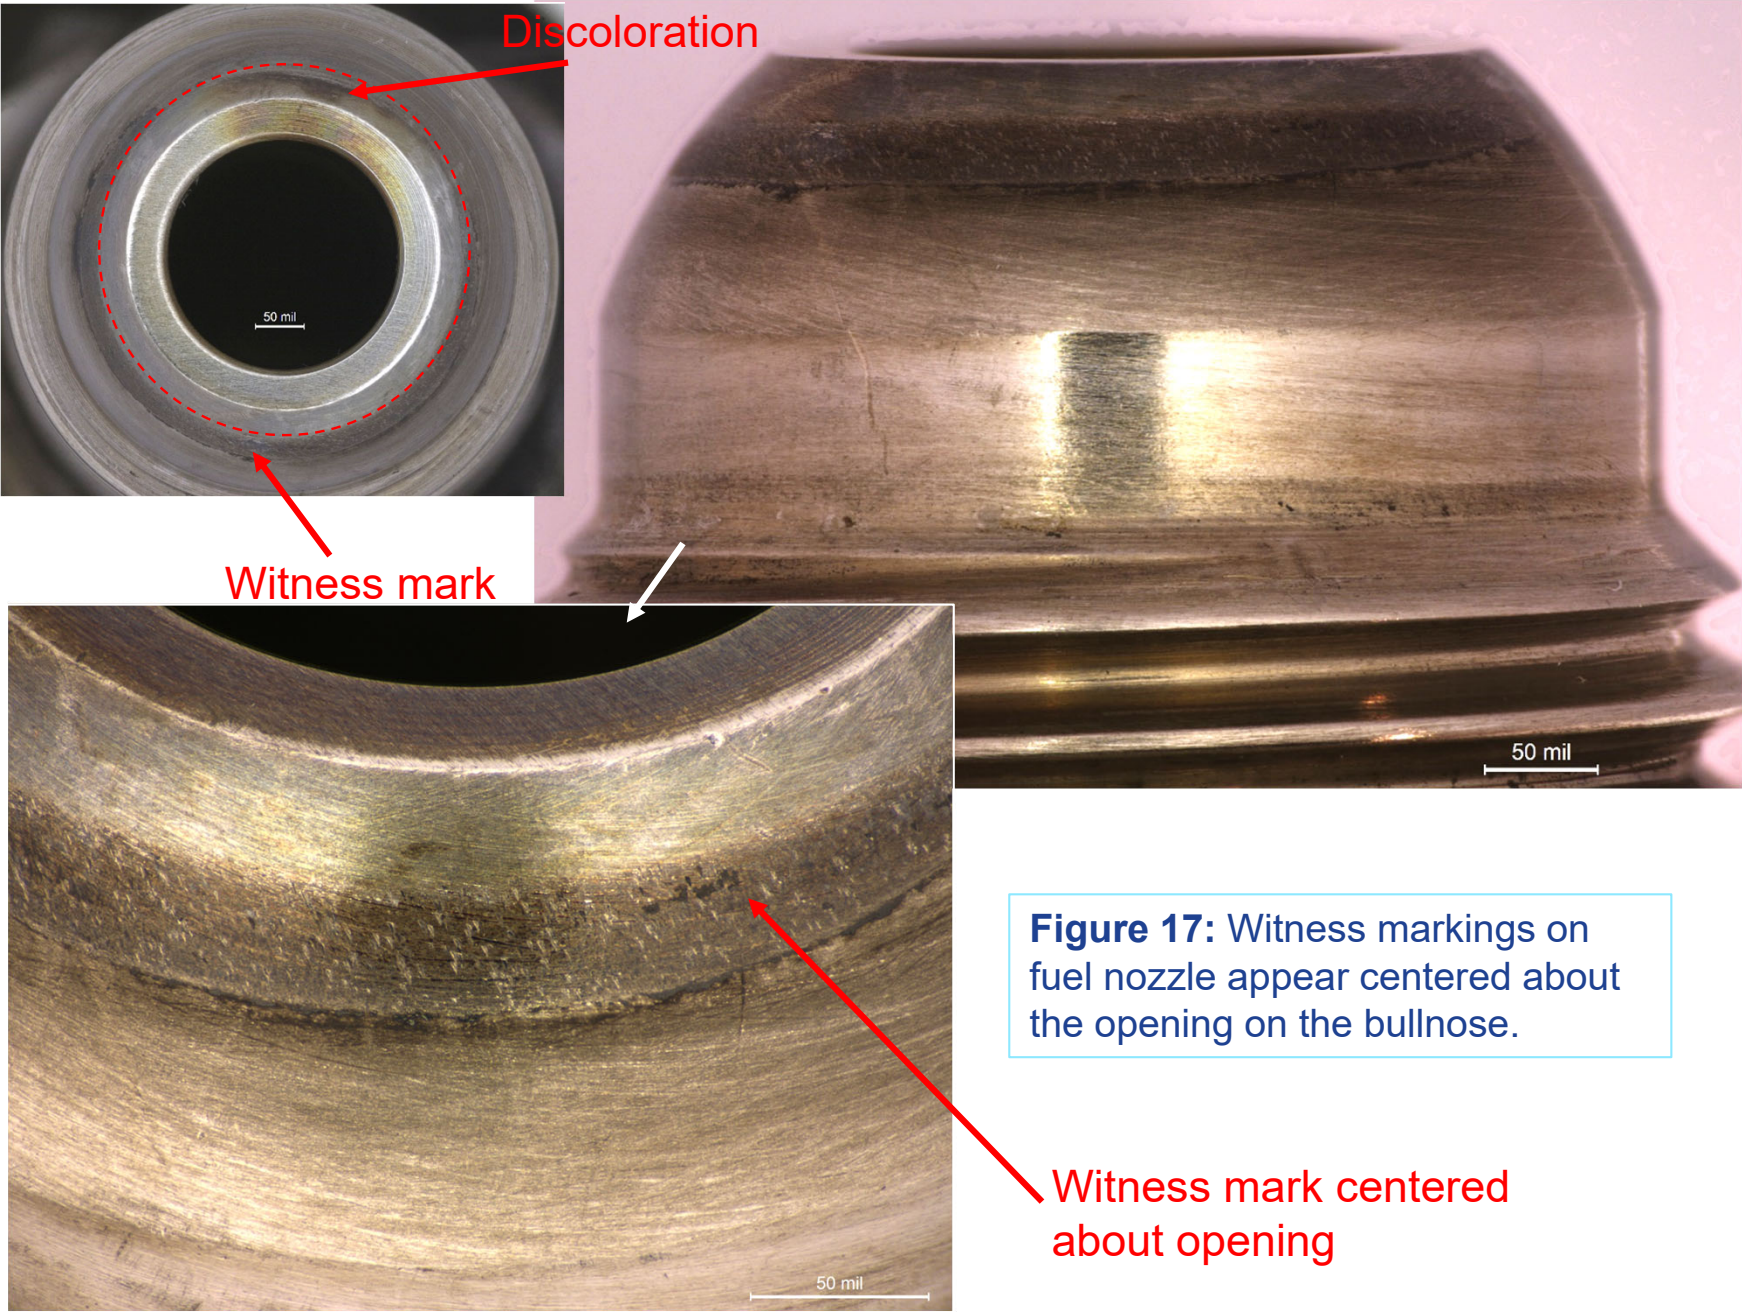
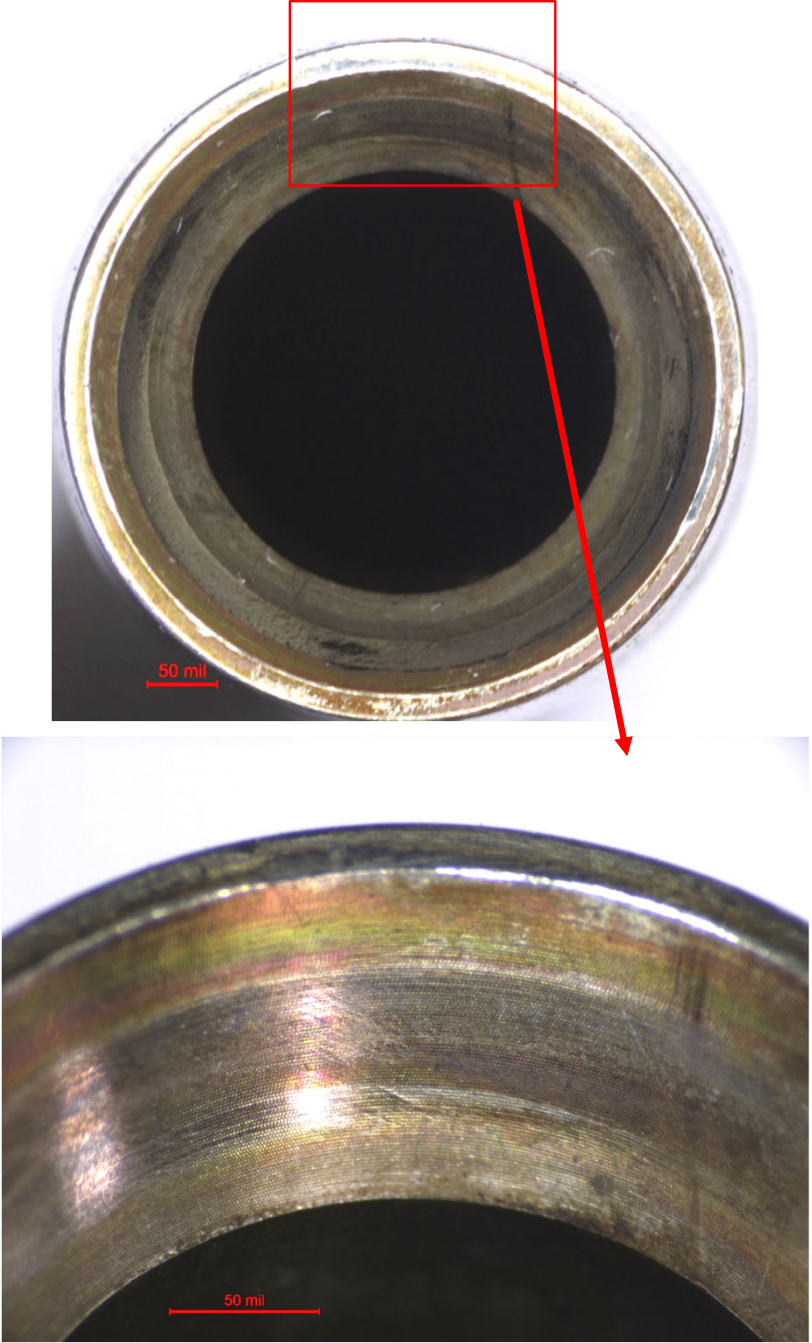
Nozzle 17, Secondary Nozzle

**Figure 17:** Witness markings on fuel nozzle appear centered about the opening on the bullnose.

Witness mark centered about opening

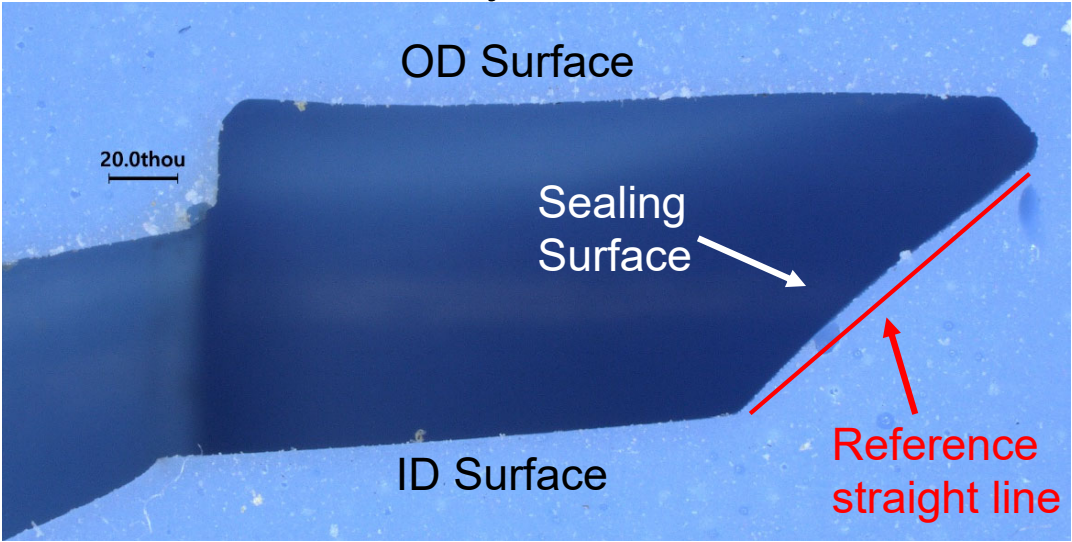
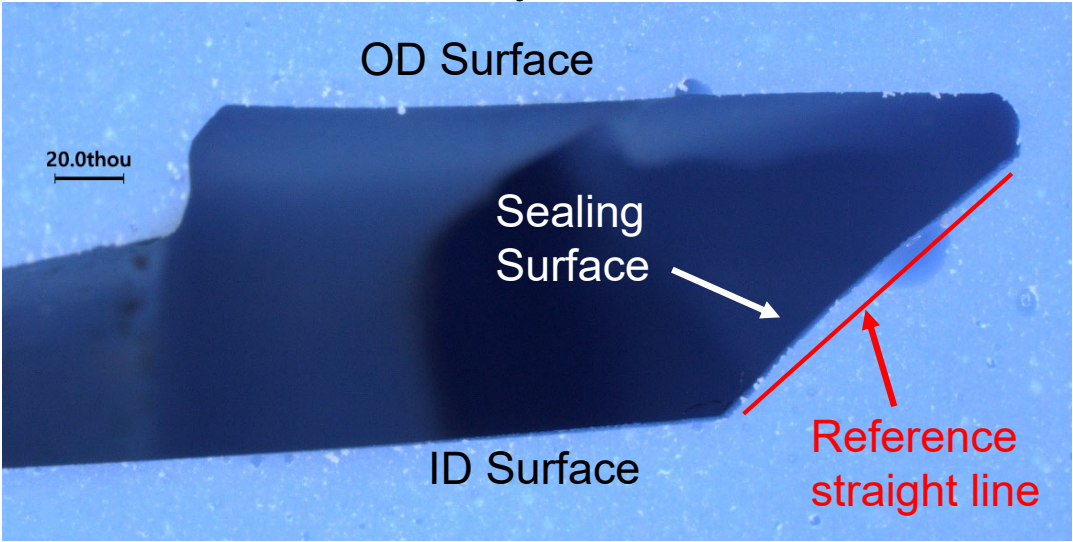
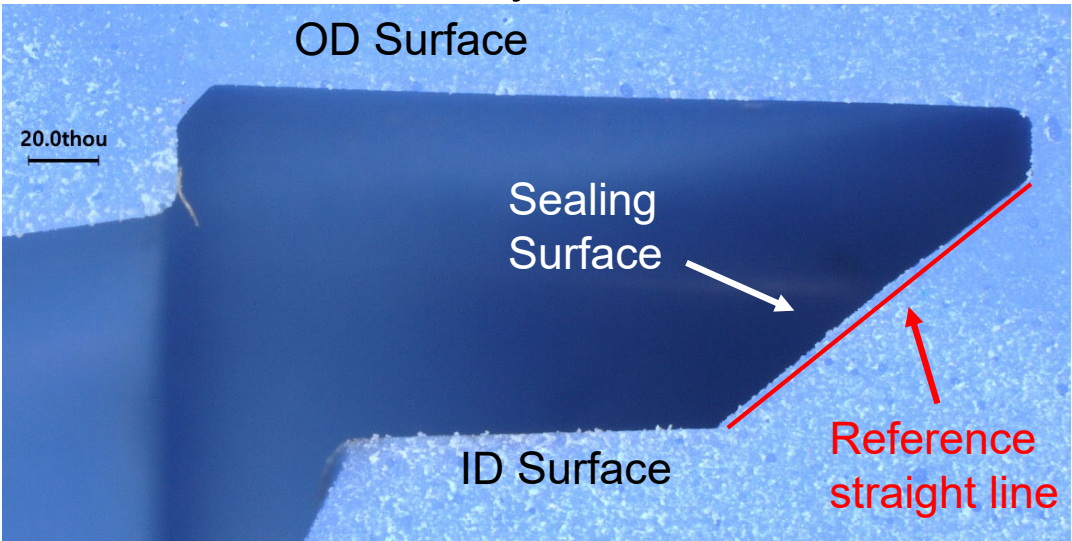
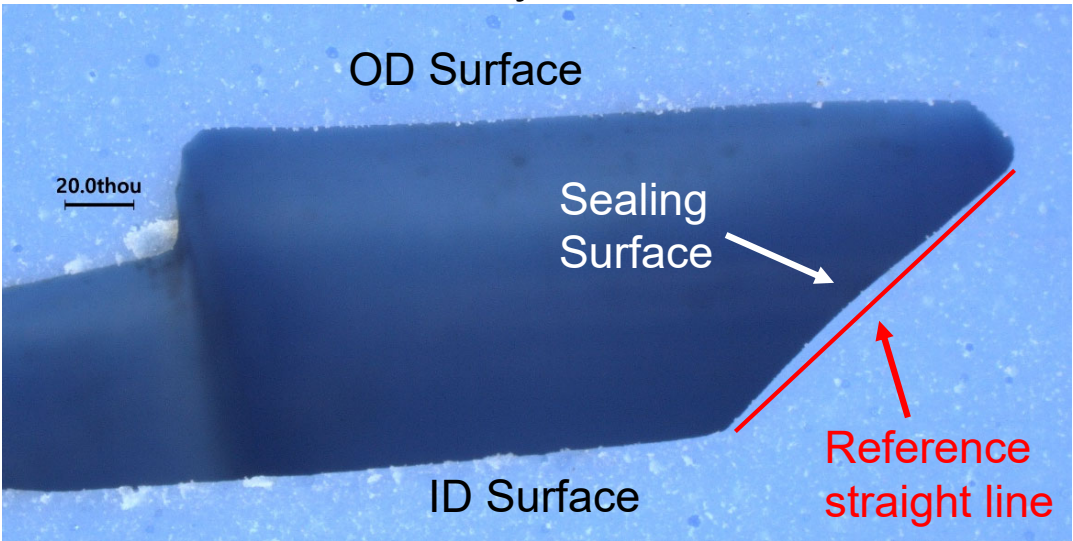
- Repo-rubber castings of the secondary manifold ferrules #4, #16, #17, and #18 were made. The sealing surfaces of each ferrule appeared slightly concave, consistent with plastic deformation from installation against the fuel nozzle bullnoses. These results are included in Appendix A.

Castings of the fuel manifold (inside and outside of fire region) showed deformation of the ferrule sealing surface, consistent with deformation from sealing at original installation. Witness marks at the bullnoses of the fuel nozzles were parallel to the sealing interface, unlike the other GE commercial engine model investigations and consistent with proper alignment. No mechanical deformation or indication of cross-threading was observed on fuel nozzles #4, #16, #17, #18. Coking was observed on the secondary nozzle mating surface of nozzles #17 and #18, both of which had a zero break-away torque. However, there was insufficient evidence to determine how long in terms of cycles a fuel leak may have occurred.

**Figure 20:** Repo-rubber castings were made of the secondary fuel manifold #4, #16, #17, and #18 ferrules. The sealing surfaces are no longer straight, consistent with plastic deformation from contact with the bullnose of the fuel nozzle during installation. The degree of deformation is greater for ferrules 4, 16, and 18 than 17.
