# National Transportation Safety Board

ENG23LA031

## **POWERPLANTS**

Group Chair's Factual Report

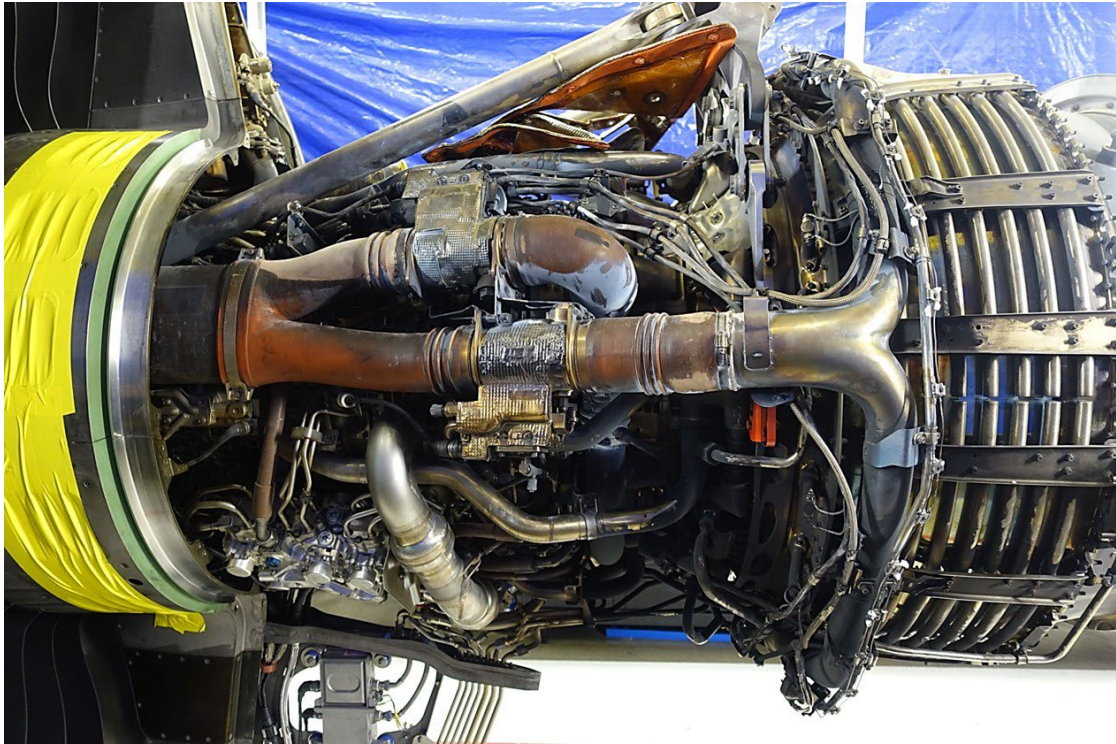
The incident No. 1 engine was shipped to GE Aerospace in Lafayette, Indiana for examination and disassembly. The shop was given permission to unbag the engine and secure it in a work gantry prior to the investigation teams' arrival. The engine was shipped with some engine build-up equipment still installed to avoid disturbing external hardware and soot patterns (**Photos 2 and 3**). The engine data plate confirmed the ESN, 60A467, and rated thrust (**Photo 4**). The fan rotated smoothly by hand with concurrent rotation of the LPT. The ODMS plug and oil scavenge screens were removed and were free of debris (**Photo 5**).

**Photo 2- Engine Left Side, as Received**

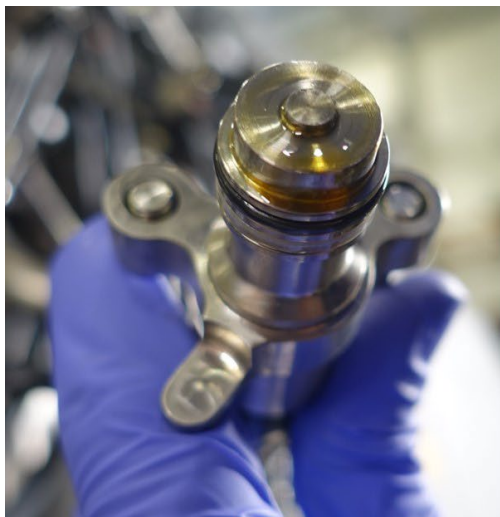
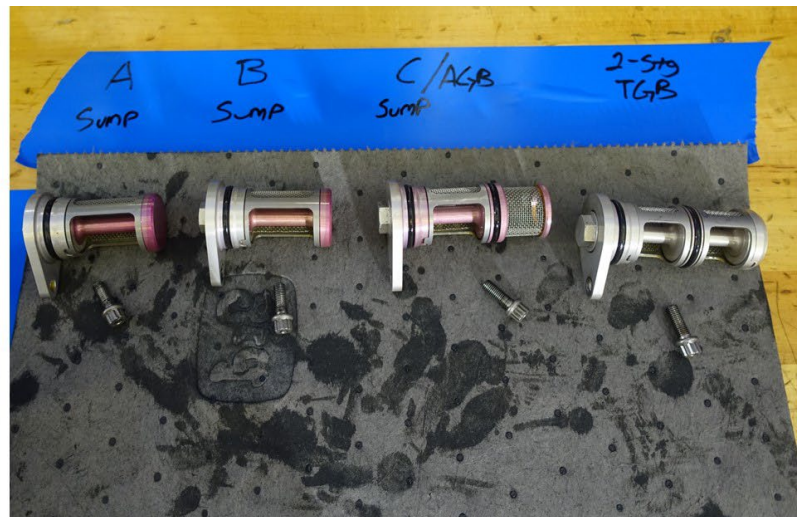
Photo 5- (L) ODMS Detector, (R) Oil Scavenge Screens

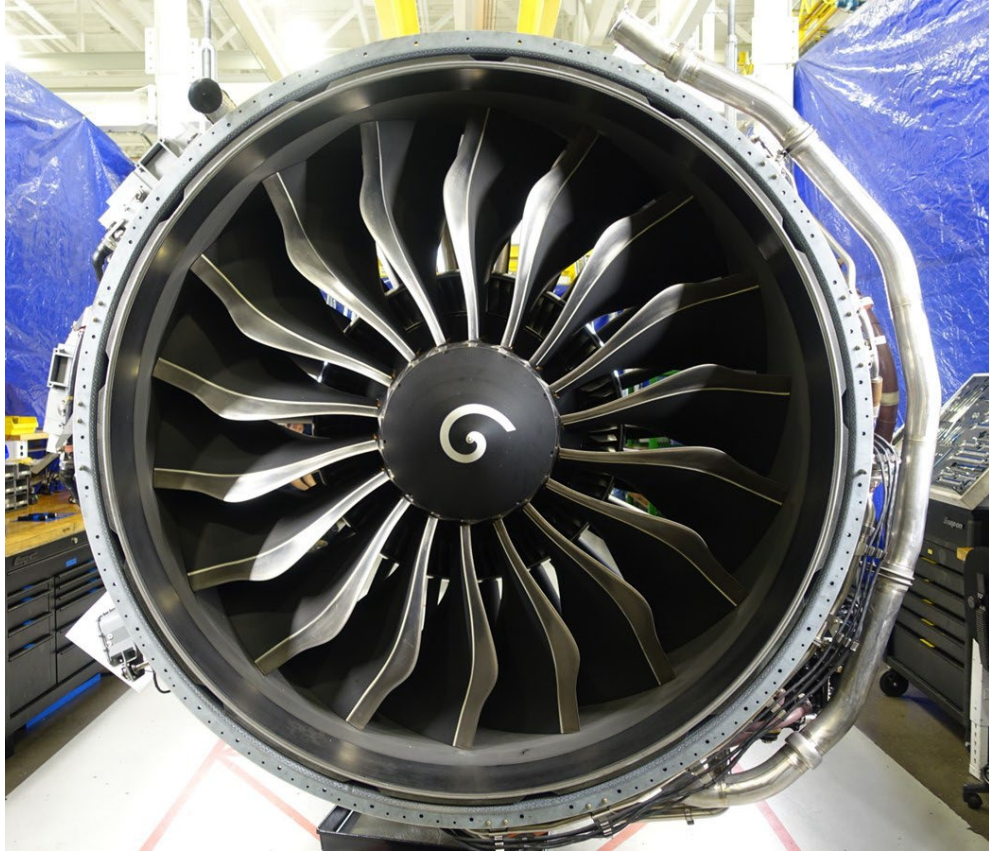
The fan blades were all intact and in good condition with minor leading edge wear consistent with similar service run engines (**Photo 6**). The fan case rub strip had light uniform tip rub that was also normal for similar engines according to CFM International.

**Photo 6- Fan Blades**

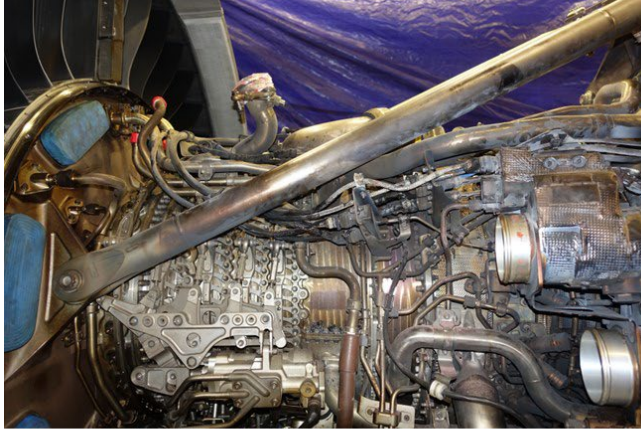
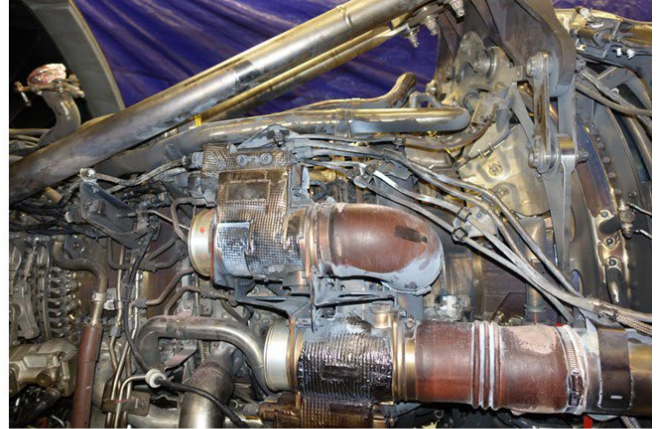
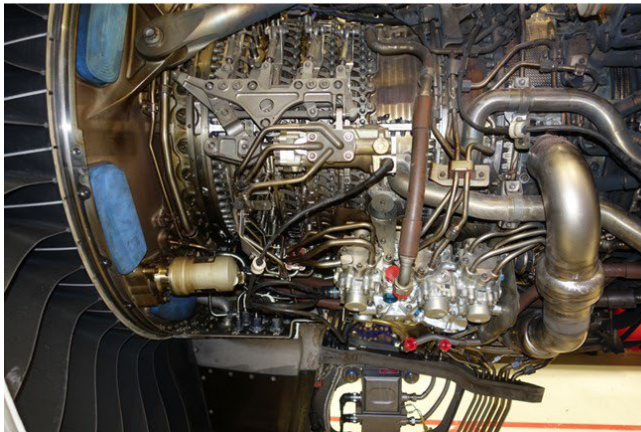
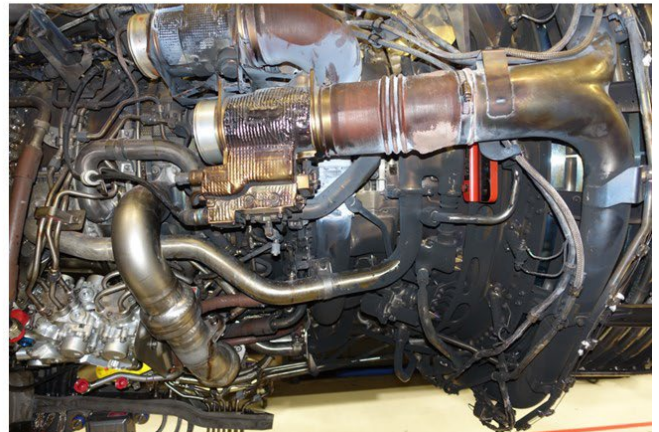
The left side of the engine exhibited multiple indications of undercowl fire exposure. The engine core was discolored/sooted from the 6 to 12 o'clock positions, between the HPC rear case and the aft flange of the HPT case. The discoloration was darkest from the 6 to 9 o'clock positions (**Photo 7**). Multiple wire harnesses including the exhaust gas temperature (EGT) and T3<sup>3</sup> harnesses were charred, and the wire sleeves were partially consumed. The wire and associated p-clamp thermal damage was mostly localized at the 10 to 11 o'clock position in axial positions coincident to the HPC front and rear cases (**Photo 8**). The silicone coating on the thermal sleeve surrounding the HPT active clearance control (ACC) duct was partially consumed. The left engine core fire detector loop isolator grommets were melted and/or consumed from the 7 to 11 o'clock positions (**Photo 9**).

**Photo 7- Left Side of Engine, Lower Core Discoloration**

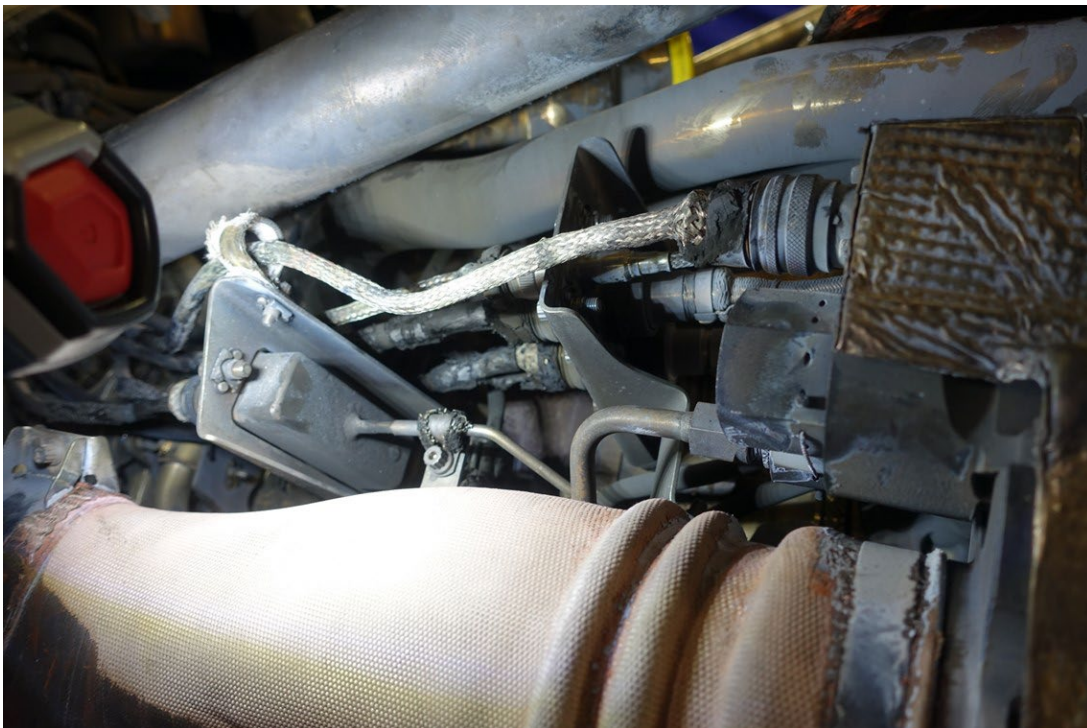
**Photo 8- Thermal Damage, 10 o'clock Position**

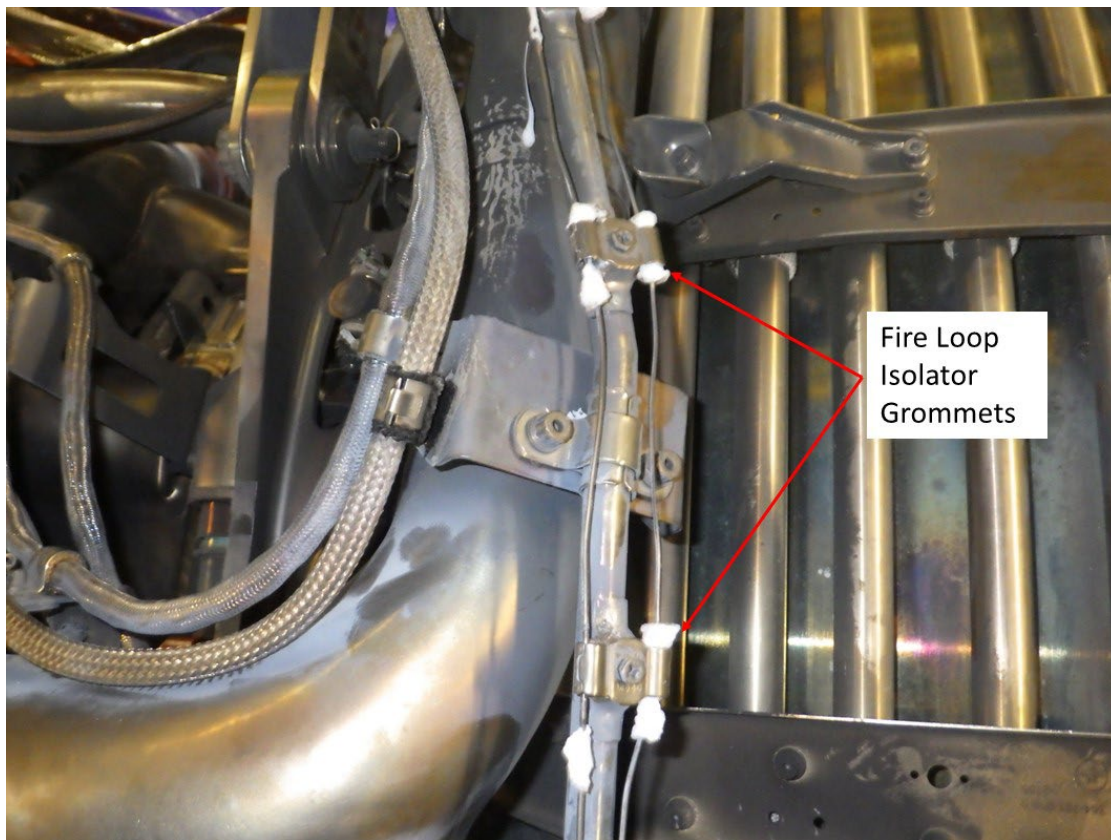
**Photo 9- Left Core Fire Detection Loop, Isolator Thermal Damage**

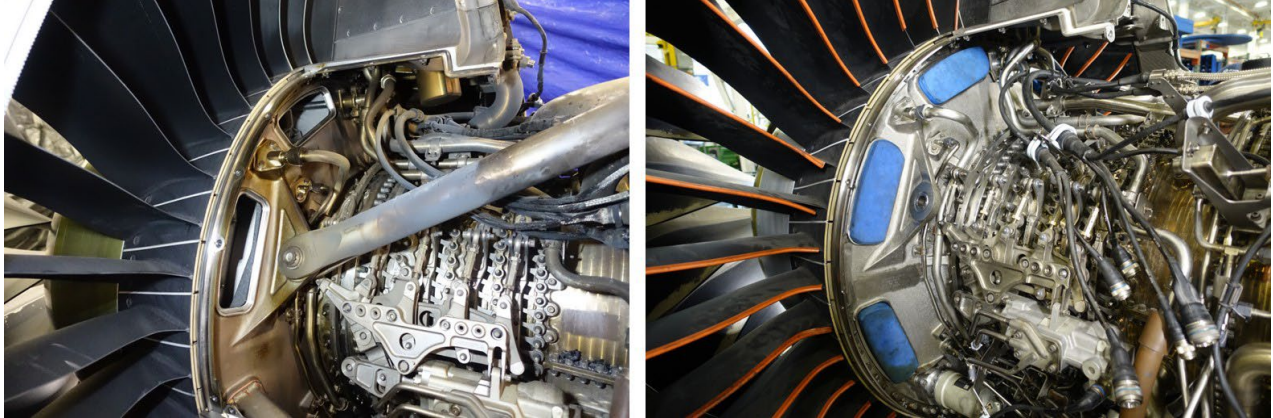
The GE-Lafayette mechanics noted that the surface inside and around the 12 o'clock fan frame strut had a bronze discoloration that appeared consistent with varnishing. The variable bleed valve (VBV) panels were removed, and the bronze discoloration extended 360 degrees around the aft side of the fan hub frame. A different LEAP-1B engine in the shop was viewed for comparison (**Photo 10**). Three pressure fuel tubes (identified in the CFM LEAP-1B illustrated parts catalog (IPC) as significant item number 3600B- fuel tube) that are routed down through the 12 o'clock strut were also discolored in areas not shielded by a metal plate bracket and the interior of the 12 o'clock strut around the fuel tube upper braze joints appeared wetted. The fuel lines were capped at the 12 o'clock position on top of the fan hub frame, the engine core connection b-nuts were disconnected, and pressurized nitrogen (45 pounds per square inch (psi)) was connected to the tube on the left side of the engine and shop air (120psi) was ported into the two tubes on the right side of the engine. There were no bubbles observed when leak detection fluid was applied to the braze joints and surrounding areas. The three fuel lines were separated as an assembly and sent for fluorescent penetrant inspection with no crack indication findings (**Photo 11**).

**Photo 10- (L) Incident Engine Discoloration Under VBV Panels, (R) Exemplar Engine**

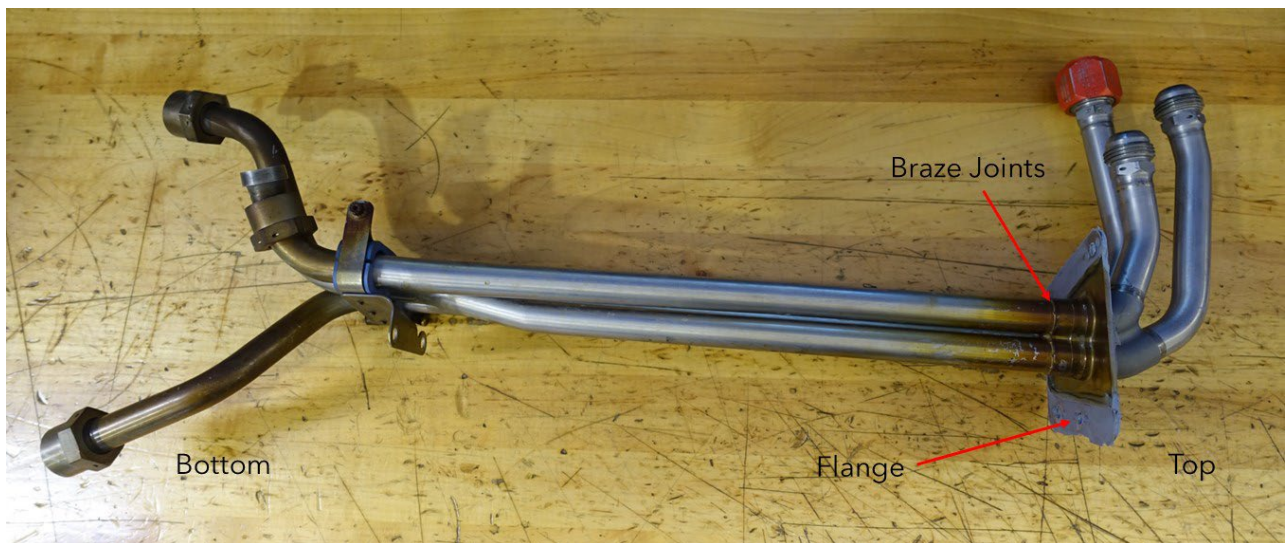
**Photo 11- Fuel Tube**

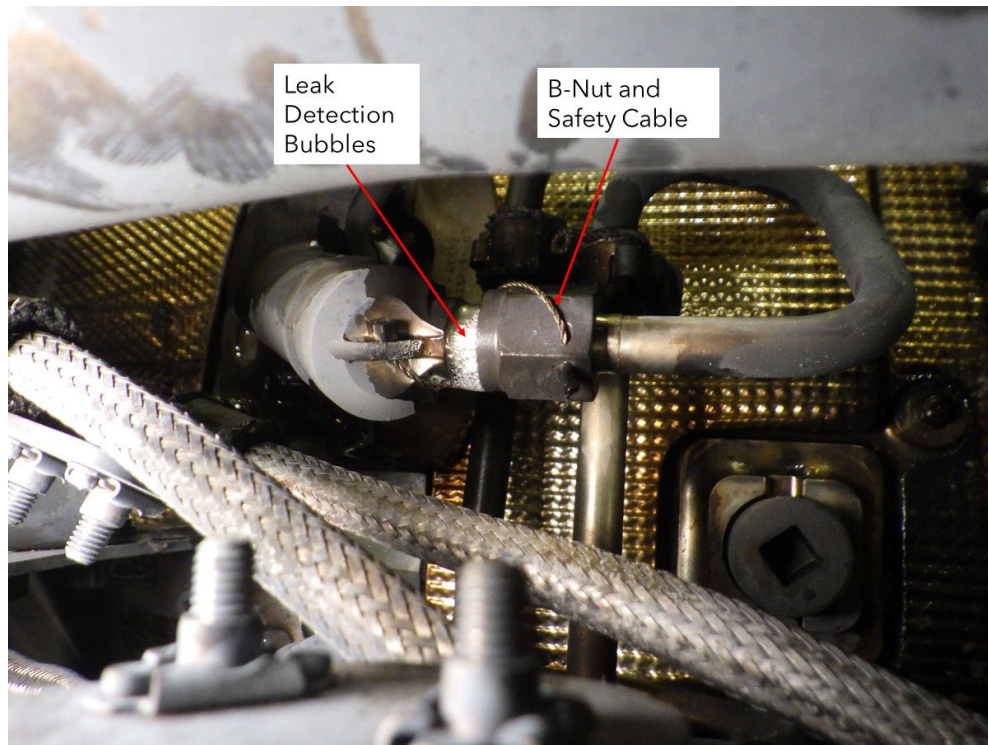
The fuel nozzle and fuel manifold were pressure leak checked in accordance with the Boeing 737-MAX 9 AMM (73-11-05-200-801-600- Fuel Nozzle and Fuel Manifold Leak Check). Pressurized nitrogen was connected to the enriched primary fuel hose tube, fuel hose manifold, and fuel hose secondary manifold and pressurized to a regulated pressure of 40 psi. Leak detection fluid was sprayed on all nozzle and b-nut connections. Leak bubbles were visible at the b-nut connection of fuel nozzle 17 pilot secondary inlet (**Photo 12**).

**Photo 12- Fuel Nozzle 17 Leak Check**

The engine externals were stripped to access the fuel nozzles. A visual inspection confirmed that the primary and secondary fuel nozzle b-nuts were all match marked with a torque stripe and safety cable installation was installed. The breakaway torque was recorded for each fuel nozzle b-nut and the nozzle was subsequently retorqued to 285 inch-pounds (in-lb) (AMM mid-range) specification and photographed. The recorded torques are available in the docket as "Powerplants Attachment #1- ESN 60A467, Fuel Nozzle B-Nut and Flange Bolt Torque Measurements. The secondary inlet b-nuts of fuel nozzles 17 and 18 both had zero torque<sup>4</sup>.

UAL revised their AMM fuel nozzle set replacement procedures following the incident to incorporate additional steps and checks to verify proper installation. The revised procedure requires additional external hardware to be removed from the engine to ensure better access to the fuel nozzles and reduce the likelihood of false torque indications. A pressurized nitrogen leak check of the fuel manifold is performed after the fuel nozzles are torqued, prior to external hardware installation. Leak detection fluid is applied to all fuel nozzle connections and each nozzle is visually inspected for leak indications. After the fuel nozzle set replacement

is complete, an engine wet motor<sup>5</sup> is performed with the cowl doors open to visually inspect for fuel leaks. During the wet motor, the fuel boost pumps are turned on, the fuel spar valve is opened, and the engine starter is engaged without engine ignition. A part-power leak check<sup>6</sup> is then performed where the engine is started and accelerated to approximately 70% N1 to increase fuel pressure above idle speed and actuate fuel system components that are only active above idle conditions. The part-power leak check is performed with the cowl doors closed. The cowl doors are subsequently open to visually inspect for leaks after engine shutdown.

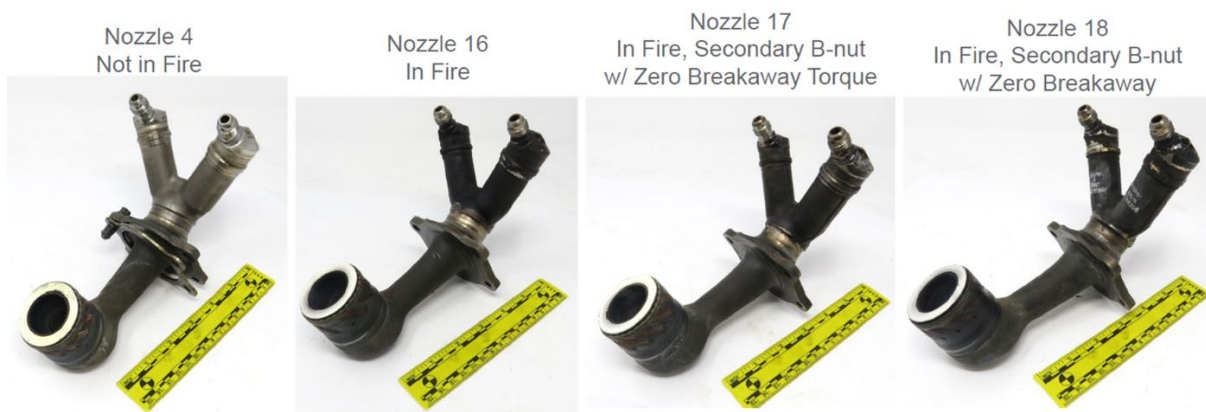
Four fuel nozzles (positions 4, 16, 17, 18) were shipped to the GE Aerospace Failure Analysis (FA) Laboratory in Evendale, Ohio for materials analysis (**Photo 13**). Fuel nozzles 17 and 18 were identified to have zero b-nut torque at the secondary inlet during the teardown examination while fuel nozzles 4 and 16 were found to have b-nut torque that fell within specifications. Fuel nozzle 16 was located

in the fire affected area, and fuel nozzle 4 was located outside the fire affected area. A visual and binocular examination of the four fuel nozzle mating faces and threads did not reveal any mechanical deformation or indications of cross threading. Rubber castings of the secondary manifold ferrules were made for each of the four fuel nozzles. The sealing surfaces of the four ferrules appeared slightly concave, consistent with plastic deformation from installation against the fuel nozzle bullnoses. Coking was observed around the mating surface of fuel nozzles 17 and 18 but was not present on nozzles 4 or 16 (**Photos 14 and 15**). The analysis concluded that there was insufficient evidence to determine how long a fuel leak may have occurred from the fuel nozzles 17 and 18 secondary inlet.

**Photo 13- Fuel Nozzles 4, 16, 17, and 18 as Received at the GE Aerospace FA Laboratory**

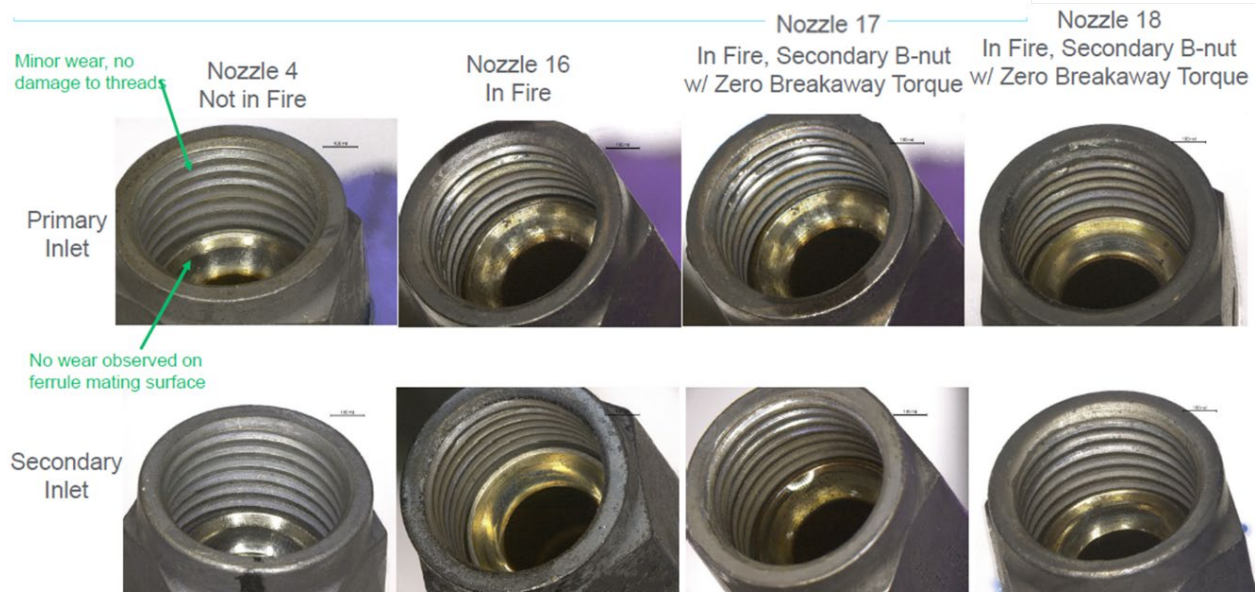
**Photo 14- Fuel Nozzles 4, 16, 17, and 18 Primary and Secondary Inlet Threads**

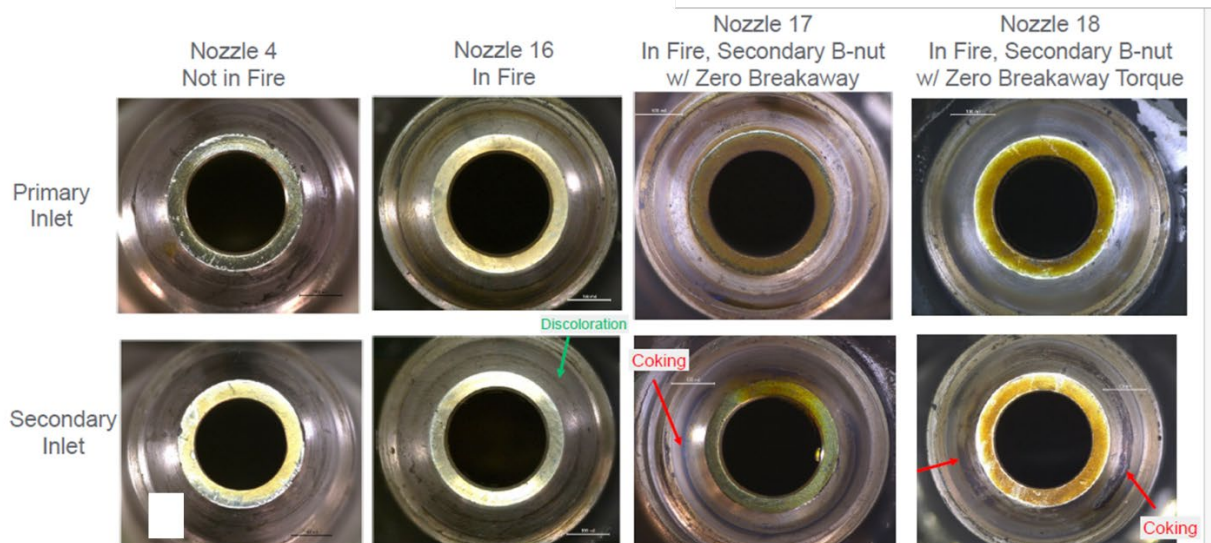
**Photo 15- Fuel Nozzles 4, 16, 17, and 18 Mating Surface**
