# National Transportation Safety Board

**ENG23LA033**

## **AIRCRAFT SYSTEMS**

Group Chair's Factual Report

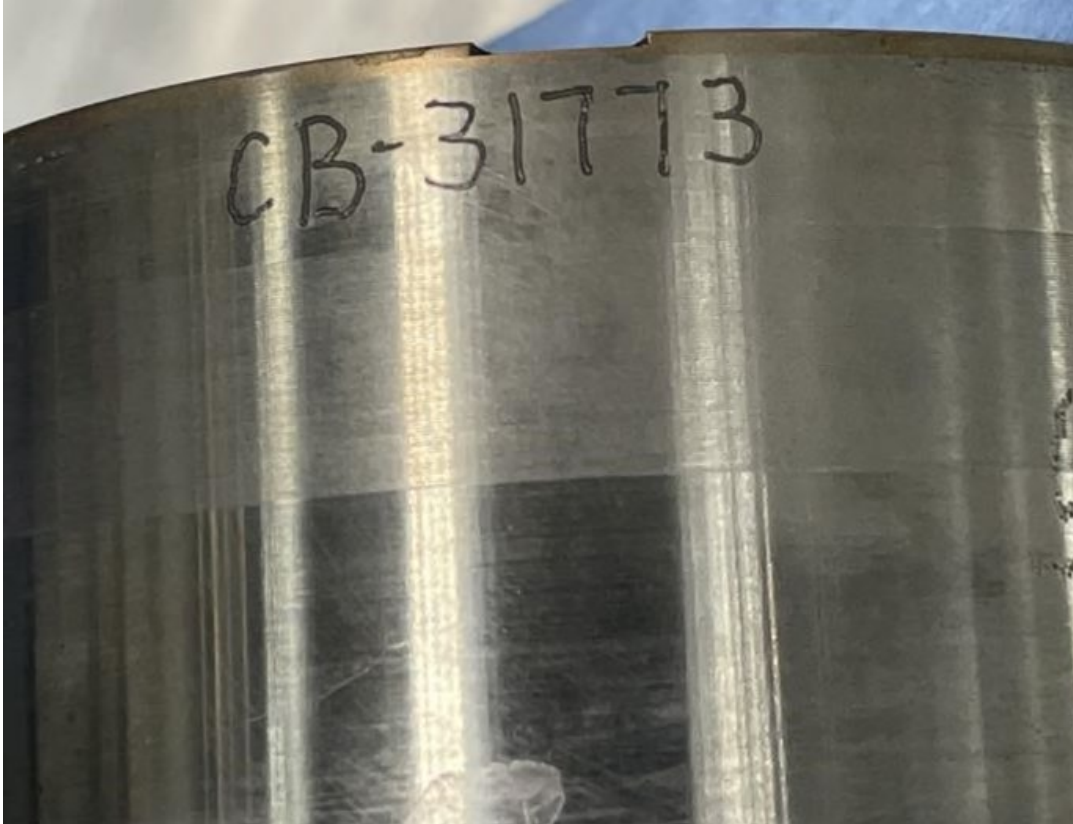
Once the hydraulic module was disassembled, the fixed cylinder block was examined. The fixed block exhibited the marking "CB-31773", indicating the block had been repaired by an FAA-approved re-sleeving process. See Figure 5. The block's serial number was noted as Y13-46-15. Each of the nine fixed cylinder block pistons were examined; all were marked as manufactured by Collins, and all were marked as Size "1".

**Figure 5.** The etched number, indicating the cylinder block had been re-sleeved.  
(Photograph courtesy of Collins Aerospace)

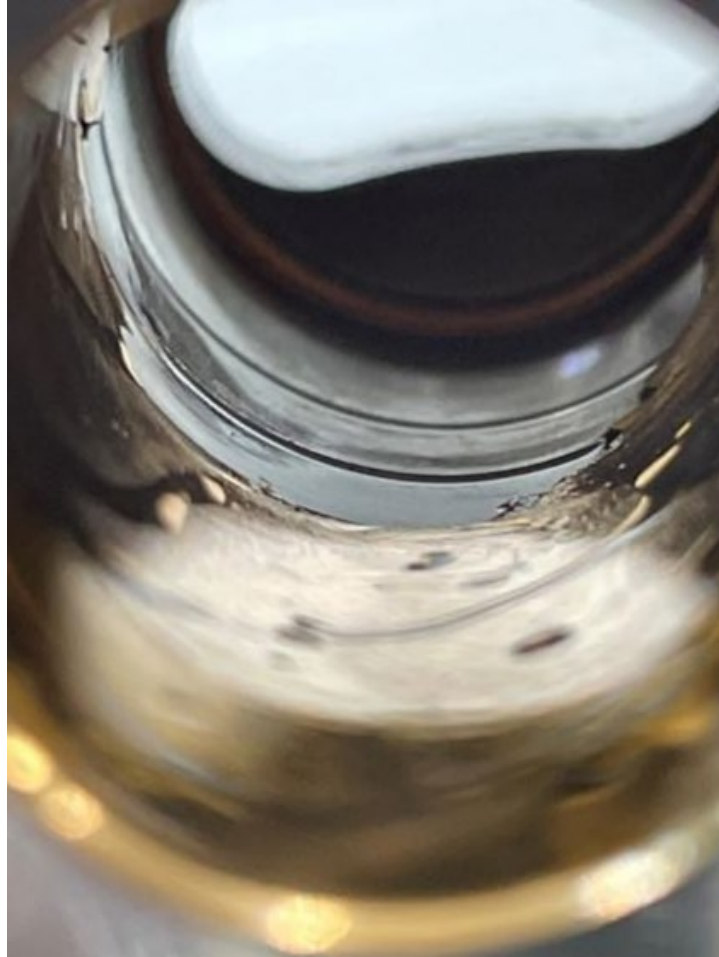
Each of the fixed cylinder block's nine bores had areas that were worn through the bronze sleeve bushings, with sections of the sleeve missing. Significant wear was noted at the bottom of several bores, with areas showing wear through the sleeve to the steel. The exposed areas of the block substrate appeared intact. See Figures 6 and 7.

**Figure 6.** Fixed block bore number 3, showing wear at the bottom of the bore through the sleeve, to the cylinder block steel. (Photograph courtesy of Collins Aerospace)

The Collins air spindle tool was used to measure the diameter (the worn size) of each of the nine cylinder bores for the fixed and variable blocks. For the fixed block, the air spindle test showed each of the bores were worn beyond the measurable limits of the air spindle tool; by this method, each of the nine bore diameters were greater than Size "5". For the variable block, the air spindle measured each of the bores at Size "2".

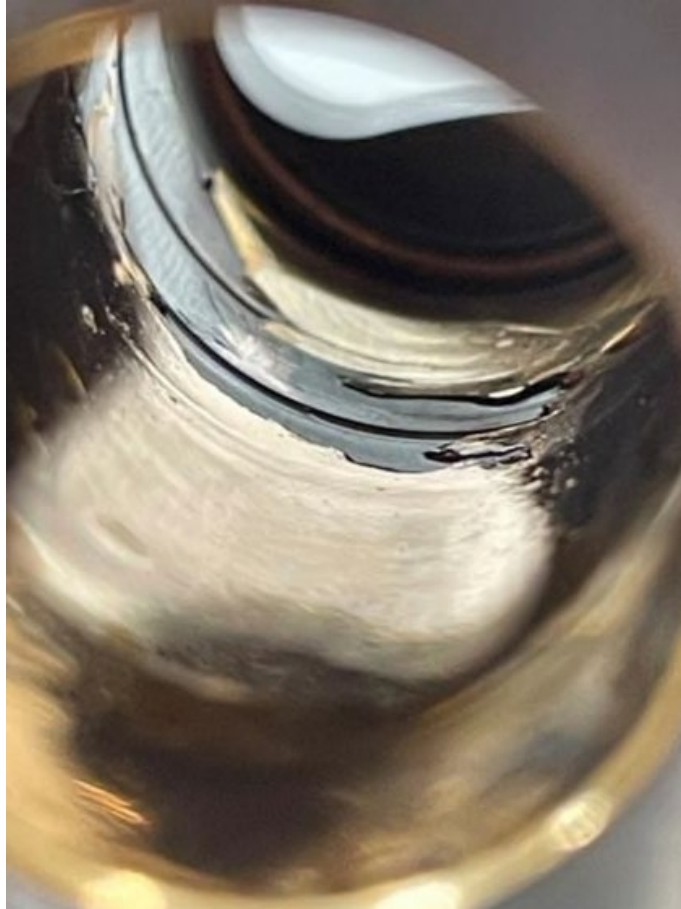
**Figure 7.** The fixed cylinder block bore number 5, showing typical wear through the bushing sleeve material to the cylinder block steel. (Photograph courtesy of Collins Aerospace)

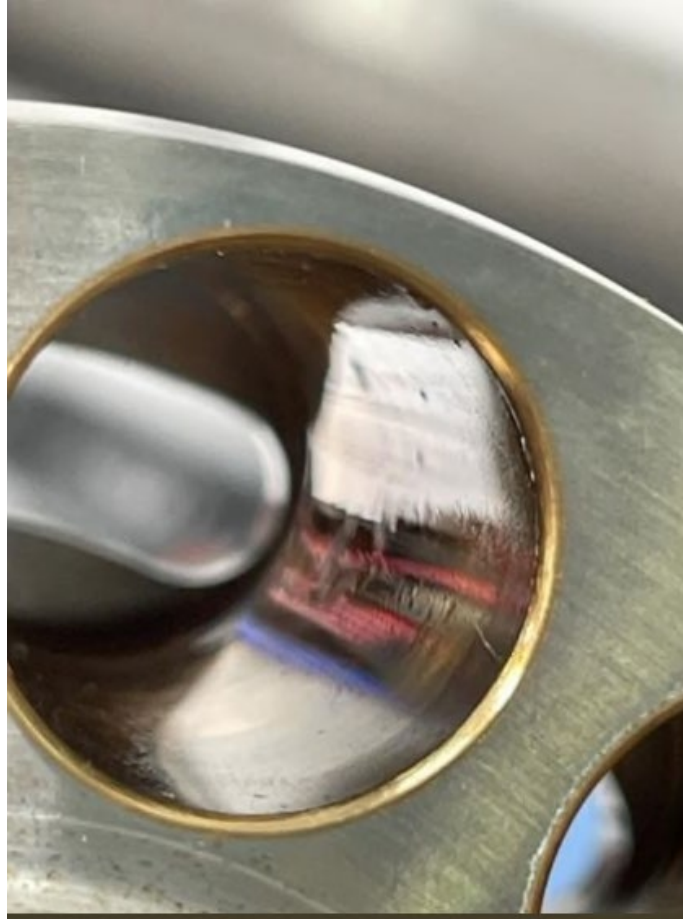
The variable block was also marked "CB-31773" to indicate that this block was repaired by an FAA-approved re-sleeving process. The etched serial number was Y13-78-32. The bores and sleeves showed minimal wear; none of the bores showed wear through the bushing to the cylinder block. See Figure 8. Each of the nine variable cylinder block pistons were examined; all were marked as manufactured by Collins, and all were marked as Size "1".

**Figure 8.** One of the variable cylinder block bores, showing minimal wear. (Photograph courtesy of Collins Aerospace)

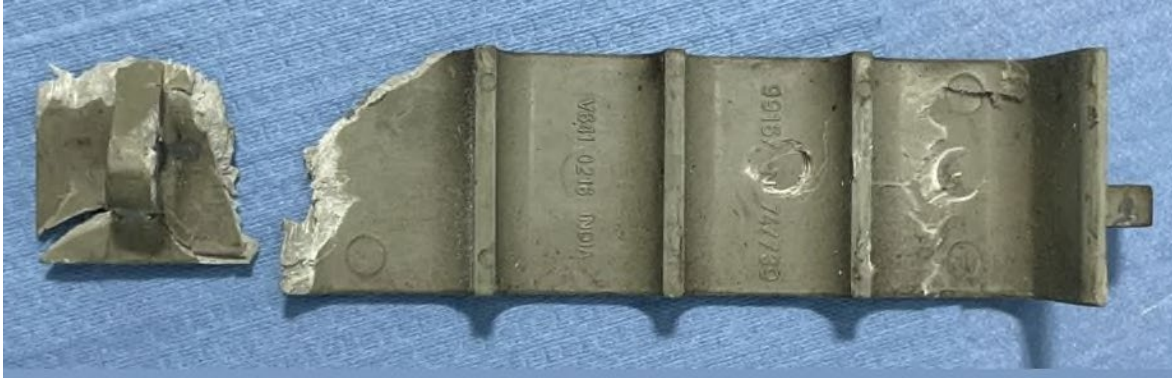
- The electrical connectors had plastic caps installed.
- A corner of the terminal block cover was broken off and the terminal block bracket beneath was heavily abraded and bent over. See Figure 10.

**Figure 10.** Damage to the terminal block. (Photograph courtesy of Collins Aerospace)

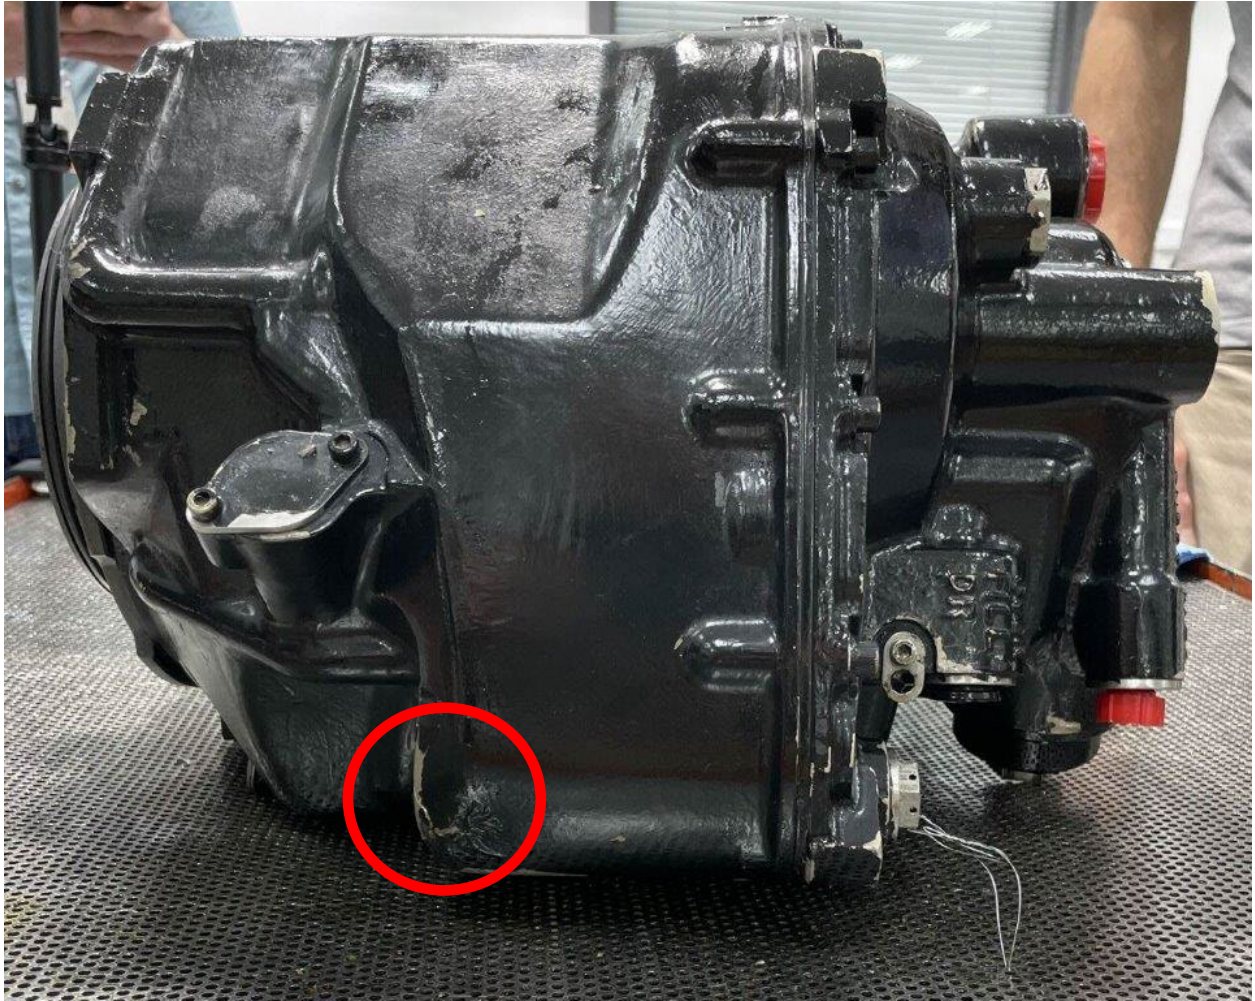
The IDG was prepared for the leak check by injecting pressurized air into the unit. When the air started, the group and test conductor heard an audible leak. A crack in the IDG was discovered on the lower input housing near the sump. See Figures 11 and 12.

**Figure 11.** View of the IDG housing with a crack, in the red circle. (Photograph courtesy of Collins Aerospace)

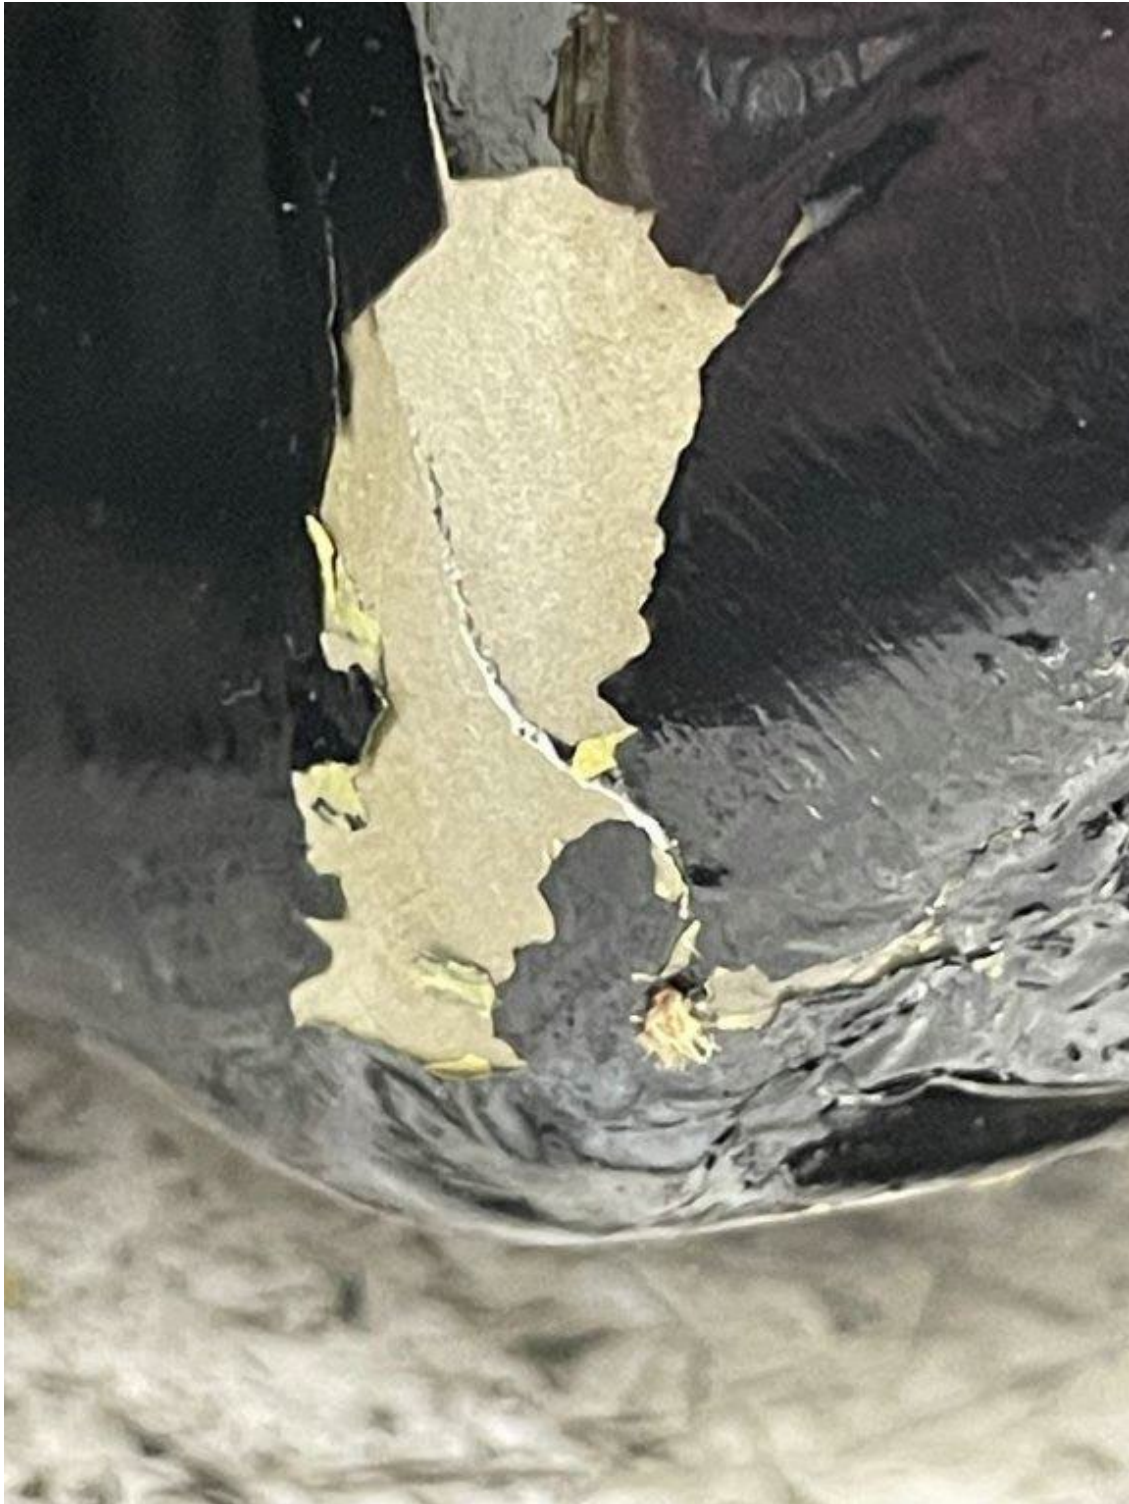
**Figure 12.** A close-up photograph of the crack found in the IDG housing.  
(Photograph courtesy of Collins Aerospace)

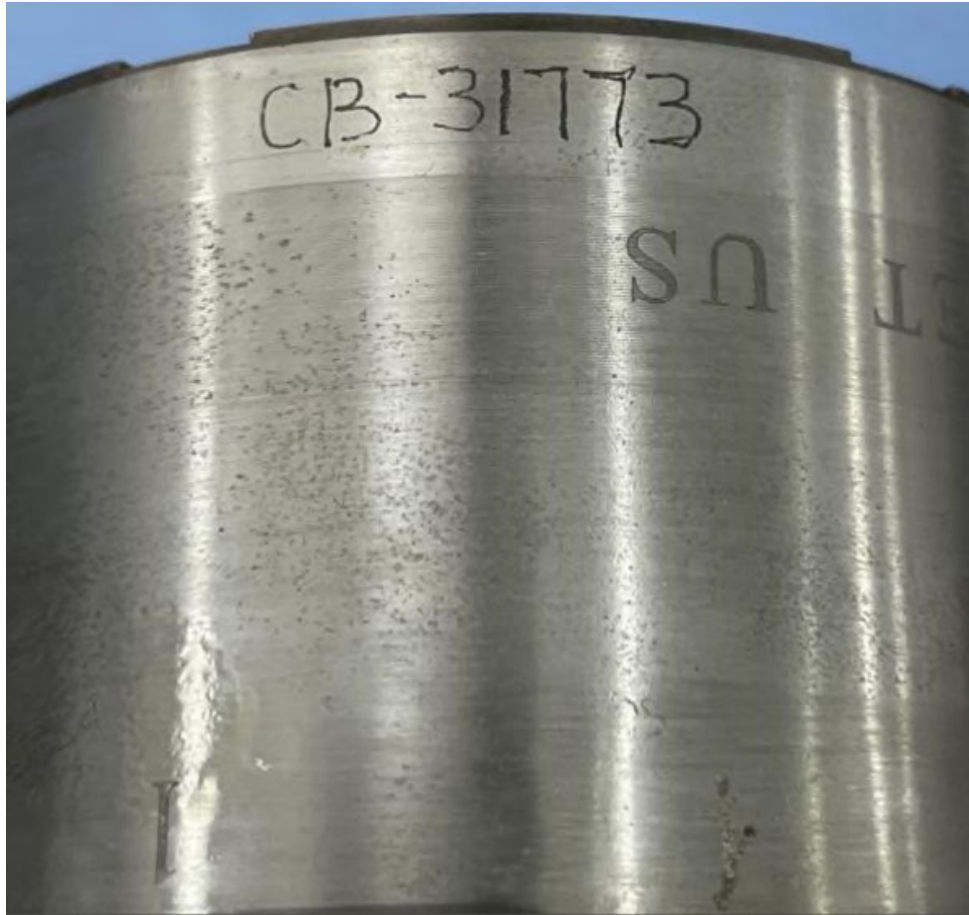
Once the hydraulic module was disassembled, the fixed cylinder block was examined. The fixed block exhibited the marking "CB-31773", indicating the block had been repaired by an FAA-approved re-sleeving process. See Figure 13. The block's serial number was noted as Y11-313-27. The nine pistons removed from the fixed block were manufactured by Collins and all were marked as Size "1".

**Figure 13.** Exterior of the number 2 IDG fixed cylinder block, showing the etched number corresponding to an FAA-approved block re-sleeving process. (Photograph courtesy of Collins Aerospace)

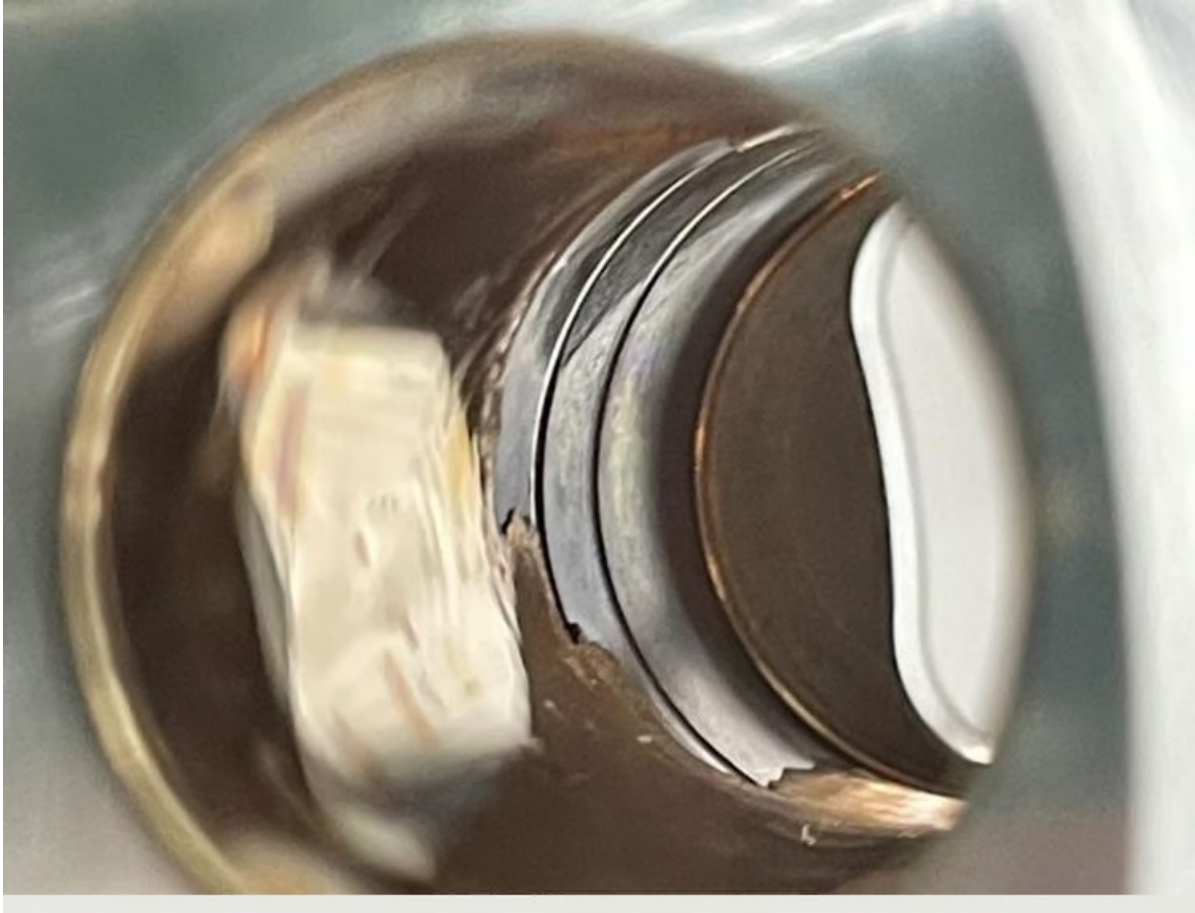
The fixed cylinder block's bores were examined. Each of the nine bores showed some wear spots through the bronze sleeves, with sections of the sleeve missing. Severe wear was noted at the bottom of all nine bores, with areas showing wear through to the cylinder block's substrate. The exposed areas of the block substrate appeared intact.

As an example, see Figure 14. The figure shows wear at the bottom of bore number 1.

**Figure 14.** Fixed cylinder block bore number 1, showing wear through the sleeve bushing to the cylinder block steel. (Photograph courtesy of Collins Aerospace)

The Collins air spindle tool was used to measure the diameter (the worn size) of each of the nine cylinder bores for the fixed and variable blocks. For the fixed block, the air spindle test showed each of the bores were worn beyond the measurable limits of the air spindle tool; by this method, each of the nine bore diameters were greater than Size "5". For the variable block, the air spindle measured each of the bores at Size "2".

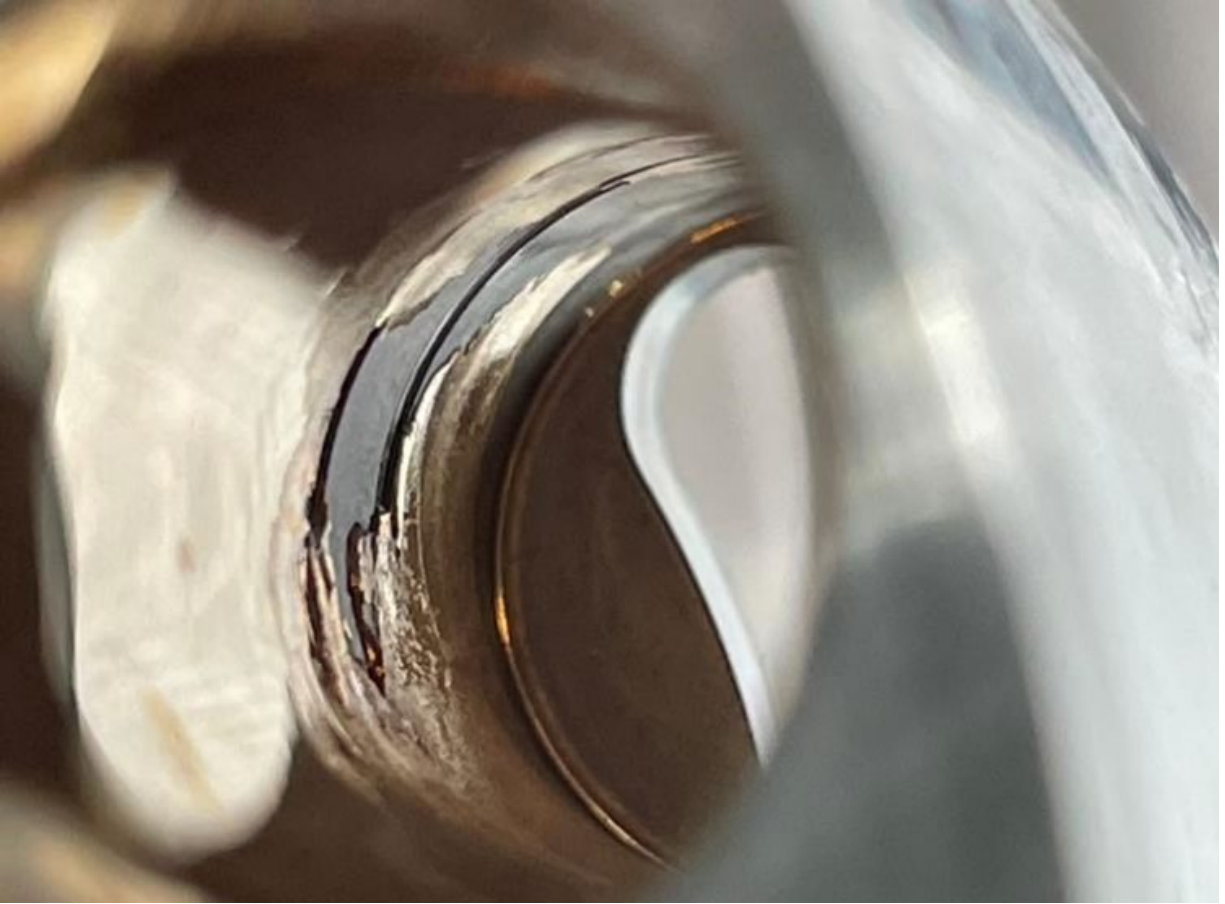
See Figure 15, noting the wear at the bottom of bore number 7.

**Figure 15.** Fixed cylinder block bore number 7, showing wear through the re-sleeved bushing to the cylinder block steel. (Photograph courtesy of Collins Aerospace)

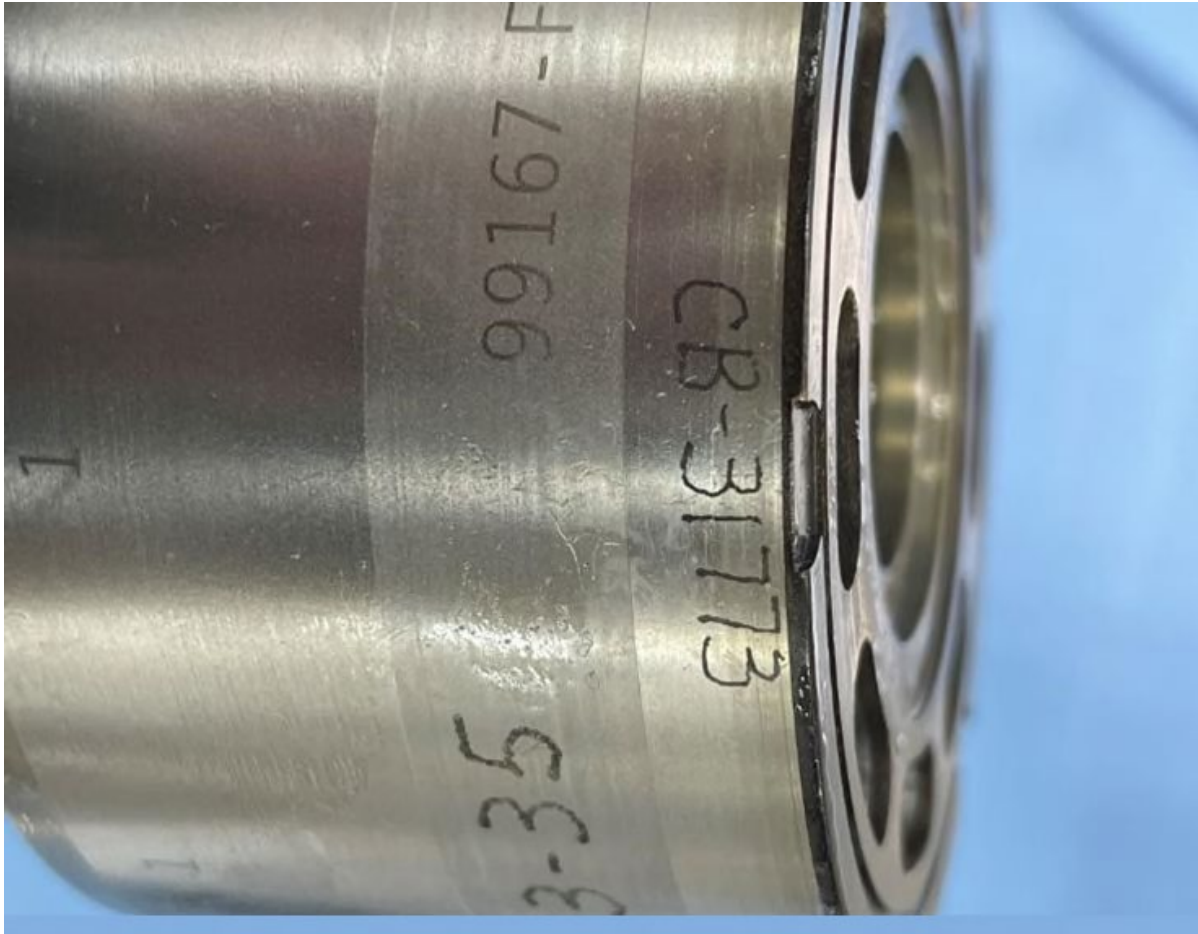
The variable block was also marked "CB-31773" indicating this block was modified by an FAA-approved re-sleeving process. See Figure 16. The etched serial number on the block's exterior was Y07-43-35. The bores and sleeves showed minimal wear; none of the bores exhibited wear through the bushing. As a comparison, see the minimal wear noted on variable block bore number 5, in Figure 17. The nine variable block pistons were removed from the block. All nine pistons were marked as manufactured by Collins and all were noted as Size "1".

**Figure 16.** Etching on variable block exterior indicating the block was modified by an FAA-approved re-sleeving process. (Photograph courtesy of Collins Aerospace)

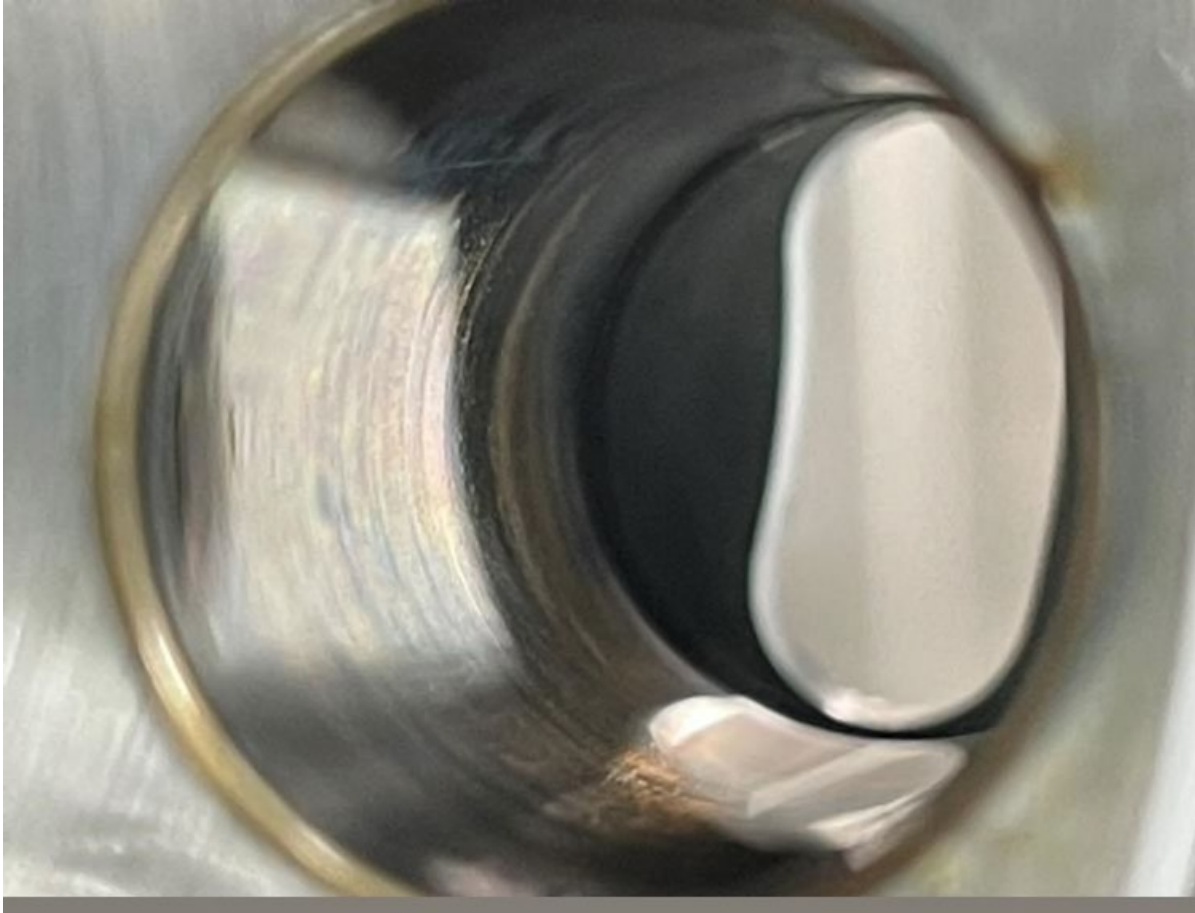
**Figure 17.** The bottom of variable block bore number 5, showing minimal wear. (Photograph courtesy of Collins Aerospace)
