# National Transportation Safety Board

ENG23LA034

## **POWERPLANT FACTUAL REPORT**

Location: Rochester, Minnesota  
Date: January 24, 2023  
Time: 1:42 central daylight time  
Airplane: Lancair Legacy, Registration Number N707MM

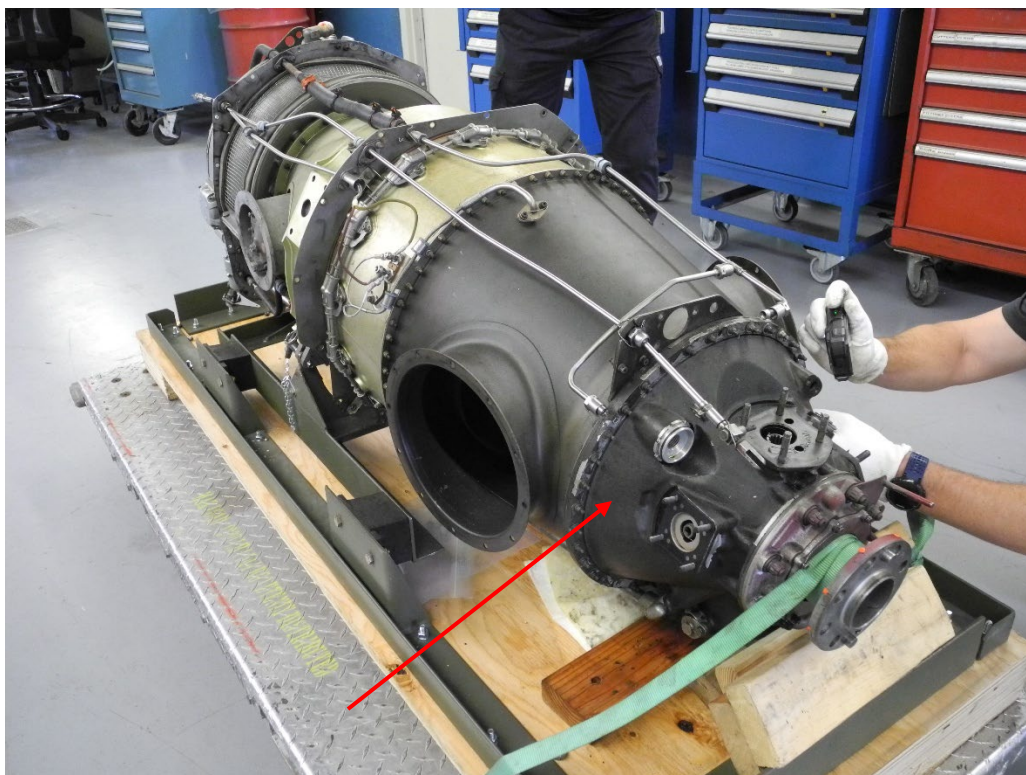
The front of the engine was not properly secured to the metal support frame with fasteners but rather was strapped to the frame. The engine (**Photo 2**) was intact; however, was in generally poor condition. The protective paint on the RGB was not present (**Photo 3**). The accessory gearbox (AGB) coating had flaked off on about 80% of the surface (**Photo 4**). There was surface corrosion noted on many external and internal parts.

**Photo 3** - PT6A-42 S/N 94119 - RGB Missing Silver Colored Protective Coating

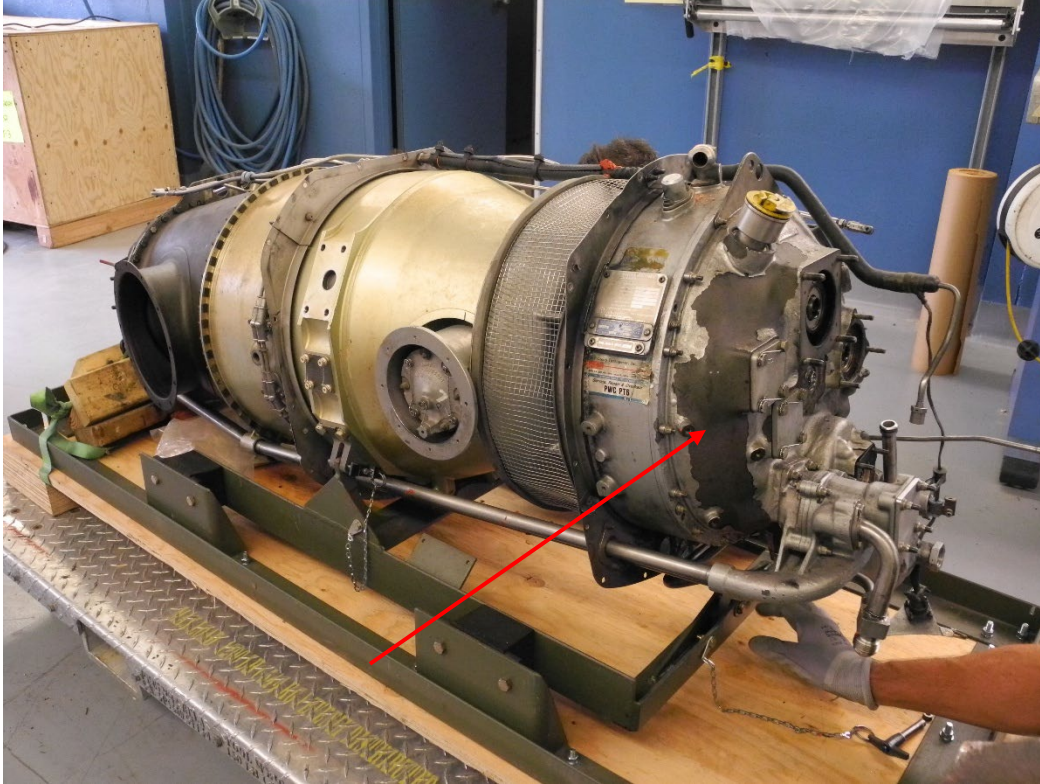
**Photo 4** - PT6A-42 S/N 94119 - AGB with Corroded and Missing Silver Colored Protective Coating

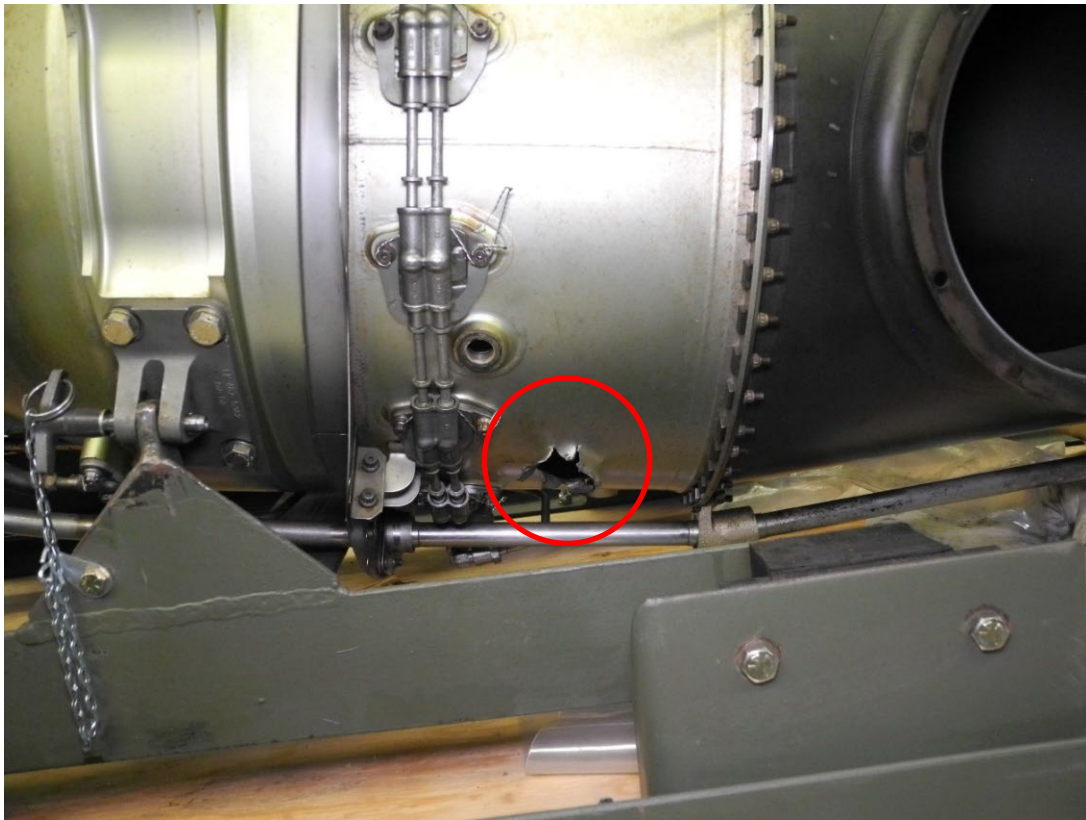
The GG case was intact; however, a hole, approximately 1-½ inches in diameter was observed at the 4:30 o'clock location<sup>1</sup>. The hole was in the plane just aft of the 2<sup>nd</sup> stage PT wheel and the case skin featured an outward petaling, consistent with a particle directional trajectory from inside out (**Photo 6** & **Photo 7**).

**Photo 6** - Hole in the GG Case

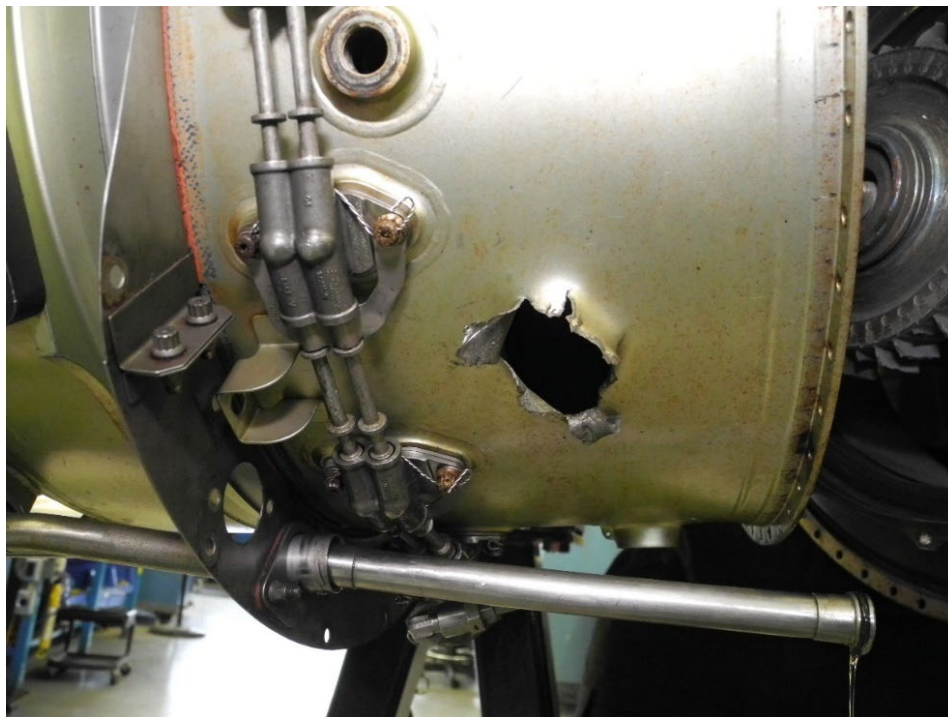
**Photo 7** - Details of Hole in GG Case - Note Petalling

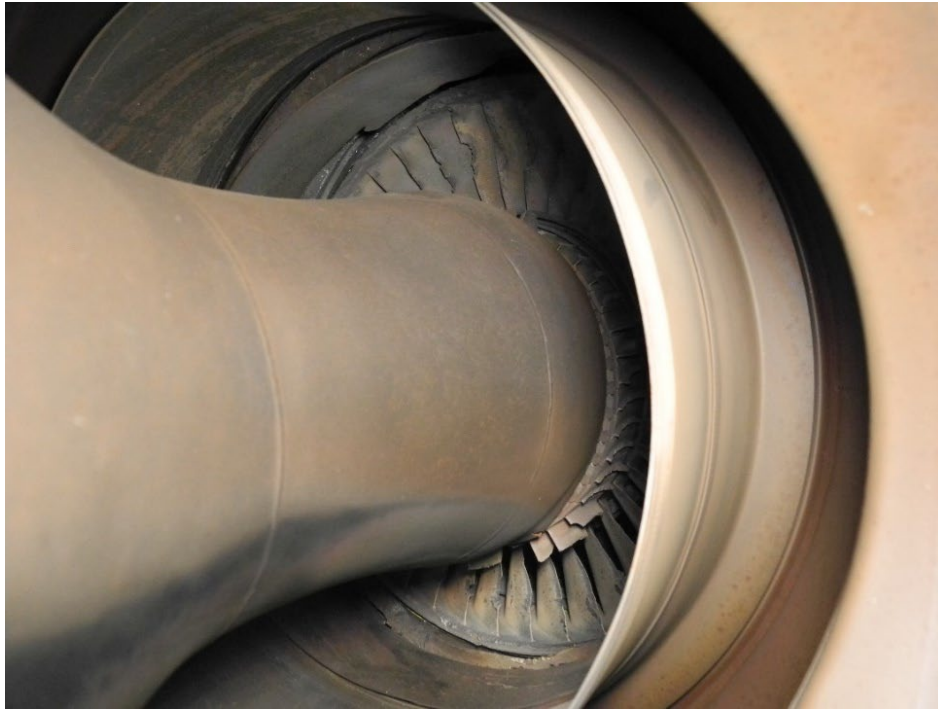
- All the blades of the 2<sup>nd</sup> stage PT were fractured near the root. The fracture surfaces of all the blades exhibited only evidence of tensile overload. The 2<sup>nd</sup> stage PT hub was intact.

The 2<sup>nd</sup> stage PT wheel, visible through the exhaust duct, was inspected revealing the loss of all the blades near the roots (**Photo 8**). The 2<sup>nd</sup> stage PT nozzle was intact; however, it was impact damaged.

**Photo 8** - 2<sup>nd</sup> Stage PT Wheel - All Blades Fractured

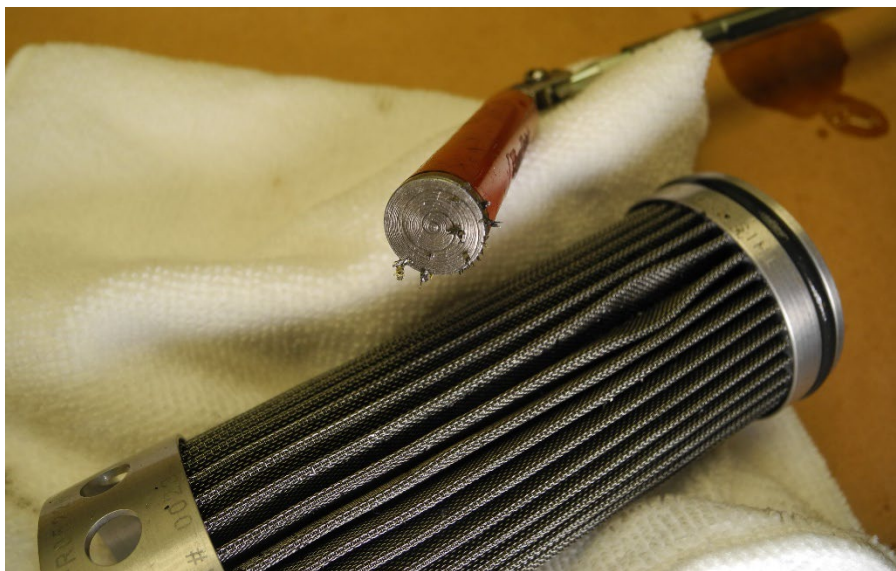
The oil tank was empty, and the drain plug was not present. Approximately 1 pint of oil was drained from the AGB. The RGB chip detector was not present. The oil filter was removed and examined, revealing many small magnetic chips (**Photo 9**).

**Photo 9** - Oil Filter and Magnet Containing Metal Chips

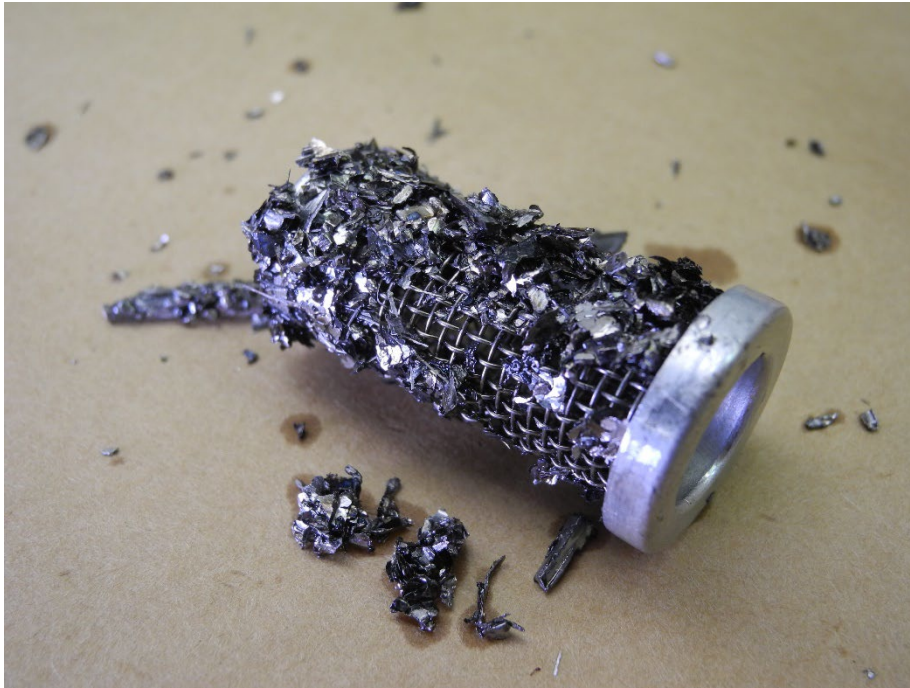
The RGB oil screen was filled with metal chips (**Photo 10**).

**Photo 10** - RGB Oil Screen - Heavily Contaminated with Metal Chips

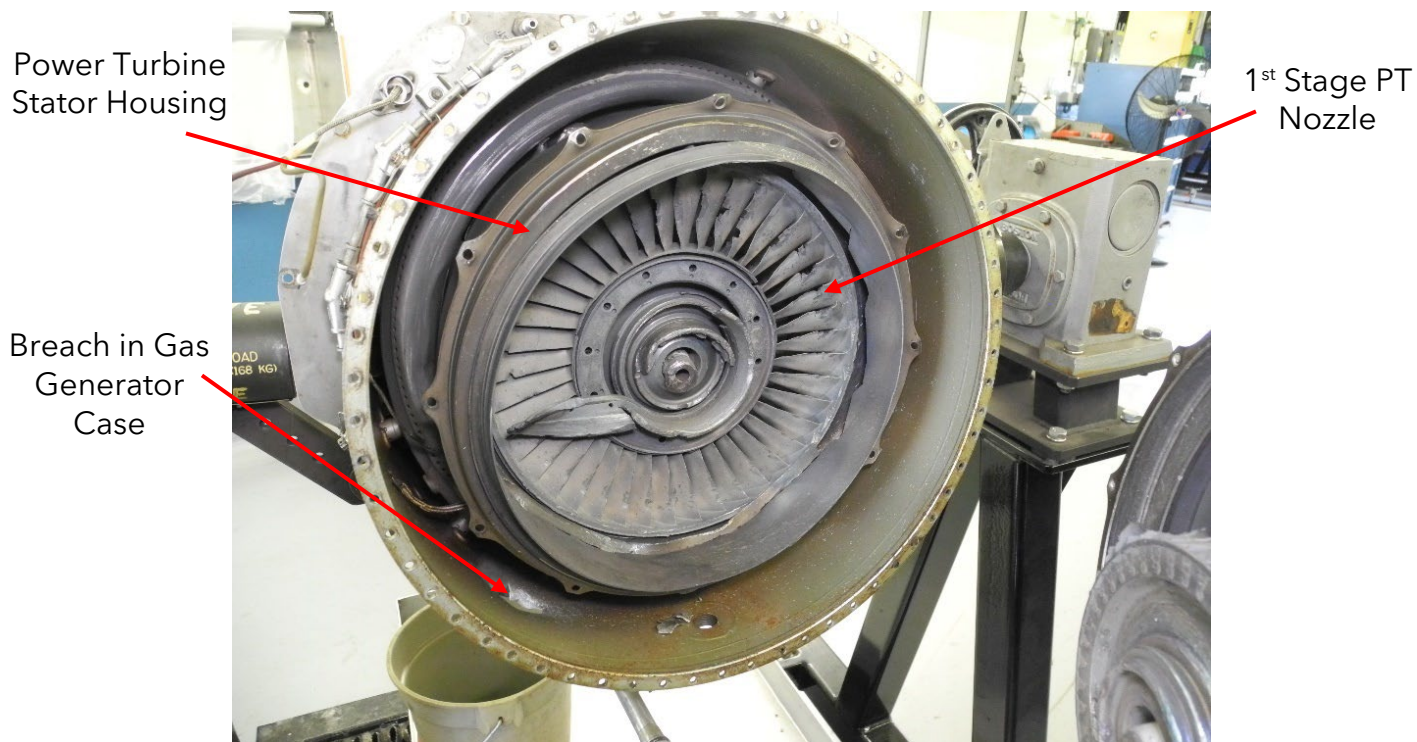
The 'C' flange was separated revealing fractures of all the 2<sup>nd</sup> stage turbine blades at the root. Only tensile overload features were observed on the fracture surfaces. The 2<sup>nd</sup> stage turbine hub was intact; however, it was thermally distressed, rotationally scored, and battered (**Photo 11**). The 2<sup>nd</sup> stage PT nozzle was deformed and thermally distressed. The PT stator housing (**Photo 12**) was deformed, internally battered and was breached at the 4:30 o'clock location (**Photo 13**) consistent with the breach location on the GG case.

**Photo 11** - Engine Split at 'C' Flange Revealing Damage to PT Rotors and Nozzles

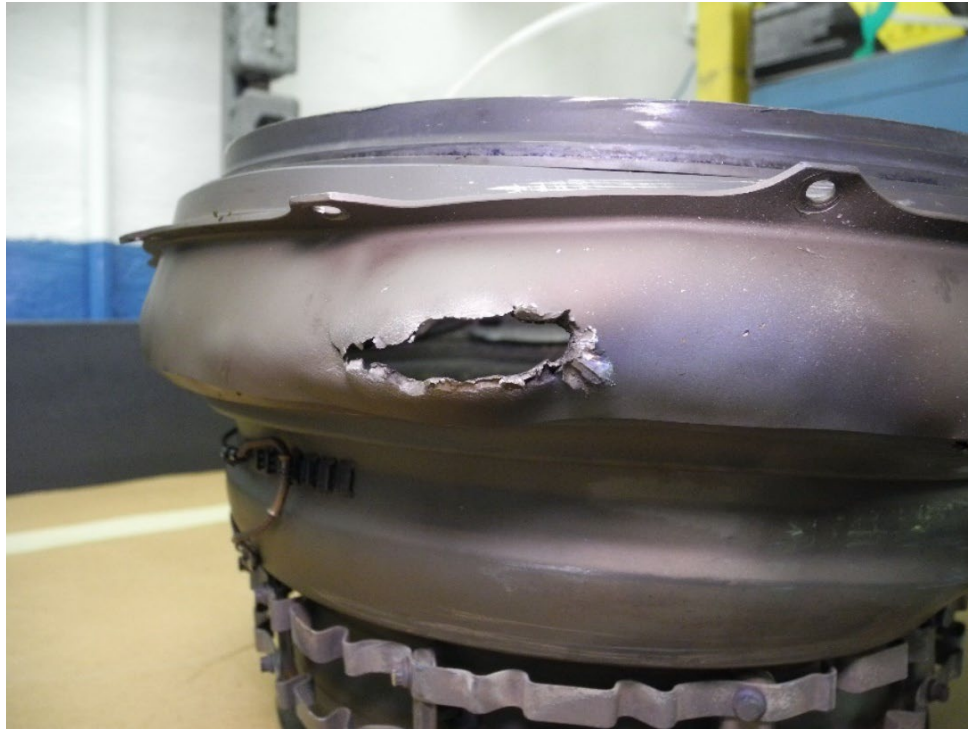
**Photo 13** - Power Turbine Stator Housing - Breach in 2<sup>nd</sup> Stage PT Plane

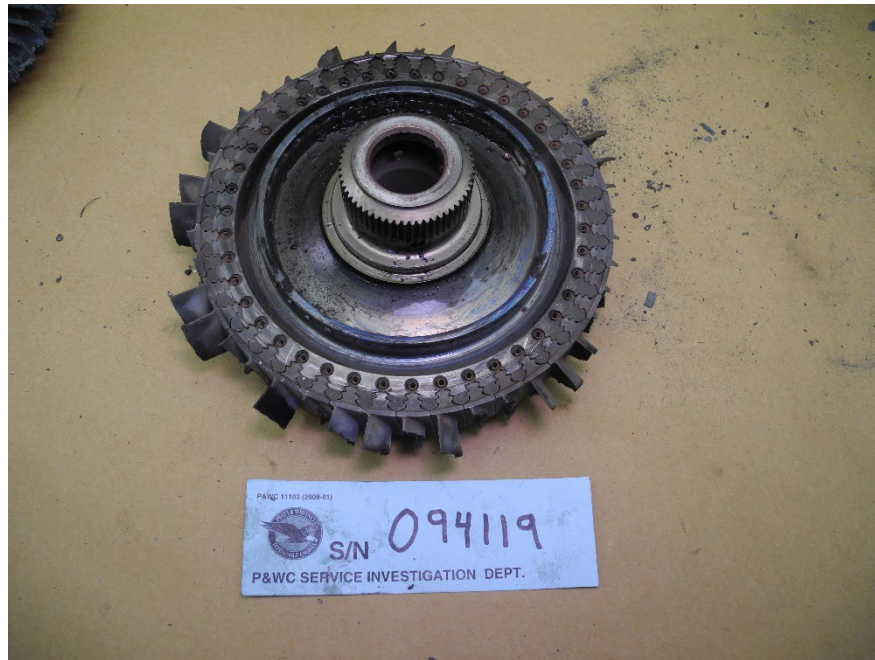
- All the blades of the 1<sup>st</sup> stage PT were fractured at various span heights. The fracture surfaces of all the blades exhibited only evidence of tensile overload. The 1<sup>st</sup> stage PT hub was intact.

All the 1<sup>st</sup> stage PT blades were fractured at varying span lengths (**Photo 14**). The 1<sup>st</sup> stage rotor hub was intact; however, it was battered and thermally distressed. The drive spline was intact and undamaged.

**Photo 14** - 1<sup>st</sup> Stage PT Rotor

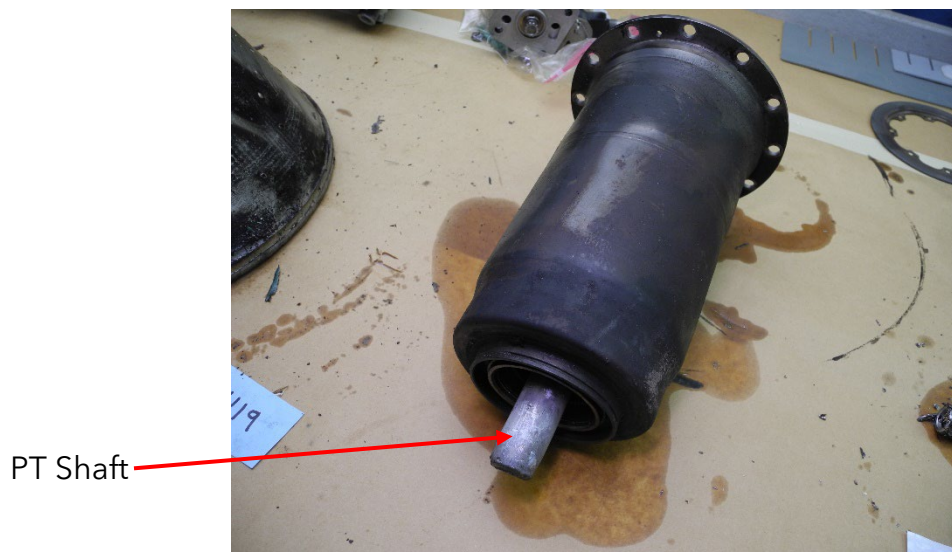
**Photo 15** - PT Shaft Housing

The PT shaft housing (**Photo 15**) was intact; however, the No. 3 bearing support was deformed and skewed. The Nos. 3 and 4 bearings were undamaged and oil wetted. The PT shaft was twisted, fractured, deformed and impact damaged (**Photo 16**).

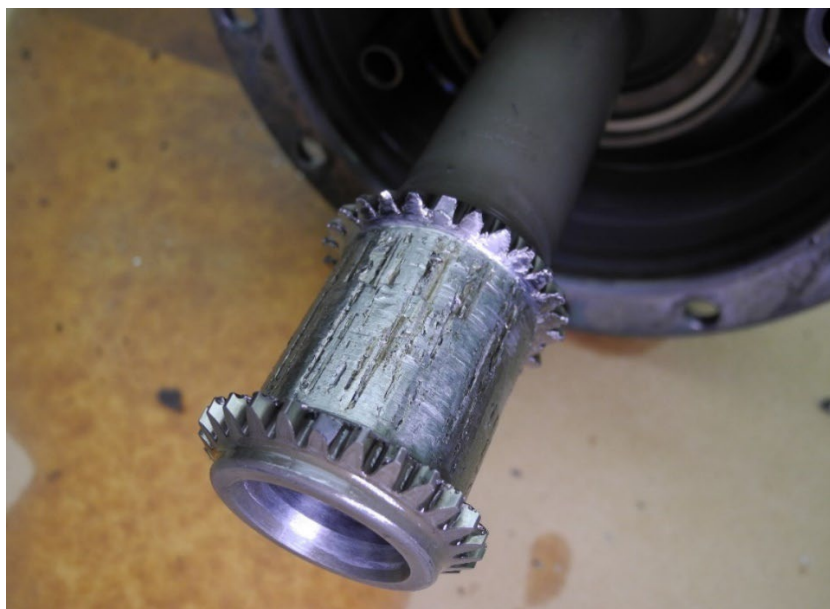
- The teeth of the reduction gearbox (RGB) 1<sup>st</sup> stage sun gear were entirely missing in the plane of the mating gear teeth of the 1<sup>st</sup> stage planet gears. The gear teeth of the three planet gears were also battered and fractured.

The 1<sup>st</sup> stage reduction sun gear shaft gear teeth were ground away in the location of the mesh plane of the planetary gears (**Photo 17**).

**Photo 17** - 1<sup>st</sup> Stage Sun Gear - Teeth Ground Away

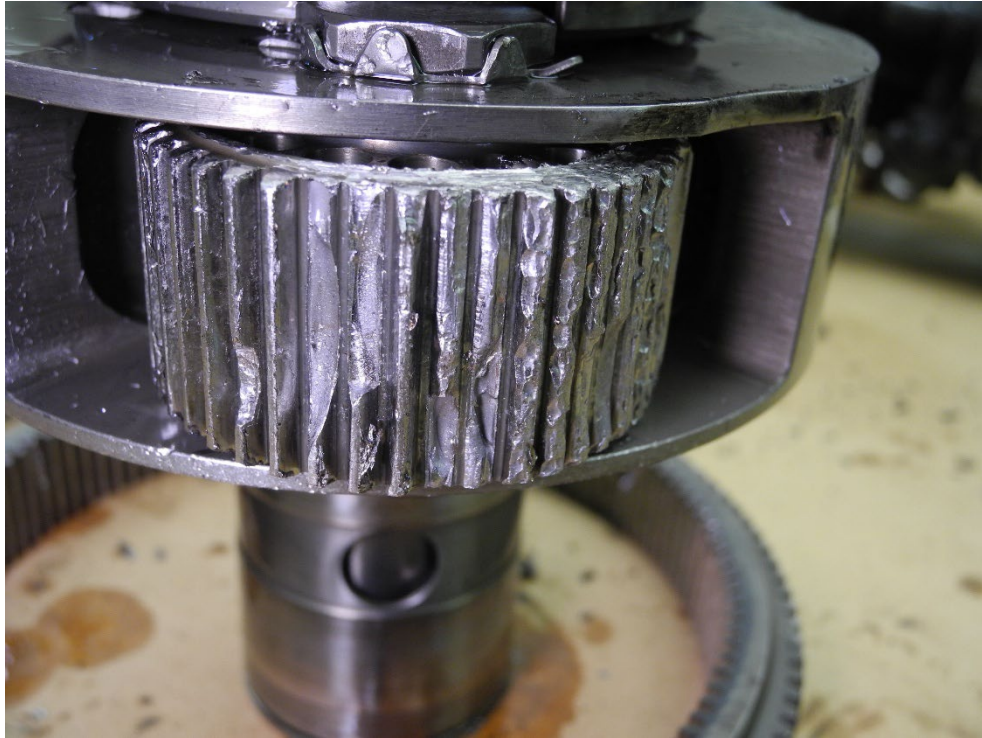
The gear teeth of the three planet gears were heavily spalled, and damaged (**Photo 18** & **Photo 19**). All the parts were oil wetted.

**Photo 18** - Spalled, Fractured and Deformed Planet Gear Still Installed in the Carrier

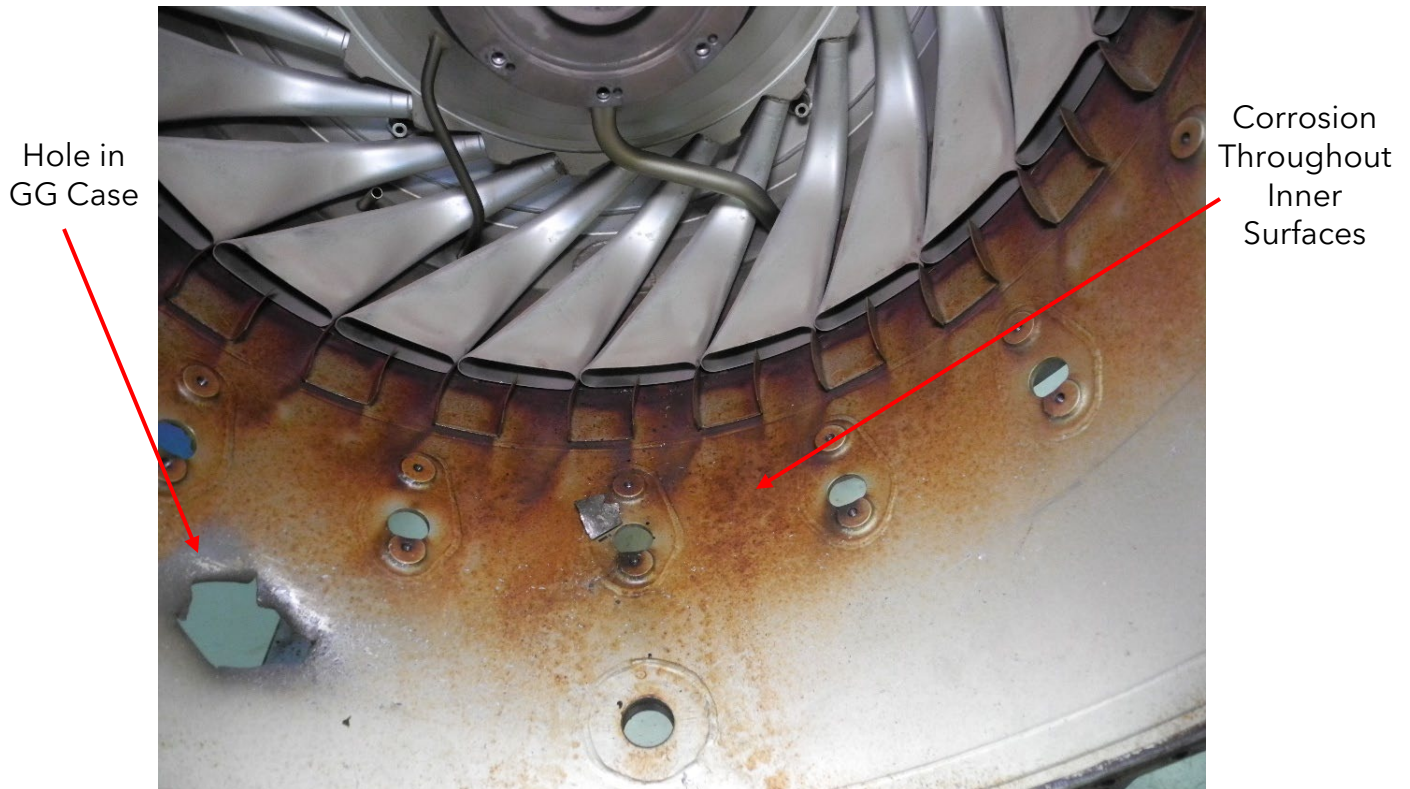
The GG case was intact; however, it had a hole, approximately 1-½ inches in diameter at the 4:30 o'clock location in the plane of the 2<sup>nd</sup> stage PT. The inner surface of the case just forward of the diffuser pipes was corroded (**Photo 22**).

**Photo 22** - Hole in GG Case - Inside View

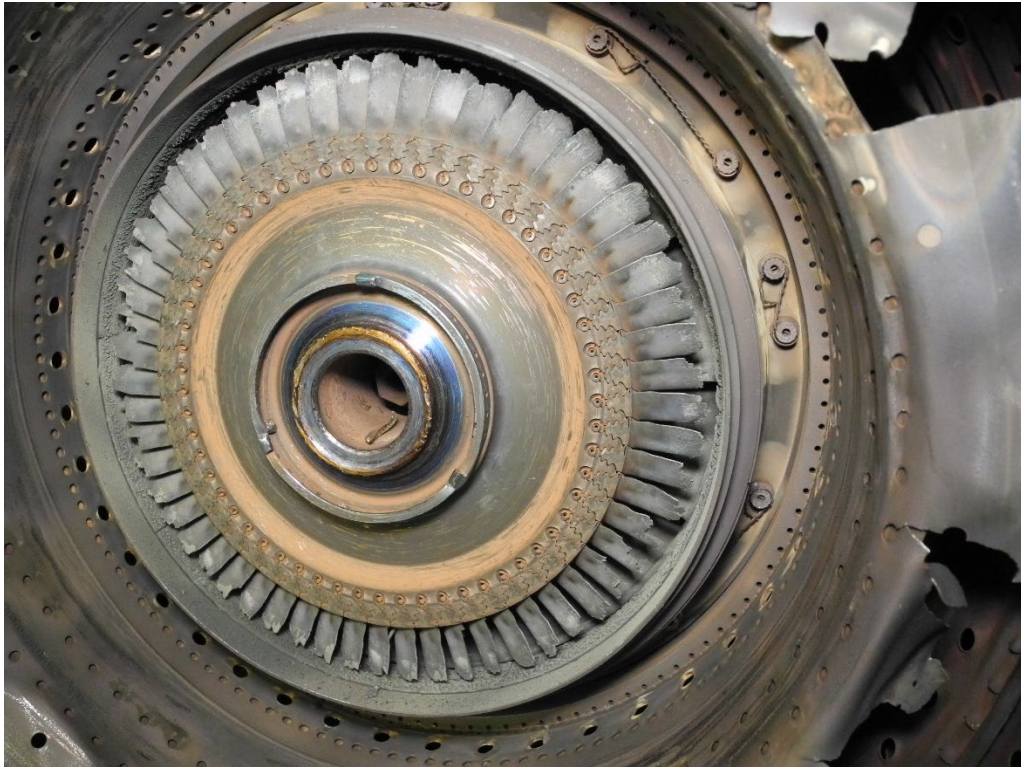
- All the compressor turbine (CT) blades were present; however, they were thermally eroded at the tips. The CT hub was intact.
- The fuel control unit (FCU) was tested and was very close to nominal production calibration.

The CT was intact; however, the blade tips were all thermally eroded (**Photo 23**). The CT shrouds exhibited a thick layer of metal deposit (**Photo 24**), consistent with liberated material from thermally distressed CT blades. The CT nozzle was intact and consistent with an operational condition.

**Photo 23** - CT - In-situ

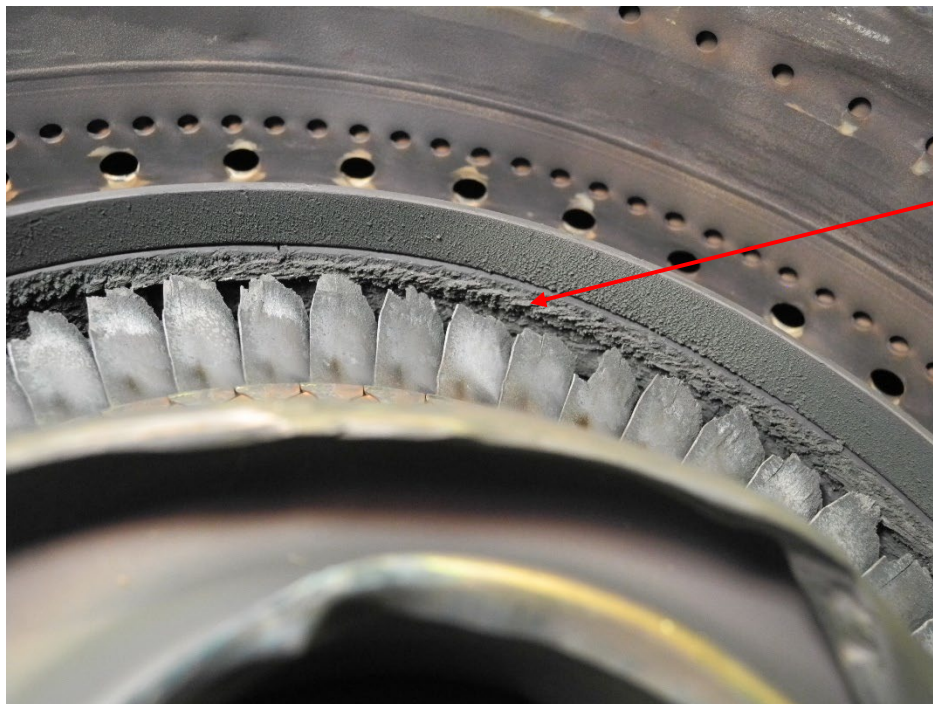
Re-Solidified  
Metal  
Deposits on  
the Shroud

**Photo 24** - CT Shroud - Coated with Re-Solidified Metal Deposits

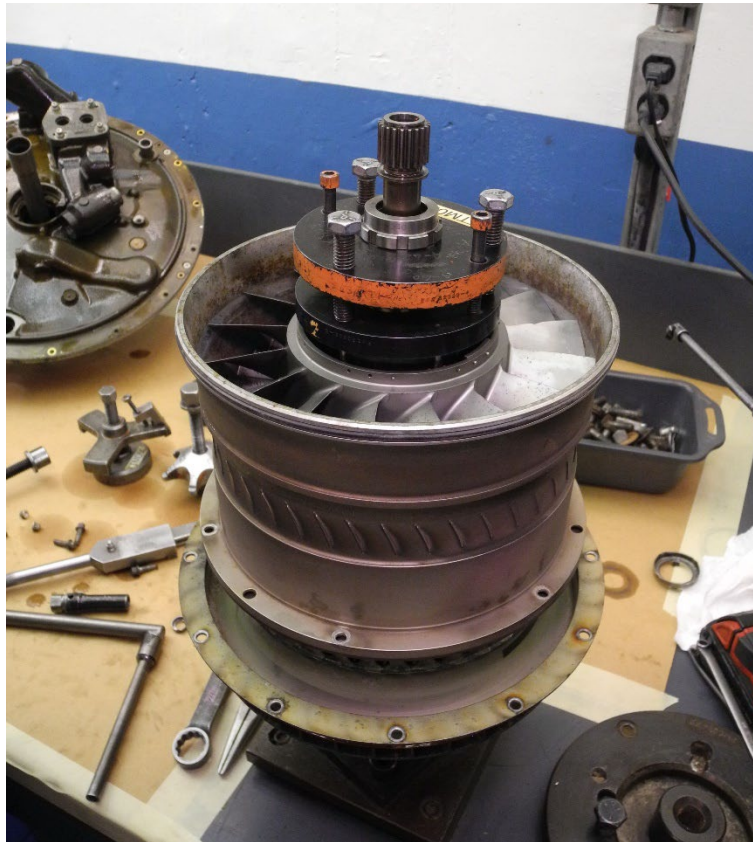
The compressor housing was intact and undamaged. The compressor stack (**Photo 25**) was intact and undamaged; however, it was extremely dirty and surface corrosion was noted throughout (**Photo 26**). It was noted that rubbing of the axial compressor blades tips against their shrouds caused a cleaning of the surface corrosion, consistent with the corrosion being present during the operation of the engine. All axial rotors and stators were intact.

**Photo 25** - Compressor Stack - Intact but Dirty and Corroded Surfaces

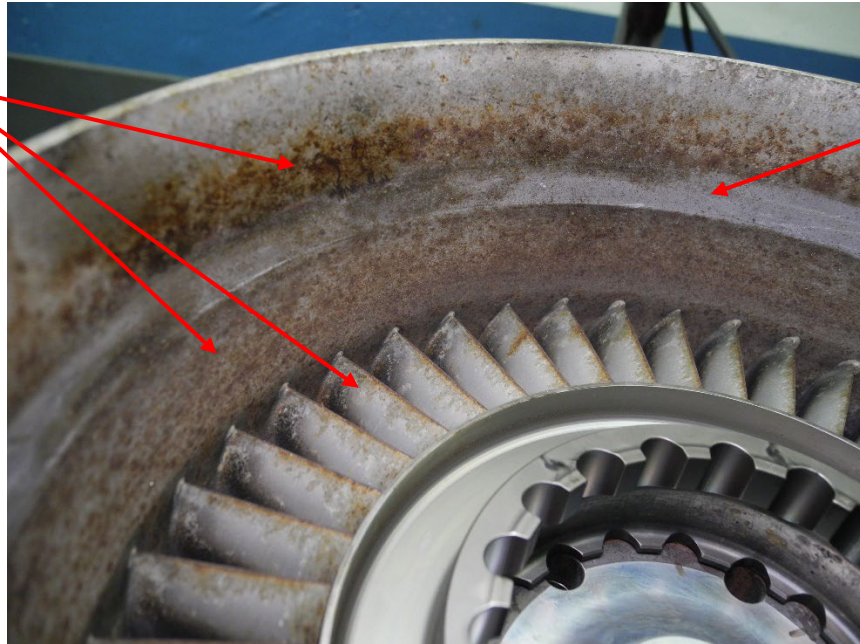
Heavy  
Surface  
Corrosion on  
Shrouds and  
Compressor  
Blades

Rubbing of the  
Compressor  
Blades  
Cleaned some  
of the  
Corroded  
Surfaces

**Photo 26** - 2<sup>nd</sup> Stage Compressor Blades and Housing

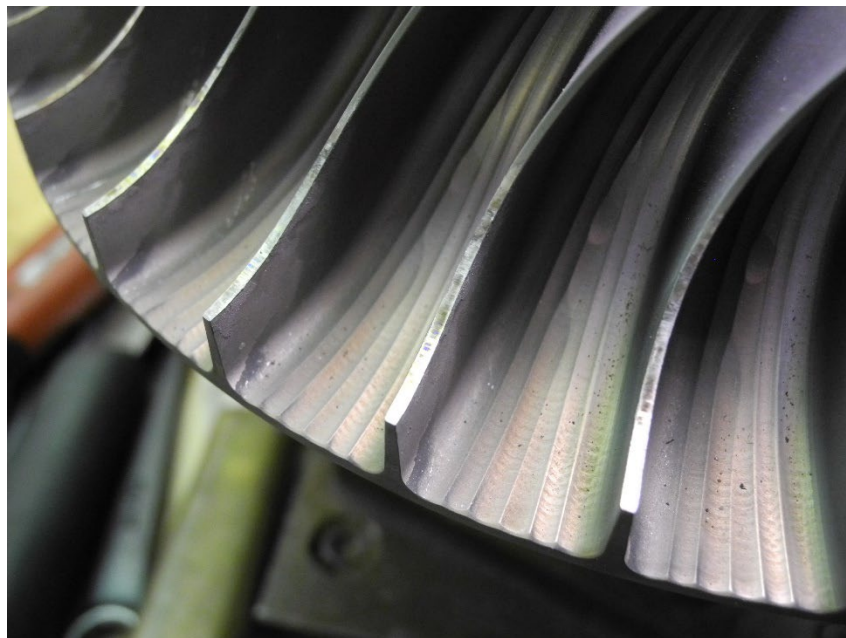
The centrifugal compressor impeller was intact; however, the vane shroud lines were rotationally scored, consistent with contact against the impeller shroud during operation (**Photo 26**). The impeller shroud was rotationally scored, predominantly near at the exducer (**Photo 27**).

**Photo 27** - Impeller Vanes Shroud Lines - Rotationally Scored

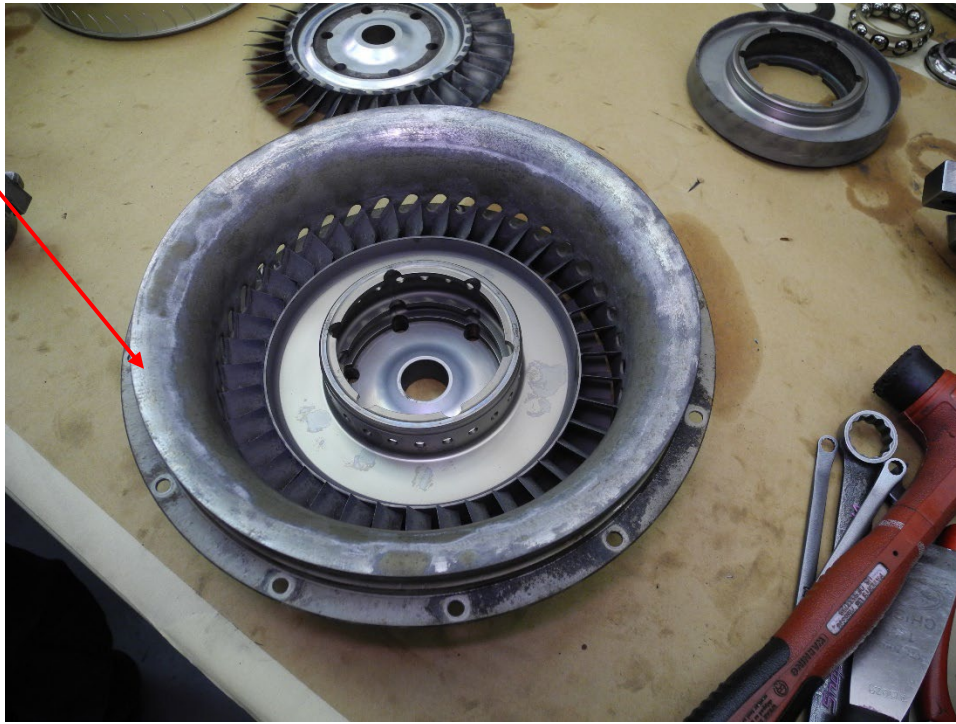
Rotational  
Scoring  
near the  
Exducer

**Photo 28** - Impeller Shroud - Rotational Scoring near Exducer End
