## **ALERT SERVICE BULLETIN**

**407-24-134**

**MODEL AFFECTED:** 407

**SUBJECT:** Tailboom Attachment Hardware and Fittings, Inspection of

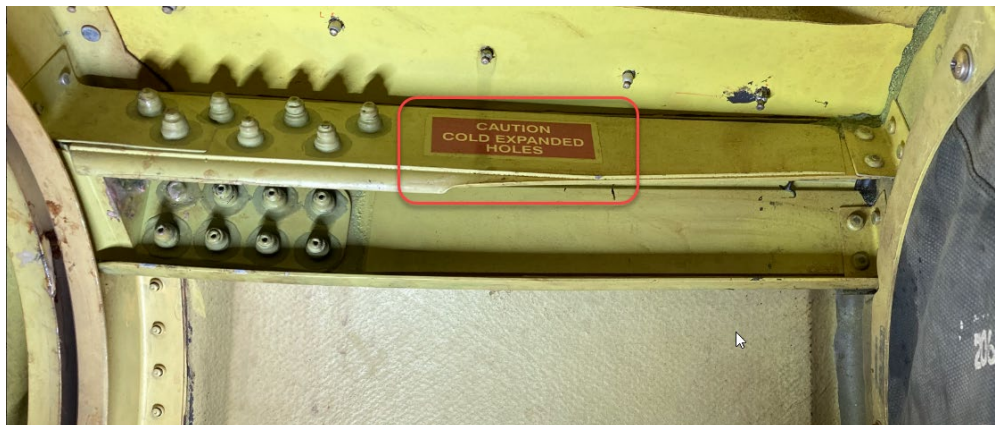
**Figure 2 – Upper Left Longerons 206-031-314-237  
“CAUTION COLD EXPANDED HOLE” decal**

407 S/N: 53001 through 54061 did not have the 206-031-314-237 longeron assembly installed from factory with the "Caution Cold Expanded Holes" decal as shown in Figure 2. If the decal "Caution Cold Expanded Holes" is present on upper left longeron as shown in Figure 2 (Analog 407 prior to S/N: 54062), the longeron assembly was field replaced per the above Technical Bulletins.

1. Prepare the helicopter for maintenance.
2. Review the helicopter technical records to determine if the upper left longeron assembly was replaced in the field in accordance with TB 407-12-96 or TB 407-17-125 or if it is still the original that was installed in production.
3. If in doubt, accomplish **PART II** of this bulletin.
4. If the upper left longeron assembly was replaced in the field as per TB 407-12-96 or TB 407-17-125 proceed with **PART II**.
5. If the upper left longeron assembly was installed in production, proceed with **PART III**.
6. All spare longeron assemblies part numbers 206-031-314-237B and 206-031-314-237S shall not be installed and must be sent back to Bell using the New Part Return process.
7. Make an entry in the helicopter logbook and historical service records indicating compliance with **PART I** of this Alert Service Bulletin.

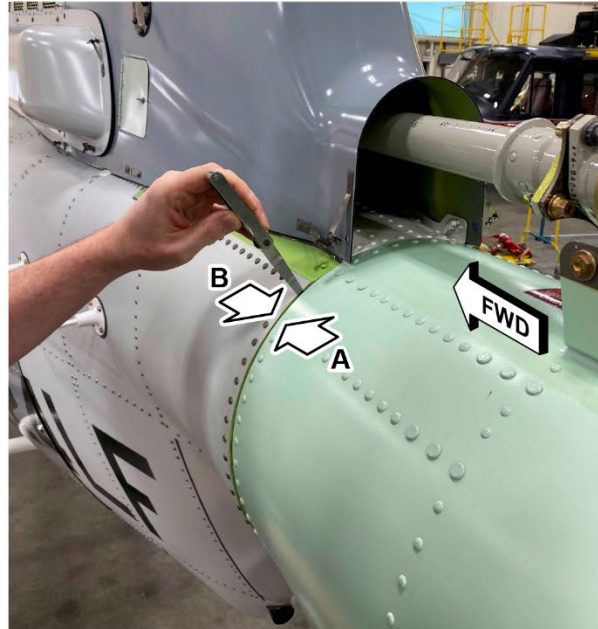
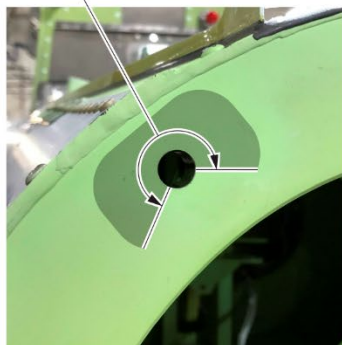
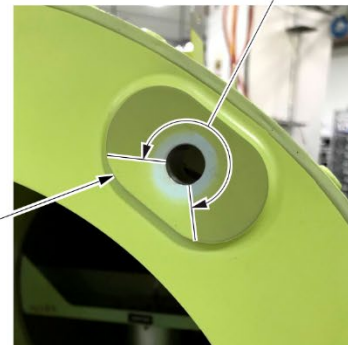
**Figure 3 - Gap check at the upper left tailboom attachment interface with tailboom and hardware installed.**

1. From the left side of the fuselage, using a strong light source and a feeler gauge, inspect for a gap at the upper left attachment interface between the aft fuselage and the tailboom. The entire tailboom forward bulkhead machined / hot bonded shim surface must be in contact with the aft fuselage bulkhead. Figure 3 shows the inspection area for possible gap between the machined / hot bonded shim and the

aft fuselage bulkhead. If a 0.003 inch (0.076 mm) feeler gauge or thicker can be inserted in the joint up to the bolt shank, contact Product Support Engineering for further instructions.

1. View A and B show the inspection area for possible gap.

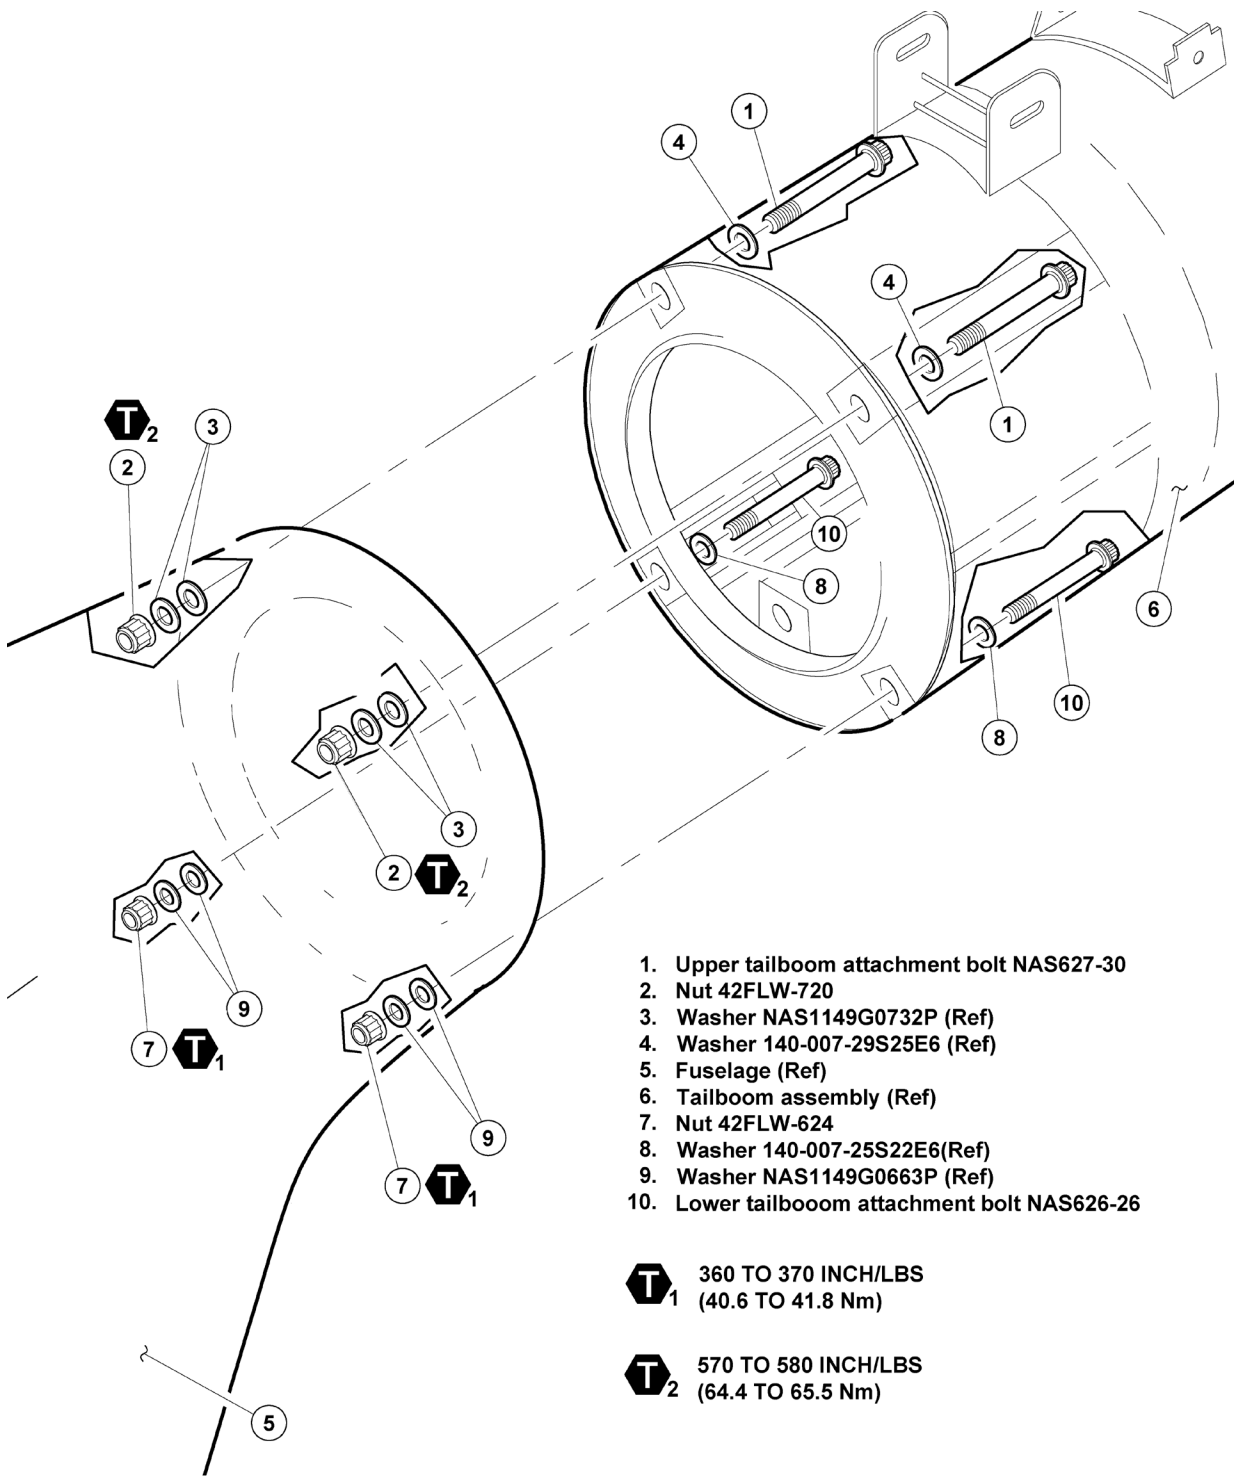
**Figure 4 Tailboom Attachment Hardware**

The torque values of the upper and lower nuts (2 and 7, Figure 4) are different. Refer to Figure 4 for the specified torque values.

For torque check purposes, the assembly torque to be applied is the minimum specified torque, plus the minimum acceptable tare torque of 14 inch-pounds (1.58 Nm) for the upper nuts and 9.5 inch-pounds (1.07 Nm) for the lower nuts (BHT-ALL-SPM, Chapter 2, Standard Practices Manual).

- e. Do a torque check of the 3 remaining tailboom to the aft fuselage attachment nuts (2 and 7, Figure 4) ([DMC-407-A-53-01-00-00A-720A-A](#)).
  - (1) If a nut fails the torque check, replace the affected bolt(s) and nut(s) with new bolt(s), nut(s), and washer(s) as applicable. Retain removed hardware for further investigation by Product Support Engineering.
    - (a) Refer to ([DMC-407-A-53-01-00-00A-720A-A](#)) for hardware installation procedures.
- f. After final torque is applied, apply corrosion preventive compound (C-586) to the head of the bolt, washers, nut, and the exposed threads.
- g. After 1 to 5 flight hours, perform the Tailboom Attachment Hardware Torque Check special inspection at every location where new hardware was installed

5. Do a torque check of the tailboom to the aft fuselage attachment nuts (2 and 7, Figure 4) ([DMC-407-A-53-01-00-00A-720A-A](#)).
  - a. If a nut fails the torque check, replace the affected bolt(s) and nut(s) with new bolt(s), nut(s), and washer(s) as applicable. Retain removed hardware for further investigation by Product Support Engineering.
