## Equipment Quality Analysis Report

**EQA NUMBER:** AS13704

**MODEL NUMBER:** 767-300F

**SUBJECT:** *Left Engine Fire During Initial Climb*

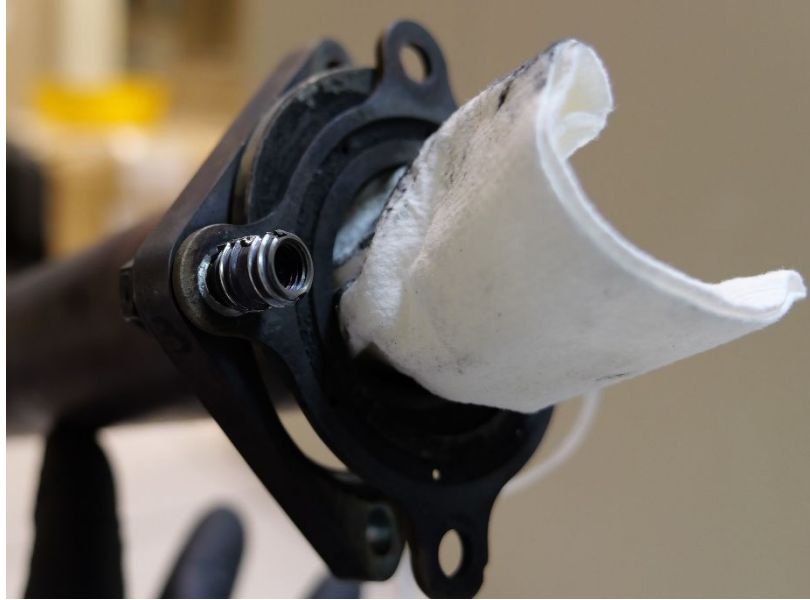
**Figure 5:** Flanged end of the hose with gasket and insert as received

On December 15, 2023, prior to the examination date, Boeing ASI requested that EQA open the container to ensure that the gasket on flanged end of the hose was received. EQA opened the container and verified the presence of the gasket. It was secured to the hose by a bolt still engaged within a threaded insert, and a zip tie; see Figure 3 through Figure 5.

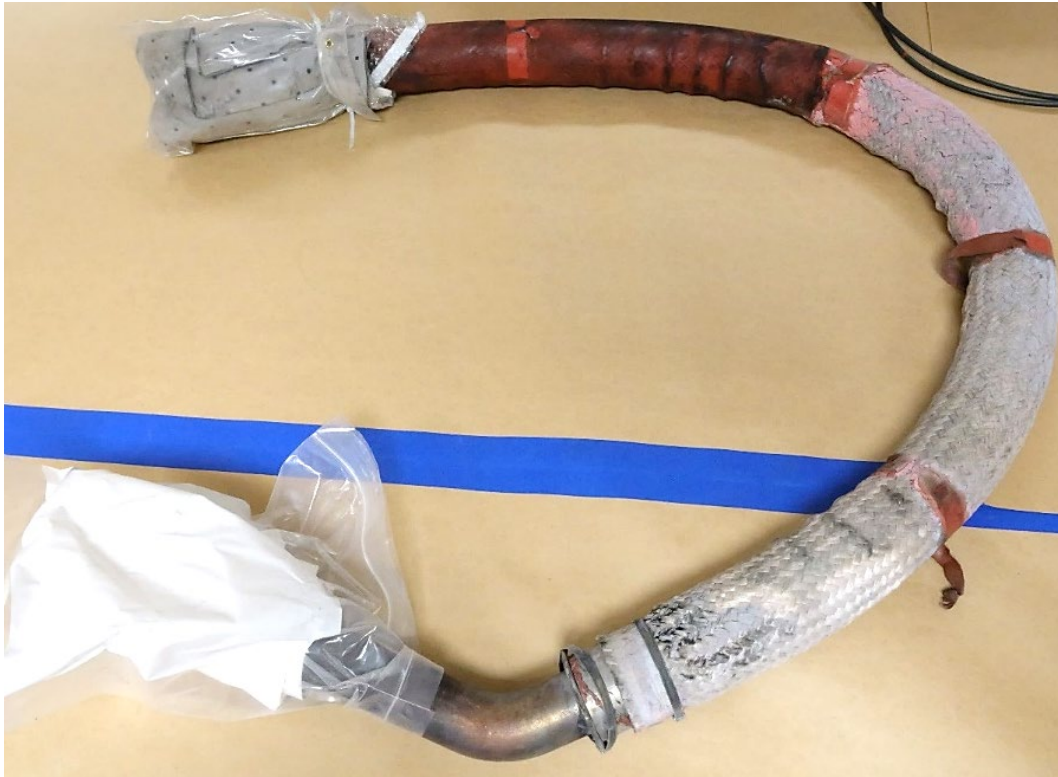
**Figure 6:** Overview of hose assembly

The hose assembly was removed from the container and images were taken capturing the overall condition. The hose had a set curvature, and both ends were sufficiently protected with absorbent pads, covered with plastic bags and secured with zip ties. It was also noted that slightly over half of the orange-colored, outer silicone rubber layer of the fire sleeve was missing. This exposed the woven fiberglass layer, which was covered in soot; see Figure 6.

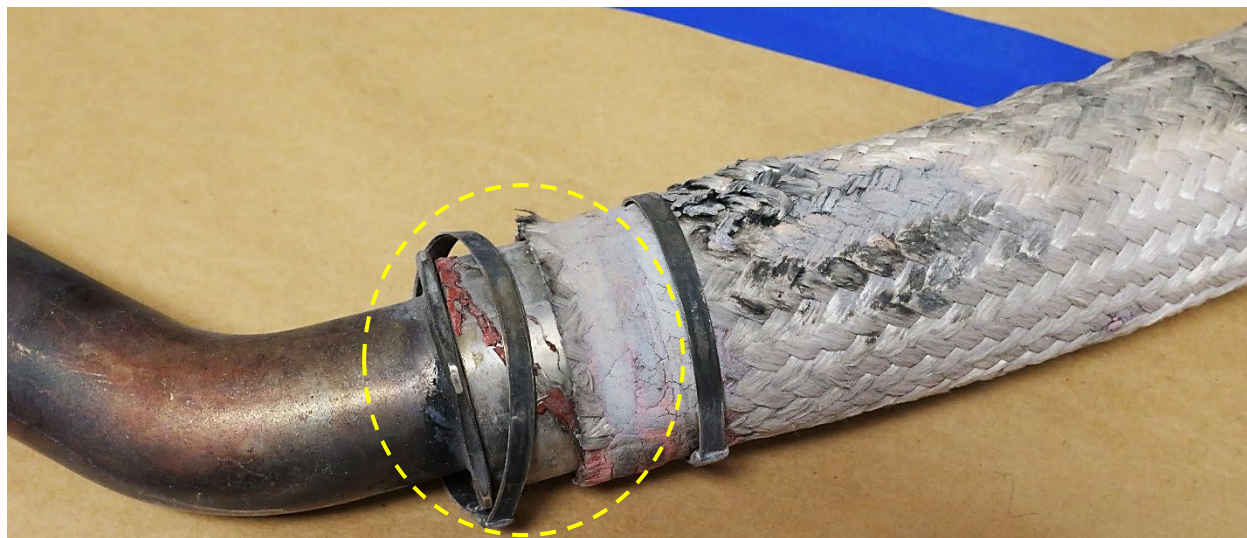
**Figure 9:** Fire shield at tube end of hose

The fire sleeve was slightly pulled away from the tube end of the hose assembly. The fire sleeve was noted to be in an expected condition, following a heating event; see Figure 9.

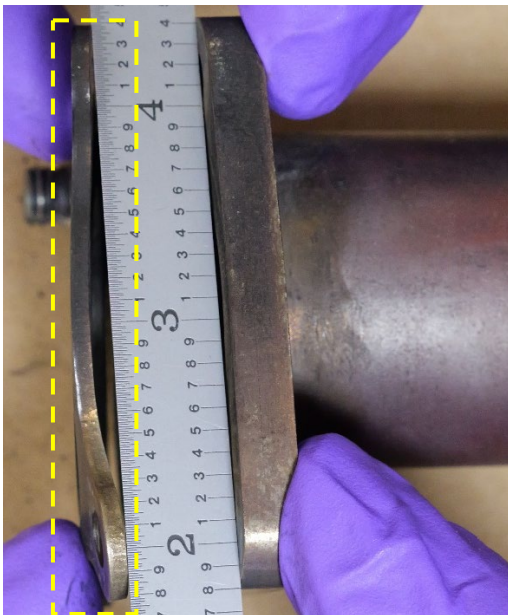
The gasket was held on by one remaining bolt still engaged within a threaded insert. The gasket was notably warped. Images were taken showing the warpage next to a scale as a visual aid only; see Figure 13 and Figure 14.

**Figure 13:** Gasket warped (between holes 1-4)

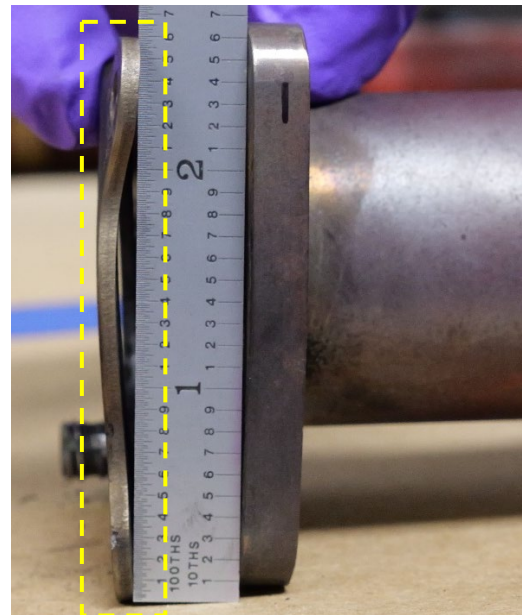
**Figure 14:** Gasket warped (between holes 1-2)

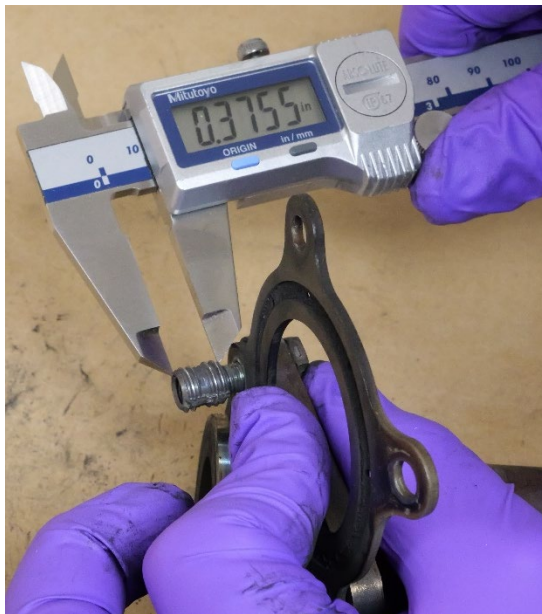
**Figure 15:** Threaded insert length measured

The threaded insert on the remaining bolt measured 0.375 inch in length; see Figure 15.

The bolt had approximately 0.25 inch of thread engagement within the insert. No evidence of tooling, or witness marks were found on the surface of the insert.

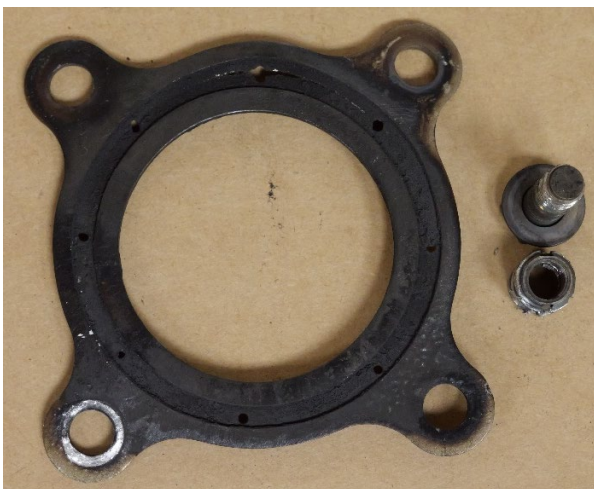
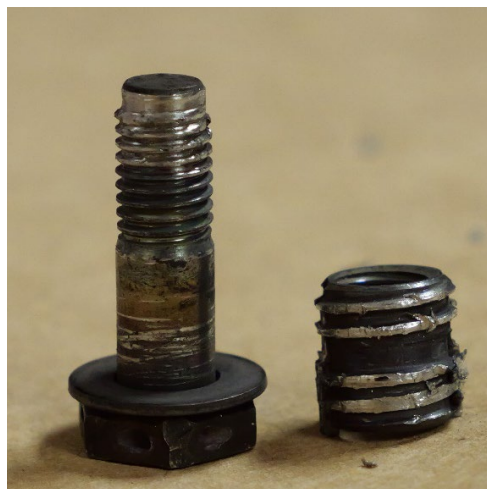
The bolt and insert were removed from the flange using a wrench and vise grip pliers; see Figure 16 and Figure 17. Excessive rotational force was needed to remove the bolt.

**Figure 16** Gasket, bolt and insert

**Figure 17:** Bolt and insert after removal

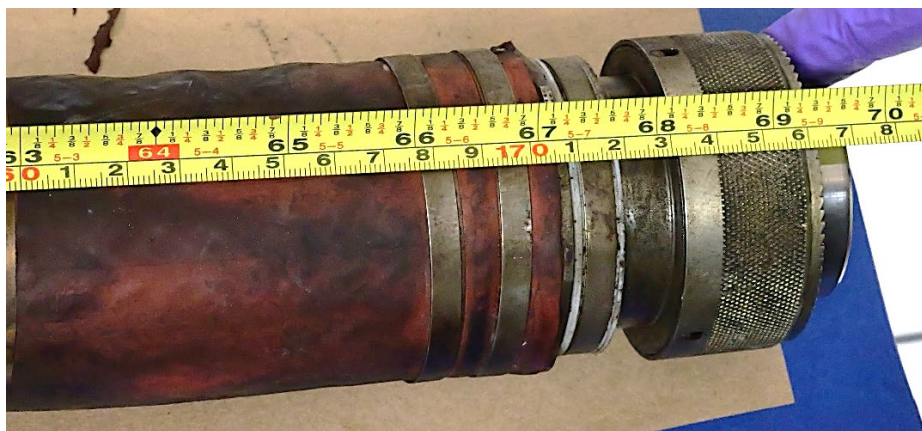
**Figure 19:** End measurement of hose assembly

The hose assembly measured approximately 69.75 inches in length using a tape measure as shown in Figure 18 and Figure 19. The hose assembly should measure 69.770 +/- 0.500 inches in length, per the reference (b) drawing.

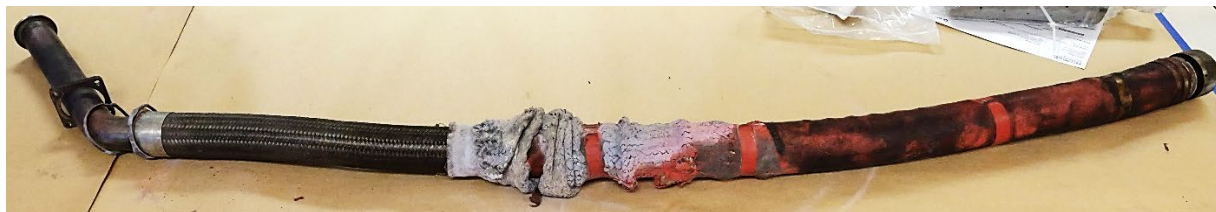
**Figure 20:** Fire sleeve pulled back

The damaged portion of the fire sleeve was pulled back from the flanged end of the hose to examine the braided stainless-steel area of the hose; see Figure 20. No notable findings were observed.

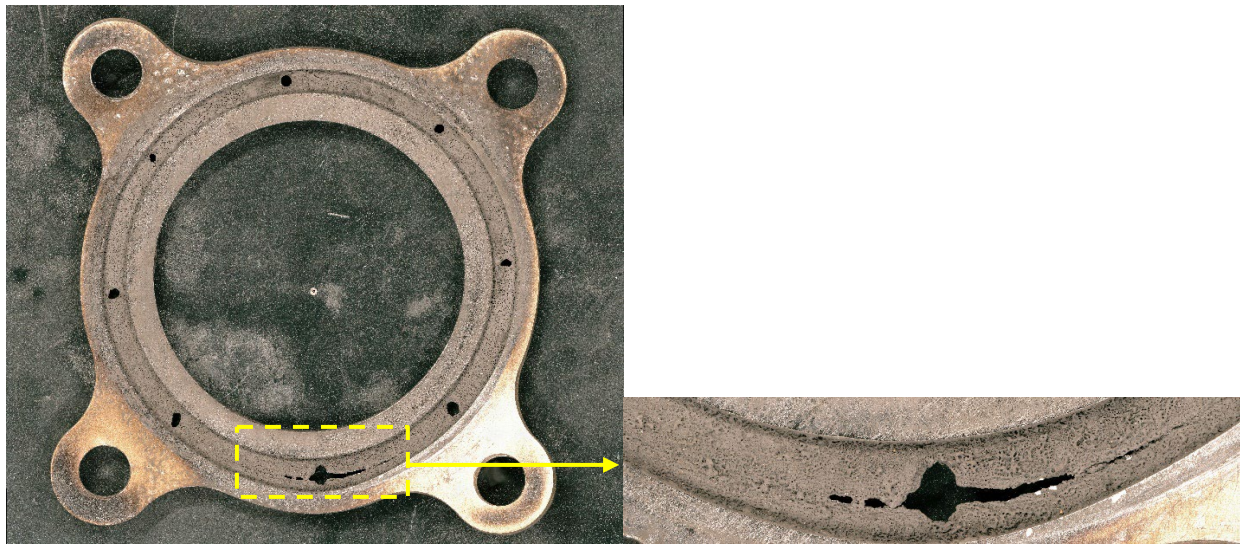
EQA examined the gasket under magnification, and observed traces of what appeared to be melted seal material within the groove; see Figure 21

**Figure 21:** Gasket groove under magnification

BR&T Analytical Chemistry performed FTIR and EDS analyses of the gasket surface. Attachment A reports that the data suggests that the dark deposits in the groove and the on the surface of the gasket are the carbon rich pyrolysis residue of the O-ring material that was burnt away in the fire event. Fluorine was found in the residue confirming a fluorine-based O-ring was present.; see attachment A for the completed report.

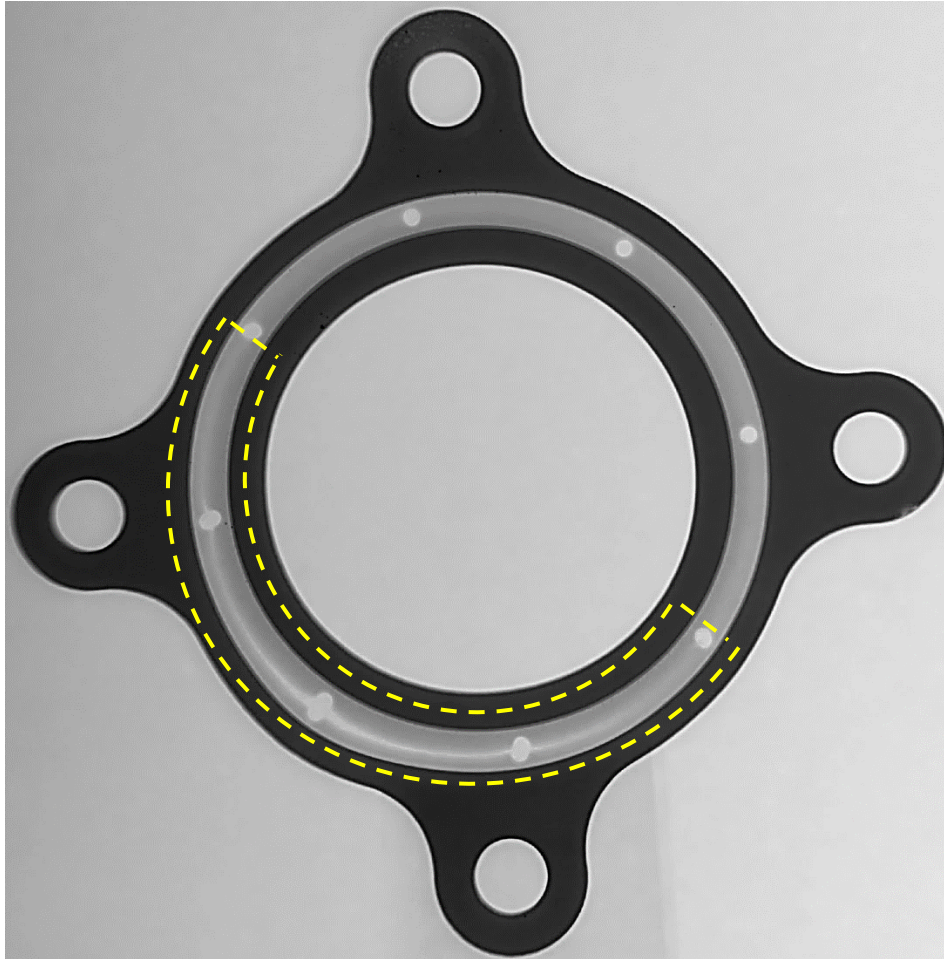
It was also noted that the metallic gasket material, initially noted as missing, appeared to be fractured. This was verified with an X-ray examination of the gasket; see Figure 22.

**Figure 22:** X-ray image of gasket showing fracture within the dashed yellow lines

Due to the level of deformation of the gasket, EQA was not able to obtain a flatness measurement.

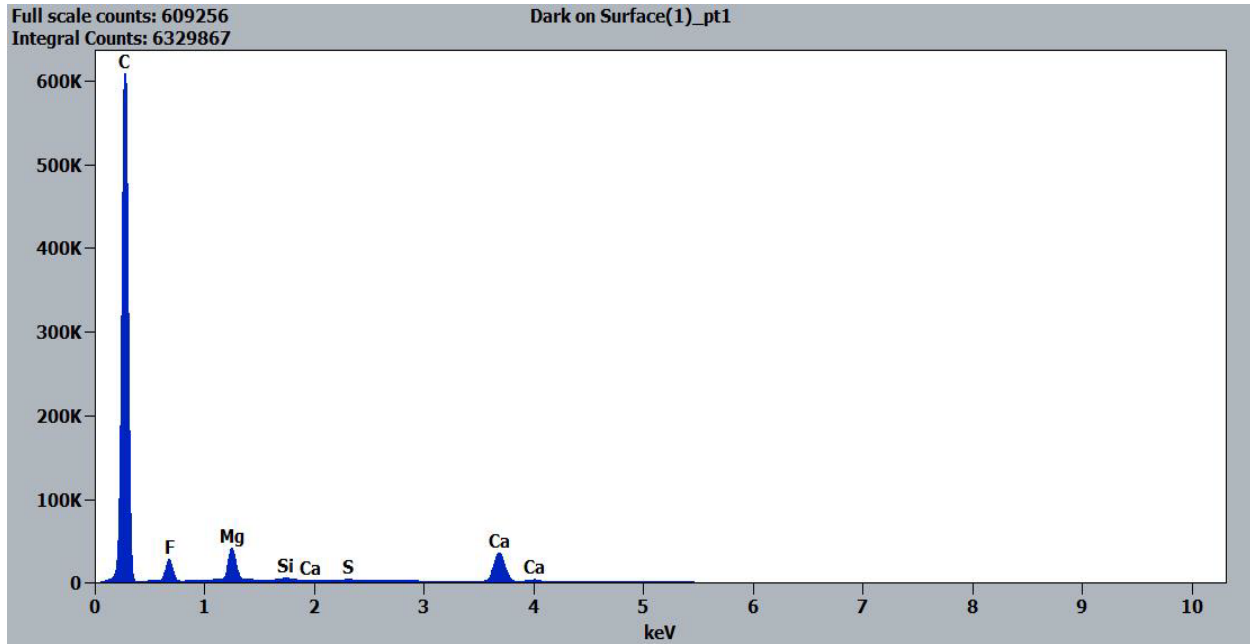
The data suggests that the dark deposits in the groove and the on the surface of the gasket are the carbon rich pyrolysis residue of the O-ring material that was burnt away in the fire event. Fluorine was detected in the residue confirming a fluorine based O-ring was present.

EDX detected carbon with a traces of fluorine, magnesium and calcium (Figure 1).

Figure 1: EDS representative elemental spectrum of dark O-ring and surface deposits.

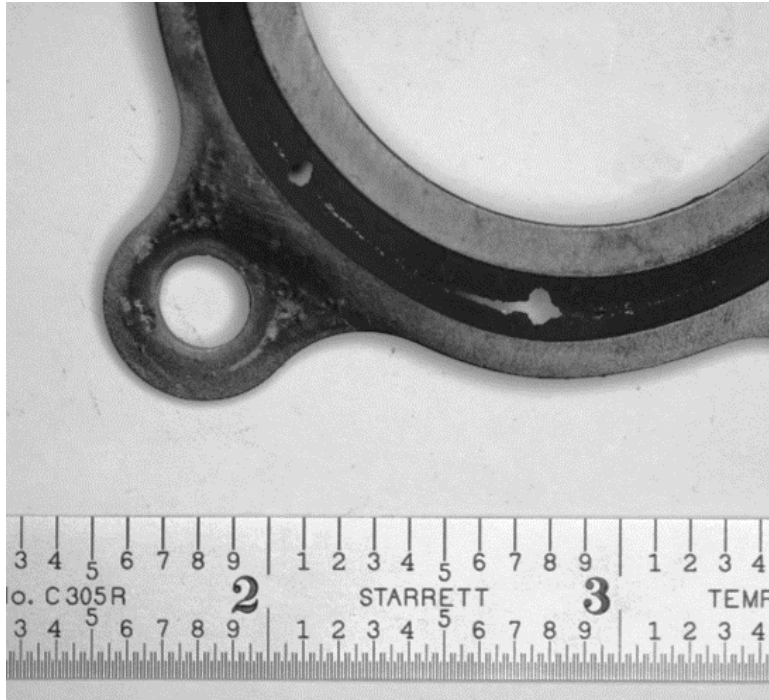
After a thermal event on a 767 a seal gasket (Sargent P/N CA-5465-0X) was submitted for fracture analysis (Figure 1). A region of cracking and absent material was found in approximately 20 percent of the circumference of the groove (Figure 2). The cracked region was excised for detailed examination with a scanning electron microscope (SEM). Figures 3 through 5 show SEM images of the fracture surface. The fractured region showed morphology indicating complete melting at the fracture surface.

Figure 2. Optical photograph showing the region of the gasket with cracking and material absent.

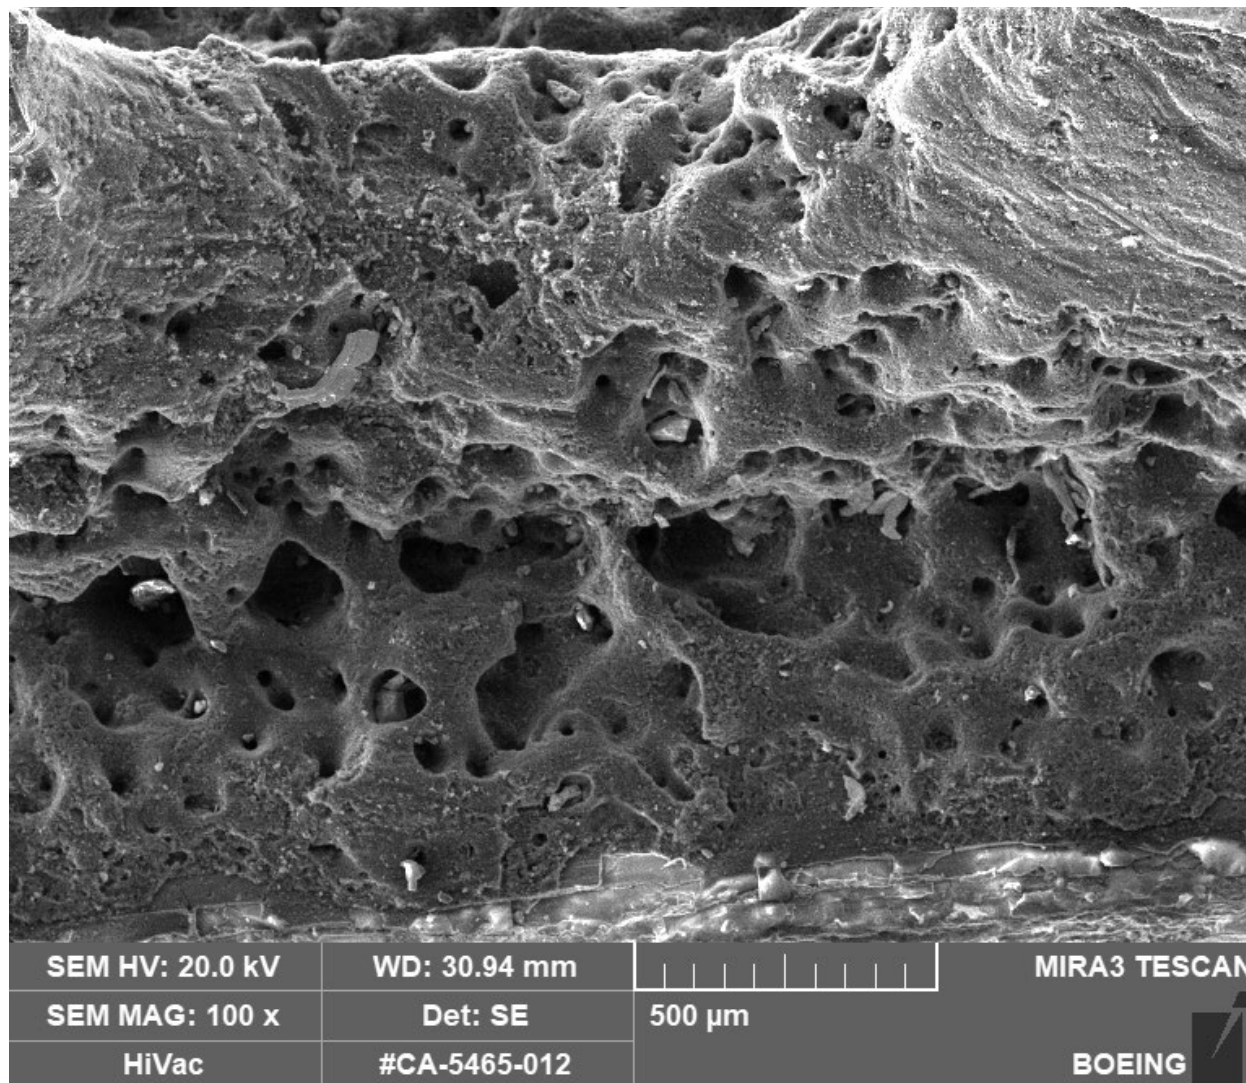
Figure 5. Higher magnification image of the region shown in Figure 4, the morphology shows complete melting of the edge of the fracture.
