# **Metallurgical Investigation Report**

## **DRB: AvEng-561264.A**

**EVALUATION OF A CF6-80C2 ESN 707-605 HMU IDLER  
ADAPTER FROM ESN 707-605 OPERATED BY FEDEX  
INVOLVED IN AN IN-FLIGHT SHUT-DOWN AND  
UNDERCOWL FIRE EVENT**

Part Number: 9395M78G10  
Part Serial Number: FIA217EE  
Part TSN / CSN: 1,421 hrs / 728 cycles

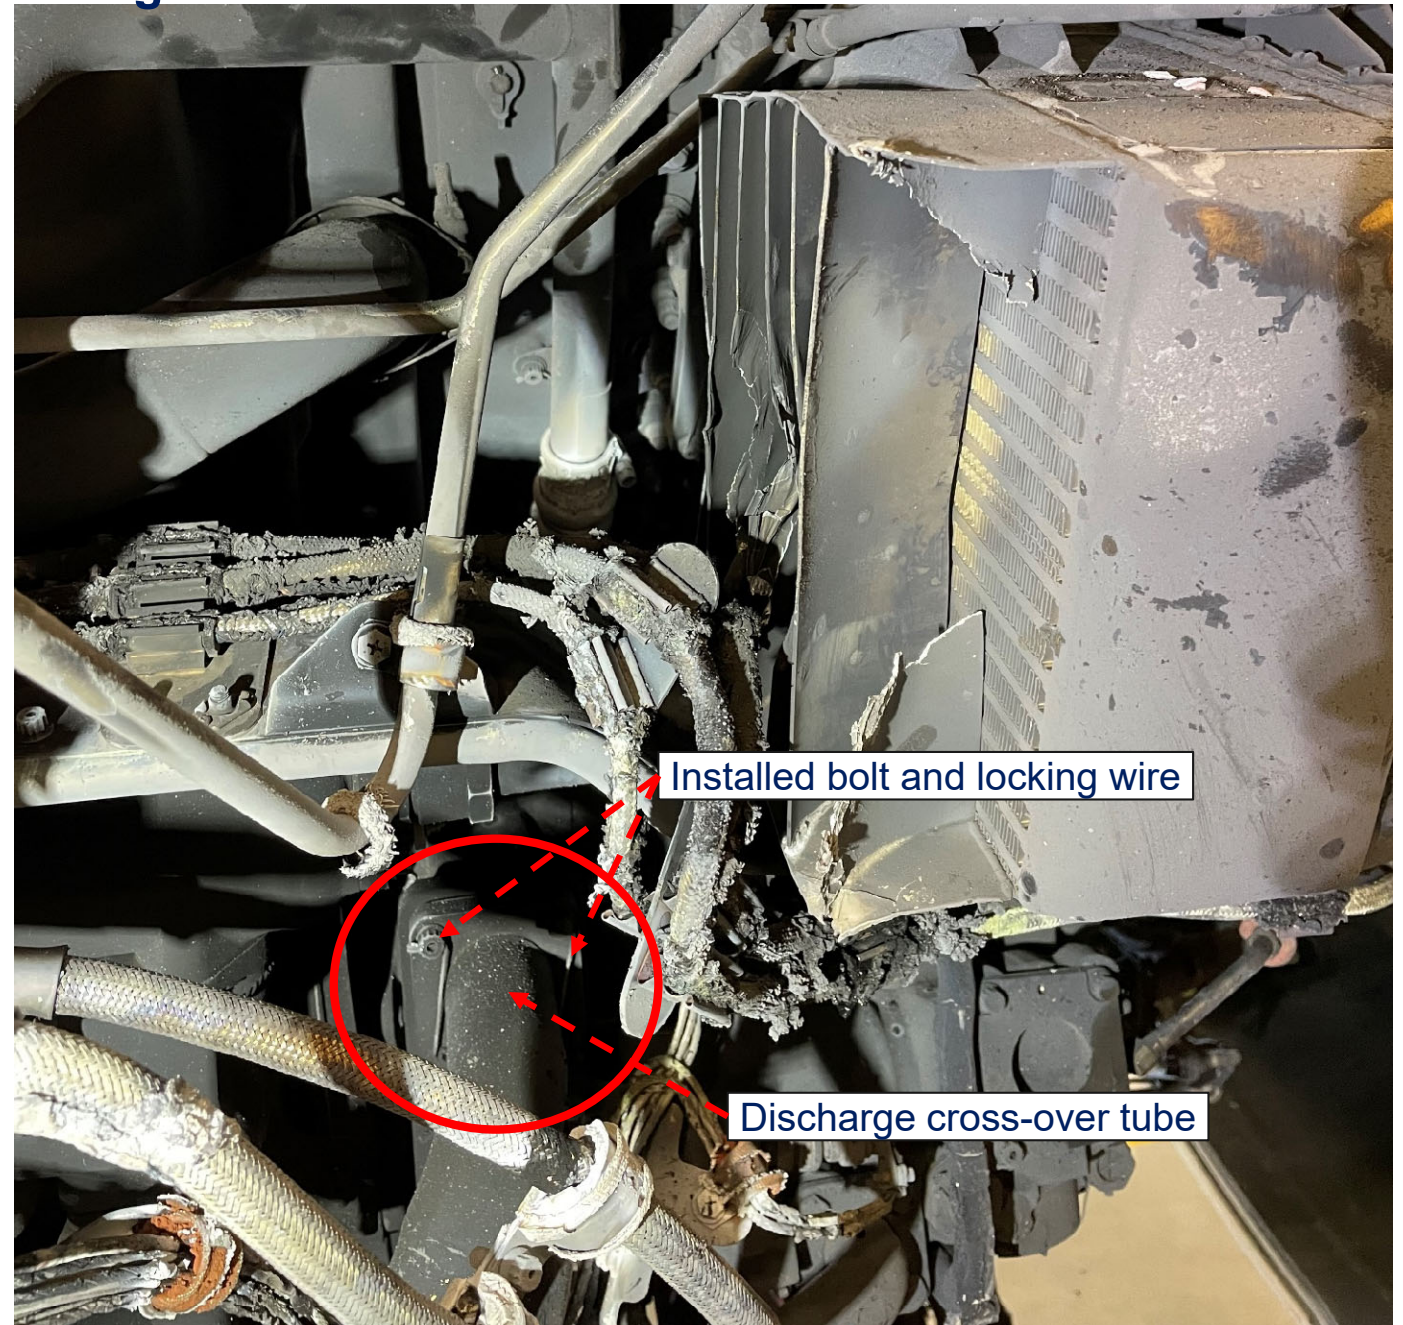
**Figure 1: Left:** A 3D model shows the assembly of the fuel pump (red) and HMU idler adapter (gold). The fuel pump sits aft of the Accessory Gearbox (AGB) and the HMU idler adapter sits forward of the AGB. A discharge cross-over tube (red) is attached by 4-bolt flanges to the fuel pump and HMU idler adapter. **Right:** an image captured during the on-site investigation shows the HMU idler adapter discharge cross-over tube flange. The top-left bolt and both locking wires are shown present. No bolts were found missing during disassembly.

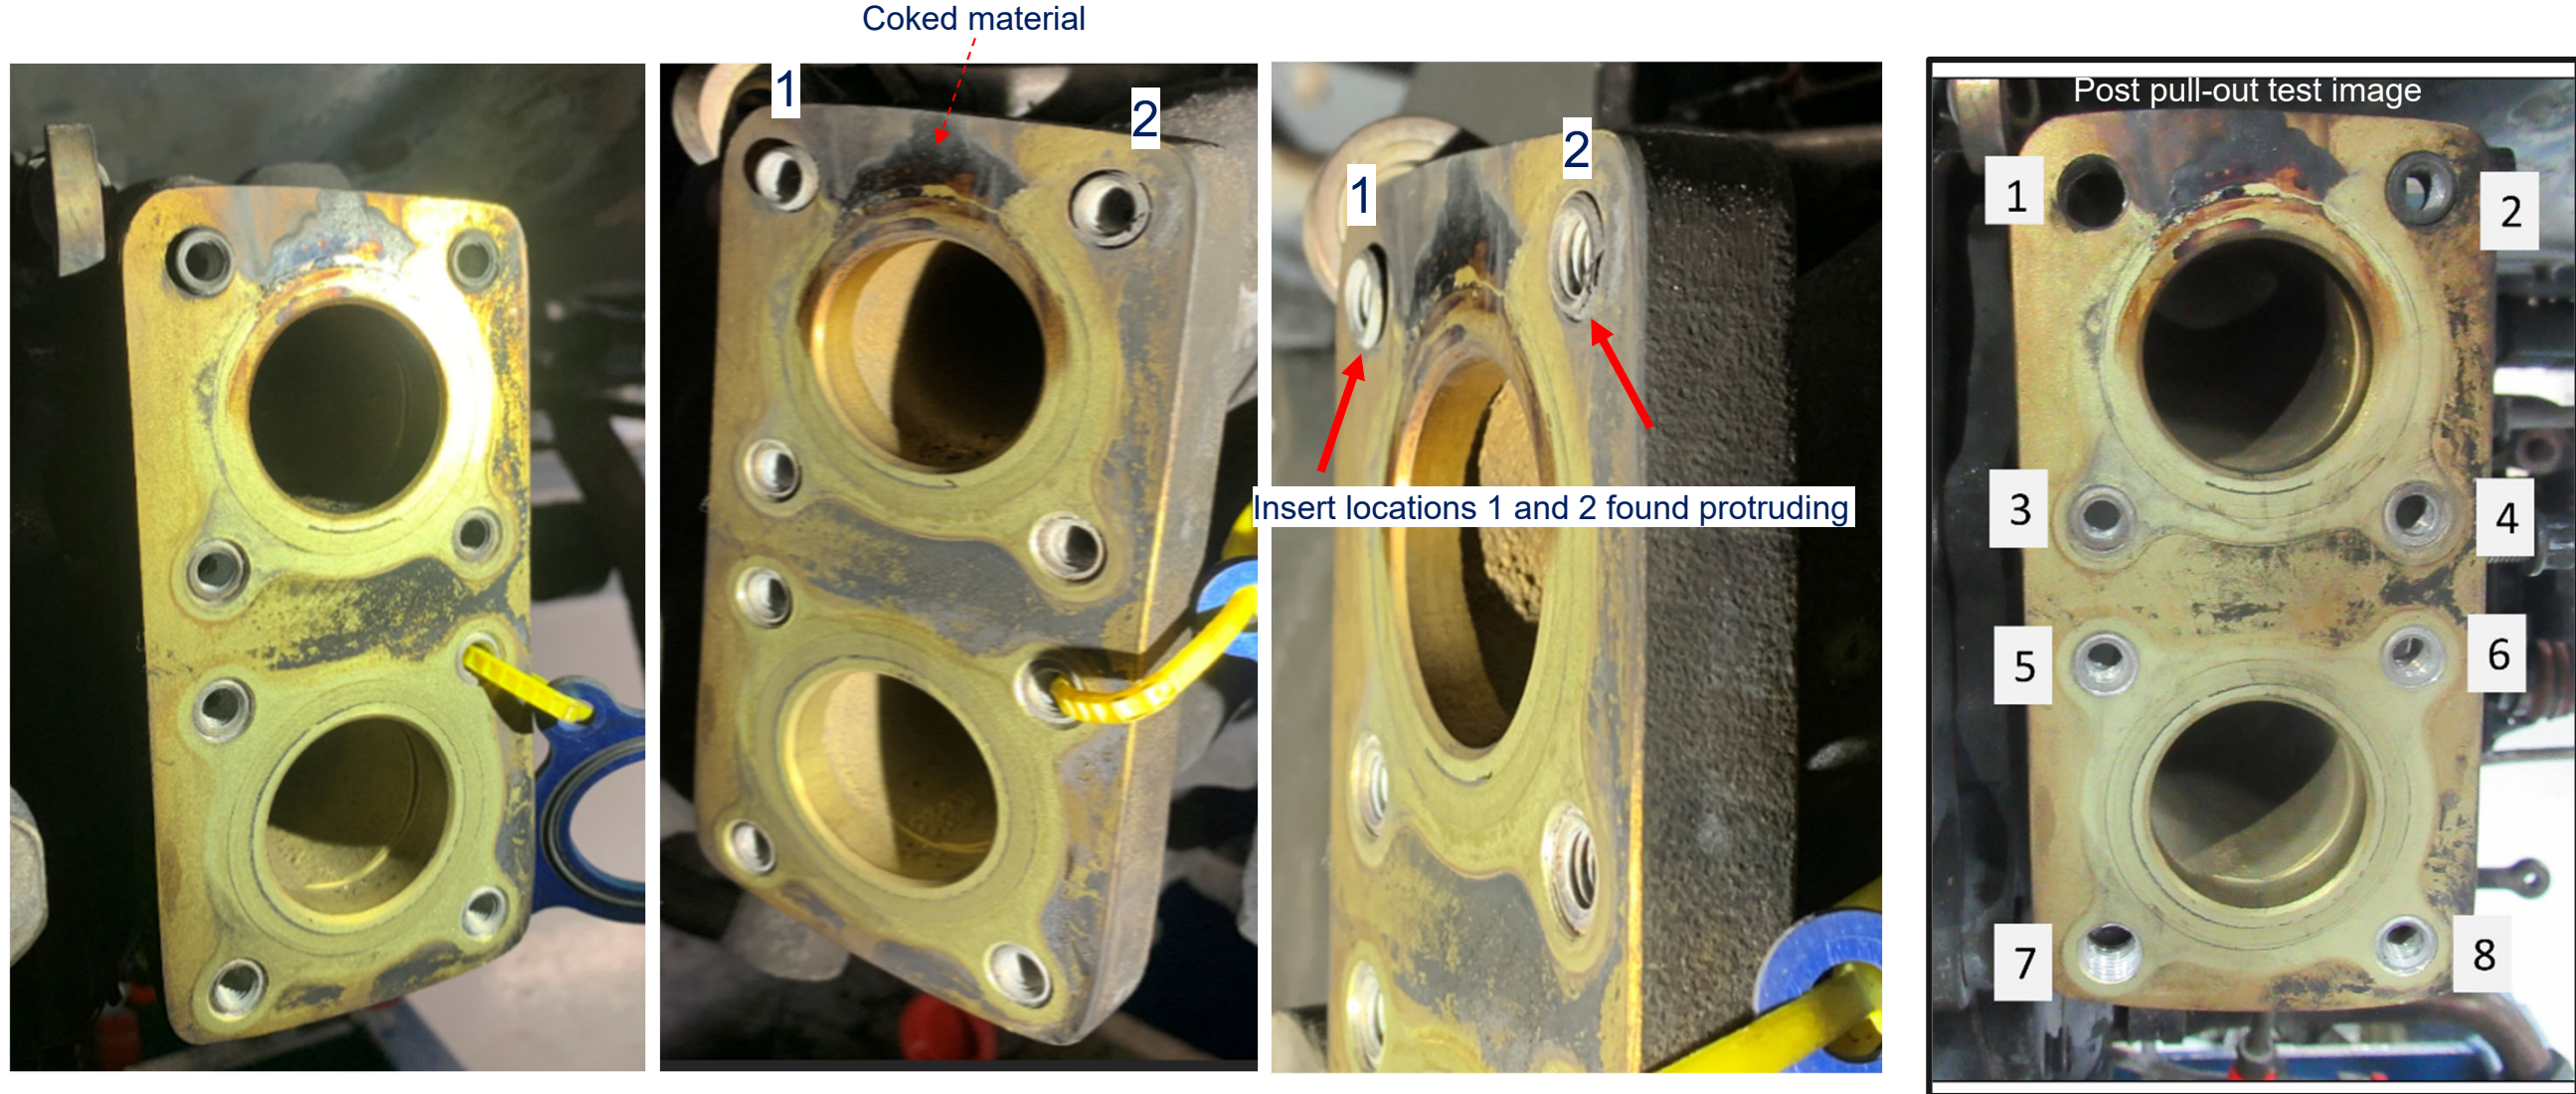
**Figure 3:** Images of the HMU idler adapter taken at GE Celma prior to the thread insert pull-out tests. The black soot has been removed from the flange surface. Coked fuel is observed on the top portion of the flange, consistent with fuel leaking in this area. The position 1 and 2 thread inserts were found protruding above the flange surface. No other thread inserts were found protruding.

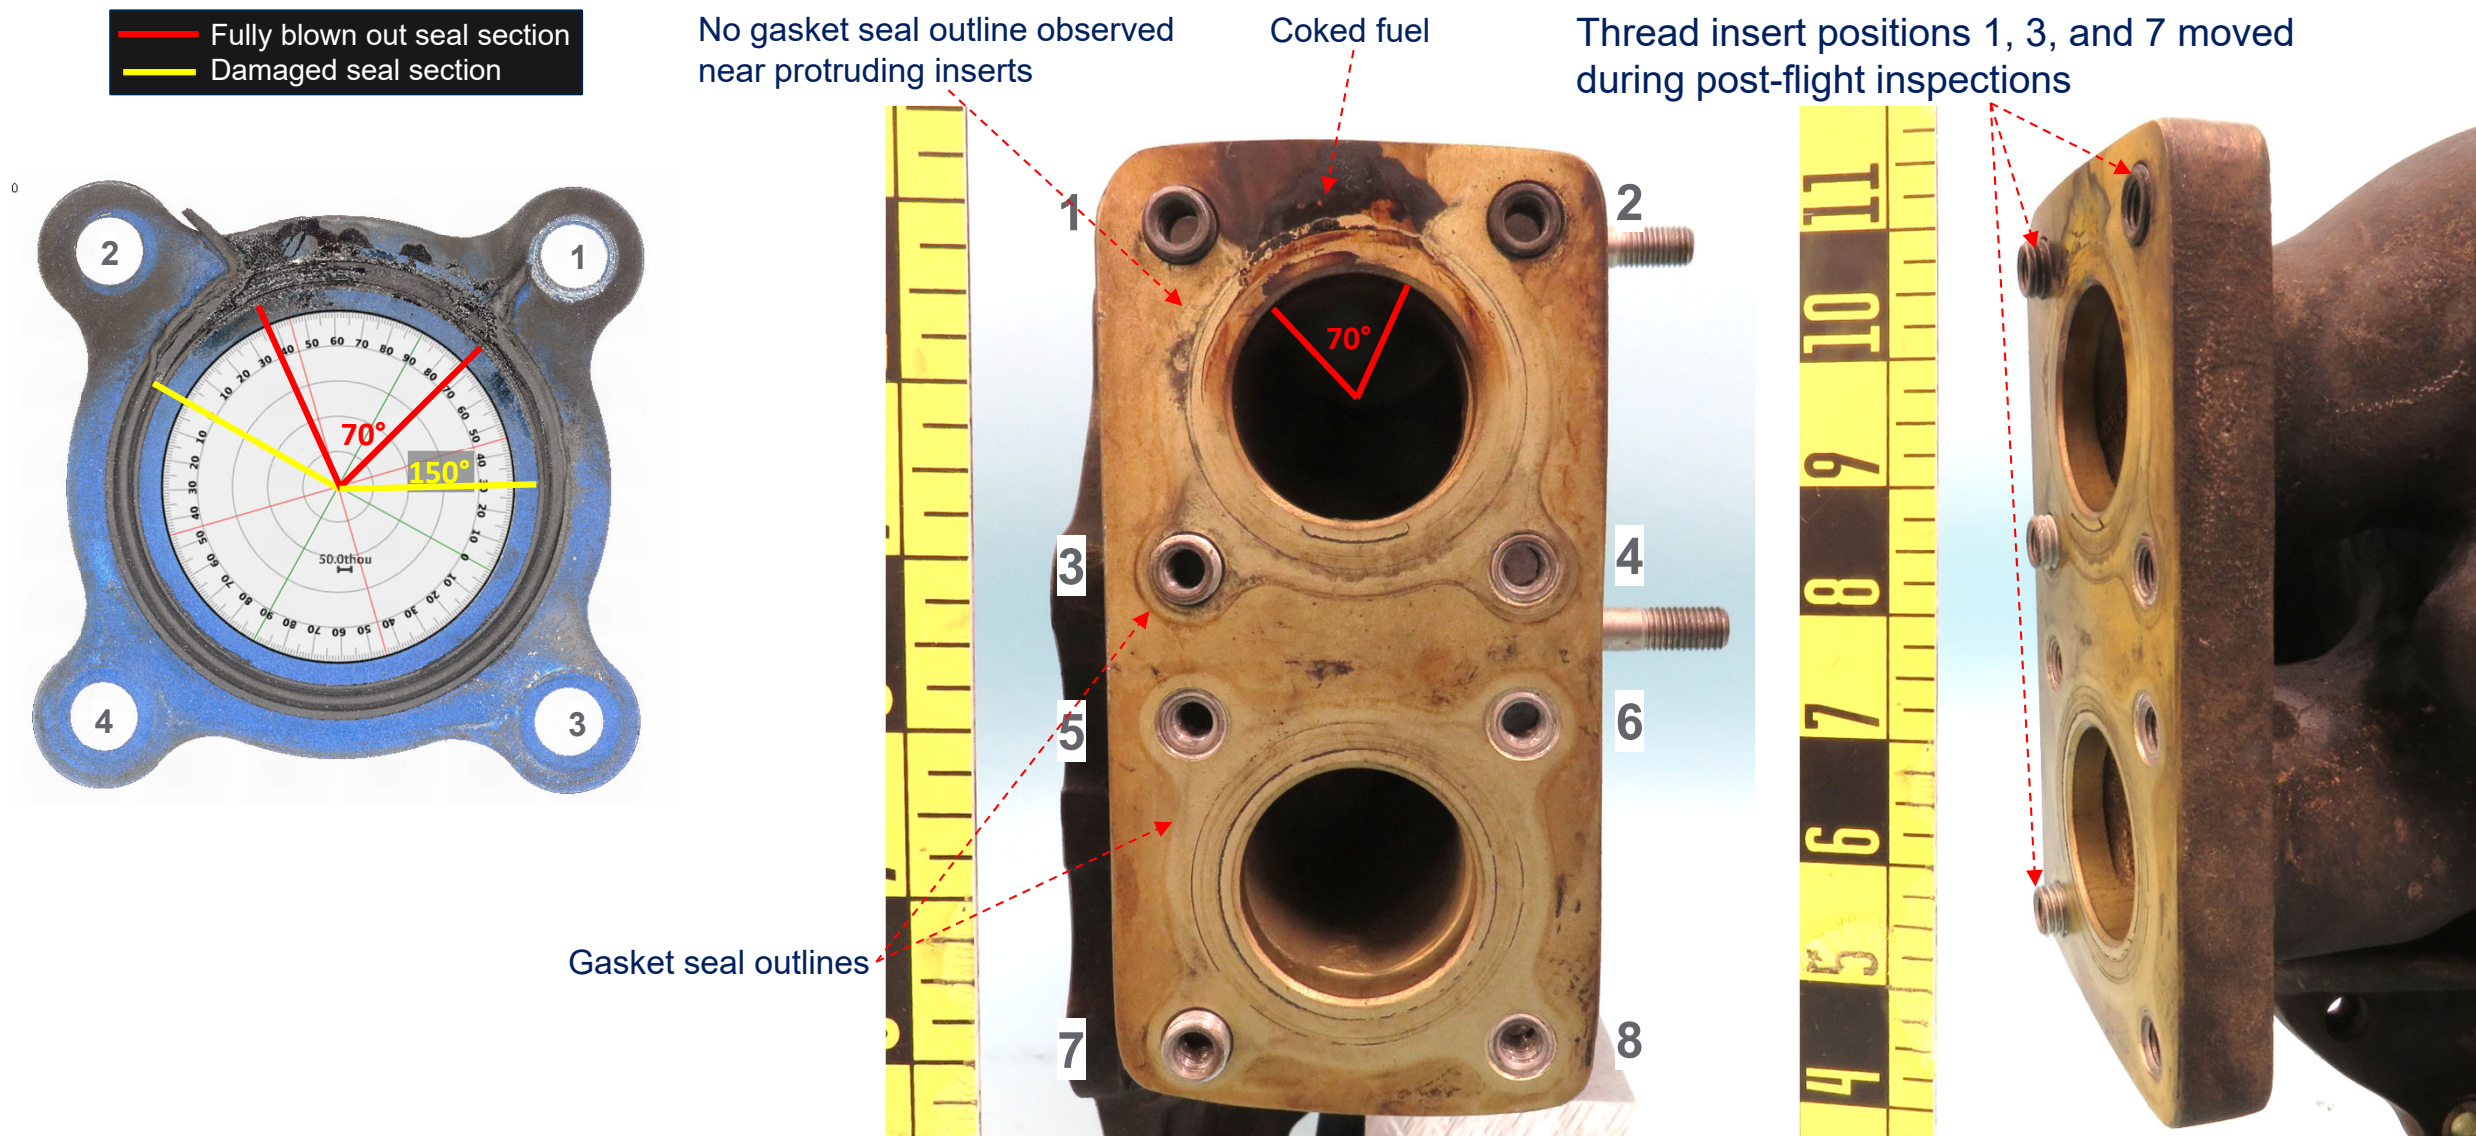
- Optical view of the HMU in the as-received condition is shown in Figure 8, along with the gasket seal in Figure 9. The images show that 2 of the inserts were proud of the flange surface (locations 1 and 2) and the gasket had a corresponding 70-degree region of blow-out seal, with corresponding coking on the flange (Figures 8 and 9).

**Figure 9:** Images of the HMU idler adapter flange in the as-received condition, after the GE Celma thread insert pull out tests. Images of the gasket seal reveals an approximately 70-degree section at the 12:00 o'clock location with the seal fully blown out. Coked fuel is observed on the flange surface at the same 70-degree location, consistent with fuel leaking in this area. Approximately 150-degrees of the seal appears damaged.

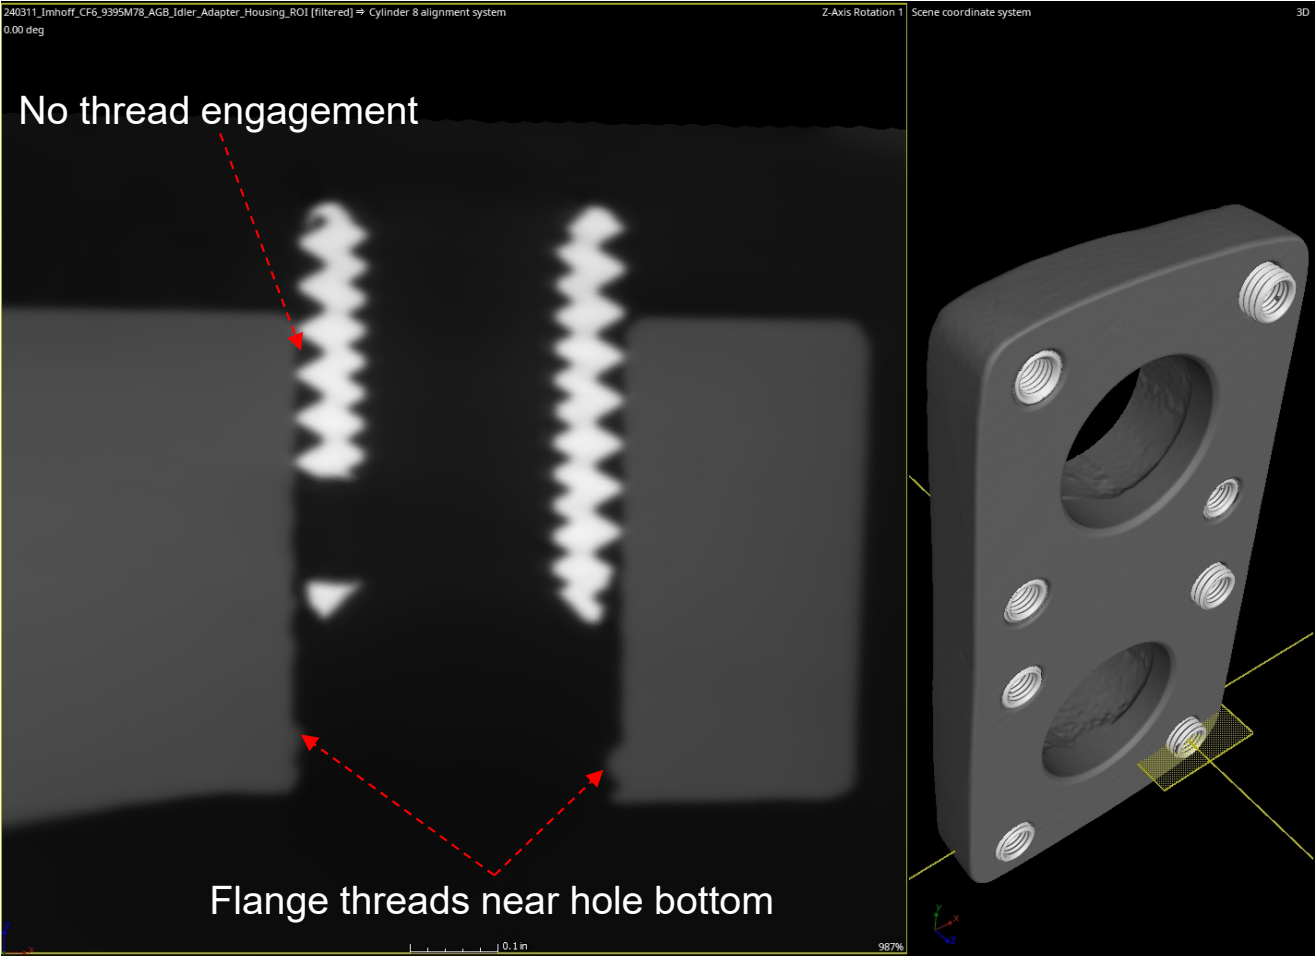
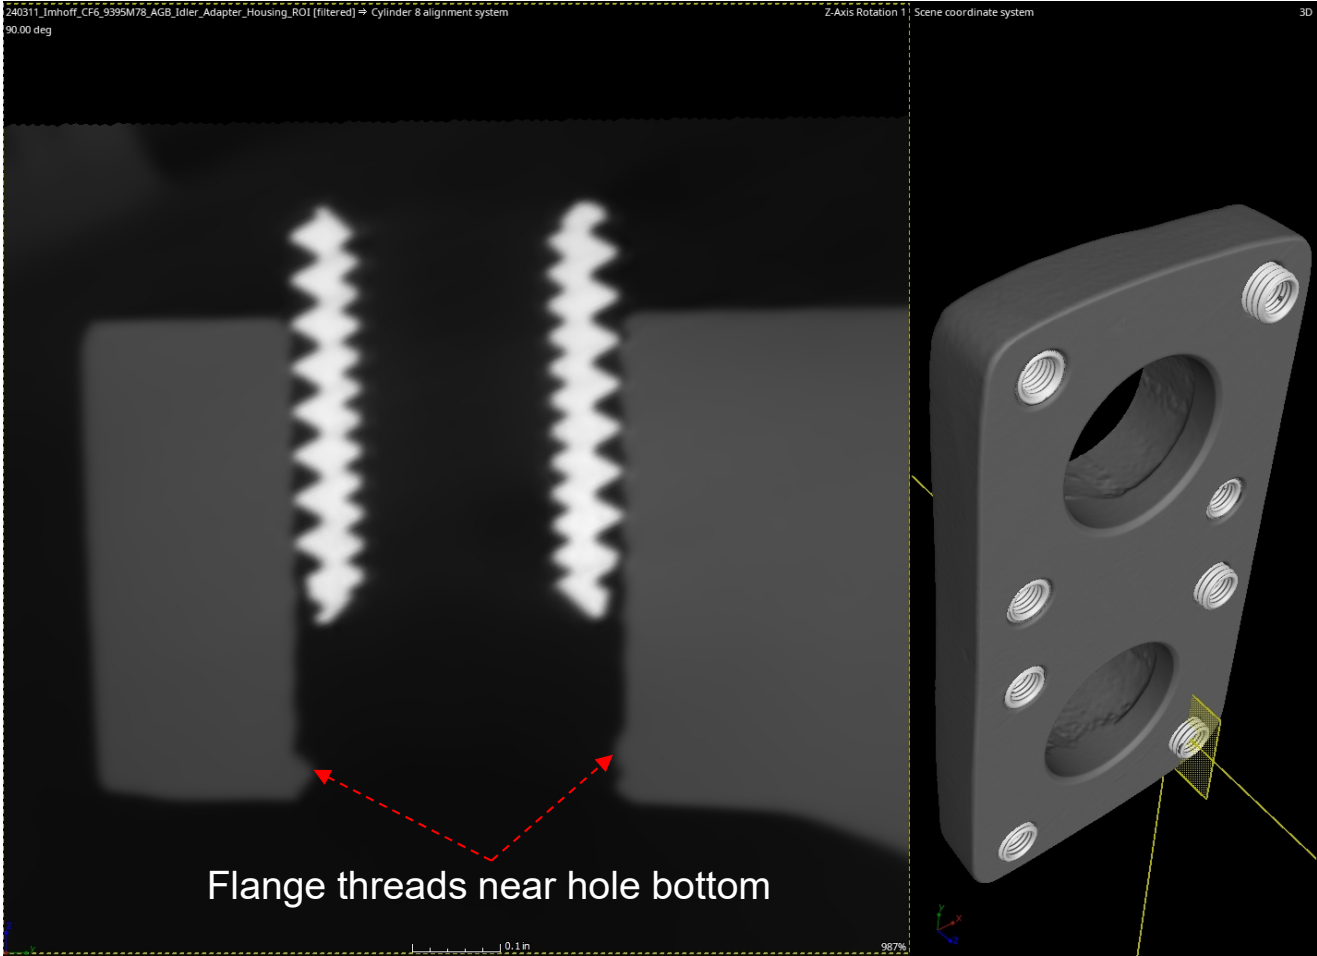
- CT scans of the event HMU idler adapter (Figures 11-18) found insert location 1, 2, and 3 were missing the pre-tapped threads and did **not have thread engagement** into the parent metal. The remaining inserts did show parent metal engagement.

**Figure 11:** CT scan cross-section of thread insert position 1. The pre-tapped internal threads are missing. No thread engagement is observed into the flange material.

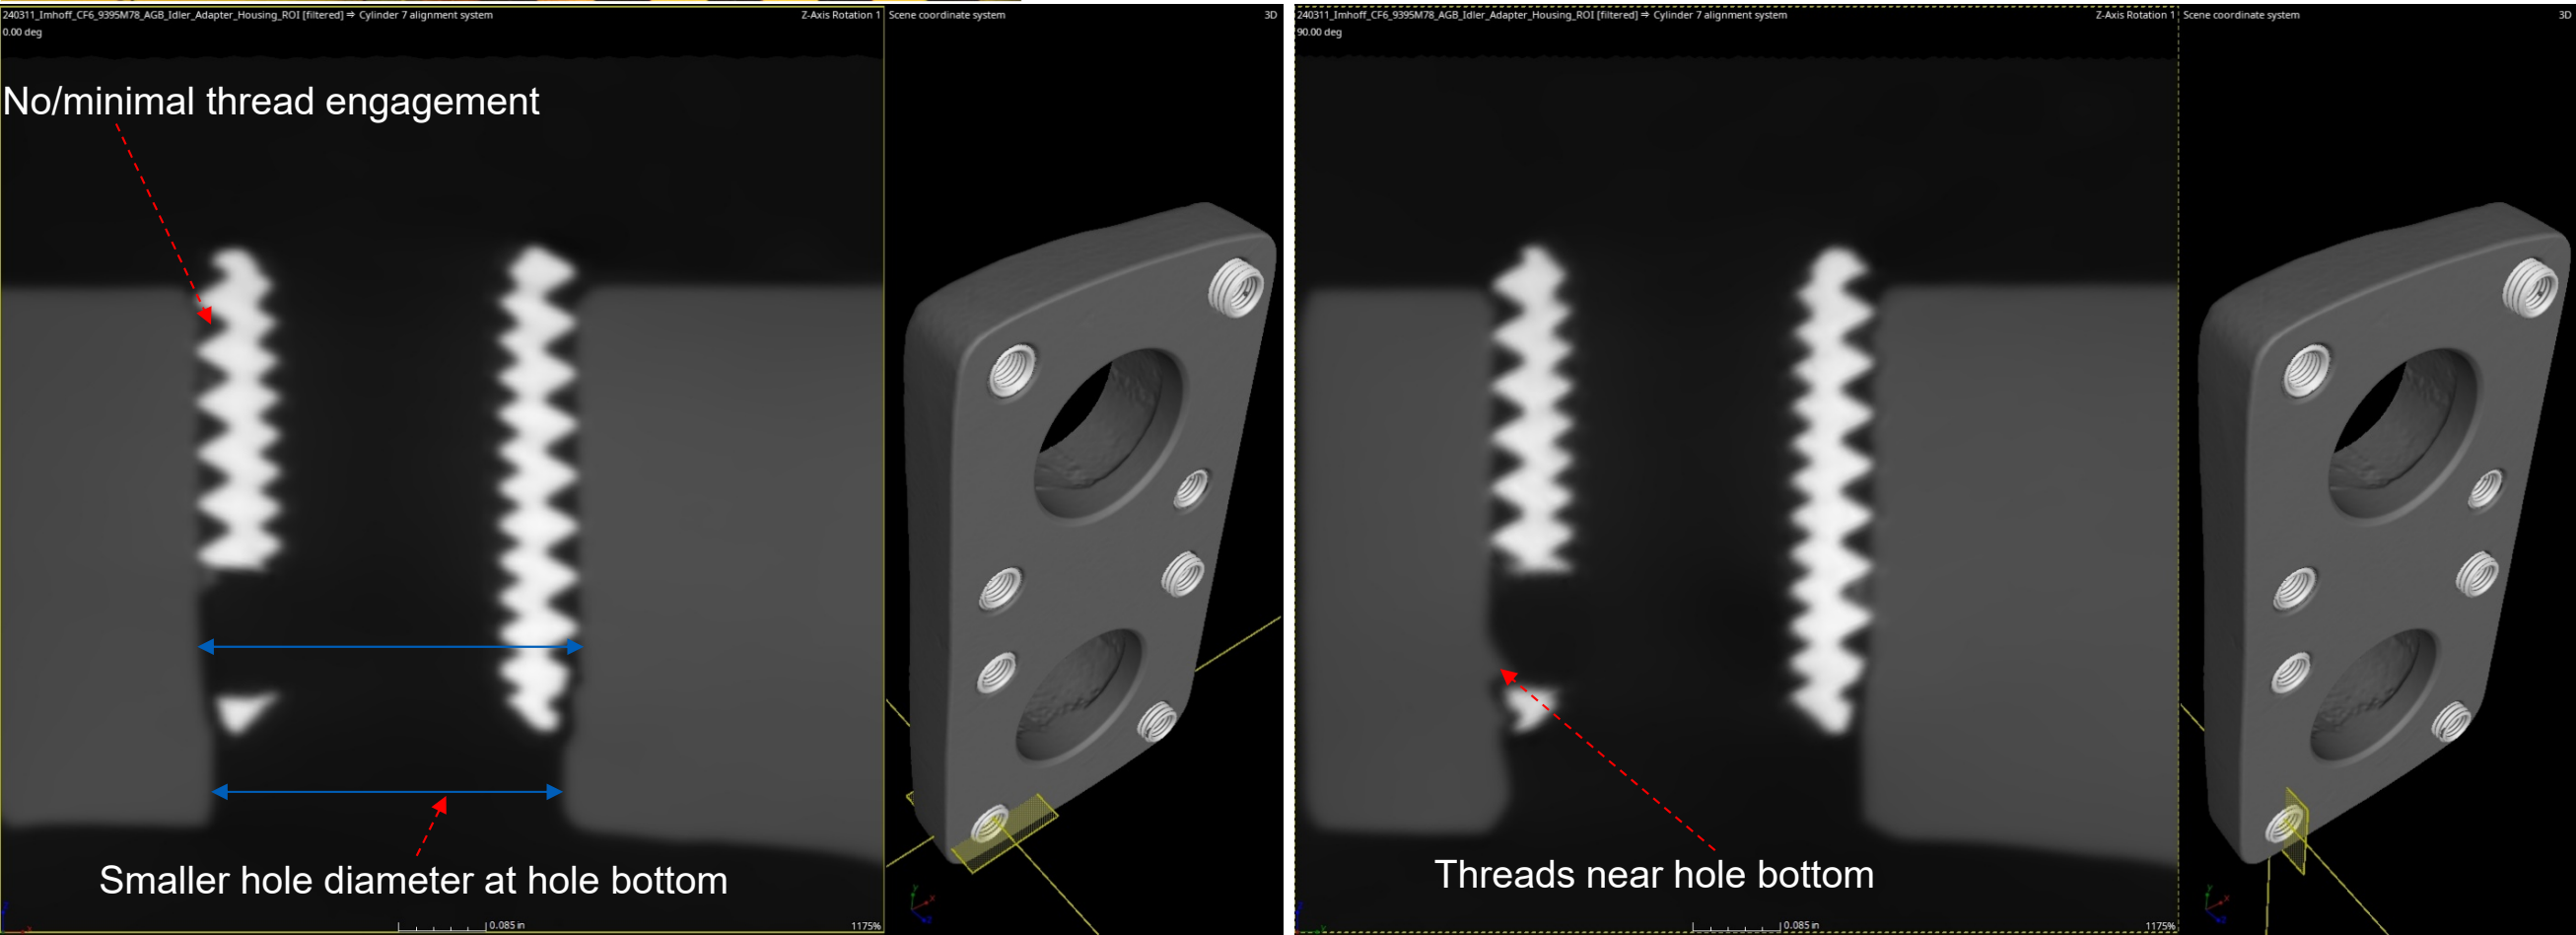
# Insert 2

**Figure 12:** CT scan cross-section of thread insert position 2. The pre-tapped internal threads are missing. No thread engagement is observed into the flange material.

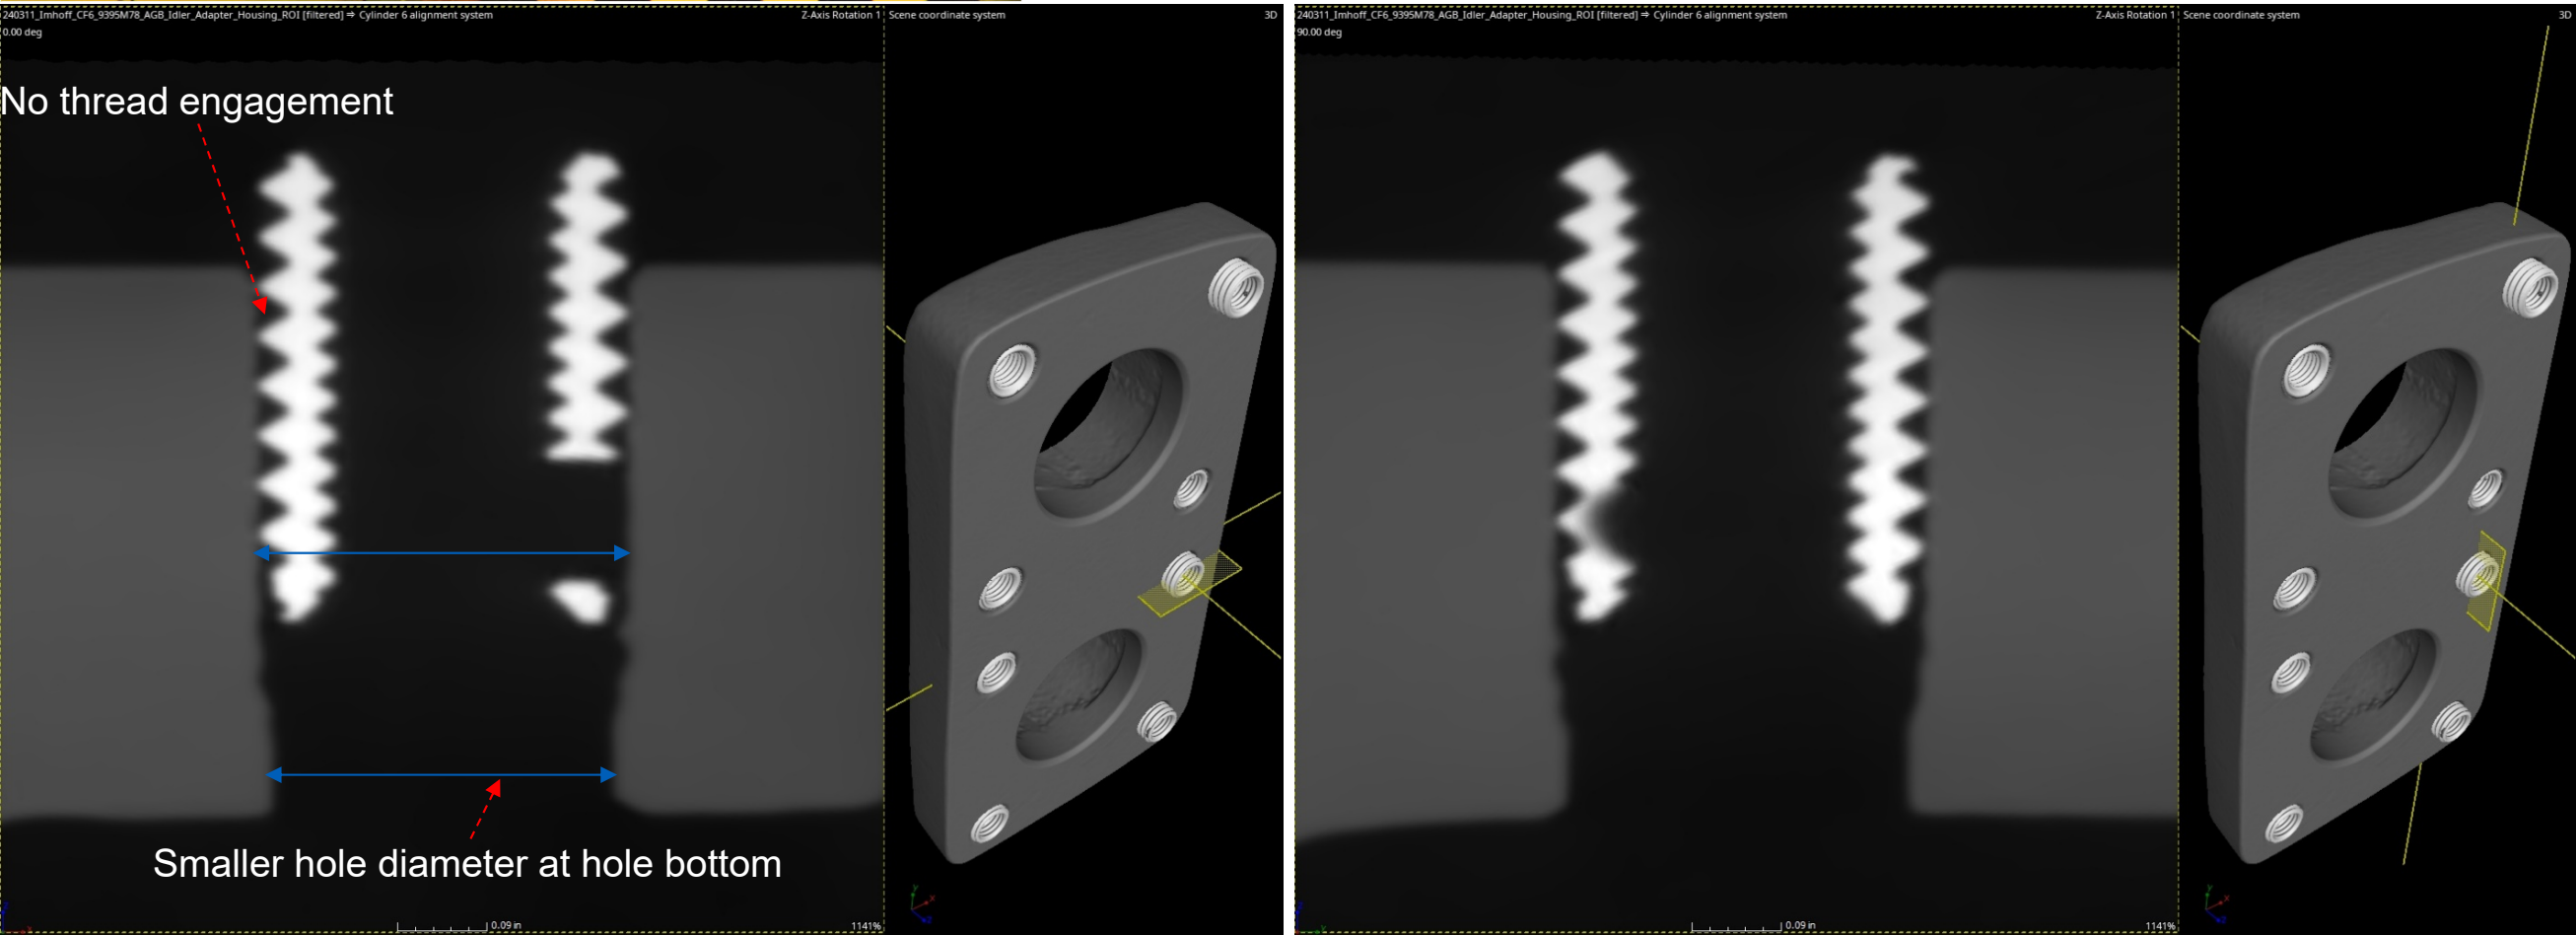
# Insert 3

**Figure 13:** CT scan cross-section of thread insert position 3. The pre-tapped internal threads are missing. No thread engagement is observed into the flange material.

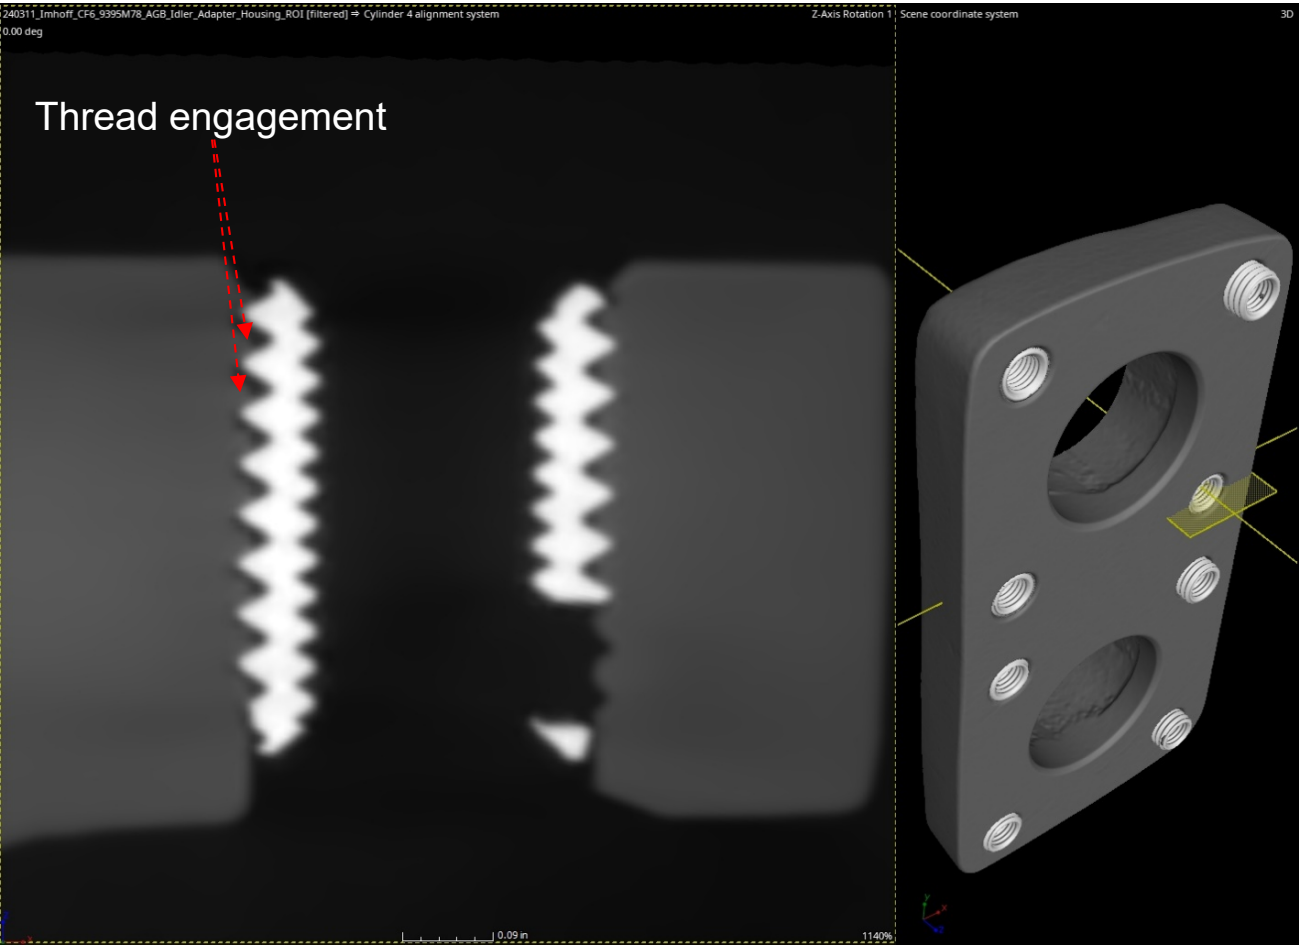
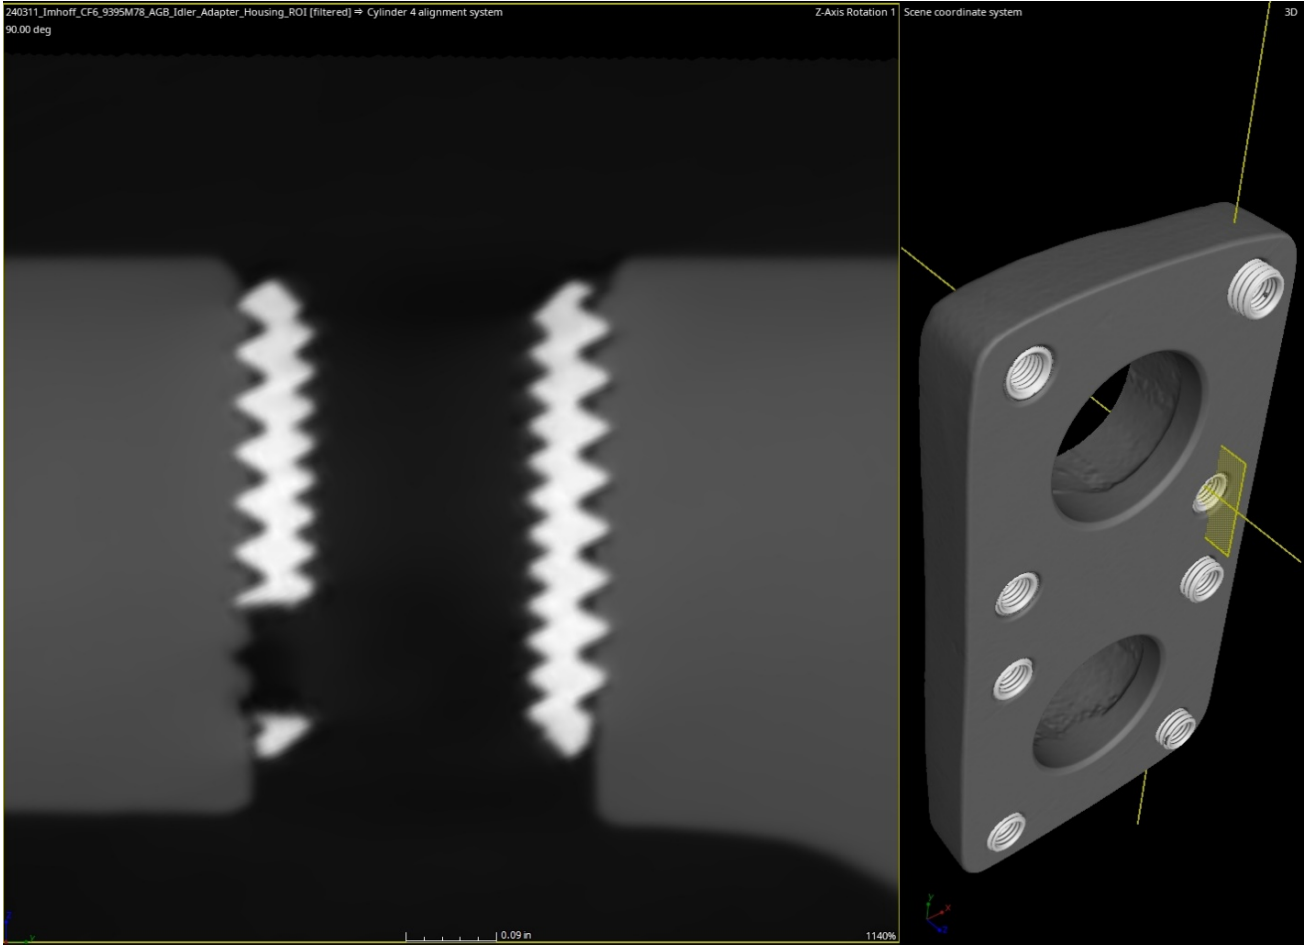
**Figure 15:** CT scan cross-section of thread insert position 5. Thread engagement is observed into the flange material.

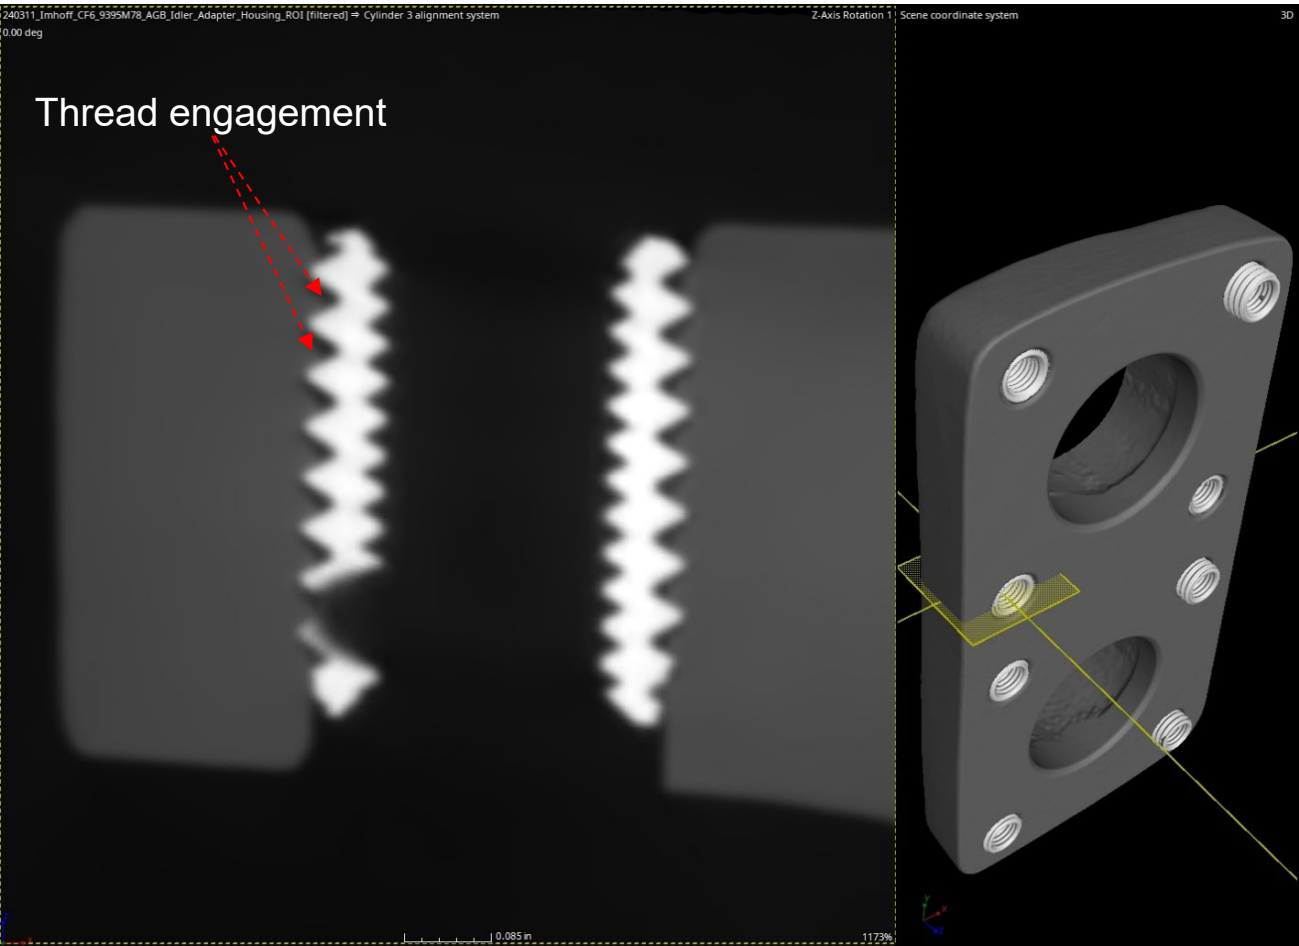
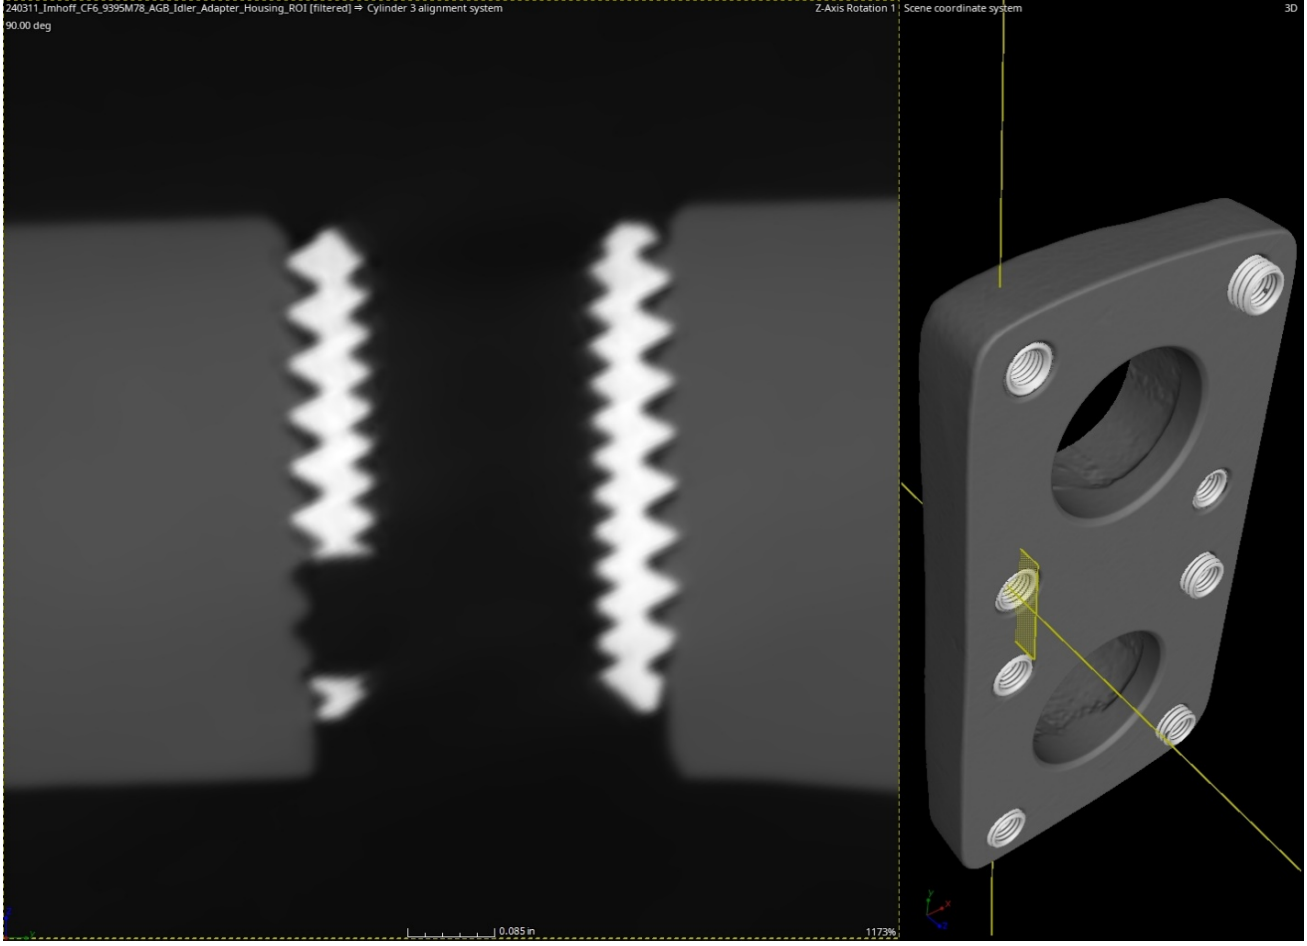
# Insert 6

**Figure 16:** CT scan cross-section of thread insert position 6. Thread engagement is observed into the flange material.

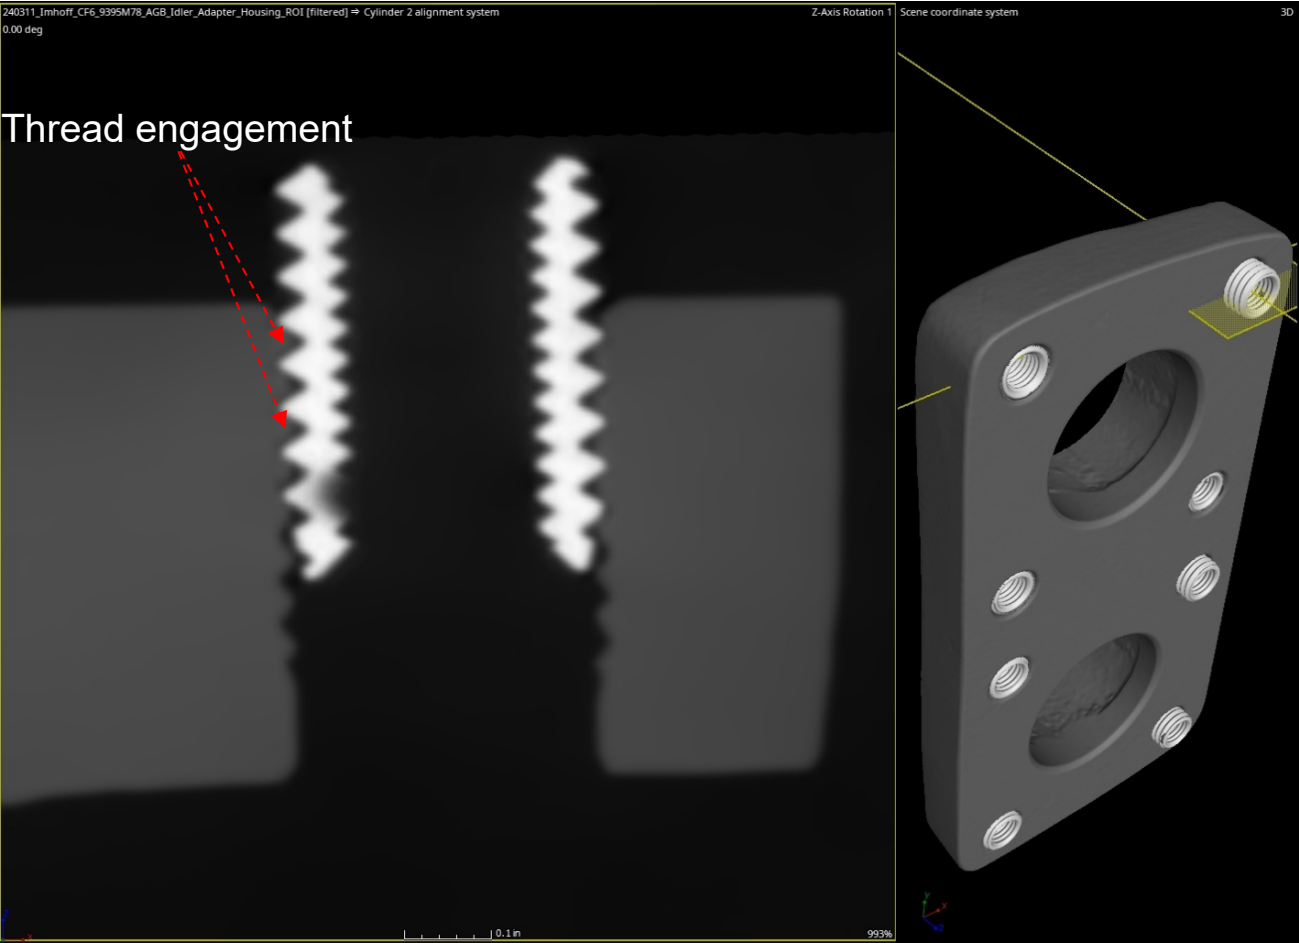
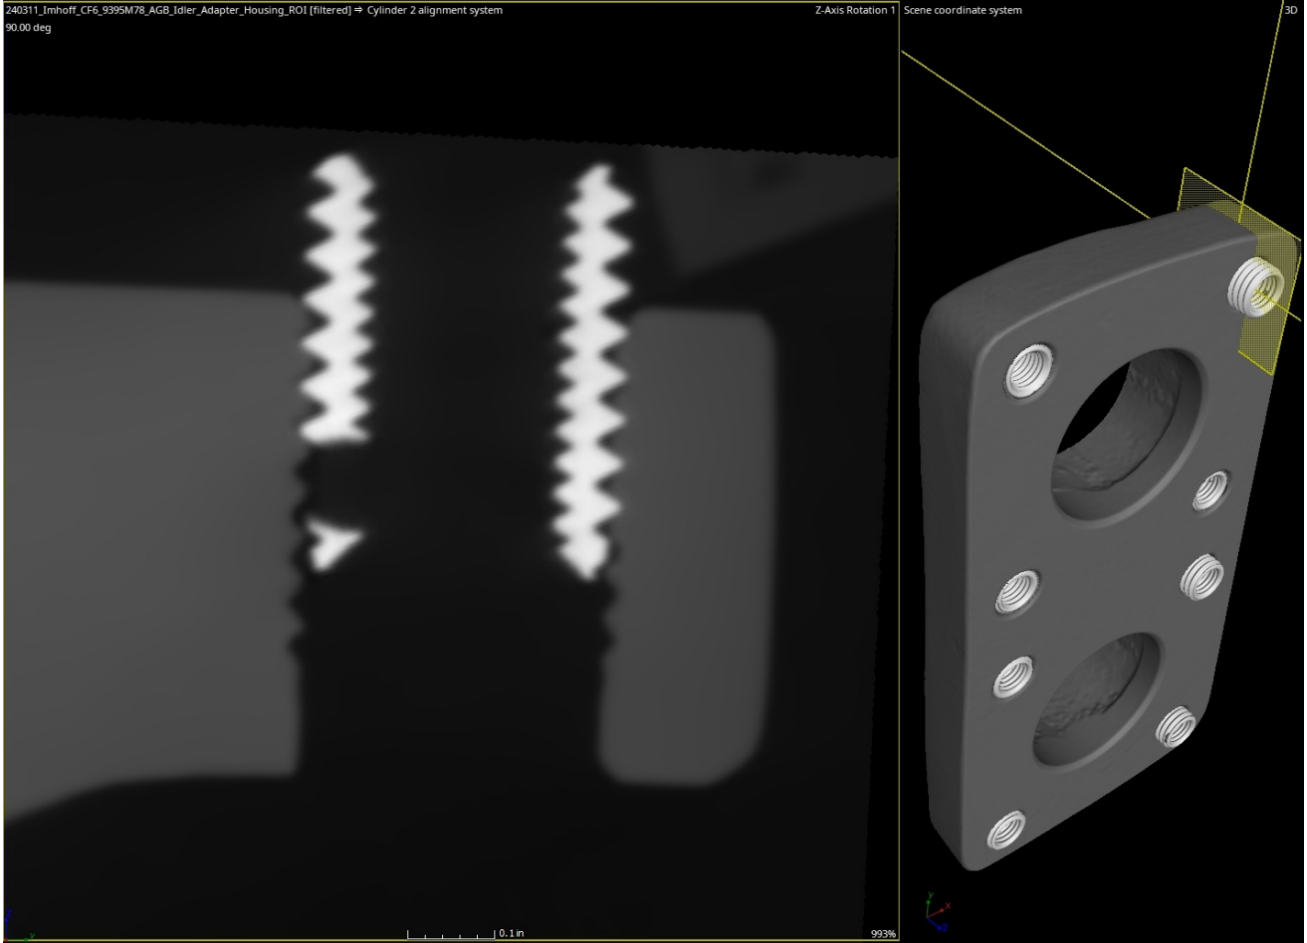
# Insert 7

**Figure 17:** CT scan cross-section of thread insert position 7. Thread engagement is observed into the flange material.
