# **Metallurgical Investigation Report**

## **DRB: AvEng-561264.A**

**EVALUATION OF A CF6-80C2 ESN 707-605 HMU IDLER  
ADAPTER FROM ESN 707-605 OPERATED BY FEDEX  
INVOLVED IN AN IN-FLIGHT SHUT-DOWN AND  
UNDERCOWL FIRE EVENT**

Part Number: 9395M78G10  
Part Serial Number: FIA217EE  
Part TSN / CSN: 1,421 hrs / 728 cycles

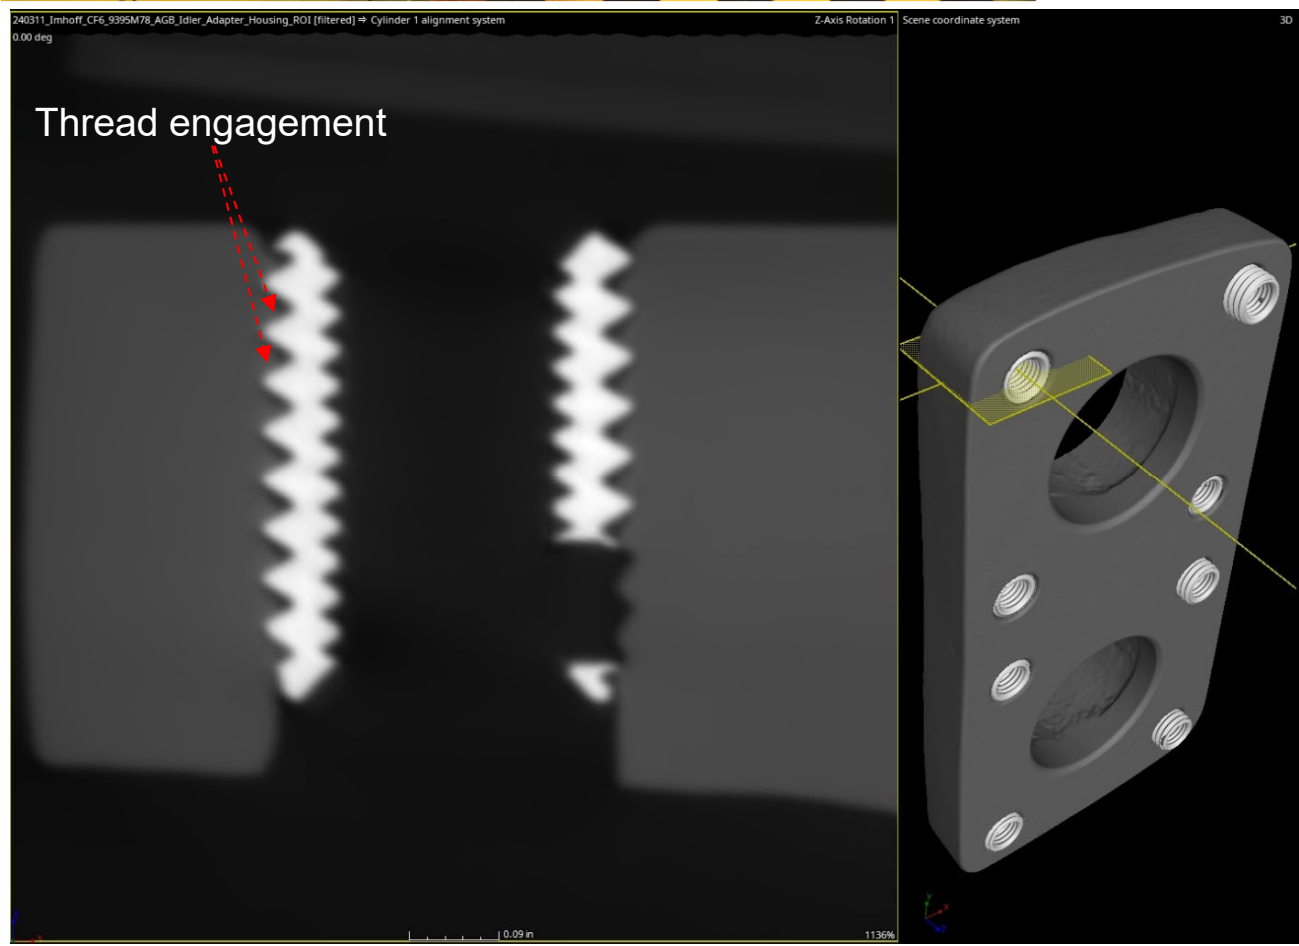
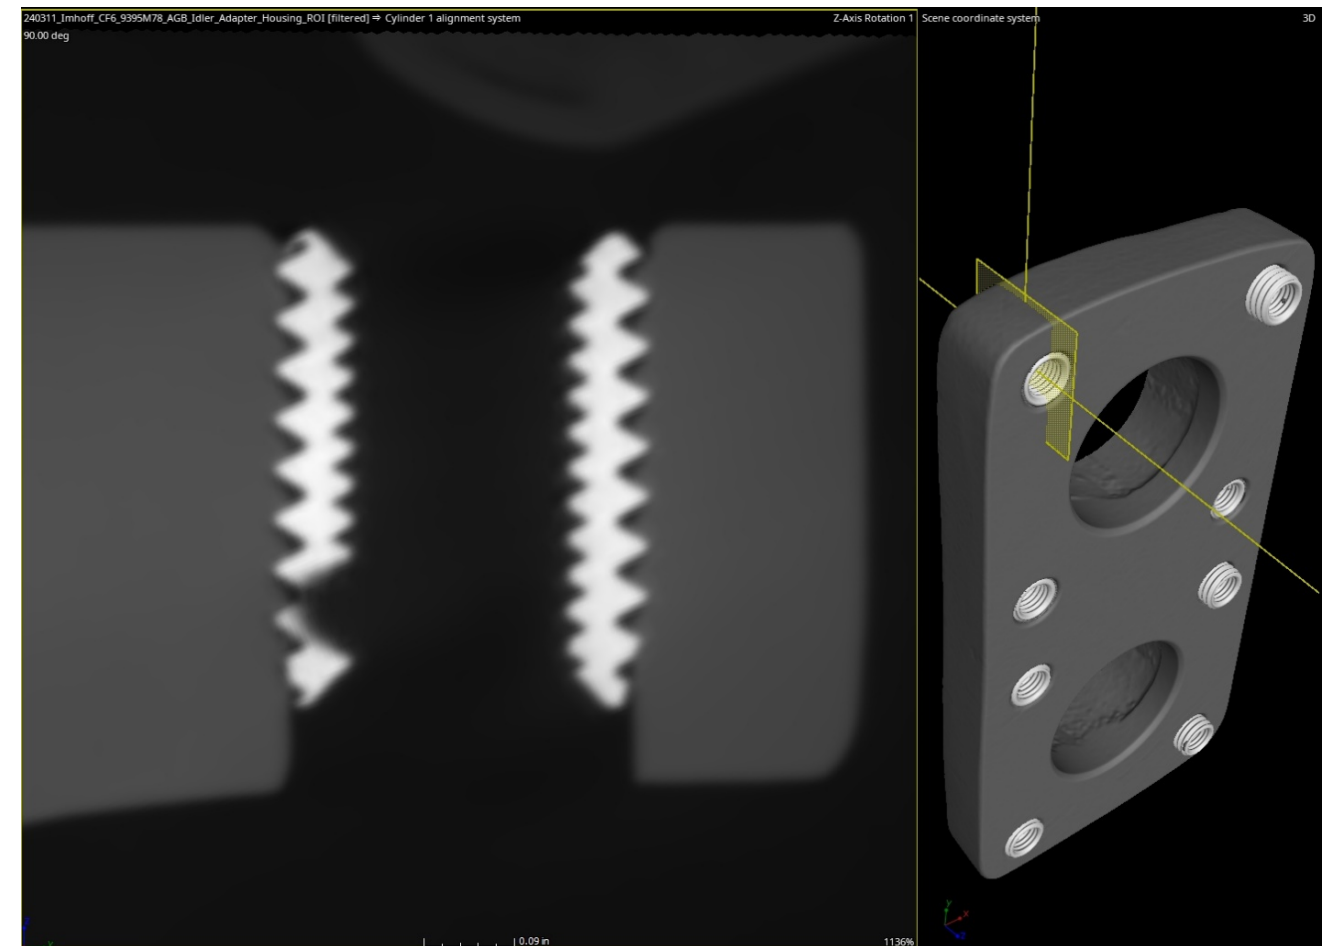
# Insert 8

**Figure 18:** CT scan cross-section of thread insert position 8. Thread engagement is observed into the flange material.

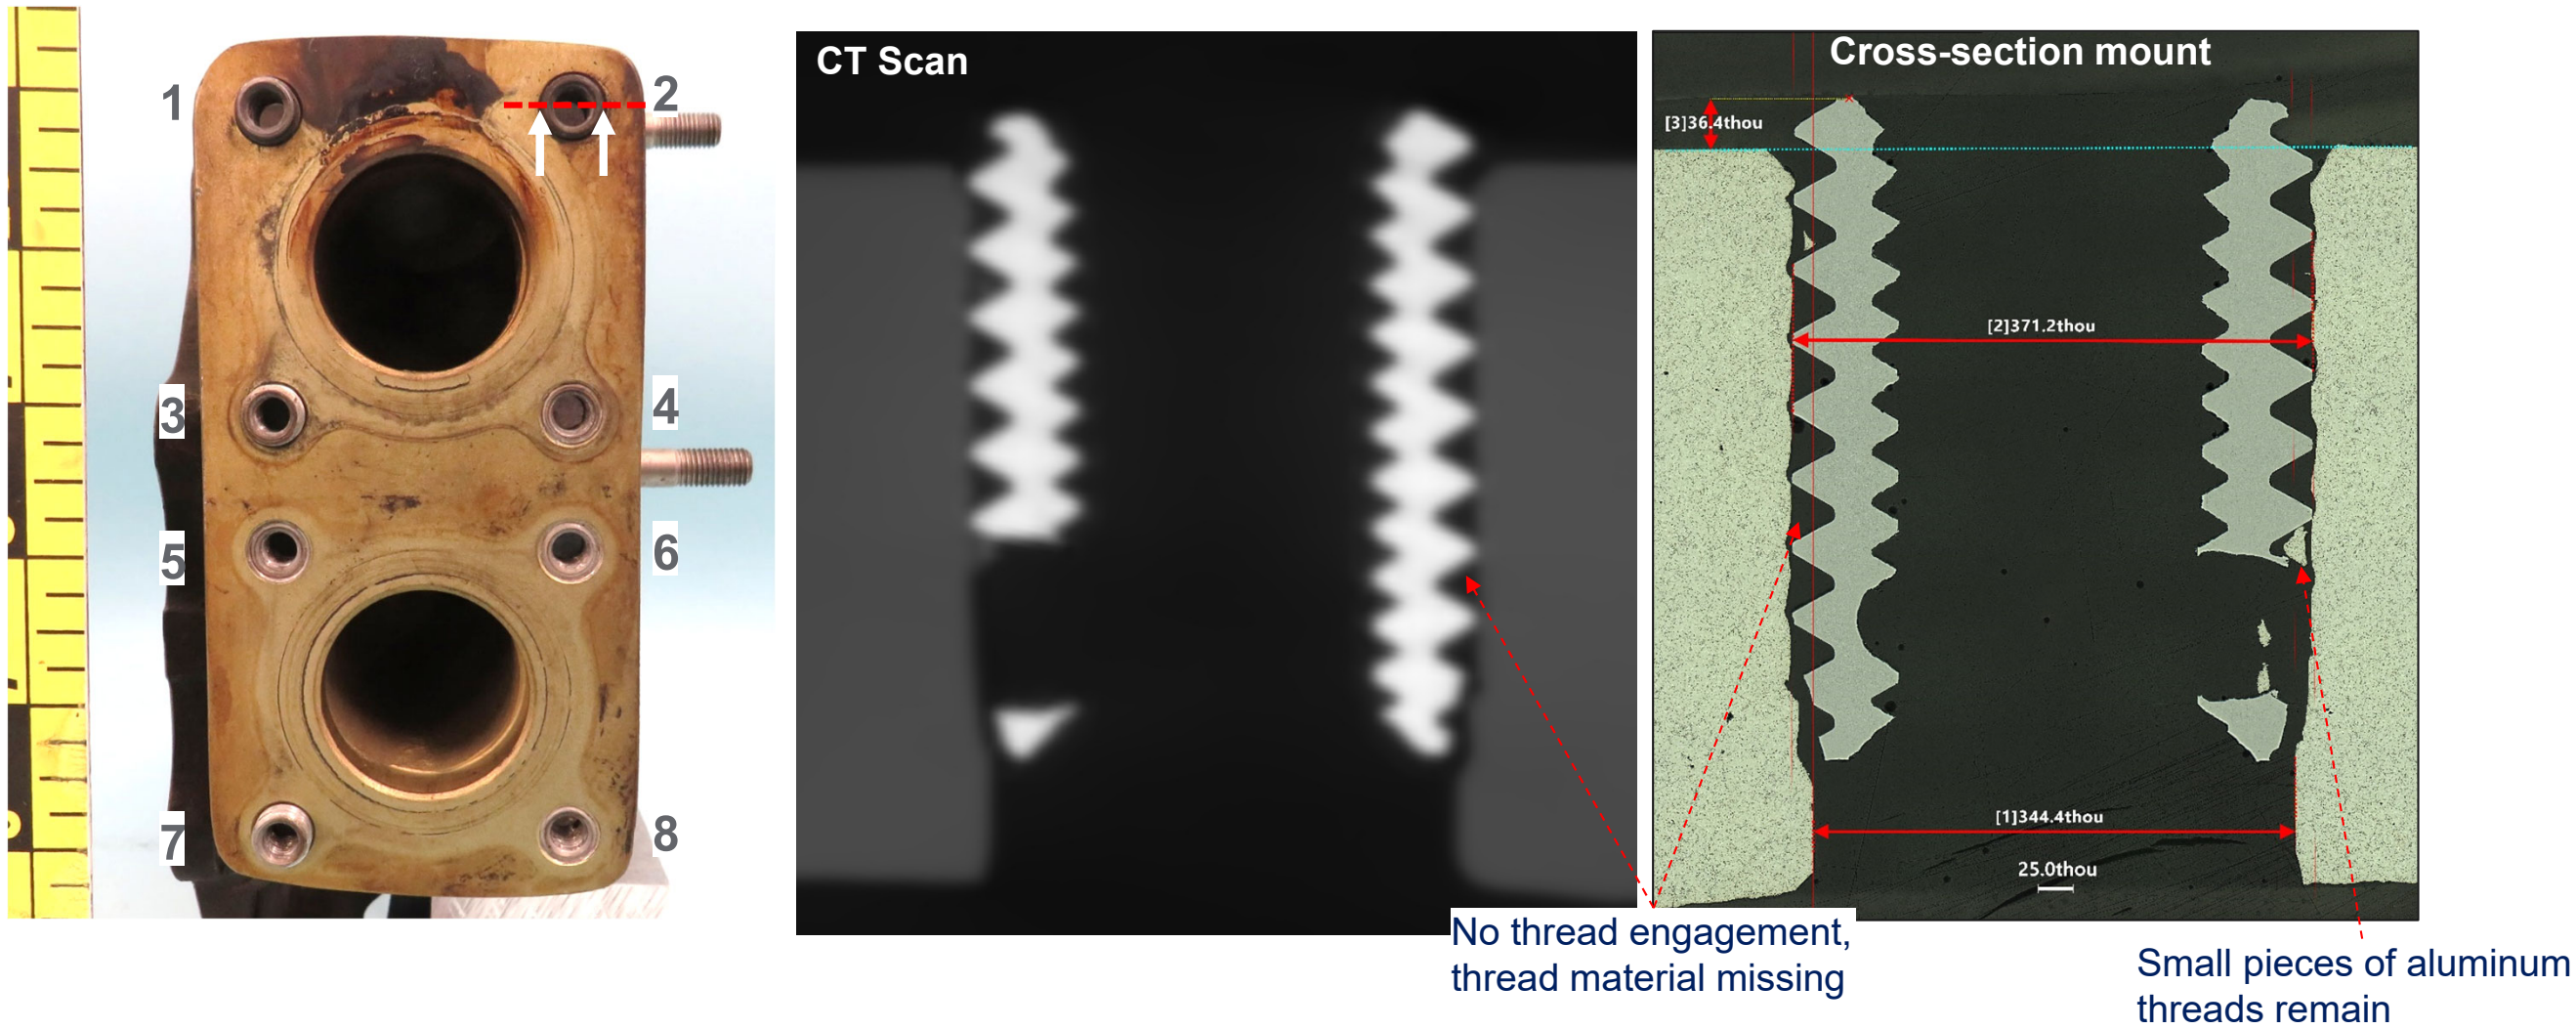
# Insert 2

**Figure 19:** Insert 2 is the only thread insert found protruding that was not disturbed by a pull-out test. Cross-section views confirms the lack of thread engagement observed in the CT scan. Small pieces of loose aluminum are observed trapped between the insert threads, however **most of the aluminum thread material is missing**. This insert has reportedly never been removed since new make.

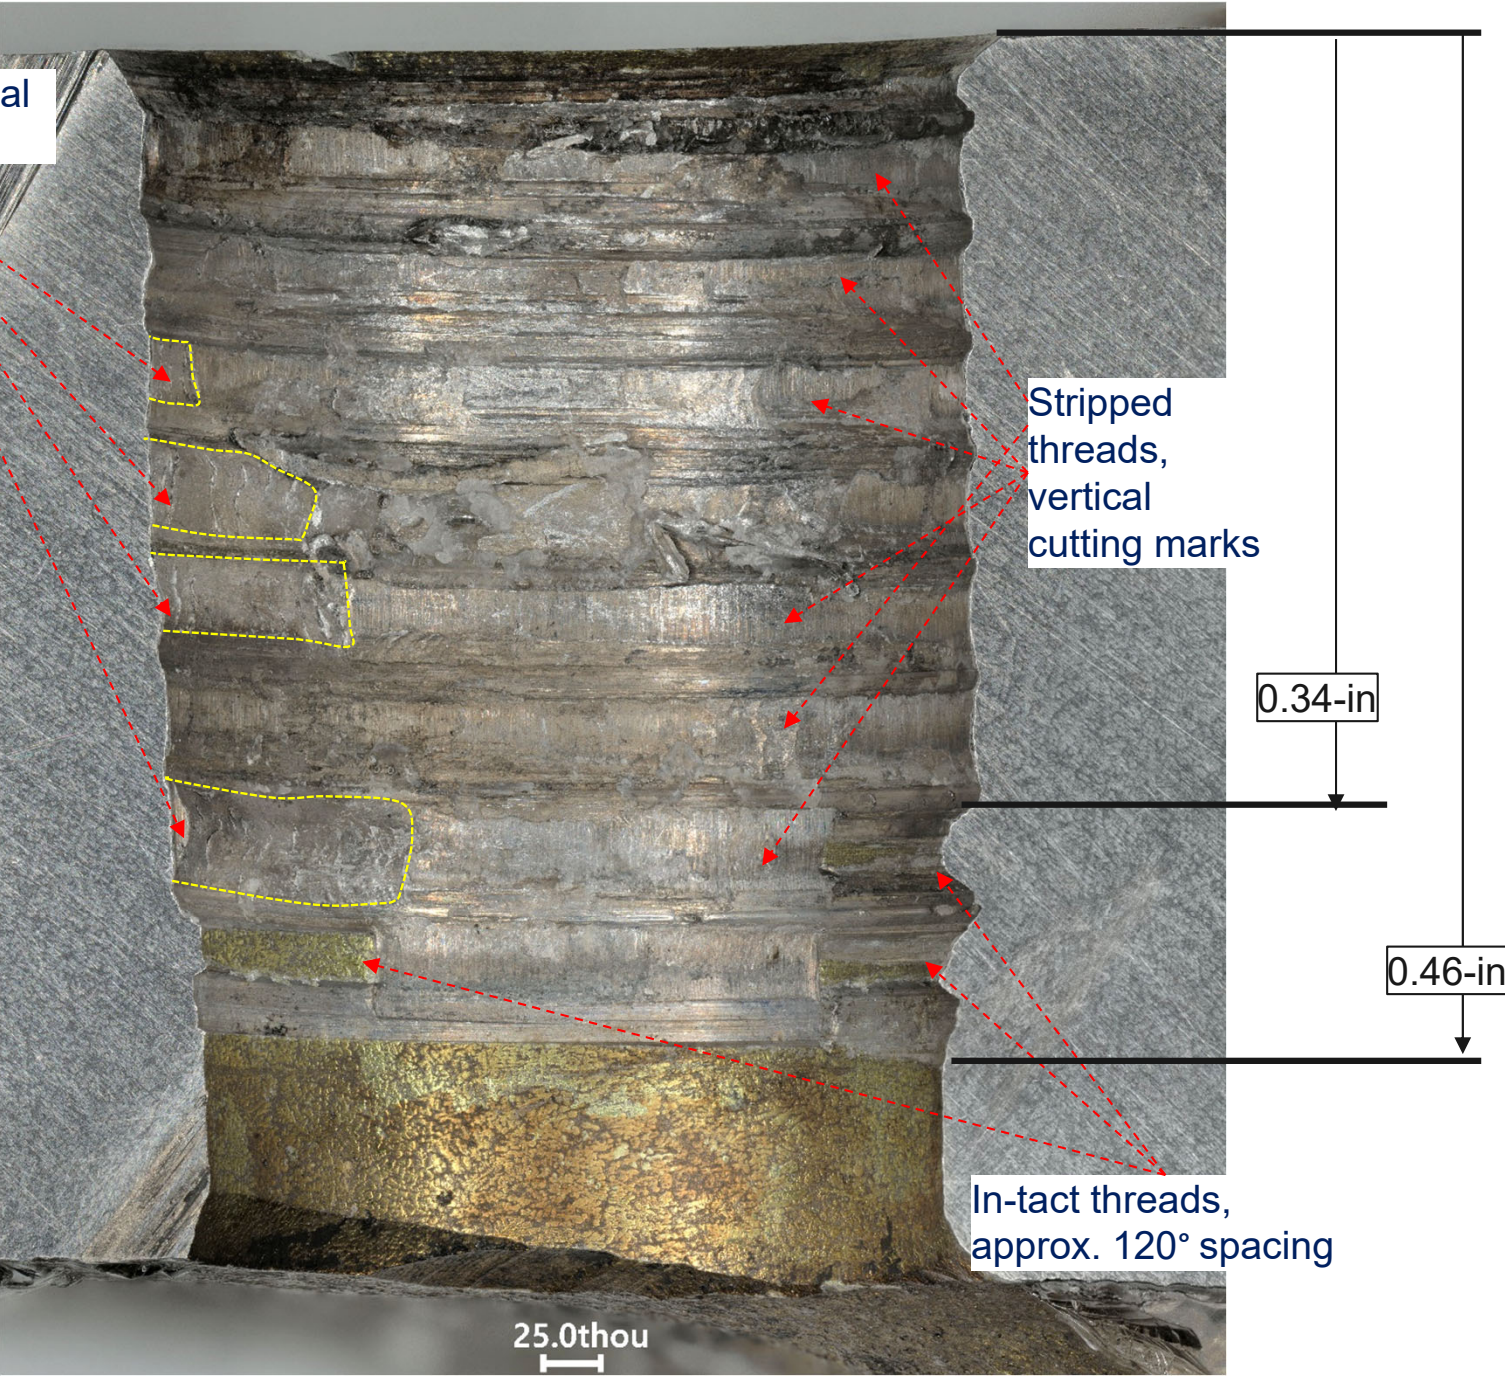
- Sectioning of insert location 2 revealed the pre-tapped threads were missing 360-degrees around the hole to a depth of approximately 0.34-inches (Figure 20). High magnification views of the microstructure at the hole surface revealed no compressed grains that would indicate severe smearing, consistent with the material being cut out by the self-tapping inserts (Figures 23). Vertical scoring lines are observed in the areas with missing internal threads consistent with the insert contacting the surface while pulling out. Smeared material in the CCW direction is observed in multiple areas (Figures 21-22). Two areas with the intact threads are observed at the bottom of the hole with the same spacing as the insert installation holes 120-degrees around (Figure 24). The missing threads between them were found trapped in the insert threads, consistent with the aluminum parent metal thread shearing when the steel insert was pulled out.

CCW circumferential smear

**Figure 20:** Optical views of the lower half of the insert 2 hole with the inset removed. Most of the threads are stripped and the thread material is missing. Two areas with the intact threads are observed with the same spacing as the insert installation holes (120°). The threads are completely missing through approximately 0.34-inches of the hole depth.

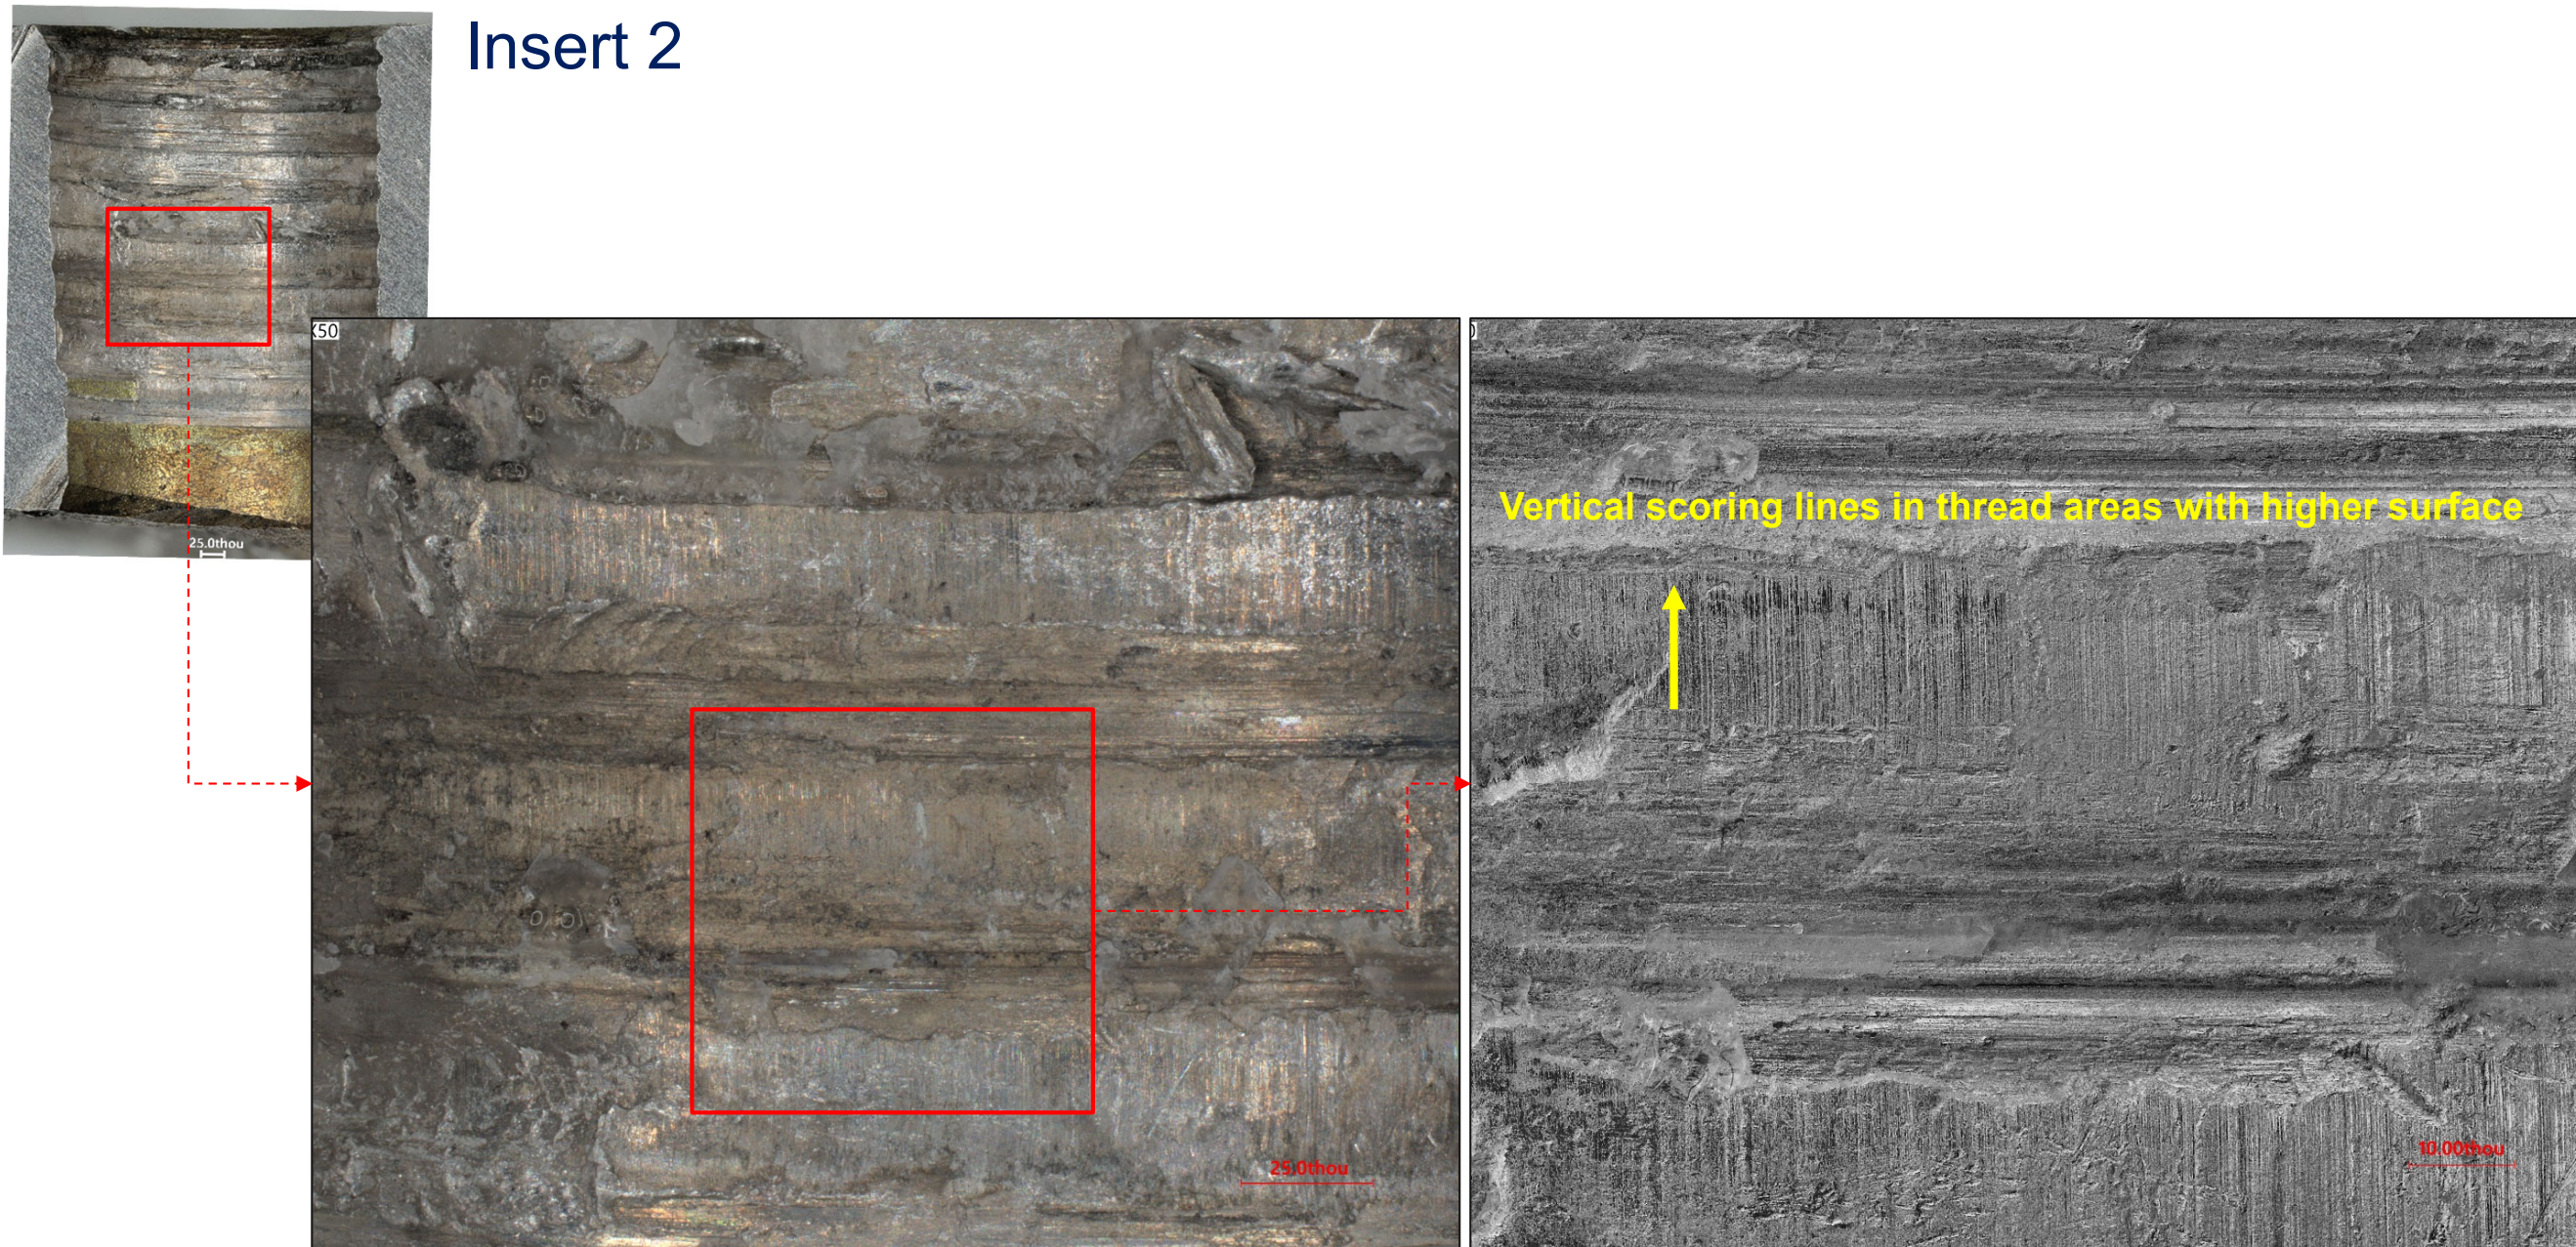
## Insert 2

**Figure 21:** High magnification views reveal vertical scoring lines consistent with contact damage from the steel thread insert pulling out.

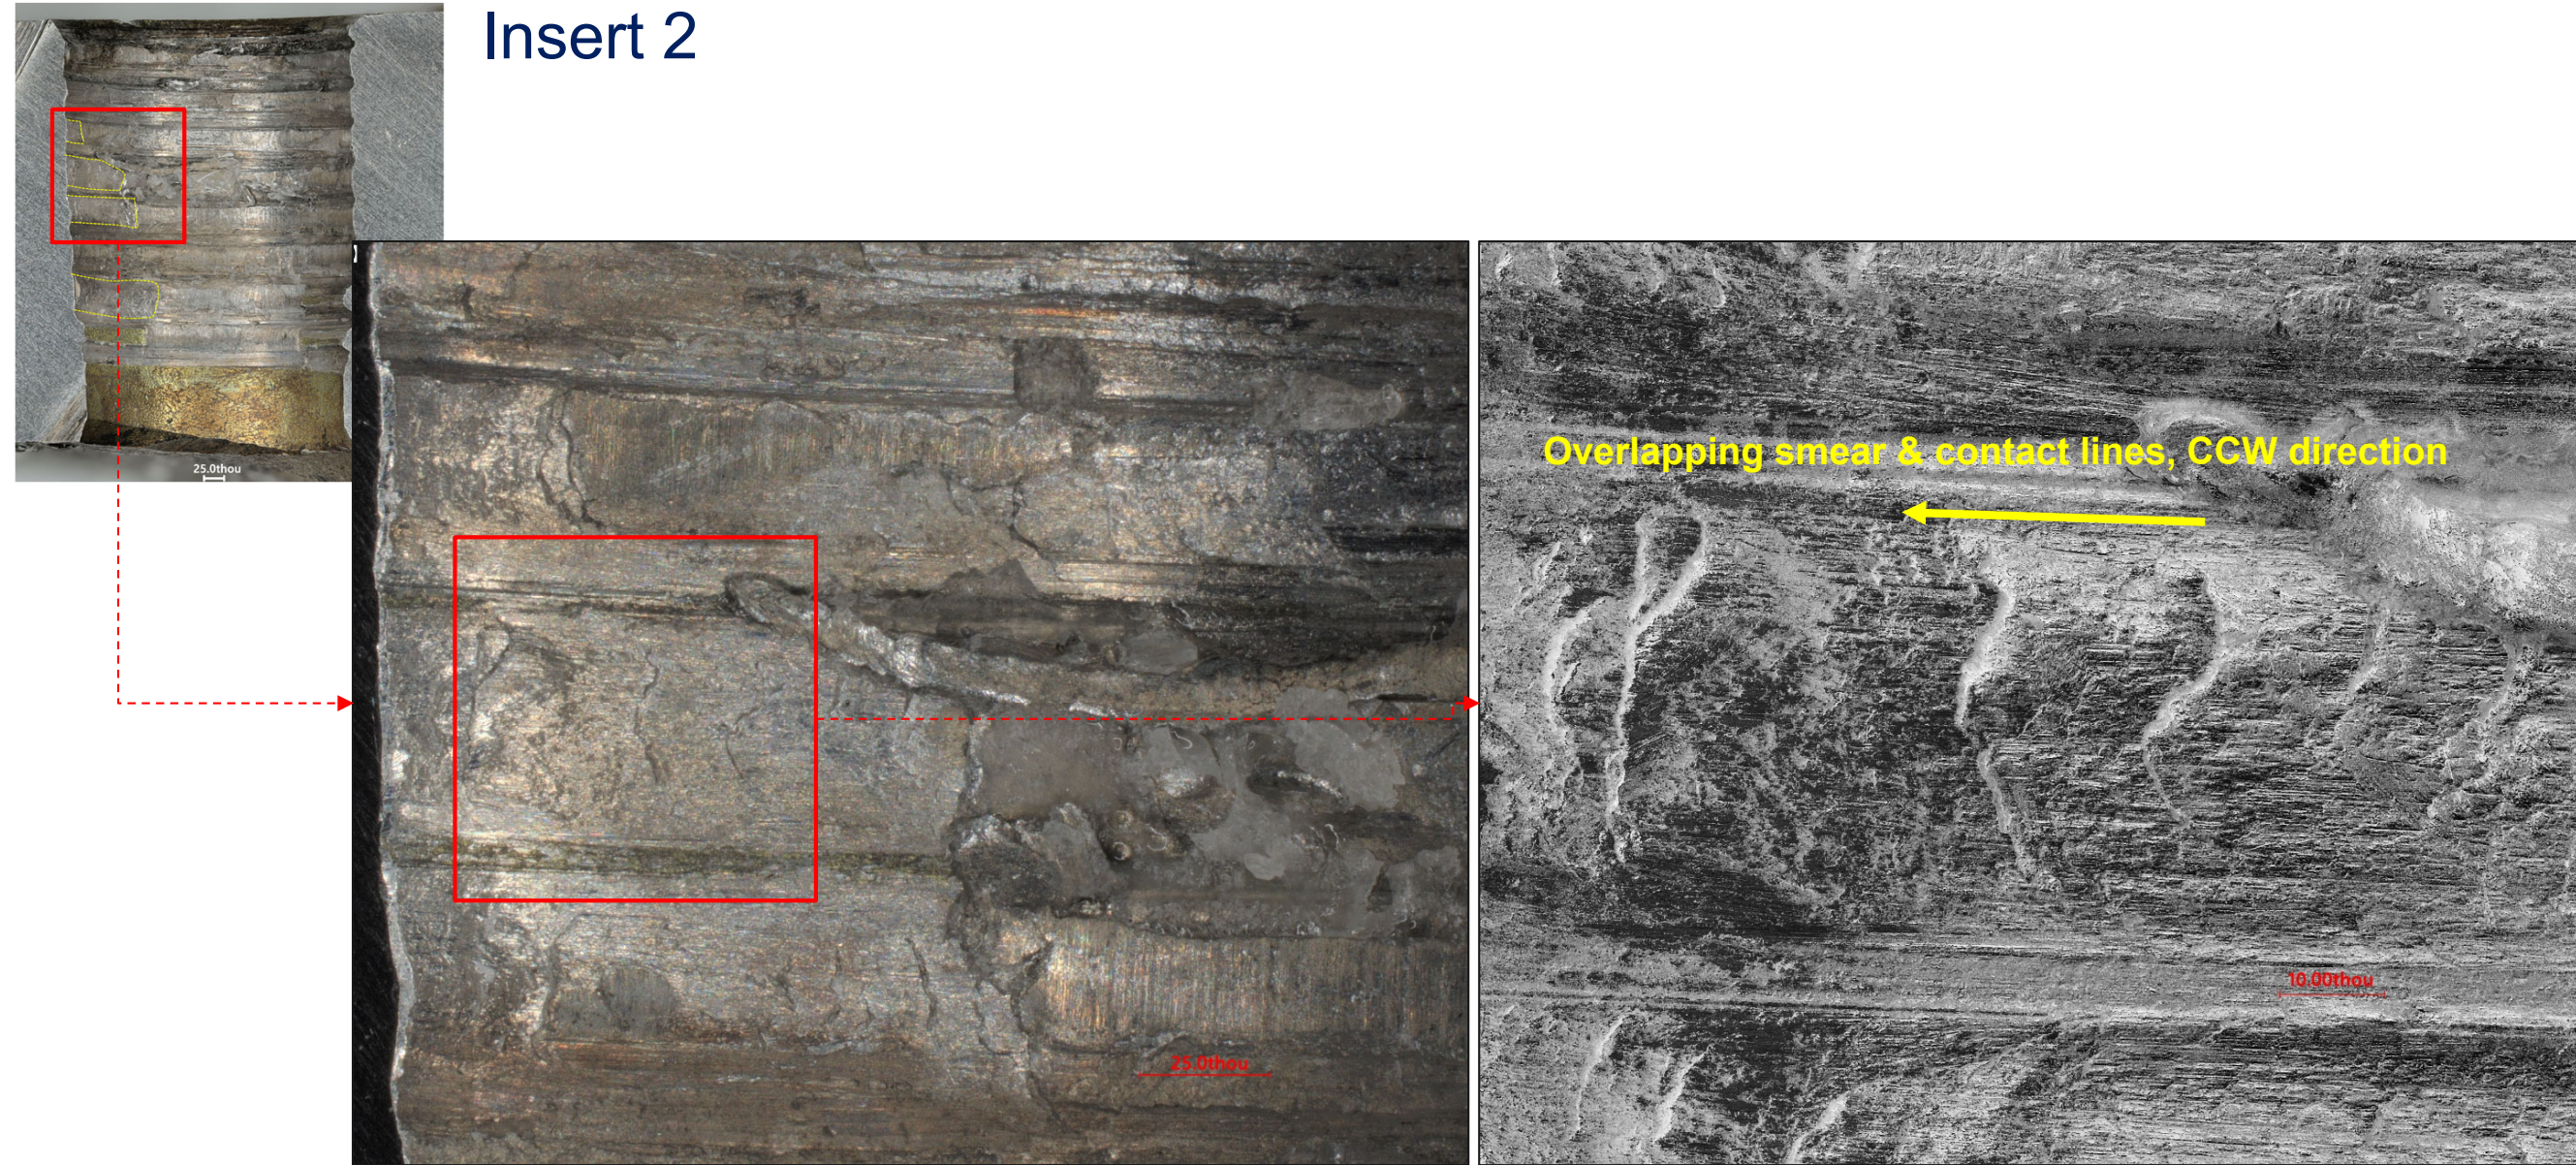
## Insert 2

**Figure 22:** High magnification views of the circumferential damage reveal overlapping smear consistent with counter-clockwise rotation. Per the part processing plan, the steel inserts should not experience a counter-clockwise rotation during installation.

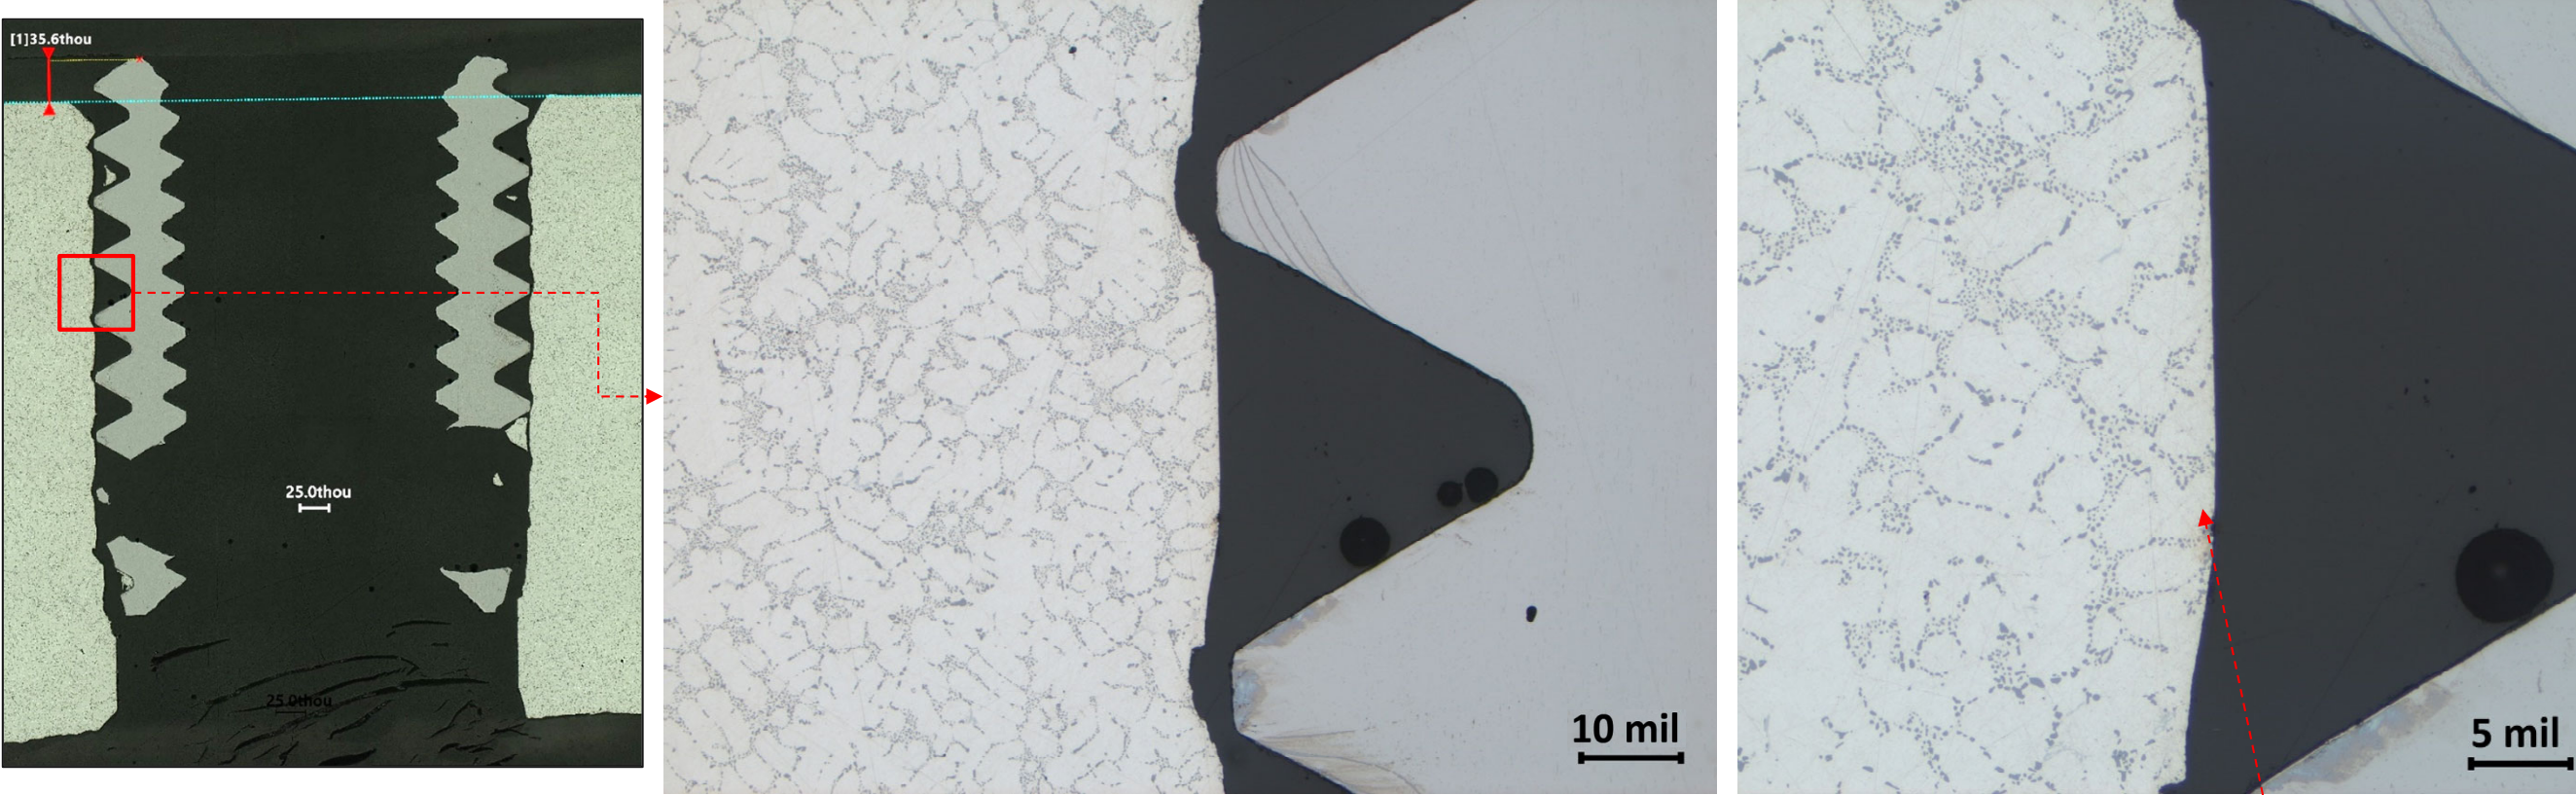
# Insert 2

Minimally deformed microstructure at the missing thread location, no evidence of compressed material

**Figure 23:** High magnification views of the aluminum hole wall reveals a minimally deformed microstructure near the edge, consistent with sheared material due to cutting (self-tapping inserts). No evidence of smeared/compacted material into the hole wall is observed.

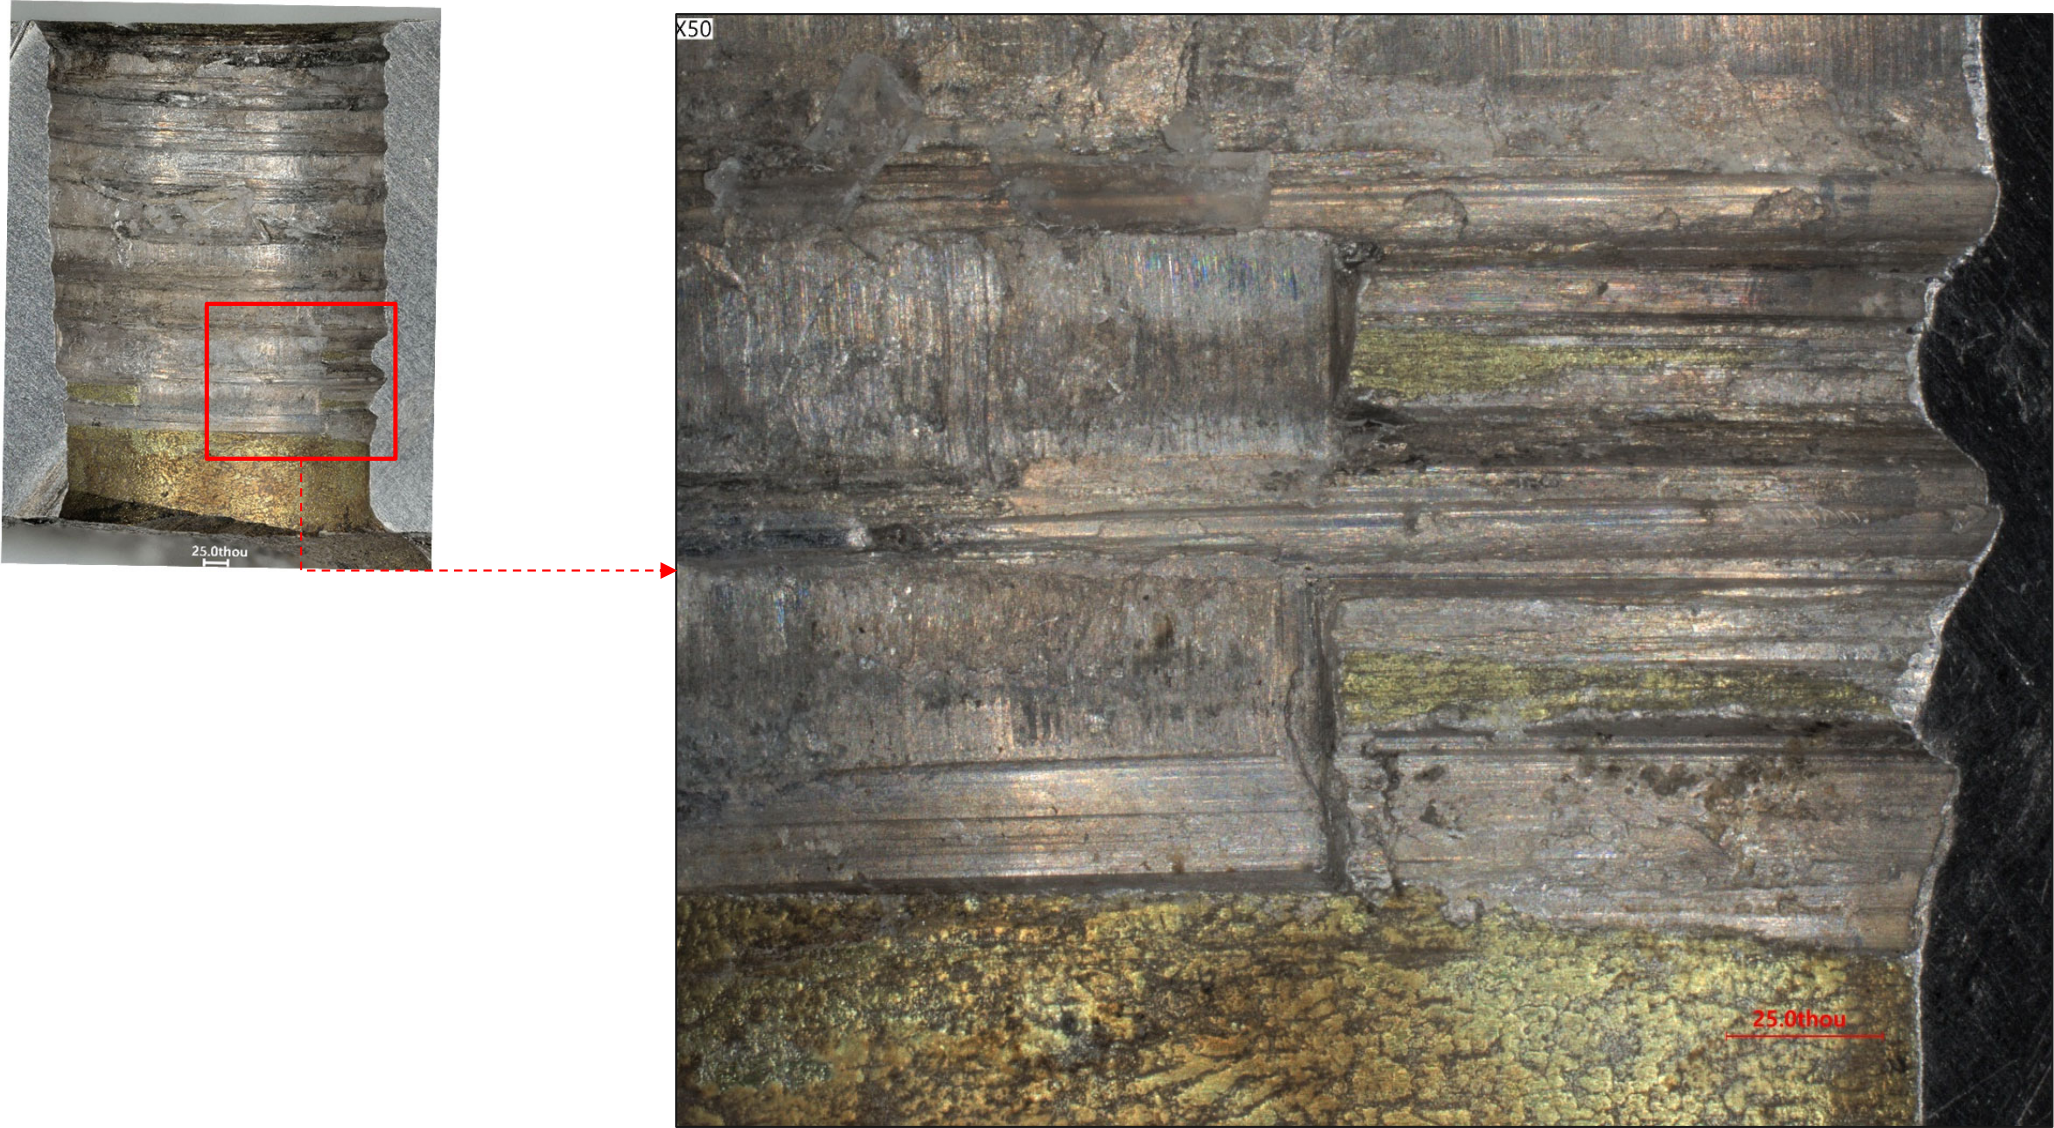
# Insert 2

**Figure 24:** High magnification view of the remaining threads that align with the insert installation hole positions. The gold-like color observed on threads is from the anodized surface treatment which occurs after hole drilling and pre-tap.

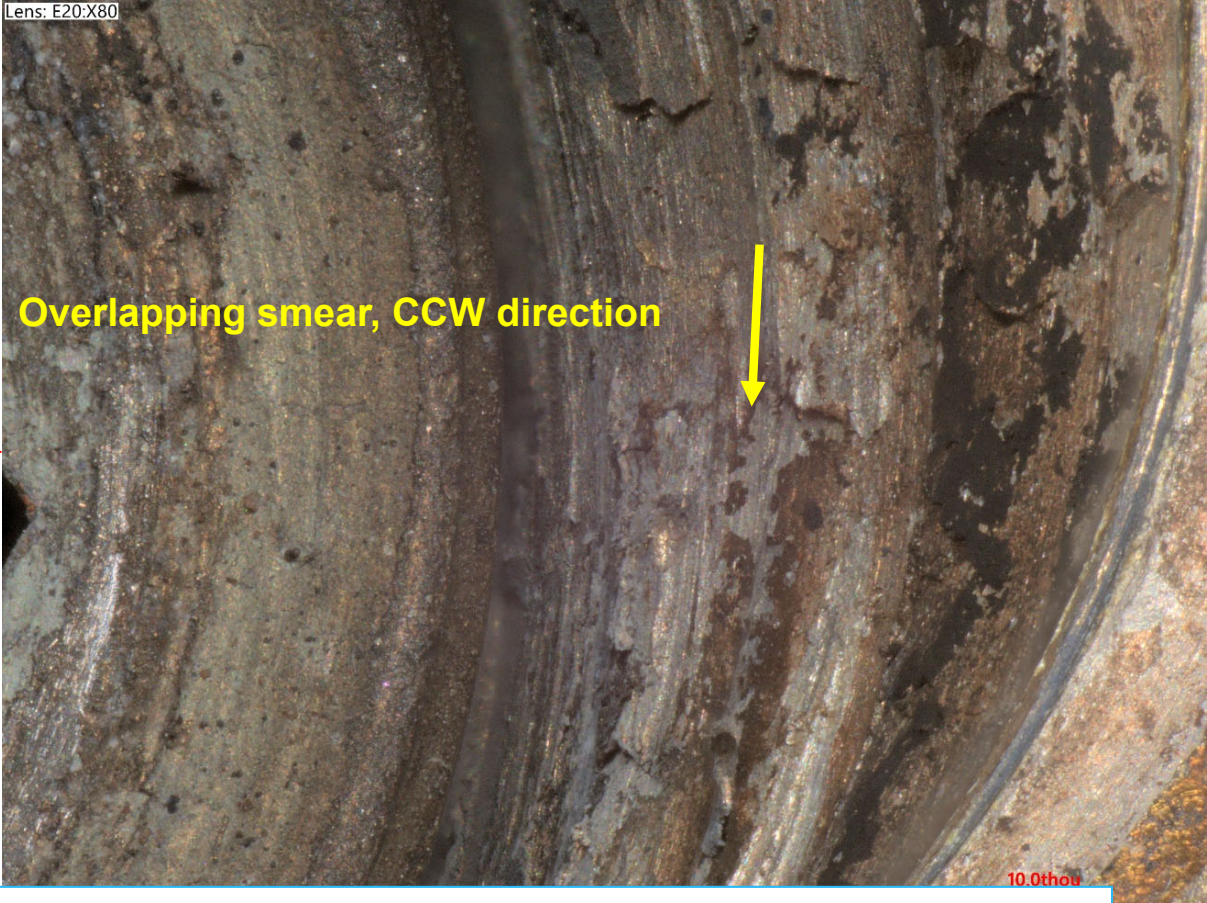
**Figure 25:** High magnification views of the Insert 1 hole circumferential damage reveal overlapping smear consistent with counter-clockwise rotation. Black soot-like material is observed on the smeared material, consistent with the smeared material existing during the fire.

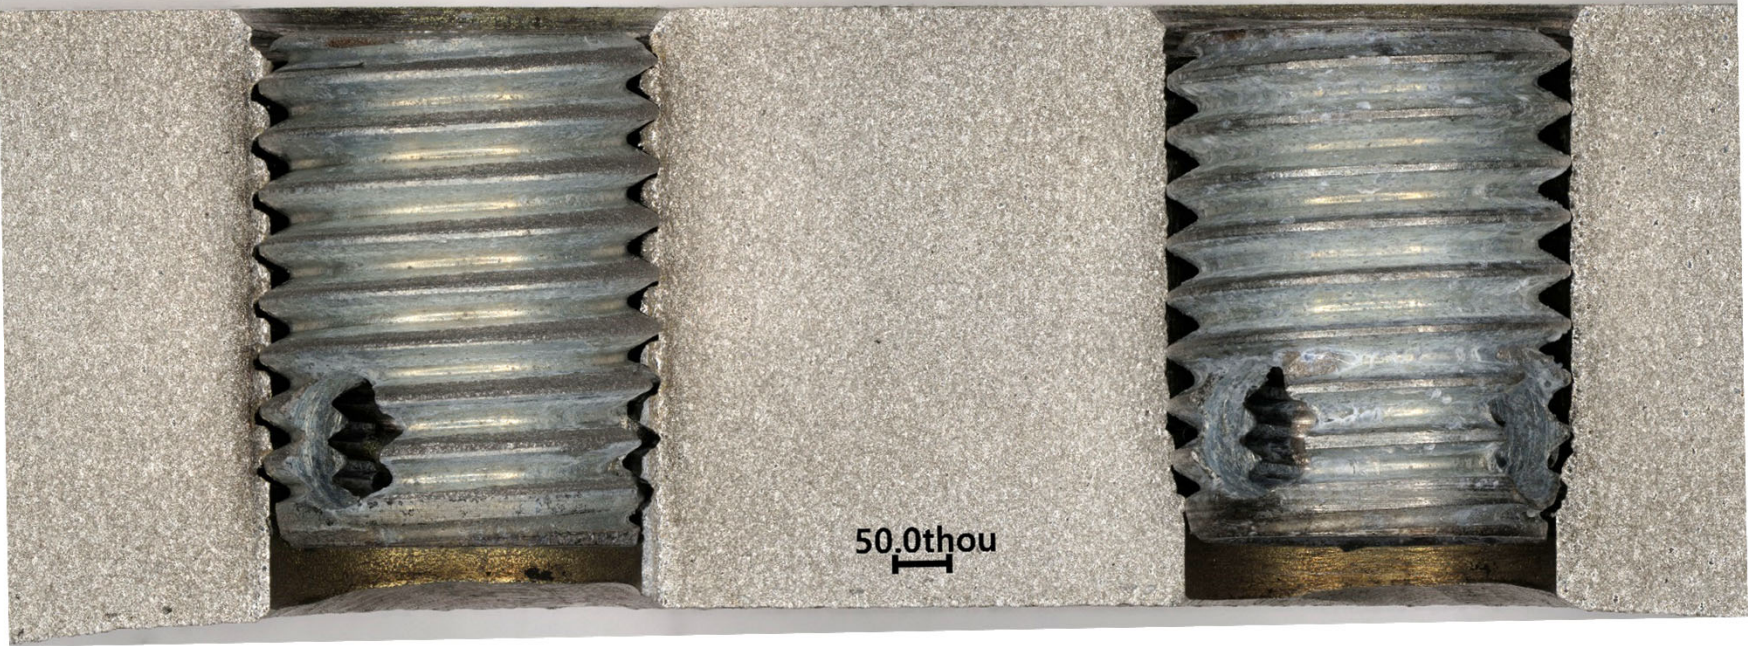
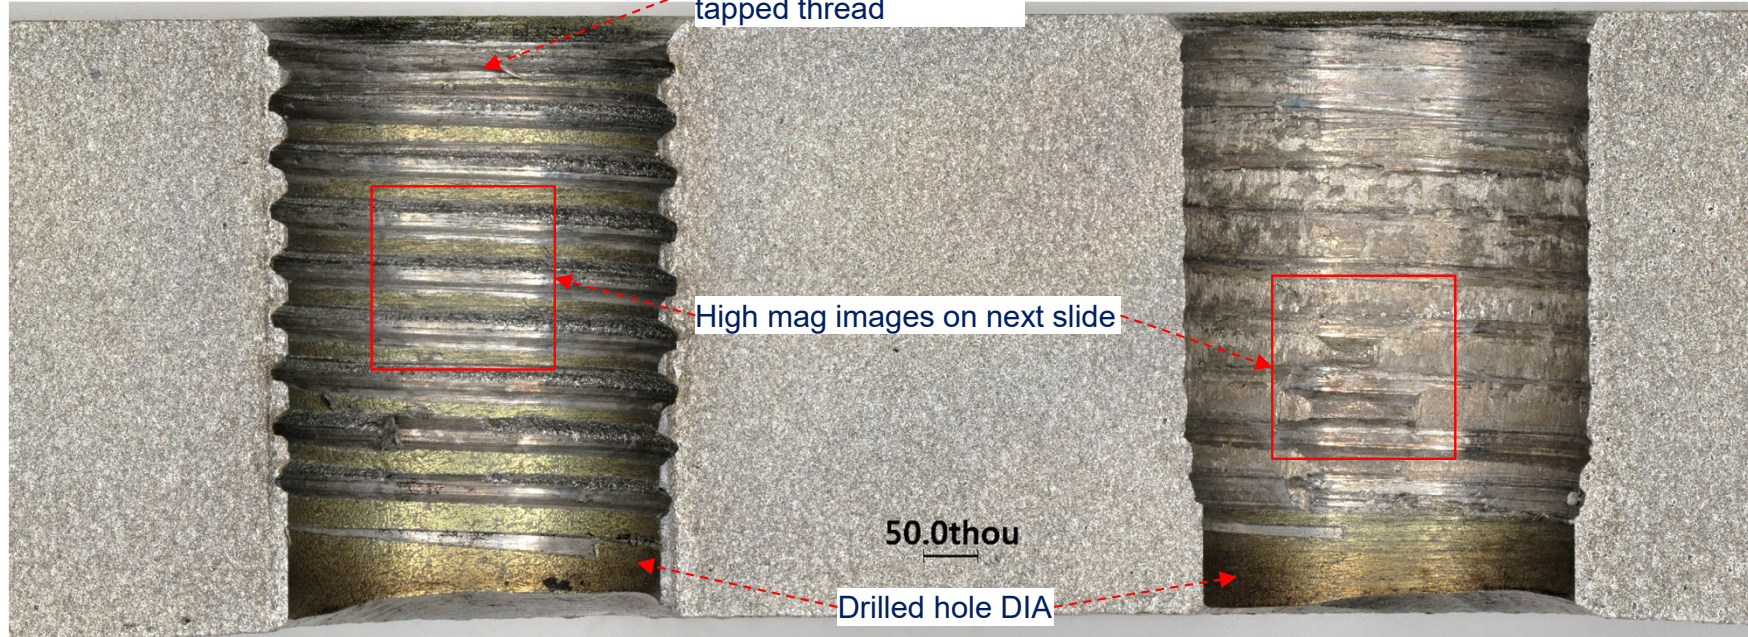
- Evaluation of a hole that showed thread engagement in the CT scan (insert 5) revealed the gold-colored anodized pre-tapped threads were still present (Figure 26). However, insert location 3 has similar vertical scoring lines and remaining lower two threads similar to findings observed in insert 2 (Figure 27). The insert 3 damaged location also showed insert cut lines that were angled and out of phase with the original pre-tapped threads, consistent with cross-threading during installation of the inserts (Figure 28).

**Figure 26:** Optical views of insert hole numbers 3 and 5 after wire EDM sectioning. Insert 3 was loose and fell out due to normal handling prior to cutting. The wire EDM cutting was stopped on both sides of Insert 5 so it could be removed and inspected. The top image shows the sectioned holes with the inserts in place, and the bottom image shows the holes with the inserts removed. The gold-like color observed on the Insert 5 hole threads is from the anodized surface treatment which occurs after hole drilling and pre-tap. The fresh, silver metal observed in Insert 5 hole is from the insert tapping threads. The insert 3 hole shows all of the threads are missing, except for three areas that align with the three insert hole locations.
