# **Metallurgical Investigation Report**

## **DRB: AvEng-561264.A**

**EVALUATION OF A CF6-80C2 ESN 707-605 HMU IDLER  
ADAPTER FROM ESN 707-605 OPERATED BY FEDEX  
INVOLVED IN AN IN-FLIGHT SHUT-DOWN AND  
UNDERCOWL FIRE EVENT**

Part Number: 9395M78G10  
Part Serial Number: FIA217EE  
Part TSN / CSN: 1,421 hrs / 728 cycles

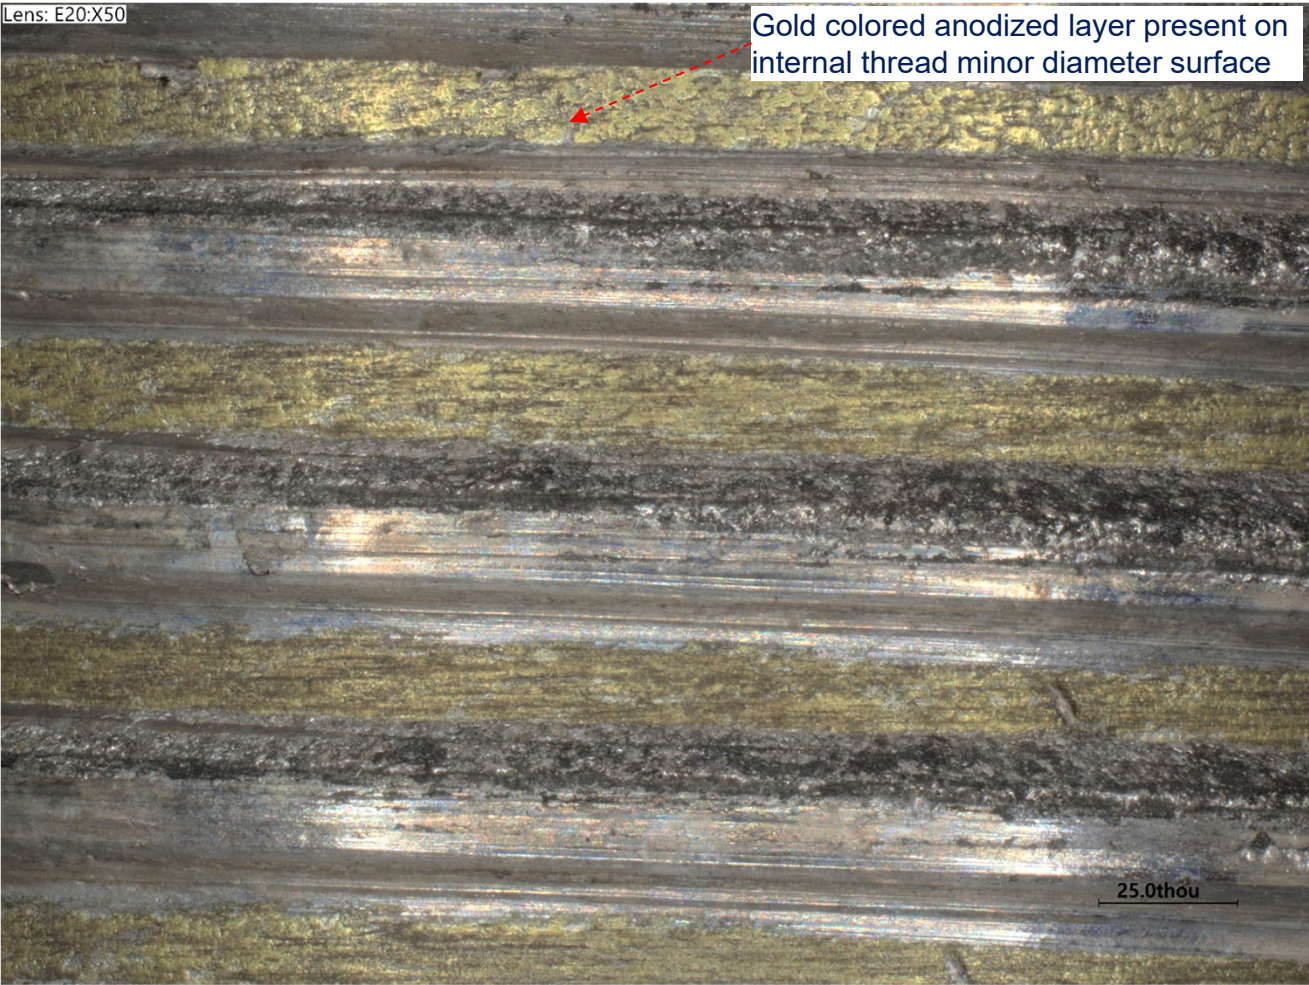
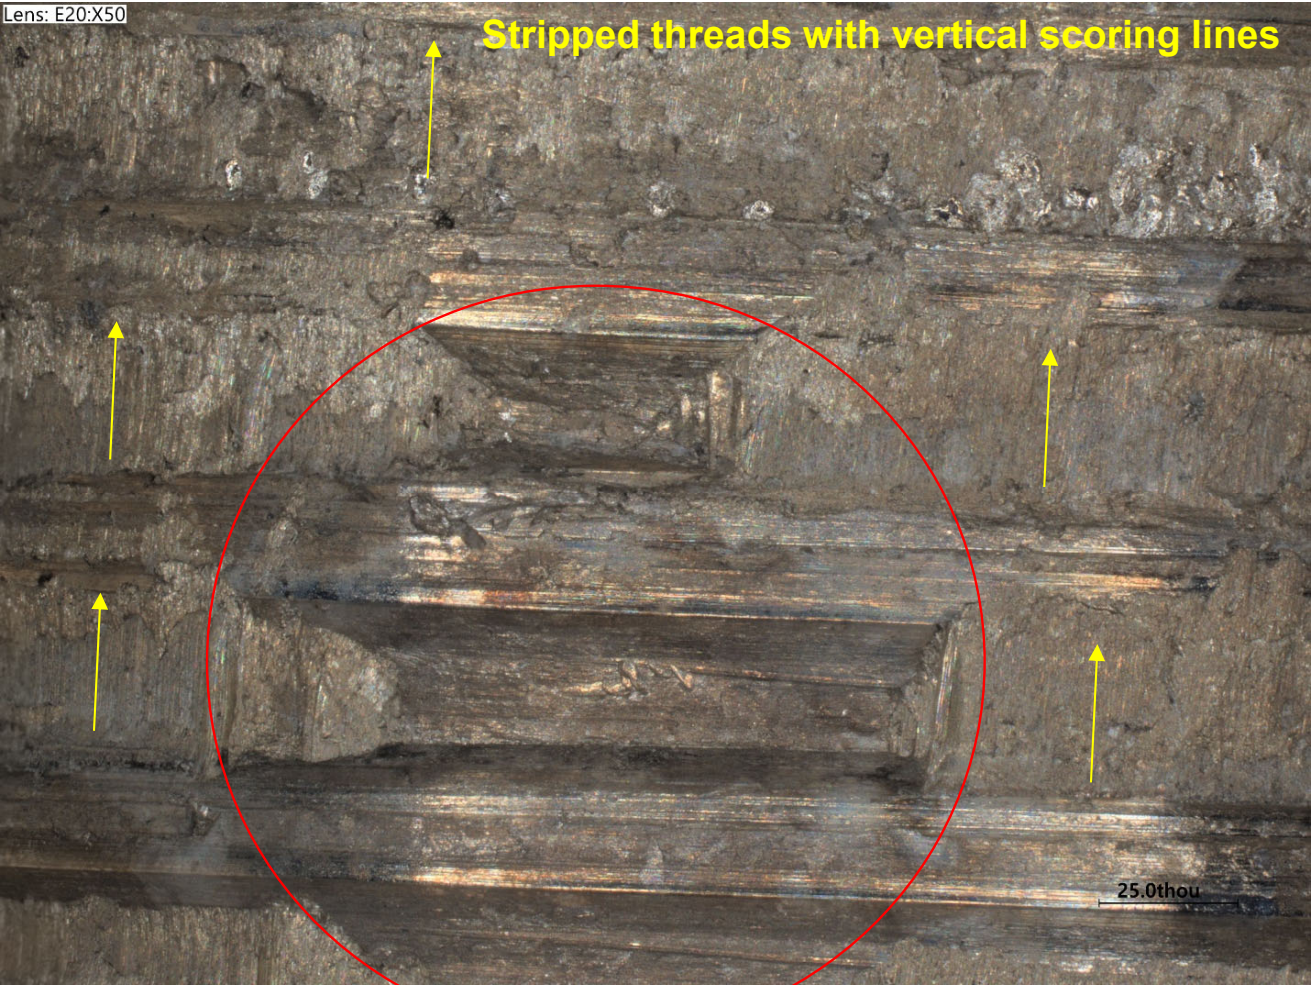
**Figure 27:** 50X optical images of insert 5 and 3 hole thread surfaces. The gold, anodized surface is observed on the tips of the insert 5 hole threads. The stripped threads in insert 3 hole have vertical scoring lines on the surface, consistent with contact damage from the steel insert during the pull-out test. No loose material was observed in the CT scan or collected inside the insert 3 hole after sectioning.

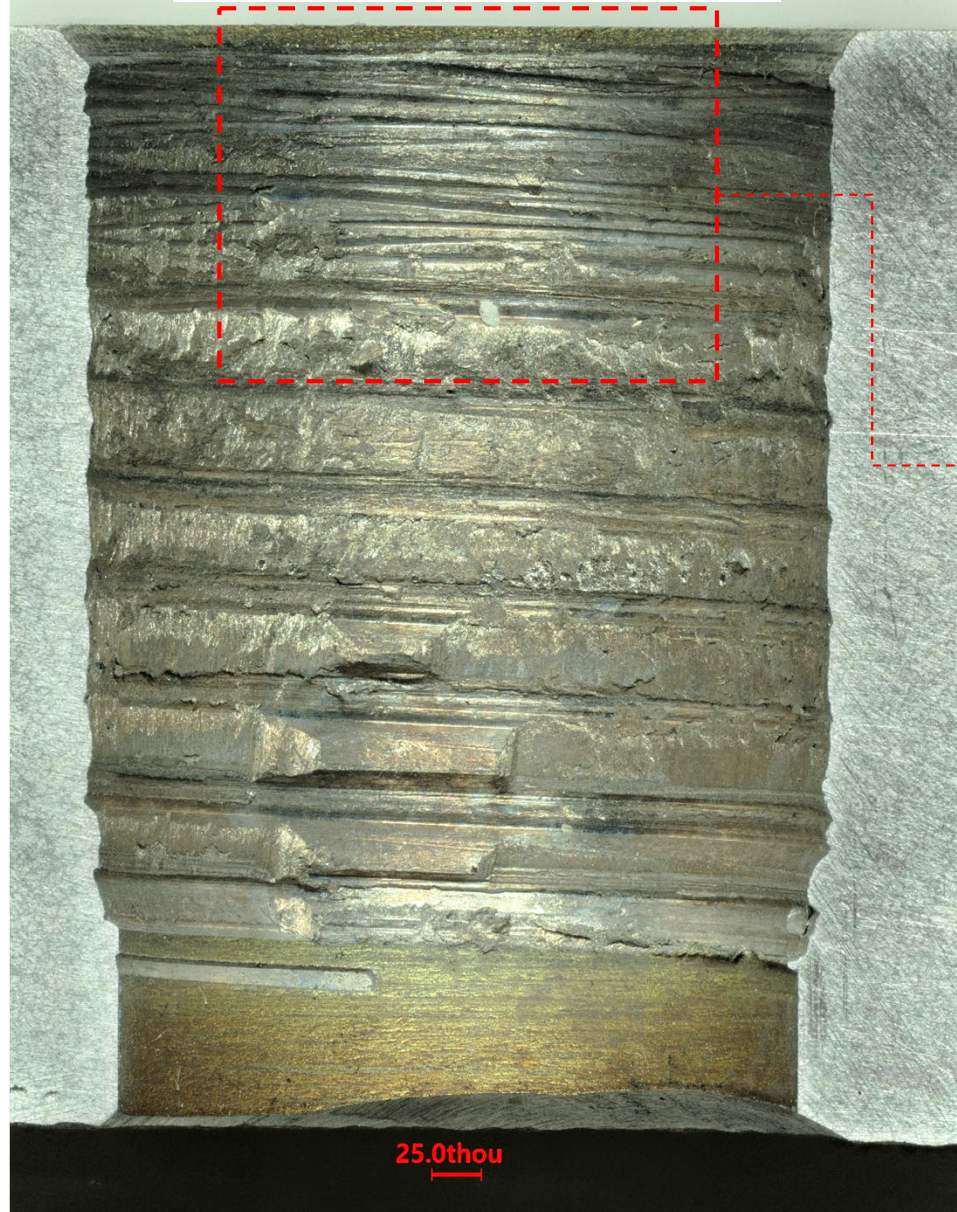
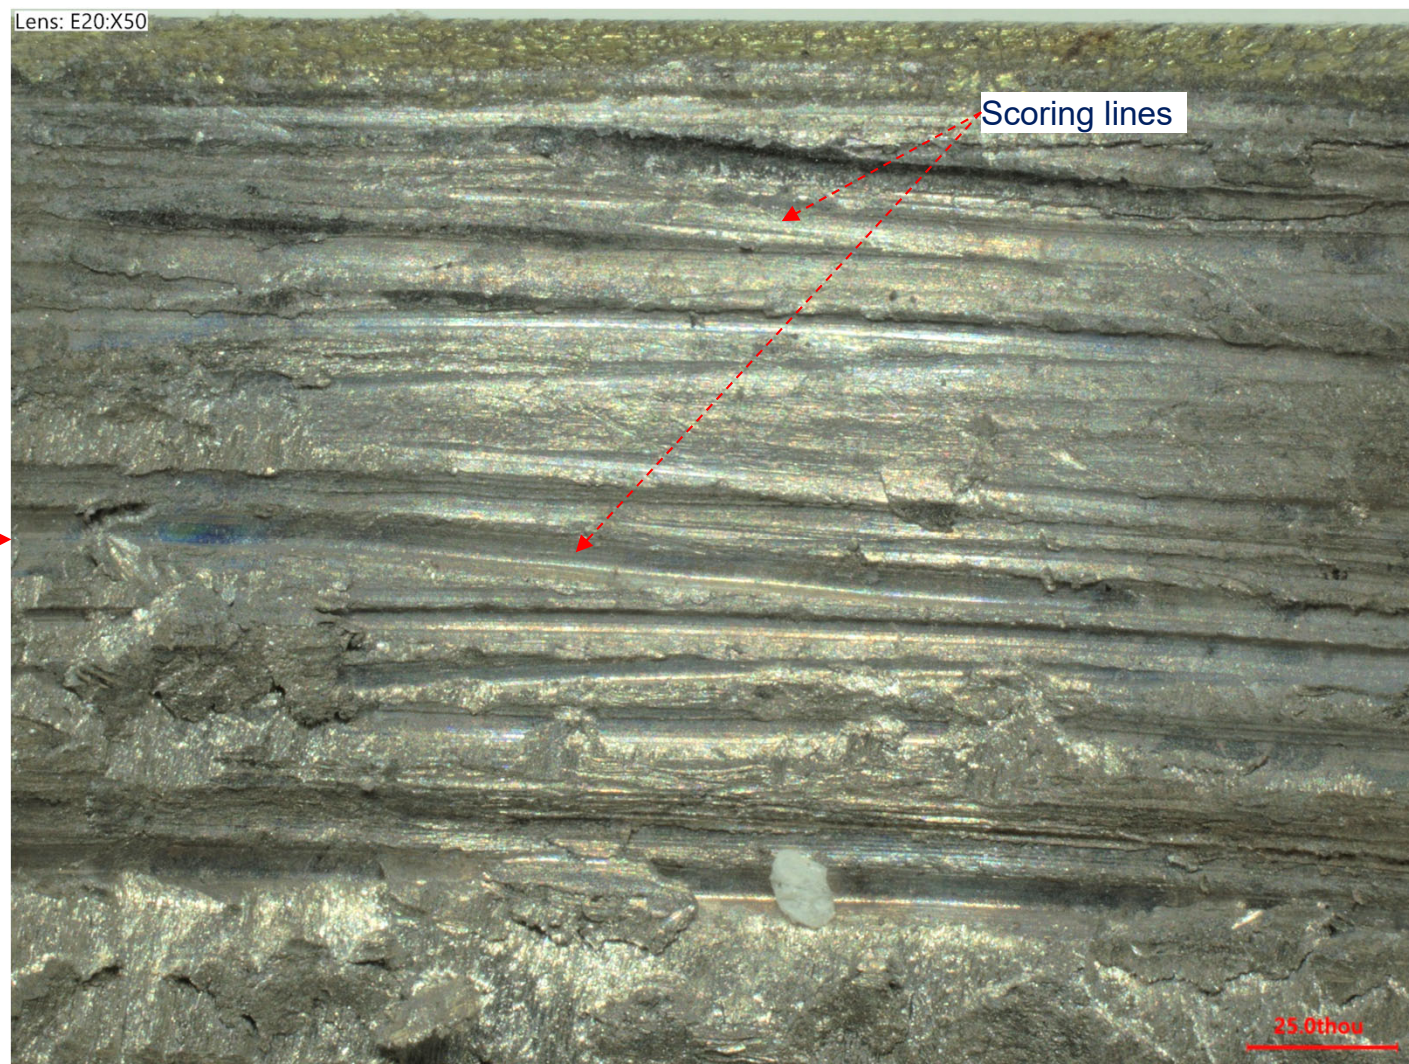
### Insert 3 (Failed pull-out test) Side Lighting

Intact threads in three equally spaced locations, matching the insert installation hole locations

**Figure 28:** Image of the Insert 3 hole location with side lighting. Scoring lines near the top of the hole are consistent with the steel insert cross-threading and cutting through the pre-tapped internal threads.

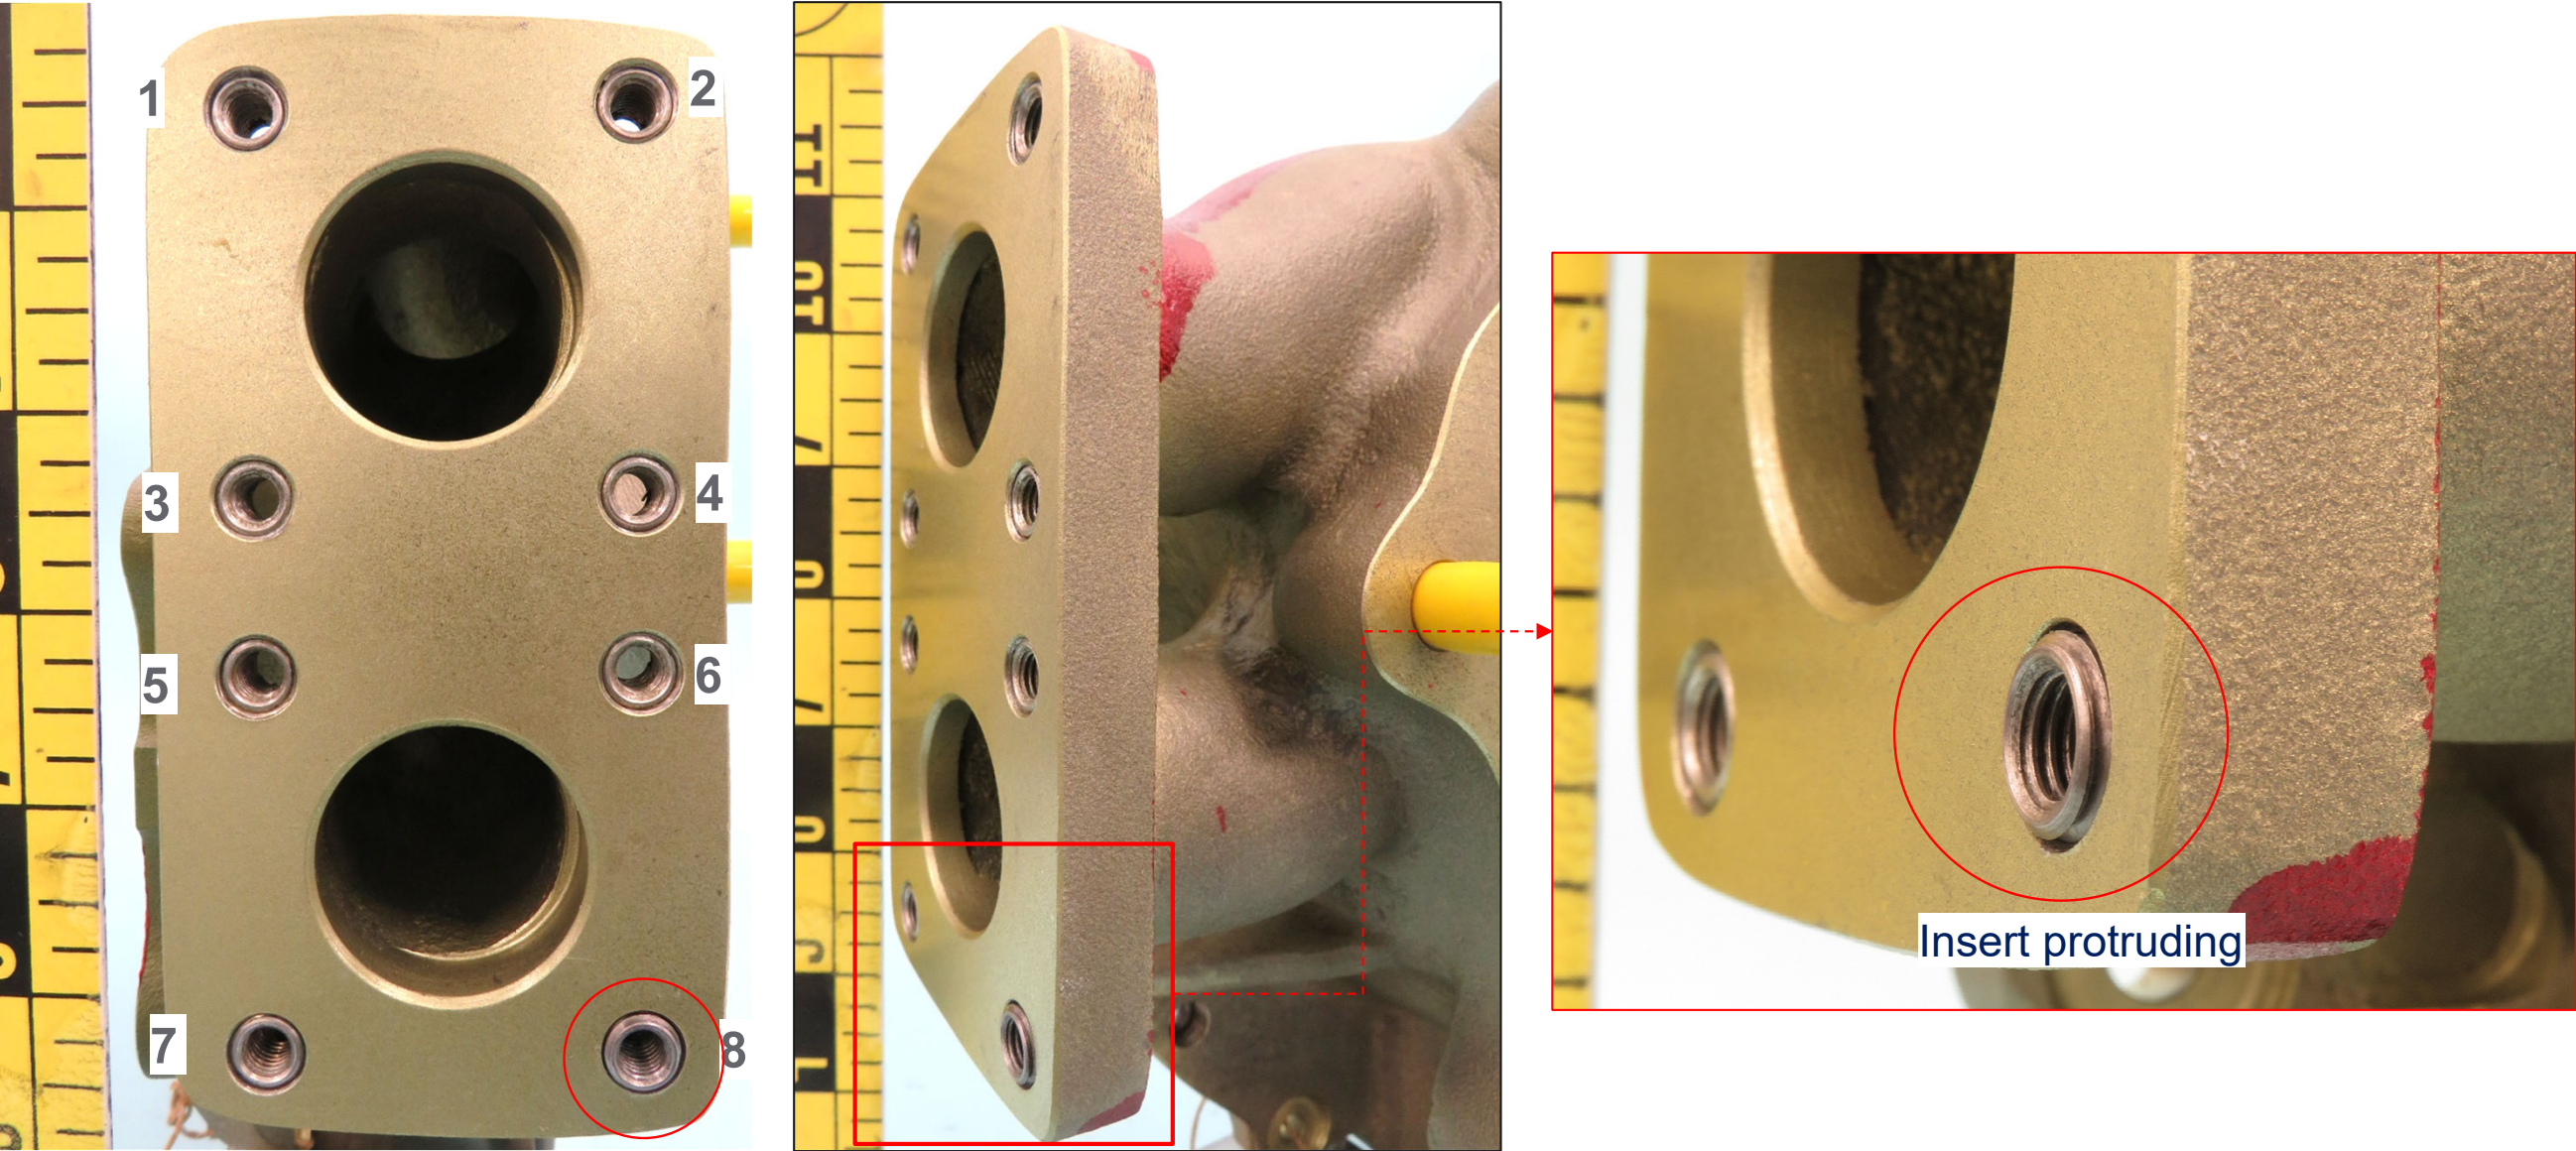
**Figure 41:** Insert location number 8 which backed out during the removal of the plastic cover is protruding approximately 0.020-inches from the flange surface. The protruding insert was found loose and easy to move by hand.

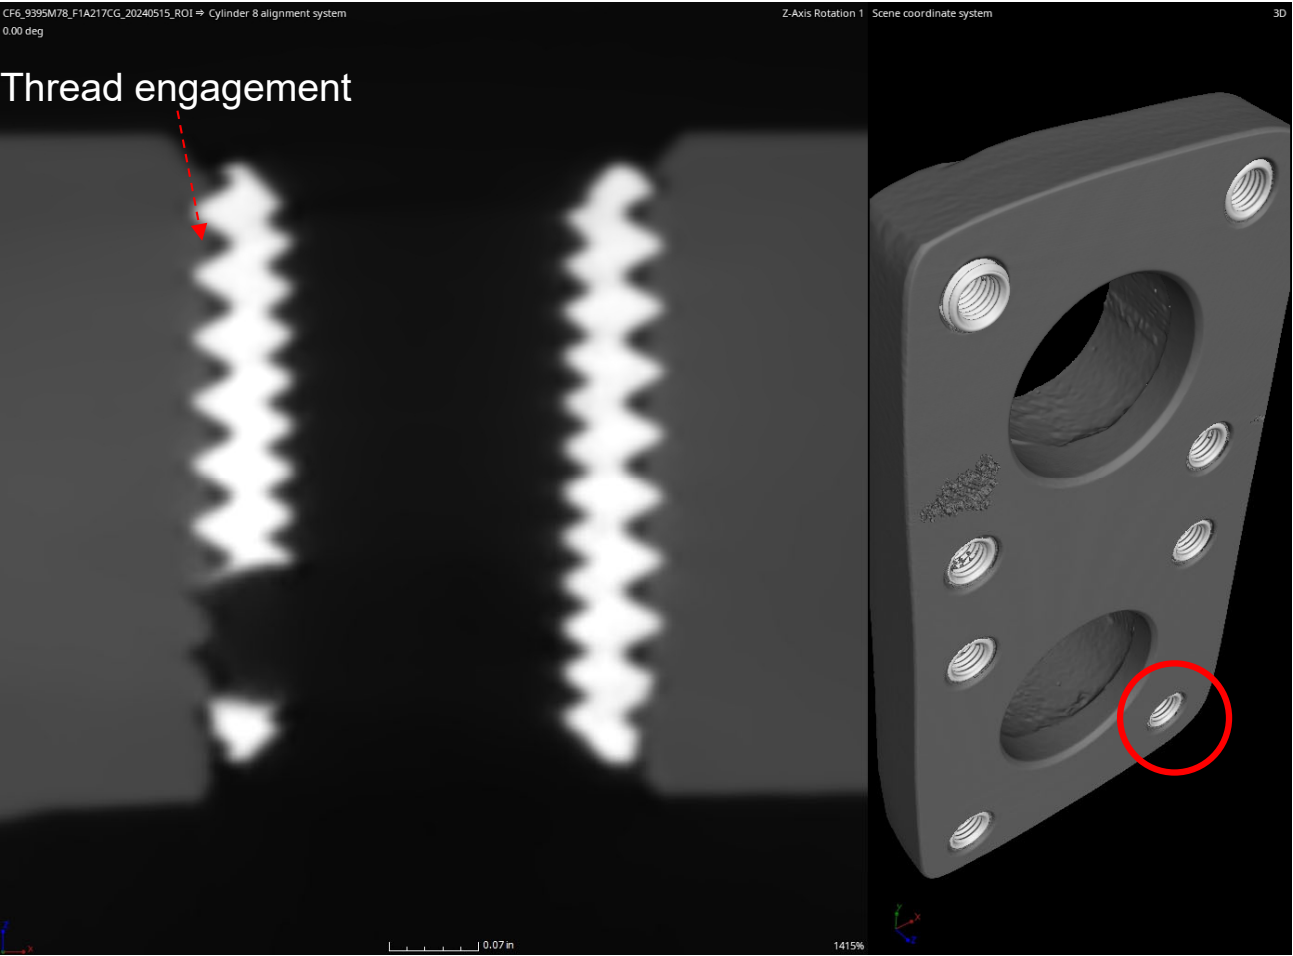
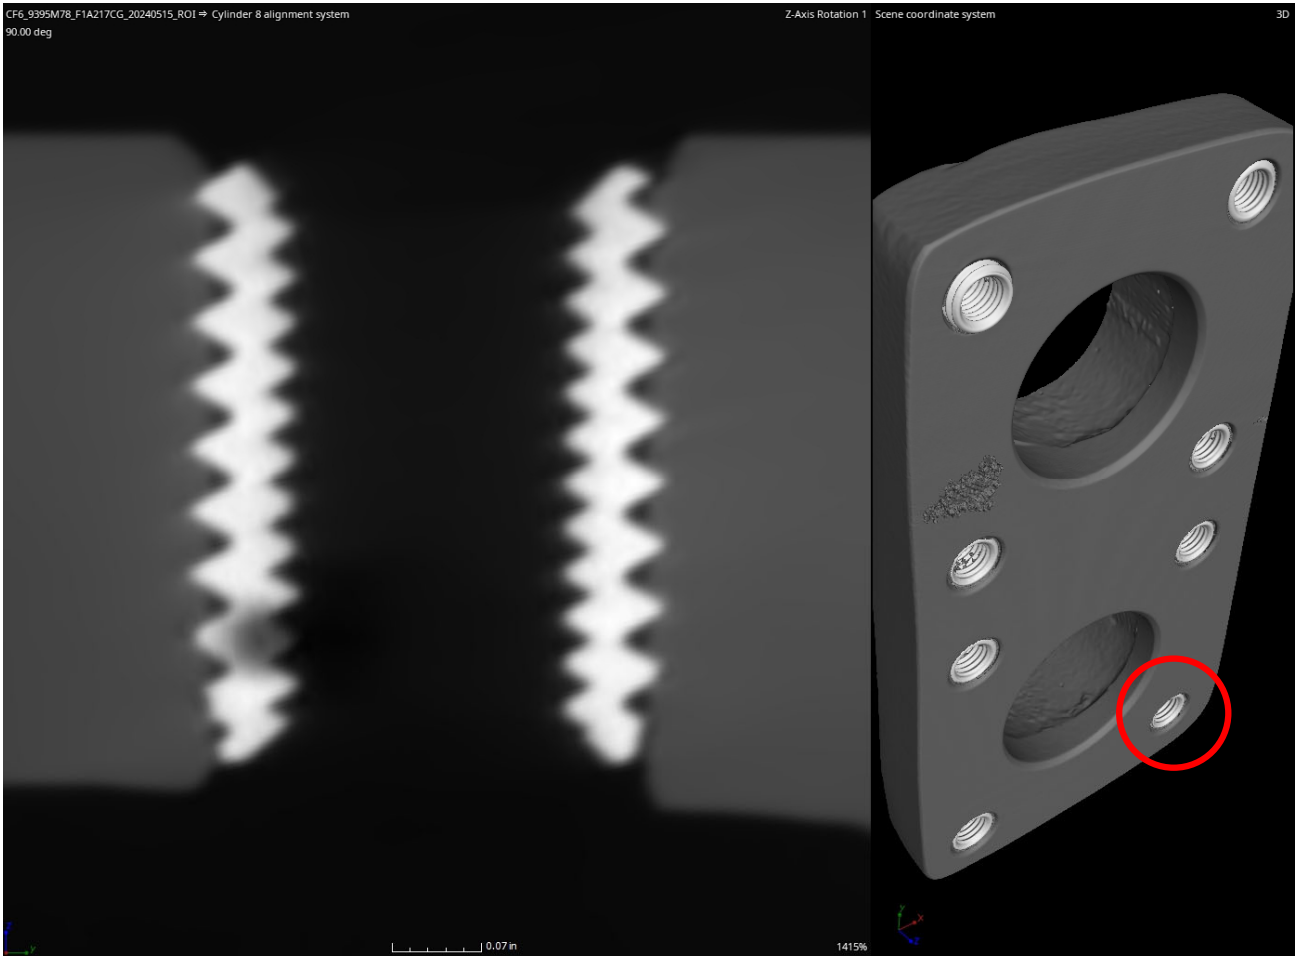
Figure 42: CT scan cross-section of thread insert position 1. Thread engagement is observed into the flange material.

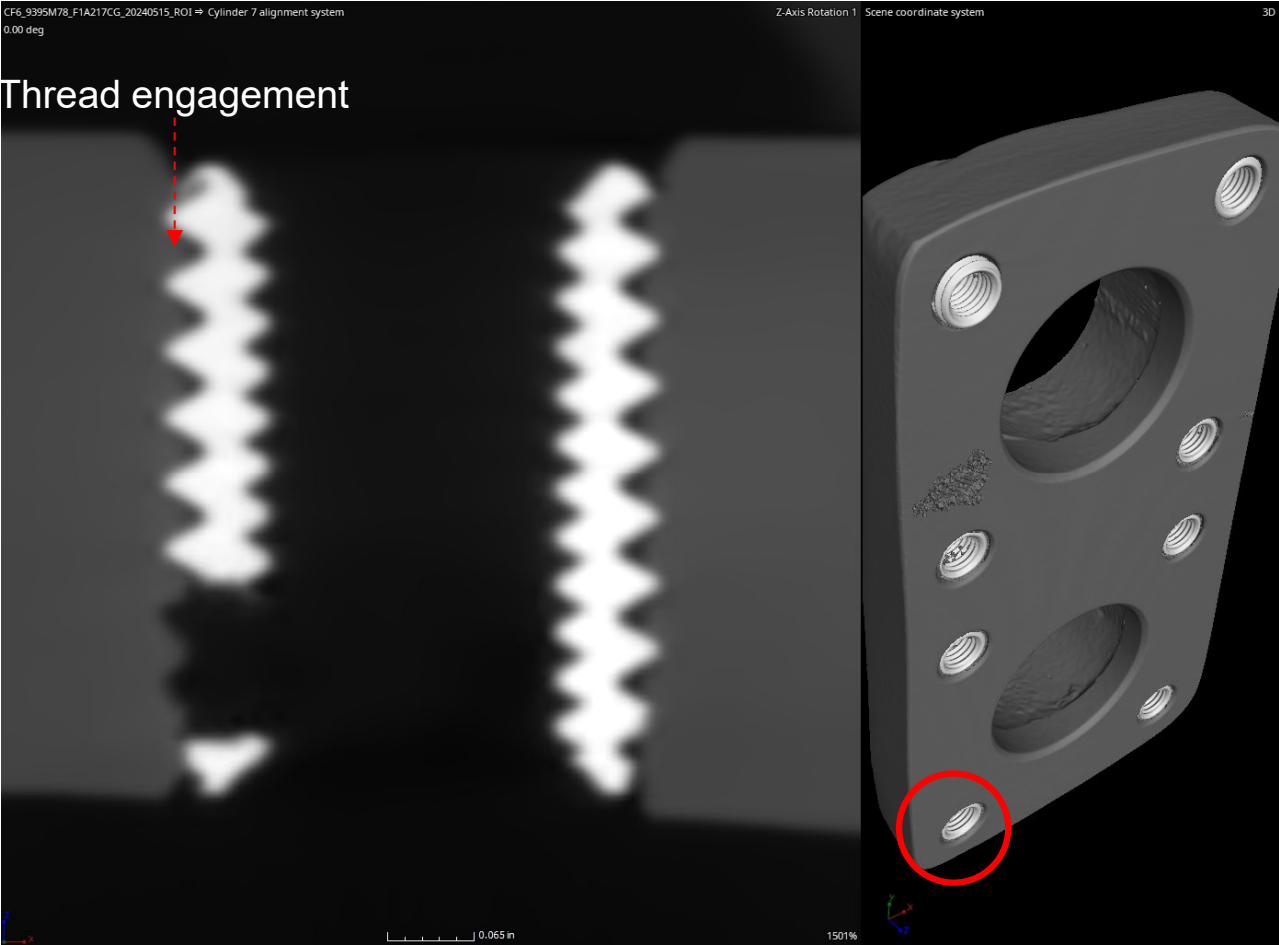
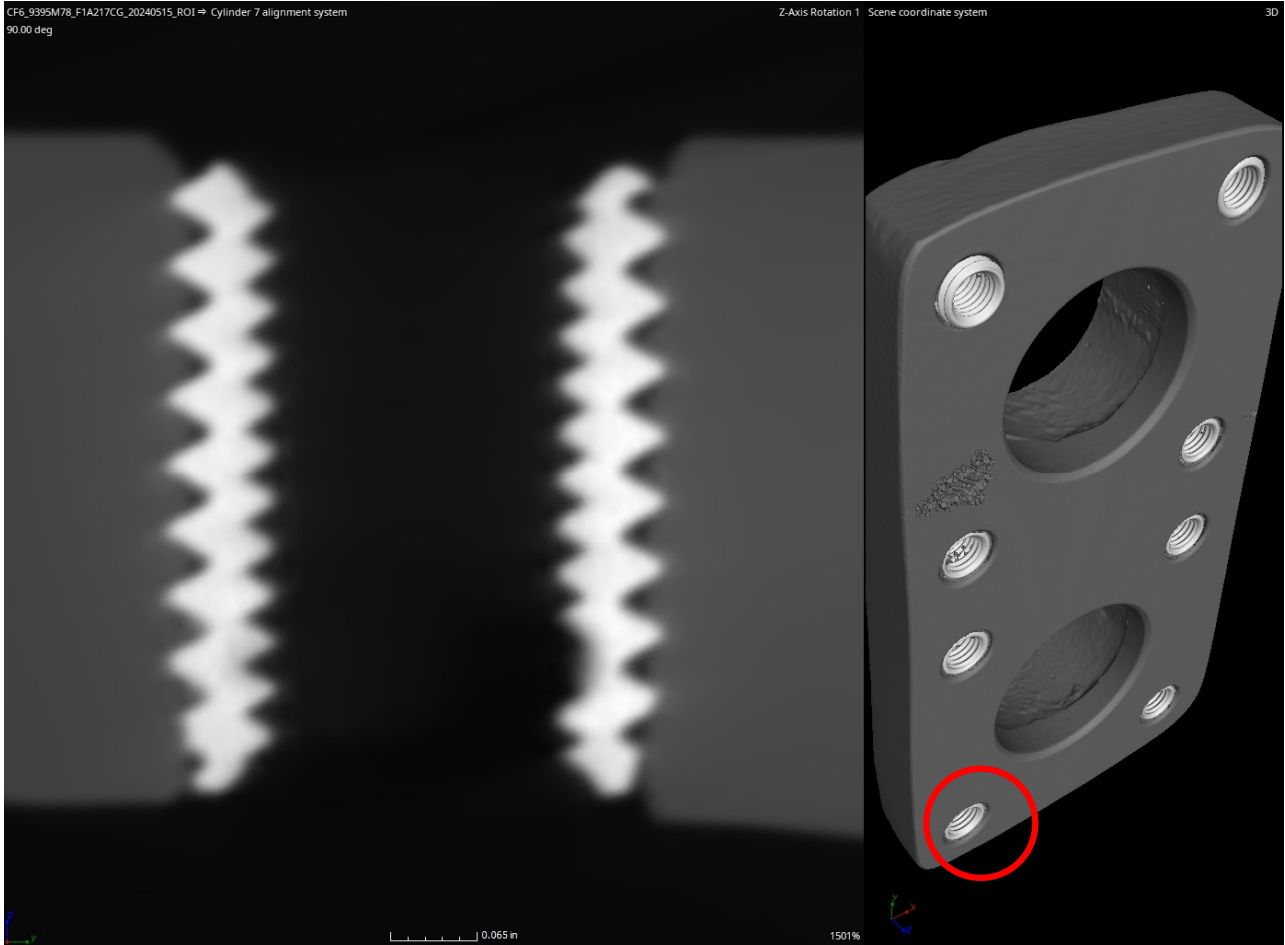
**Figure 43:** CT scan cross-section of thread insert position 2. Thread engagement is observed into the flange material.

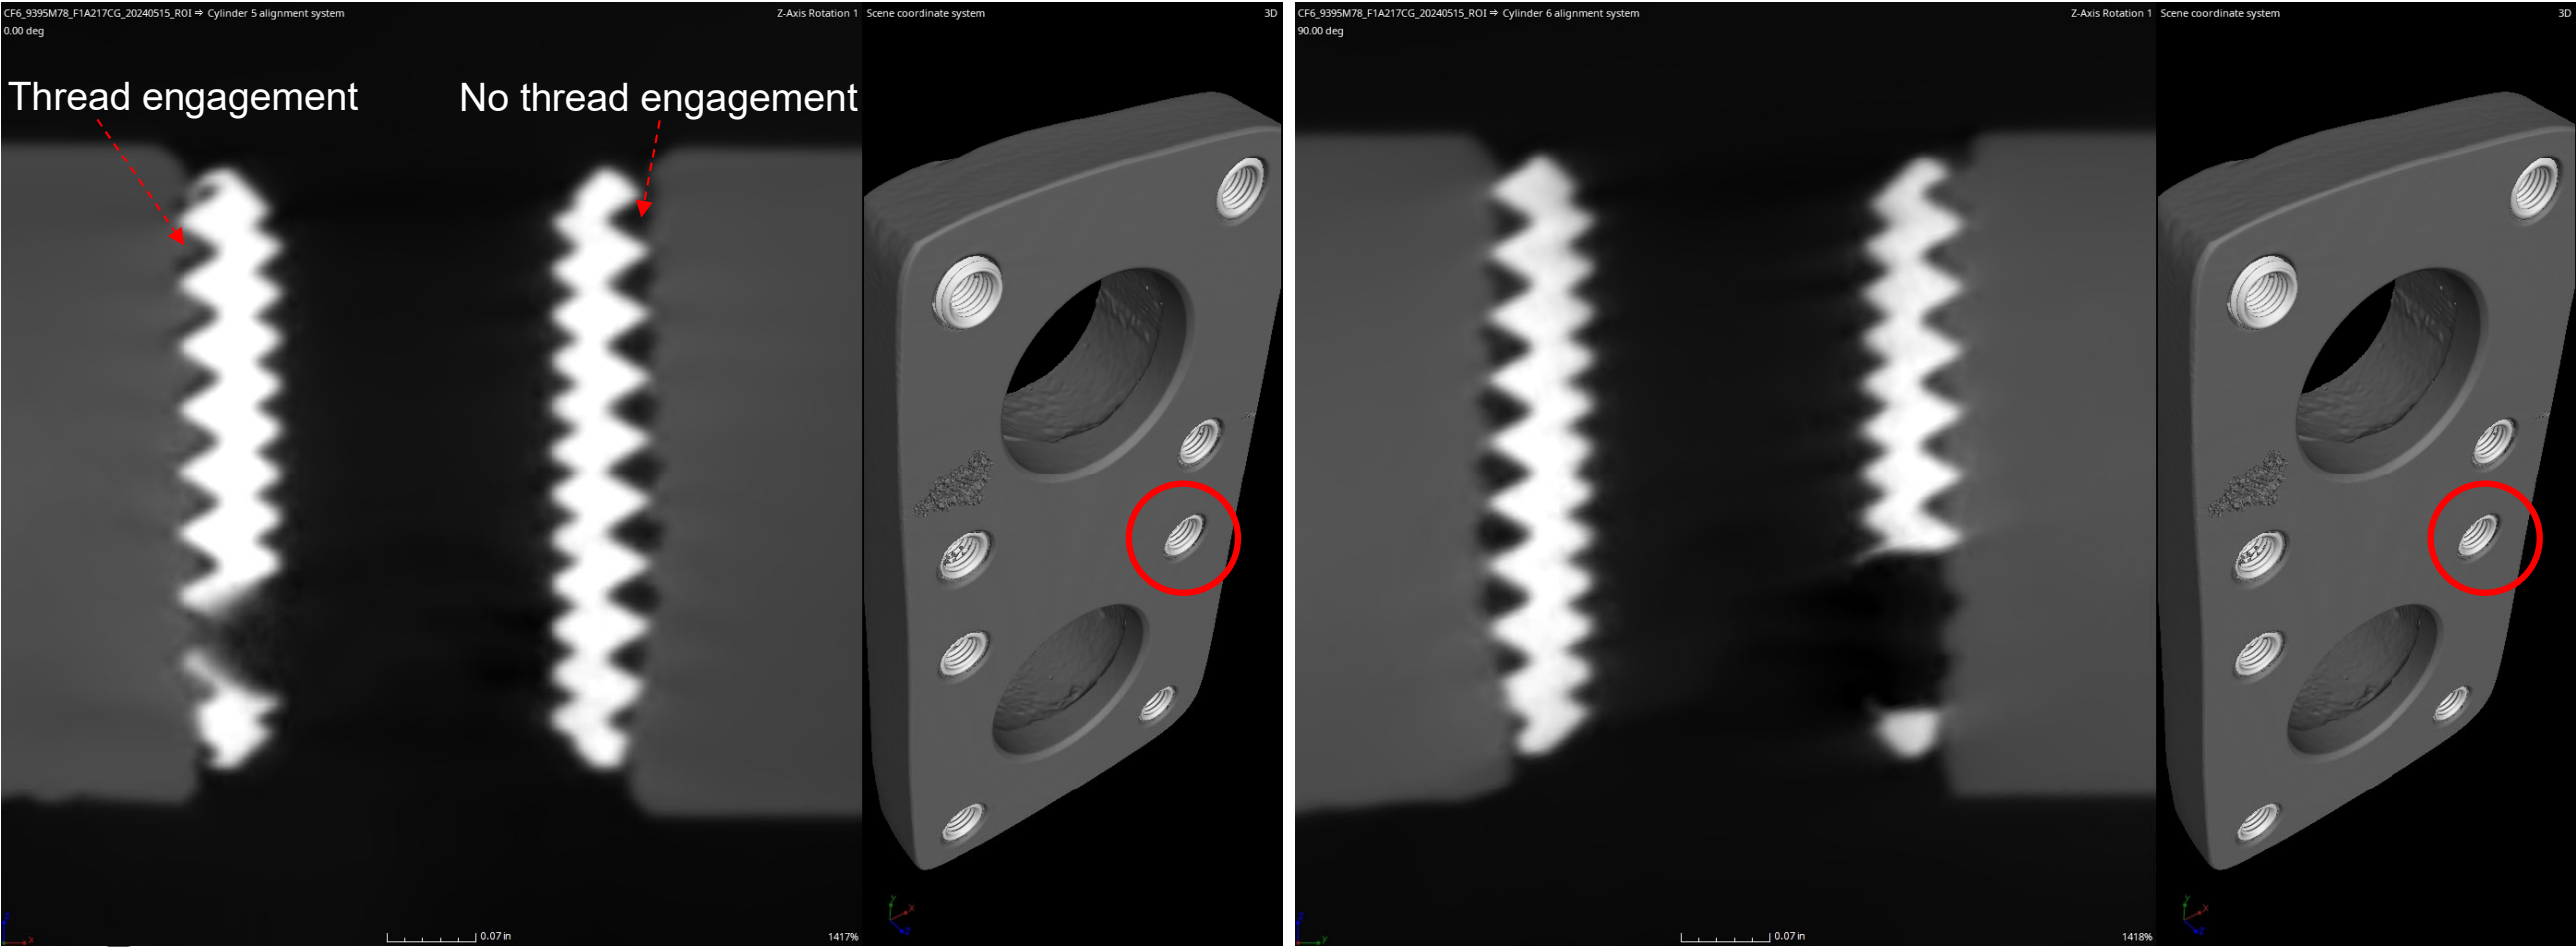
**Figure 44:** CT scan cross-section of thread insert position 3. No engagement is observed into the flange material on one side of the hole.

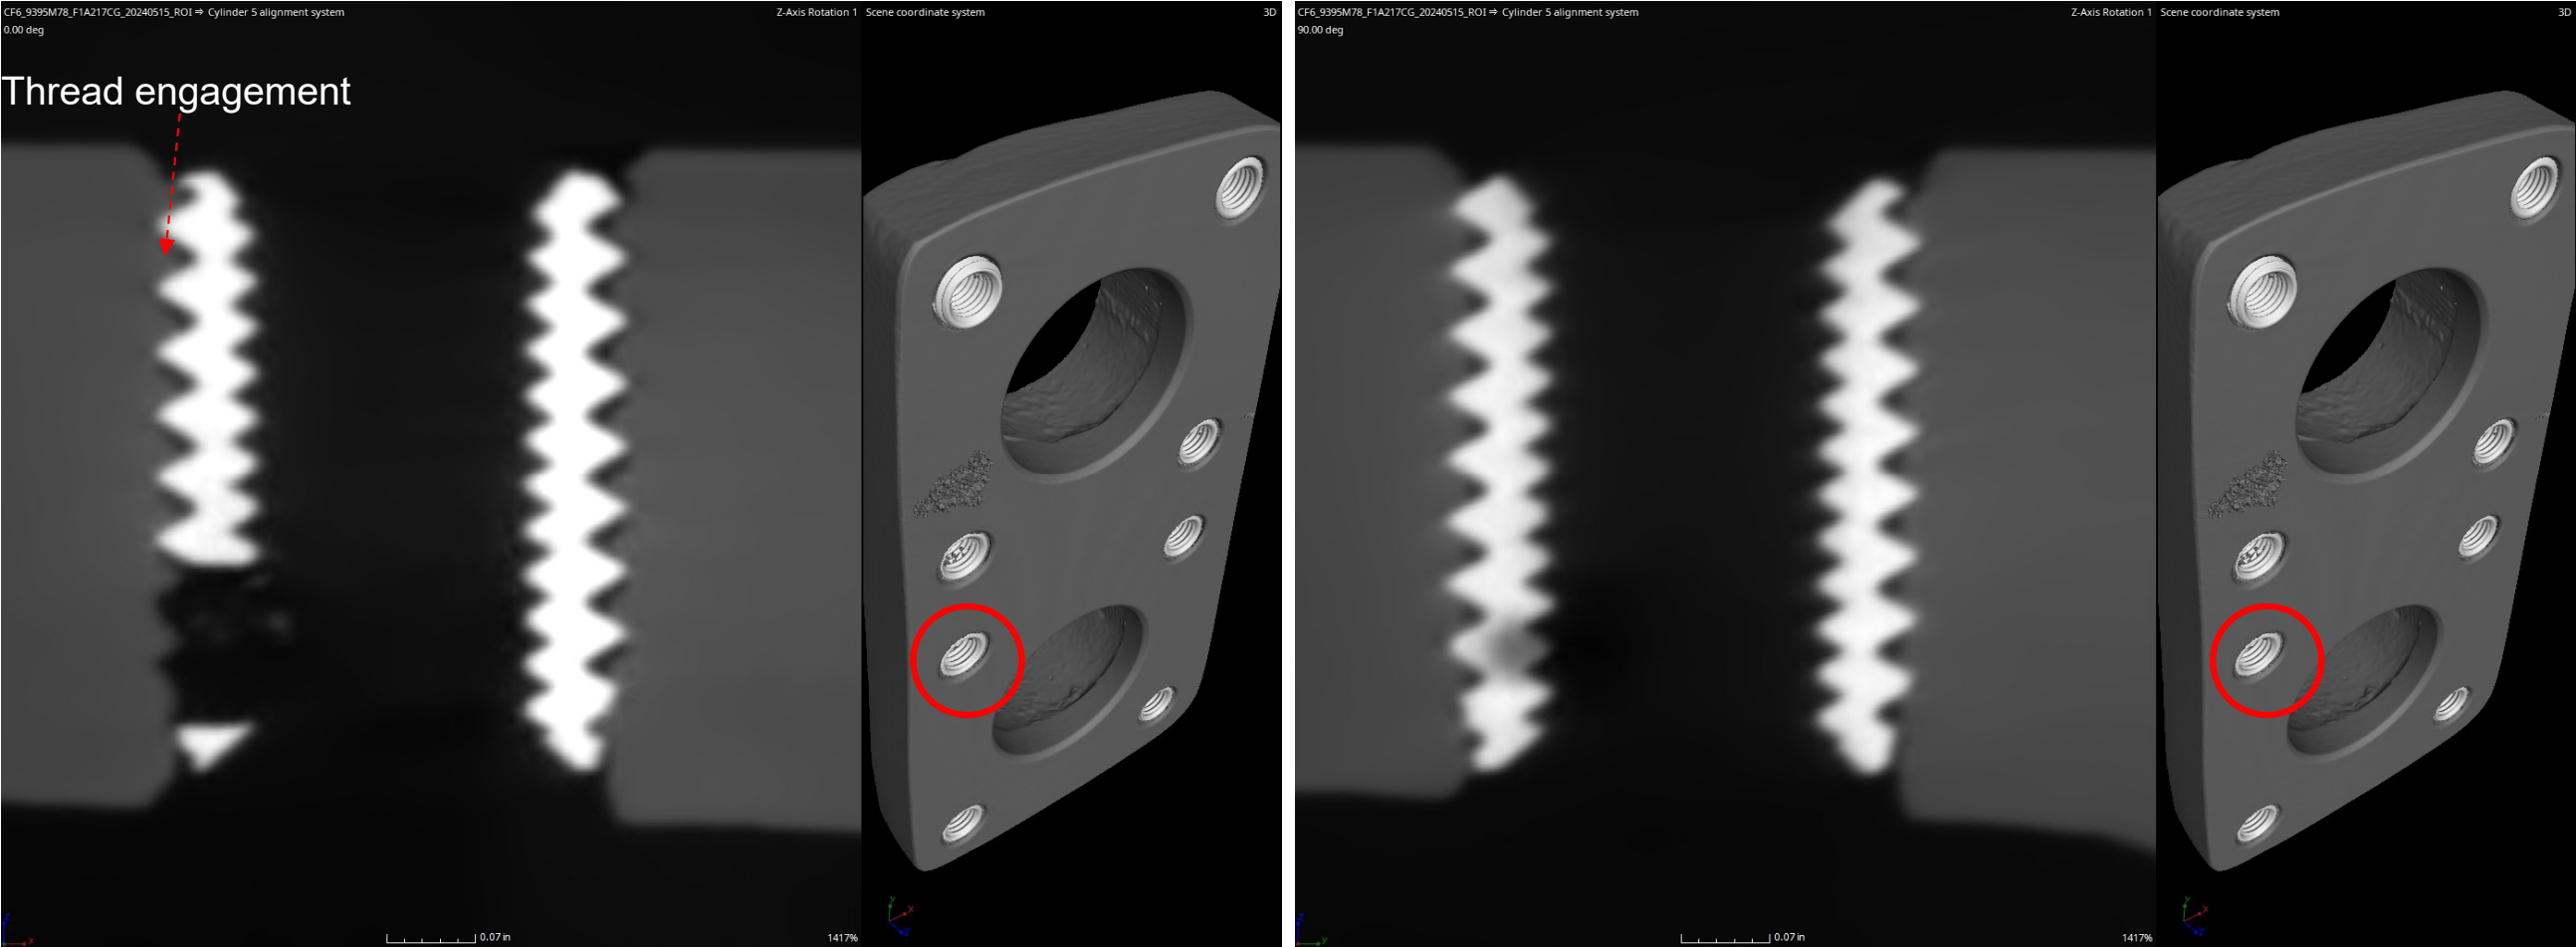
Figure 45: CT scan cross-section of thread insert position 4. Thread engagement is observed into the flange material.

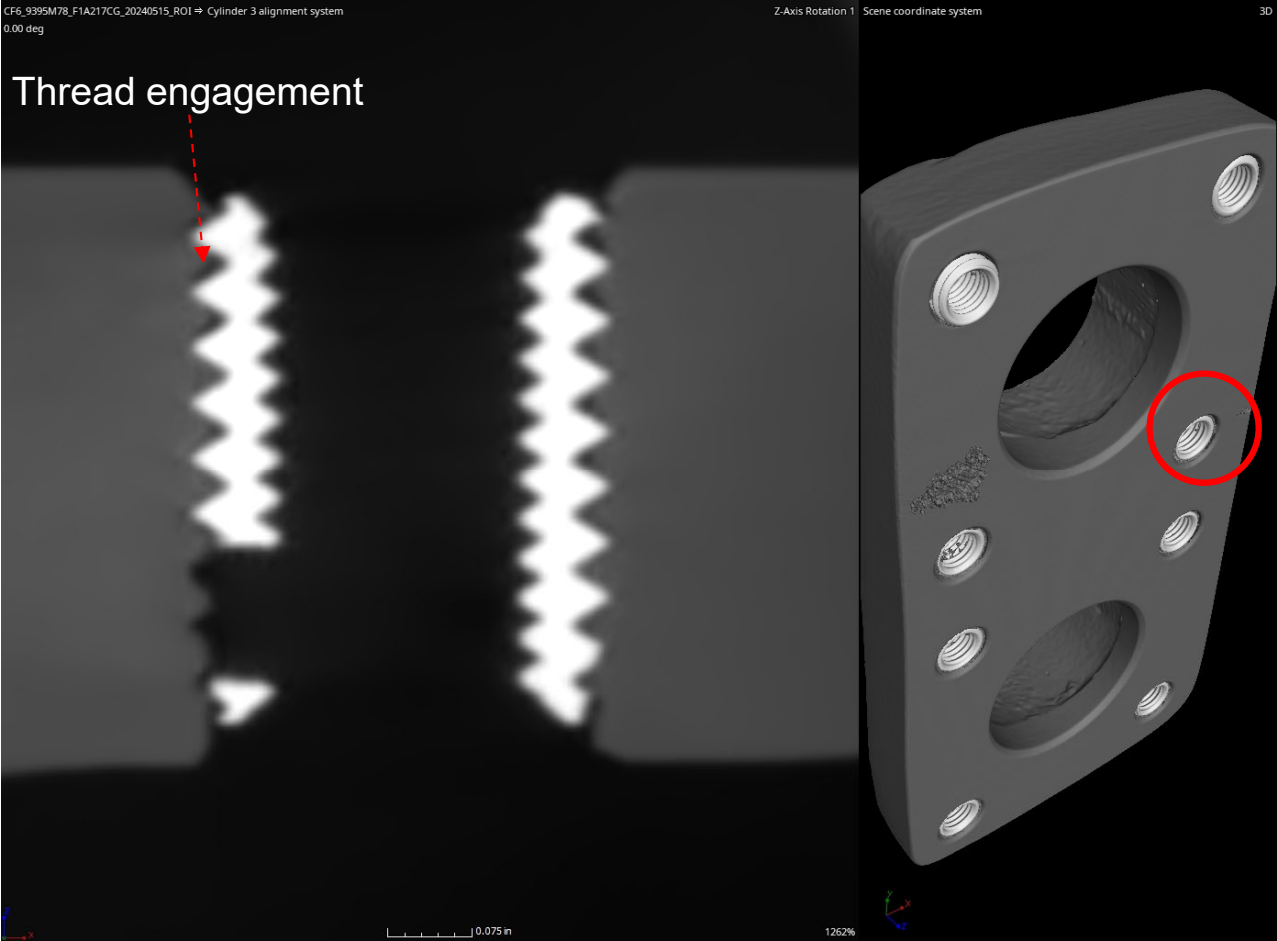
**Figure 46:** CT scan cross-section of thread insert position 5. Thread engagement is observed into the flange material.

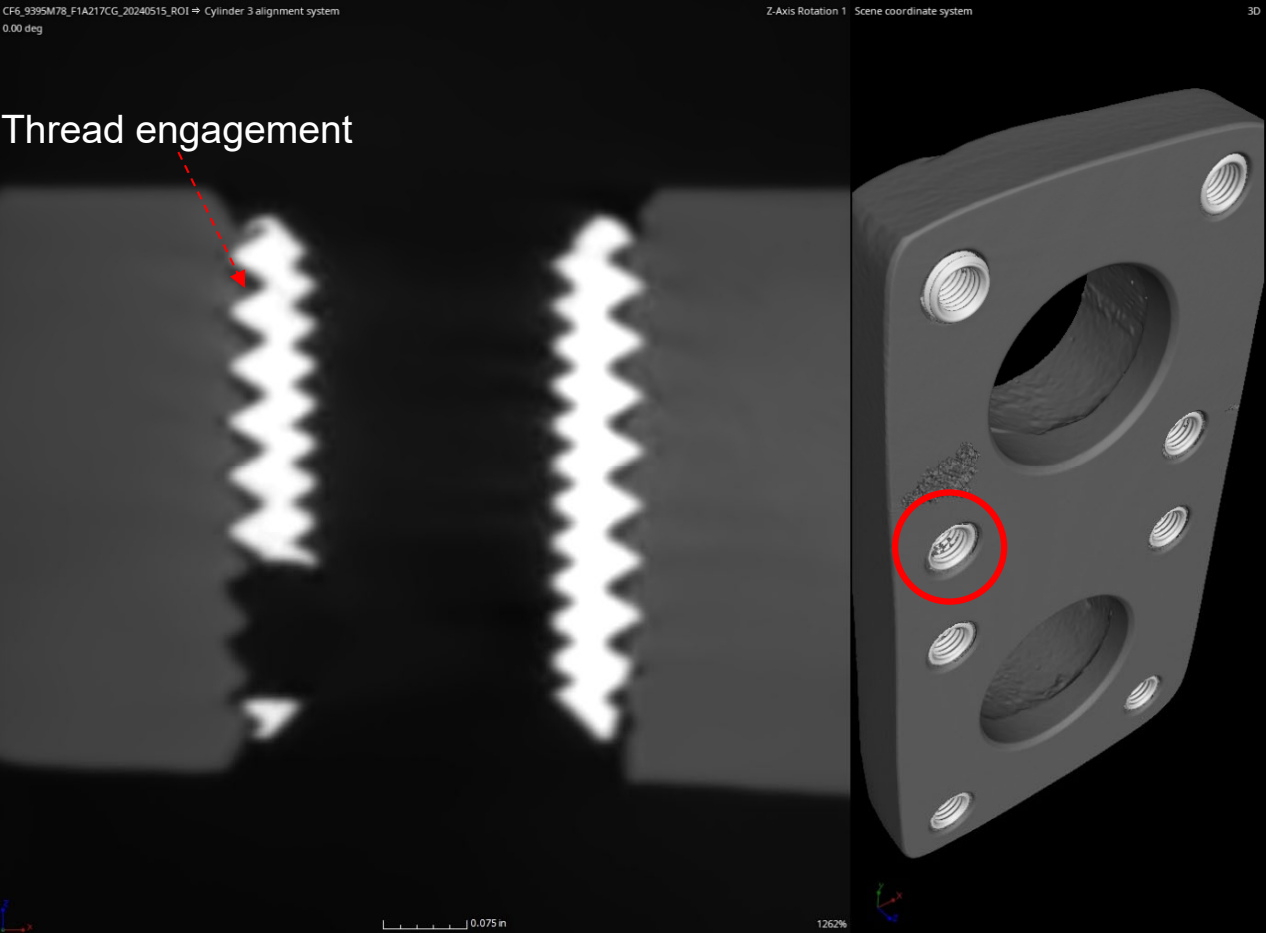
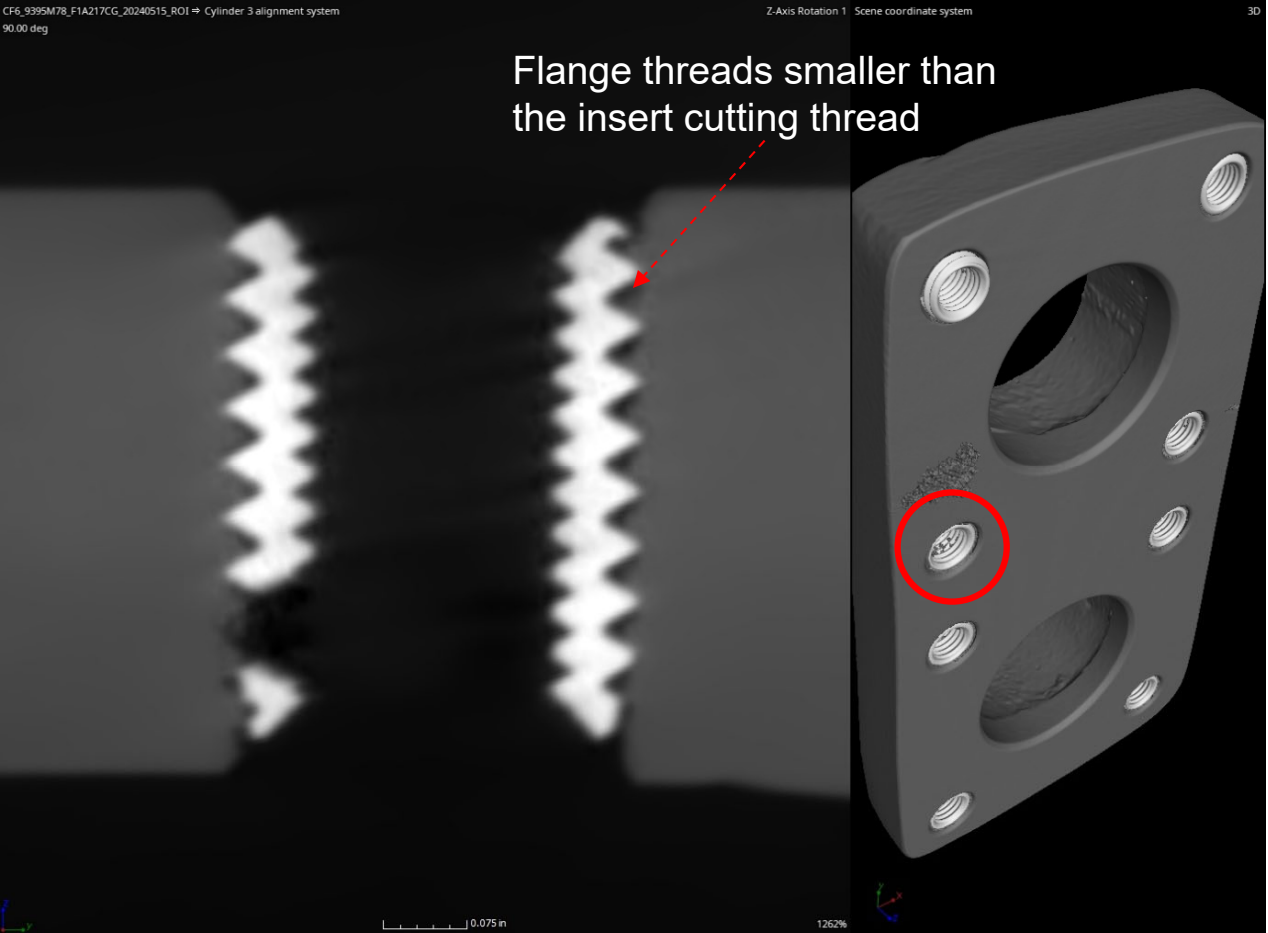
**Figure 47:** CT scan cross-section of thread insert position 6. Thread engagement is observed into the flange material.
