# **Metallurgical Investigation Report**

## **DRB: AvEng-561264.A**

**EVALUATION OF A CF6-80C2 ESN 707-605 HMU IDLER  
ADAPTER FROM ESN 707-605 OPERATED BY FEDEX  
INVOLVED IN AN IN-FLIGHT SHUT-DOWN AND  
UNDERCOWL FIRE EVENT**

Part Number: 9395M78G10  
Part Serial Number: FIA217EE  
Part TSN / CSN: 1,421 hrs / 728 cycles

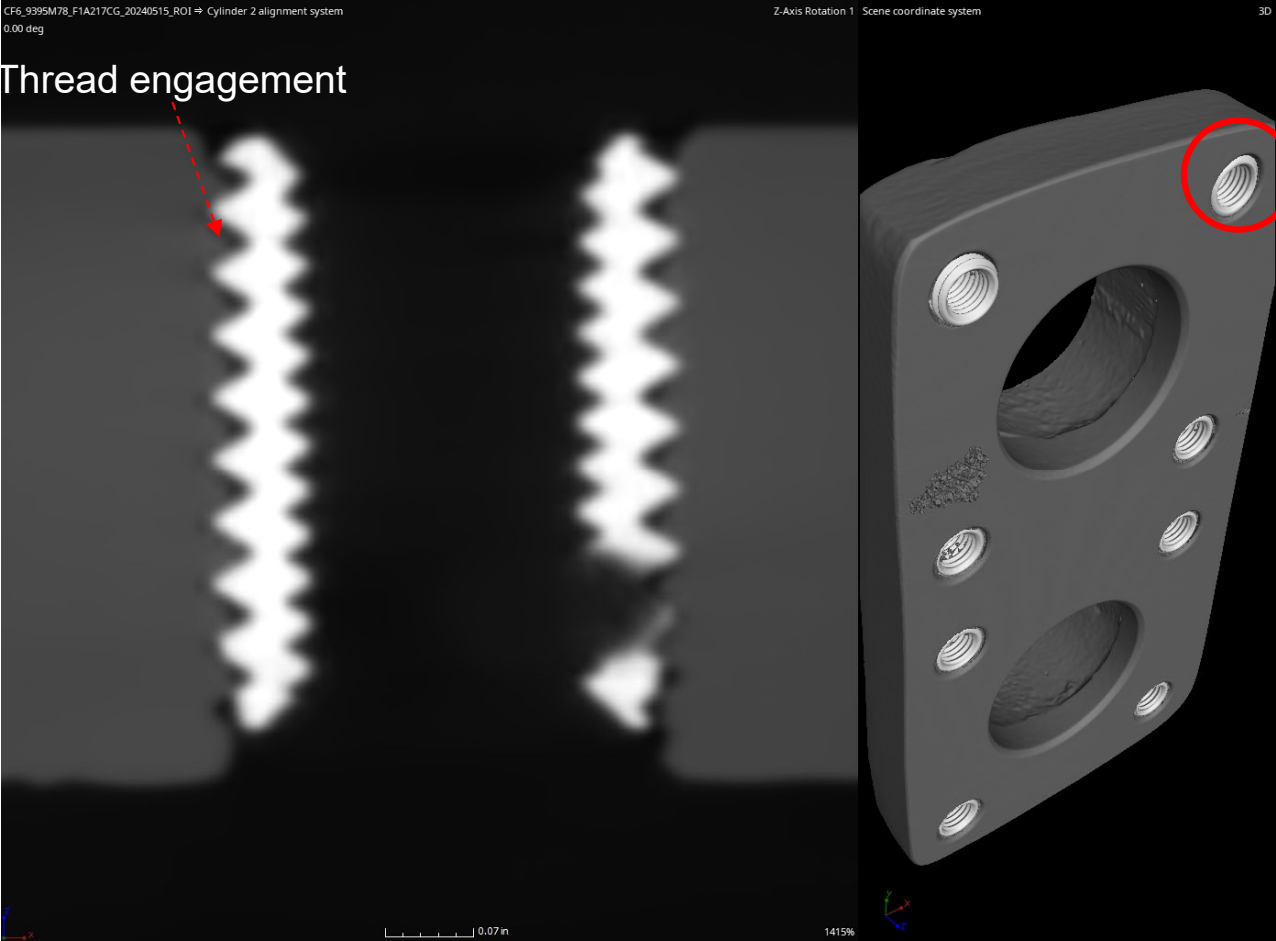
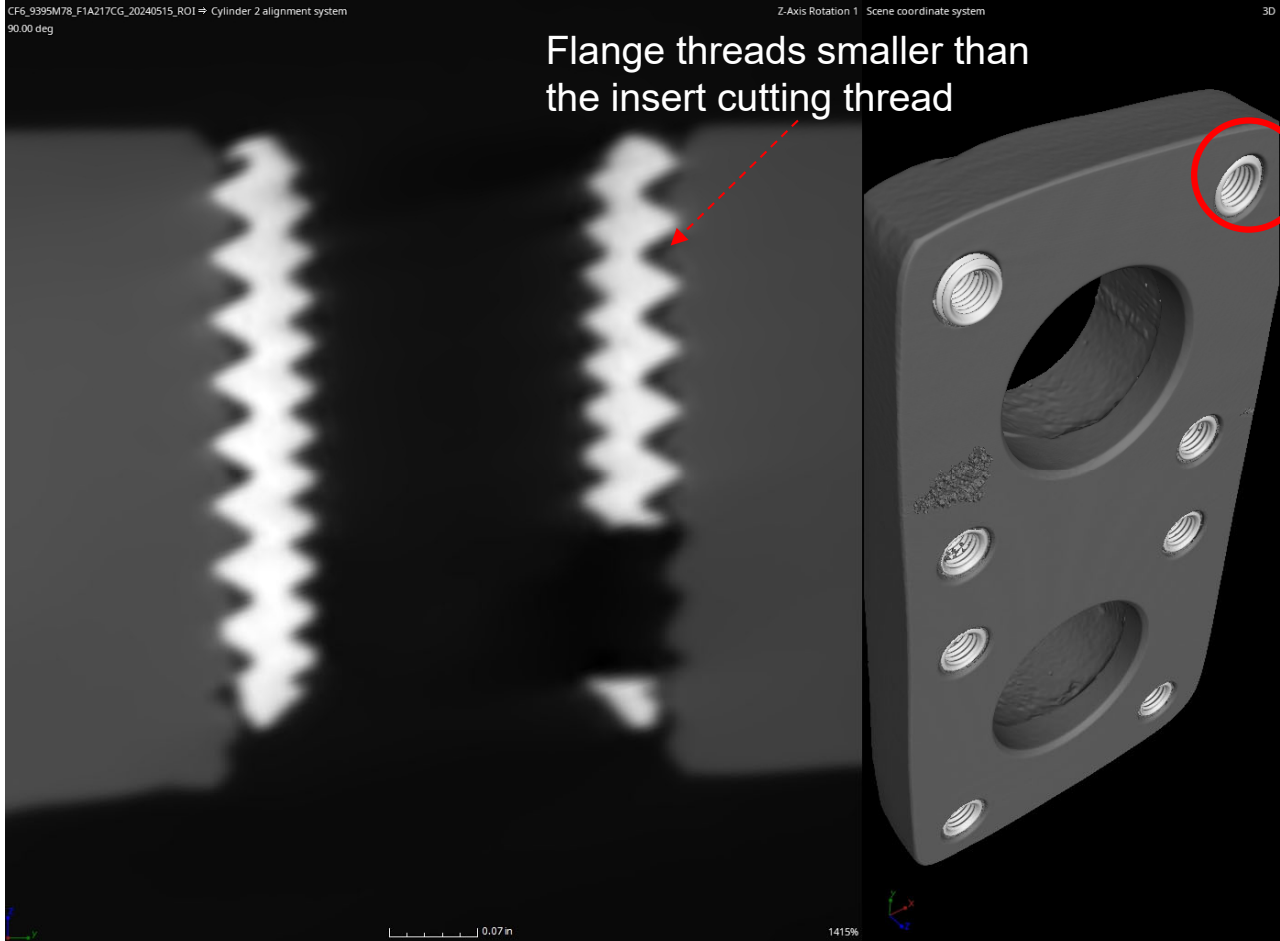
Figure 48: CT scan cross-section of thread insert position 7. Thread engagement is observed into the flange material.

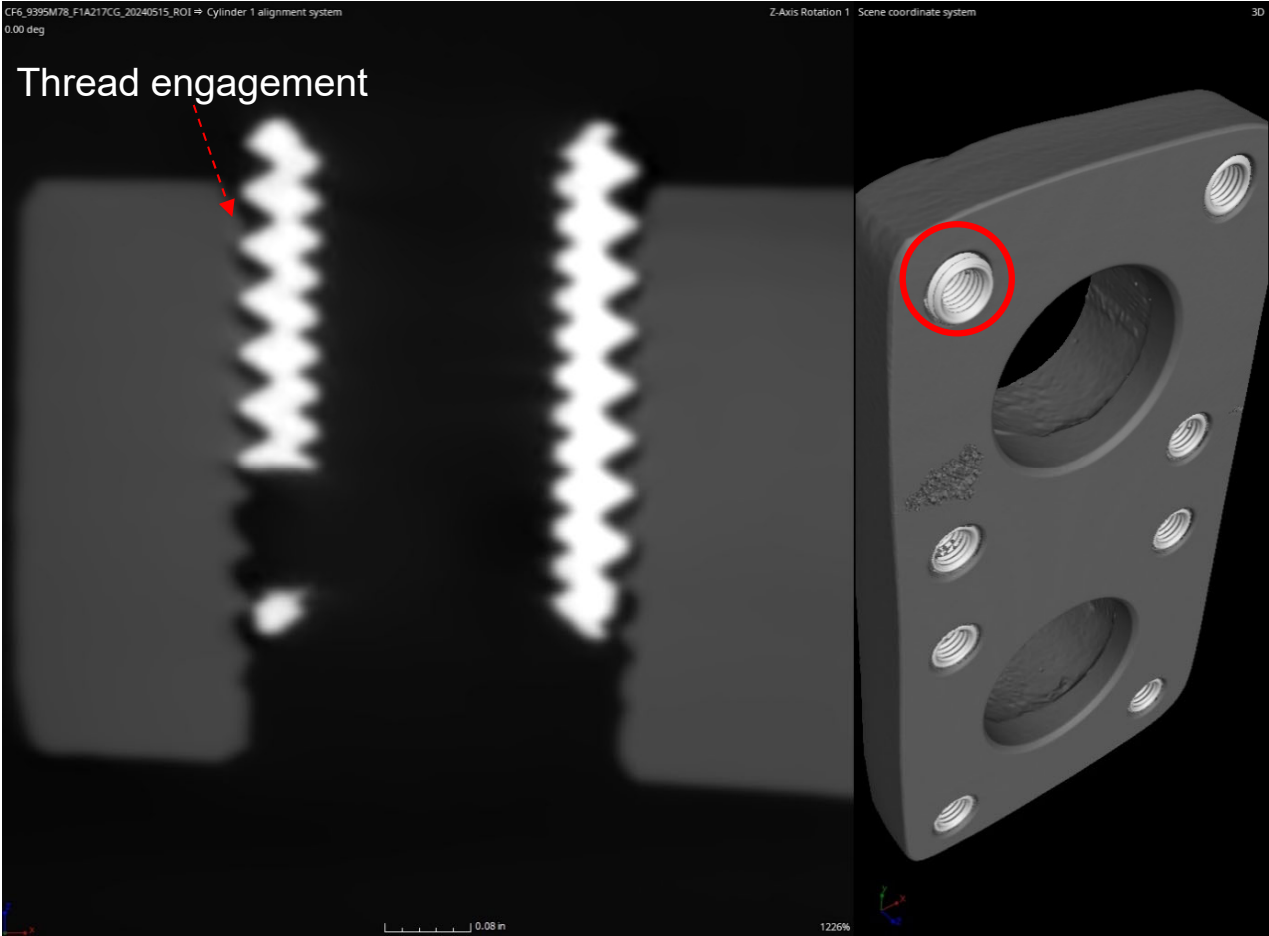
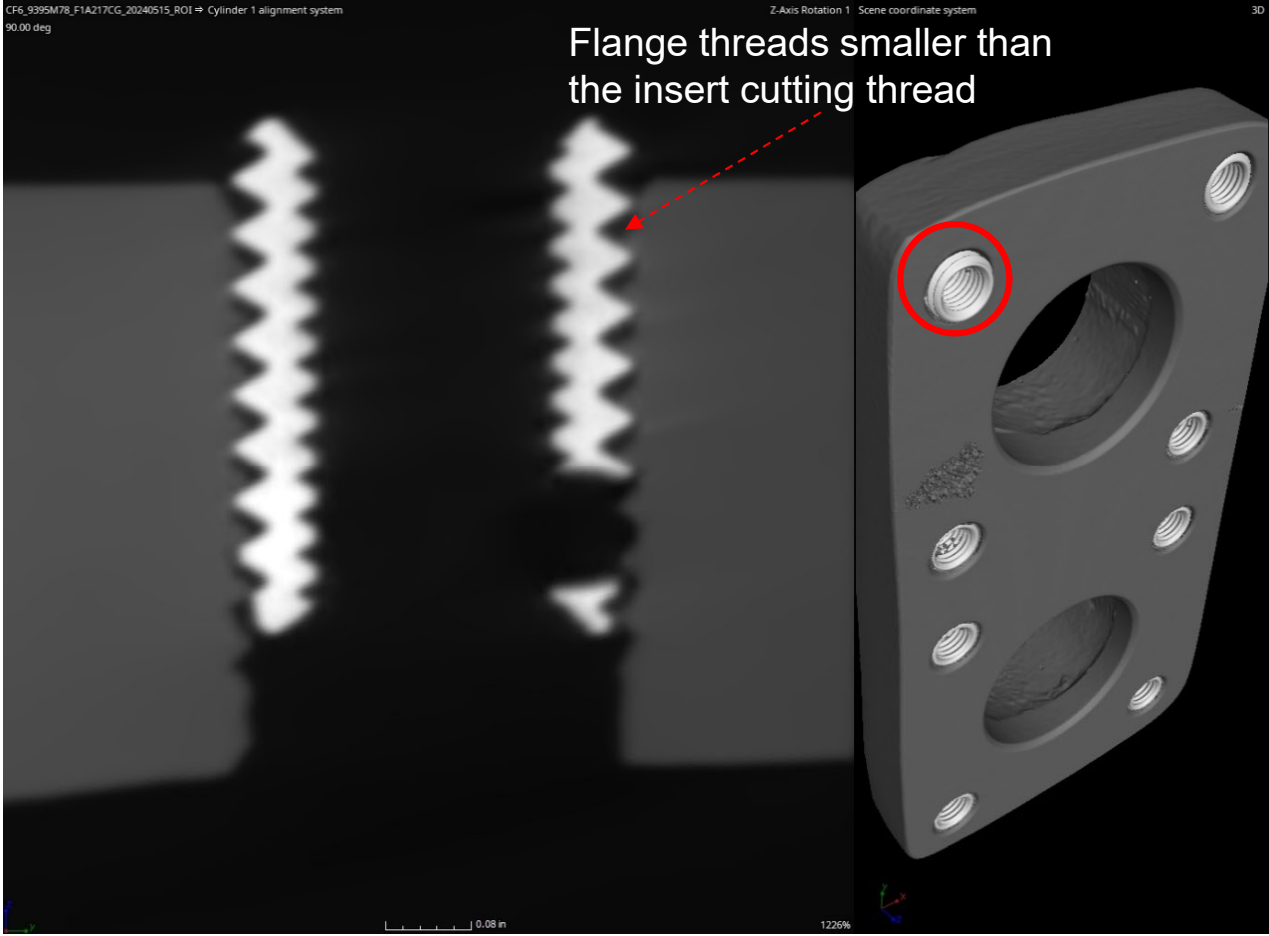
**Figure 49:** CT scan cross-section of thread insert position 8. Thread engagement is observed into the flange material.

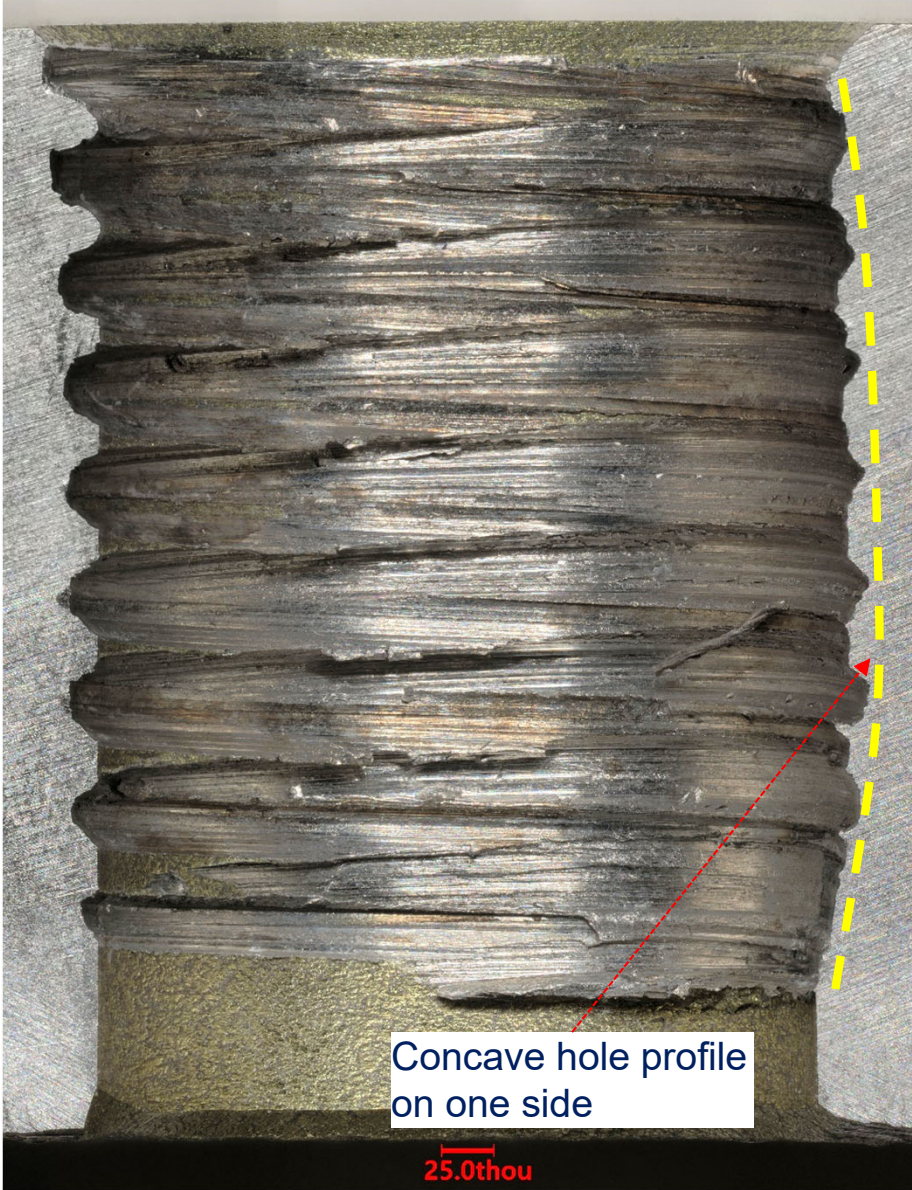
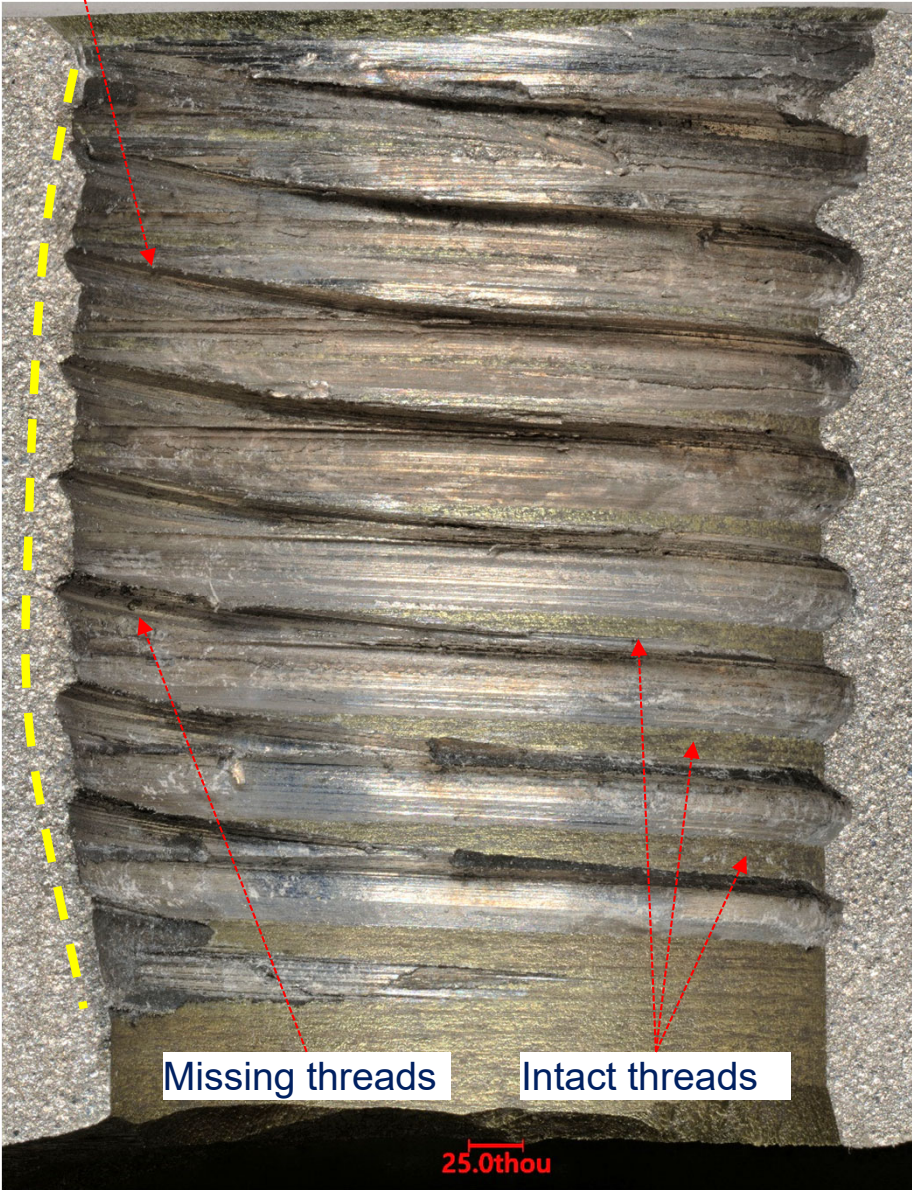
**Figure 51:** Optical views of insert location 3 reveals angled cut threads consistent with cross-threading. One side of the hole has a concave profile and is missing threads, while the opposite side of the hole is straight with some threads intact, consistent with the insert being installed at an angle and cutting through the pre-tapped threads.

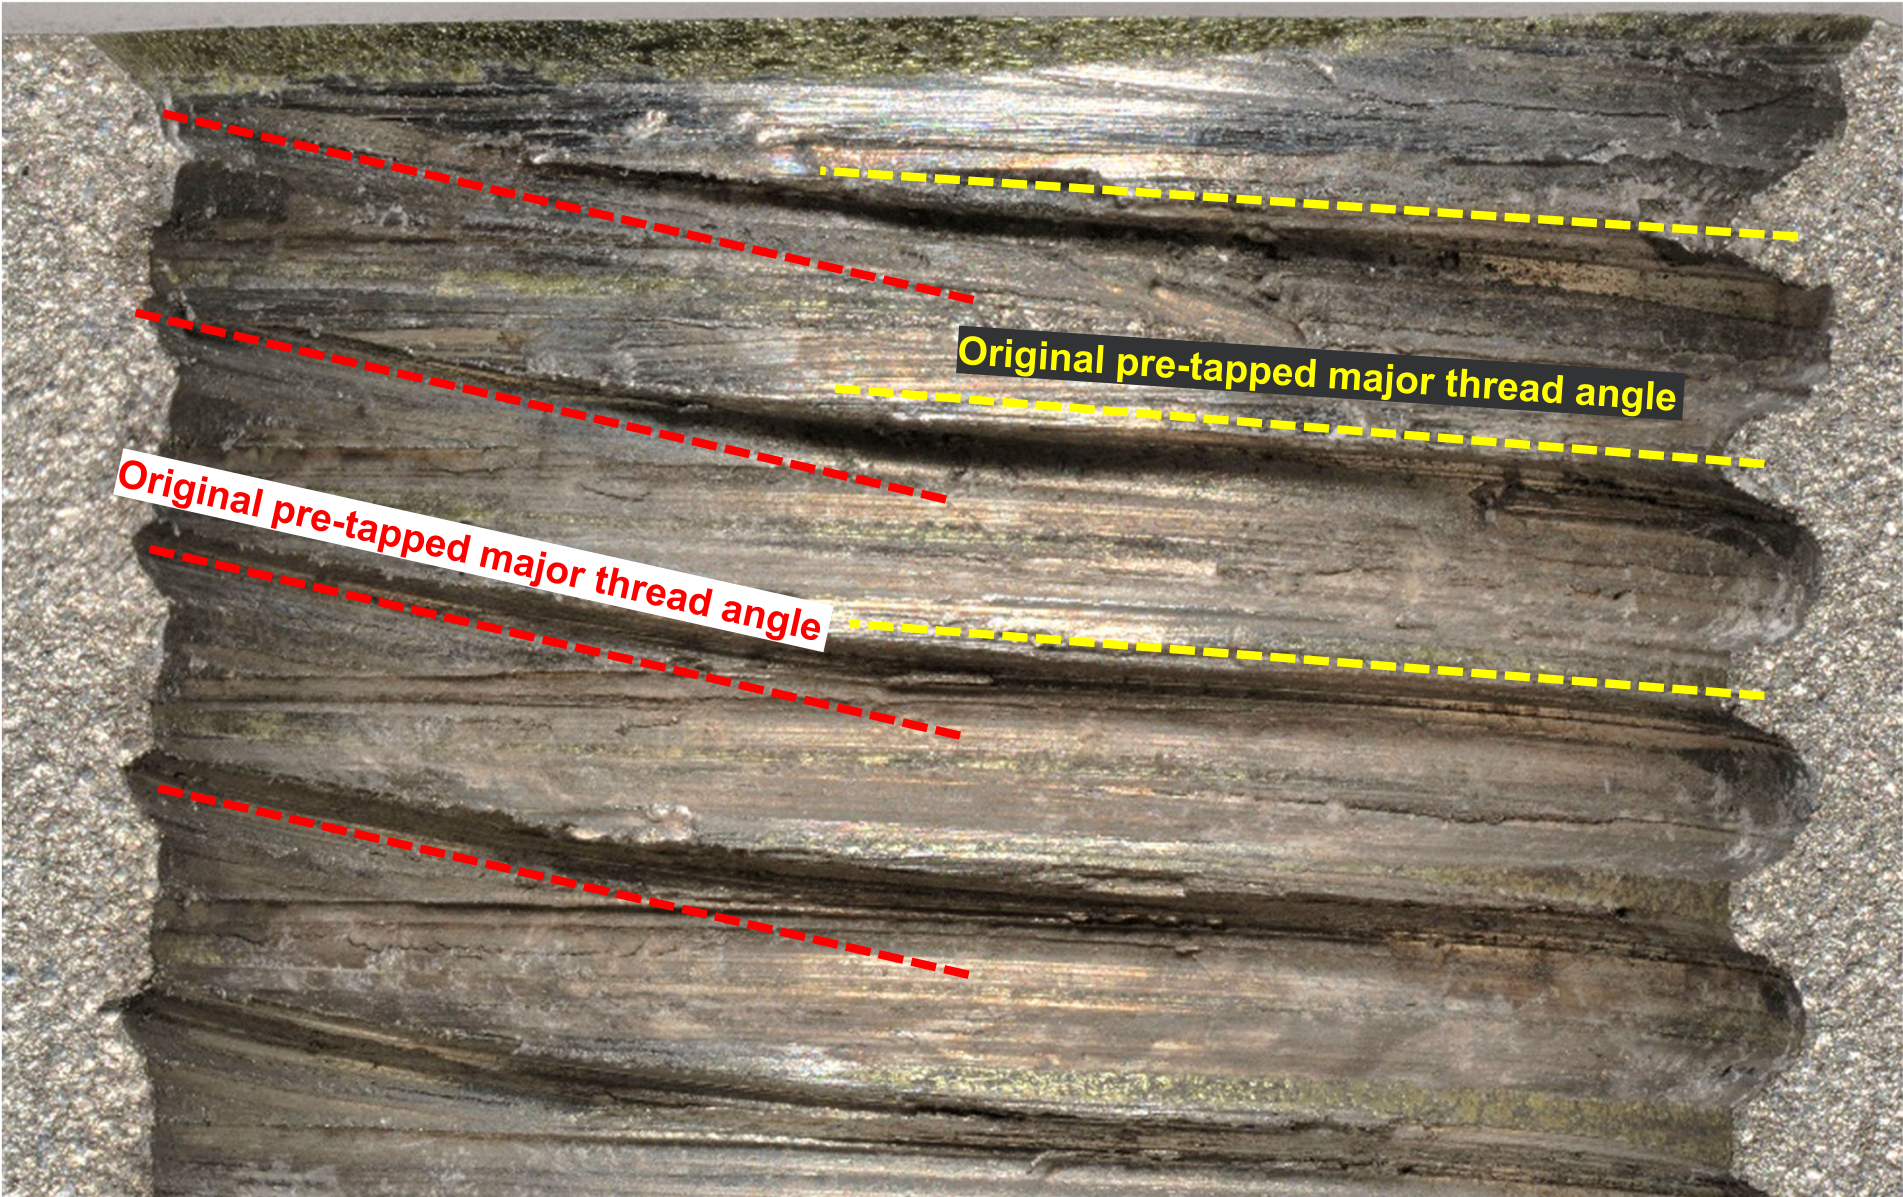
**Figure 52:** High magnification views show the angled cut lines through the flange female threads, consistent with the thread insert cross-threading and cutting through the flange threads.

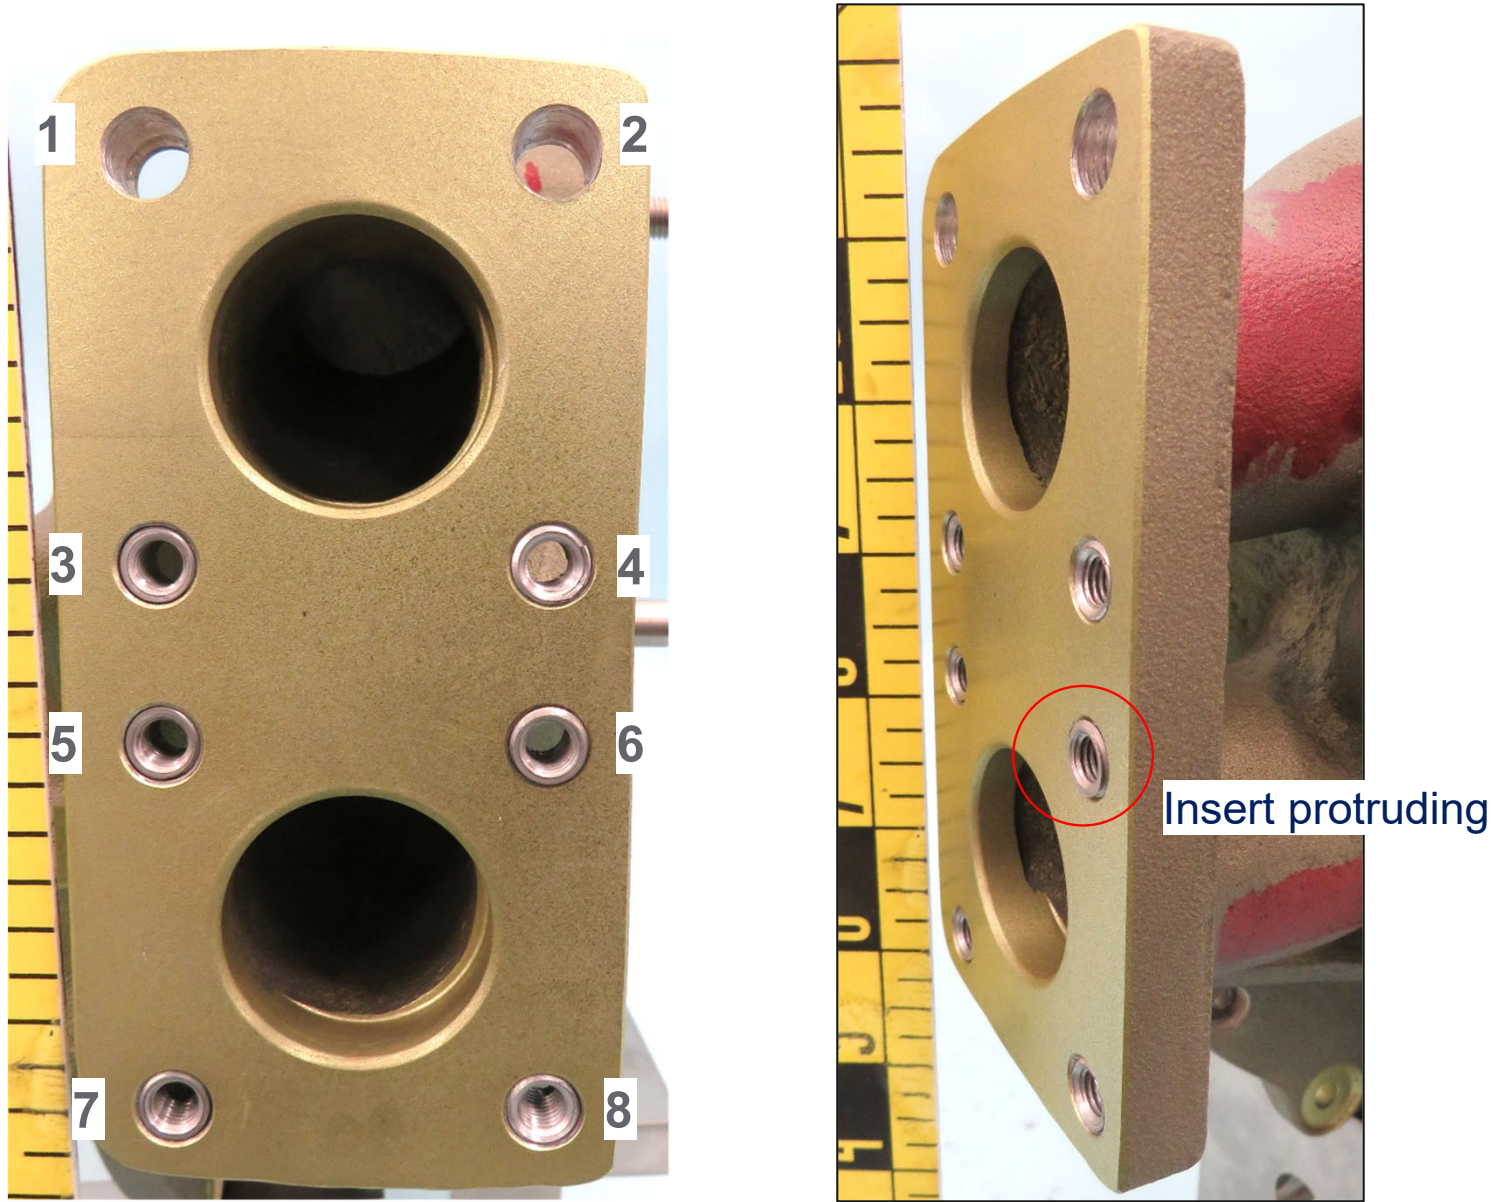
**Figure 54:** Insert locations 1 and 2 were removed prior to arriving to the FA lab. Insert number 6 was found protruding from the flange surface.

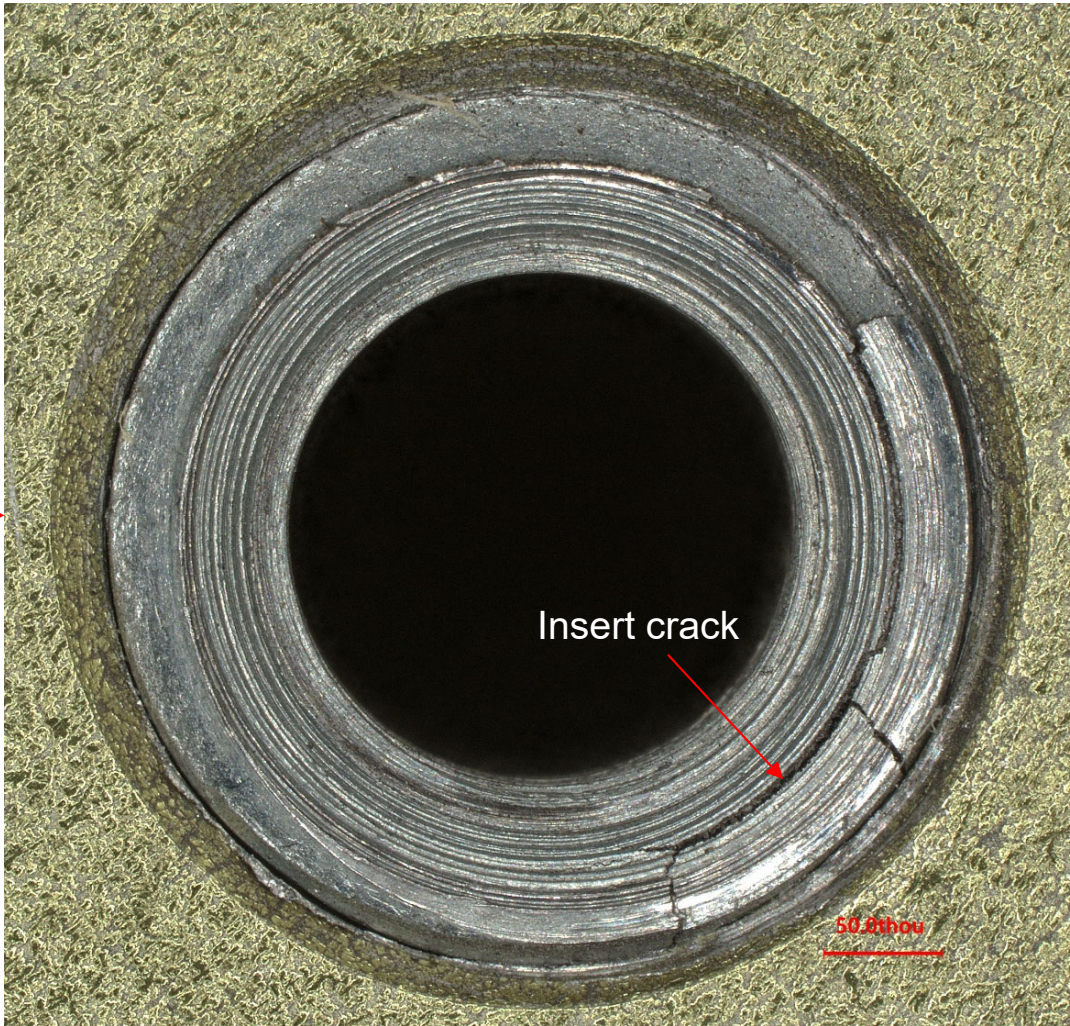
**Figure 55:** Insert locations 4 and 8 have cracked top threads as shown above.

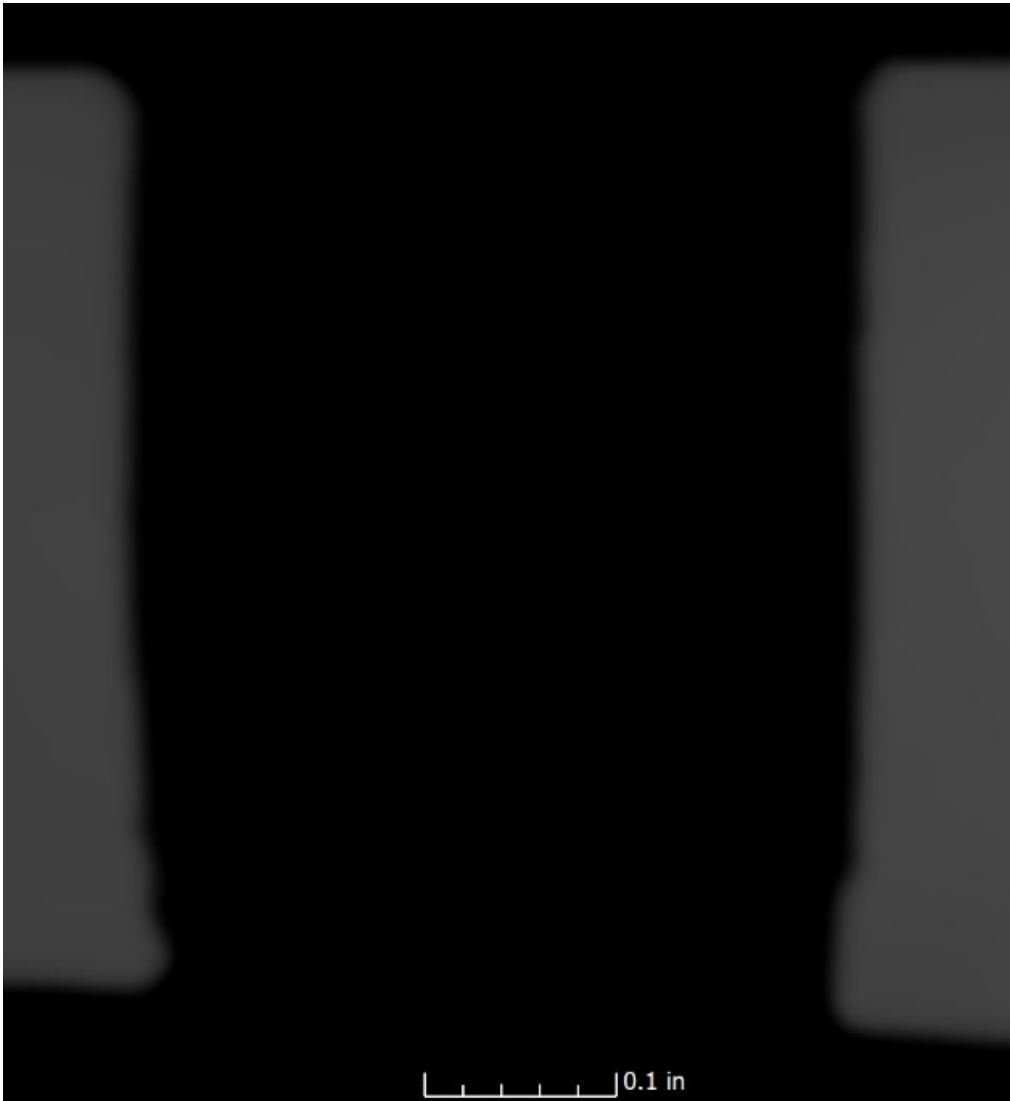
Insert 1 Side 1

**Figure 64:** Optical views of insert hole 1 reveals damaged threads.

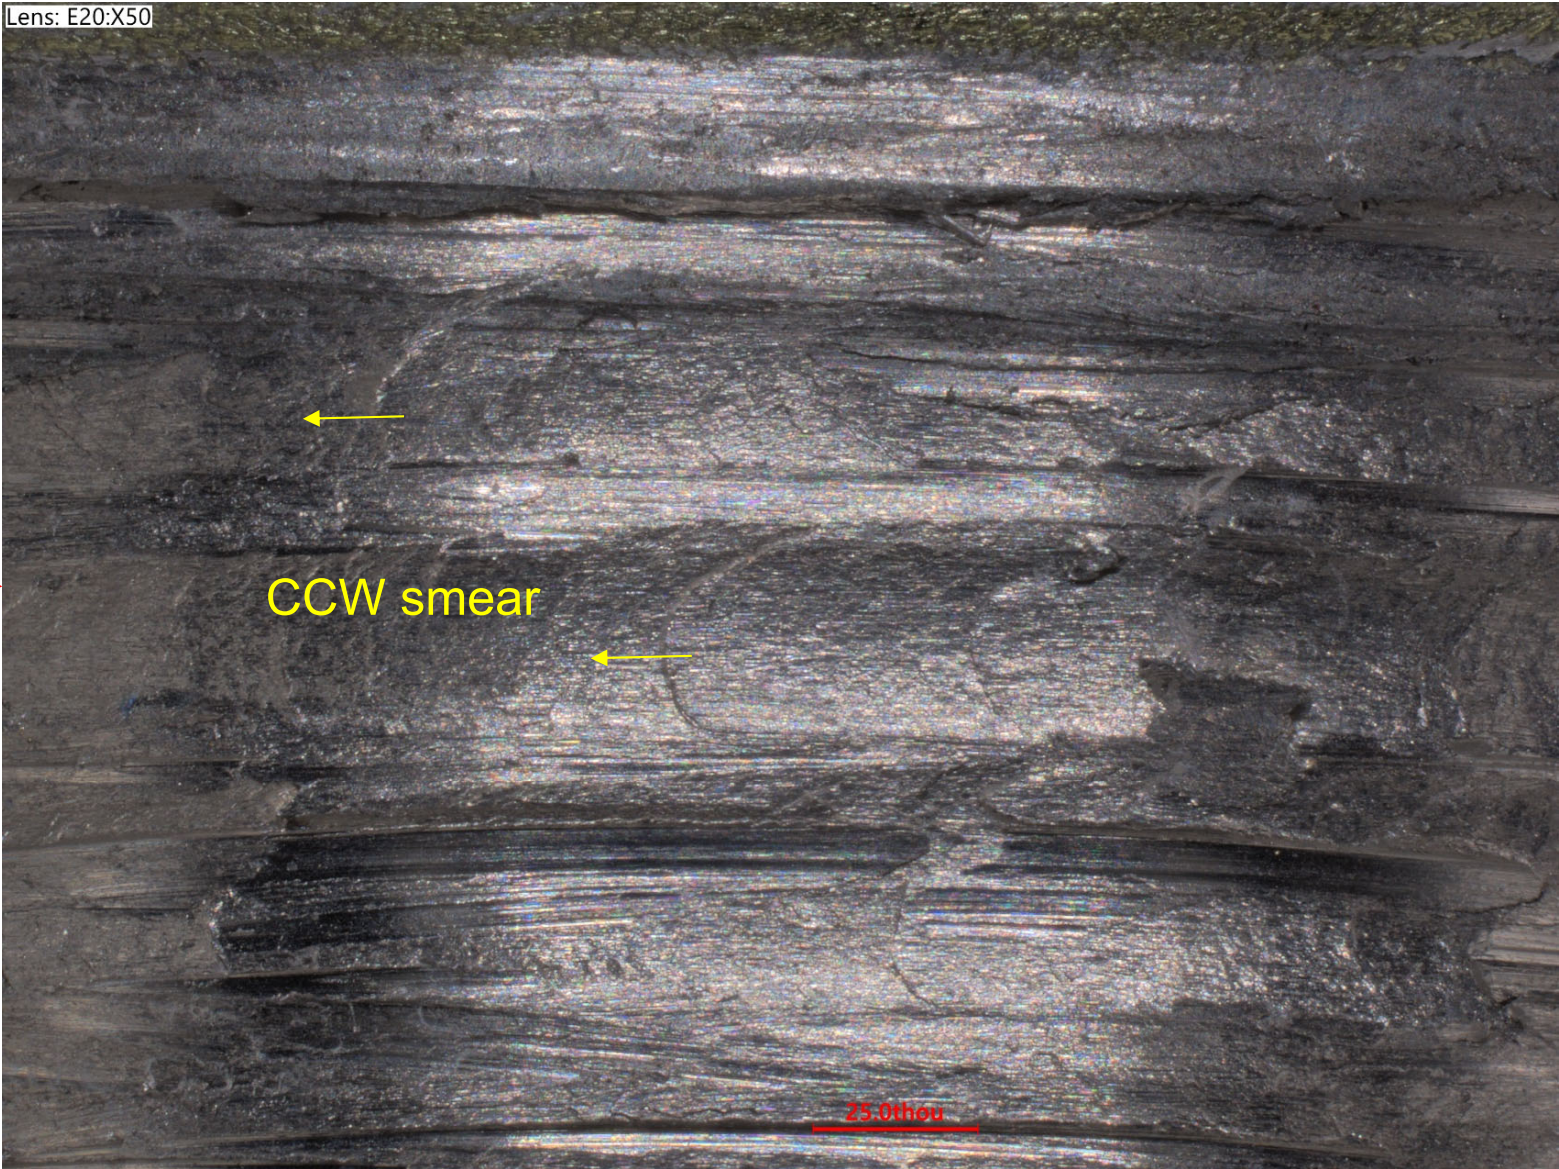
Insert 1 Side 1

**Figure 65:** Optical view of insert hole 1 reveals vertical smear lines consistent with the insert pulling out and overlapping smeared material consistent with CCW rotation.

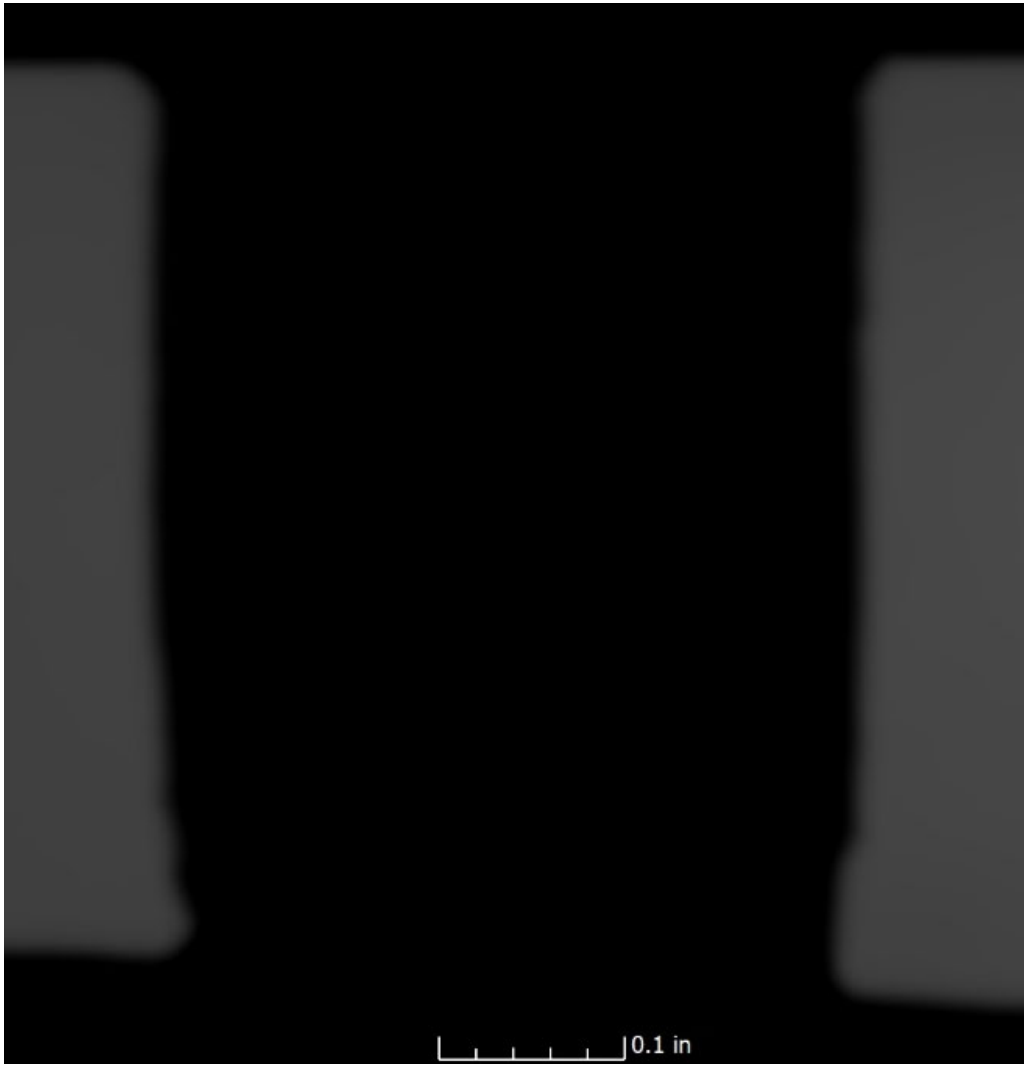
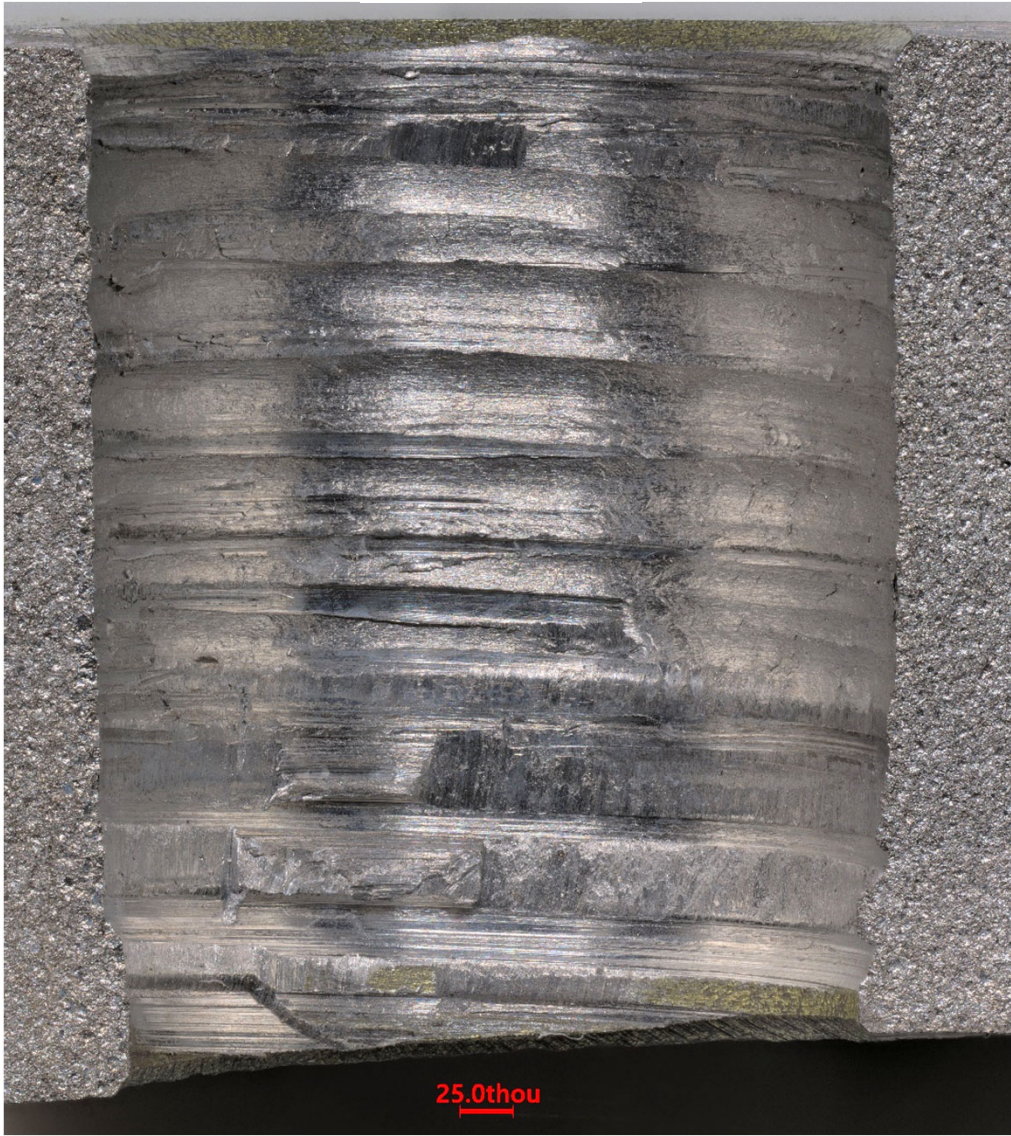
Hole 2 Side 1

Figure 66: Optical views of insert hole location 2 reveals damaged threads.

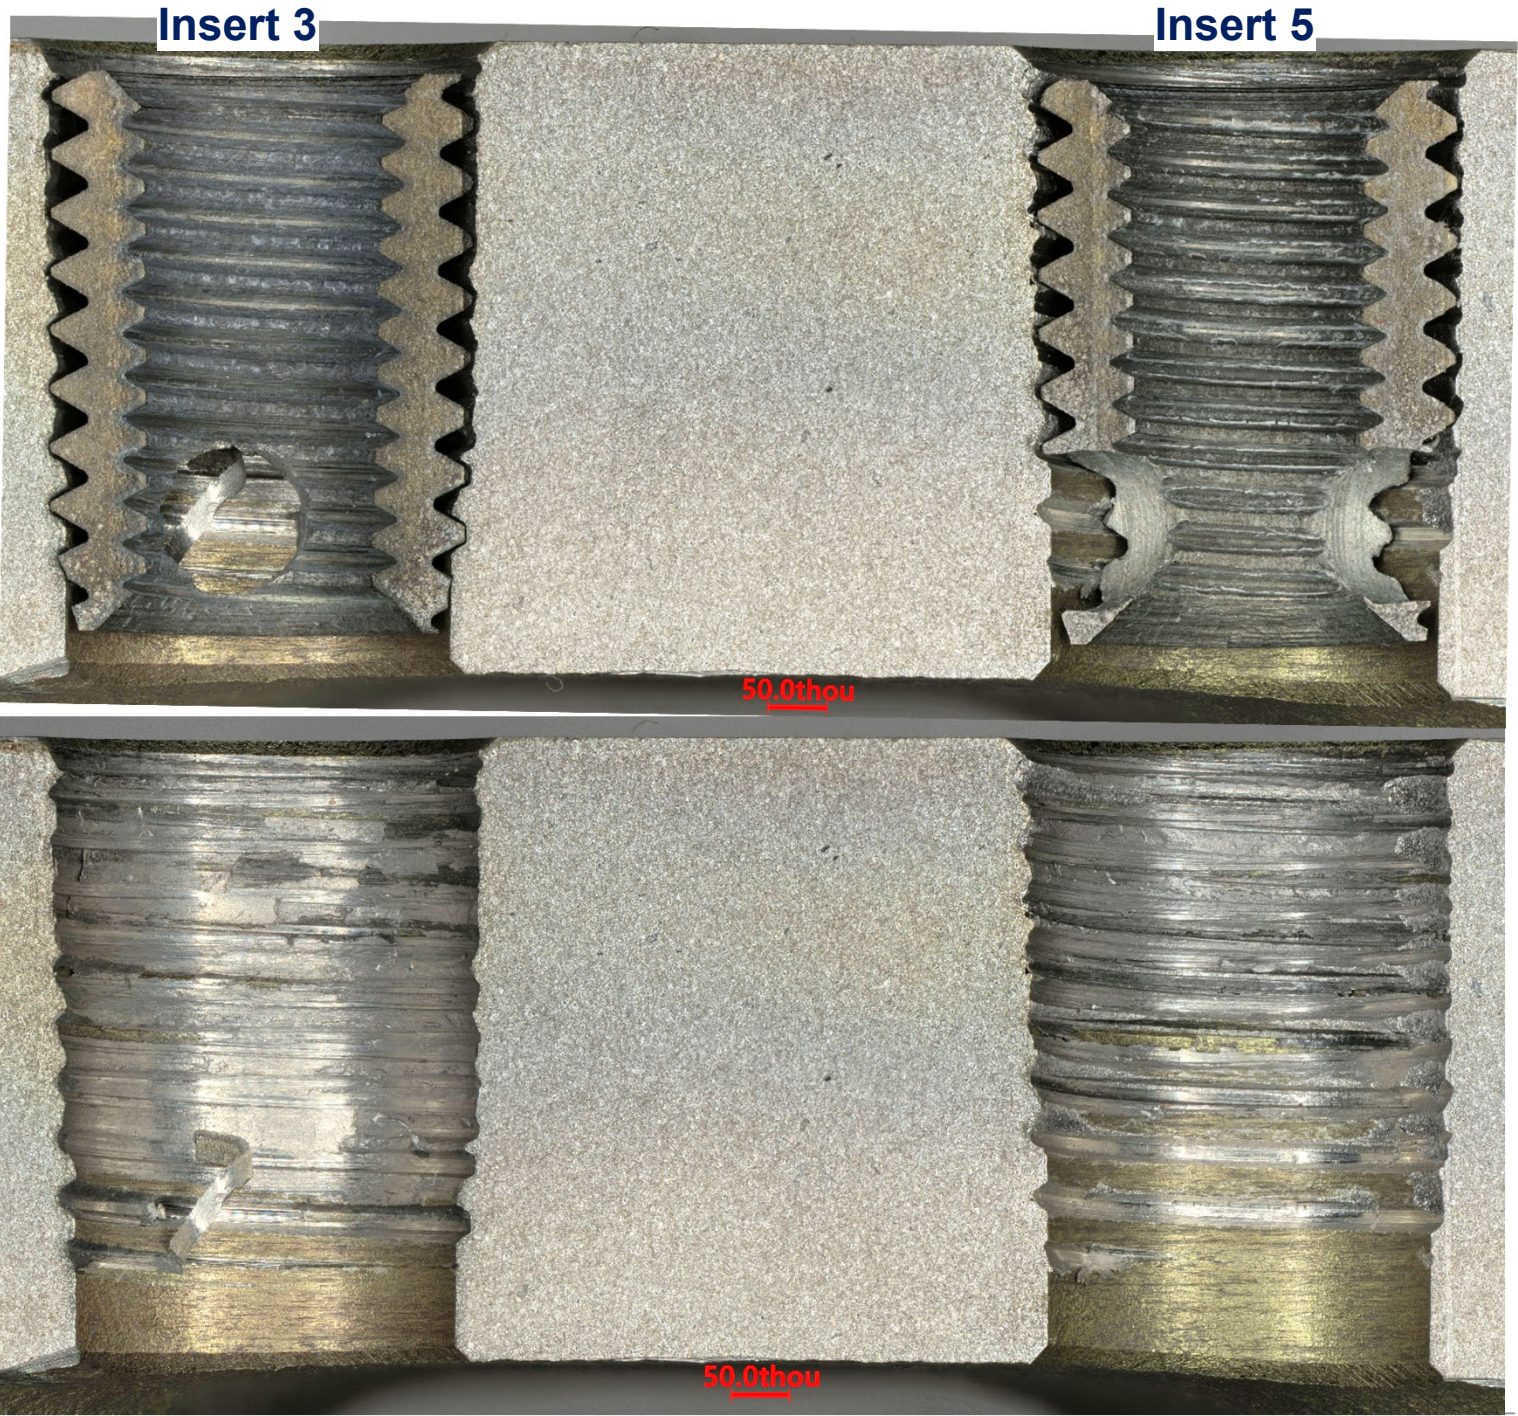
**Figure 69:** Optical views of insert locations 3 and 5 with the inserts in place and removed. Both insert holes have damaged and missing threads.

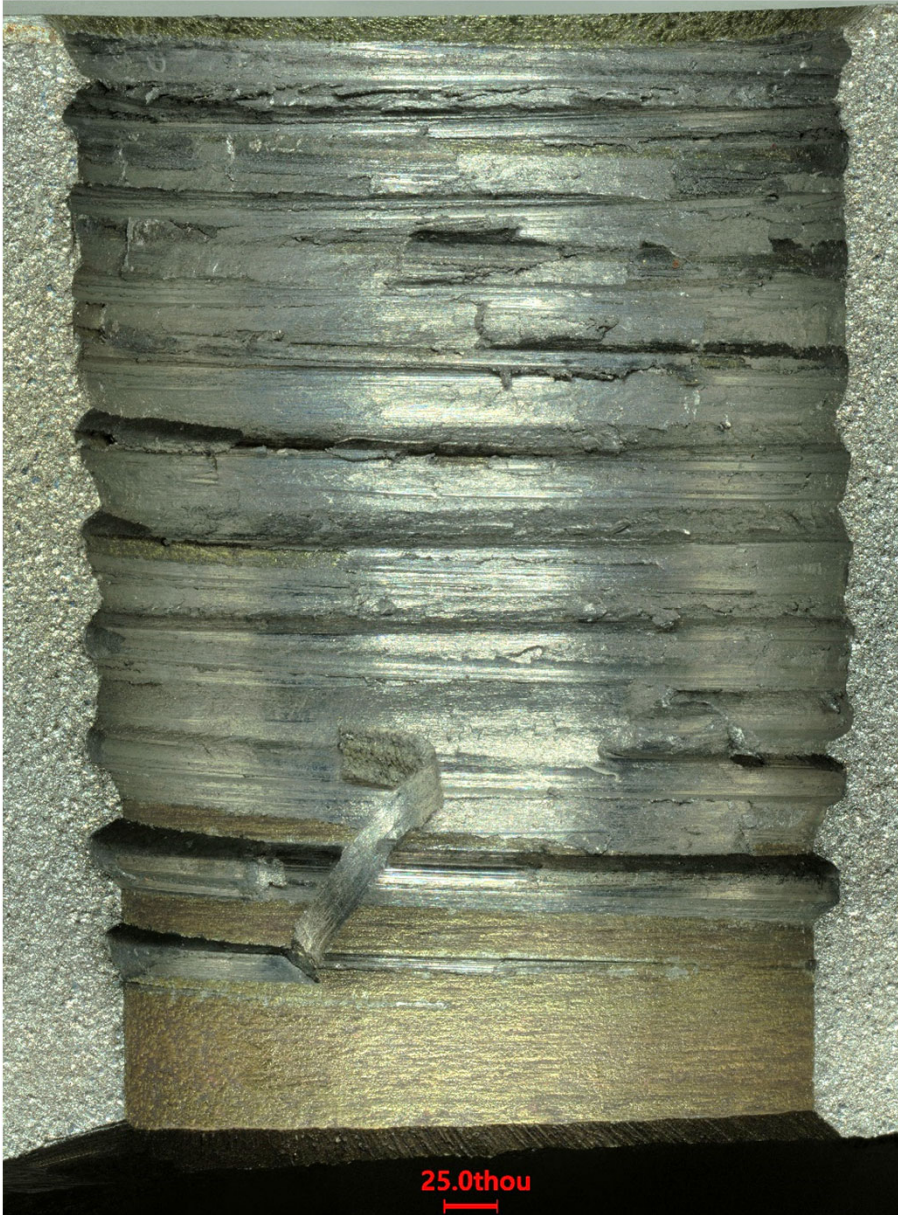
**Insert 3 Side 1**

**Figure 70:** Optical views of insert hole location 3 reveals damaged threads.
