# **Metallurgical Investigation Report**

## **DRB: AvEng-561264.A**

**EVALUATION OF A CF6-80C2 ESN 707-605 HMU IDLER  
ADAPTER FROM ESN 707-605 OPERATED BY FEDEX  
INVOLVED IN AN IN-FLIGHT SHUT-DOWN AND  
UNDERCOWL FIRE EVENT**

Part Number: 9395M78G10  
Part Serial Number: FIA217EE  
Part TSN / CSN: 1,421 hrs / 728 cycles

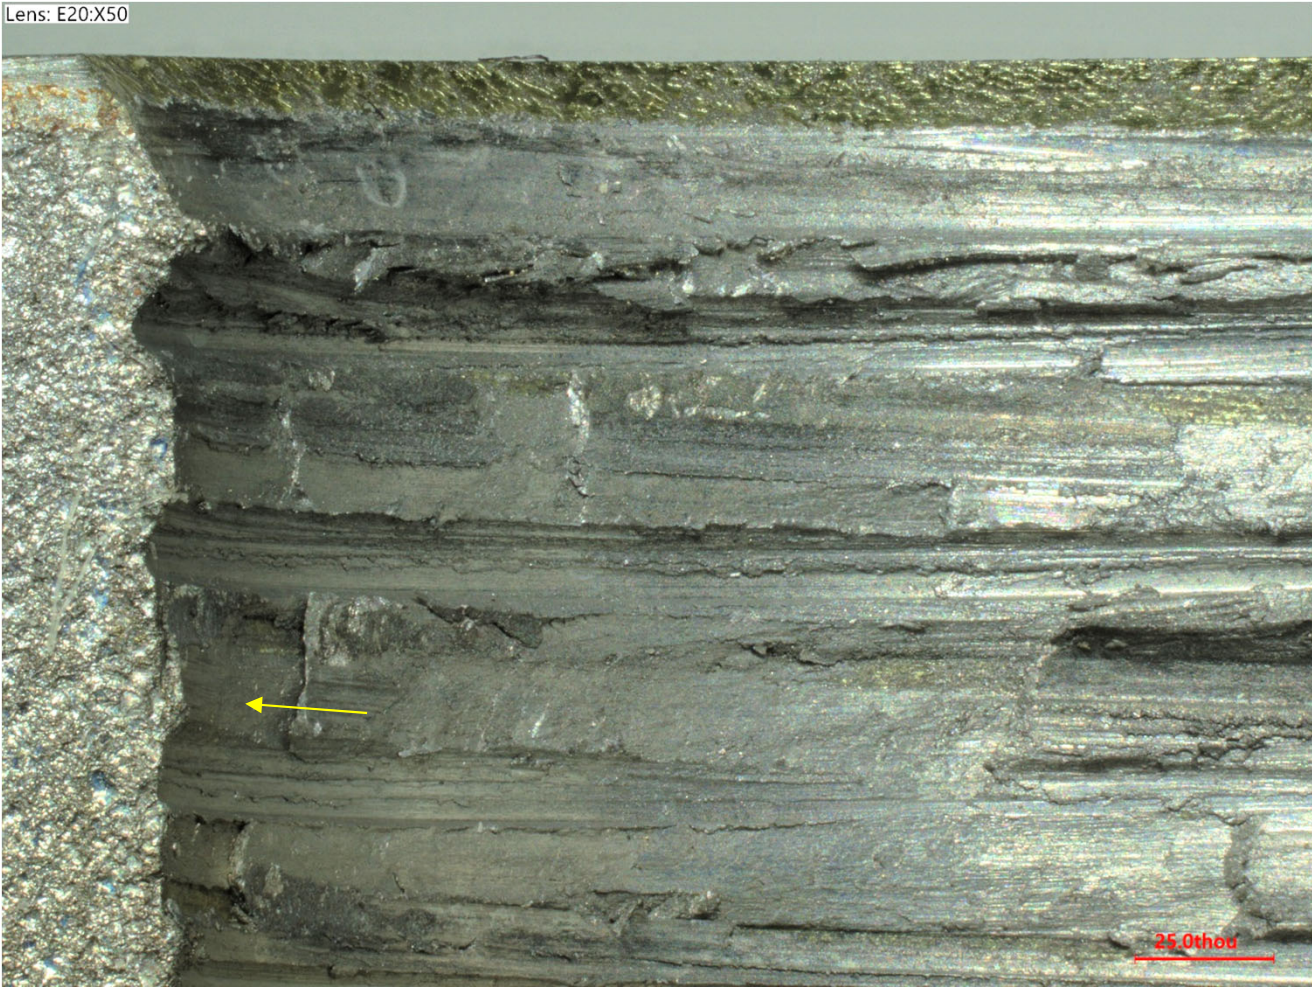
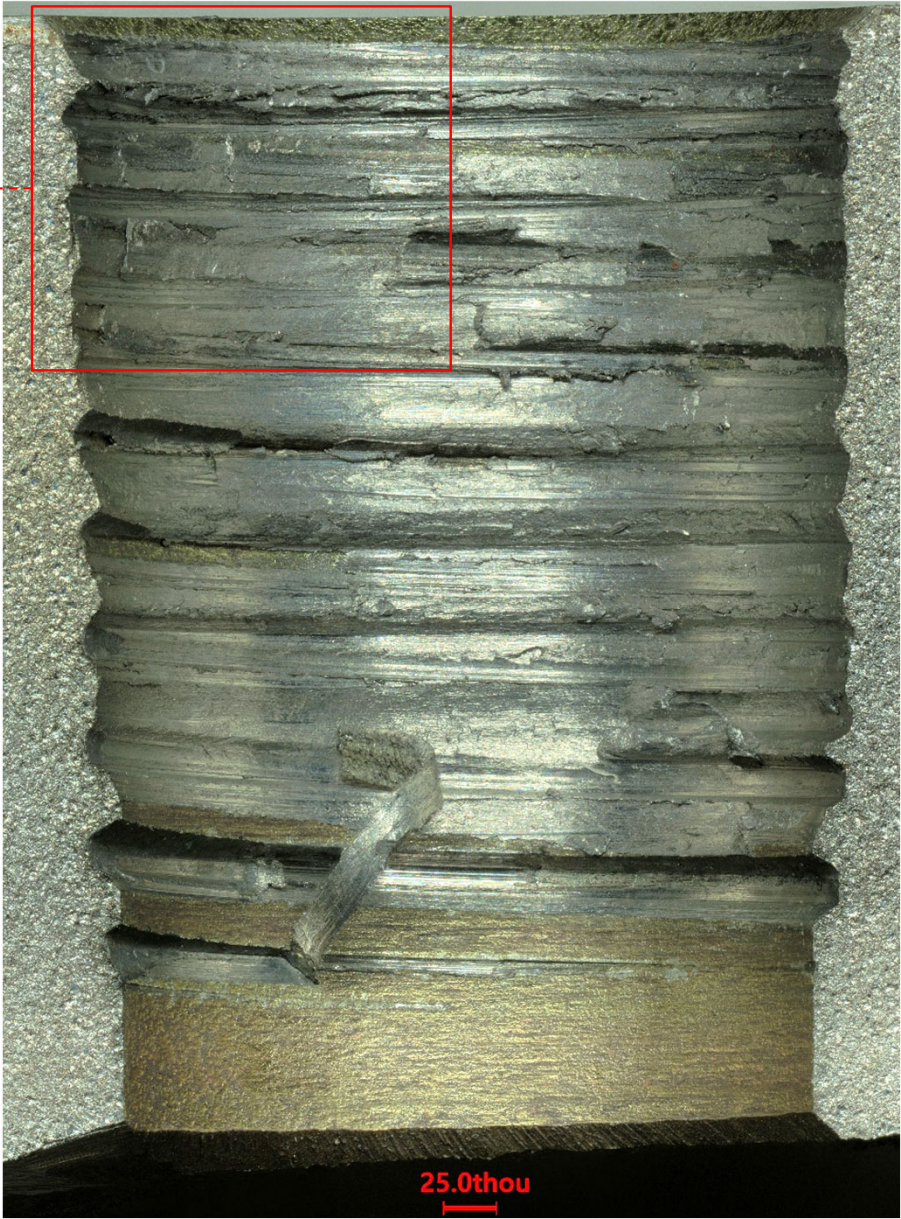
Insert 3 Side 1

**Figure 71:** High magnification views show the damaged threads reveals overlapping smeared material consistent with CCW rotation.

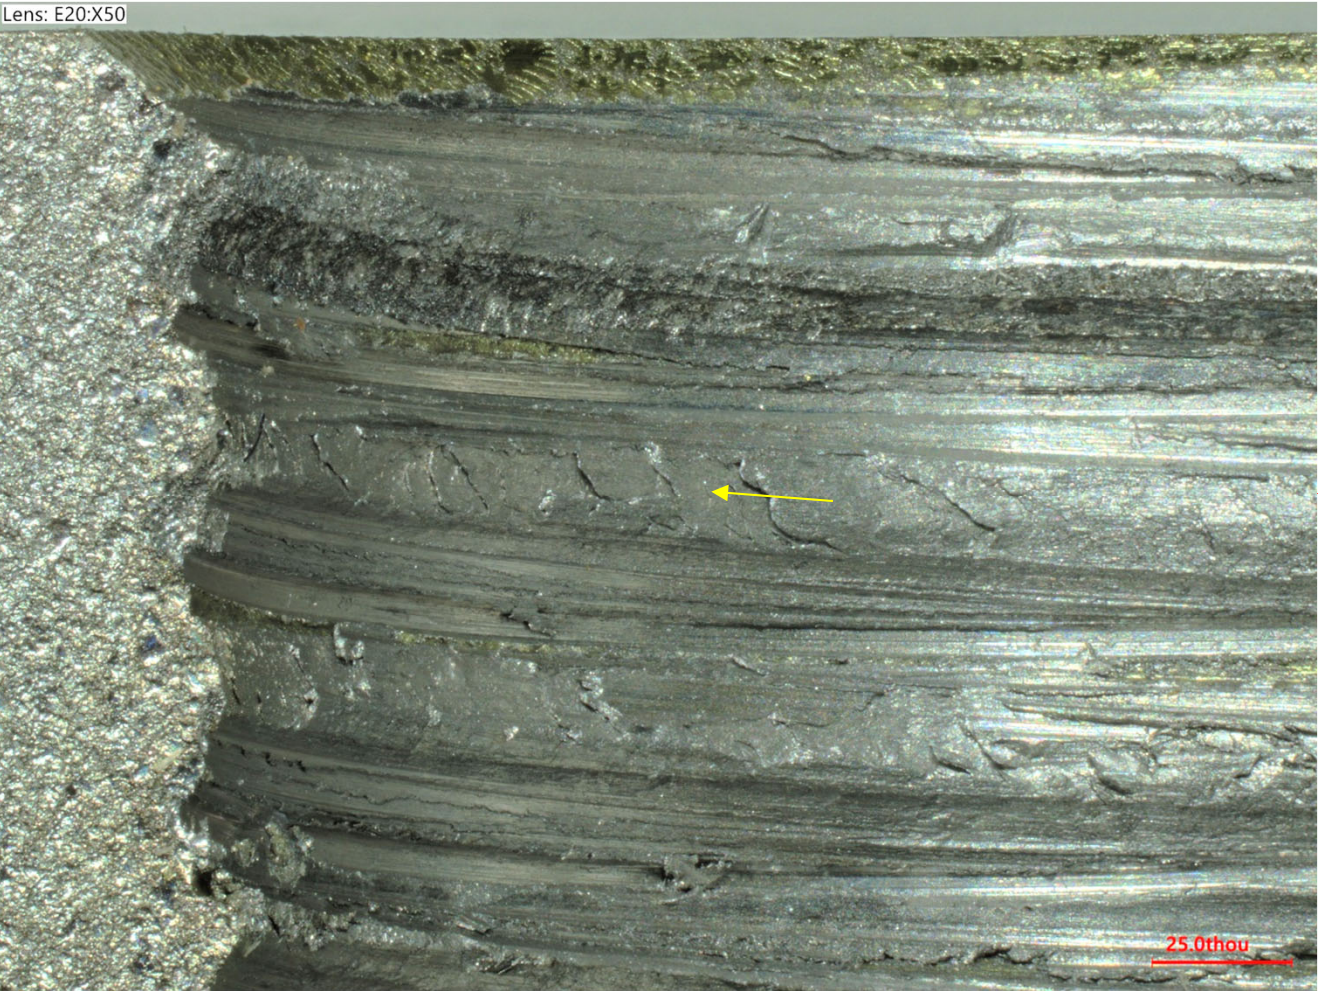
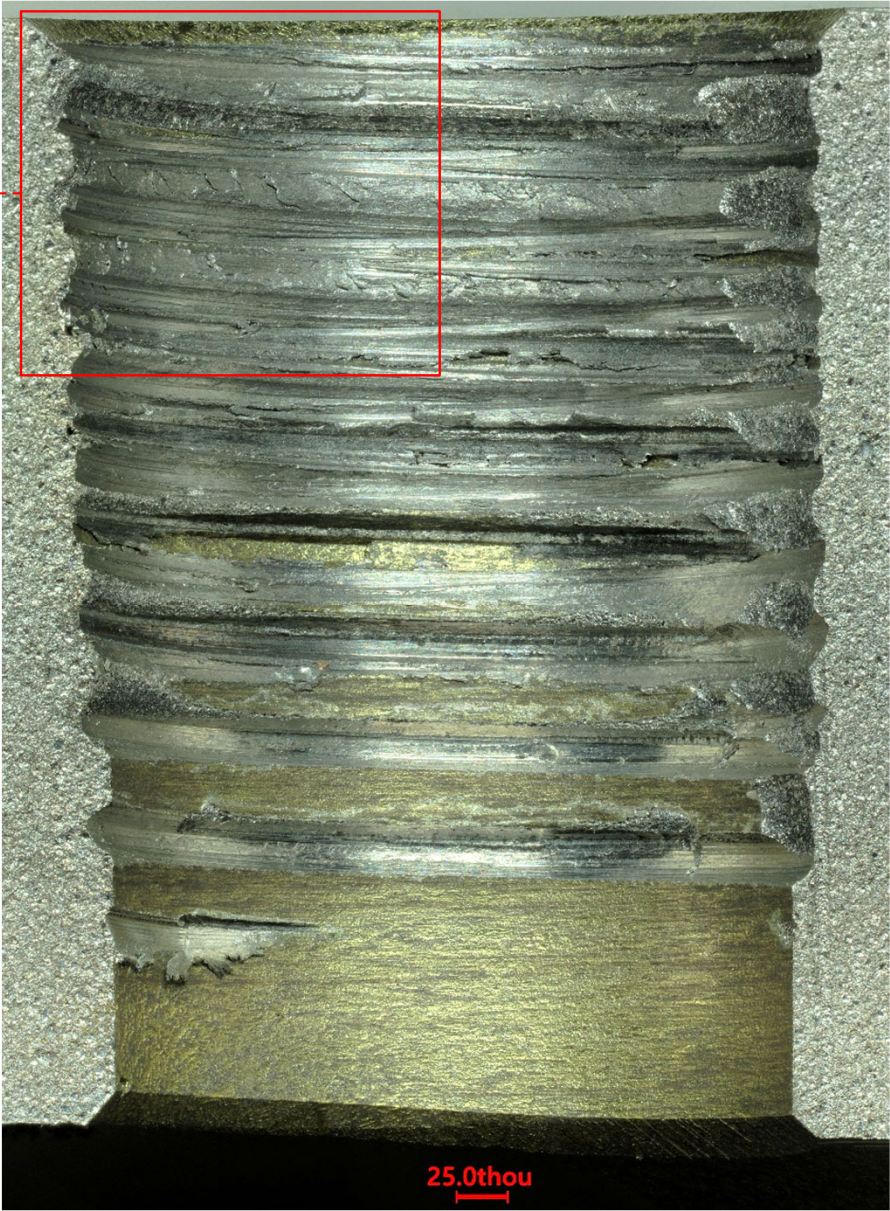
Insert 5 Side 1

**Figure 73:** High magnification views show the damaged threads reveals overlapping smeared material consistent with CCW rotation.

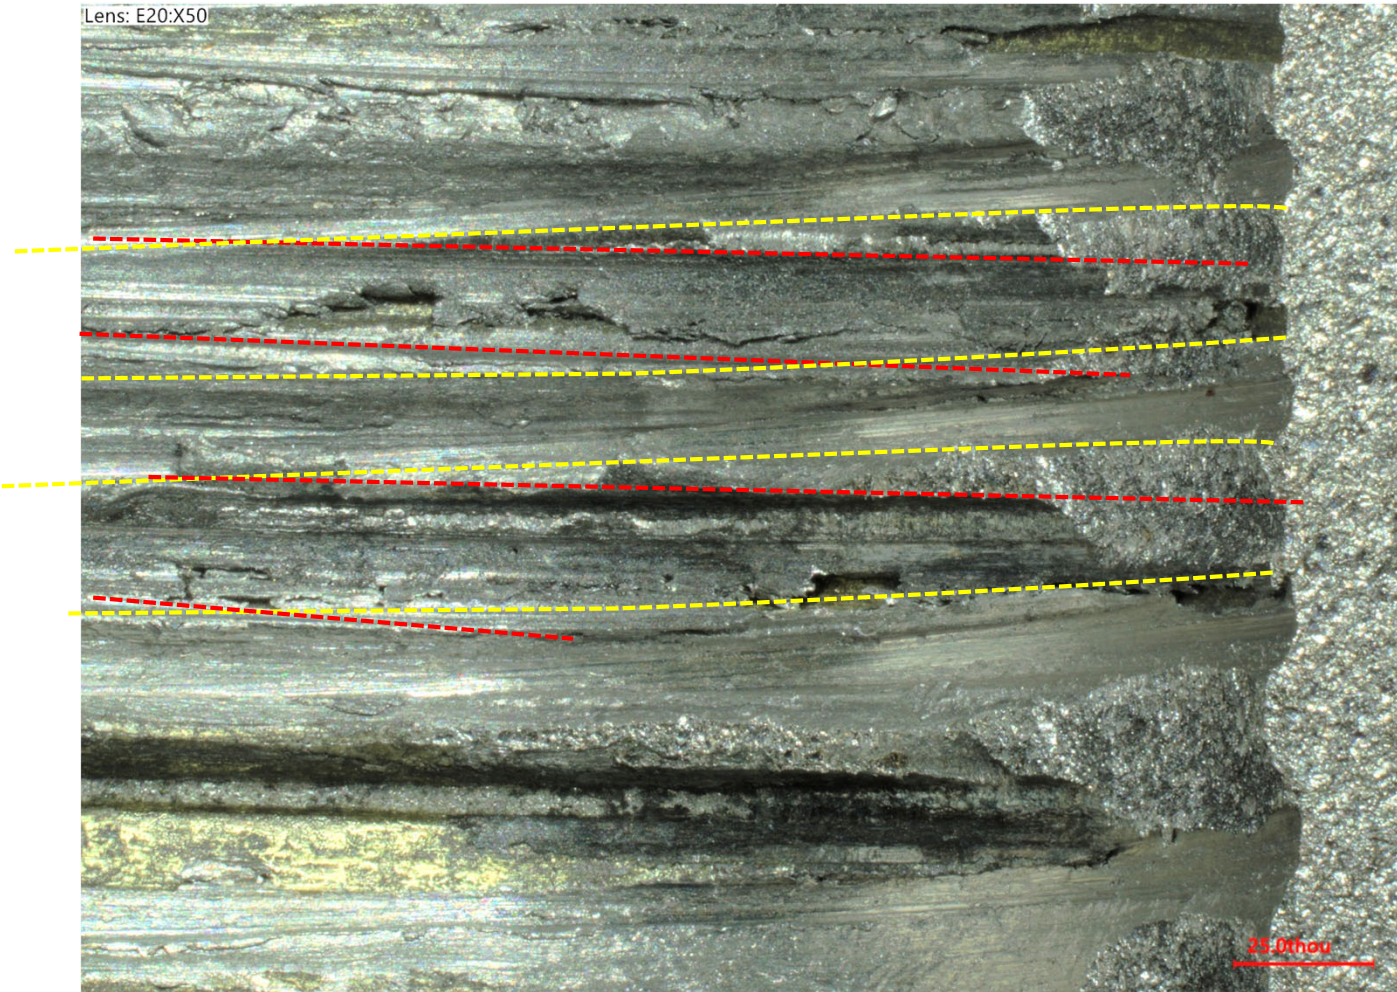
Insert 5 Side 1

**Figure 74:** High magnification views show the damaged threads reveals angled cut lines through the flange female threads, consistent with the thread insert cross-threading and cutting through the flange threads.

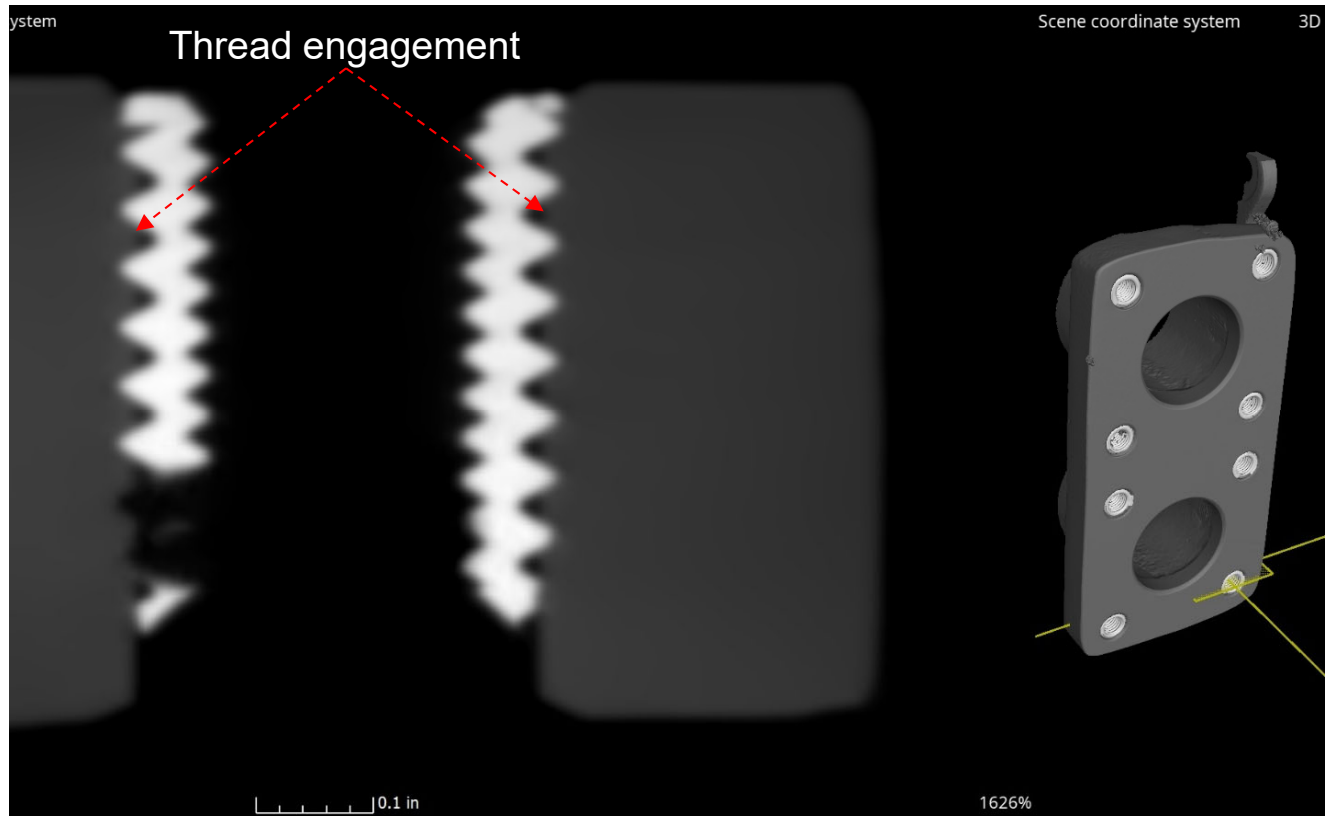
**Figure 83:** CT scan cross-section of thread insert position 1. Thread engagement is observed into the flange material.

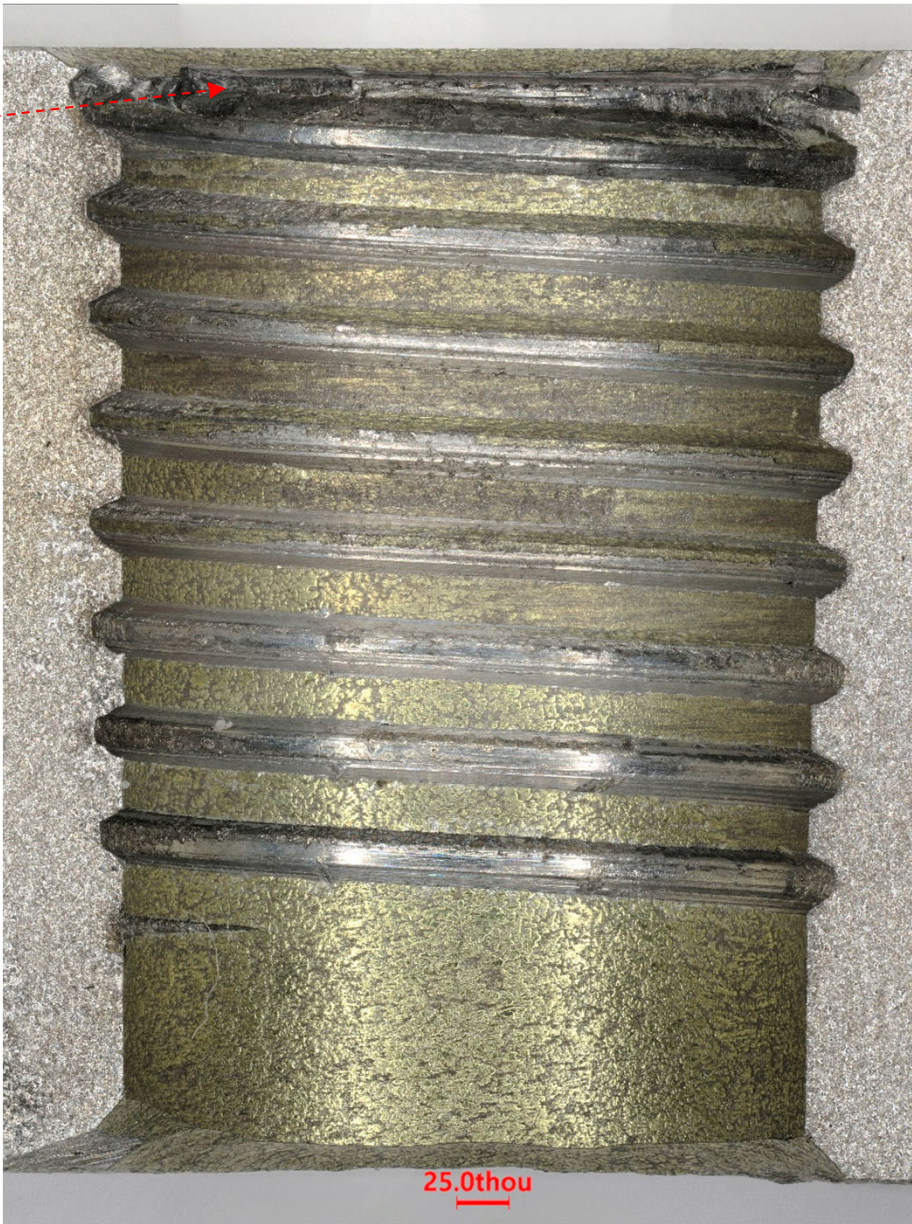
**Figure 92:** Optical views of insert locations 3 and 5 reveal intact threads with the gold-colored anodized surface.

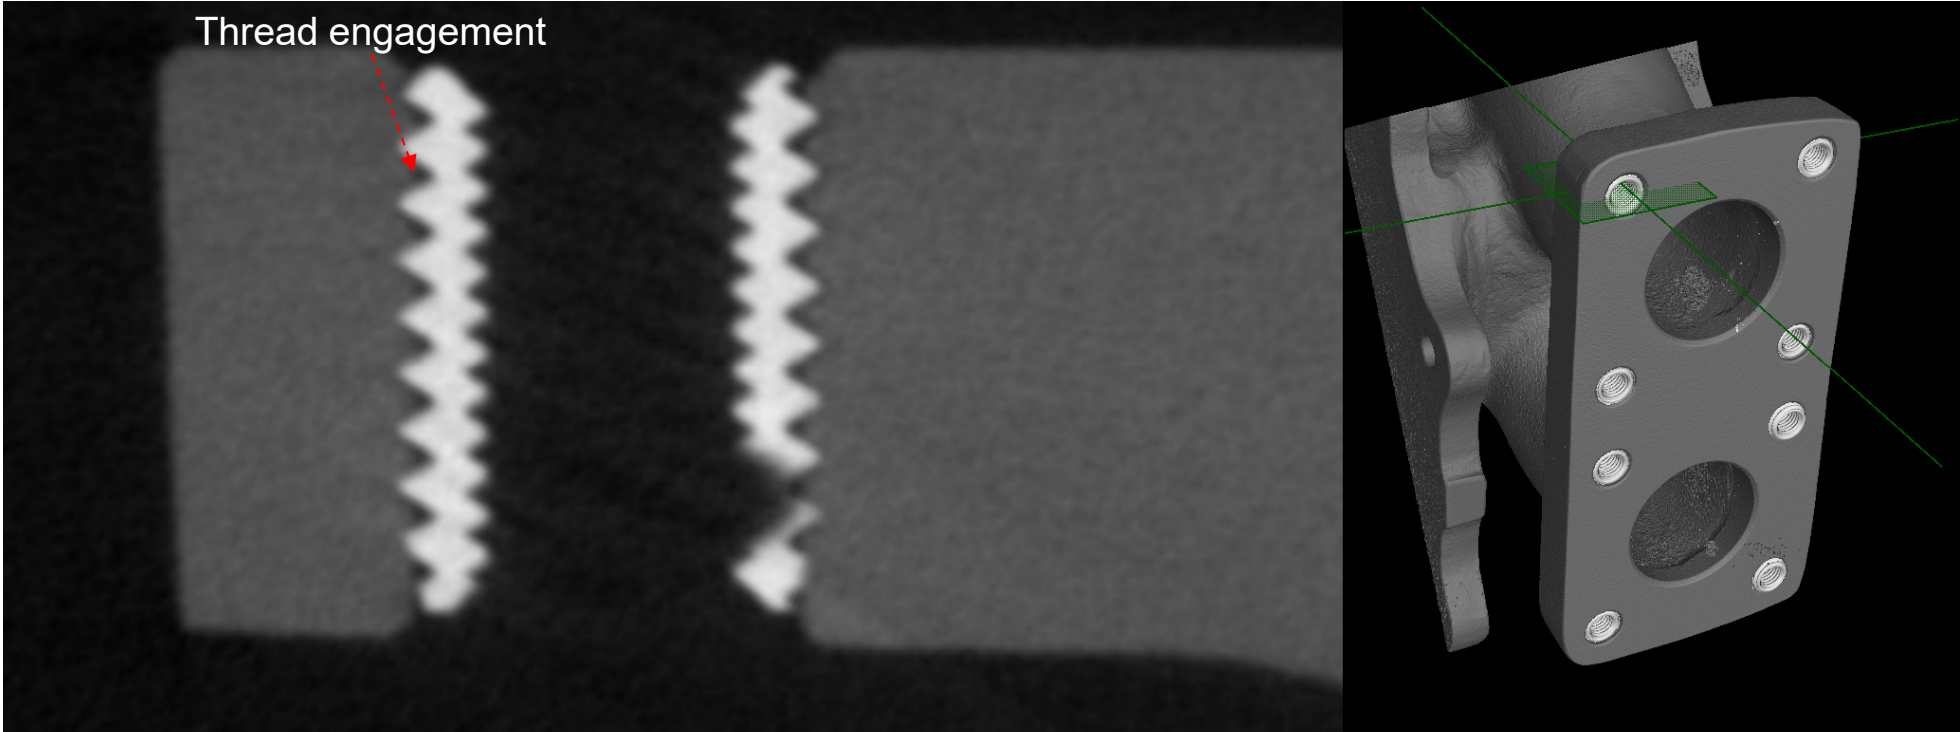
**Figure 94:** CT scan cross-section of thread insert position 1. Thread engagement is observed into the flange material.

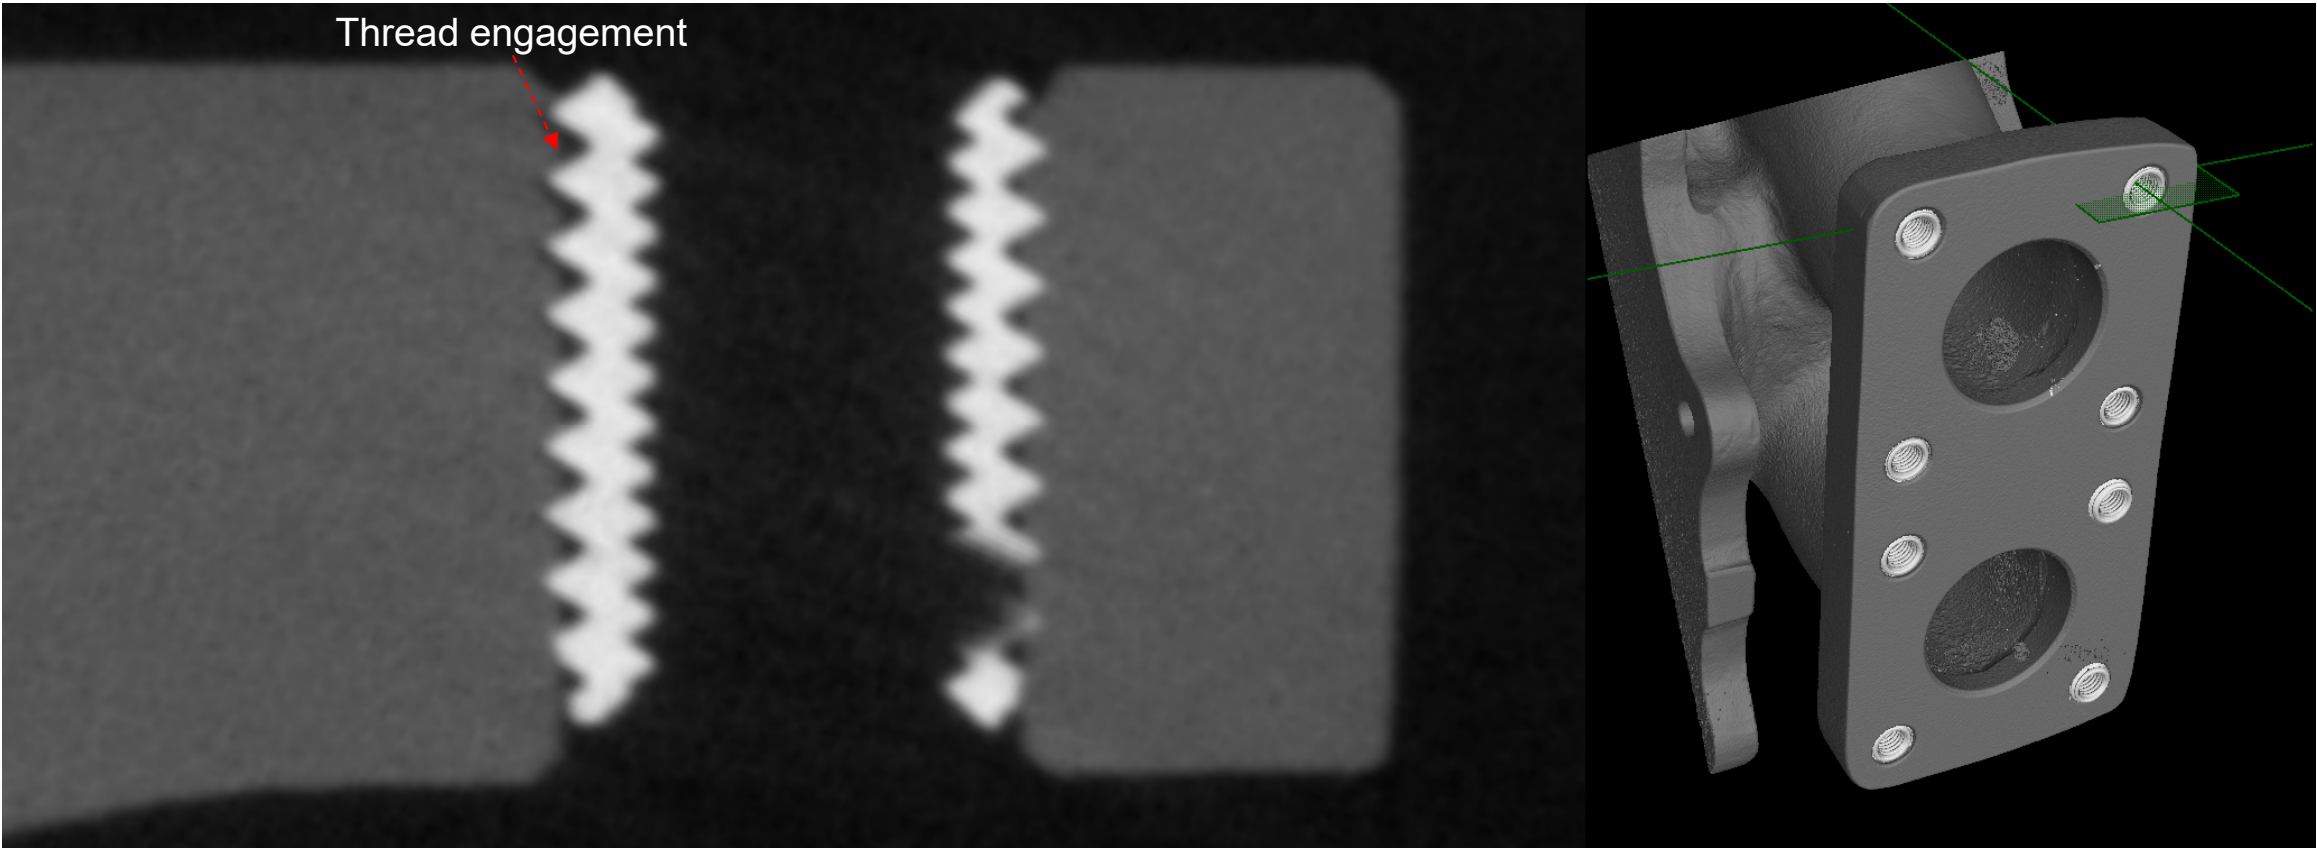
**Figure 95:** CT scan cross-section of thread insert position 2. Thread engagement is observed into the flange material.

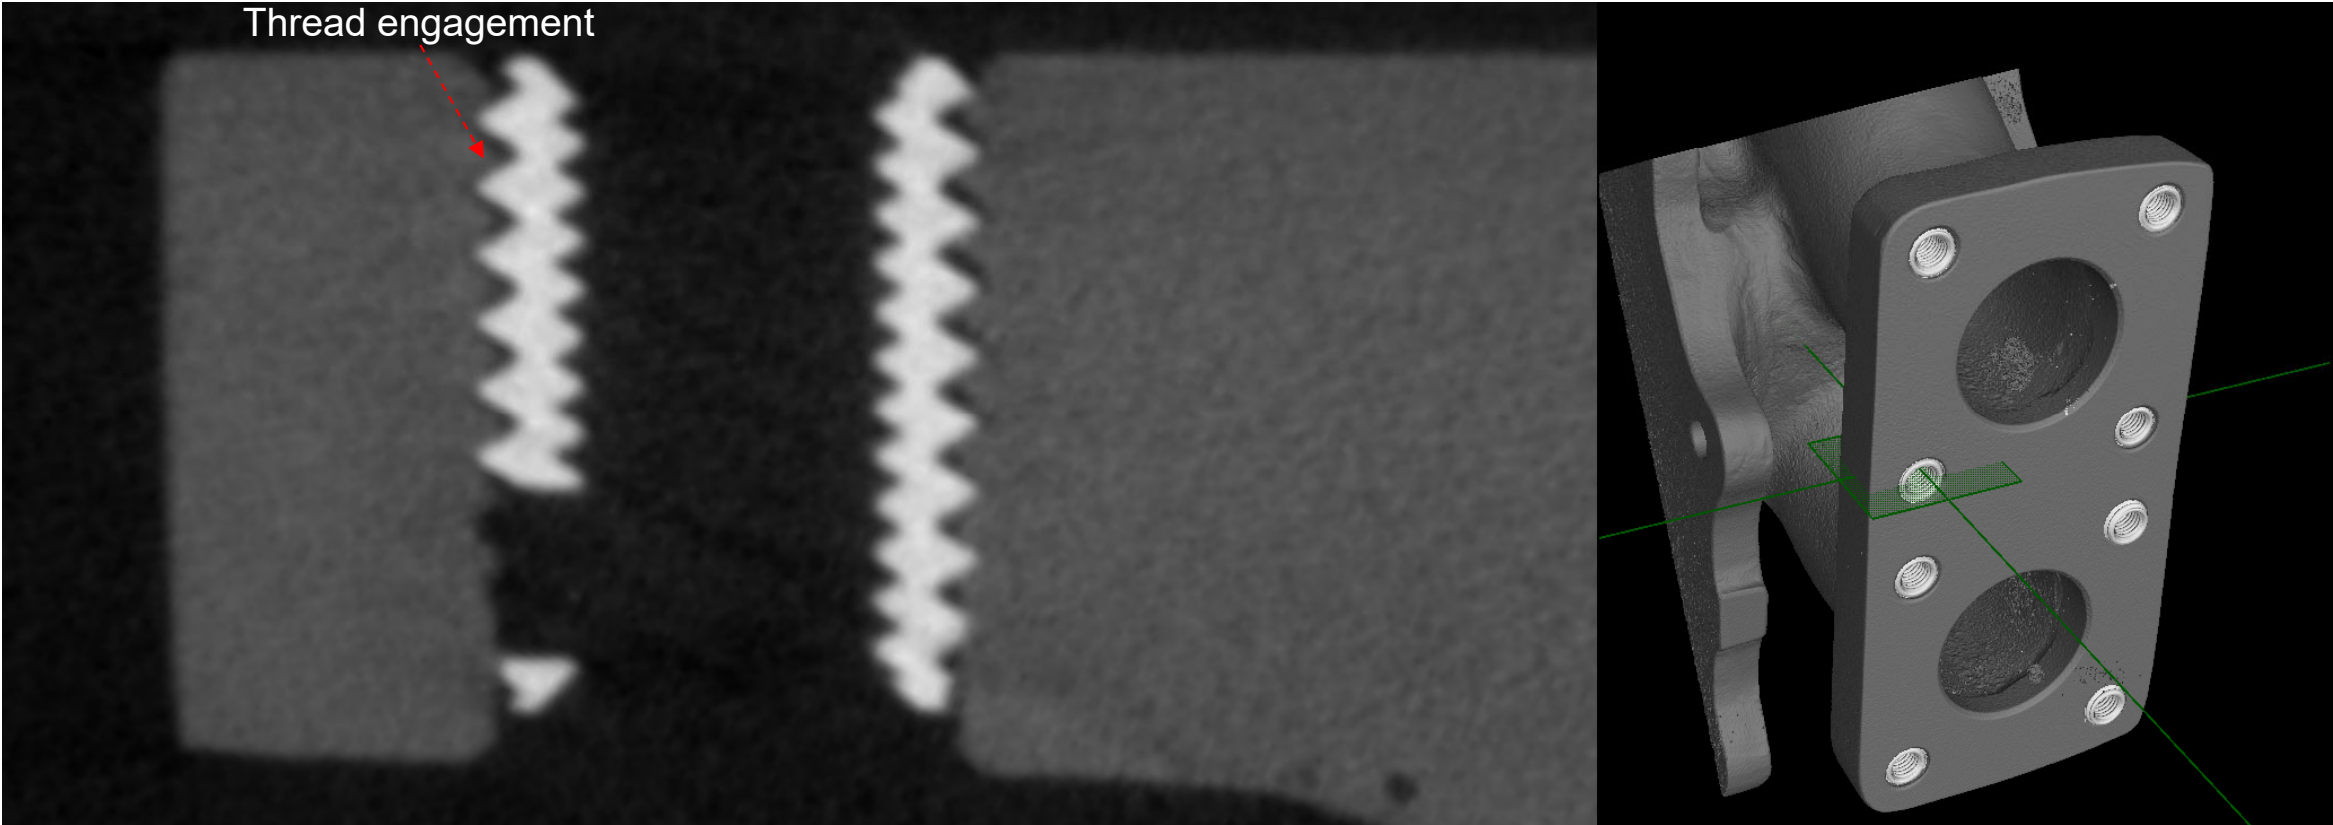
**Figure 96:** CT scan cross-section of thread insert position 3. Thread engagement is observed into the flange material.

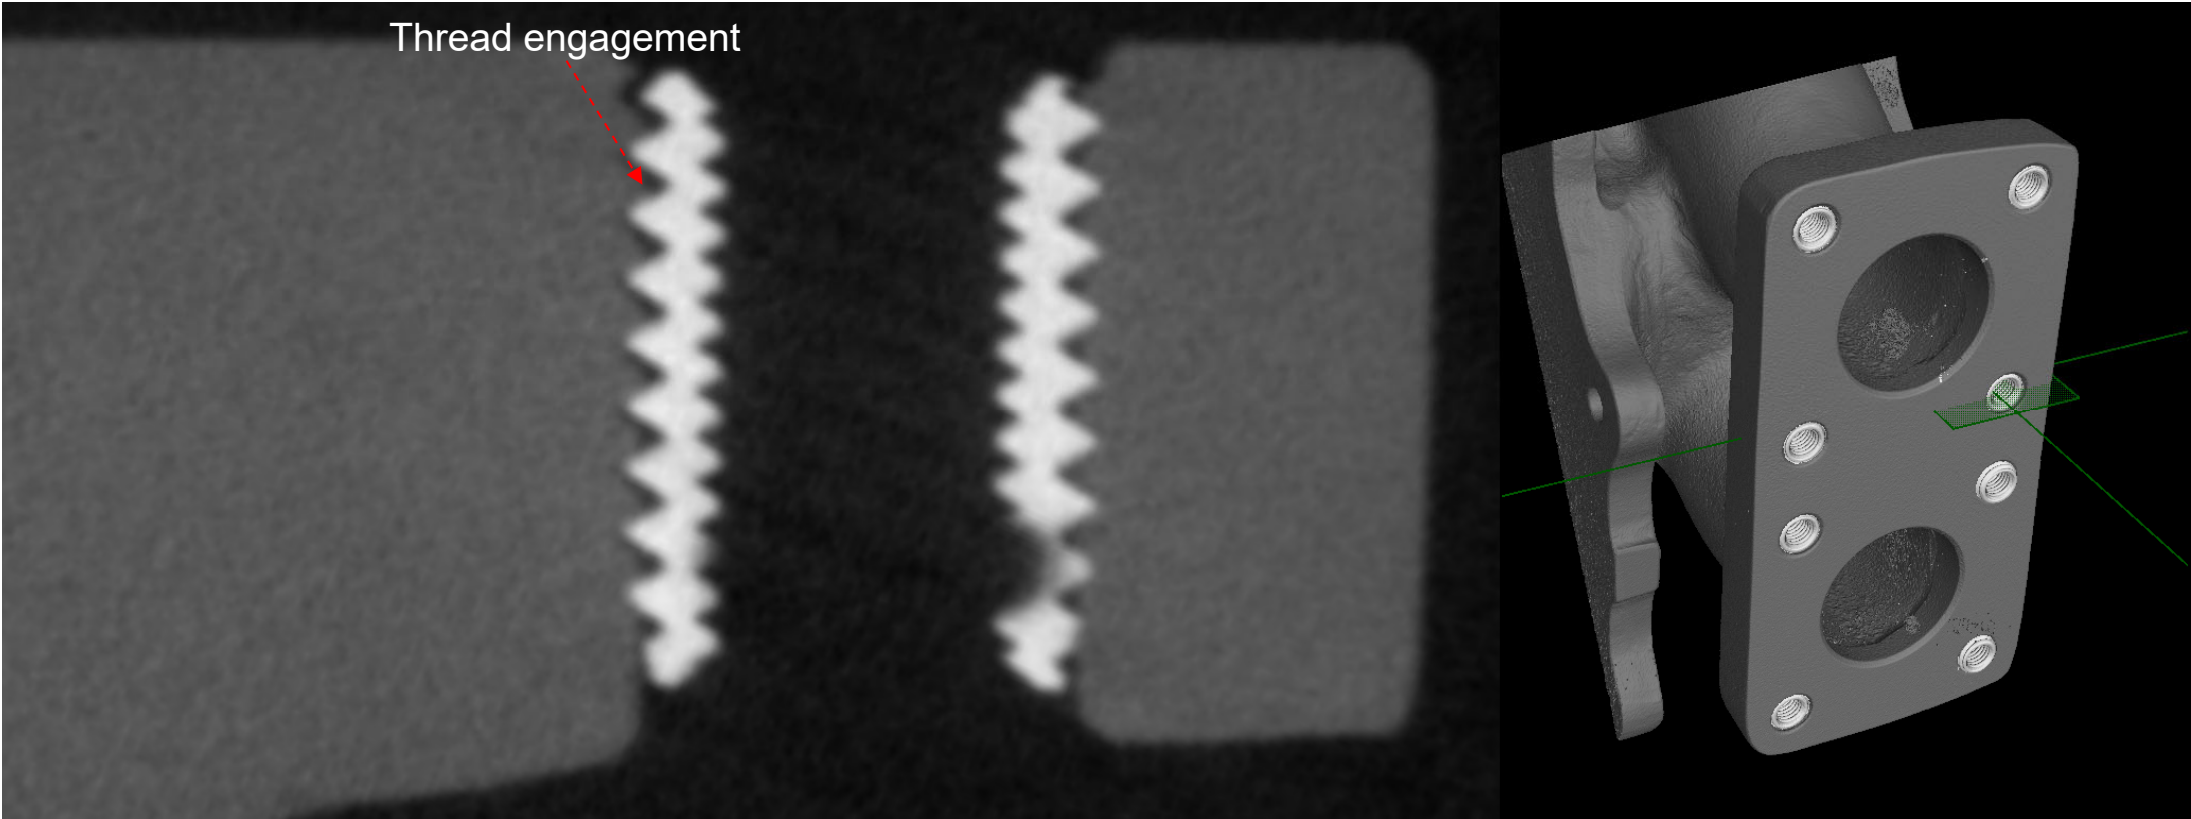
**Figure 97:** CT scan cross-section of thread insert position 4. Thread engagement is observed into the flange material.

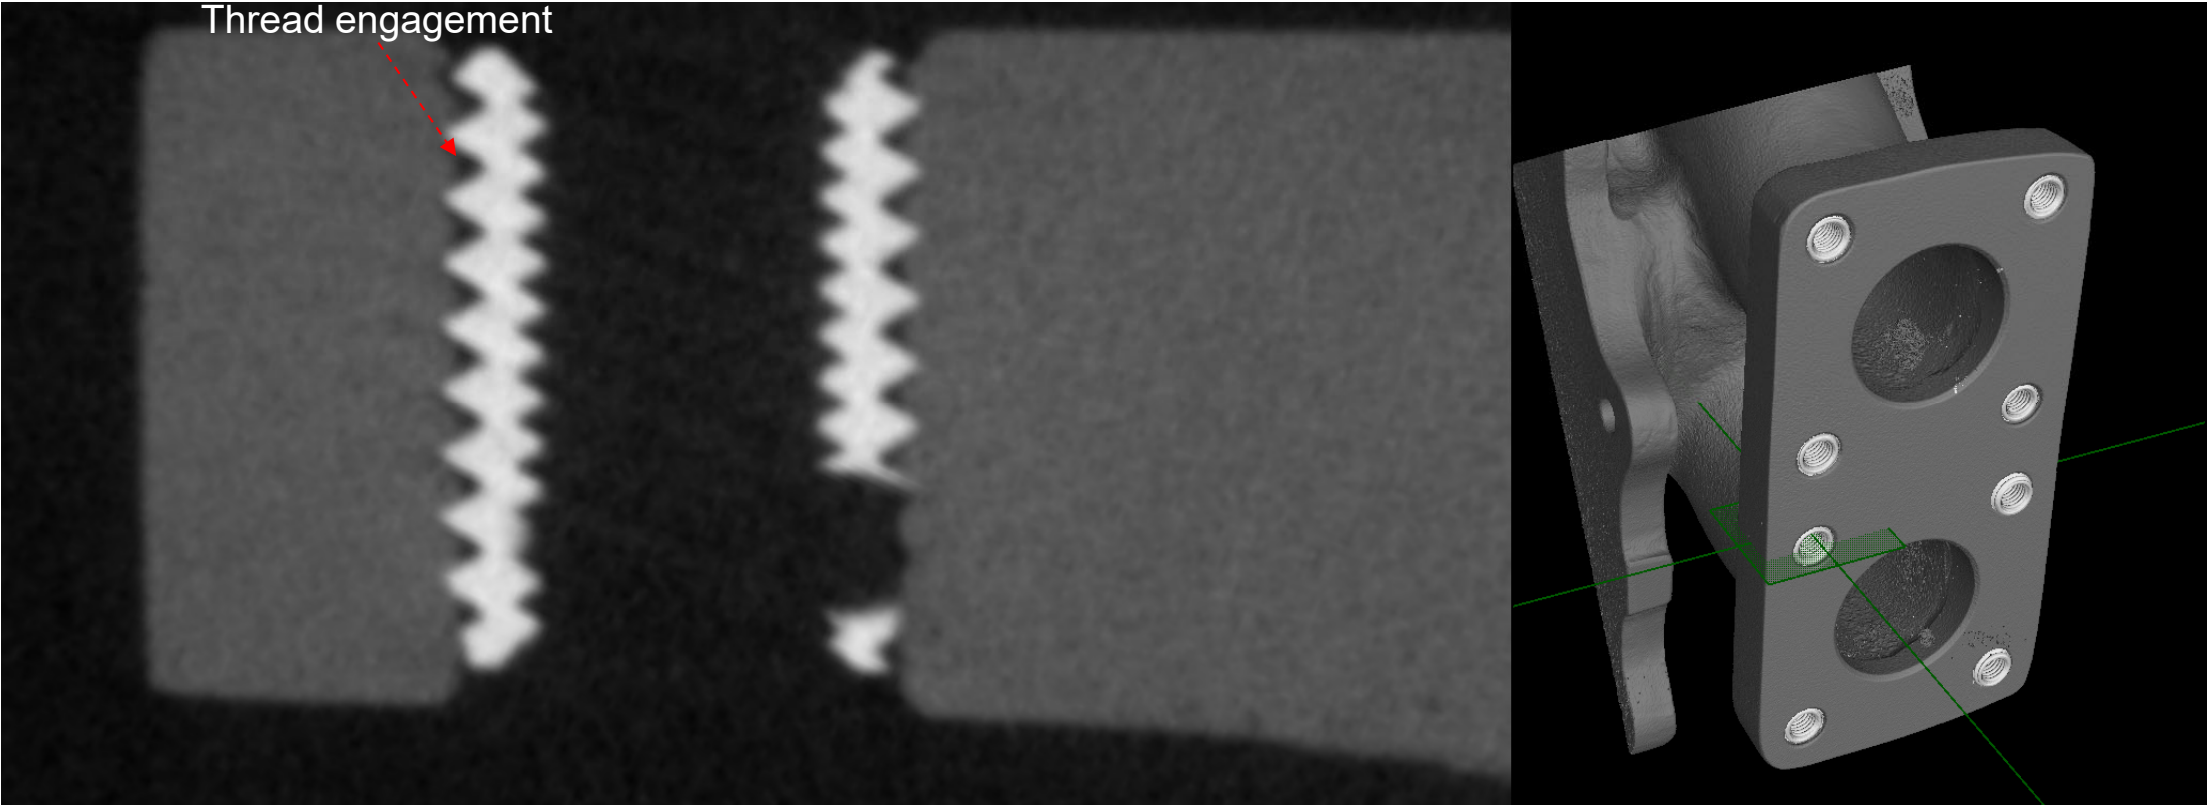
**Figure 98:** CT scan cross-section of thread insert position 5. Thread engagement is observed into the flange material.

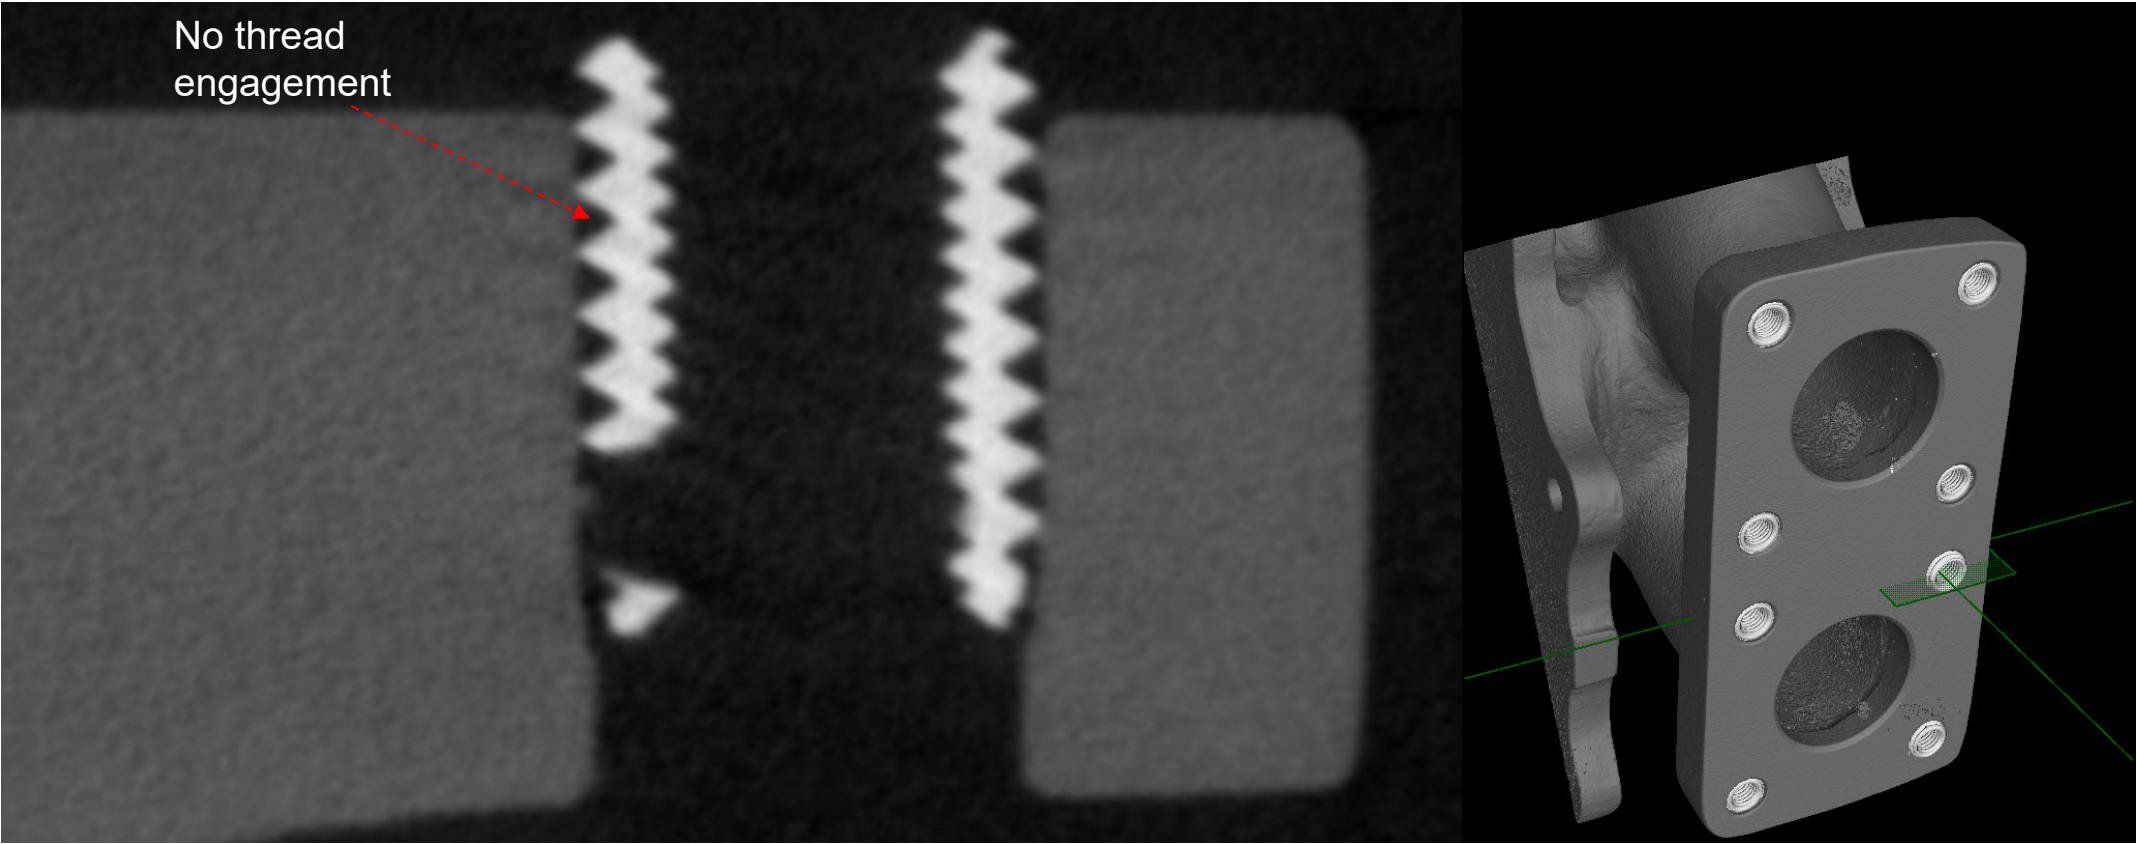
**Figure 99:** CT scan cross-section of thread insert position 6. No thread engagement is observed into the flange material.

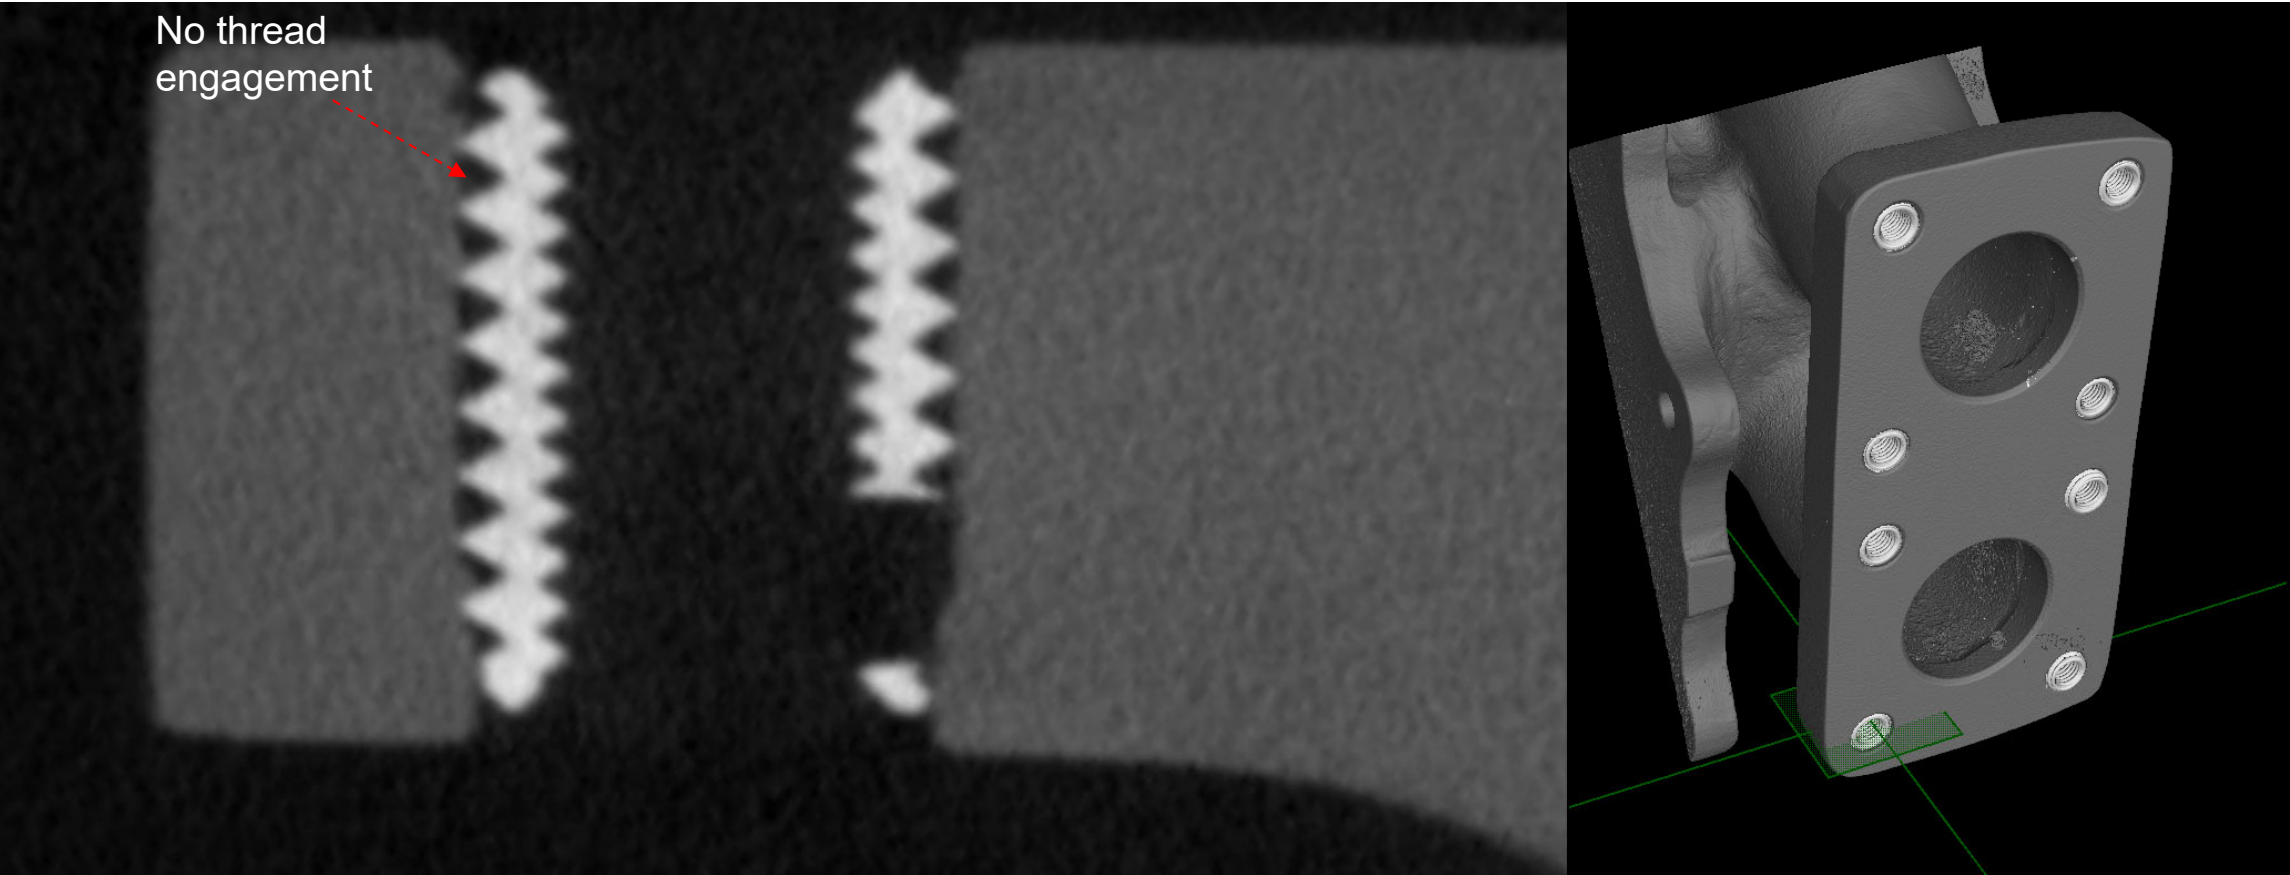
**Figure 100:** CT scan cross-section of thread insert position 7. No thread engagement is observed into the flange material.
