# **Metallurgical Investigation Report**

## **DRB: AvEng-561264.A**

**EVALUATION OF A CF6-80C2 ESN 707-605 HMU IDLER  
ADAPTER FROM ESN 707-605 OPERATED BY FEDEX  
INVOLVED IN AN IN-FLIGHT SHUT-DOWN AND  
UNDERCOWL FIRE EVENT**

Part Number: 9395M78G10  
Part Serial Number: FIA217EE  
Part TSN / CSN: 1,421 hrs / 728 cycles

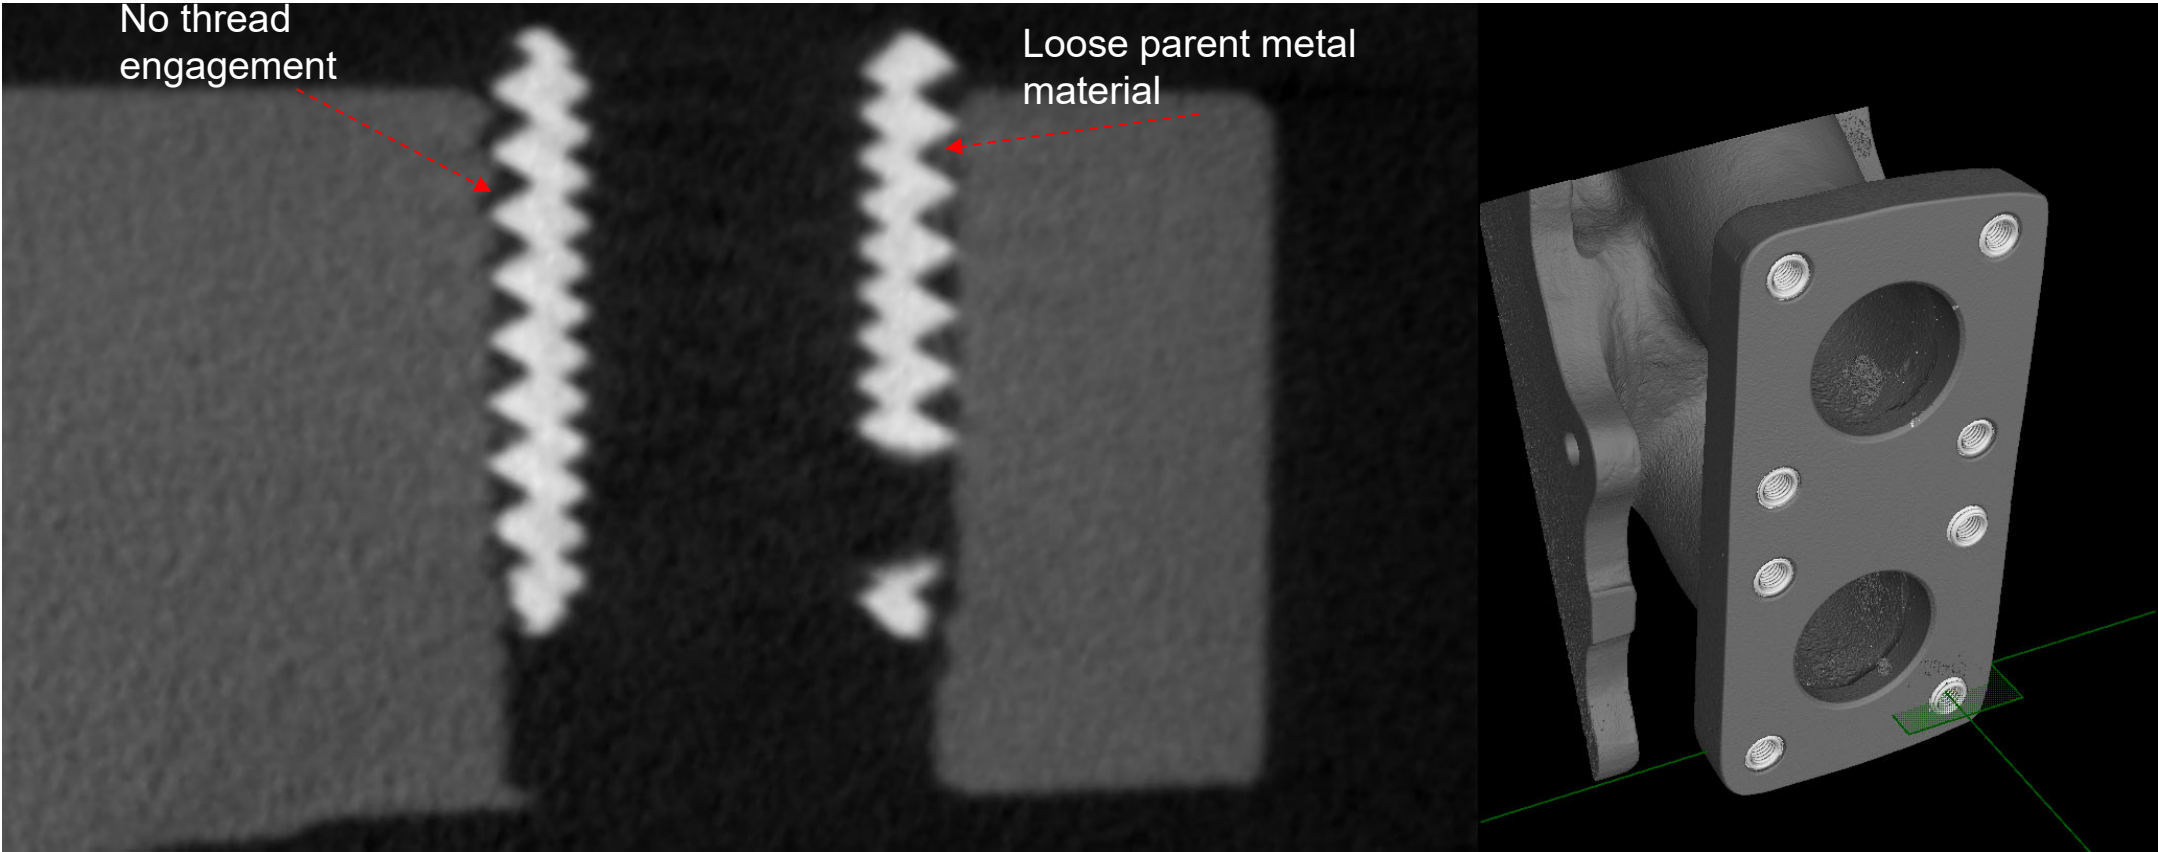
**Figure 101:** CT scan cross-section of thread insert position 8. No thread engagement is observed into the flange material.

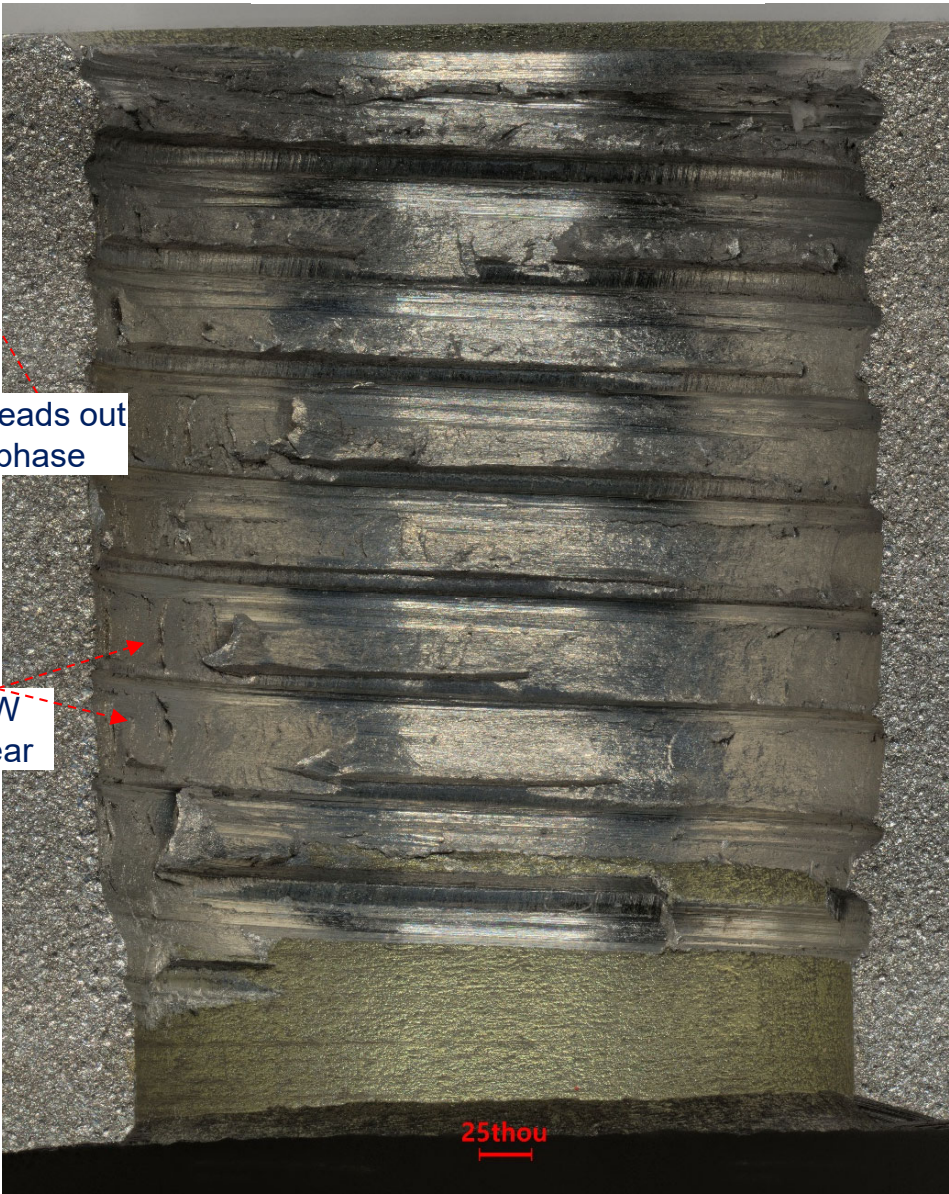
Insert 7: Insert removed

CCW smear

**Figure 102:** Optical views of insert location 7 with the inserts in place and removed. The threads have been removed 360-degrees around the hole and the insert is observed out of phase with the original pre-tapped threads, consistent with cross-threading. CCW smear is also observe in the damaged area.
