**Examination of Two Hydromechanical  
Units from a CF6-80C2 Turbofan  
Engine  
Memphis, Tennessee, USA  
Boeing 767-300F Incident  
Aircraft  
Registration N287FE**

This report presents the findings of the investigation of two hydromechanical units (HMU) performed at the Honeywell Aerospace facility in Rocky Mount, NC on February 7-8, 2024.

The investigation was conducted at the request of the National Transportation Safety Board (NTSB). Representatives from the NTSB, FAA, FedEx, GE and Honeywell were present at the examination.

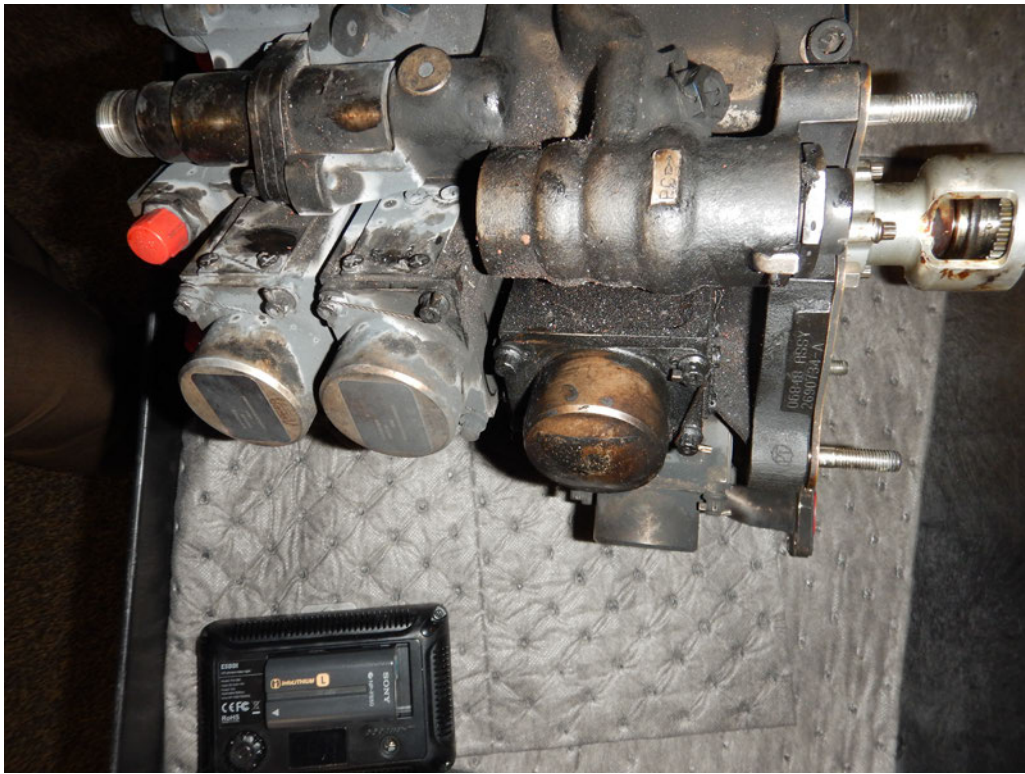
**Figure 10. BECK5069 as Received**

- b. According to an 8130-form dated September 18, 2023, by CIMA aviation, it noted the incorrect installation of shutoff solenoid and no fuel leakage found. It was also noted that the incorrect installation would not have affected operation.
- c. The unit was received in a wooden shipping container (Figure 2 and Figure 3).
- d. The HMU was soot covered and exhibited thermal damage to some of its features (Figure 4 - Figure 9).
- e. The HMU mounting gasket appeared to be intact (Figure 6).
- f. There were varying degrees of soot covering the area of the electrohydraulic servo valves (Figure 9).
- g. The housing cover on the high pressure turbine active clearance control electrohydraulic servo valve (HPTACC EHSV) was bulged and the name

- plate was not attached due to the distorted area – the exterior surfaces of the valve appeared to be damp (Figure 10).
- h. The Channel 'A' and 'B' cannon plugs' electrical connector pins appeared to be intact and did not appear to be thermally damaged (Figure 11).

Bulging was noted to the HPTACC EHSV cover. However, according to the Honeywell subject matter expert, the bulging condition does not affect operation of the component.

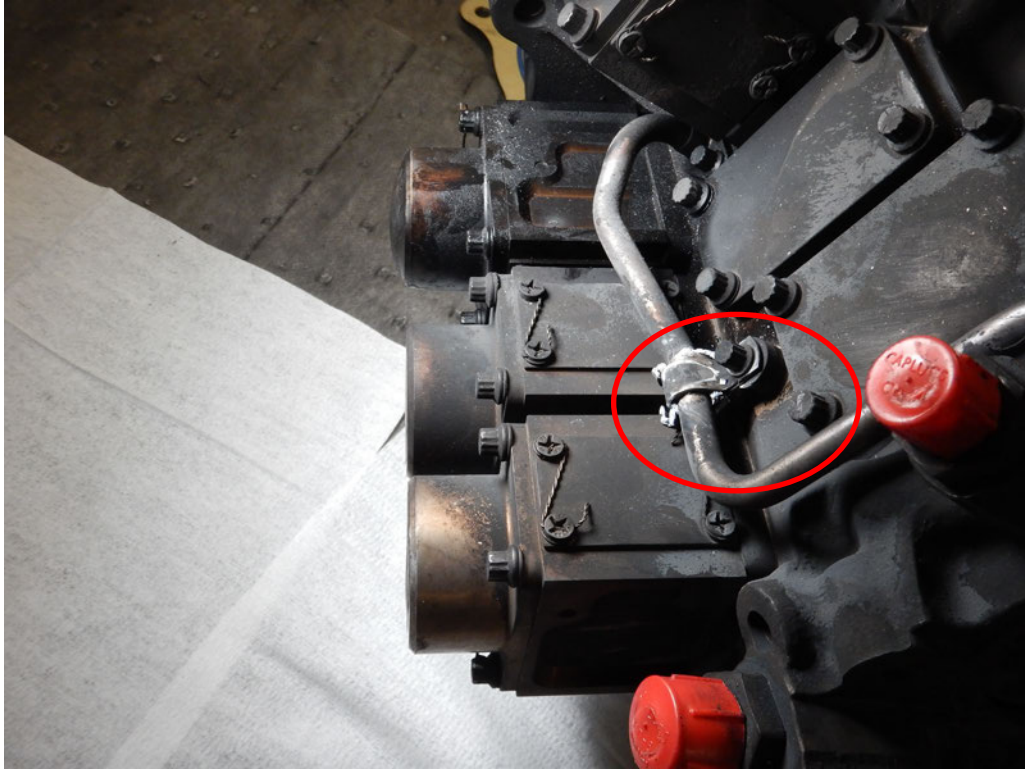
**Figure 12. BECK5069 as Received**

- i. The insulation/rubber on one of the P-clamp exhibited thermal damage (Figure 12).
  - j. The conduit feature of the resolver housing (Cover Assembly) exhibited thermal damage (Figure 13).

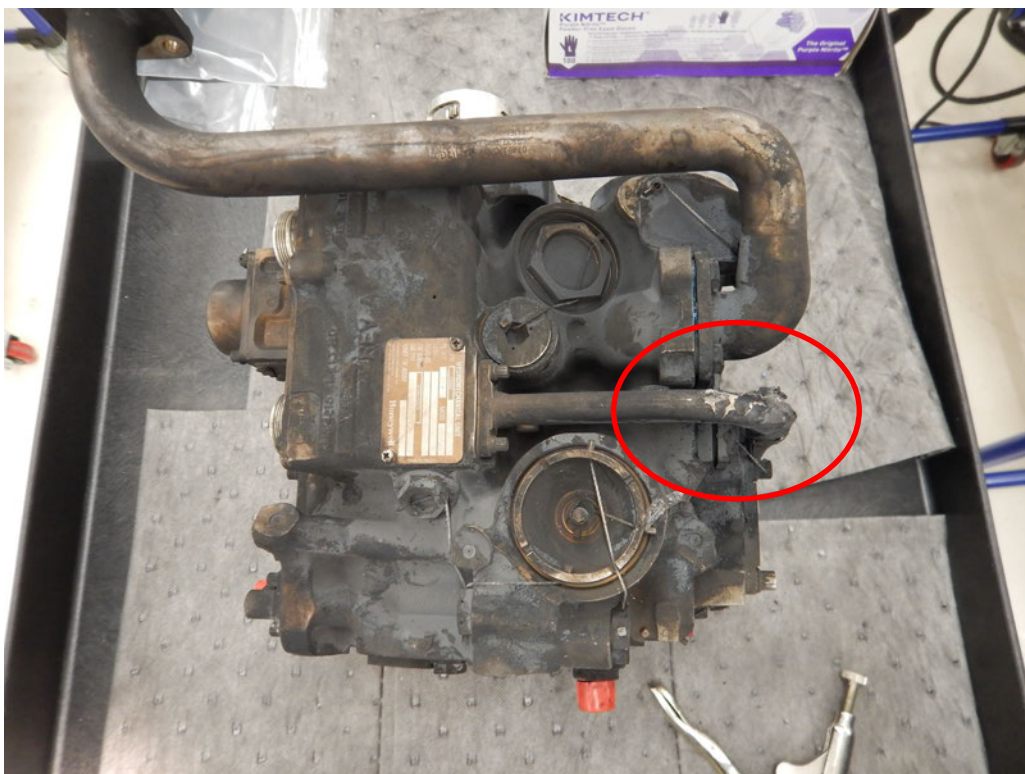
The incident HMU failed almost all the electrical check related to the resolvers. However, this is likely due to thermal distress as evidence by the damage to the cover assembly as well as the charring to the wire insulation and the resolver potting compound.

**Figure 13. Damaged Resolver Housing**

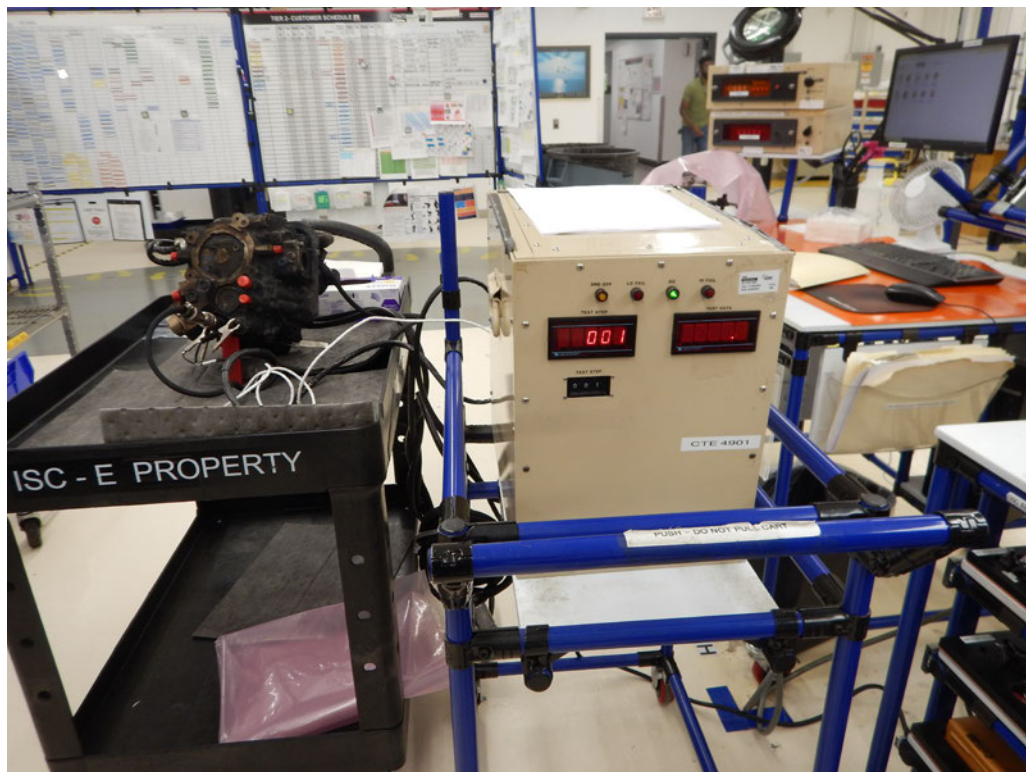
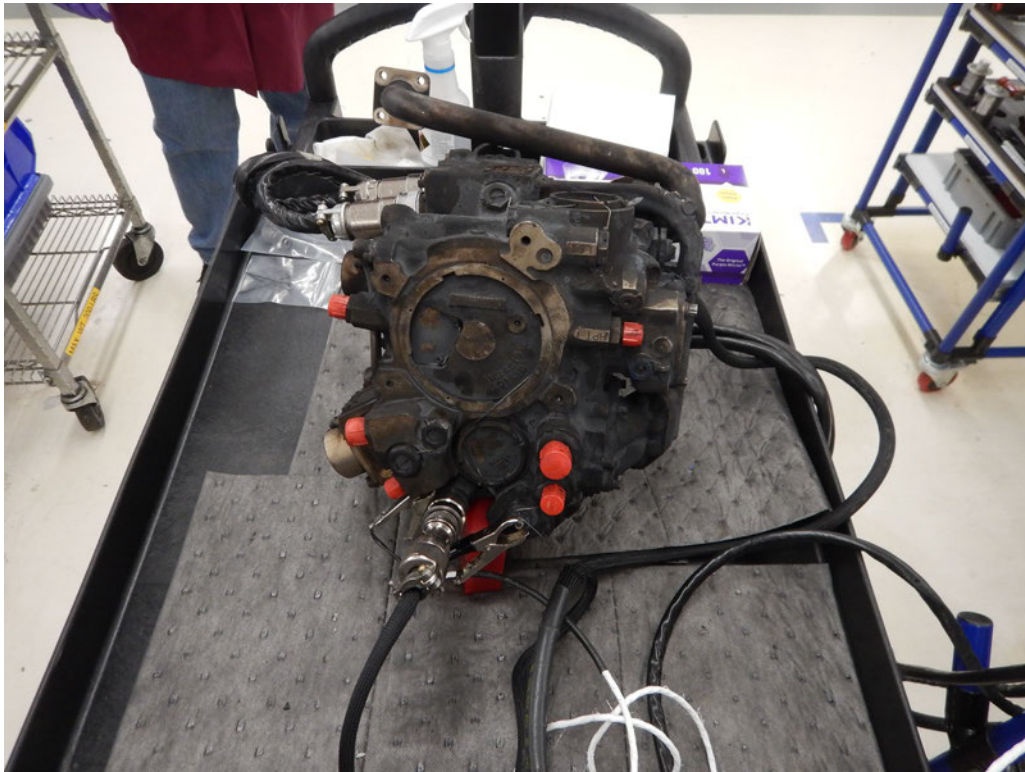
Figure 15. Electrical Test Bench

- k. The data plate was present and legible (Figure 14).
  - l. The electrical check portion of the acceptance test procedure was performed on the unit (Figure 15 and Figure 16). Most of the resolver related checks did not pass the required test points. All other test points were acceptable as noted by the 'GO' finding.

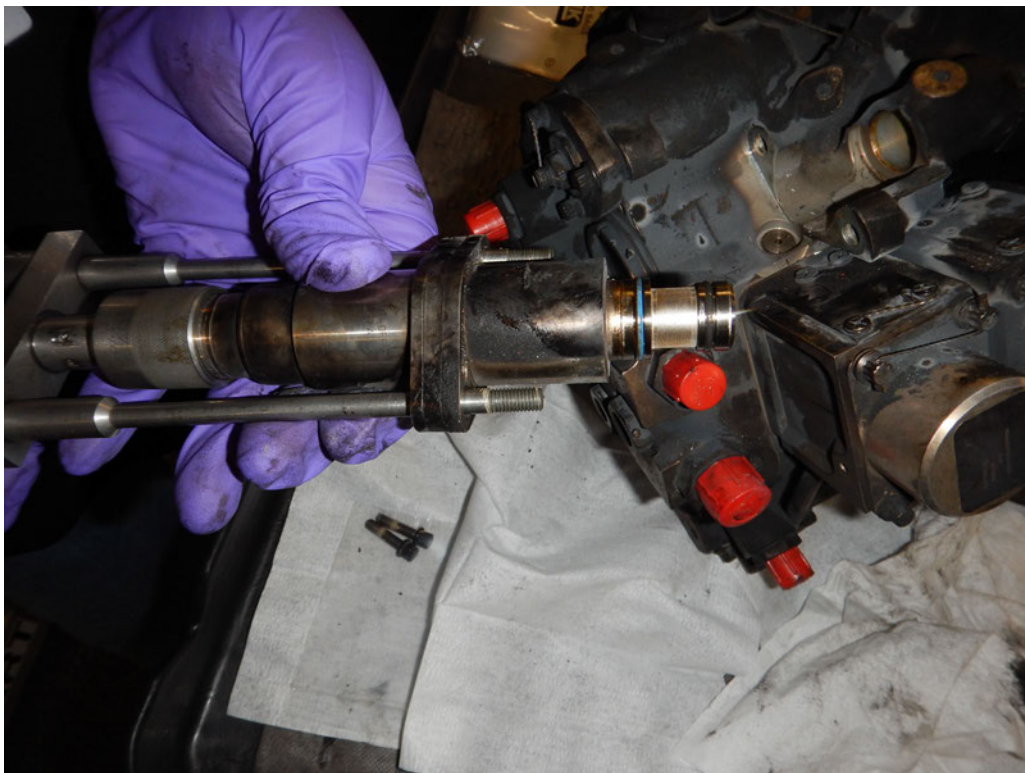
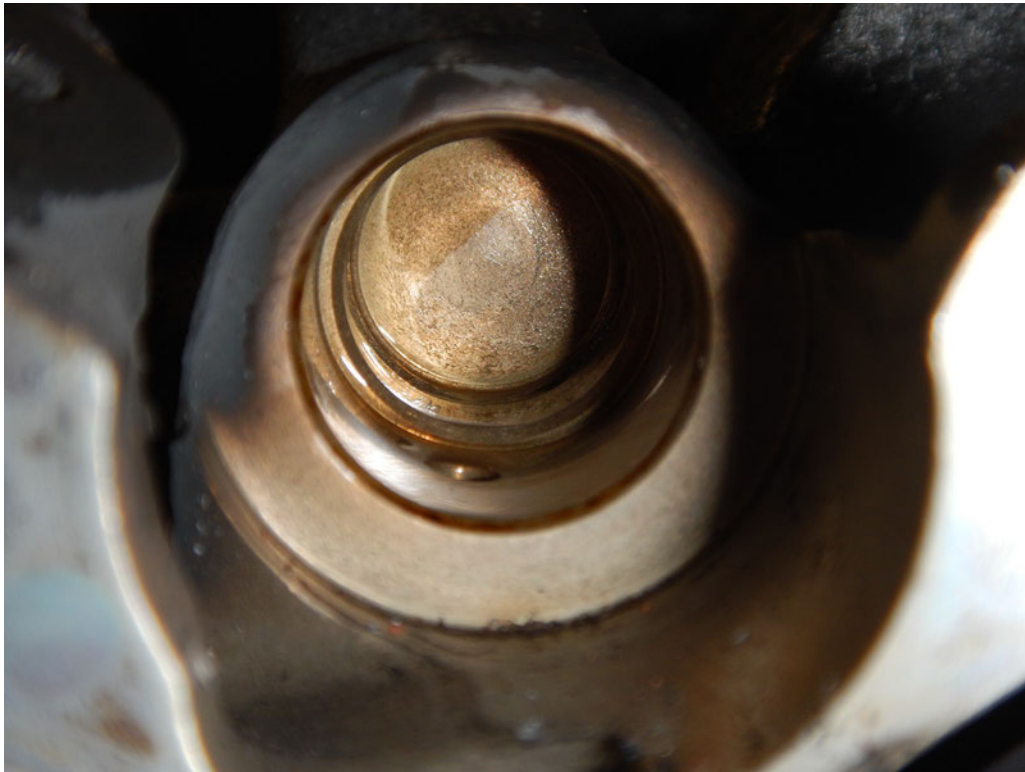
- m. No additional testing was performed on the unit due to the thermal damage and the resulting risk of contaminating the test bench.
  - n. The Airframe Shutoff Valve Solenoid was removed from the HMU (Figure 17). No foreign debris was noted within the housing once the shutoff valve was removed (Figure 18).

- o. The airframe shut off valve solenoid was tested electrically on the bench. According to the technician, audible evidence of actuation was noted.

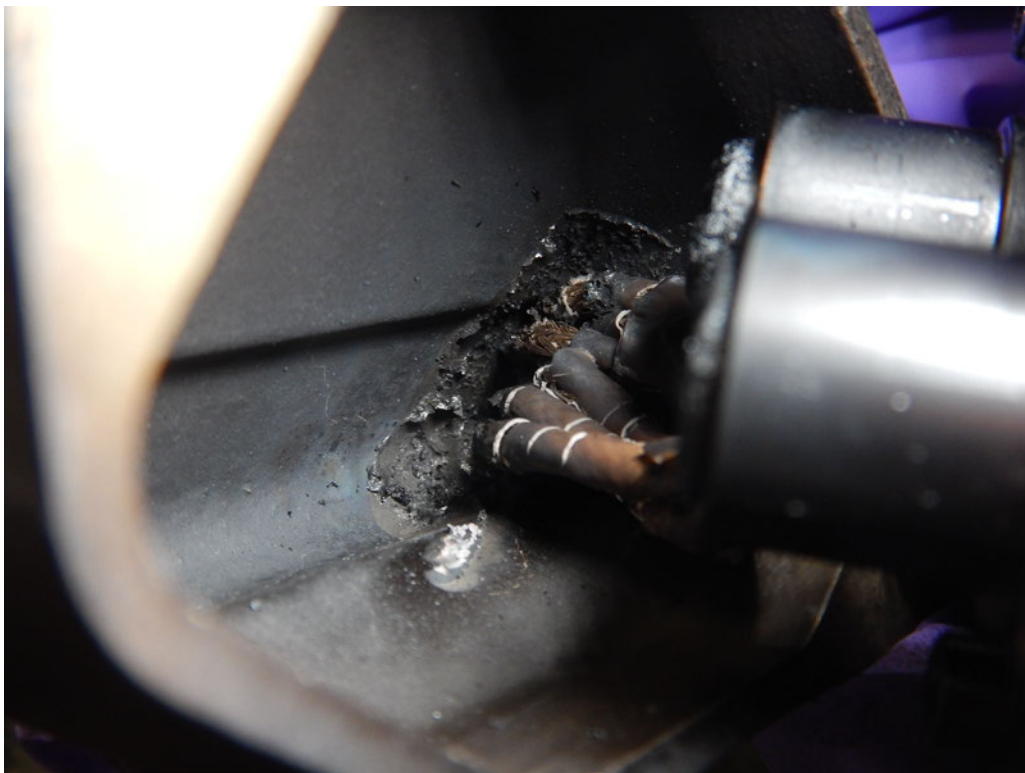
- q. The metering valve resolvers were successfully removed from the HMU (Figure 22). However, due to the thermal damage to the resolver housing (Cover Assembly) the wires could not be easily pulled through as would normally be expected. Charring was noted to the wire insulation near the resolvers (Figure 23).

**Figure 23. Resolver Wire Damage**

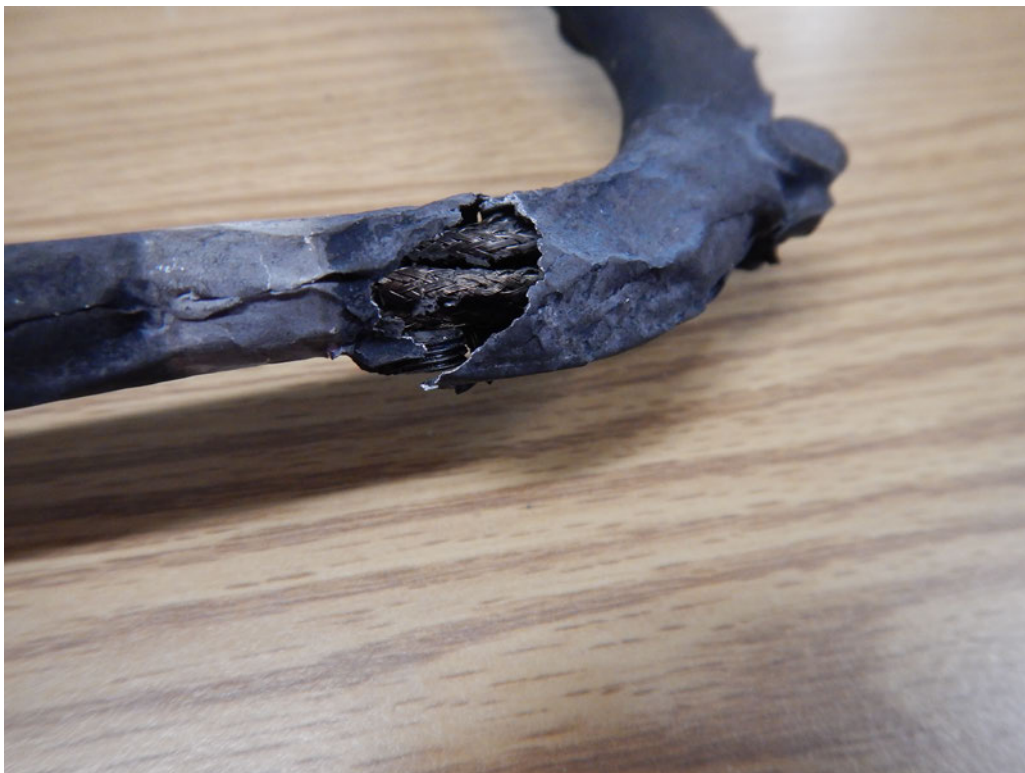
**Figure 25. Resolver Wires**

- r. The conduit portion of the resolver housing (Cover Assembly) was fractured to facilitate removal of the resolvers (Figure 24). Once exposed, the wire insulation appeared charred (Figure 25).

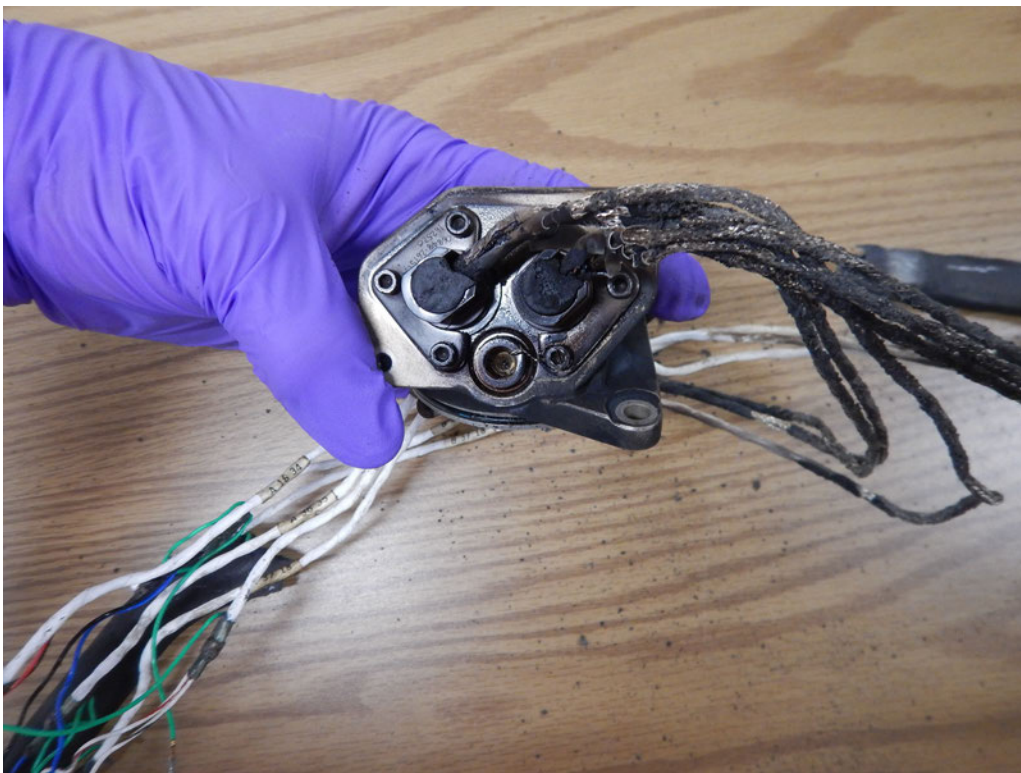
**Figure 27. Resolver Potting Compound**

- t. Thermal damage was noted to resolver potting compound (Figure 27). The resolvers were retained for further evaluation.
  - u. All of the interior (fuel wetted) surfaces within the HMU exhibited a brownish coloring.

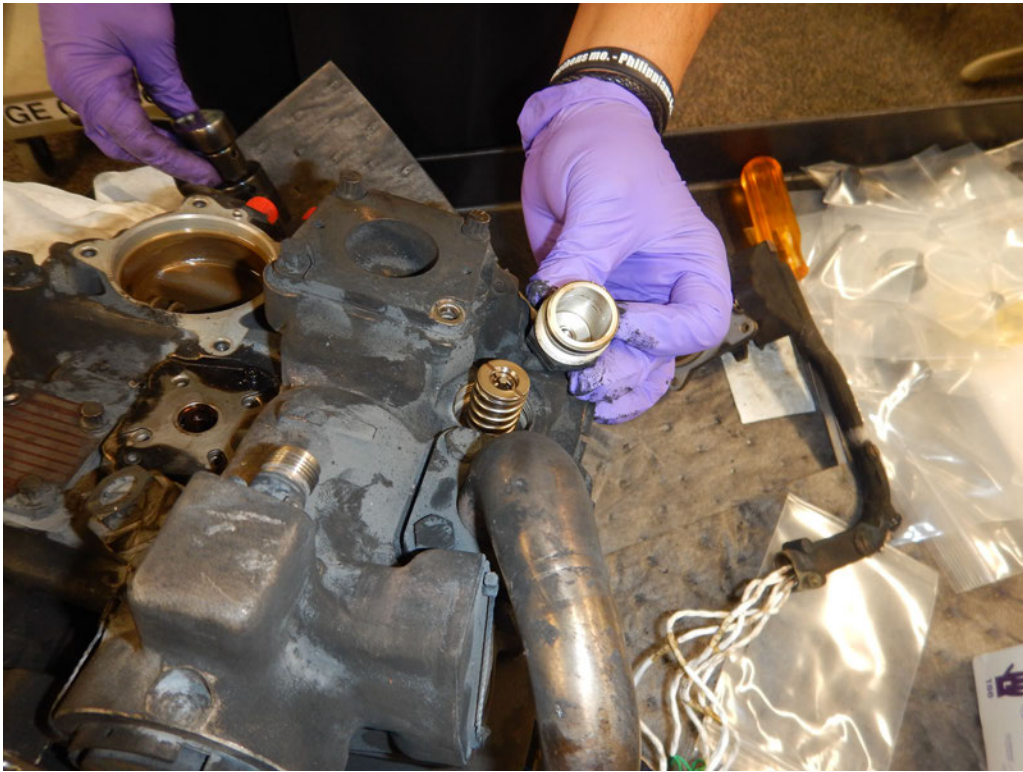
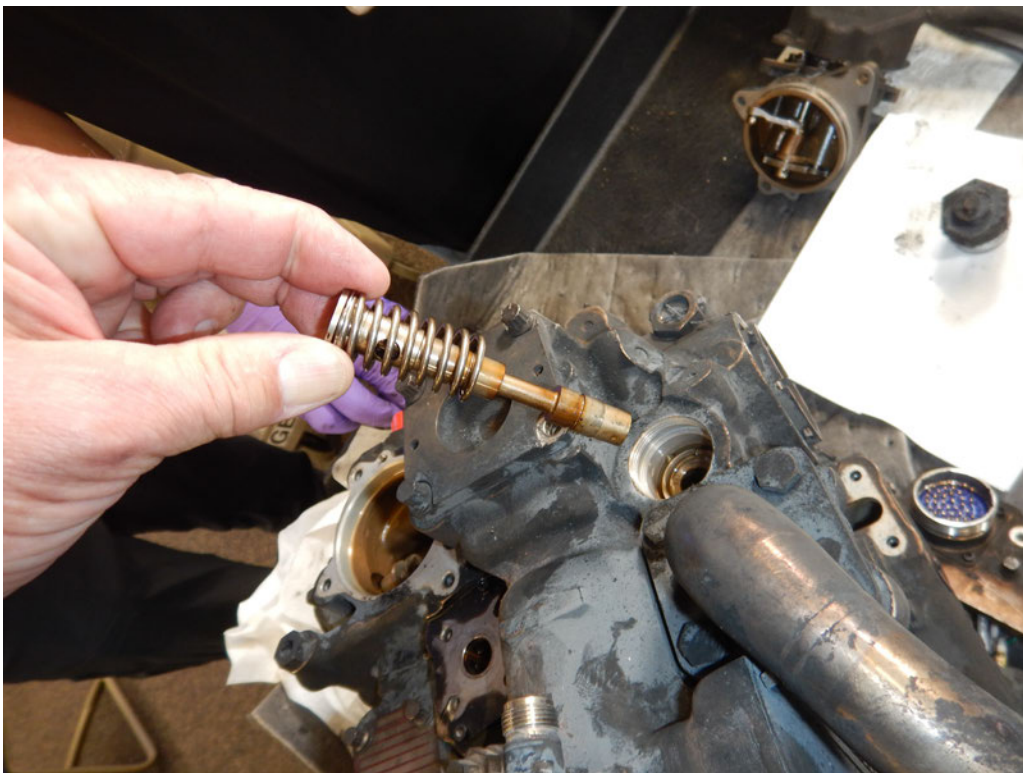
- v. The fuel shutoff shuttle valve was removed and appeared to be intact (Figure 28 and Figure 29).
  - w. DC510 Freezer oil was applied, and standard tooling was used to remove the fuel shutoff shuttle valve sleeve (Figure 30). Once removed and as result of removal, one O-ring was noted to have had a section cut and separated (Figure 31). When looking into the bore, the section of separated O-ring was located (Figure 32) and collected and the cut features matched (Figure 33). The sleeve appeared to be intact.

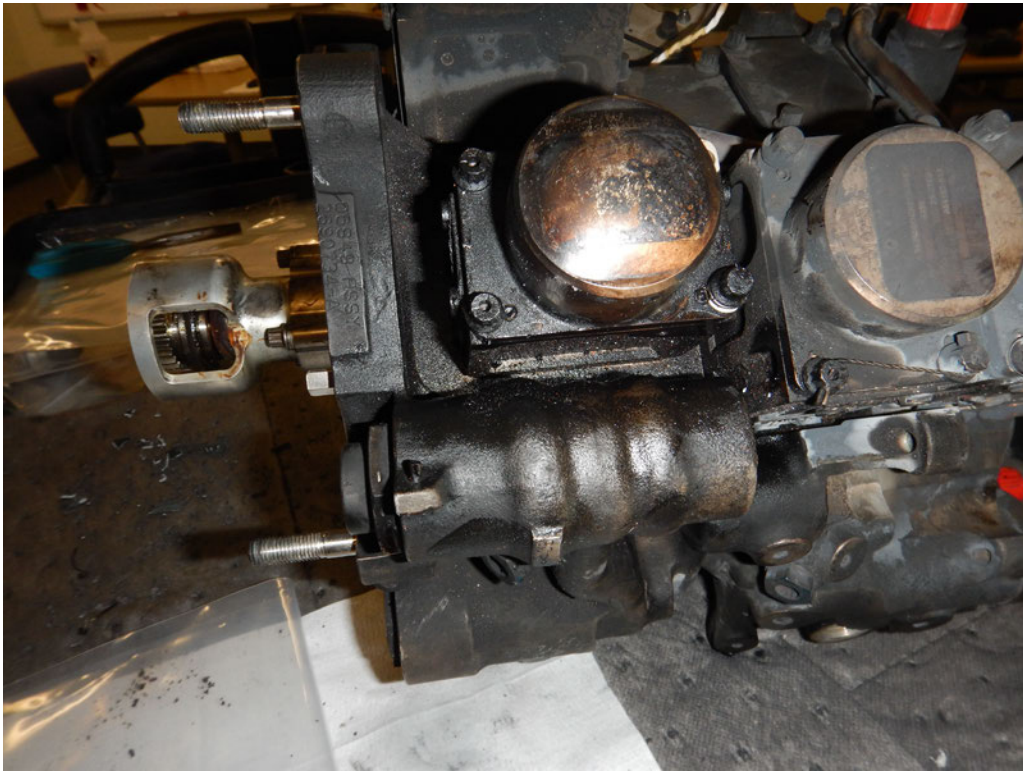
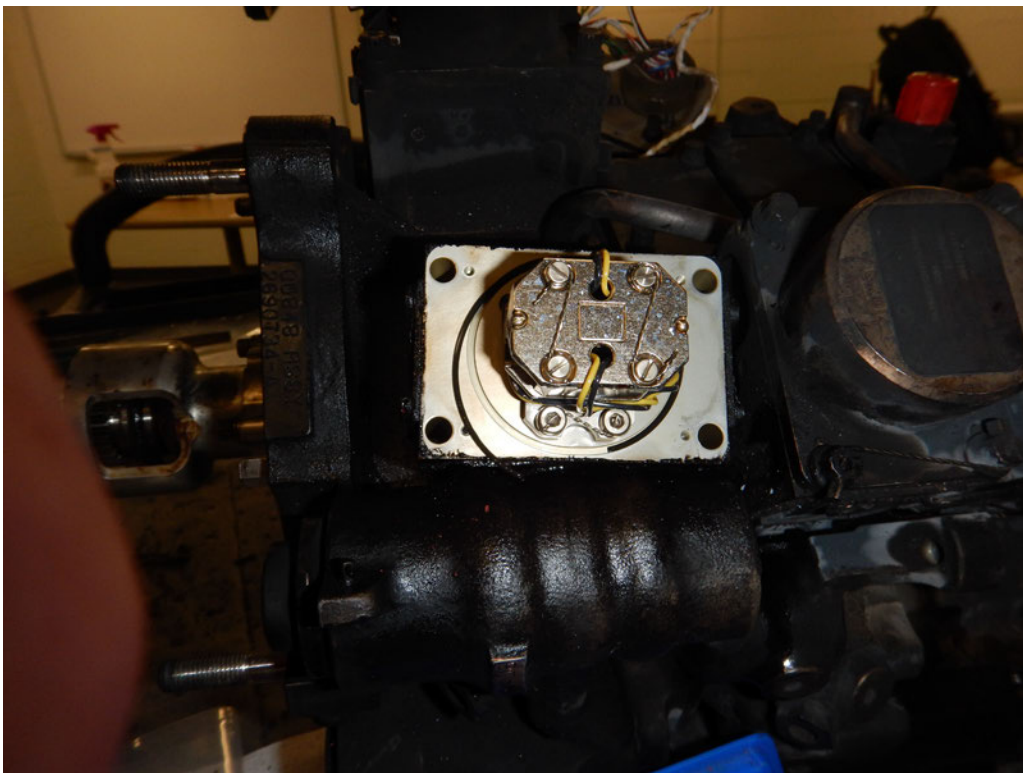
**Figure 34. HPTACC EHSV**

- x. The cover was removed from the bulging HPTACC EHSV ([Figure 34](#) and [Figure 35](#)). During removal, weeping fluid was noted at the joint of the cover. The O-ring was noted to have been cut when accessed.
- y. No additional work was performed on the HMU.

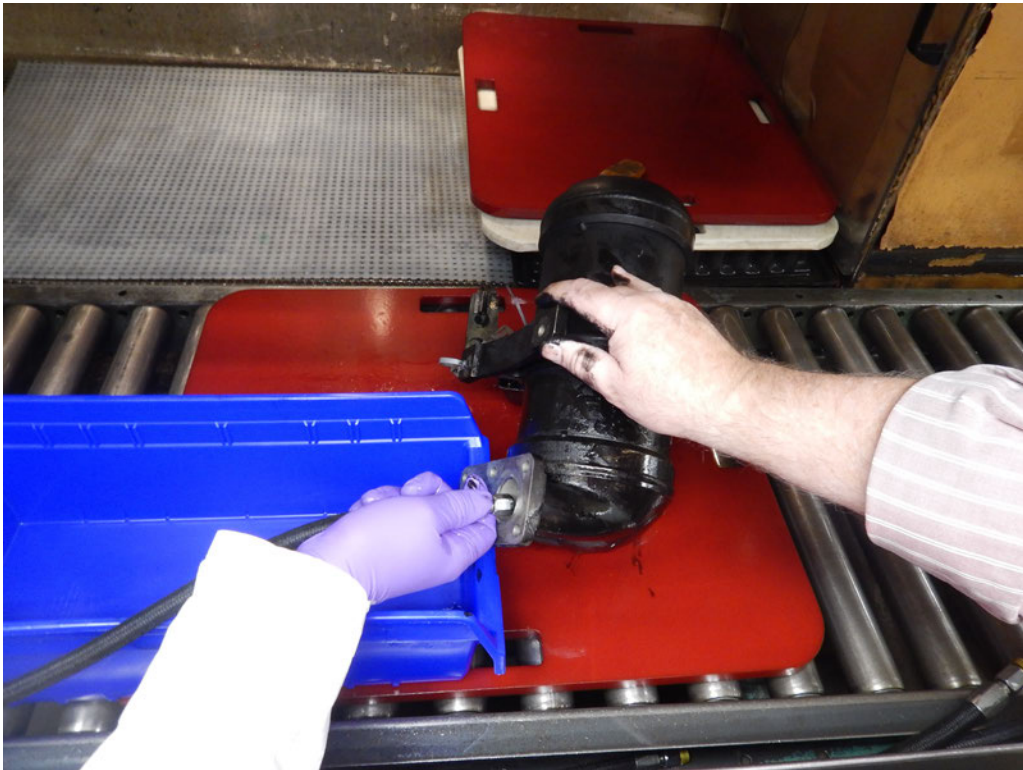
Figure 42. Fuel Oil Heat Exchanger

- (a) The fuel portion of the fuel oil heat exchanger (FOHX) assembly was flushed with 1010 oil ([Figure 42](#)) and metal particles were present within the captured oil. Also, after visual inspection it was discovered metal particles were present internally. Fine particle debris was recovered from the fuel inlet port and retained by GE for future analysis ([Figure 43](#)).
