## Materials Project Report

Report No. 20230667

Subject: CF6 Input Housing P/N 5006834M Failure Investigation

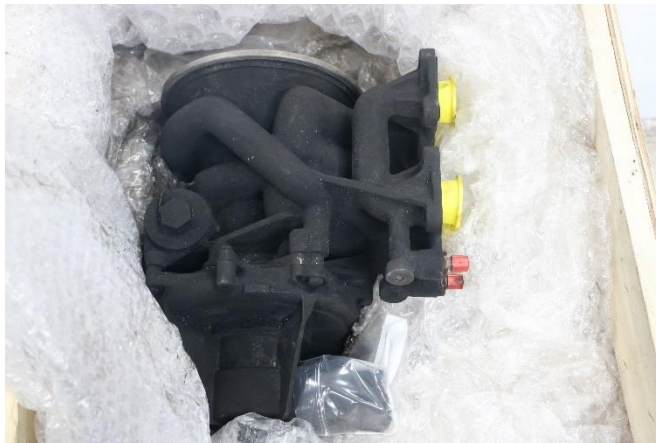
**Figure 1**

Optical image showing the fuel pump assembly in the as-received condition.

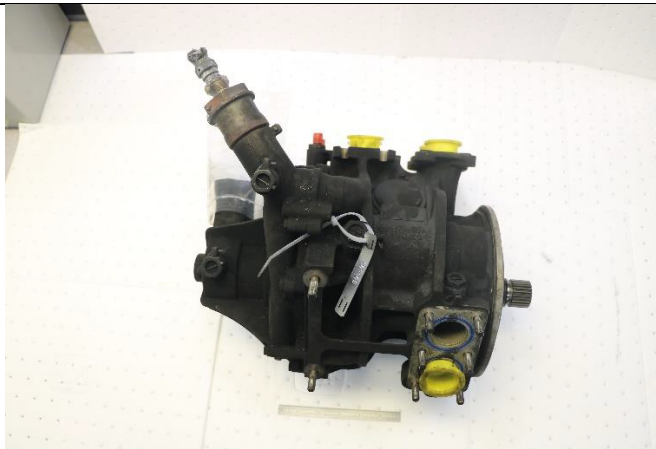
**Figure 2**

Optical image showing the fuel pump in the as-received condition.

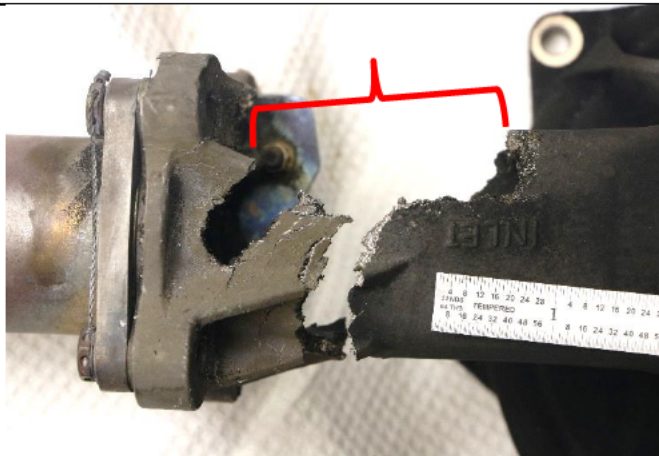
**Figure 6**

Optical image showing the remnants of the failure surfaces from the fuel pump assembly. The shape of the opposing failure surfaces exhibited general alignment with respect to the features present in the image. The bracketed annotation in the image is identifying material that is no longer present from the inlet takeoff arm of the input housing.

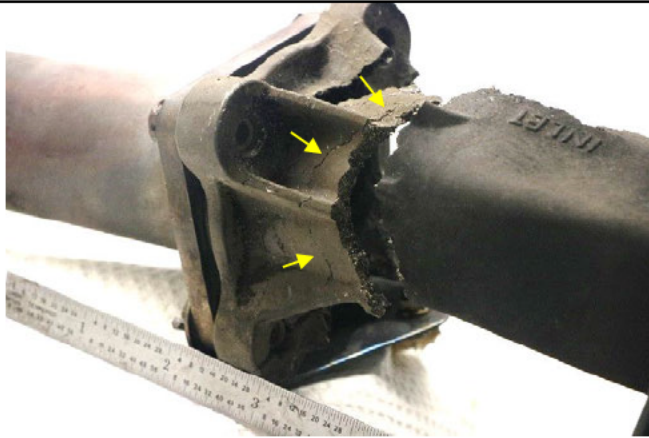
**Figure 7**

Optical image showing the failure location of the fuel pump assembly at a different orientation. There are several linear indications propagating through the mounting flange remnant material. The arrows in the image denote the largest of linear indications visible in this image.

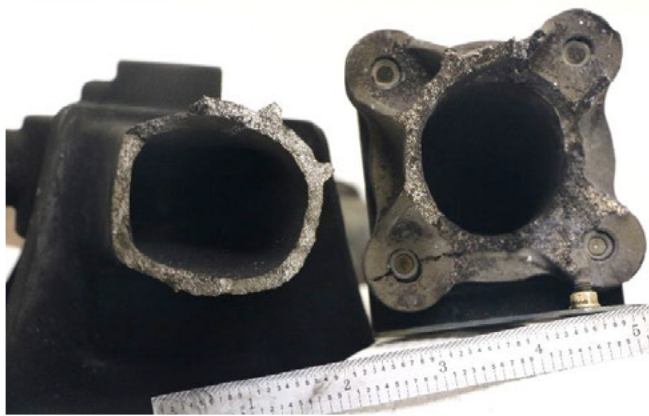
**Figure 8**

Optical image displaying the mating failure surfaces positioned next to each other. The mounting flange generally exhibits more discoloration and contamination on the failure surfaces than the opposing surface on the input housing takeoff arm.

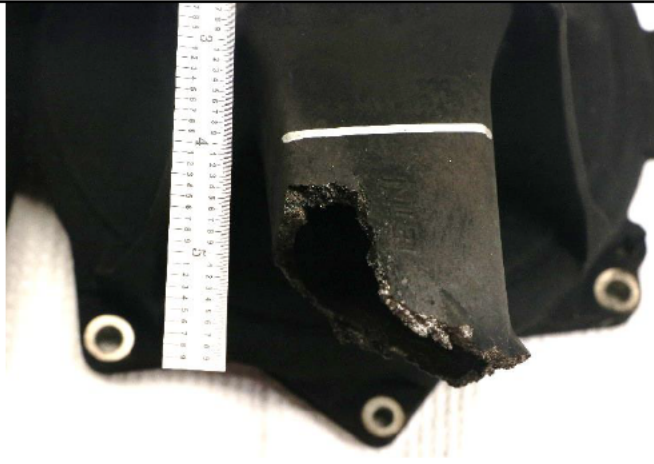
**Figure 13**

Optical image showing the top down view of the failure location in the input housing. The gray line across the input tube is the location at which sectioning were to take place for further analysis of the failure surface.

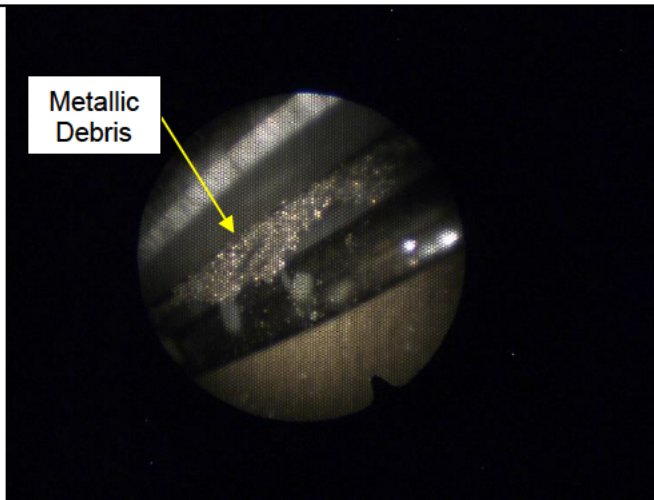
**Figure 14**

Fiberscope image showing accumulation of metallic debris within the gear discharge area. Metallic debris was observed on multiple gear teeth at this location.

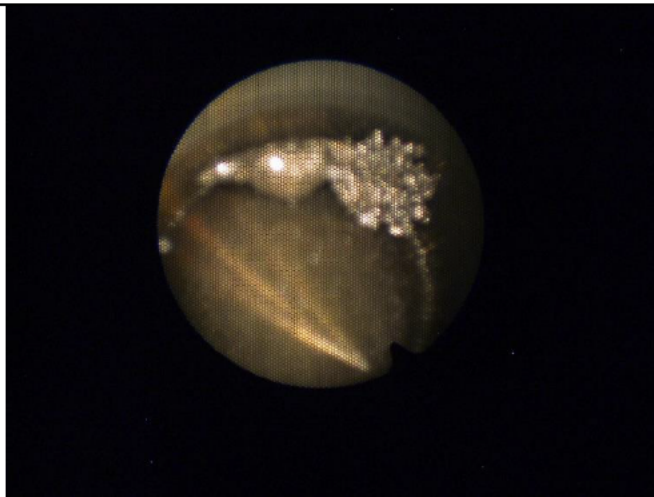
**Figure 15**

Fiberscope image showing accumulation of metallic debris within the gear discharge area.

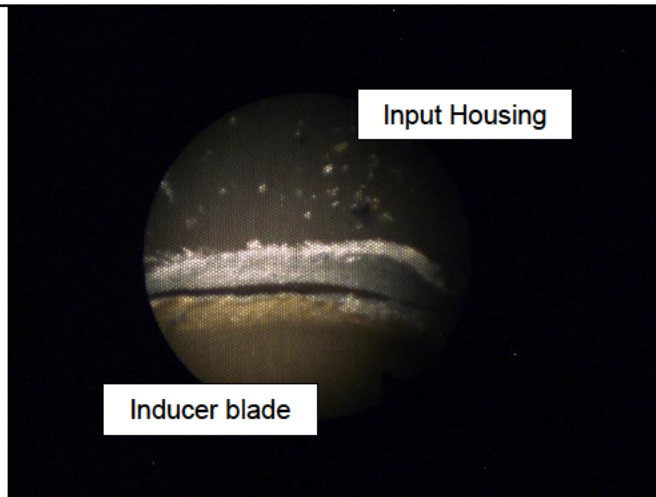
**Figure 16**

Fiberscope image showing evidence of damage to the inducer blade and interior surface of the input housing.

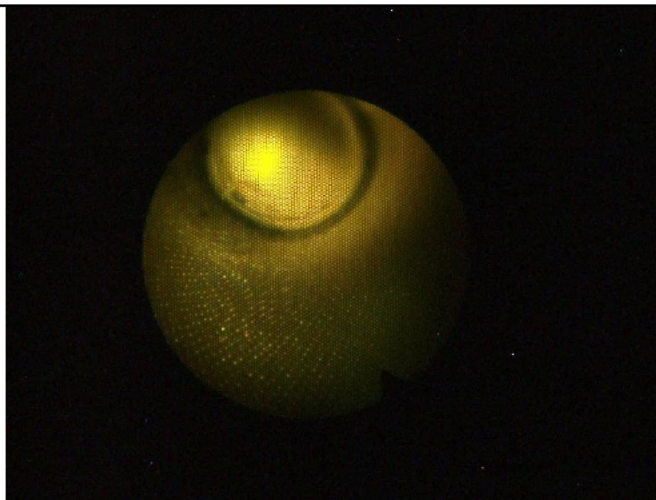
**Figure 17**

Fiberscope image showing the boost discharge filter inlet. A minimal amount of debris was observed within the filter.

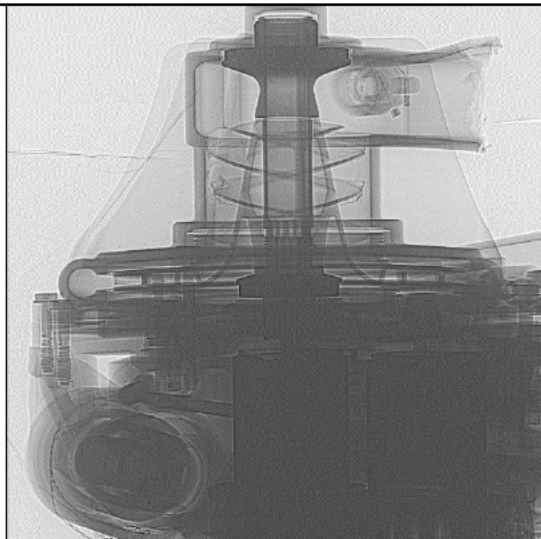
**Figure 18**

Evidence of damage to the inducer section of the impeller assembly was observed adjacent to the damage inlet tube (**Figure 18**). DR imaging of the lower half of the fuel pump assembly revealed debris that had collected or accumulated at the bottom with the pump in the vertical orientation (**Figure 19**). The debris exhibited a higher density than the surrounding pump assembly features as it was darker within the radiographic image. Additional debris was observed at the bottom of the assembly as well as in a filter when the unit was re-oriented for additional imaging (**Figure 20**).

2D radiographic image using the digital Wallis filter to modify the image. Utilizing the Wallis filter helps to accentuate part features that would otherwise be too dense or obscured within the radiographic image. The damaged inlet tube is shown at the top of the image.

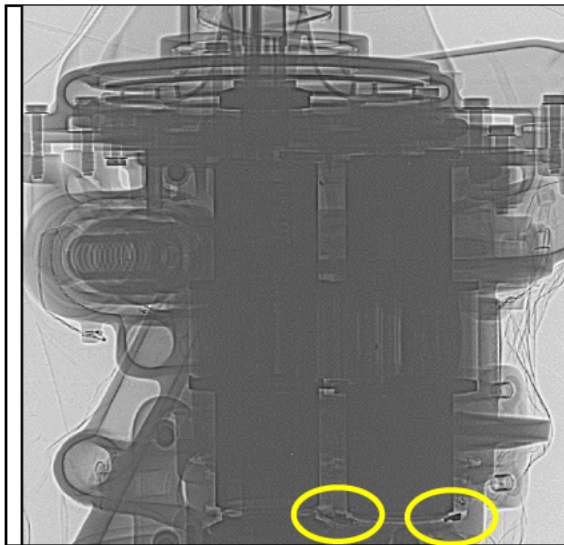
| | <p><b>Figure 19</b></p> <p>2D radiographic image using the digital Wallis filter to modify the image. Evidence of debris was observed to have collected in a core near the bottom of the unit in this viewing orientation.</p> |

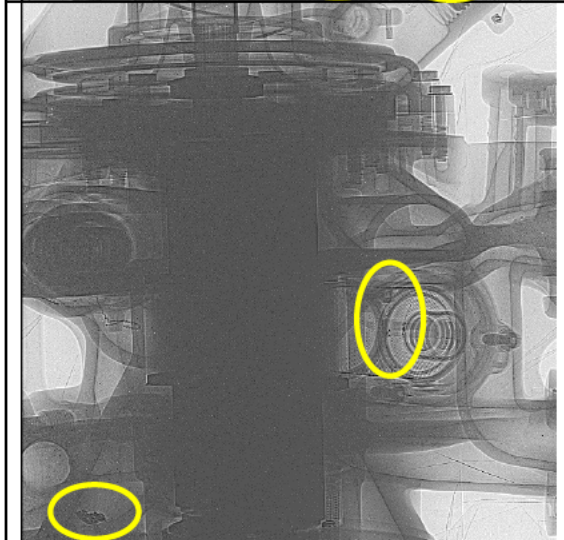
| | <p><b>Figure 20</b></p> <p>2D radiographic image using the digital Wallis filter to modify the image. Evidence of debris was observed to have collected in a core near the bottom of the unit as well as in a filter.</p> |

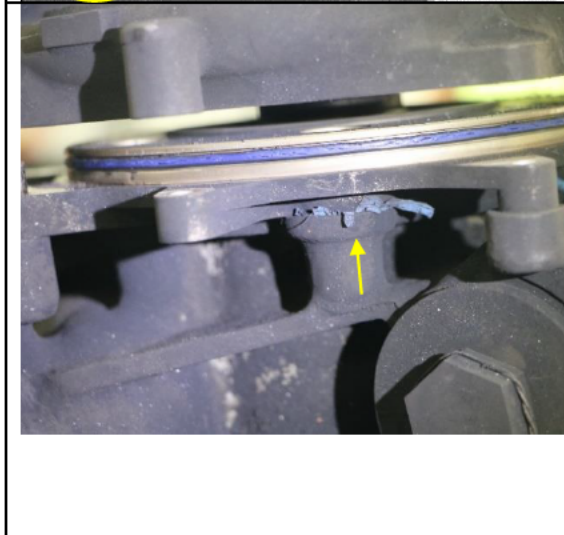
| | <p><b>Figure 21</b></p> <p>Optical image showing the seal around the larger diameter orifice. The seal exhibited cracking around the circumference of the part. Evidence of material extrusion was also observed as identified by the arrow in the image.</p> |

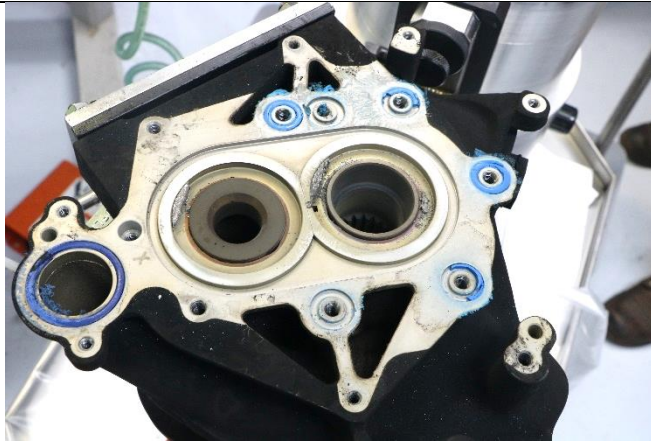
**Figure 22**

Optical image showing accumulation of metallic material. Thermally induced damage was observed for the seals in each bore interface at the split line. Evidence of material extrusion onto the mating surfaces and out of the assembly was present.

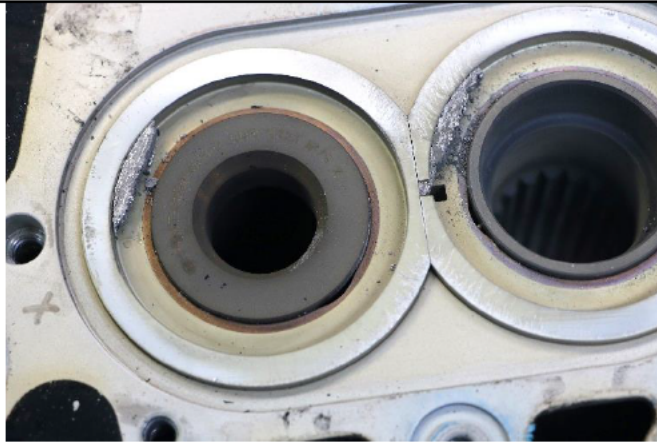
**Figure 25**

Evidence of lead extraction was observed around the leaded bronze bearings. The lead had accumulated within the orifice of the bearings (**Figure 25**). Additional metallic debris was observed on the bearing after removal from the pump assembly. A large metallic piece that exhibited evidence of mechanical deformation along with small spherical particles consistent with metallic spatter were observed (**Figure 26 & Figure 27**).

Optical image at increased magnification showing accumulation of lead around the orifice of the leaded bronze bearings. The accumulated material is evidence of lead extraction of the leaded bearings during the failure event.

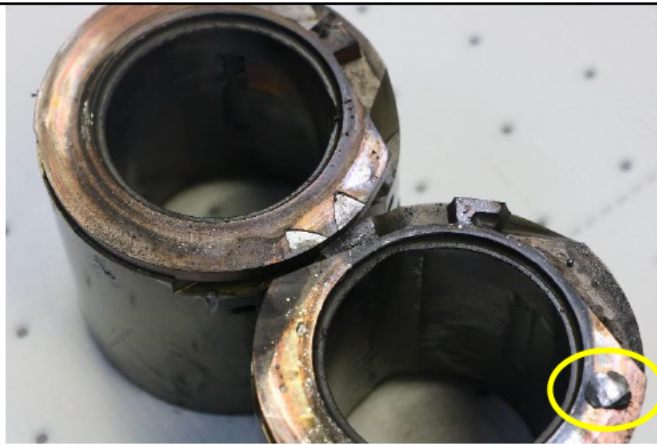
**Figure 26**

Optical image showing the journal bearings after removal from the fuel pump assembly. Impressions from the gear teeth were observed in the leaded bronze surface that were reported to have been generated during the disassembly process. Metallic material was also discovered on the surface of one journal bearing.

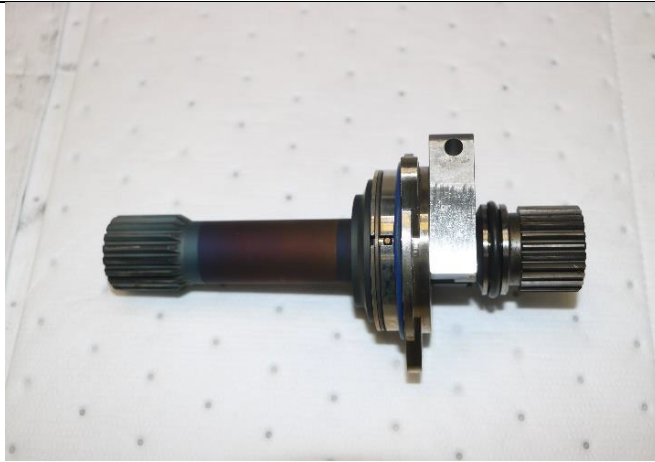
**Figure 31**

An optical image showing the input shaft after disassembly and removal from the fuel pump is shown in **Figure 31**. Coloration of the shaft was observed when removed from the fuel pump assembly during disassembly.

Optical image showing the input shaft after disassembly and removal from the fuel pump. Coloration of the shaft is from exposure to elevated temperatures.

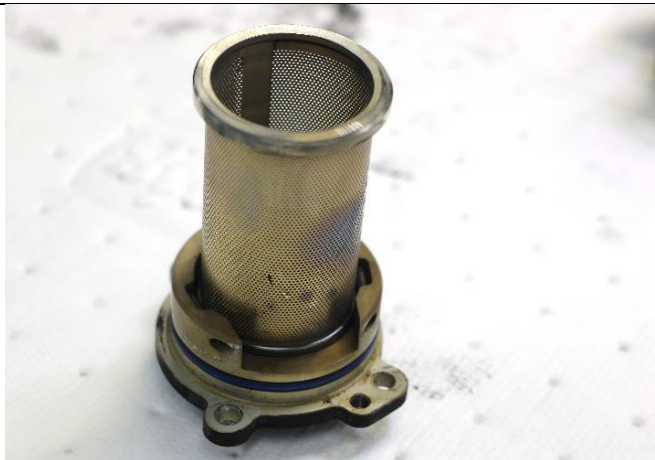
**Figure 32**

Optical image showing the filter after removal from the fuel pump. No cleaning or collection of debris occurred prior to visual examination and capture of this image. Evidence of discoloration was noted on the exterior surface of the filter.

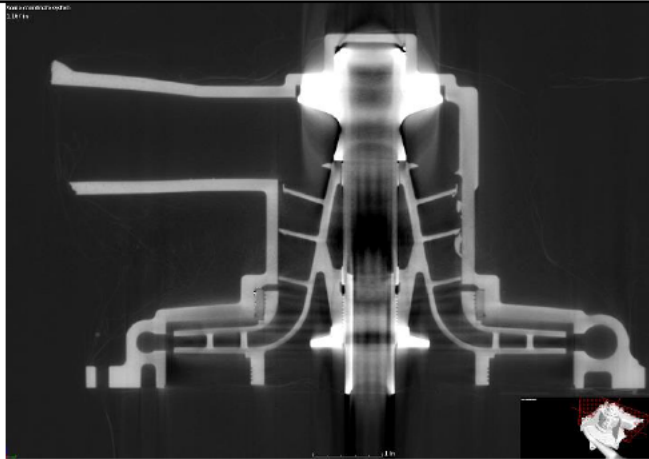
**Figure 37**

2D CT image showing a 2D cross section from the volumetric data set. The image shows a cross section of the inlet pump housing with the impeller assembly retained in the housing. The unit is in the as-received condition after disassembly of the fuel pump assembly.

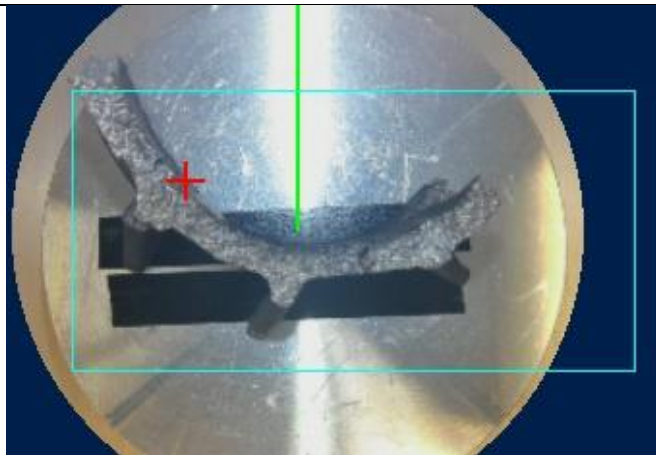
**Figure 45**

Optical image showing Section 1 of the housing flange remnant that was engine side. This piece was excised from the overall fracture to create a topographically uniform surface for SEM analysis.

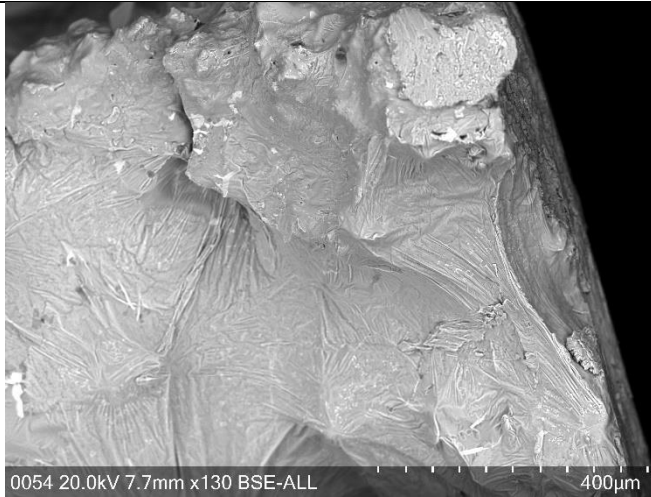
**Figure 46**

Representative SEM image showing the fracture surface from Section 1. The surface exhibited evidence of melting and re-solidification.

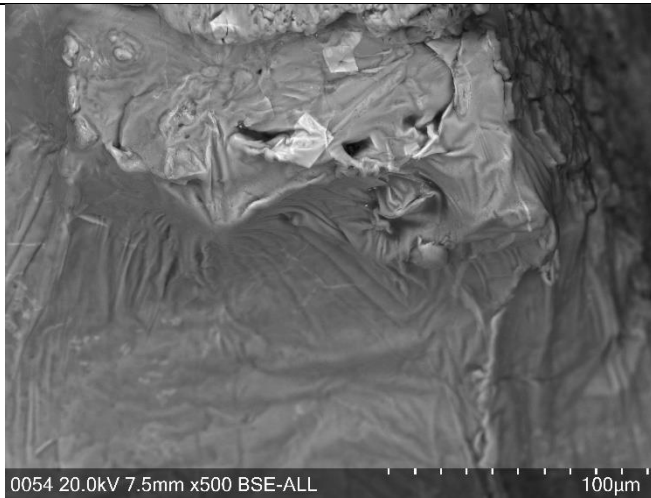
**Figure 47**

Representative SEM image at increased magnification showing the fracture surface from Section 1. The surface exhibited evidence of melting and re-solidification.

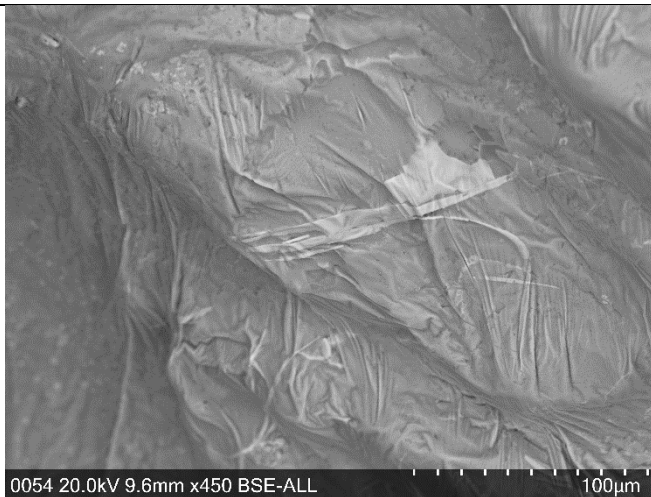
**Figure 48**

Representative SEM image showing the fracture surface from the middle of the wall thickness of Section 1. The surface exhibited evidence of melting and re-solidification as evidenced by the wrinkled appearance of the surface. No indications of a mechanical failure mode were observed at this location.

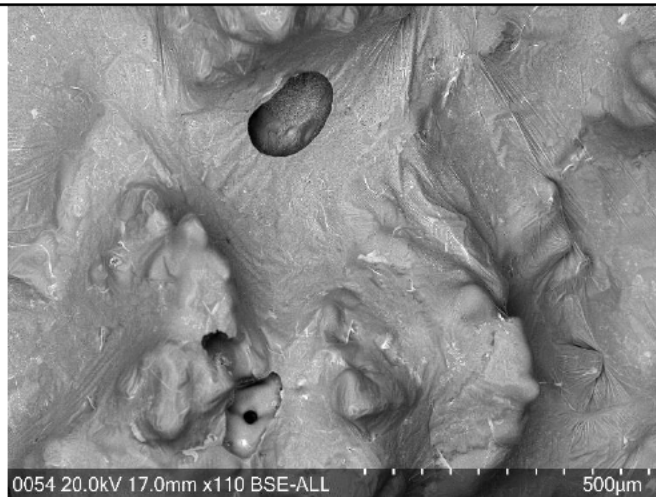
**Figure 51**

Representative SEM image from section 2 of the mounting interface showing evidence of a melted and re-solidified surface. The entirety of the fracture surface was examined at various magnification levels revealing similar features across this section.

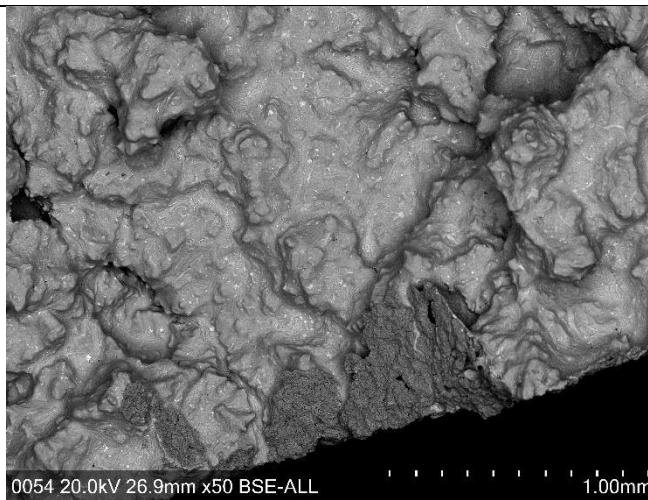
**Figure 53**

Representative SEM image showing the OD of the fracture surface from location 2. Evidence of melting and re-solidification was observed throughout the surface. The surface at location1 from this view / orientation exhibited similar features.

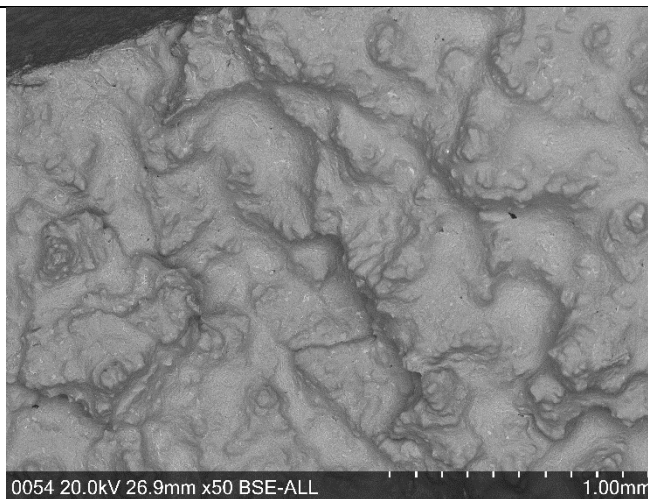
**Figure 54**

Representative SEM image showing the OD of the fracture surface from location 2. Evidence of melting and re-solidification was observed throughout the surface.

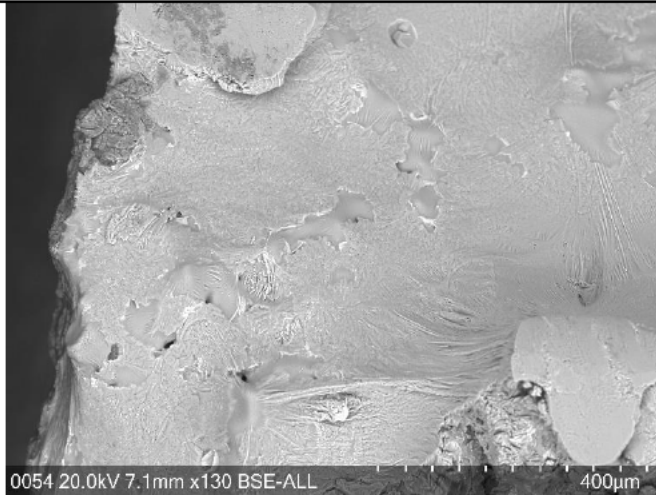
**Figure 55**

Representative SEM image showing the OD of the fracture surface from another viewing area of location 2. Evidence of melting and re-solidification were again prevalent throughout the surface.

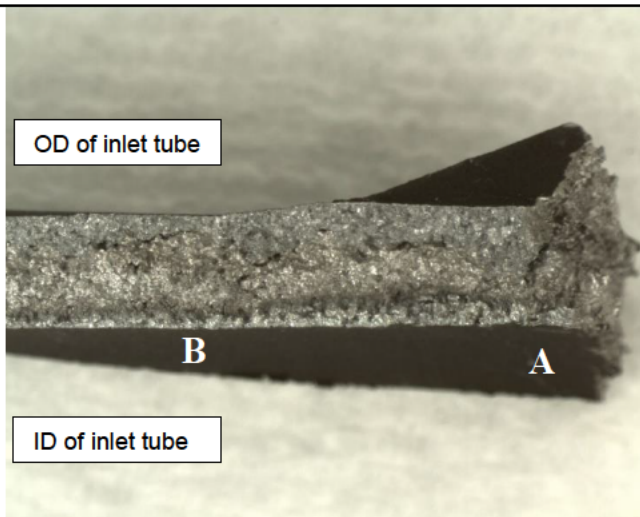
**Figure 56**

Optical image showing the exposed fracture surface after performing a lab overload failure. The ID and OD surfaces of the inlet tube are identified in the image. Locations A and B for SEM analysis are identified in this image.

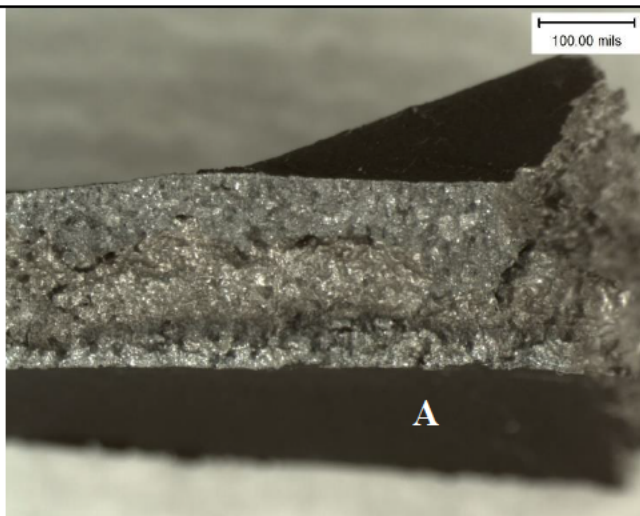
**Figure 57**

Optical image showing the end of the exposed secondary crack at increased magnification. Location A for SEM analysis is identified in this image.

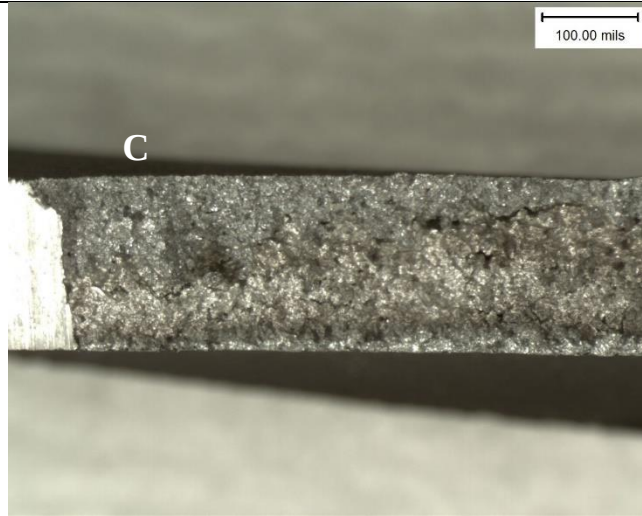
**Figure 58**

Optical image showing the back of the exposed secondary crack at increased magnification. The back cut surface where the end of the original crack was visually determined to be located is shown in the left side of this image. Location C for SEM analysis is identified in this image.

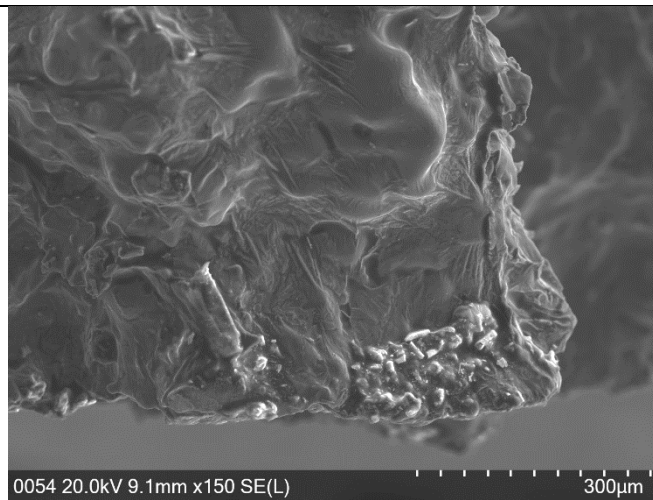
**Figure 59**

SEM image from location A along the ID of the tube showing a smooth surface and evidence of melting and re-solidification on the fracture surface.

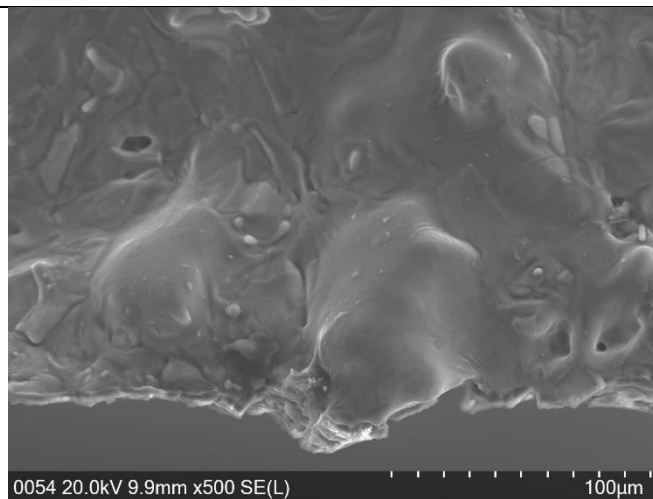
**Figure 60**

SEM image from location B along the ID of the inlet tube secondary crack showing a smooth surface consistent with melting and re-solidification.

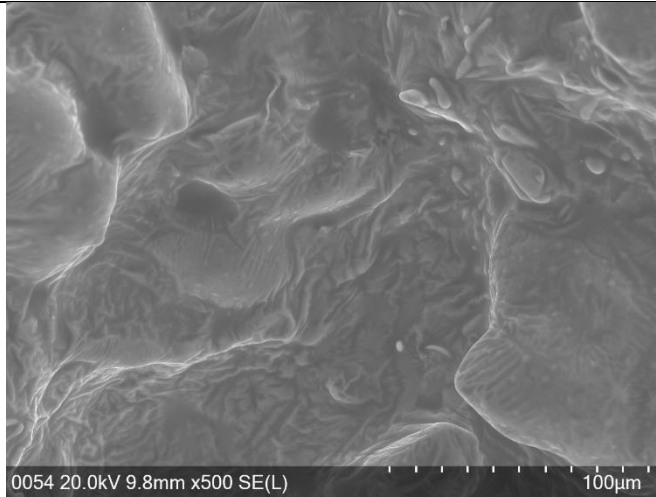
**Figure 61**

SEM image from location B in the middle of the wall thickness, showing a smooth surface consistent with melting and re-solidification.

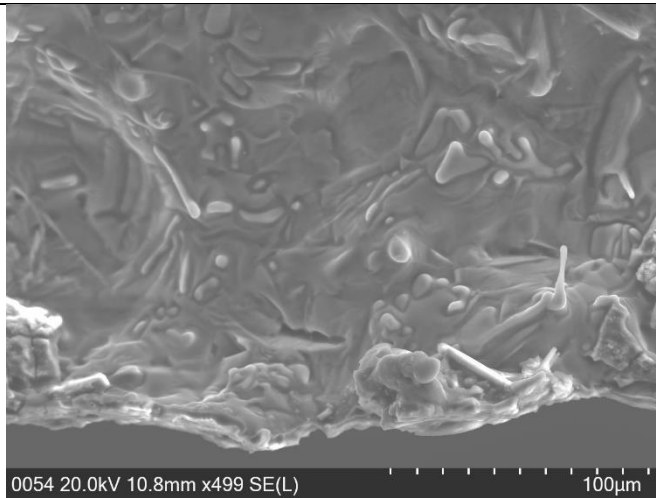
**Figure 62**

SEM image from location C from the ID surface of the inlet tube showing evidence of exposure to elevated temperatures. The morphology of the silicon rich intermetallic particles within the aluminum matrix are globular in appearance. The surrounding aluminum matrix fracture surface was also smooth in appearance, consistent with a partially melted and re-solidified surface.

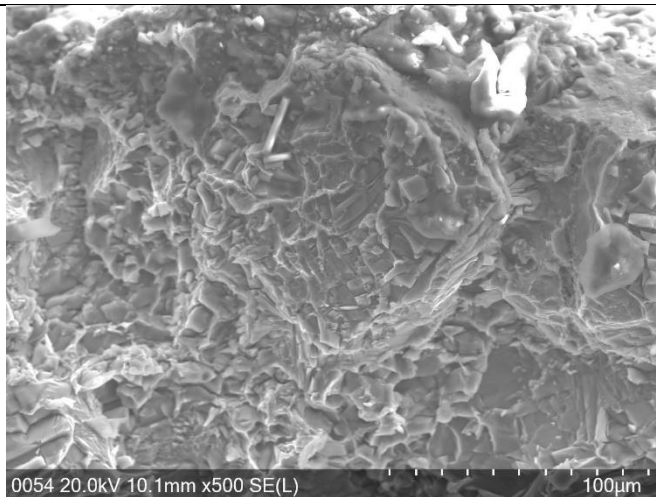
**Figure 63**

SEM image from location C from the OD surface of the inlet tube showing evidence of mechanical failure created during the lab overload testing to expose the secondary crack fracture surface.

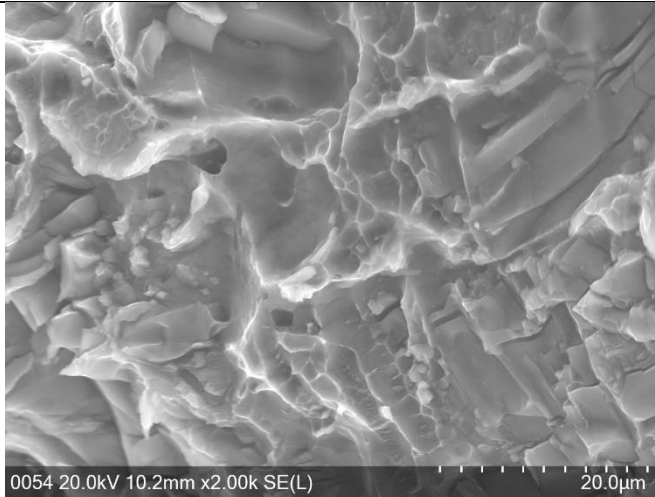
**Figure 64**

SEM image at increased magnification from location C along the OD surface of the inlet tube and the same location that is shown in **Figure 63**. Evidence of ductile overstress rupture was observed at this location.

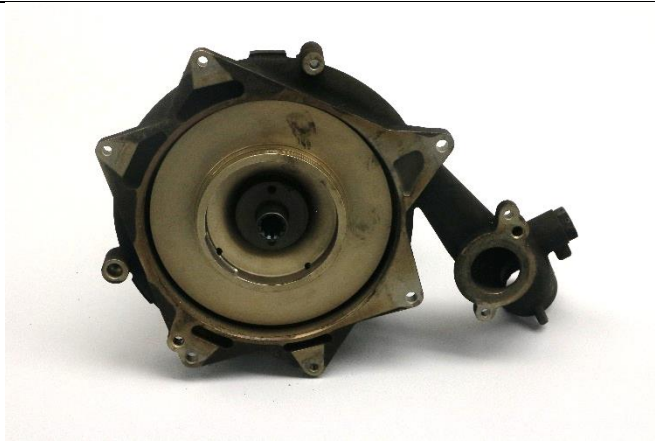
**Figure 65**

Optical image showing the impeller assembly that had been retained within the input housing after the failure event. It could not be removed without the aid of tools or other methods.

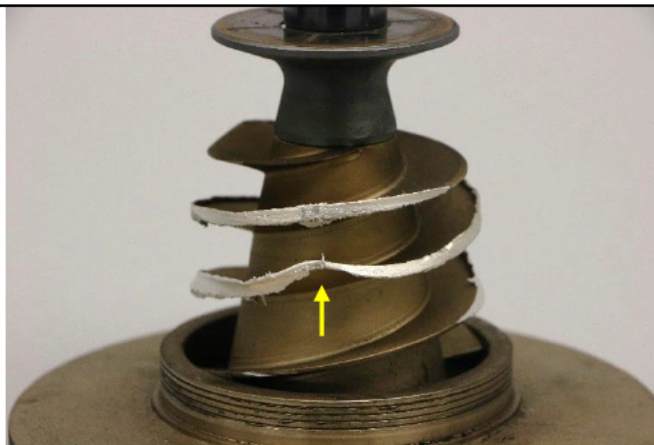
**Figure 68**

Optical image of the impeller assembly after removal from the fuel pump inlet housing. Deformation of the inducer blade was observed after removal. The deformation aligns with the location of adhered material on the interior surface of the housing observed during CT inspection of the assembly.

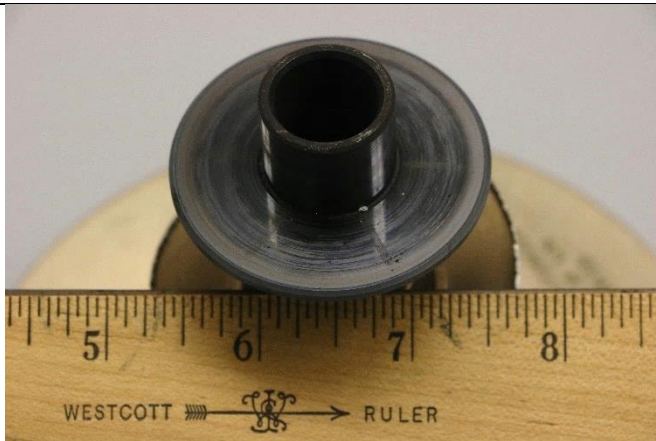
**Figure 71**

Representative optical image showing the wear surface from the top of the impeller assembly. This area exhibited no indications of wear marks or damage that would be consistent with entrapment of abrasive or foreign material.

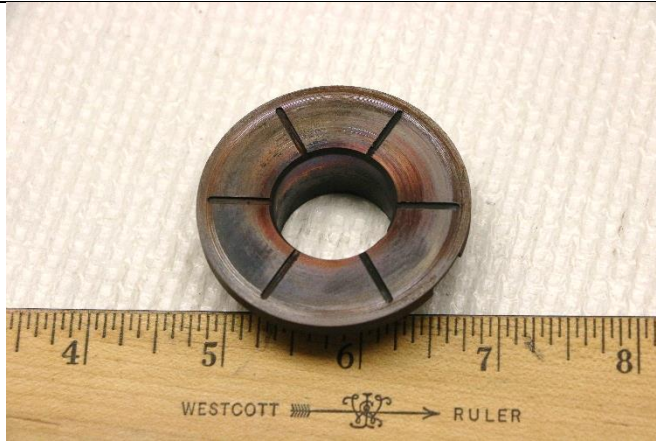
**Figure 73**

Optical image of the journal bearing. No evidence of material adhesion, adhesive failure, or material transfer was observed on the mating surface of the bearing.

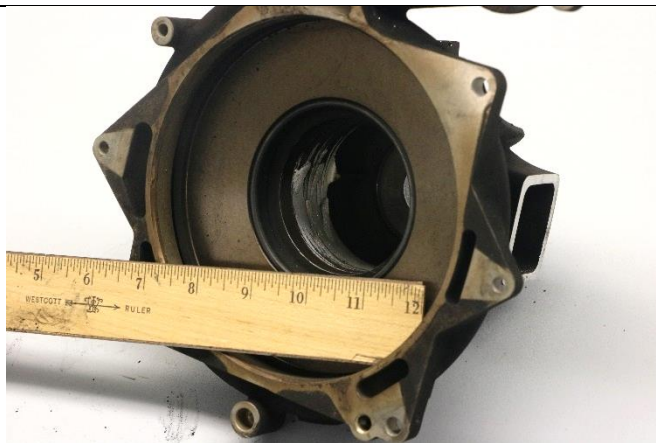
**Figure 74**

Optical image showing evidence of material transfer on the interior surface of the inlet housing.

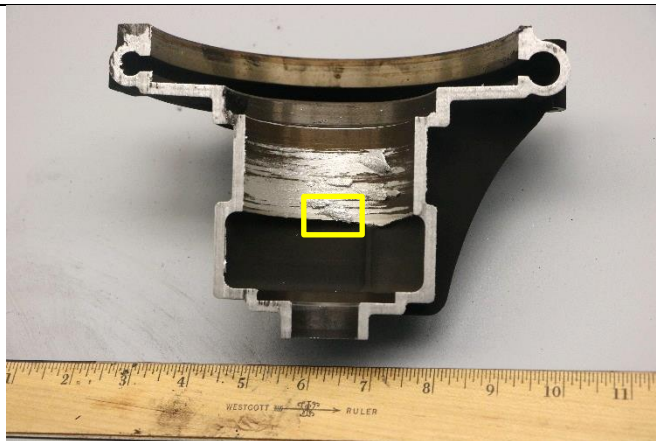
**Figure 75**

Optical image showing the interior surface of the input housing after removal of the impeller assembly. Material was found adhered to the surface that exhibited a lateral adhesion pattern consistent with the motion of the inducer during operation of the fuel pump. The side shown is from the discharge side of the housing.
