National Transportation Safety Board  
Office of Aviation Safety  
Washington, DC 20594

ENG24LA014

## **POWERPLANTS**

Group Chair's Factual Report

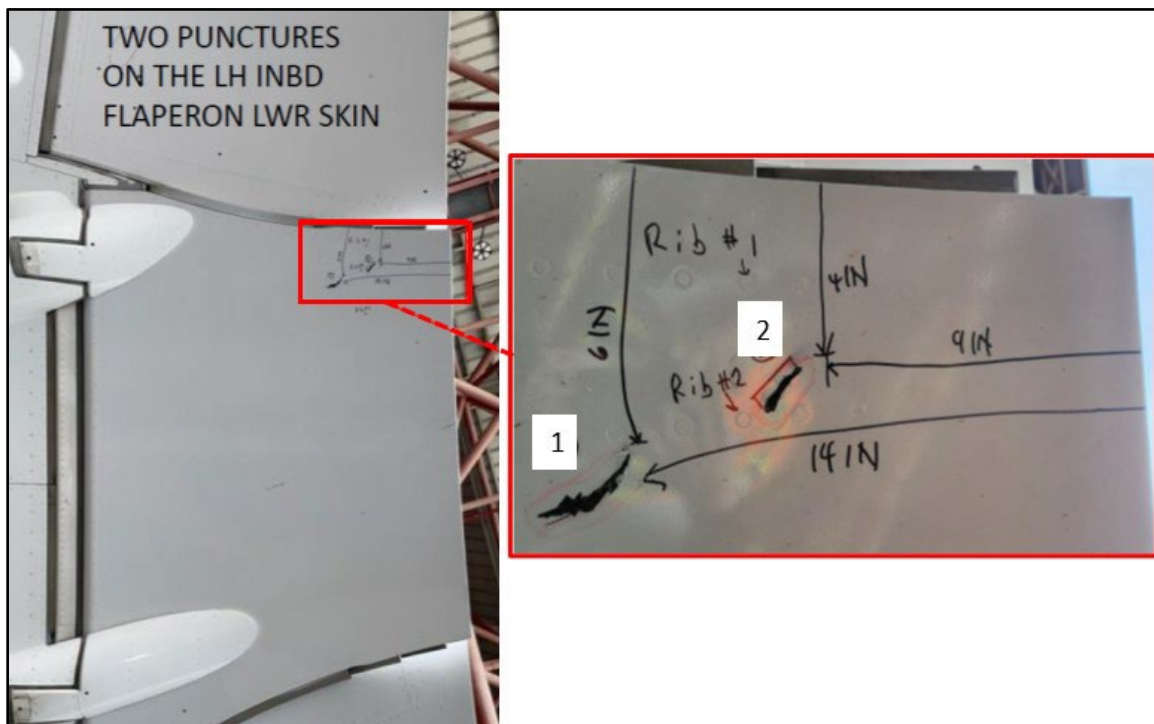
**Figure 9.** LEFT HAND INBOARD FLAPERON DAMAGE - LOWER SKIN

The on ground inspection of the airplane found the left hand inboard flaperon exhibited two penetration holes through the lower skin/surface (Figure 9), where penetration number 1 is approximately 2.6 inches and penetration number two was approximately 1.6 inches in length.

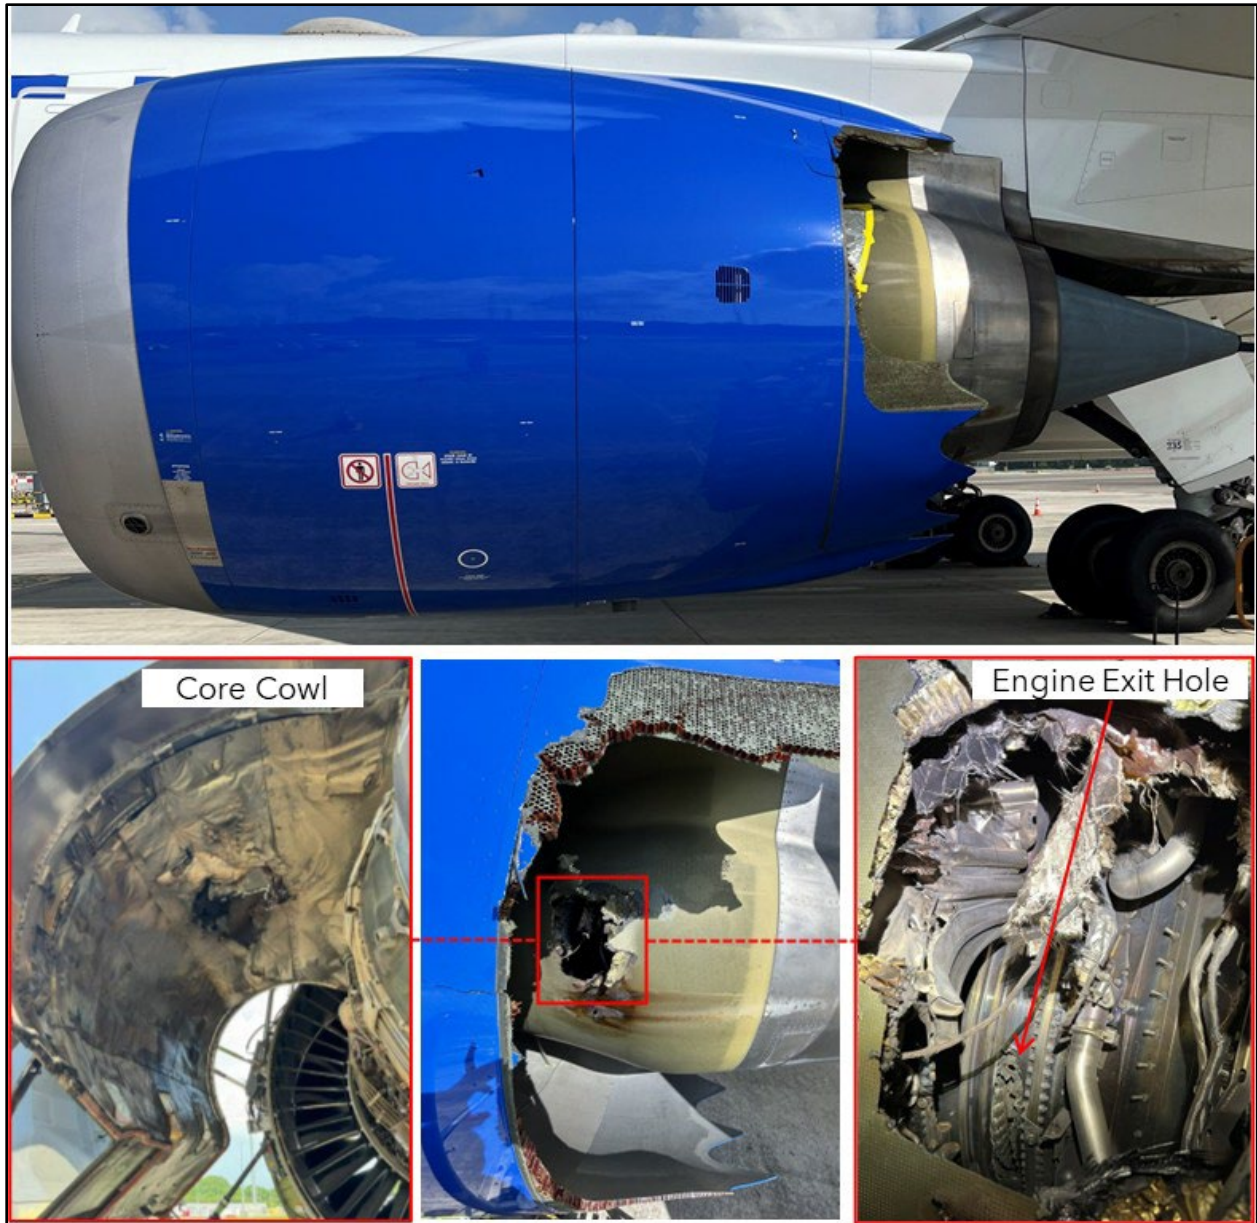
**Figure 10.** No. 1 Engine - Outboard Damage

Damage and penetration of the outboard TR IFS was found at approximately the 10:00 o'clock position (Figure 10) and the outboard (left) side of the TR (translating sleeve) was missing material between approximately the 8:00 and 11:00 o'clock positions.

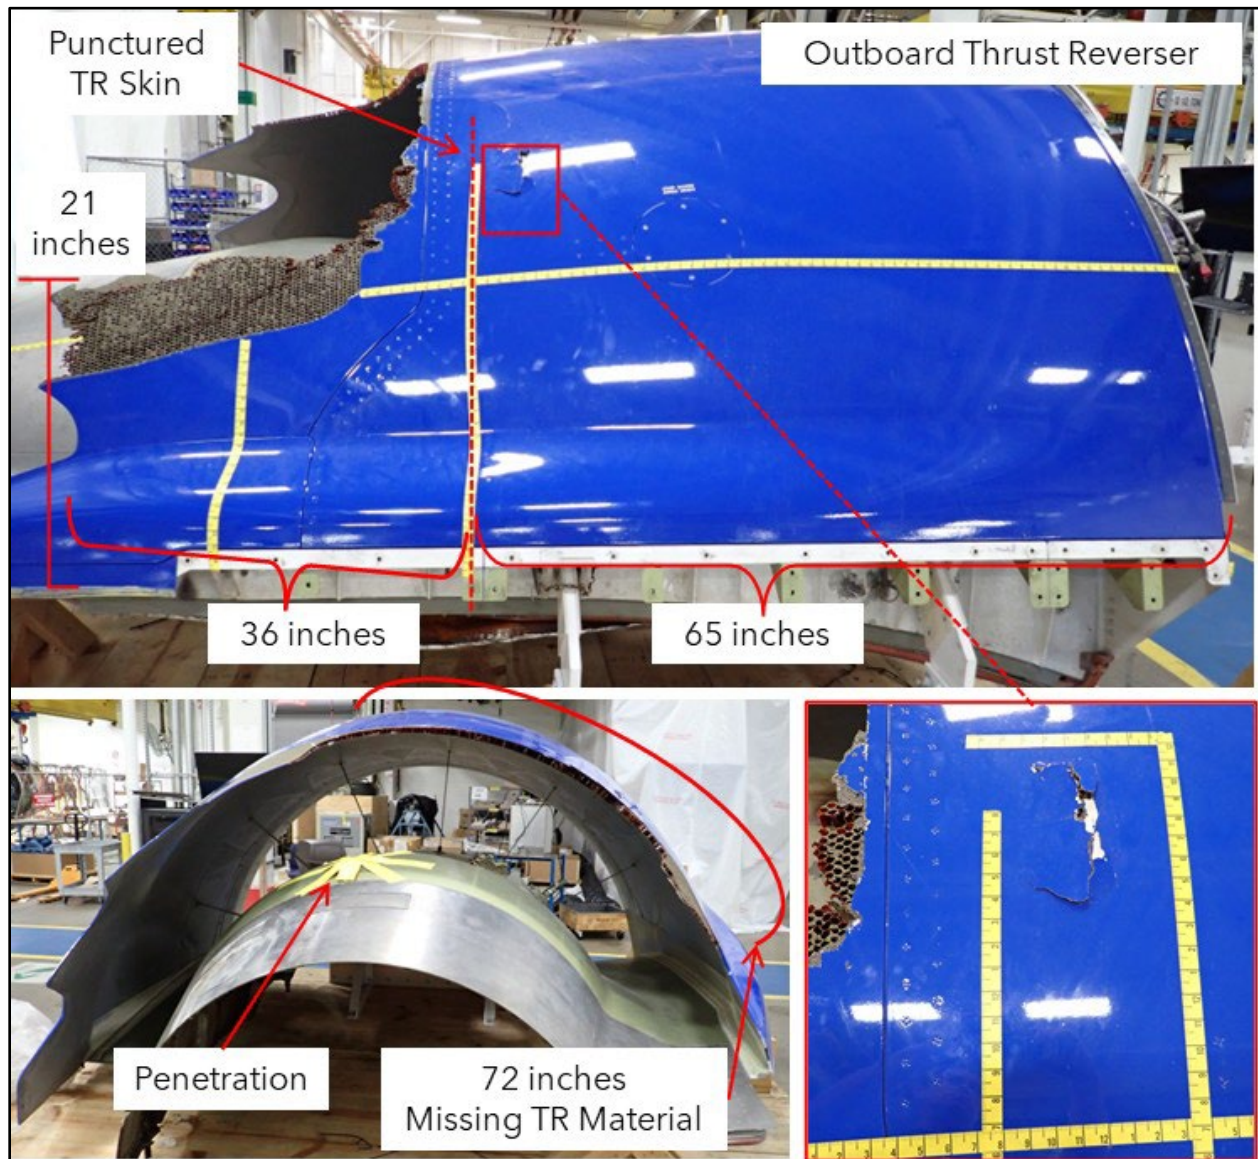
**Figure 11.** Outboard Thrust Reverser

The outboard (left side) TR was missing material from the translating sleeve, with dimensions of approximately 72 inches circumferentially and 36 inches axially, located approximately 21 inches from the top edge of the TR and 65 inches from forward edge of the TR (Figure 11). Forward of the TR missing material was an area of additional deformation to the outer TR skin which was opposite of the lodged debris located on the inner side of the TR. The TR skin puncture appeared pushed outward but did not appear to be a full penetration of the TR skin.

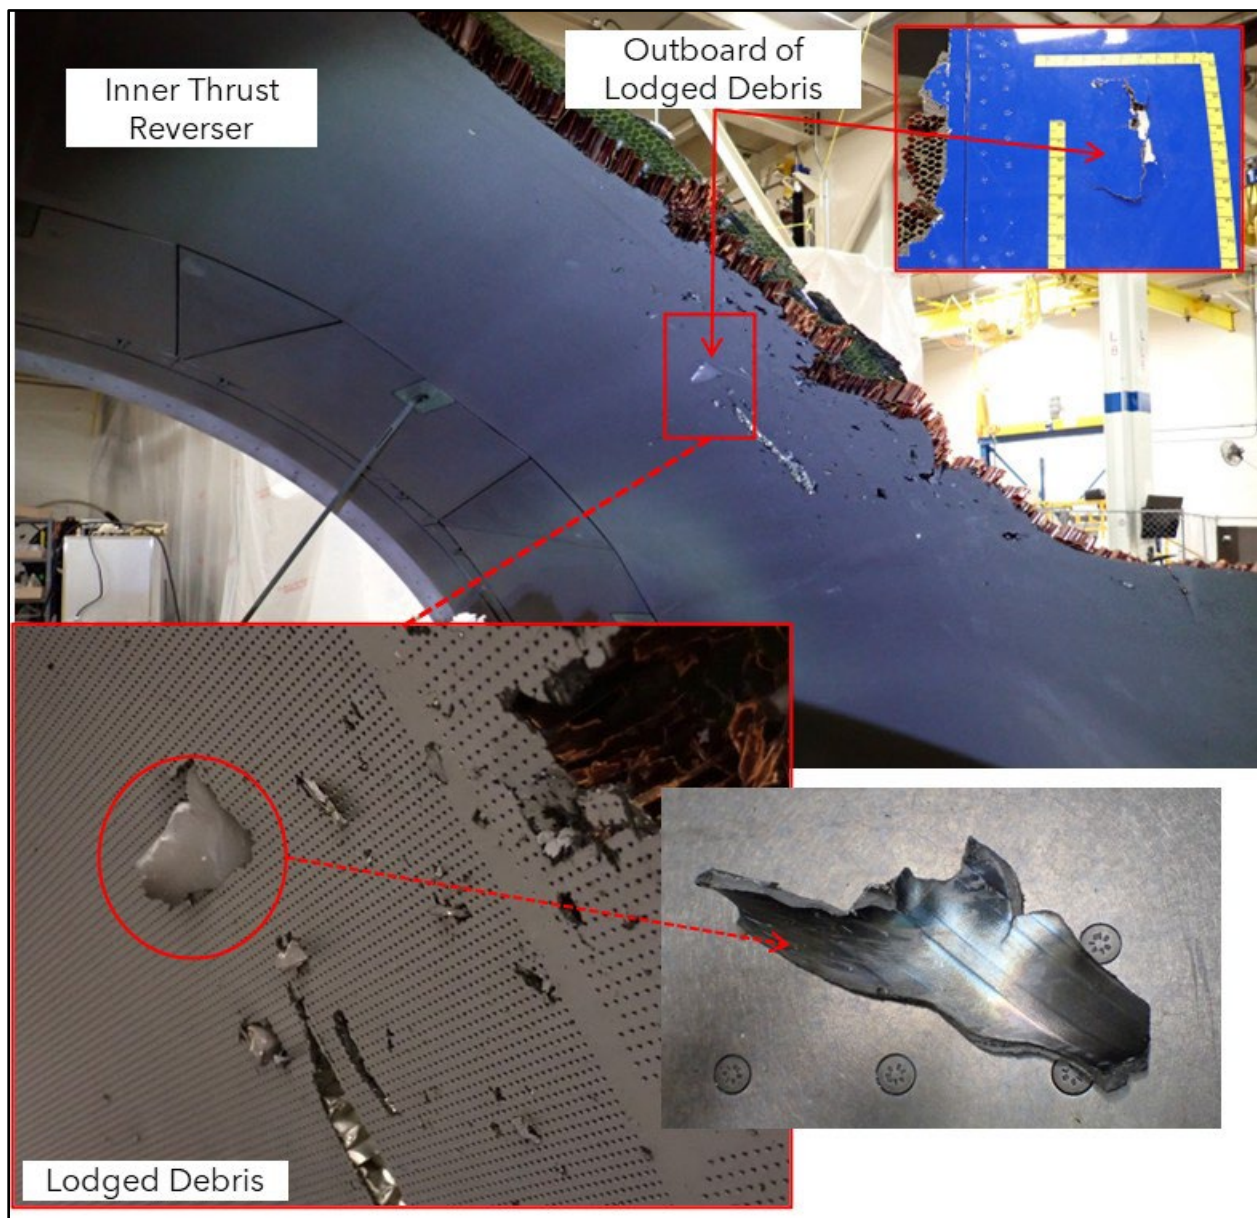
**Figure 12.** Lodged Debris in Thrust Reverser

The TR was found with lodged debris on the inner diameter of the TR, located outboard of the TR IFS exit hole and forward of the missing translating sleeve material. Multiple pieces of debris were recovered and retained for identification and future examination (Figure 12).

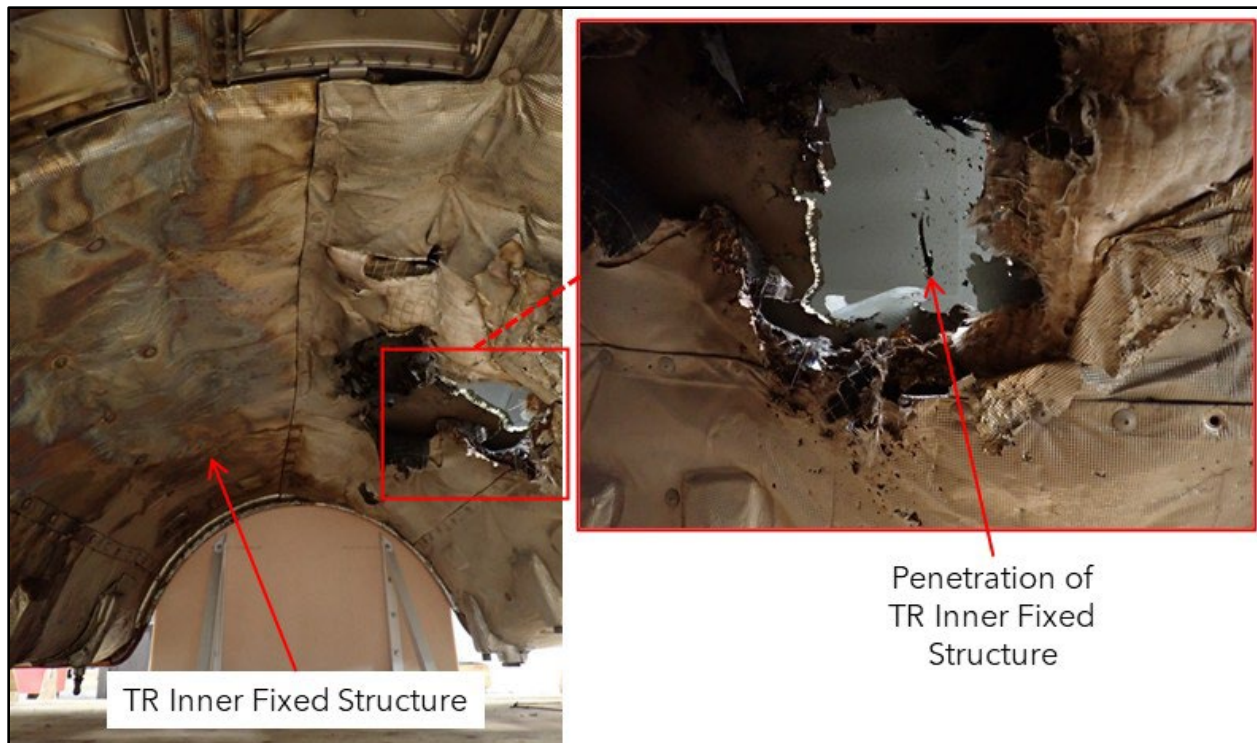
**Figure 13.** Punctured TR IFS

The TR IFS contained an exit hole approximately 13 inches axially and 15 inches circumferentially in size, located approximately 54 inches from the forward edge of the TR IFS and 51 inches from the rear edge of the TR IFS (Figure 13). The fireproof thermal blanket<sup>6</sup> located on the inner diameter of the TR IFS did not appear fire damaged or sooted.

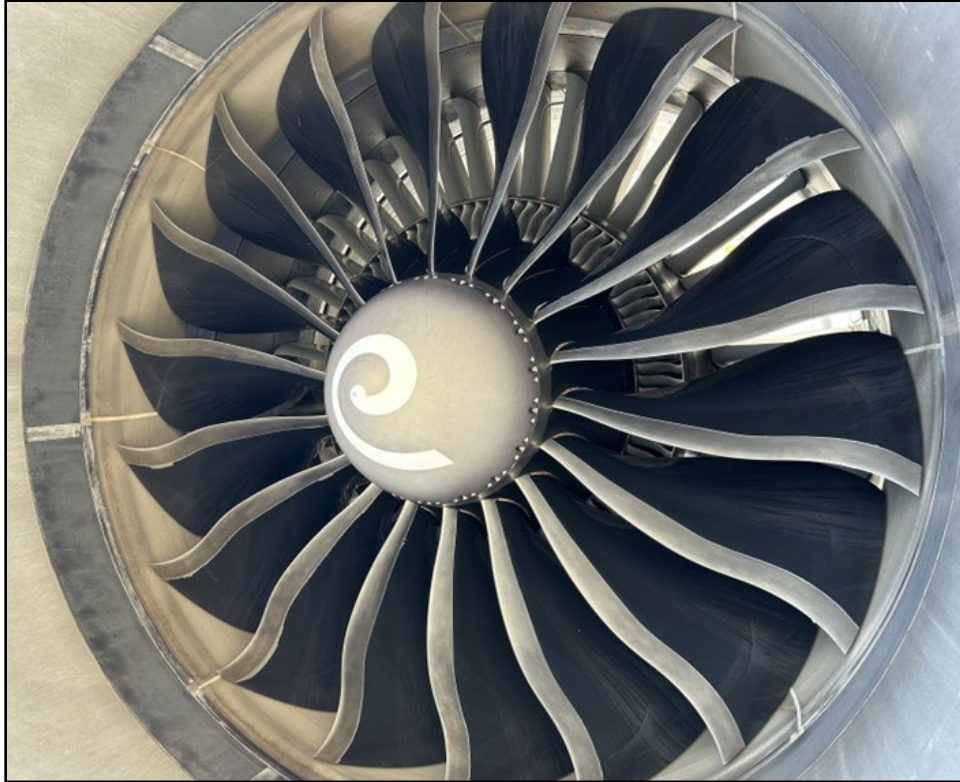
**Figure 14.** Front View of Fan Blades

The fan blades were full length and appeared undamaged (Figure 14).

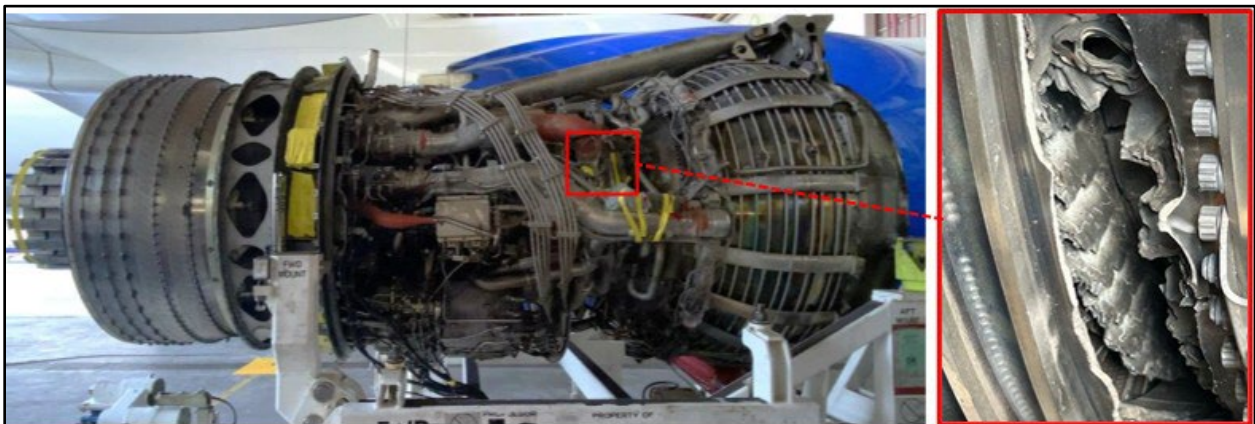
**Figure 15.** No. 1 ENGINE REMOVED - HPT CASE EXIT HOLE

With the cowls opened, the exterior of the engine was visible. The turbine case was missing a section of case skin between approximately the 8:00 - 10:00 o'clock positions, near the flange that attaches the turbine case to the TCF and axially in-plane with HPT stage 2 nozzles (Figure 15). Hardware visible through the penetration/exit hole in the HPT case included the HPT stage 1 nozzles, HPT stage 1 blades, HPT stage 2 nozzle and the HPT rotating interstage seal (RIS). The HPT stage 1 aft blade retainer was not visible and appeared to be missing.

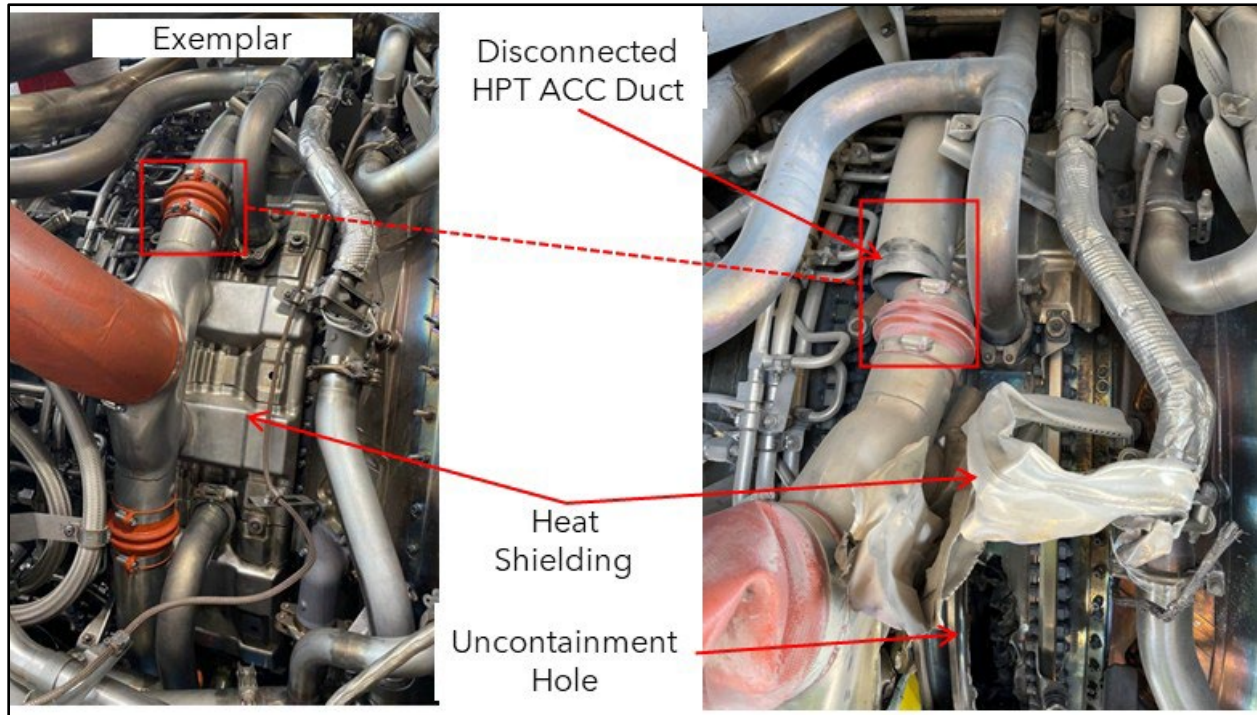
**Figure 16.** Damage to Heat Shielding and HPT ACC Ducts

A portion of the HPTACC cooling duct/manifold<sup>7</sup> near the turbine case exit holes was damaged (Figure 16). The heat shielding located between the turbine case and the HPTACC ducts was damaged outboard of the exit holes.

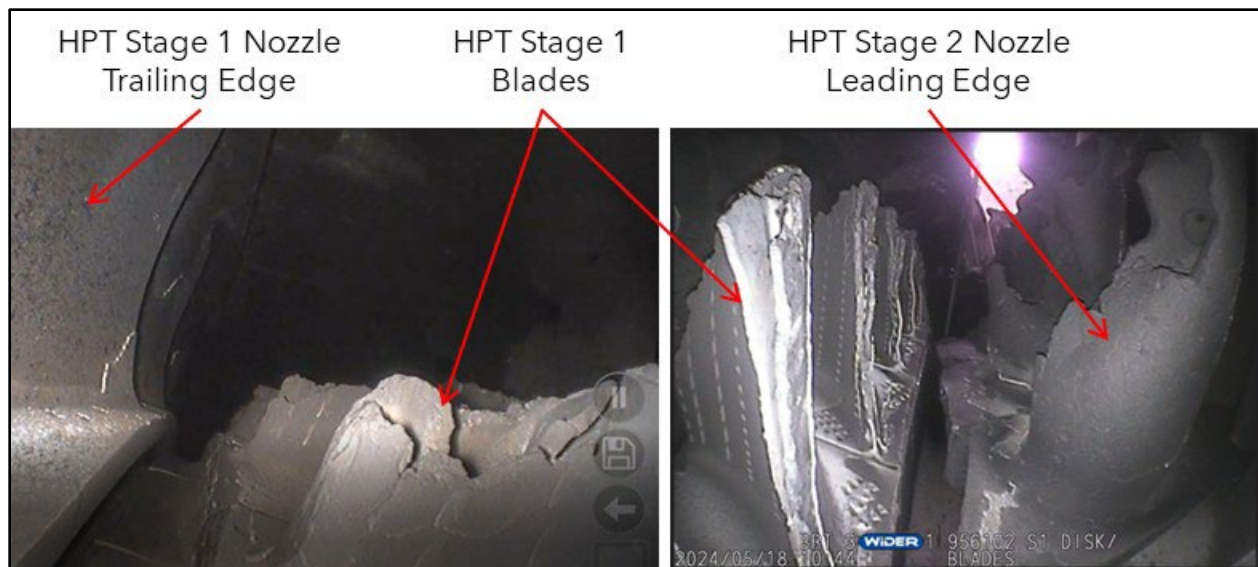
**Figure 17.** BSI - HPT Stage 1 Blades

Two borescope inspections (BSI) of the HPT module were conducted to view as much of the circumference at the location of the HPT stage 1 aft blade retainer as possible; it was estimated that about 95% of the circumference was viewable. The following HPT BSI observations are only for what was visible during the BSI and should not be construed as the condition of the entire module. The HPT stage 1 blades were fractured transversely across the airfoil at approximately 25% span but did not appear to exhibit thermal distress/melting of the fracture surfaces (Figure 17). The HPT stage 1 nozzles appeared to be present and intact with some nozzle segments appearing to be displaced. The HPT stage 2 nozzles were present but detached from the turbine case at the exit hole.

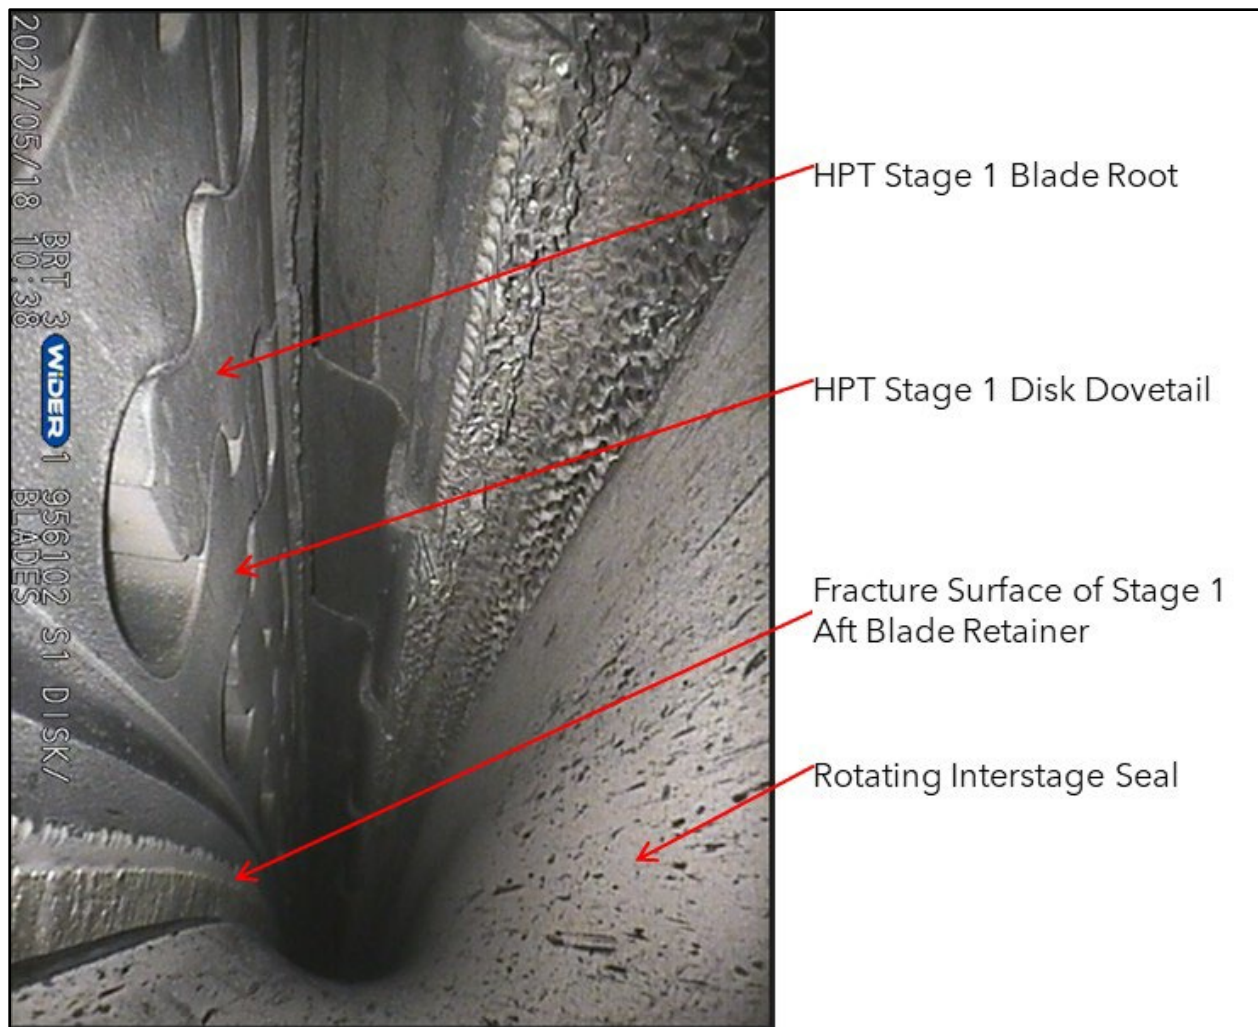
**Figure 18.** STAGE 1 HPT AFT BLADE RETAINER FRACTURED AND MISSING

The HPT RIS is composed of 4 knife-edge seal teeth and is attached to both HPT stage 1 and HPT stage 2 disks. The HPT RIS provides air flow sealing between the HPT rotor stages by rubbing into the HPT stage 2 nozzle stationary seal honeycomb. The HPT RIS appeared to be intact. The HPT stage 1 aft blade retainer, installed on the aft side of the HPT stage 1 disk, provides axial retention for the HPT stage 1 blades in the disk dovetail and provides air sealing for the blade cooling circuits. The HPT stage 1 aft blade retainer appeared to be missing the outboard portion of the part while viewed with the borescope; the HPT stage 1 disk posts and blade dovetails should not be visible with an intact and present HPT stage 1 aft blade retainer (Figure 18).

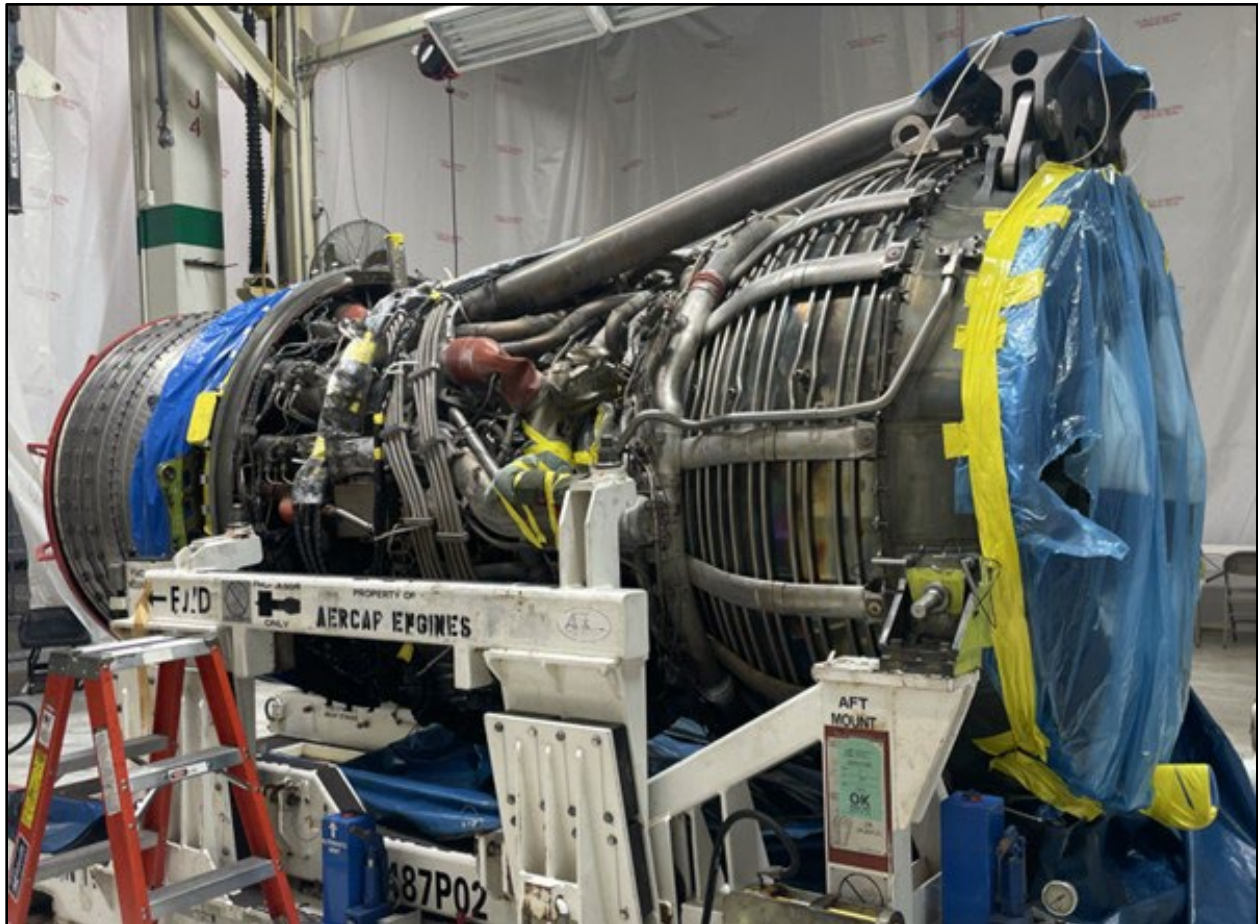
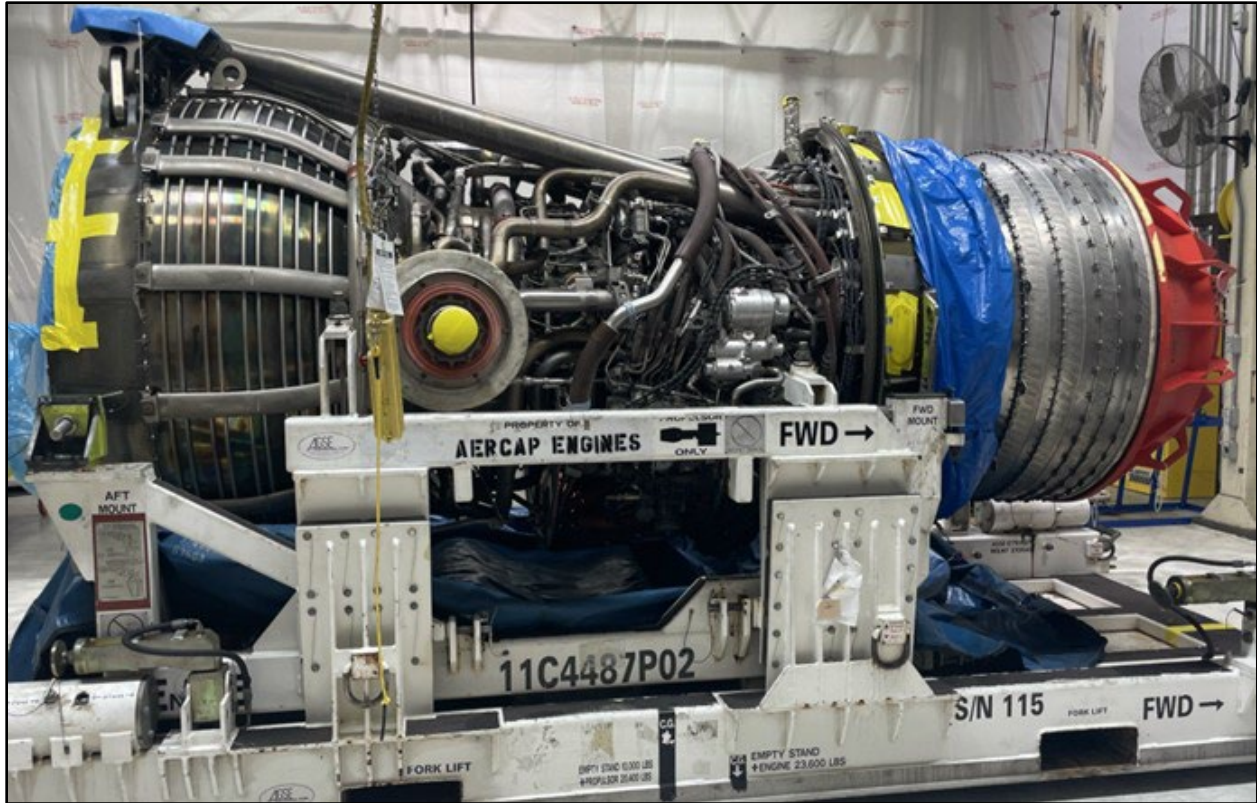
The propulsor was received in the transportation stand and unwrapped by GE personnel (Figure 20 and Figure 21). The engine did not exhibit any evidence of an undercowl fire but a fire assessment of the propulsor and various hardware was performed during the Group examination.

**Figure 20.** ENGINE AS-RECEIVED, LEFT SIDE

**Figure 21.** Engine As-Received, Right Side

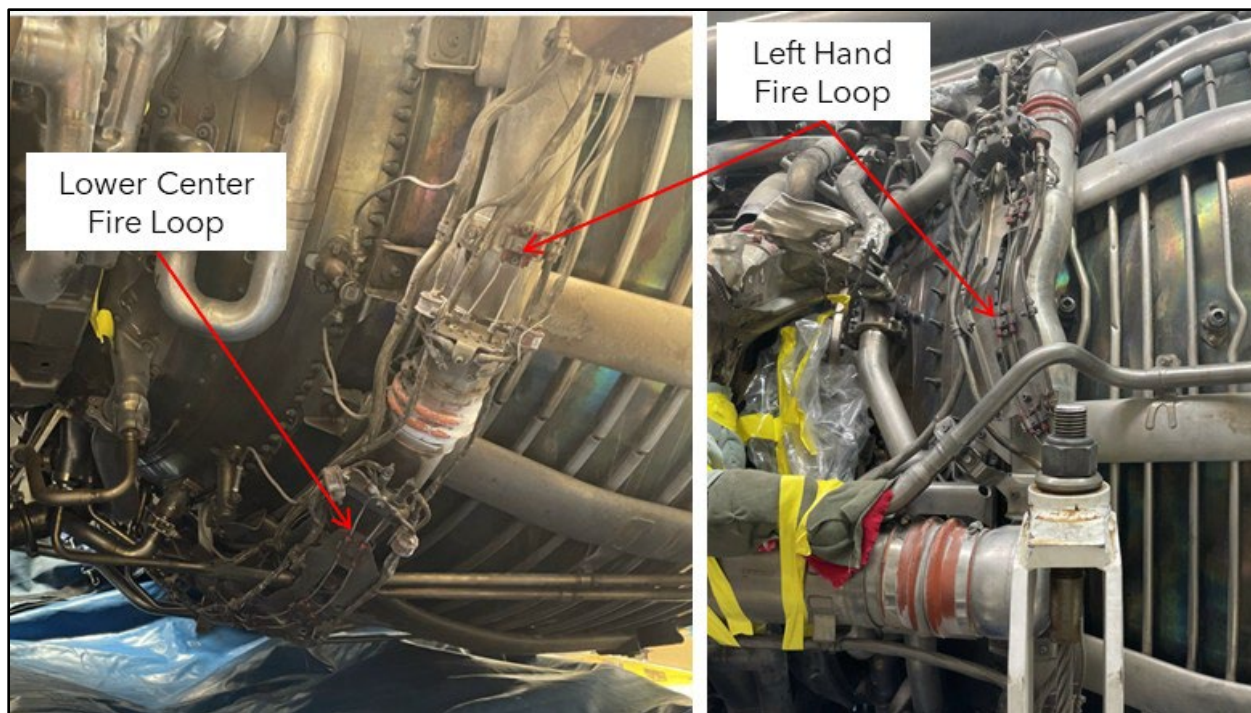
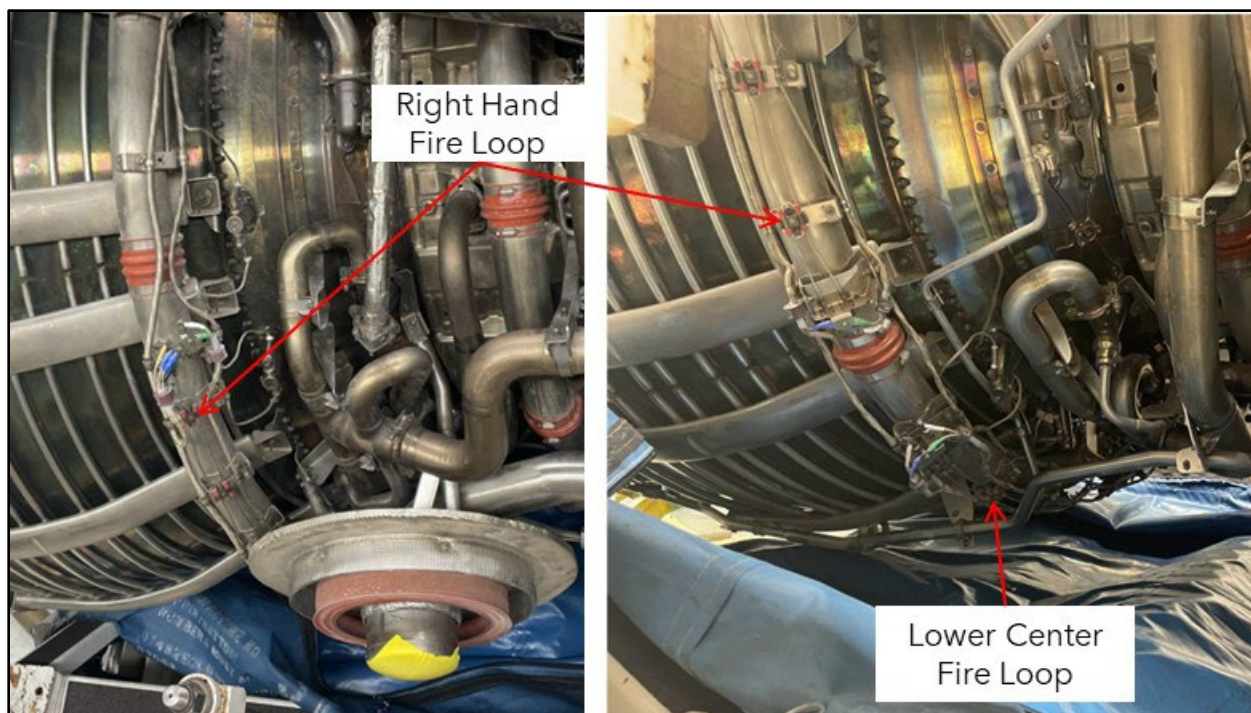
The left hand, right hand, and lower center fire loops were all present and appeared to be intact. All fire loop isolators were present and appeared undamaged (Figure 22 and Figure 23).

**Figure 22.** Left Hand and Lower Center Fire Loops

**Figure 23.** Right Hand and Lower Center Fire Loops

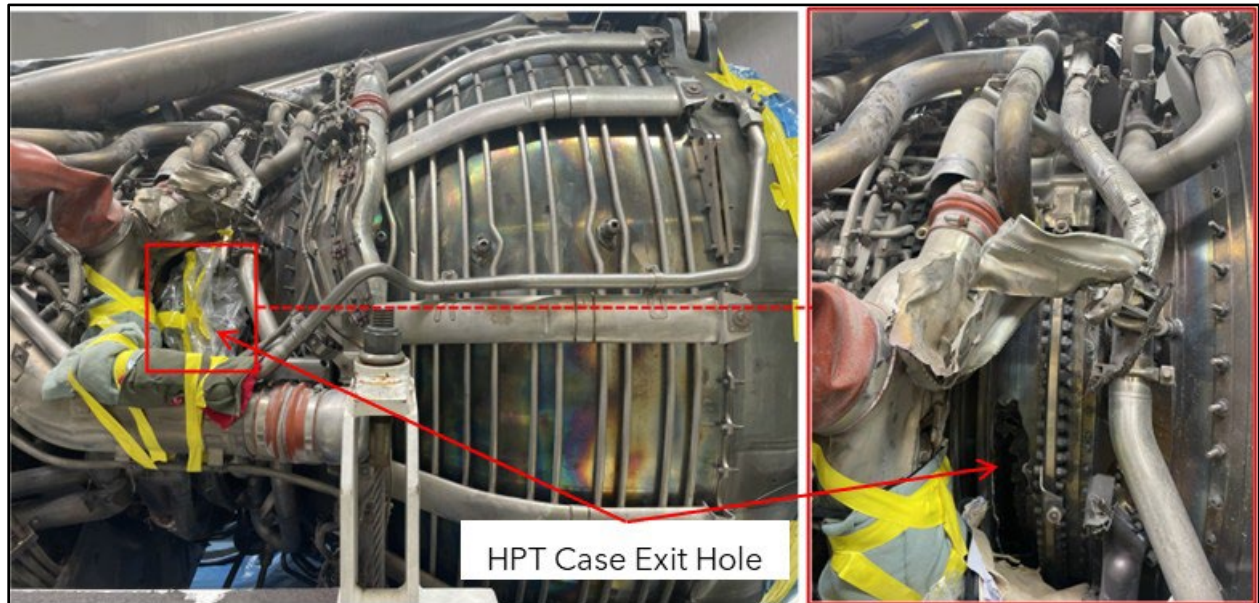
**Figure 24.** HPT Case Exit Hole

The exit holes in the HPT case were located circumferentially between approximately the 7:30 and 9:30 o'clock positions and located axially between the HPT turbine case aft flange and the aft stiffening ring (Figure 24).

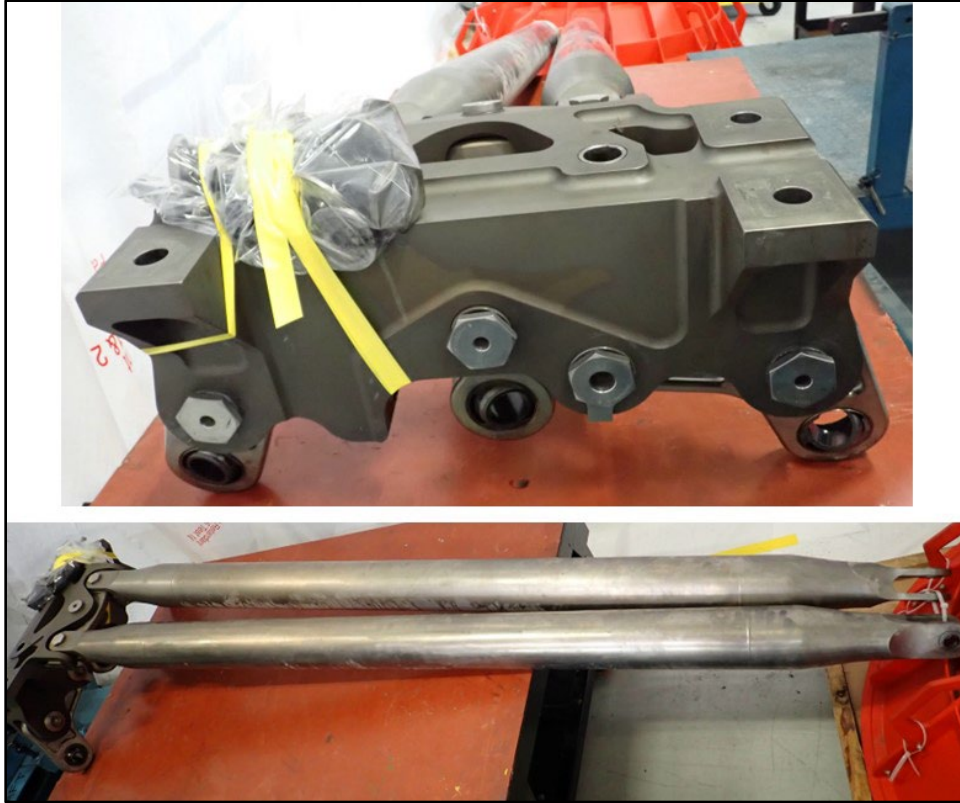
**Figure 25.** Thrust Links and Rear Engine Mounts

The engine thrust links and rear engine mount were removed and found to be intact and undamaged (Figure 25). The spherical bearings between the rear engine mount and the engine-to-rear mount attachment links rotated freely.

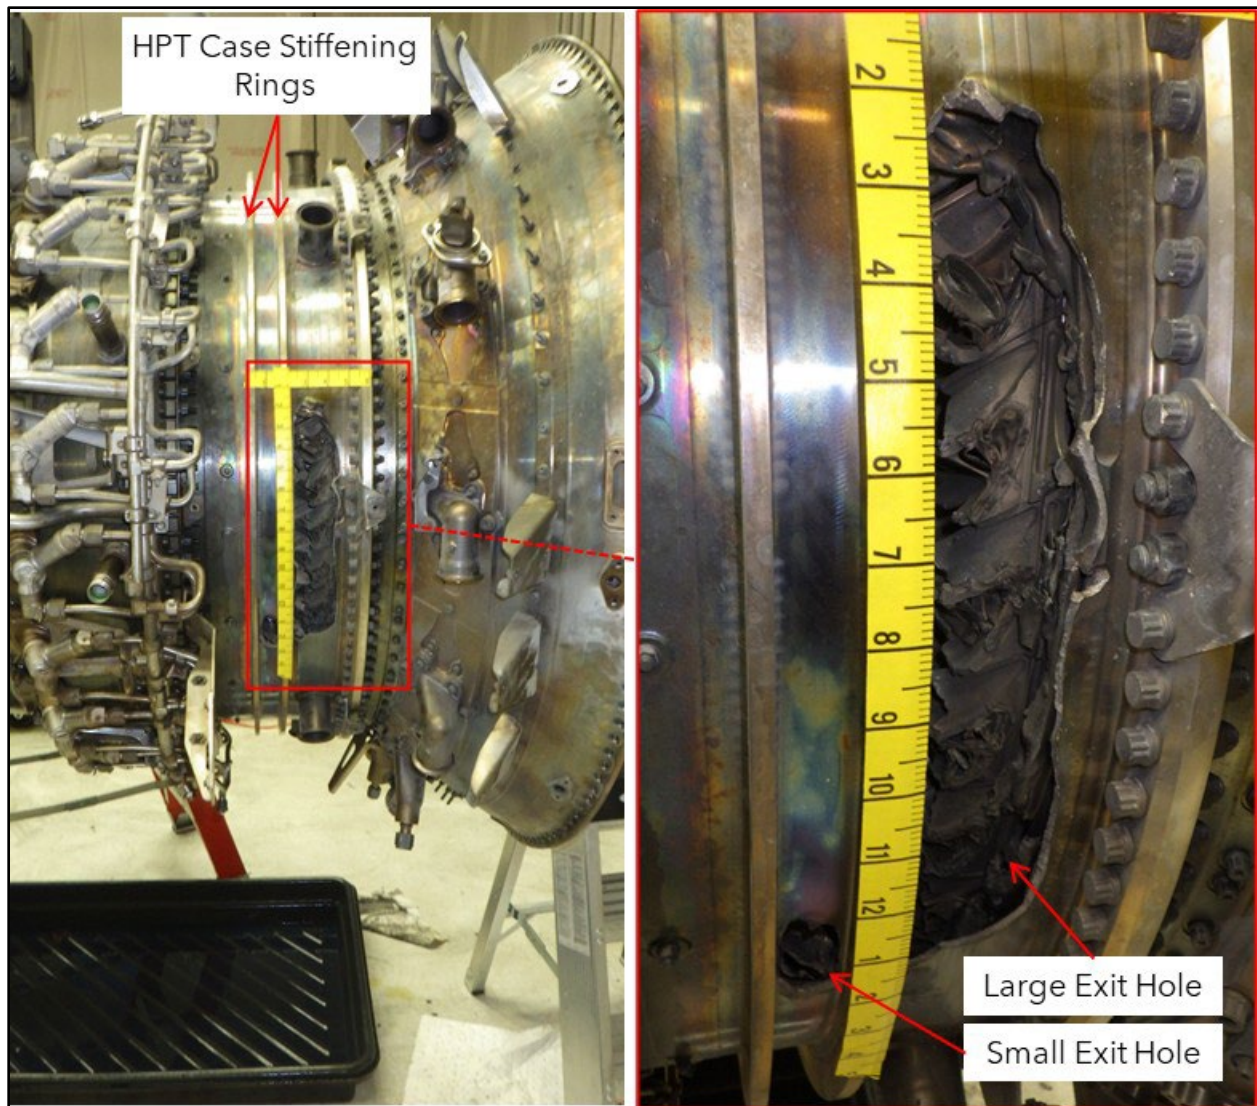
**Figure 26.** HPT Case with Exit Holes

With the accessory hardware removed, two exit holes were observed in the HPT case (Figure 26). The larger hole, located between the TCF/HPT case flange and the aft HPT case stiffening ring, measured approximately 2.25 inches axially by 11 inches circumferentially. The smaller hole, located between the HPT case stiffening rings, measured approximately 2 inches by 2 inches.

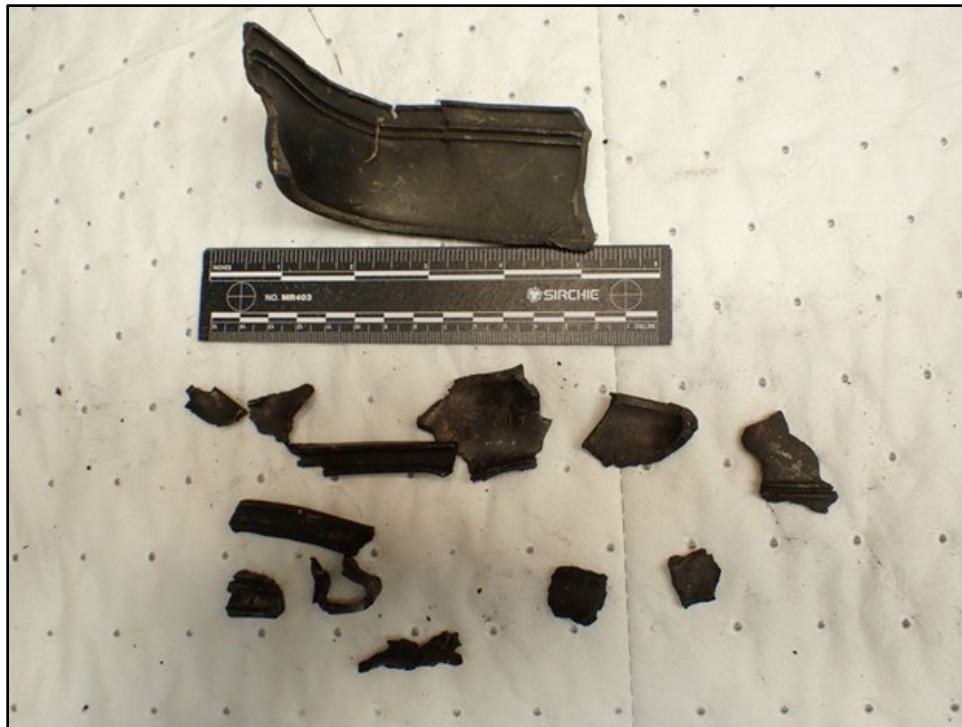
**Figure 29.** BOXED HARDWARE, PORTIONS OF HPT STAGE 1 AFT BLADE RETAINER

Portions of the HPT stage 1 blade aft retainer were found within a box containing various pieces of hardware collected during the on-scene investigation, these pieces were separated out for further examination by GE's material laboratory (Figure 29).

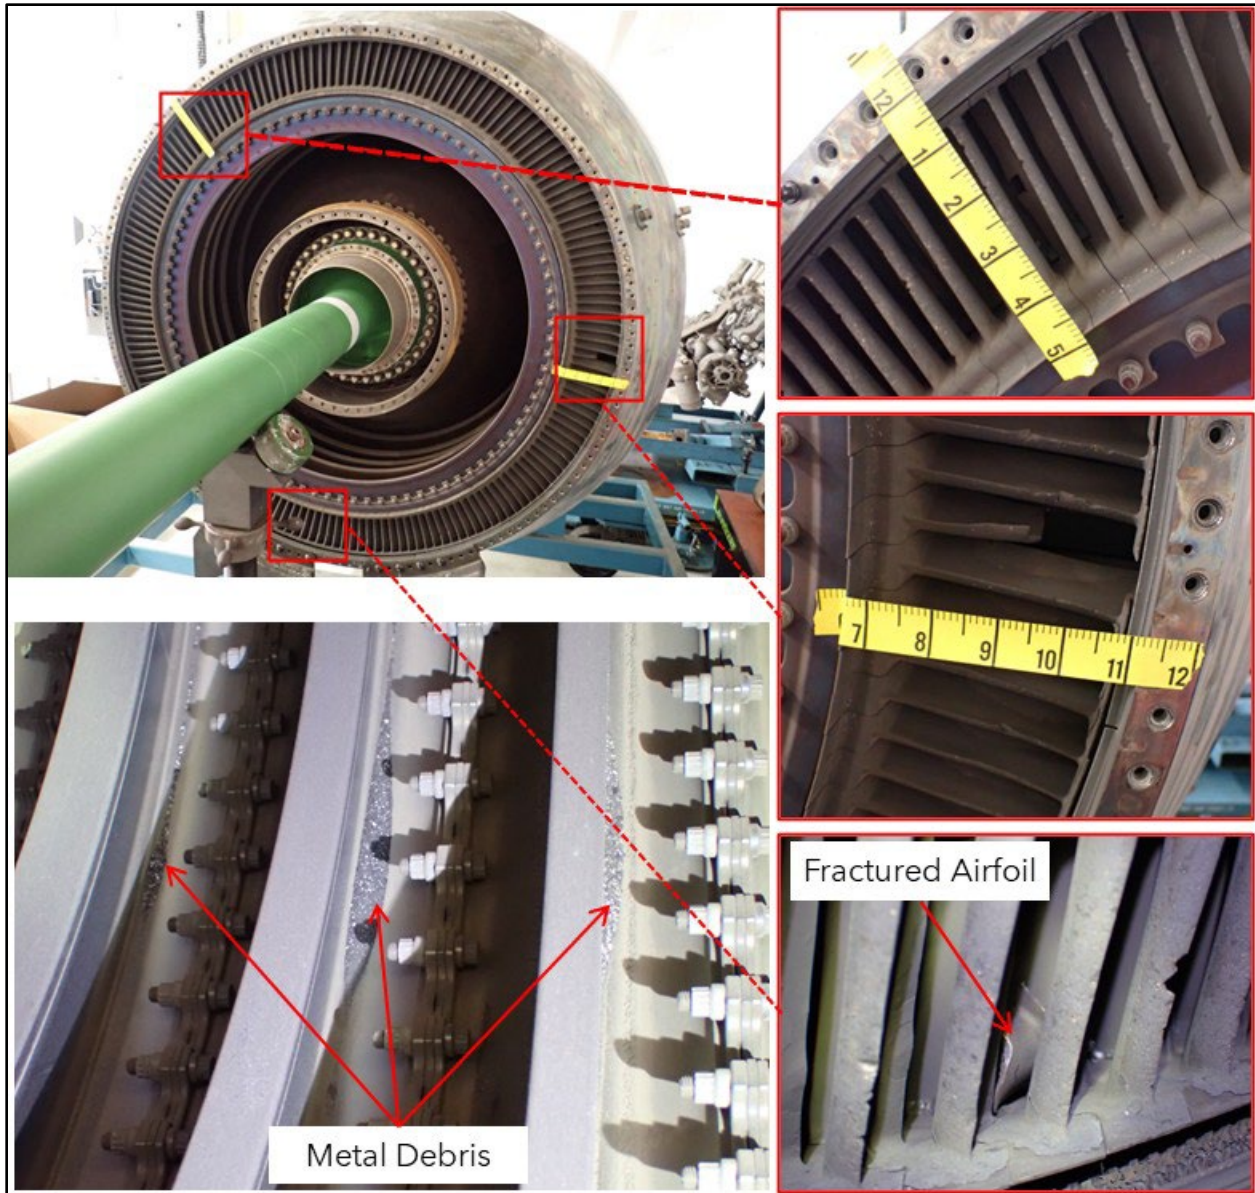
**Figure 31.** LPT - IMPACT DAMAGE AND LOSS OF MATERIAL

All the LPT stage 1 blades exhibited hard body impact damage, one airfoil was fractured at approximately midspan and missing the outboard material (Figure 31). The LPT shaft was intact and appeared undamaged. When looking at the rear of the engine, the LPT stage 7 blades were all present and appeared undamaged.

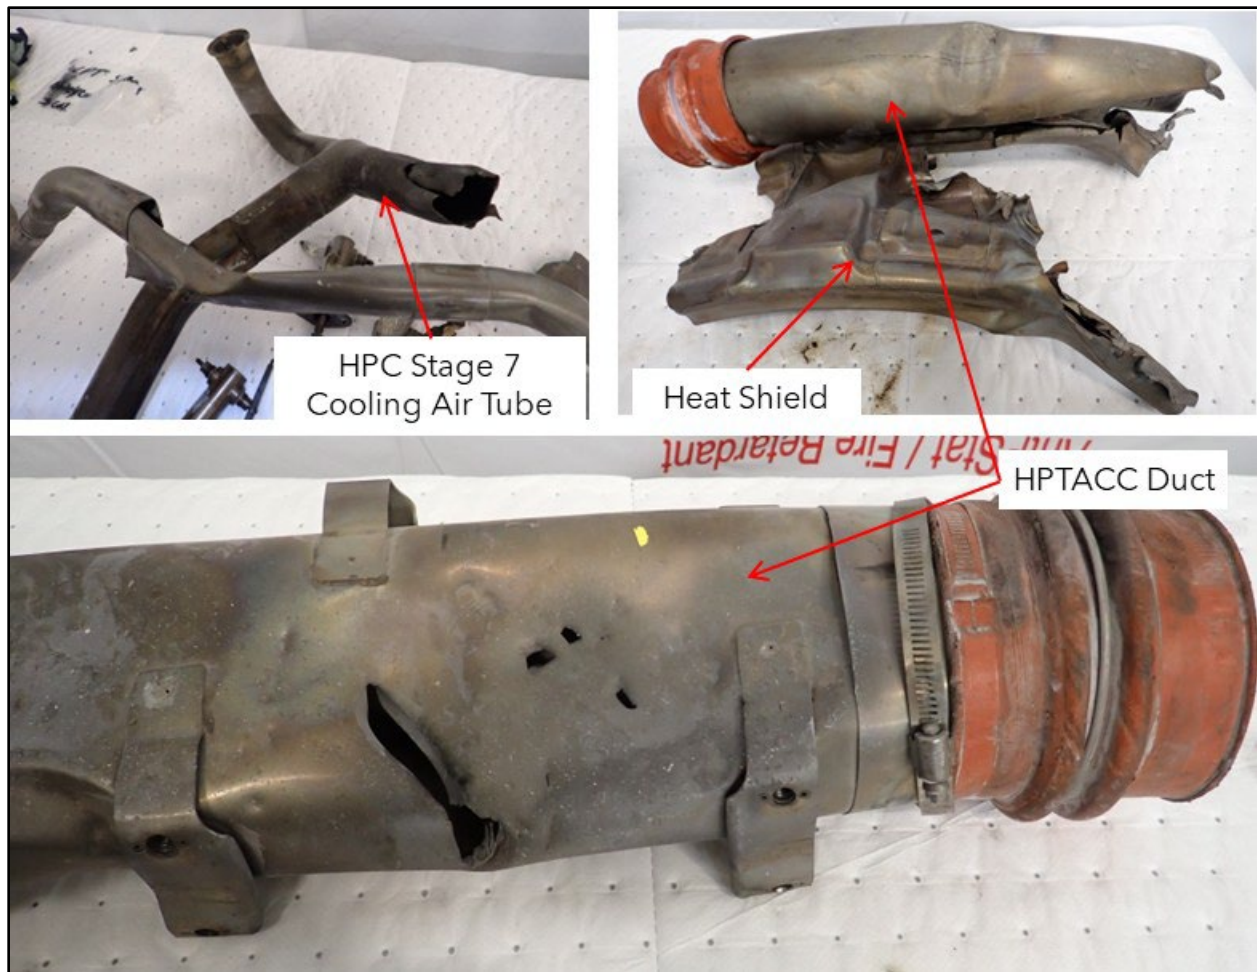
**Figure 32.** Damaged HPTACC Ducts and HPC Stage 4 Cooling Manifold

Located on the tables in the disassembly area were several damaged components that were removed prior to the team's arrival. This include one HPC stage 7 cooling air tubes, supplying cooling air to the 8 supply ports on the HPT case, was completely severed near the exit hole, which corresponded to the HPT case supply port that was missing, located within the exit hole (Figure 32). Other items on the table included an ignitor cable, a speed sensor/cable, and multiple pieces of the HPTACC ducts/manifolds, and the HPC stage 4 cooling manifold which contained multiple puncture holes and crushed/tearing damage (Figure 32).
