National Transportation Safety Board  
Office of Aviation Safety  
Washington, DC 20594

ENG24LA014

## **POWERPLANTS**

Group Chair's Factual Report

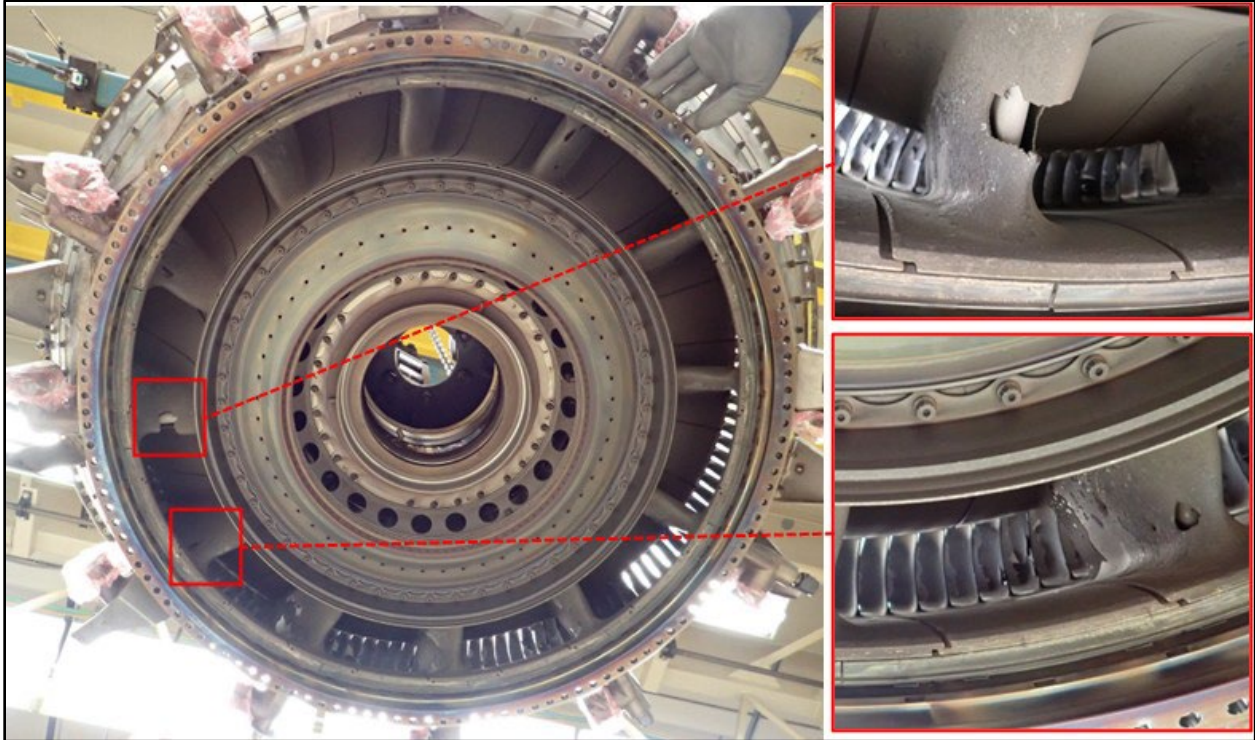
**Figure 34.** TCF Removed - Strut Impact Damage

With the TCF removed, multiple TCF flow path liners and struts, located on the forward side of the TCF, sustained hard body impact damage and had missing material. Multiple struts exhibited puncture holes and imbedded debris (Figure 34). The honeycomb seals located on the inner bore of the TCF appeared to have consistent trenching around the whole circumference.

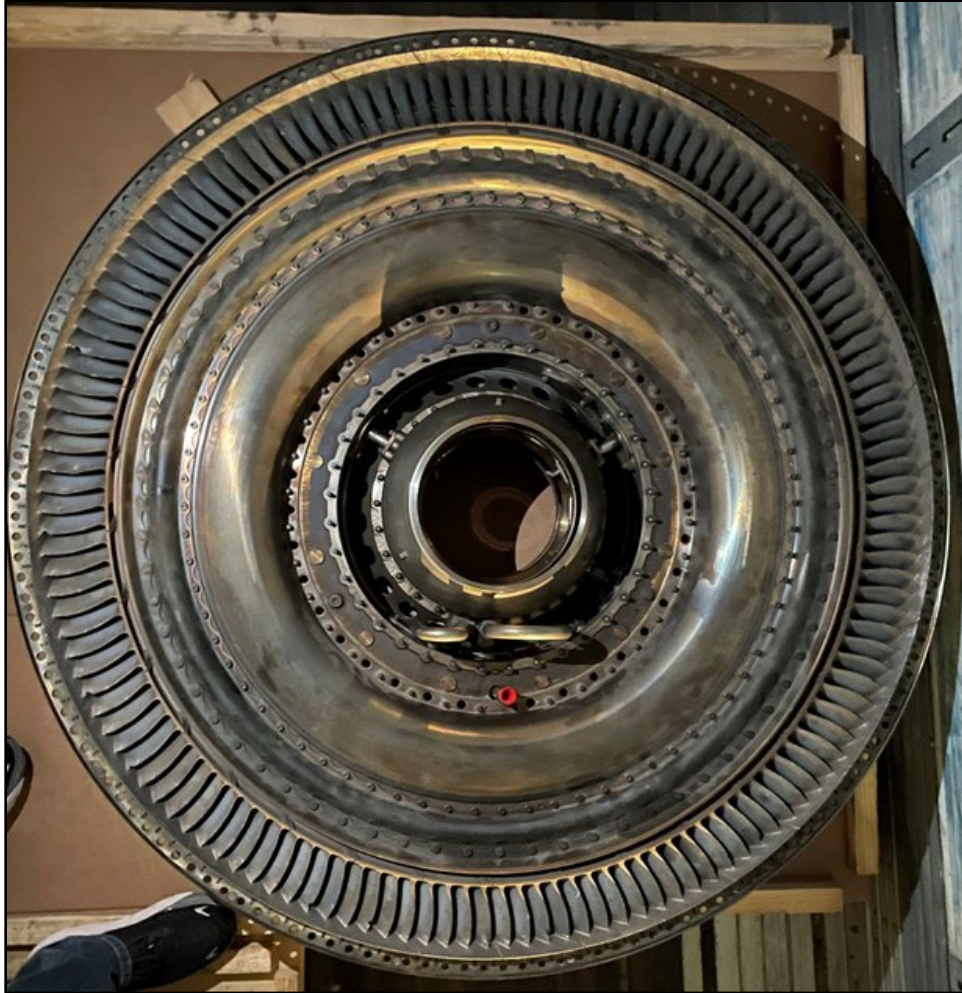
**Figure 35.** AFT SIDE OF TCF

All the LPT stage 1 nozzles segments (4 nozzle airfoils per nozzle segment), located on the aft side of the TCF, were present and engaged. The stage 1 nozzle airfoils exhibited hard body impact damage (Figure 35).

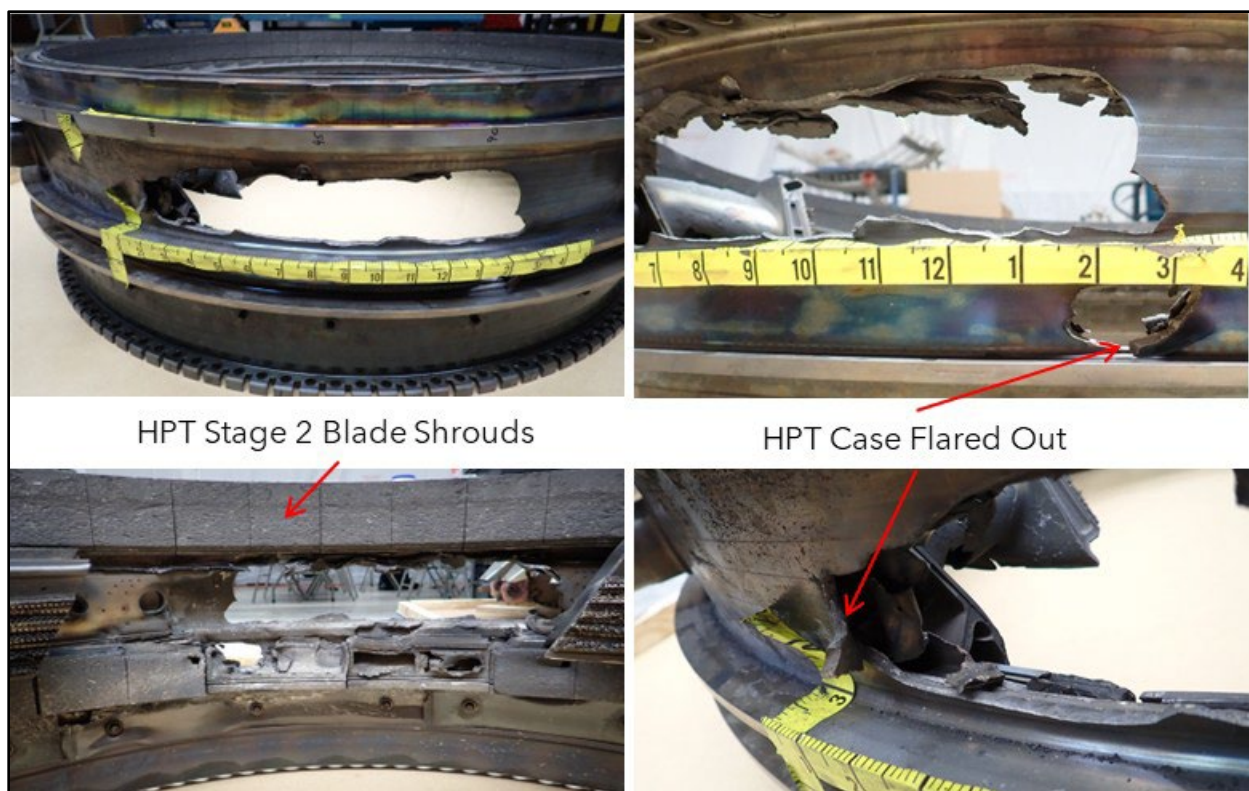
**Figure 36.** HPT Case Removed

With the HPT case removed, an unobstructed view of the uncontainment location showed the HPT case wall to be distorted outward and the edges appeared flared, jagged and exhibited mechanical damage (Figure 36). Every HPT stage 2 nozzle sustained damage to the airfoil leading edges, significant thermal distress and hard body impact damage.

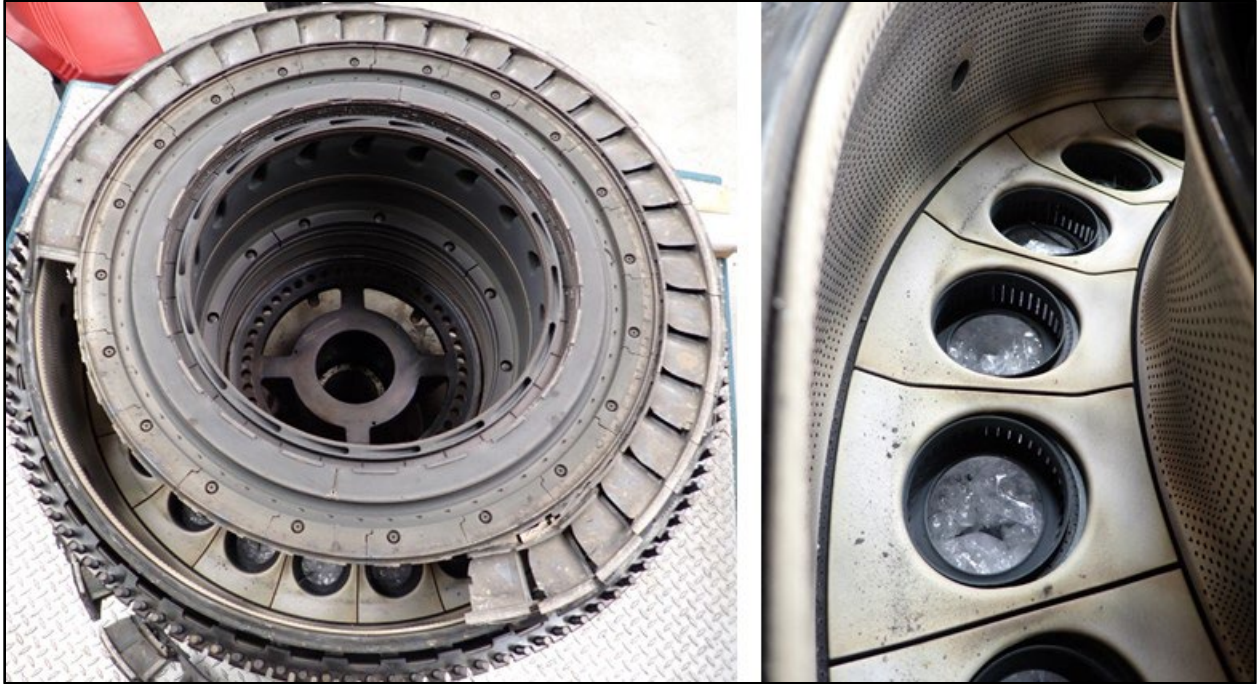
**Figure 37.** HPT Stage 1 Nozzle Segments and Combustion Chamber

The combustion chamber, forward of the HPT stage 1 nozzle segments, appeared typical of normal engine operation, there were no signs of fuel nozzle streaking, hot spots, or burn throughs (Figure 37). The HPT stage 1 nozzle consists of 20 nozzle segments installed into the combustion case; each nozzle segment contains two vanes that are brazed together to create one nozzle segment. All nozzle segments were accounted for, a quantity of 15 nozzle segments were found still engaged to the combustion case and a quantity of 5 nozzle segments adjacent to the exit hole were disengaged (Figure 37). The vane trailing edges sustained significant hard body impact damage and missing material.

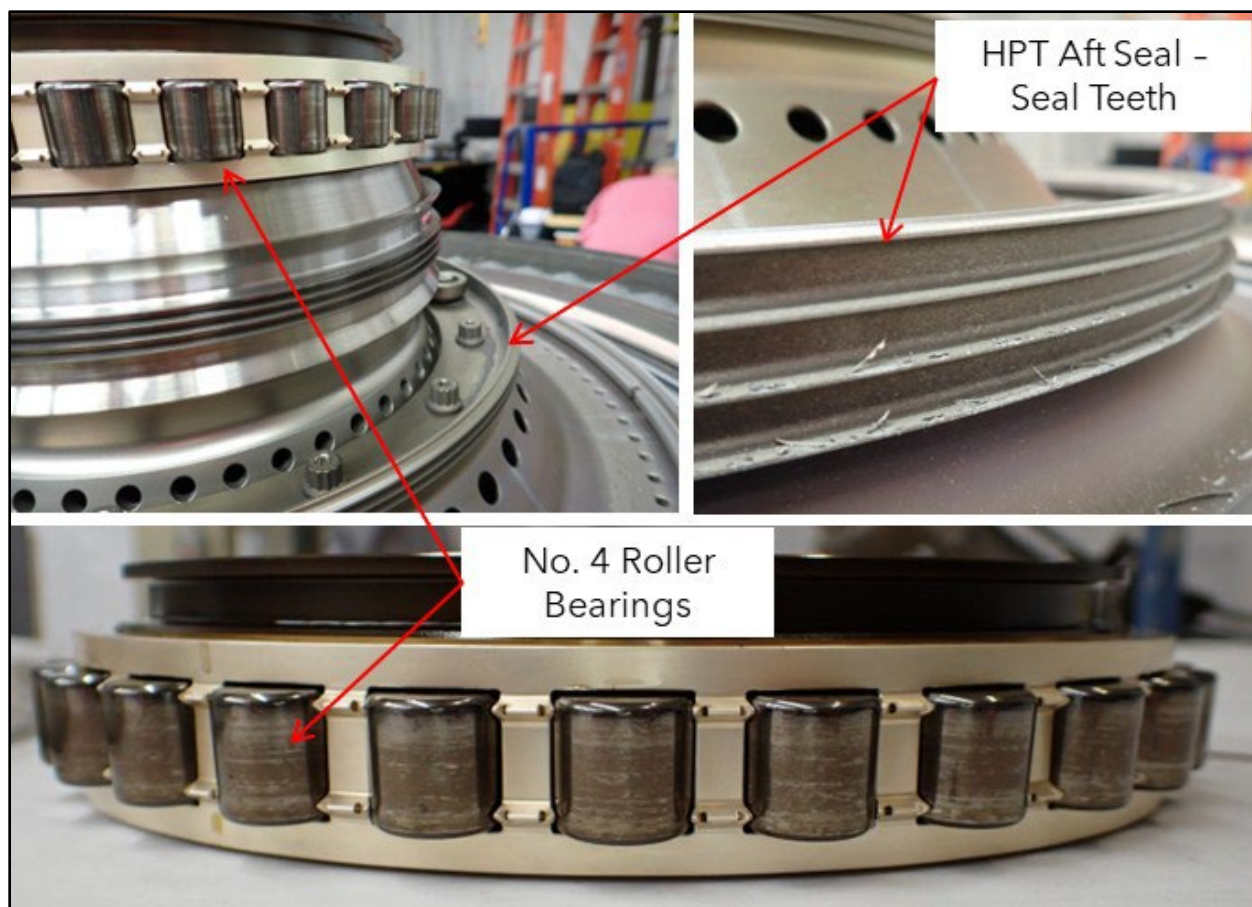
**Figure 38.** NO. 4 ROLLER BEARINGS AND HPT AFT SEAL

The No. 4 roller bearing assembly appeared oil wetted, undamaged and with discoloration consistent with that of engine run hardware (Figure 38). The HPT aft seal, secured to the aft side of the HPT stage 2 disk by 15 bolts, was intact but loss of coating and peeling coating on the seal teeth was observed.

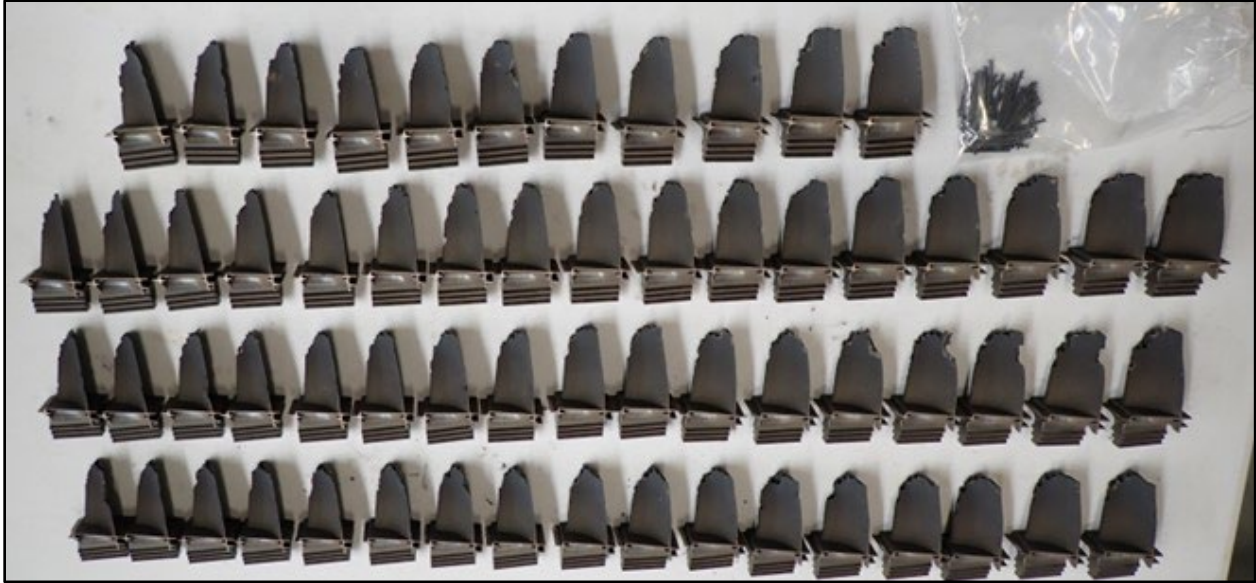
**Figure 40.** HPT STAGE 2 BLADE DAMAGE

All the HPT stage 2 blades were present and fractured transversely across all the airfoils between approximately 85%-95% blade span above the platform. The airfoils sustained leading and trailing edge hard body impact damage, missing material, tears, and material transfer (Figure 40).

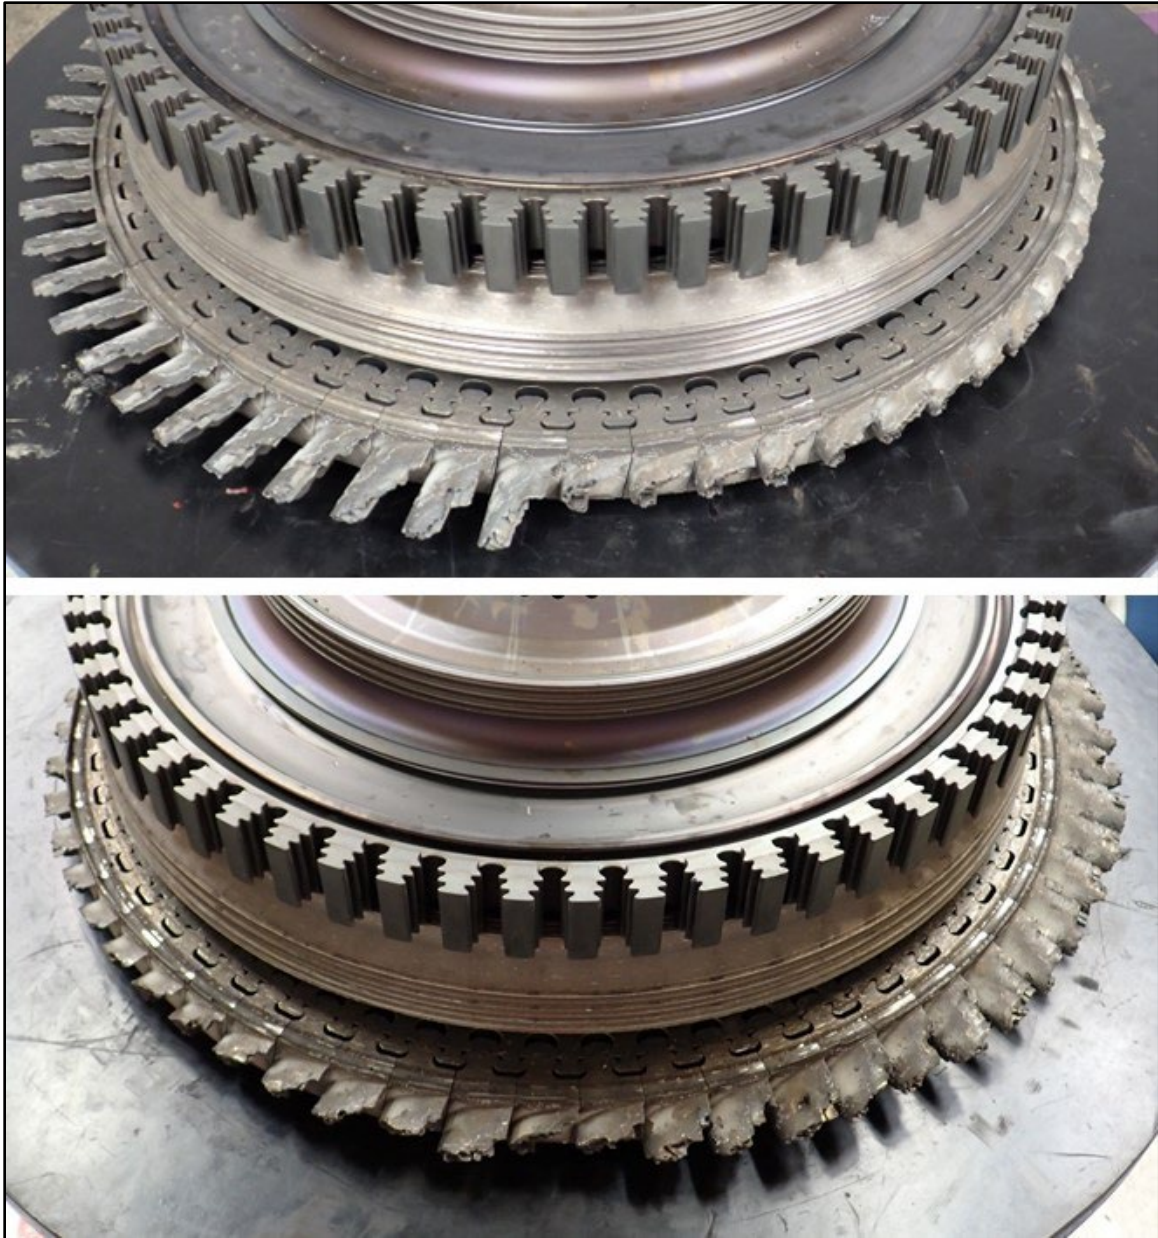
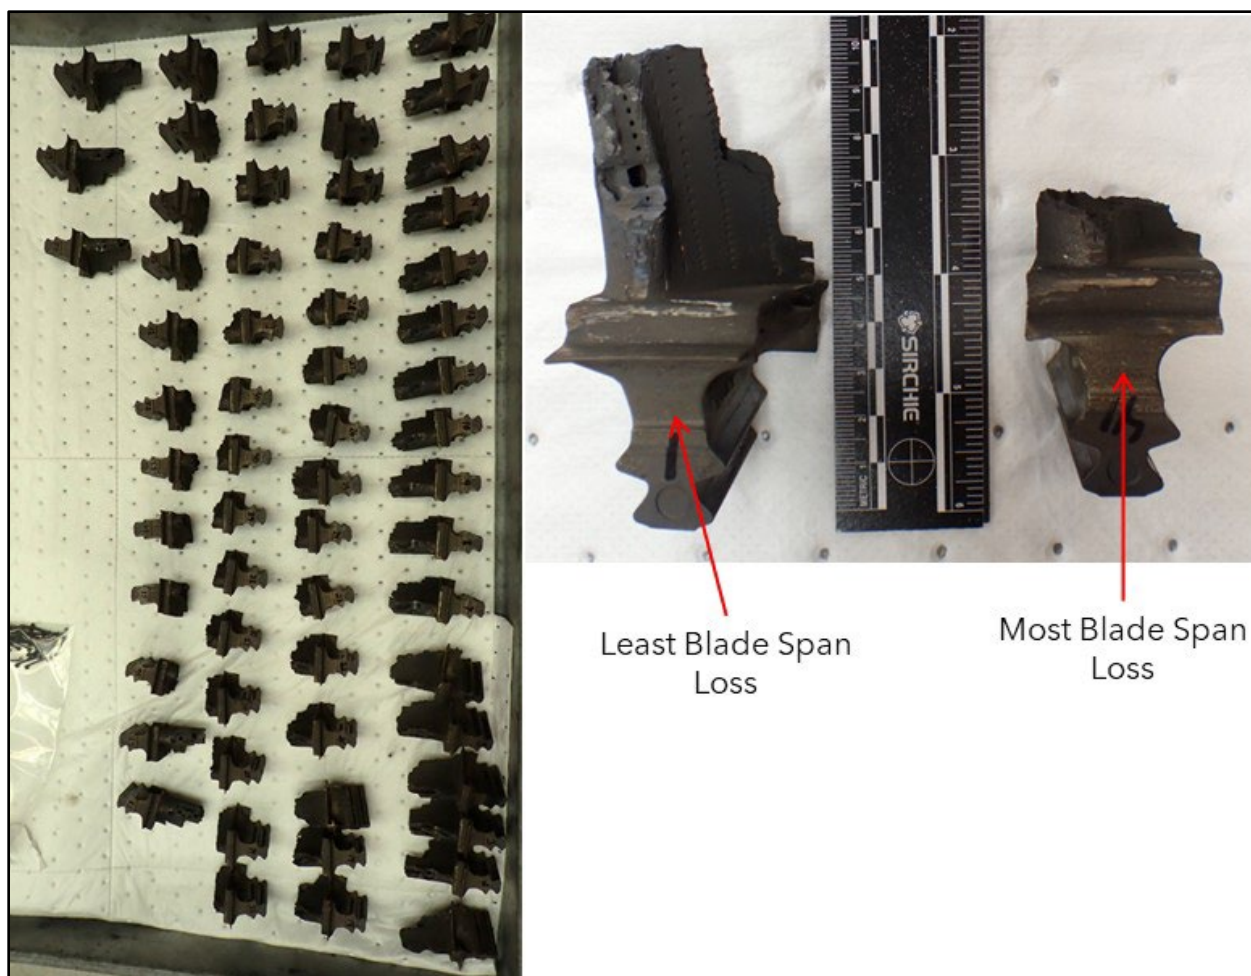
The HPT stage 1 blades were fractured transversely at varying span lengths with approximately half being of a similar length, the other half of the blades had an increasing span length (Figure 41). All the HPT stage 1 blades sustained significant thermal distress and hard body impact damage. The blade platform has a single seal on the forward face and a double seal on the rear face; these seals are referred to as angel wings seals and they regulate airflow around the blade and in the HPT stage 1 cavity. The aft side angel wings of all HPT stage 1 blades were damaged and sustained significant loss of material to all angel wings, the forward blade angel wings were all present and intact with only localized rubbing contact (Figure 42).

**Figure 41.** HPT Stage 1 Blades - Installed

**Figure 42.** HPT STAGE 1 BLADES REMOVED – SHORTEST AND LONGEST

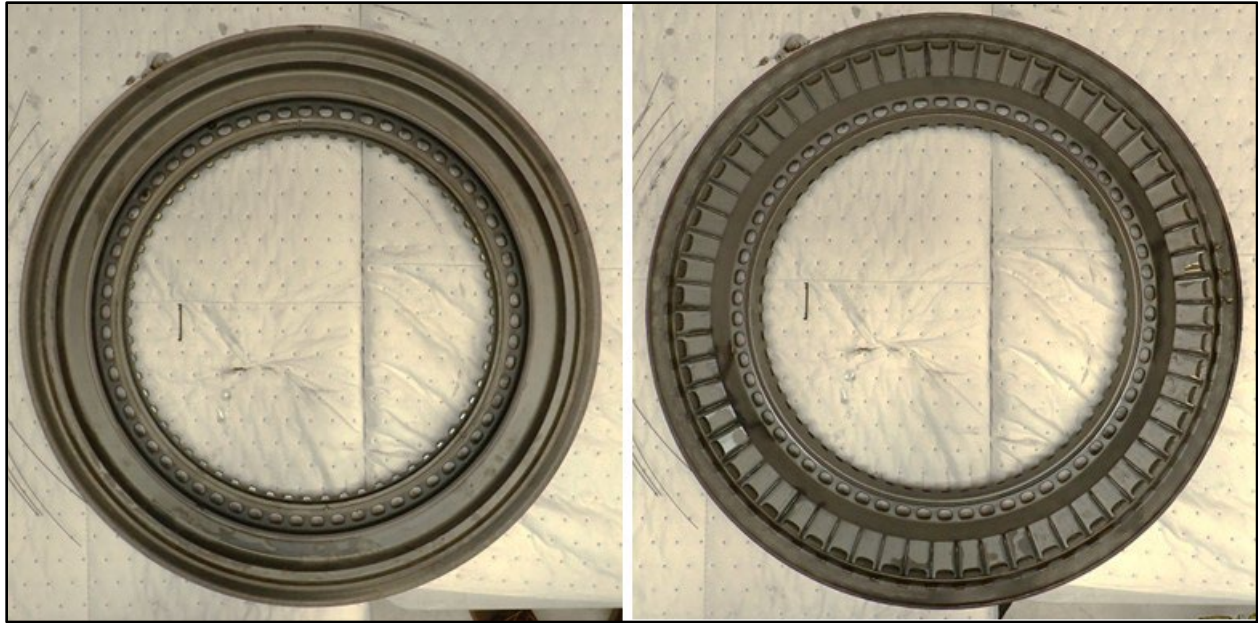
**Figure 43.** HPT FORWARD SEAL

The HPT forward seal serves both as a blade retainer for the forward side of HPT stage 1 blades and also directs/modulates cooling air to the HPT stage 1 blades. The HPT forward seal appeared intact and visually in good condition. The forward side seal teeth were also visually in good condition with no rollovers, but coating chips were observed, which is consistent with rubs into the stationary honeycomb (Figure 43).

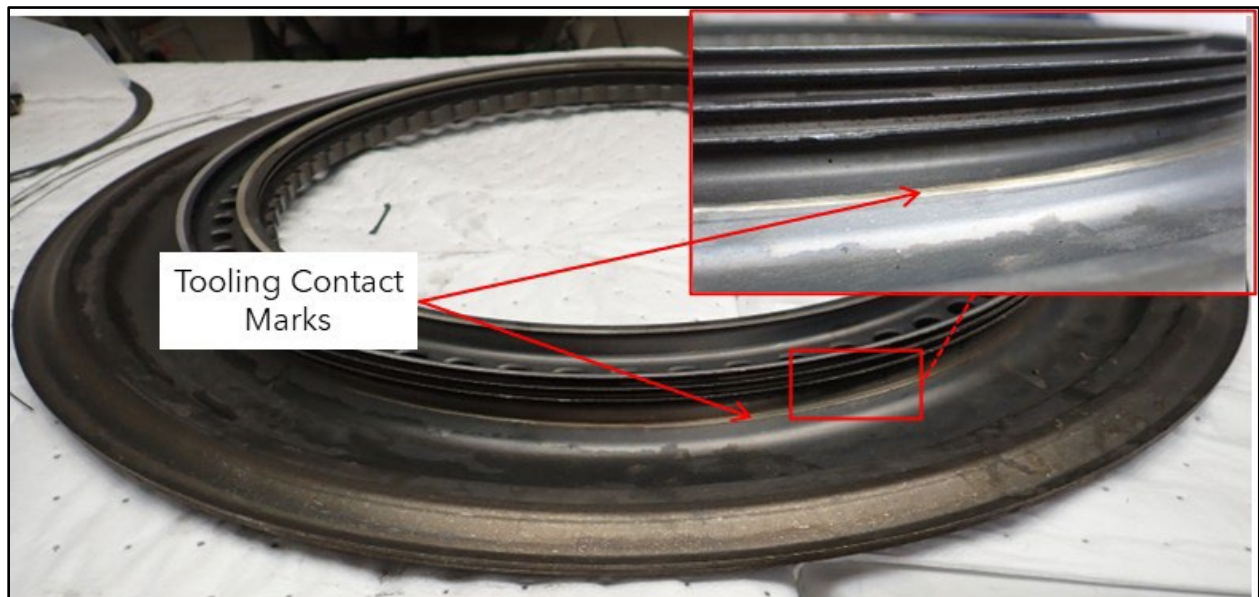
**Figure 44.** HPT FORWARD SEAL – DISASSEMBLY DAMAGE

During the removal of the HPT forward seal, the tooling made contact with the part and left a circumferential rub/cuff mark on the lower web of the forward side (Figure 44).

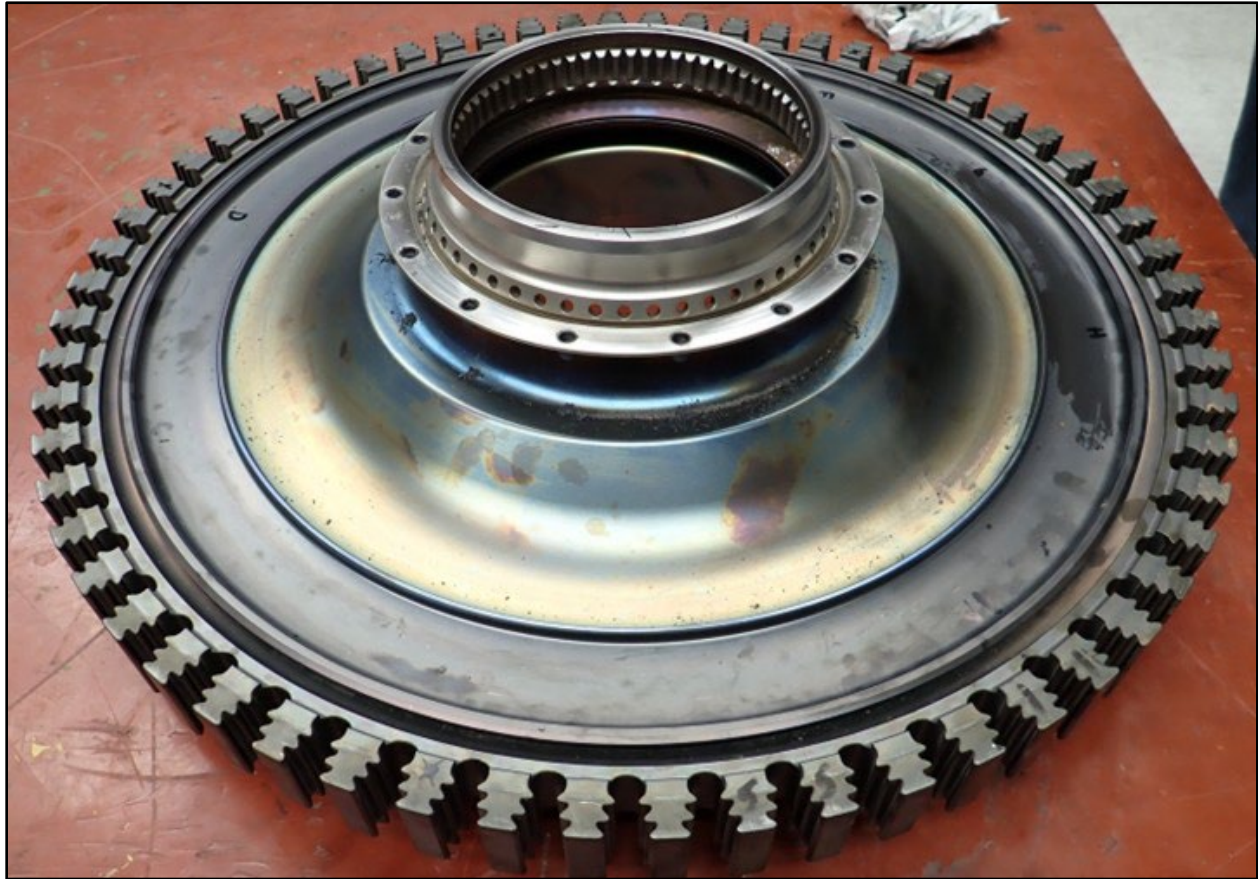
**Figure 45.** HPT STAGE 2 DISK

threads and the splines of the coupling nut were visually in good condition and undamaged. The HPT stage 2 disk posts appeared intact and visually in good condition, the dovetails and splines on the inner diameter of the HPT stage 2 disk were visually in good condition and undamaged (Figure 45).

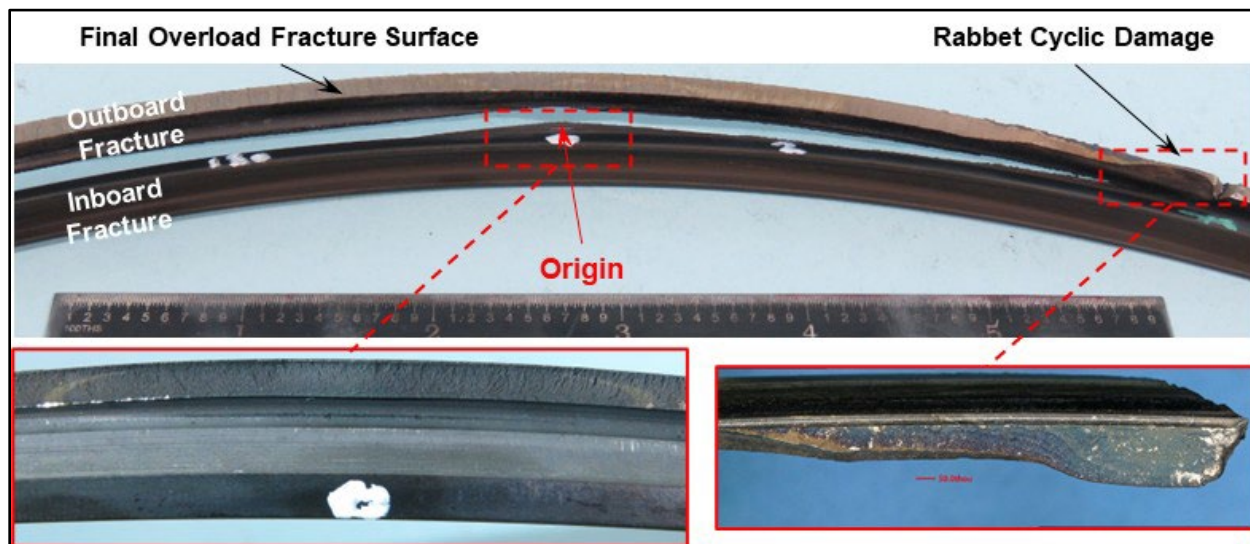
**Figure 52.** HPT Aft Blade Retainer Fracture Surfaces

The HPT stage 1 aft blade retainer presented a 360-degree circumferential fracture surface adjacent to the rabbet undercut fillet and the outboard retainer arm was missing. Fractography revealed the crack initiated in the upper collet radius at a single point of origin which corresponded to a surface connected anomaly that measured 0.005 inches by 0.015 inches by 0.0005 inches. The surface connected anomaly was determined to be a cluster of particles enriched with Titanium, Aluminum, Zirconium, Magnesium, and Oxygen, which is consistent with a cluster of Oxide/Carbonitride/Nitride/Carbide (OCNC) particles. The fracture surface contained an area of intergranular fracture morphology with visible beach marks, consistent with hold-time fatigue growth and the remaining fracture surface was consistent with overload fracture.

cluster was also visible on the outboard side of the fracture but was significantly more smeared.

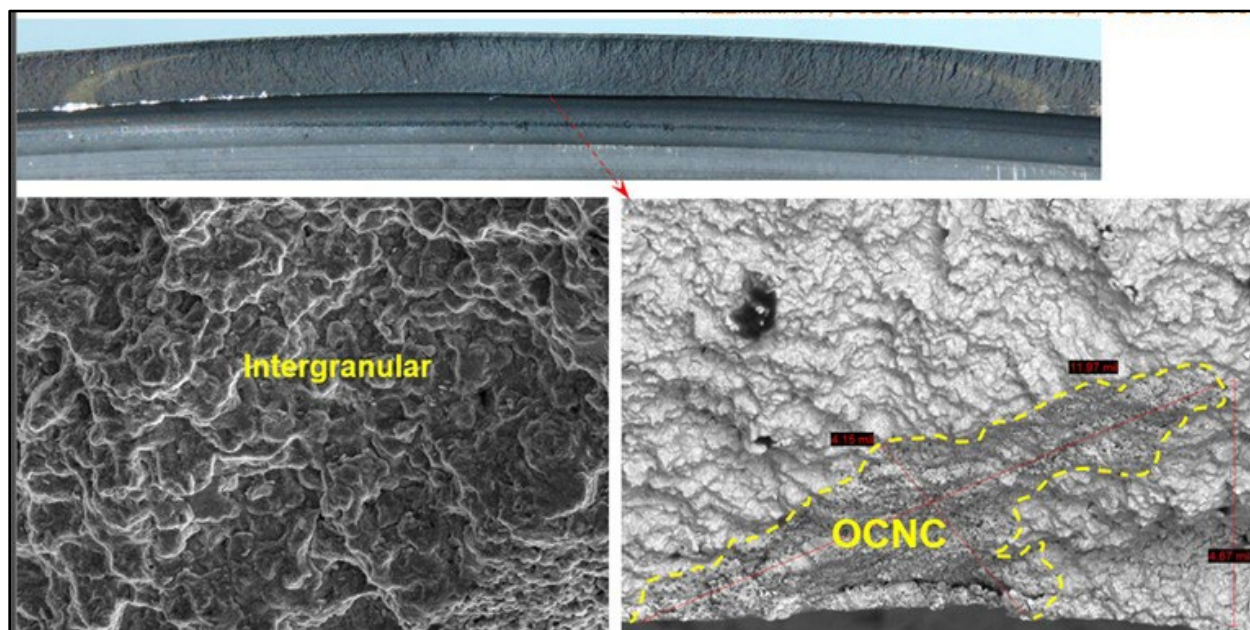
GE's analysis of material test data suggests that surface connected OCNCs have a reduced crack incubation/nucleation life at high stress conditions, and that surface connected OCNCs do not behave according to traditional crack growth threshold behavior. Due to the difference between the original calculated life capability (e.g. crack initiation) and the observed operational cycles, GE performed a material sensitivity study to assess the sensitivity of the collet feature in the HPT stage 1 aft blade retainer to various parameters identified within the fault tree. The event HPT stage 1 aft blade retainer is manufactured from Rene 65, a wrought nickel-base superalloy. GE initiated material test plans to explore the Rene 65 material behavior with focus on low cycle fatigue (LCF) and sustained peak low cycle fatigue (SPLCF) capabilities, by using standard test bar specimens and coupons representative of the collet feature. The studies found that activating surface connected OCNCs can in fact reduce material fatigue life capability and that not every OCNC will initiate a crack, suggesting an unknown bimodal behavior.

**Figure 53.** Inboard Side - Intergranular Fracture (L), OCNC Particle Cluster (R)

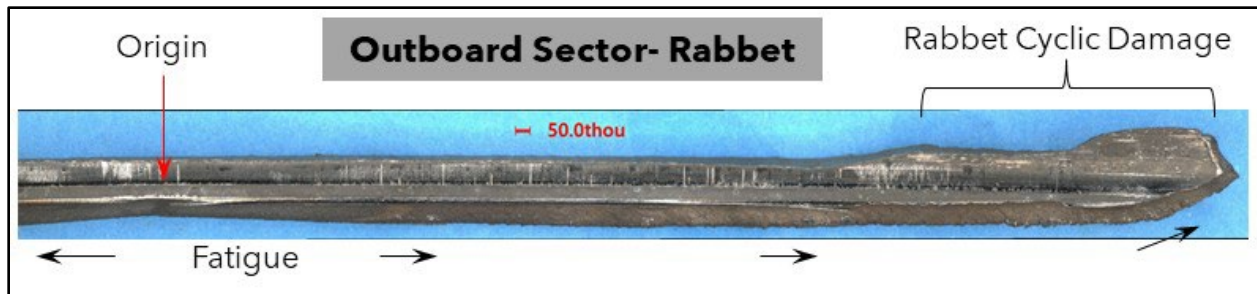
**Figure 55.** Outboard Side - Crack Origin (L), Rabbet Cyclic Damage (R)

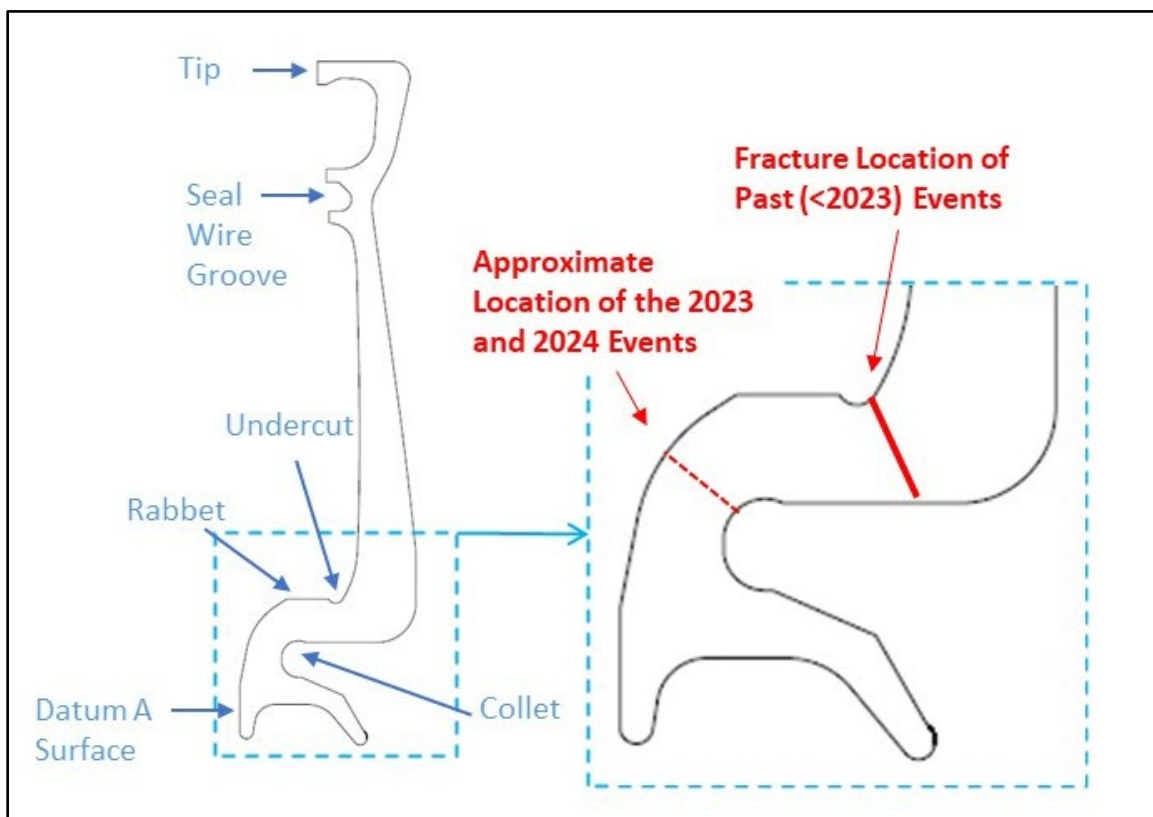
The investigation of this retainer supplements the ongoing investigation into two other cracked HPT stage 1 aft blade retainers; one was an opportunistic find during a scheduled maintenance activity and the other was an in flight failure that led to an uncontained failure event similar to the UAL event covered within this report. A fault tree was established to consider various aspects of the component design, material, and operational factors to identify possible causes and contributing factors.

**Figure 57.** HPT Stage 1 Aft Blade Retainer – Current & Past Fracture Locations

The corrective actions focused on inspection/removal of suspect HPT stage 1 aft blade retainers, and continuous fleet monitoring for specific shifts in core engine vibration trends. The short-term containment actions include service bulletins (SB) for the removal/inspection/replacement of the HPT stage 1 aft blade retainer at the piece part level, SBs for the ultrasonic inspection of the HPT stage 1 aft blade retainers at the module level, and the use of a data analytic tool to monitor core vibration trends in all GENx engines. At the time this report was nearing completion, there were at least 477 HPT stage 1 aft blade retainers removed from service for inspection and at least 55 HPT modules ultrasonically inspected, with zero crack findings to date.

The long-term corrective action being pursued by GE will re-establish the manufacturing process for the previously approved HPT stage 1 aft blade retainer configuration made of a Rene 88 alloy, a nickel-based superalloy powder metal. GE intends to make the Rene 88 retainer the primary configuration. The Rene 65 retainer will remain certified for use and listed in the illustrated parts catalog (IPC) but it will no longer be available as a spare part, further diminishing the population of the Rene 65 retainers through attrition.
