# National Transportation Safety Board

ENG24LA014

GE Aerospace - Metallurgical Investigation Report (DRB AvEng-558171.A)

**METALLURGICAL EVALUATION OF A GENX-1B  
HPT STAGE 1 AFT BLADE RETAINER INVOLVED IN  
AN UNCONTAINED EVENT FROM ESN 956-102  
OPERATED BY UNITED**

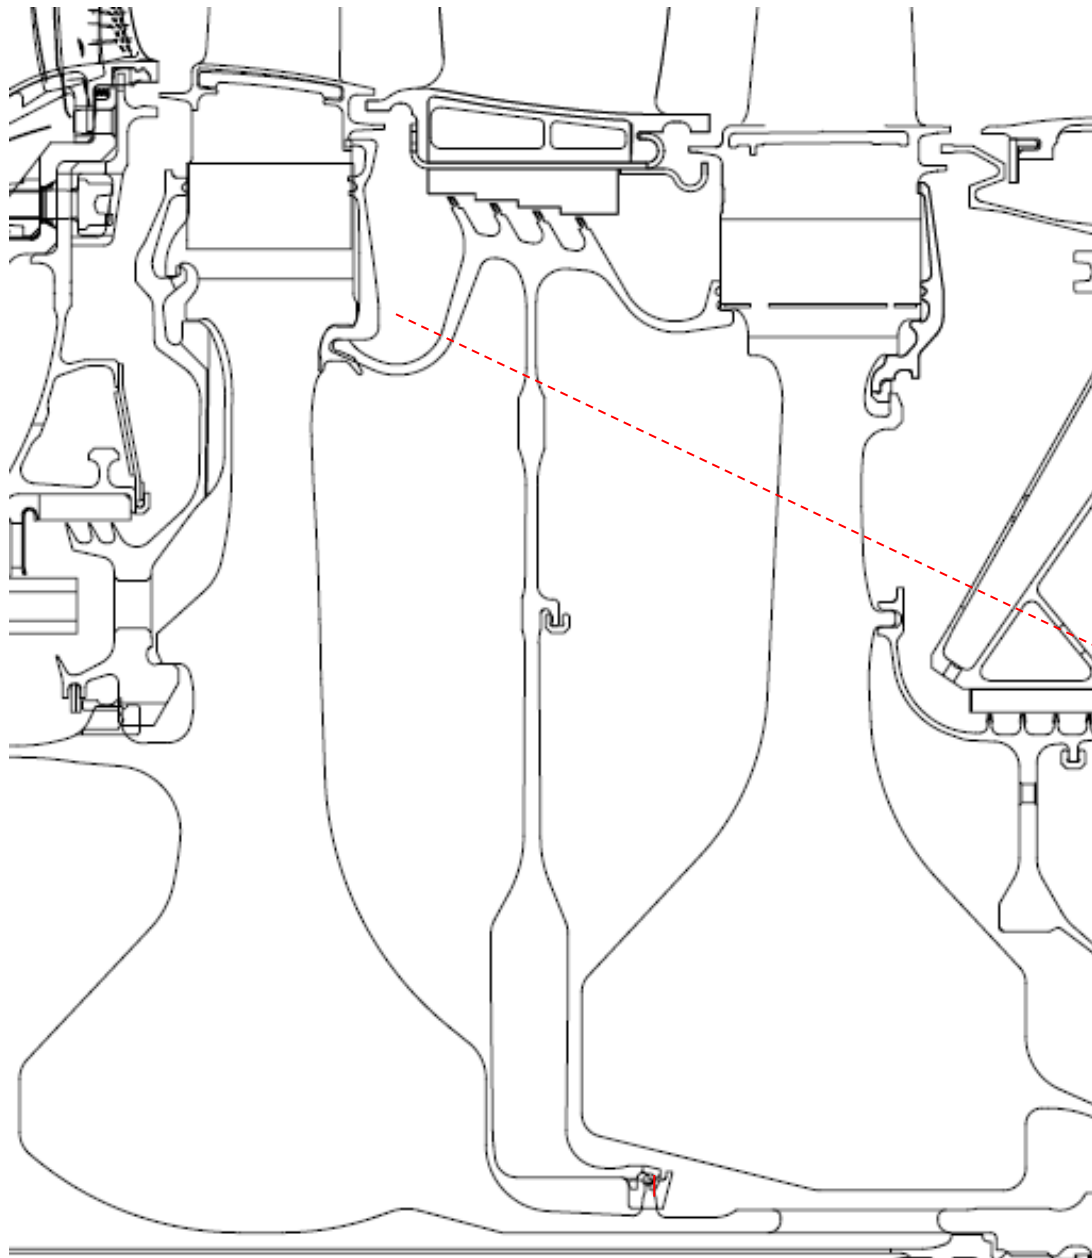
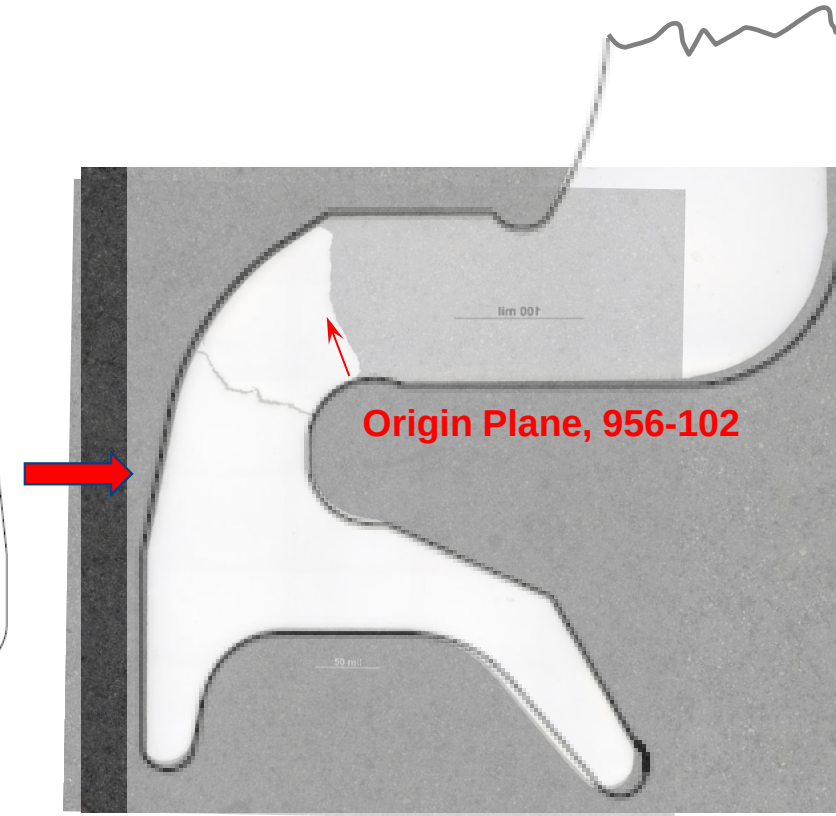
**Figure 1:** Schematic of the GEnx cross-section showing the location/configuration of the retainer and the fracture plane for 956-102 that grew from the outer area of the collet radius and grew outboard.

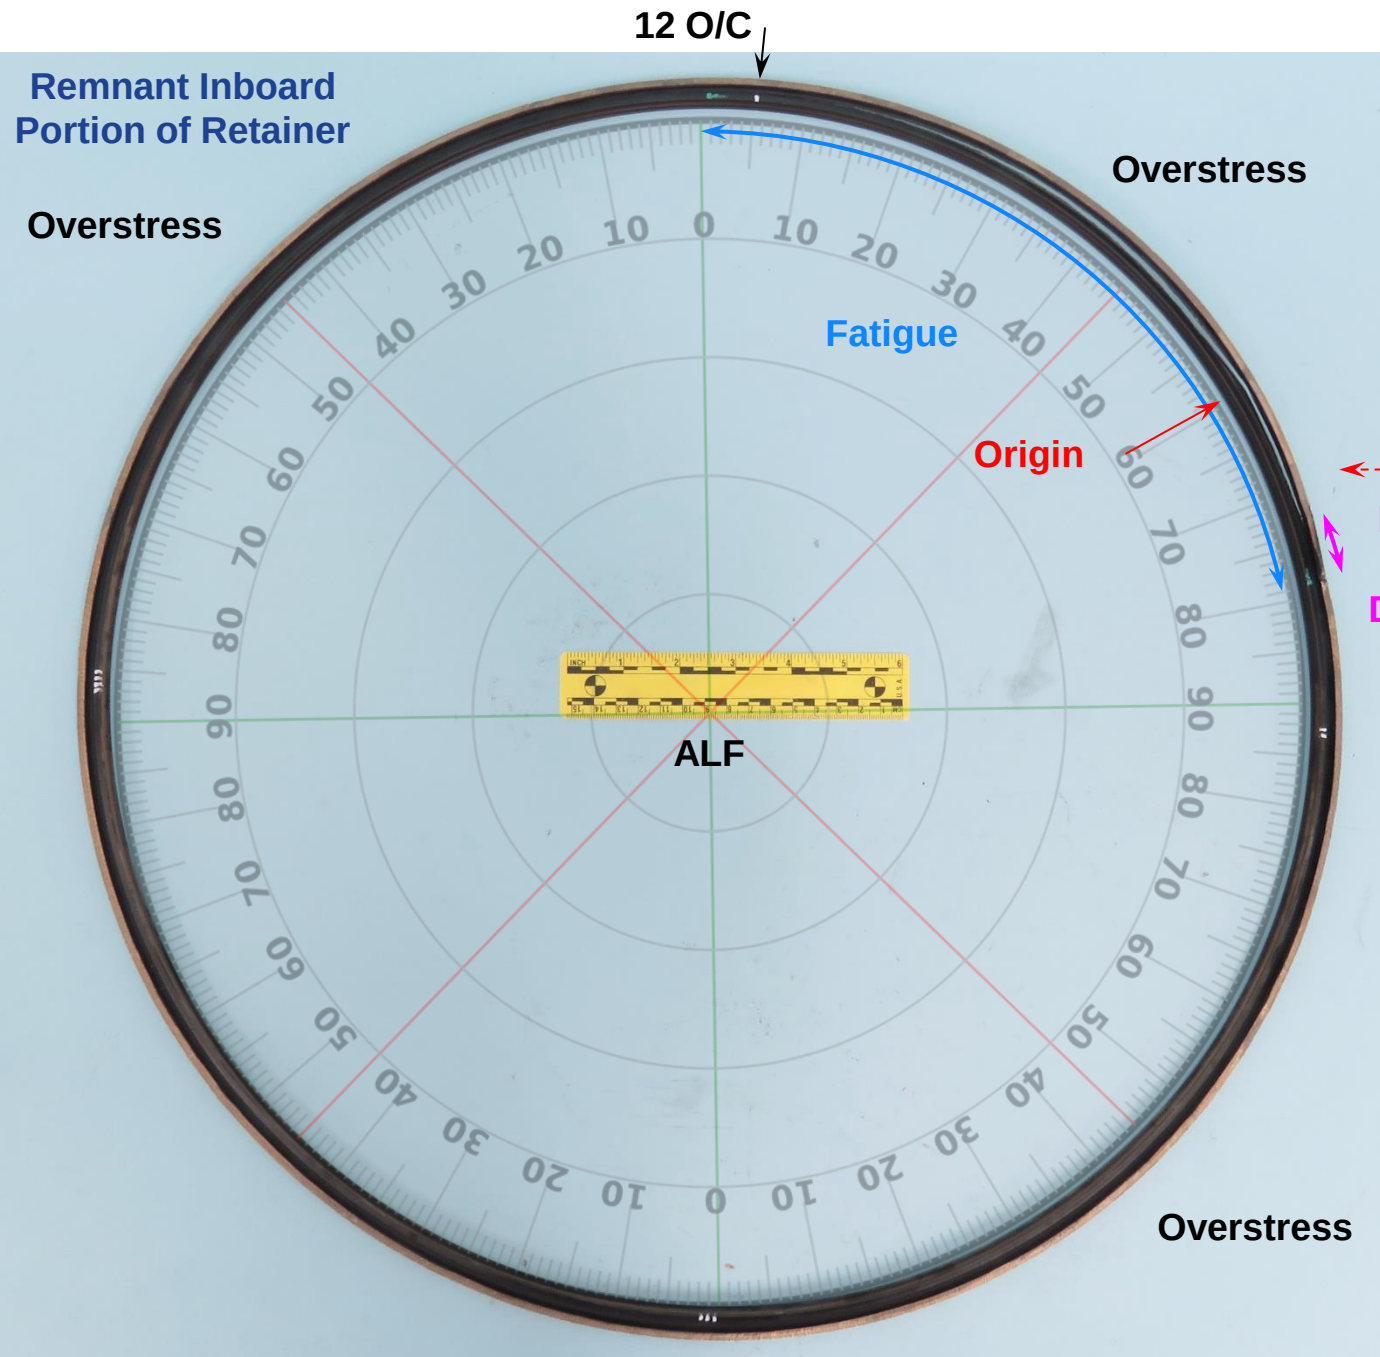
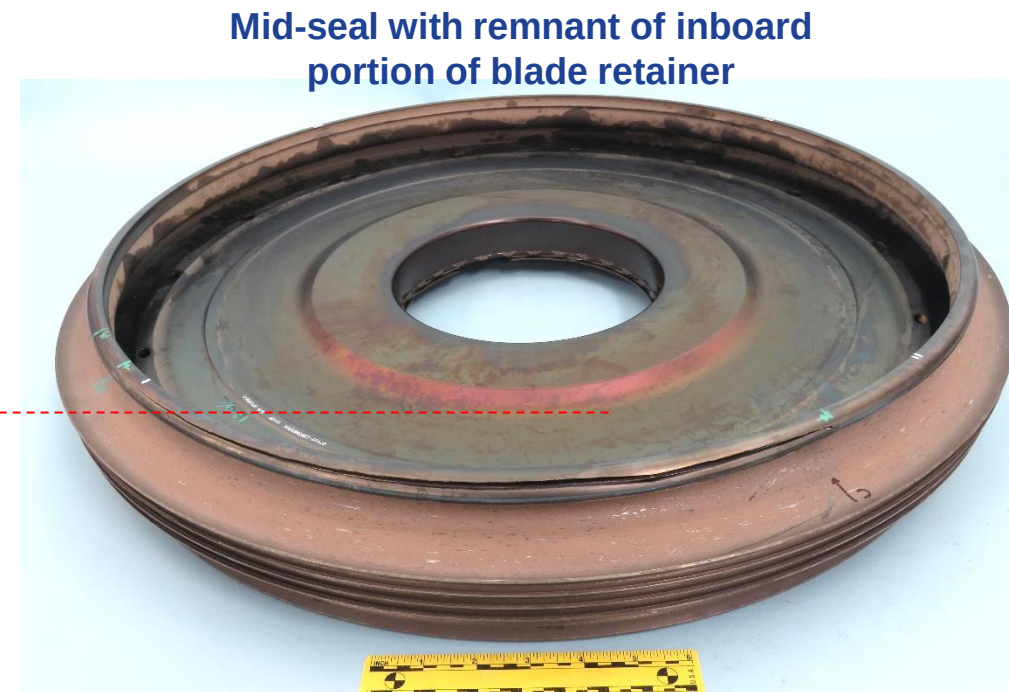
- Visual examination revealed that the entire outboard arm from the disk undercut rabbet radius was liberated. The inboard portion had an approximate **80-degree through-wall circumferential** crack between approximately 12-2:30 (relative to S/N) in the inboard **collet radius** consistent with fatigue (Figure 2). The crack then moved aft into the retainer disk rabbet radius and fractured 360 degrees around with features consistent with overstress (overlapping the fatigue region). At the fatigue/overstress transition region there was also a region with cyclic damage (Figures 2-3).

**Figure 2:** Optical views of the mated mid-seal and remnant portion of the retainer (right), with a view of only the retainer remnant on the left. The images show an approximate **80 degree** circumferential region consistent with fatigue that extended along the outboard part of the collet radius. The fracture then extended further aft in the disk rabbit radius in overstress and extended 360 degrees around and overlapped the fatigue region. In addition, there was a small region of cyclic damage near the end of the stable fatigue region.

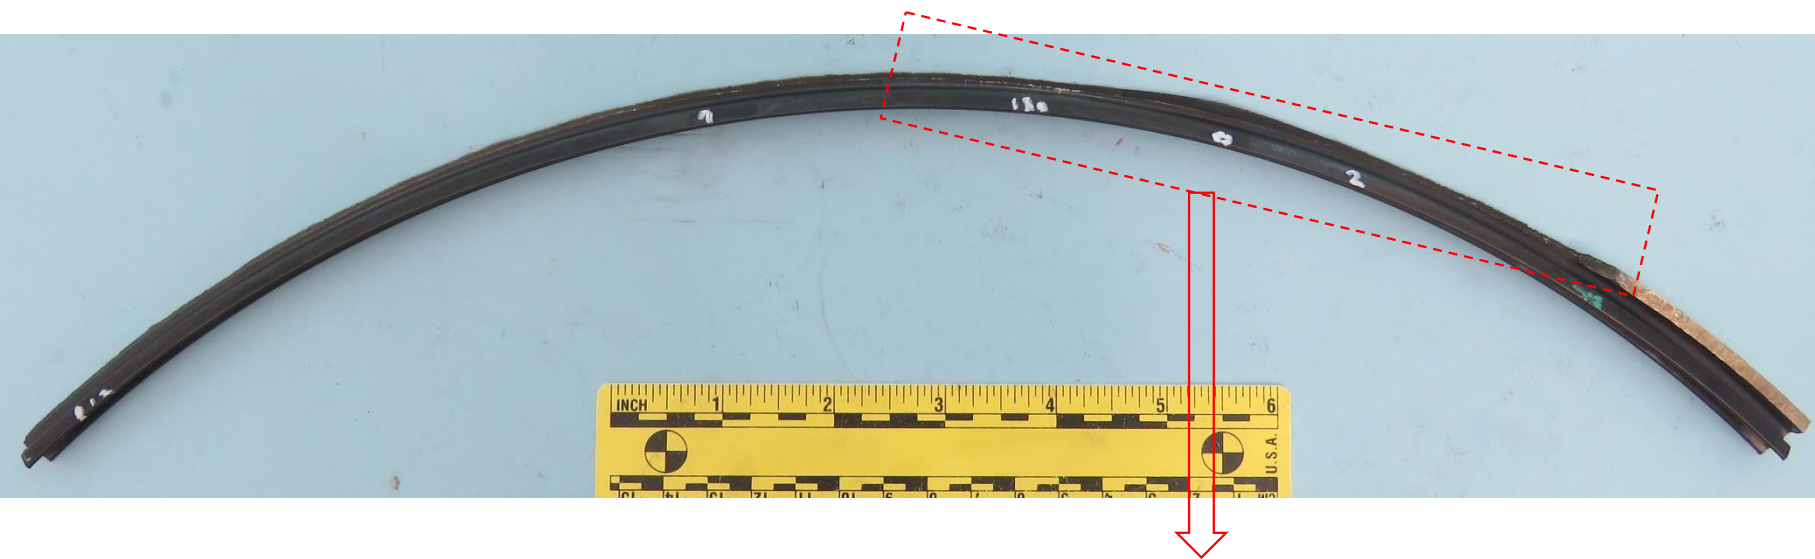
**Figure 3:** Optical view of the excised mating halves of the inboard portions of the retainers that remained in the engine. The images show that the fatigue region initiated at the top (outboard) side of the collet feature and then moved further inboard as it grew circumferentially. Near the end of the fatigue region, additional cyclic damage was observed in the rabbet undercut region growing inward (pink area). The crack then finally separated in overstress 360 degrees around in the plane of the undercut radius.

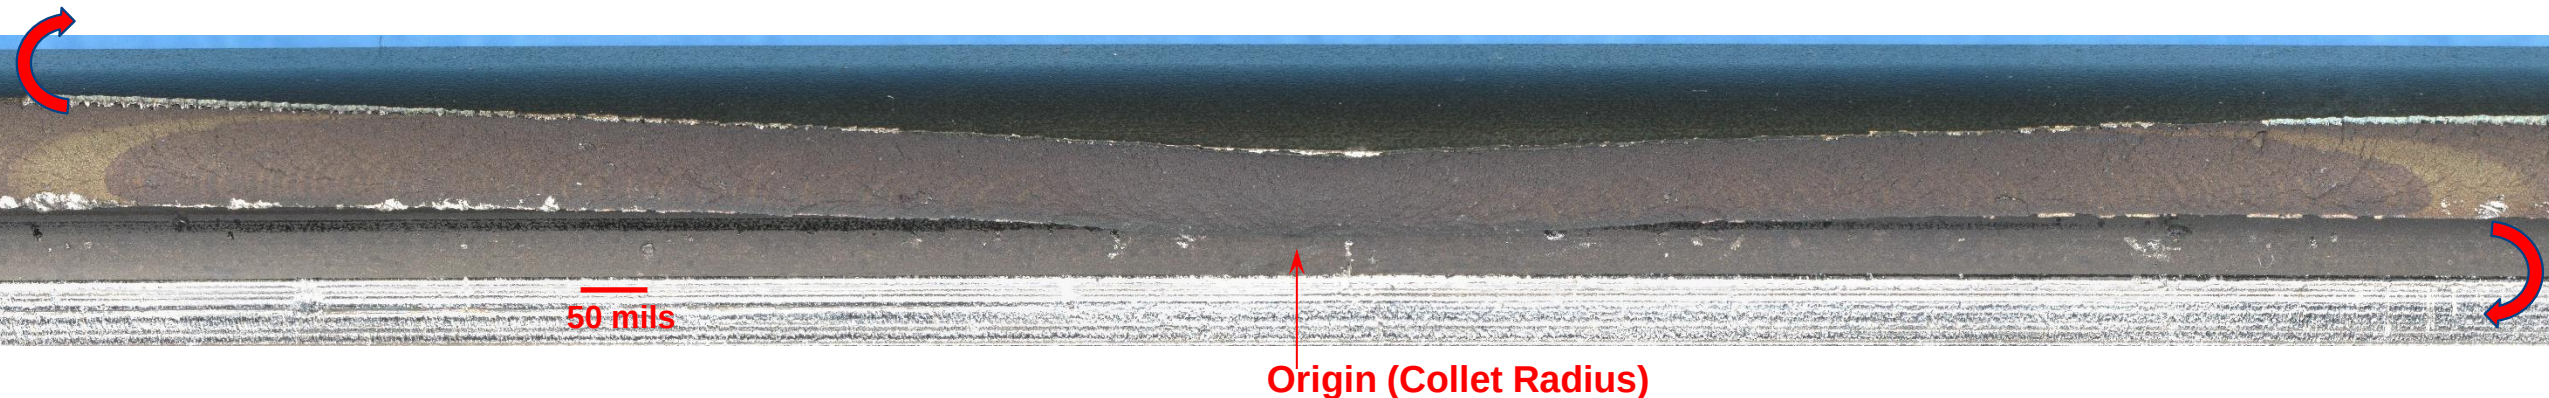
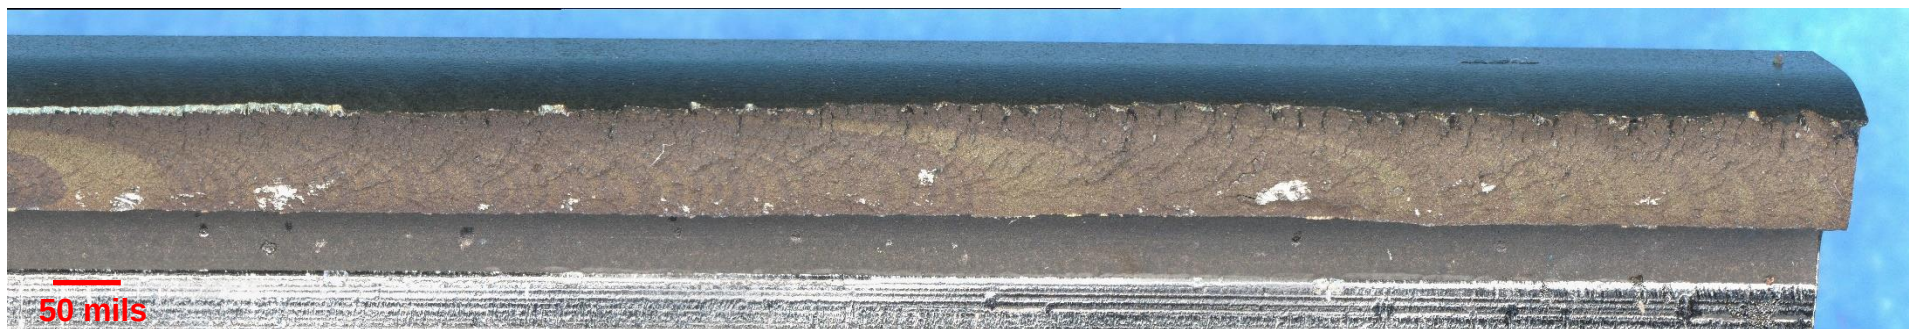
- Beyond the inclusion, the entire fracture surface was **intergranular** consistent with **hold-time fatigue growth**. No visible striations were observed, though beach marks were observed (Figures 4 and 15).

**Figure 4:** Optical views of the inboard fracture surface showing opposing beach marks consistent with cyclic growth/fatigue growing in both circumferential directions from the origin area in the collet radius.

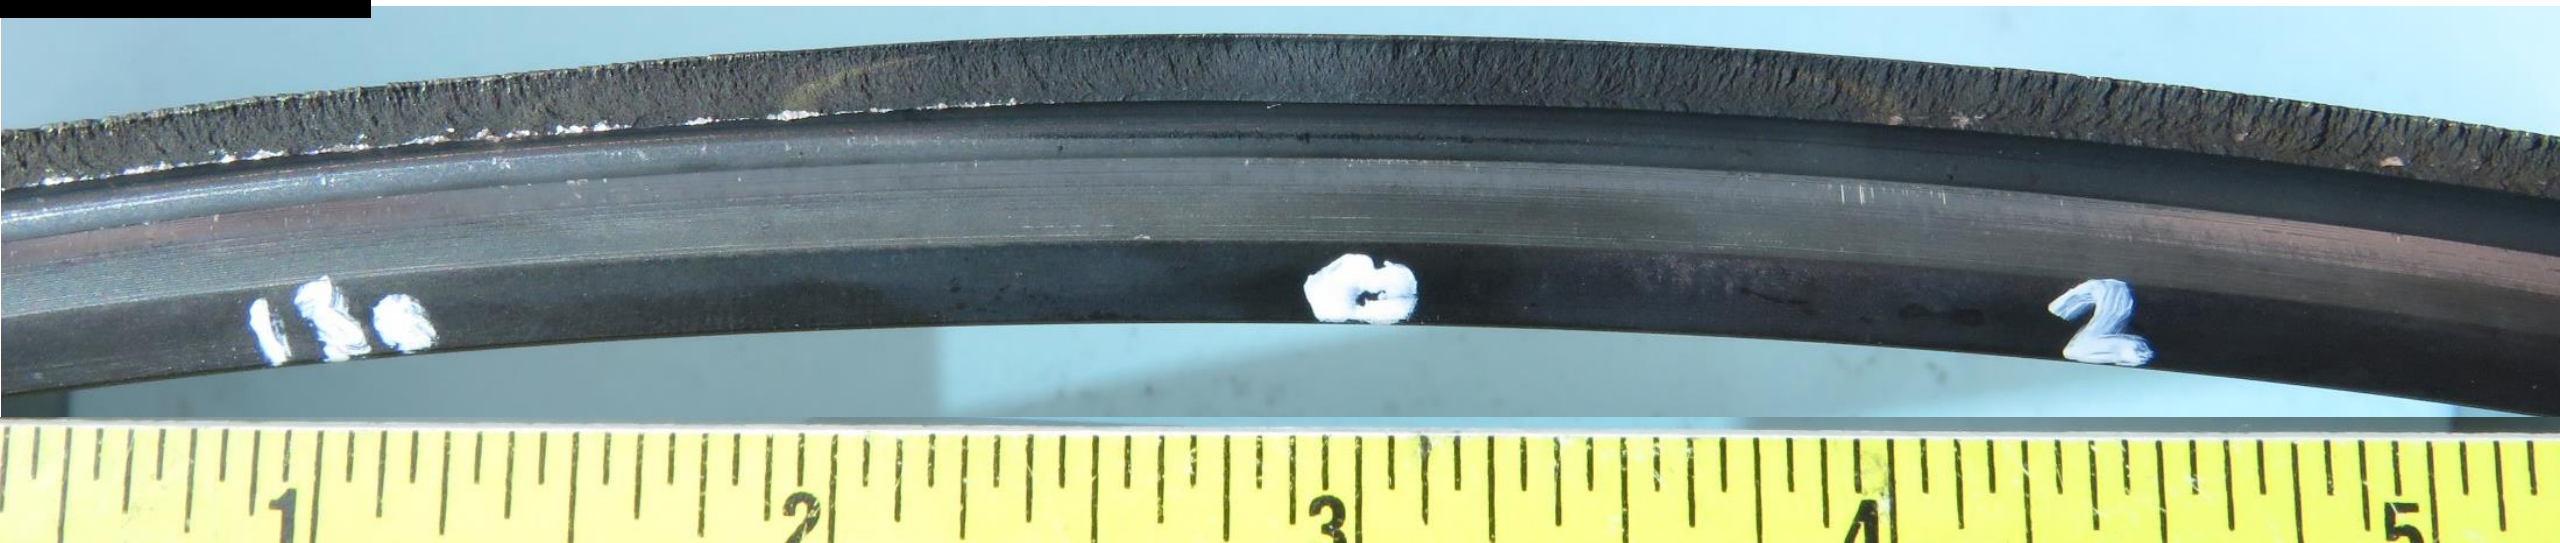
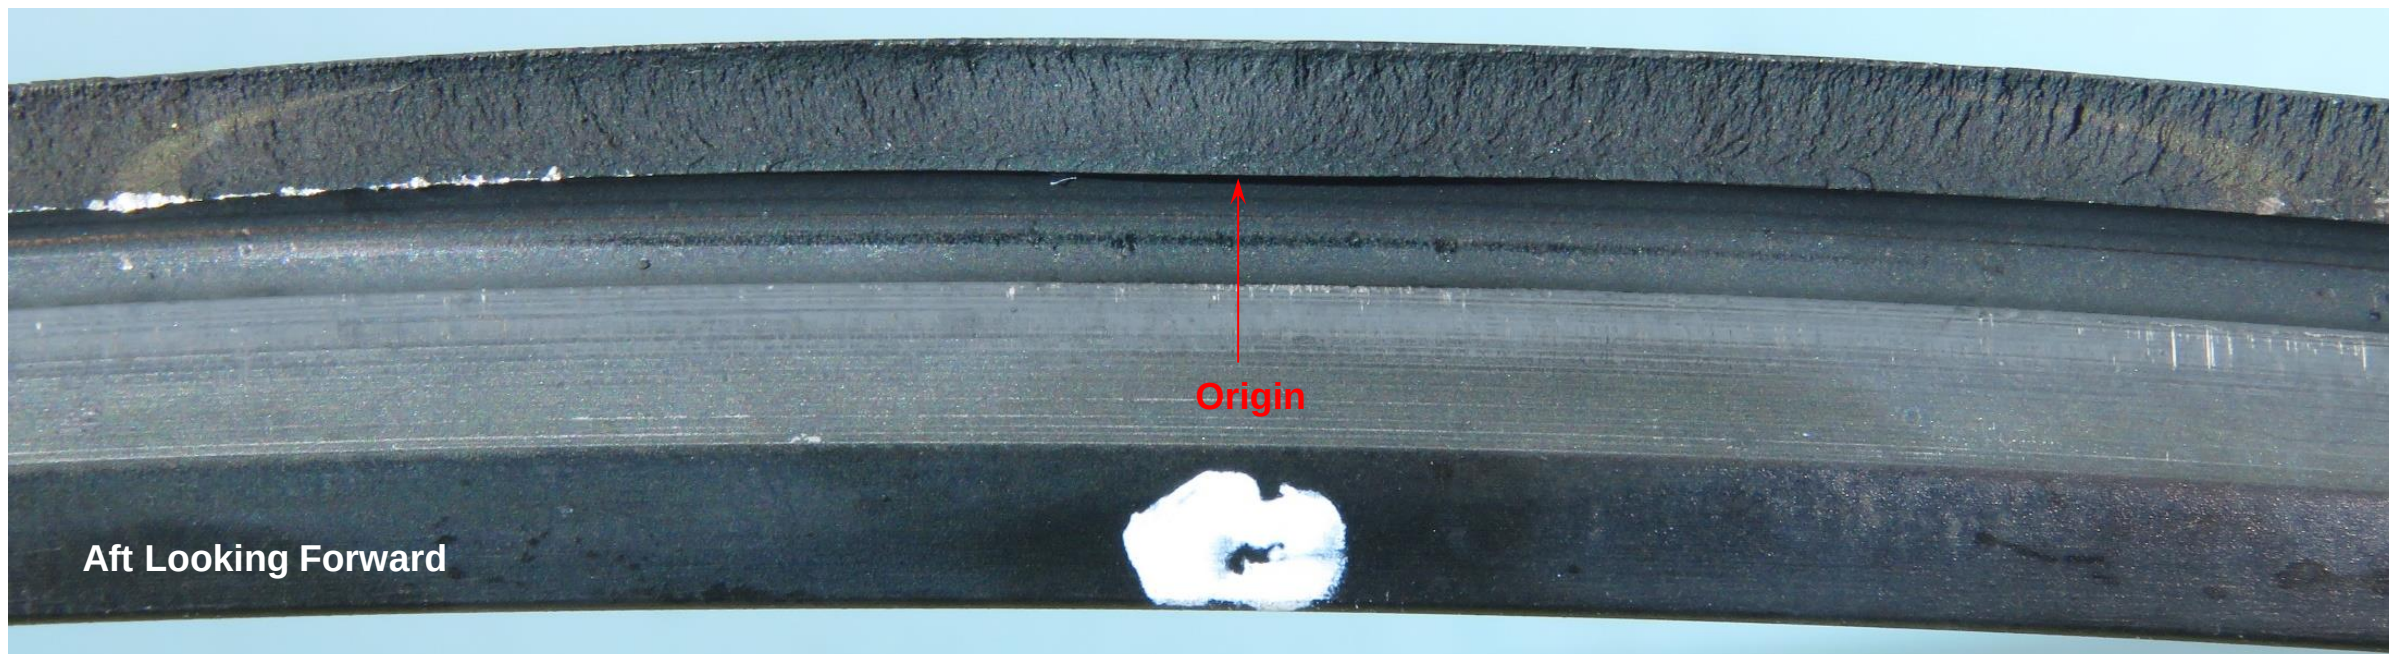
- Examination of the collet region showed that the fracture **initiated** from the collet rabbet radius **surface** from a **single origin**. The fracture grew in a planar manner with beach marks consistent with **fatigue**. The origin fracture plane was initially close to **20 degree angle from vertical** and initiated approximately **48 mils** forward of mid-seal OD rabbet, then moved further inboard toward mid-radius (Figures 3-6 and 30).

**Figure 5:** Close-up low-angle optical lighting view of the inboard fracture showing it was planar consistent with fatigue extending from a single origin at the collet surface growing through-thickness and circumferentially in both directions.

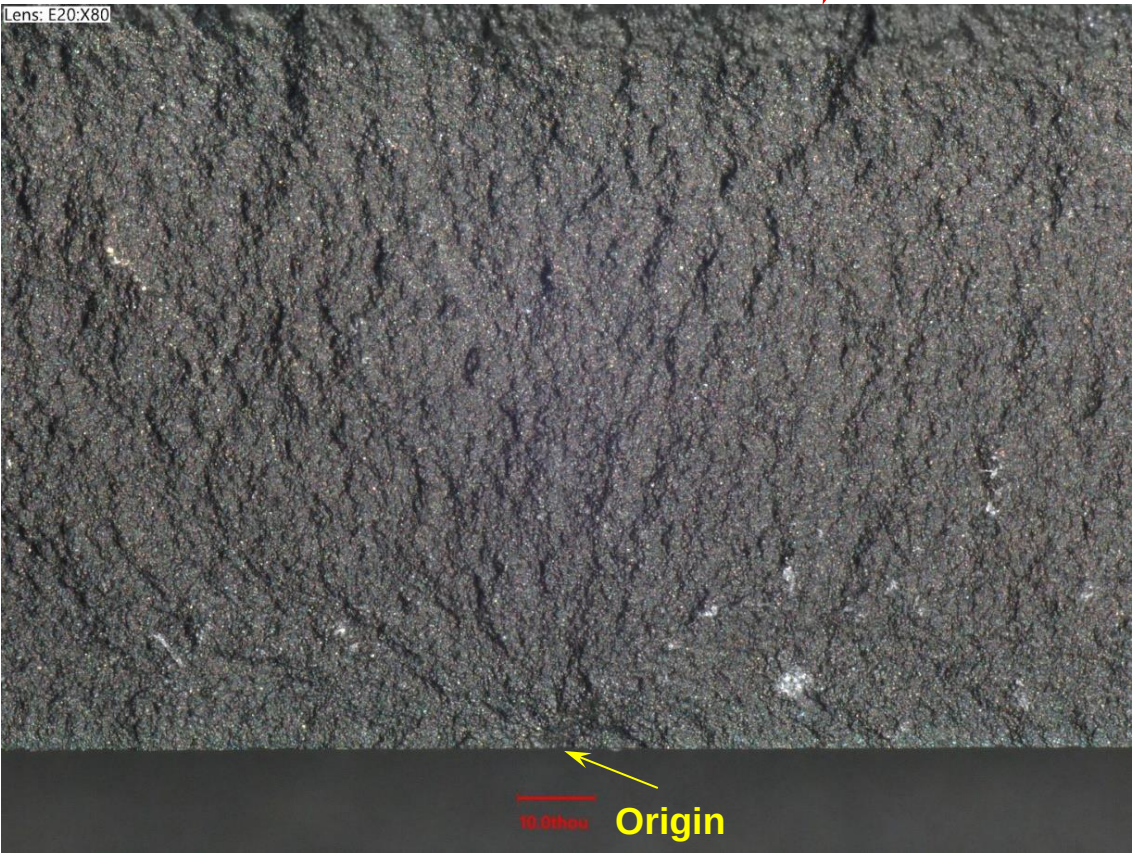
**Figure 6:** Close-up optical view of the fracture surface in the region of the origin showing that it initiated from a single origin at the surface (see SEM).

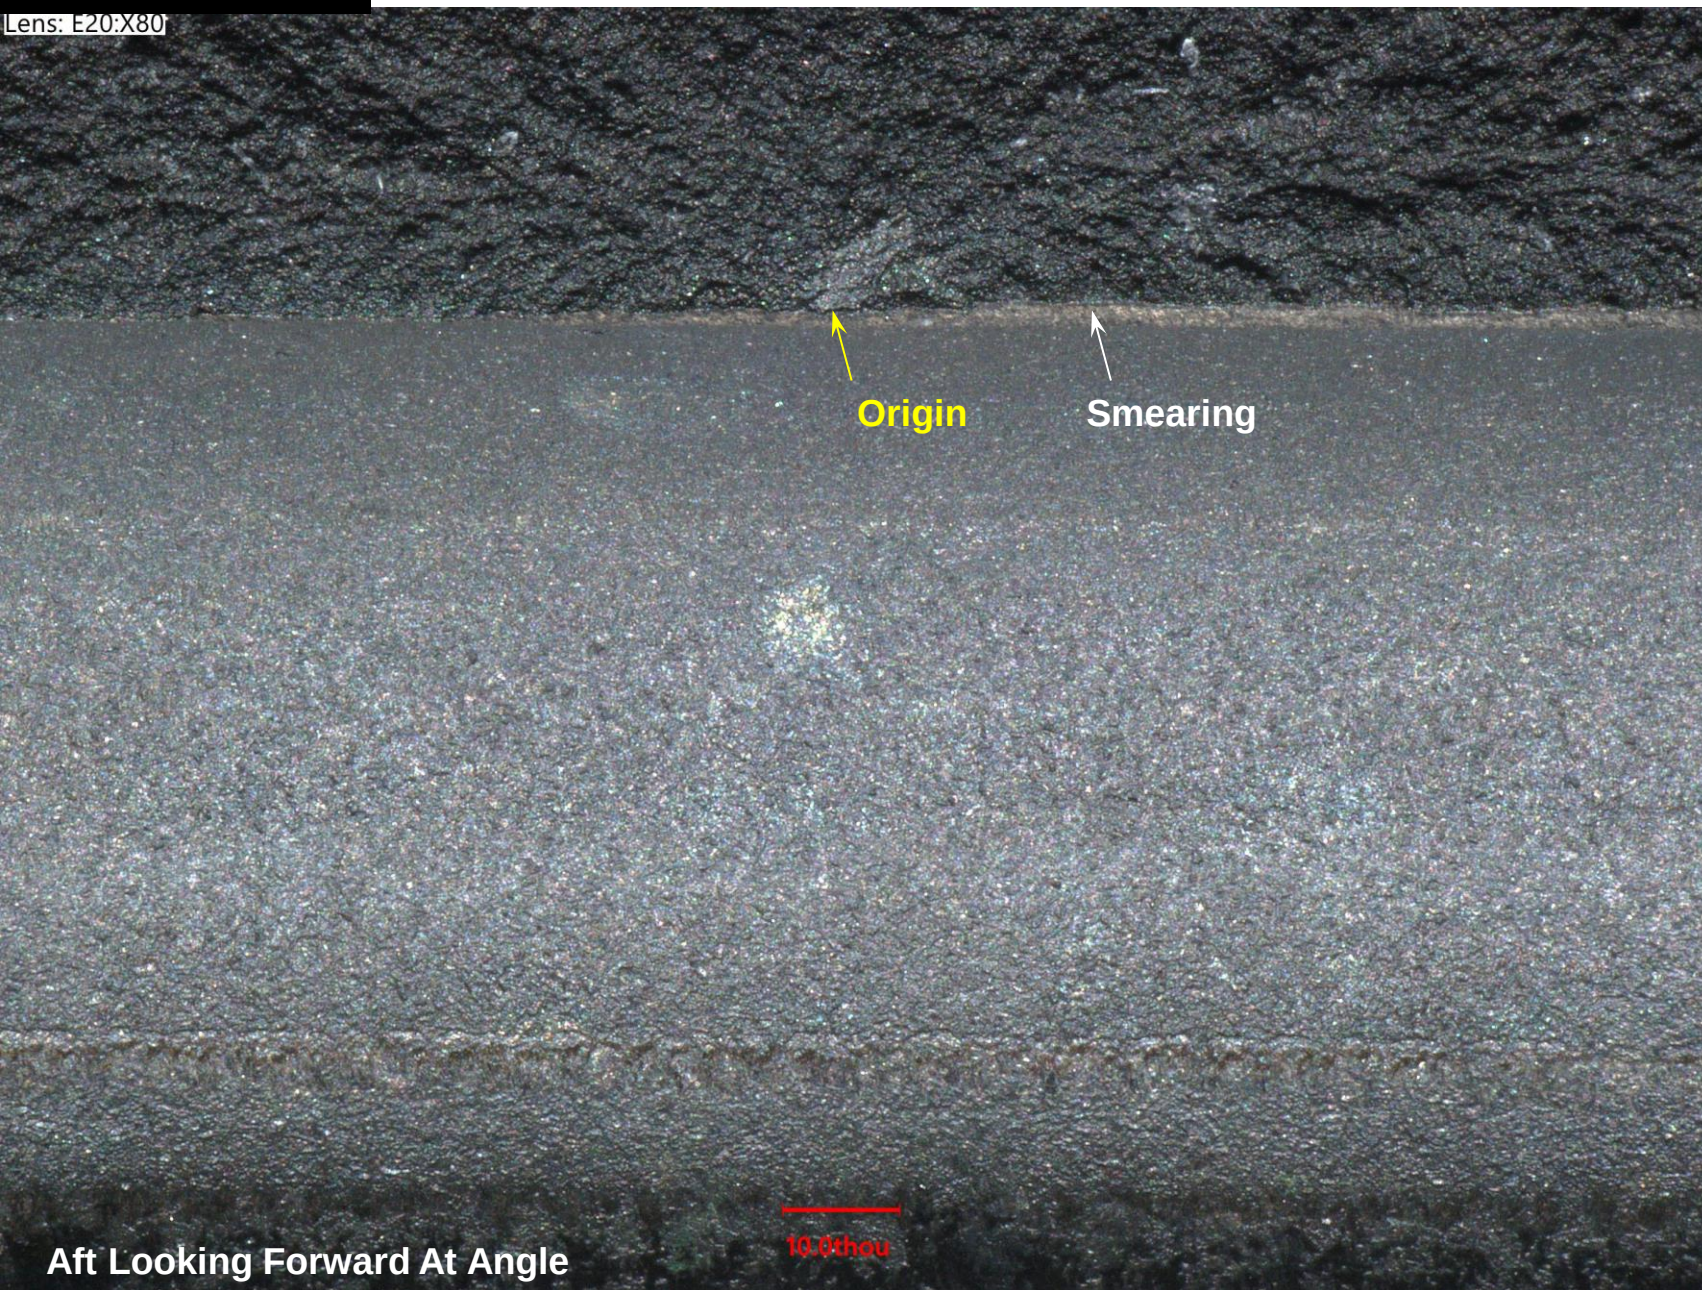
- **No surface anomalies** were observed such as machining/scoring marks, and the surface had dimpled depressions and a roughened surface, consistent with having been shot-peened and wet-blasted per the requirements (Figs. 7 and 14; comparison retainer views are shown in Appendix B).

**Figure 7:** Close-up optical view of the collet surface in the area of the origin showing that the surface had a dimpled pattern with roughened features, consistent with having been shot-peened and wet-blasted per the requirement.

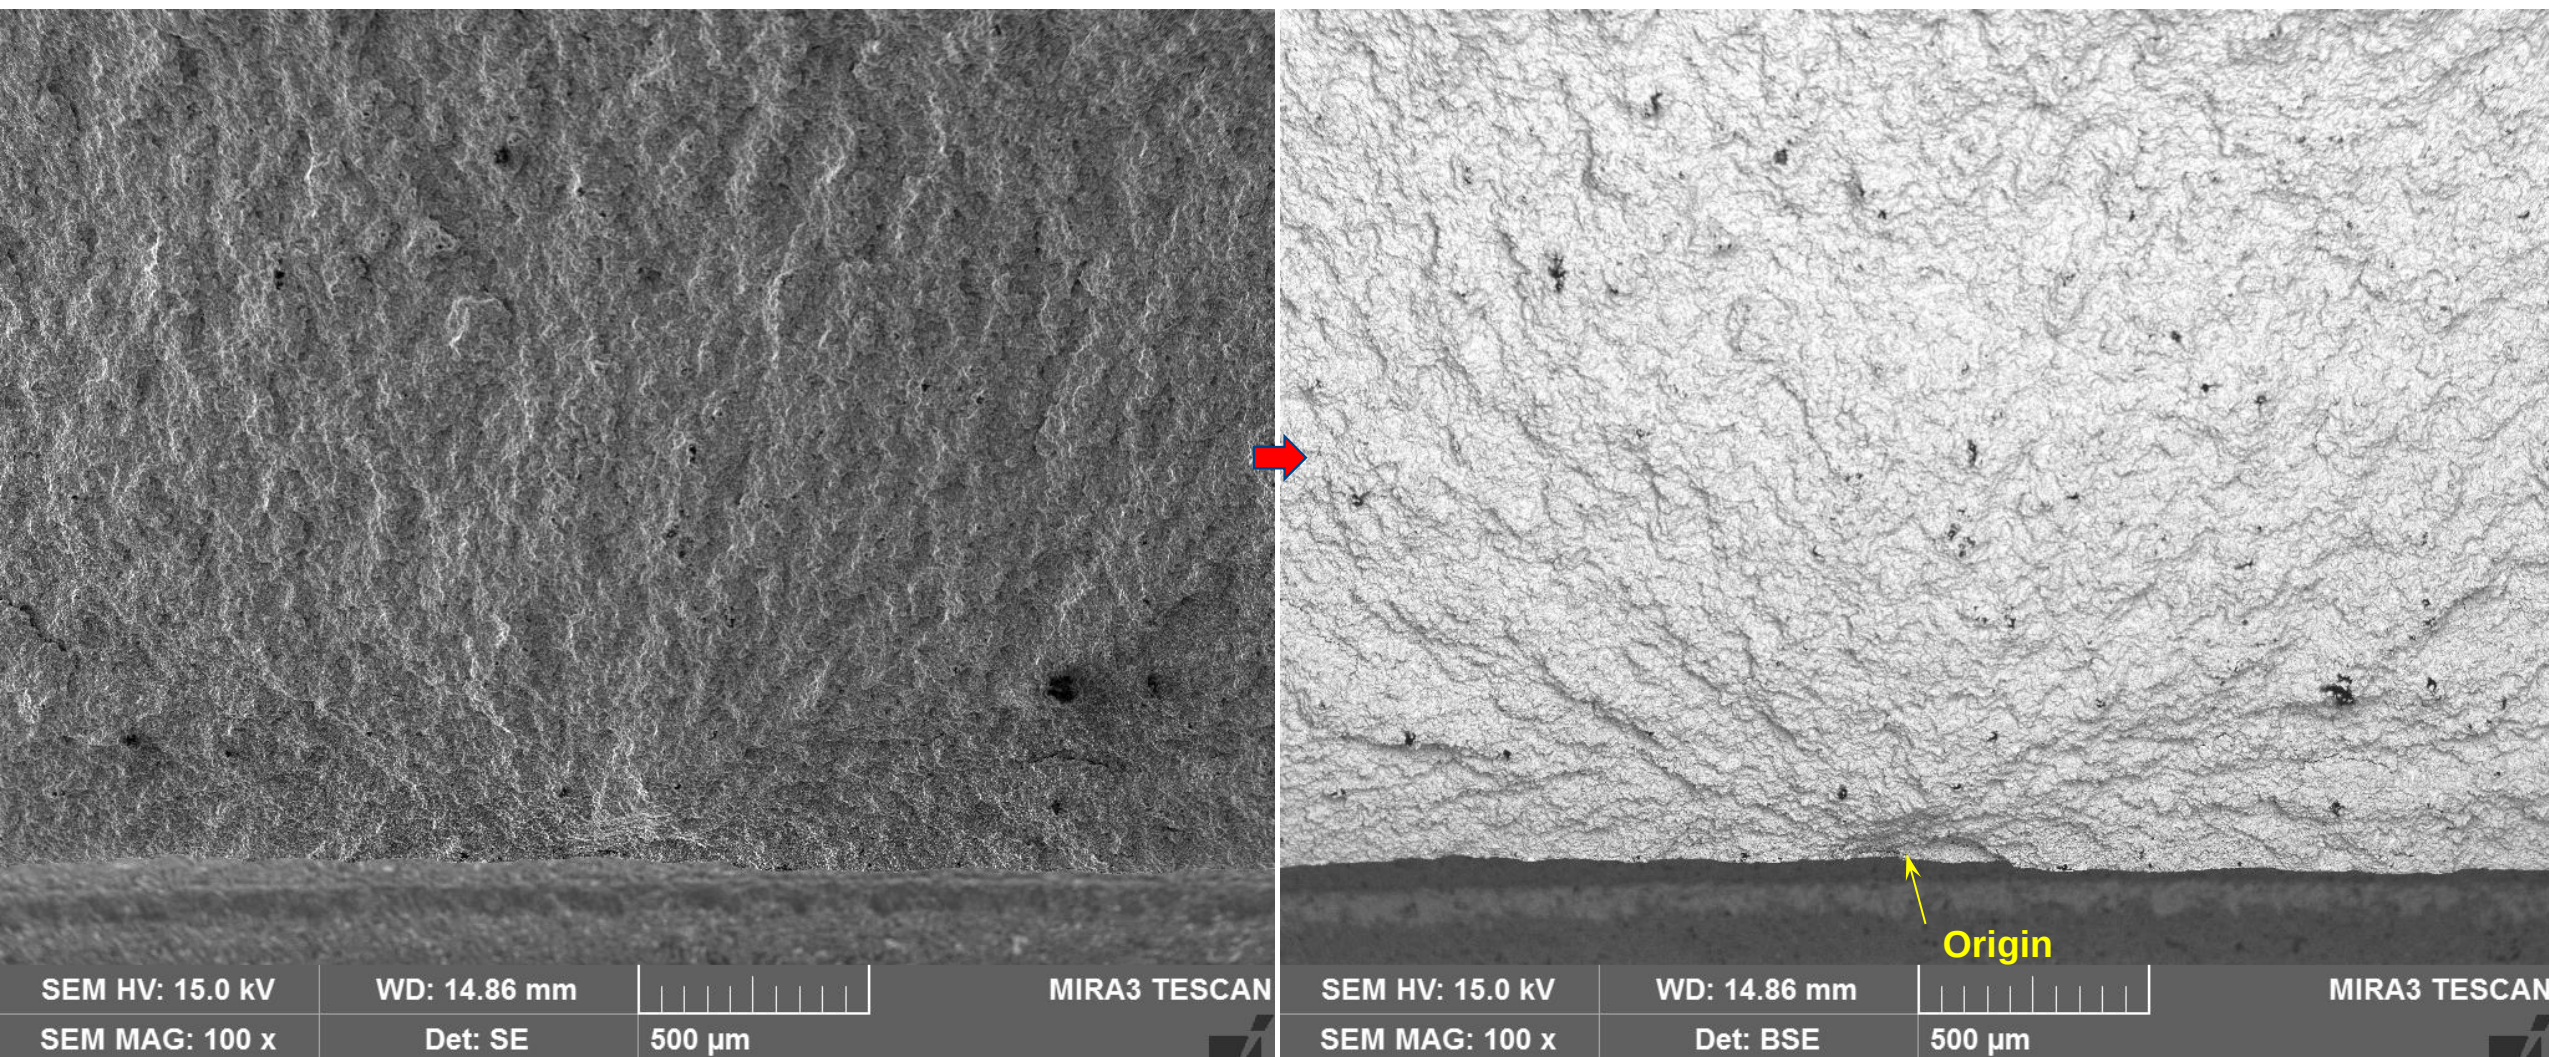
**Figure 8:** SEM examination in SEI and BEI modes confirmed initiation at the surface from a single origin where an OCNC inherent inclusion was observed (see following pages).

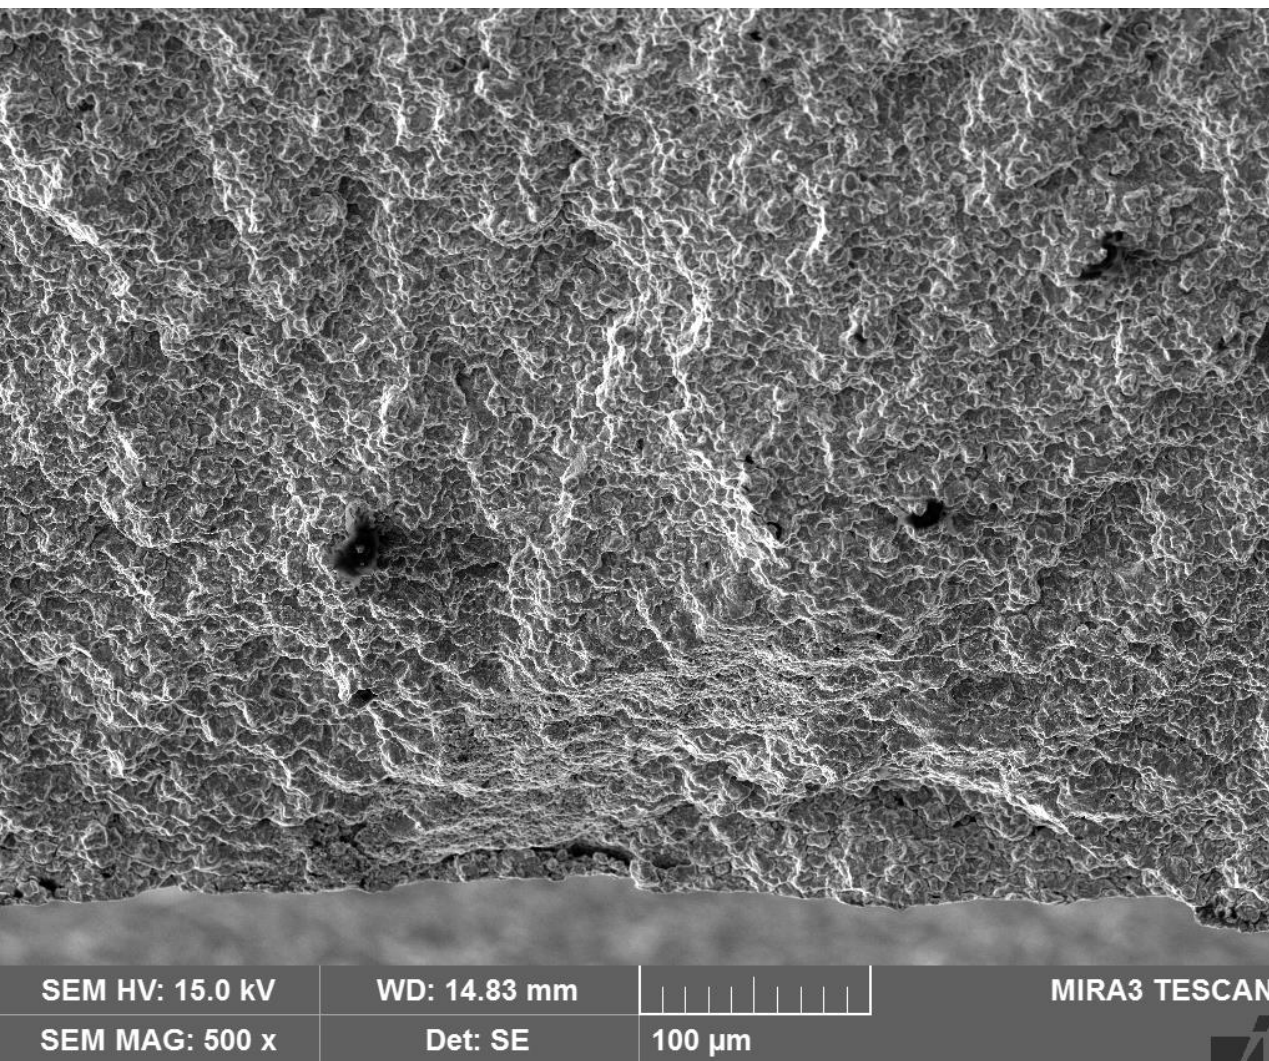
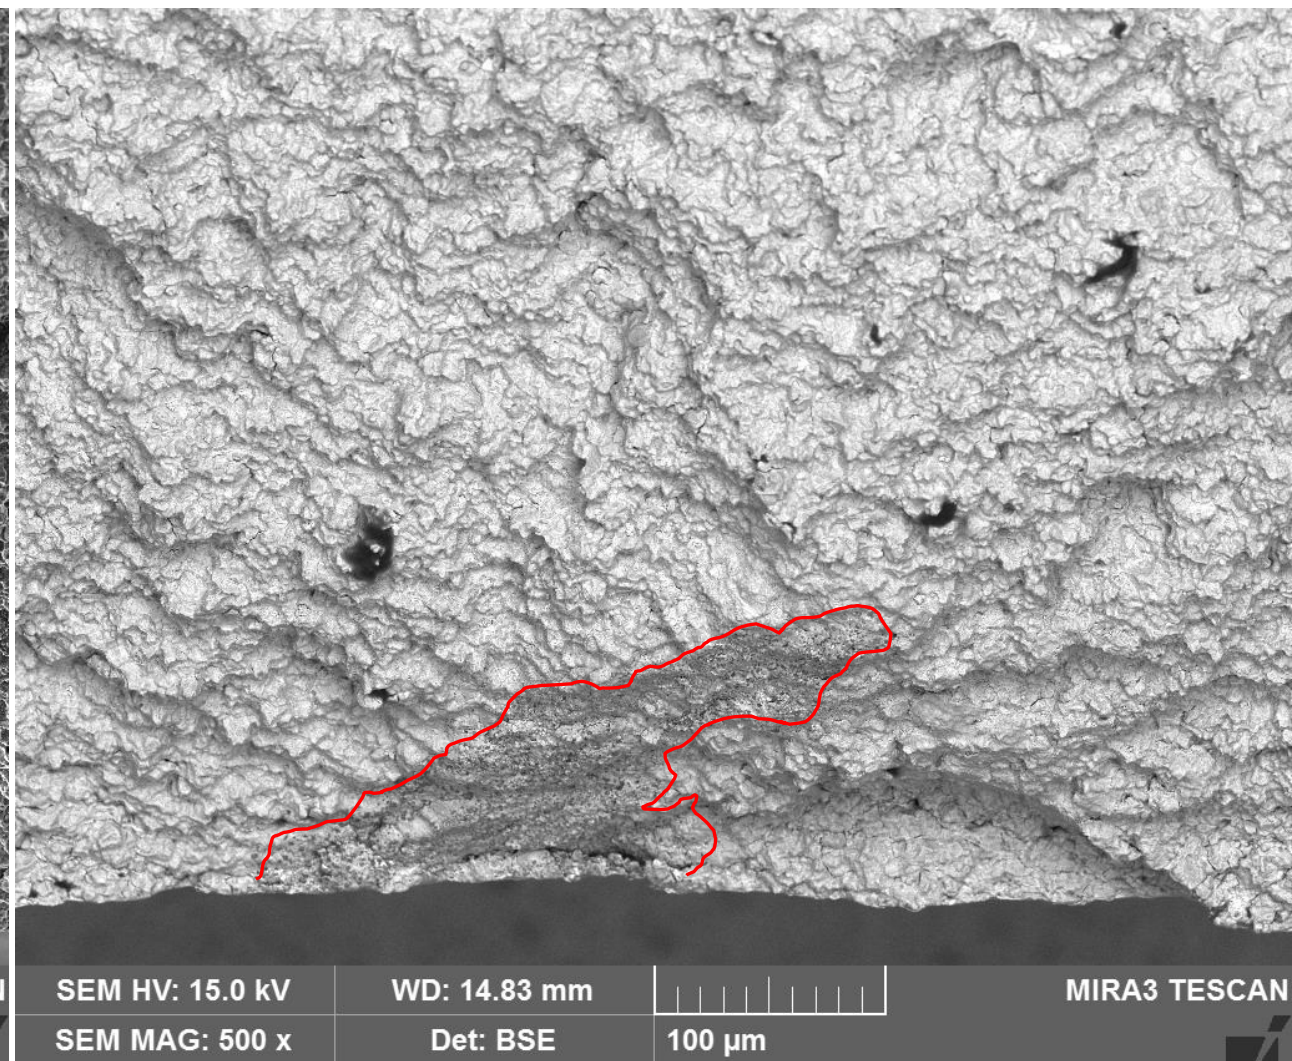
**Figure 9:** Higher magnification SEM images showing initiation from a surface-connected OCNC.

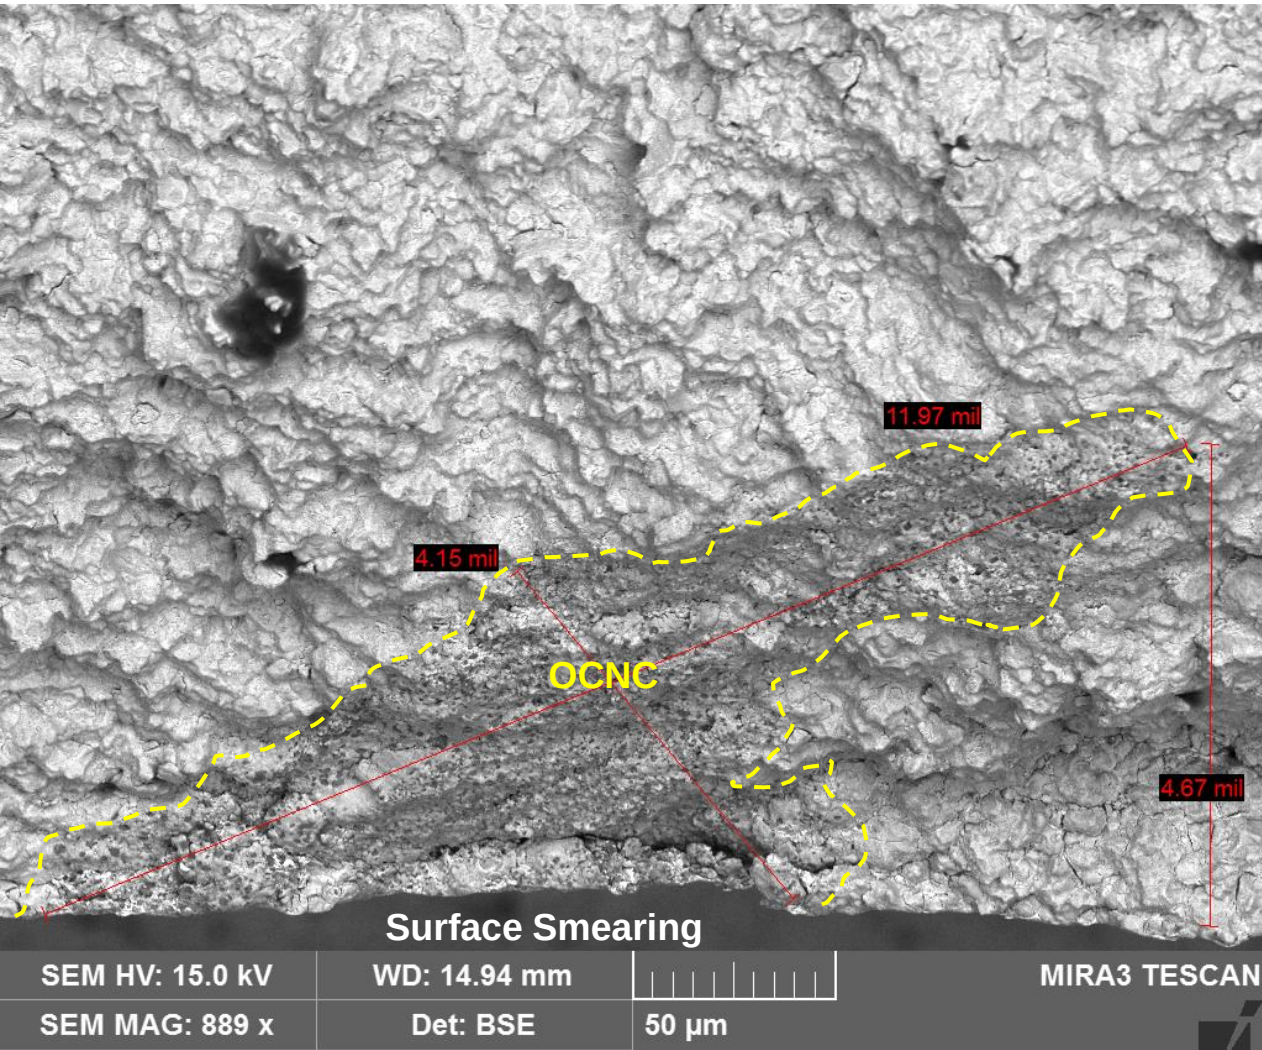
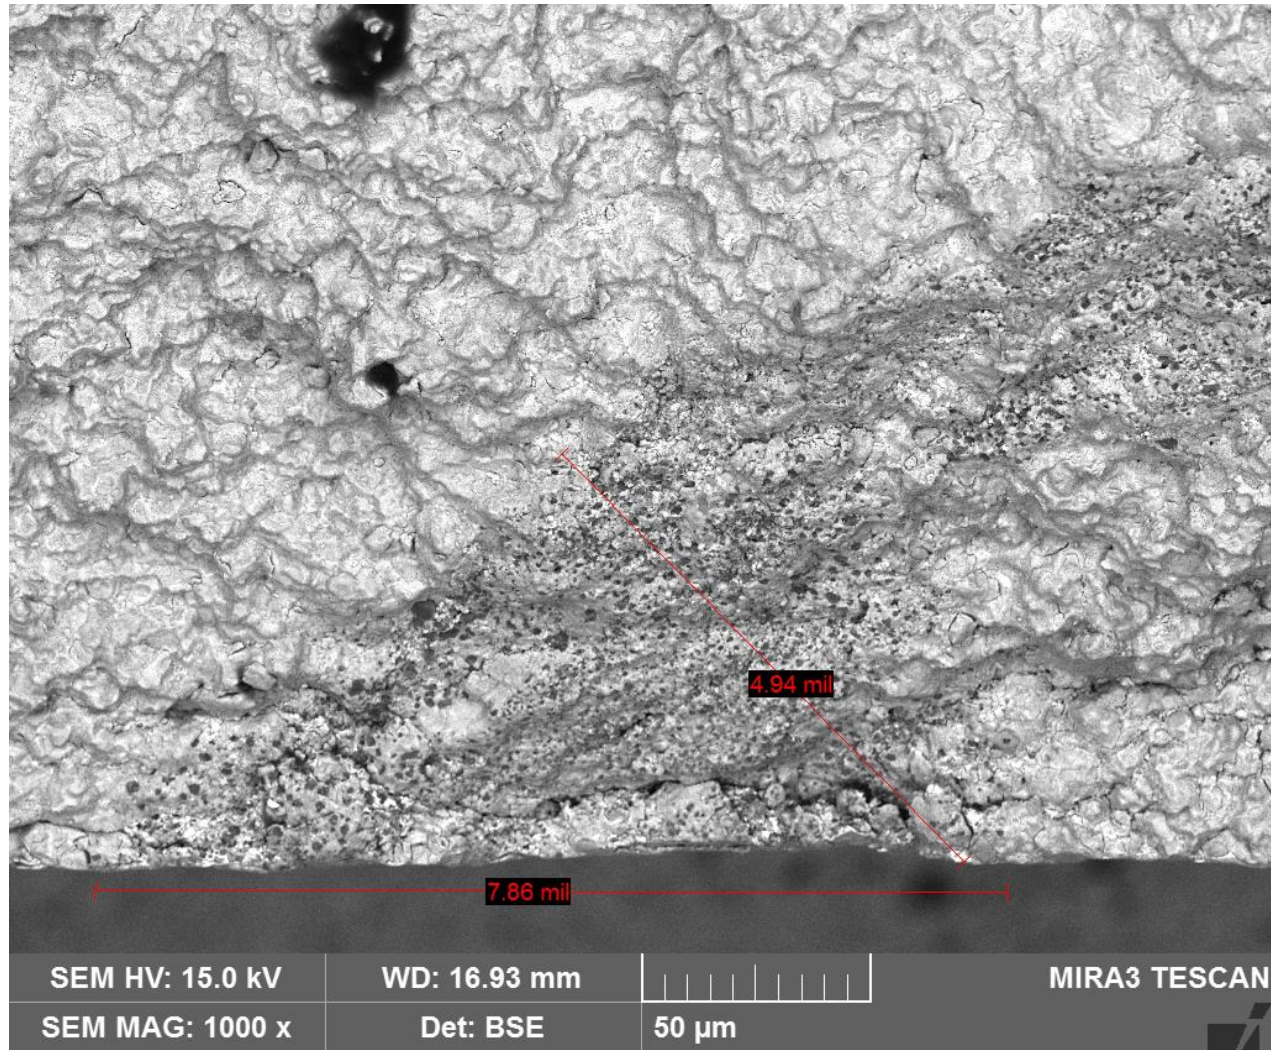
- Optical and scanning electron microscope (SEM) examination of the fracture **origin** revealed it was a **surface-connected inclusion** approximately **15\* x 5 mil** (\*there was post-fracture smearing damage on both fracture halves, so the length is estimated based on visible 12 mils on the inboard half, 13 mils on the outboard half, and adding approximately 2 mils of smearing to the largest measured)- Figures 7-10 and 31. The inclusion area using an ellipsoid shape was estimated to be approximately **60 square mils**.

**Figure 10:** Higher magnification SEM images of the OCNC at different angles showing that it was approximately **5 mils wide** by **12 mils long** (not including smeared area; **13 mils** visible on the smeared outboard fracture). The surface-connected portion of the OCNC was approximately 8 mils long.
