# National Transportation Safety Board

ENG24LA014

GE Aerospace - Metallurgical Investigation Report (DRB AvEng-558171.A)

**METALLURGICAL EVALUATION OF A GENX-1B  
HPT STAGE 1 AFT BLADE RETAINER INVOLVED IN  
AN UNCONTAINED EVENT FROM ESN 956-102  
OPERATED BY UNITED**

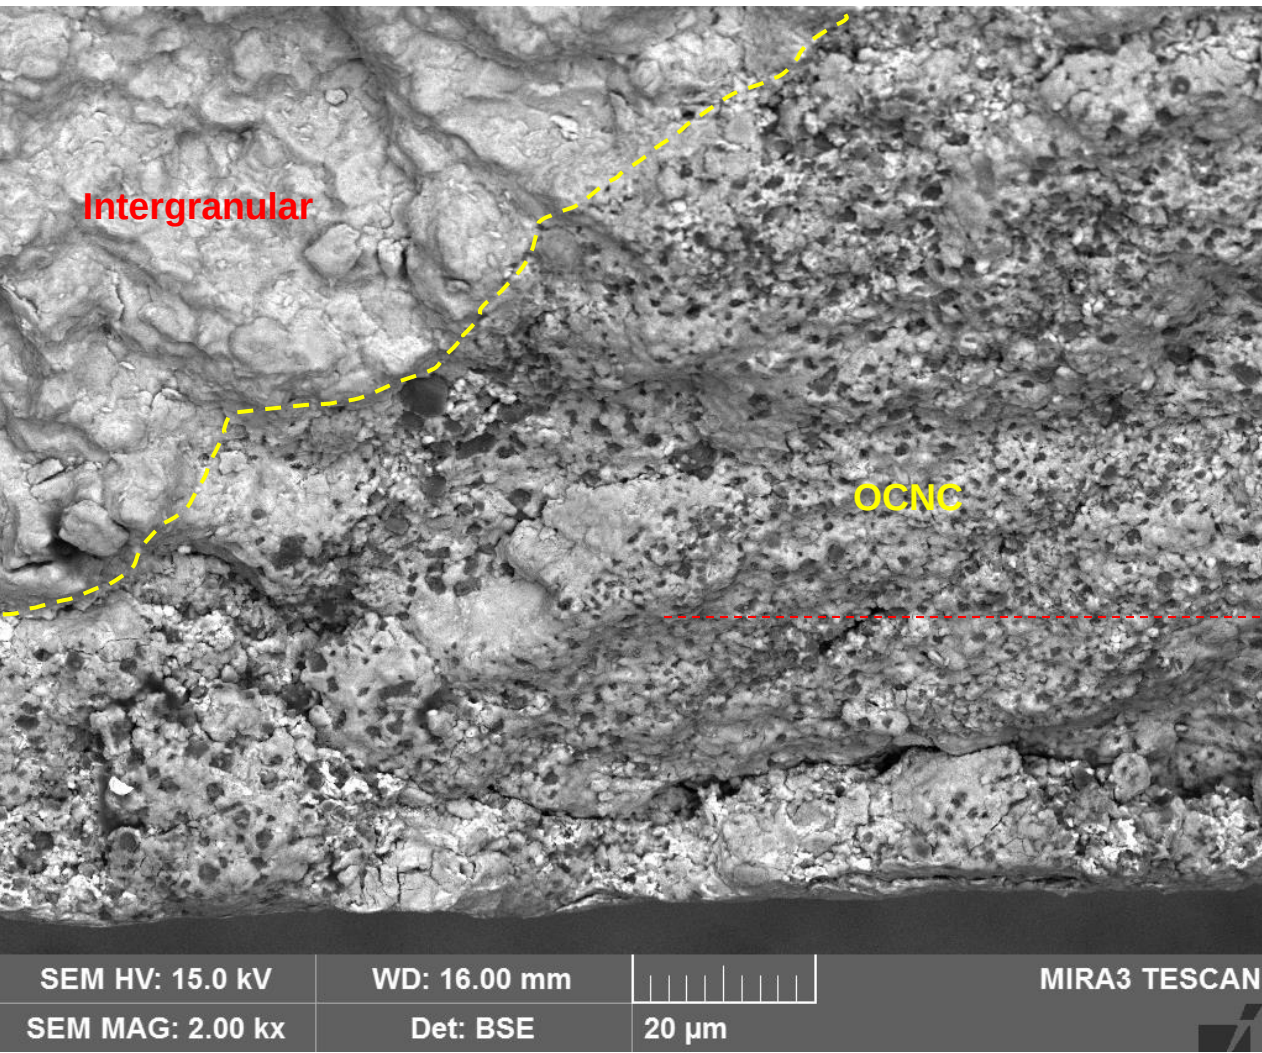
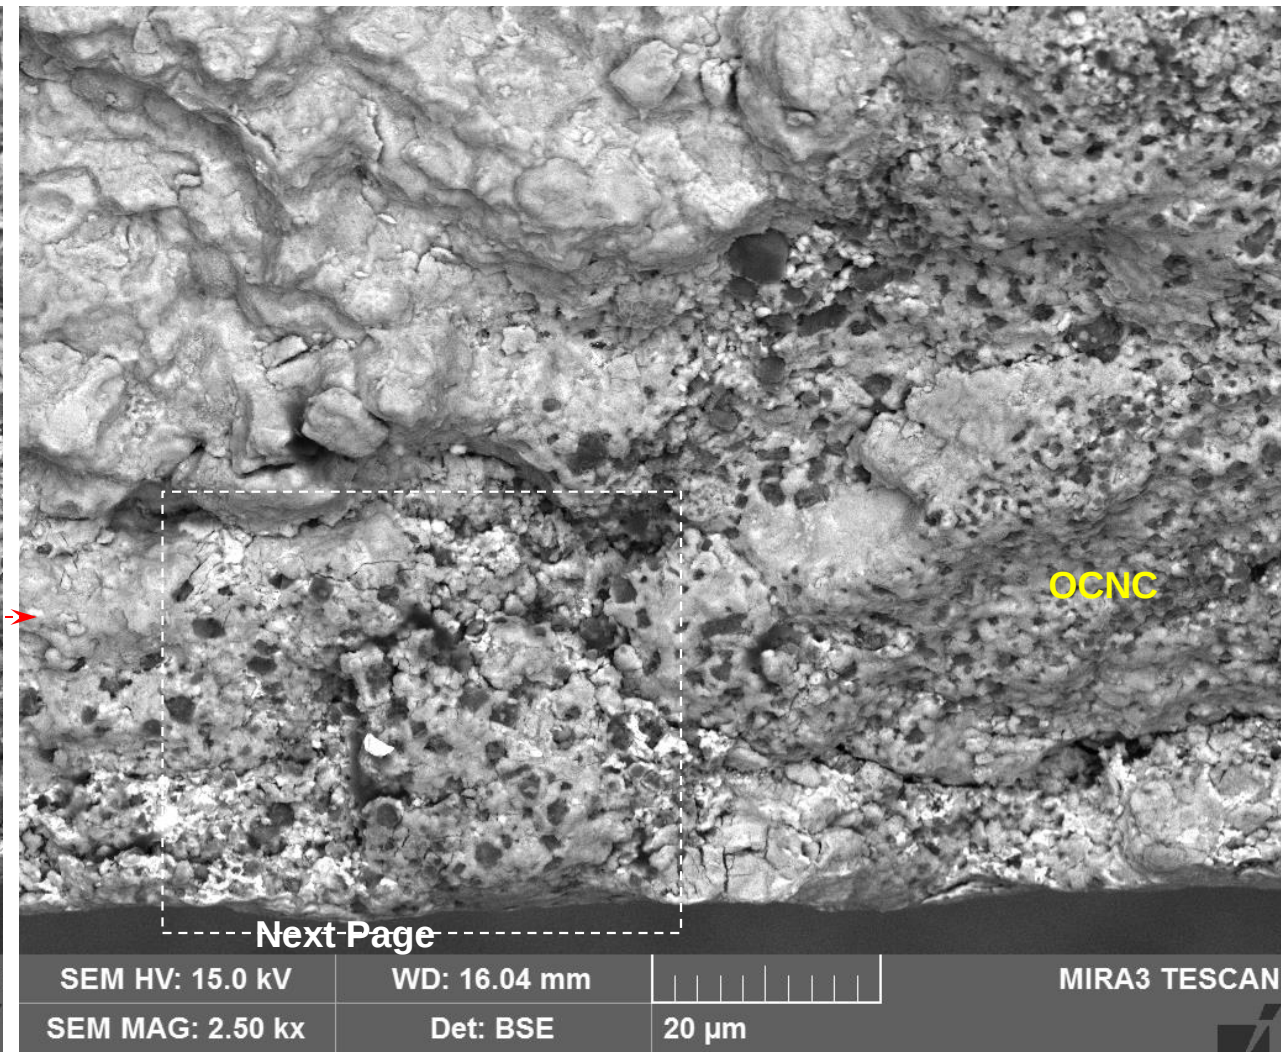
**Figure 11:** Higher magnification views of the OCNC that showed a “cluster” morphology with mixed oxides present (see following slides). The fracture then propagated in an intergranular manner from the OCNC.

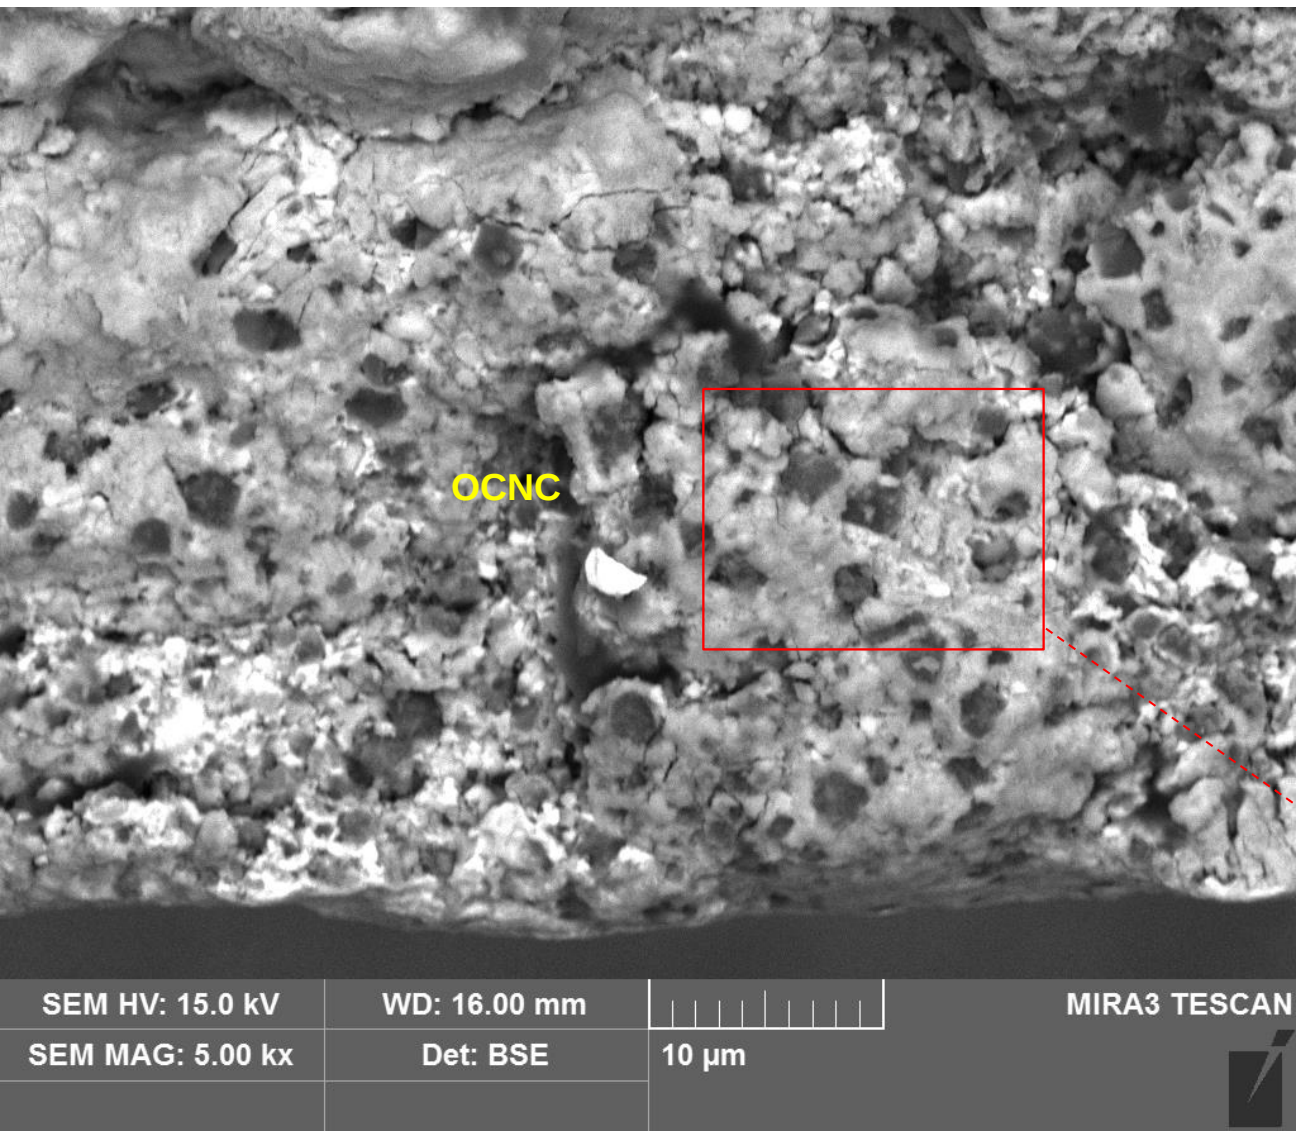
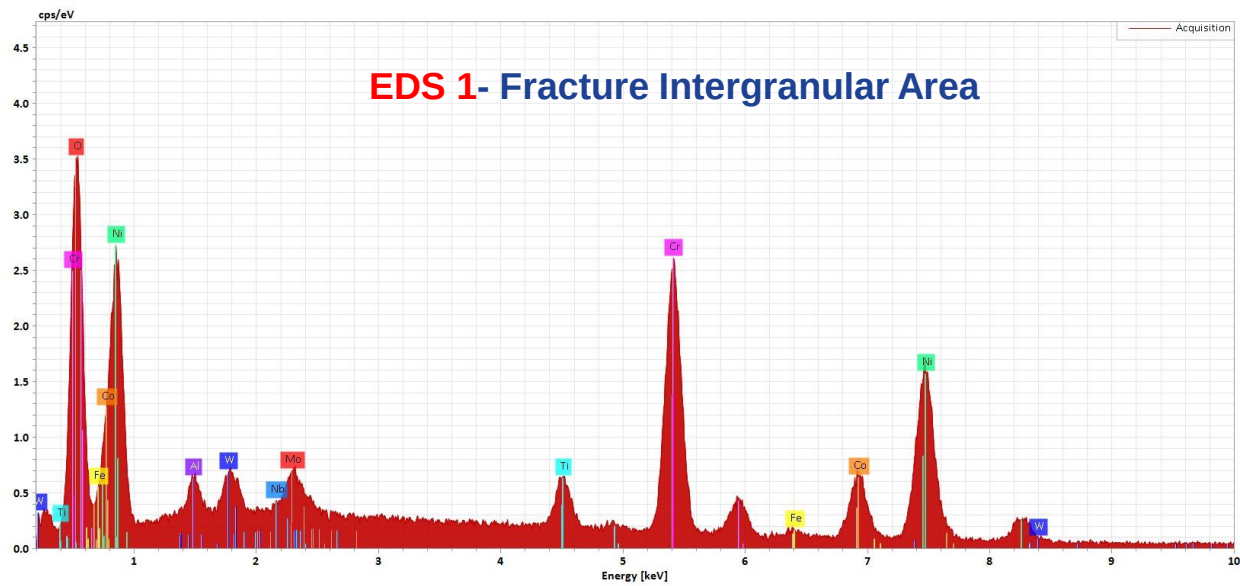
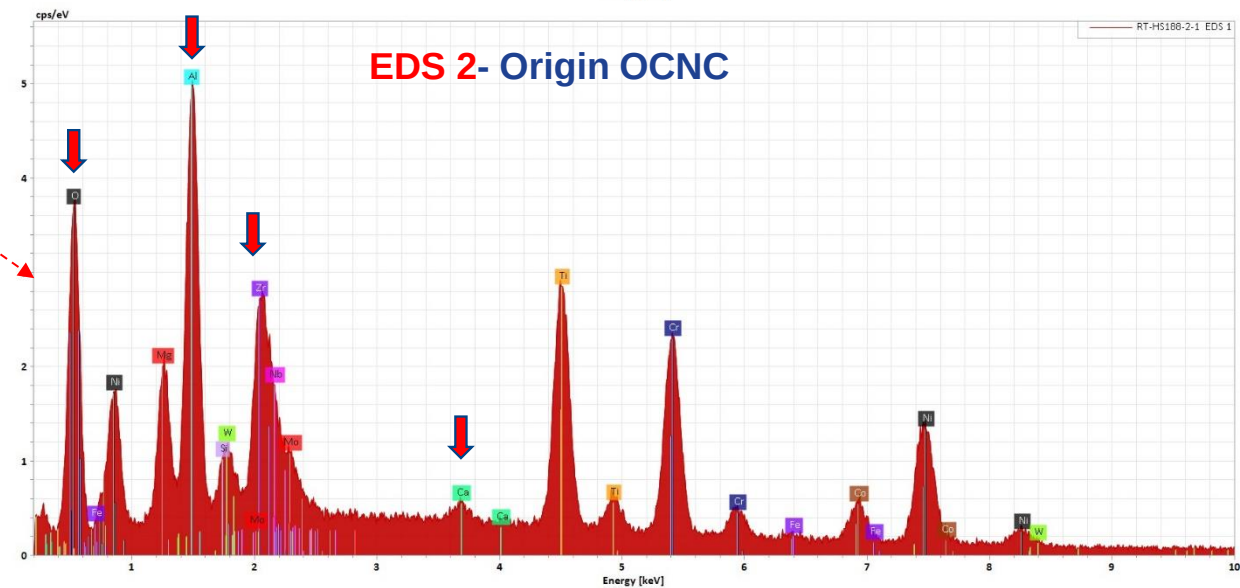
- Energy dispersive spectroscopy (EDS) spectra and dot maps showed the inclusion was rich in **Ti, Al, Zr, Mg, Ca, O**, consistent with an **inherent melt-related OCNC**. In addition, the inclusion was not a single particle, but a “cluster” of mixed oxides (EDS 1 and 2 in Figures 10-13).

**Figure 12:** EDS analysis of the origin showed the presence of mixed oxides rich in **Ti, Al, Zr, Mg, Ca, O**, consistent with an inherent Oxide/Carbonitride/Nitride/Carbide (OCNC) inclusion.

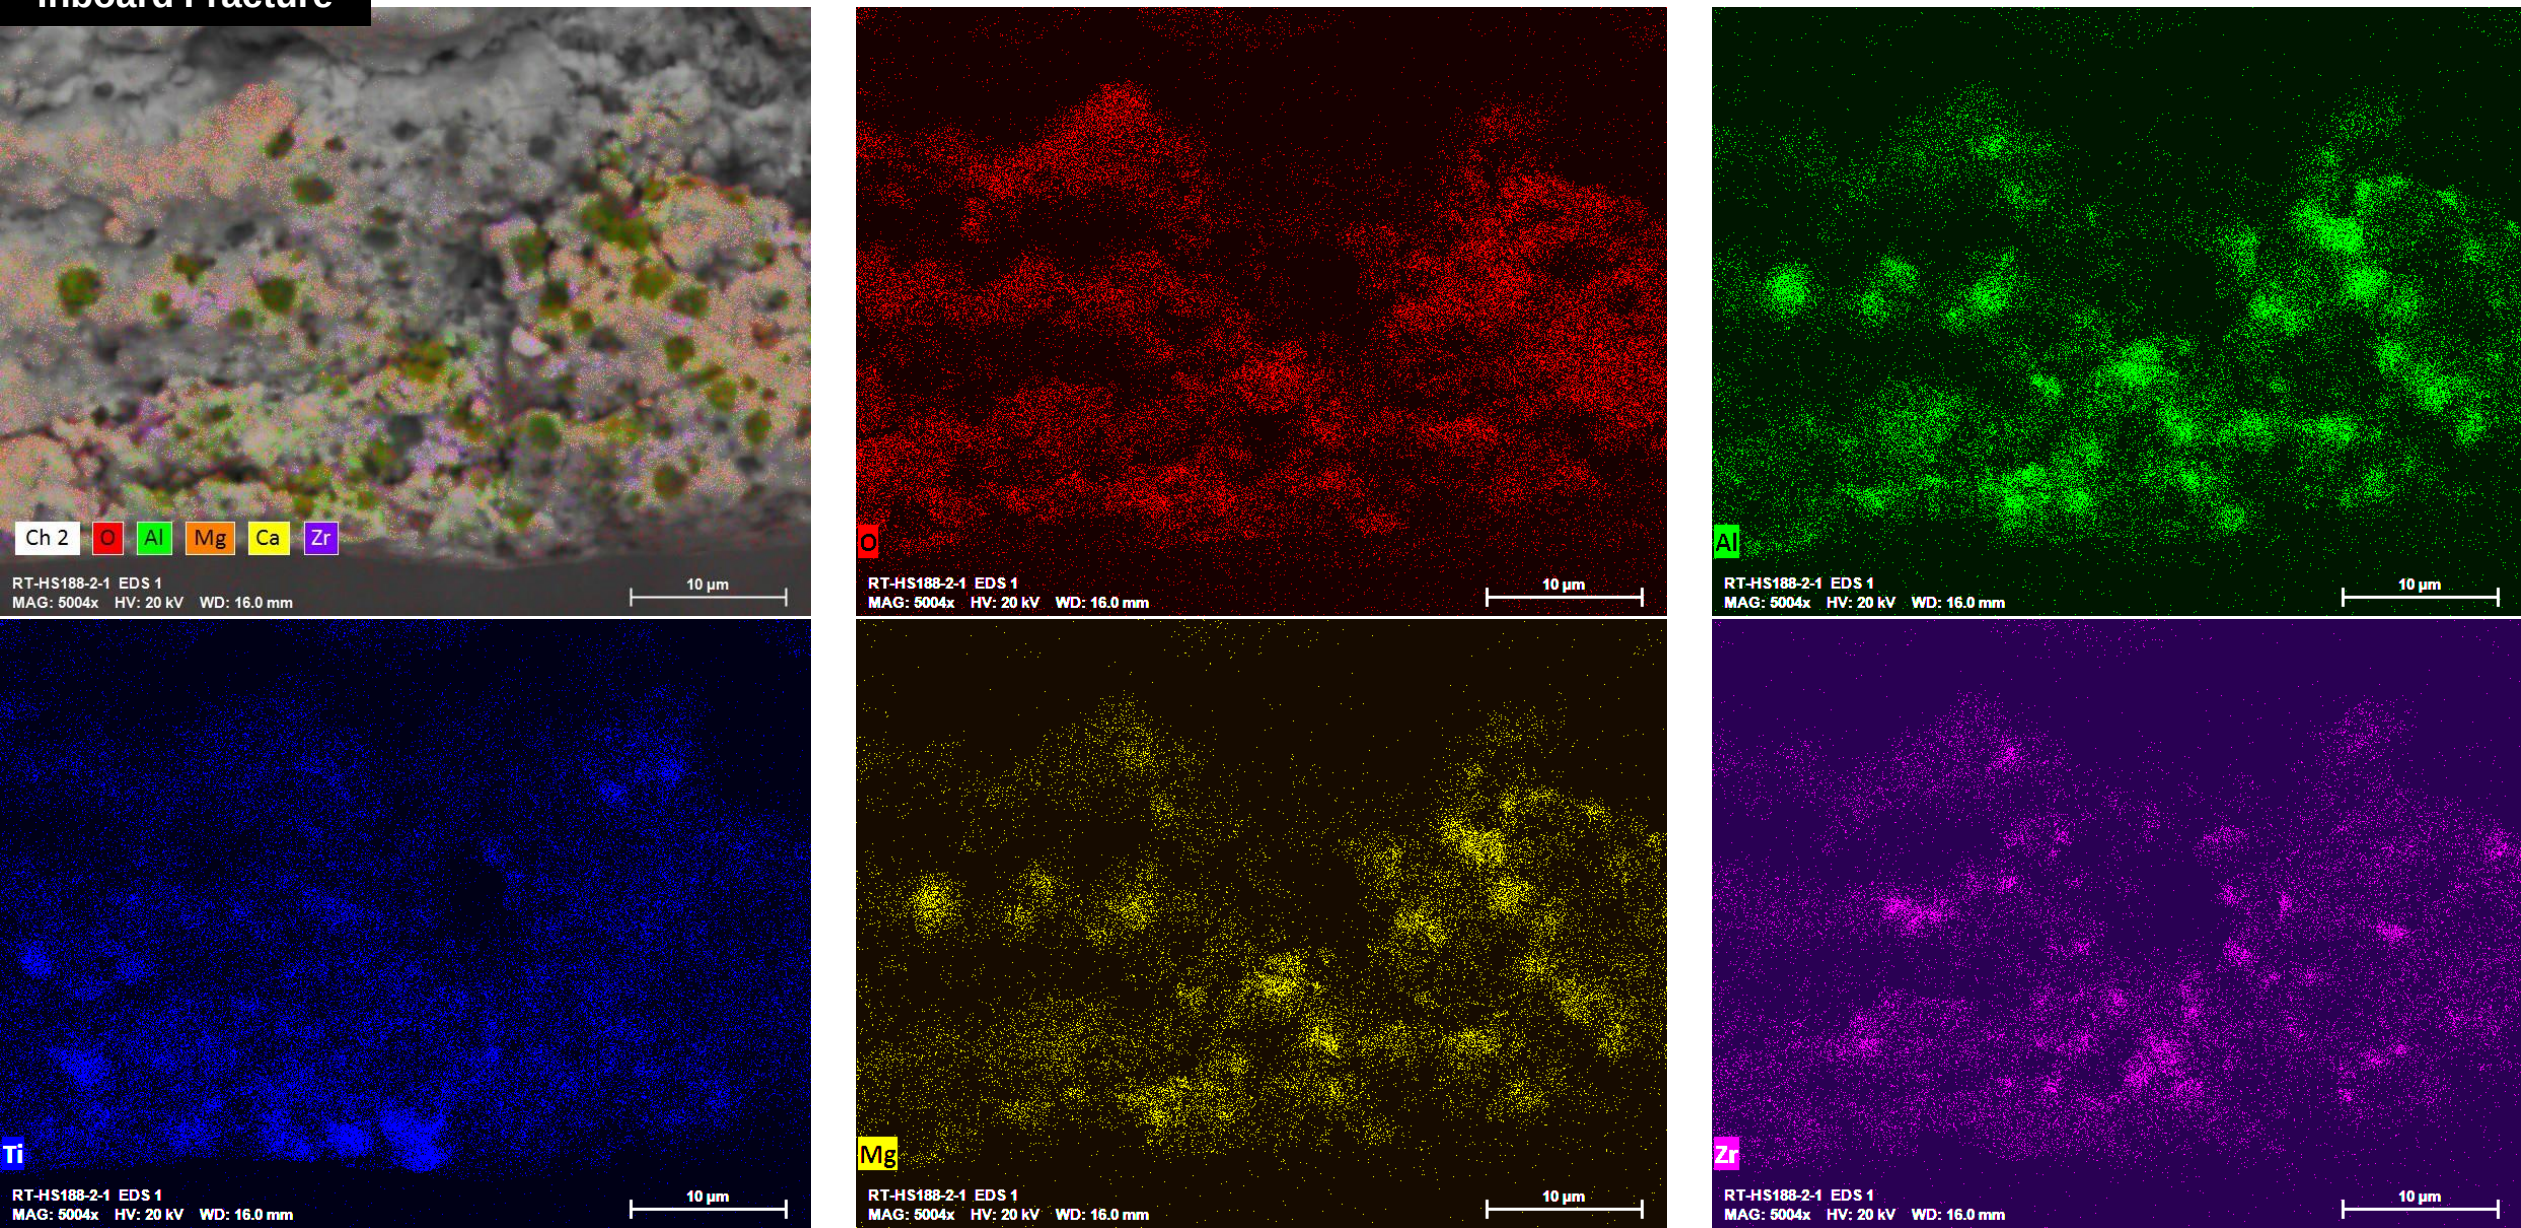
**Figure 13:** EDS dot maps showed similar results with mixed oxides rich in **Ti, Al, Zr, Mg, Ca, O**, consistent with an inherent OCNC inclusion.

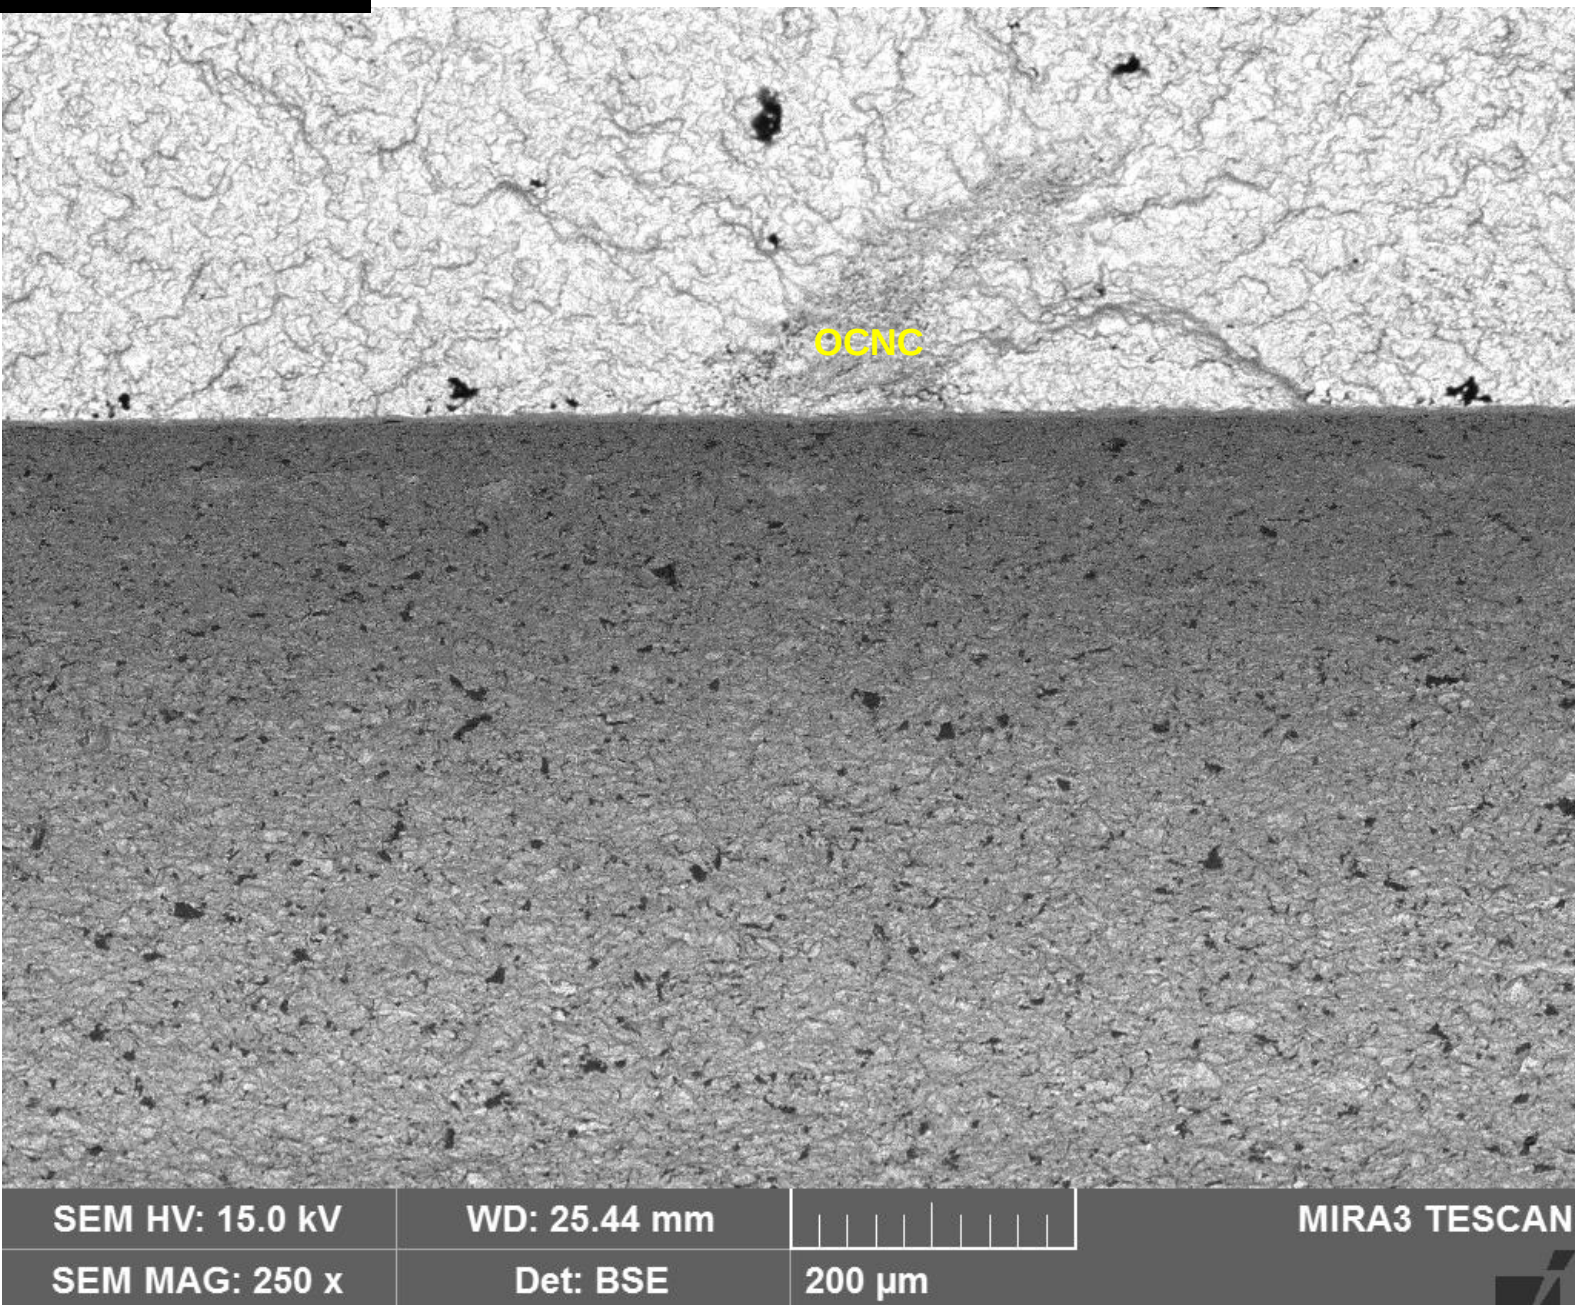
**Figure 14:** An angled SEM view of the origin area did not reveal any surface anomalies such as scoring marks, nor secondary cracking. The surface was roughened and had angular particulates, consistent with having been grit-blasted per the requirements.

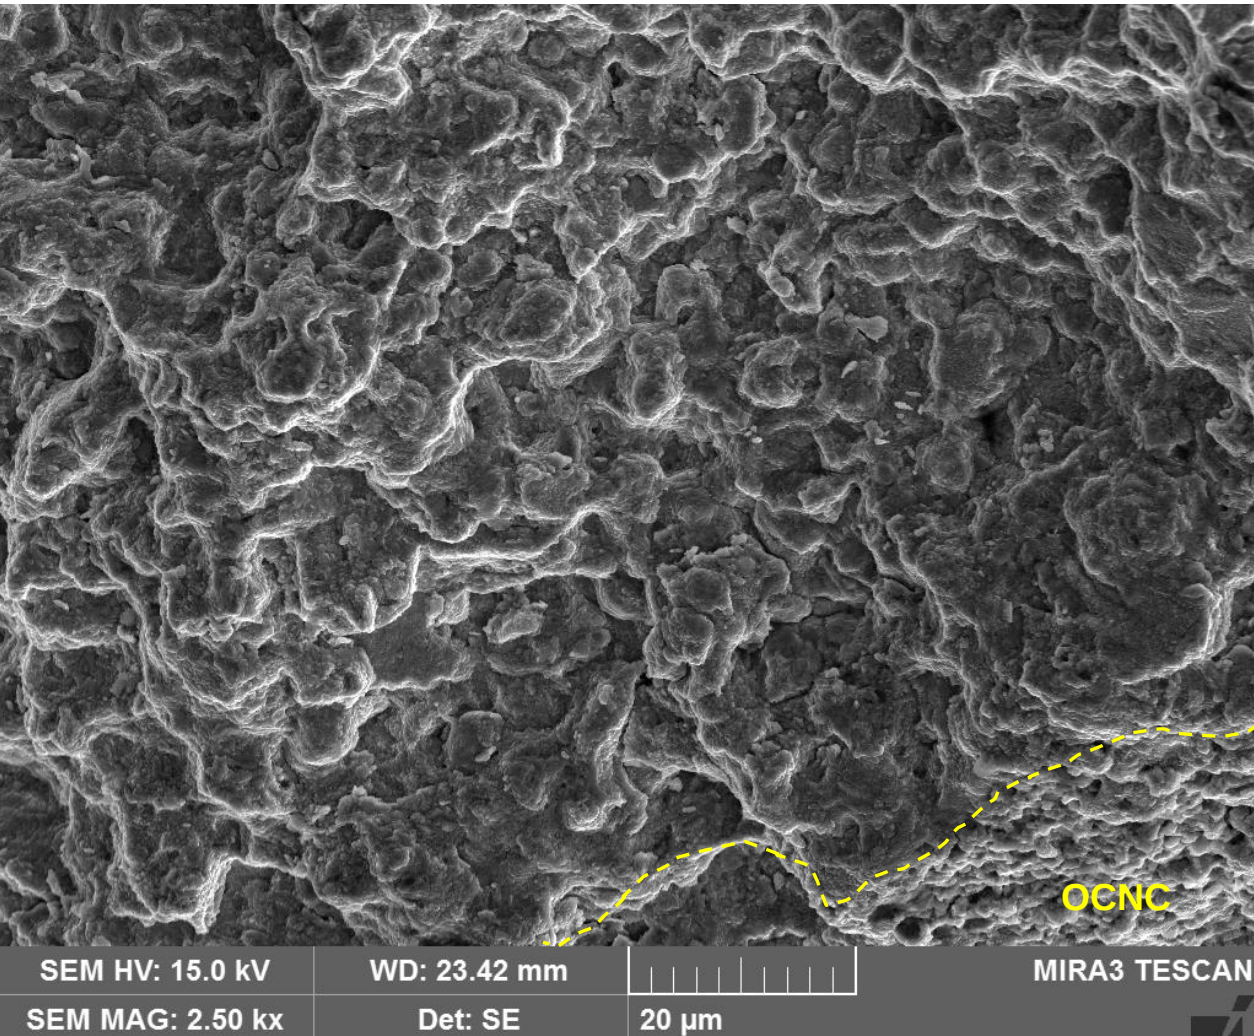
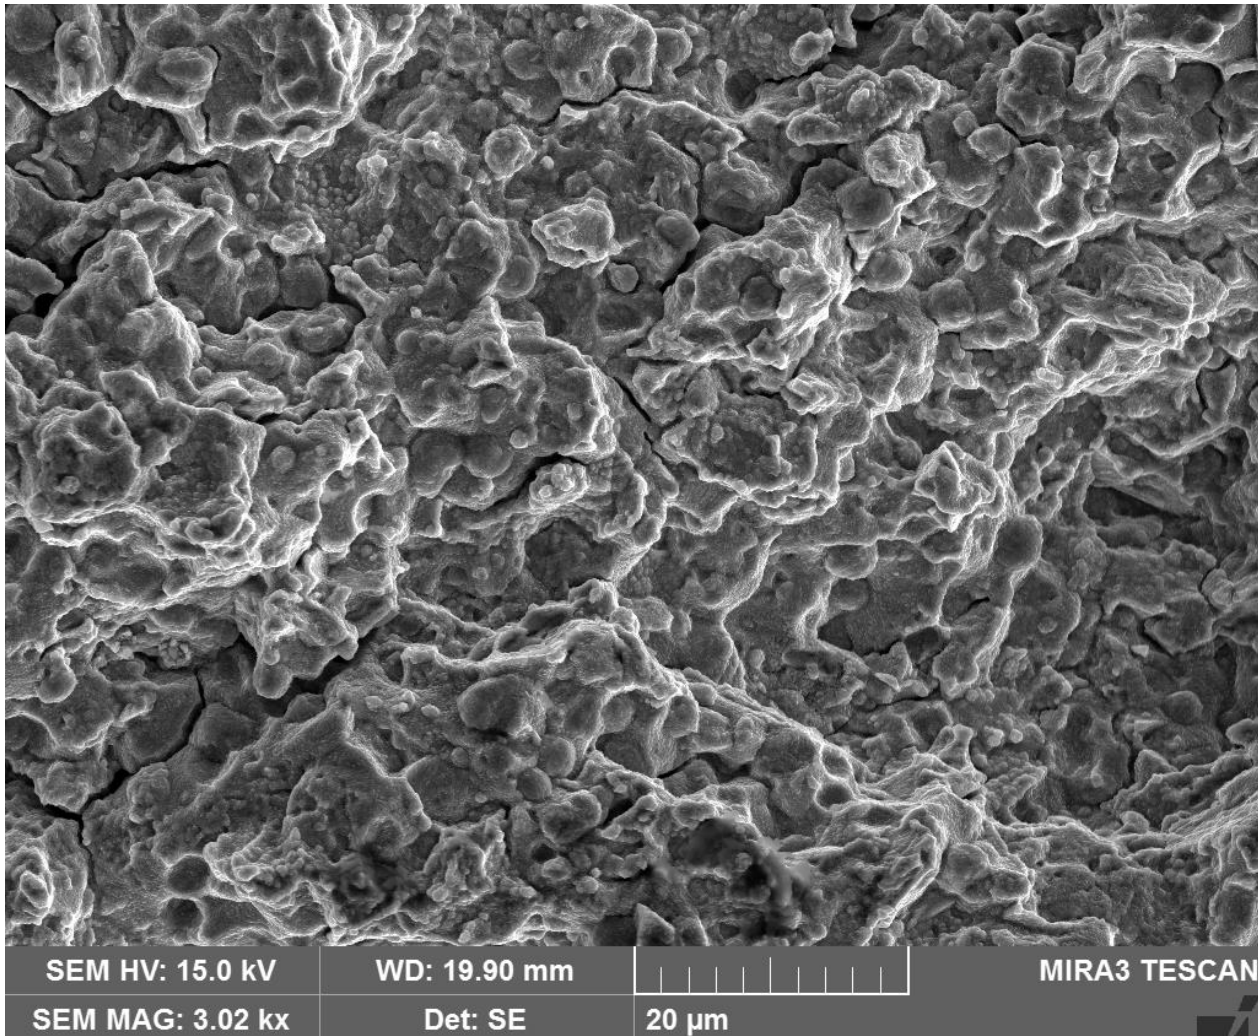
**Figure 15:** The fracture grew in a fully intergranular manner throughout the collet region with more secondary cracking observed far from the origin area, consistent with SPLCF/hold-time fatigue crack growth.

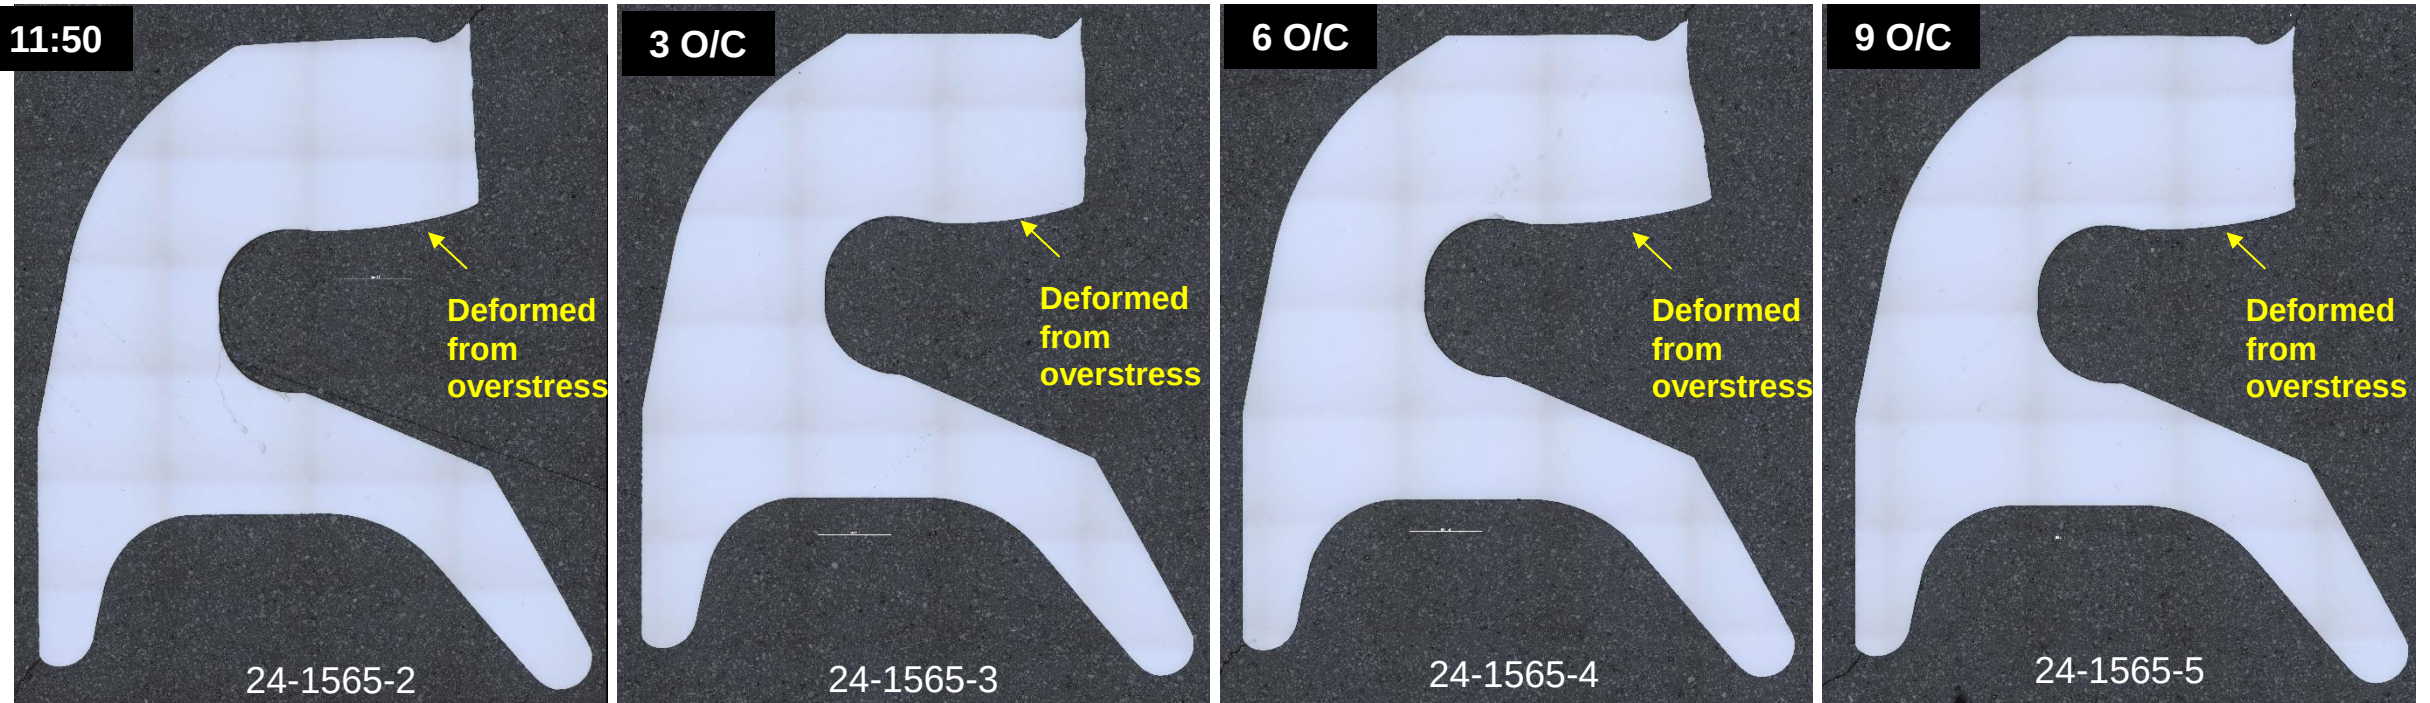
- A series of axial/radial metallographic mounts were made showing the following (Figures 16-35):
  - In the undamaged remaining areas of the part the dimensions were generally conforming (aside from the deformation adjacent to the overstress fracture (Figure 16).

**Figure 16:** Four cross-sectional mounts made at the intact regions of the collet (beyond the fatigue crack) generally showed a conforming geometry, except in the outboard region adjacent to the disk rabbet, consistent with deformation from final overstress.

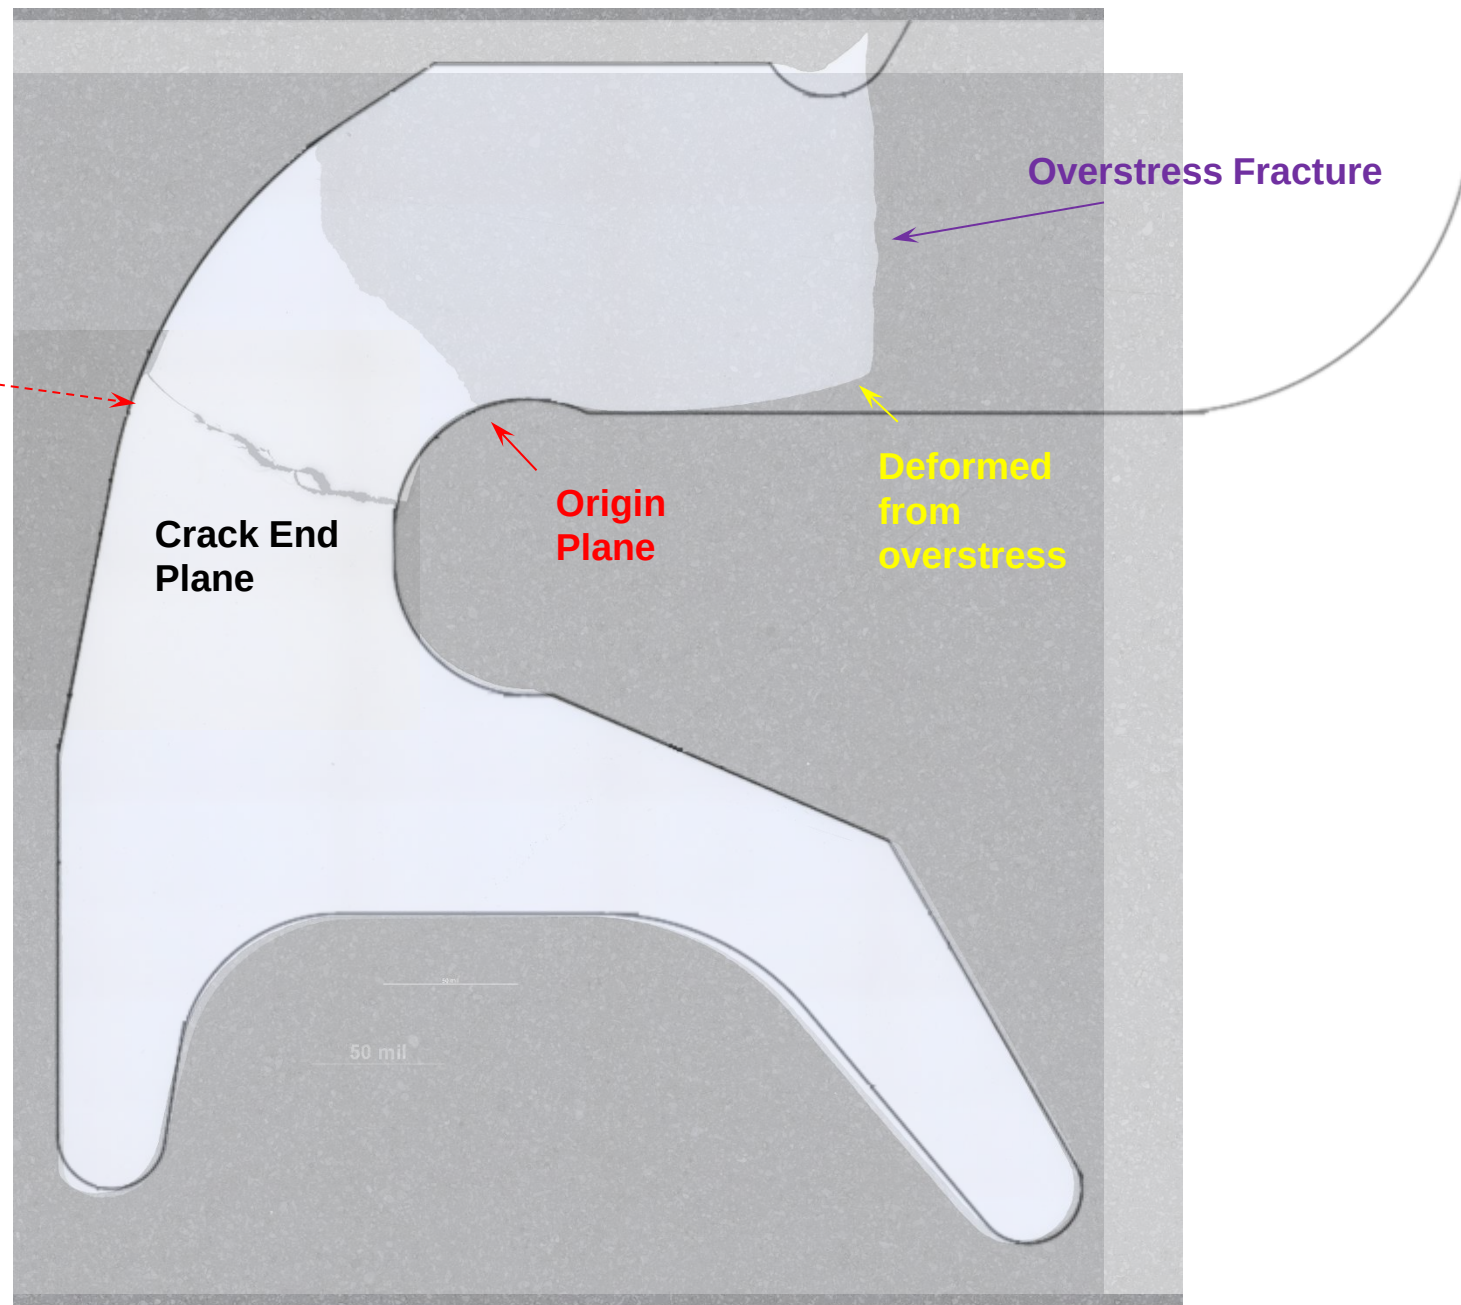
- Mounts made at the origin (near 1:45) and the crack end (near 12 o'clock), confirmed that the initial fracture plane was at the upper portion of the collet radius, then moved inboard as the crack grew larger into the peak predicted stress location (Figures 17 and 19).

**Figure 17:** The left image shows a micro through the end of the crack showing the that the fracture plane changed from the upper/outboard side of the collet radius near the origin to further inboard near the center of the collet near the crack end.

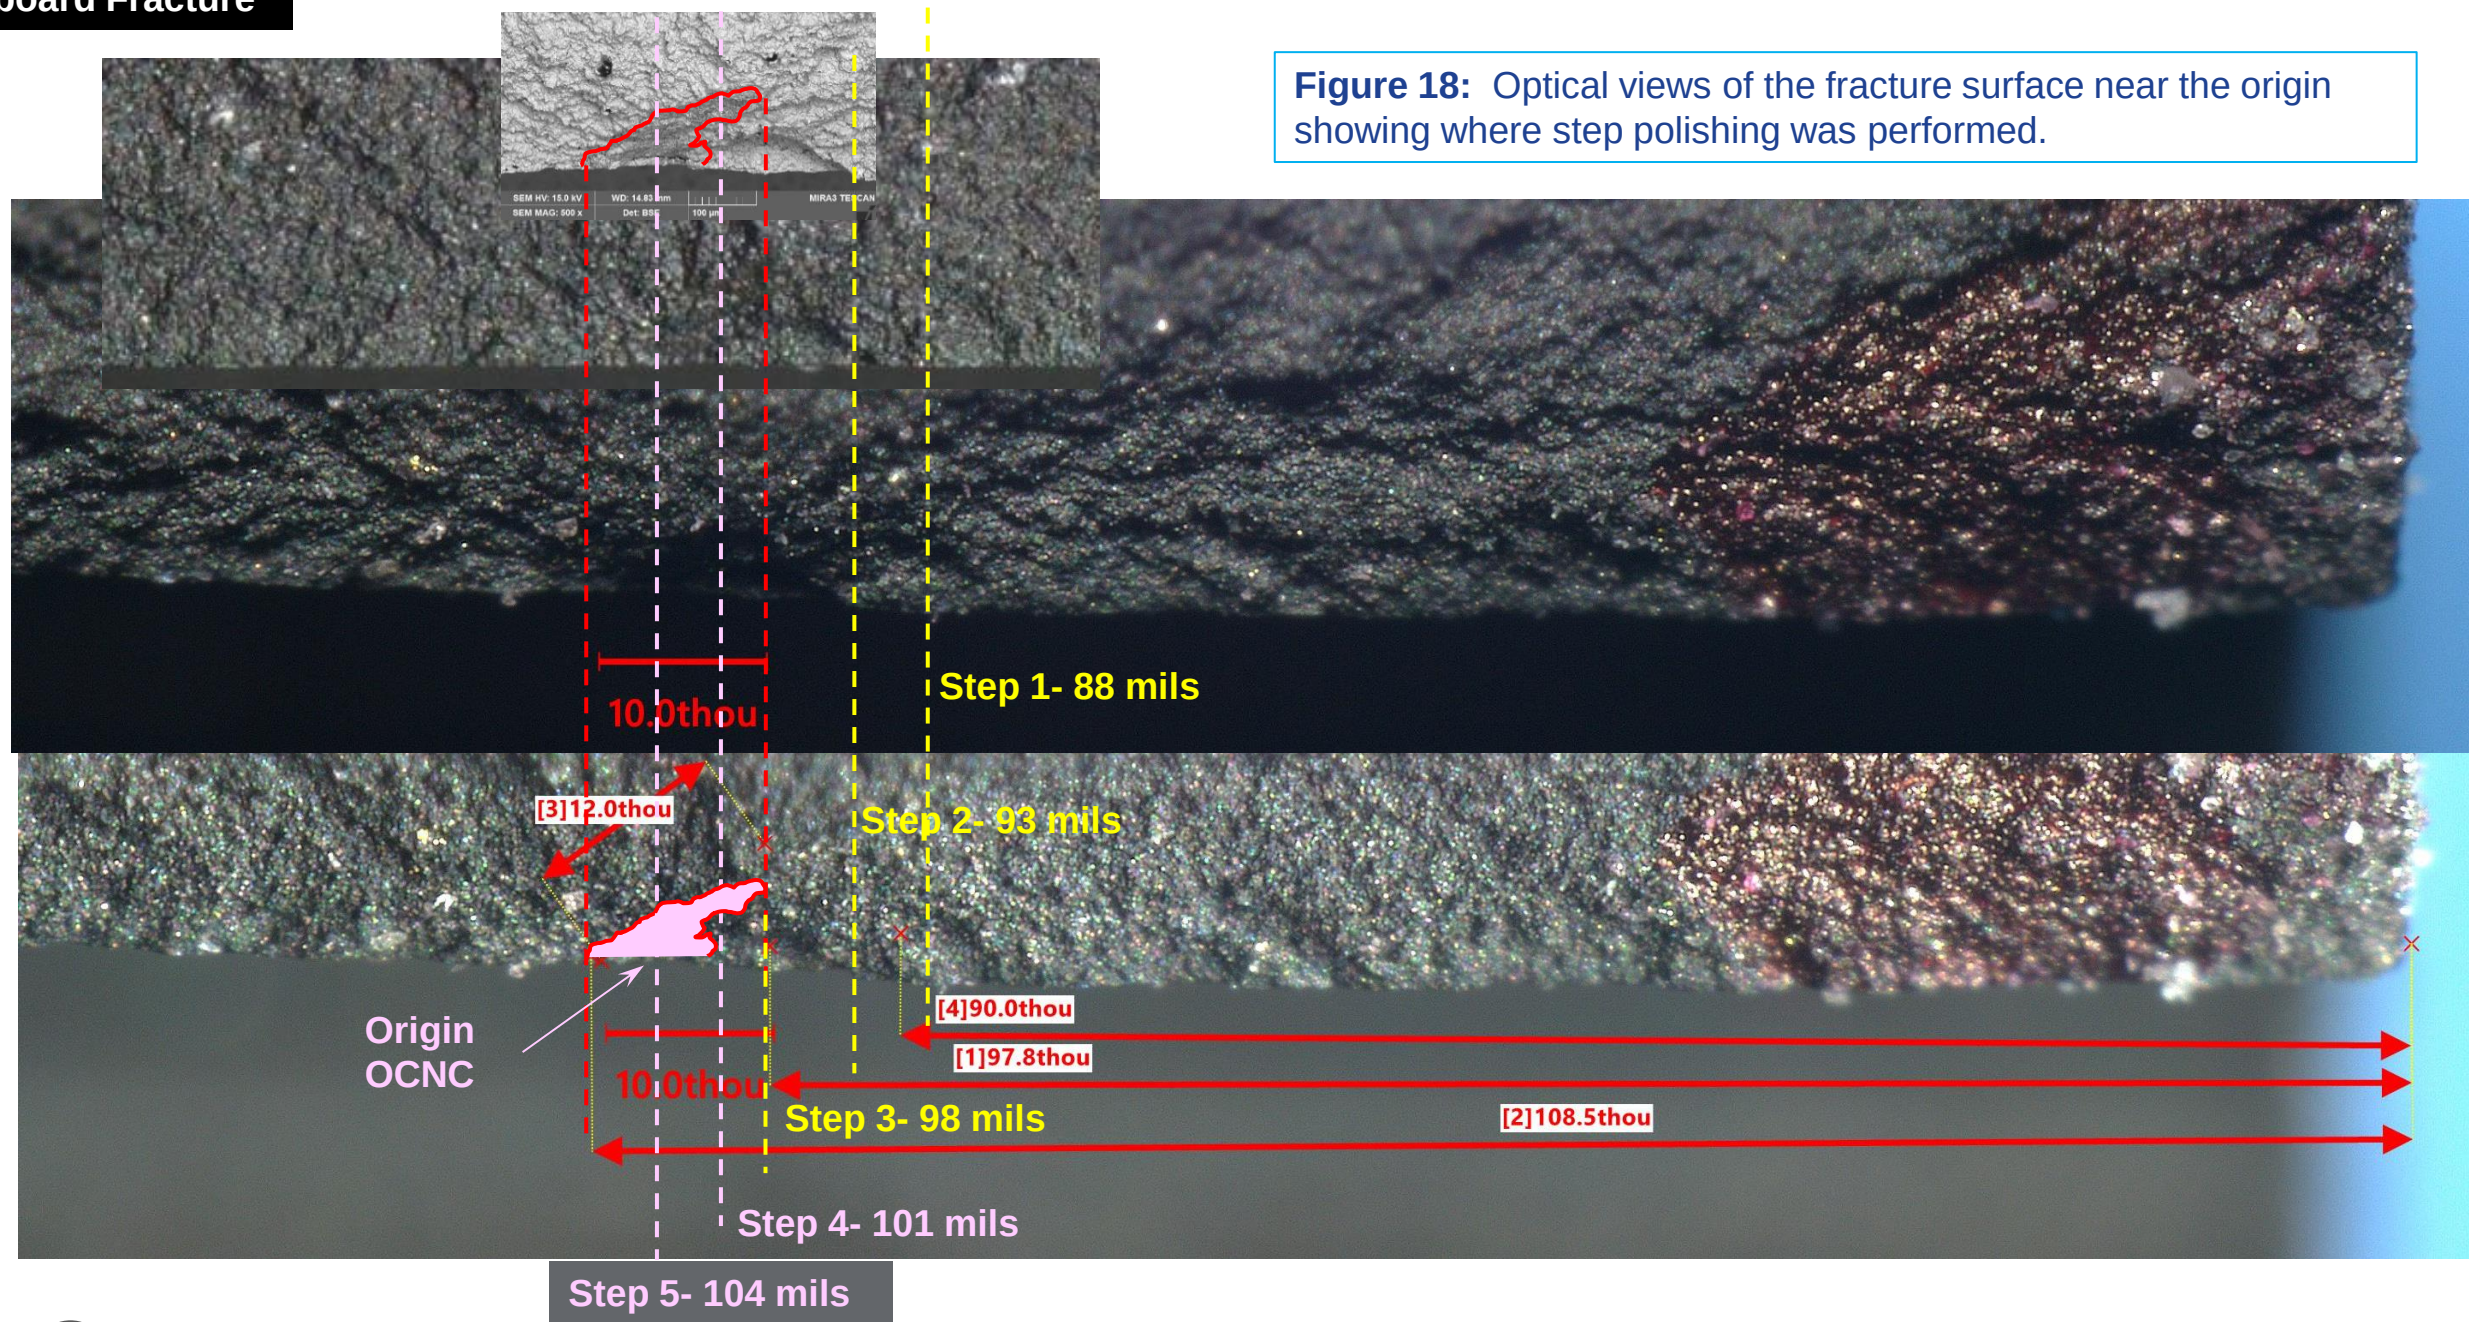
**Figure 18:** Optical views of the fracture surface near the origin showing where step polishing was performed.

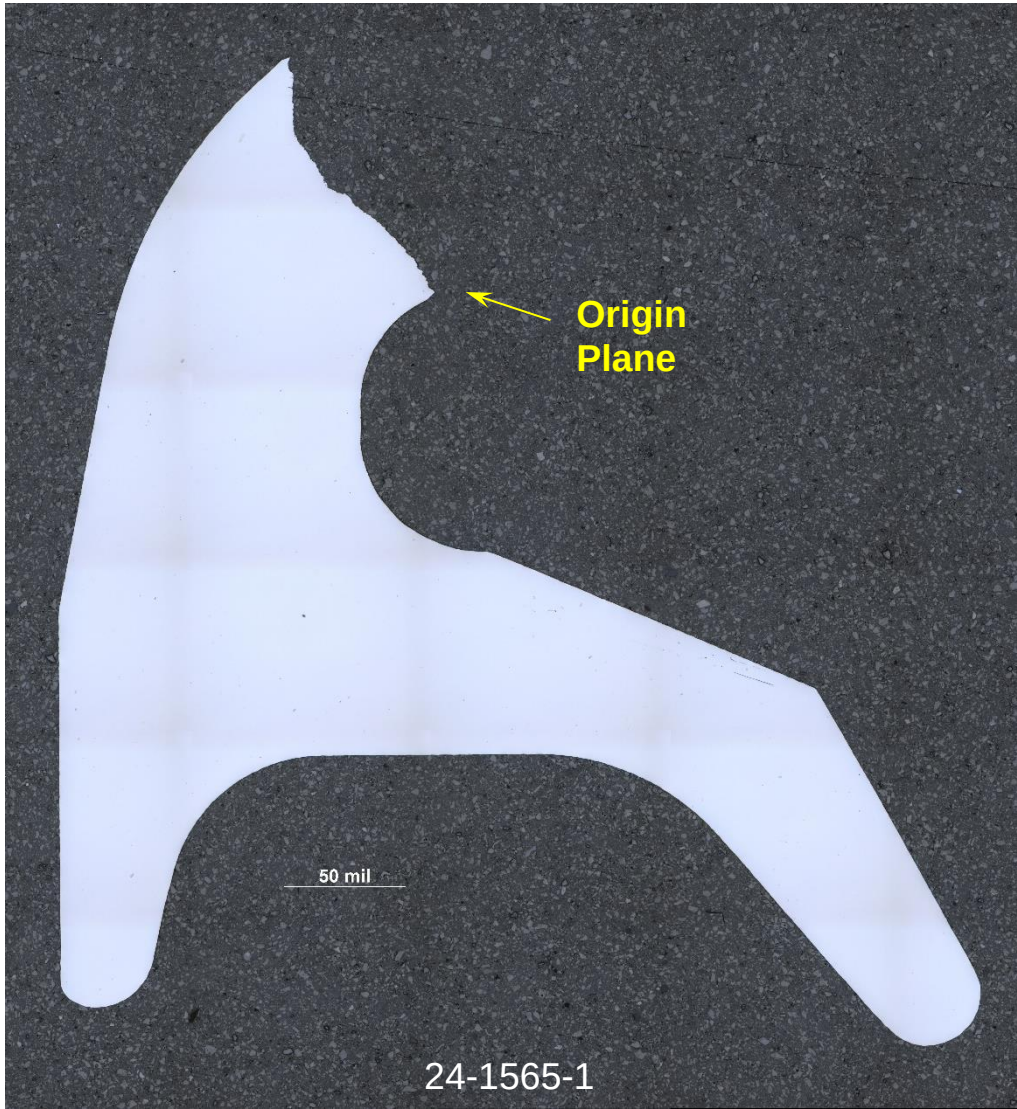
**Figure 19:** A cross-sectional micro made in the 1<sup>st</sup> step polish showed that the origin plane initiated just outboard of the predicted highest stress location in the collet radius and grew through the thickness at an angle toward to forward/outer diameter.
