# National Transportation Safety Board

ENG24LA014

GE Aerospace - Metallurgical Investigation Report (DRB AvEng-558171.A)

**METALLURGICAL EVALUATION OF A GENX-1B  
HPT STAGE 1 AFT BLADE RETAINER INVOLVED IN  
AN UNCONTAINED EVENT FROM ESN 956-102  
OPERATED BY UNITED**

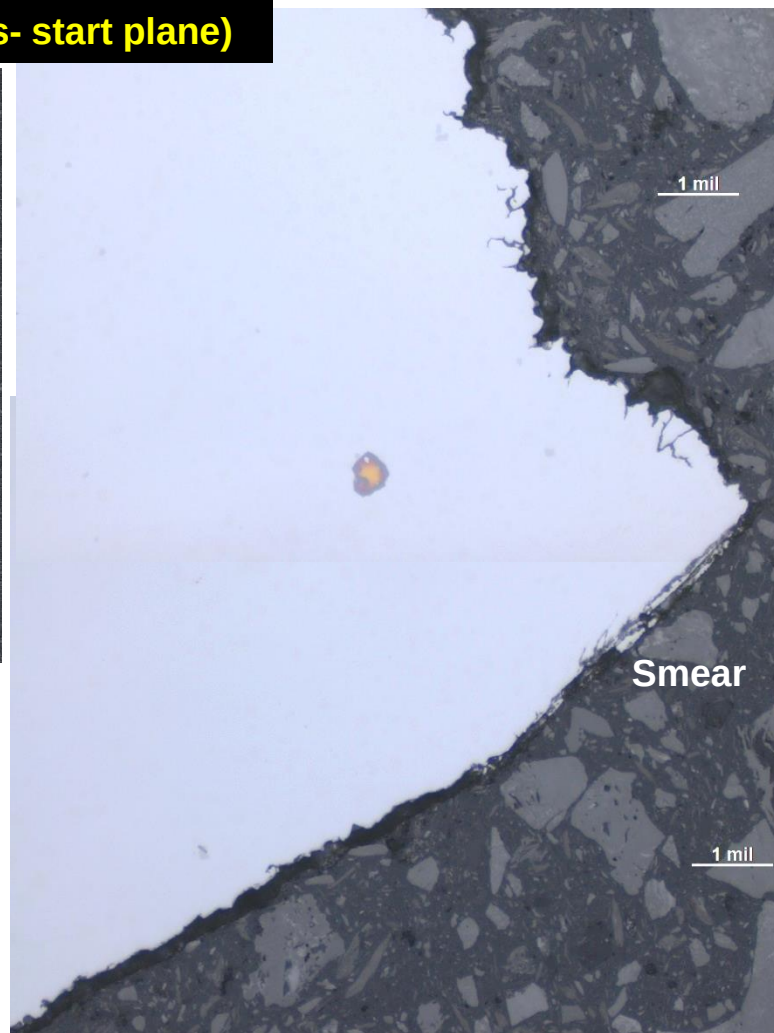
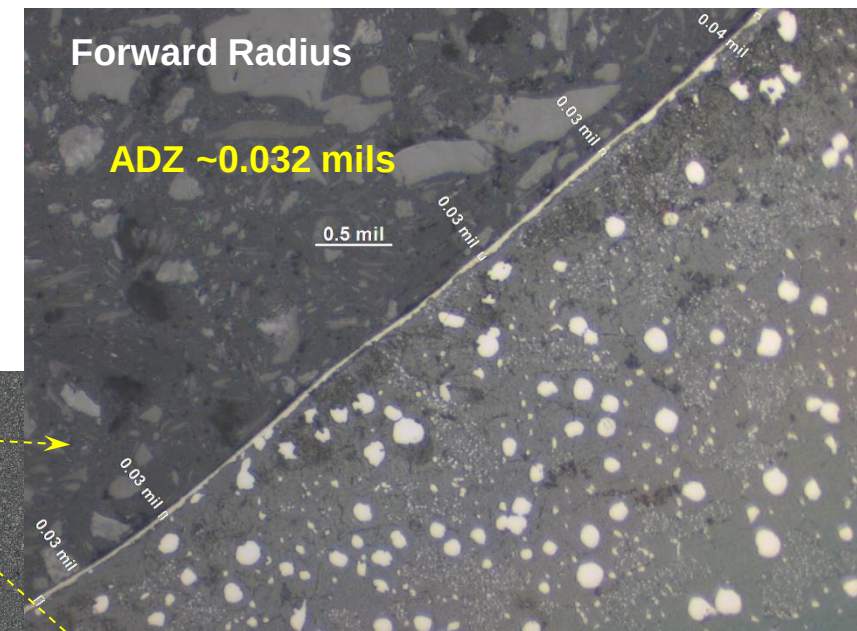
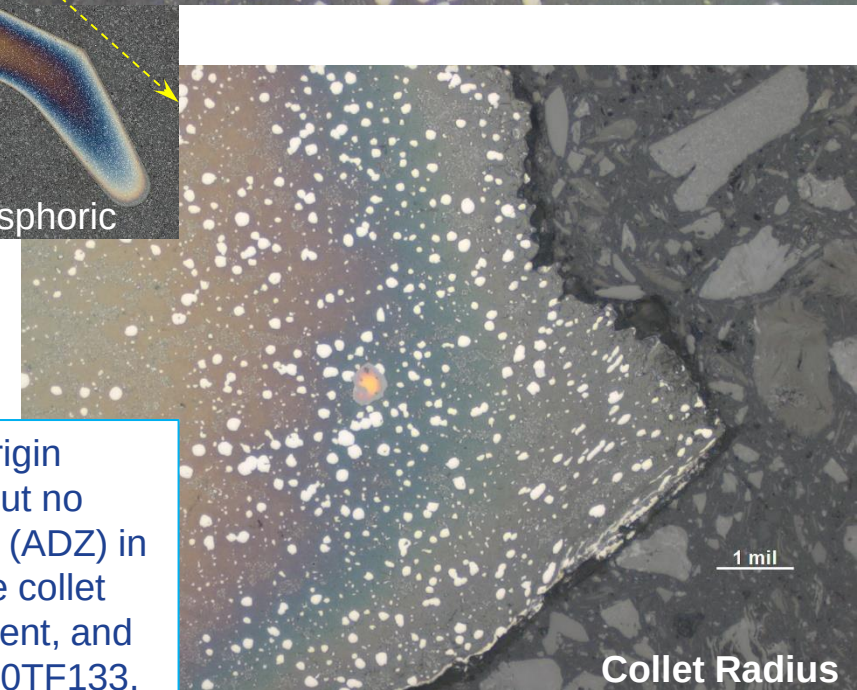
**Figure 20:** 1<sup>st</sup> step as-polished and etched micros showing that the origin region had approximately 1.7 mils of post-fracture smeared material, but no other material anomalies were observed and the alloy depletions zone (ADZ) in the undamaged forward radius was approximately 0.03 mils thick. The collet radius was approximately 45 mils, conforming to the drawing requirement, and the microstructure was consistent with properly processed R65 per C50TF133.

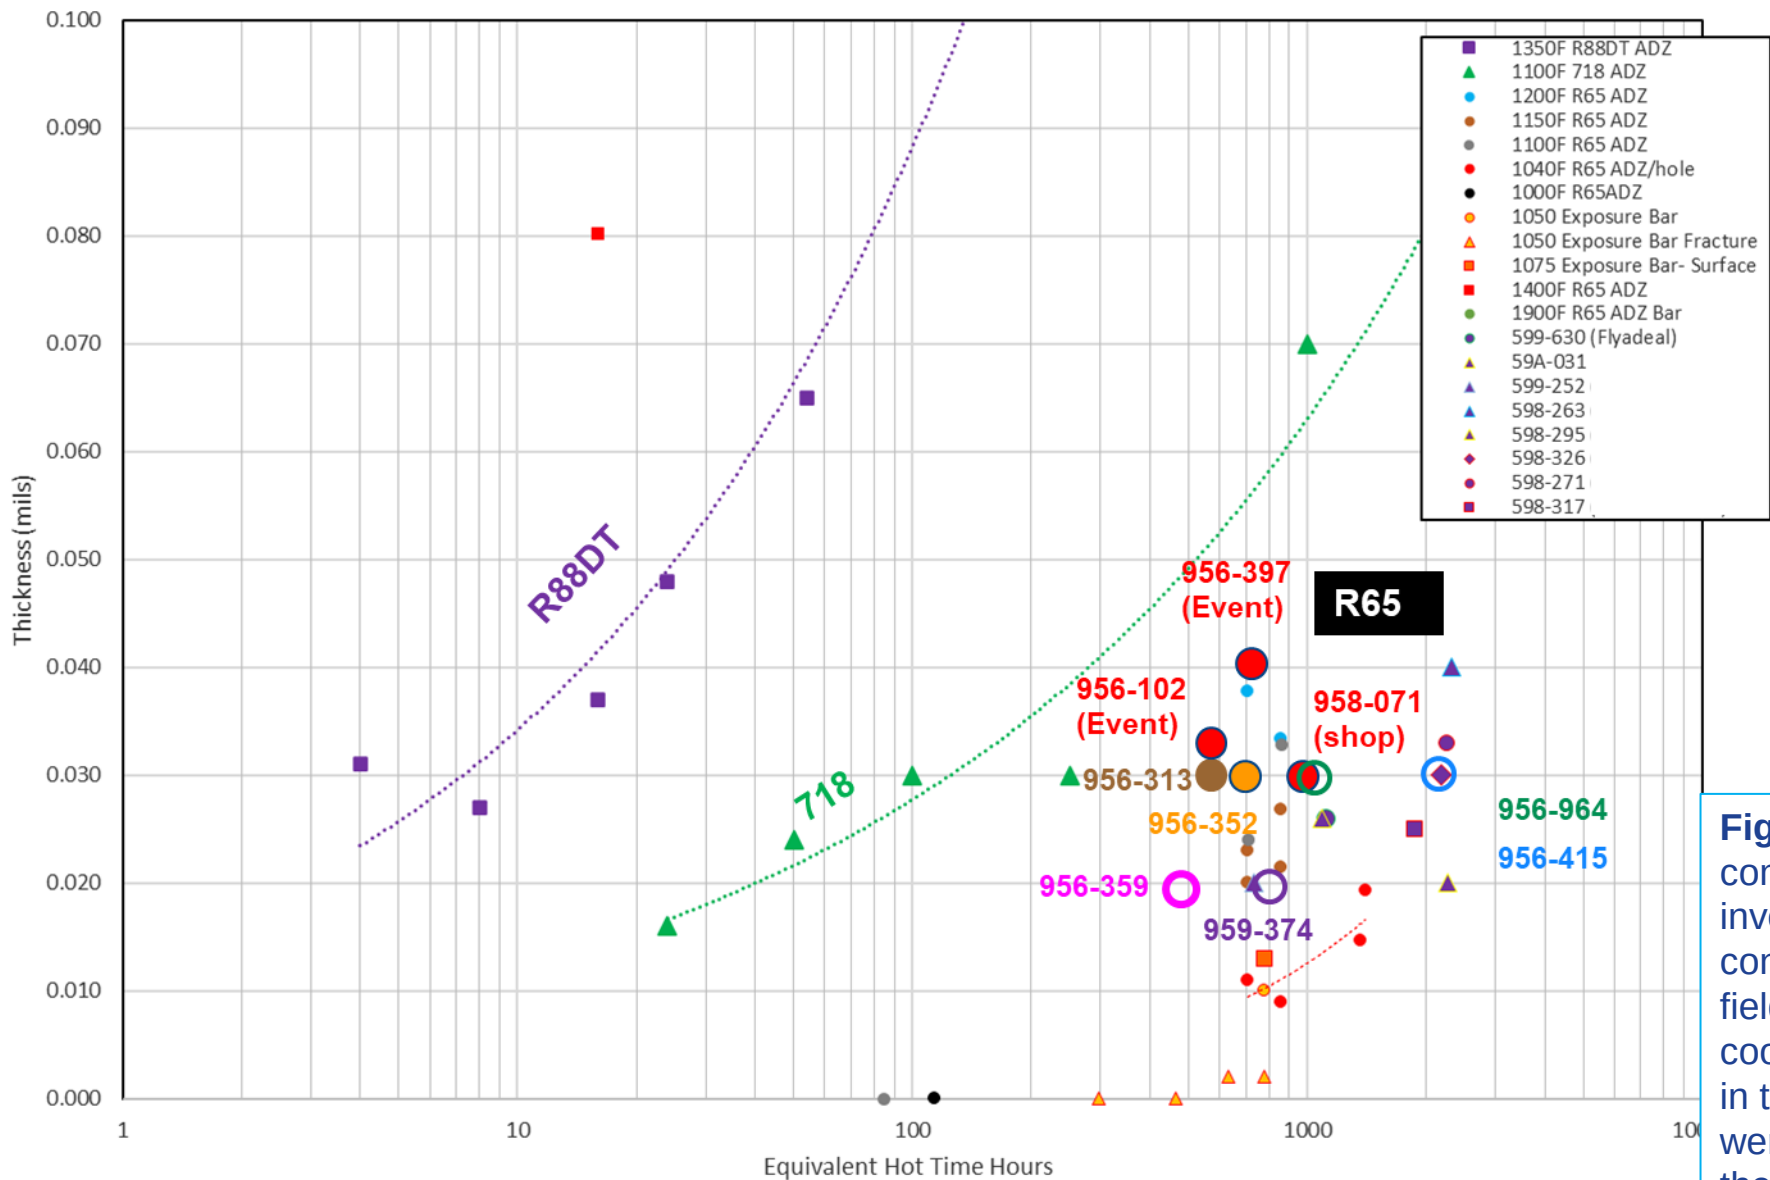
- EDS analysis of the base material was consistent with the requirement of R65 per C50TF133 (EDS 3- Figure 27).
- The alloy depletion zone (**ADZ**) thickness near the cracked area was approximately **0.032 mils thick**. Based on limited ADZ growth data the part is consistent with **exposures in the 1150-1200°F** range using an assumed 583 hours of hot time (20 min/cycle), consistent with predicted part exposure regime, though on the hotter side of parts examined (Figures 20-21). In addition, no grain boundary phases were observed, consistent with similar temperature estimates (Figure 28).

Figure 21: Based on limited R65 ADZ comparison data, the current part and 2 investigation retainers (large red circles) were consistent with operation near 1200°F. Other field retainers were in a similar range or slightly cooler. The solid circles show parts examined in the dirty condition, while the empty circles were cleaned at the shop (slight alteration of the surface).

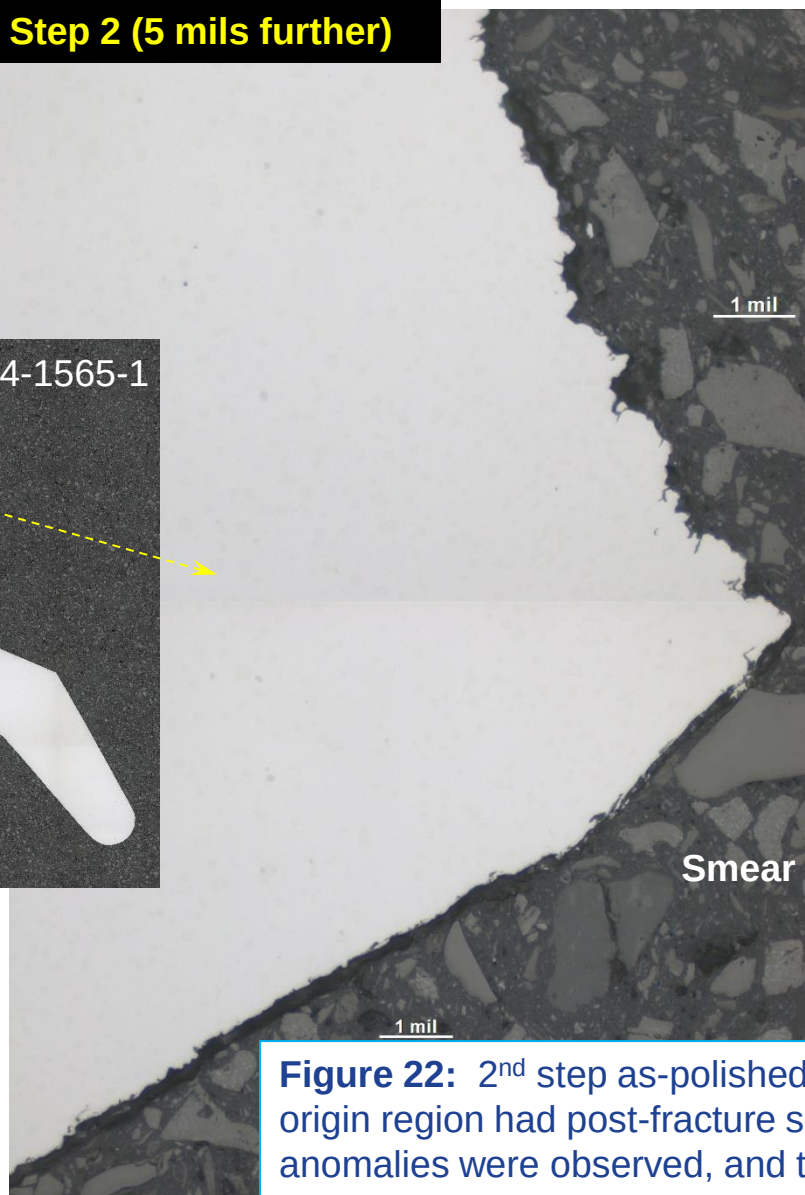
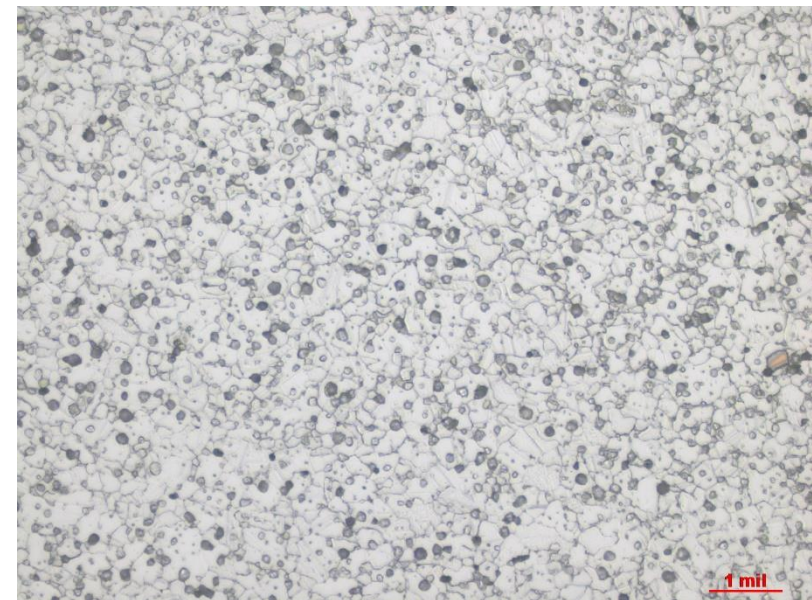
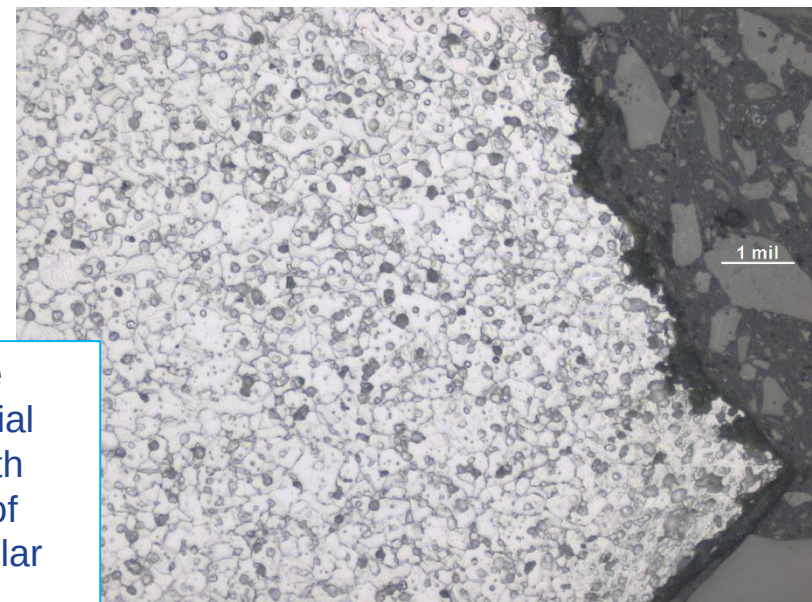
**Figure 22:** 2<sup>nd</sup> step as-polished and etched micros showing that the origin region had post-fracture smeared material, but no other material anomalies were observed, and the microstructure was consistent with properly processed R65 per C50TF133, with an average grain size of approximately ASTM 10.5. The fracture progressed in an intergranular manner, consistent with fatigue hold time crack growth.

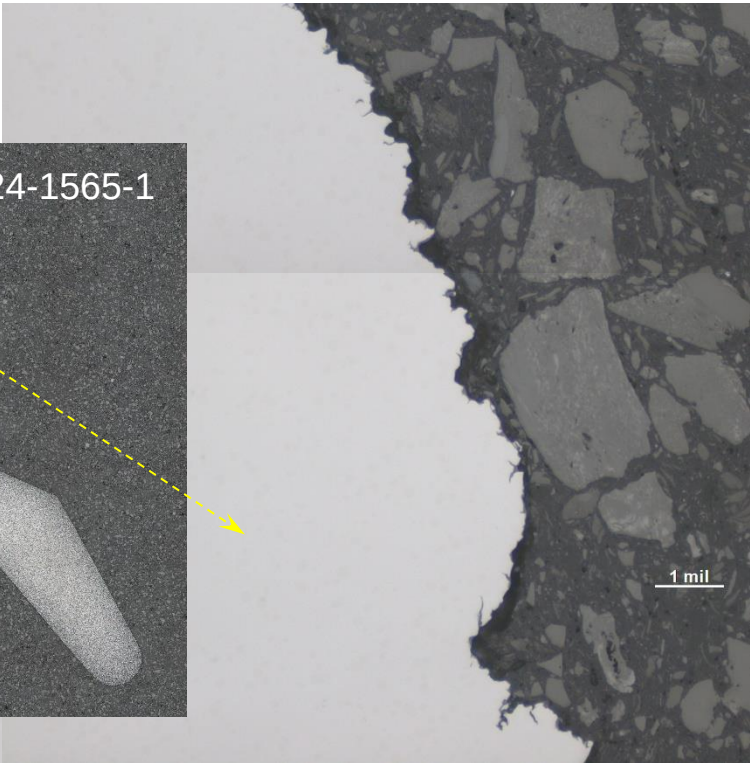
- The **microstructure** was consistent with properly processed R65 material, with an average grain size of approximately **ASTM 10.5**, conforming to the requirements of C50TF133 CL-A (Figures 22 and 23).

**Figure 23:** 3<sup>rd</sup> step as-polished and etched micros at the edge of the origin showing it had post-fracture smeared material, but no other material anomalies were observed, and the microstructure was consistent with properly processed R65 per C50TF133, with an average grain size of approximately ASTM 10.5.

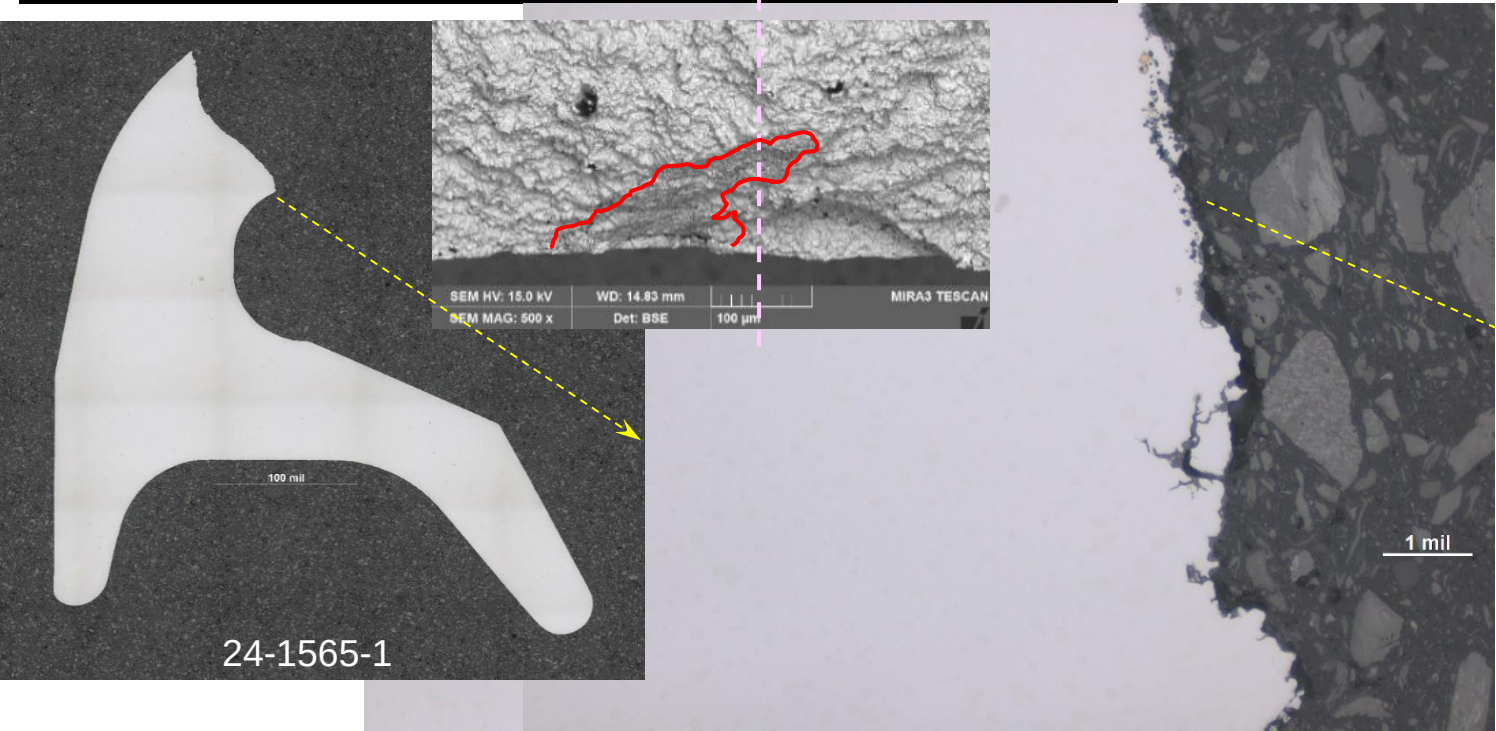
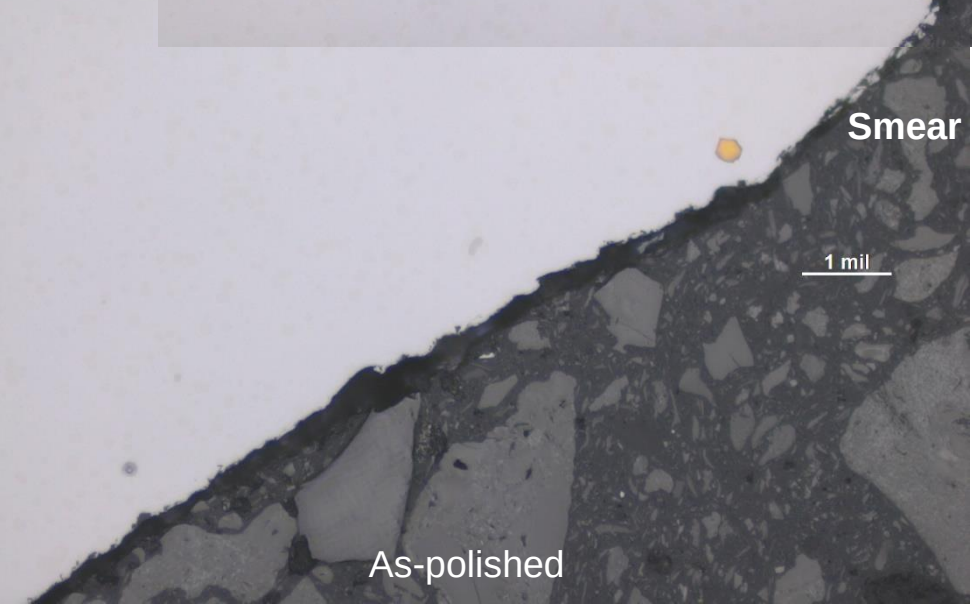
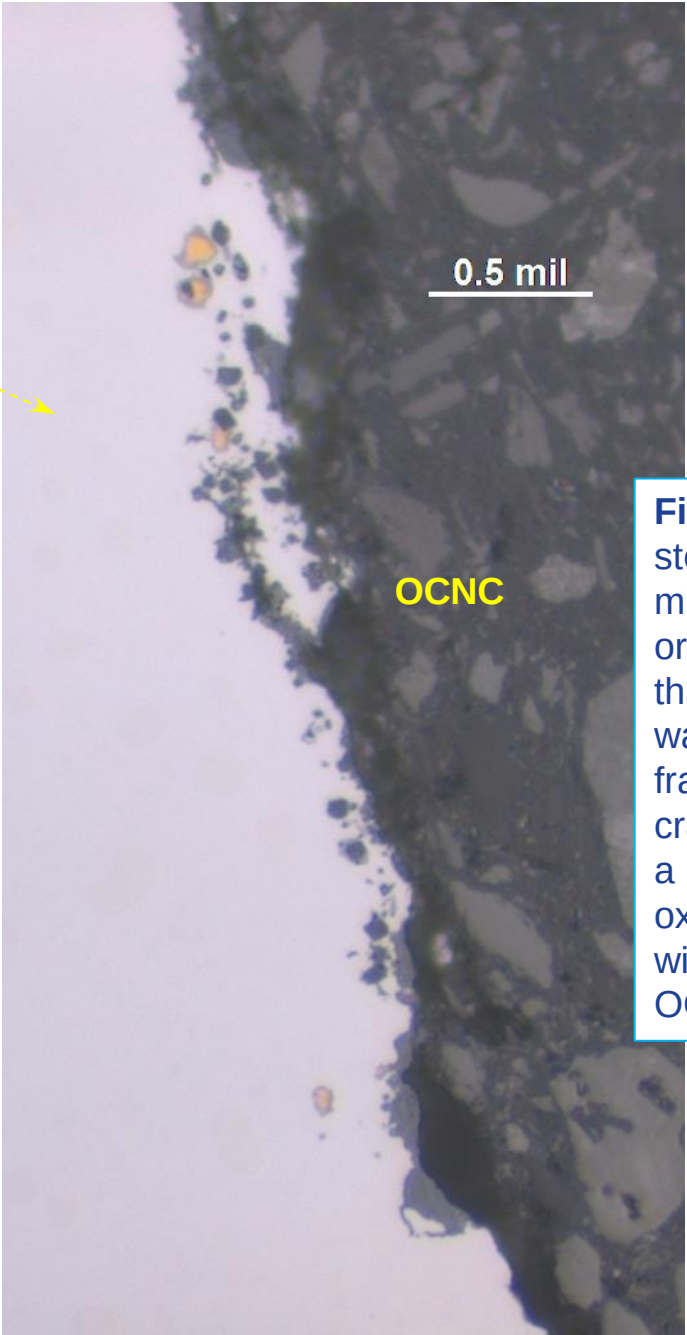
- The surface adjacent to the origin was smeared on both fracture halves consistent with post-fracture damage, but the origin itself was a combination of oxide particles that was up to approximately 0.5 mils thick in the plane of polish with no adjacent alteration of microstructure consistent with an OCNC with similar elements as the fracture EDS (Figures 24-26 and 34-35).

**Figure 24:** 4th<sup>rd</sup> step as-polished micros through the origin area showing that the surface itself was smeared (post-fracture), but the crack extended from a region of mixed oxides consistent with an inherent OCNC inclusion.

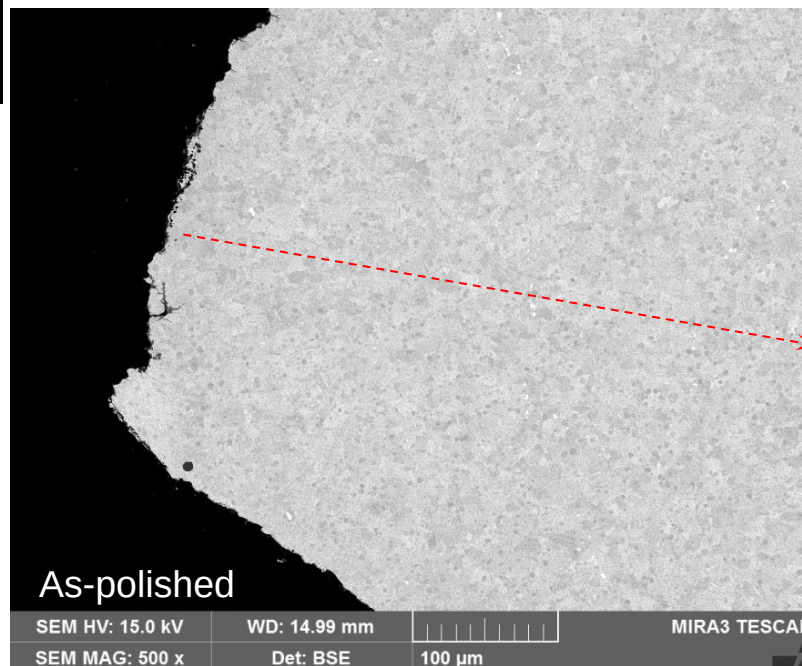
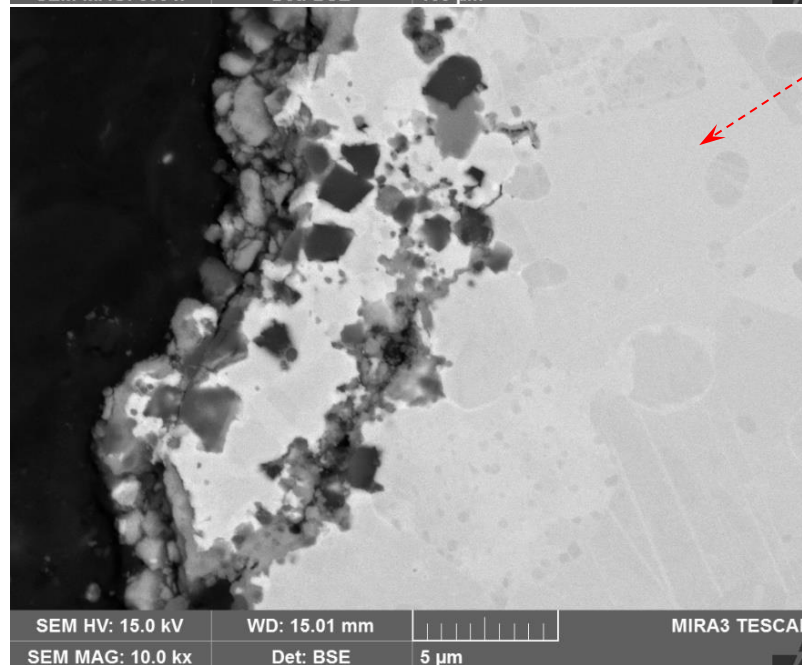
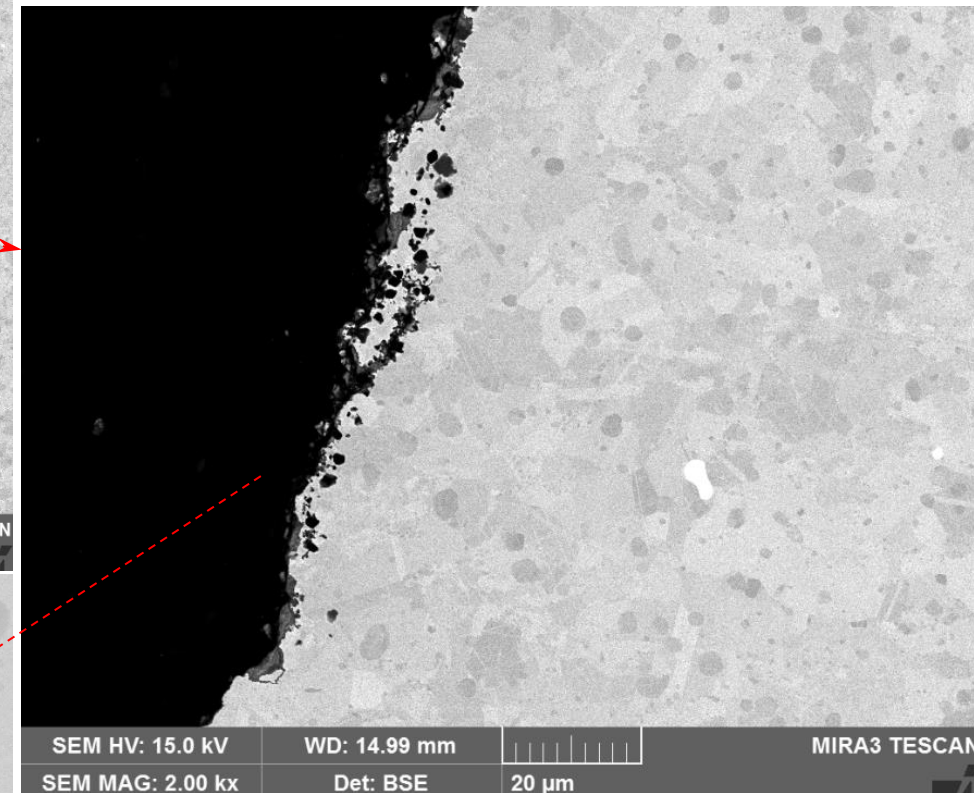
**Figure 25:** Views of the same micro in the as-polished condition in the SEM showing a conforming microstructure, but the origin area had mixed-oxides, consistent with an inherent OCNC (see next page).

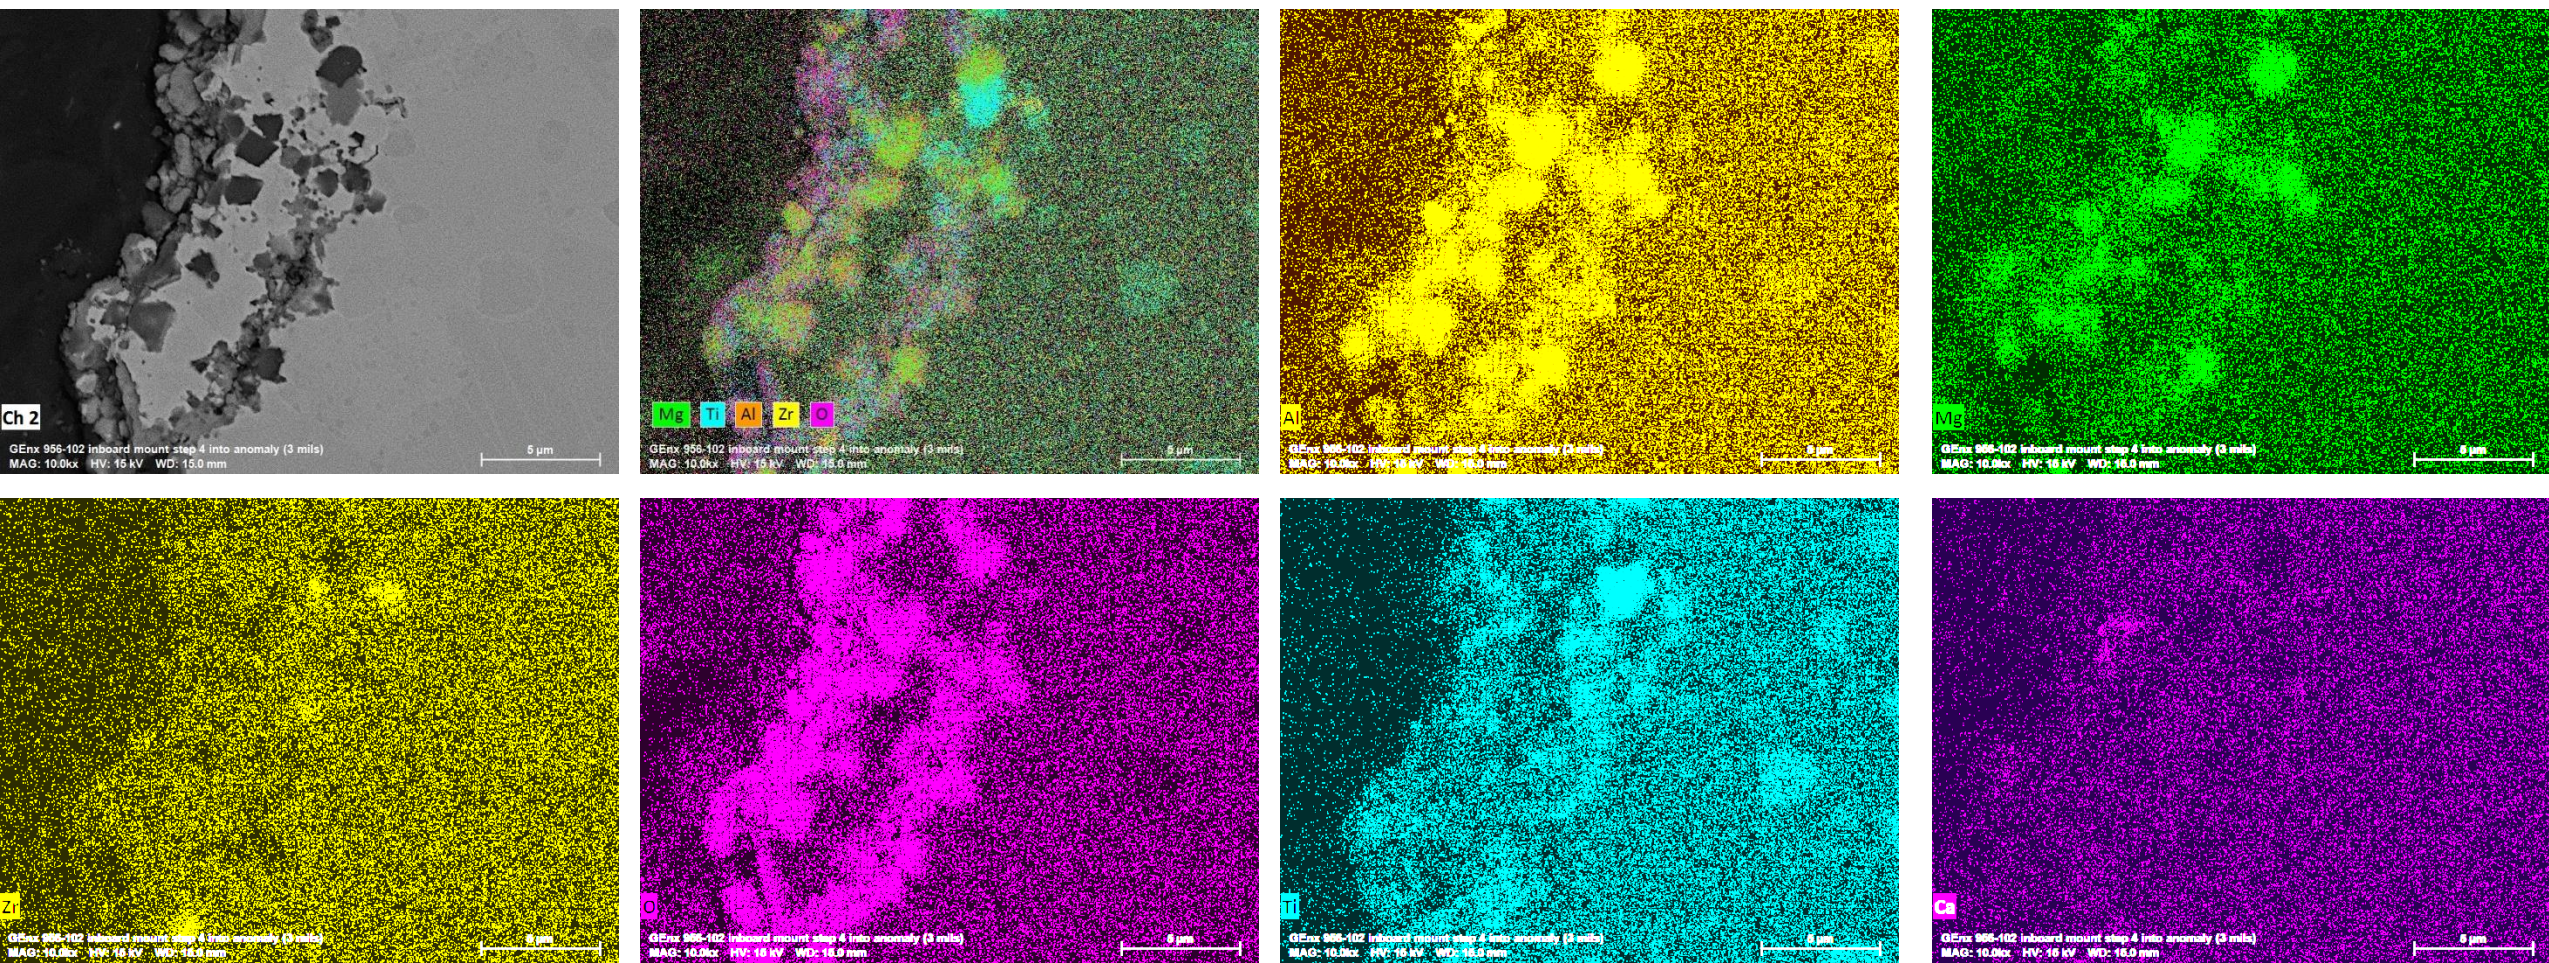
**Figure 26:** EDS dot maps taken across the origin area showed a region of mixed oxides rich in Al, Mg, Zr, Ti, O, consistent with an inherent OCNC inclusion.

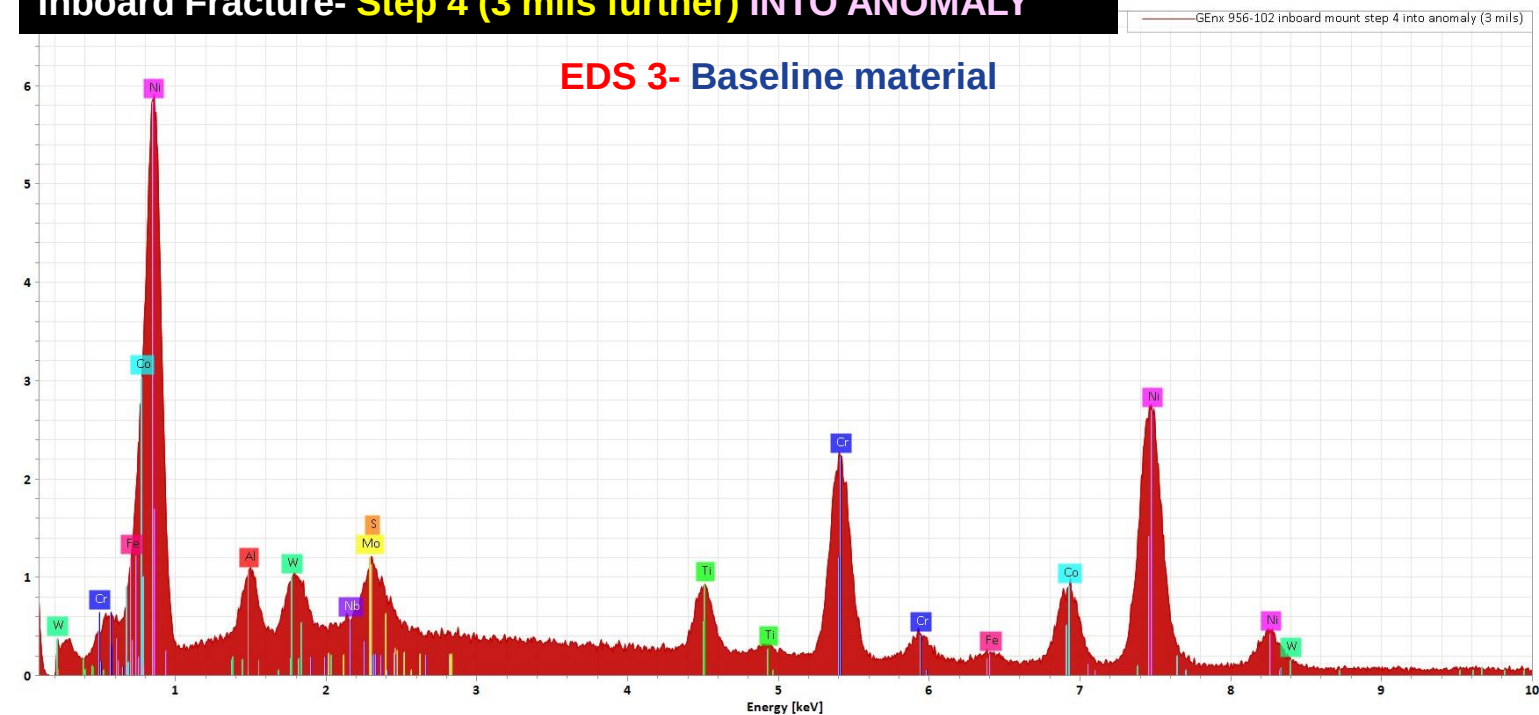
Figure 27: An EDS spectrum and semi-quantitative readings were consistent with the requirement of R65 per C50TF133.

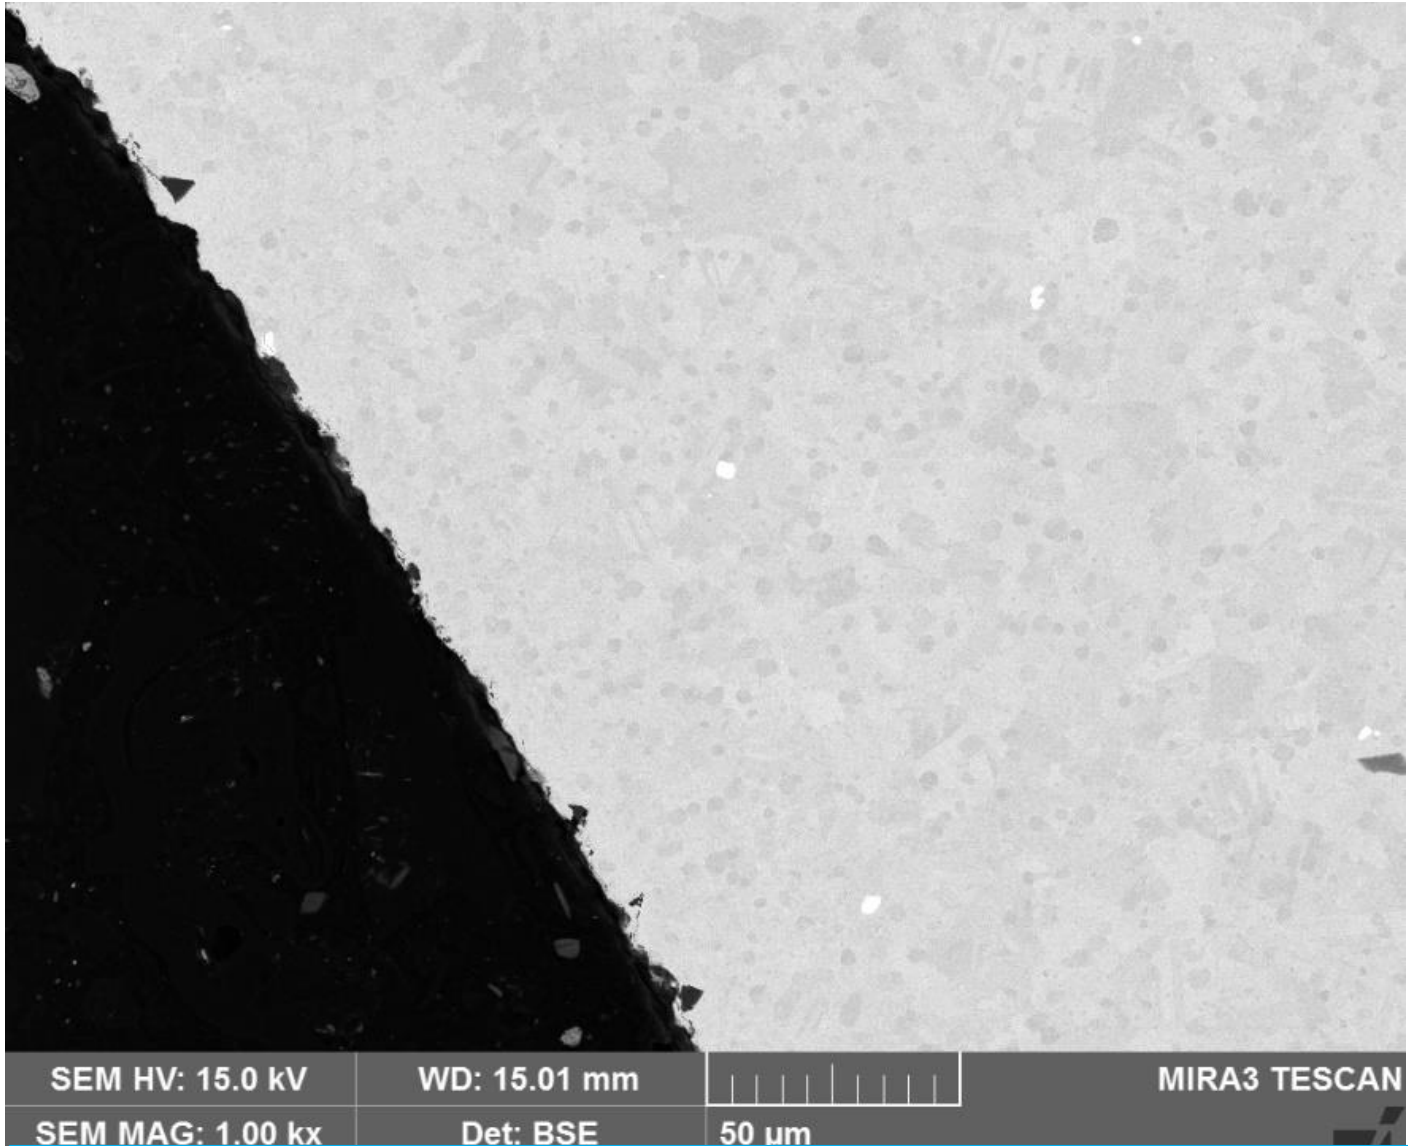
Figure 28: Work performed by GE Aerospace Research showed that there were no grain boundary precipitated phases observed, consistent with the part operating near/below 1200°F assuming 583 hot hours of hot time (20 min/cycle).

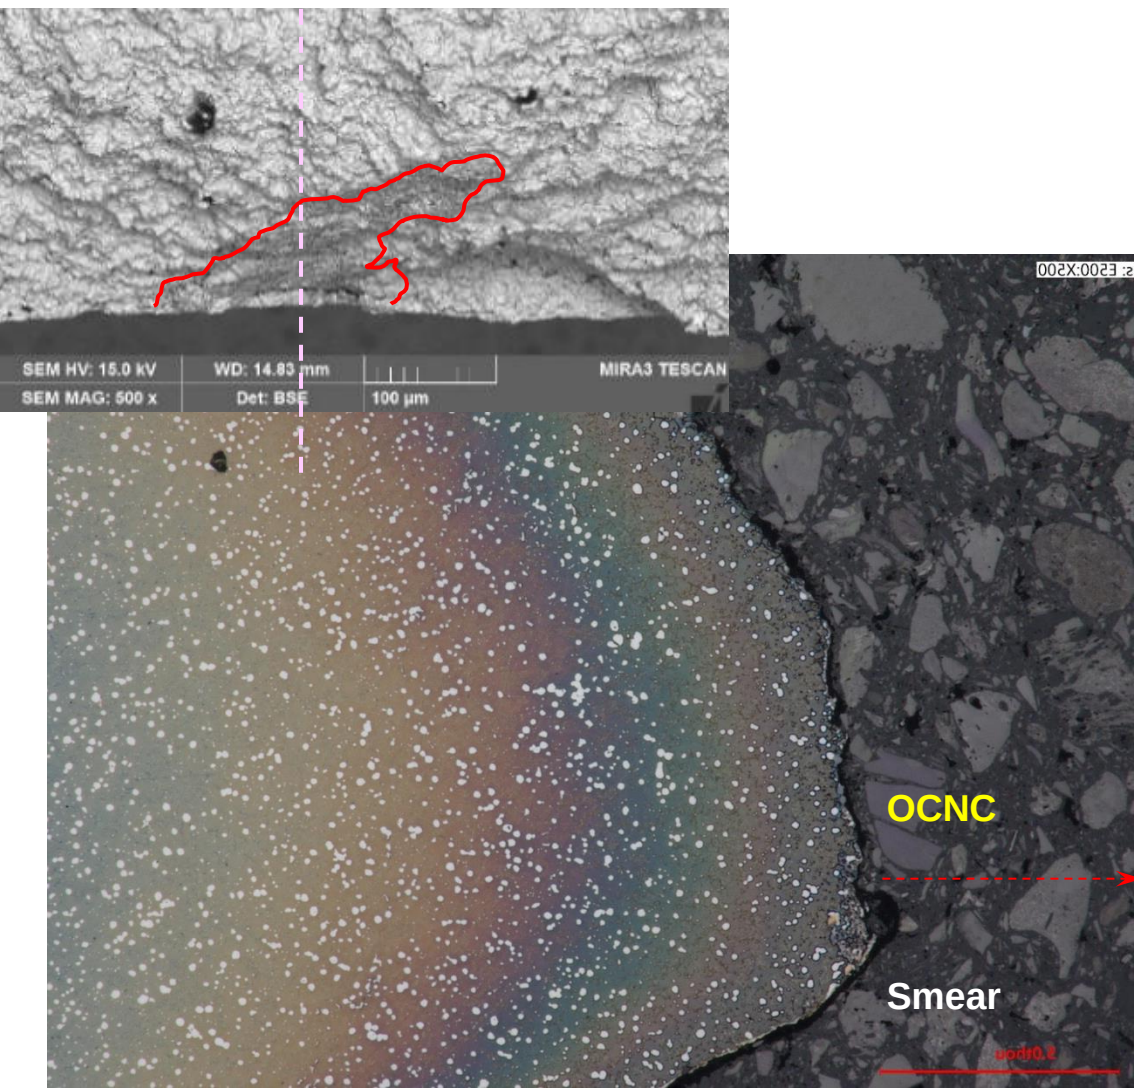
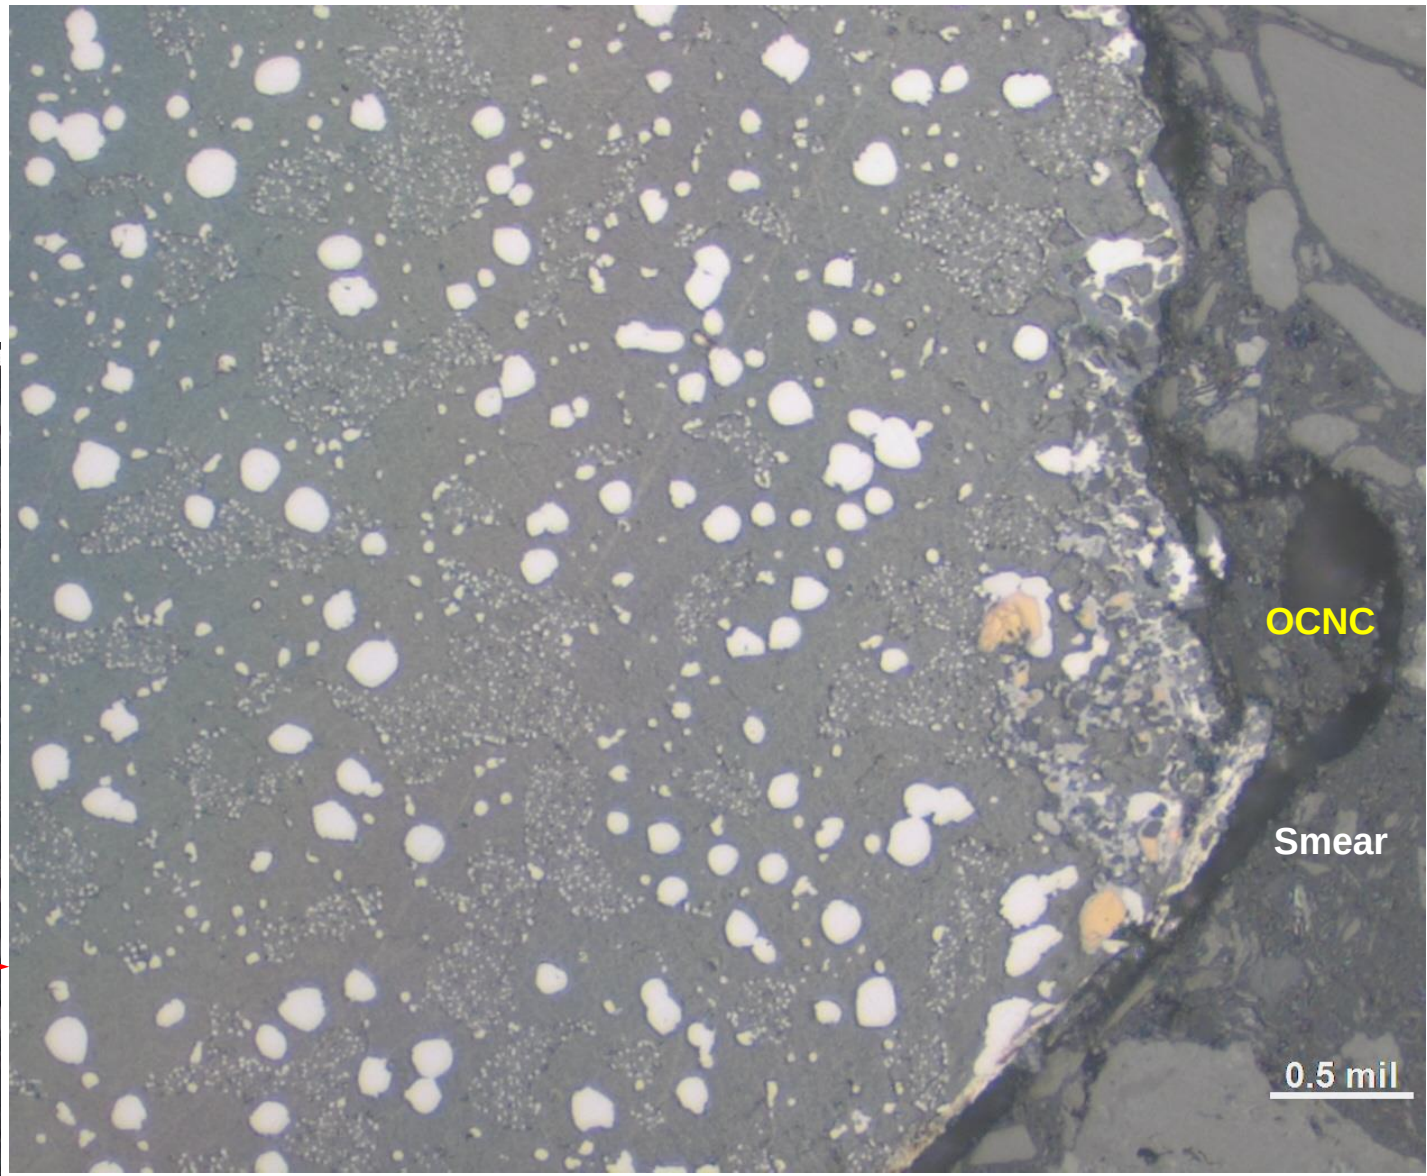
**Figure 29:** 5<sup>th</sup> step etched micro through the origin area showing that the surface itself was smeared, but the crack extended from a region of mixed oxides consistent with an inherent OCNC inclusion that was approximately 0.5 mils thick in the plane of polish.
