# National Transportation Safety Board

ENG24LA014

GE Aerospace - Metallurgical Investigation Report (DRB AvEng-558171.A)

**METALLURGICAL EVALUATION OF A GENX-1B  
HPT STAGE 1 AFT BLADE RETAINER INVOLVED IN  
AN UNCONTAINED EVENT FROM ESN 956-102  
OPERATED BY UNITED**

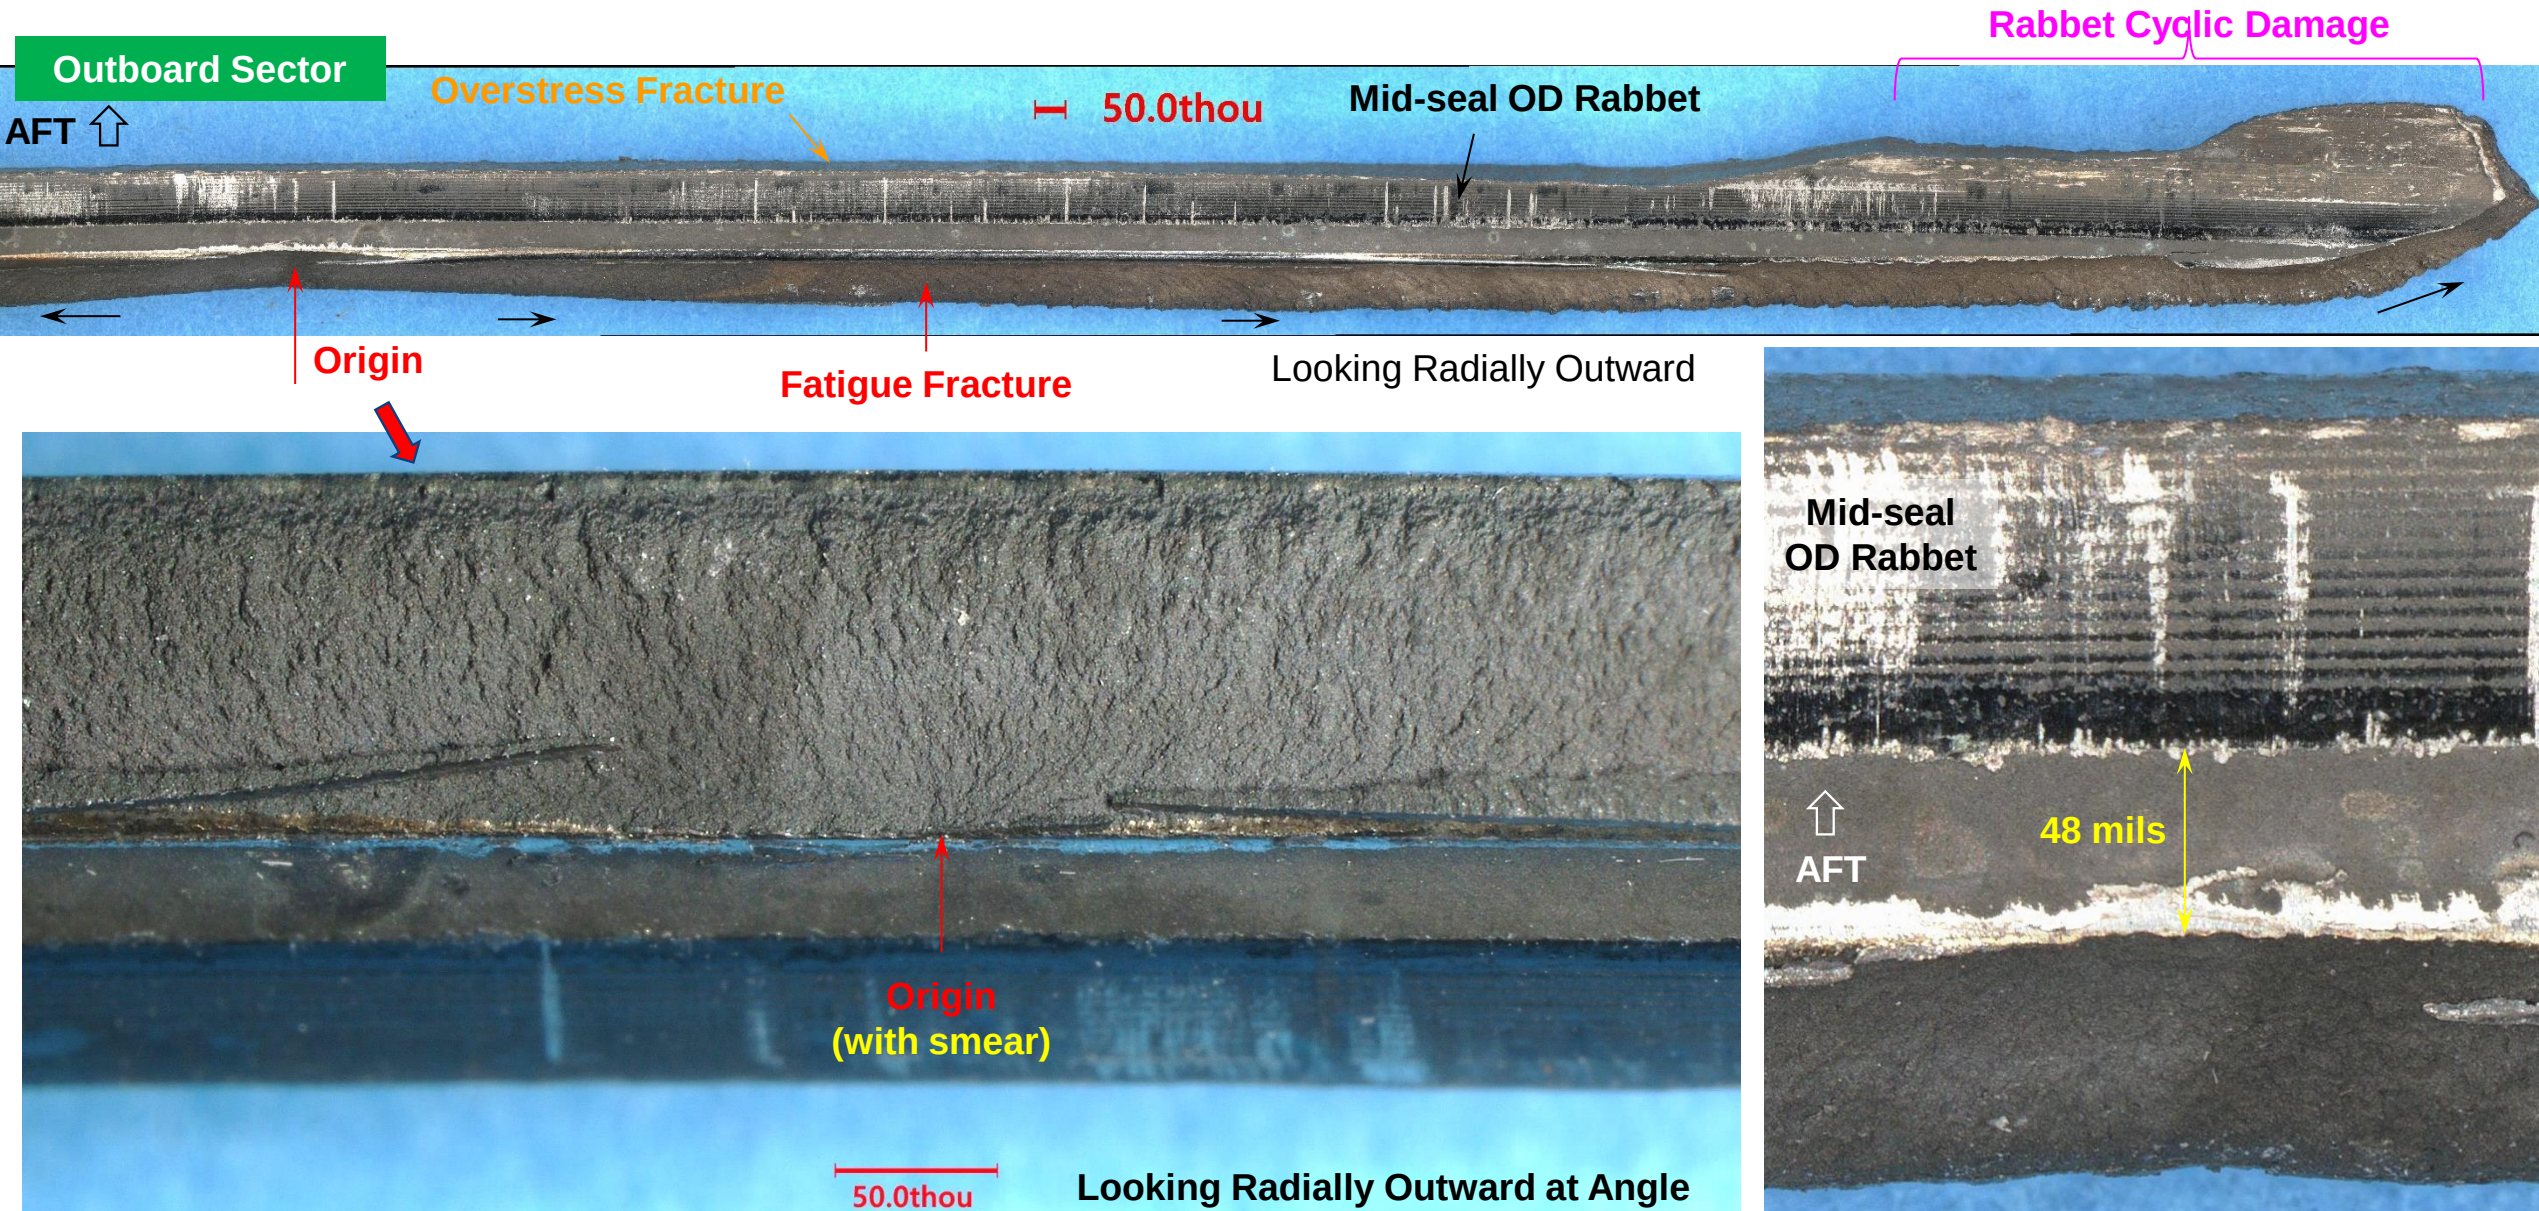
**Figure 30:** Optical views of the outboard fracture half showing a similar single point origin at the surface, but the surface itself had more pronounced post-fracture smearing (shiny). The origin area was approximately 48 mils forward of the mid-seal OD rabbet. Also visible are the secondary fracture plane in the region of the disk rabbet undercut radius with features consistent with overstress (orange) and cyclic tensile/hold time (pink).

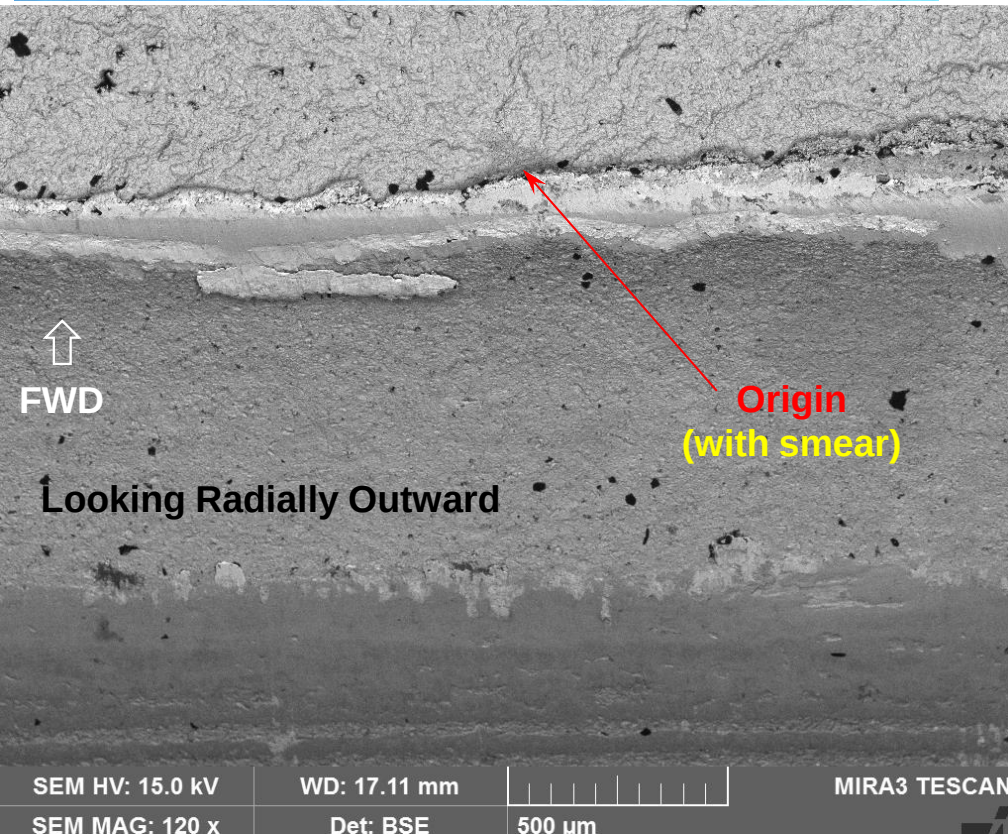
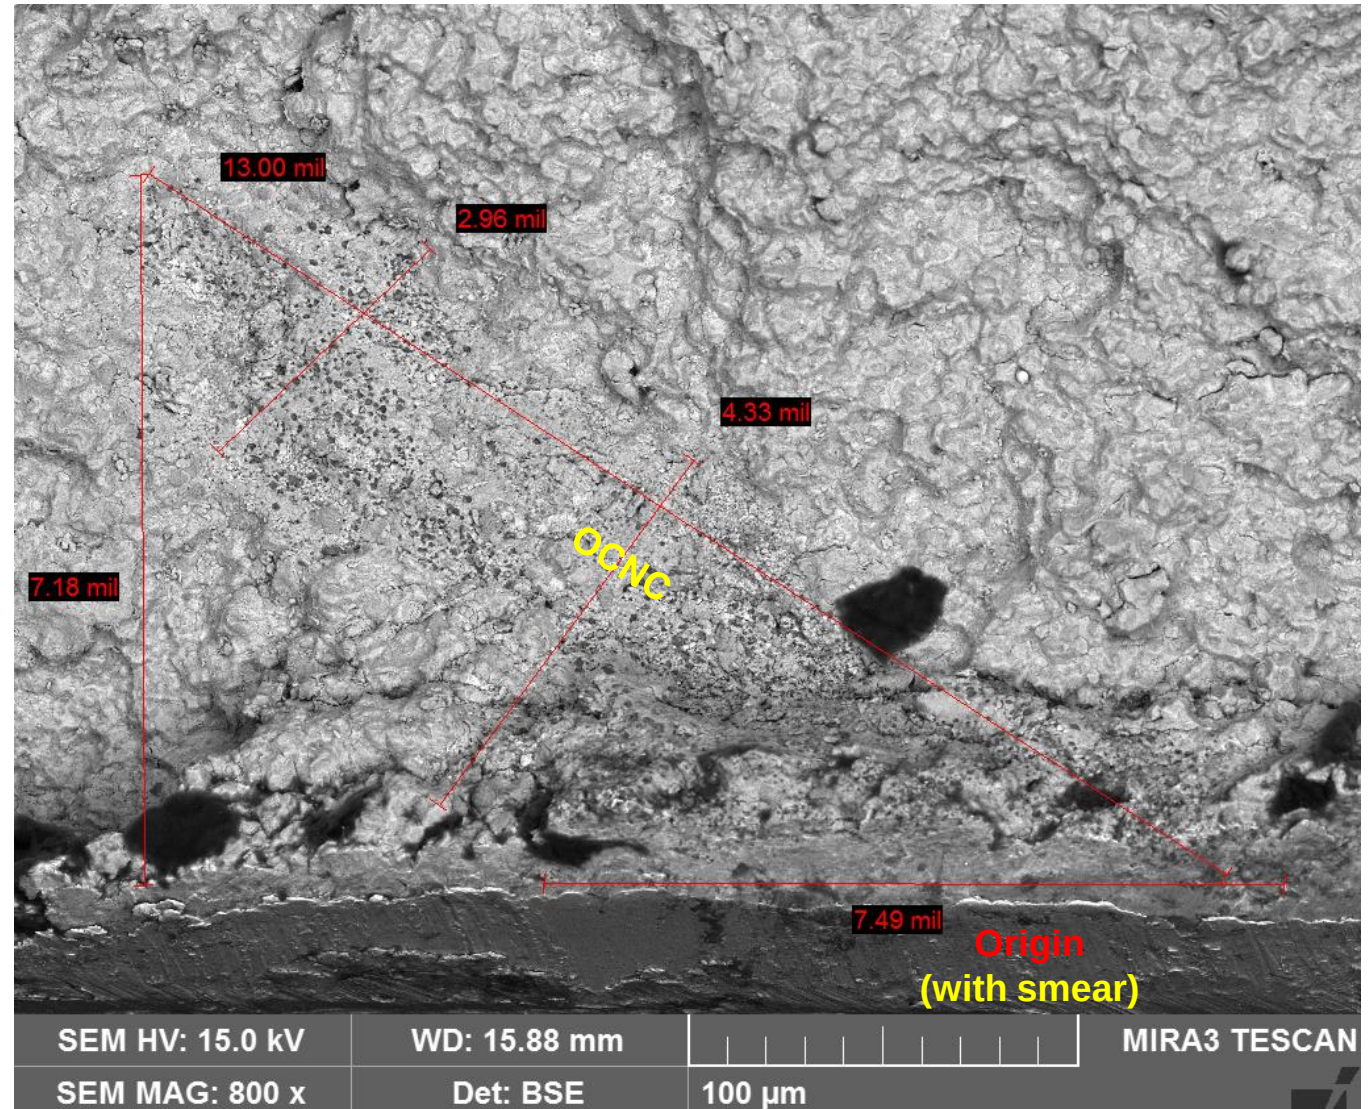
**Figure 31:** SEM views of the mating outboard origin area showing that it had the similar region of mixed oxides and was estimated to be approximately **13 mils** long with post-fracture smearing observed at the surface.

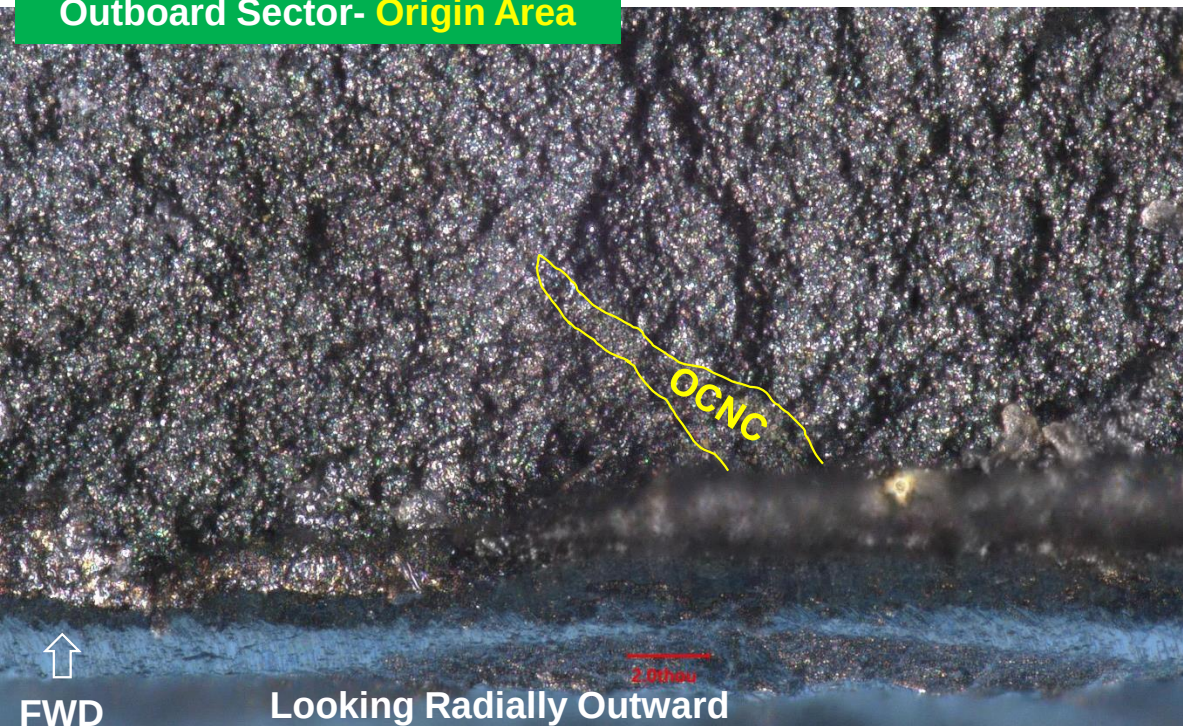
**Figure 32:** Optical views of the outboard fracture surface at/near the origin showing where step polishing was performed.

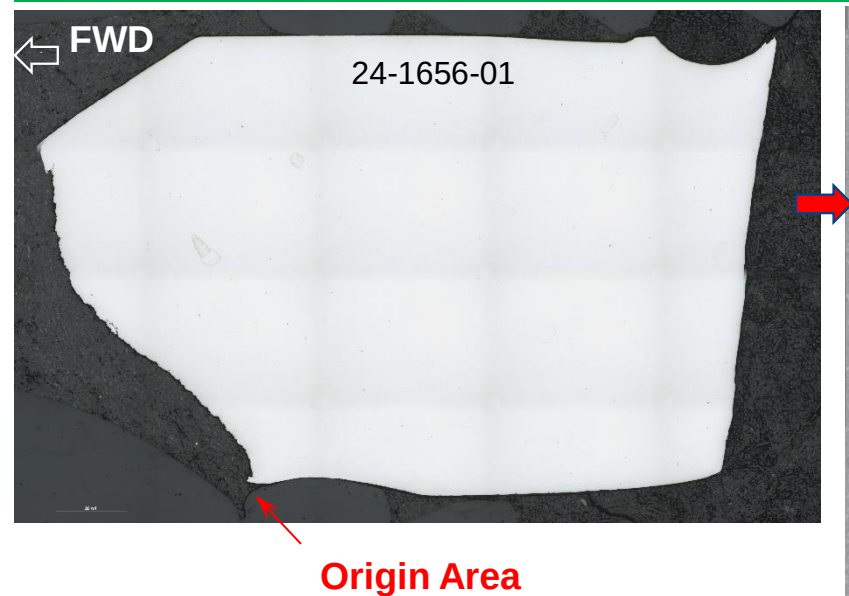
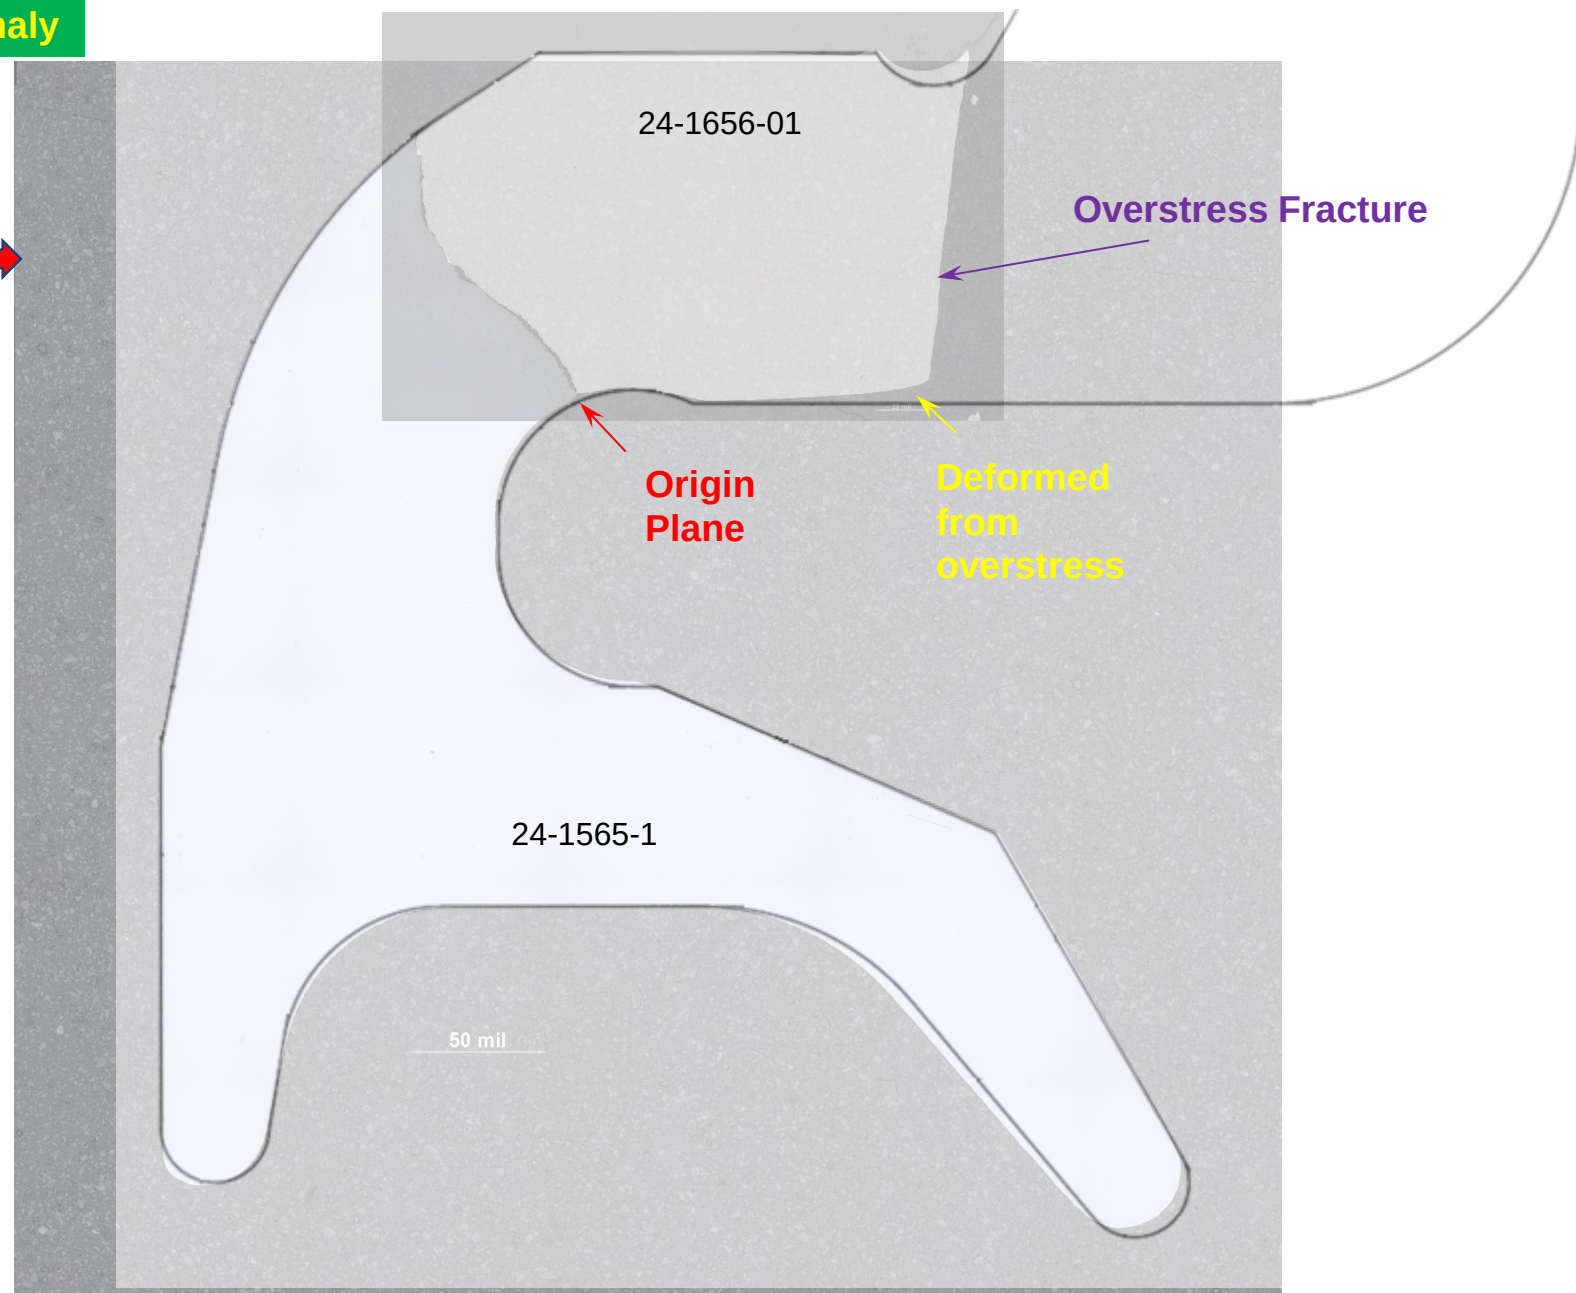
**Figure 33:** A cross-sectional micro made in the 1<sup>st</sup> step polish of the outboard sector showed that the origin plane initiated near the top/outboard side of the collet radius. The section was deformed at the aft end consistent with damage from the final overstress of the part.

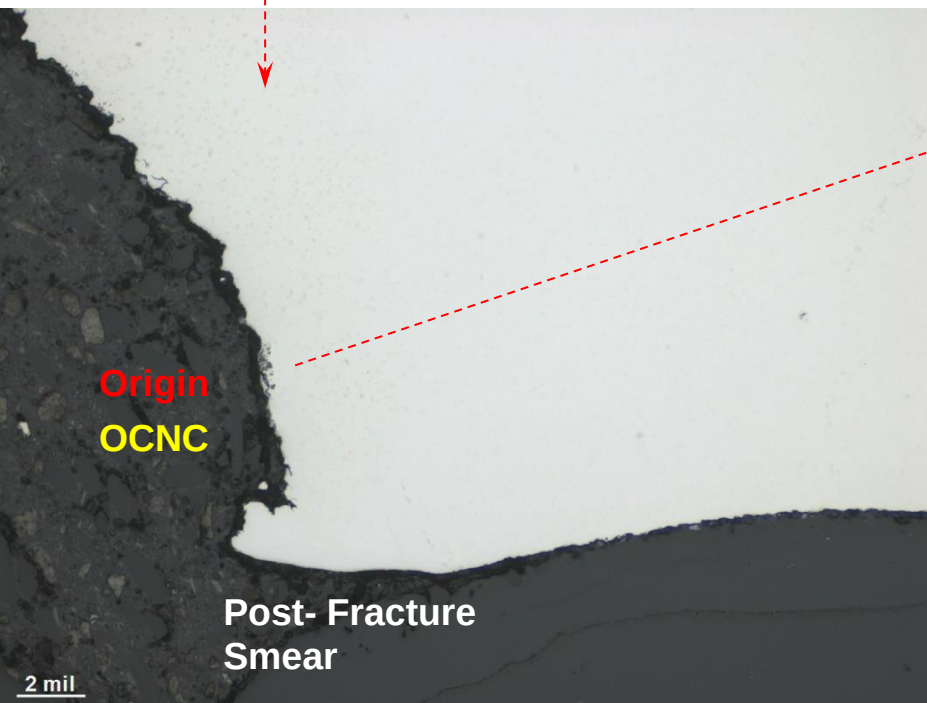
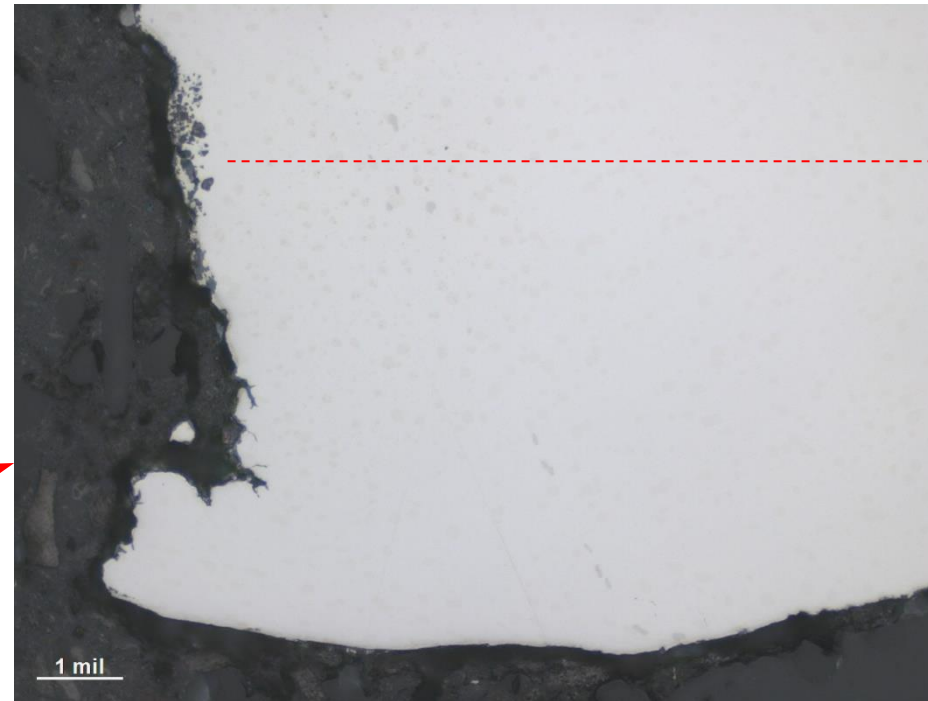
**Figure 34:** A cross-sectional micro made across the outboard mating origin half showed that that the surface itself was smeared, but the crack extended from a region of mixed oxides consistent with an inherent OCNC inclusion that was approximately 0.5 mils thick in the plane of polish.

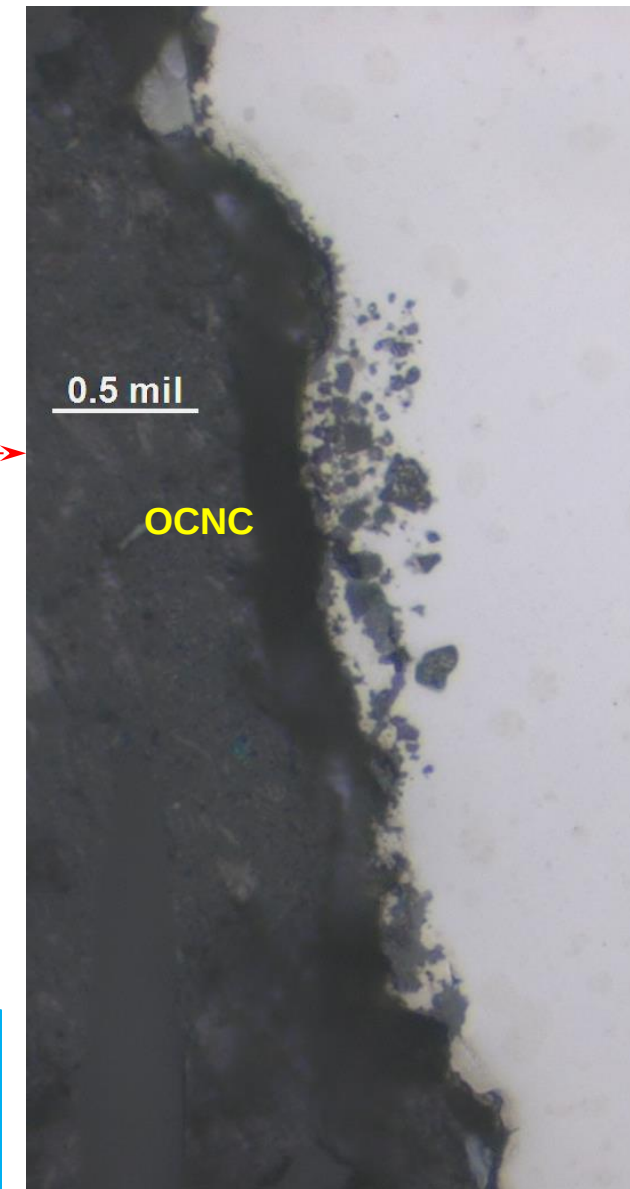
**Figure 35:** Etched views of the origin area showing mixed oxides consistent with an inherent OCNC inclusion.

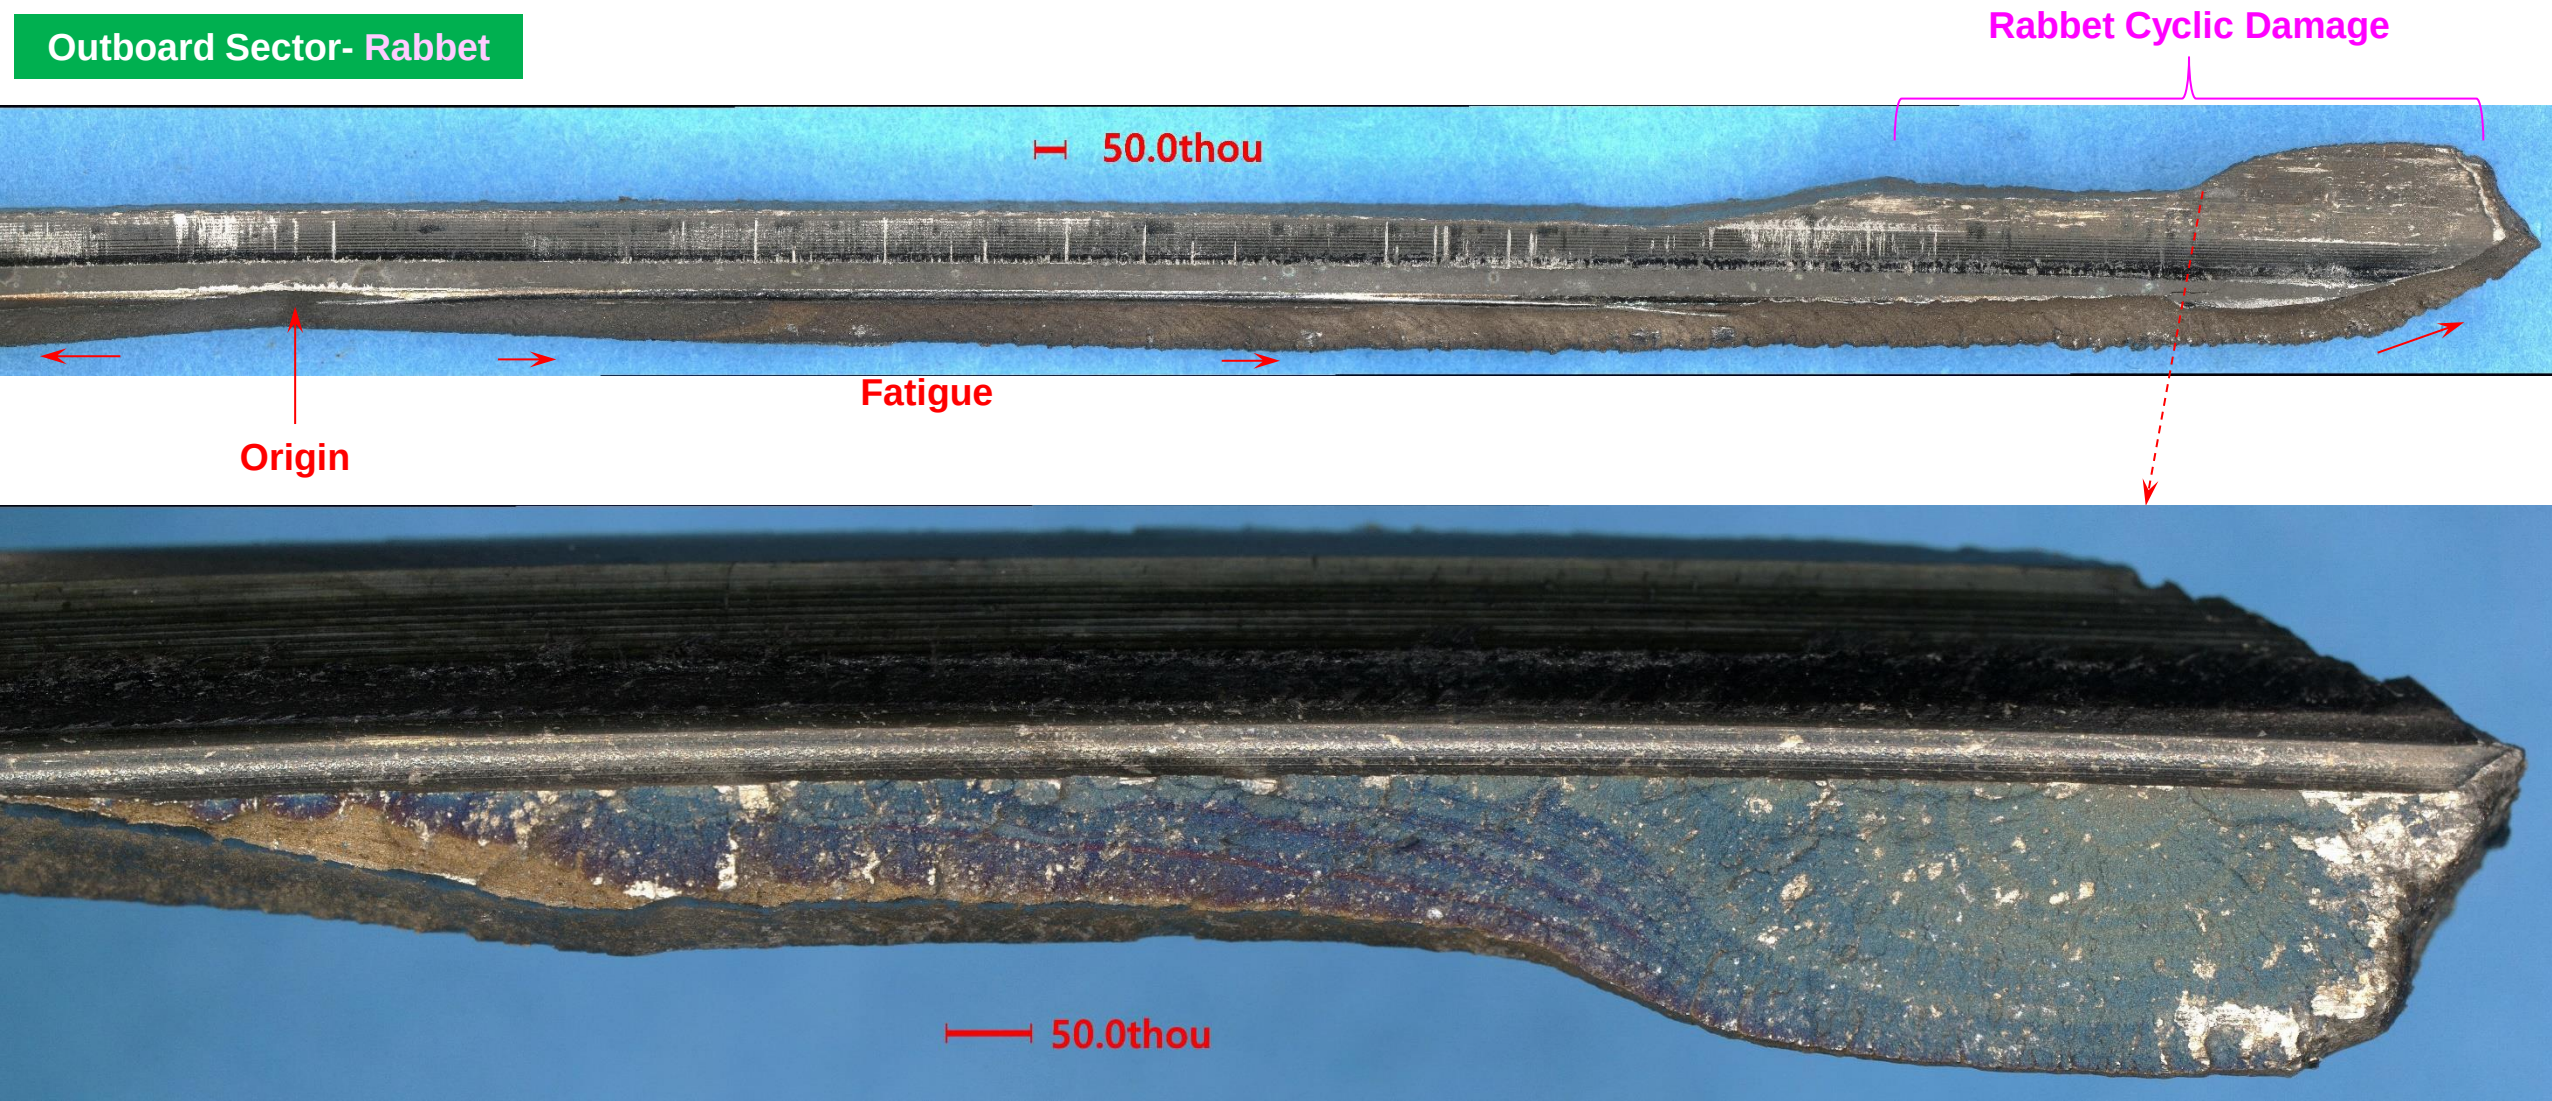
- The average micro-**hardness** (Vickers, 500g load) was approximately **HRC 49**, conforming to the requirements of C50TF133 CL-A (not shown).
- At the crack transition from stable fatigue to overstress near 2:30, there was additional cracking further aft growing from the disk rabbet undercut radius inboard with progression marks consistent with cyclic damage. Optical and SEM examination showed that the larger cracks were intergranular and the smaller cracks near the edge had a mixture of intergranular and dimpled features. The overall findings are consistent with secondary, shorter-term hold time/cyclic tensile cracking (Figures 36-38). A laboratory study showed that static intergranular cracking could be produced in as little as 8 hours depending on the loading conditions used at 1100°F (Appendix A).

**Figure 36:** Optical image showing that near the end of the stable fatigue region (red), there was additional cracking extending from the disk rabbet undercut radius and growing toward the ID. The region had multiple origins and had progression/beach marks, consistent with secondary cyclic hold-time/tensile cracking (see following slides).

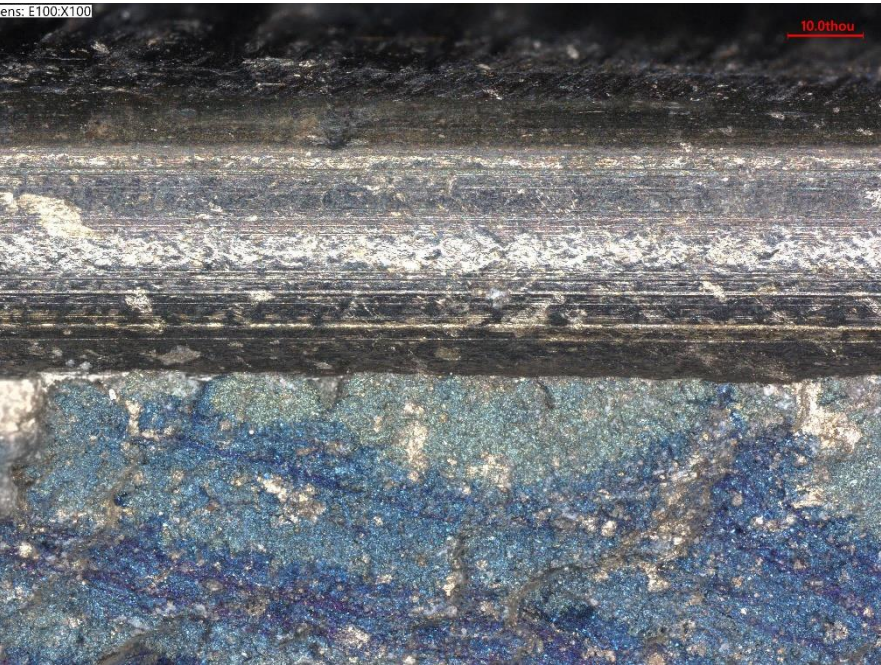
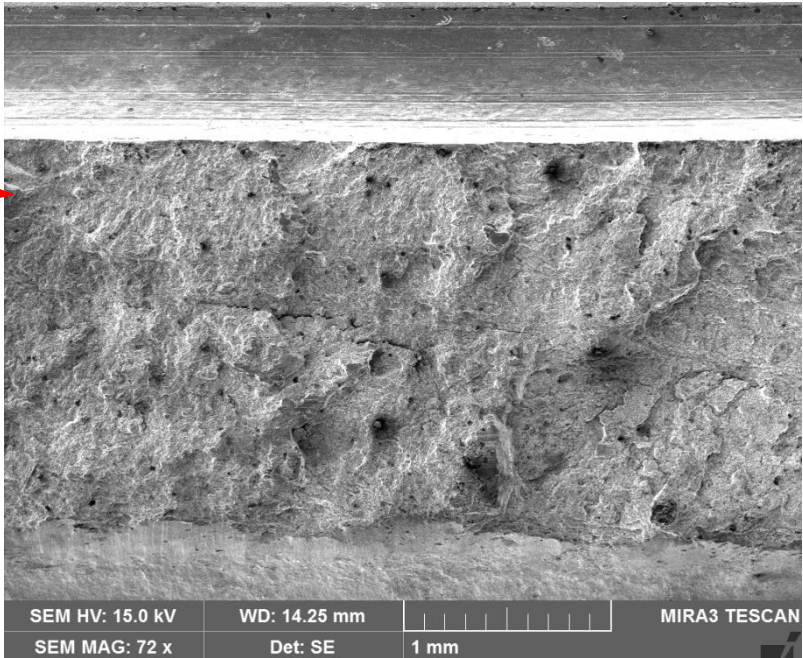
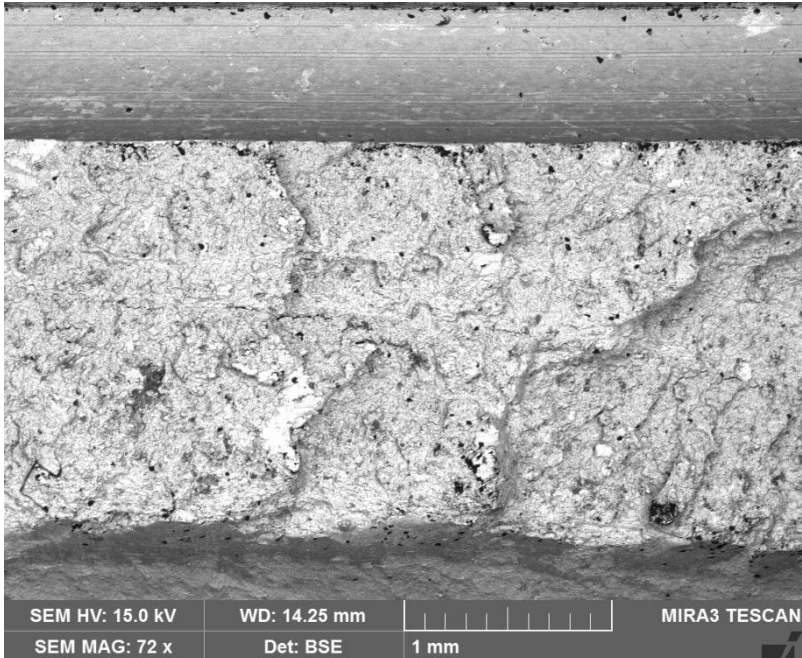
**Figure 38:** Moving toward one of the smaller thumbnails in the OD rabbet radius beach mark region revealed a combination of intergranular and ductile dimple regions, consistent with secondary cyclic tensile/hold time fatigue region.

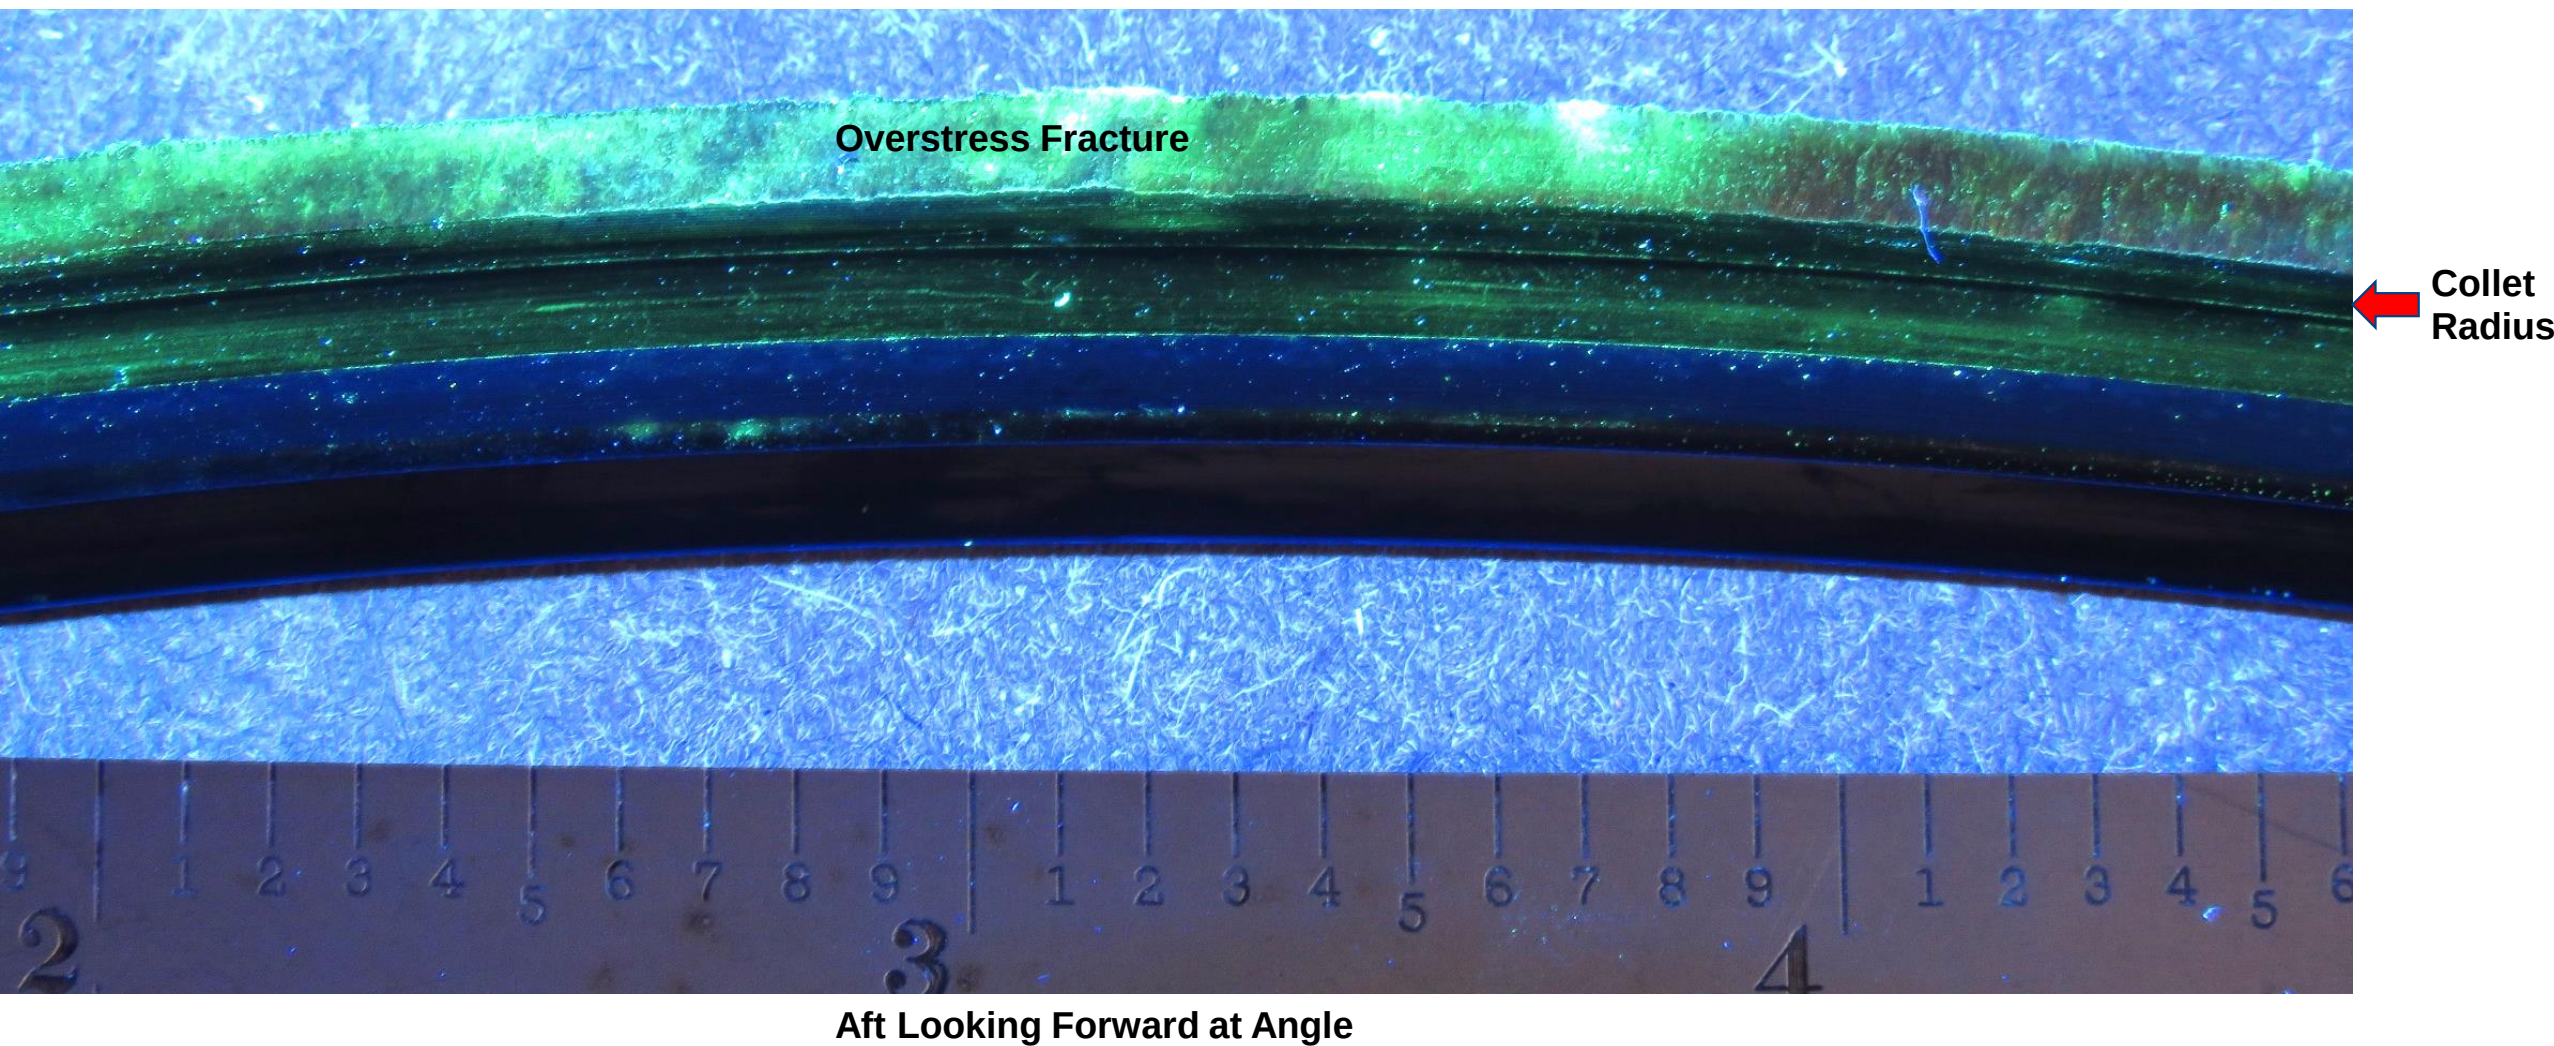
- Fluorescent penetrant inspection (**FPI**) of remaining retainer revealed **no crack-like** linear indications (Figure 39).
- Due to the discrepancy between predicted part lifing and the event timing, part specific feature fatigue tests with the exact geometry/surface condition (peening/roughness) were performed by extracting ½ inch wide specimens from fielded parts with the intent to examine the following:

**Figure 39:** The remainder of the retainer was FPI'ed and no additional crack-like indications were observed.

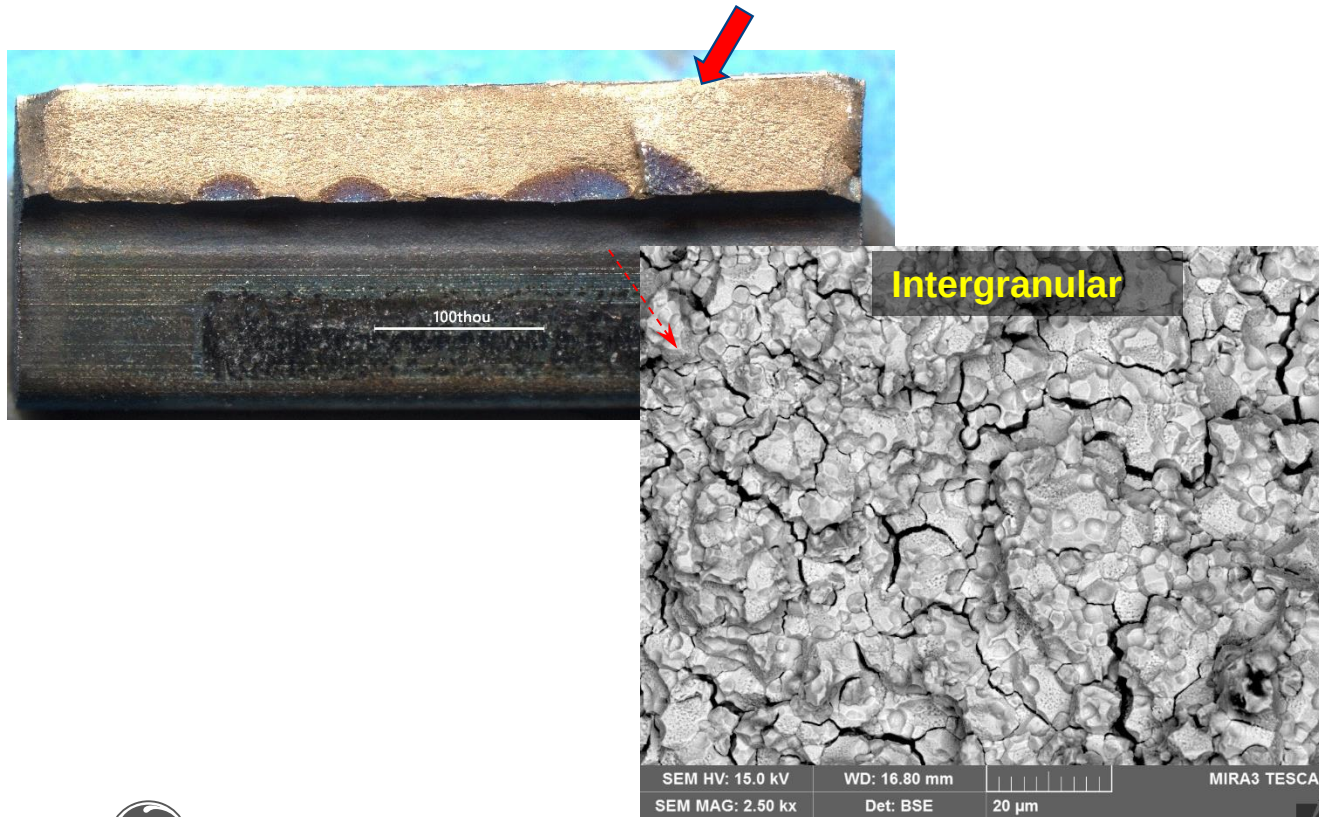
1100°F; 1000 lbs (arm fracture)

- 1) 1100°F, **1000 lbf** → Fracture in **46 hours** → Fracture **intergranular**.
- 2) 1100°F, **1200 lbf** → Fracture in **8.5 hours** → features are **intergranular** (undercut radius)

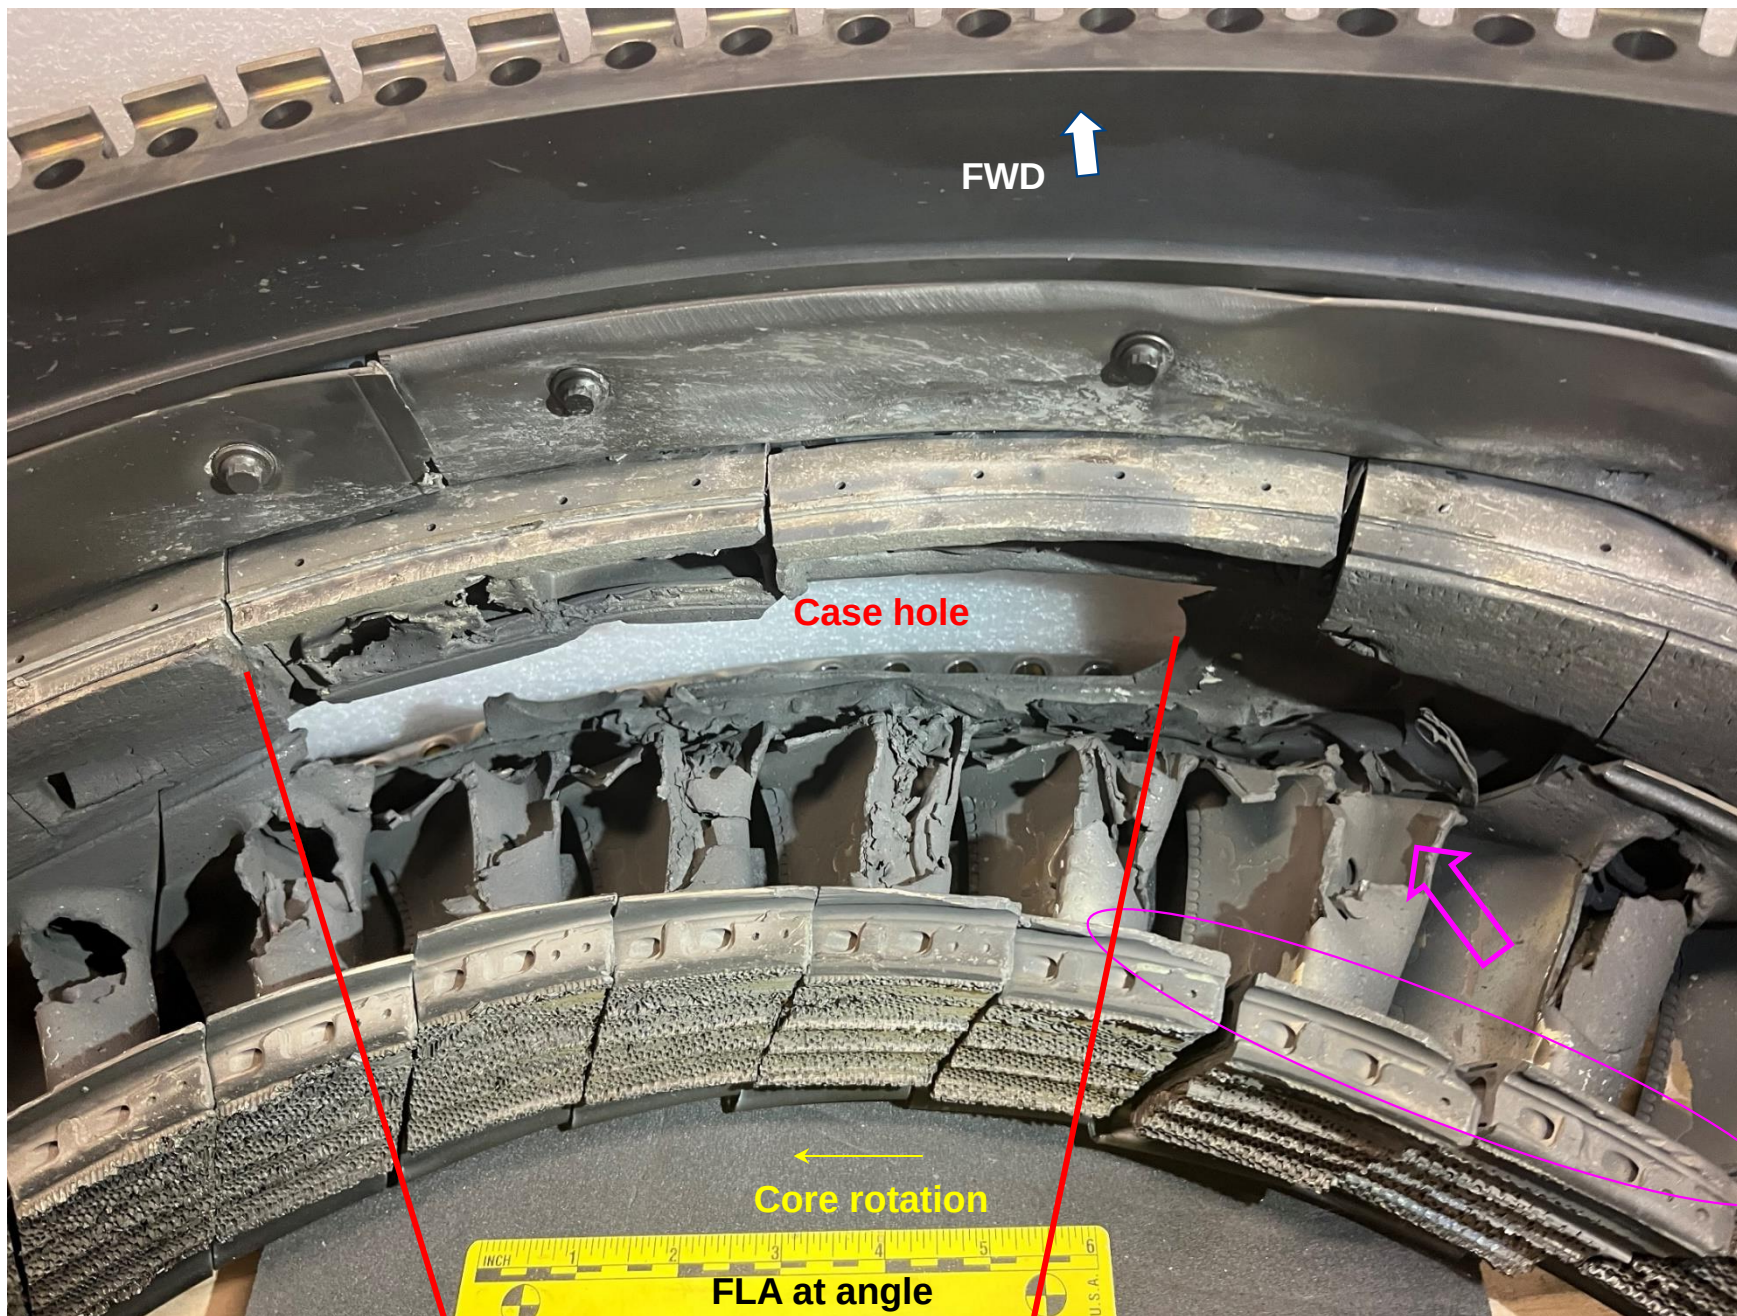
Circumferential offset of damage progressing from the retainer/S2 nozzle forward angel wing outward

Missing/damaged S2N forward angel wing
