# National Transportation Safety Board

## **MATERIALS LABORATORY**

Factual Report 25-009

Location: Dulles, Virginia  
Date: November 19, 2024  
Vehicle: Bombardier CL-600-2C11, N501GJ  
Investigator: Adam Huray, AS-40

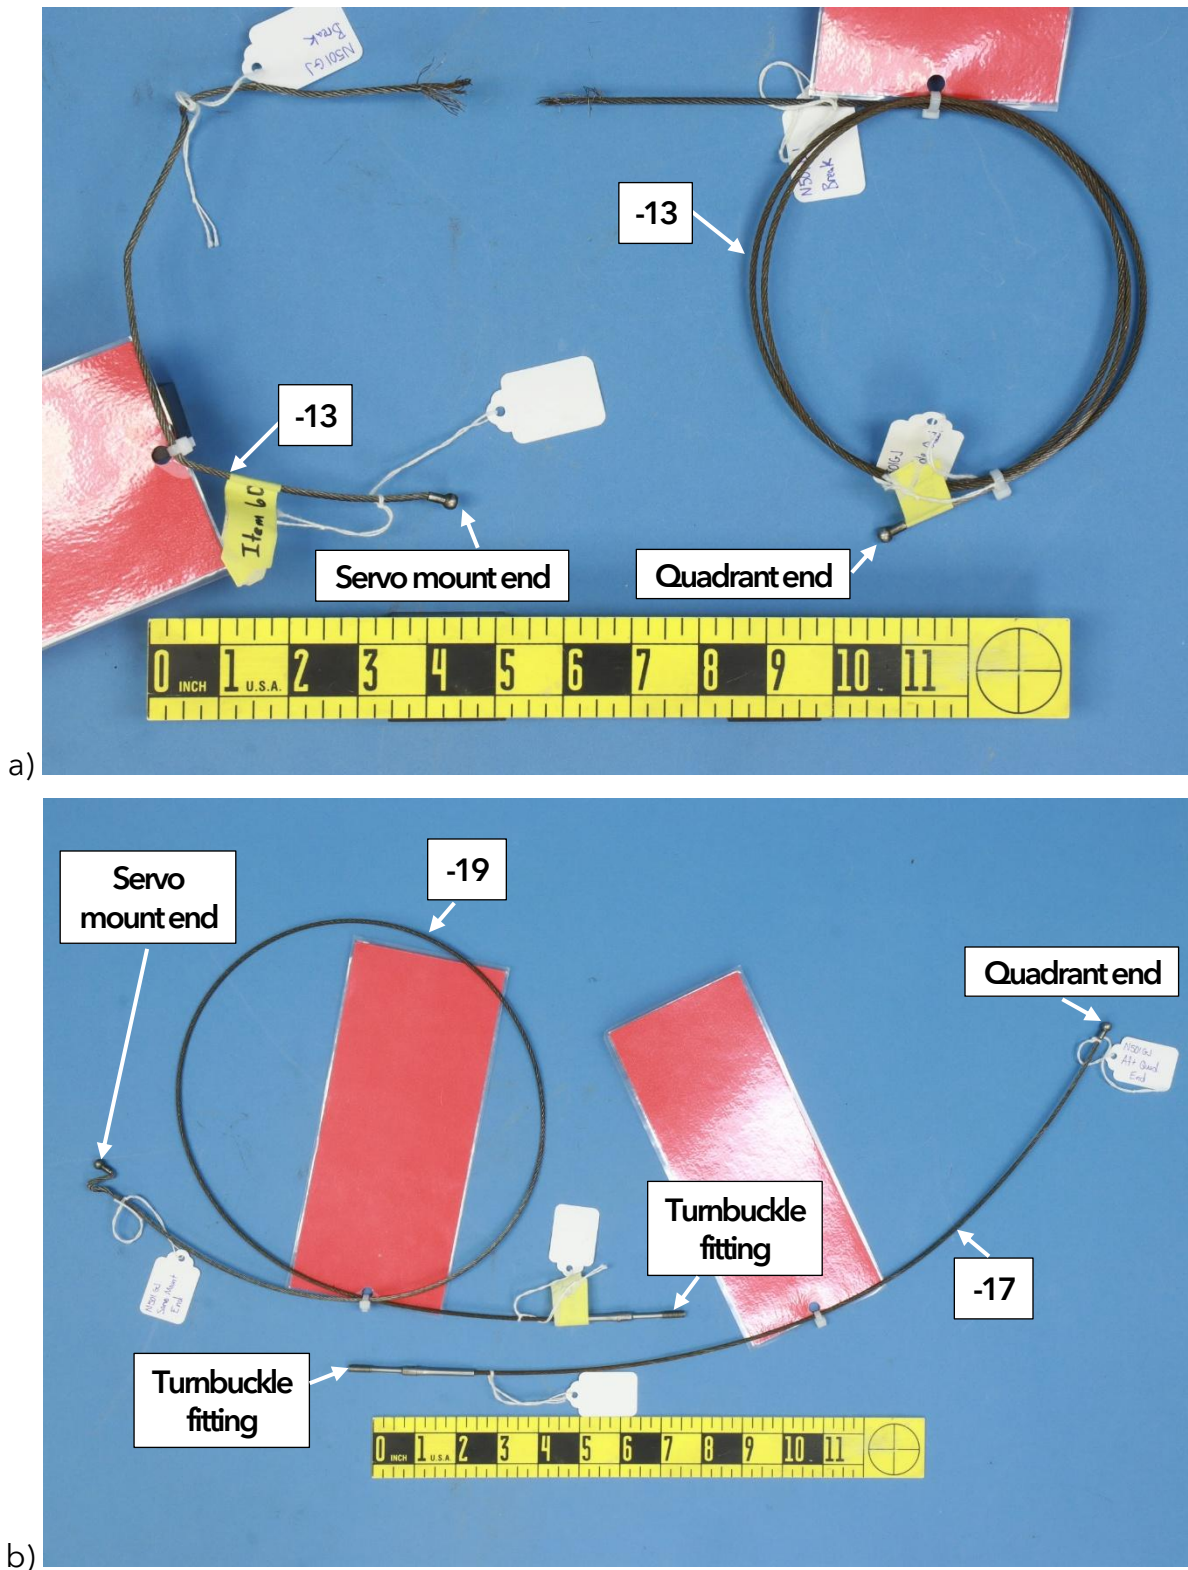
Autopilot elevator control cable assemblies from the incident aircraft were submitted to the NTSB Materials Laboratory for examination (figures 1a and 1b). A piece of fractured control cable from sister aircraft N502GJ was also submitted for examination (figure 2). One of the cables from the subject aircraft was fractured approximately 14 inches from the end that connected to the autopilot servo mount. The cable from sister aircraft N502GJ was fractured approximately 14-3/4 inches from the same end.

**Figure 1.** Elevator control cables from N501GJ: a) "-13" assembly, fractured and b) "-17" and "-19" assemblies absent the connecting turnbuckle.

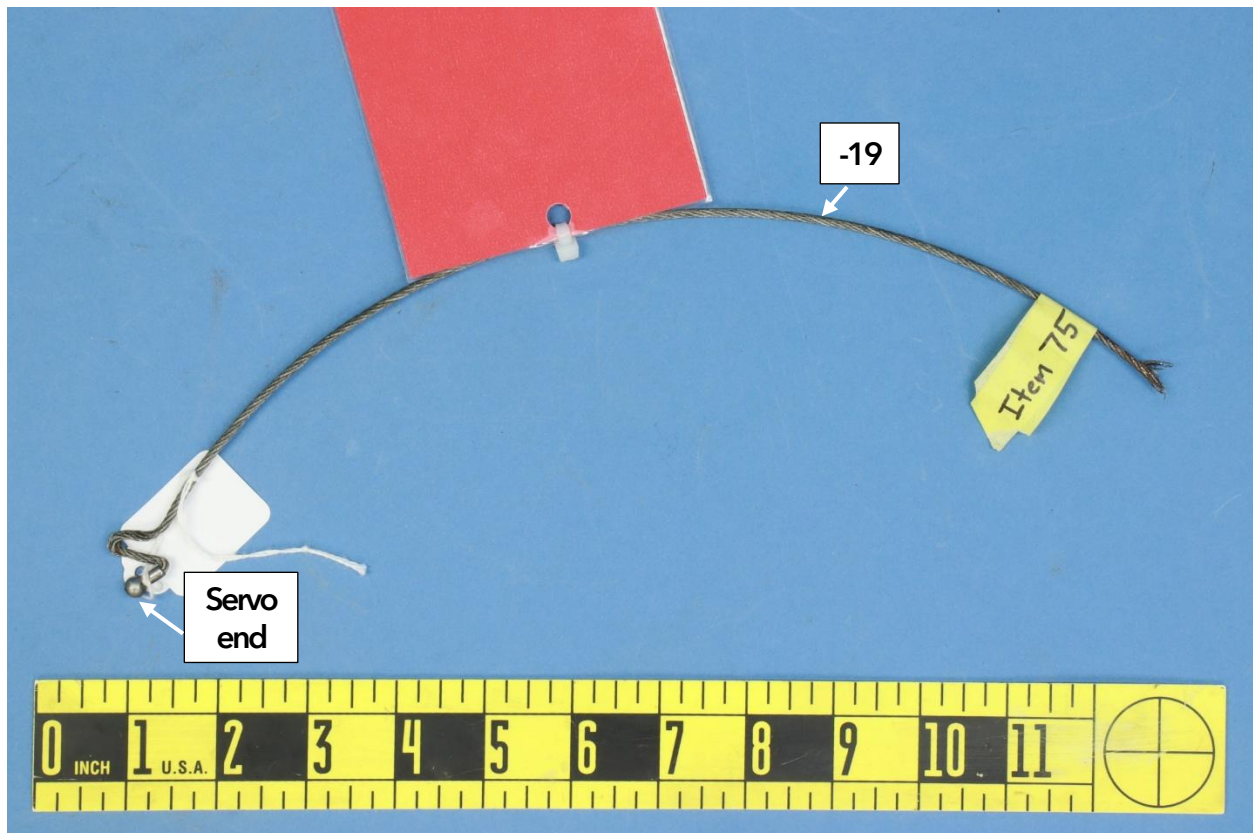
The fractured cable fragment from sister aircraft N502GJ was from a "-19" cable (figure 2). The "-19" cable assembly connected to the servo mount at one end and terminated at a threaded turnbuckle fitting at the other. The cable was fractured approximately 14-3/4 inches from the servo end. Near the fracture, regions of the cable exhibited a rust-colored tint and only a few strands/wires exhibited deformation

**Figure 2.** Piece of fractured "-19" elevator control cable assembly from sister aircraft N502GJ. The cable is listed as "Item 75" in the aircraft Illustrated Parts Catalog.

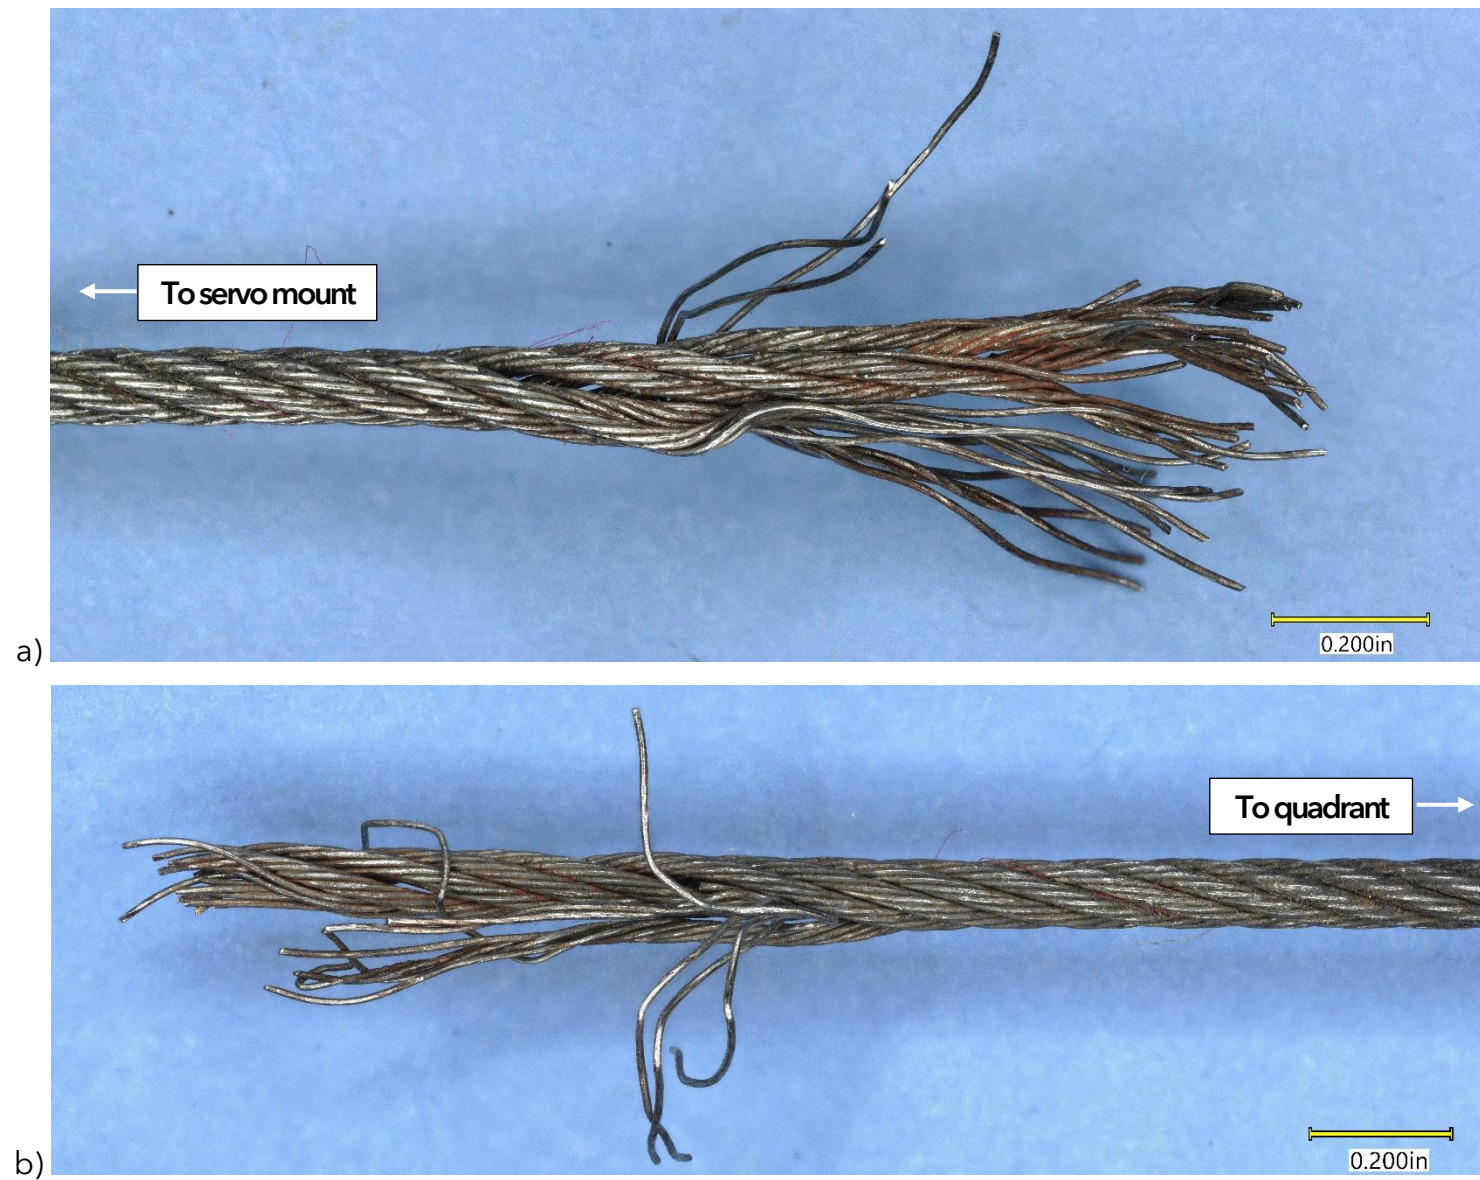
The fractured cable from the incident aircraft was a "-13" cable that connected to both the servo mount and the quadrant. The cable had fractured approximately 14 inches from the servo mount end. Near the fracture, regions of the cable exhibited a rust-colored tint, and only a few strands/wires exhibited deformation bending or splaying (figures 3a and 3b). Closer examination of the fractured cable ends indicated that most of the wires exhibited flat fracture surfaces. The majority of individual wires were worn within the rust-tinted region and, in particular, worn adjacent to the wire fractures (figures 4a and 4b).

**Figure 3.** Fractured mating ends of the "-13" cable from N501GJ: a) input-side fracture and b) output-side fracture.

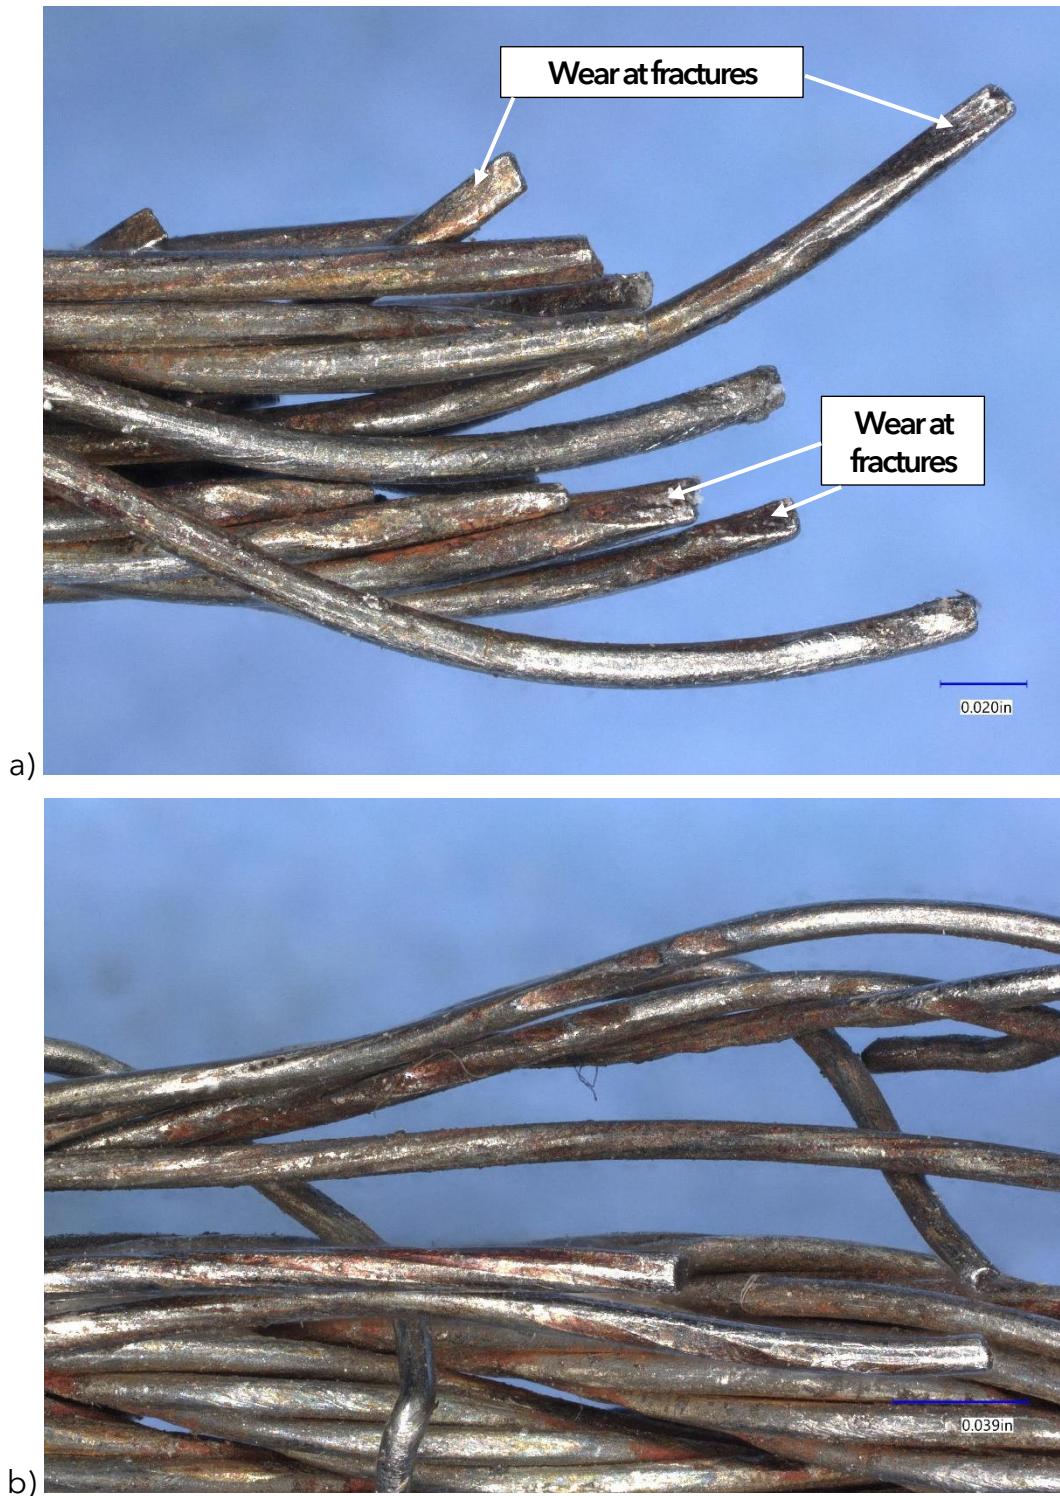
**Figure 4.** a) and b) Optical microscope images of the fractured “-13” cable showing flat-fractured wires and wear adjacent to the fractured wire ends and within the rust-tinted region.

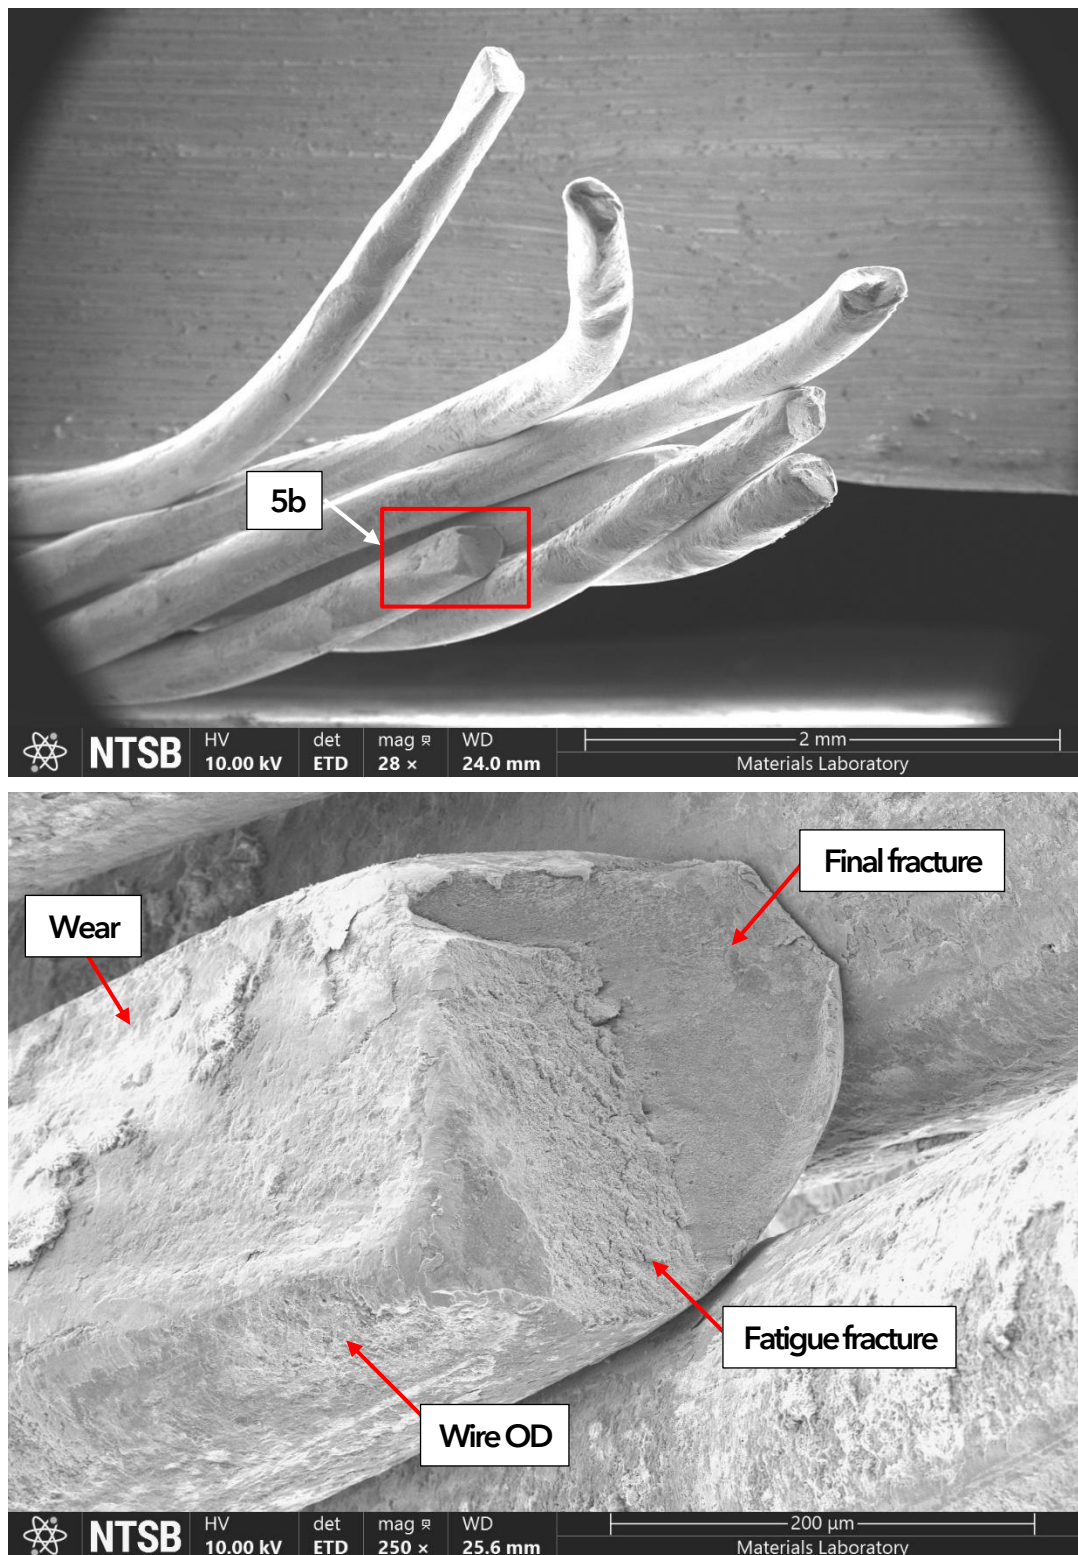
The wire fractures exhibited features consistent with cyclic fatigue. The fatigue cracking initiated near the edge of worn regions, progressing along the transverse direction through the wires. The fractured cable end on the output (quadrant) side of the fracture was cut in the laboratory from the rest of the cable, and the strands were separated (seven strands total, seven wires per strand, i.e., a 7x7 cable). Several strands that exhibited predominantly flat fractures were examined using a scanning electron microscope (SEM) (for example, figures 5a and 5b). The flat fracture regions were covered in debris and exhibited pitting and rubbing damage. One side of the wire had fractured on a slant plane, consistent with a region of final overstress fracture. On the opposite side of the wire, the edge of the flat wear region met the original outer diameter surface of the wire.

**Figure 5.** a) Low magnification scanning electron microscope image of a strand and b) higher magnification image of a wire showing the flat fatigue fracture region and the slant fracture at the point of final separation.

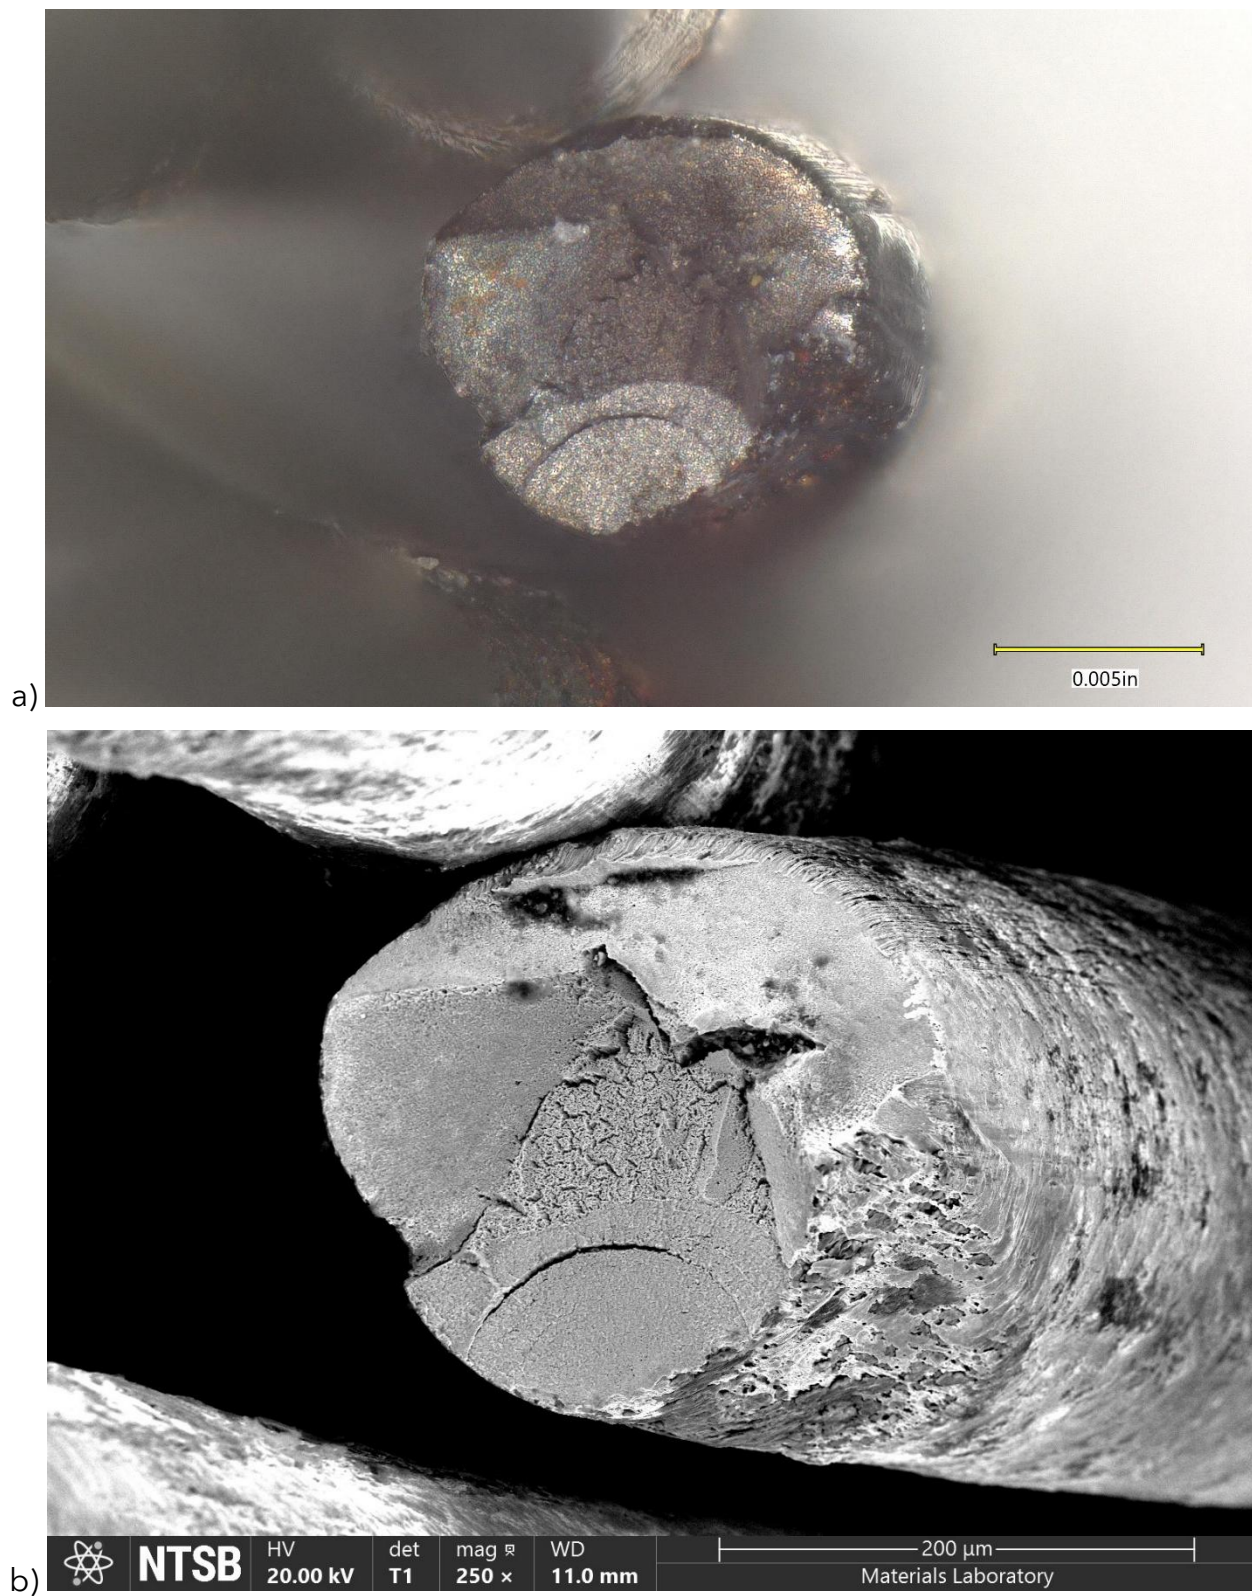
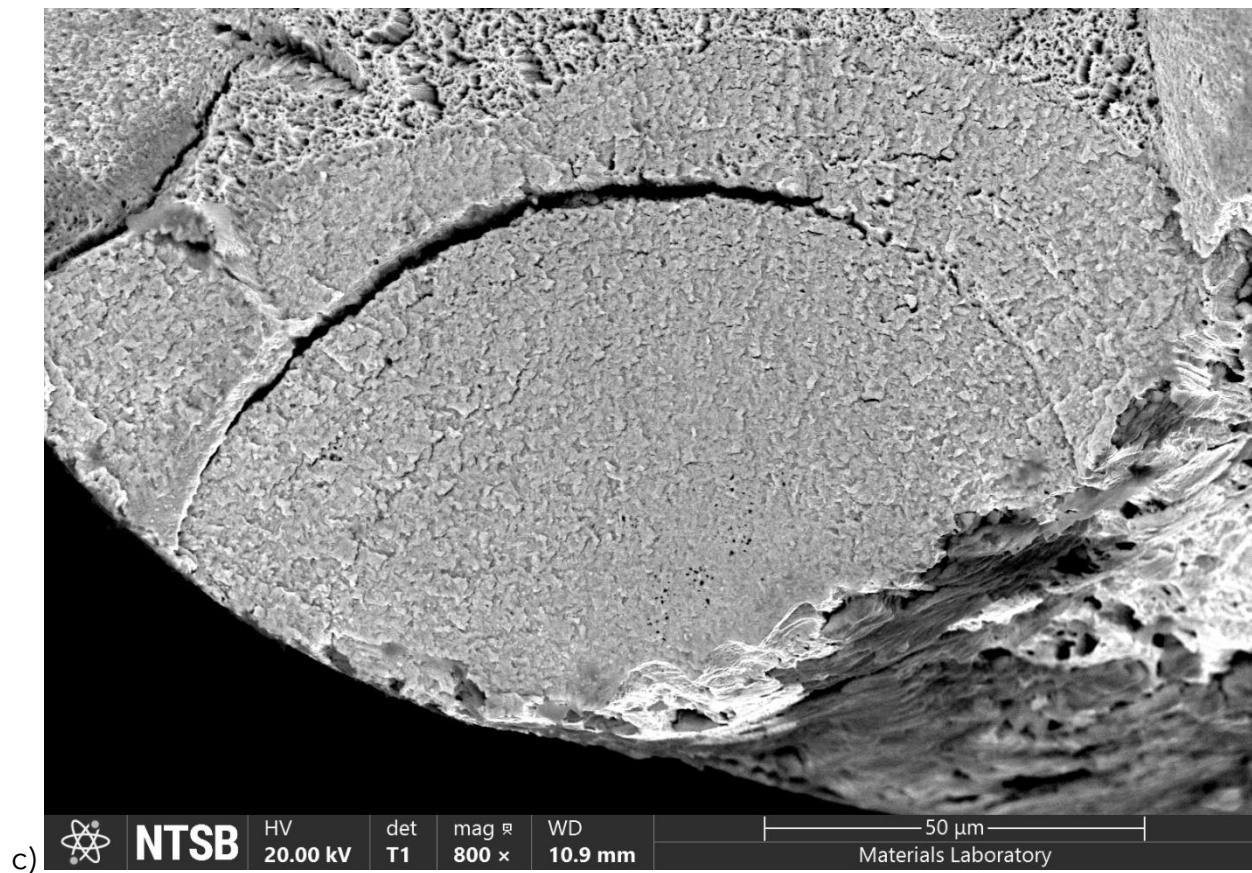
The other strands were examined to find one with less damage to the wire fracture surfaces. One strand displayed flat fracture regions that comprised approximately 25 % of the fracture surface or less. These fractures exhibited less post-fracture damage. A wire from that strand is shown in figures 6a - c after a 5-minute soak in a chelating rust removal solution. The fracture surface exhibited a thumbnail-shaped region with a silver-metallic appearance, consistent with progressive fracture. Closer examination of the thumbnail region by SEM revealed curved crack arrest marks and a fine feathery appearance, consistent with cyclic fatigue. The fracture originated near the edge of a wear region on the outer surface of the wire.

**Figure 6.** a) Optical microscope image of fracture wire with thumbnail-shaped progressive fracture region; b) scanning electron microscope image of the same wire; and

**Figure 6 (cont.).** c) higher magnification image of progressive fracture region showing crack arrest marks and feathery features, consistent with cyclic fatigue.

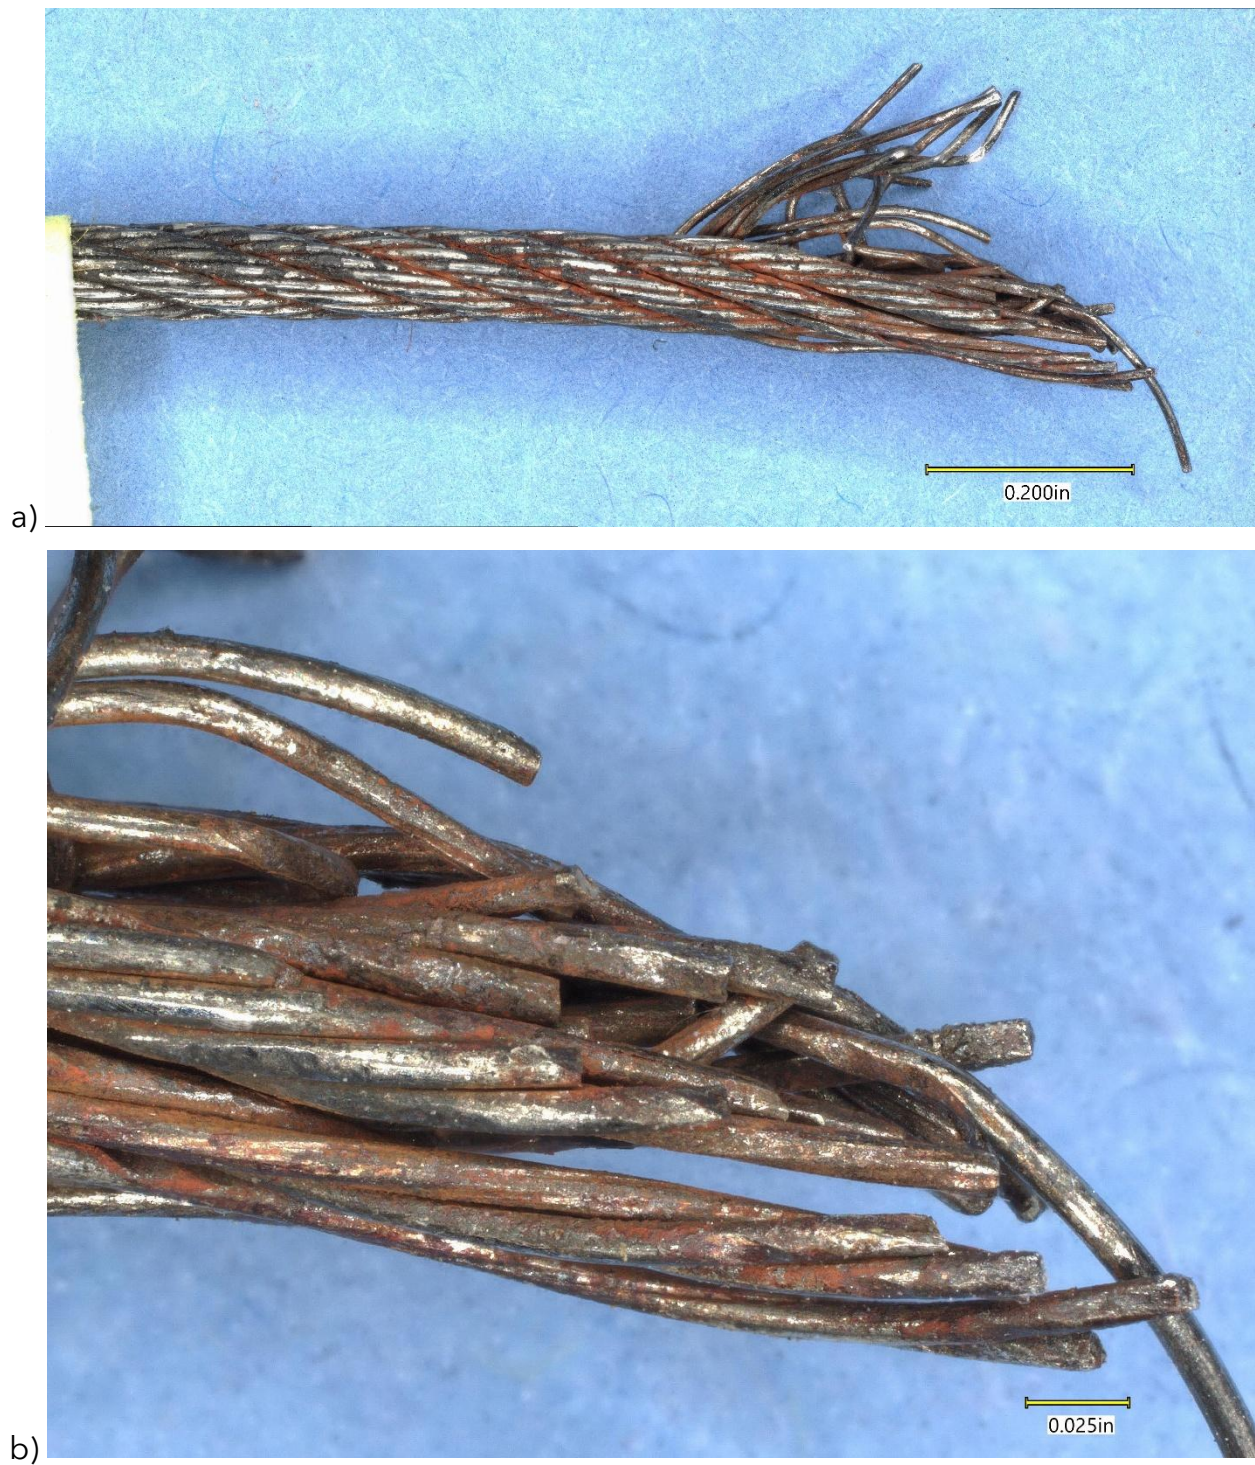
bending or splaying (figure 7a). Closer examination of the fractured cable ends indicated that most of the wires had flat fracture surfaces and that the individual wires exhibited wear adjacent to the fracture surfaces and the adjoining wire surfaces (figure 7b). The location of the fracture, wear features, and fracture features were similar to those found on the fractured cable from the incident aircraft, consistent with wear and cyclic fatigue.

**Figure 7.** Fractured "-19" cable assembly from N502GJ: a) overview image of fractured end and b) higher magnification image showing wire wear and flat fractures.

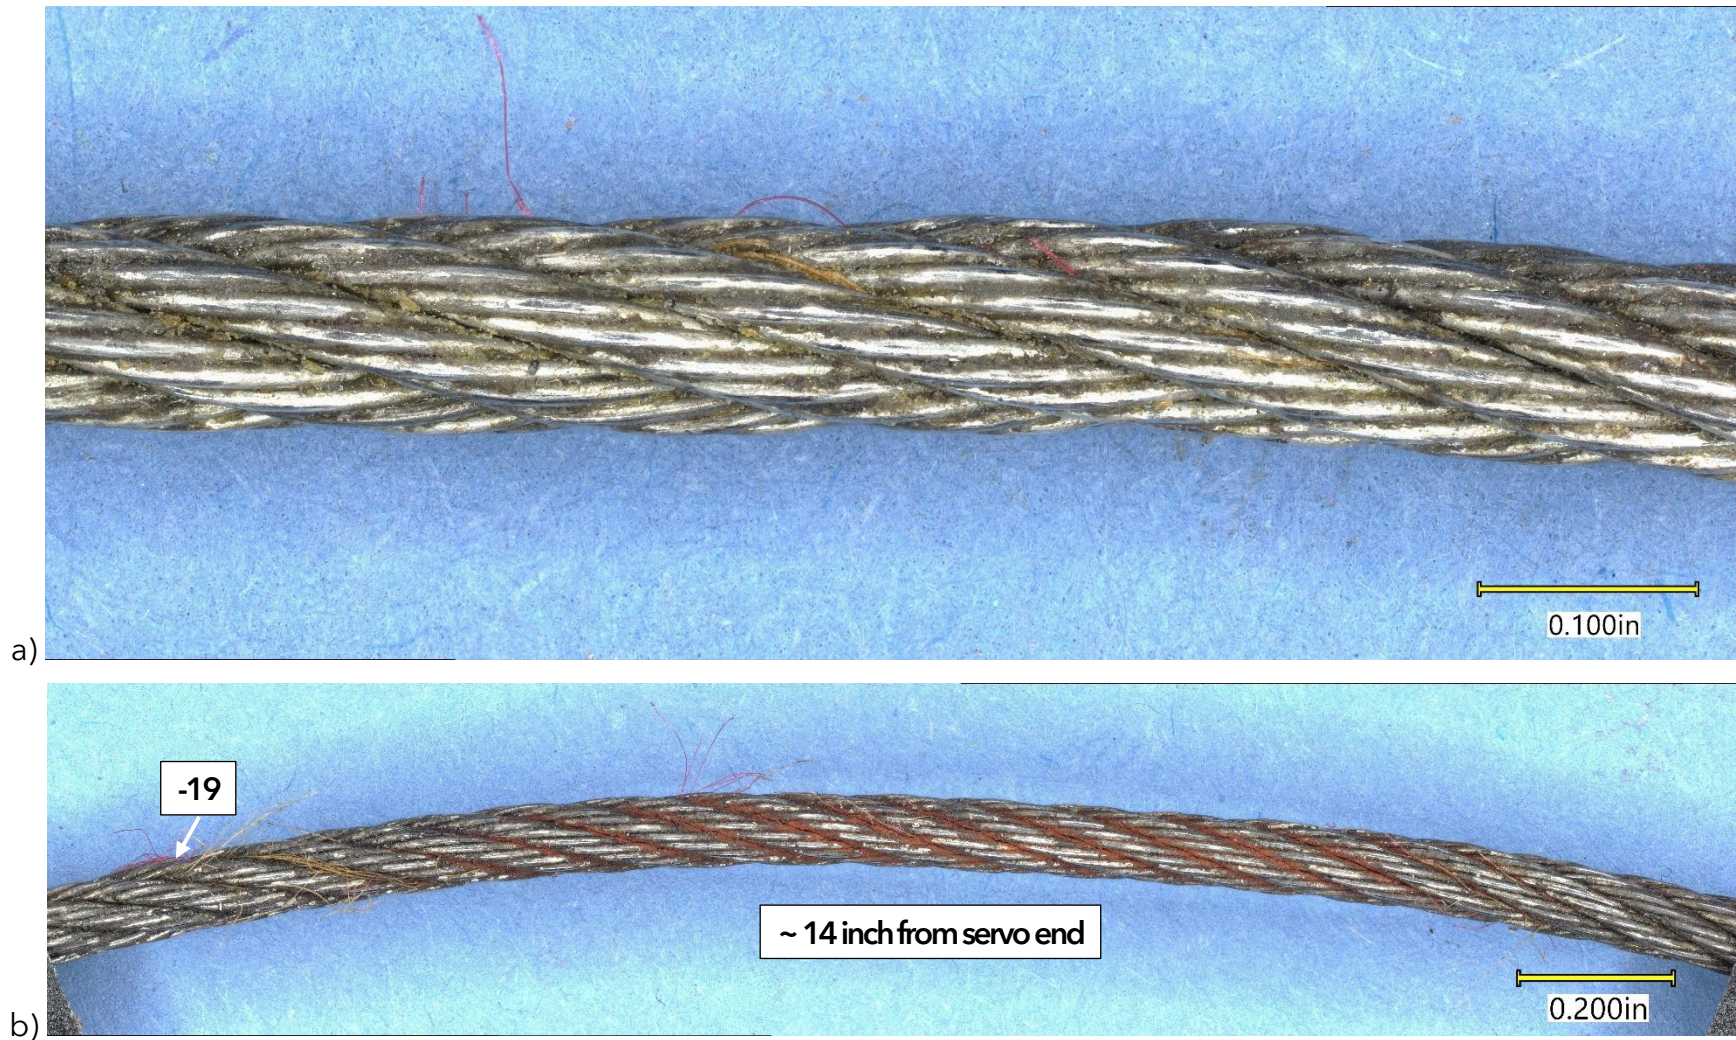
The wear indications were observed on the incident aircraft "-19" cable approximately 14 inches from the servo mount end (figure 8b), "-13" cable approximately 3-1/2 inches from the quadrant end (figure 9a), and "-17" cable approximately 3-1/2 inches from the quadrant end (figure 9b). The approximate lengths of the rust/wear regions were 1.25 in, 1.1 in, and 0.8 in, respectively.

**Figure 8.** a) Image of typical cable section and b) image of rust-colored wear region, approximately 14 inches from the servo mount end on the "-19" cable from the incident aircraft.

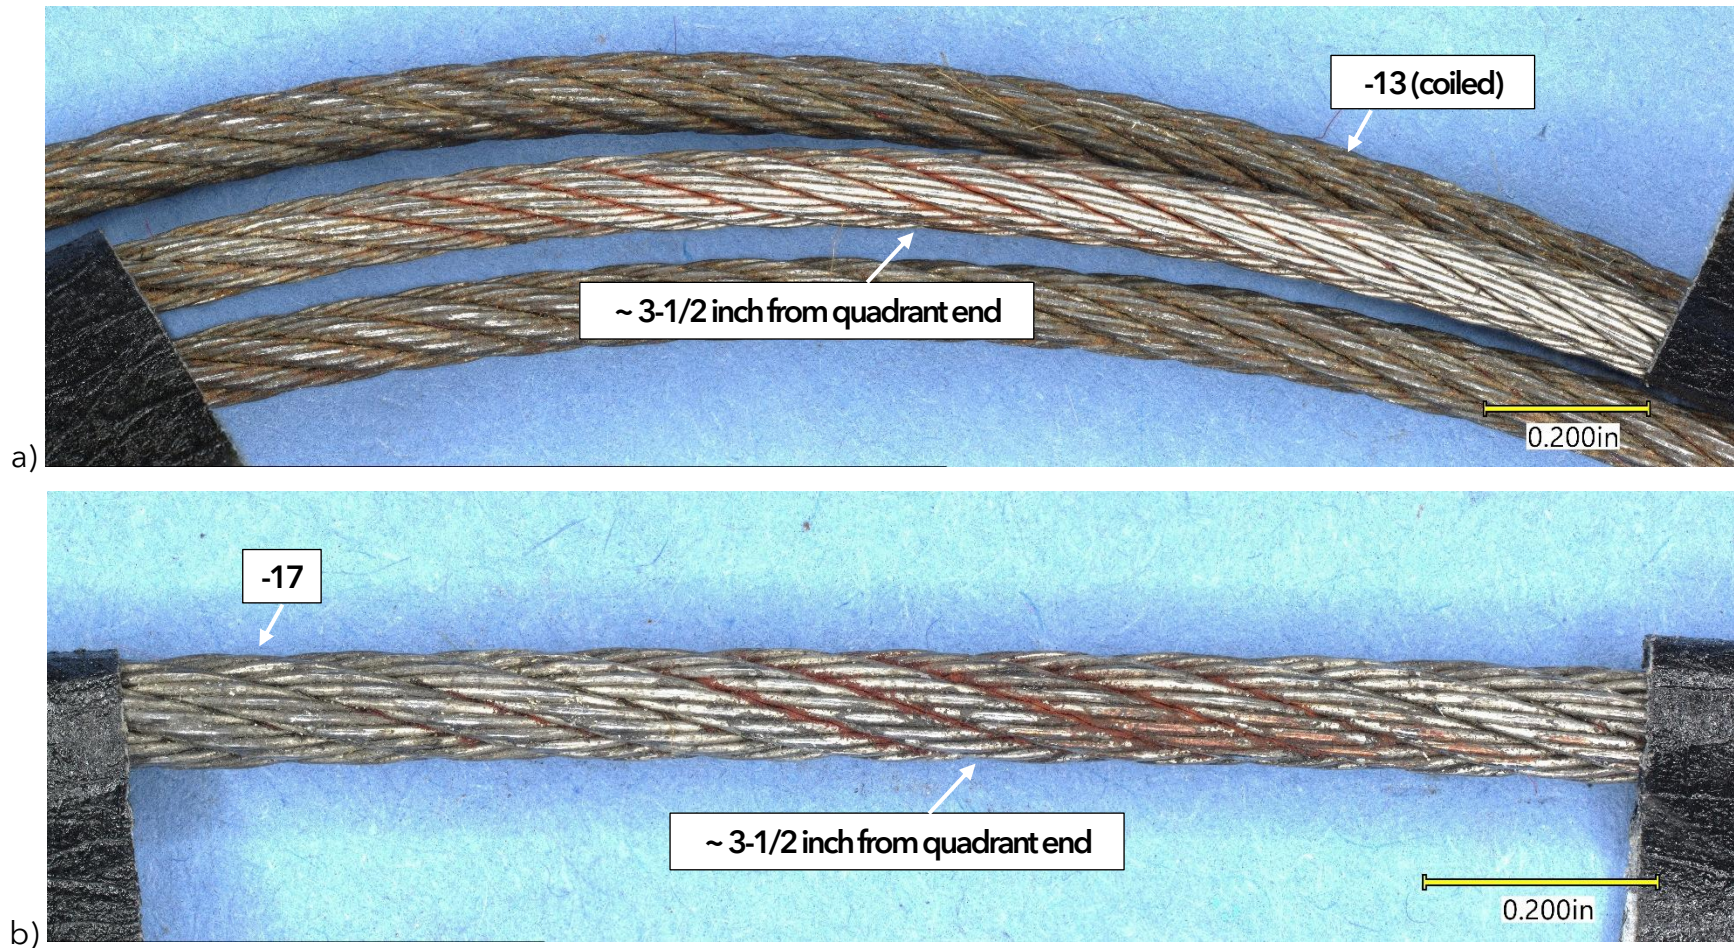
**Figure 9.** a) Image of rust-colored wear region, approximately 3-1/2 inch from the quadrant end on the "-13" cable from the incident aircraft and b) image of rust-colored wear region, approximately 3-1/2 inch from the quadrant end on the "-17" cable from the incident aircraft.

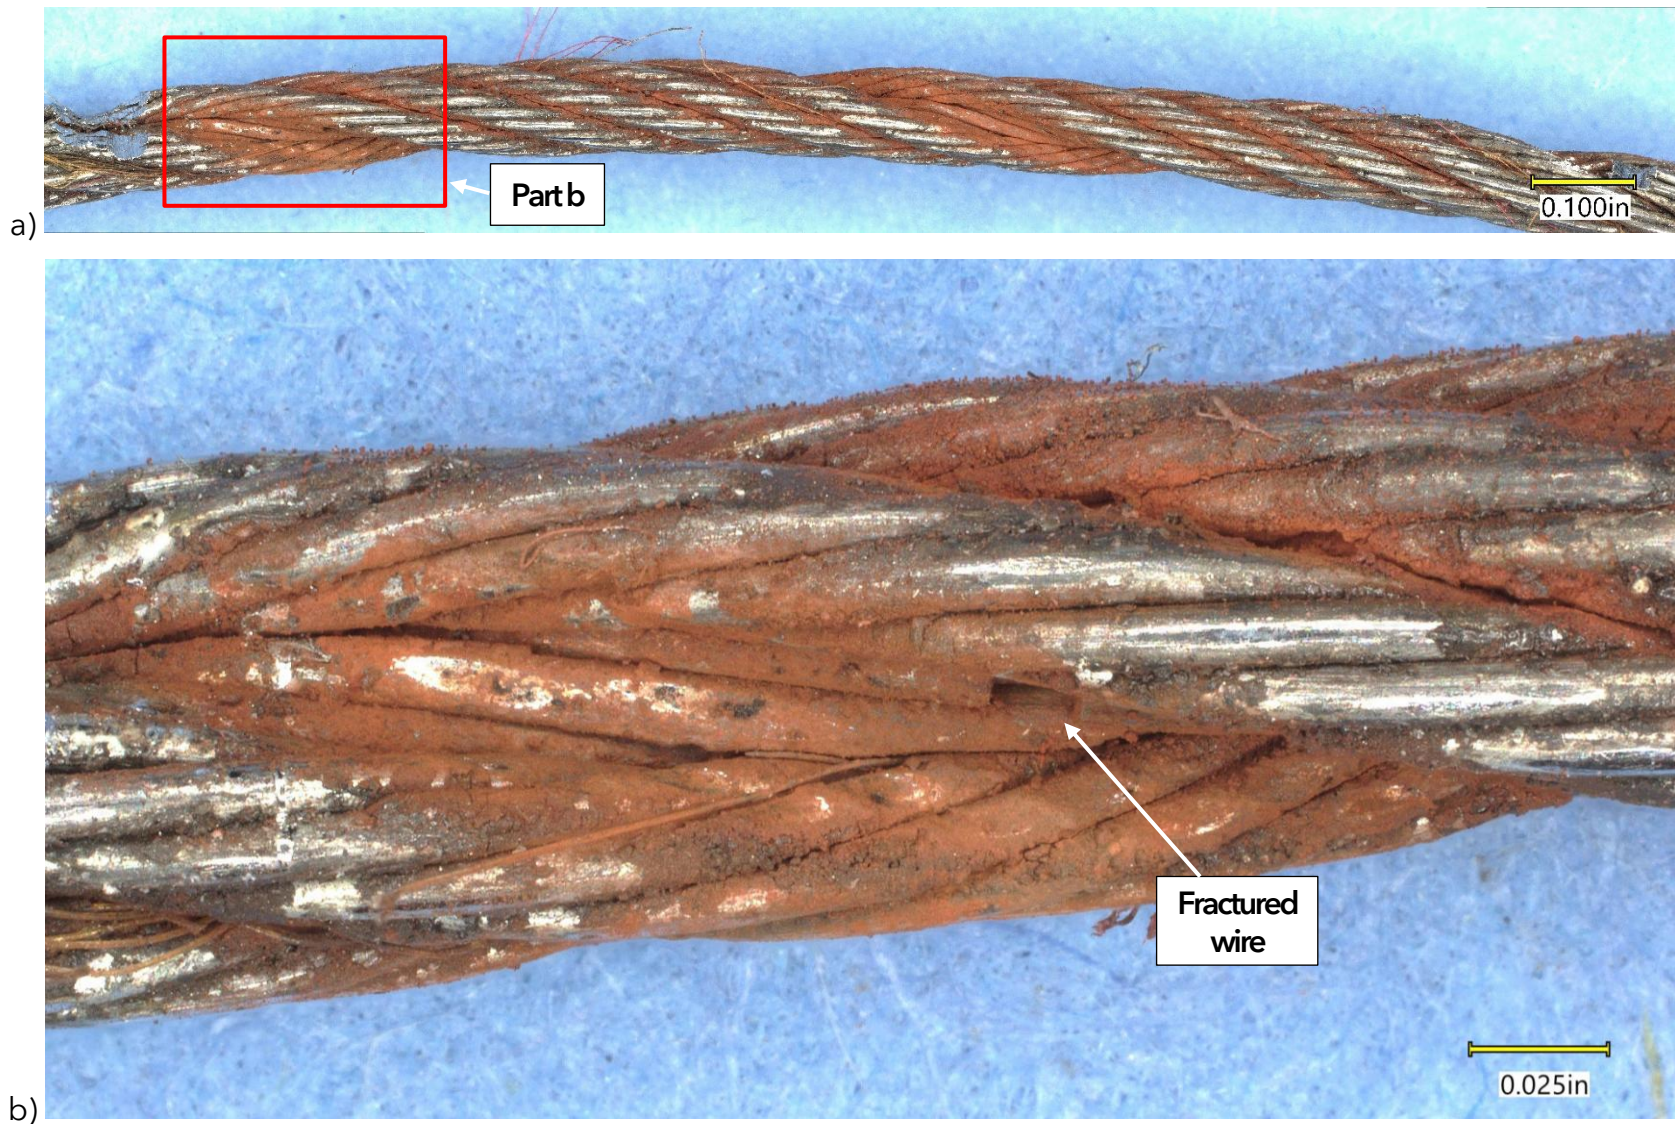
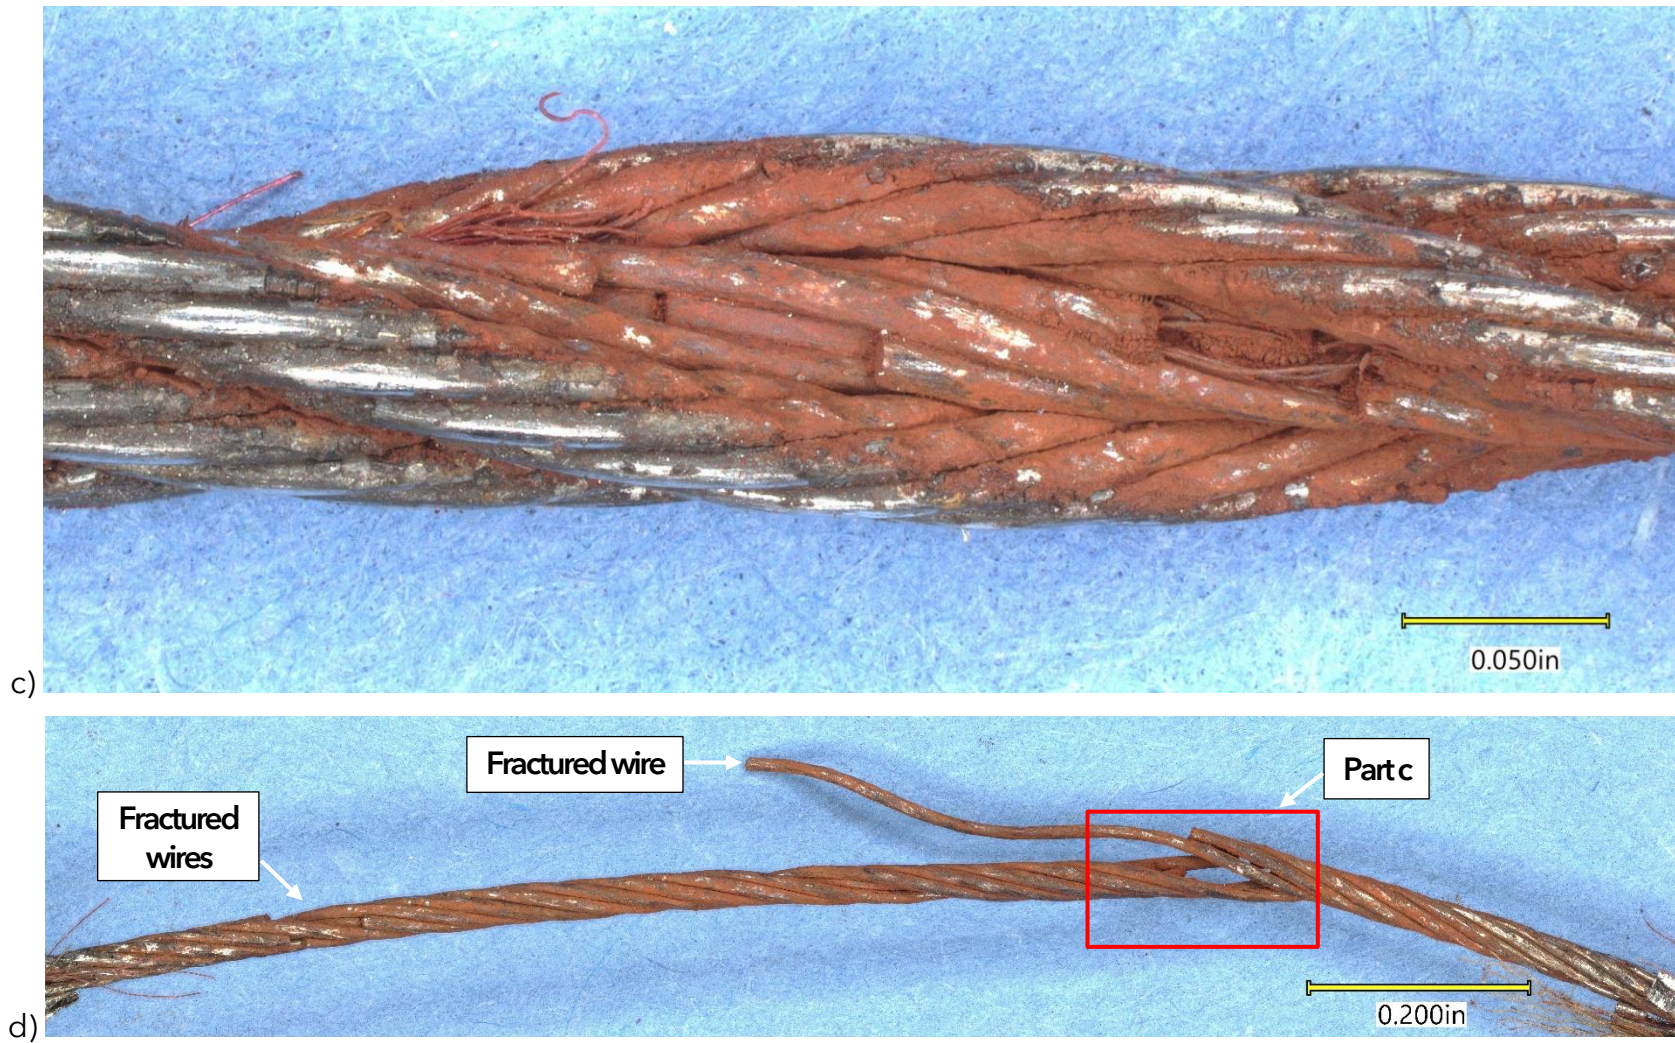
The "-19" cable outer strands were removed at the location of the rust/wear indication and the underlying wires were worn, rusted, and, in some instances, fractured. The strands were cut initially by using a handheld rotary tool with grinding disk and finished using a utility knife. First, a single strand was removed (figure 10a). The underlying wires exhibited wear and were coated by rust-colored wear debris. A wire that was part of the core strand was fractured at the location indicated in figure 10a and shown in figure 10b.

Strands were removed one at a time until all the outer helical strands were removed (figures 10c and 10d). The core strand (figure 10d) exhibited wear, was covered in rust-colored wear debris, and contained approximately 10 wire breaks over an approximately 1.25-inch length. All wires were fractured in at least one location and some wires were fractured in multiple locations. Four of the six outer helical strands contained a single fractured wire. Examples from two of those strands are shown in figures 11a and 11b. The fractured wires were worn and exhibited rust-

**Figure 10.** Images of the wear region on the “-19” cable from the incident aircraft: a) overview image with one strand removed; b) close up image showing fractured wire on core strand;

**Figure 10 (cont.).** c) close-up image with two strands removed from area indicated below in part d; and d) overview image of core strand with all outer helical strands removed.
