# National Transportation Safety Board

## **MATERIALS LABORATORY**

Factual Report 25-009

Location: Dulles, Virginia  
Date: November 19, 2024  
Vehicle: Bombardier CL-600-2C11, N501GJ  
Investigator: Adam Huray, AS-40

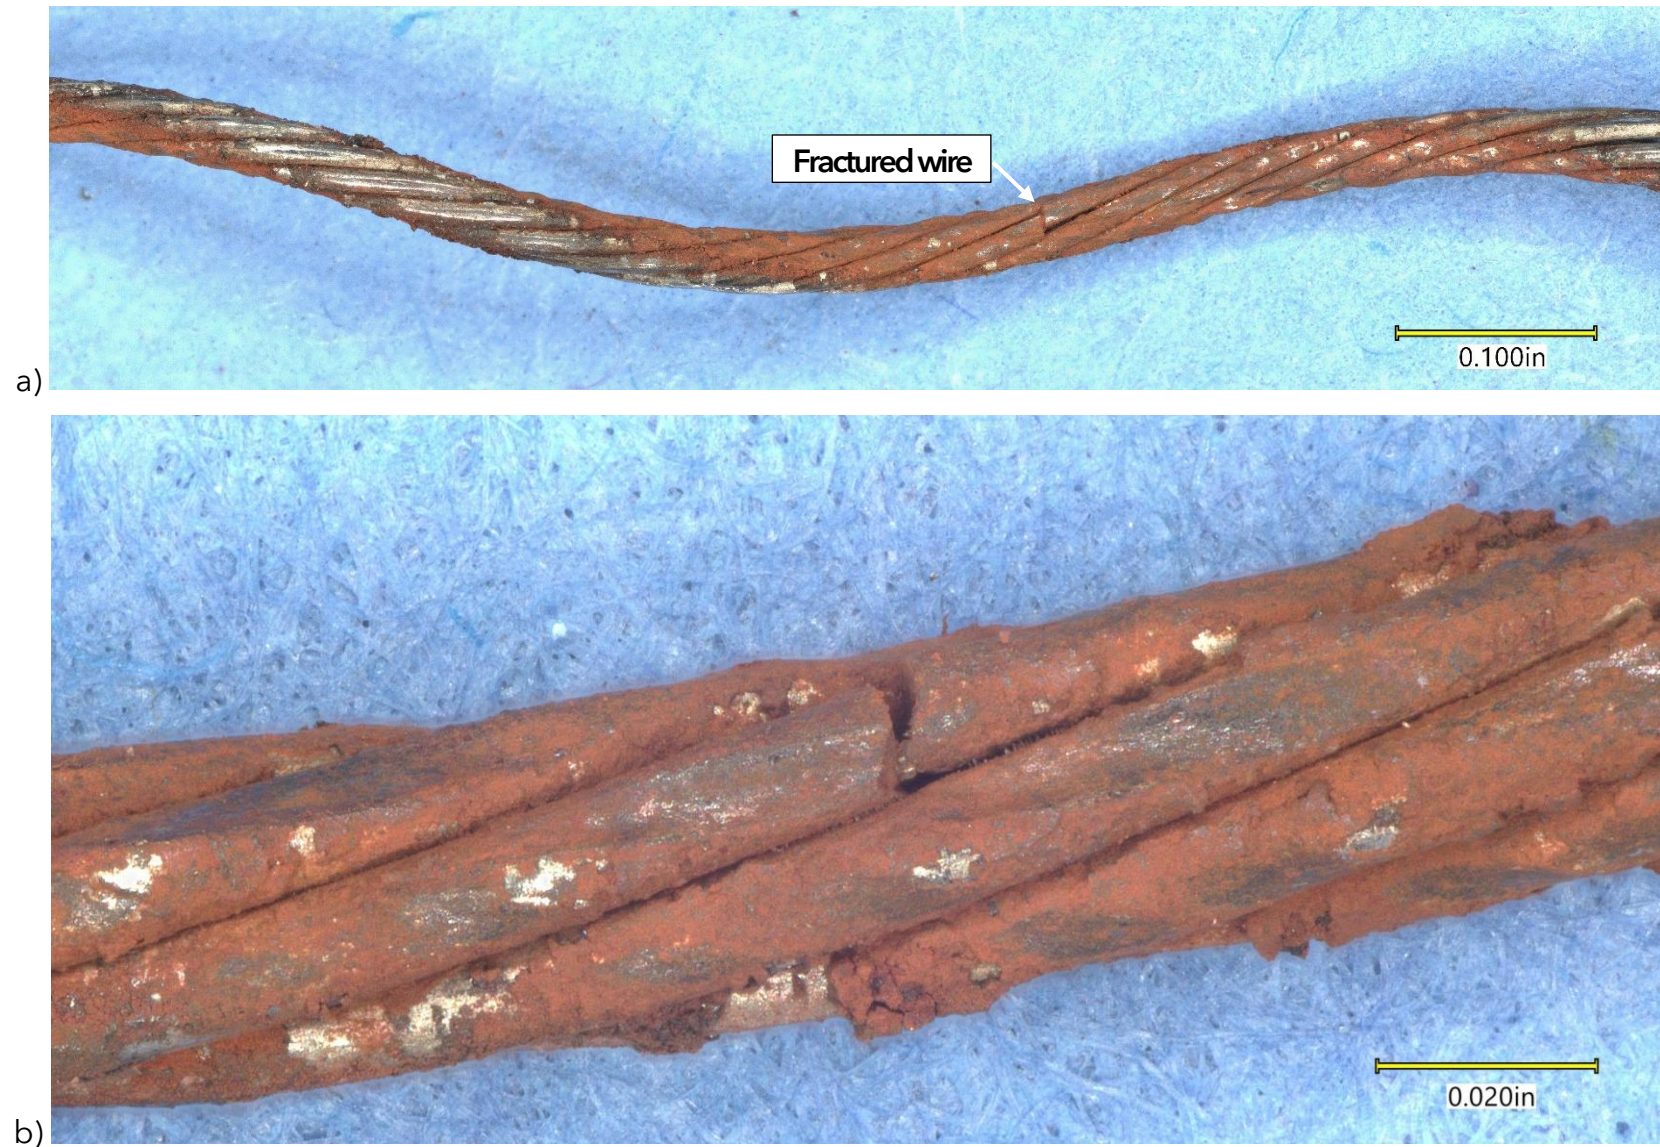
Strands were removed one at a time until all the outer helical strands were removed (figures 10c and 10d). The core strand (figure 10d) exhibited wear, was covered in rust-colored wear debris, and contained approximately 10 wire breaks over an approximately 1.25-inch length. All wires were fractured in at least one location and some wires were fractured in multiple locations. Four of the six outer helical strands contained a single fractured wire. Examples from two of those strands are shown in figures 11a and 11b. The fractured wires were worn and exhibited rust-

colored wear debris at the fractures, consistent with fracture occurring on the inward facing wires within the strands.

**Figure 11.** a) Lower magnification image of helical strand with fractured wire and b) higher magnification image of fractured wire on a second helical strand.
