# National Transportation Safety Board

ENG25LA009

## **SYSTEMS**

Group Chair's Factual Report

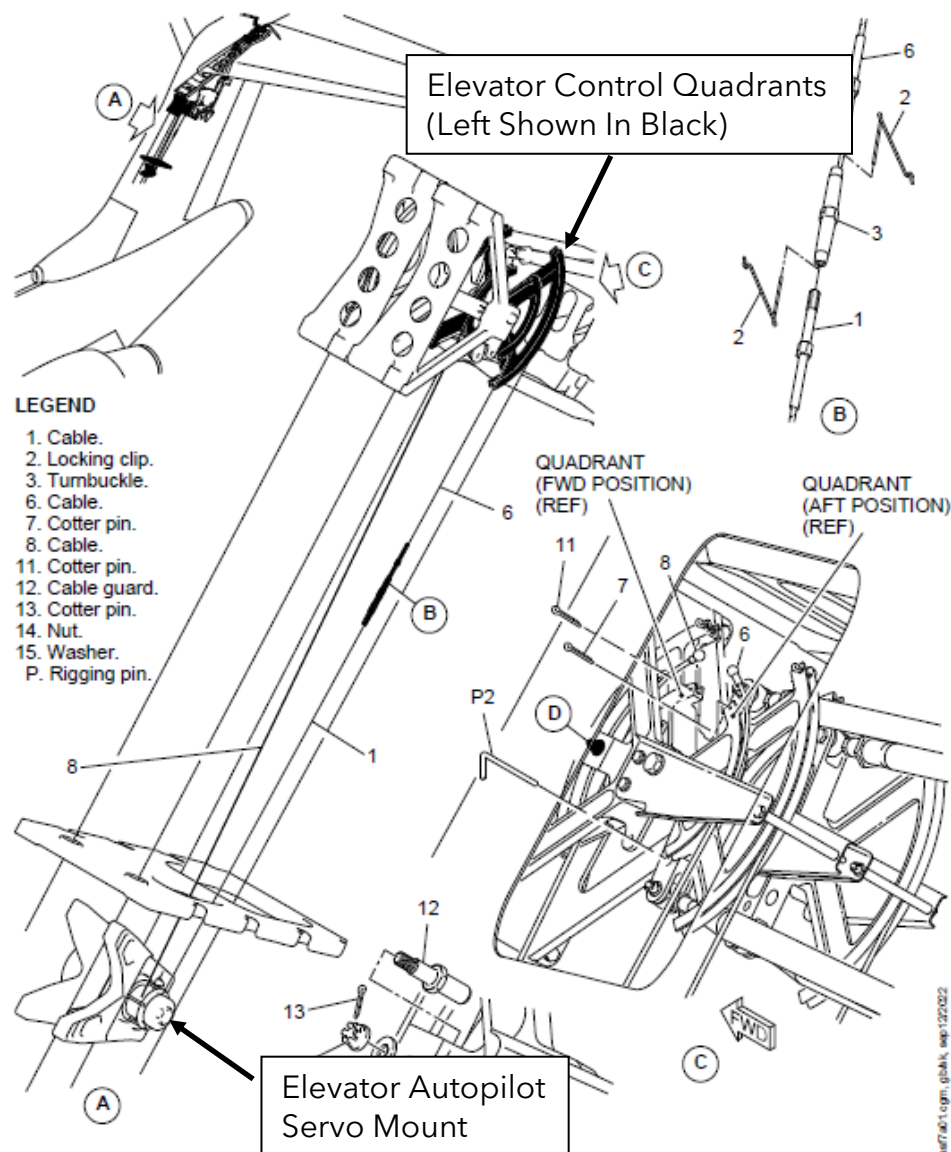
override capability. The servo mount is connected to the left elevator control quadrant by cables (see Figure 2). The forward end of the elevator control quadrant is connected to the servo mount by a single cable (Figure 2, item 8, part number BA670-93710-13). The aft end of the elevator control quadrant is connected to the servo mount by two cables (Figure 2, items 1 and 6, part numbers BA670-93710-19 and BA670-93710-17 respectively) which are joined by a turnbuckle (Figure 2, item 3, cutout B). Rotational movement of the servo mount moves the cables, which in turn rotate the left elevator control quadrant about its pivot. Per the Maintenance Review Board (MRB) Task 273000-201A (Detailed Inspection of the Elevator Mechanical Control Path and Control Cables) these cables are required to be inspected for condition and wear at intervals not exceeding 16,000 flight hours.

**Figure 2:** Elevator autopilot servo to left elevator control quadrant cables. (Courtesy of MHIRJ)

After the airplane landed maintenance requested that the flight crew pull the pitch disconnect handle to troubleshoot where the flight control bind was. After the disconnect only the captain's side (left side) was restricted in the aircraft nose-up (control column aft) direction. A maintenance inspection found that the elevator autopilot servo control cable (Figure 2, item 8, part number BA670-93710-13) had fractured into two sections. The lower section had backlashed around the servo mount, binding the cable between the elevator autopilot servo mount and the cable guide pins (see Section E.5, Figures 4-6, for similar examples). The bound cable

interfered with the rotation of the servo mount, which remained connected to the aft side of the elevator control quadrant by the intact aft cables (Figure 2, items 1 and 6). This condition resulted in the limited rotation of the elevator control quadrant in one direction. According to GoJet Airlines maintenance personnel, the elevator appeared to move normally in the downward direction but only about three quarters of its full range in the upward direction.

The broken cable was sent to the NTSB Materials Laboratory for further examination (see the Materials Laboratory Factual Report in the public docket for this investigation). The construction of the cable was 7x7 (seven strands, seven wires per strand) and made from carbon steel. The fracture occurred 14 inches from the elevator autopilot servo mount end. Examination revealed that the individual wires near the fracture were worn and exhibited features consistent with cyclic fatigue. Additional areas of wear were observed on the cable approximately 3.5 inches from the elevator control quadrant end, as well as on the other two cables that connected the elevator autopilot servo to the elevator control quadrant. GoJet Airlines reported that the airplane had accrued 47,106 flight hours and 37,439 flight cycles at the time of the cable failure. The cable was last inspected per MRB Task 273000-201A in May of 2016, 12,024 flight hours prior to the failure. GoJet Airlines stated that the cable had not been replaced since they acquired the airplane in October of 2019.

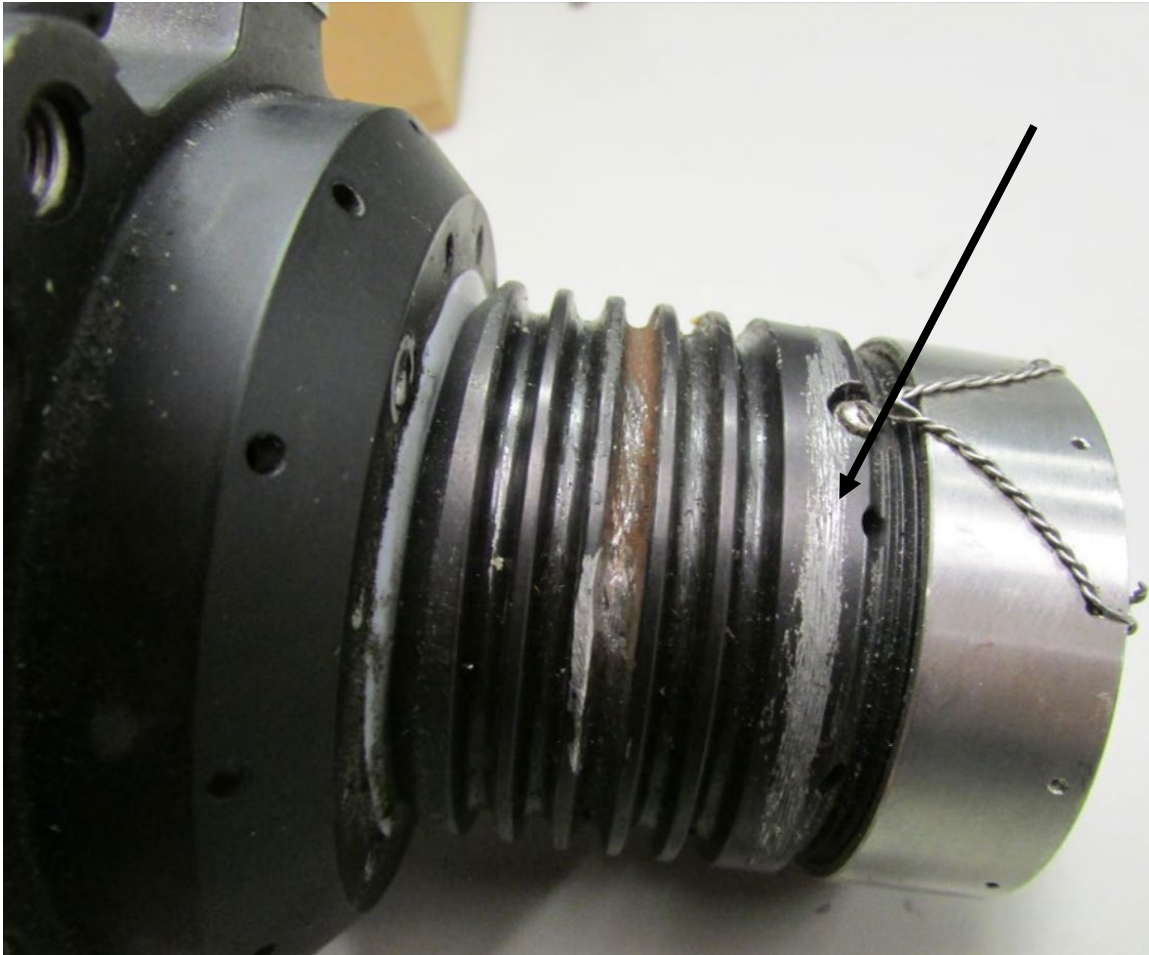
The servo mount (serial number 18PU) was visually inspected and no significant damage was observed. It was noted that no guide pins were present; however, GoJet Airlines confirmed that they had removed the guide pins to facilitate component removal. Wear marks were observed outside of the typical cable operating area (see Figure 3). The unit was subjected to the tests detailed in Rockwell Collins Instruction Book 523-0772563, Table 5-6, titled "SMT-87() Servo Mount Detailed Test Procedures". Step 3, "Maximum Breakaway Torque Test", was not performed because the actual breakaway torque was measured per Step 7.1, "Nominal Breakaway Torque Test", without performing adjustments. The nominal breakaway torque was found to be 121.1 in-lb. The MHIRJ CRJ700/900/1000 AMM specified the breakaway torque to be between 130 and 142 in-lb and provided instructions for adjustment if it was found out of this range. According to Collins the lower breakaway torque would result in the mount slip clutch releasing at a lower applied force in the event of undesired servo movement or a jam condition. For Step 4.2, (Ensure clutch teeth engage with a supply voltage of 21V), the test passed three times but the voltage level at which the teeth first engaged could not be determined due to test bench limitations. In addition, Step 4.3, (With a supply voltage of 21 V apply various torques and verify the two clutch halves do not ratchet), was not performed due to test bench limitations. The unit passed all other performed tests.

**Figure 3:** Servo mount serial number 18PU. Arrow points to wear marks outside of the typical cable operating area. (Courtesy of Collins Aerospace)

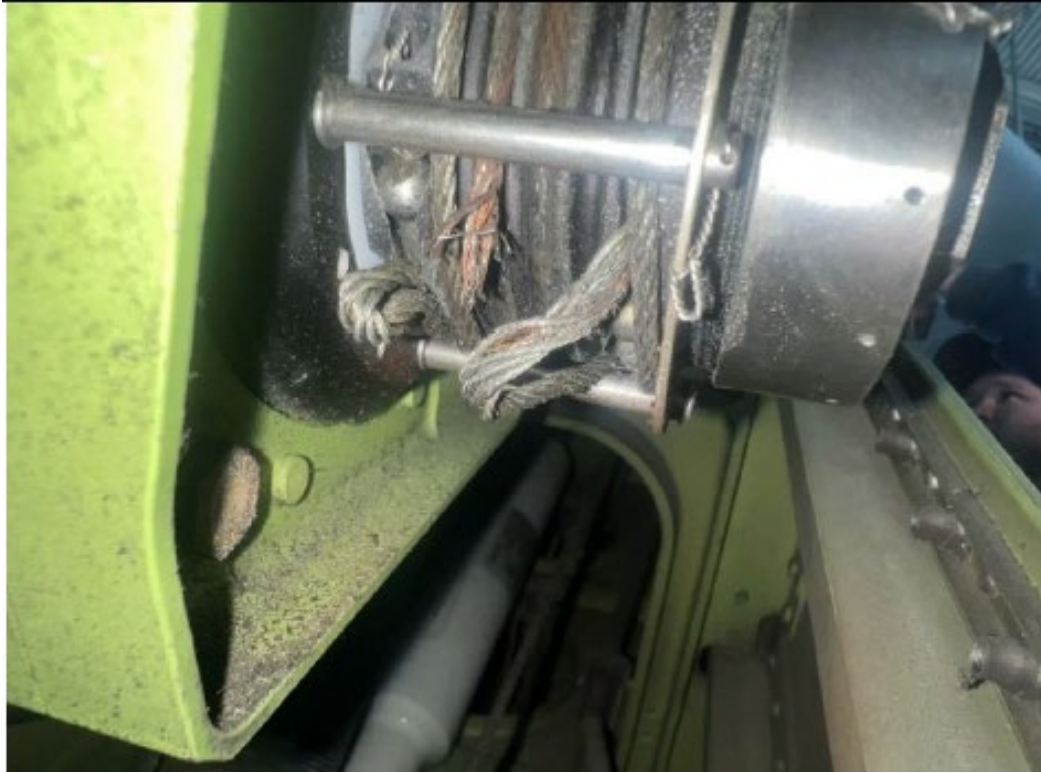
On November 24, 2024, GoJet Airlines maintenance personnel found the elevator autopilot control cable (Figure 2, item 1, part number BA670-93710-19) broken on a different CRJ-550 (registration number N502GJ, serial number 10011). The pilot report that prompted maintenance to troubleshoot the autopilot system stated "Autopilot Vertical Speed Mode not actuating flight controls. Will not climb or descend." This failure resulted in the cable backlashing around the servo mount but did not cause any reported restrictions to manual elevator control (see Figure 4). Laboratory analysis revealed that the cable failed approximately 14.75 inches from the servo mount end. Most of the wires exhibited flat fracture surfaces, and individual wires showed wear adjacent to the fracture locations (see Materials Laboratory Factual Report in the public docket for this investigation). The airplane had accrued 48,386 flight hours and 38,137 flight cycles at the time of the cable failure. The cable was last inspected per MRB Task 273000-201A in December 2020, 5,579 flight hours before the failure occurred. GoJet Airlines stated that the cable had not been replaced since they acquired the airplane in December of 2019.

**Figure 4.** Cable backlashed in elevator autopilot servo mount from the N502GJ event. (Courtesy of GoJet Airlines)

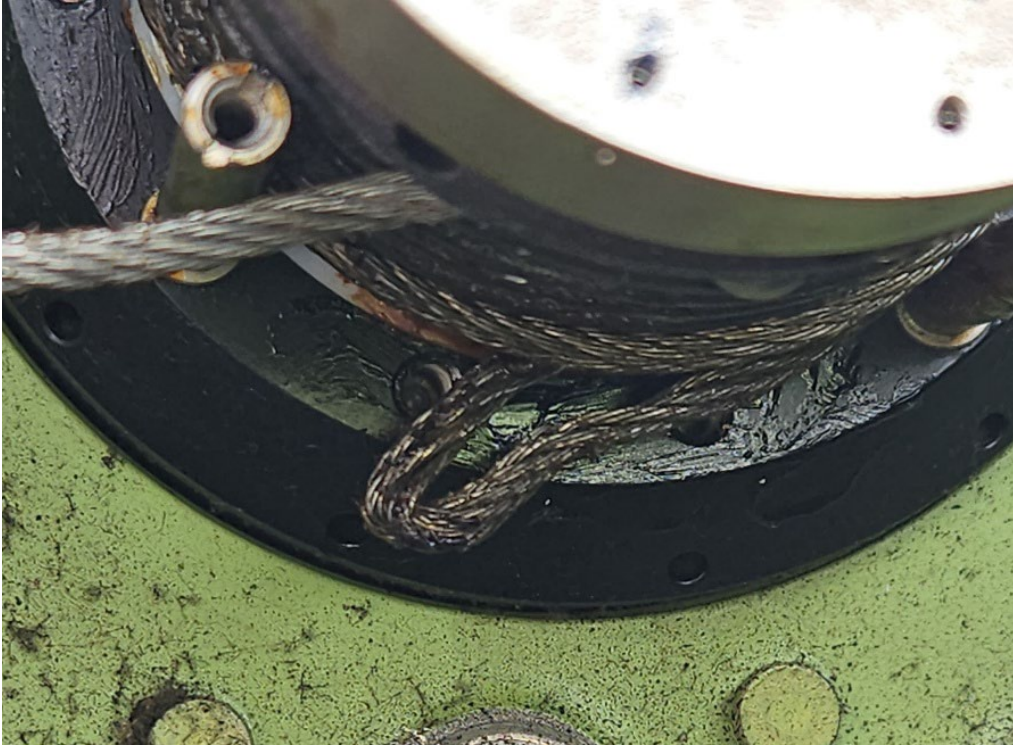
On August 3, 2025, GoJet Airlines maintenance found elevator autopilot control cable (Figure 2, item 8, part number BA670-93710-13) broken on a third CRJ-550 (registration number N506GJ, serial number 10041). The crew reported that they felt a pitch restriction in the aircraft nose up direction when pulling back on the column during flare, but the airplane landed without incident. The failed cable and the adjacent cable (Figure 2, item 1, part number BA670-93710-19) were found backlashed around the servo mount, binding the cables between the elevator autopilot servo mount and the cable guide pins (see Figures 5 and 6). The break occurred approximately 14 inches from the servo mount end. The fracture surface was similar to the other failed cables in that many of the wires had flat fracture surfaces and individual wires exhibited wear adjacent to the fracture surfaces. This failure region also had a relatively high number of wires (when compared to the other examples examined by the NTSB laboratory) that demonstrated necking and non-flat fracture surfaces consistent with overload. In addition, the fracture area had some rust, but not as much as the other examples. The airplane had accrued 46,833 flight hours and 37,217 flight cycles at the time of the cable failure. The cable was last inspected per MRB Task 273000-201A in March of 2025, 656 flight hours before the failure occurred. GoJet Airlines stated they did not replace the cable since they acquired the airplane in October of 2019.

**Figure 5.** Cables backlashed in the elevator autopilot servo mount from the N506GJ reported event. (Courtesy of GoJet Airlines)

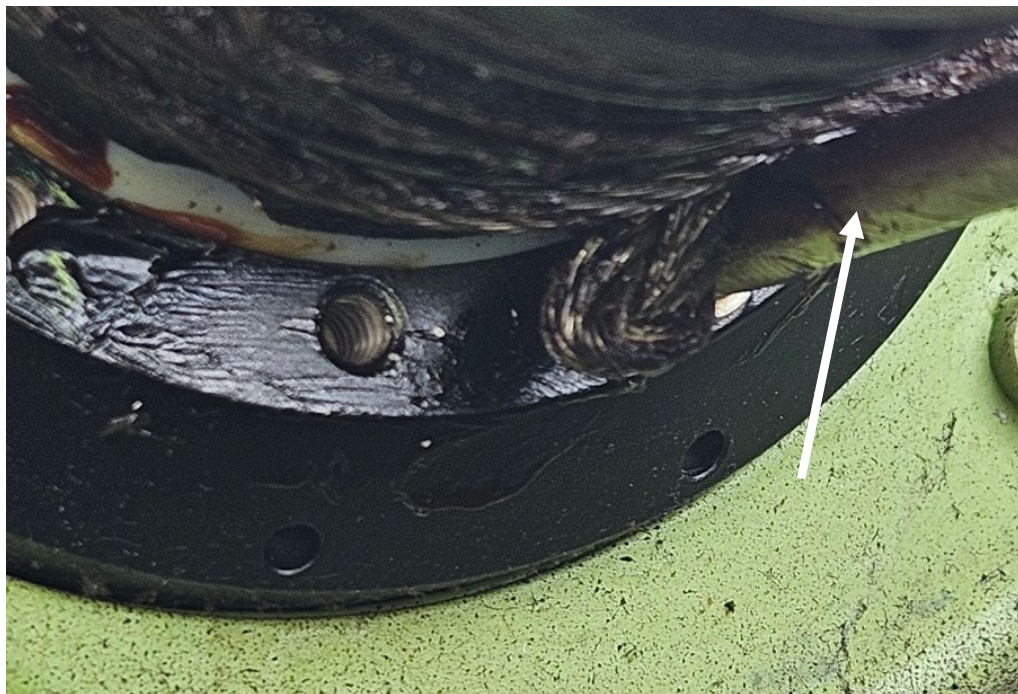
**Figure 6.** Cables backlashed in the elevator autopilot servo mount from the N506GJ reported event. The arrow points to a cable guide pin. (Courtesy of GoJet Airlines)
