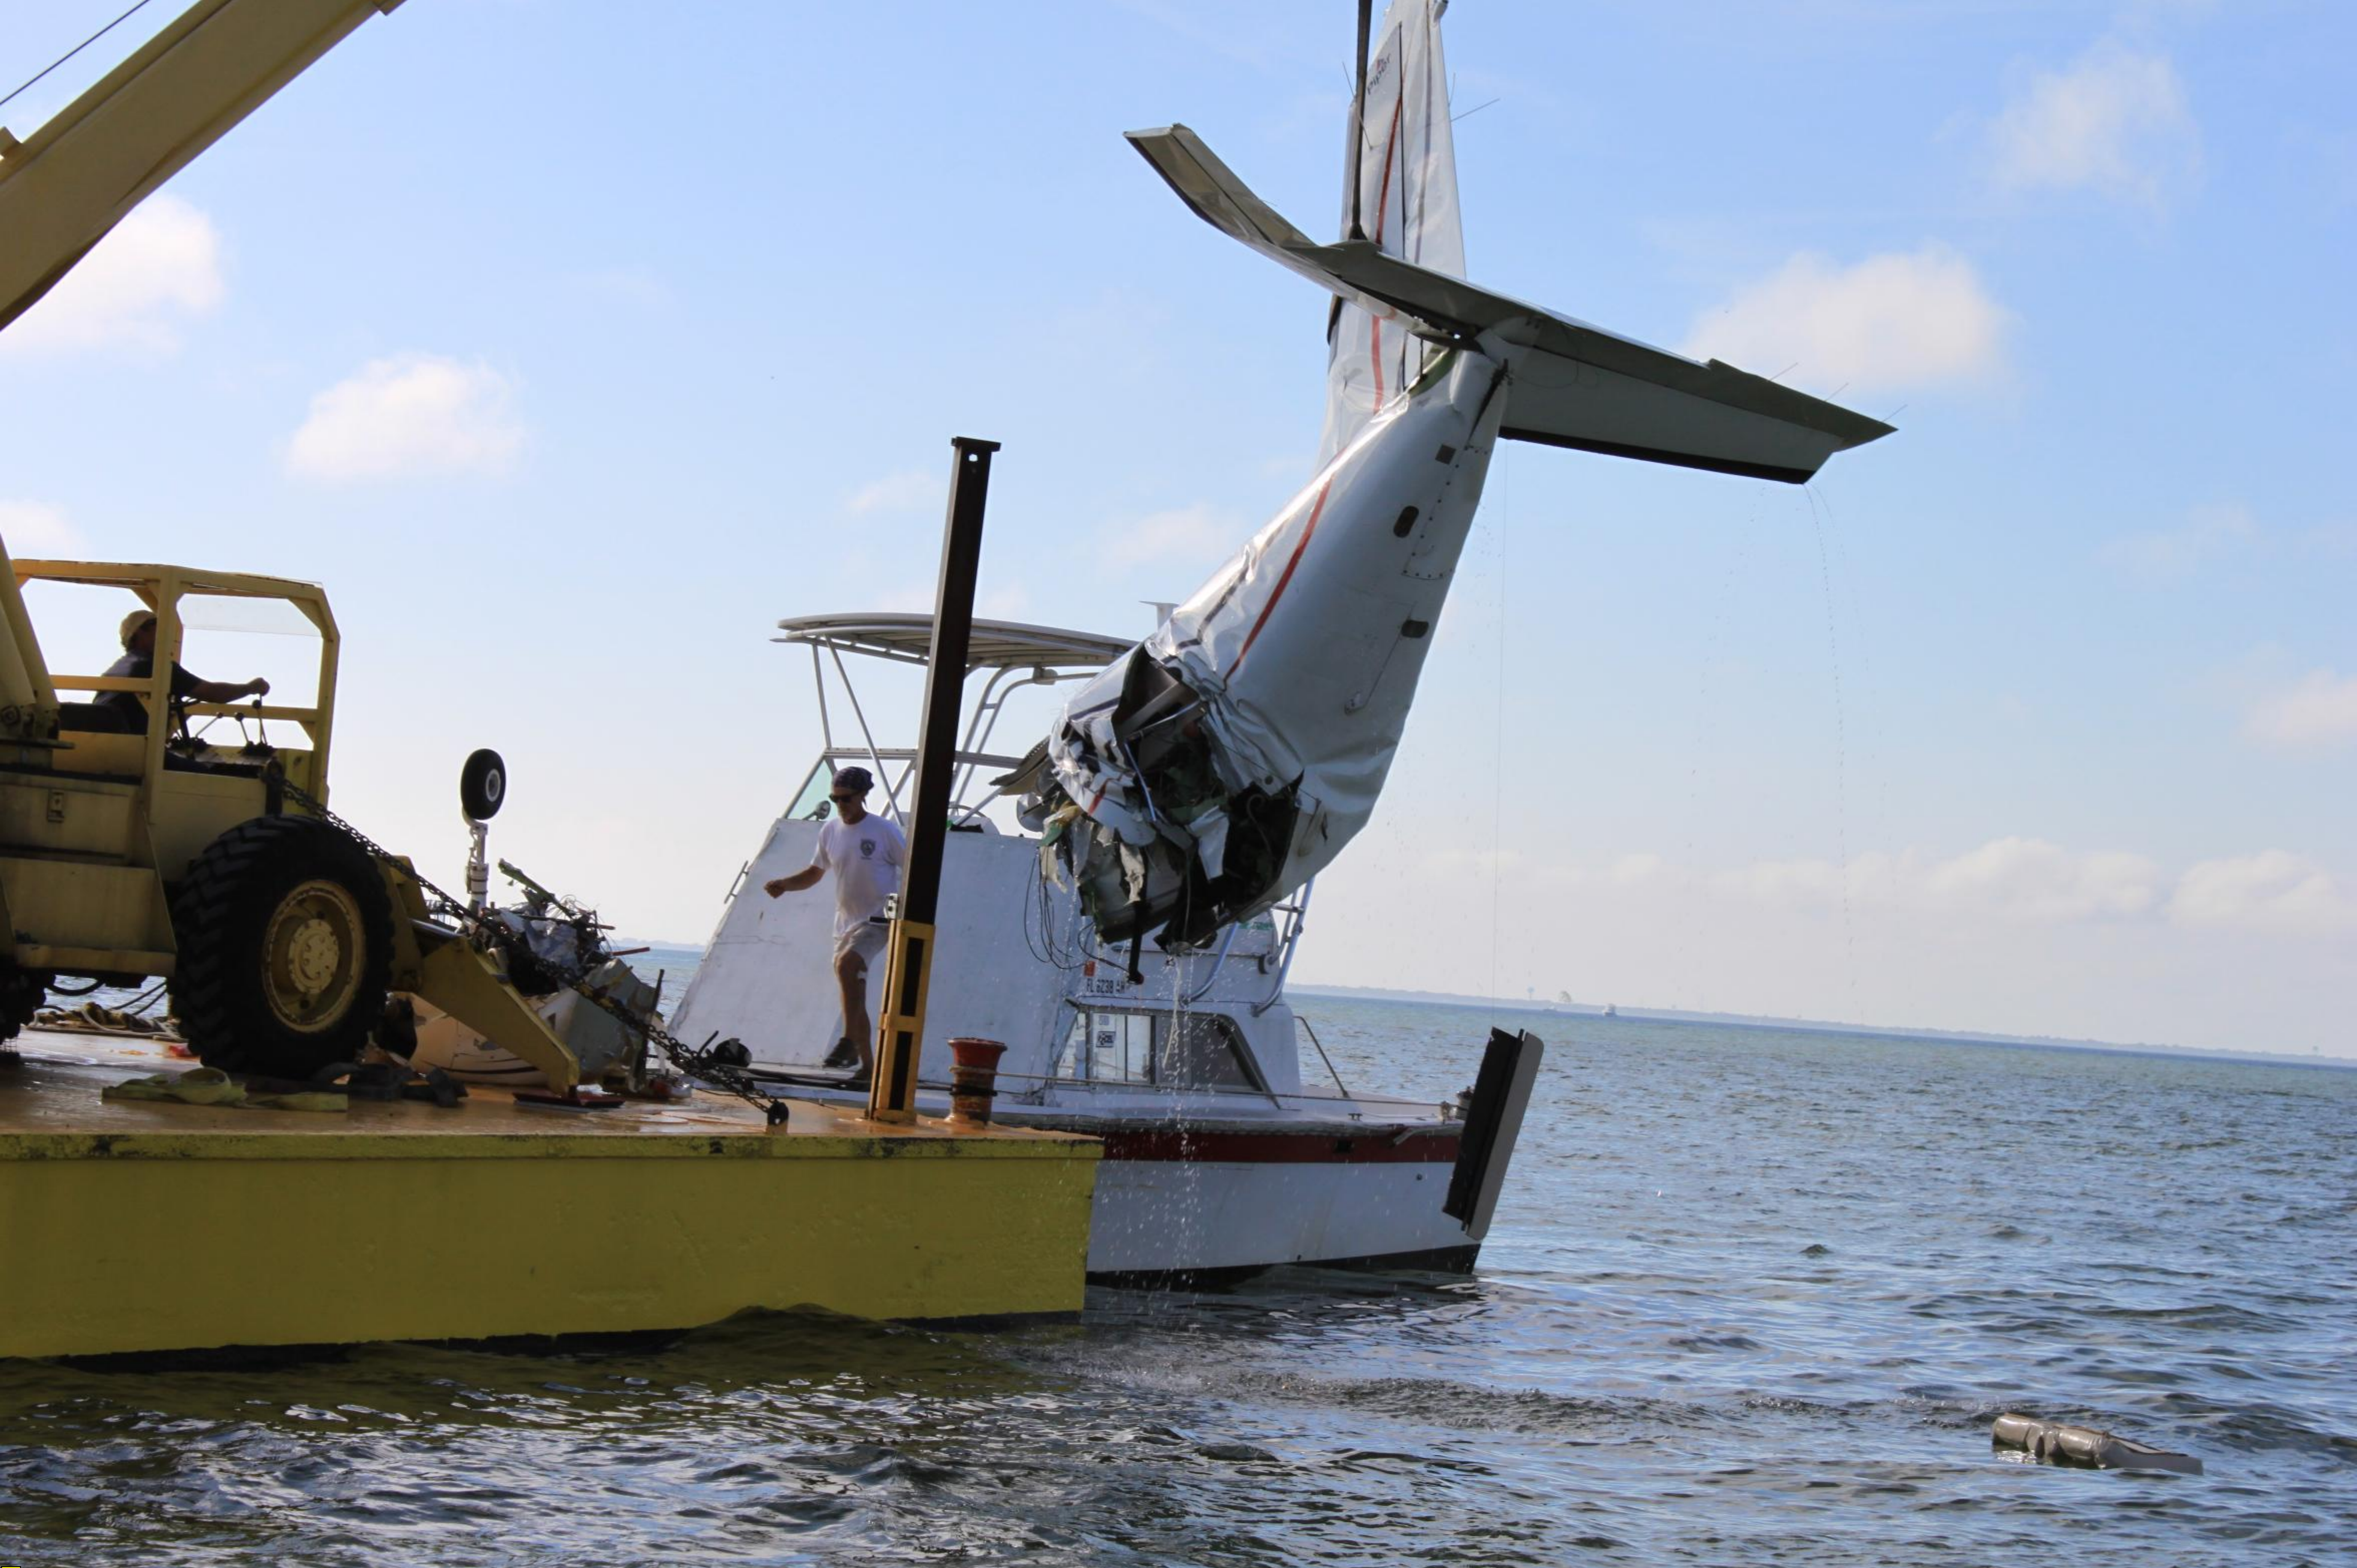
Photo 3: Tail Section Being Removed from the Water
