## NATIONAL TRANSPORTATION SAFETY BOARD

### Left Main Landing Gear Actuator Examination Field Notes

**ERA11FA070**

| Aircraft: | Piper PA-46-350 (Malibu Mirage) |

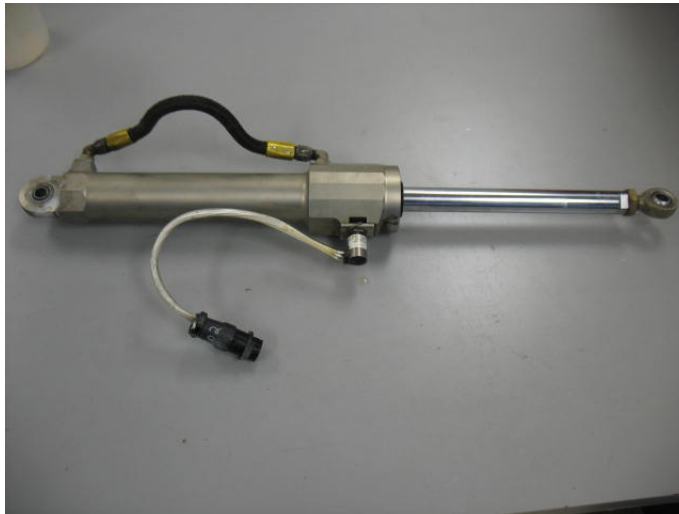
The incoming visual examination determined conformance with respect to envelope, mounting provisions, safety wiring markings, nameplate, and workmanship. The external surface had no damage; however, a small amount of corrosion was noted on the forward faceplate seal, connector pins, and there was evidence of trace amounts of water within the hydraulic fluid. The housing external surfaces were cleaned and the unit was rinsed using new hydraulic fluid in order to prevent contamination to the test stand.

**Photo 1. Unit as Received (Courtesy of Triumph Actuation Systems)**

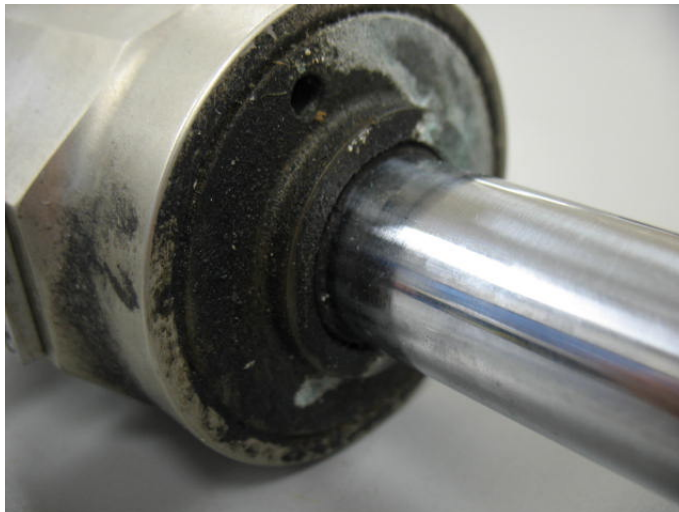
**Photo 2. Corrosion on scraper faceplate (Courtesy of Triumph Actuation Systems)**

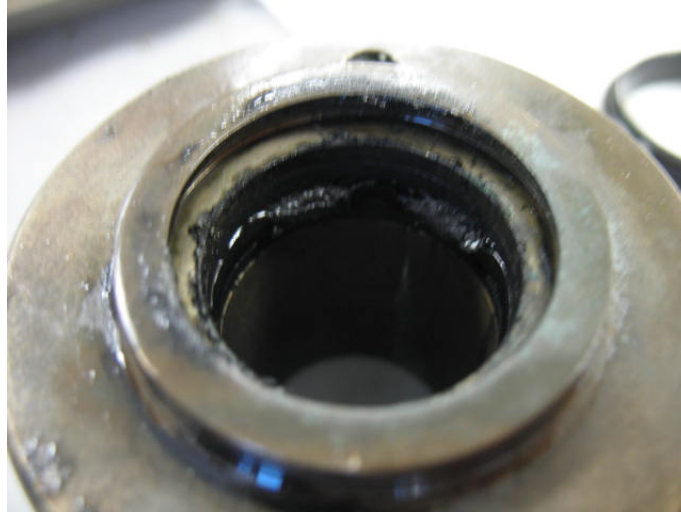
The unit was removed from the test stand to a work station for disassembly. The four screws around the switch were removed to expose the seal. The seal was observed intact and no damage was observed when viewed under a microscope; however, there appeared to be an oil water mixture encrusted on the outside diameter of the plunger surface. The rod end was difficult to remove due to what appeared to be corrosion on the thread, once removed the internal mechanism appeared normal around all seals and the rod was visually checked utilizing a metal straight edge/ruler and was found to have no noticeable deformation. The piston rod dynamic T-seal showed signs of "rolling phenomenon," this is also known in the industry as "pockmarking," which was common on the "dash 1" configuration. Subsequent configurations were "upgraded" with an associated actuator dash number progression. This phenomenon leads to seal breakdown and eventual physical failure with a noticeable fluid leak. This T-seal had not progressed to the point of fluid leaking; however, did exhibit some seal elastomer material breakdown and associated debris at the T-seal groove, with some migration of debris and hydraulic fluid to the adjacent scraper seal area. The scraper seal showed signs of grit/grime build up at the external lip and evidence of T-seal material at the inboard surfaces, but was otherwise intact. This phenomenon is further discussed in Appendix B. The subsequent revisions incorporated an upgraded dynamic rod seal design which prevented this phenomenon from occurring, and are summarized in Appendix B. Other than atheistic reasons the "rolling phenomenon" was not a hazard to safe flight. The chrome finish on the piston rod showed limited areas of what appeared to be "pitting or abrasion" approximately 3.25 inches from the head. "Loose" reassembly of the unit revealed that the area was located immediately under the damaged T-seal when the rod was in the fully extended position. The pitting/abrasion damage was attributed to operation and parking with the rod in the full extended, or gear down, position. Examination of the sealing system which included the rod, scraper, and piston seals were considered "adequate" to provide a leak-free sealing during both static and dynamic conditions.

**Photo 3. T-Seal in Groove Showing "Rolling Phenomenon" (Courtesy of Triumph Actuation Systems)**

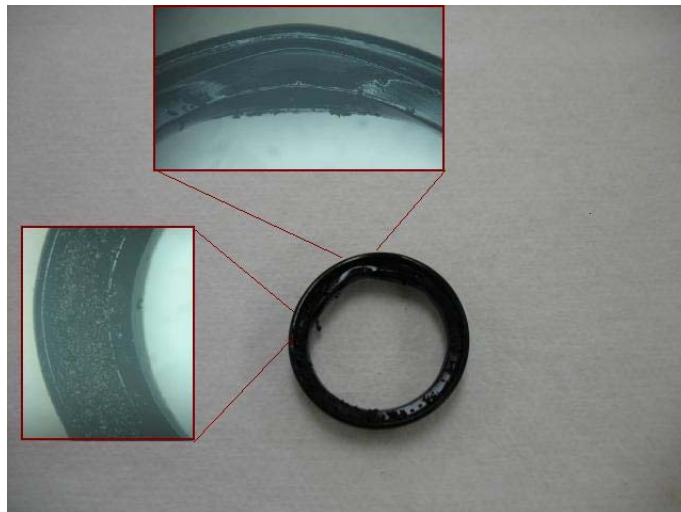
**Photo 4. Rod T-Seal As Examined Under a Microscope (Courtesy of Triumph Actuation Systems)**

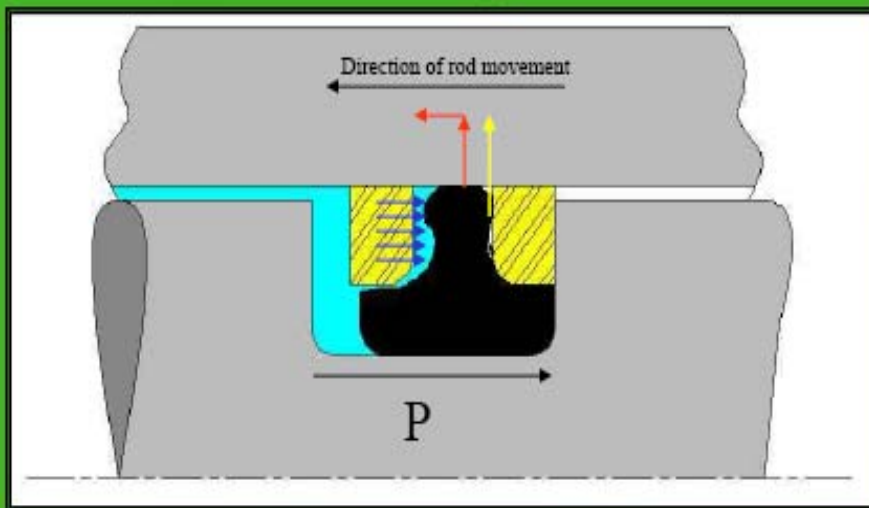
## GT Rings - "Pockmarking"

In rod seals when the pressure is applied to the seal, the dynamic contact surface moves in a direction opposing the pressure.

There is a **normal force** providing sealing on the elastomer crown, given by the squeeze and system pressure.

The friction between the elastomer and the dynamic contact surface exerts a **force,  $\mu N$** , which tries to maintain the status quo between the two.

Opposing this force is the **pressure** in the system, acting on the sidewall of the elastomer crown.

If the force resulting from this pressure is sufficient to negate the friction force then, as in stress plot 2, the stress transition results in a **tensile force** in the crown wall which less than the maximum tensile stress of the elastomer.

However if the **system pressure derived force is not enough to negate the friction force** then, as in stress plots 3, 4 and 5 the stress transition results in a **tensile force** in the crown wall which exceeds the maximum tensile stress of the elastomer. This results in a **tear** in the elastomer which follows the stress planes seen in the stress profiles.

The **tears** result in "pockmarks" being generated and material being removed. This changes the stress profiles in the elastomer, so that the next time tears form they do so in a different place, hence the appearance.

It should be noted that pockmarking damage occurs in the -1 actuator when the following specific conditions are prevalent: 1) rod motion sudden start when the seal is pressurized (during unlock), and 2) exposure of the rod to the environments for significant periods of time (parking), causing the rod surface to dry out and lose lubricity.
