# NATIONAL TRANSPORTATION SAFETY BOARD

## MATERIALS LABORATORY FACTUAL REPORT

Report No. 11-090

Place : Altavista, Virginia  
Date : April 22, 2011  
Vehicle : Cessna 210D  
NTSB No. : ERA11FA258  
Investigator : Alex Lemishko (ASI-ERA)

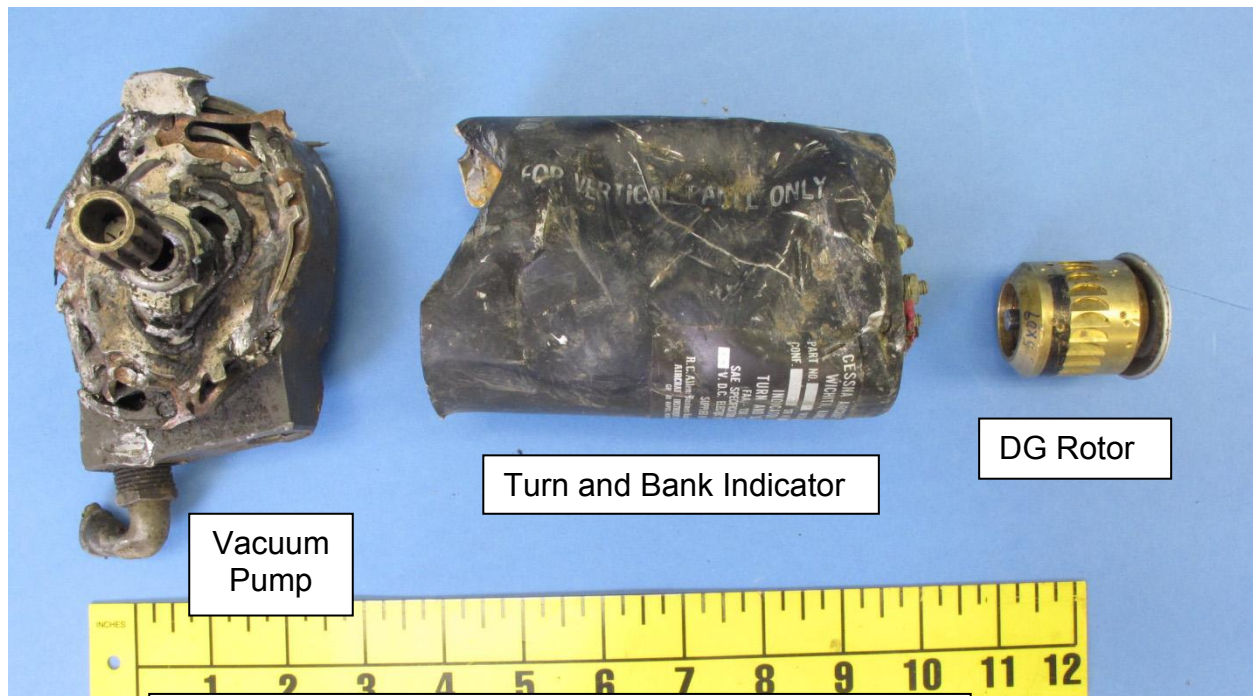
The received components are displayed in figure 1.

Figure 1. Overall view of the as-received components.

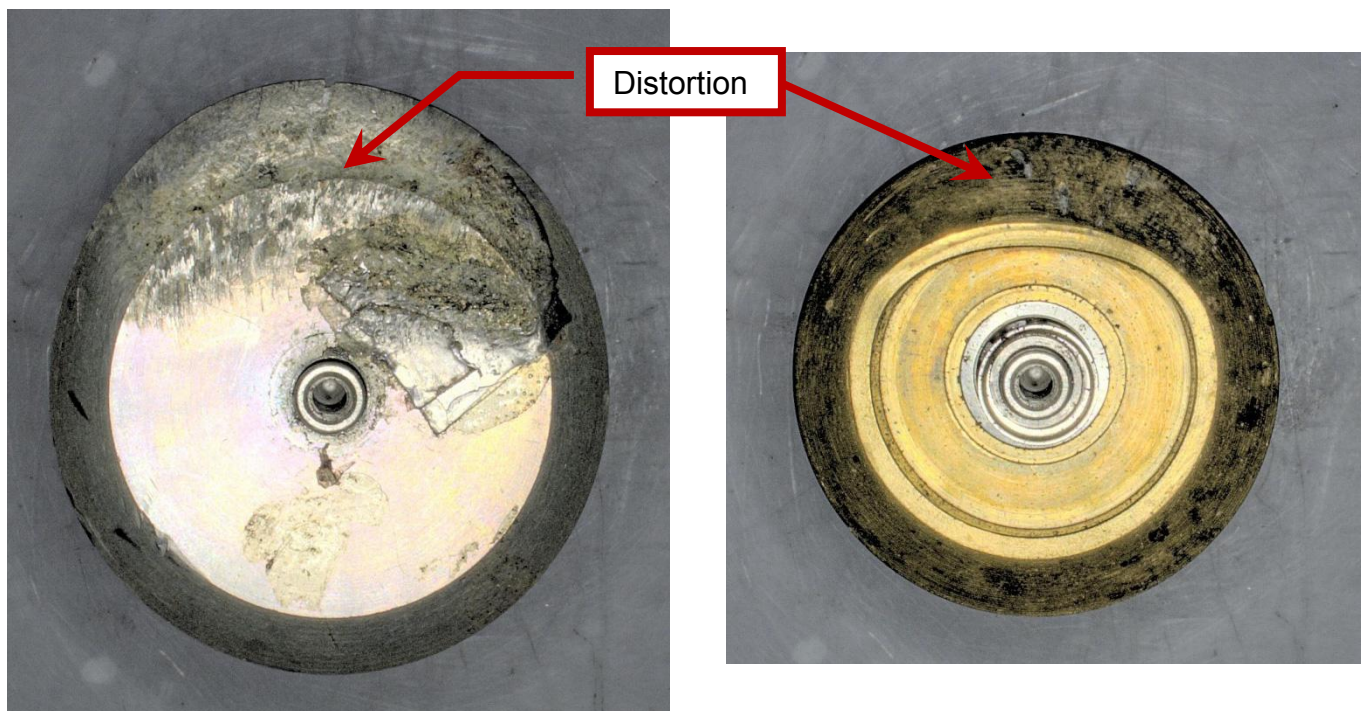
Only the rotor and cap were received from the directional gyro, the gyro was pneumatically powered. The cap was heavily dented inward and distorted on one side as shown in the left view of figure 2. Removal of the cap revealed a mating dent and deformation in the end of the gyro rotor as shown in the right view of figure 2. Close optical examinations did not reveal rotational marks on either the rotor or cap.

Figure 2. Left view shows the exterior of the rotor cap with distortion in the upper half. Right view shows the matching dent in the end of the rotor.

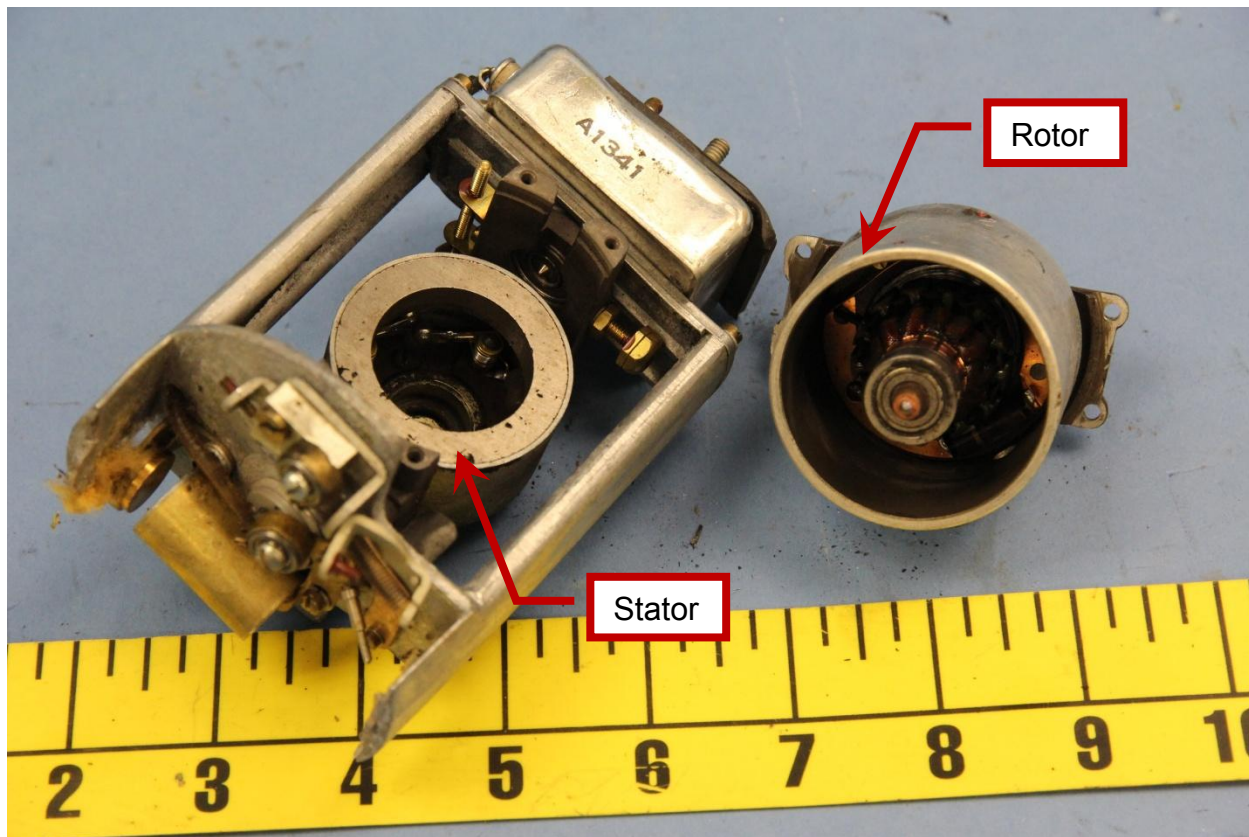
The case of the turn and bank indicator was partially crushed and the indicator face was not received. The case was cut open to reveal the interior components. The indicator contained an electrically-powered gyroscopic weight. The gimbal structure surrounding the gyro was intact with little or no damage. Disassembly of the gyro revealed light rotational marks on the exterior of the stator (non-rotating) and on the interior of the rotor consistent with normal operation, see figure 3.

Figure 3. The intact gimbal structure with gyro disassembled.

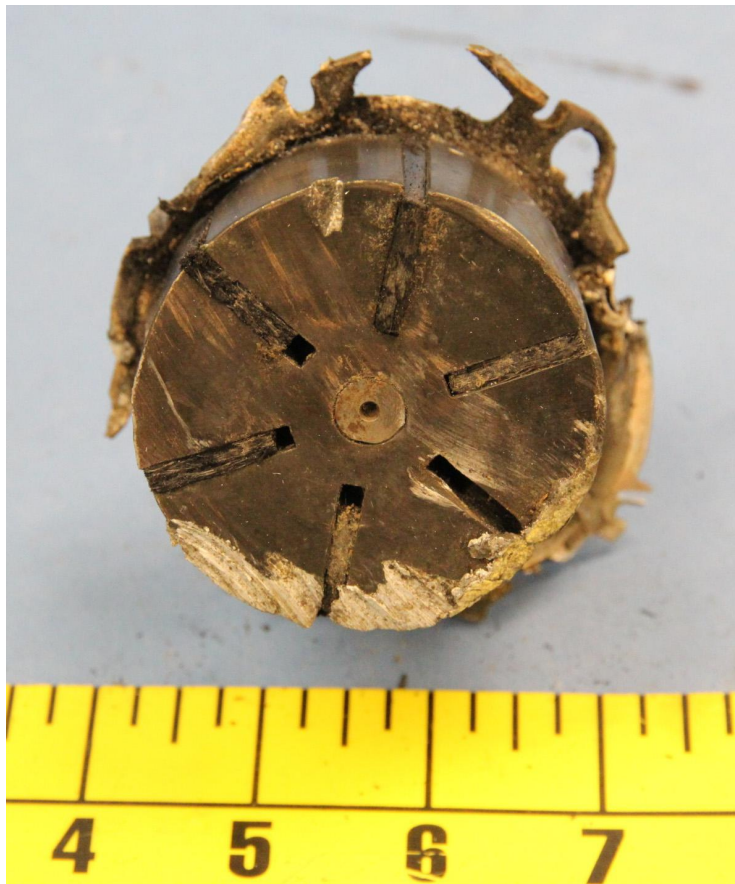
The vacuum pump was severely distorted and damaged. Both end caps of the pump were missing and the housing was crushed onto the rotor. The pump vanes were mostly intact. The input drive shaft and reduced shear section were intact and continuous to the pump rotor. The pump housing was longitudinally cut and the rotor released. Magnified examinations uncovered dents and scuff marks to the end of the rotor consistent with non-rotating impacts, as indicated in figure 4.

Figure 4. The end face of the pump rotor showing non-rotational damage, dents and scrapes.
