# NATIONAL TRANSPORTATION SAFETY BOARD

MATERIALS LABORATORY FACTUAL REPORT

Report No. 12-005

Place : Okeechobee, Florida  
Date : September 19, 2011  
Vehicle : Heinlein GH 125  
NTSB No. : ERA11LA519  
Investigator : Heidi Moats

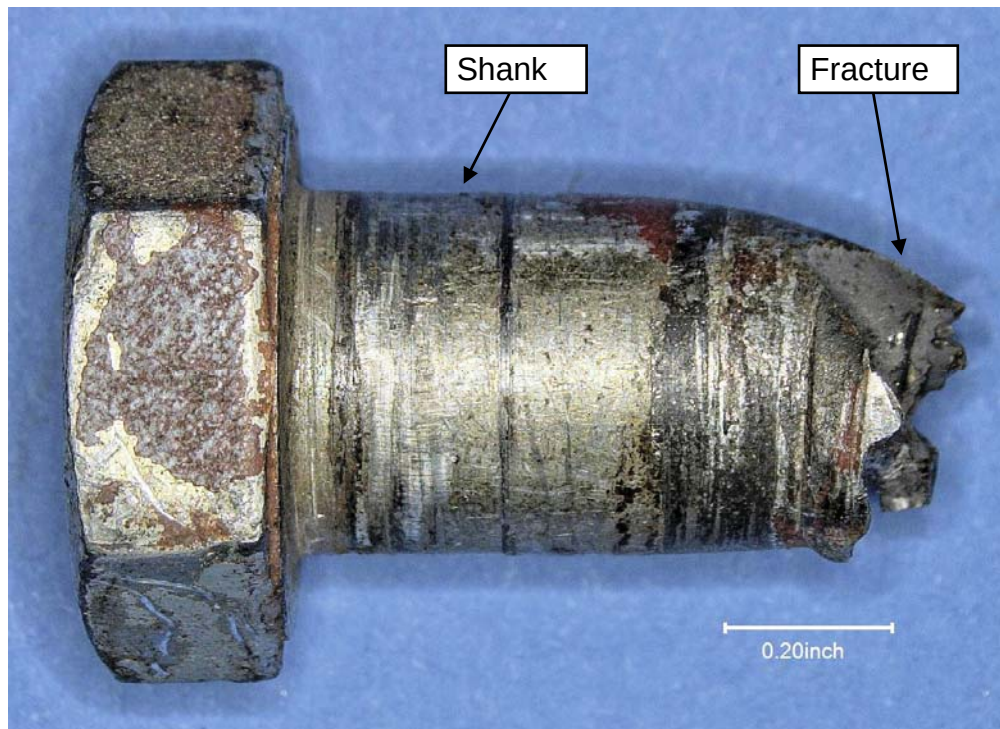
An overall photograph of the landing gear bolt piece is shown in Figure 1. The fracture surface of the bolt is shown in Figure 2. As-received, a portion of the fracture surface was damaged due to a saw cut. Based on the deformation of the bolt shank and the fracture surface features, the bolt fractured in overstress due to concomitant shear and bending stresses.

Figure 1 Image showing the as-received bolt piece.

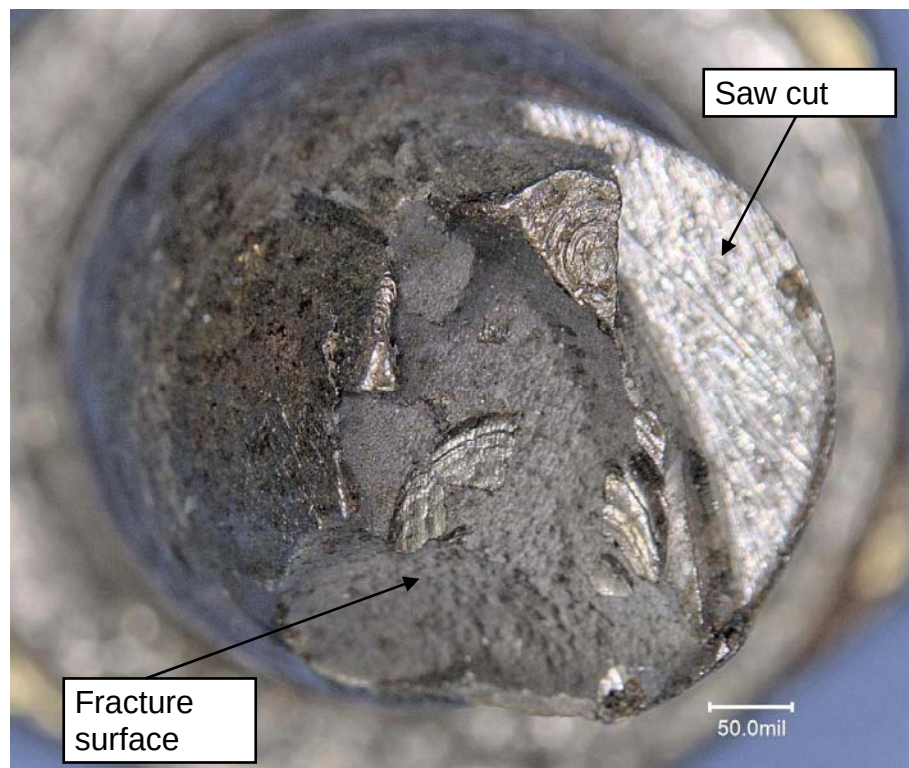
Figure 2 Image showing the fracture surface of the bolt piece.
