# NATIONAL TRANSPORTATION SAFETY BOARD

## MATERIALS LABORATORY FACTUAL REPORT

Report No. 12-021

Place : Jackson, Mississippi  
Date : January 28, 2012  
Vehicle : Cessna 172 N427CP  
NTSB No. : ERA12IA169  
Investigator : Jose L. Obregon, AS-ERA

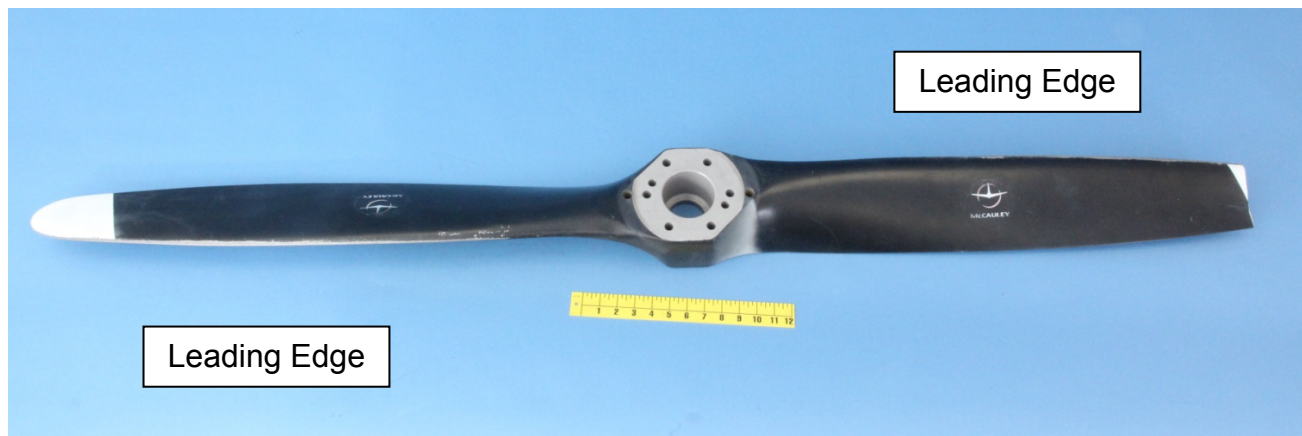
The tip of one blade was fractured approximately 35.8 inches from the prop centerline, as shown in figure 1. The other blade tip measured 38 inches indicating that slightly more than 2 inches of the tip was not received.

Figure 1. An overall view of the chamber side of the as-received propeller with the fracture at the right.

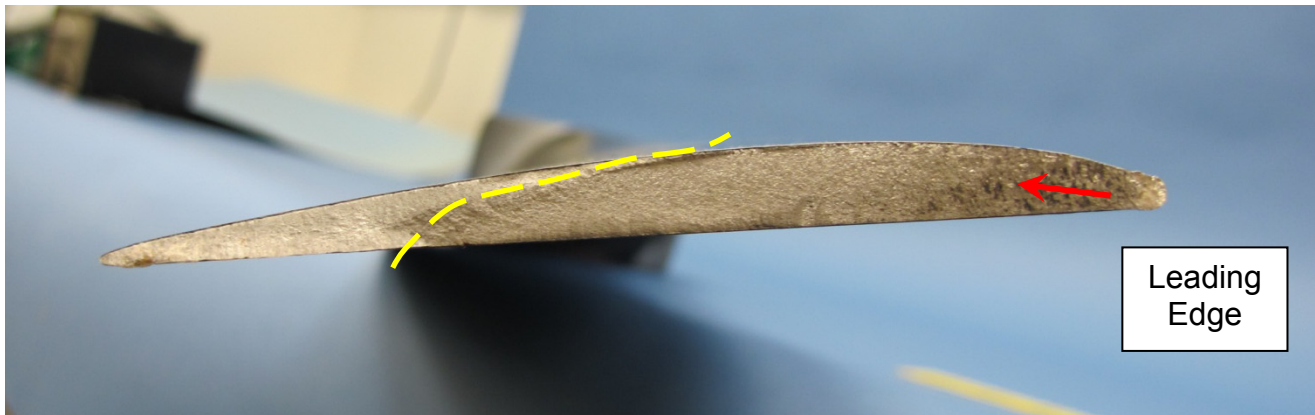
Optical examinations of the fracture face revealed fracture markings indicative of fatigue progression in aluminum alloys as shown in figure 2. The fatigue initiated near the leading edge and propagated chordwise (red arrow) through an estimated 60 to 70% of the blade cross section with the remaining fracture consistent with tensile overstress separation. The demarcation between fatigue progress and overstress is indicated by the yellow dashed line in the upper view of figure 2.

Figure 2. Above, a view of the as-received fracture face showing fatigue progression from the leading edge, red arrow, up to the dashed yellow line. Below, an enlarged and cropped portion of an on-scene image of the fracture showing the leading edge area (dashed red line) with no appreciable damage.

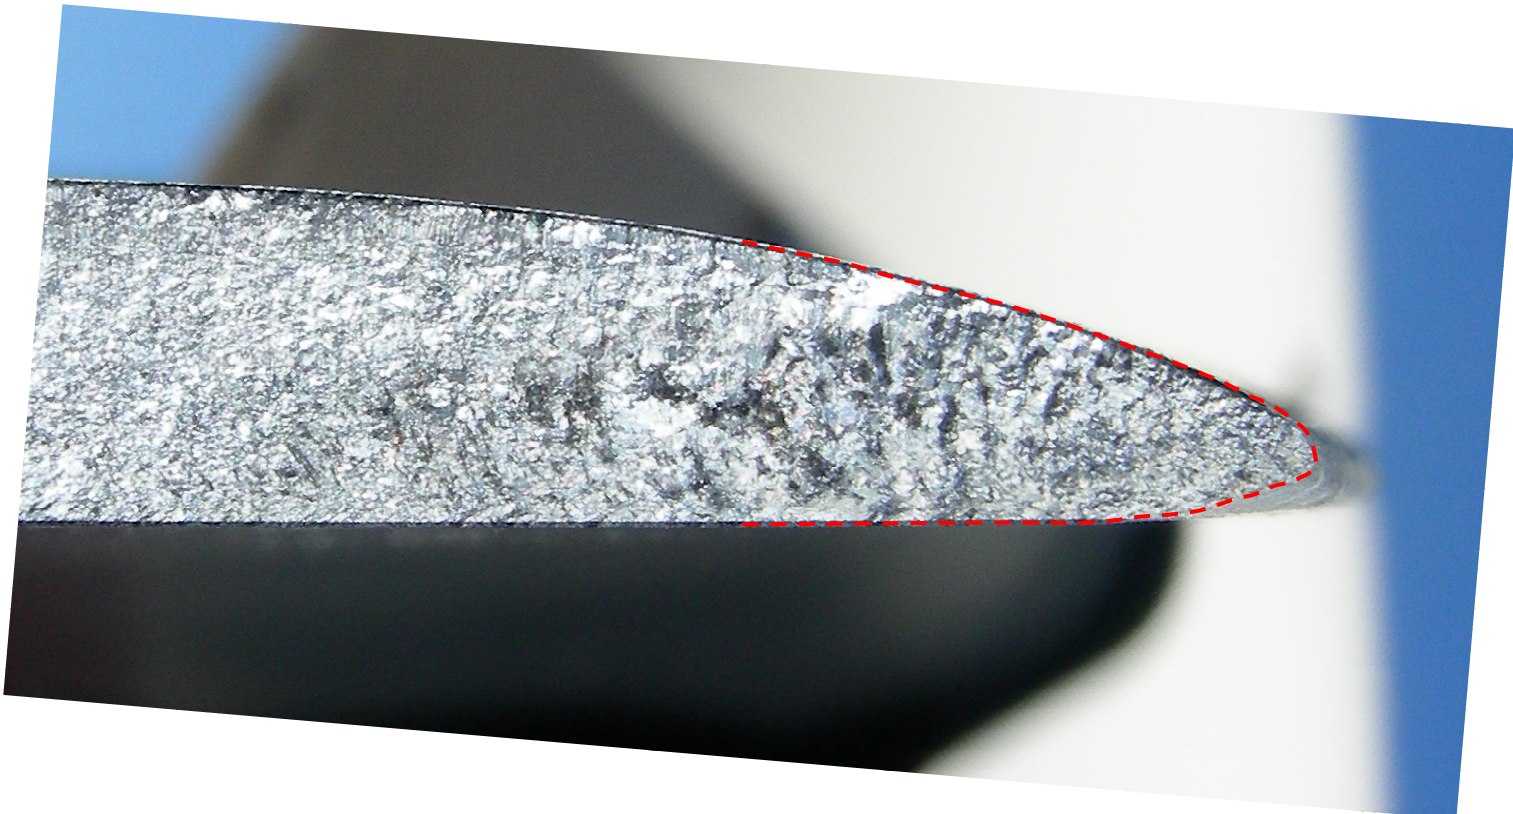
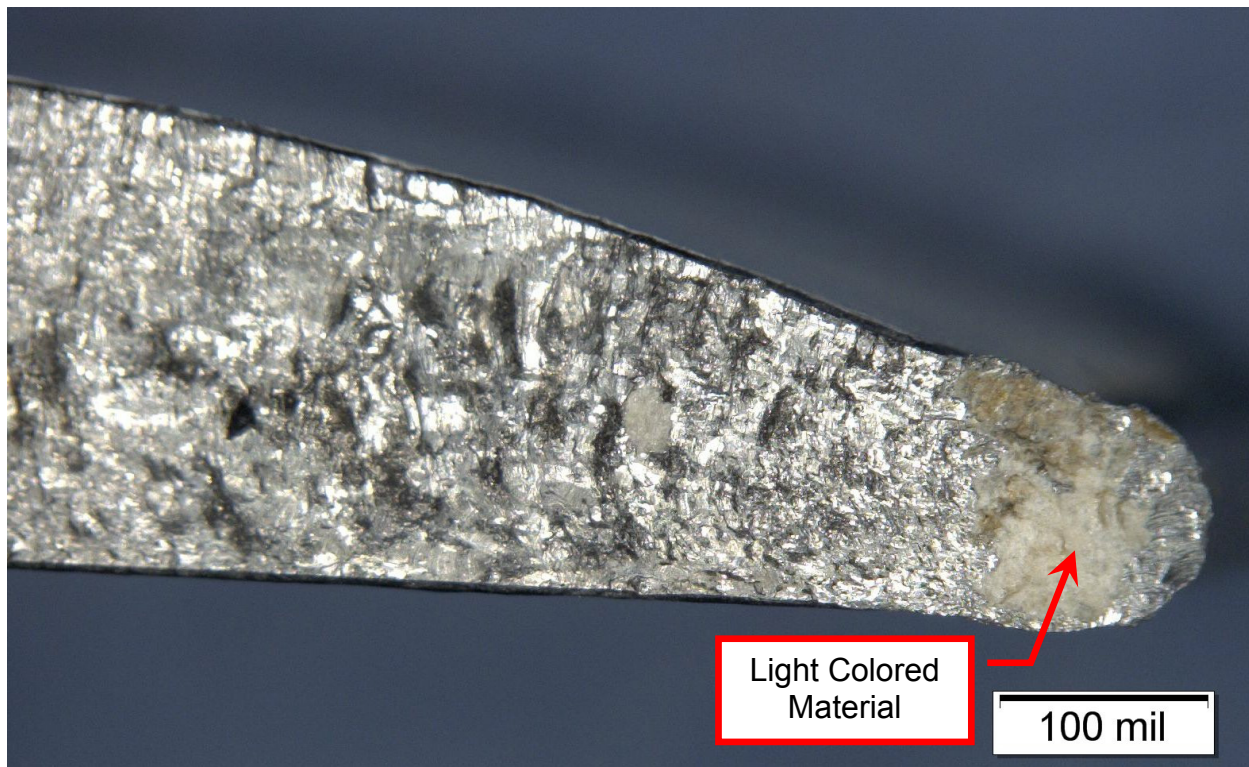
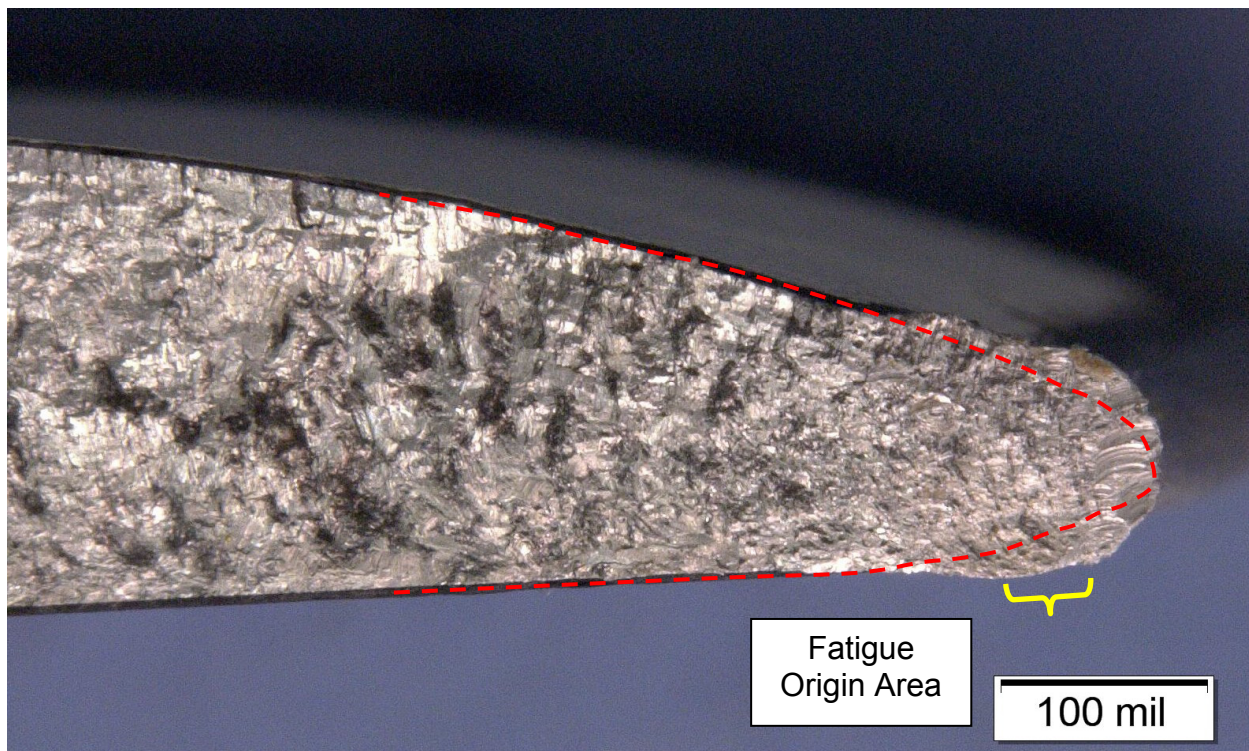
On the as-received propeller, approximately 0.1 inch of the fracture face was obscured by a light colored material embedded into the fracture as shown in the upper view of figure 3. The adjacent blade material was deformed and bulged consistent with post fracture impact and displacement of the fracture surface. On-scene images of the blade fracture, as shown in the lower view of figure 2, did not show damage at the leading edge of the blade. To illustrate the extent of damage a digital tracing of the leading edge shape was made from the on-scene image and matched and overlaid on the lower image of figure 3 as a dashed red line.

A sample of the obscuring material was retained and the remainder was removed by successive cleanings in acetone with ultrasonic agitation to reveal the surface shown in the lower view of figure 3. Magnified examinations, optical and scanning electron, found that the larger fracture features remained mostly visible but the fine microscopic details had been obliterated. The macroscopic features indicated that the fatigue initiated in the close vicinity of the leading edge on the flat face side of the blade. The bracket in the lower view of figure 3 indicates the approximate origin location. No significant corrosion or damage was noted on the adjacent intact leading edge of the blade.

Figure 3. Two magnified view of the leading edge area of the fracture before and after removal of the light colored material. Fracture features indicated fatigue origination in the area of the yellow bracket in the lower view. Dashed red line in lower view denotes the shape of the leading edge before damage.

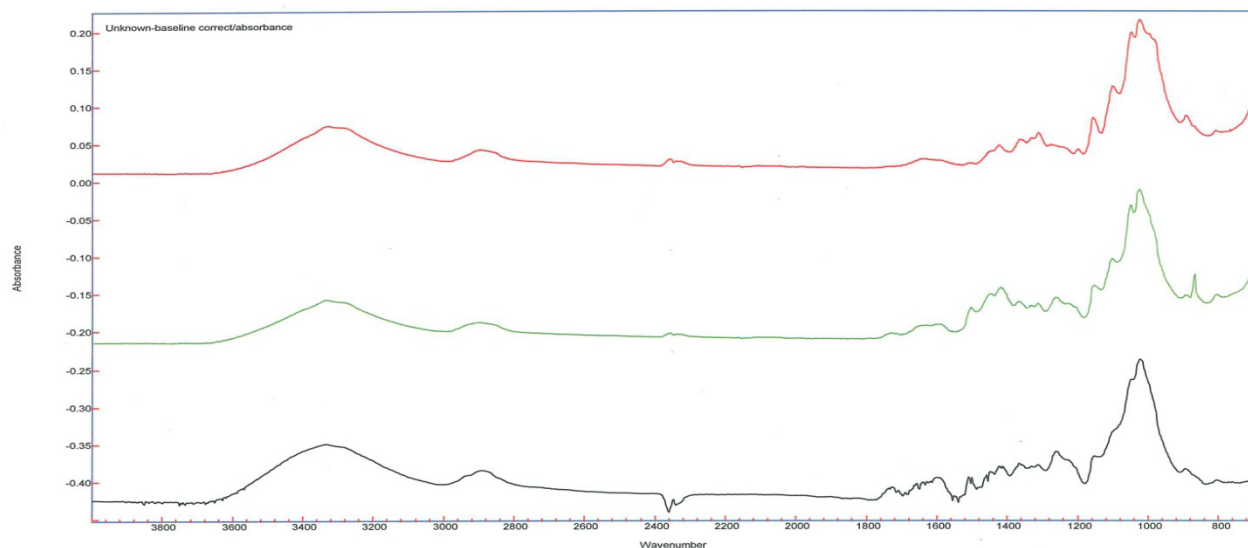
Fourier-Transform Infrared (FTIR) spectra of the retained obscuring material identified it as methyl cellulose. FTIR spectral comparisons of the unknown material found a close spectral match with a light colored paper product used as packing dunnage in cardboard shipping container, as shown in figure 4. Inspection of the interior ends of the shipping package revealed crushing and denting of the cardboard in the approximate shape of the blade fracture as shown in figure 5.

Figure 5. FTIR spectra comparing the light colored material from the fracture face (top red line) to the two kinds of paper dunnage in the shipping box (green line white paper, black line brown paper).

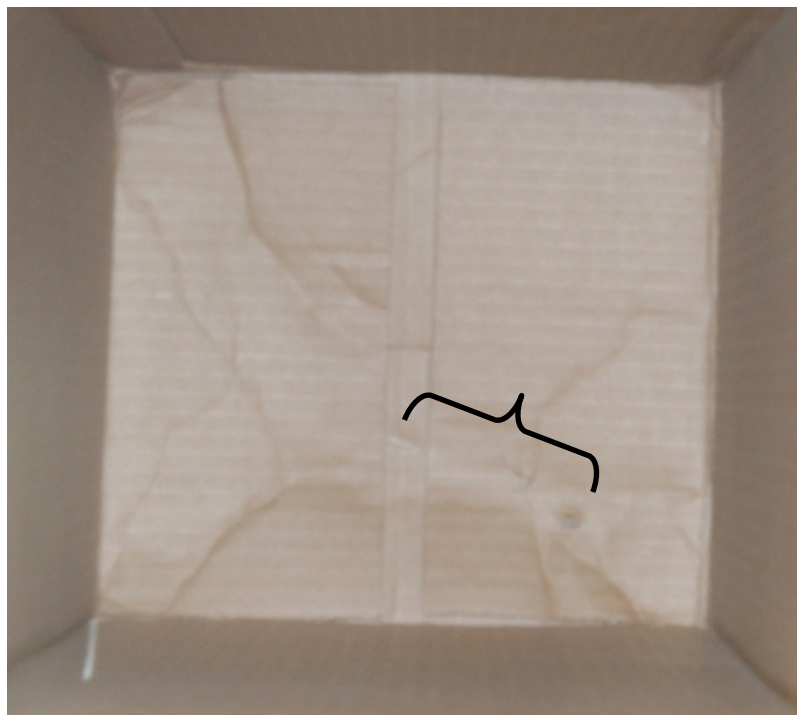
Figure 6. The interior end of the shipping box showing blade shaped crushing (bracket).
