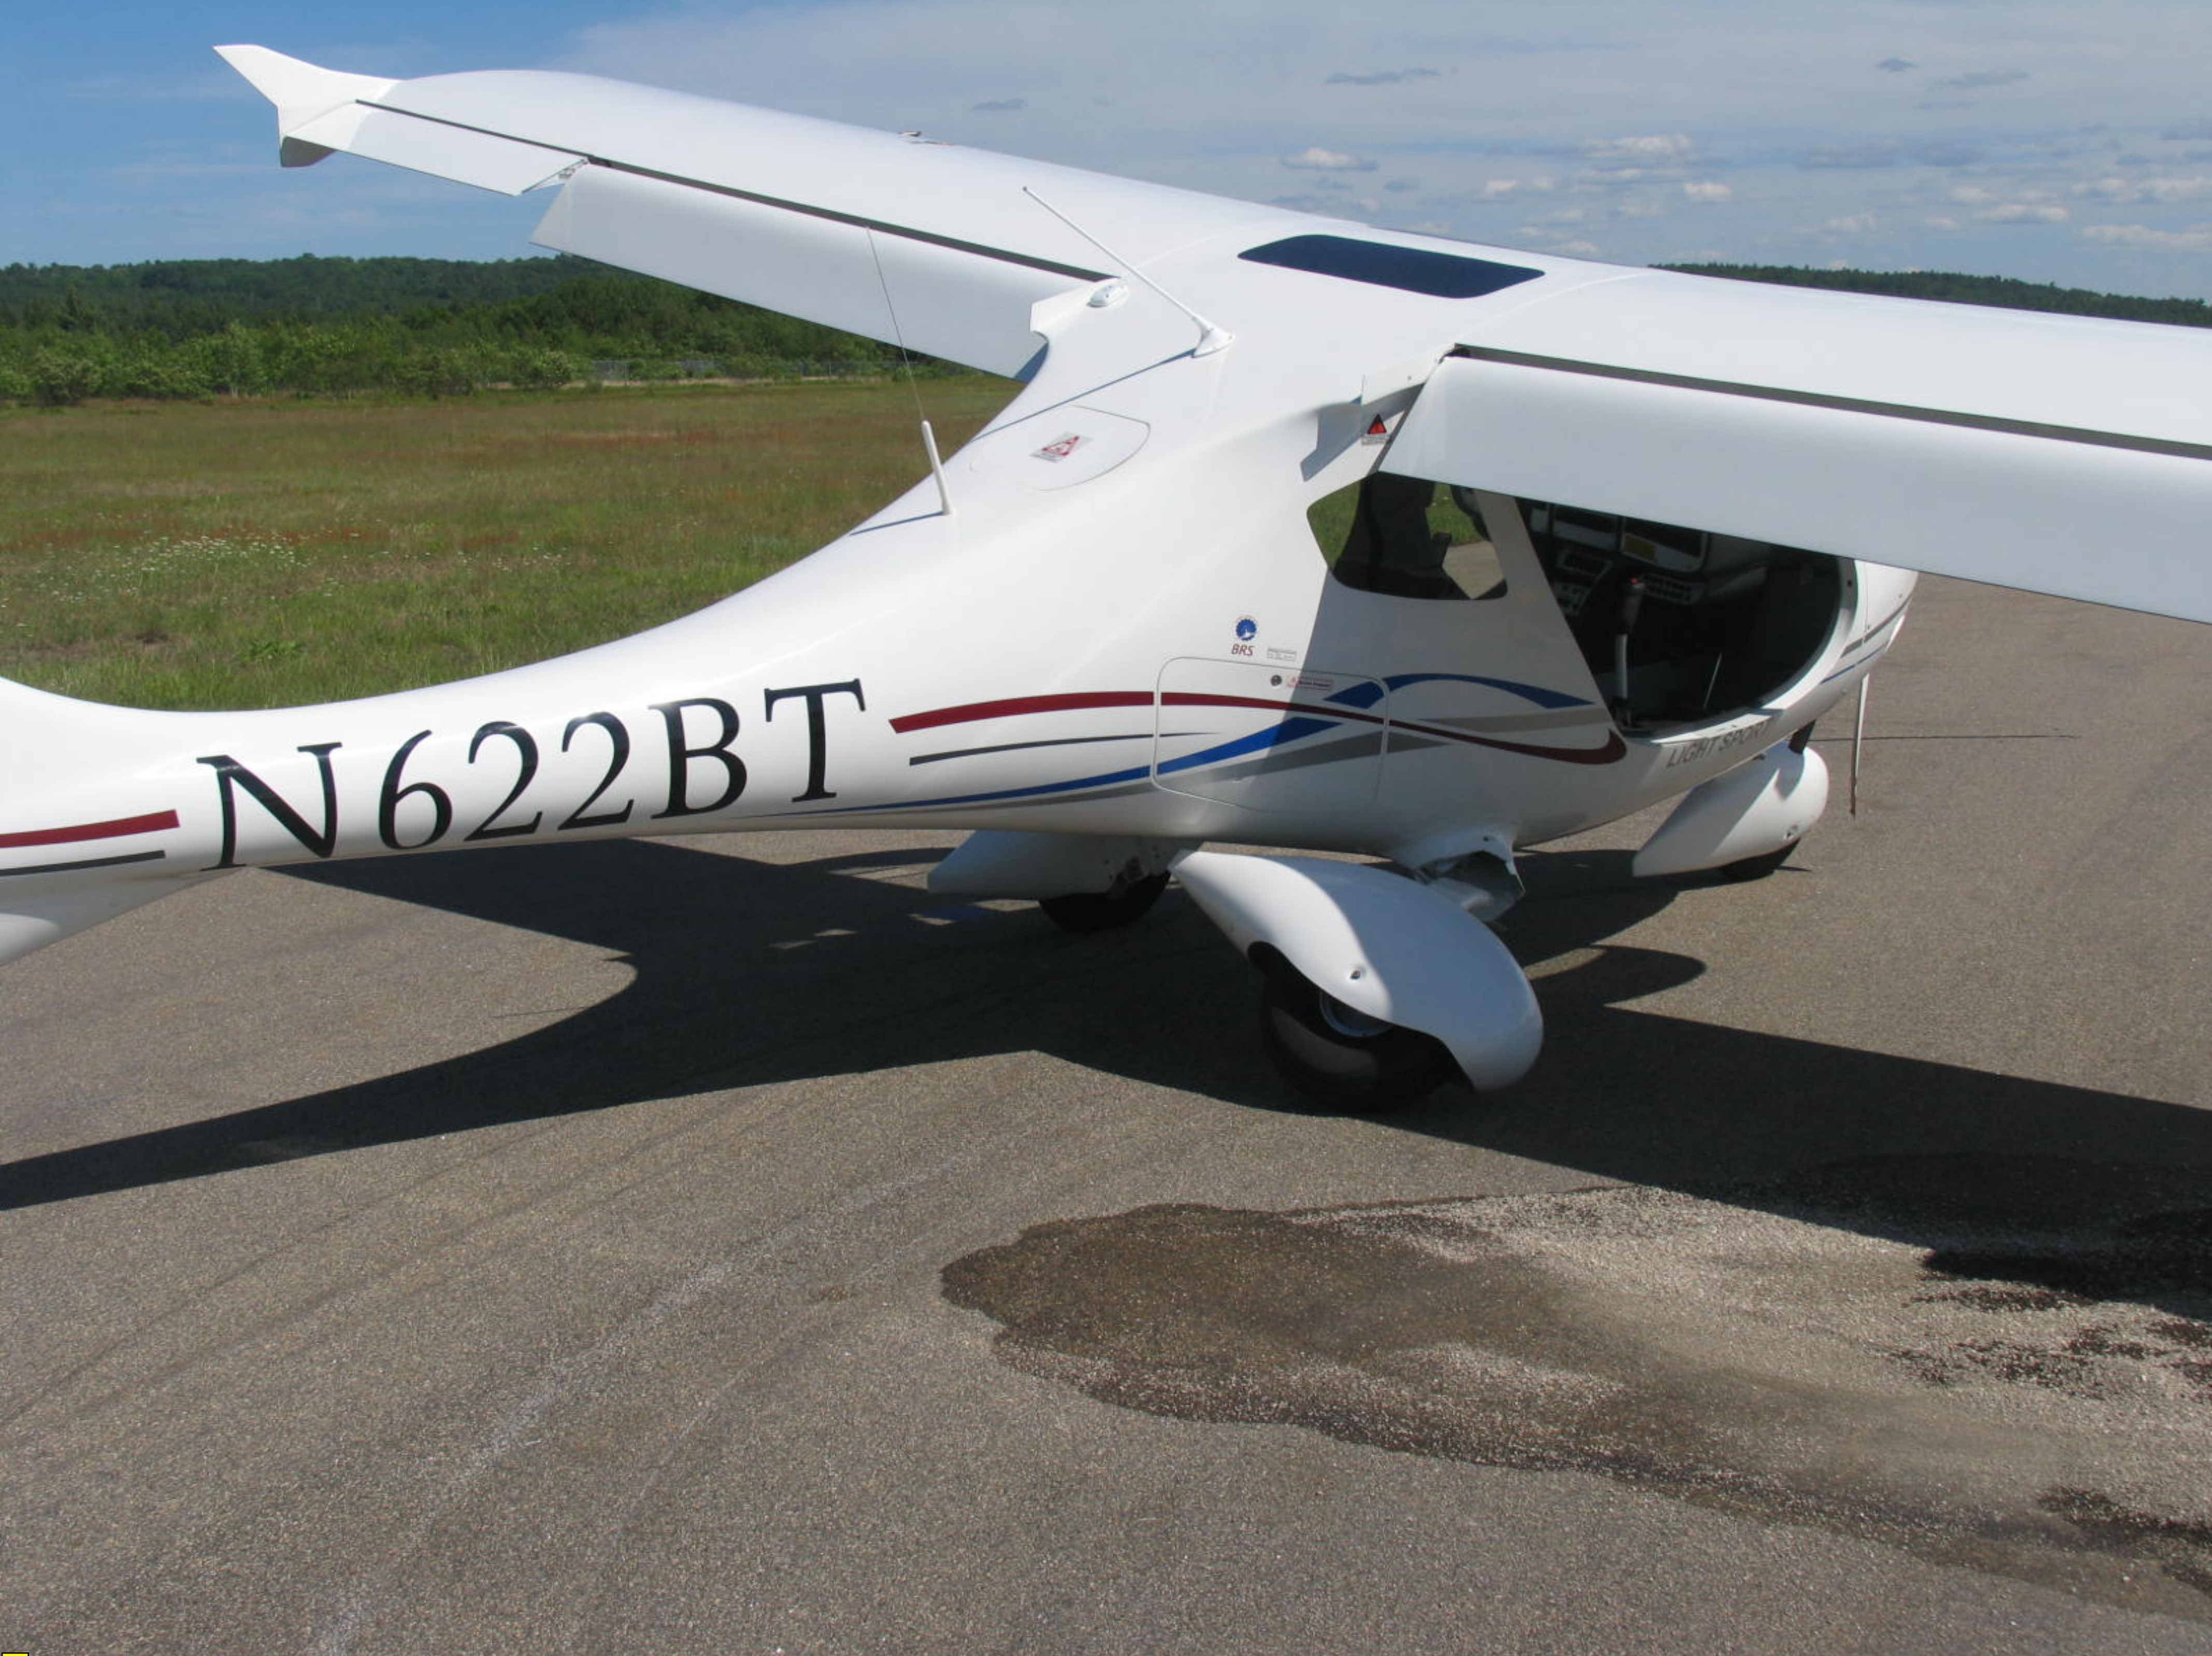
Photo 1: Damaged Right Landing Gear.
