# NATIONAL TRANSPORTATION SAFETY BOARD

## MATERIALS LABORATORY FACTUAL REPORT

Report No. 14-013

Place: Lake Park, Georgia.  
Date: December 10, 2012.  
Vehicle: Diamond DA 40, N840DS.  
NTSB No.: ERA13FA083.  
Investigator: Todd Gunther.

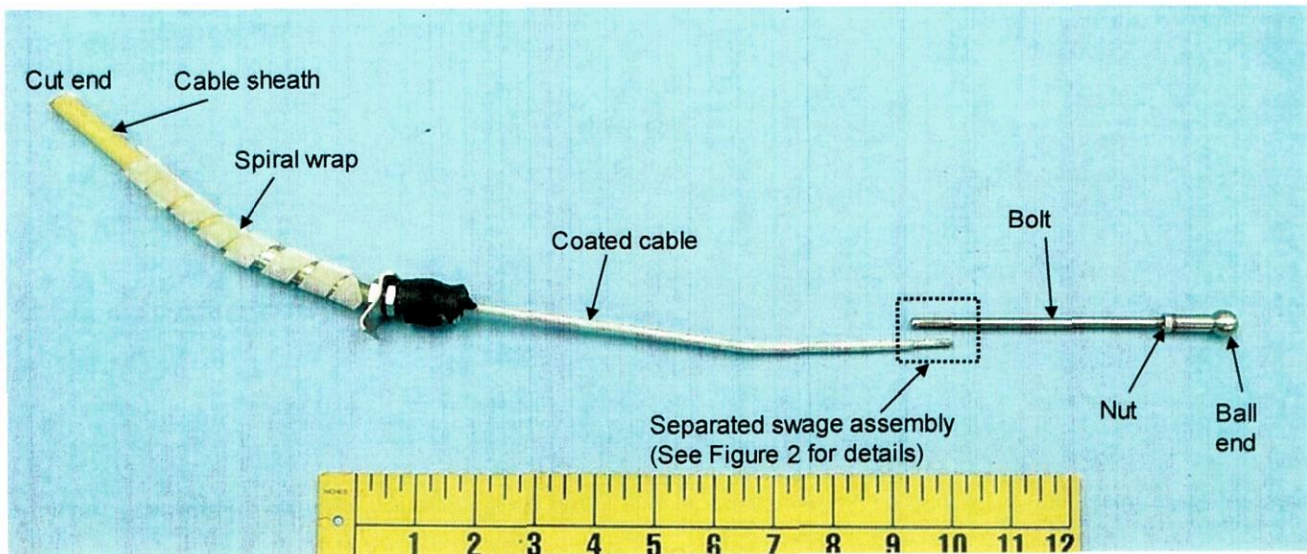
The as-received portion of the elevator trim cable assembly showing the separated swage bolt is depicted in figure 1. A closer view of the separated area is shown in figure 2. The aircraft manufacture, Diamond Aircraft Industries (DAI), supplied drawing DAI-9027-38-01 (document 1 in section C) which contained DURA drawing 1-6662020R03 00. DAI also supplied DURA drawing 1-6662020R03 00 (document 2 in section C), VOFA drawing 1020001-009R3403 (document 3 in section C), and Vofa-Werk drawing 1350151R0401 (document 4 in section C) and a translation of notes on the drawings.

Figure 1 Overall image of the as-received accident elevator trim cable with the separated bolt and ball end identified.

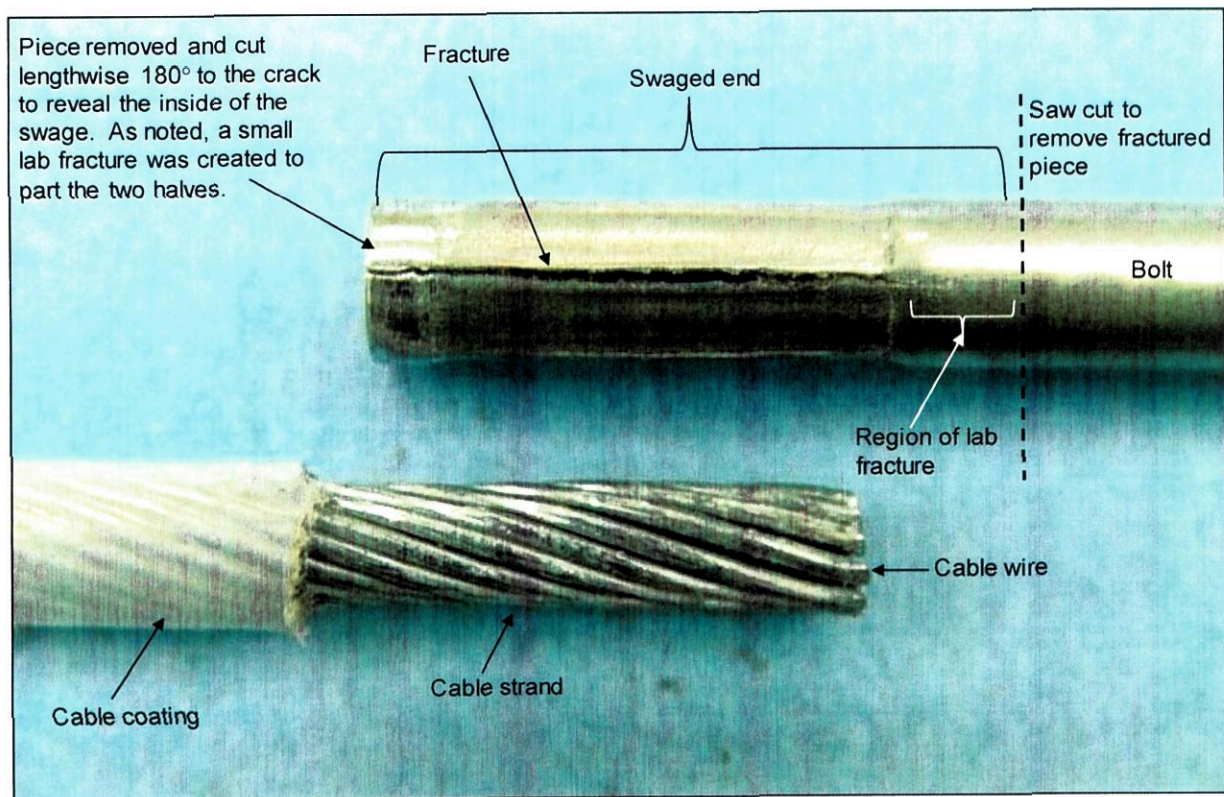
The separated ends of the accident trim cable are depicted in figure 2, with the bolt and the core cable identified. The core cable consists of the cable strand with a plastic

coating<sup>4</sup> that is removed in the area where the bolt is swaged onto it. The fractured swaged end of the bolt is identified.

Examination of the cable strand revealed twelve outer wires that were clean and exhibited bands of deformed material along their outermost surfaces. A closer view of the cable strand is illustrated in figure 2. The strand contains nineteen wires in the configuration of 7 inner wires and 12 outer wires (e.g. 7 x 12, 19-wire strand). Via micrometer, the average strand outside diameter is about 0.142 inch (3.6 mm). Measured by digital microscopy, the average wire diameter is about 0.027 inch (0.7 mm). The outer wires are wound in a right lay<sup>5</sup>. Drawing 1350151R0401 indicates that the strand had a diameter of 3.5 mm (0.138 inch) and consists of nineteen zinc-coated wires, each with a diameter of 0.7 mm (0.027 inch). The drawing also illustrates and specifies a left lay.

Figure 2 Closer view of the separated cable and fractured swaged area on the bolt. Locations of sample cutting are indicated.

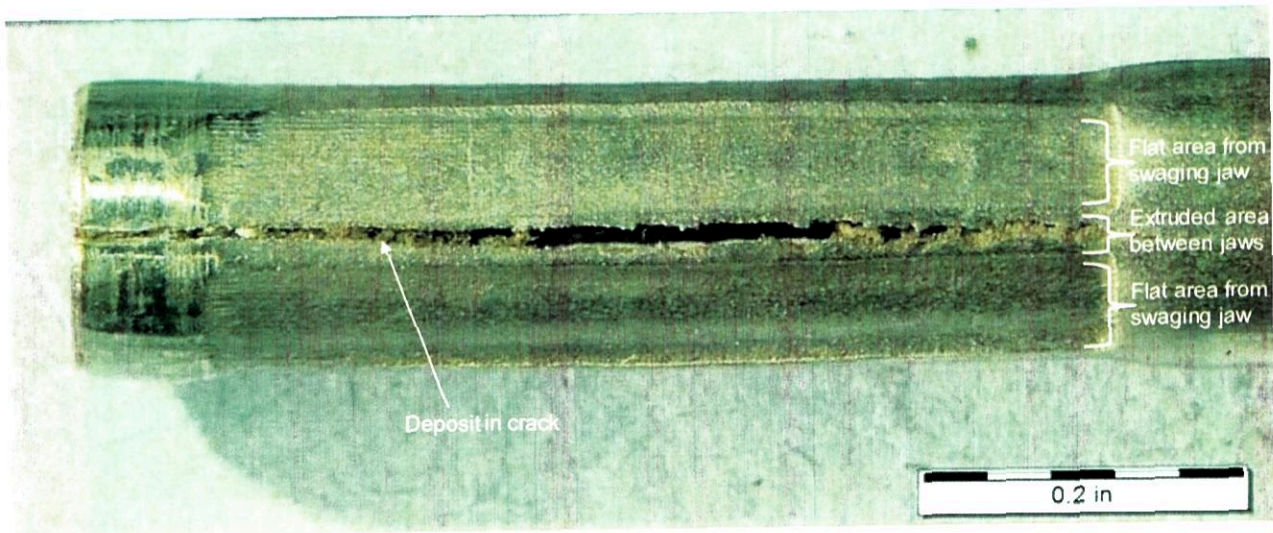
The ball end and the nut were removed from the bolt and measurements revealed that the bolt satisfied the dimensional requirements in drawing 1020001-009R3403. The drawing specified the bolt material as DIN 1.4305 (compositionally equivalent to UNS S30300) and drawing 1-6662020R03 00 specifies the bolt material as stainless steel. A closer view of the fractured swaged end is illustrated in figure 3. The swaging tool pressed five flat regions equally spaced around the circumference. Ribs of extruded material are formed between the flat swaging jaws. The fracture occurred along a rib of extruded material between the swaging jaws. Brown-colored deposits are present in the fracture as indicated in figures 3 and 4.

Figure 3 Closer view of the crack on the accident swaged bolt and the presence of a brown-colored deposit in the crack.

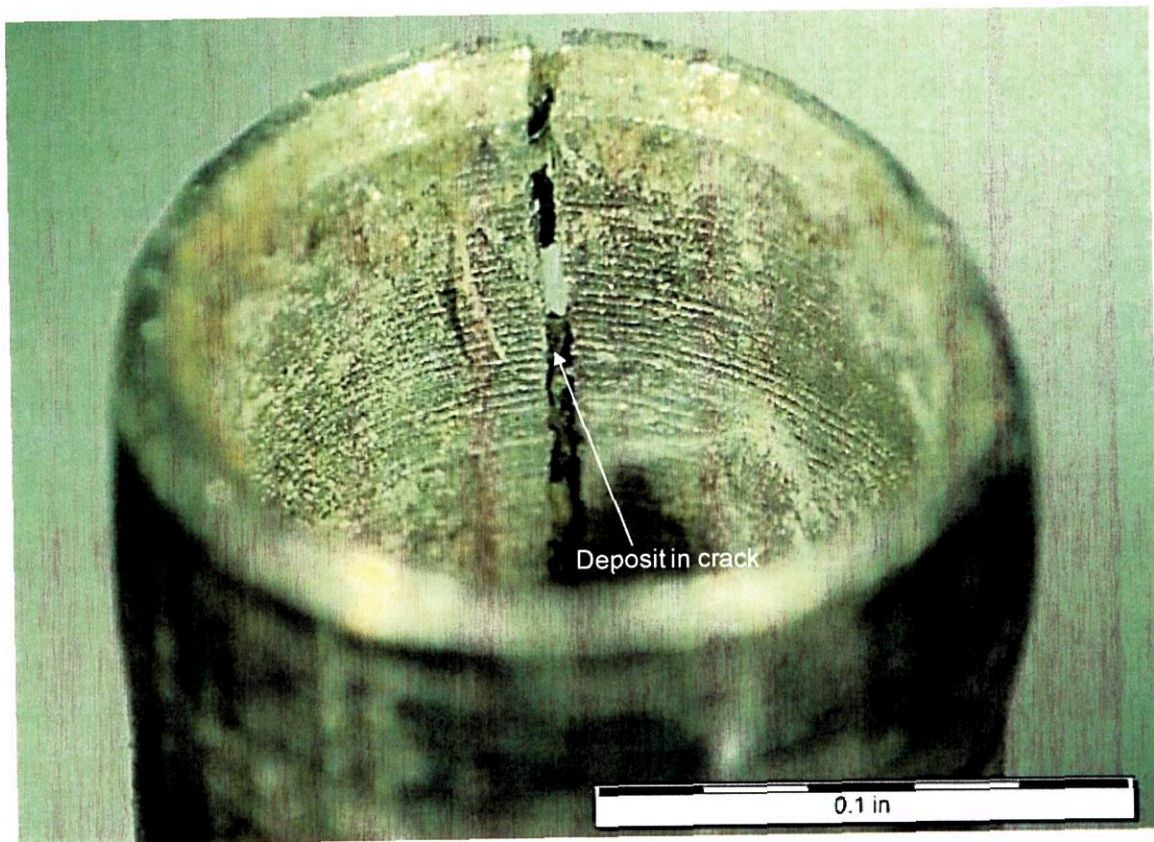
Figure 4 View from the inside of the crack on the accident swaged bolt and the presence of a brown-colored deposit in the crack.

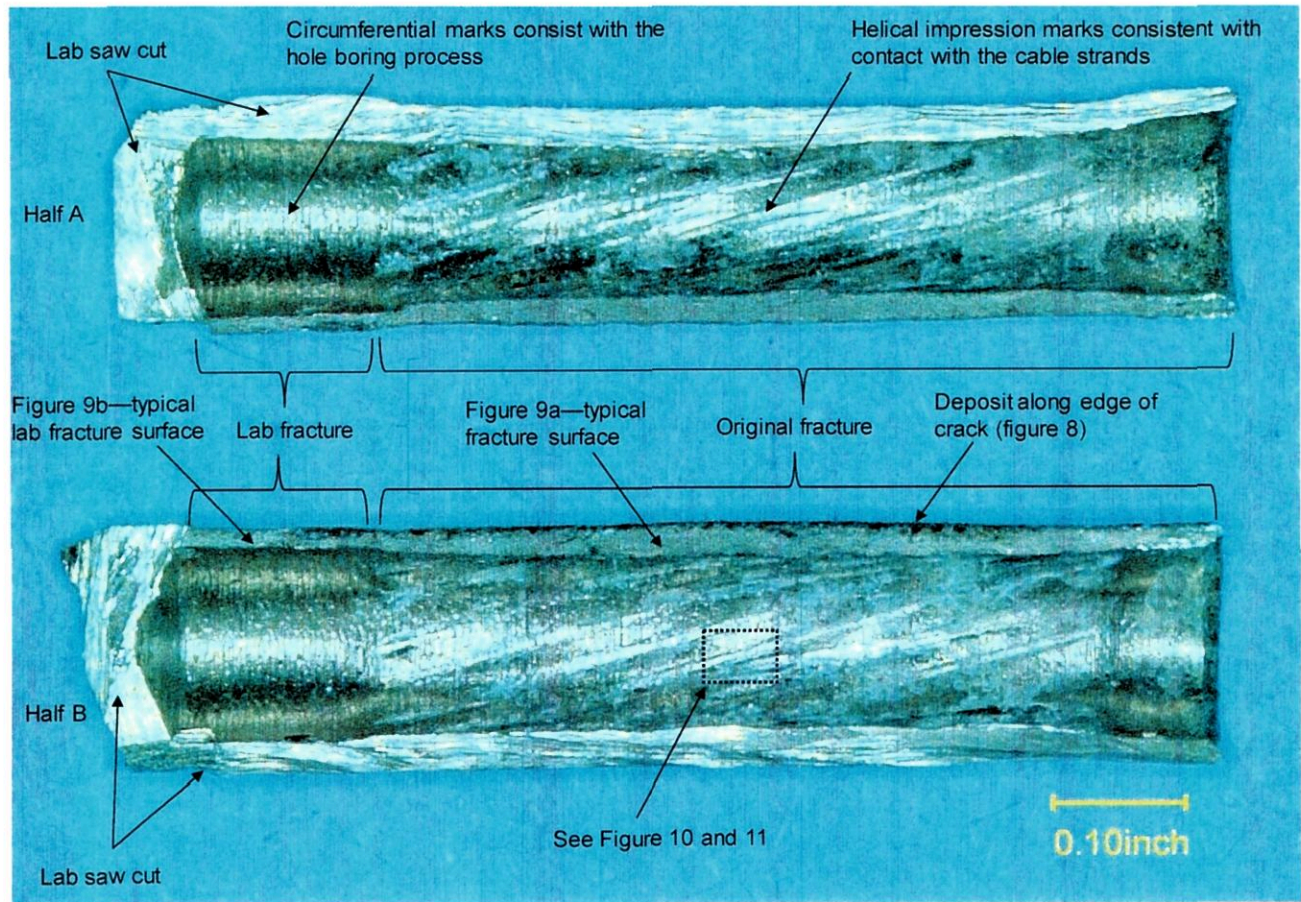
As show in figure 2, the swaged area was cut from the bolt and was then cut lengthwise 180° to the crack to reveal the inside of the swage. As noted, a small lab fracture was created to part the two halves. The inner surface of the bolt swage area adjacent to the fracture is illustrated in figure 5 where circumferential lines consistent with a drilling operation and helical impression marks consistent with contact with the cable wires is identified. External views of the swaged are shown in figures 6 and 7.

As identified in figure 5, the inside surfaces of the bolt swage area exhibited helical impression marks (e.g. grooves) consistent with permanent deformation from contact with the cable wires (see figure 10.) In some of the helical impression grooves, flakes of zinc electroplating from the cable strands were present as shown in figure 10b. EDS analysis (figure 10a) revealed that the flakes are zinc. In many regions of the inside surfaces of the swage, white-colored salts were present in the helical impression grooves as shown in figure 11. EDS analysis (figure 11a) indicates that the white salts are composed largely of zinc and oxygen, consistent with zinc corrosion product.

Figure 5 View of the inner surfaces of both halves of the swaged-portion of the bolt after cutting.

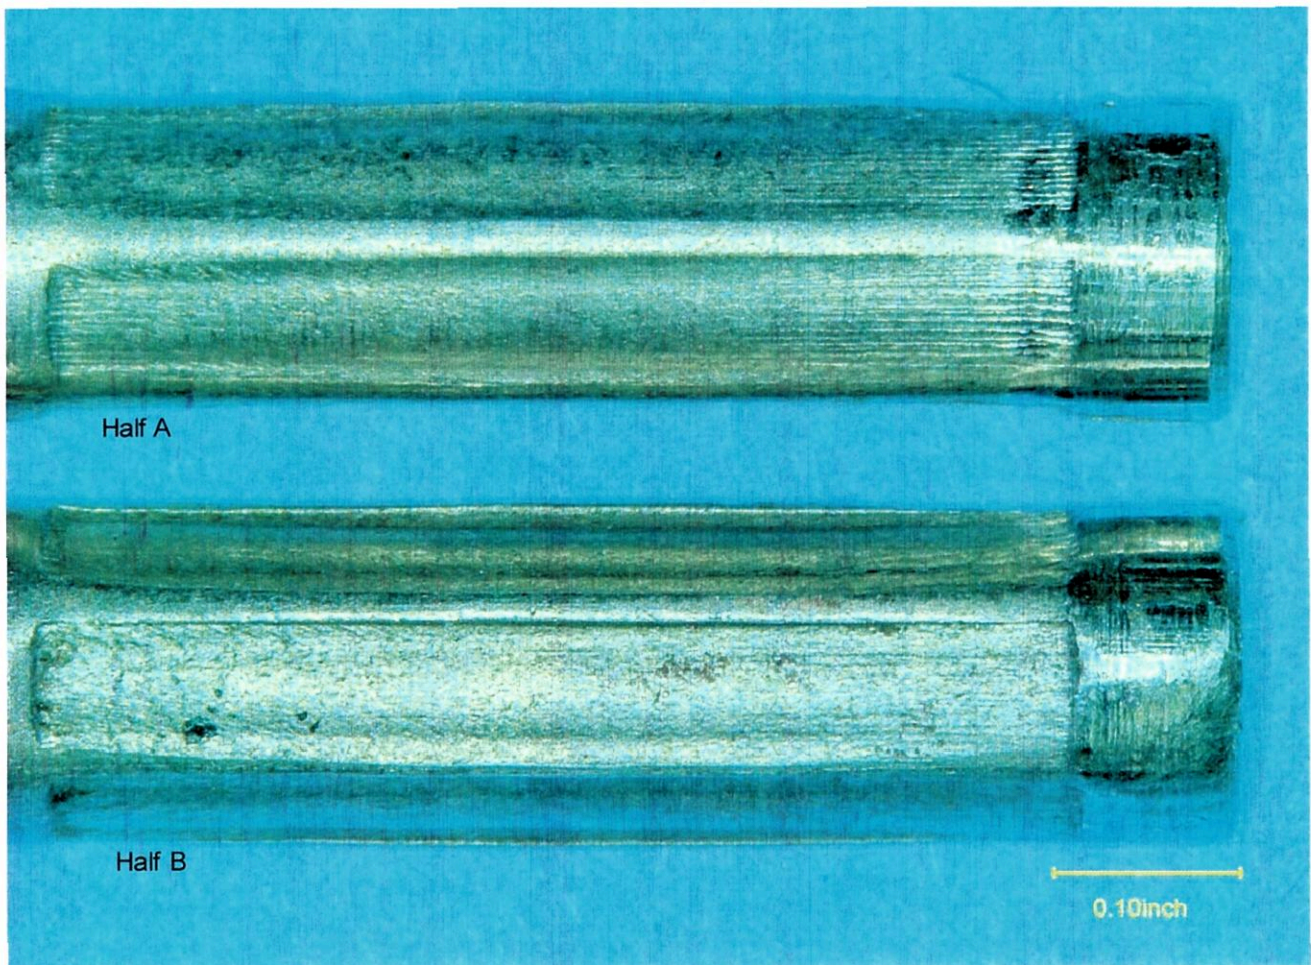
Figure 6 View of the outer surfaces of both halves of the swaged-portion of the bolt after cutting.

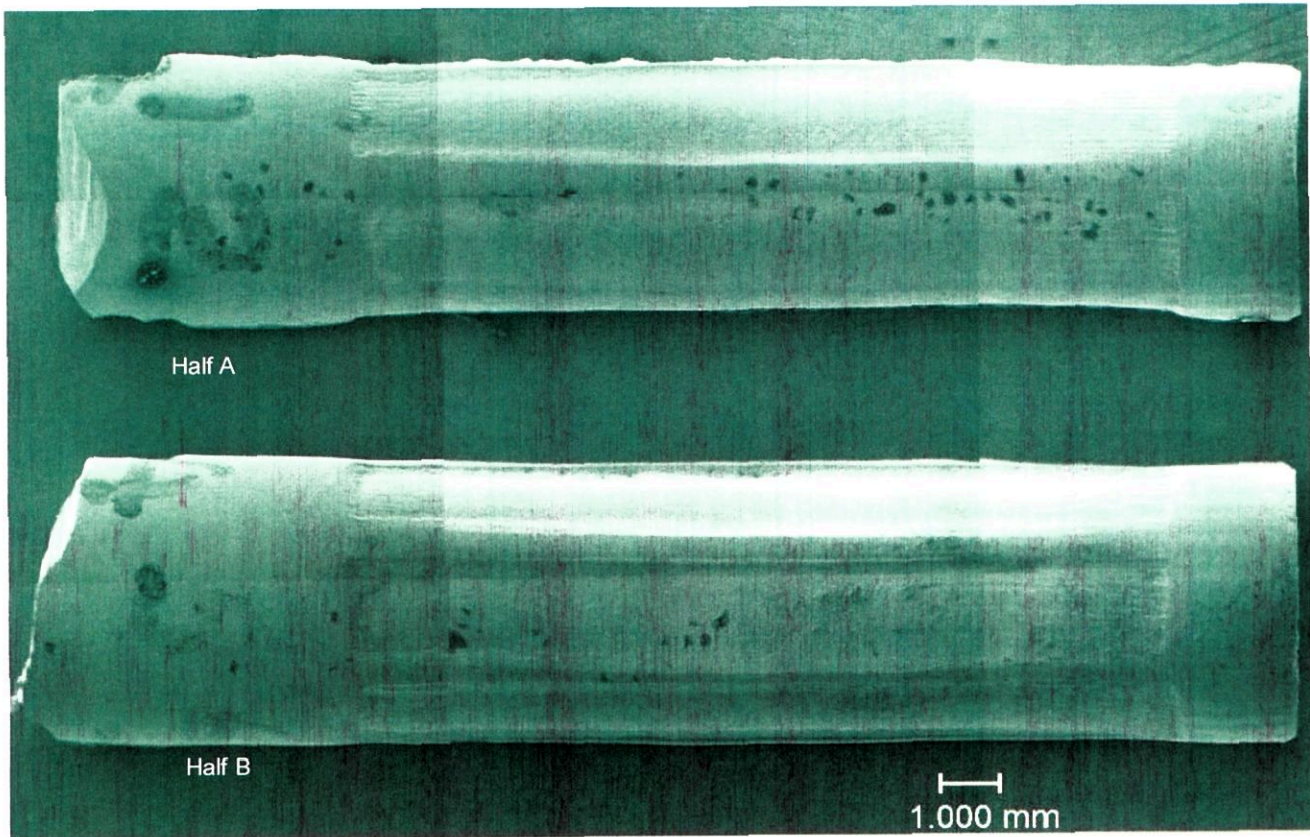
Figure 7 SEM image of the outer surfaces of both halves of the swaged-portion of the bolt after cutting.

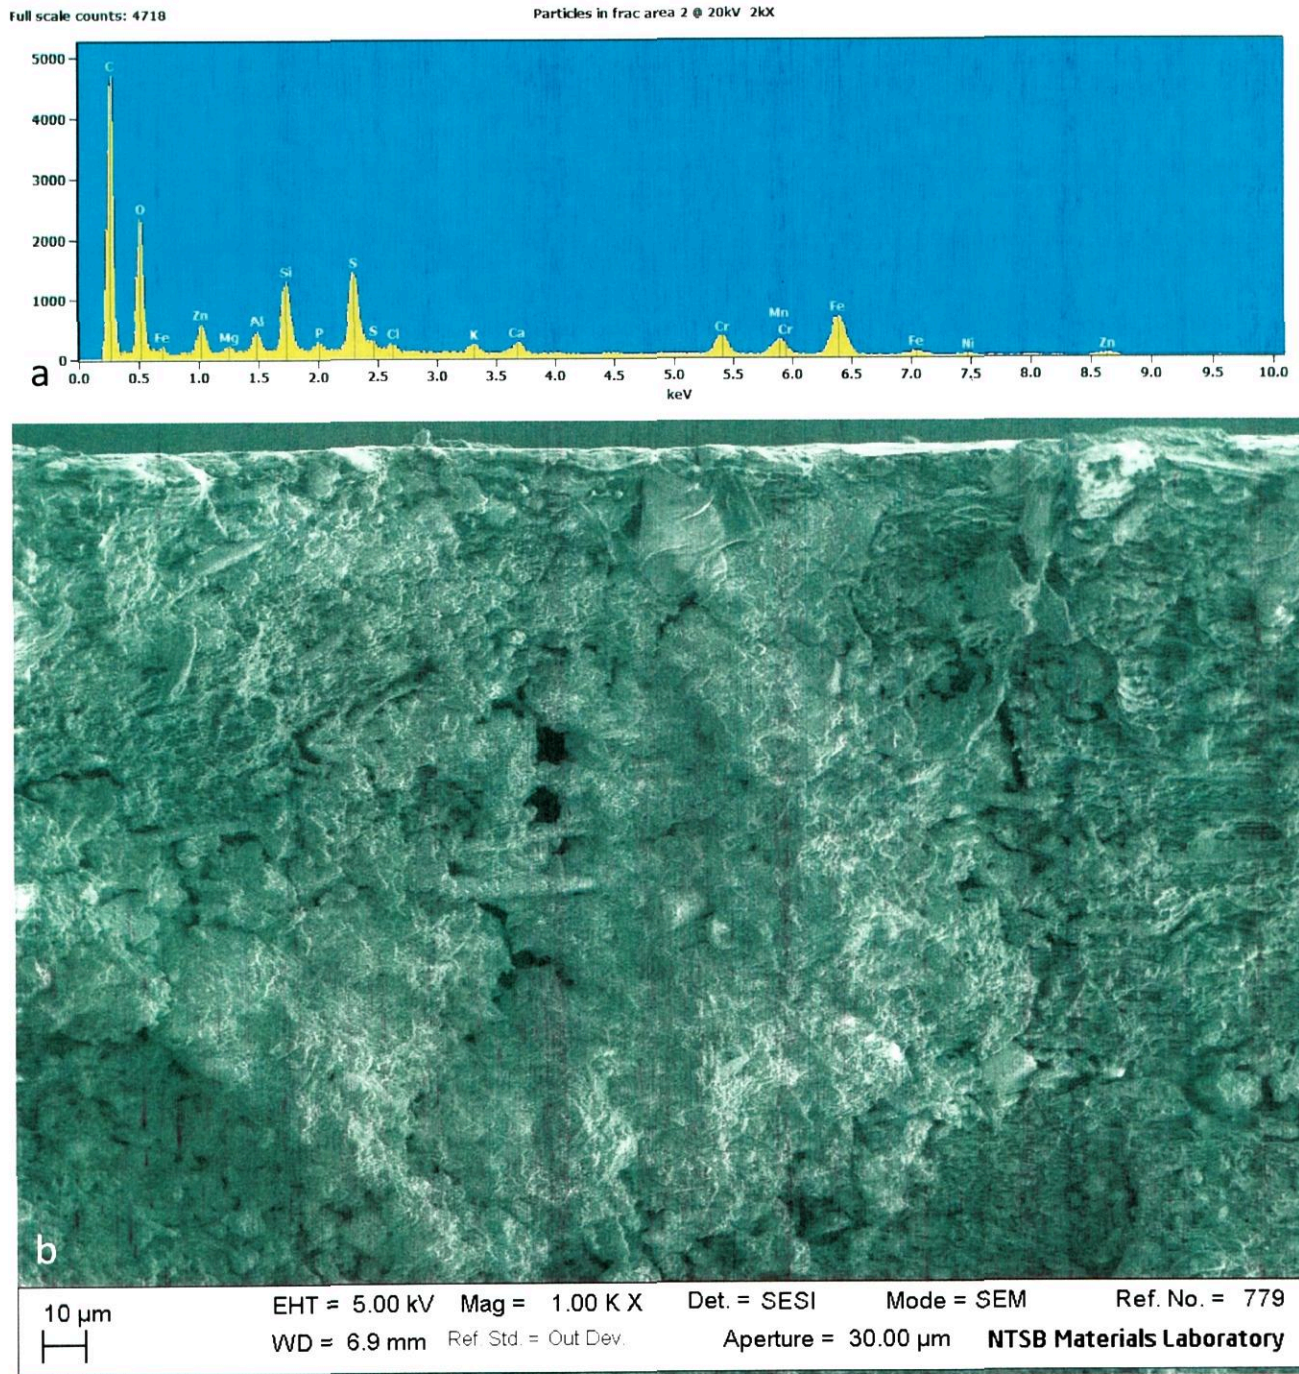
As identified in figure 5 (see also figures 3 and 4), the deposit in the crack was evaluated by scanning electron microscopy (SEM) and standardless semi-quantitative energy dispersive spectroscopy (EDS). The EDS spectra, as shown in figure 8a, revealed the presence of carbon, oxygen, iron, zinc, magnesium, aluminum, silicon, phosphorous, sulfur, chlorine, potassium, calcium, chromium, manganese, and nickel. An SEM image is shown in figure 8b.

Figure 8 View (a) is an EDS spectra of the brown-colored deposit in the crack of the separated swaged assembly. View (b) is an SEM image of the brown-colored deposit in the crack of the separated swaged assembly.

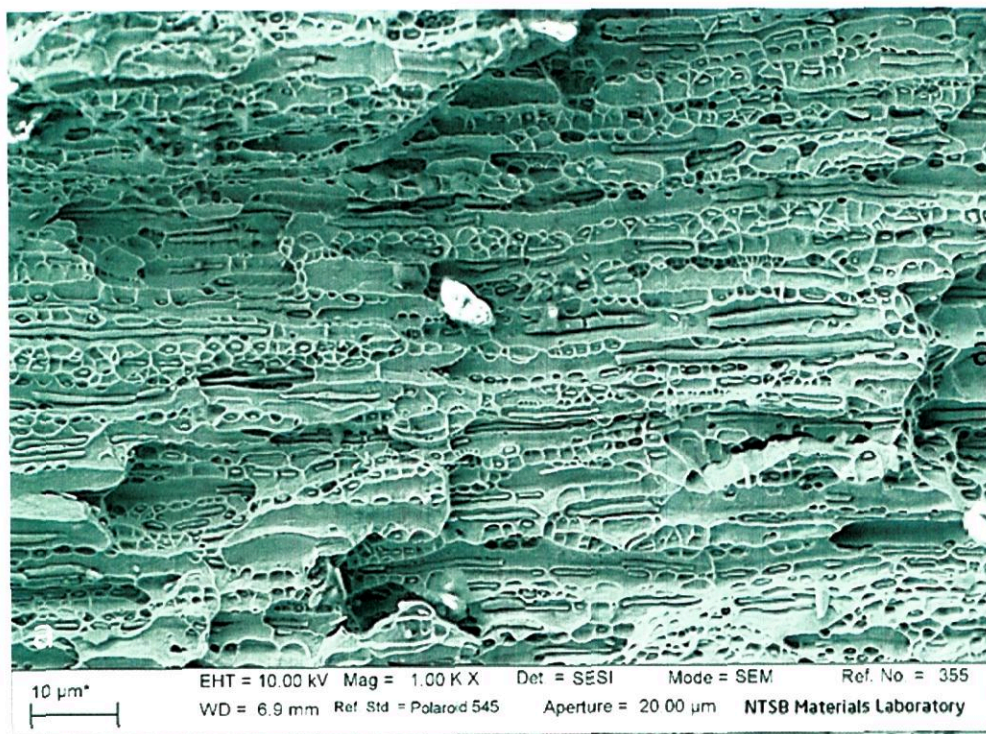
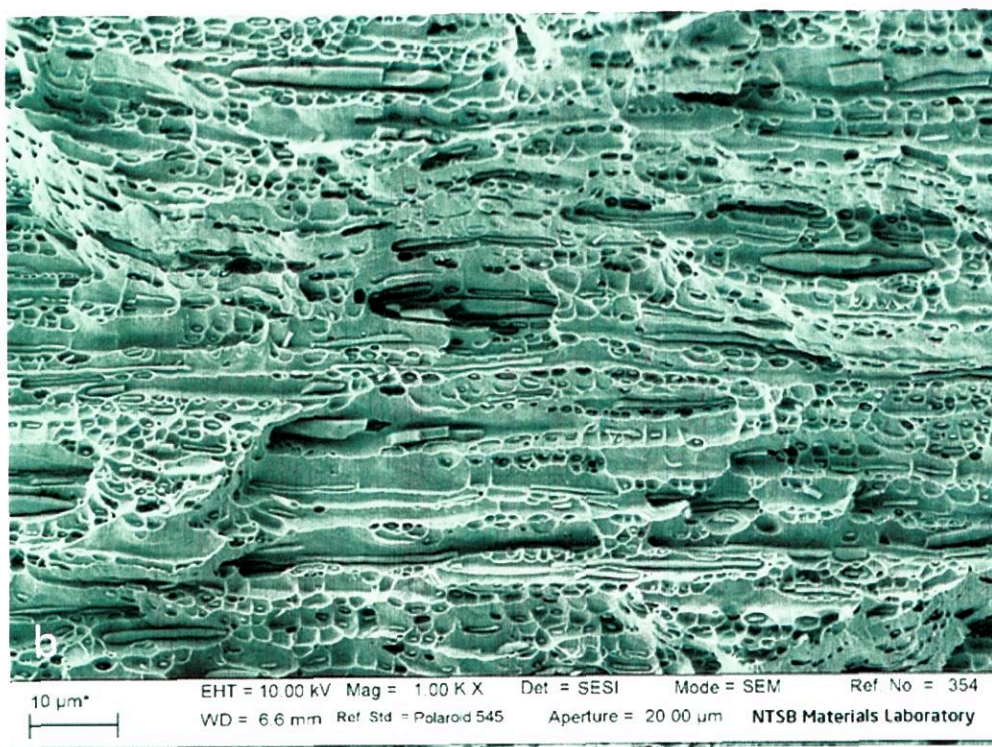
The fracture surface of the swage area (see figure 5), was examined by SEM and a typical scanning electron fractograph is shown in figure 9a. For comparison a scanning electron fractograph of the lab fracture region is shown in figure 9b. In both instances, the fracture micro-mode is microvoid coalescence (MVC) due to overstress. The longitudinal orientation of stringers within the fracture surface are consistent with a resulfurized steel such as UNS S30300.

Figure 9 View (a) is an SEM fractograph of the crack in the swaged assembly. View (b) is an SEM fractograph of the lab fracture created in the swaged assembly when it was opened up.

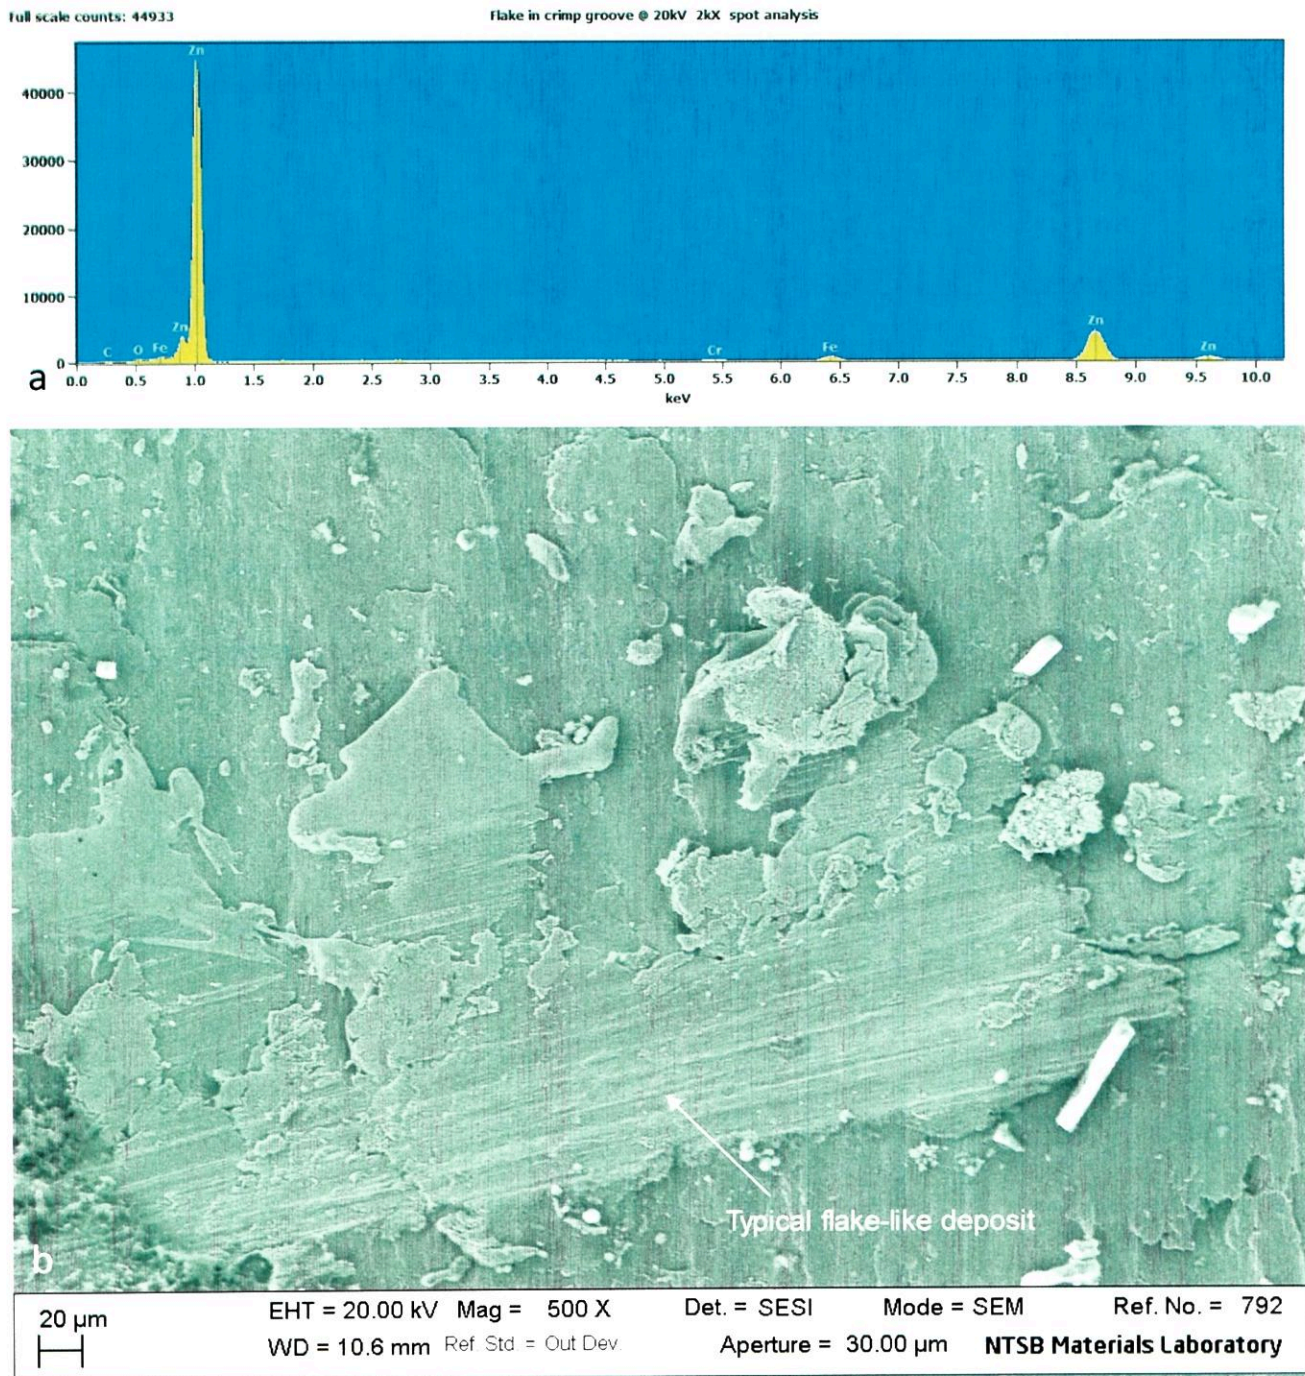
Figure 10 View (a) is an EDS spectra of a flake-like deposit in a helical impression groove. View (b) is an SEM micrograph of a flake-like deposit in a helical impression groove.

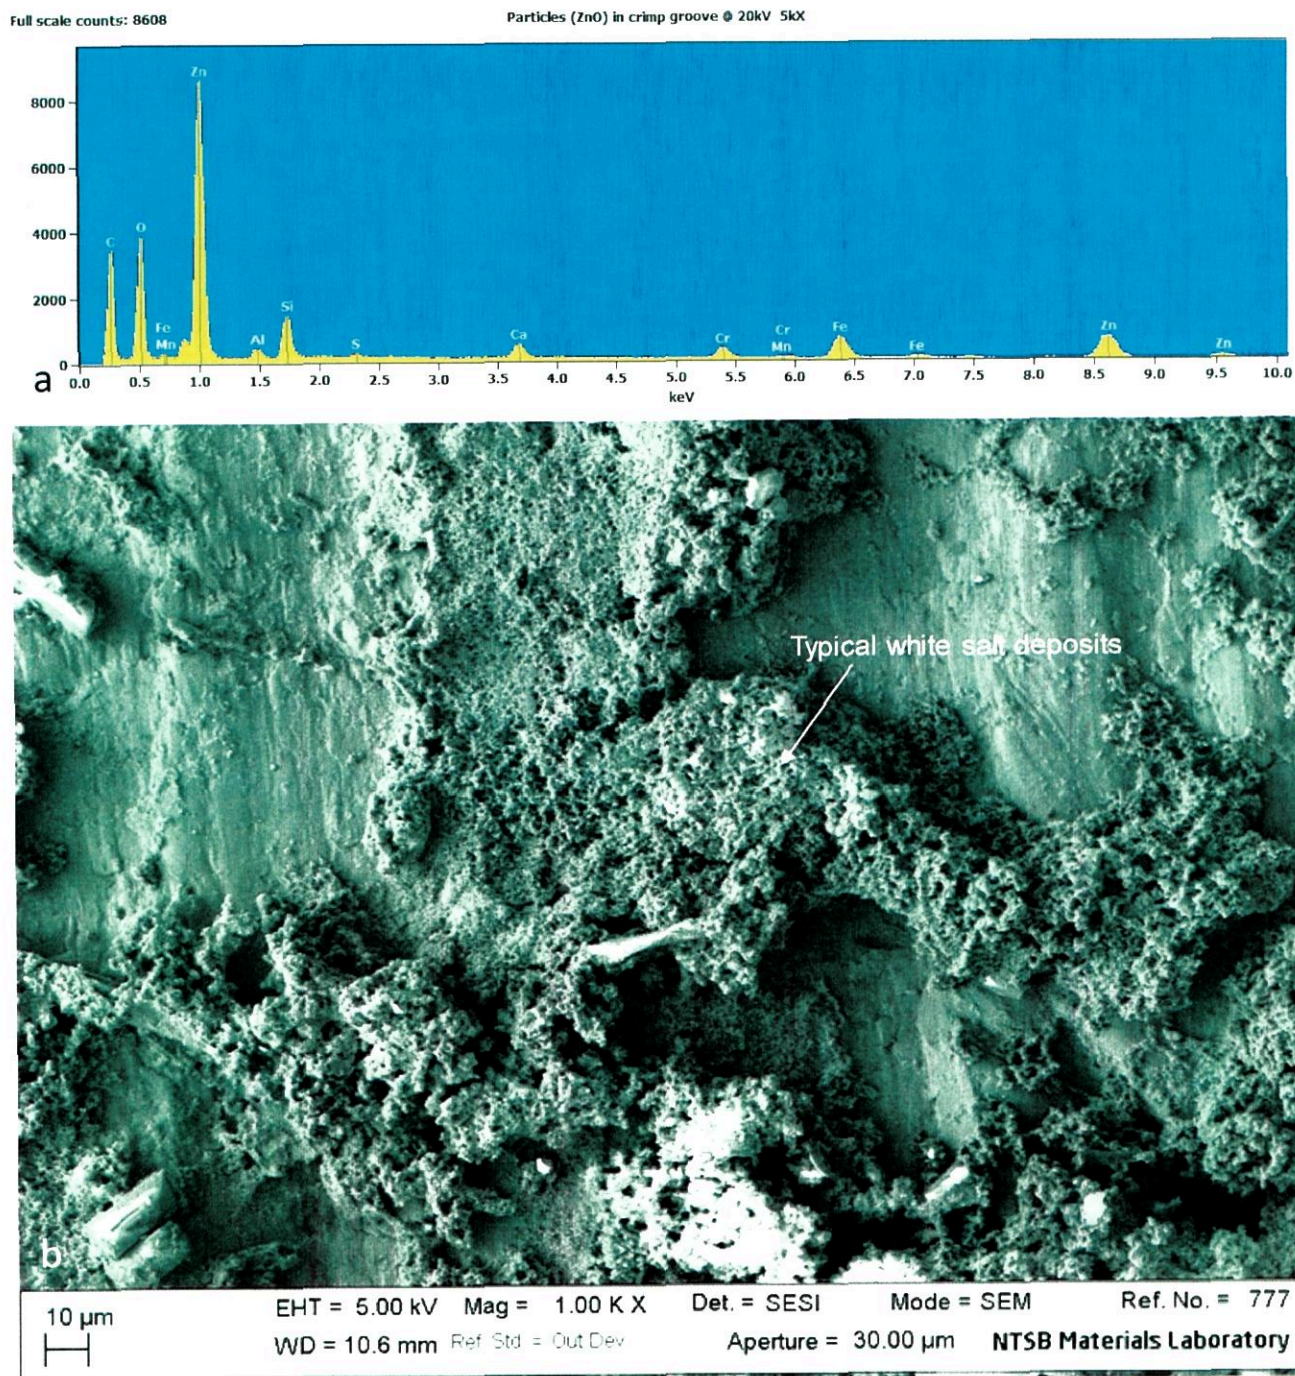
Figure 11 View (a) is an EDS spectra of white salt deposits in a helical impression groove. View (b) is an SEM micrograph of white salt deposits in a helical impression groove.

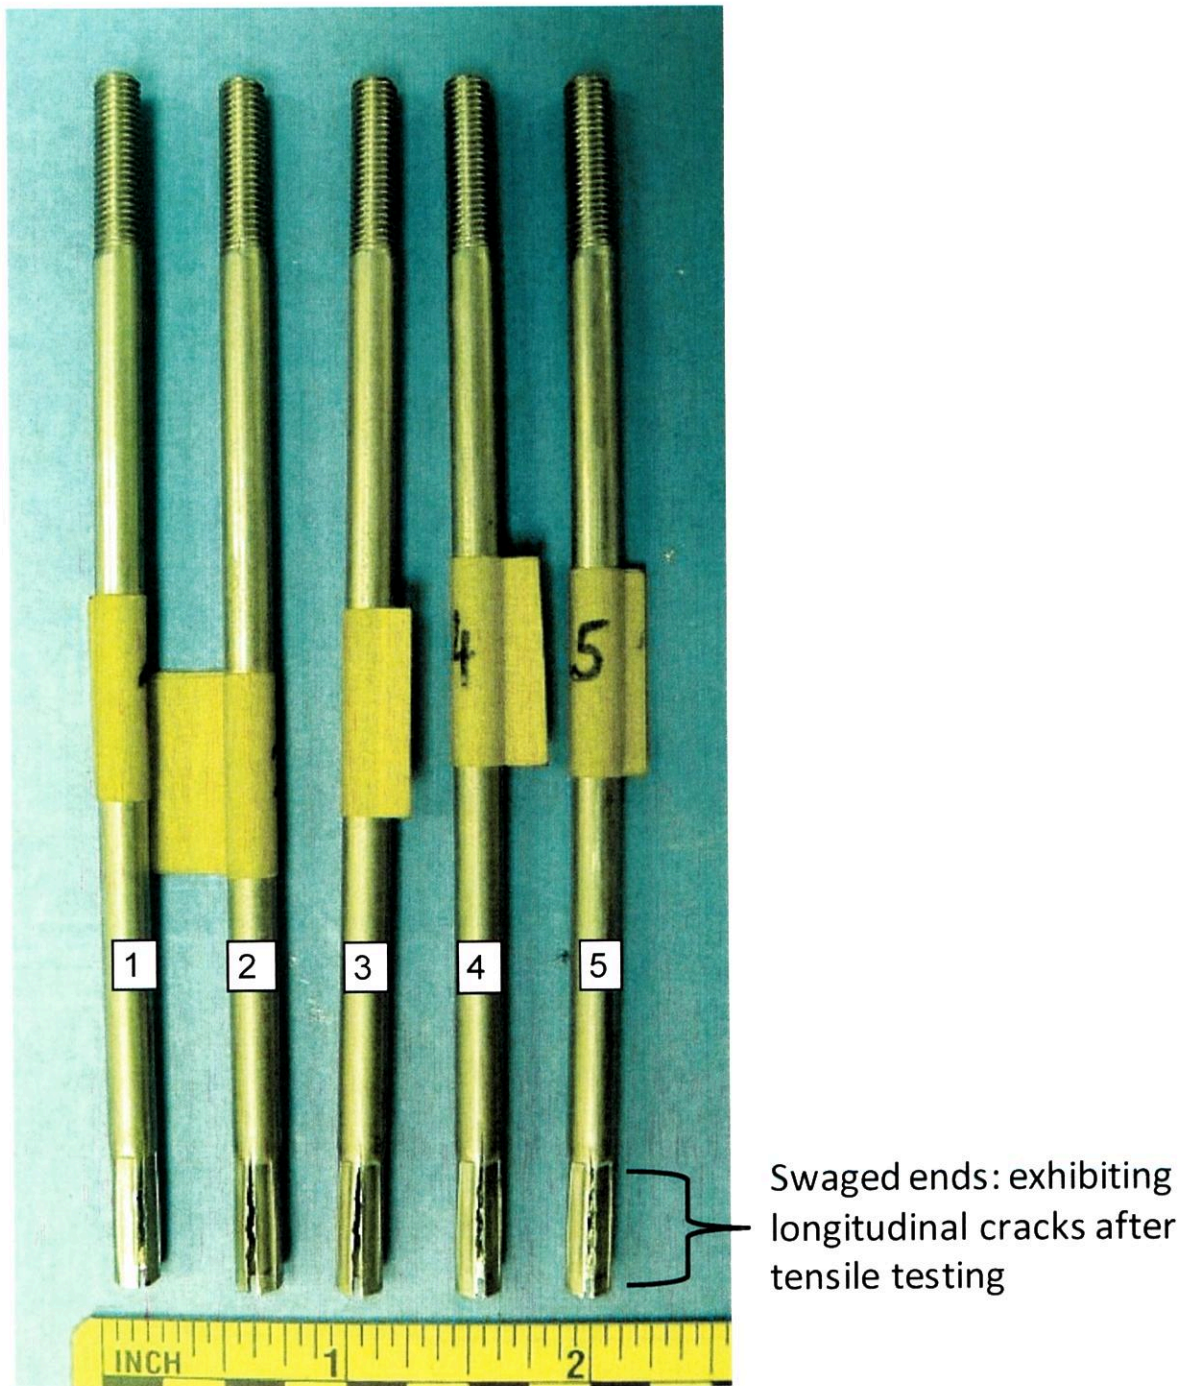
At NTSB request, DURA, through DAI, performed five tensile tests on cable and bolt samples that had been assembled in accordance with the production specification. For the test the bolt samples were identified as 1, 2, 3, 4 and 5 and are illustrated in figure 12 with the swaged ends identified. The force to cable pull-out is shown in table 1. According to the manufacturer, the cable assembly (including the swaged area) is rated for 2000 N (about 450 lbf.) In each instance, the swaged region of the bolt developed a longitudinal crack as shown in figures 12 and 13. In all instances the cracks developed along the extruded rib between the flat regions of the swage (see figure 3 for example.) Similar to the inner surface of the accident swage, the inner surface of the tensile test swages exhibited helical impression marks consistent with contact with the cable wires as shown in Figure 14. SEM analysis of each fracture revealed that the crack occurred in overstress with a microvoid coalescence fracture mechanism. An example of a typical scanning electron fractograph is shown in figure 15.

Figure 12 Image of the five exemplar test samples after tensile testing.

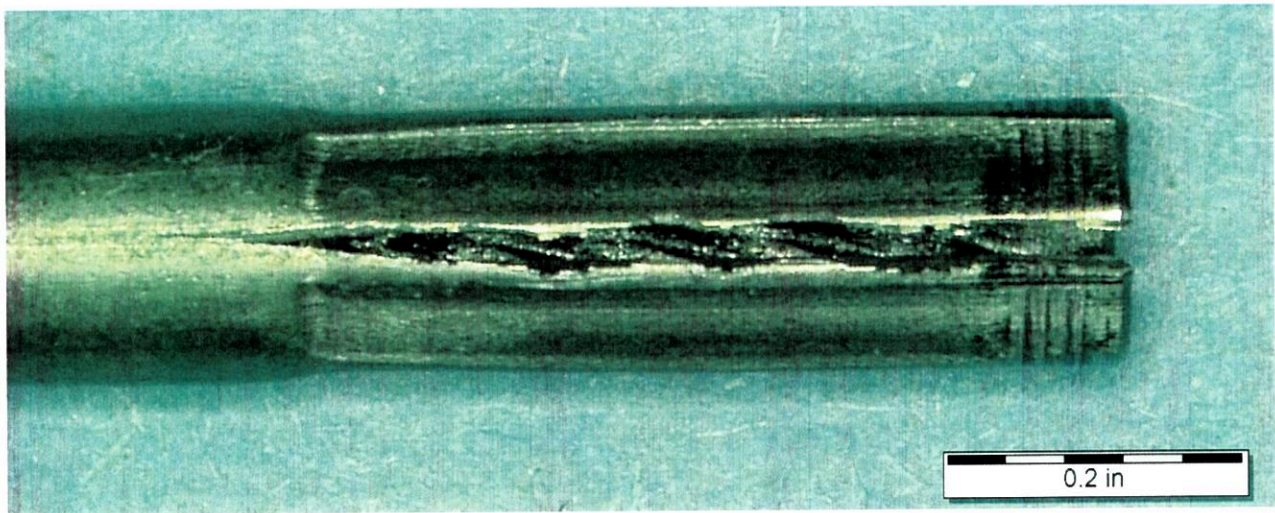
Figure 13 Example of a longitudinal fracture along the extruded rib in one of the exemplar tensile test samples.

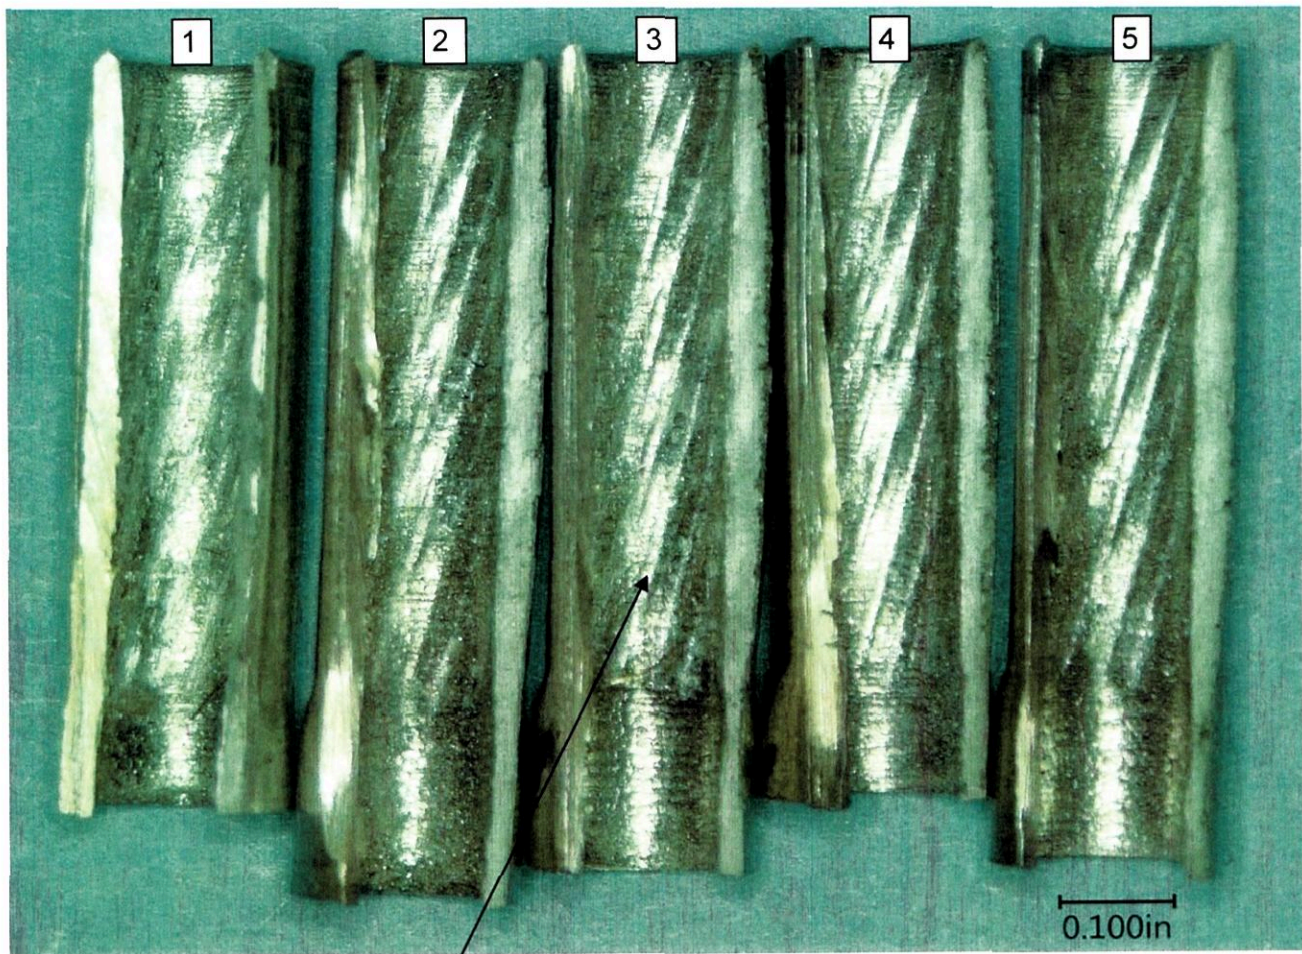
Typical helical impression marks consistent with  
contact with the cable wires

Figure 14 The inner surfaces of the swaged portion of the exemplar tensile test samples. The samples identification numbers are indicated.

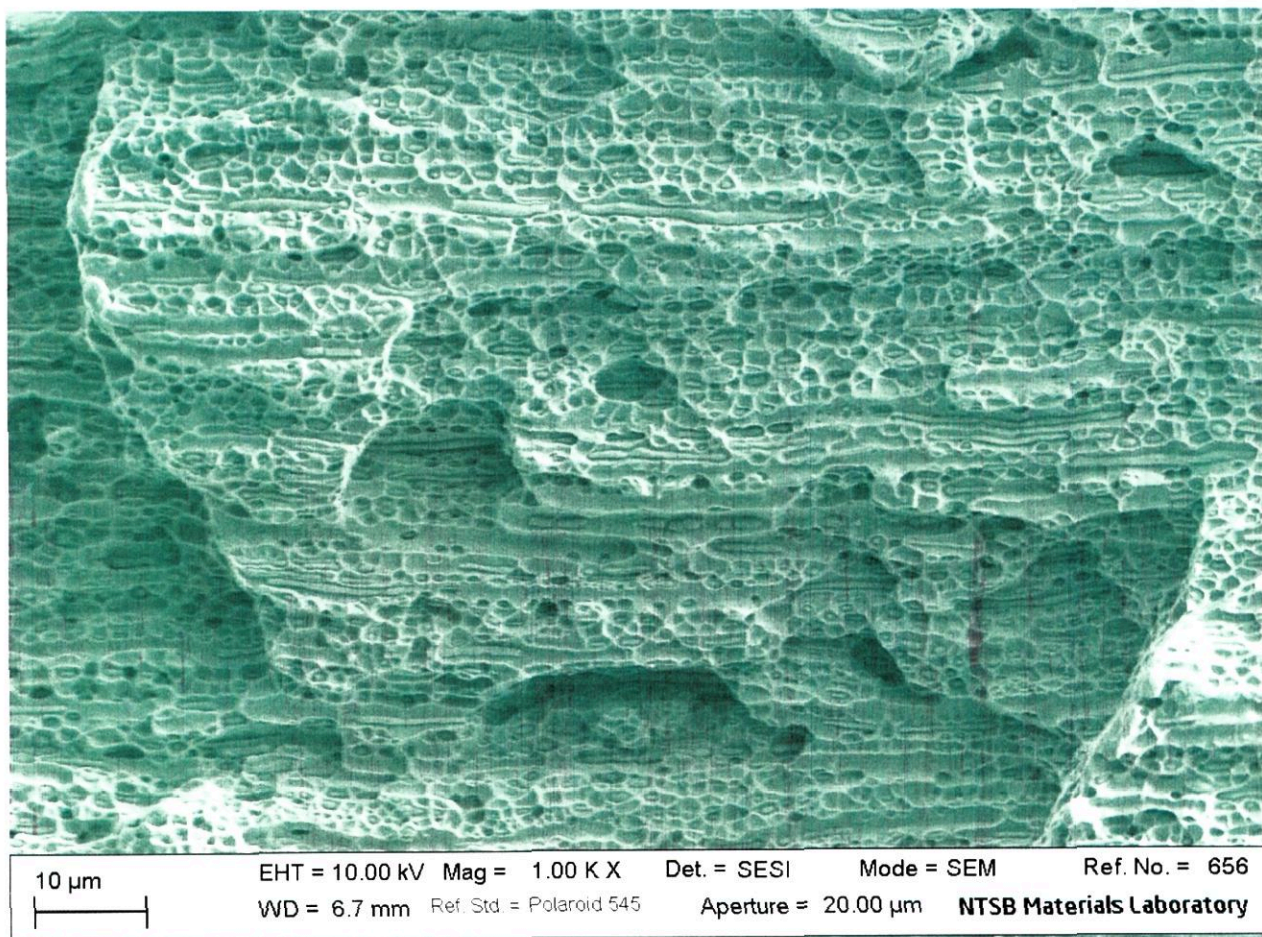
Figure 15 Scanning electron fractograph of the longitudinal fracture surface on exemplar test sample 4.
