**NATIONAL TRANSPORTATION SAFETY BOARD**  
Vehicle Recorder Division  
Washington, D.C. 20594

## **Image Recorder**

### **Specialist's Factual Report By George Haralampopoulos**

Location: Winston Salem, North Carolina  
Date: March 31, 2013  
Aircraft: Lancair LC 42-550FG  
Registration: N6506L  
NTSB Number: ERA13FA184

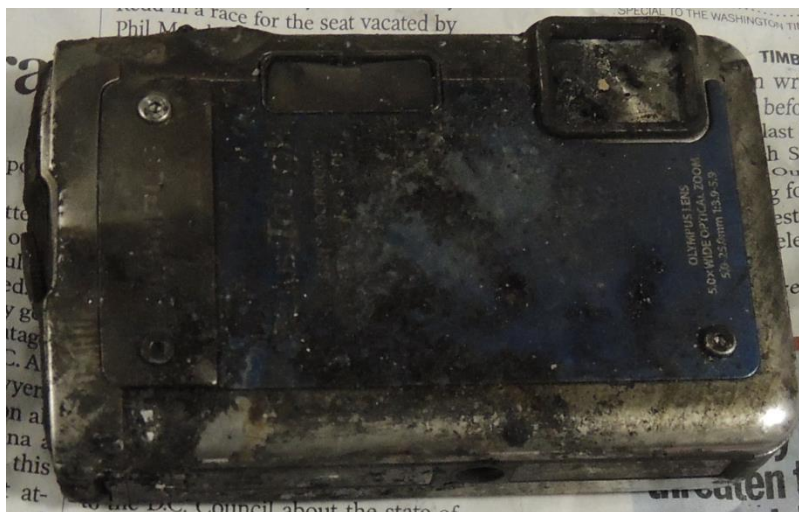
Upon arrival at the Vehicle Recorder Laboratory, an exterior examination revealed that the Stylus Tough 8010 had sustained major fire damage (figure 1 and 2). The SD card was located and removed from the camera and the data was extracted using the manufacturers recommended procedures.

**Figure 1. Front of Stylus Tough 8010 as recovered.**

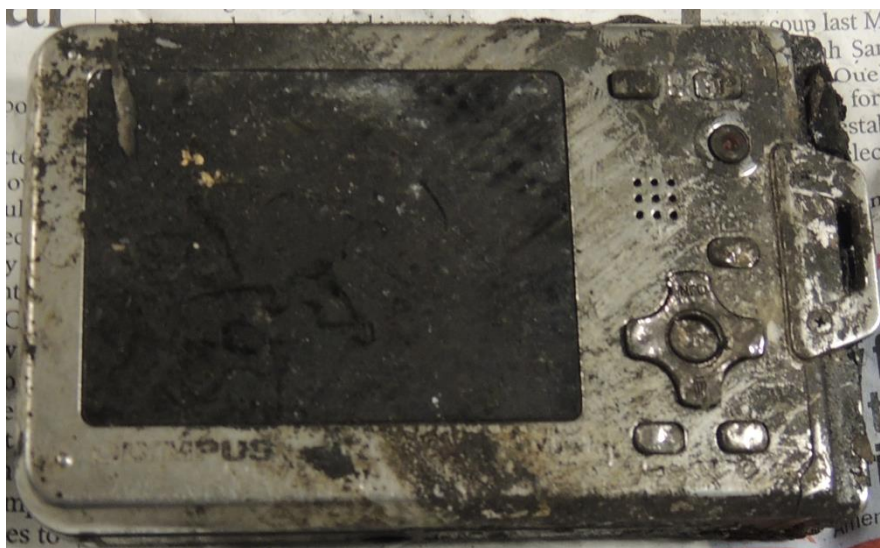
**Figure 2. Back of Stylus Tough 8010 as recovered.**

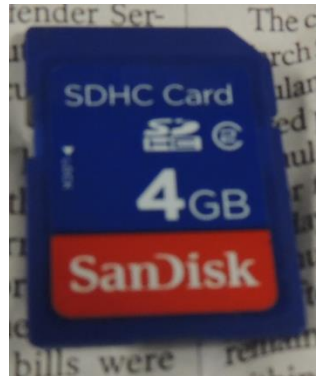
Figure 3. Internal SD Memory Card of Stylus Tough 8010.

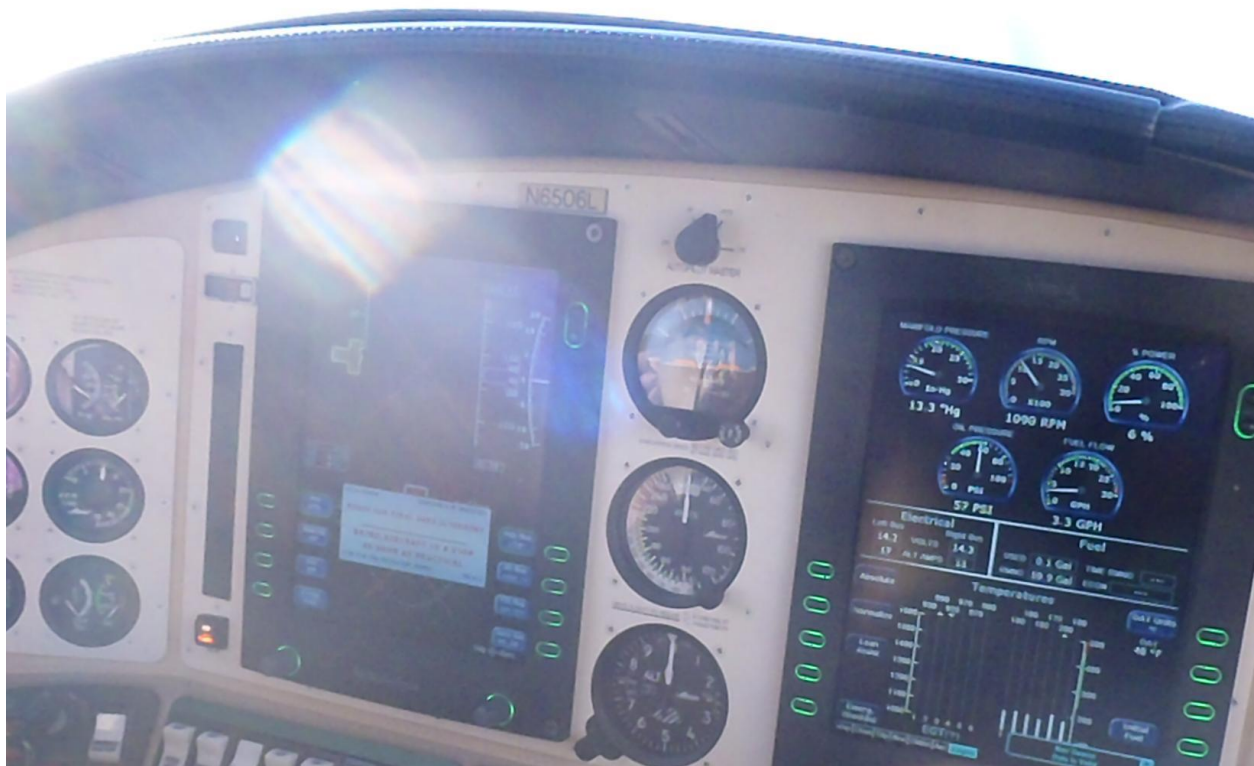
The SD card contained multiple images from the owner of the aircraft. Two relevant photos were identified that contained the accident aircraft's instrument panel configuration. The two photos were identified to not be from the accident day and were cropped due to privacy reasons.

Figure 4. Recovered photo of accident aircraft's instrument panel.

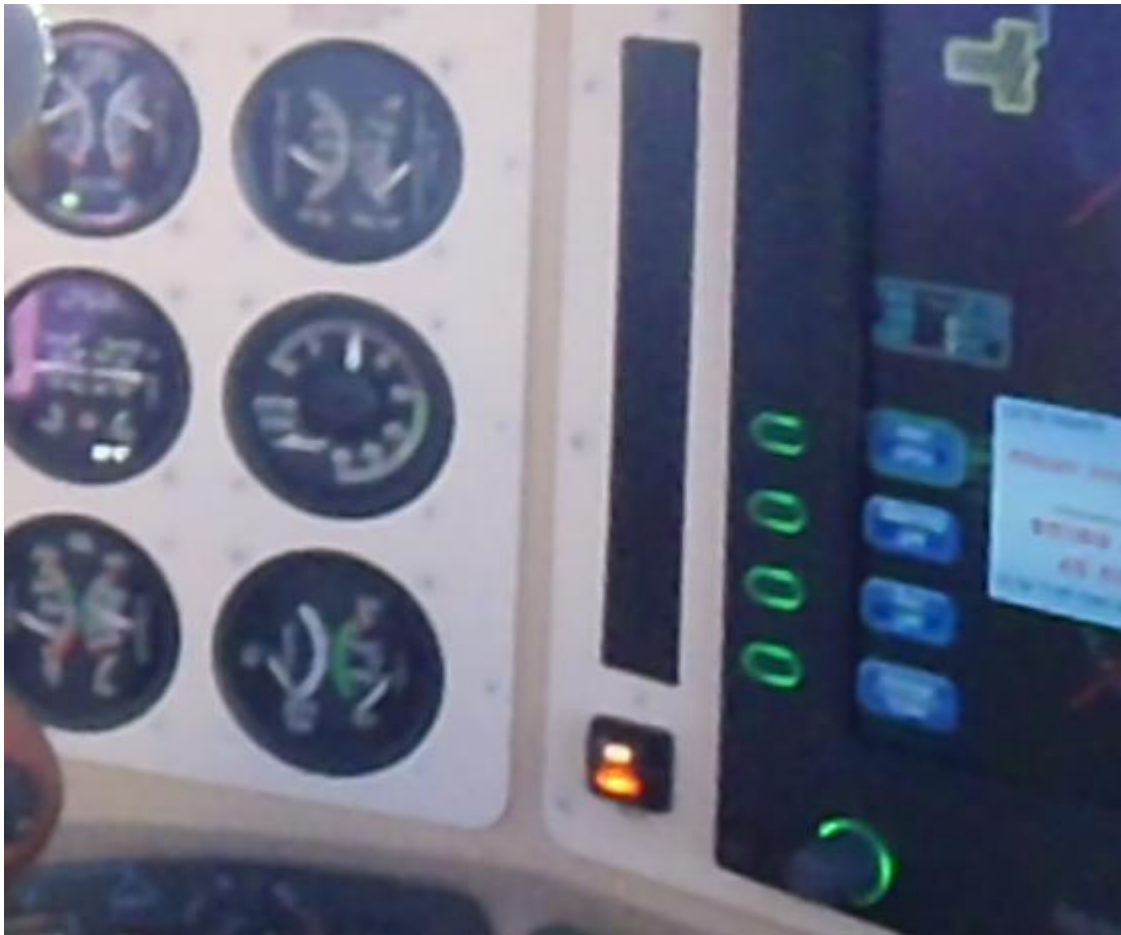
Figure 5. Recovered photo showing accident aircraft's instrument gauges.
