# NATIONAL TRANSPORTATION SAFETY BOARD

MATERIALS LABORATORY FACTUAL REPORT

Report No. 13-050

Place : Macon, Georgia  
Date : May 27, 2013  
Vehicle : Piper PA-32R-300  
NTSB No. : ERA13FA256  
Investigator : Eric Alleyne

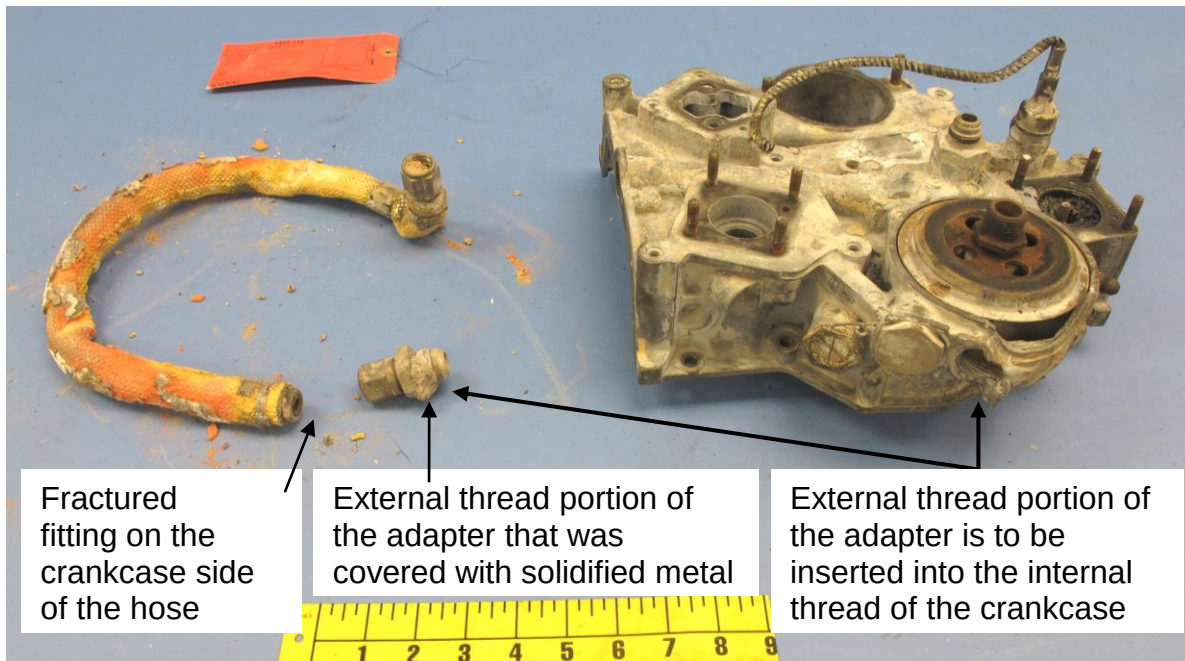
Figure 1 shows a photograph of the as-received crankcase portion and right oil cooler hose. The fitting on the crankcase side of the hose had fractured. Bench binocular microscope examination of the hose revealed the fractured fitting contained a slant fracture that extended all around the fitting. The fracture face exhibited a rough texture consistent with overstress separation with no evidence of crack arrest marks (fatigue cracking). An adapter was attached to the fractured fitting. The exposed end of the adapter contained an external thread. The external thread portion was covered with solidified metal. The mating threads (internal threads located on the crankcase) and crankcase in the general area of the internal threads was severely deformed from exposure to heat from a fire. Close examination of the adapter revealed the corner adjacent to the external threads and in the area below the solidified metal contained material exhibiting size and contour consistent with a gasket (figure 2).

Figure 1. Overall view of the as-received crankcase portion (right side of the page) and right oil cooler hose (left side of the page). The fitting on the crankcase side of the hose had fractured.

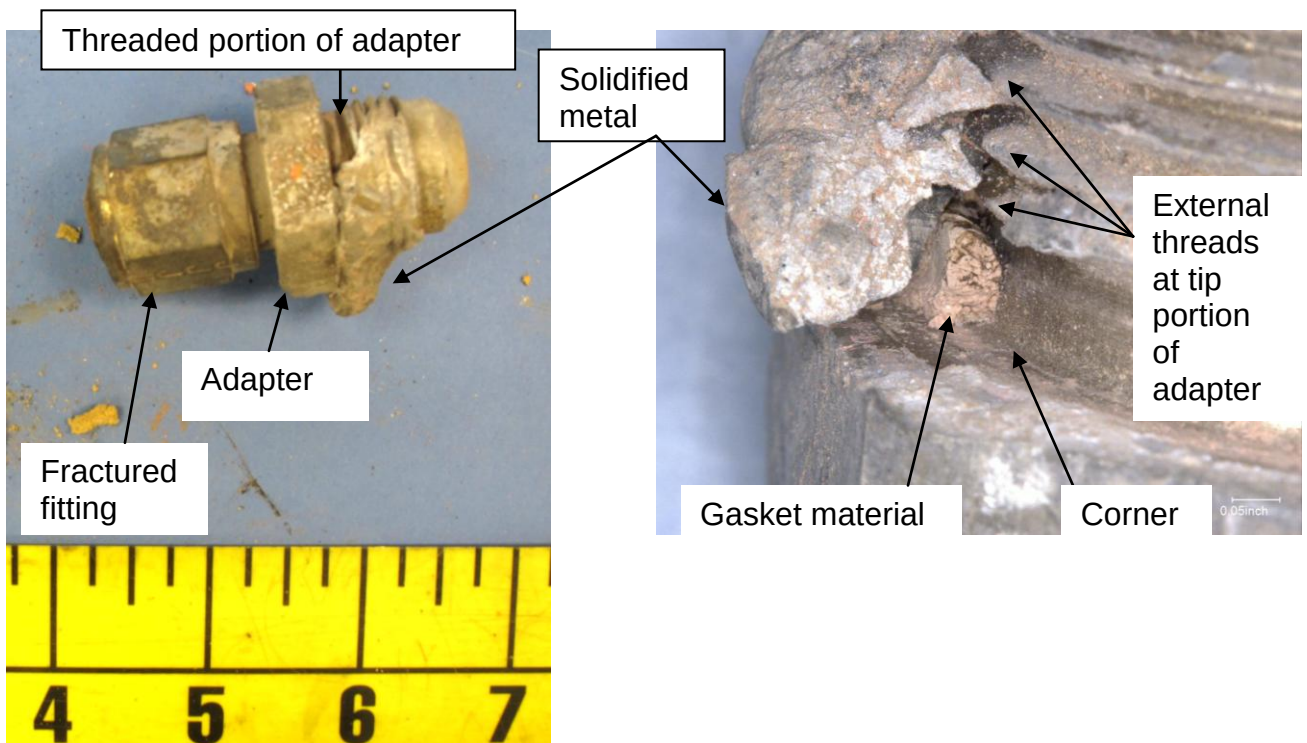
Figure 2. Fractured fitting and adapter portion (lower left side of page) and close up photograph of the gasket material that was found at the corner of the adapter underneath solidified metal (lower right side of page).
