## Airworthiness Directive

Docket No. 94-CE-28-AD; Amendment 39-9472; **AD 95-26-13**

Airworthiness Directives; The New Piper Aircraft, Inc. (formerly Piper Aircraft Corporation)  
PA28 and PA32 Series Airplanes  
**PDF Copy (If Available):**

**[Docket No. 2000-NE-36-AD; Amendment 39-12779; AD 2002-12-07]**

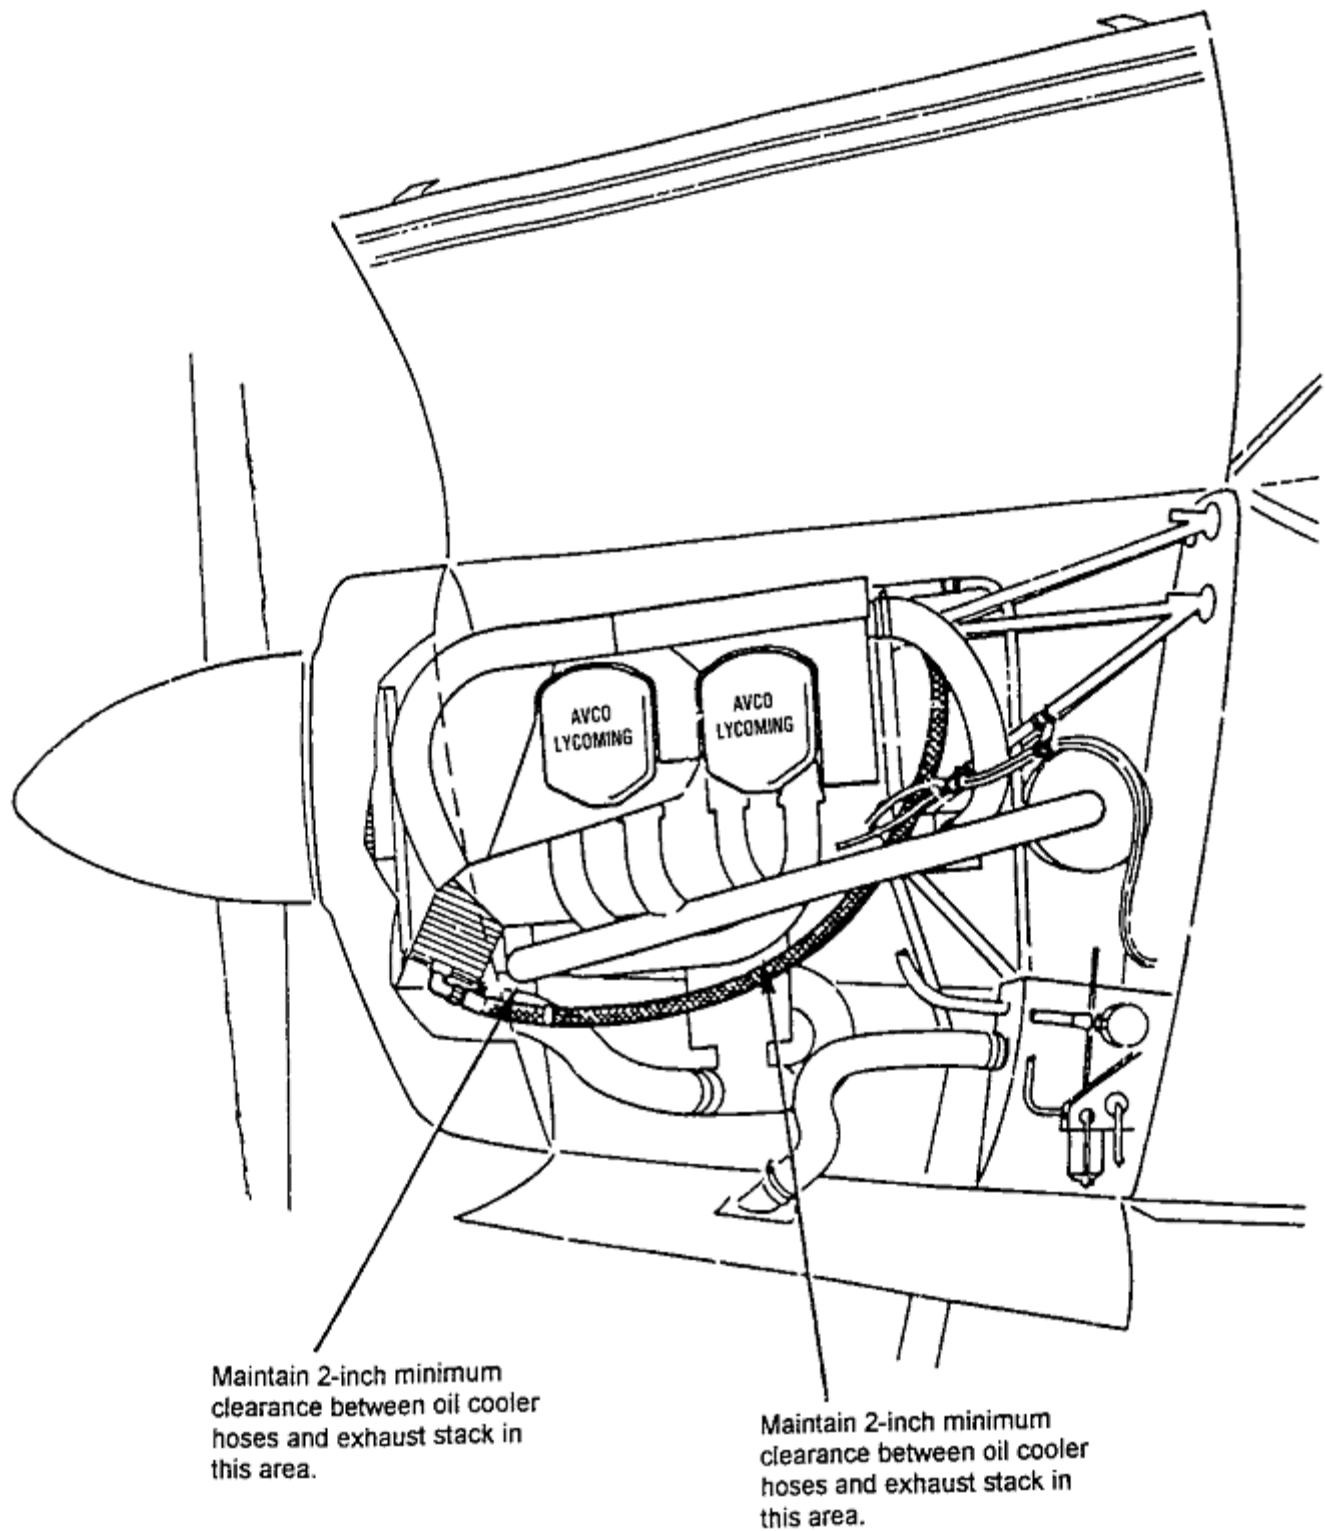
(1) For airplanes that have any oil cooler hose assembly mounted at the front or back of the airplane, or both, the fire sleeve of the hose should not be soaked with oil or have a brownish or whitish color, and there should be no evidence of deterioration as a result of heat, brittleness, or oil seepage. Prior to further flight, replace any hose that is soaked with oil, has a brownish or whitish color, or has evidence of deterioration.

NOTE 2: Figure 1 of this AD relates to the conditions specified in paragraphs (a)(2)(i) and (a)(2)(ii) of this AD.

(2) Replace each oil cooler hose assembly with an approved TSO-C53a, Type D, hose assembly ensuring that there is a minimum of 2 inches between the oil cooler hoses and exhaust stacks (as applicable) upon installation. Ensure that there is a minimum bend radius of 6.5 inches on oil cooler assemblies incorporating 0.75-inch outer diameter hoses.
